**CROCODILE EAST WATER PROJECT (CEWP)
MODULE 1: TECHNICAL FEASIBILITY STUDY**

**Pre-Feasibility Study:
Environmental Screening Report**

June 2023

Final

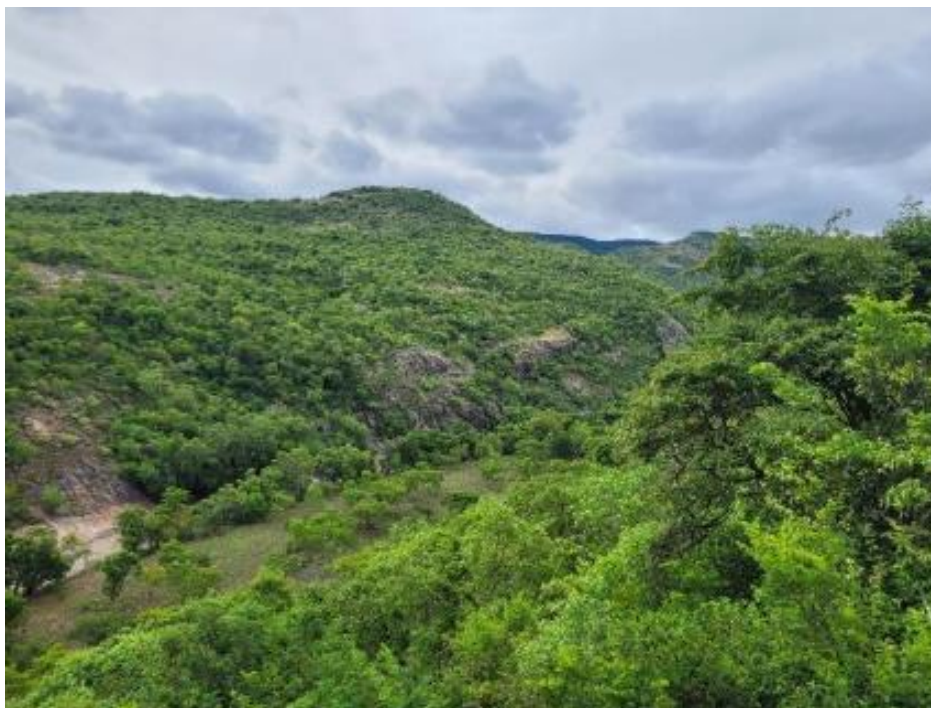
Figure 3-2: Montrose Dam: General View towards Dam Wall

The dam basin comprises a steep gorge cut into the granite bedrock where the Elands River and Crocodile River meet at an elevation of 772 mamsl, downstream of the Montrose Falls. A photograph showing typical topography in the vicinity of the dam wall is shown in **Figure 3-2**.

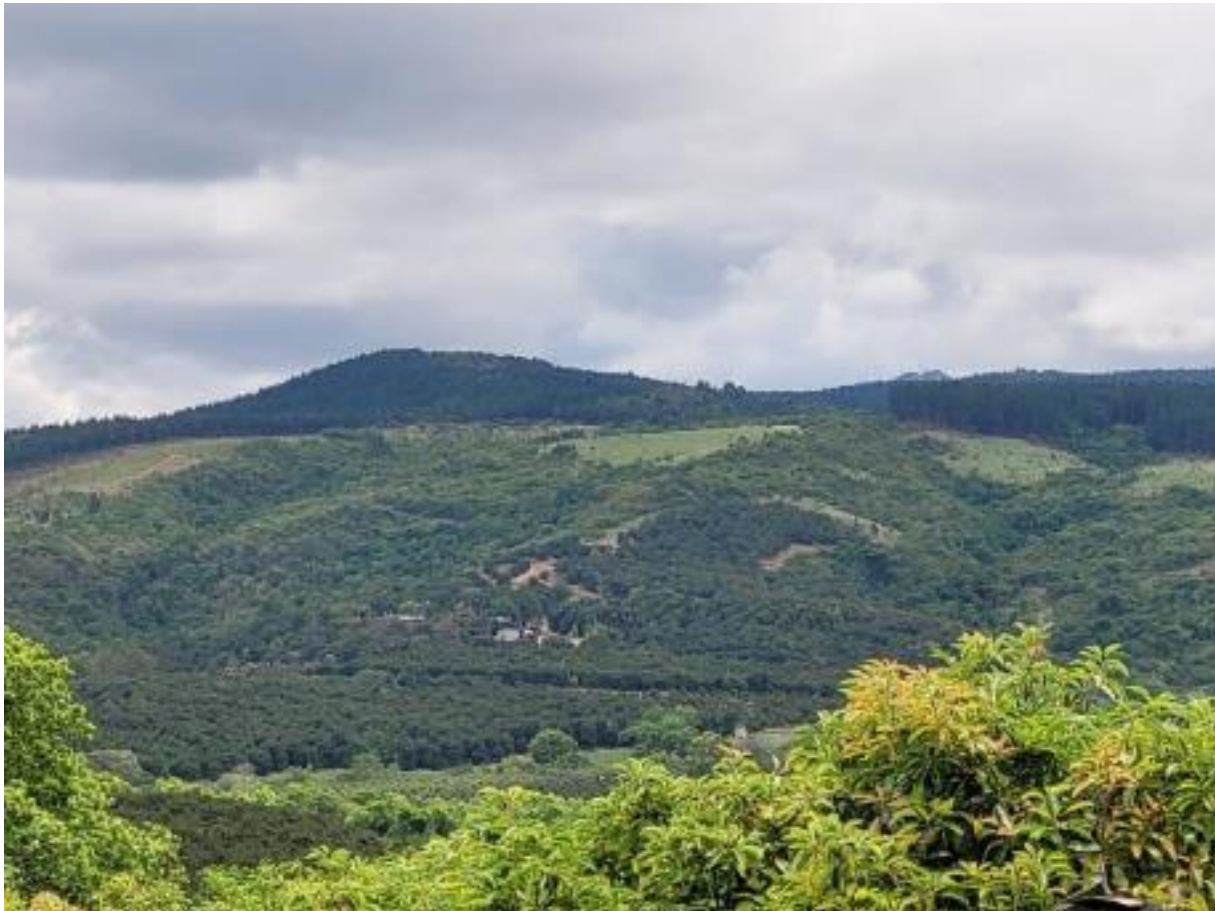
Figure 5-2: Boschjeskop Dam: Topographical View

basin of the dam broadens out behind the dam wall and floods the aforementioned road (DWA, 2008). A general topographical view for the proposed dam is shown in **Figure 5-2**.
