A High Confidence Reserve Determination Study for Surface Water, Groundwater, and Wetlands in the Upper Orange

WP11343 Final Wetland Fieldwork Report

REPORT NO.:
RDM/WMA13/00/CON/COMP/0522

APRIL 2022

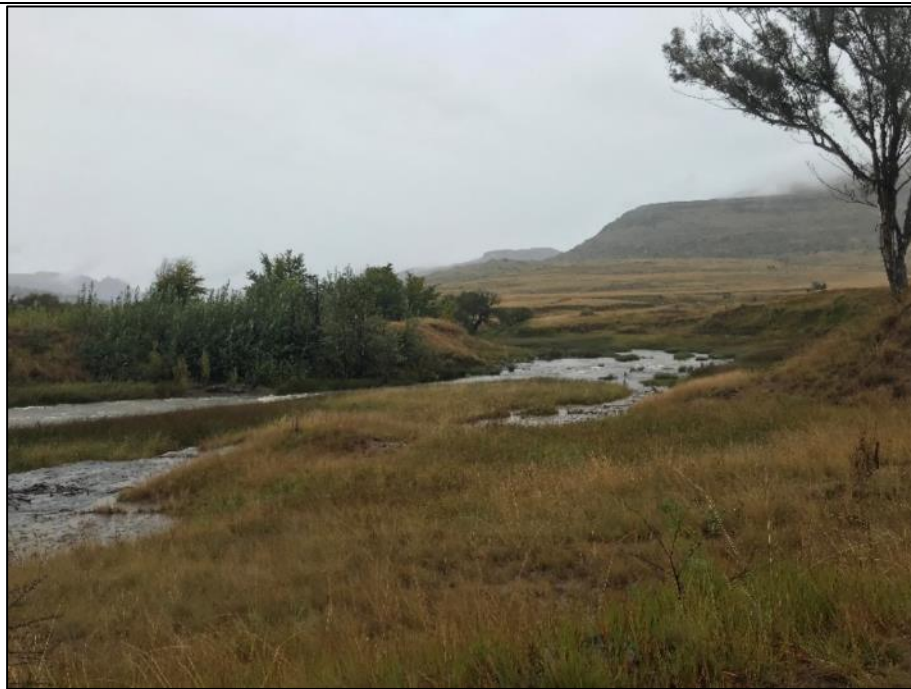
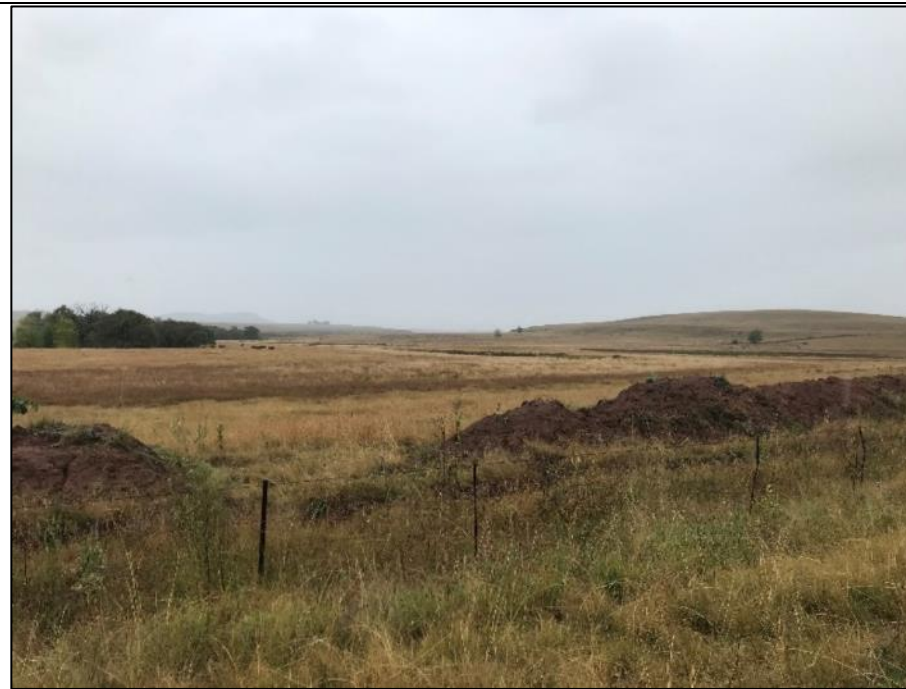
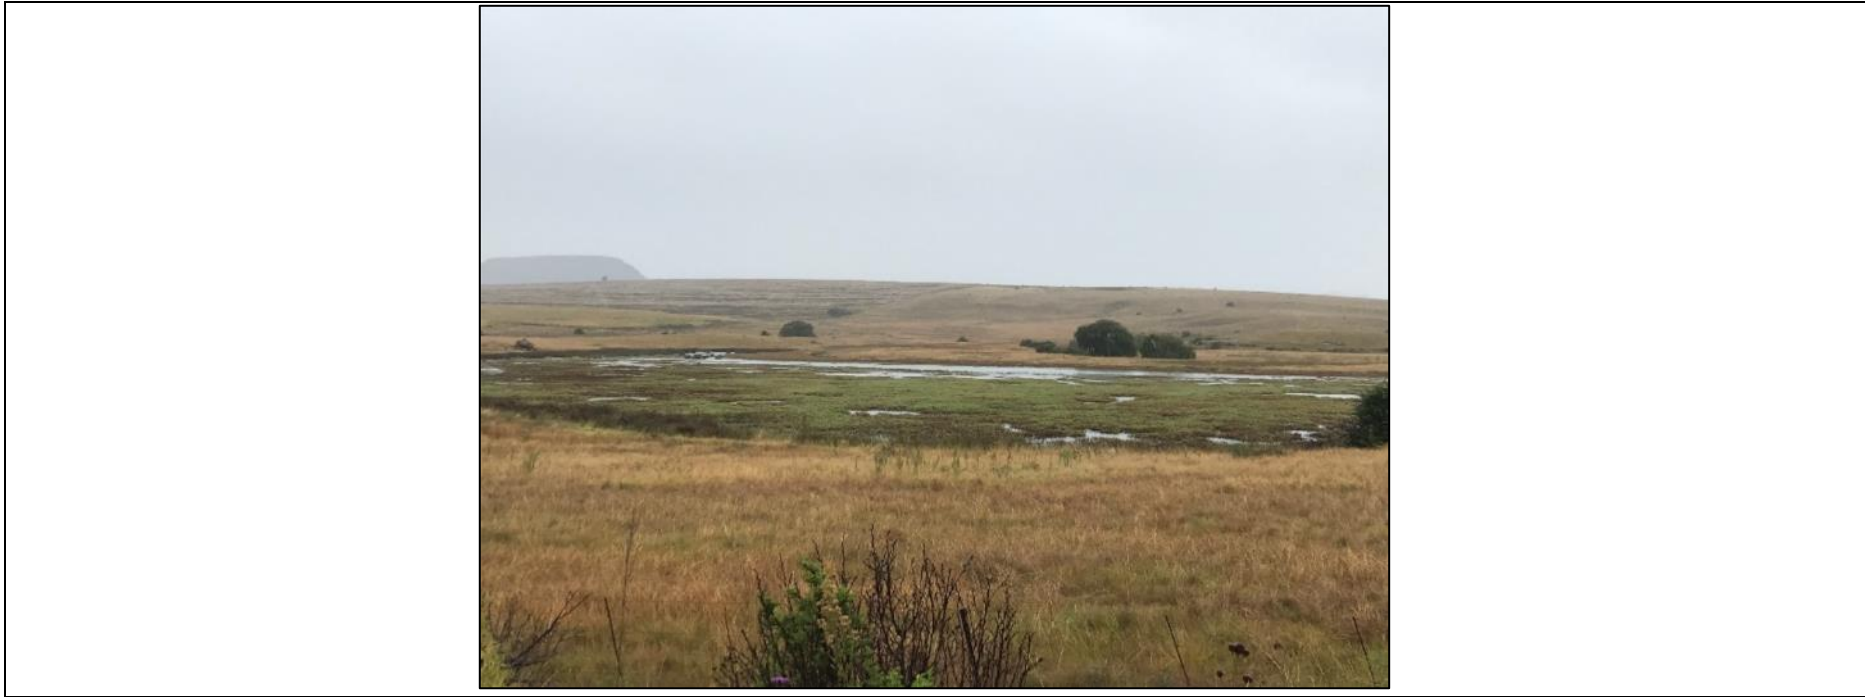
Site Name: WRU02

Top Left: Deeply incised and widened channel of the Brandwater River as it flows out of the southern portion of the WRU02 wetland.

Top Right: Floodplain features still maintained by lateral processes as indicated by darker patches of vegetation in the central and right-hand side of the photograph.

Bottom: Oxbow lake located in the northern portion of the floodplain wetland.

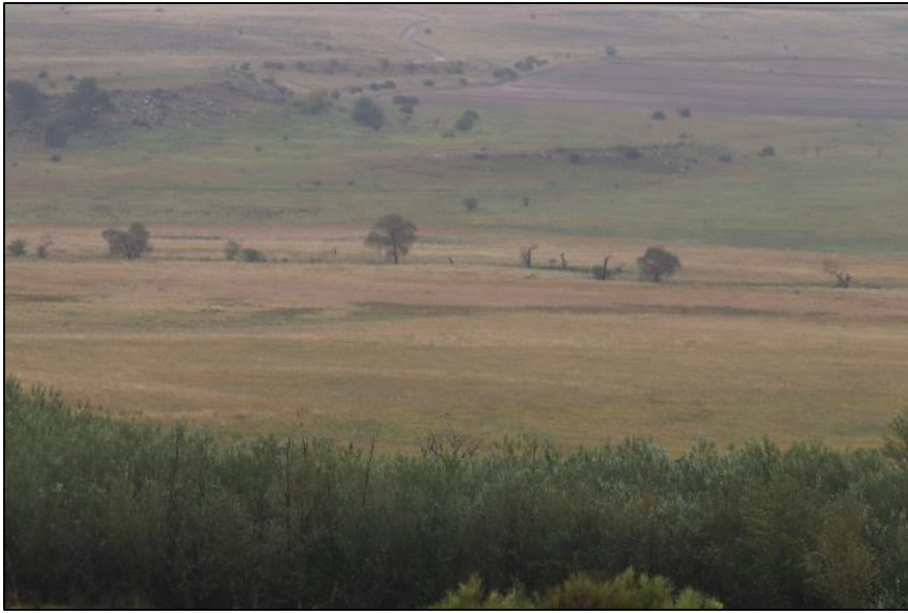
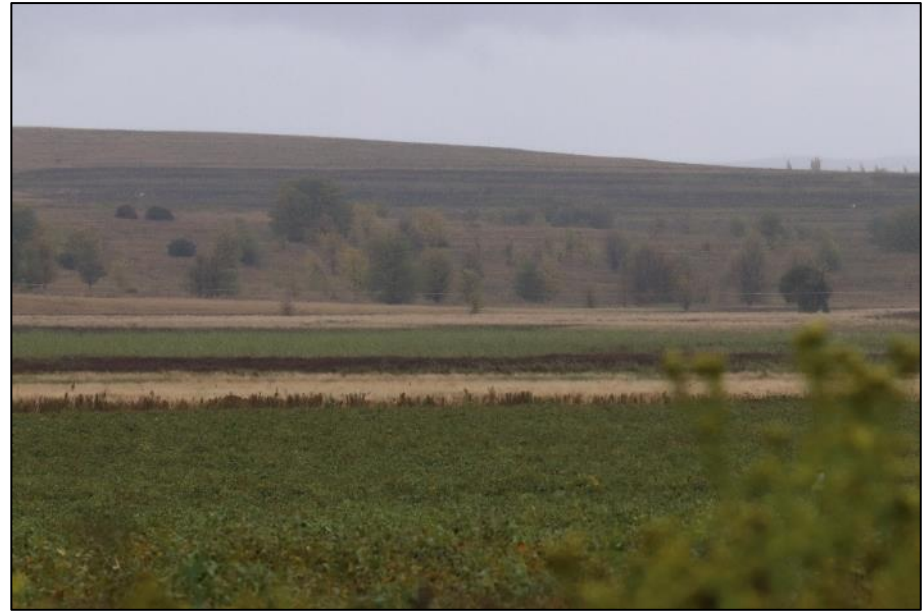
Site Name: WRU13

Left: Middle section of the floodplain wetland before it loses confinement. Dark patches adjacent to the channel indicate wetland vegetation and lateral seep processes that support wetland habitat.

Right: Picture taken from the toe of the wetland looking upstream. Green fields in the foreground are cultivated and green band in the middle of the picture is the extensive unchannelled valley-bottom and reedbed.

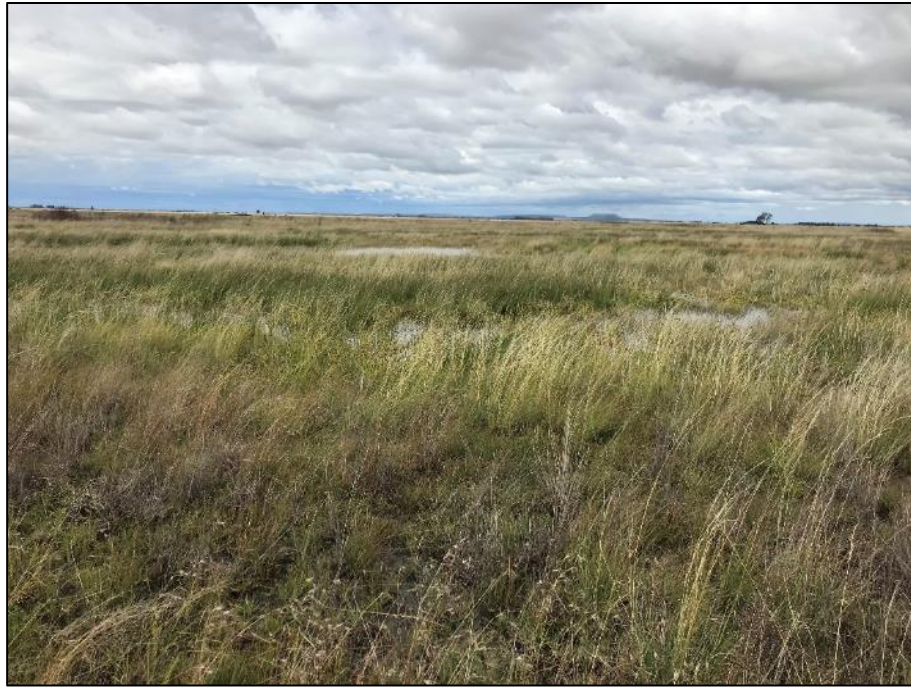
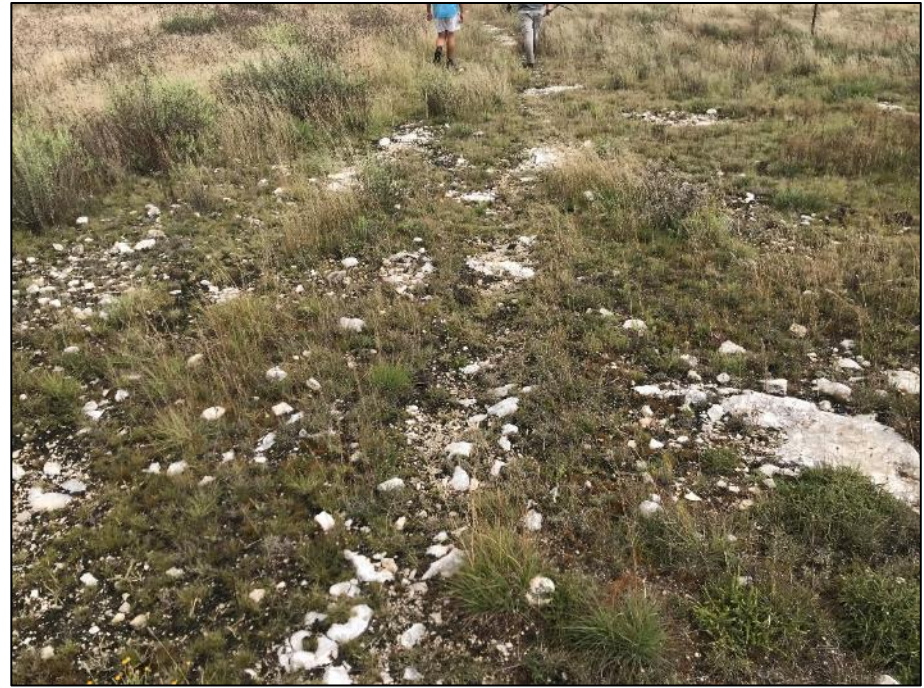
Site Name: WRU12

Left: Middle section of the large wetland flat looking upstream. Extremely flat topography with extensive areas of standing water due to recent heavy rains in the region.

Right: Evidence of very shallow soils in areas of the wetland. Picture depicts area of non-wetland, but similar outcrops were encountered frequently when augering within the wetland boundary itself.

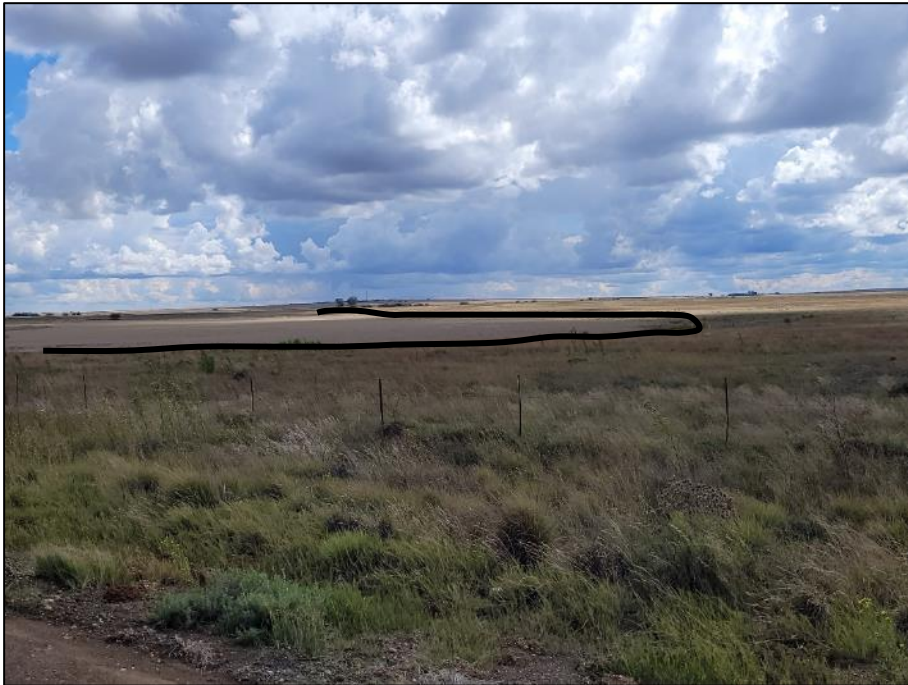
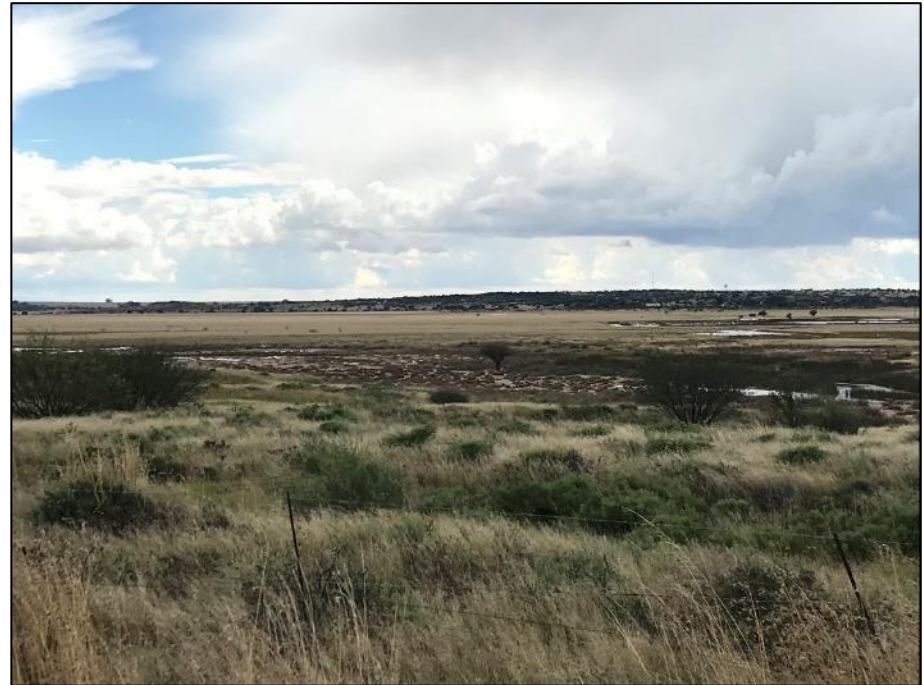
Site Name: WRU03

Left: Large depression wetland forming a part of WRU03. Grassed depression wetland is depicted within the black line in the photograph.

Right: Picture of Soutpan with evidence of vegetation clearing in the foreground in preparation to set up a salt mining operation, and an active salt mining operation located to the right of the photograph.

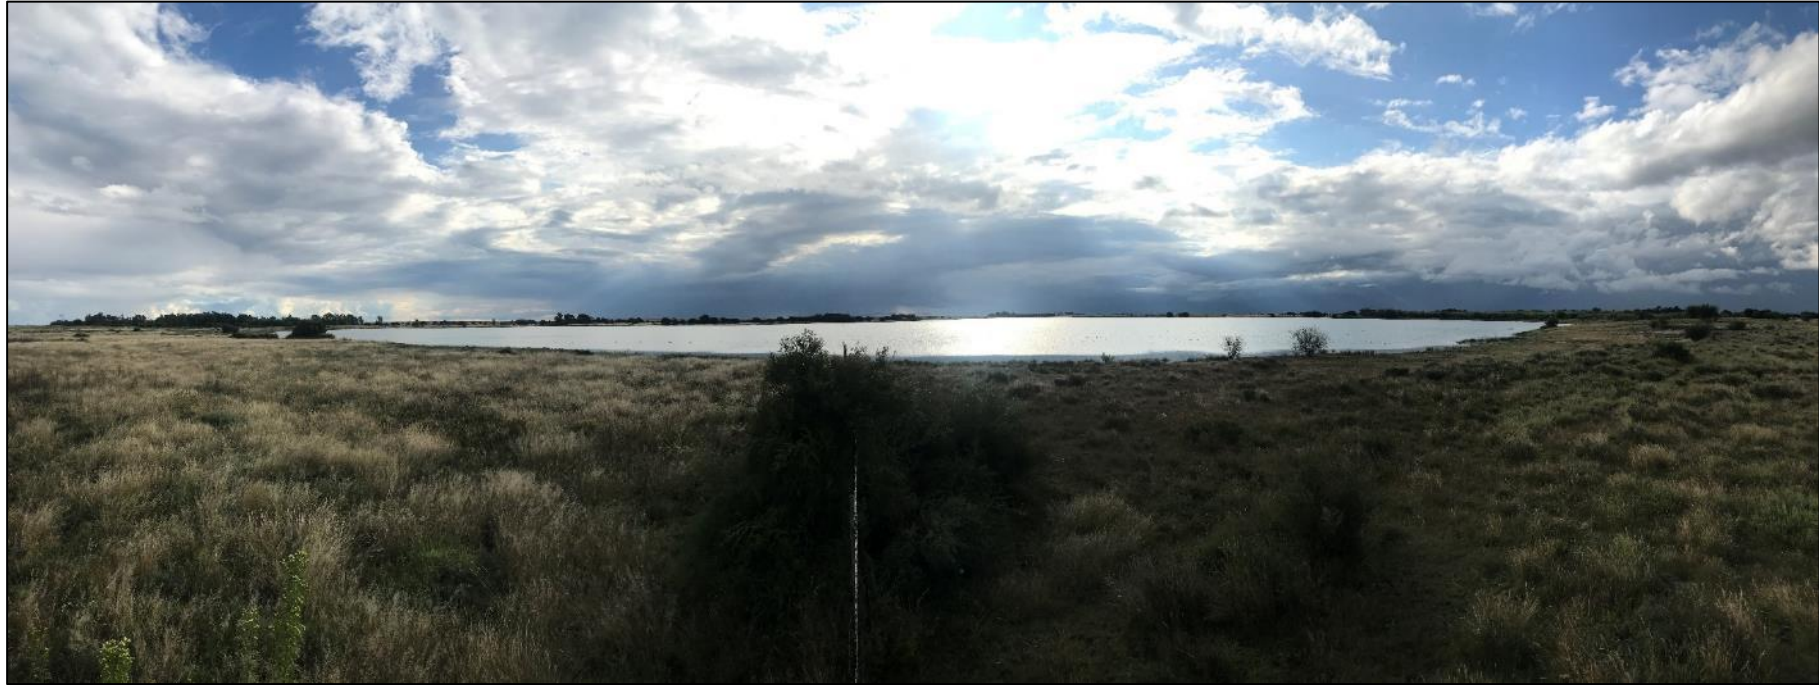
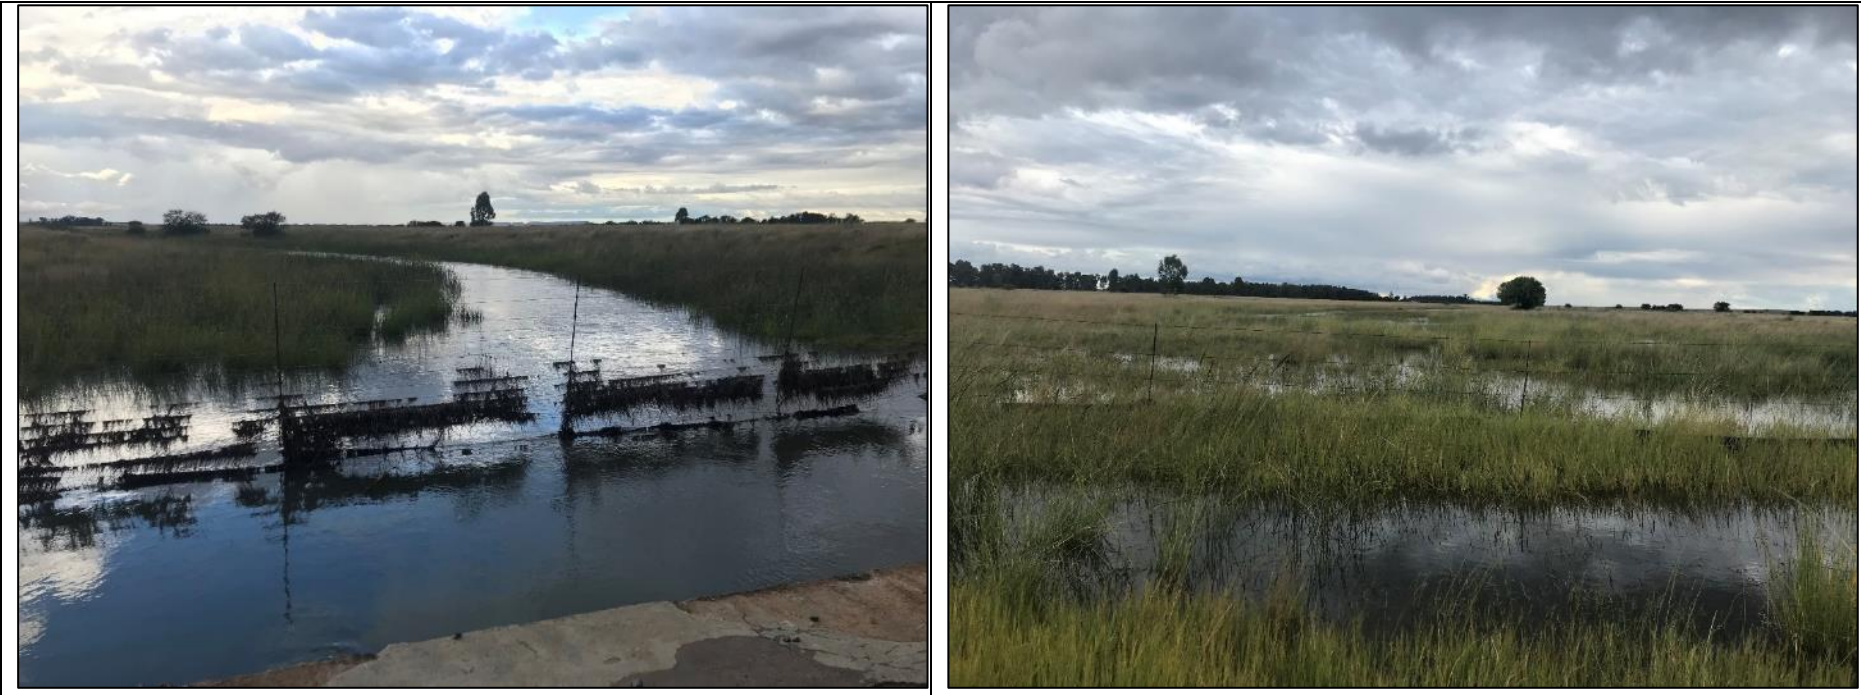
Site Name: WRU11

Top: Large depression wetland forming a part of WRU11. This depression wetland is unique in that it receives water from the main valley-bottom wetland at its head and feeds water back into the valley-bottom wetland at its toe.

Bottom Left: Channelled section of wetland towards the north of the mainstem valley-bottom wetland.

Bottom Right: Discontinuously channelled valley-bottom section in the wide central portion of the mainstem wetland.

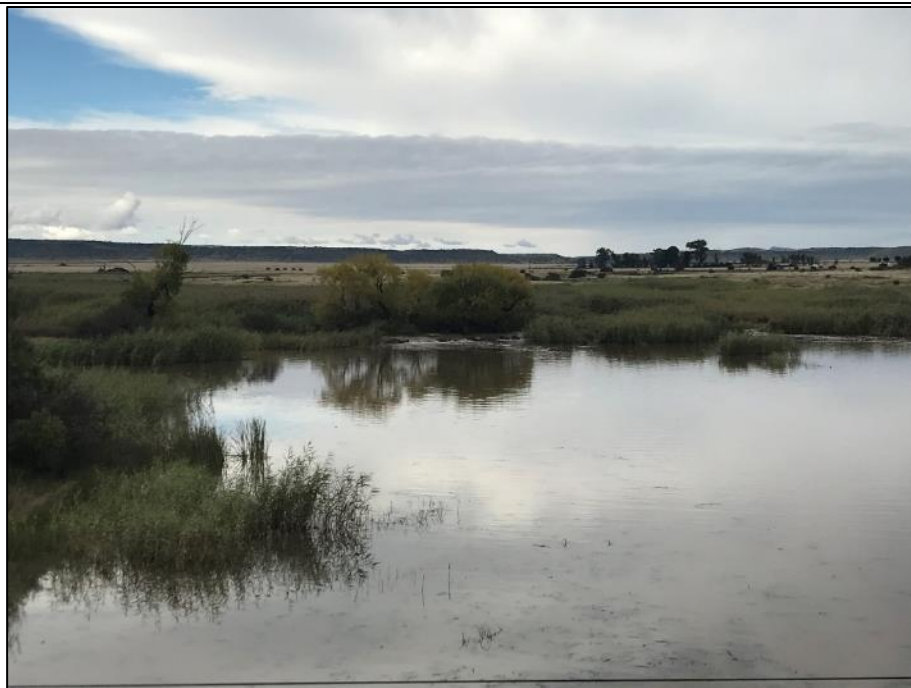
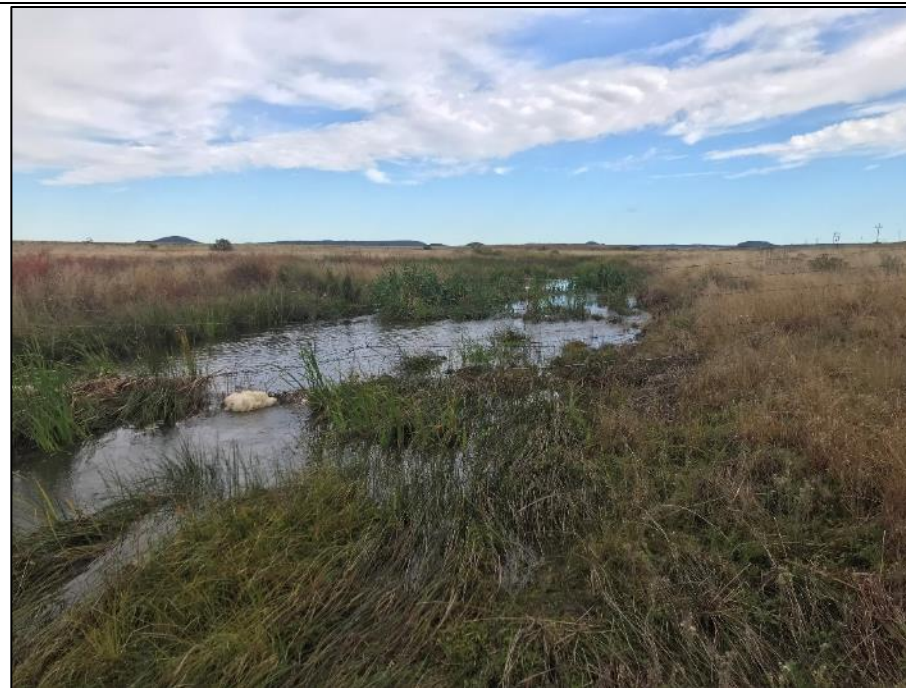
Site Name: WRU15

Left: Large reedbed at the confluence of the four valley-bottom wetlands.

Right: Photograph of the northern-most wetland arm with foam and signs of pollution evident within the channel

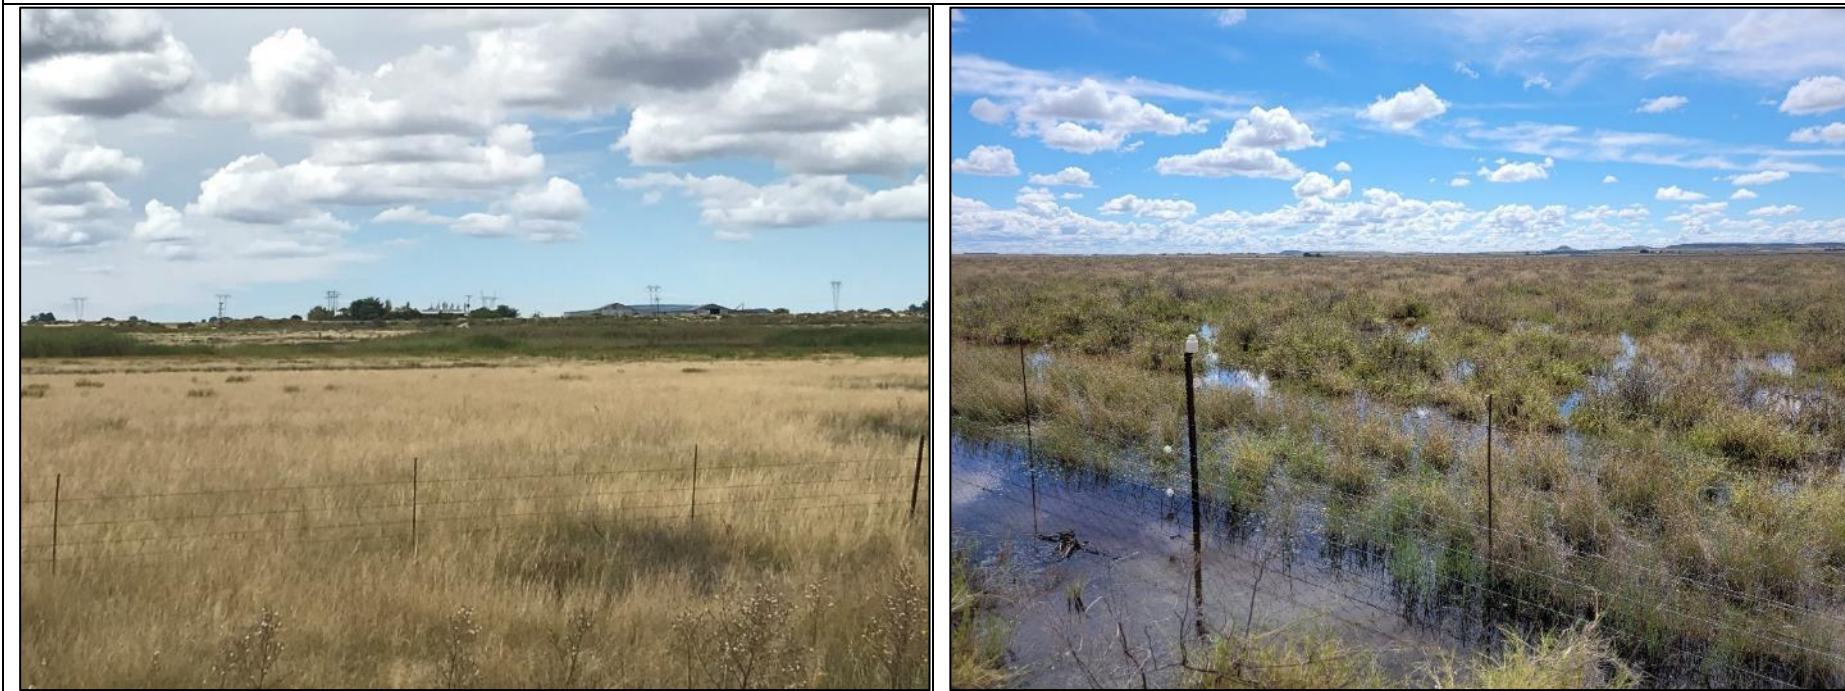
Site Name: WRU10

Left: The depression wetlands are connected by large reedbeds as depicted by the tall green vegetation in this photograph.

Right: Extensive water within the depression wetlands (the road runs through the temporary zone of the wetland). Recent heavy rain has resulted in the wetting of the temporary zone of these depression wetlands.

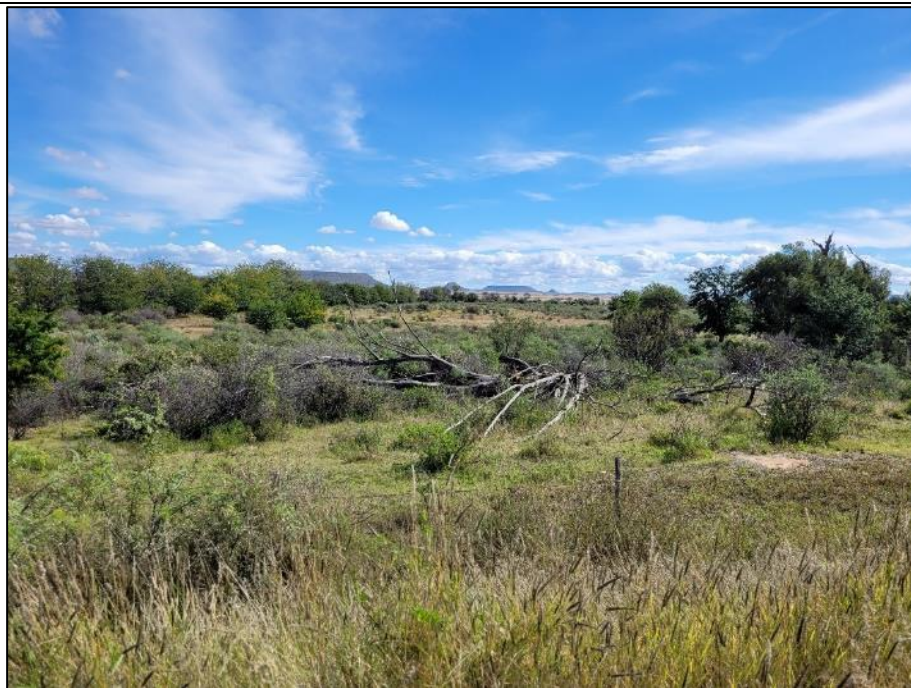
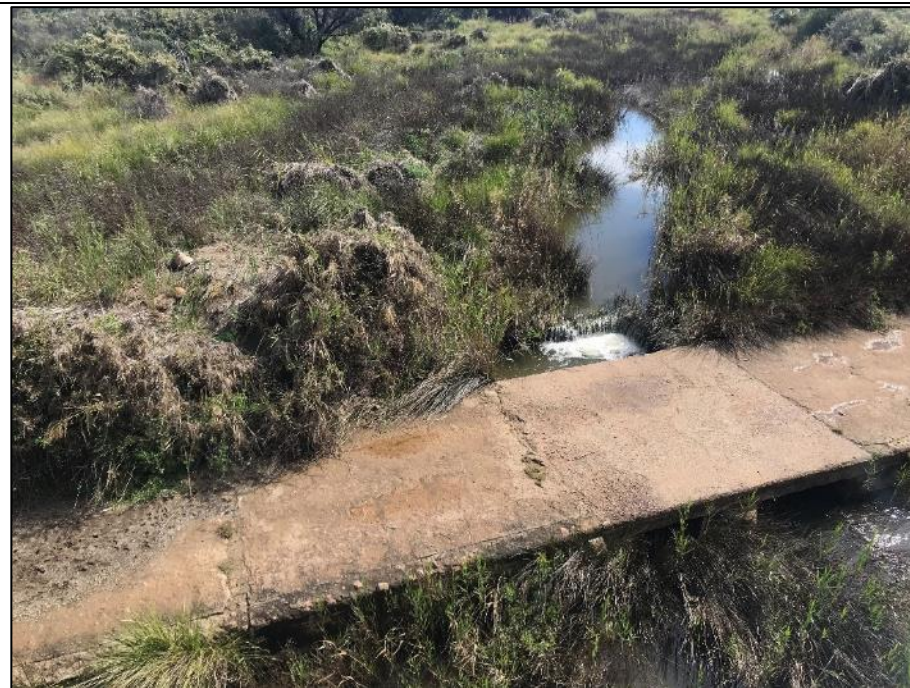
Site Name: WRU09

Left: Little evidence of wetland vegetation with extensive bush encroachment into the area where the WRU had been mapped.

Right: Predominantly fluvial and riparian habitat at the toe of the WRU. Some wetland vegetation was present but limited to the confines of the channel.

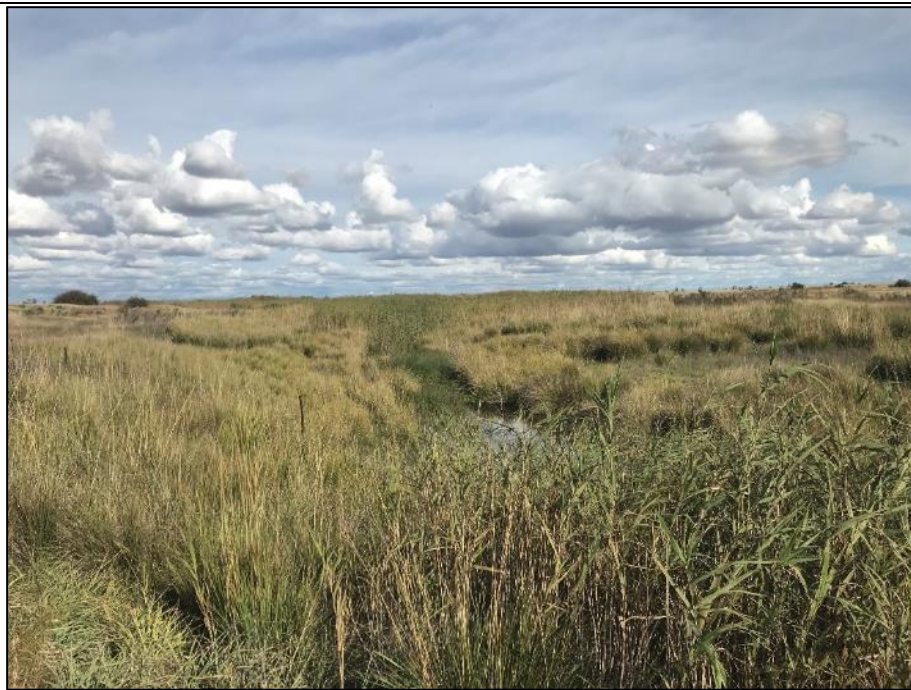
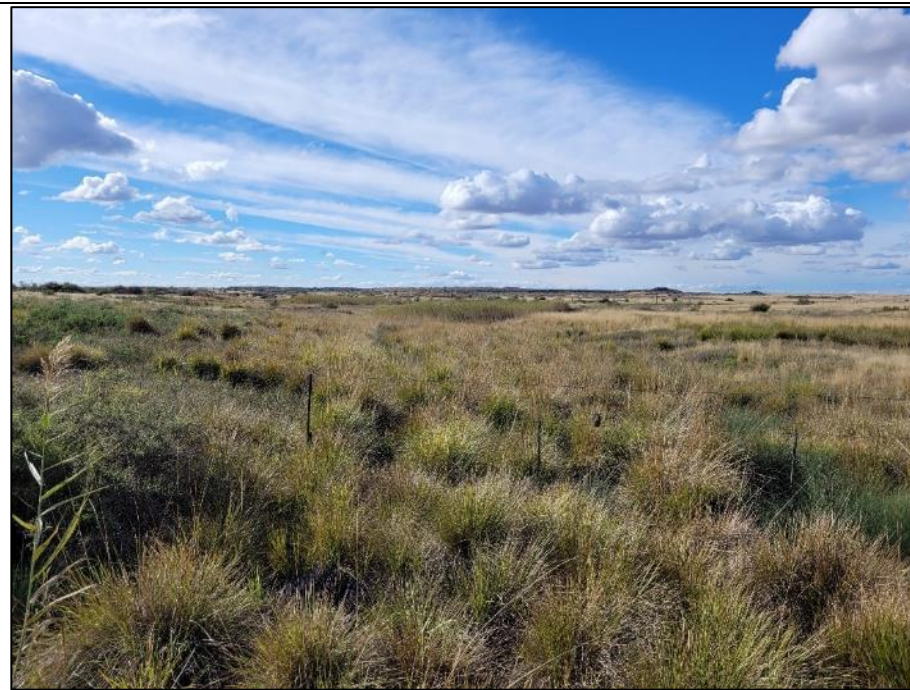
Site Name: WRU04

Left: Extensive *Phragmites australis* reedbed located upstream of gradient change in wetland.

Right: Extensive *Phragmites australis* reedbed located downstream of road crossing with extensive stands of *Miscanthus capensis* along the valley-bottom wetland.

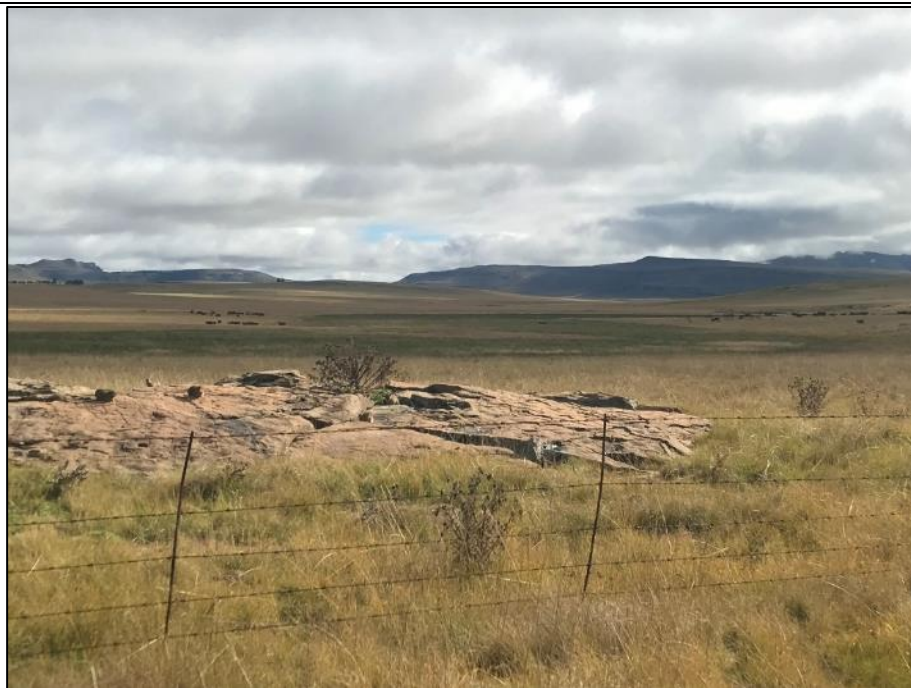
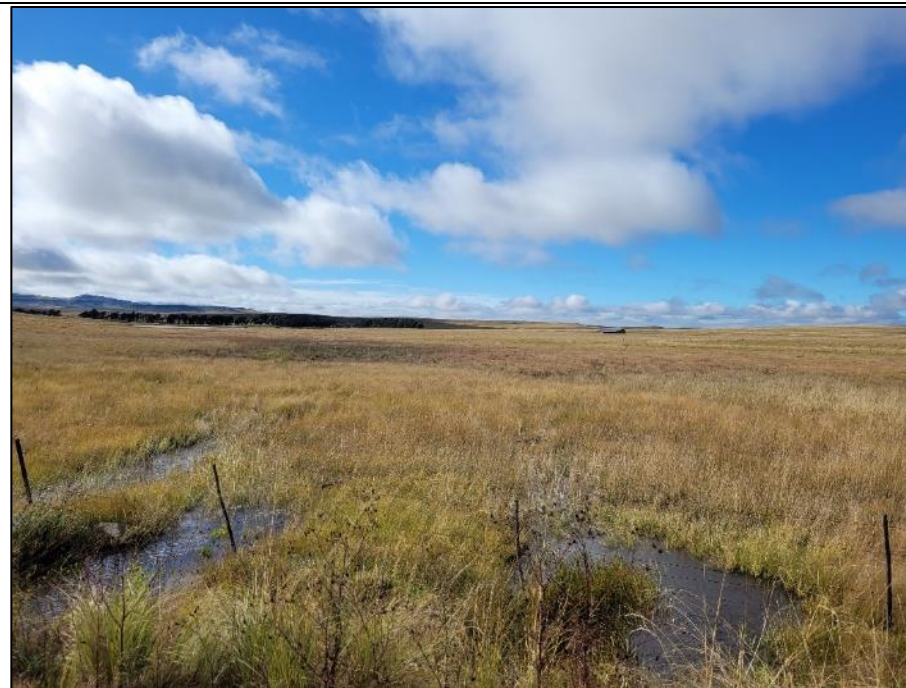
Site Name: WRU05

Left: Broad valley-bottom wetland with a number of head of cattle on either side of the wetland.

Right: Indication of the level of flows from one of the seep wetlands into the mainstem valley-bottom wetland.

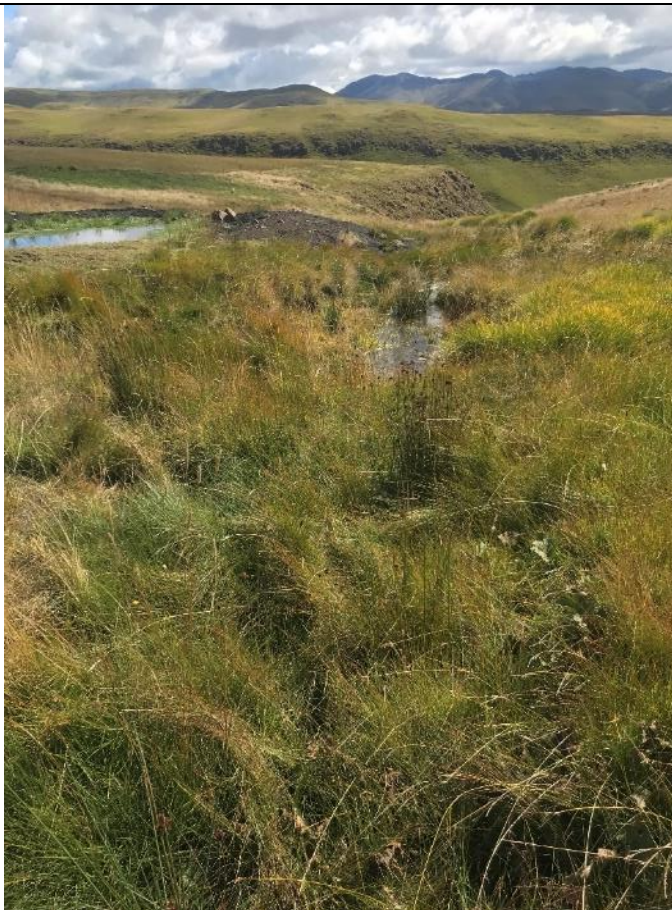
Site Name: WRU16

Centre: A small hillslope seep downstream of WRU16 which would be indicative of the hillslope seep habitat in WRU16 – the vegetation dominated by *Merxmuellera disticha*.

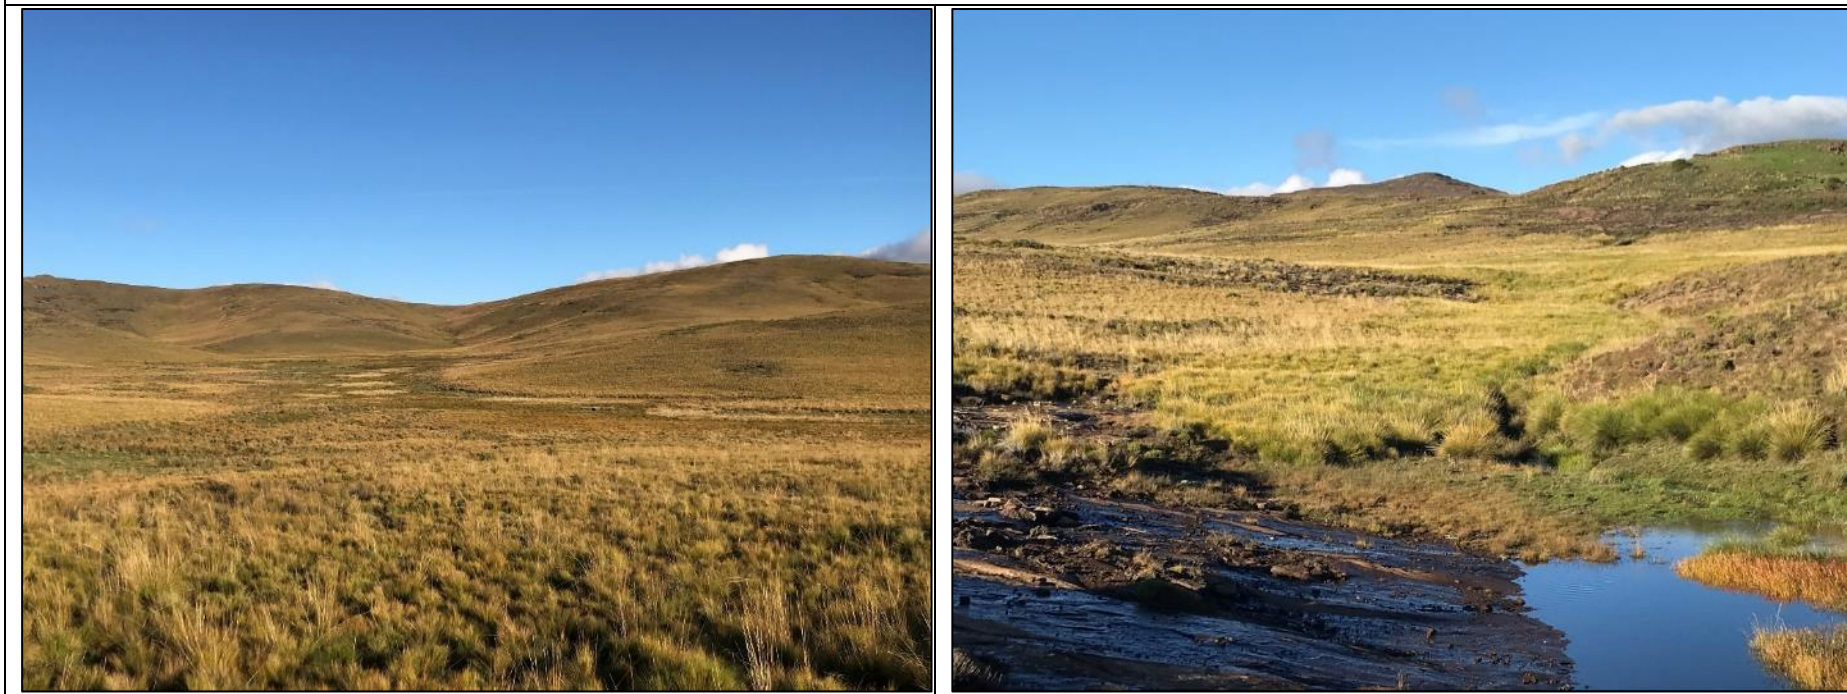
Site Name: WRU17

Left: Broad valley-bottom wetland with a number of seeps feeding into it. The darker colour in the landscape indicates the approximate valley-bottom wetland extent.

Right: An example of an intact hillslope seep wetland dominated by *Merxmuellera disticha*.
