**RESERVE DETERMINATION STUDIES FOR SELECTED SURFACE
WATER, GROUNDWATER, ESTUARIES AND WETLANDS IN THE
USUTU/MHLATUZE WATER MANAGEMENT AREA:**

RIVER INTERMEDIATE EWR

VOLUME 1: ECOCLASSIFICATION

AUGUST 2014

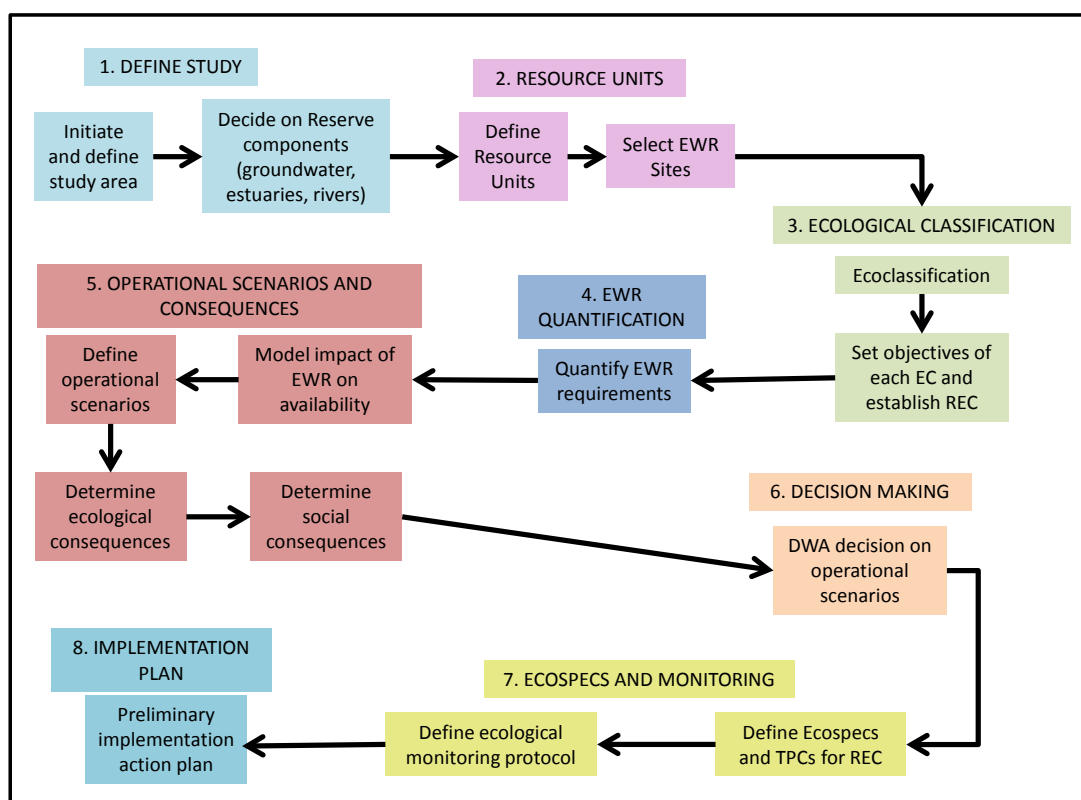
Figure 1-1 Generic procedure for the determination of the Ecological Reserve

This report serves to document the results of the ecological classification (Step 3 in Figure 1-1) for the EWR sites in the Usuthu-Mhlatuze catchments for which Intermediate EWR determinations were undertaken.

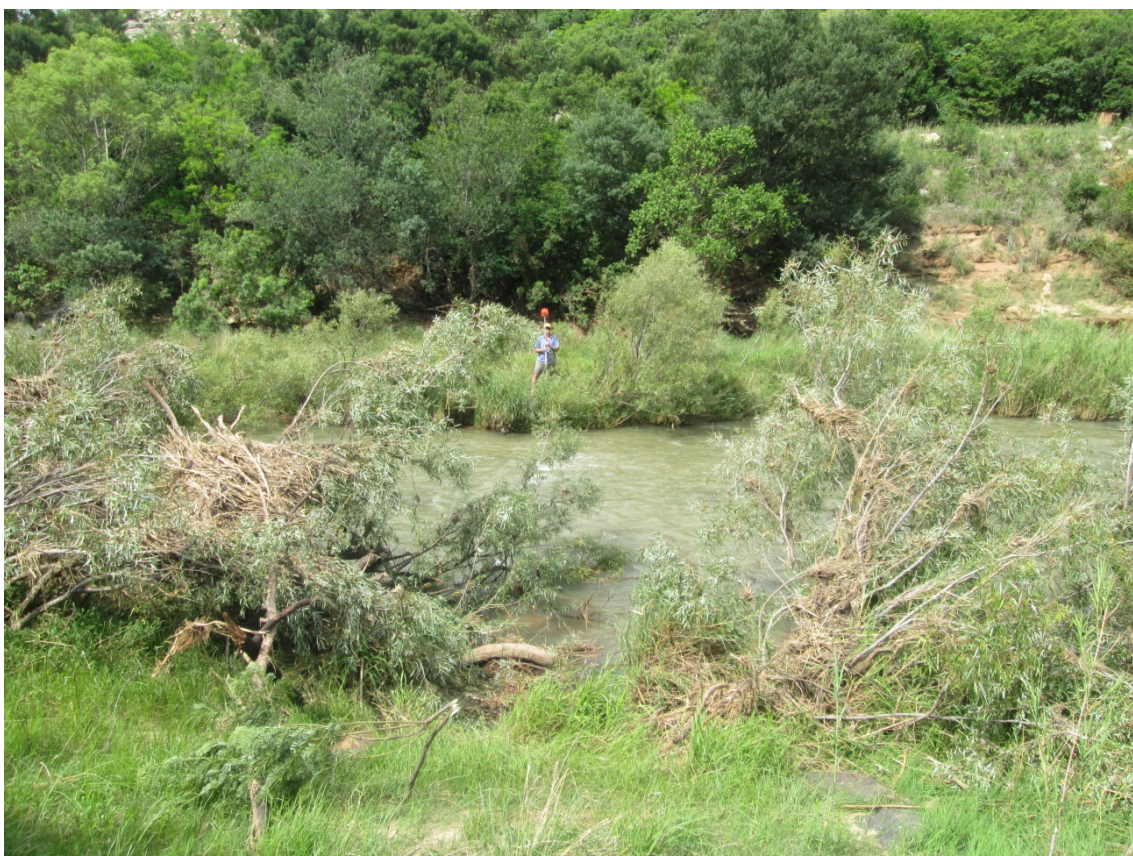
Comments: EWR AS1 is the site of a previous EWR assessment (EWR site JMB2, Louw and Koekemoer 2008). It comprises a riffle, rapid and run section flanked by indigenous vegetation. There is a camp site and picnic area on the left bank.

Figure 3-1 EWR Site AS1: Assegaii River, September 2013

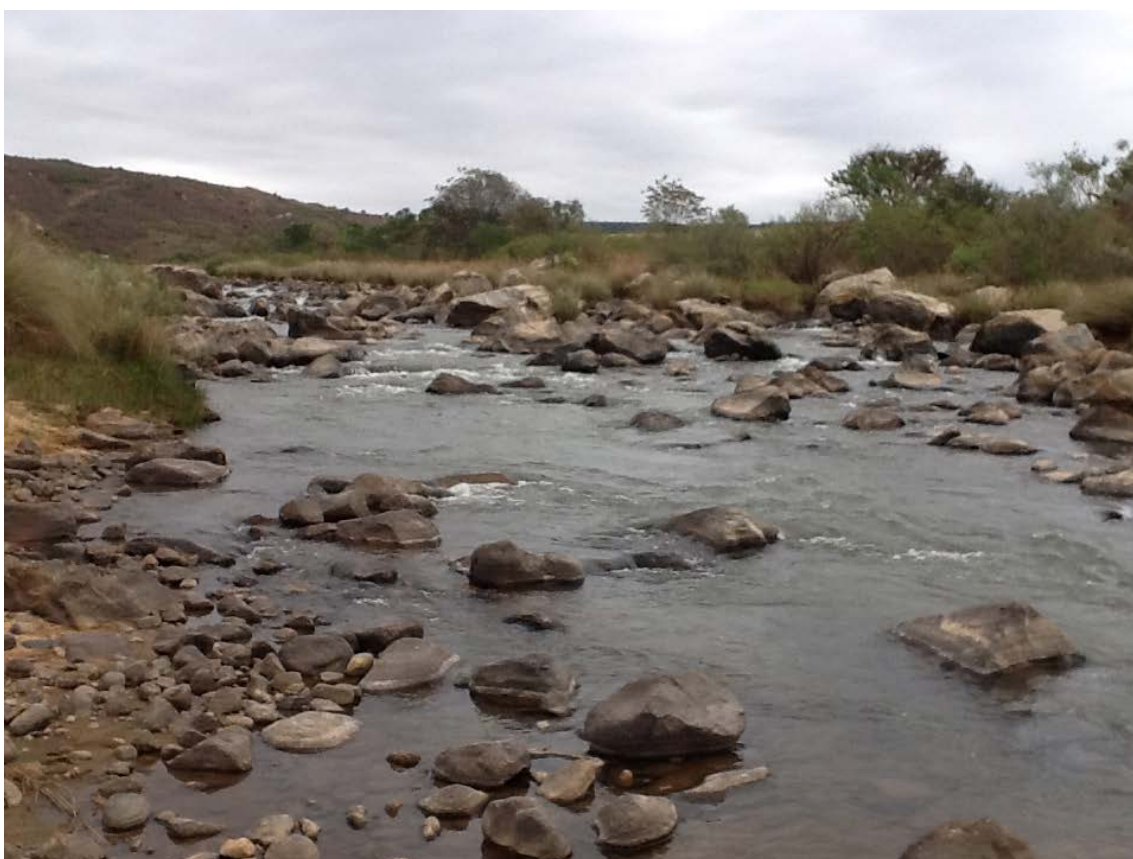
Comments: This site has a range of habitats including riffles, pools and a variety of riparian vegetation while the area downstream is afforested.

Figure 4-1 EWR Site UP1: Upper Pongola River, September 2013

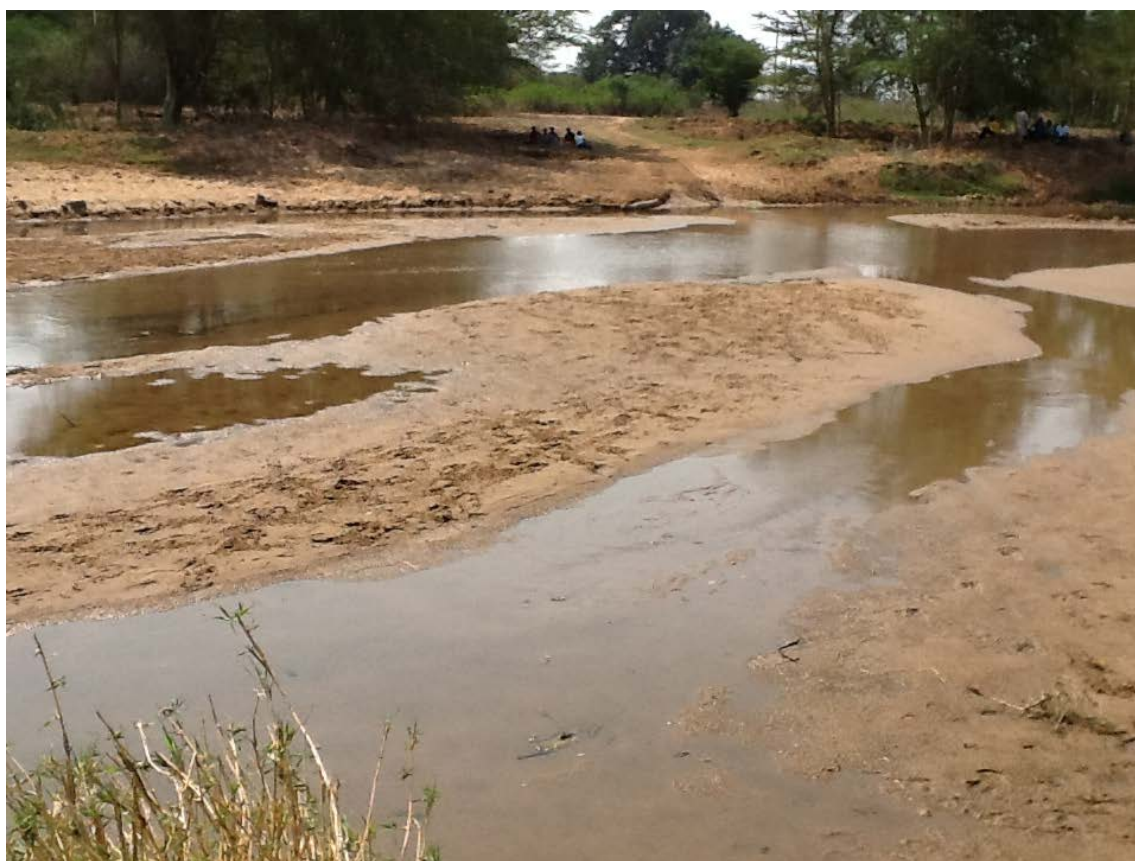
Comments: The channel at this site was wide, the substratum sandy and there was well established riparian vegetation. This is also an existing River Health Monitoring site (W3MKZ-DNYDR).

Figure 5-1 EWR Site MK1: Mkuze River, September 2013

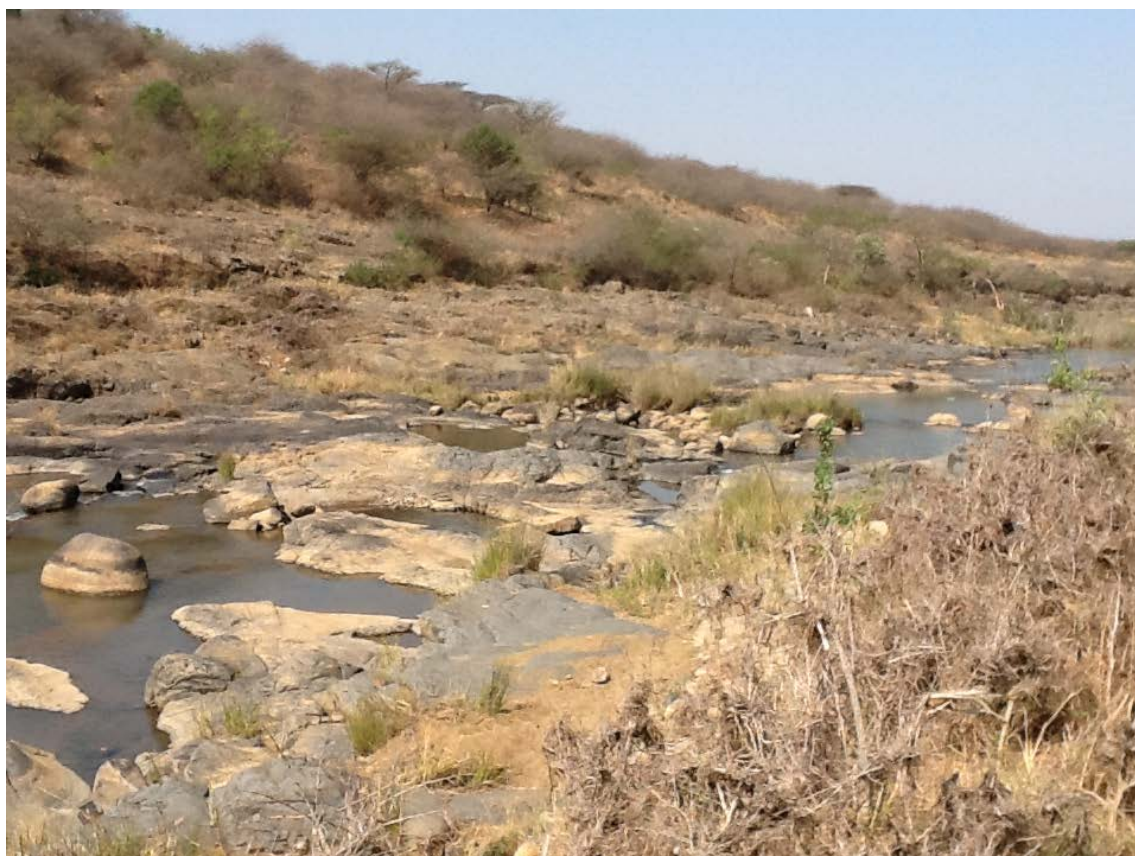
Comments: There is good access to this bedrock controlled site and a gauging weir is located upstream. There are distinct high and low-flow zones and a good range of aquatic habitat available.

Figure 6-1 EWR Site BM1: Black Mfolozi, September 2013

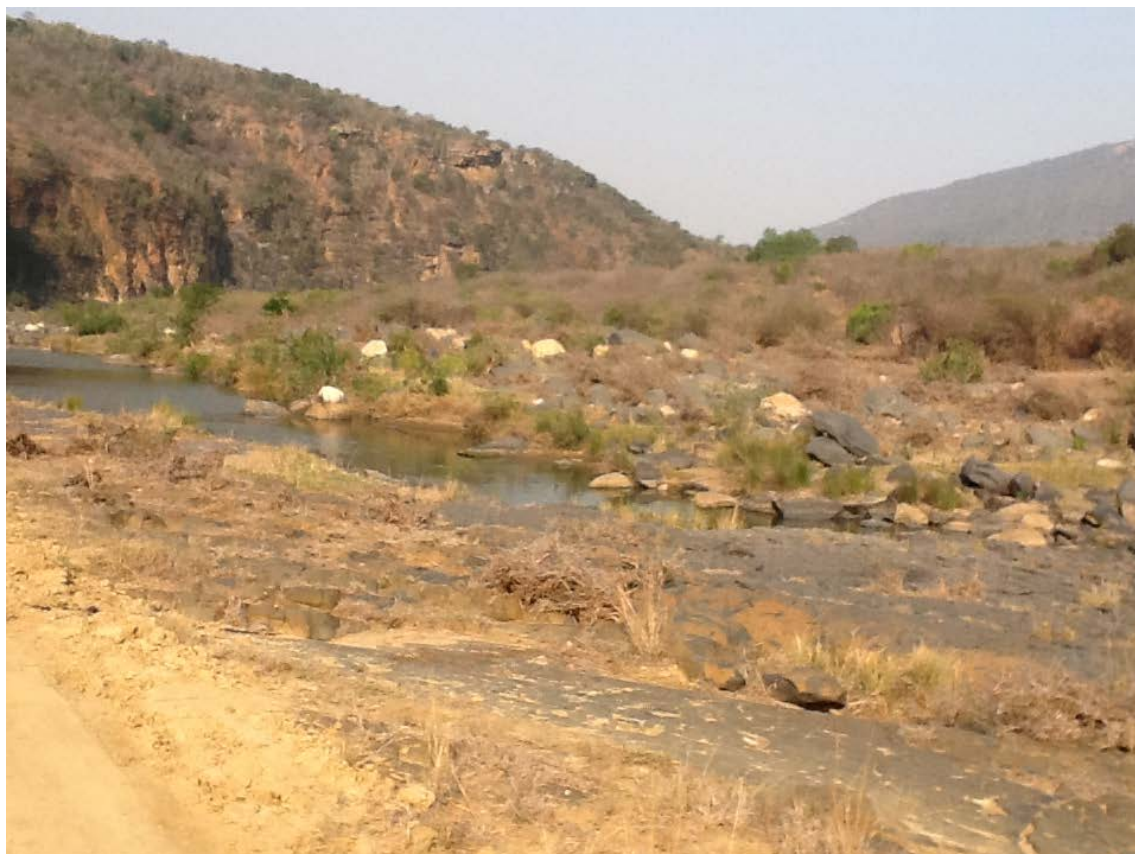
Comments: There are large boulders at this bedrock controlled site, which offers a good range of aquatic habitats to river organisms.

Figure 7-1 EWR Site BM2: Black Mfolozi River, September 2013

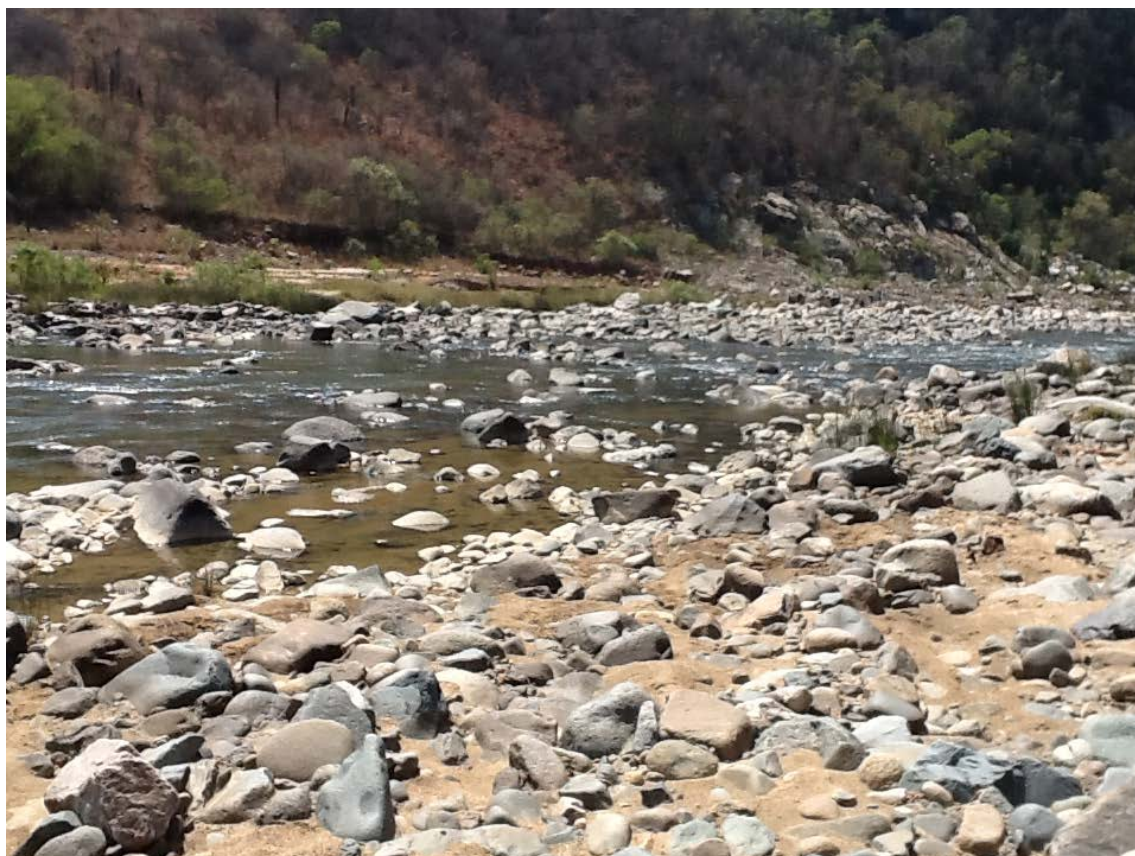
Comments: There is a gauging weir immediately upstream of the site that is located downstream of a road bridge with large culverts that do not impede flow. This site has distinct high and low flow zones and offers a large variety of habitat to river organisms.

Figure 8-1 EWR Site WM1: White Mfolozi River, September 2013

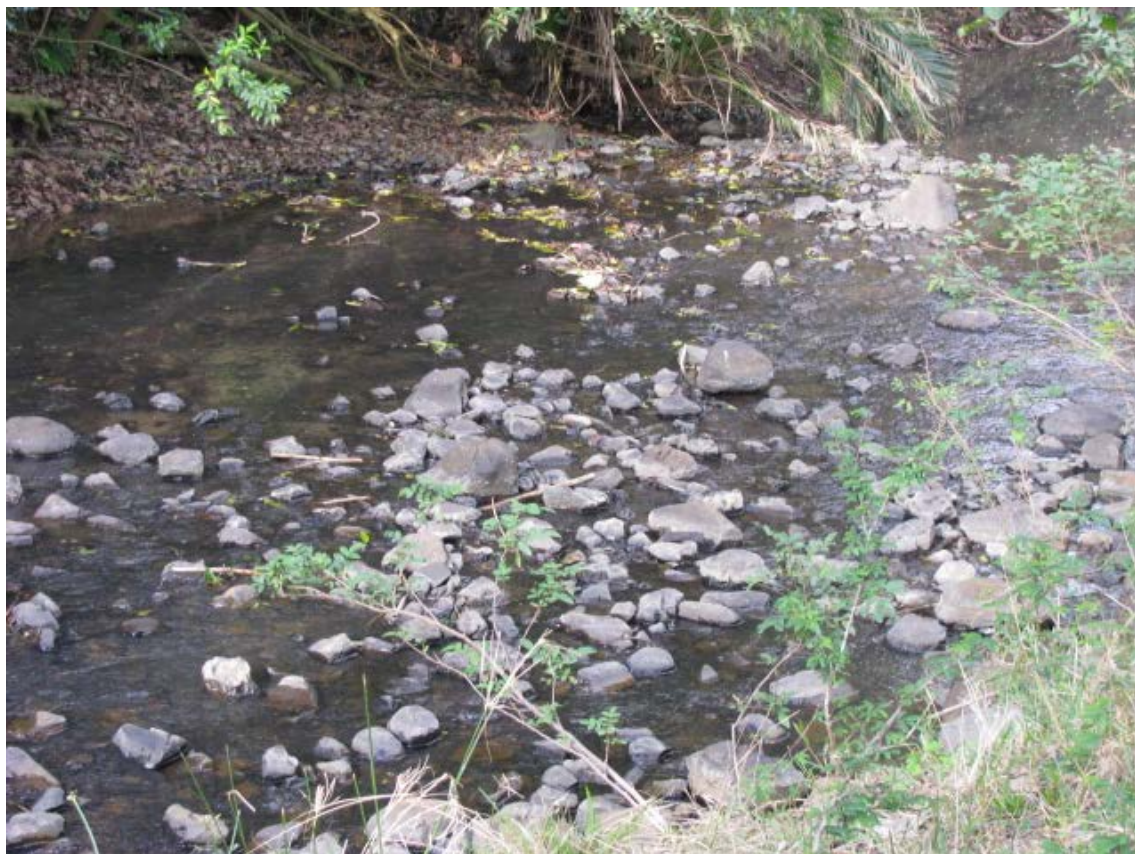
Comments: EWR Site NS1 is the site of a previous EWR assessment (EWR 6 –: Louw and Koekemoer 2008).

Figure 9-1 EWR Site NS1: Nseleni River, September 2013

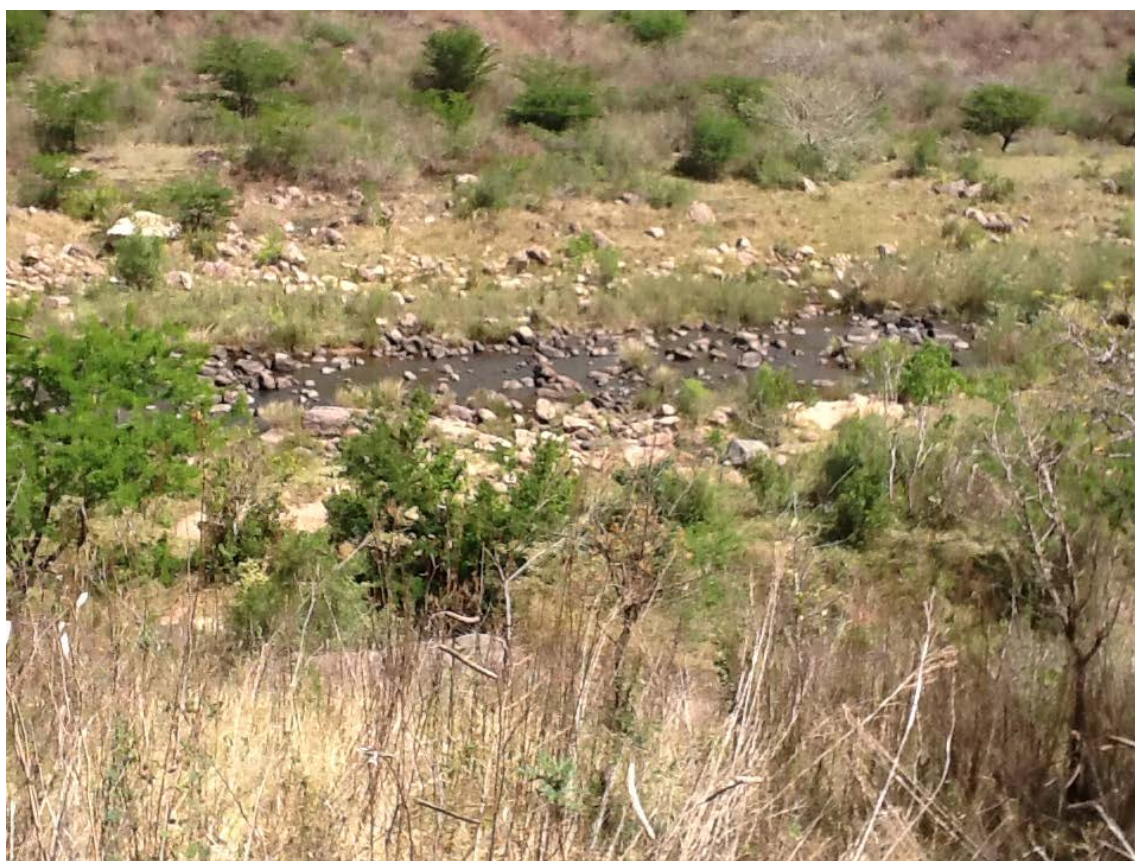
Comments: The channel is bedrock controlled and fairly straight and comprises a variety of aquatic habitats, controlled bedrock section of the river with a variety of habitats. Water is abstracted at the gauging weir upstream of the EWR site while cattle are grazed and domestic washing takes place downstream.

Figure 10-1 EWR Site MA1: Matigulu River, September 2013
