## A High Confidence Reserve Determination Study for Surface Water, Groundwater and Wetlands in the Upper Orange

WP11343

### Eco-Categorisation Report VOLUME 1

REPORT NO.:  
RDM/WMA13/00/CON/COMP/1223 (a)  
August 2023

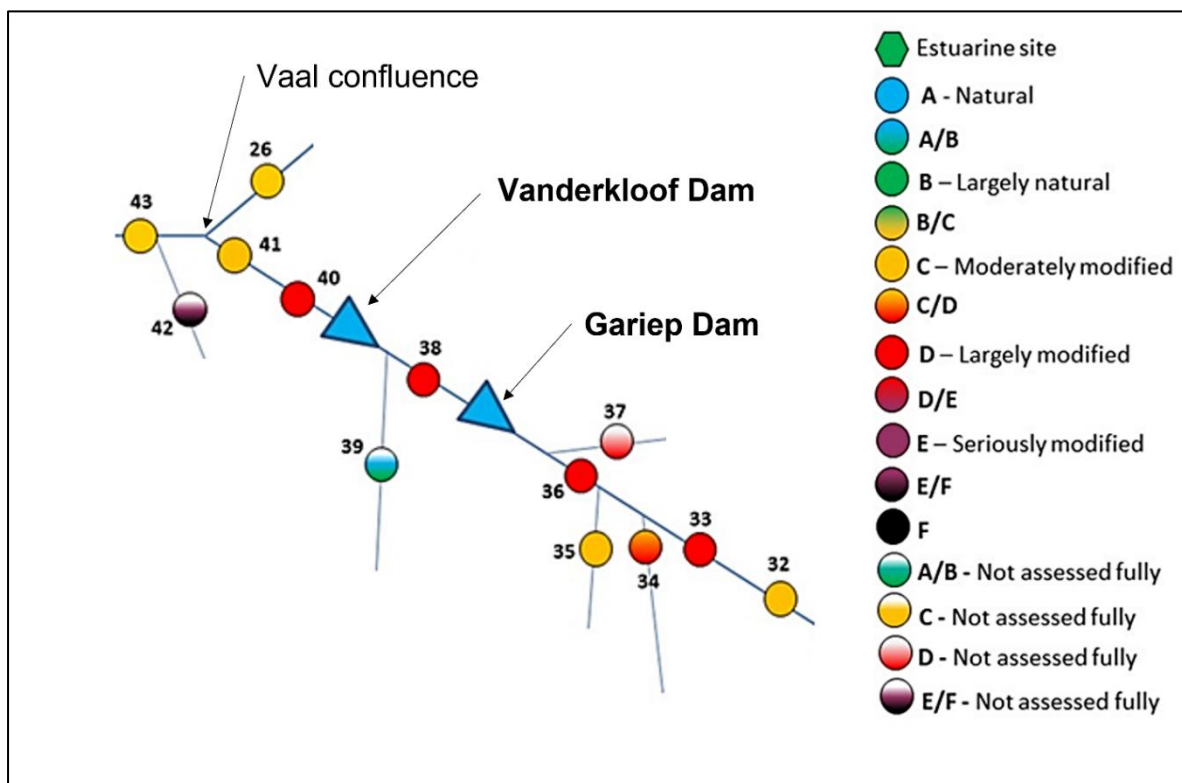
**Figure 4-4:** Schematic representation of the overall ecological status (key on right hand side) of relevant sample sites from the third Joint Basin Survey (JBS3) aquatic ecosystem health assessment by the Orange-Senqu River Commission (ORASECOM, 2023a).

At the conclusion of the third Joint Basin Survey (JBS3) in 2022 (ORASECOM, 2023a), the sites immediately downstream of the dams were assessed to be in largely modified states, with degraded fish, macroinvertebrate, and vegetation communities (Figure 4-4). This decline suggests there is a need to evaluate if there are any geomorphological, hydrological, or biological thresholds that are about to be crossed with critical, irredeemable negative consequences which need to be presently mitigated. The ecological condition improved progressing further downstream as the impacts of the flow alterations are slowly ameliorated (Choi *et al.*, 2005; Wu *et al.*, 2019). Upstream sites were also impacted, but largely by water quality issues associated with wastewater pollution and degradation associated with agriculture (Figure 4-4; ORASECOM, 2023a).

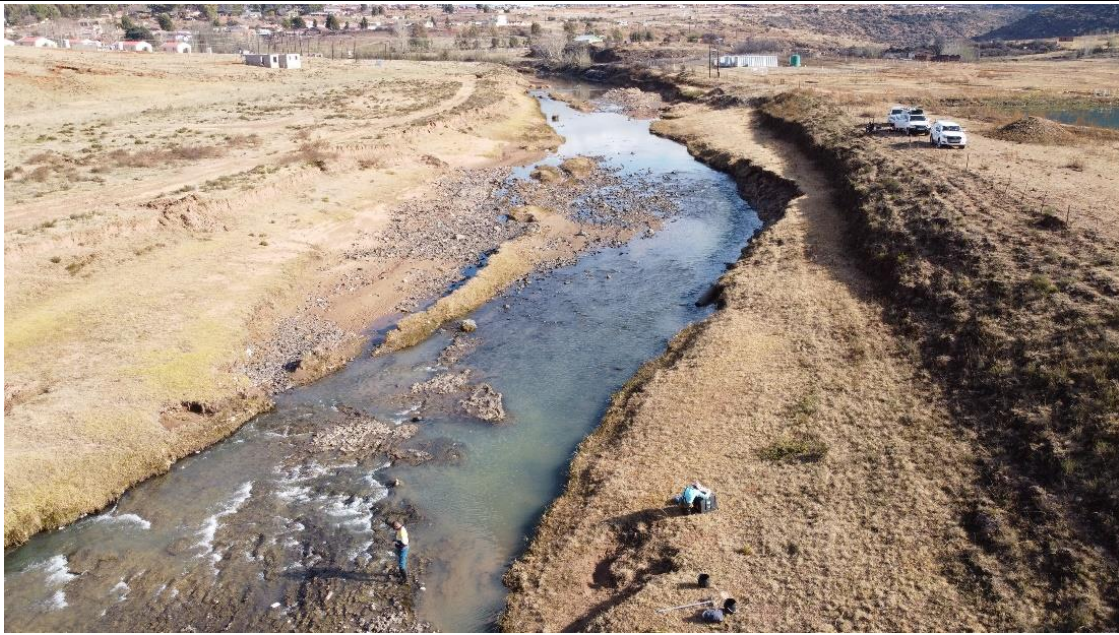
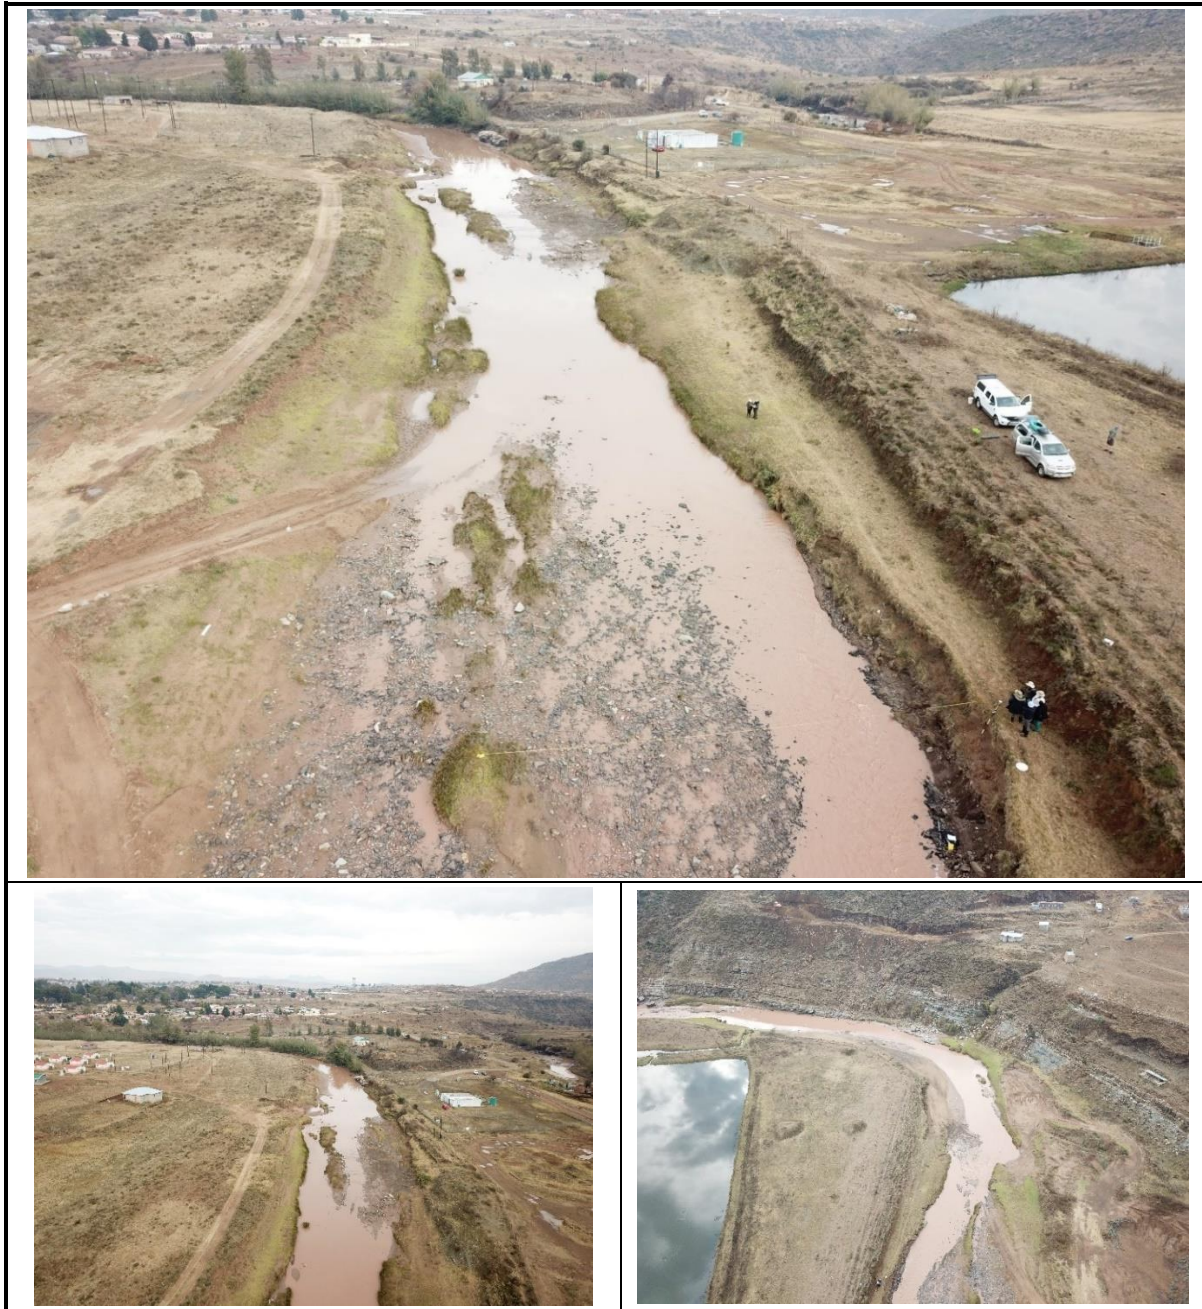
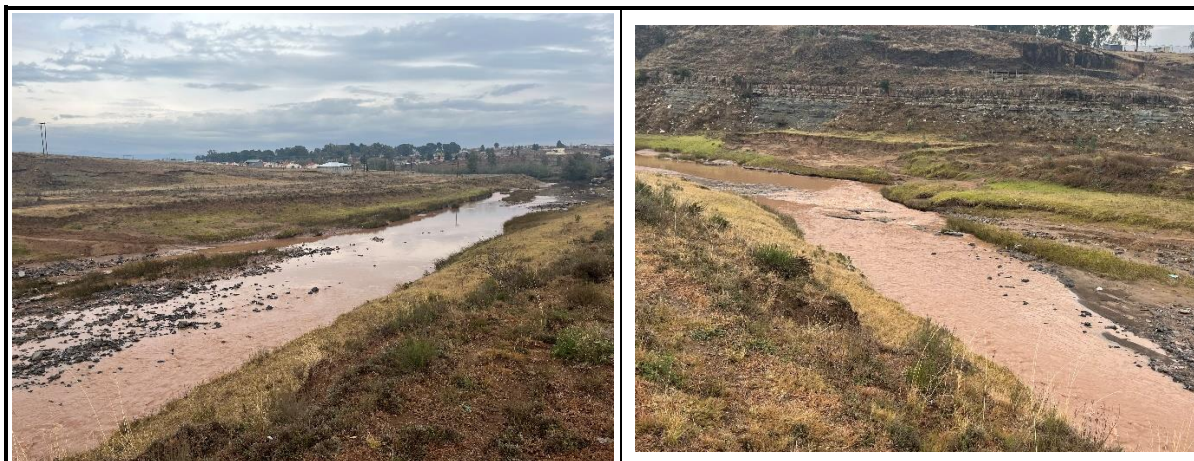
**Figure 7-5:** Site photographs of the Sterkspruit EWR site

Upstream	Downstream
<b>Site Description:</b>	
<p>The site is located downstream from the town of Sterkspruit and Hershell, but just upstream of the Sterkspruit sewage maturation pond (see inlet and overflow into the Sterkspruit in the above image). The valley setting is confined, with cobbles, boulder and bedrock forming riffles and pools. The river is ~5m to 10m wide (macro channel 30m wide) with some bed and channel modifications, erosion on both banks, and cattle trampling and grazing. Biotopes available for macroinvertebrates included SIC, SOOC and slated/fractured bedrock, along with Gravel, Sand, Mud (GSM) and limited marginal vegetation, owing to undercut banks and vegetation die-back during both surveys. For fish there was Slow-Deep (SD), Slow-Shallow (SS) and FS. Various sections of riffles and runs present. Moderate algae content and very high macroplastics in-stream, including domestic plastic (nappies).</p> <p>During the May 2023 survey, the water was considerably turbid, likely owing to recent rainfall events resulting in sediment loading downstream. Furthermore, there is extensive sand mining taking place, particularly at the EWR site itself, in-channel (Figure 1), and just above the site, mountain cutting activities are taking place to clear foundations for settlements (Figure 2). All having a detrimental impact on the functioning of this ecosystem.</p> <p>Both marginal and non-marginal zones have been severely impacted by sand mining operations at various points across the site, with additional impacts from rubbish dumping, livestock grazing/trampling, invasive alien plants (IAPs), bank erosion/collapse and sediment deposition.</p> <p>Nevertheless, the riparian zone appears intact, with some encroachment from terrestrial plant species. Areas not directly impacted by sand mining support good marginal vegetation dominated by <i>Cyperus marginatus</i>. The non-marginal zone is dominated by the grass <i>Cynodon dactylon</i> and has a higher number of IAPs, notably Kikuyu (<i>Pennisetum clandestinum</i>), Tall Khaki Weed (<i>Tagetes minuta</i>) and Blackjack (<i>Bidens pilosa</i>).</p>

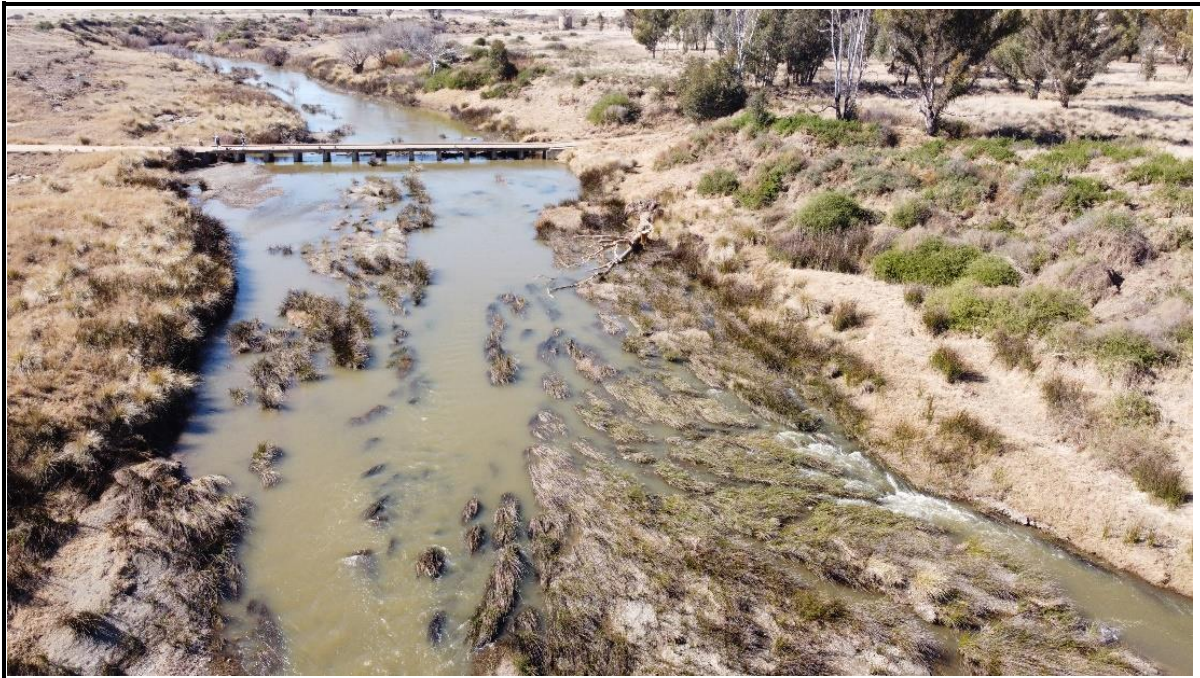
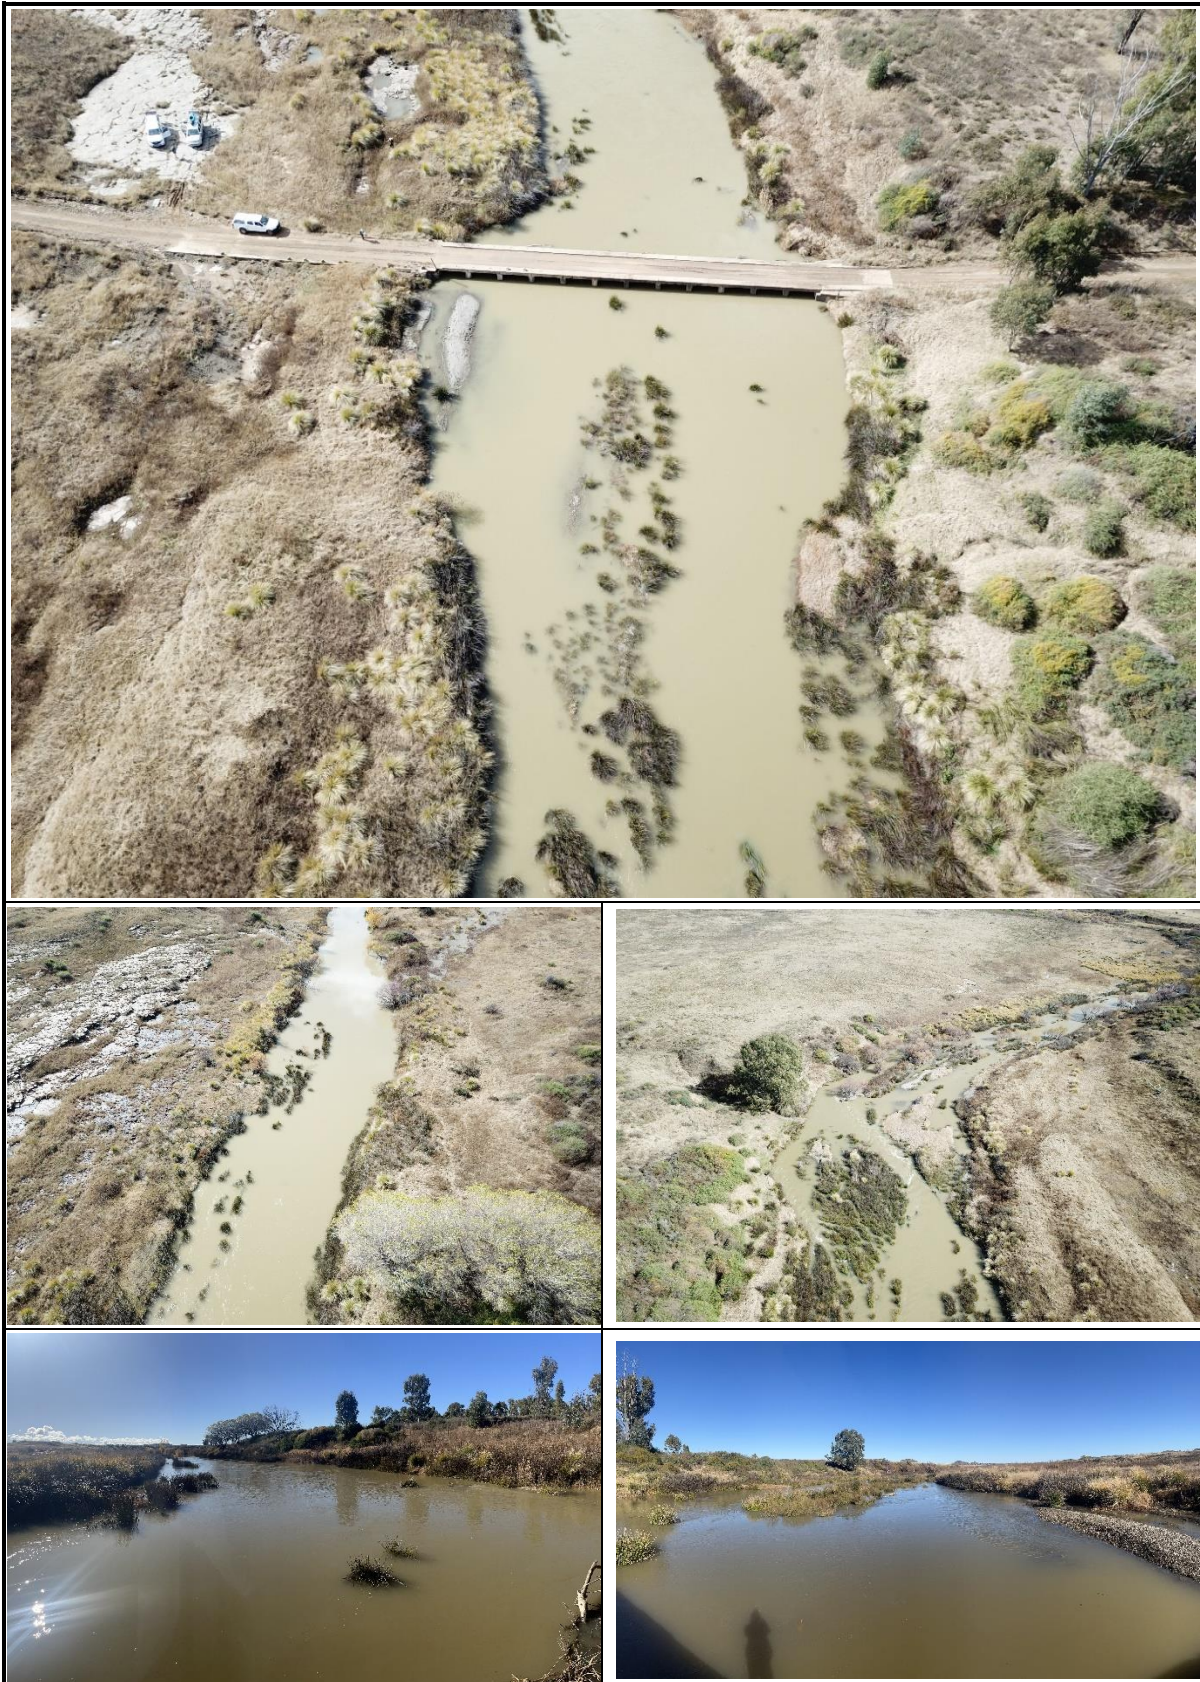
**Figure 7-17:** Site photographs of the Upper Riet EWR site

Upstream	Downstream	
<b>Site Description:</b>		
<p>The reach is largely unconfined, with the macro channel incised into the gently sloping hillslopes. The river has a straight to sinuous macro channel pattern, with a braided low flow channel pattern. Bedrock, boulder, gravel and silt sediment types at the site. This site is located in the upper reaches of the Riet River, upstream of the Kalkfontein Dam Nature Reserve and ~20km upstream of the confluence of the Kromellenboog. Upstream of this site is the DWS REMP site and previous JBS3 site C5RIET-IFR03 and 26_10 respectively. The Riet River is a main tributary of the Vaal River and flows in a western direction. The site is located just downstream of a low water cross-over bridge, where log jams have occurred upstream of the bridge, impeding the hydraulics of the river, as well as inundation of the system upstream.</p> <p>The channel is approximately 40m wide and braided downstream of the bridge owing to in-stream vegetated and gravel islands. These formed braids have resulted in small streams running through the instream islands with rocky habitat for macroinvertebrates and fish. The substrate at the site is dominated by gravel and cobbles, as well as a section of bedrock along the left side of the channel. The increased flows have allowed aquatic grass to establish in the deep runs. Marginal vegetation was abundant and comprised reeds, grasses and sedges. Bank erosion from cattle trampling was evident, more so along the right bank, along with undercut banks.</p> <p>The riparian zone is characterised by a fairly steep left bank with denser vegetation and a wider, flatter, more open right bank with areas of exposed bedrock and alluvium. The marginal zone is narrow and dominated by dense clumps of <i>Schoenoplectus</i> interspersed by the occasional woody shrub/tree (e.g., <i>Salix mucronata</i>), which leads into a grassy strip of tall/robust <i>Miscanthus capensis</i> defining the lower edge of the non-marginal, with a broader band of <i>Cynodon dactylon</i> and other grasses above extending across the upper zone into the terrestrial areas. The upper, left bank has numerous patches of low, dense thicket comprising <i>Lycium</i> and <i>Asparagus spp.</i> with several large, alien trees (<i>Eucalyptus</i> and <i>Populus spp.</i>) scattered along the middle to upper bank. There are a number of islands and clusters of emergent <i>Schoenoplectus</i> with <i>Gomphostigma virgatum</i>. Impacts to the riparian zone are low to moderate and tend to be localised around the road crossing.</p>

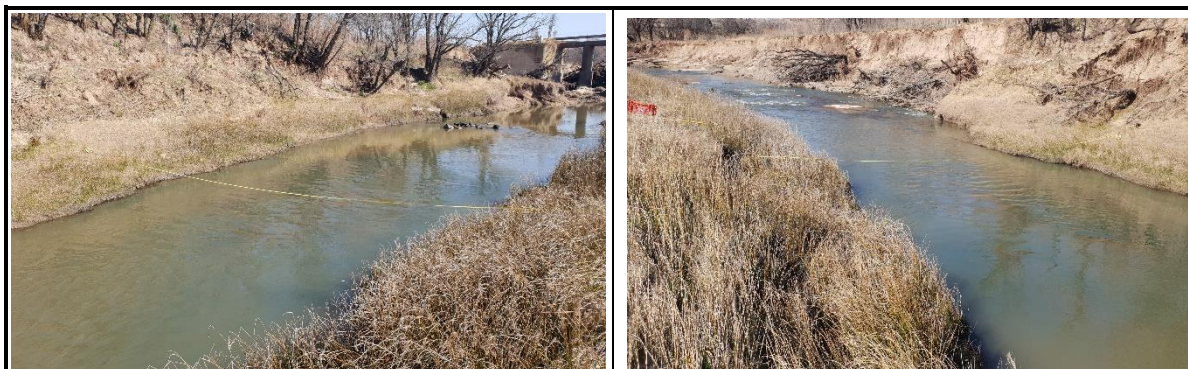
**Figure 8-8:** Site photographs of the Mopeli EWR site

The site is located off the R26 and S872 roads along a confined valley setting. Upstream of the site is a derelict weir, a cross-over bridge, along with a broken-up causeway bridge, where much of the bridge rubble and log jams are impeding the hydraulics of the river and associated left bank. The site on the Mopeli is considerably modified – both the channel, banks and high flow modification. The highly eroded banks, particularly the right bank is being scoured as a result of the blockage at the bridge altering the local hydraulics. Following recent flood events, much vegetation debris has accumulated upstream by the cross-over bridge, resulting in blocking and slowing the high flows, reducing flow velocities directly downstream of the bridge and leading to excessive sediment deposition. This has formed a large lee bar that is diverting the river to the right, eroding the right bank and eroding the side/approach of the bridge. Furthermore, consolidated mud islands have formed further downstream due to the erosion of former consolidated floodplain deposits along the channel.

Biotopes available for macroinvertebrates are dominated by bedrock, with mud, but limited gravel and sand. Marginal vegetation was absent owing to undercut banks and vegetation die-offs. For fish, there was SD, SS and FS. The system is eutrophic, with significant algae masses smothering the bedrock habitat and turbid water. The riparian zone on the left bank is degraded with much of the sediment loading taking place, while the right bank is slightly more vegetated with trees, although some have fallen due to erosion. The flows were higher than expected for the dry season owing to enhanced baseflows due to a very wet and late rainfall season.

- Remove derelict bridge and weir as well as logs against the road bridge.
- Refer to Chapter 11 for general recommendations.
- Land use activities within the upstream catchment should be managed to prevent degradation of the ecological health of the system and deterioration of the water quality (riparian buffer zones should be implemented).
- Where instream movement barriers are proposed, ensure such developments consider facilitating movement of biota (e.g., fishways).

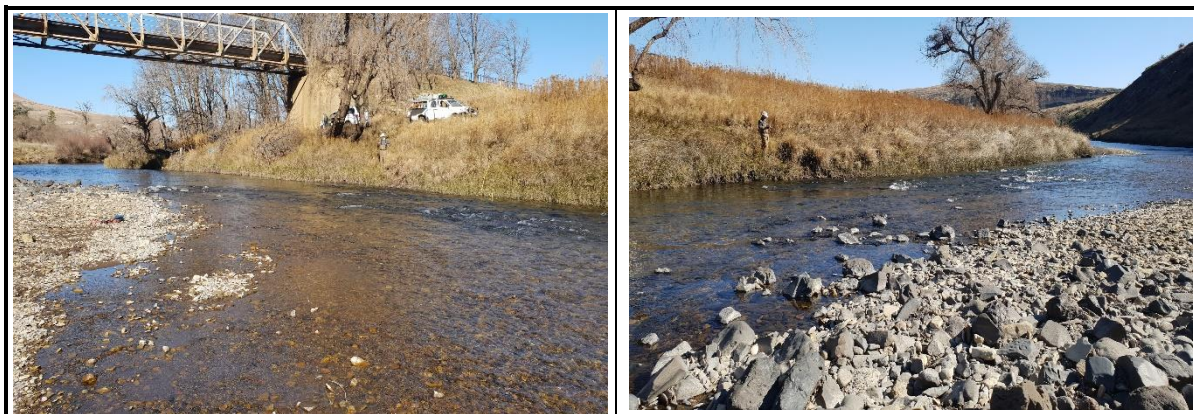
**Figure 8-11:** Site photographs of the Upper Kraai EWR site

The upper Kraai site is located along a partly confined valley. The channel is approximately 40m wide and follows a pool-riffle longitudinal pattern. It is located just downstream of the Bell/Kraai River, approximately 200m downstream of the confluence with the Sterkspruit. Localised bed and channel modification is observed downstream of the large bridge crossing and upstream weir, along with some cattle trampling along the riparian zone. Localized erosion and lateral head cut erosion, mostly up and downstream of the bridge. Some scouring along both banks with several lee bars in-stream and along the left bank downstream. The riparian zone is partly intact, representative of the season. The left bank is generally covered with grasses, shrubs (blackjacks) and *Salix sp.* The right bank is along a cliff face and shrubs.

- Refer to Chapter 11 for general recommendations;
- Land use activities within the upstream catchment should be managed to prevent degradation of the ecological health of the system and deterioration of the water quality (buffer zones to be implemented); and
- Where instream movement barriers are proposed, ensure such developments consider facilitating movement of biota (e.g., fishways).

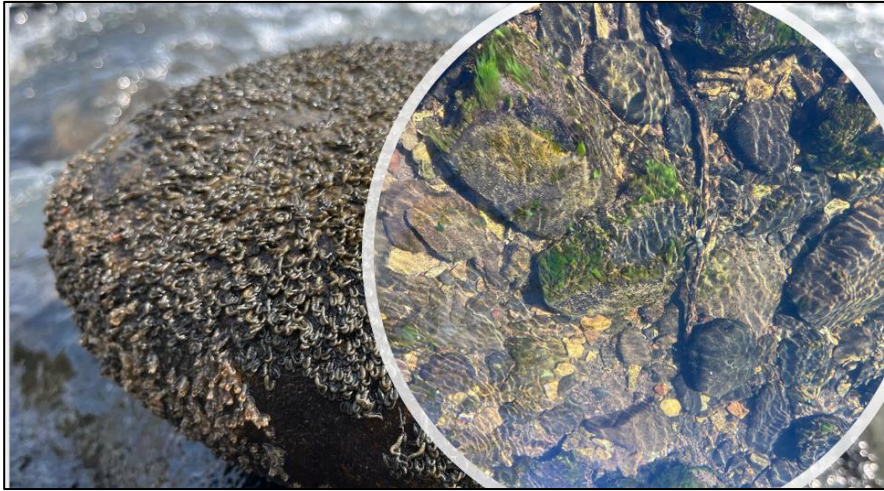
<p>Figure a: Simuliidae (Blackfly larvae)</p>

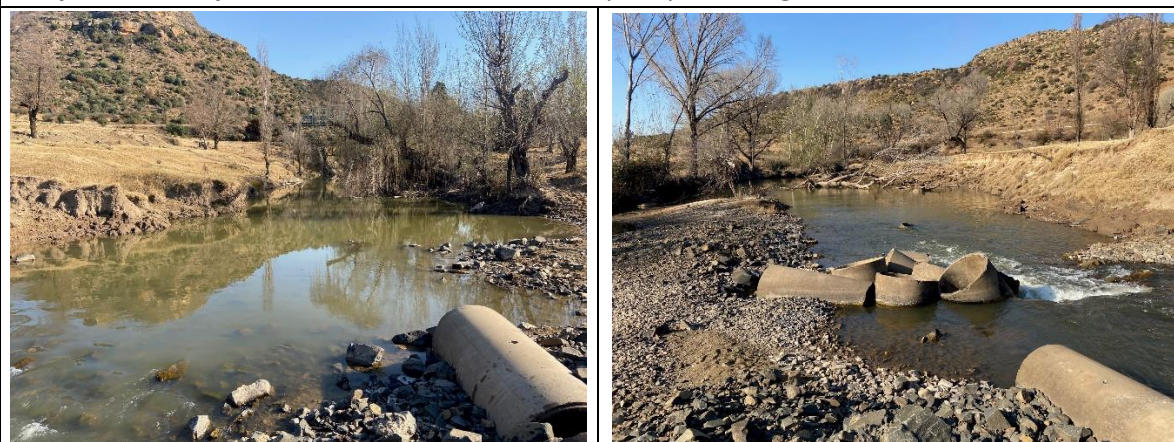
Figure 9-1: Site photographs of the Meulspruit field verification site

Upstream	Downstream
<b>Site Description:</b>	
<p>The site is located just outside Ficksburg off the R26 road, just downstream of the Meulspruit Dam wall. The Meulspruit Dam has no release capacity and does not release into the Meulspruit. Thus, there are periods when this tributary is dry. The site on the Meulspruit is located upstream of the confluence with the Caledon River, with high baseflows owing to recent flooding events.</p> <p>The site is located along a confined reach with possible bedrock influence. The river is ~6m wide with bed and channel modification owing to railway bridges constructed upstream, coupled with</p>

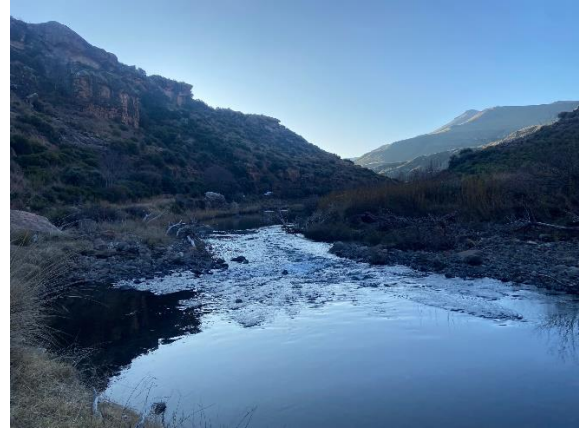
<b>Figure 9-4:</b> Site photographs of the Karringmelkspruit field verification site			
<b>Upstream</b>		<b>Downstream</b>	
<b>Site Description:</b>			
<p>The Karringmelkspruit is a tributary of the Kraai River. The site was located along a confined valley dominated by boulder and cobble bed material. This almost pristine meandering river through a gorge comprises all macroinvertebrate biotopes namely SIC, SOOC, GSM, although the marginal vegetation is limited owing to undercut banks and vegetation die-off. There are large fallen down boulders from the adjacent gorge in-stream, some with sediment abrasions from previous floods. The fish habitats comprise FS, SS and SD. Limited impacts, clear water and no algae visible. Some bank erosion on both banks due to the recent floods. The riparian zone is partly intact, representative of the season, particularly the left bank while the right bank has some areas of bare soil. Some encroachment of alien invasive vegetation along the riparian zone, including blackjacks.</p>

<b>Site impacts:</b>			
<ul style="list-style-type: none"> <li>• Limited abstraction for irrigation</li> <li>• Cattle grazing</li> </ul>			
<b>Preliminary Results</b>			
<i>In situ</i> water quality:

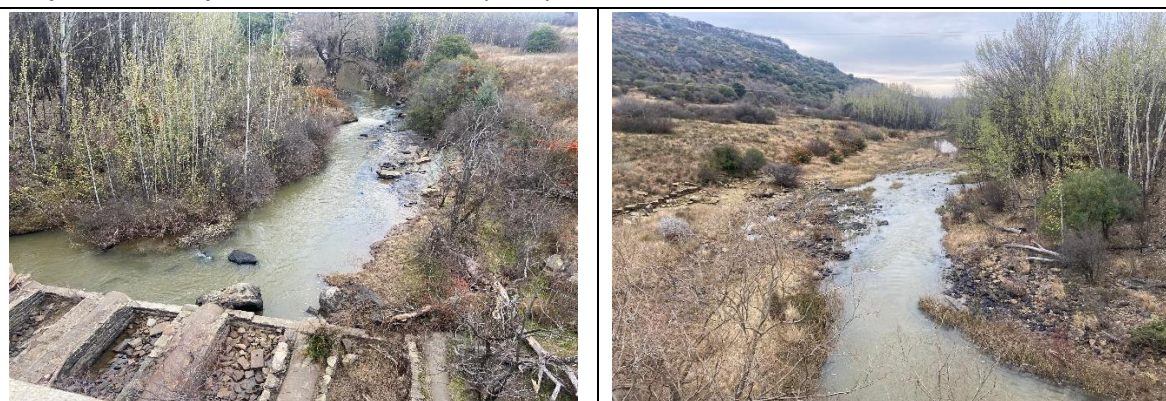
Upstream	Downstream
<b>Site Description:</b>	
<p>The site is located near Floukraal along a confined valley. The Holspruit has localised modifications owing to a cross-over bridge which impedes the river channel, along with an upstream weir and derelict and broken-down culverted bridge coupled with construction debris. Furthermore, beneath the cross-over bridge in-stream are artificial cement slabs. Both banks up and downstream of the bridge are well vegetated although dominated by alien invasives namely <i>Populus sp.</i>, as well as pockets of <i>Salix sp.</i> and <i>Pyracantha</i>. Although these are aiding in bank stability. All these impediments have resulted in the multiple diversions of the river flowing downstream, with a lee bar on the left bank downstream of the bridge. Turbid waters with some algae and sediment loads over the stone's biotopes.</p> <p>Biotopes available for macroinvertebrates is dominated by various sections of riffles, SIC and SOOC. Marginal vegetation is present but limited owing to undercut banks and vegetation die-off (representative of the season). Fish habitats comprised SD, SS, FD and FS.</p>

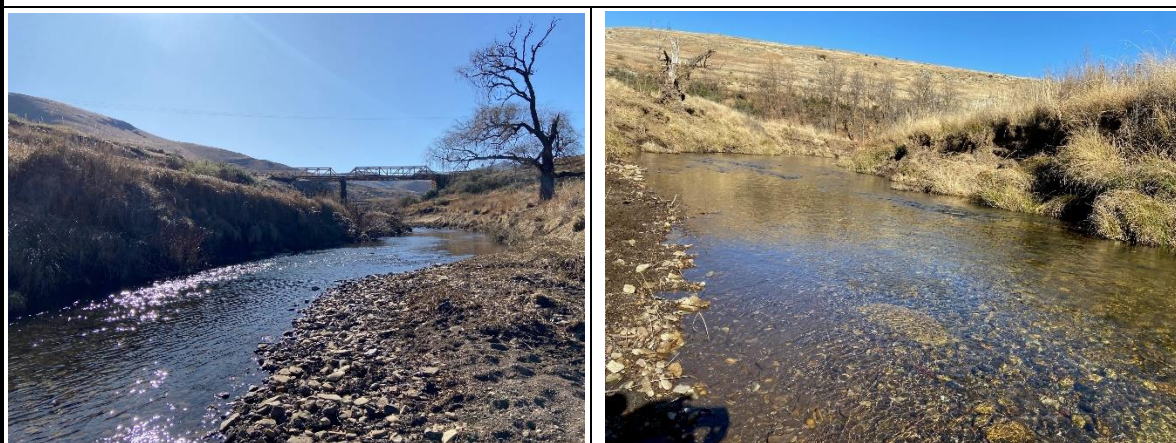
Figure 9-8: Site photographs of the Bell field verification site

Upstream	Downstream
<b>Site Description:</b>	
<p>The Bell River (although still named the Kraai according to PES, 2014), and which lies approximately 3km upstream from UO_EWR04_R (Upper Kraai River) is in an almost pristine condition with localised impacts. A large upstream bridge has been constructed on solid boulders and bedrock foundation, although some head cut erosion taking place on the left bank of the bridge. There is scouring and bank erosion on both banks going downstream, the recent floods being a contributing factor coupled with on-going widespread cattle grazing and trampling. Gravel and cobble bars are common along the reach. The riparian zone is intact, mostly covered with grasses, shrubs (blackjacks) and trees (<i>Salix sp.</i>) along the reach.</p> <p>The river comprises various sections of riffles and pools up and downstream of the bridge. All biotopes for the macroinvertebrates are present, SIC, SOOC, GSM, although vegetation is limiting owing to undercut banks and vegetation die-back. Localised algae covering the SIC biotope. For fish, there is FD, SS and FS habitats.</p> <p>The land use is predominantly farmlands, with small croplands and widespread cattle grazing.</p>

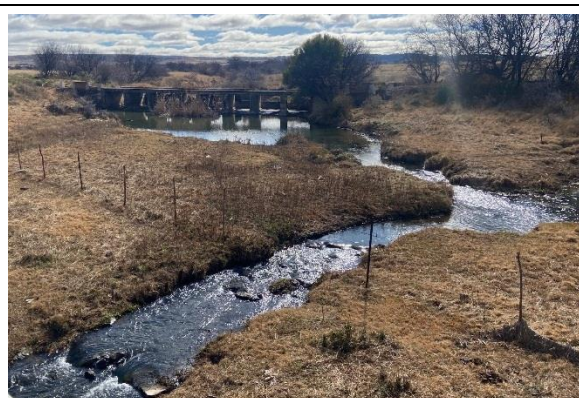
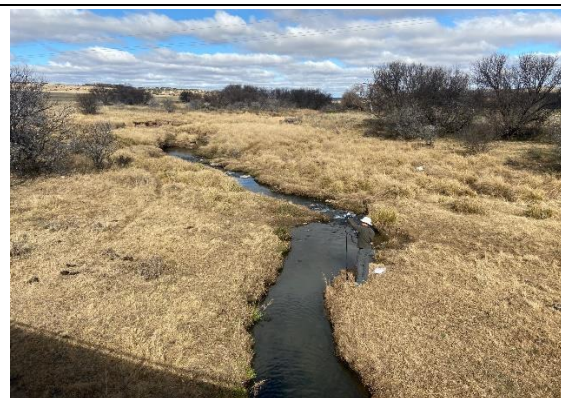
Figure 9-9: Site photographs of the Groenspruit field verification site

Upstream	Downstream
<b>Site Description:</b>	
<p>The site is located off the N6 road on the 1036/1981 bridge (main bridge), downstream of Smithfield. The Groenspruit is a tributary of the Skulpspruit, which is a tributary of the Caledon River within a partly confined floodplain setting. Several small farm dams upstream. A derelict bridge is located just upstream of the main bridge, causing a blockage of vegetation debris, a restriction of flow and thus the river pools at this area. Downstream of the main bridge the channel narrows to approximately 1.5m wide, with head-cut erosion occurring along both banks downstream.</p> <p>The habitats available for macroinvertebrate include SIC, SOOC, GSM and no marginal vegetation owing to undercut banks and vegetation die back. Some algae are smothering the SIC biotope. Fish habitats include SS, SD and FS. The riparian zone is dominated by grasses and shrubs, but trees are limited.</p> <p>The land use is predominantly open lands, low-intensity agriculture with some croplands and cattle grazing areas.</p>

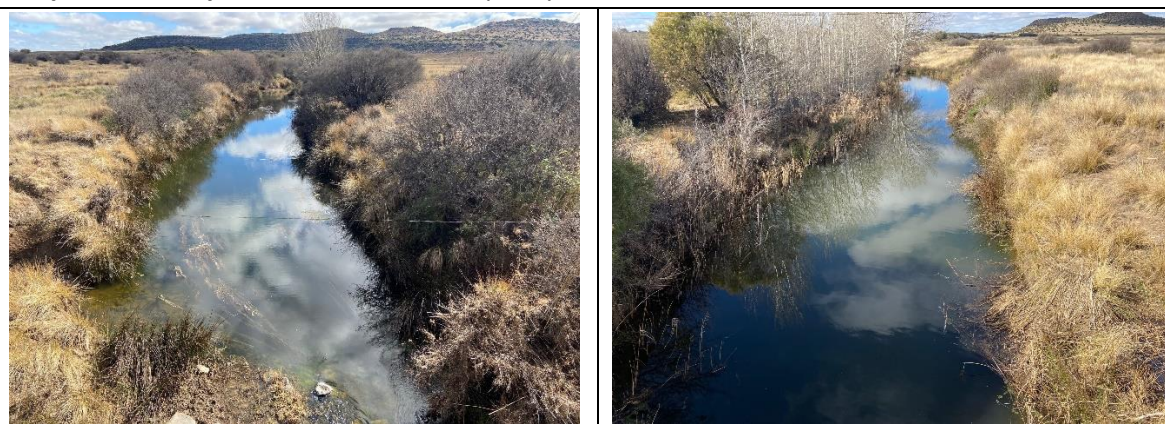
**Figure 9-10:** Site photographs of the Skulpspruit field verification site

Upstream	Downstream
<b>Site Description:</b>	
<p>The site is situated off the R701 at a single high-water bridge crossing. The Skulpspruit is a tributary of the lower Caledon River with small in-stream farm dams upstream, primarily low-intensity agricultural activities. The river is located within a partly confined floodplain setting. The channel is ~10 m wide and relatively homogenous up and downstream of the bridge. There is a small diversion where the channel has several sections of riffles with SIC and SOOC biotopes for macroinvertebrates. The increased flow has allowed aquatic grass to establish in the deep runs. Marginal vegetation was limiting owing to undercut banks and vegetation die-back/erosion. The habitats available for fish comprise SD, SS, FD and FS. The riparian vegetation is relatively intact with grasses, shrubs, as well as trees (both indigenous – <i>Searsia lancea</i> (Karee) and some alien <i>Salix sp</i> and <i>Acacia</i> (wattle)).</p> <p>The land use is predominantly open lands, low-intensity agriculture with some croplands and cattle grazing areas.</p>

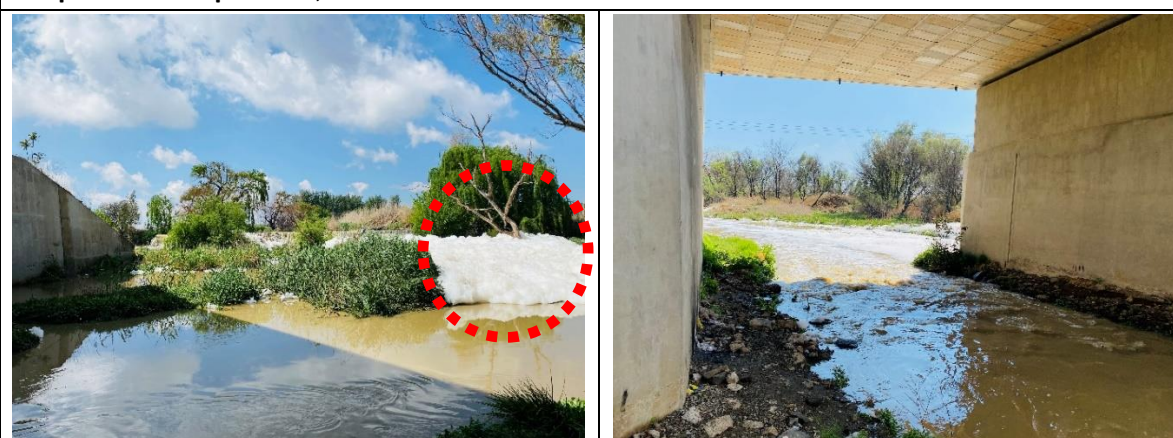
**Figure 9-12:** Site photographs of the Renoster field verification site (The red dotted line indicates the foam, indicative of raw sewage)

Upstream	Downstream
<b>Site Description:</b>	
<p>This site is located off the N8 road. It is a tributary of the Modder River. The reach receives return flows from the semi-formal settlements upstream and a number of WWTWs in the Bloemfontein area.</p> <p>During the site visit the flows were very high due to heavy rains the previous day. Some smaller dams are situated in smaller tributaries and some abstraction for irrigation occurs just upstream of the site.</p>	
<b>Site impacts:</b>	
<ul style="list-style-type: none"> <li>• Upstream dysfunctional WWTWs and high return flows</li> <li>• Upstream urban/ semi-urban activities</li> <li>• Upstream dams and irrigation</li> </ul>	
<b>Preliminary Results</b>	
<p><i>In situ</i> water quality: Not taken (probable health hazard; sewage smell and foam on the water surface)</p>

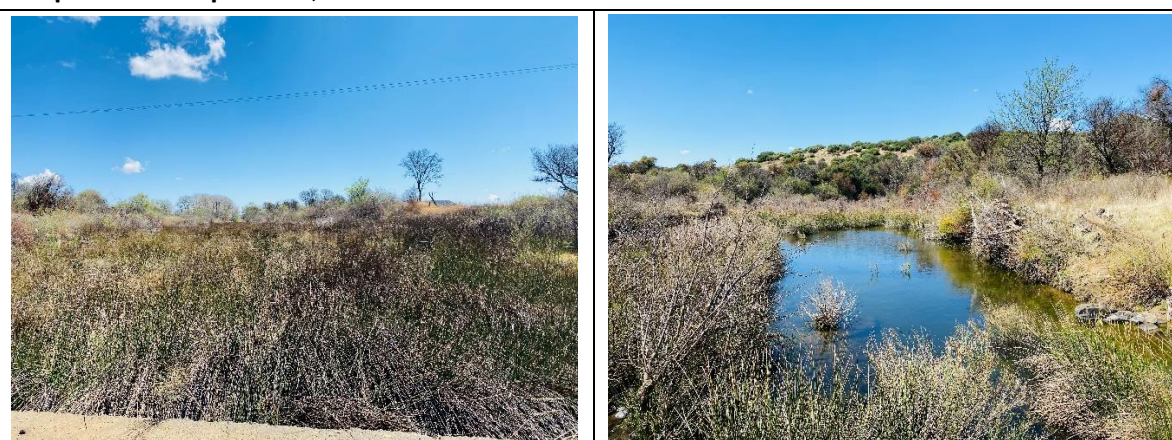
Figure 9-13: Site photographs of the Os-spruit field verification site

Upstream		Downstream		
<b>Site Description:</b>				
This site is located off the R717 road off the N1 near Bloemfontein. It is a tributary of the Modder with a low-level stream crossing over the site. The reach is densely populated with vegetation i.e., <i>Phragmites</i> sp. and water remains in pools during the dry season when there is little flow.				
<b>Site impacts:</b>				
<ul style="list-style-type: none"> <li>• Water quality</li> <li>• Irrigation</li> <li>• Cattle farming</li> </ul>				
<b>Preliminary Results</b>				
<i>In situ</i> water quality: Not taken				
Discharge: Not taken				
<b>DIATOMS</b>				
No. species	SPI	Categorisation (quality)	%PTV	%Deformed cells
33	12.8	C (Moderate)	4.5	0.25
<b>Dominant Species</b>		<i>Epithemia sores</i> Kützing

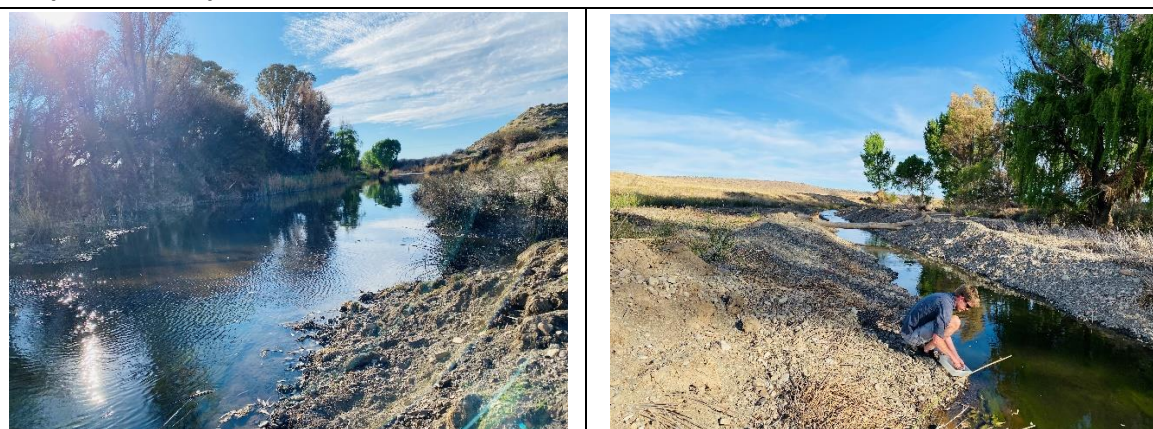
**Figure 9-16:** Site photographs of the Slykspruit field verification site

This site is located off the R701 road towards Bethulie. It is a tributary of the Caledon River, located upstream of Gariiep Dam. Water in the channel was slow-moving on the day of the verification as a result of back flooding from downstream. Diatom samples were taken from rocks found close to the channel banks. Both banks show evidence of erosion and marginal vegetation was absent possibly due to cattle grazing.

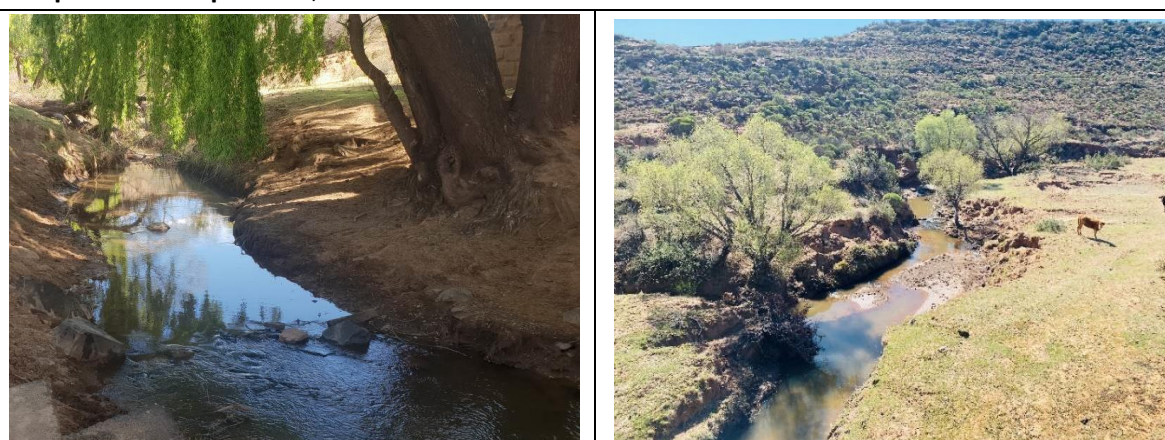
**Figure 9-18:** Site photographs of the Wasbankspruit field verification site

Upstream	Downstream
<b>Site Description:</b>	
<p>The site is located northeast of Rossouw off the R396 road towards Barkly East. It is a tributary of the Kraai River. The reach has a partly confined valley setting and the channel is incised. Both banks show evidence of erosion and marginal vegetation was absent owing to undercut banks and grazing.</p> <p>The land use is rural development and cattle farming.</p>	
<b>Site impacts:</b>	
<ul style="list-style-type: none"> <li>• Cattle farming</li> <li>• Cultivation</li> <li>• Limited Irrigation</li> <li>• Rural development</li> </ul>	
<b>Preliminary Results</b>	
<i>In situ</i> water quality: Not measured

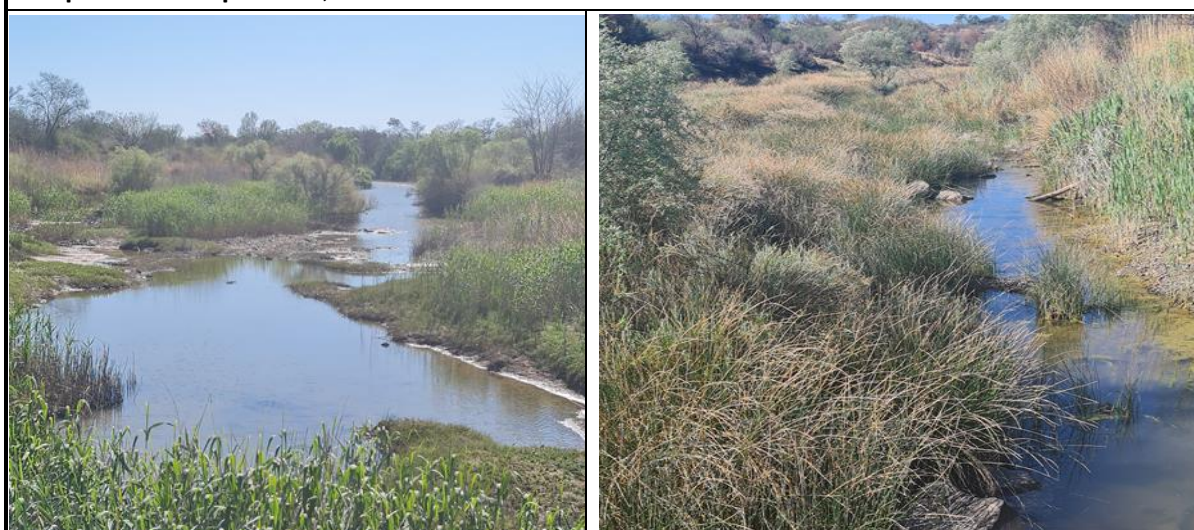
**Figure 9-19:** Site photographs of the Lower Modder field verification site

Upstream	Downstream			
<b>Site Description:</b>				
The site is located approximately 30km downstream of Krugersdrift Dam. The channel is 50m wide. Numerous weirs in this reach for the abstraction of water for mainly irrigation purposes. Substrates observed were boulders, cobbles and gravels. The downstream reaches were vegetated with grasses and sedges. The primary land use is cultivation.				
<b>Site impacts:</b>				
<ul style="list-style-type: none"> <li>• Weirs</li> <li>• Irrigation</li> </ul>				
<b>Preliminary Results</b>				
<i>In situ</i> water quality: Not measured				
Discharge: Not measured				
<b>DIATOMS</b>				
<b>No. species</b>	<b>SPI</b>	<b>Categorisation (quality)</b>	<b>%PTV</b>	<b>%Deformed cells</b>

Recommended Ecological Category	
C	<ul style="list-style-type: none"> <li>Limited options to improve flows due to various weirs in the system and Krugersdrift Dam upstream.</li> <li>The aim must be to improve water quality through catchment management practices.</li> <li>Water quality and flow-sensitive aquatic macroinvertebrates present under reference conditions namely Leptophlebiidae and Tricorythidae.</li> </ul>

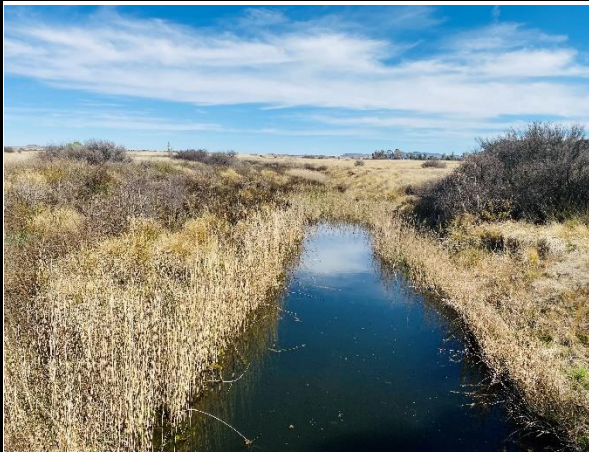
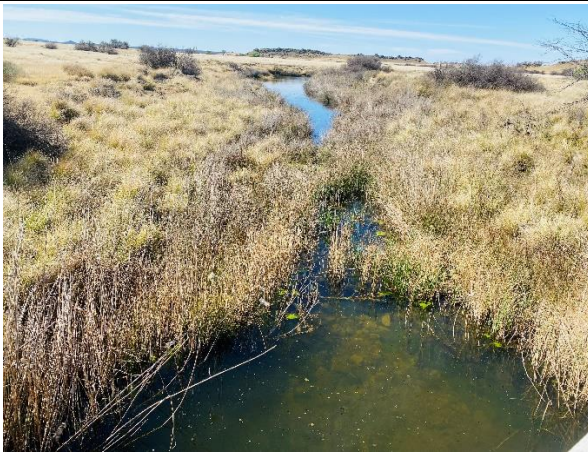
<b>Figure 9-20:</b> Site photographs of the Upper Kromellenboog field verification site			
<b>Upstream</b>		<b>Downstream</b>	
<b>Site Description:</b>			
<p>The site is located at a low water cross-over bridge located off the R717 road approximately 10km outside of Trompsburg. The Kromellenboog is a tributary of the Riet. The reach is located along a partly confined valley setting with a straight to sinuous macro channel plan format. At the time of the site visit, the river was flowing low with high water marks visible on the banks. The riverbanks are vegetated with grasses, sedges and <i>Phragmites</i> sp.</p>

<b>Site impacts:</b>			
<ul style="list-style-type: none"> <li>• Irrigation</li> <li>• Cultivation</li> <li>• Game farming</li> <li>• Small-scale cattle farming</li> </ul>			
<b>Preliminary Results</b>			
<i>In situ</i> water quality: Not measured			
Discharge: Not measured

Recommended Ecological Category	
<b>B</b>	<ul style="list-style-type: none"> <li>Instream and riparian habitat integrity continues to be stable.</li> <li>Small system with few impacts and can be improved through catchment management practices.</li> </ul>

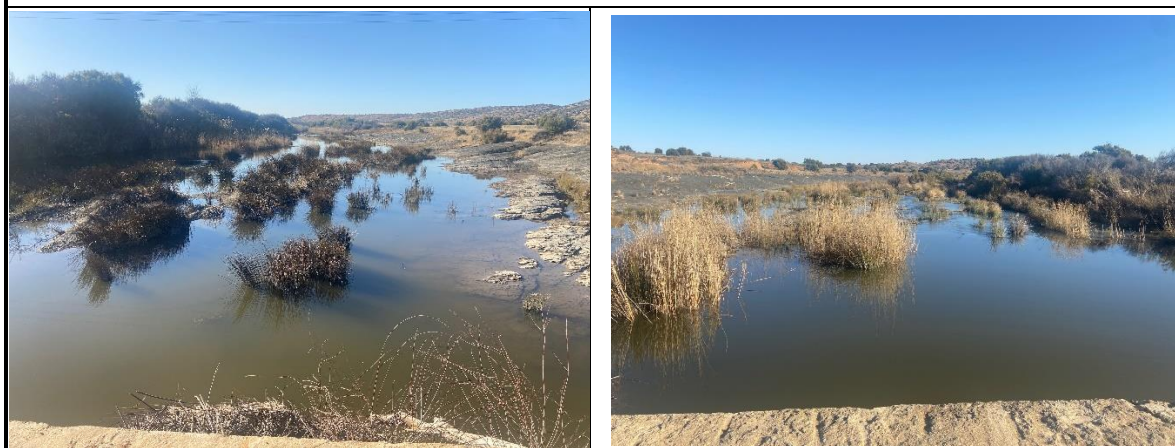
**Figure 9-21:** Site photographs of the Lower Kromellenboog field verification site

All biotopes are present for macroinvertebrates, which include SIC (which also comprised broken down slate bedrock), SOOC, GSM and both in-stream (including freshwater alien invasive macrophytes – i.e., *Azolla filiculoides* (red water fern)) and marginal vegetation. Some fine silt and algal growth predominantly over the SIC biotope. Fish habitats include SS, SD and FD.

Recommended Ecological Category	
B/C	<ul style="list-style-type: none"> <li>Instream and riparian habitat integrity continues to be stable</li> <li>Water quality must be improved by appropriate catchment management practices; aquatic macroinvertebrates with a preference for good water quality will establish within the reach, improving the overall ecological category of the macroinvertebrate assemblage</li> <li>Ecological Importance was revised to High</li> </ul>

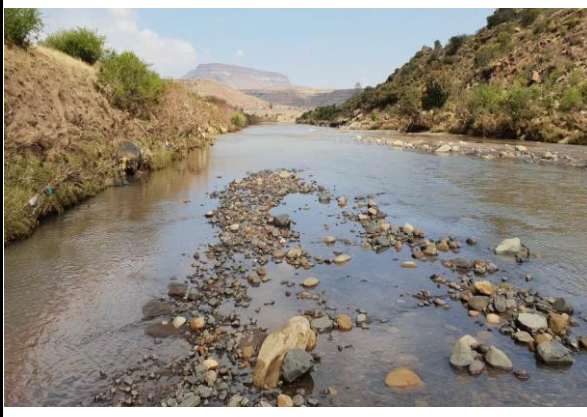
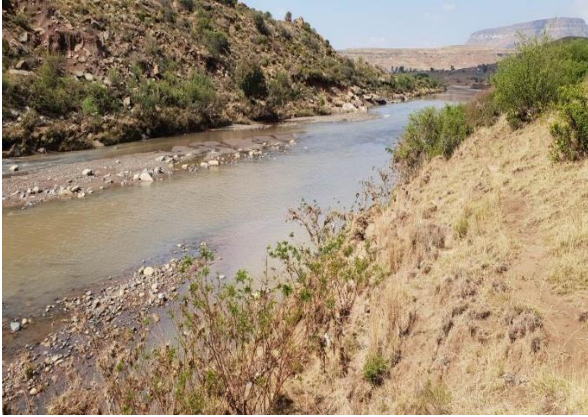
<b>Figure 9-22: Site photographs of the Tele field verification site</b>			
<b>Upstream</b>		<b>Downstream</b>	
<b>Site Description:</b>			
<p>This site is located off the R393 road just outside of the town Tele on the Southwestern border of Lesotho and South Africa. It is a tributary of the Orange River. The river reach is relatively straight, along a confined valley consisting of all aquatic biotopes, although at the time of the survey, the flow was high just after some heavy rains. Both banks showed evidence of erosion and marginal vegetation showing signs of cattle trampling, grazing and paths.</p>

<b>Site impacts:</b>			
<ul style="list-style-type: none"> <li>• Cultivation</li> <li>• Cattle grazing and trampling</li> <li>• Bank erosion</li> </ul>			
<b>Preliminary Results</b>			
<i>In situ</i> water quality: Not measured			
Discharge: Not measured			
<b>DIATOMS</b>			
No diatom cells present in the sample

Recommended Ecological Category	
C	<ul style="list-style-type: none"> <li>• Instream and riparian habitat integrity continues to be stable</li> <li>• Transboundary river, with most of the catchment within Lesotho</li> </ul>

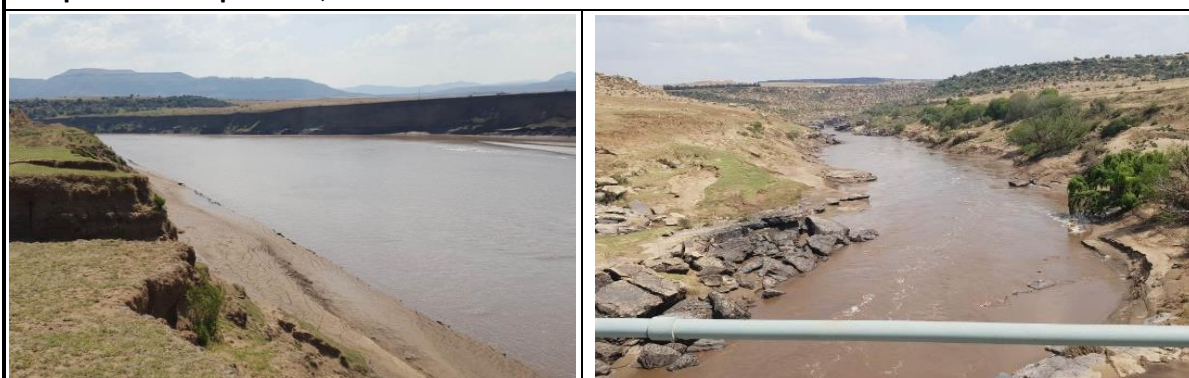
**Figure 9-23:** Site photographs of the Upper Orange River field verification site

This site is located off the R726 road on the main stem of the Orange River, just downstream of the confluence with a small tributary named Hendrik Smitstroom, adjacent to the town of Walaza. The river reach is a wide channel, along a confined valley dominated by bedrock. Extensive marginal vegetation clearing on both banks and severe bank erosion owing to poor catchment management practices, including sand mining and road cutting for vehicle access to the river (see site photographs below). The water is also highly turbid.
