## A High Confidence Reserve Determination Study for Surface Water, Groundwater and Wetlands in the Upper Orange

WP11343

### Eco-Categorisation Report VOLUME 1

REPORT NO.:  
RDM/WMA13/00/CON/COMP/1223 (a)  
August 2023

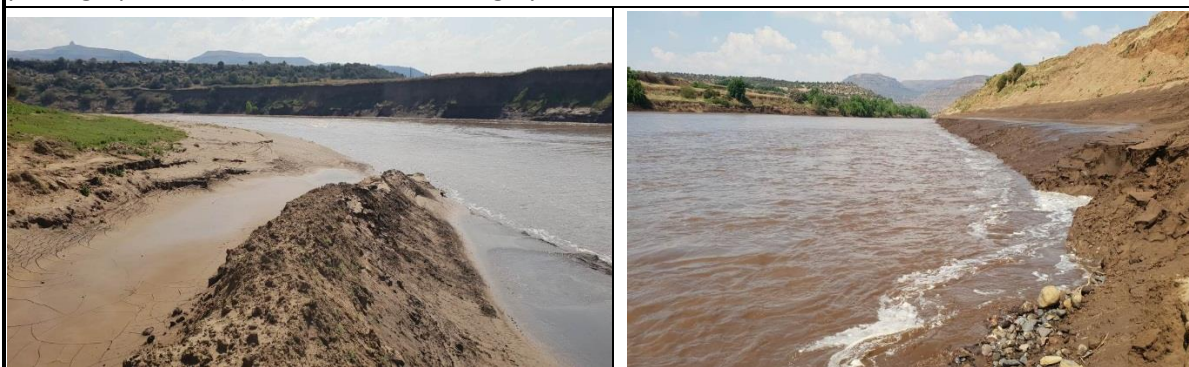
This site is located off the R726 road on the main stem of the Orange River, just downstream of the confluence with a small tributary named Hendrik Smitstroom, adjacent to the town of Walaza. The river reach is a wide channel, along a confined valley dominated by bedrock. Extensive marginal vegetation clearing on both banks and severe bank erosion owing to poor catchment management practices, including sand mining and road cutting for vehicle access to the river (see site photographs below). The water is also highly turbid.

<ul style="list-style-type: none"> <li>• Extensive sand mining</li> <li>• Cattle grazing and trampling</li> <li>• Extensive bank erosion</li> <li>• Dams in Lesotho changing flow regime</li> <li>• Riparian zone completely modified</li> </ul>
<b>Preliminary Results</b>
<i>In situ</i> water quality: Not measured
Discharge: Not measured
<b>DIATOMS</b>
High load of fine sediment, very few diatom cells present

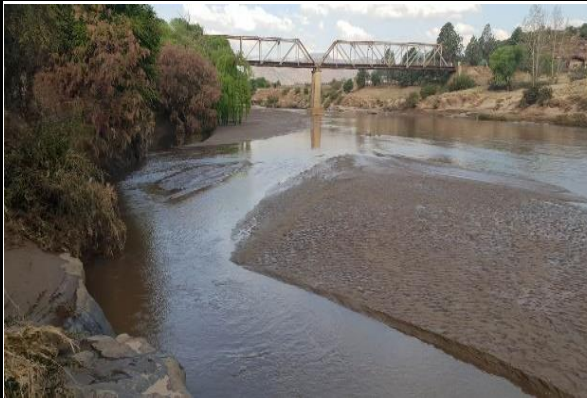
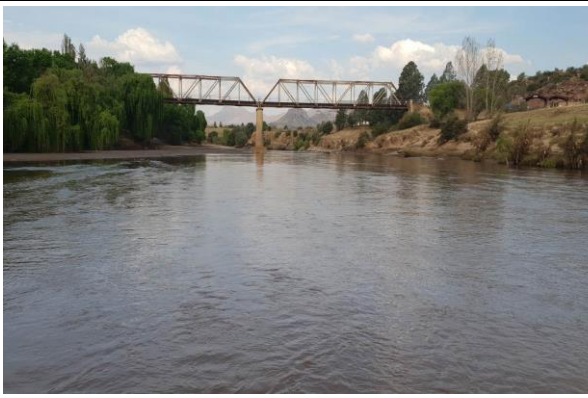
<b>Figure 9-24:</b> Site photographs of the Maghaleng field verification site			
<b>Upstream</b>		<b>Downstream</b>	
<b>Site Description:</b>			
<p>The site is located on the lower reaches of the Maghaleng River and is dominated by a muddy substrate with extensive bank erosion, particularly along the right bank. Limited aquatic biotopes are present due to high siltation caused by extensive catchment degradation. Furthermore, these sediment loads are contributing to channel widening along the system.</p> <p>Maghaleng River originates in Lesotho with overgrazing and trampling resulting in erosion and high sediment loads entering South Africa.</p>

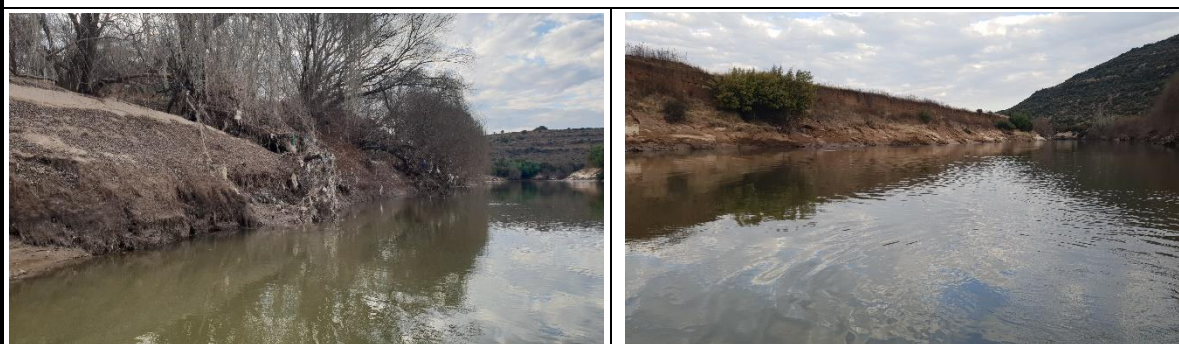
**Figure 9-25:** Site photographs of the Middle Caledon field verification site

The reach has a partly confined valley setting and a straight to sinuous macro-channel pattern. The active channel has a wandering planform, alternating between sand bars. The channel is deeply incised into the surrounding terraces, with a narrow active floodplain. The site is a wide and homogenous sand bed channel with limited habitat diversity. Localised fine to medium gravel bars form along the active channel. The inset benches were largely missing due to widespread bank erosion, with limited evidence of new benches forming. The banks are composed of fine sand and silt, steep and highly erodible. The banks have clusters of Salicaceae and Salix trees upstream and a heavy infestation of Populus sp. on the riverbanks downstream of the site. The river is ~50m wide and with some inundated sandbars along the channel. The water is turbid, and the riverbed has a high silt and clay content.

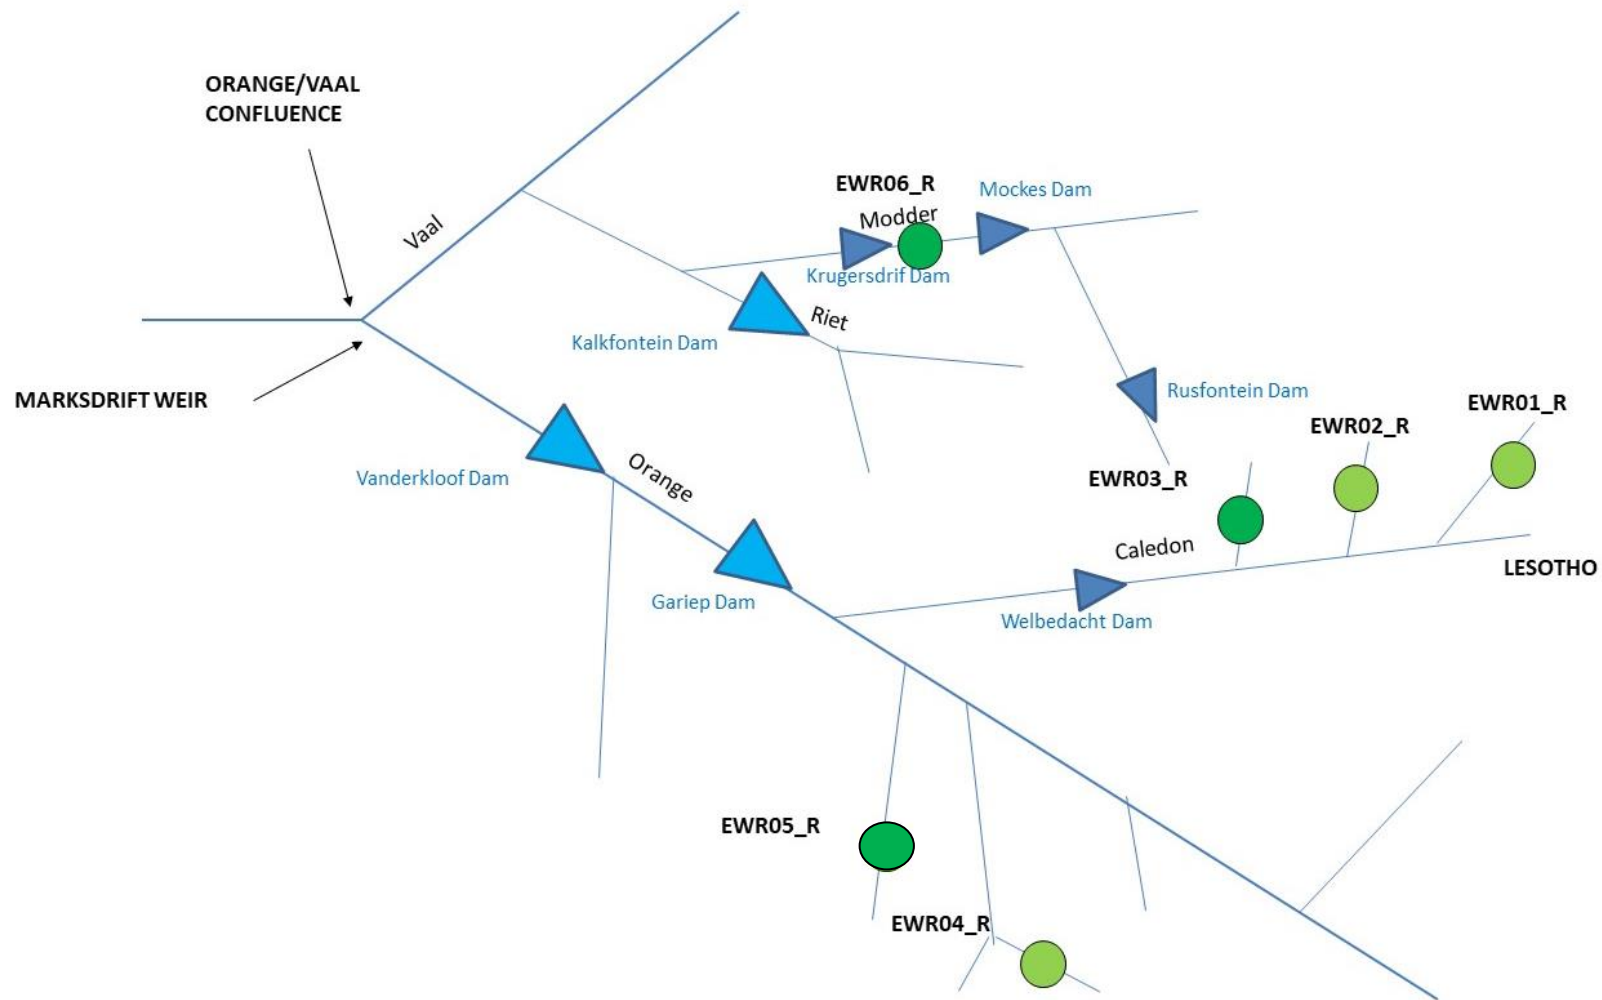
Figure 12-4: Summary of the PES trend for all Rapid 3 EWR sites
