DEPARTMENT OF WATER AND SANITATION

A High Confidence Reserve Determination Study for Surface Water, Groundwater and Wetlands in the Upper Orange

Scenario and Consequences Report

REPORT NO.:
RDM/WMA13/00/CON/COMP/1423
December 2023

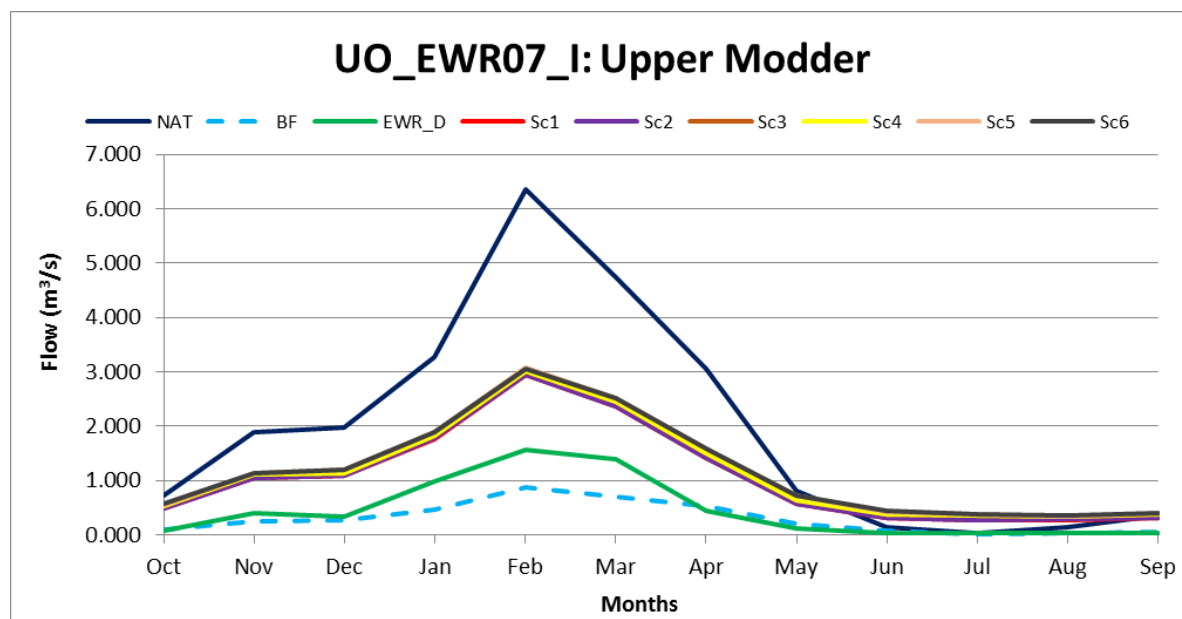
Figure 5-7: Seasonal distribution of scenarios at site UO_EWR07_I: Upper Modder

All the scenarios show reduced floods in the summer months, as the river is dependent on spills from the upstream Rustfontein Dam. Higher baseflows than natural in dry months due to the WWTW upstream that discharges into the Little Modder River. It should be noted that the Upper Modder was changed from a seasonal to a more perennial system due to return flows from upstream WWTW.

The seasonal distribution (hydrograph) plot was prepared using the flows provided for the scenarios and is illustrated in **Figure 5-7** below. The flow durations of the scenarios for the Upper Modder (UO_EWR07_I) for July (dry) and February (wet) are shown in **Table 5-44** and **Table 5-45**. The 'red' highlighted areas in the tables indicate where the EWR could not be met.

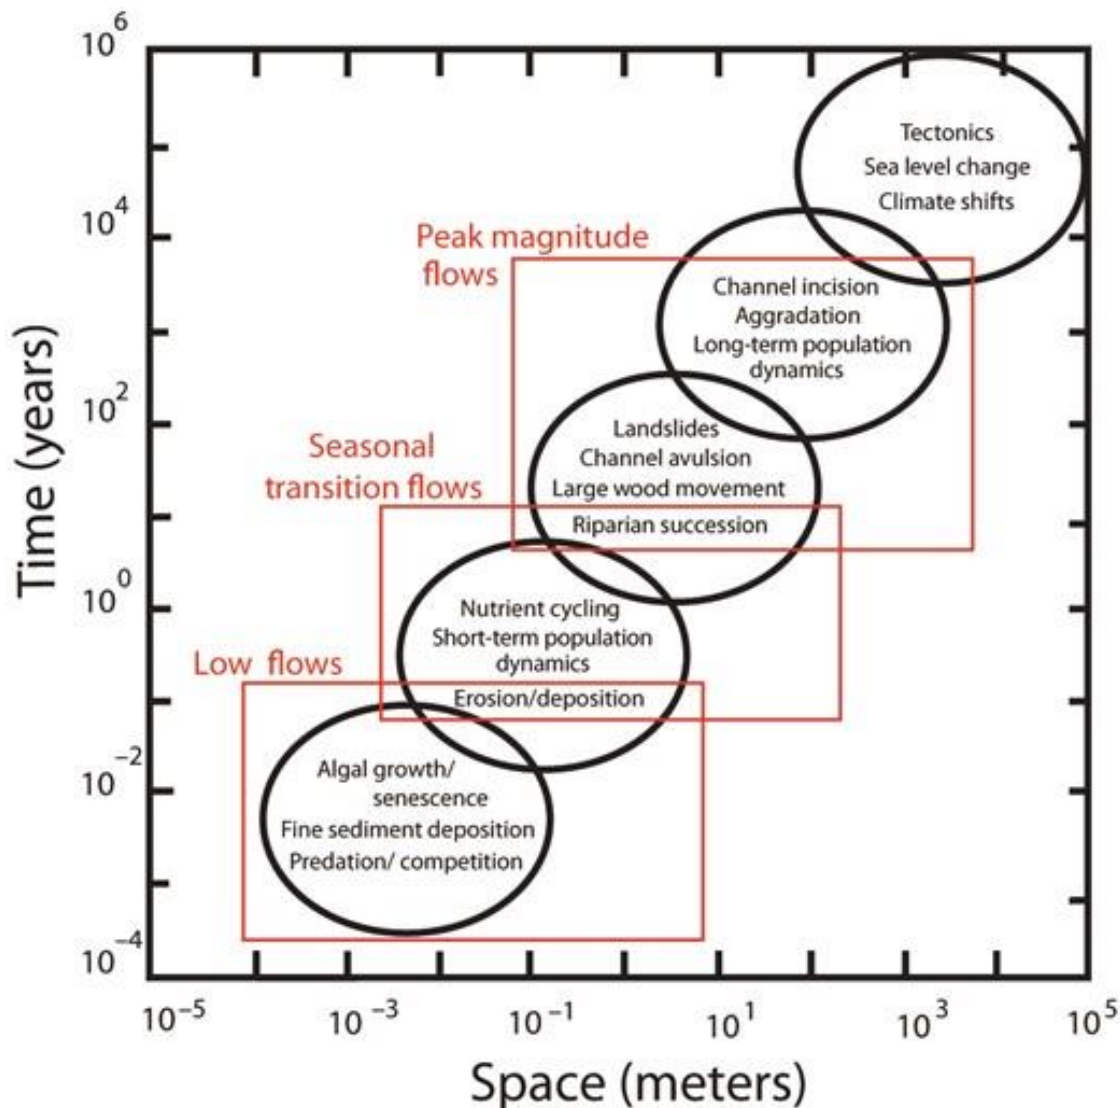
Figure 7-1: “Examples of interrelated physical and ecological riverine processes at varying spatial and temporal scales. Key functional flows supporting specific processes are shown in boxes.” – from Yarnell *et al.* (2015).

The interaction between the temporal and volume components of flow are illustrated by Yarnell *et al.* (2015) (**Figure 7-1**).

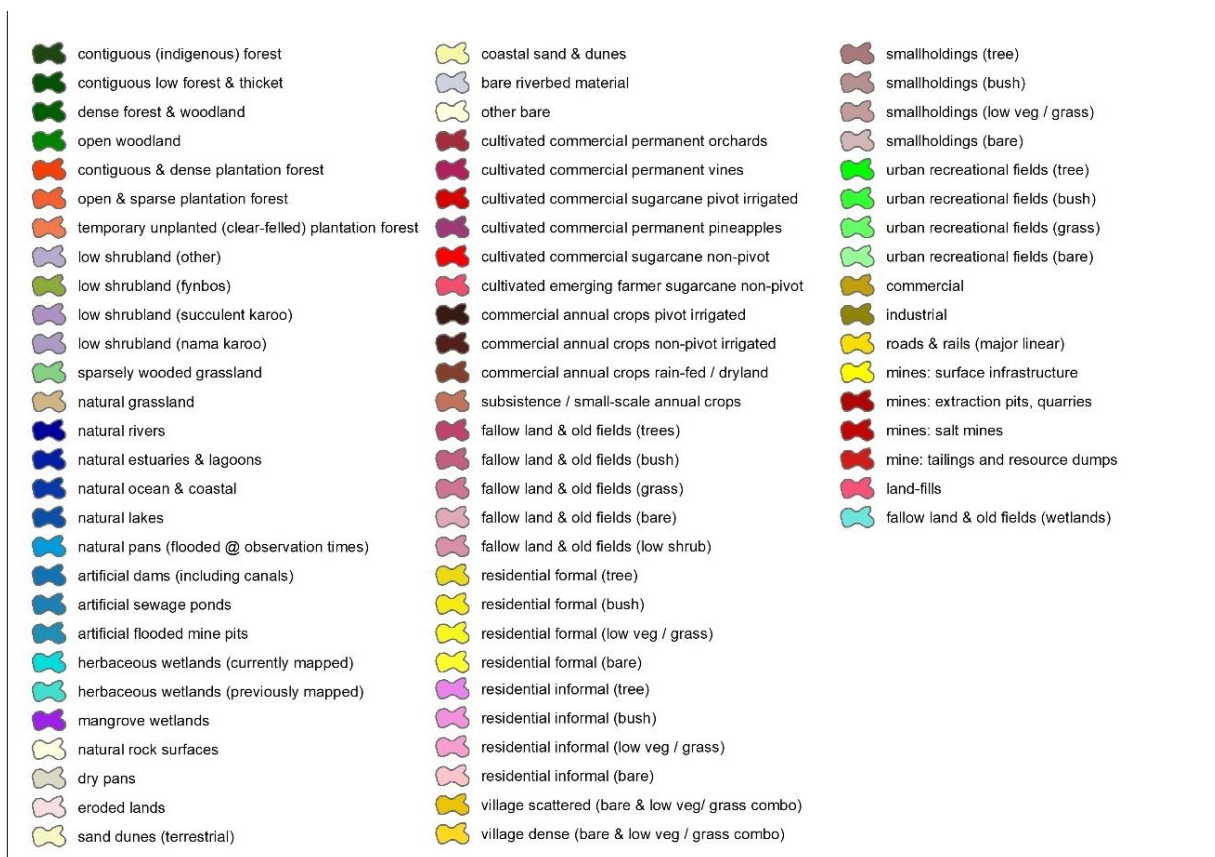
Figure A3: Legend explaining the colour coding for different land uses within the Upper Orange River catchment

Figure A10: Land-use and land cover profile within the catchment according to most recent (2020) land-use dataset available from the Department of Forestry, Fisheries, and the Environment (DFFE; https://egis.environment.gov.za/sa_national_land_cover_datasets). Land use data were not available for the parts of the Upper Orange River catchment within the Kingdom of Lesotho. For a detailed legend explaining colours, see Figure A3 below.
