# Comprehensive Reserve Determination Study for Selected Water Resources (Rivers, Groundwater and Wetlands) in the INKOMATI WATER MANAGEMENT AREA, MPUMALANGA

PROJECT NO: WP 9133

REPORT NO.: 26/8/3/10/12/009

**SABIE AND CROCODILE SYSTEMS: ECOCLASSIFICATION REPORT:  
FINAL**

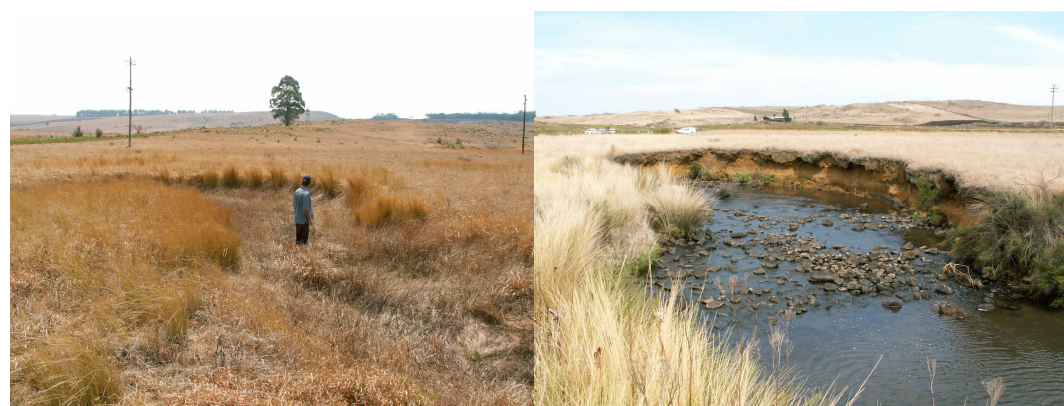
| <b>Morphology of the site</b> | <p>No good quality Google Earth imagery was available. The site is a typical meandering floodplain with ox-bow features on the floodplain. The floodplain consists of cut banks, advancing point bars and cut-off meanders. An oxbow lake is evident on the eastern flank of the floodplain. Aerial photograph analysis indicates that this predates 1956. No directional changes could be observed from the aerial photographs due to the large scale of the photographs and the narrow channel. The channel appears to have been straightened upstream of the site between 1956 and 1964. These changes are associated with agricultural activities which are evident at this time. Other localised impacts have arisen from the roads.</p> | | |

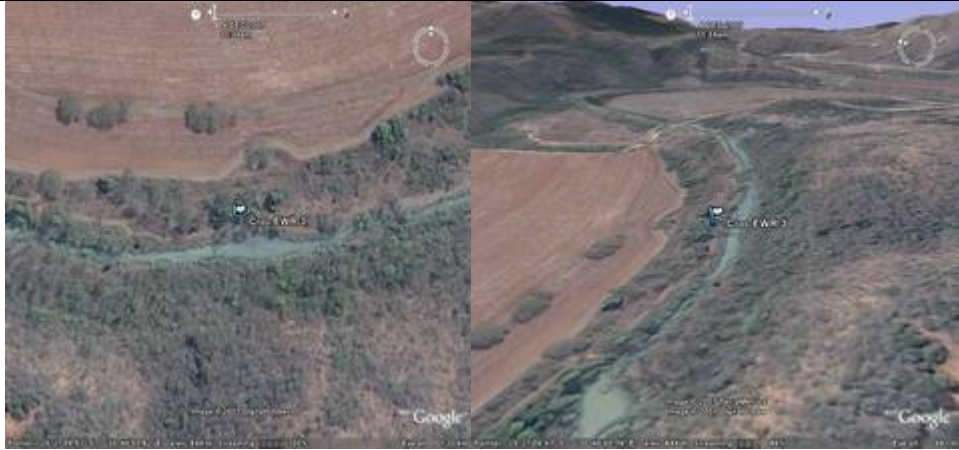
| <b>Morphology of the site</b> | Cut banks are present on both banks (water is very turbid), and channel narrowing is evident from the aerial photographs. The channel in this pool riffle site is incising in response to the clean water releases, as well as the prolonged elevated base flows which are being released from Kwena Dam. The active channel is composed of loose cobbles with some gravels and occasional fixed boulders. There are no fines anywhere along the reach in the channel and very few gravels (extremely coarse) are present. | | |

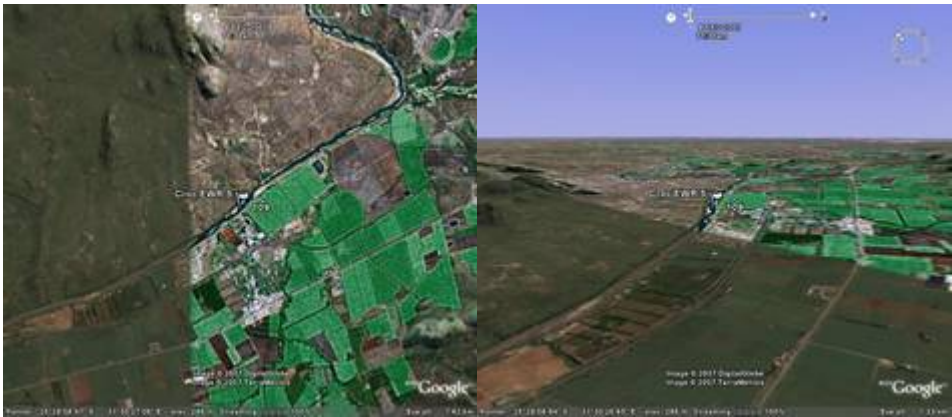
| | <p>EWR 5 is classified as an alluvial braided channel type and is representative of the macro-reach. The channel consists of an active channel inset into a wider macro-channel. The channel is alluvial, with sand dominating the bed. The bed is mobile, even under the lowest flow conditions. The channel morphology is currently characterised by vegetated mid-channel bar, lateral bars, in-channel benches and terraces. Riparian and in-channel vegetation (particularly reeds) play an important role in stabilizing the channel banks, and have an important effect on the sedimentation processes in the active channel.</p> | | |

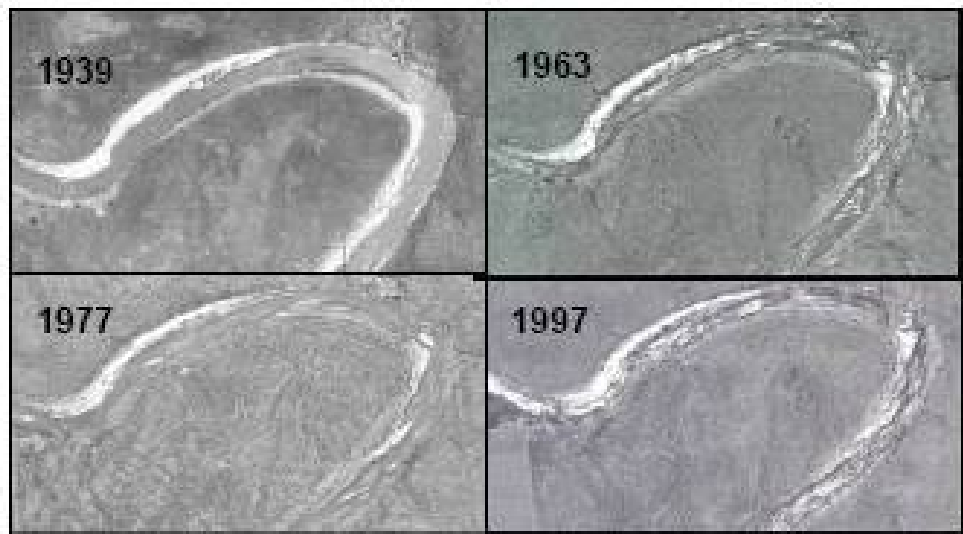
| Reference conditions | Conf |
|---|---|
| <p><b>Croc EWR site 6</b><br/>As with EWR Sites 4 and 5, aerial photographs indicate an increase in mid-channel bars and lateral bars, coincidental with colonisation by vegetation, suggesting a directional change towards more stable, vegetated morphological features. This is probably due to reduced floods.</p> | 3 |
| The reference state is a more open wider active channel, larger (wider) rapids and smaller bar areas. | |

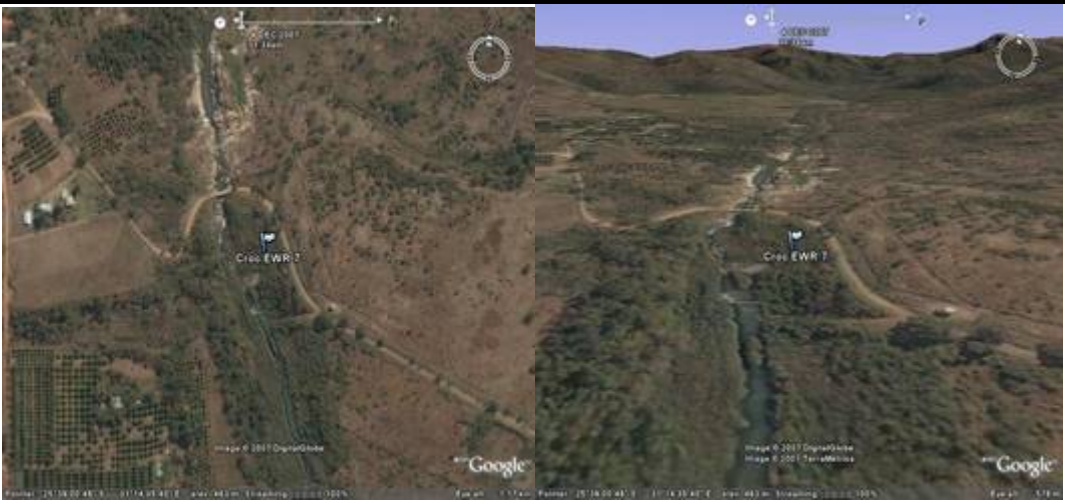
| <b>Morphology of the site</b> | <p>EWR 7 is classified as a bedrock gorge channel type and is representative of the Kaap River. The cross-section traverses a riffle. The strong bedrock influence means that the site is highly resistant to change so that little morphological adjustment is likely to occur in response to flow regulation. The bed material is predominantly cobble and boulder with very little sand and gravel. It is possible that upstream of the bridge there has been some enhanced sediment deposition at high flows due to flow constrictions through the narrow bridge crossing, and also associated with disturbance on the banks.</p> | | |

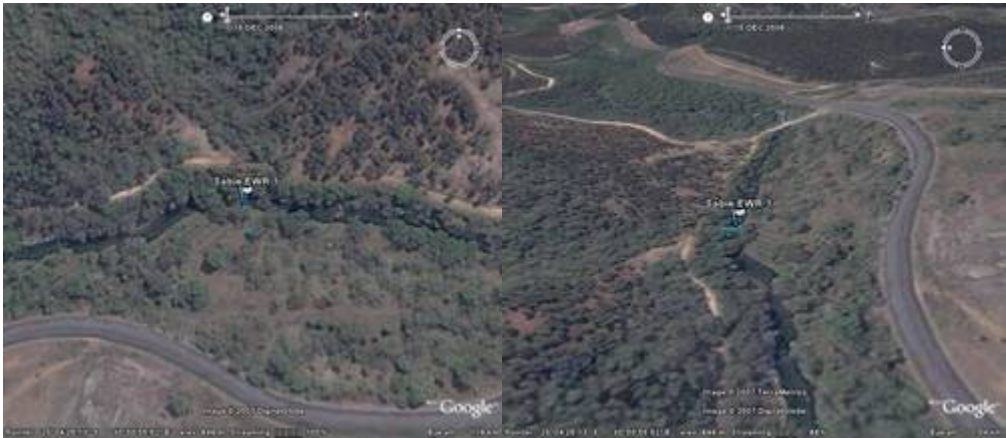
| <b>Site description</b> | <p>Upstream impacts upon the site include:<br/>Forestry;<br/>A few, small weirs and illegal abstraction, and<br/>Return sewage flows from Sabie town.<br/>Virgin MAR: 152 MCM; Present MAR: 115 MCM</p> | | | |
| | <p>The site is a pool-riffle system with a boulder/cobble bed and gravel and large sand component. It is possible that the sand component has increased due to upstream forestry activities and has led to a reduction in channel size. Aerial photos indicate an increase in woody vegetation cover. The riparian zone is heavily infested with exotic vegetation and has recently burnt prior to the site visit. The flood terraces are composed of fine sands and not paired, as one bank is a steep cut bank.</p> | | | |

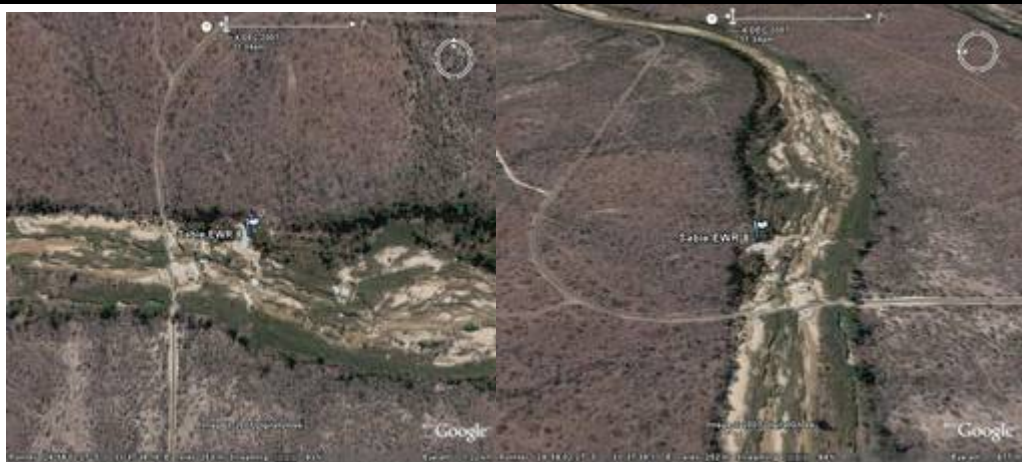
| Morphology of the site | This section is a mixed anastomosing channel type section and consists of multiple mixed (sandy with bedrock influence) channels across the macro-channel floor. There are sandy areas with large bedrock outcrops, extensive reed vegetation across the macro channel floor, and large sandy lateral bars in places. The increased sediment loads from the degrading catchment have likely caused an increase in sediment storage and likely reduction in instream habitat diversity, depth of channel and volume of instream habitat. This has been verified by independent unpublished rapid assessments of the condition of bedrock sections of the Sand River (Rountree, unpublished report for the Kruger National Park). | | |
