**THUKELA WATER PROJECT
DECISION SUPPORT PHASE**

RESERVE DETERMINATION MODEL

RESOURCE UNIT REPORT

January 2003

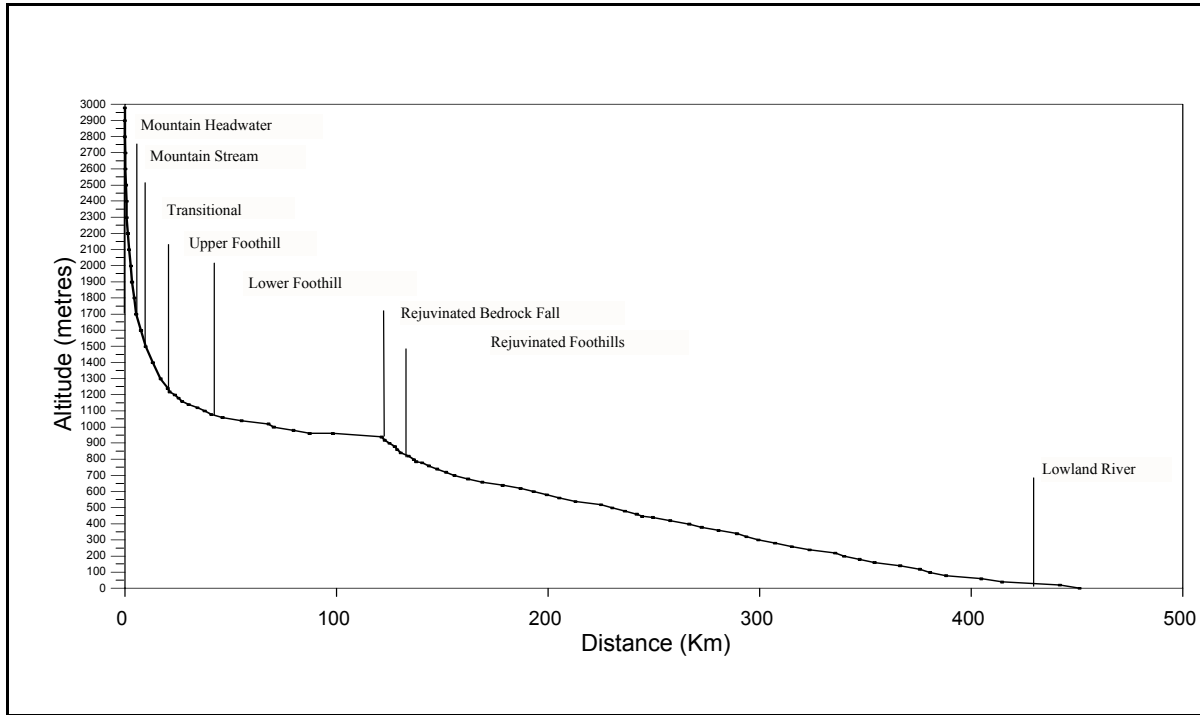
Figure 4.6a Longitudinal Profile of the Thukela River

Each of the major tributaries to be considered in this study have been analysed according to channel gradient and valley form. The longitudinal profiles together with the geomorphological zones are illustrated in figures 4.7a, b, c, d, e and f.

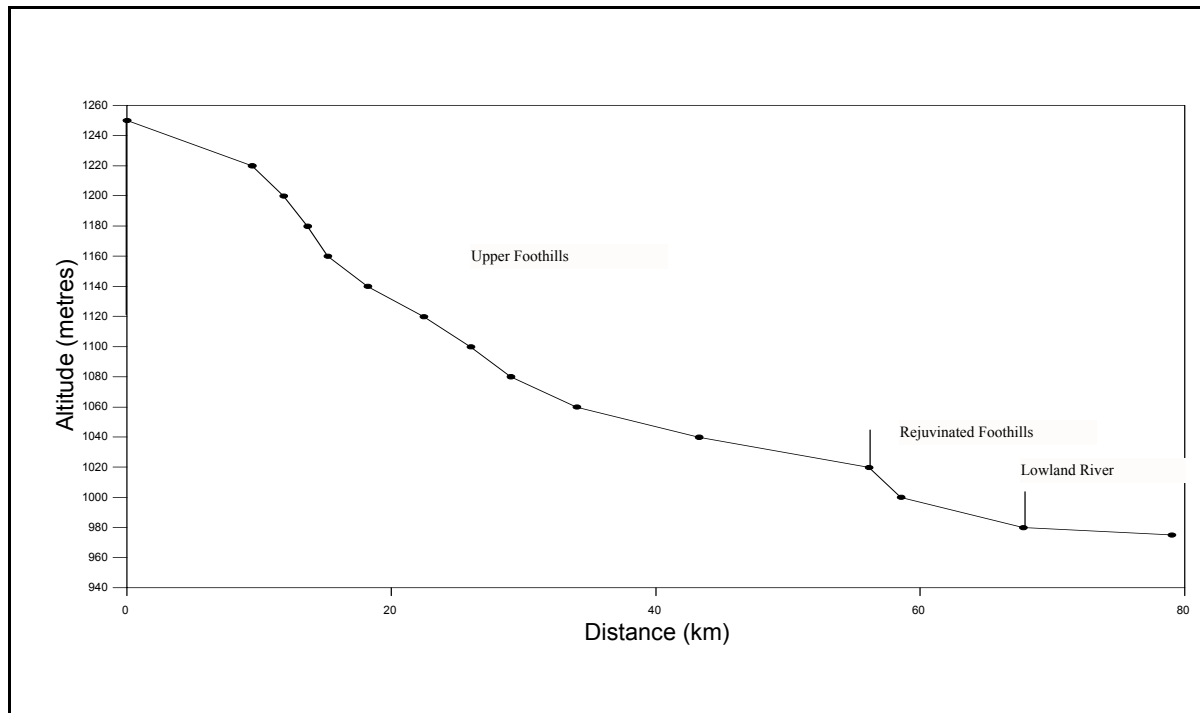
Figure 4.6b Longitudinal Profile of the Little Thukela River

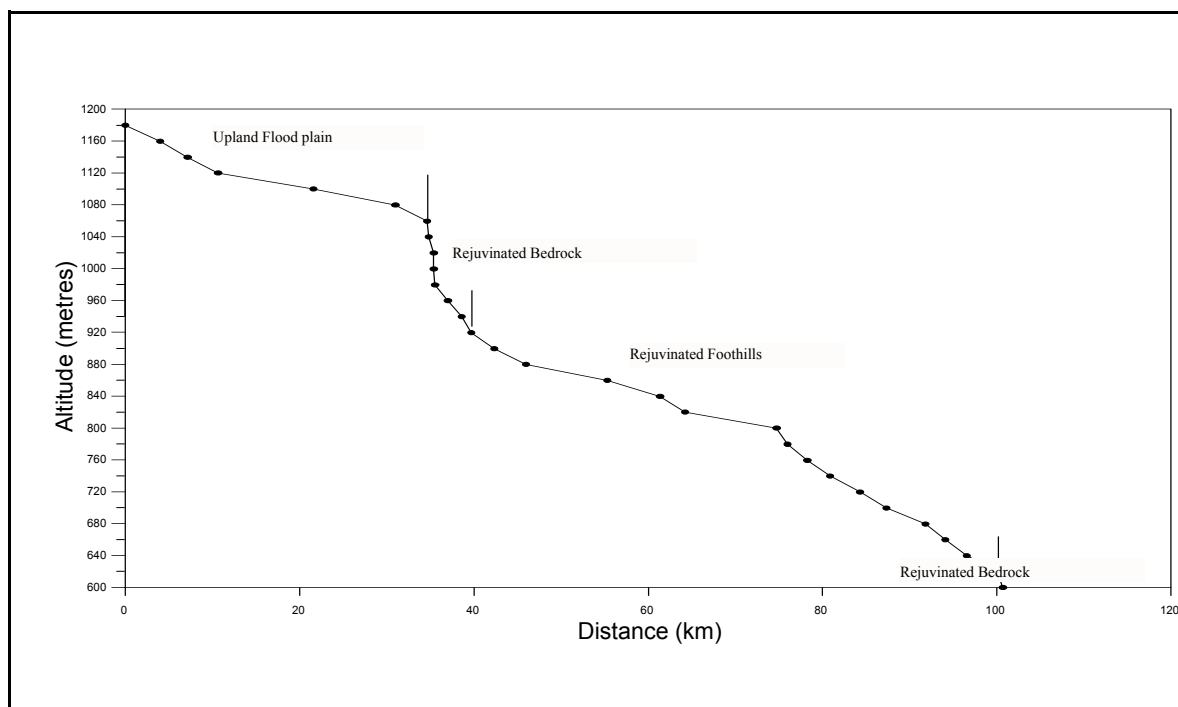
Figure 4.6d Longitudinal Profile of the Sundays River

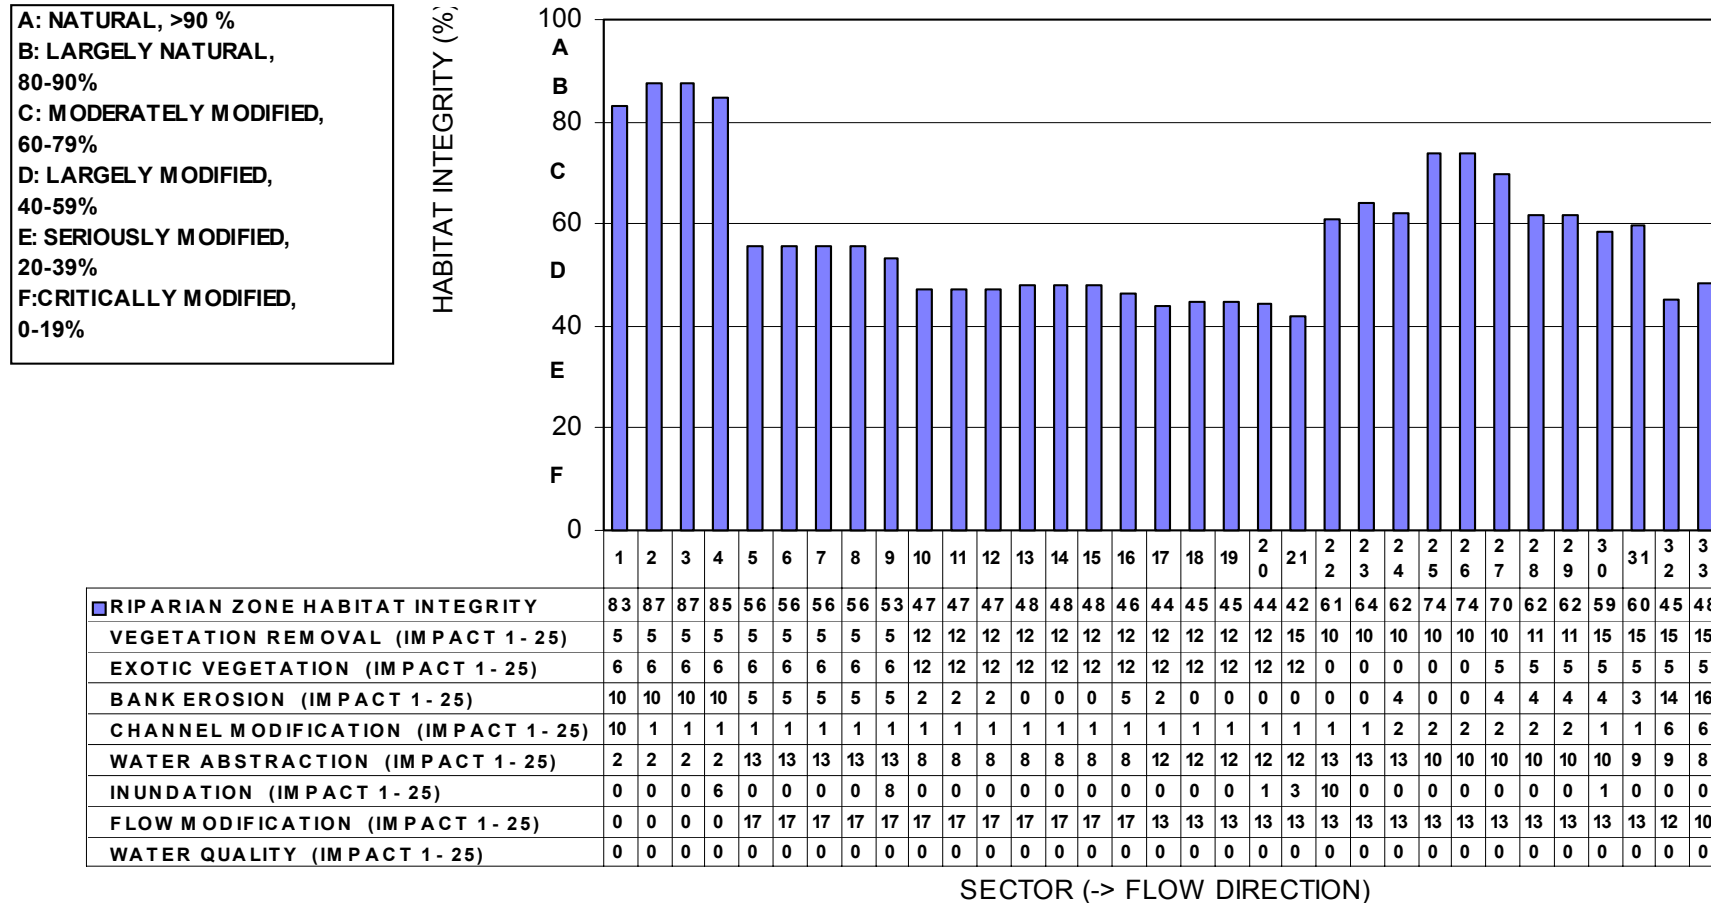
Fig 5.3: Upper Thukela River, Riparian zone Habitat integrity

The riparian zone of the Thukela River has been significantly impacted by the devastating force of large historical flood events which have left some areas without suitable substrate for the recolonisation of riparian vegetation. Bank erosion, resulting mainly from the impact of livestock activities, subsistence and formal agriculture, and the excessive utilisation of river resources has been significant in the further degradation of the riparian zone as well as serving to prevent its natural recovery after large floods. The riparian zone has also been impacted by the regulation and modification of the flow regime, which has largely resulted in the changes in the marginal zone habitats. Exotic riparian species have had a major impact on the availability of riparian habitats for indigenous trees and have therefore also retarded the natural recovery of the riparian zone.

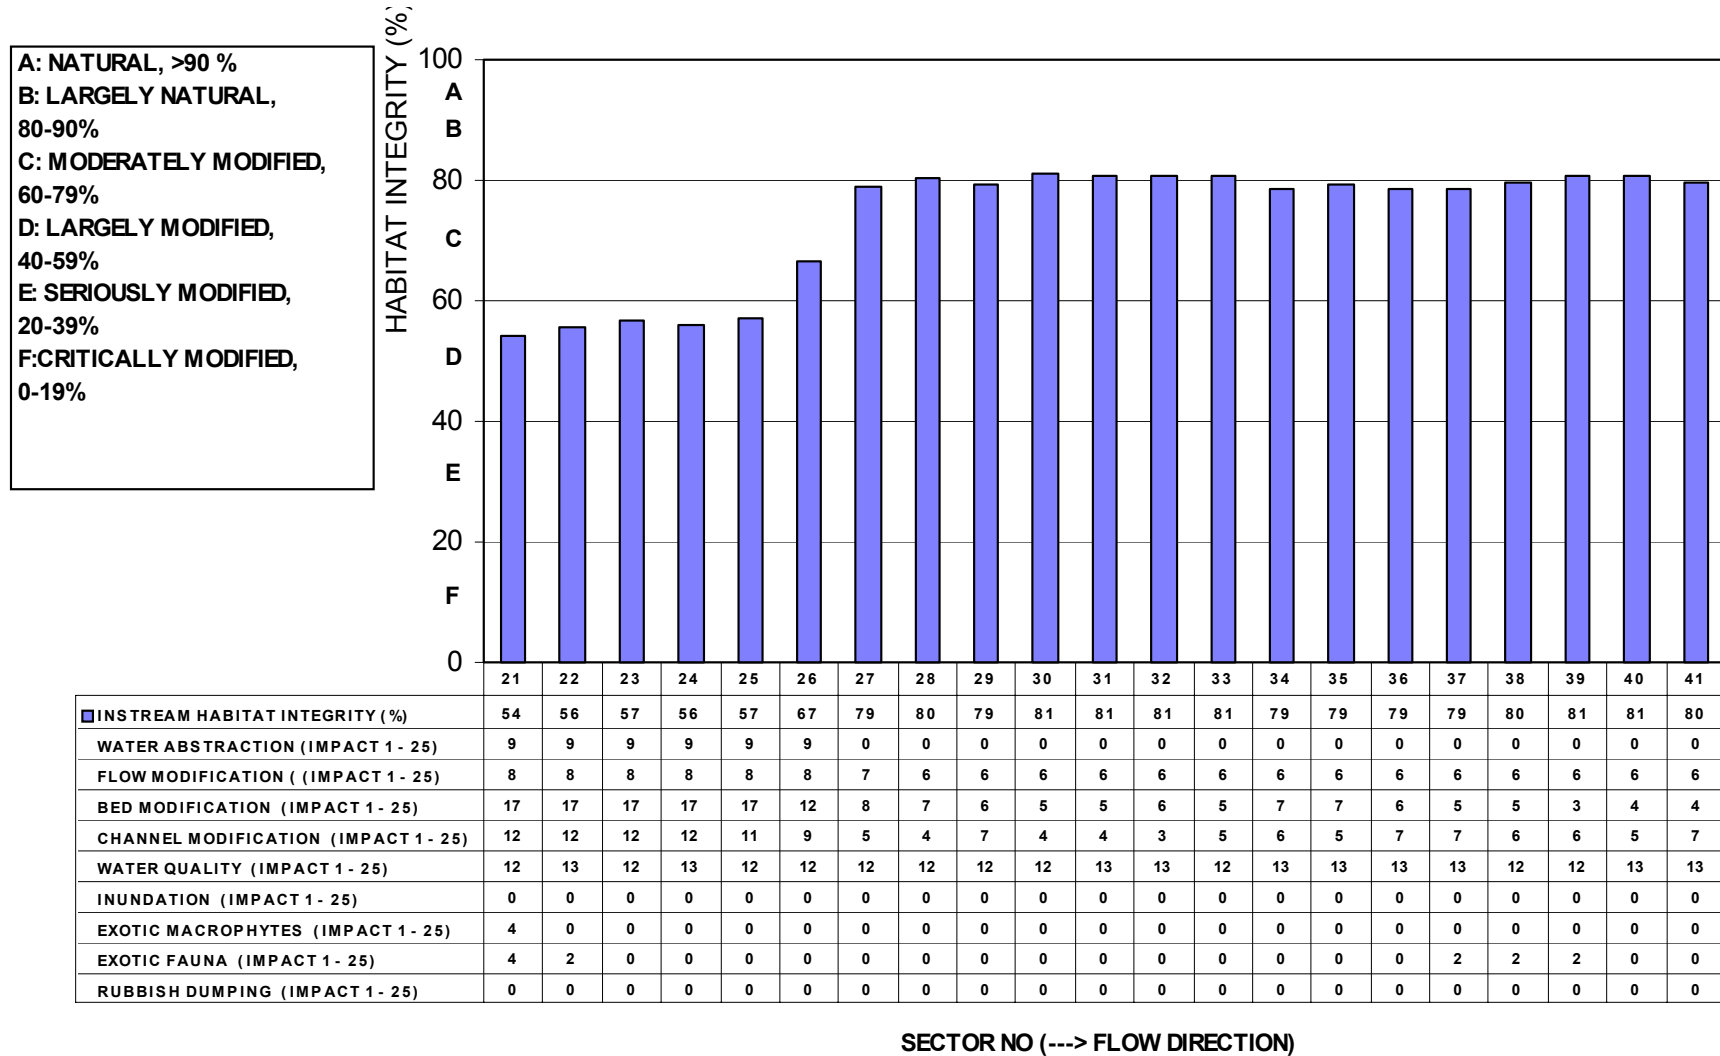
Fig 5.14: Lower Buffalo River, Instream Habitat Integrity

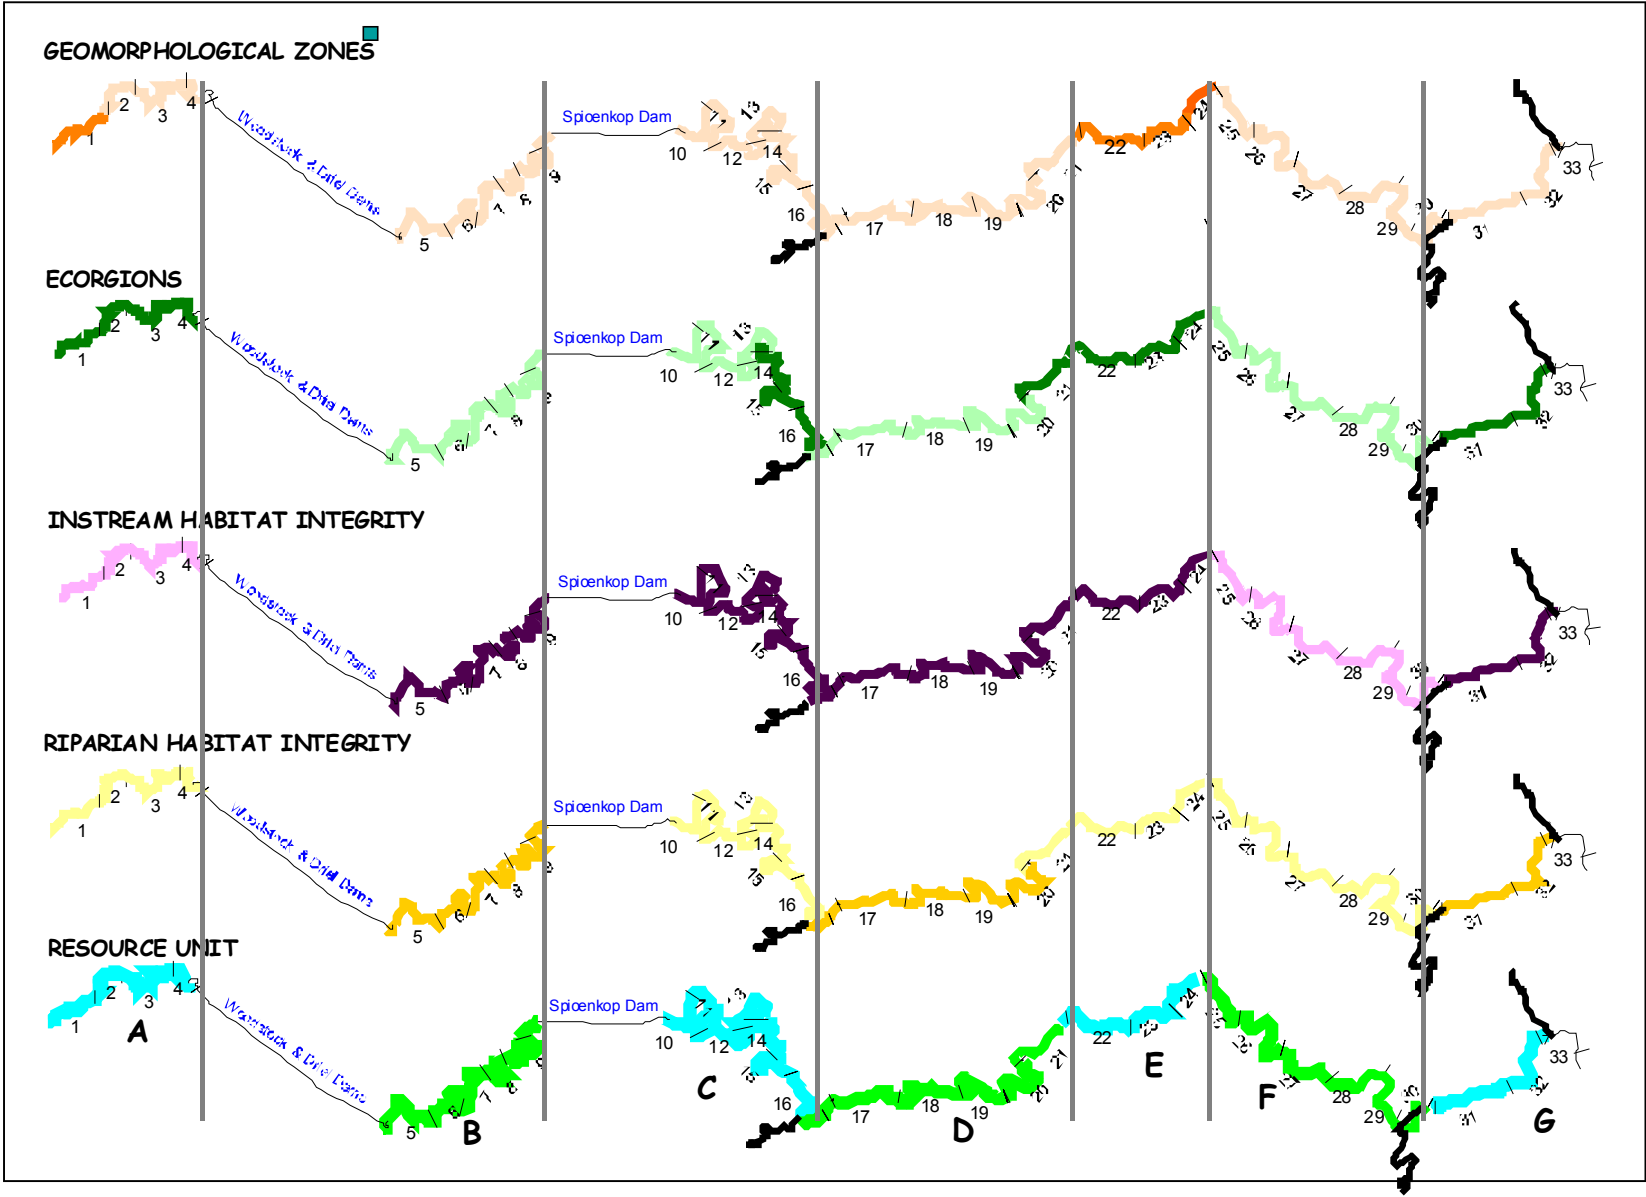
Fig 6.2 Upper Thukela: Comparison between geomorphological zones, ecoregions, instream and riparian Habitat Integrity

6.4.3 Resource Unit C: Segment 10 - 16 (Spioenkop Dam to Little Thukela confluence) (Figure 6.2)

Dams do not form part of the RU and RU C therefore starts at the Spioenkop Dam wall. For all the components considered, apart from the ecoregions, the stretch of river between Spioenkop Dam to the Little Thukela confluence forms a homogenous unit. Two different ecoregions occur within this zone, but due to the length of river concerned, as well as considering that all the other components are homogenous, it was decided that this RU would incorporate the two ecoregions. The Little Thukela confluence forms the break for the downstream ecoregion as well as a clear hydrological and operational break (attenuation of the Spioenkop Dam operation) and the Klein Thukela confluence therefore forms the logical end point of RU C.

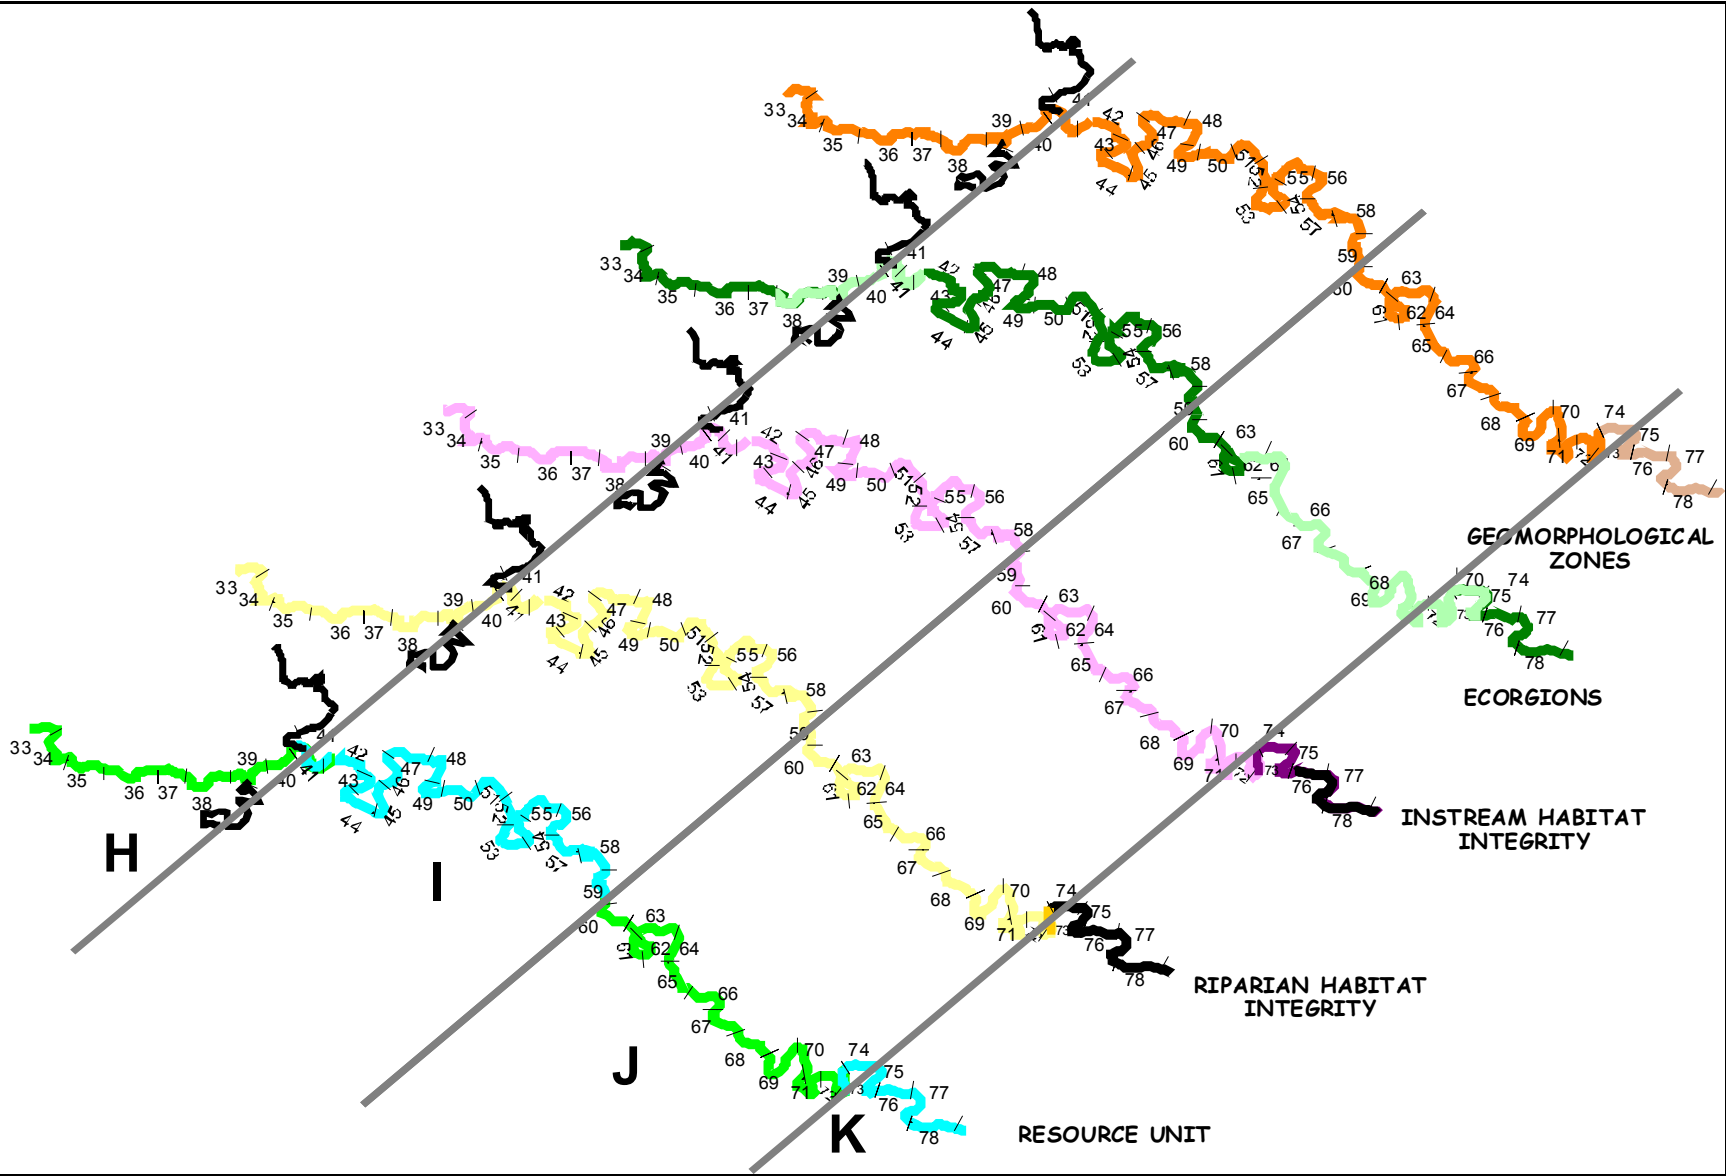
Fig 6.3 Lower Thukela: Comparison between geomorphological zones, ecoregions, instream and riparian Habitat Integrity

6.4.9 Resource Unit I: Segment 41 - 59 (Buffalo confluence to Middledrift) (Figure 6.3)

The RU I starts at the end of RU H, i.e. the Buffalo confluence. An ecoregion break occurs at approximately segment 61. Middle Drift which forms one of the few access points in this section of River as well as according to the local knowledge illustrates a change in River was selected as the end point of the RU. It was felt that the ecoregion break supported this as the resolution on the ecoregions are such that it cannot be pinpointed to an exact locality. The Middle Drift transfer scheme also provides motivation for this break considering operational units.

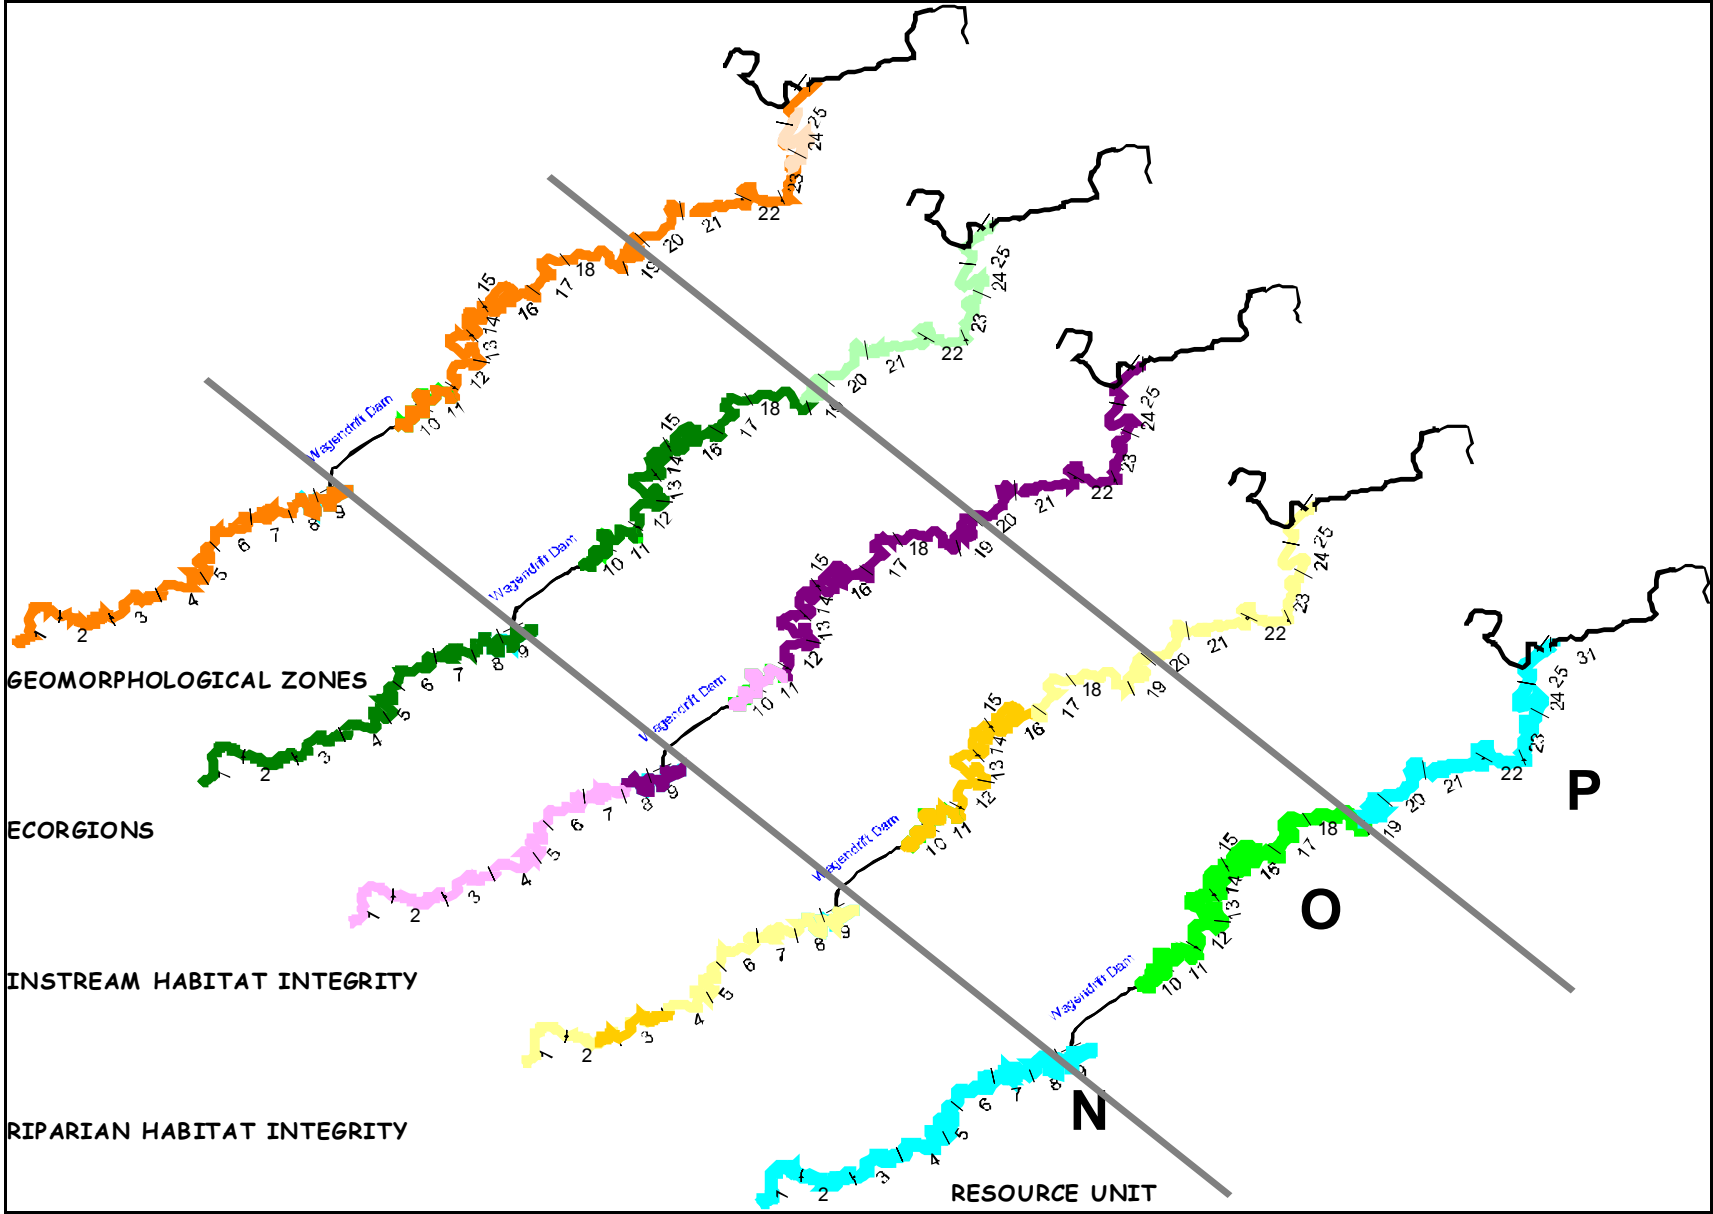
Fig 6.5 Bushmans River: Comparison between geomorphological zones, ecoregions, instream and riparian Habitat Integrity

6.4.16 Resource Unit P: Segment 19 - 25 (Lower Foothills to Thukela confluence) (Figure 6.5)

This RU starts at the end of RU O, i.e. segment 19 and ends at the Thukela confluence. No significant changes in this unit are illustrated by any of the components.

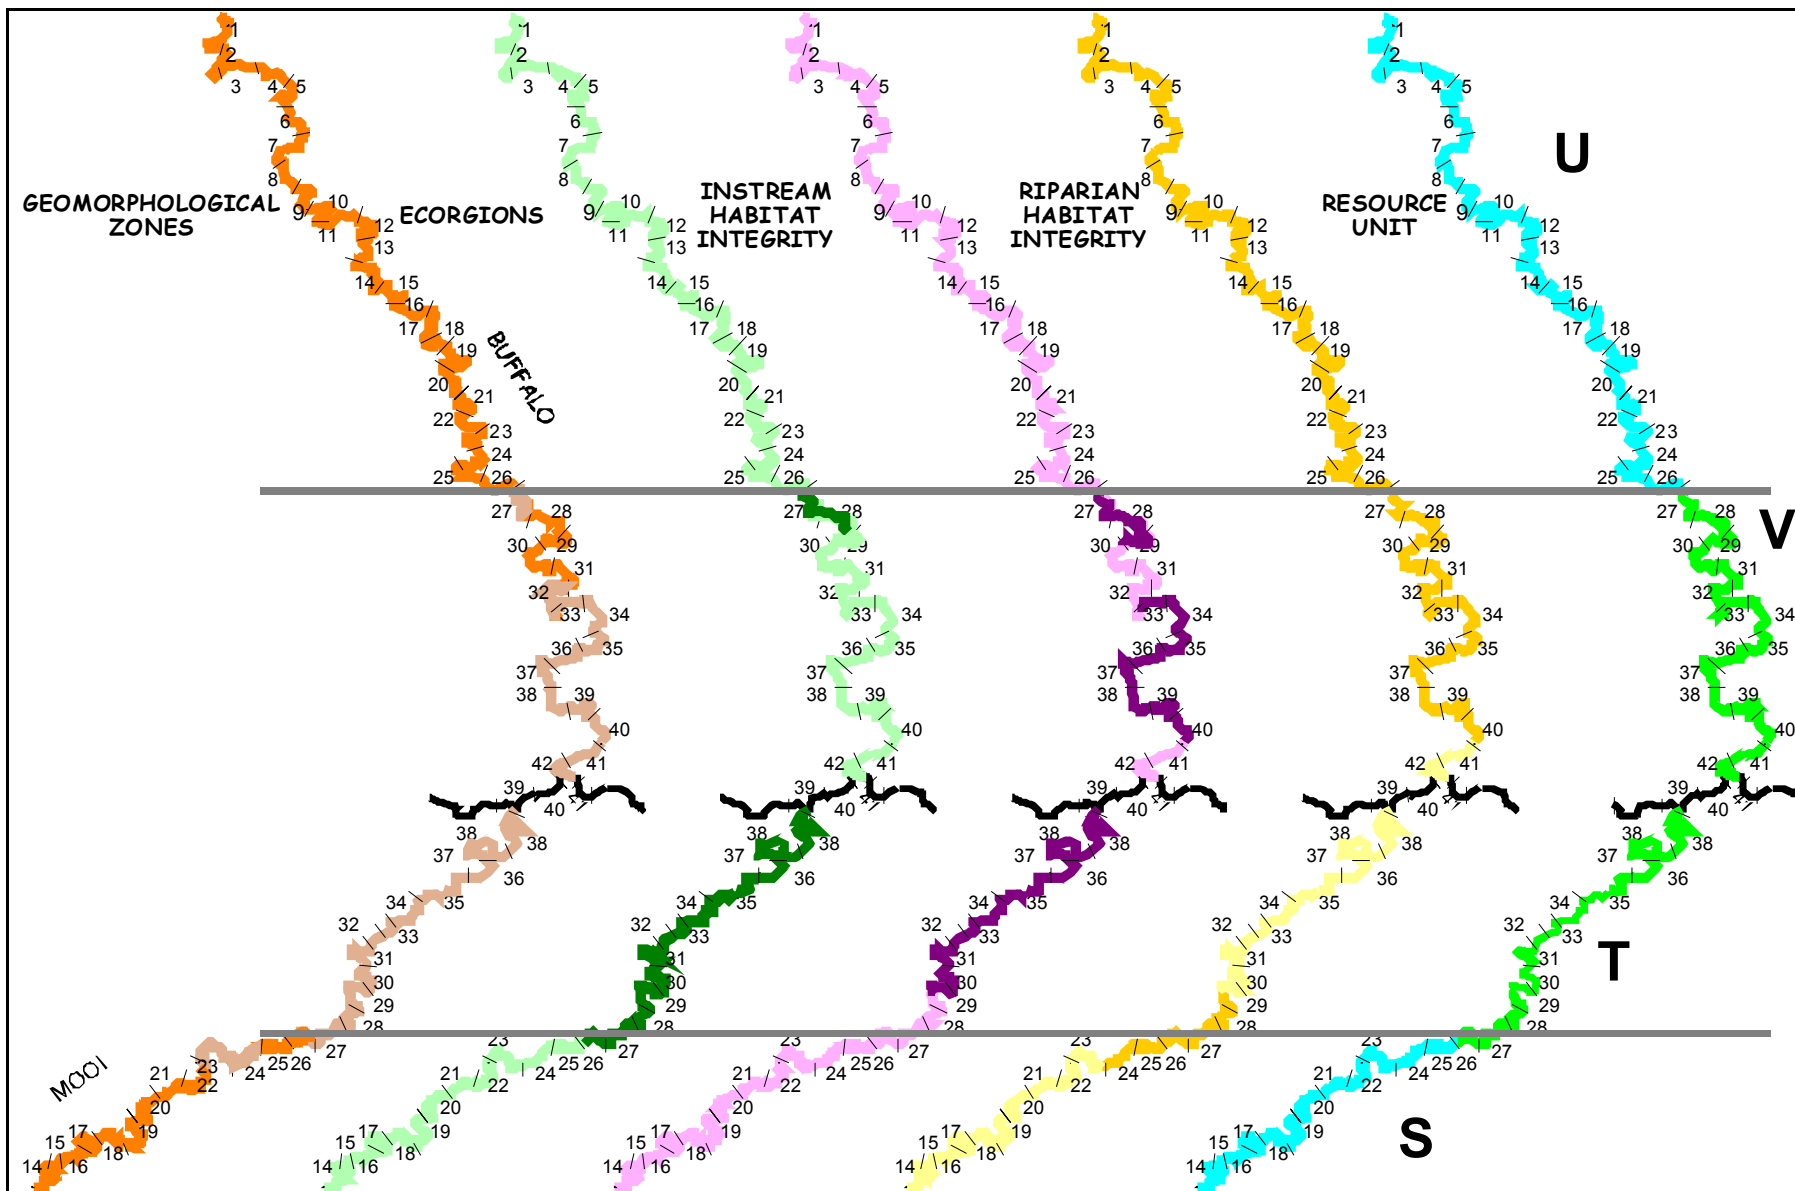
Fig 6.6 Buffalo River: Comparison between geomorphological zones, ecoregions, instream and riparian Habitat Integrity

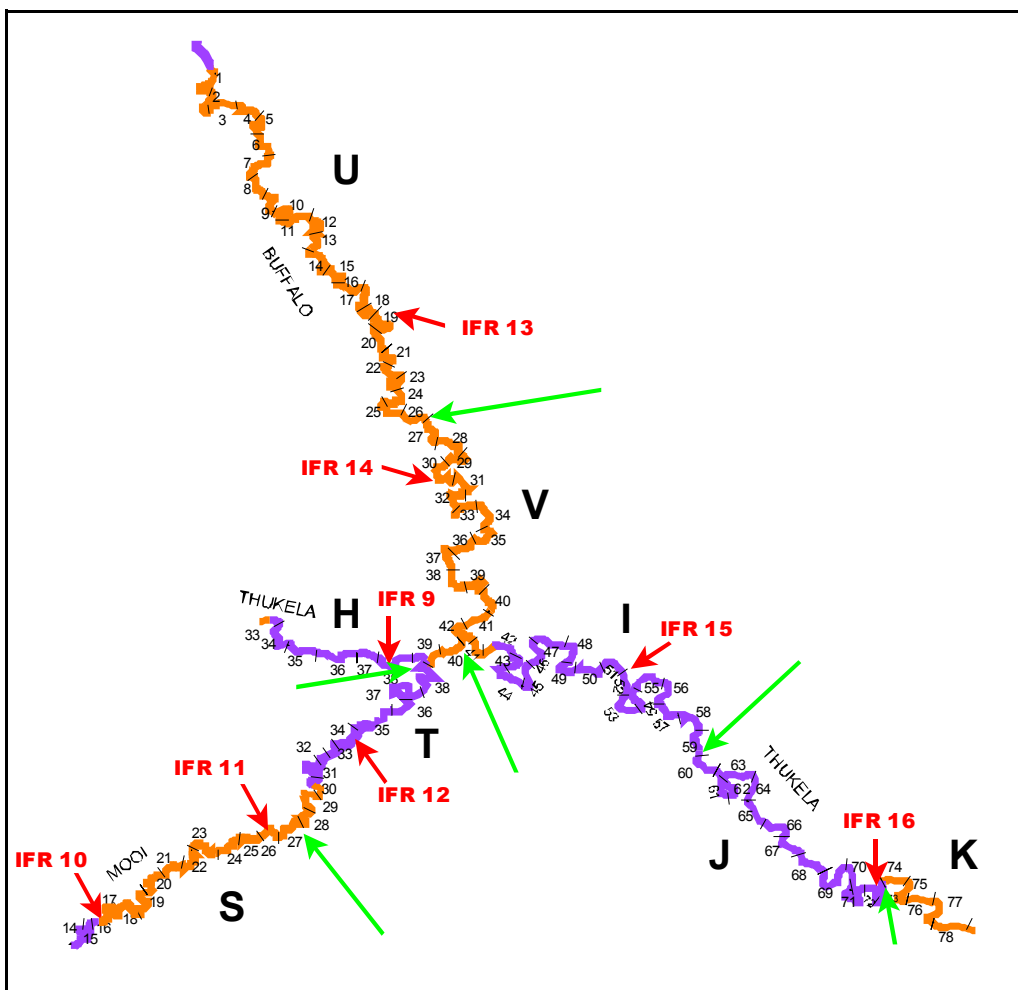
Fig 7.2 Lower Thukela Quantity RUs

The final Quality RUs are listed in Appendix A-1 and illustrated in Figures 7.1 and 7.2. In the figures, the Quantity RUs are also illustrated for reference purposes. The RU letters refer to the Quantity RUs. In the Appendix, the position of the RUs are listed in relation to segment numbers and RUs, as used by the Water Quantity task group. In areas where no water quality data is available, neighbouring Quality RUs may have to be amalgamated.

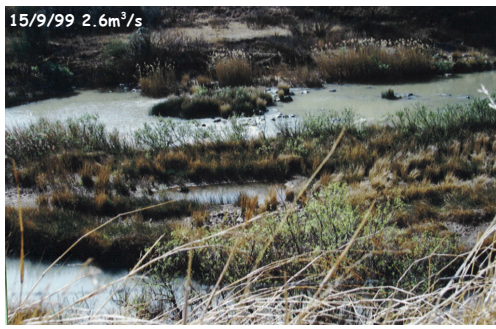
Fig 8.3 IFR 1, 15/9/99, 2.6m³/s

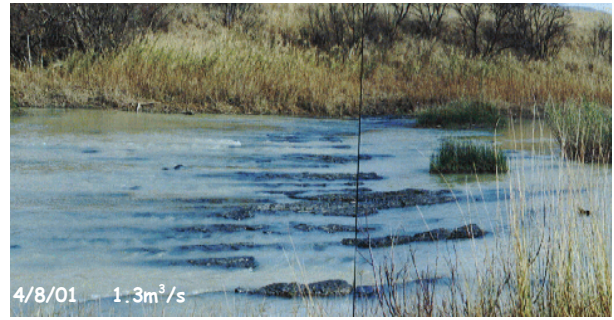
Fig 8.4 IFR 2, 4/8/01, 1.3m³/s

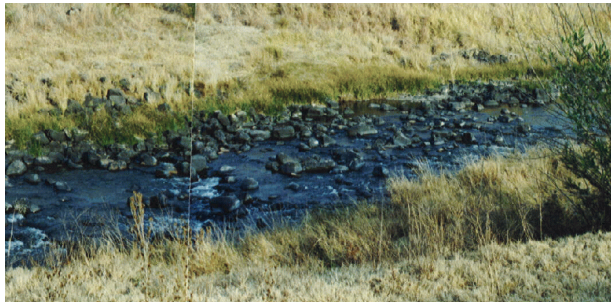
Fig 8.5 IFR 3, 31/7/01, 0.37m³/s

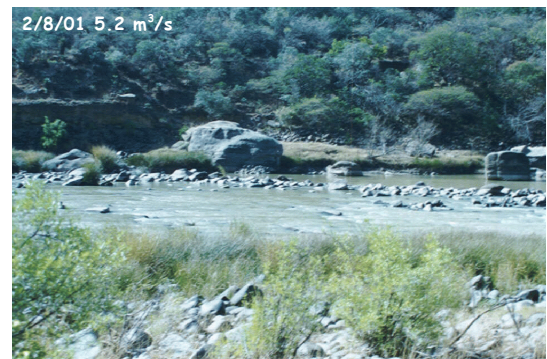
Fig 8.6 IFR 4A, 2/8/01, 5.2m³/s

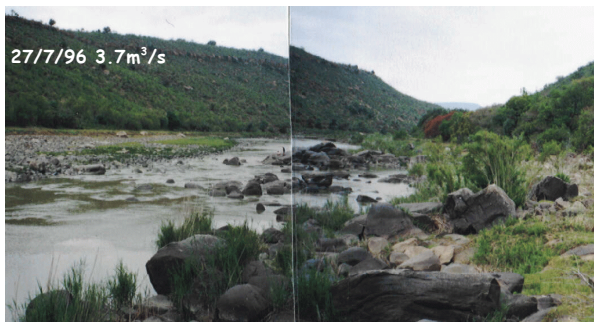
Fig 8.7 IFR 4B, 27/7/96, 3.7m³/s

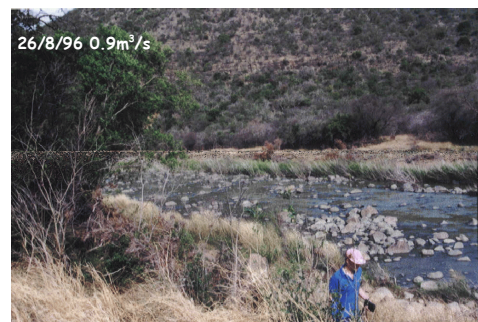
Fig 8.8 IFR 5, 26/8/96, 0.9m³/s

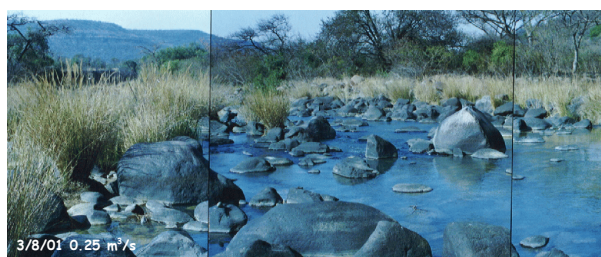
Fig 8.10 IFR 7, 3/8/01, 0.25m³/s

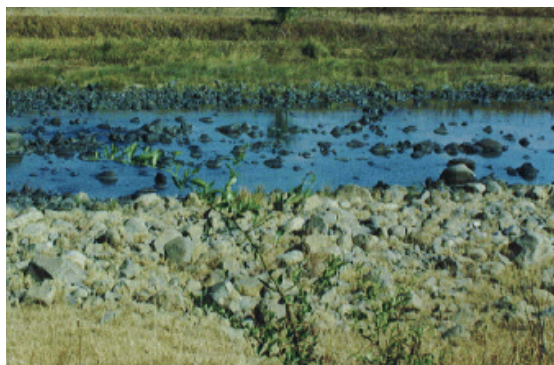
Fig 8.11 IFR 8, 06/8/01, 0.31m³/s

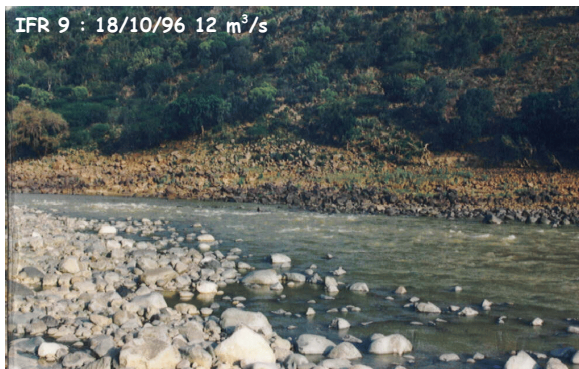
Fig 8.12 IFR 9, 18/10/96, 12m³/s

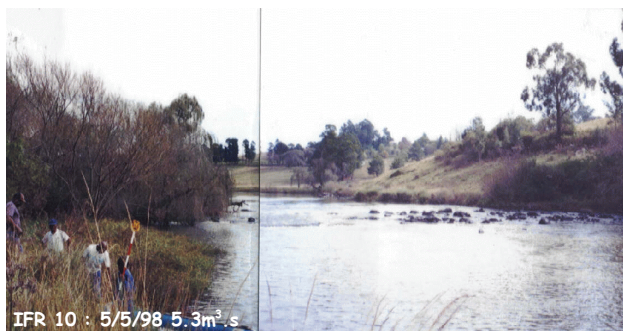
Fig 8.13 IFR 10, 5/5/98, 5.3m³/s

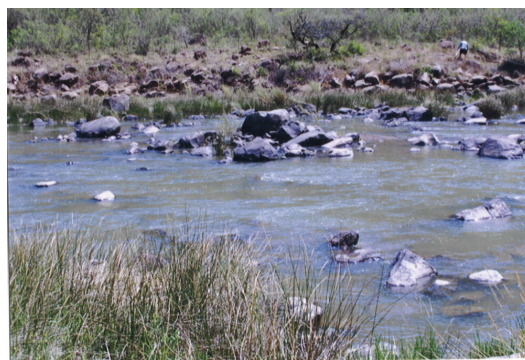
Fig 8.14 IFR 11, 5/10/01, 2.9m³/s

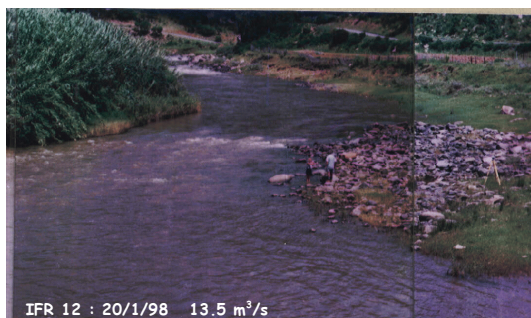
Fig 8.15 IFR 12, 20/1/98, 13.5m³/s

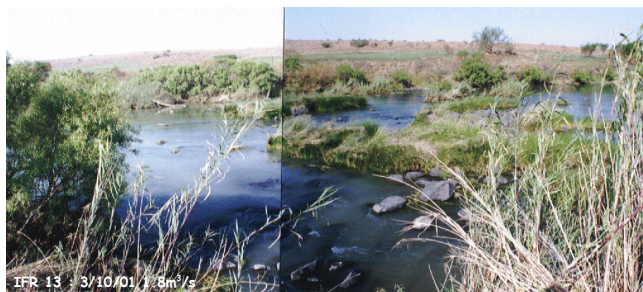
Fig 8.16 IFR 13, 3/10/01, 1.8m³/s

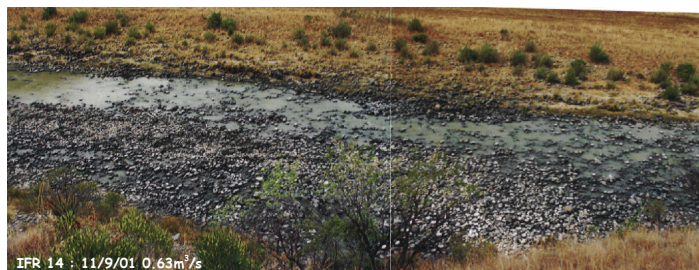
Fig 8.17 IFR 14, 11/9/01, 0.63m³/s

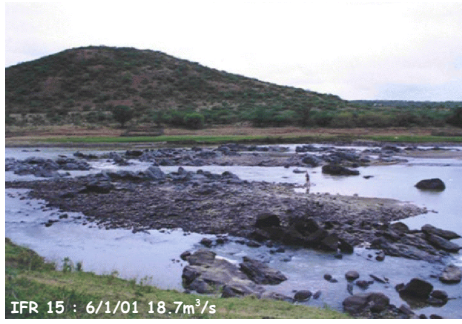
Fig 8.18 **IFR 15, 6/1/01, 18.7m³/s**

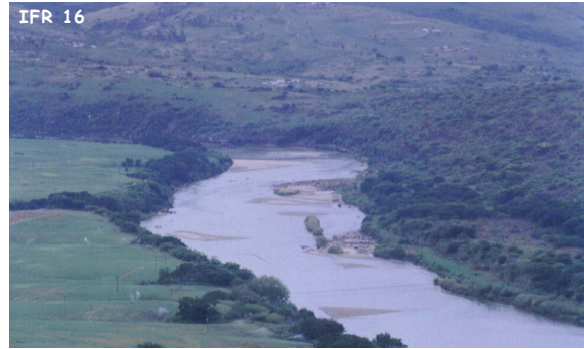
Fig 8.19 **IFR 16, 15/9/01**
