Determination of Water Resource Classes, Reserve and the Resource Quality Objectives in the Keiskamma and Fish to Tsitsikamma Catchments

WP11354 River Field Survey Report 1

REPORT NO.:
WEM/WMA7/00/CON/RDM/0722

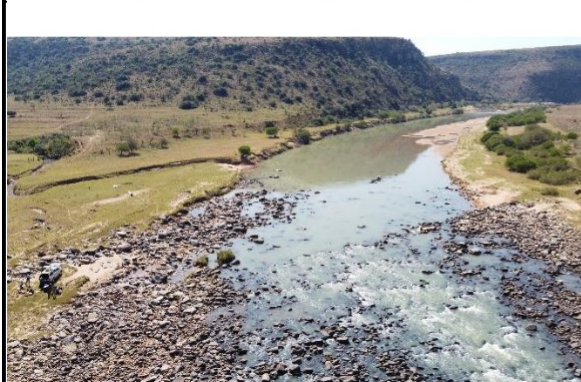
Upstream

<p>Site Description:</p> <p>The site is located near the eMgudwane and is 4km (straight distance) from the N2.</p> <p>The site is located along a partly confined valley setting with a single channel and narrow flood features. The channel is straight to wandering and follows the sinuous valley alignment. It follows a pool-riffle or pool-rapid reach type, often with long pools, and is dominated by boulder, cobble and sand sediment types. Benches are composed of silt and sand. There is high embeddedness along riffles, runs and pools. There are signs of erosion and deposition along the channel margins and on the flood benches. Large sand bars form along the pools and there is a fine sand or silt drape across boulder and cobble habitats where flow velocities are low. Grazing and trampling takes place along the banks and flood features.</p> <p>Biotopes available for aquatic macroinvertebrates were dominated by the SIC and SOOC habitat, GSM was available in pockets along the right banks, as well as within the interstitial spaces amongst the SOOC. Sand benches (mud) were mostly along the left bank. There was no instream aquatic vegetation, and very limited marginal vegetation. Varying flow velocity and depth classes were available for fish, namely SD, SS, FS and FD.</p>

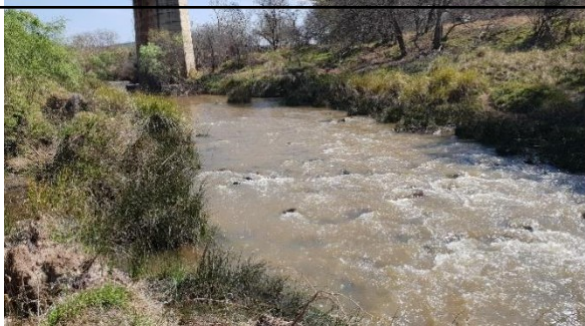
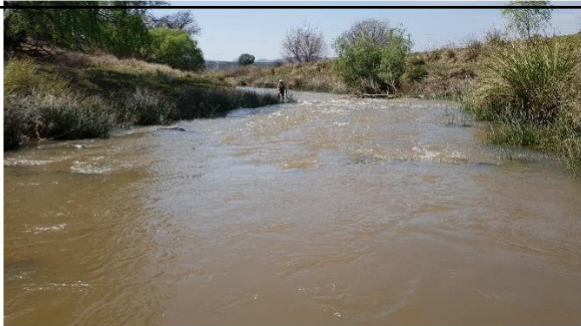
Upstream		Downstream	
Site Description:			
<p>The site is located near Tylden, about 4 km upstream from the N6.</p> <p>The site is located in a partly confined valley setting with a single channel and narrow flood features. The channel is straight to wandering, incised into the surrounding landscape and follows the sinuous valley alignment. It follows a pool-riffle and pool-rapid reach type and is dominated by boulder, cobble, gravel and sand sediment types at the site. There are significant bedrock sections with localised bedrock steps. Benches are composed of sand. There is embeddedness of cobble and gravels where flow velocities are lower. <u>There is widespread grazing along the banks and flood zones, with trampling evident at the site. Some alien trees and shrubs are growing along the riparian zone.</u></p> <p>Biotopes available for aquatic macroinvertebrates included a combination of bedrock, SIC and SOOC. Marginal vegetation was limited, while GSM was sampled along the banks (mostly mud). Fish habitats included SD, SS, FD and FS.</p>

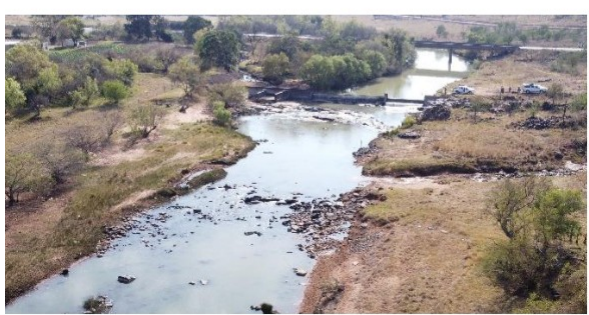
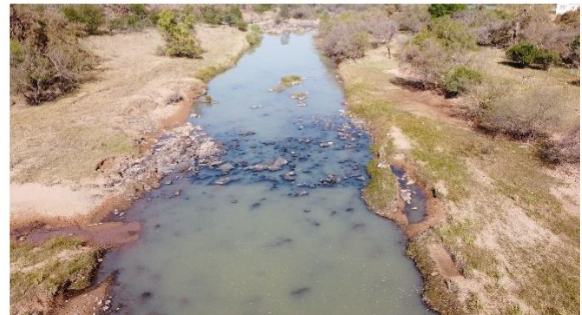
Upstream		Downstream	
Site Description:

The site is located near Tsomo, just downstream of the R409 and gauging weir S5H002.

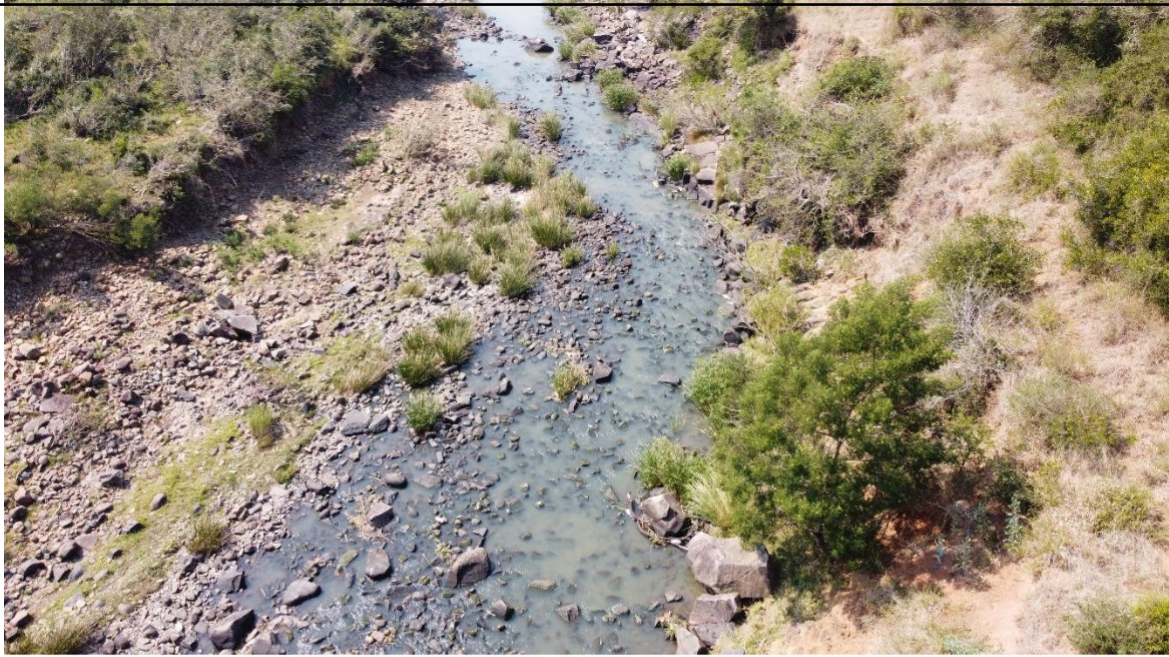
Upstream		Downstream	
Site Description:			
The site is located downstream of Laing Dam and 1.5 km upstream of Bridle Drift Dam.

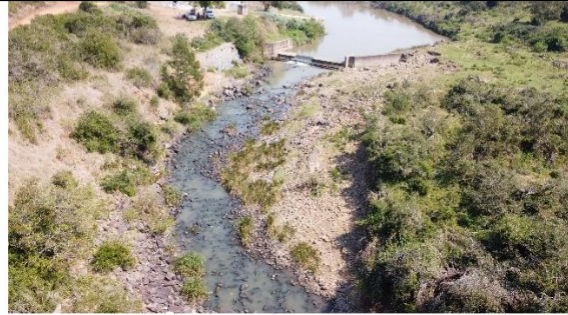
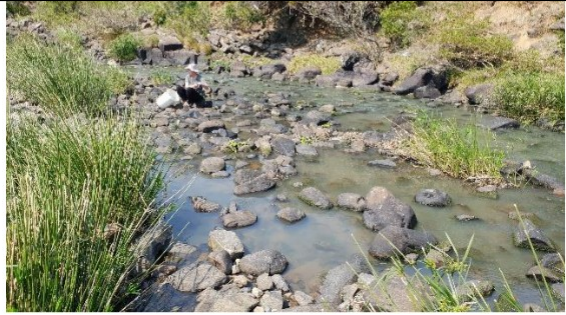
The site is located in a partly confined valley setting with a single channel and narrow flood features within a deeply incised macro channel. The channel is straight to wandering and follows the sinuous valley alignment. It follows a pool-riffle and pool-rapid reach type and is dominated by boulder, cobble, gravel and silt sediment types. The banks and benches are composed of cobble, gravel, sand and silt. The gravels and cobbles along the riffle margin have a moderate extent of silt cover, indicating higher silt loads during higher flows. This can be seen in the pools with thick silt drapes across the various low velocity habitats. Livestock grazing and trampling is widespread. There is widespread erosion along the banks and inset benches. Very localised sand deposition takes place on the lower flood features, with widespread evidence of recent erosion.

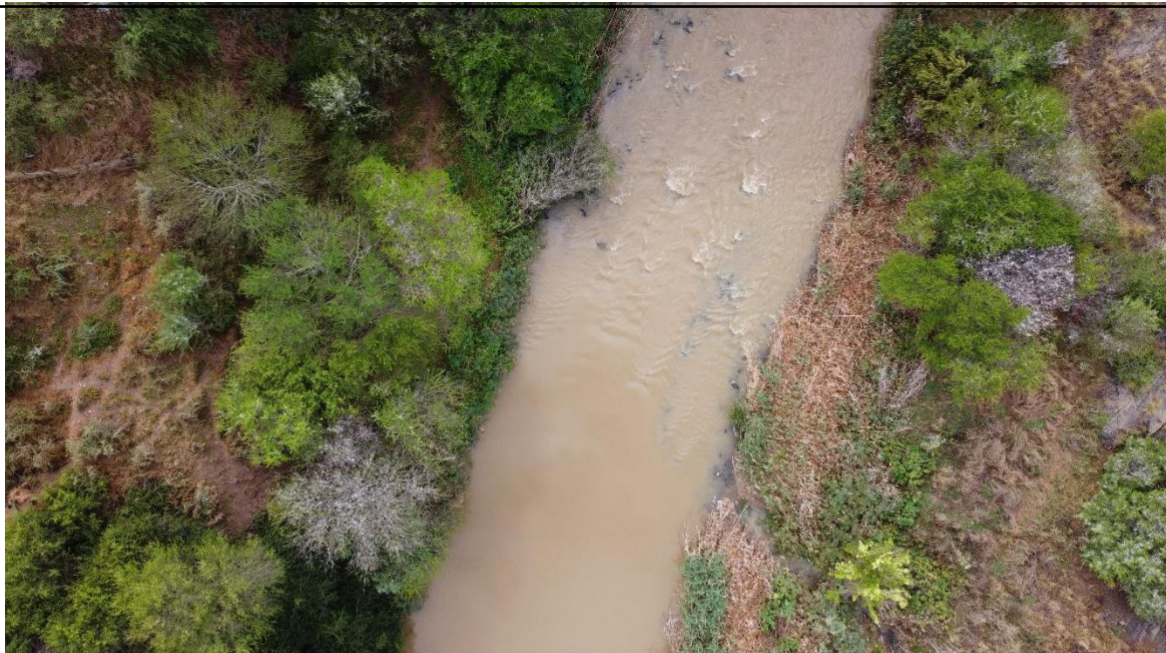
Upstream		Downstream	
Site Description:			
The site is located at the Carlisle Bridge along the R350.

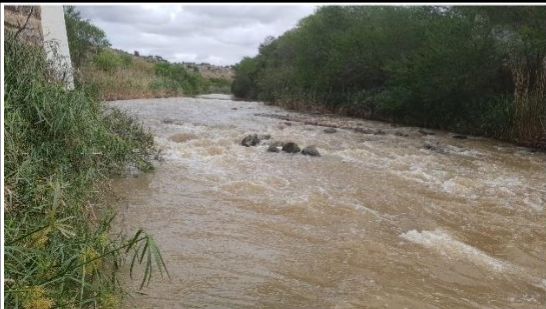
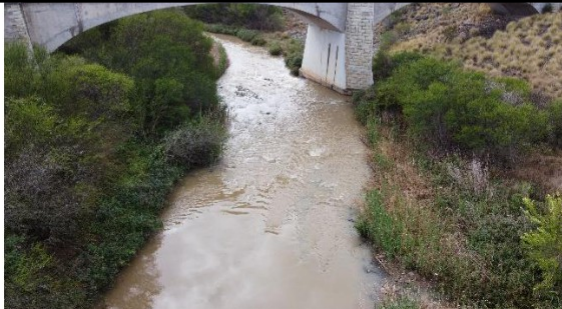
The site is located in a moderately confined valley setting with a single channel and narrow flood features within a deeply incised macro channel. The channel is straight to wandering and follows the sinuous valley alignment. It follows a pool-riffle and pool-rapid reach type and is dominated by boulder, cobble, gravel and silt sediment types. The banks and benches are composed of fine sand and silt, with bedrock along rapids and along the outer bends. The channel has dense sedge, reed and tree vegetation with some localised trampling where game cross or drink from the channel. Bank erosion is localised and the bed along the riffle has a limited gravel and sand deposits, due to increased flow levels. Siltation takes place along the pools with a silt drape covering slow flowing habitats.

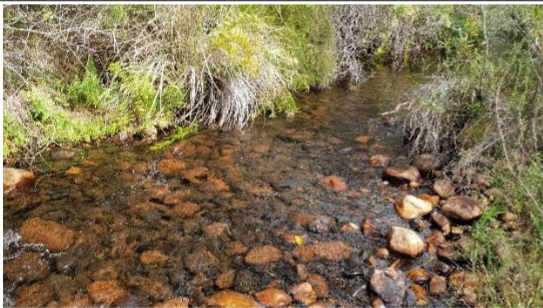
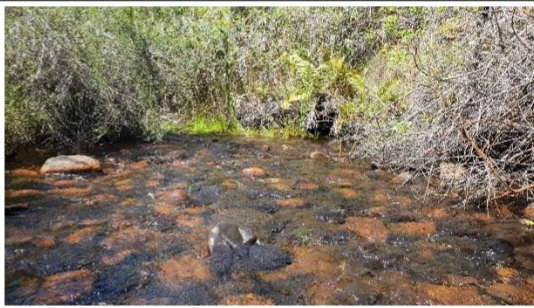
Drone access denied owing to conservation area			
Upstream		Downstream	
Site Description:			
<p>The site is located in Groendal Natrue Reserve, about 5 km (straight distance) downstream of the Groendal Dam.</p> <p>The site is located in a partly confined valley setting with a single channel and floodplain along the left bank. The active channel has narrow flood benches and is deeply incised into the valley floor. The channel is straight to wandering and follows the sinuous valley alignment. It follows a pool-riffle reach type and is dominated by boulder, cobble, gravel and sand sediment types. The floodplain, banks and benches are composed of boulder, cobble, gravel and sand, with bedrock cliffs or steep hillslopes along parts of the outer bends. The channel is densely vegetated with shrubs, sedges and tall grasses. There were very limited signs of grazing and trampling along the banks. Undercut banks and bank erosion is fairly common and the bed along the riffle and pools have very low embeddedness, possibly due to sediment starvation caused by the Groendal Dam. Small inset benches are forming and are composed of medium sand.</p>

All biotopes for aquatic macroinvertebrate habitats were available. Fish habitats only included FS and SD.

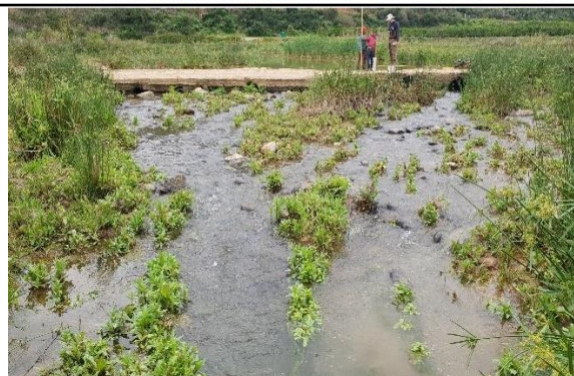
Upstream

<p>Site Description:</p> <p>The site is located roughly 10 km in an upstream direction from Patensie and 10 km downstream of the Kouga Dam (both straight line distances).</p> <p>The site is located in an unconfined valley setting with a single channel and floodplain along both banks. The valley floor is composed of cobbles, boulders and gravel with a fairly shallow channel. Inset benches and shallow flood channels are present. Terraces and alluvial fans are common along the valley floor and buffer the channel from the steep hillslopes. The channel is straight to wandering and follows the sinuous valley alignment. It follows a pool-riffle reach type and is dominated by boulder, cobble, gravel and sand sediment types. The floodplain, banks and benches are composed of boulder, cobble, gravel and sand, with bedrock cliffs or steep hillslopes along parts of the outer bends. The channel margins and flood features are vegetated with small shrubs and sedges. Grazing and trampling takes place along the banks and floodplain. Undercut banks and bank erosion is fairly uncommon at the site and the bed along the riffle and pools have a moderate level of embeddedness. A silt drape is present across coarser sediment in slow flowing habitats, such as pools.</p> <p>All biotopes for aquatic macroinvertebrate habitats were available. Fish habitats only included FS, SD and SS.</p>

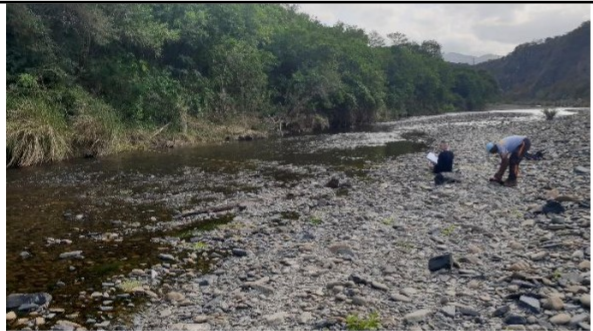
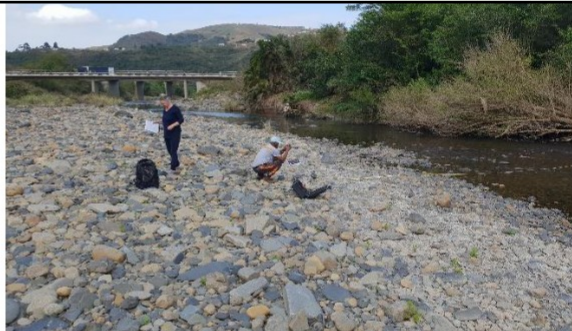
Site Description:			
<p>The site is located near Qhaka, about 15 km from Port St Johns and 9km from the coastline.</p> <p>The site is located in a confined valley setting with a single channel and narrow flood features. The channel is straight to wandering and follows the sinuous valley alignment. It follows a pool-riffle reach type and is dominated by boulder, cobble and gravel sediment types. Large gravel and cobble bars alternate along the active channel. Benches are composed of silt and sand. There is low embeddedness along riffles, runs and pools.</p> <p>All biotopes were present for macroinvertebrates. There was no instream aquatic vegetation, and limited marginal vegetation owing to undercut banks along both banks. Fish habitats included SS, SD and FS.</p> <p>Site impacts:</p> <ul style="list-style-type: none"> • Gravel mining • Construction activities (bridges) • Road access • Alien invasive plants (riparian zone) (lantana, peanut cassia, bugweed)

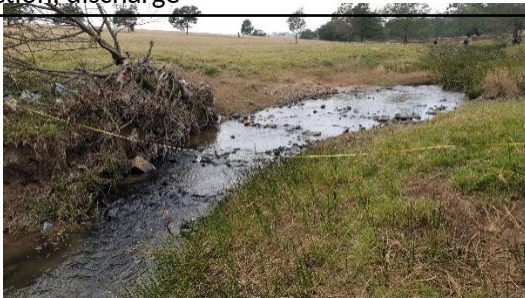
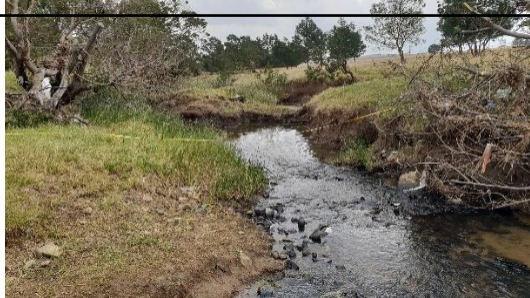
Upstream		Downstream	
Site Description:			
<p>The site is located near Idutywa, about 7 km from the N2 in a downstream direction.</p> <p>The site is located in a partly confined valley setting with a single channel and floodplain along both banks. It has localised islands where the channel has avulsed. The channel is straight to wandering and follows the sinuous valley alignment. It follows a pool-riffle reach type and is dominated by cobble, gravel and sand sediment types. There are bedrock sections with localised bedrock steps. Benches are composed of silt and sand. There is low embeddedness along riffles and rapids, but significant embeddedness along pools. Bank erosion is widespread.</p> <p>Good availability of marginal vegetation and GSM biotopes for aquatic macroinvertebrates, with a few seams of SIC and SOOC, although shallow over these areas. Fish habitats included SD, SS and FS.</p>

Site impacts:			
<ul style="list-style-type: none"> • Considerable macroplastics within the riparian zone (due to earlier flood event) • Cattle grazing and trampling • Erosion • Alien invasive plants within the riparian zone 			
Preliminary Results

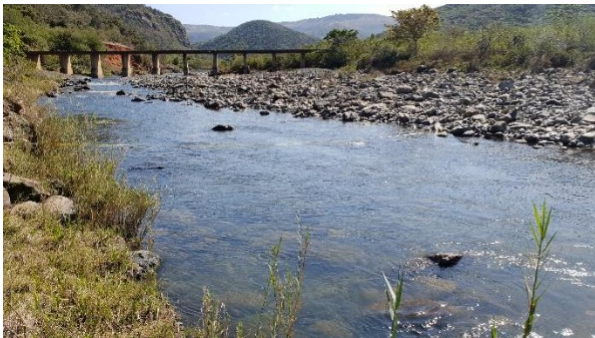
Upstream		Downstream	
Site Description:			
<p>The site is located about 10 km from the Holy Cross Hospital and 25km from the coastline.</p> <p>The site is located in a confined valley setting with narrow flood features. The channel is straight to wandering and follows the sinuous valley alignment. It follows a pool-riffle reach type and is dominated by boulder, cobble and gravel sediment types. Bedrock is locally present. Large gravel and cobble bars alternate along the channel. Benches are composed of silt and sand. There is very low embeddedness along riffles, runs and pools.</p> <p>All biotopes were available for macroinvertebrates, although marginal vegetation was limited owing to undercut banks along the right-hand bank and sand bars along the left bank. Fish habitats included Slow-Shallow (SS), Slow-Deep (SD) and Fast-Shallow (FS).</p>

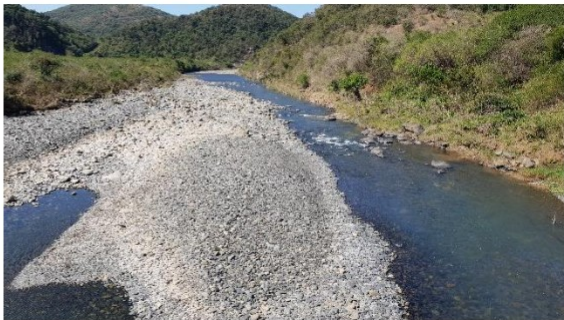
Site impacts:			
<ul style="list-style-type: none"> • Alien invasive plant species within the riparian zone (lantana, peanut cassia) • Localised gravel mining • Erosion • Cattle trampling

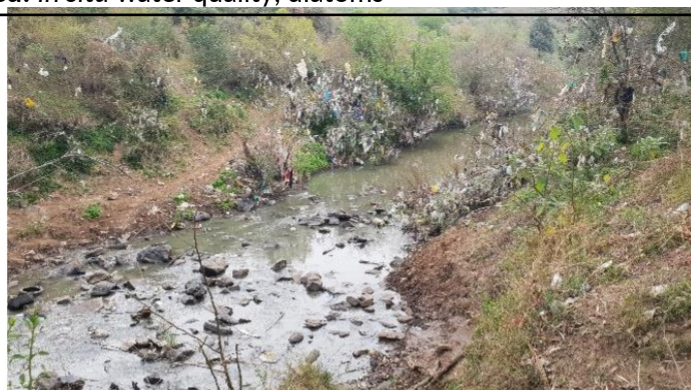
Site associated with raw sewage – health hazard

A suitable site could not be identified. First site downstream of the town was associated with health hazards (sewage), downstream of the dam, there was no flow and upstream of the dam, was pooled. The site will be assessed in March 2023 during the intermediate survey. Diatom and in situ water quality undertaken at site downstream of town.

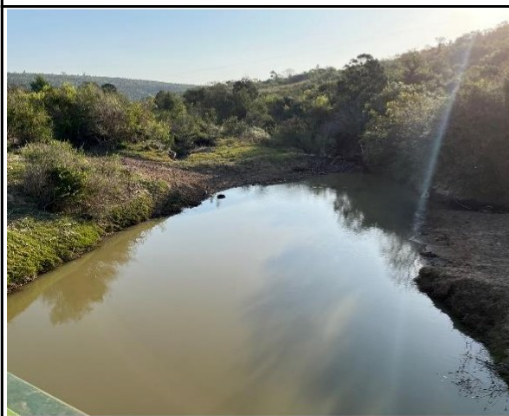
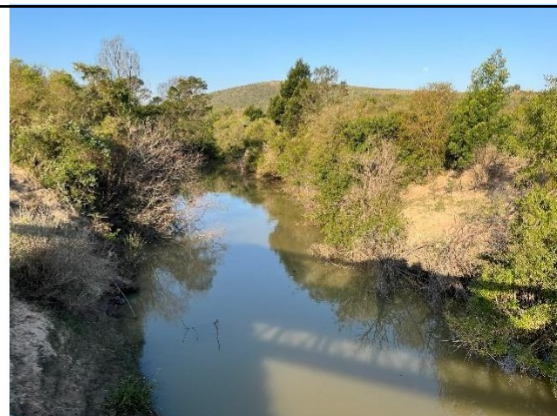
Upstream of the Gcuwa dam (pooled, no flow)

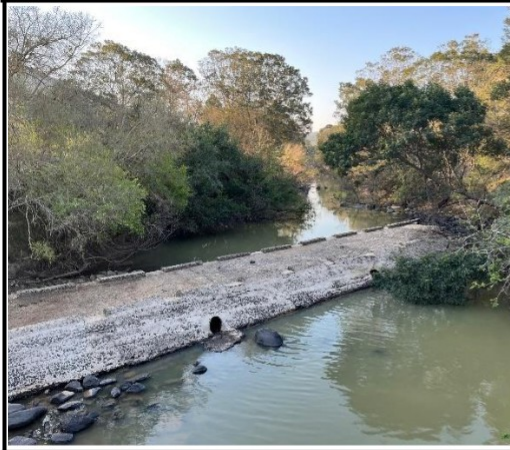
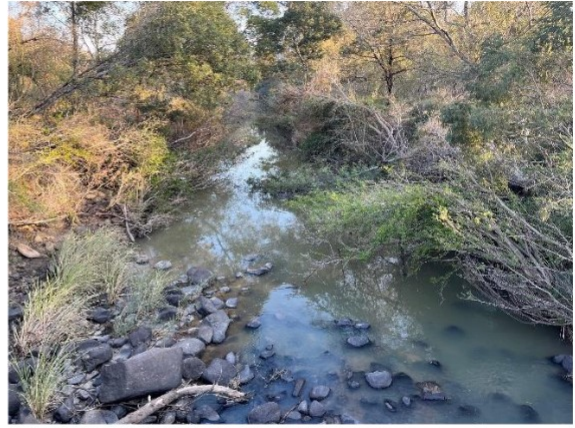
Further upstream of the Gcuwa dam. Limited flow conditions.

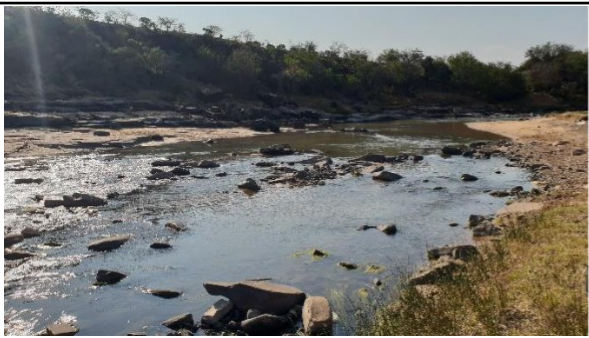
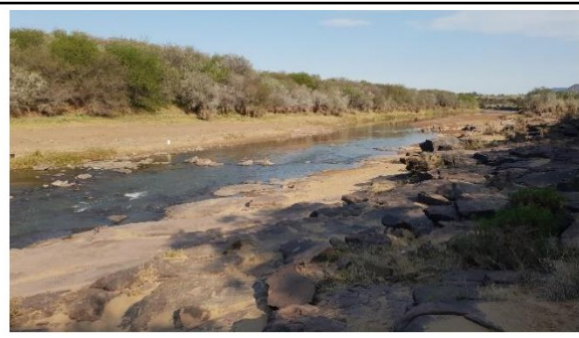
Upstream		Downstream	
Site Description:			
<p>The site is located near Saint Marks, about 1 km upstream of the R61.</p> <p>The site is located in a moderately confined valley setting with a single channel. The river is incised into the surrounding landscape with narrow flood features along the left bank. It has localised islands where bedrock or large boulders form obstructions. The channel is straight to wandering and follows the sinuous valley alignment. It follows a pool-riffle and pool-rapid reach type and is dominated by boulder, cobble and sand sediment types. There are localised bedrock sections with localised bedrock steps. Benches are composed of silt and sand. There is low embeddedness along riffles and rapids, but significant embeddedness along pools. Large sand bars form along pool sections.</p> <p>Aquatic Macroinvertebrate biotopes were dominated by bedrock, with some SIC, SOOC. SIC were heavily embedded compromising this biotope. Good availability of the GSM biotope. No marginal vegetation was present at this site owing to exposed banks and sand mining along the left bank. Varying fish habitats comprised FD, FS, SD and SS.</p>

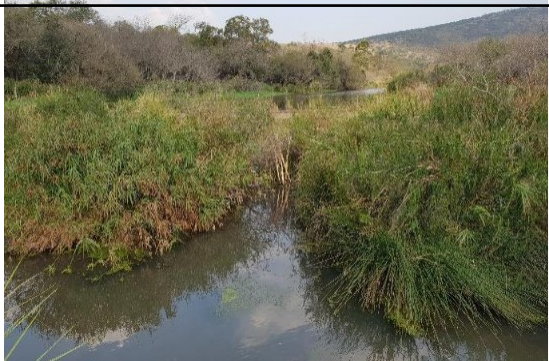
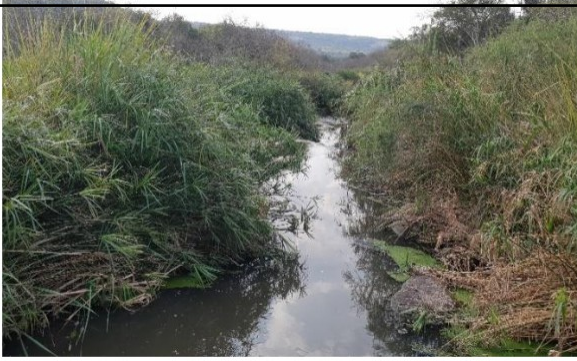
Upstream		Downstream	
Site Description:			
Bedrock with no flows, limited aquatic biotopes and pools.			
Site impacts:			
<ul style="list-style-type: none"> • Agriculture and irrigation • Alien invasive plants within the riparian zone 			
Preliminary Results			
<i>In situ</i> water quality:			
<ul style="list-style-type: none"> • pH: 7.39 • EC: 290.4 uS/cm

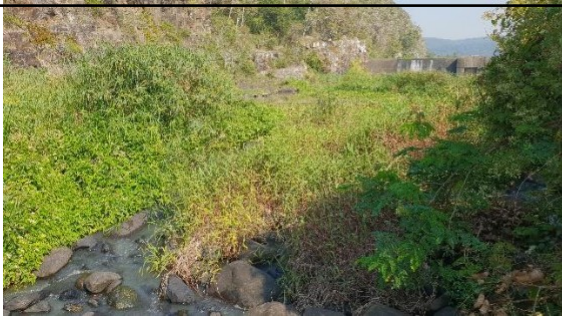
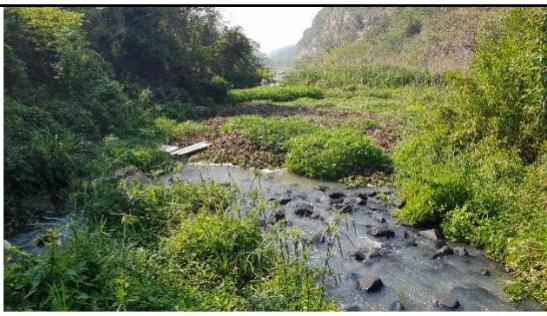
Upstream		Downstream	
Site impacts: <ul style="list-style-type: none"> • Weir • Water abstraction • Alien invasive aquatic macrophytes (<i>Eichhornia crassipes</i> – Hyacinth) • Nutrients (algae) mainly from WWTW pipeline leakage downstream • Cattle trampling and grazing <ul style="list-style-type: none"> • Alien invasive trees within riparian zone (<i>Syringa</i> sp., <i>Caesalpinia pulcherrima</i> - Pride of Barbados) • Downstream of Bridle Drift Dam

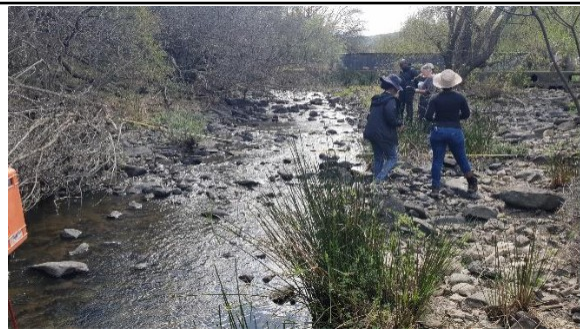
Upstream		Downstream	
Site Description:			
<p>The site is located near Calderwood, about 15 km downstream (straight distance) from Fort Beaufort and a few kilometres upstream of the Great Fish confluence.</p> <p>The site is located in a partly confined valley setting with a single channel and narrow flood features. The channel is incised into the surrounding landscape. The channel is straight to wandering and follows the sinuous valley alignment. It follows a pool-riffle and pool-rapid reach type and is dominated by boulder, cobble, gravel and silt sediment types. The banks and benches are composed of sand and silt.</p> <p>All biotopes were available for macroinvertebrates (SIC, SOOC, marginal vegetation and GSM). Fish habitats included SS, SD, and FS.</p>

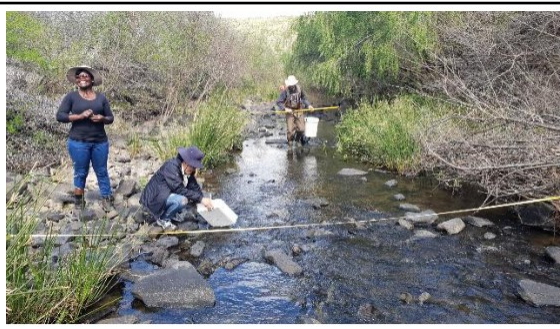
Site impacts:			
<ul style="list-style-type: none"> • Upstream weir • Abstraction and irrigation, mainly citrus • Alien invasive plants (<i>Salix</i> and <i>Eucalyptus</i> sp.) • Alien instream aquatic macrophytes 			
Preliminary Results			
<i>in situ</i> water quality:			
<ul style="list-style-type: none"> • pH: 9.11

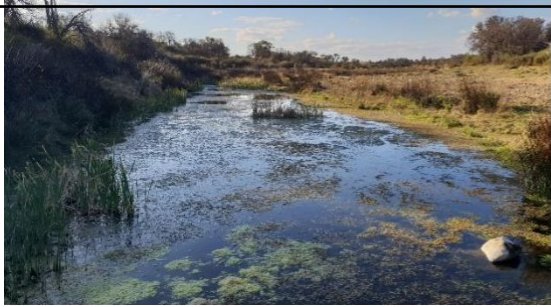
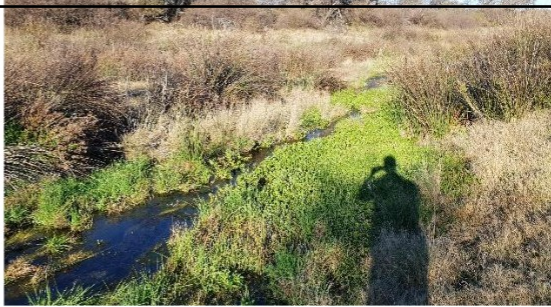
Upstream		Downstream	
Site Description:			
<p>The site is located near Visrivier and 2.2 km from the N10 and is upstream of the Fish transfer scheme.</p> <p>The site is located in a partly confined valley setting with a single channel and narrow flood features. The channel is straight to wandering and follows the sinuous valley alignment. It follows a pool-riffle reach type and is dominated by thick silty deposits over bedrock and gravel sediment types. Extensive aquatic weed beds are present along the pools and riffle sections. The banks and benches are composed of gravel and sand. There is very high embeddedness along riffles with silt.</p> <p>Aquatic macroinvertebrate biotopes were limited owing to the thick silty deposits. Limited SIC and SOOC. There was good availability of both marginal and instream vegetation. Fish habitats included SD and SS.</p>

Site impacts:			
<ul style="list-style-type: none"> • Agriculture (localised) • Cattle trampling and grazing • Upstream weir and diversion into canal • Water abstraction • Algae owing to reduced flows • Low water bridge • Instream macrophytes (red water fern)

<ul style="list-style-type: none">• Bank erosion on microchannel
Preliminary Results
<i>In situ</i> water quality: <ul style="list-style-type: none">• pH: 7.77• EC: 864 uS/cm• TDS: 0.700 g/l• DO: 8.5 mg/l• DO%: 84.5 %• Clarity: >100 cm• Temperature: 14.6 °C• Salinity: 0.54
Discharge: 0.009 m ³ /s

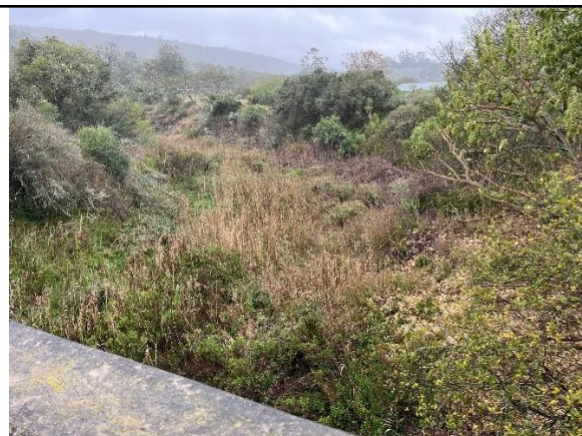
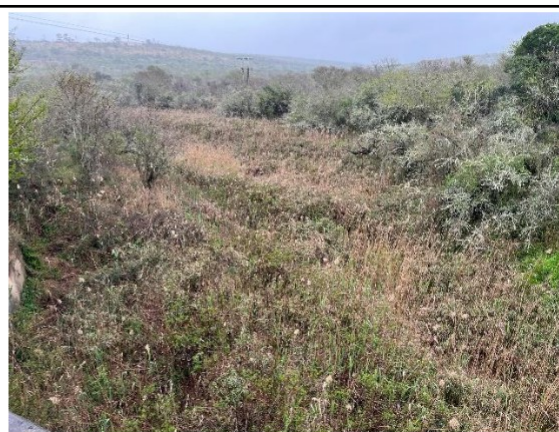
Site dry due to drought and dams upstream with no releases, thus down-scaled to a rapid 3 to be surveyed in March 2023.

Components sampled: None - site dry

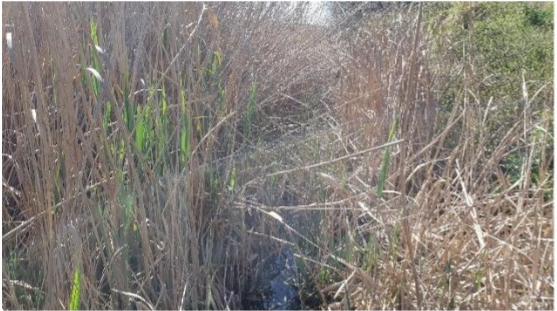
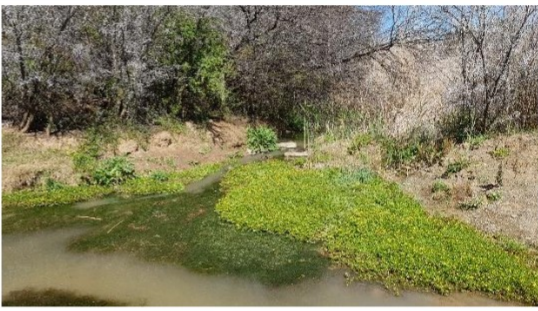
Upstream		Downstream	
Site Description:			
<p>The site is located 8 km downstream (straight distance) from Kommandodrift Dam and Lake Arthur and 3 km from the N10.</p> <p>The site is located in a partly confined valley setting with a single channel and narrow flood features within the historical macro channel. The channel is incised into the surrounding landscape and has subsequently filled in with sediment from tributaries due to reduced flooding along the mainstem Tarka. The channel is straight to wandering and follows the sinuous valley alignment. It follows a pool-riffle reach type and is dominated by sand and silt sediment types. Gravel and cobble is locally present, but possibly introduced for river crossings. The banks and benches are composed of sand and silt. The local land owner mentioned channel siltation of 2+m due to reduced flows downstream of the dam.</p> <p>Biotores for aquatic macroinvertebrates were of poor habitat availability. Limited SIC were available, however there was some SOOC, GSM and marginal and aquatic vegetation. The marginal vegetation was dominated by Phragmites sp. encroaching the channel due to the silt sediment types. Fish habitats only included SS and limited FS habits.</p>

Site impacts:			
<ul style="list-style-type: none"> • 2 x large upstream dams with no releases into the river • River crossings

- Agriculture (irrigation mainly from canals with water released from upstream dams)
- Return flows (irrigation)
- Sedimentation and siltation
- High nutrients (algae)

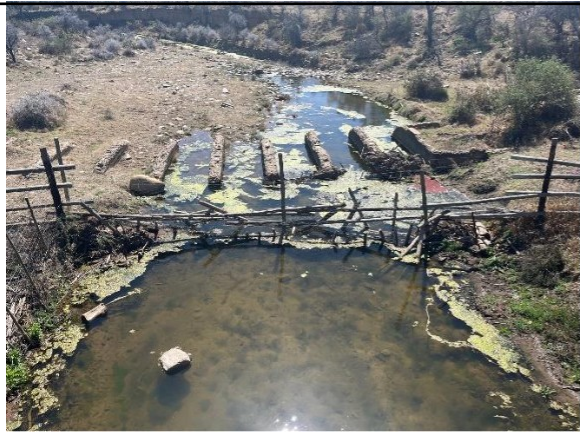
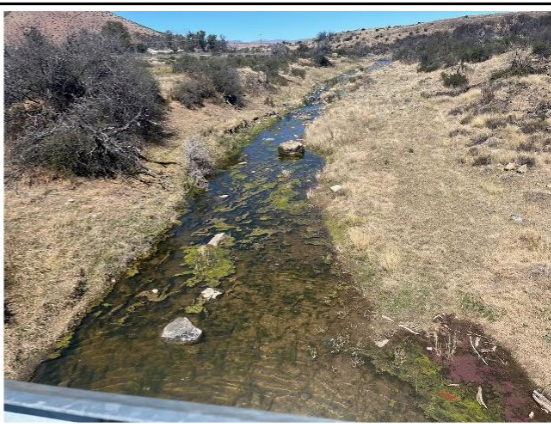
Upstream		Downstream	
Site impacts:			
<ul style="list-style-type: none"> • Cattle grazing and trampling • Bank erosion

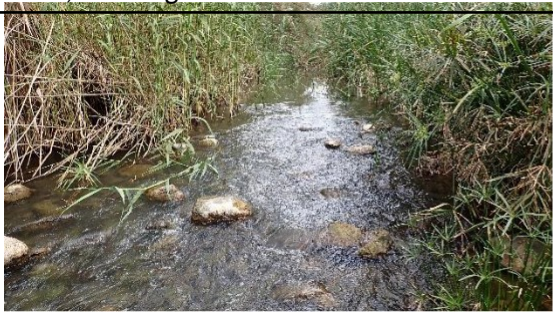
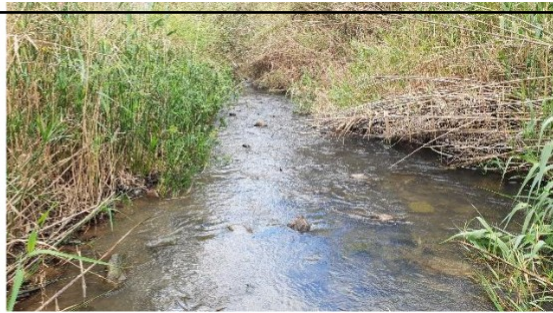
Upstream		Downstream	
Site Description:			
<p>The site is located 3.5 km upstream from Kirkwood.</p> <p>The site is located in an unconfined valley setting with a single macro channel and narrow flood features. The macro channel is deeply incised into the valley floor. The channel has a sinuous planform along the broad and relatively flat valley floor. It follows a pool-riffle reach type and is dominated by cobble and gravel substrates along riffles. The banks and benches are composed of gravel, sand and silt. The banks are densely vegetated with reeds and sedges. There is very low embeddedness along riffles with fine sediment.</p> <p>The aquatic macroinvertebrate biotopes were dominated by SIC and SOOC. The marginal vegetation was limited to reeds and the GSM was primarily within the interstitial spaces of the SIC and SOOC. The fish habitats included SS, FS and SD.</p>

Site impacts:			
<ul style="list-style-type: none"> • Abstraction

- Irrigation
- Return flows
- Upstream weir (Korhaansdrift) and dam (Darlington Dam)
- Vehicle crossing through channel
- Algae, high electrical conductivity and salinity
- Low bank erosion
- Aliens within the riparian zone (Spanish reed, Syringa)

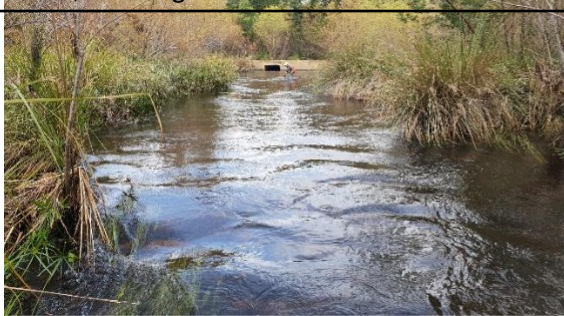
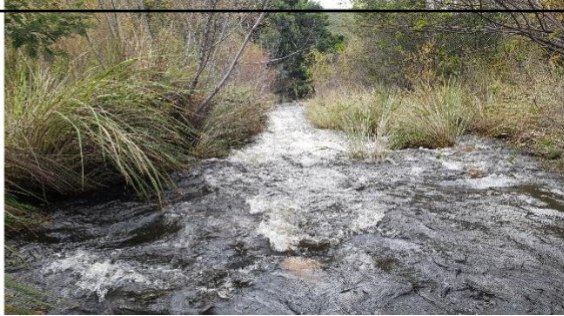
Upstream		Downstream	
Site Description:			
<p>The site is located 15 km east of Joubertina.</p> <p>The Kouga reach is located in a confined valley or gorge setting with a single channel and narrow flood features. The channel is straight to wandering and follows the sinuous valley alignment. It follows a pool-riffle and pool-rapid reach type and is dominated by boulder, cobble, gravel, sand and silt sediment types. The banks, benches and bars are composed of boulders, cobble, gravel and sand.</p> <p>Aquatic macroinvertebrate biotopes comprised SIC, SOOC and both marginal and aquatic vegetation. The sand and mud from the GSM biotope were limited to none. The fish habitats included FD, SS and SD.</p>

Site impacts:			
<ul style="list-style-type: none"> • Extensive alien invasive plants within the riparian zone (Black wattle) • Downstream weir • Low water bridge crossing • Irrigation (upstream) 			
Preliminary Results

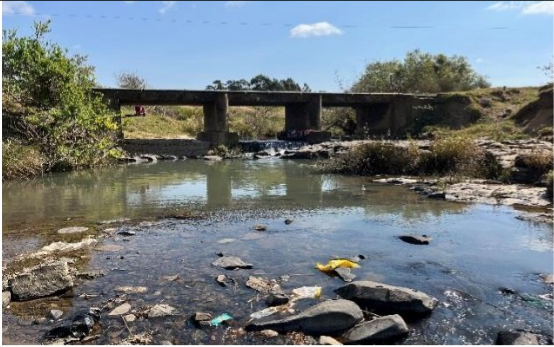
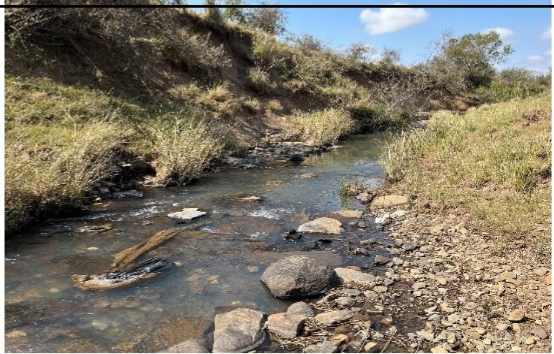
Site impacts:			
<ul style="list-style-type: none"> • Localised washing/chemicals • Erosion • Cattle trampling/grazing • In-stream/riparian litter 			
Preliminary Results			
<i>In situ</i> water quality: <ul style="list-style-type: none"> • pH: 8.39 • EC: 447.6 uS/cm • TDS: 0.3498 g/l • DO: 8.59 mg/l • DO%: 87.5 % • Clarity: 70 cm • Temperature: 16.2 °C • Salinity: 0.26 ppt

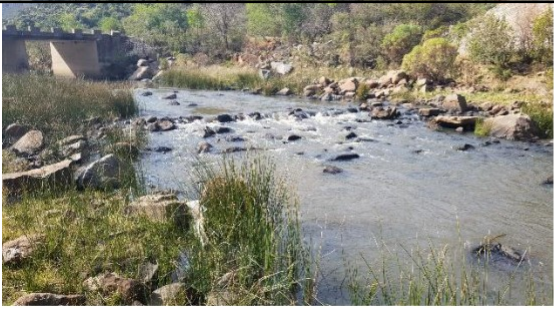
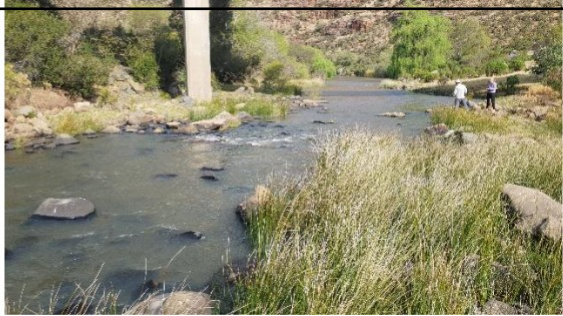
Upstream		Downstream	
Site impacts:			
<ul style="list-style-type: none"> • Bridges • Alien invasive plants along riparian zone (<i>Salix</i> sp.) 			
Preliminary Results			
<i>In situ</i> water quality: <ul style="list-style-type: none"> • pH: 8.02 • EC: 93 uS/cm • TDS: 0.0725 g/l • DO: 9.84mg/l • DO%: 100.6 % • Clarity: 47cm • Temperature: 16.3°C • Salinity:0.06 ppt

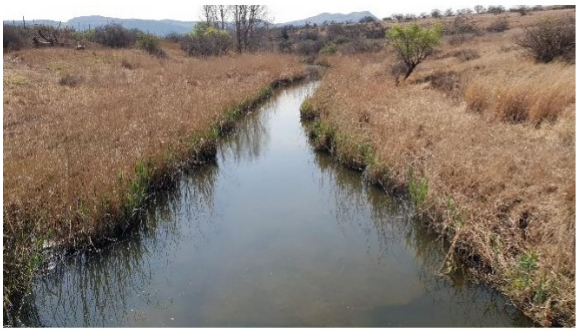
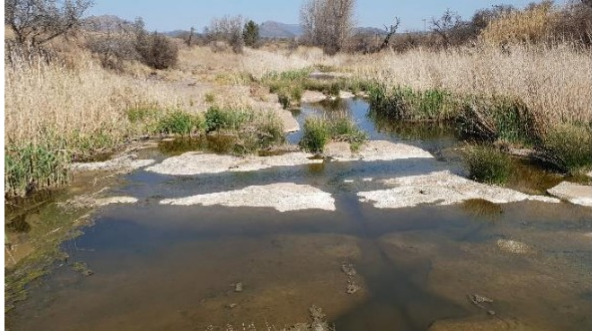
Upstream		Downstream	
Site impacts:			
<ul style="list-style-type: none"> Eutrophication based on the <i>in situ</i> water quality data, mainly from WWTW (Queenstown) in the Komani River Abstraction for irrigation and off-channel dams Alien invasive species within the riparian zone (<i>Salix</i>, <i>Eucalyptus</i> and <i>Populus sp.</i>) 			
Preliminary Results			
<i>In situ</i> water quality:

This river was identified for a rapid 3 assessment. However due to very low flows, mainly sewage from the Komani River that flows through Queenstown, it was seen as a health hazard to undertake the surveys. Only diatom and *in situ* water quality sampling were taken.

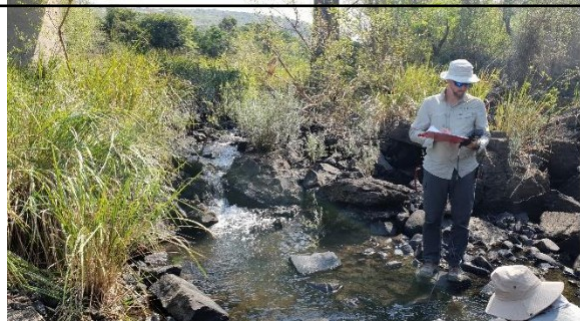
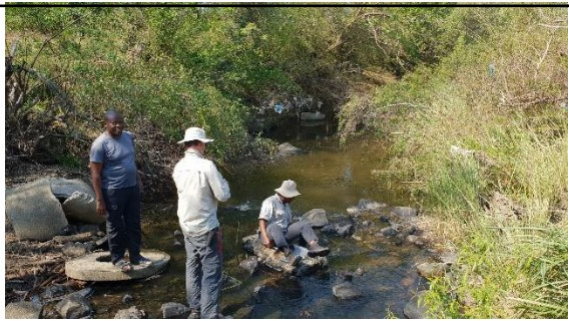
Upstream		Downstream	
Site impacts:			
<ul style="list-style-type: none"> Nutrient enrichment (algae) Alien invasive plants along riparian zone (<i>Eucalyptus sp.</i>) 			
Preliminary Results			
<i>In situ</i> water quality: <ul style="list-style-type: none"> pH: 8.15 EC: 755 uS/cm TDS: 0.569 g/l DO: 8.65 mg/l DO%: 91.3 % Clarity: 85 cm Temperature: 17.8 °C Salinity: 0.43 ppt

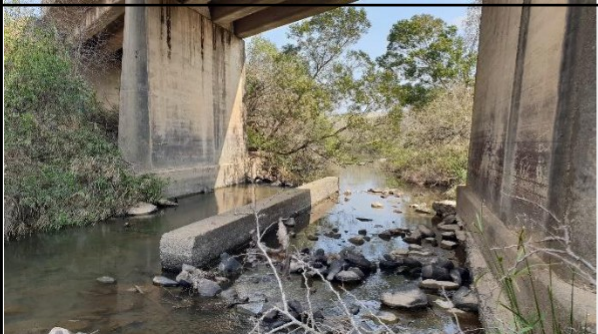
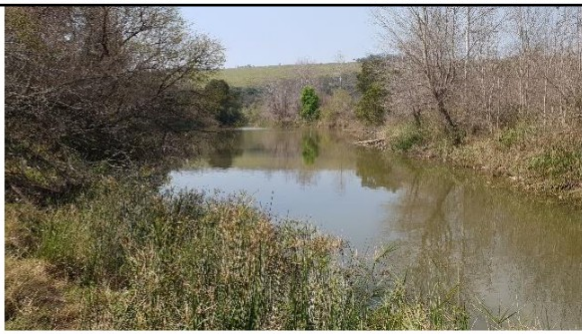
Upstream		Downstream	
Site impacts:			
<ul style="list-style-type: none"> • Forestry • Nutrient enrichments (algae) • Alien invasive plant species within riparian zone • Solid waste • Bank erosion/collapse 			
Preliminary Results			
<i>In situ</i> water quality:			
<ul style="list-style-type: none"> • pH: 8.08 • EC: 205.1 uS/cm • TDS: 0.1570 g/l • DO: 9.79 mg/l • DO%: 101.2 % • Clarity: 79 cm • Temperature: 17.1 °C • Salinity: 0.12 ppt

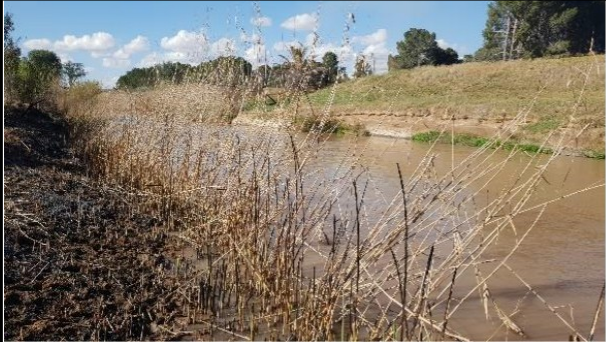
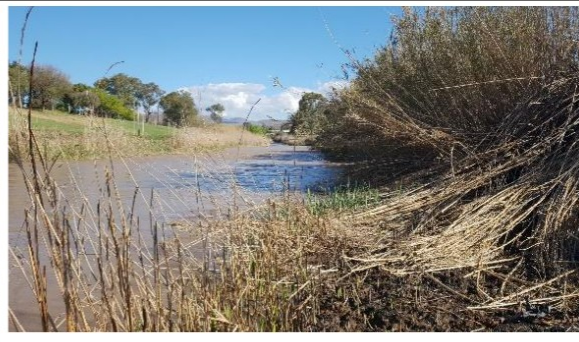
Upstream		Downstream	
Site impacts:			
<ul style="list-style-type: none"> • Interbasin transfer (flow modification) • Irrigation and return flows • Sedimentation • Weirs • Bridges • Alien invasive plants within riparian zone (Spanish Reed) 			
Preliminary Results			
<i>In situ</i> water quality:			
<ul style="list-style-type: none"> • pH: 8.42 • EC: 272.6 uS/cm • TDS: 0.2172 g/l • DO: 8.52 mg/l • DO%: 85.8 % • Clarity: 7 cm • Temperature: 15.4 °C • Salinity: 0.16 ppt

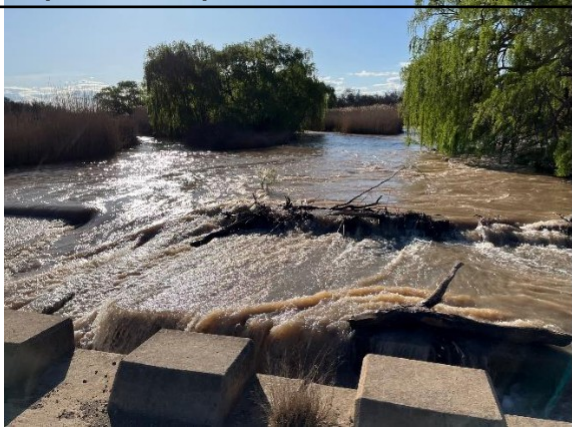
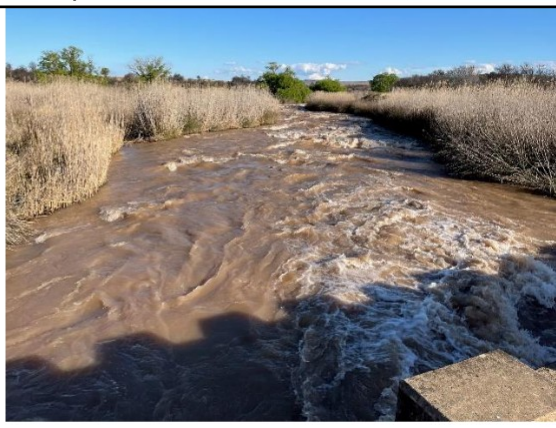
Upstream		Downstream	
Site impacts:			
<ul style="list-style-type: none"> • Sedimentation (high turbidity) • Interbasin Transfer scheme (flow modification) • Bank erosion (increased flows) 			
Preliminary Results			
<i>In situ</i> water quality: <ul style="list-style-type: none"> • pH: 8.41 • EC: 214.1 uS/cm • TDS: 0.1722 g/l • DO: 8.75 mg/l • DO%: 87.6 % • Clarity: 7 cm • Temperature: 15.0 °C • Salinity: 0.13 ppt

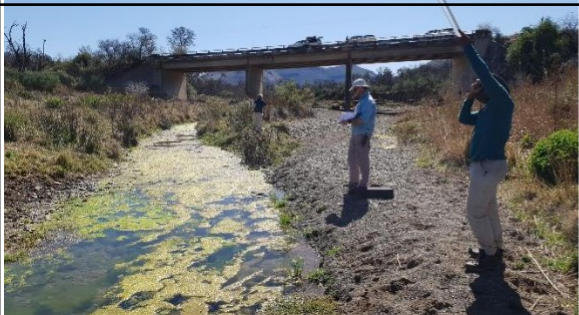
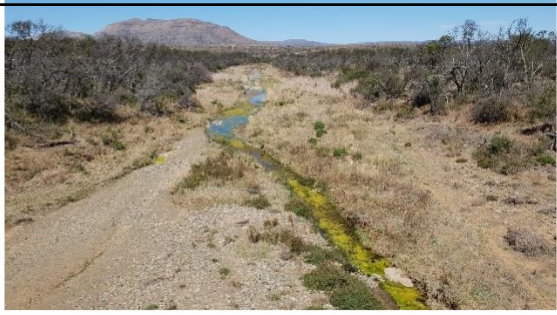
Site dry, only puddles, no flow and stagnant as all water abstracted upstream of site

Upstream		Downstream	
Site Description:			
<p>The site is located on the R337.</p> <p>The site is located in a partly confined valley setting with a single channel and narrow flood features. The channel is straight to wandering and follows the sinuous valley alignment. It follows a pool-riffle reach type and is dominated gravel with localised bedrock, cobble, sand and silt sediment types. The banks and benches are composed of gravel, sand and silt. There is moderate embeddedness along riffles and rapids with silt.</p>

Site impacts:			
<ul style="list-style-type: none"> • Agriculture • Irrigation • Significant water abstraction • Cattle trampling and grazing • Bank erosion (localised) • Bridge 			
Preliminary Results			
<p><i>In situ</i> water quality:</p> <ul style="list-style-type: none"> • pH: 7.53

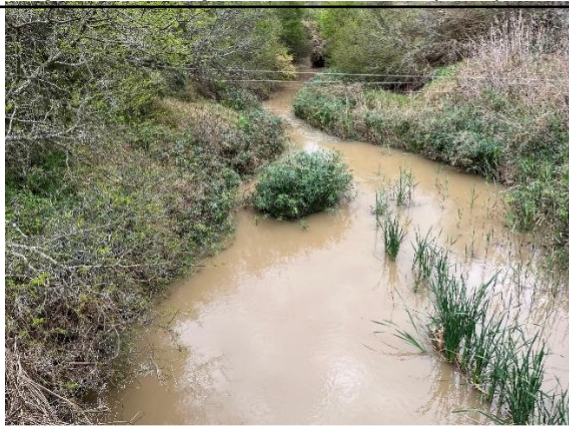
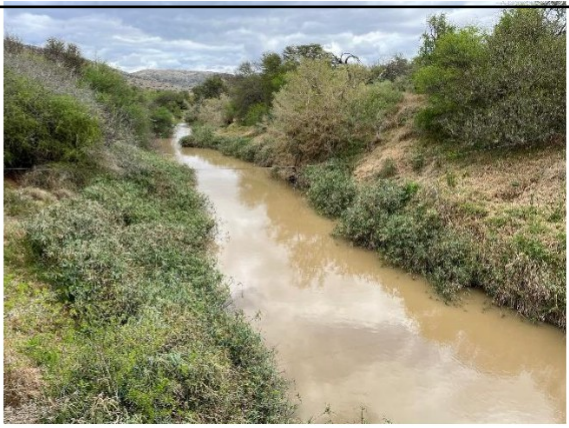
Upstream		Downstream	
Site impacts:			
<ul style="list-style-type: none"> • Interbasin Transfer scheme (flow modification) • Bank erosion • Cattle trampling and grazing • Irrigation and return flows 			
Preliminary Results			
<i>In situ</i> water quality: <ul style="list-style-type: none"> • pH: 8.48 • EC: 1246 uS/cm • TDS: 1.003 g/l • DO: 8.55 mg/l • DO%: 85.1 % • Clarity: 8 cm • Temperature: 15.0 °C • Salinity: 0.78

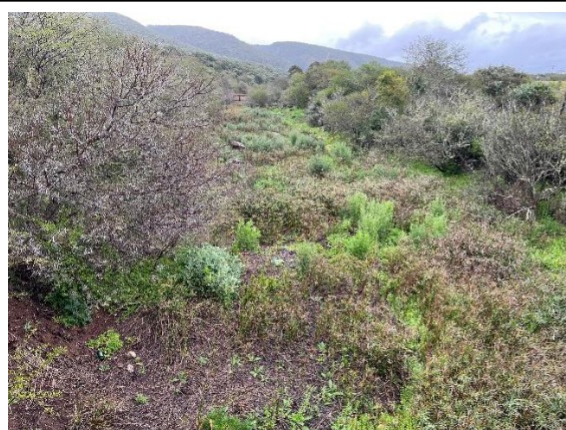
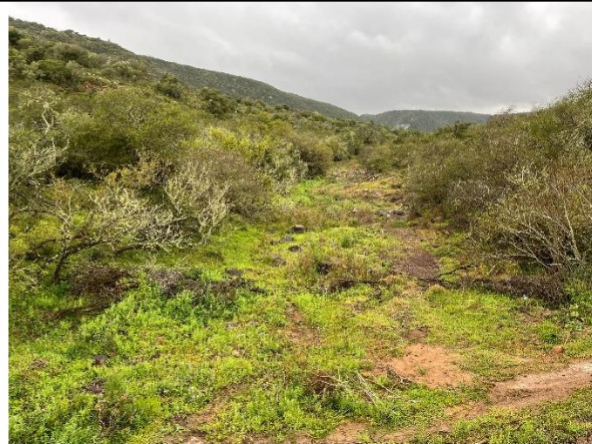
Components sampled: None - dry

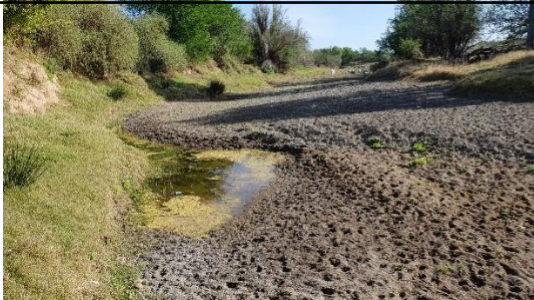
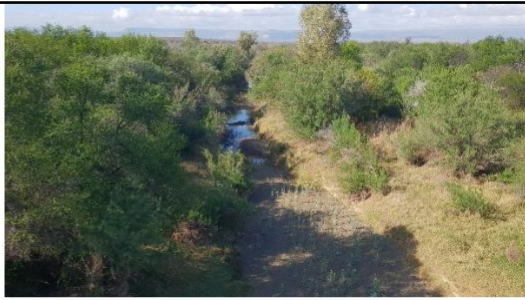
Dry riverbed with isolated and shallow pools. In situ water quality was measured and a diatom sample collected. Desktop assessment to be undertaken.

Upstream		Downstream	
Site impacts:			
<ul style="list-style-type: none"> • Cattle trampling and grazing • Bank erosion • Bridge • Upstream weir • Canal (left bank) • Exotic vegetation within riparian zone (<i>Tamarisk parviflora</i>, <i>Nicotiana glauca</i>, <i>Eucalyptus sp.</i>, <i>Terminalia australis</i>, <i>Onopordum acanthium</i>) 			
Preliminary Results

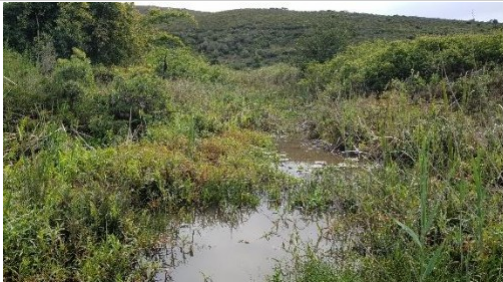
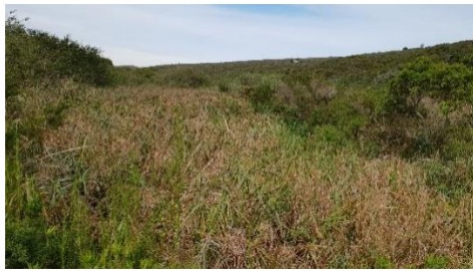
Upstream		Downstream	
Site impacts:			
<ul style="list-style-type: none"> • Irrigation in upper catchment • Cattle trampling and grazing • Some alien invasive plants • Various dams 			
Preliminary Results			
<i>In situ</i> water quality:			
<ul style="list-style-type: none"> • pH: 6.80 • EC: 447.6 uS/cm • TDS: 0.3593 g/l • DO: 7.94 mg/l • DO%: 78.7 % • Clarity: 39 cm

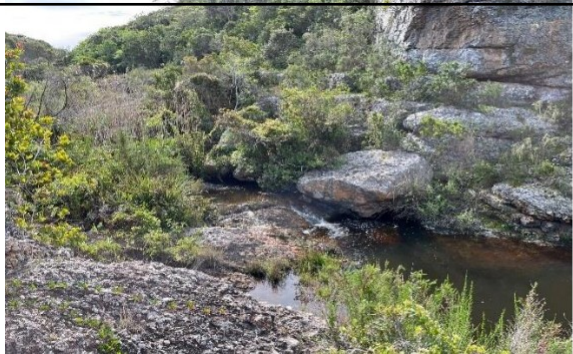
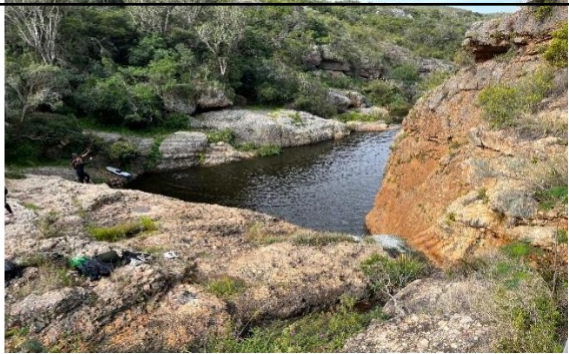
Upstream		Downstream	
Site impacts:			
<ul style="list-style-type: none"> • High water abstraction • Extensive irrigation • Citrus farming • Acidic waters (down to a pH of a 3.0 according to the farmer) • Various dams throughout 			
Preliminary Results			
<i>In situ</i> water quality: <ul style="list-style-type: none"> • pH: 6.87 • EC: 573 uS/cm • TDS: 0.4511 g/l • DO: 8.29 mg/l • DO%: 83.4 % • Clarity: >1m • Temperature: 15.8 °C • Salinity: 0.34 ppt
