Determination of Water Resource Classes, Reserve and the Resource Quality Objectives in the Keiskamma and Fish to Tsitsikamma Catchments

WP11354 River Field Survey Report 1

REPORT NO.:
WEM/WMA7/00/CON/RDM/0722

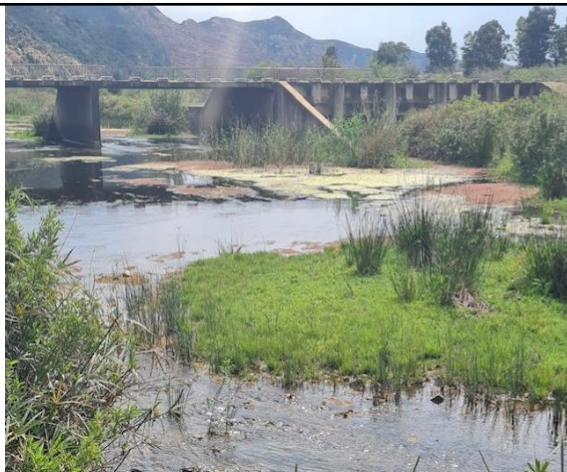
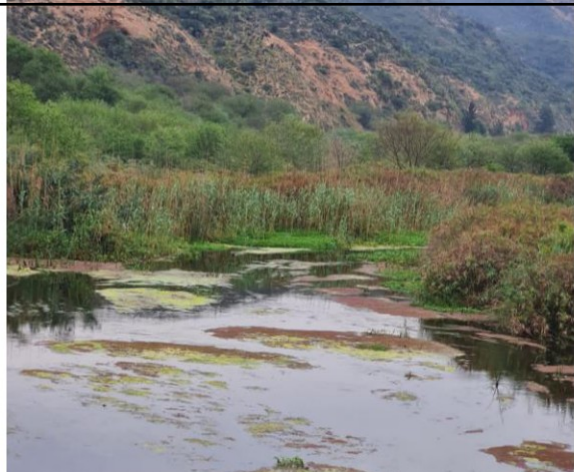
Upstream		Downstream	
Site impacts:			
<ul style="list-style-type: none"> • Cattle trampling and grazing • Bridge • Citrus farming • Irrigation • Return flows • Nutrients (high algae content) • Some erosion 			
Preliminary Results			
<i>In situ</i> water quality: <ul style="list-style-type: none"> • pH: 7.92 • EC: 2172 uS/cm • TDS: 1.652 g/l • DO: 8.03 mg/l

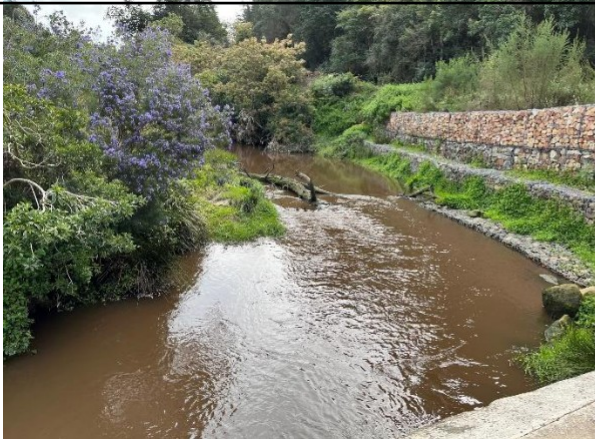
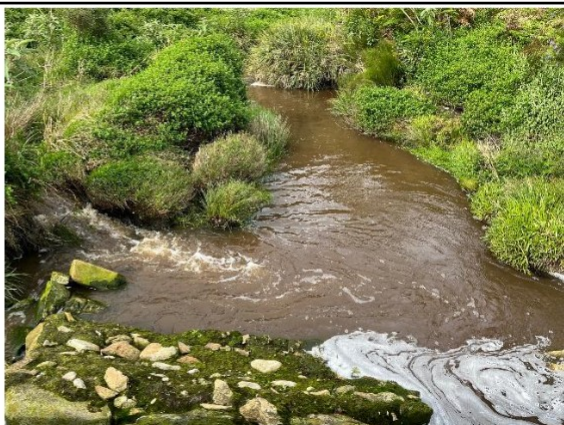
Upstream		Downstream	
Site impacts:			
<ul style="list-style-type: none"> • Weir upstream • Low water bridge • Extensive forestry • Forestry roads • Alien vegetation within riparian zone (Black Wattle, Bugweed, Bramble) 			
Preliminary Results			
<i>In situ</i> water quality:			
<ul style="list-style-type: none"> • pH: 5.45 • EC: 177.7 uS/cm • TDS: 0.1443 g/l

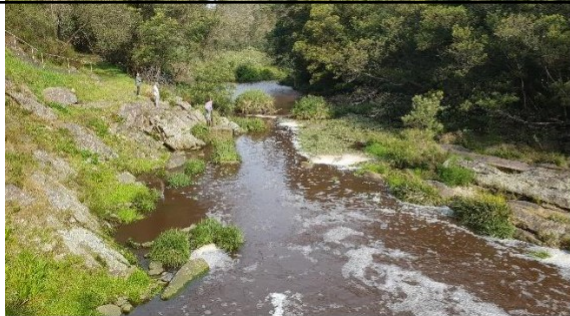
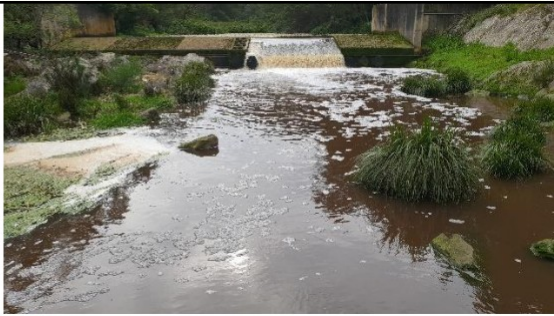
Upstream		Downstream	
Site impacts:			
<ul style="list-style-type: none"> • Weir upstream • Extensive forestry • Forestry roads • Alien vegetation within riparian zone (Black Wattle, Bugweed, Bramble) 			
Preliminary Results			
<i>In situ</i> water quality:			
<ul style="list-style-type: none"> • pH: 5.45 • EC: 177.7 uS/cm • TDS: 0.1443 g/l • DO: 8.94 mg/l • DO%: 87.4 % • Clarity: 24 cm • Temperature: 14.8 °C • Salinity: 0.11 ppt

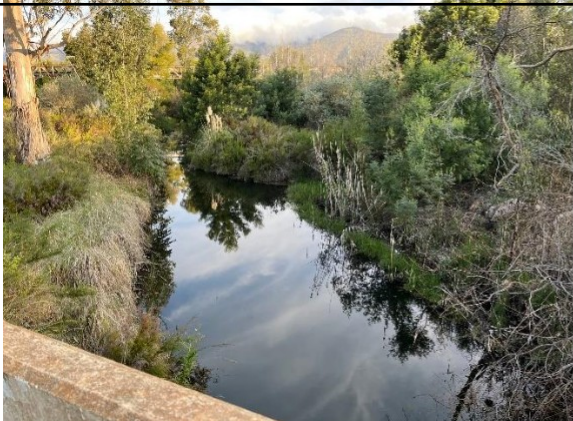
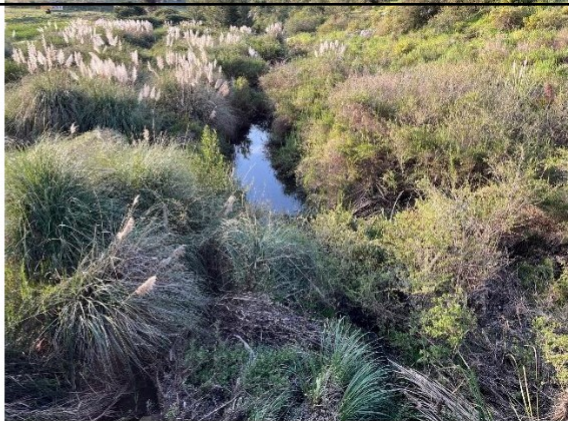
Upstream		Downstream	
Site impacts:			
<ul style="list-style-type: none"> • Downstream town of Twee Riviere • WWTW • Nutrients from sewage (algae) • Bridge, river crossings • and railway crossing • Some erosion • Alien invasive plants within riparian zone • Cattle trampling and grazing 			
Preliminary Results			
<i>In situ</i> water quality: <ul style="list-style-type: none"> • pH: 6.67 • EC: 138.2 uS/cm • TDS: 0.1090 g/l • DO: 8.76 mg/l
