Determination of Water Resource Classes, Reserve and the Resource Quality Objectives in the Keiskamma and Fish to Tsitsikamma Catchments

WP11354 Wetland Field Survey Report

REPORT NO.:
WEM/WMA7/00/CON/RDM/0522

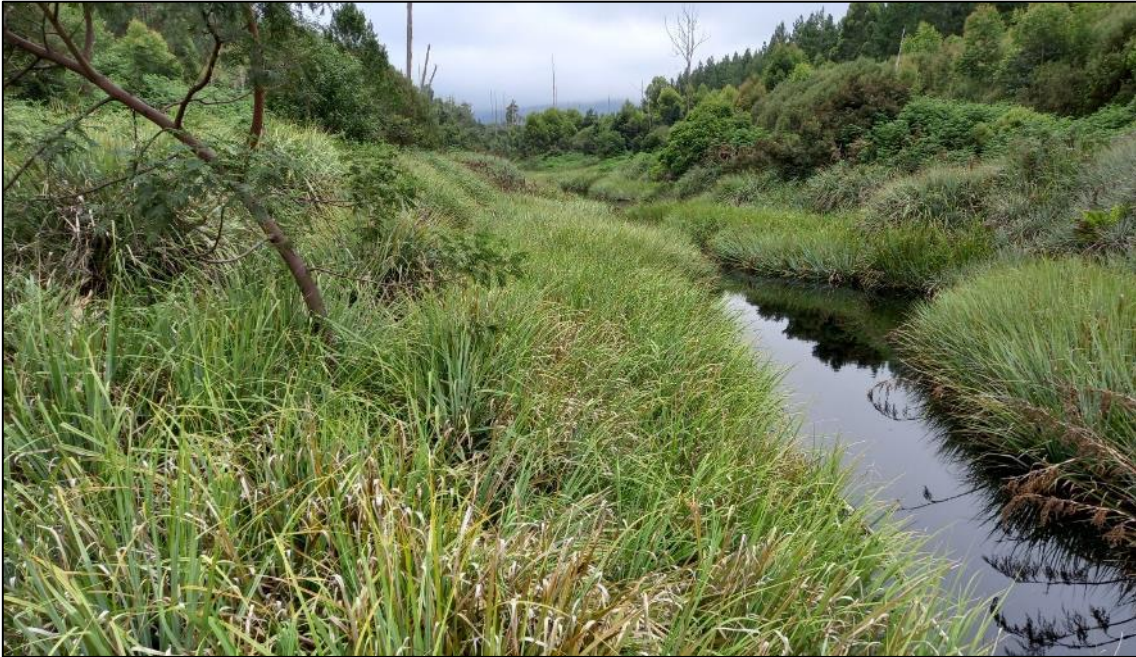
Figure 3-2 Channelled valley bottom dominated strongly by palmiet (*Prionium serratum*), especially in the central wettest portions, and moderately infested with invasive alien plants, especially on its margins.

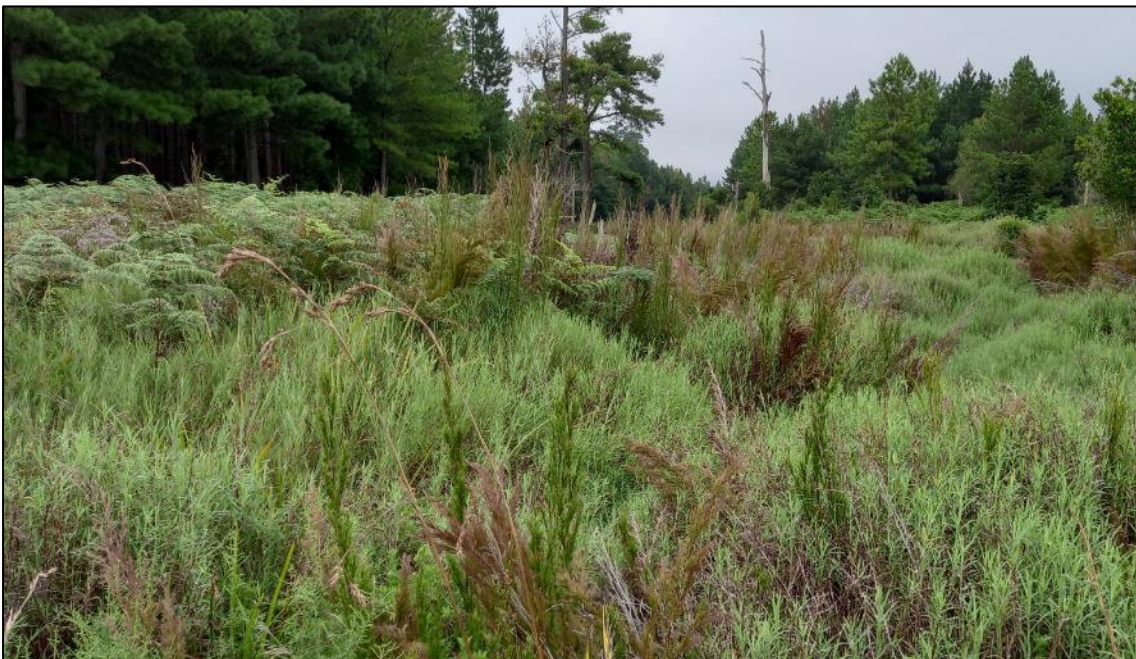
Figure 3-3 An area of channelled valley bottom with a mix of restios (*Restio panicuata*), the grass-like shrub *Cliffortia gramineae* and a margin now strongly dominated by the bracken fern (*Pteridium aquilinum*). Also, pine plantations can be seen extending very close to the wetland margin.

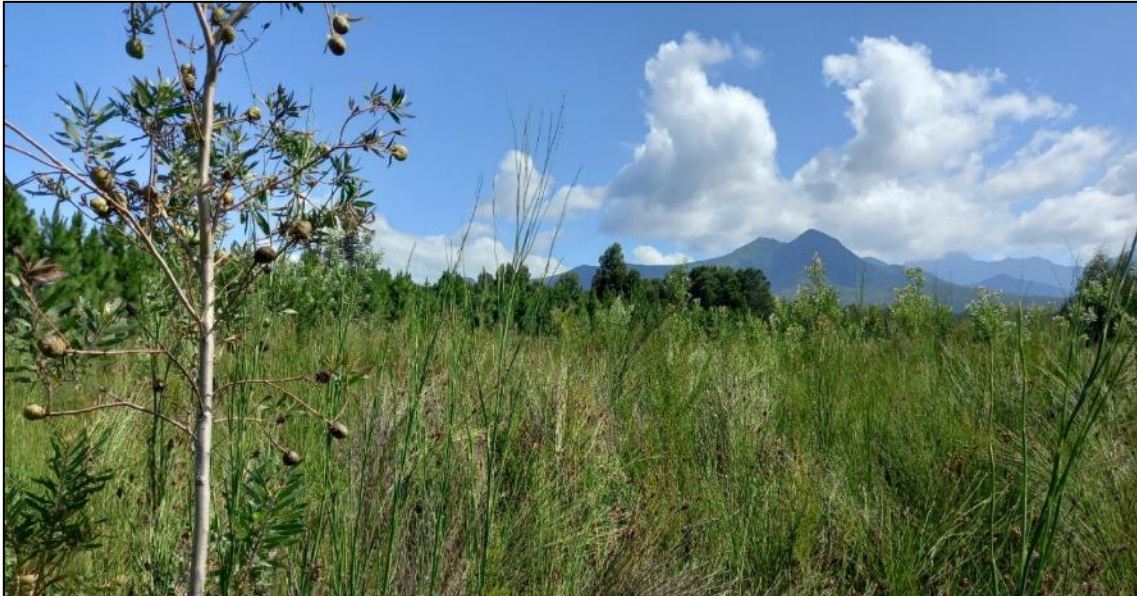
Figure 3-4 An unchanneled valley bottom with restios (*Platycaulos callistachyus*) and the near-threatened Garden Route Conebush (*Leucadendrom conicum*)

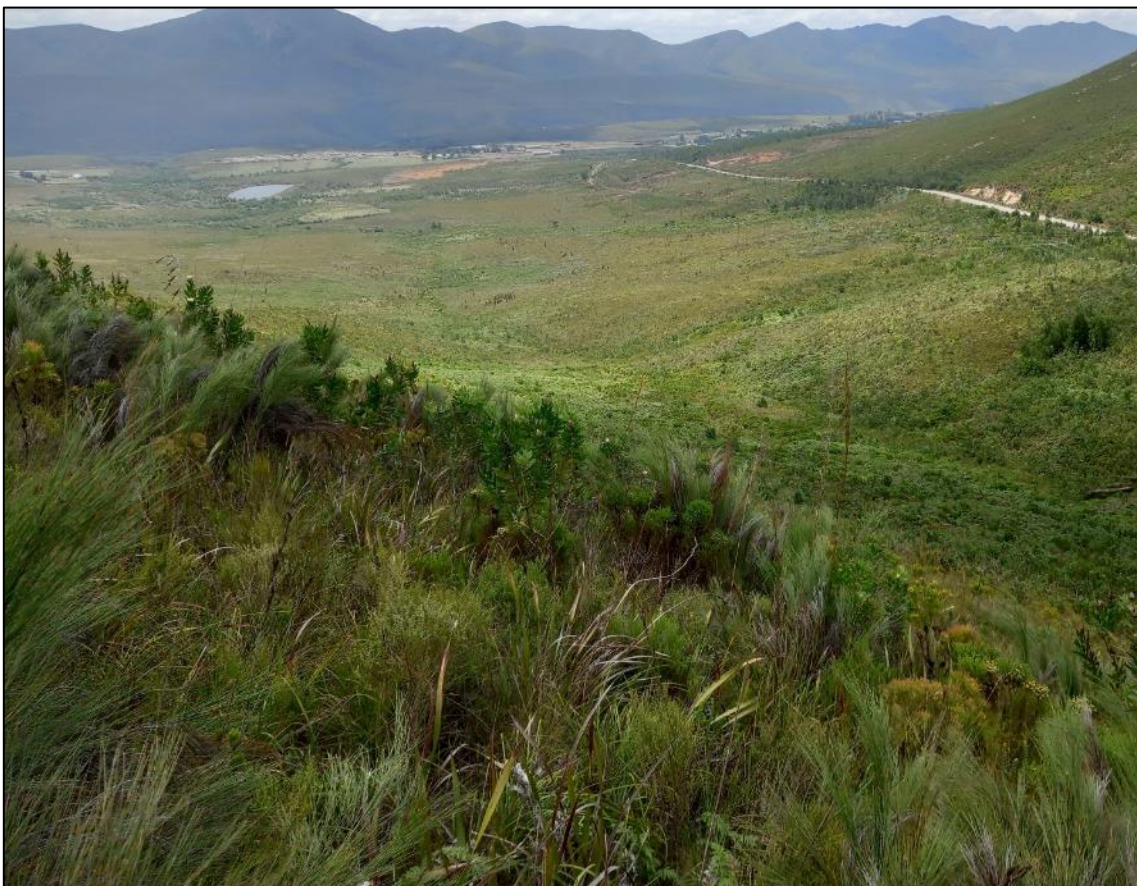
Figure 3-5 A hillslope seep wetland area near the Kareedouw pass, comprising a mix of restios (notably *Platycaulos callistachyus*) and shrubs (notably *Protea mundii* and *Berzelia intermedia*).

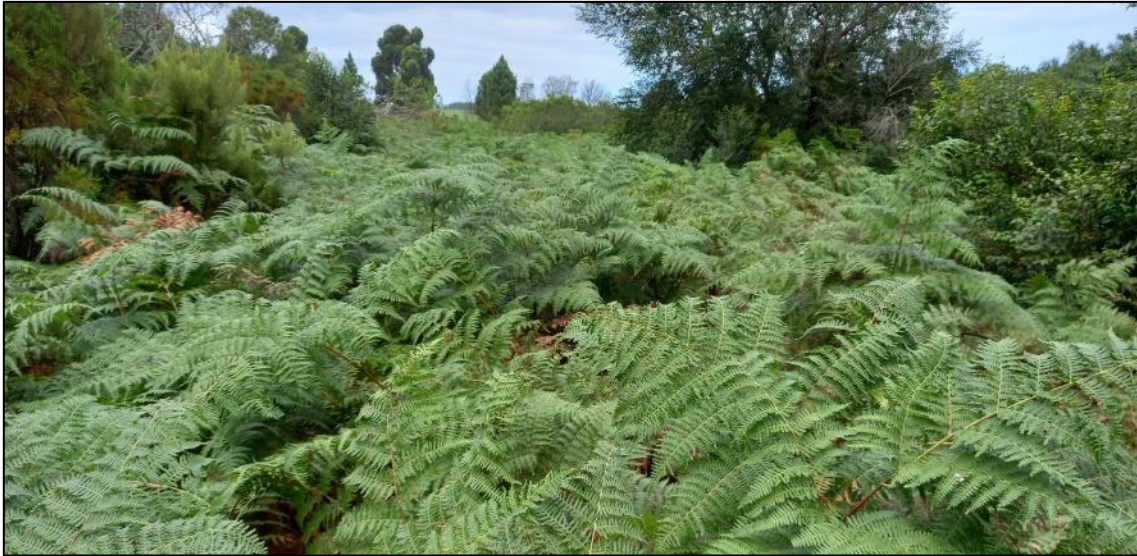
Figure 3-6 An historically disturbed and now infrequently burnt wetland area in poor ecological condition, which is dominated by bracken fern, with a few typical wetland species such as *Berzelia intermedia* as well as several *Halleria lucida* shrubs, a forest precursor species.

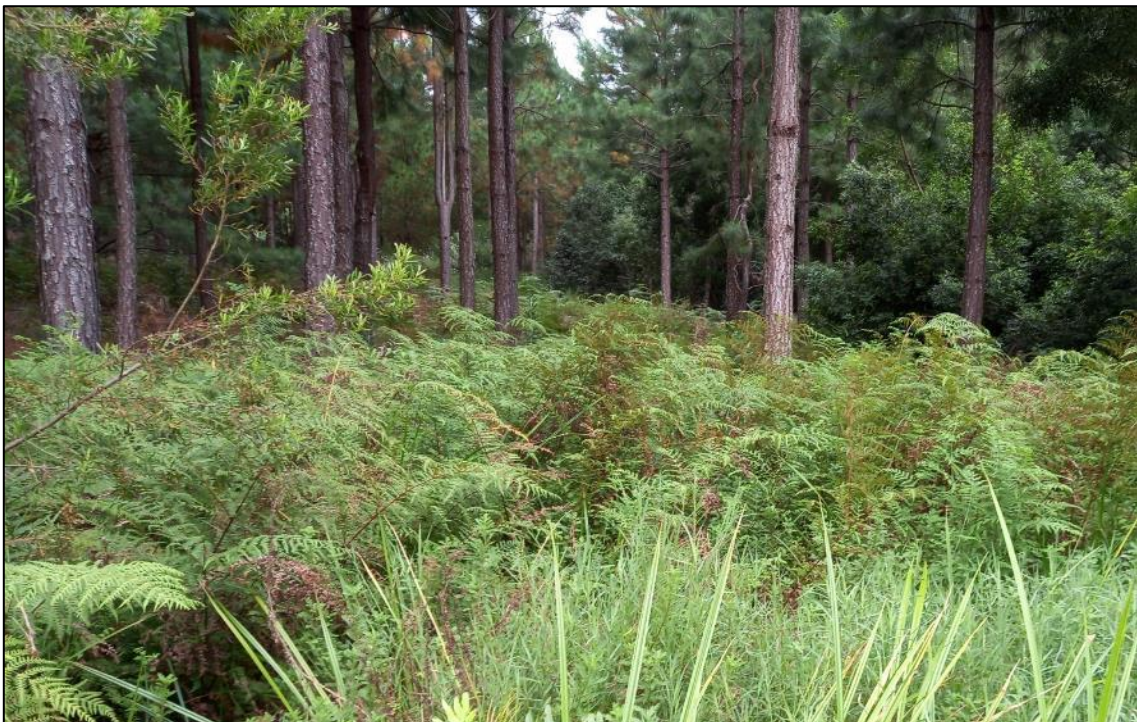
Figure 3-7 The edge of wetland lying close to a forest plantation, which has favoured the fern *Hypolepis sparsisora*, typically adapted to forest margin situations. Visible in the foreground, and further into the wetland, are typical wetland species *Carpha glomerata* and *Cliffortia graminea*

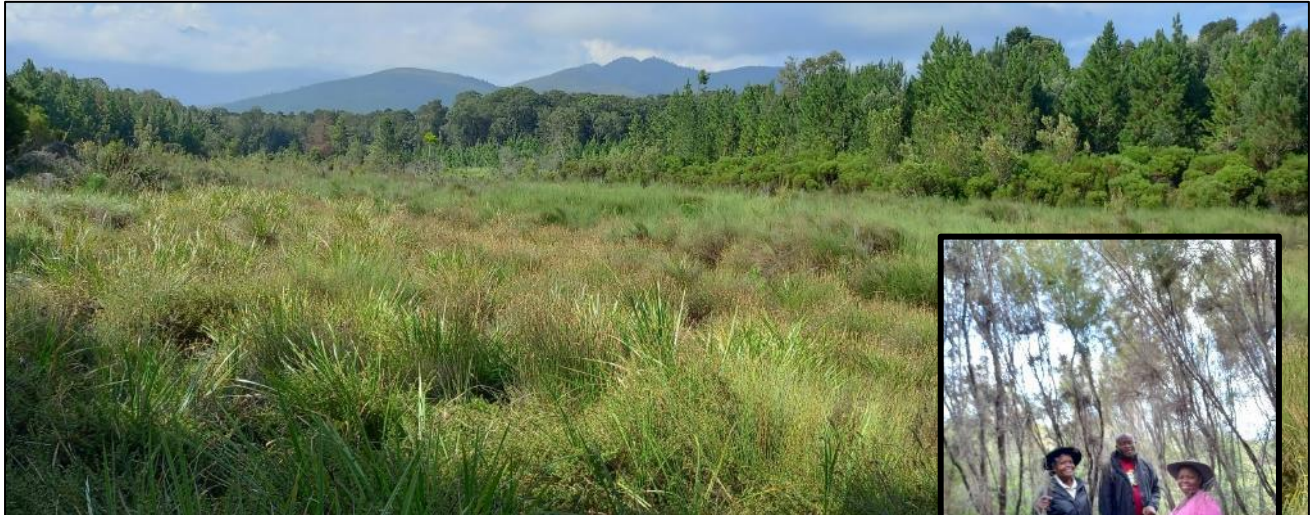
Figure 3-8 A relatively broad valley bottom wetland, with the tall shrub *Berzelia intermedia* (see insert), which is a facultative wetland species, dominating the margin of the wetland adjacent to the tree plantations

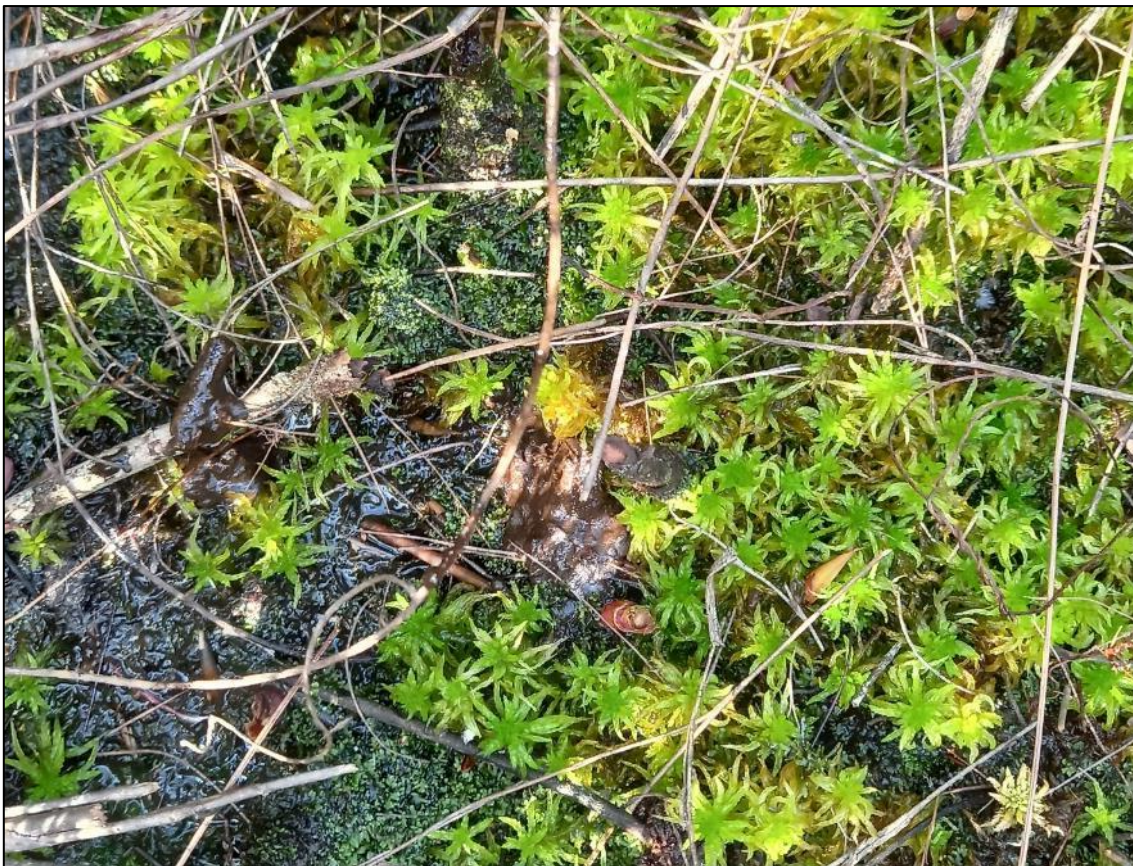
Figure 3-9 Sphagnum moss growing in the wetland shown above in the core wettest area of the wetland, which has organic soils.

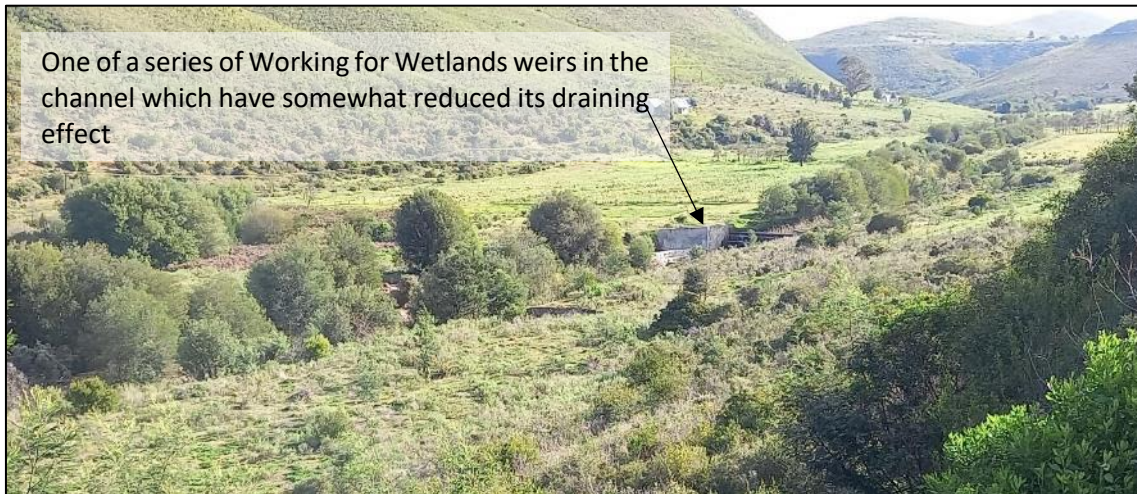
Figure 3-11 The inflow portion of the wetland, highly transformed by agricultural development over most of its surface and with an excavated and incised central channel with invasive alien infestation along its entire length.

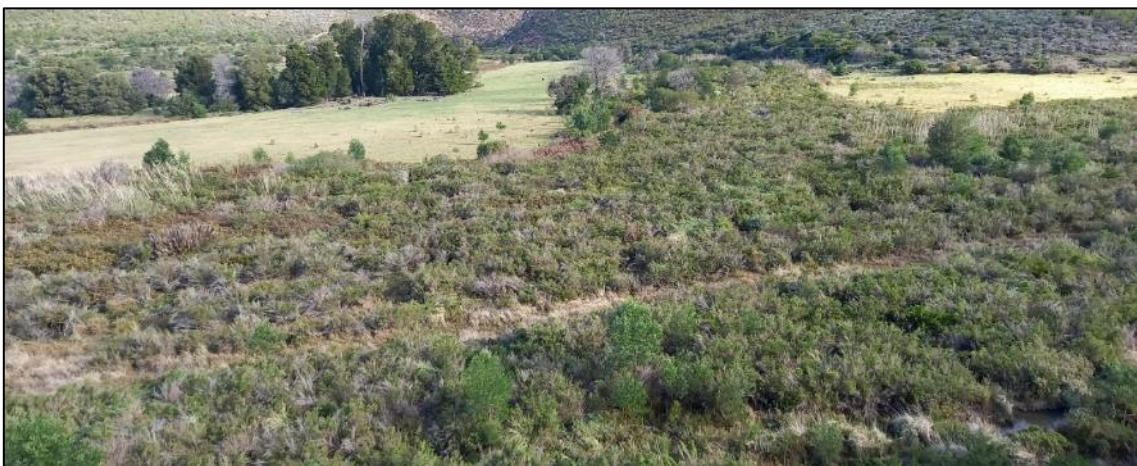
Figure 3-12 The upstream end of the Krugersland Basin portion of the wetland, with its largely-intact natural vegetation comprising restios (e.g. *Restio paniculata*) and shrubs (e.g. *Cliffortia strobilifera*) and scattered young black wattle (*Acacia mearnsii*) trees.

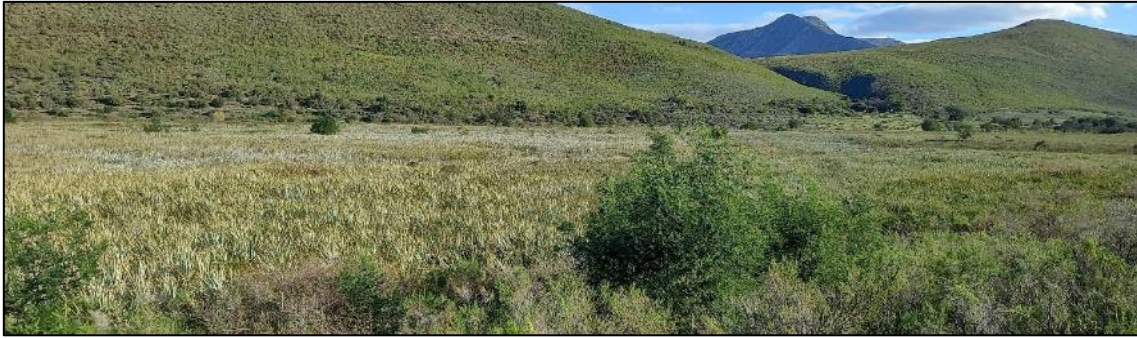
Figure 3-13 The main Krugersland Basin portion of the wetland, dominated by an extensive palmiet (*Prionium serratum*) area

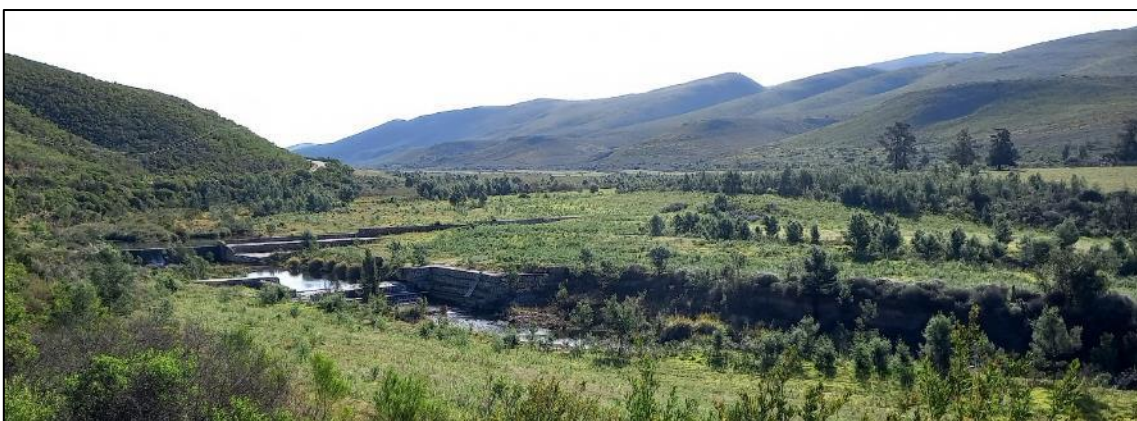
Figure 3-15 Two major rehabilitation weirs lying at the downstream end of the Kompanjiesdrif Basin, and which continue to prevent the headward advance of a major erosion gully threatening the basin's palmiet wetland. Also visible are localized dense infestations of young black wattles

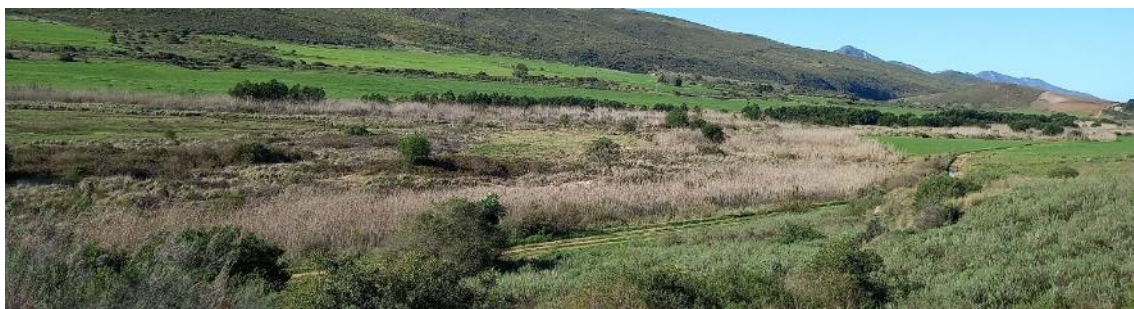
Figure 3-18 The middle portions of the Jagersbos basin comprising predominantly natural vegetation, but with cultivated pastures on the margins.

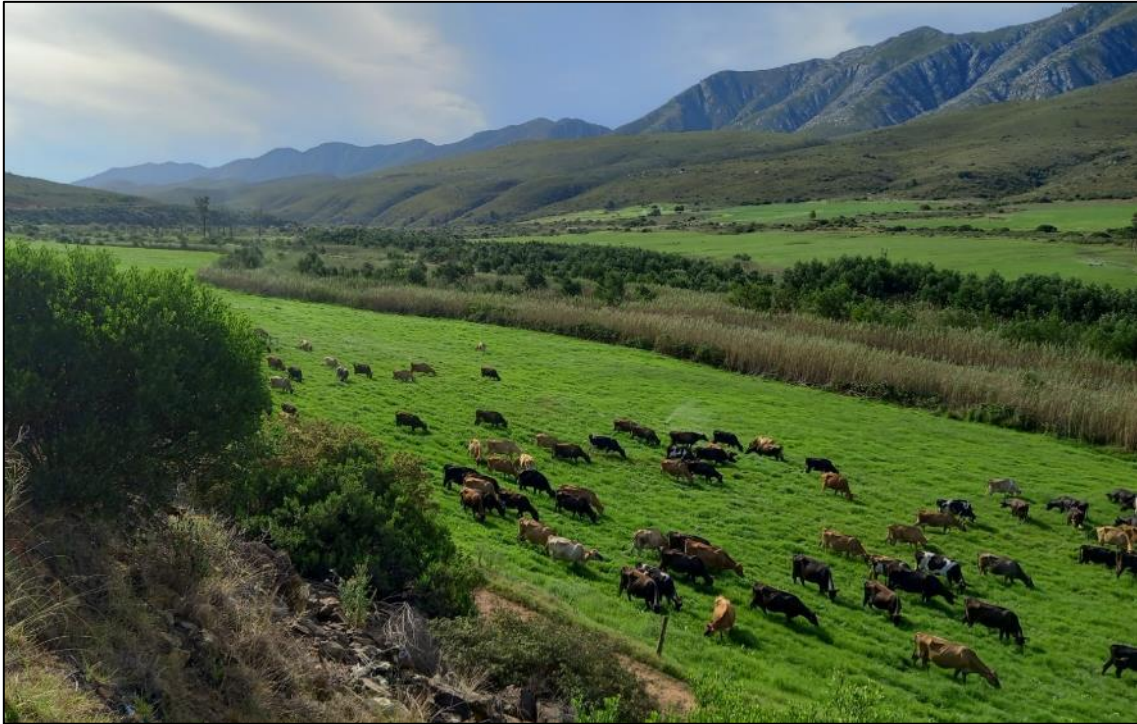
Figure 3-19 The lower portions of the Jagersbos basin, with extensive cultivation of dairy pastures and a central area of natural vegetation dominated mainly by *Phragmites australis* and with extensive black wattle infestation.

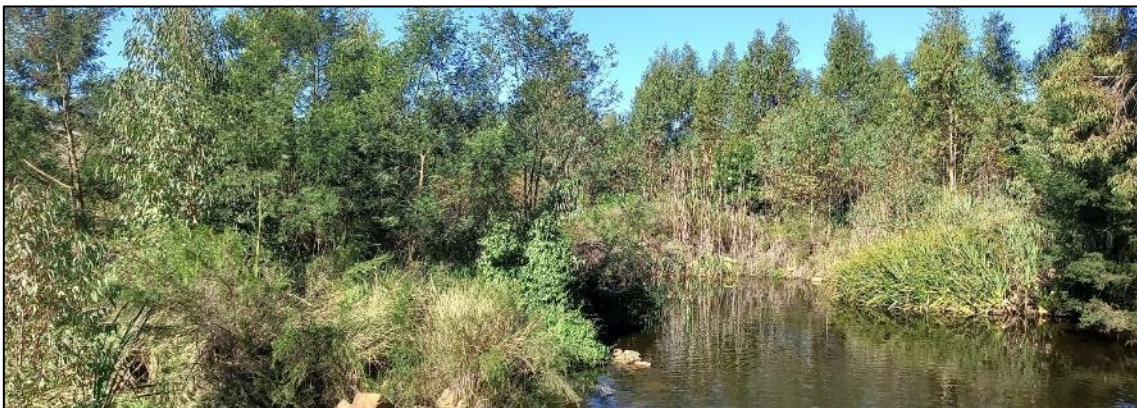
Figure 3-20 The upper portions of the Assegaibosch basin with the shrub *Cliffortia strobilifera*, common reed (*Phragmites australis*) and palmiet, together with a high level of infestation of young *Eucalyptus sp.* and wattle trees

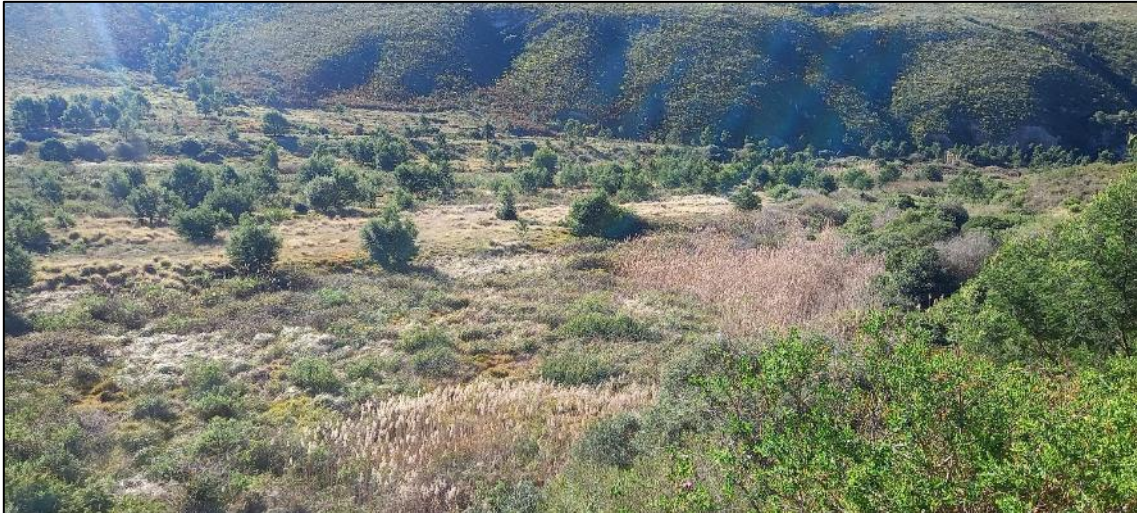
Figure 3-21 The mid portions of the Assegaibosch basin comprising mainly indigenous vegetation, including common reed (*Phragmites australis*) the grass *Pennisetum macrourum*, the shrub *Cliffortia strobilifera* and palmiet, and with both scattered and localized dense infestations of young black wattle.

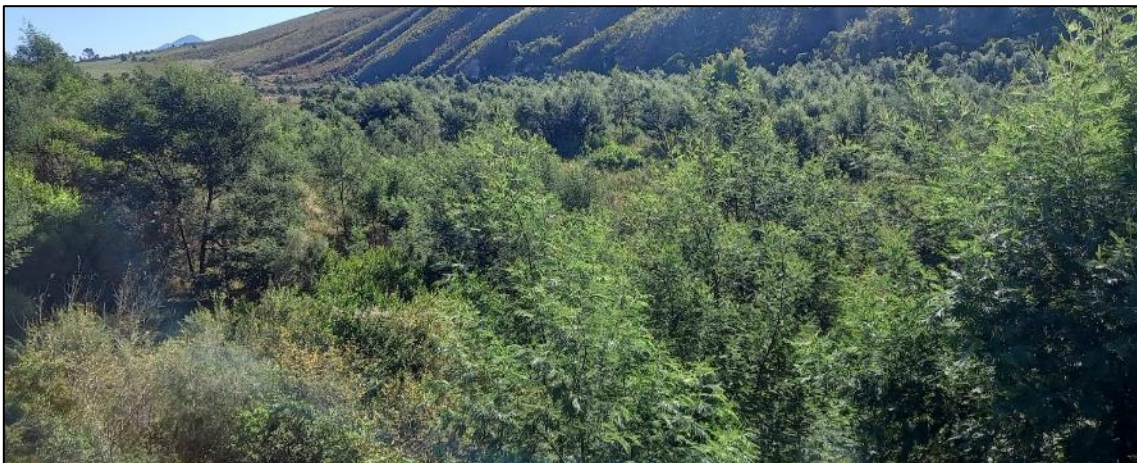
Figure 3-22 The lower portion of the Assegaibosch basin (immediately upstream of the R62 bridge over the Kromme River) extensively infested with young black wattle.

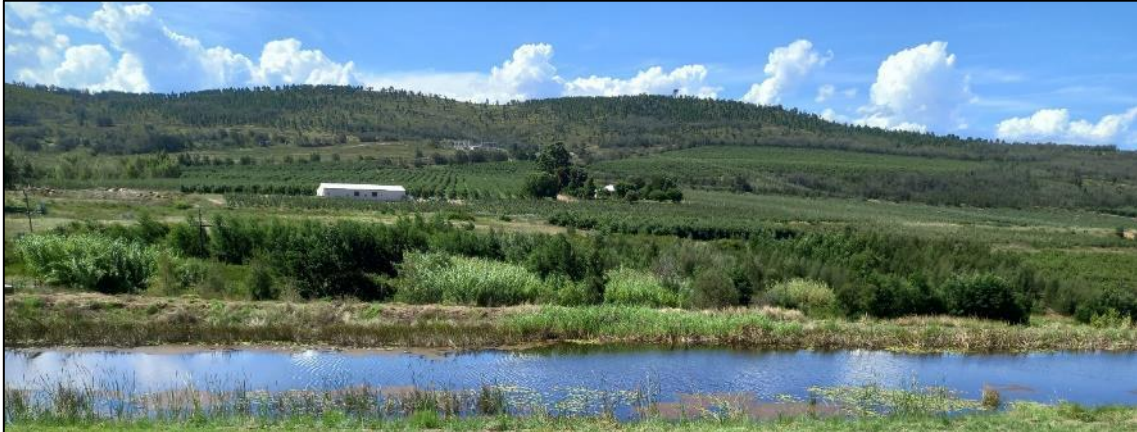
Figure 3-24 The wetland in the upper reaches of the Krakeel River (visible in the foreground) comprising a mosaic of orchards, dams and semi-natural wetland (with large clumps of the invasive alien Spanish reed, *Arundo donax*, while extensive orchards adjacent to the wetland can be seen in the middle ground and an area of natural vegetation in the catchment infested with IAPs.

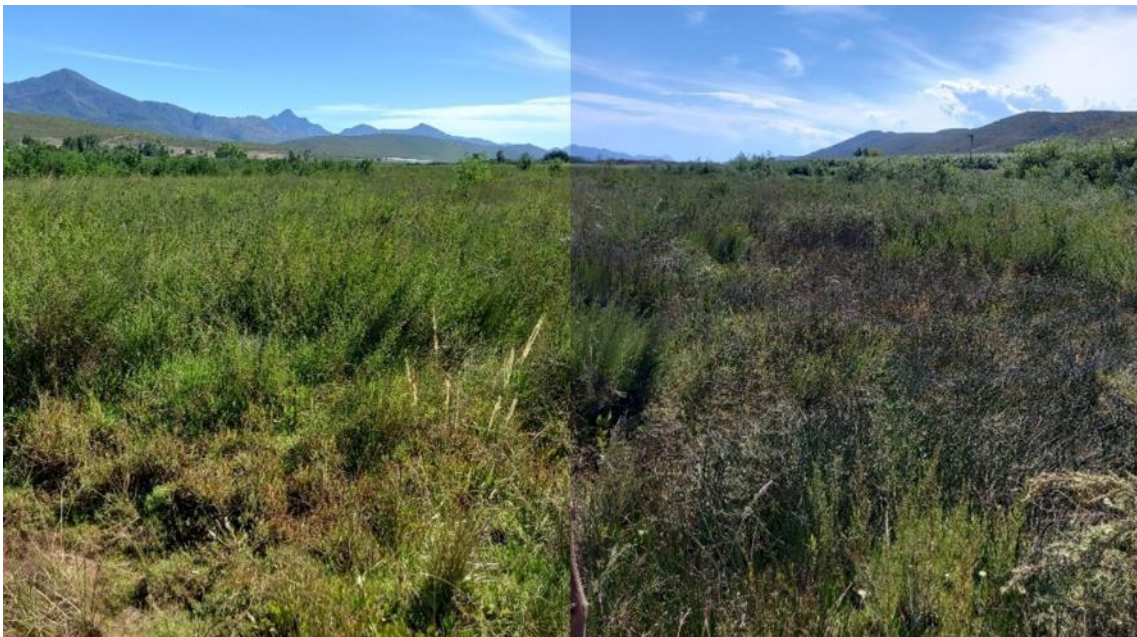
Figure 3-25 Mixed restio/sedge/grass/shrub vegetation in Krakeel portion of the wetland, with a clump of young black wattle trees visible to the extreme left

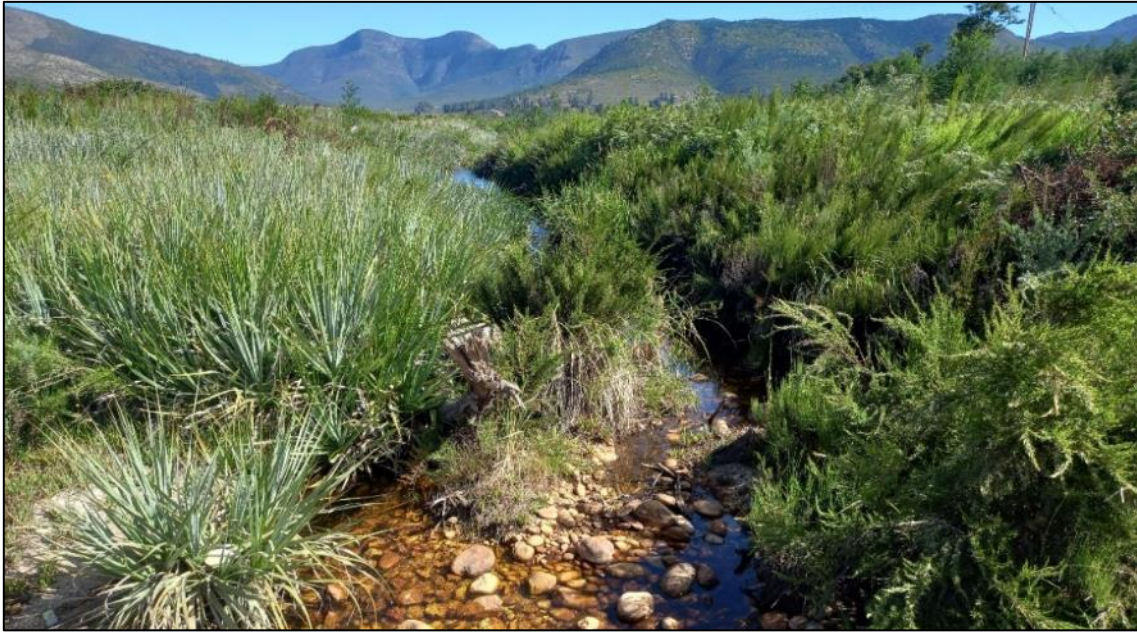
Figure 3-26 The Wabooms River with flanking palmiet (left) and mixed shrub/restio vegetation (right)

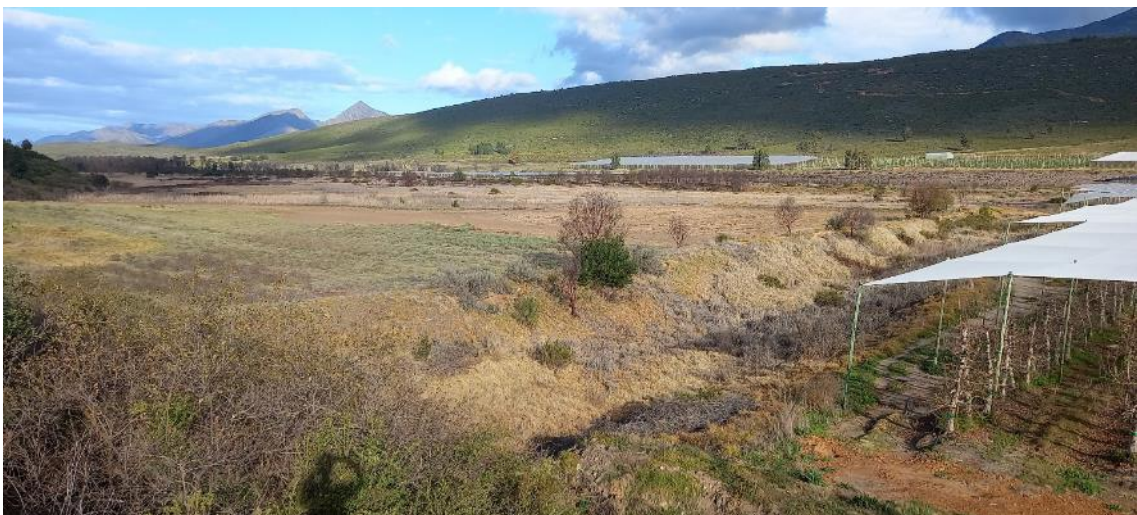
Figure 3-27 The transition between the central portion of the Krakeel wetland which is highly developed to orchards and the lower portion which is under natural and semi-natural vegetation with extensive invasive alien plant infestation, in particular black wattle. Also visible is a drainage furrow associated with the orchard development

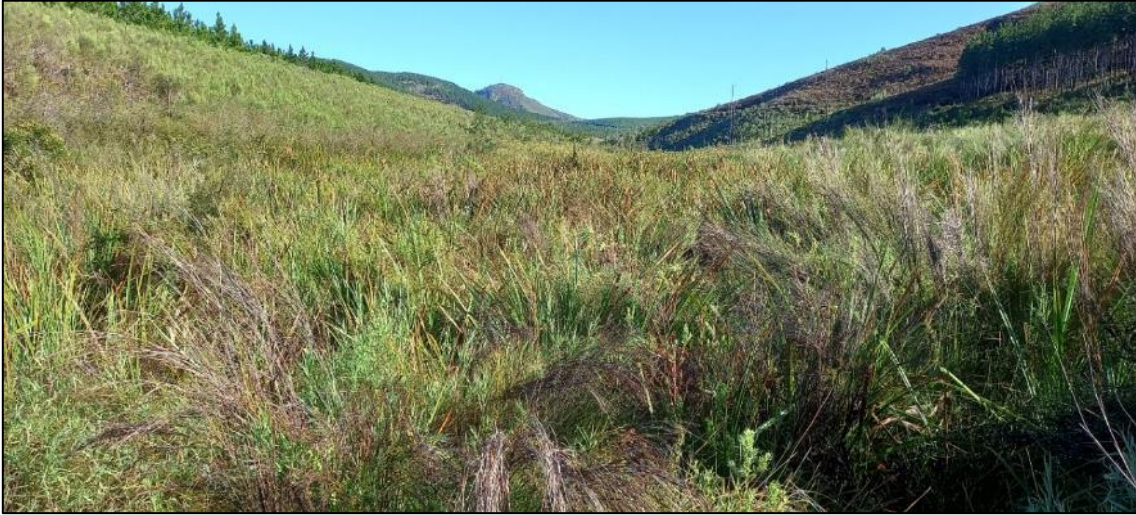
Figure 3-29 A valley bottom area with intact natural vegetation comprising a mix of restios (*Platycaulos callistachyus*), sedges (*Carpha glomerata*) and the grass-like shrub (*Cliffortia gramineae*), and almost entirely free of invasive alien plants.

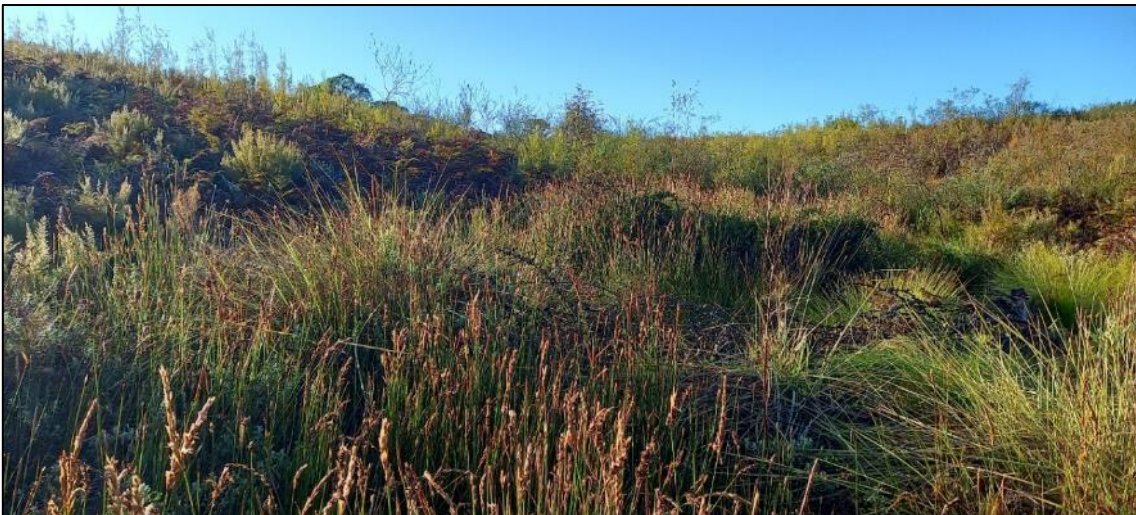
Figure 3-30 A hillslope seep area with intact natural vegetation comprising a diverse mix of shrubs (*Erica* spp., *Psoralia* spp. and the vlei boegoe, *Empleurum unicapsulare*), restios (*Elegia fistulosa*) and grass (*Miscanthus capensis*) and also almost entirely free of invasive alien plants.

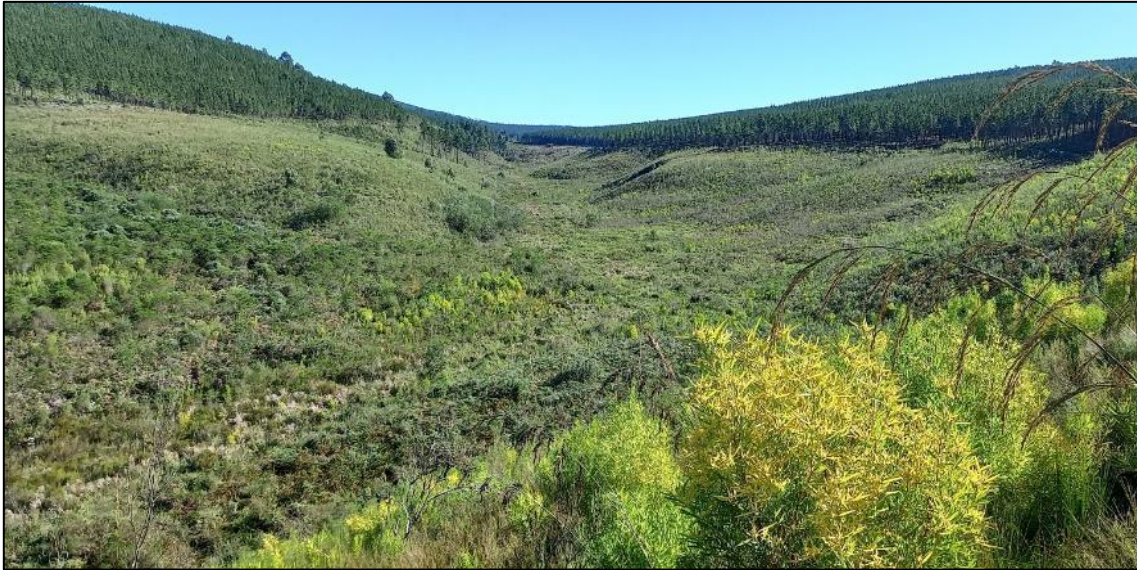
Figure 3-31 A valley bottom wetland comprising intact natural vegetation with a low density of invasive alien plants and a relatively generous wetland buffer, which is mostly clear of invasive alien plants, especially to the right. The buffer was expanded greatly to its current position after the major fire of 2005 and when the tall pine trees in the buffer on the left are harvested they will not be replanted.

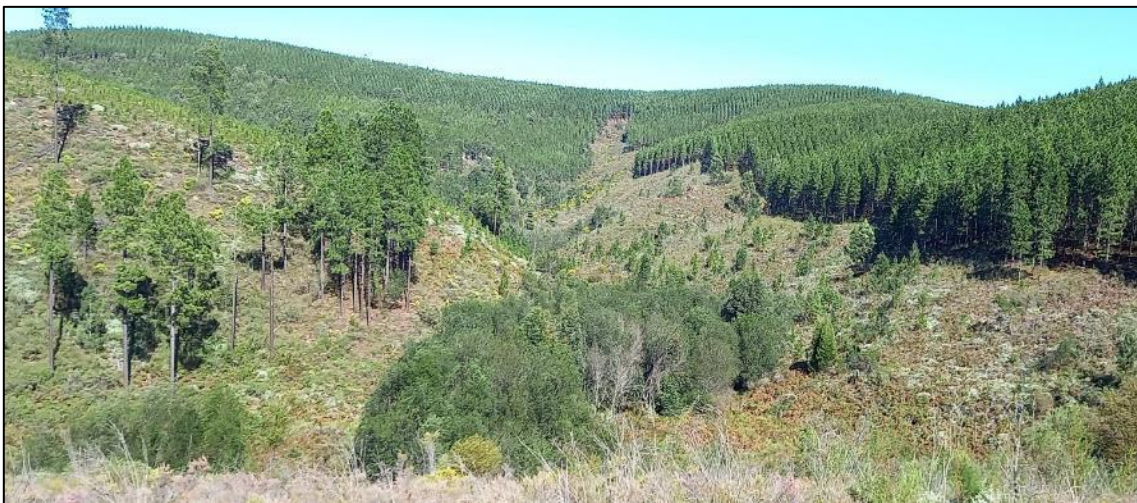
Figure 3-32 A narrow wetland area in a steep-sided valley. In the wetland buffer to the left are some mature pine trees (also visible in the previous photo) and in the wetland is a dense clump of the indigenous forest-pioneer tree the Keurboom (*Virgilia divaricata*), both of which escaped the 2017 fire. In the buffer to the right are scattered pine trees established after the 2017 fire.

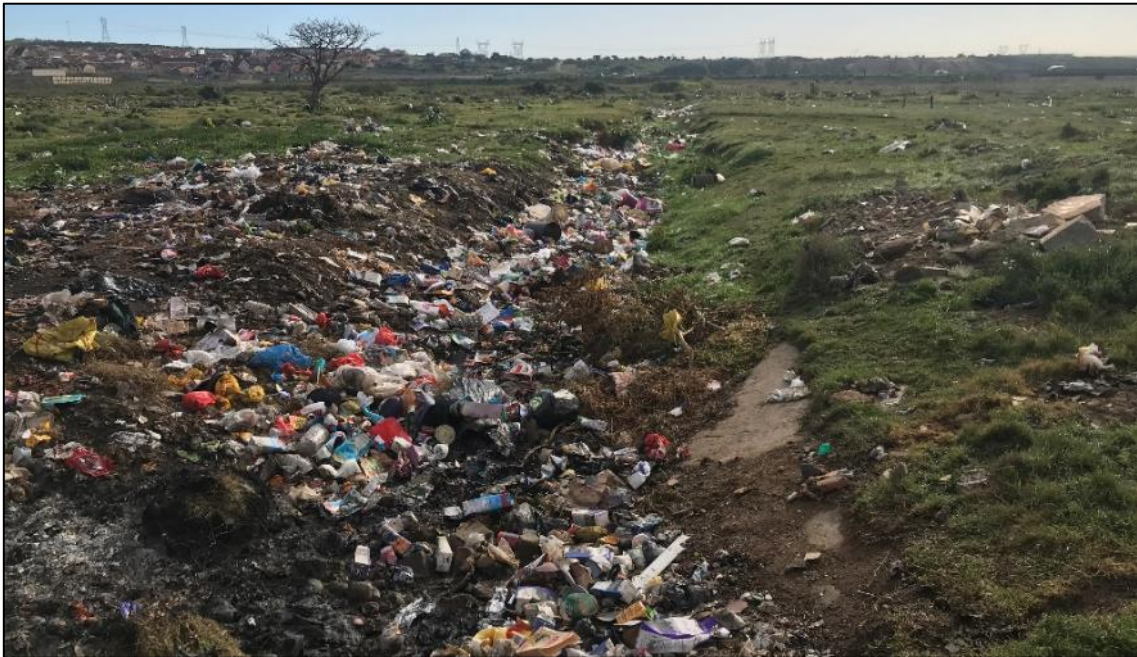
Figure 3-36 One of the many stormwater canals that conveys stormflows into the Chatty River Wetlands. Many of these canals have been totally blocked by the litter and debris, causing them to overflow into inhabited areas, potentially posing a health risk to those living nearby. In addition, the canalised stormwater conduits that are not blocked were observed to, in some cases, have resulted in erosion and scour of the downstream wetland.

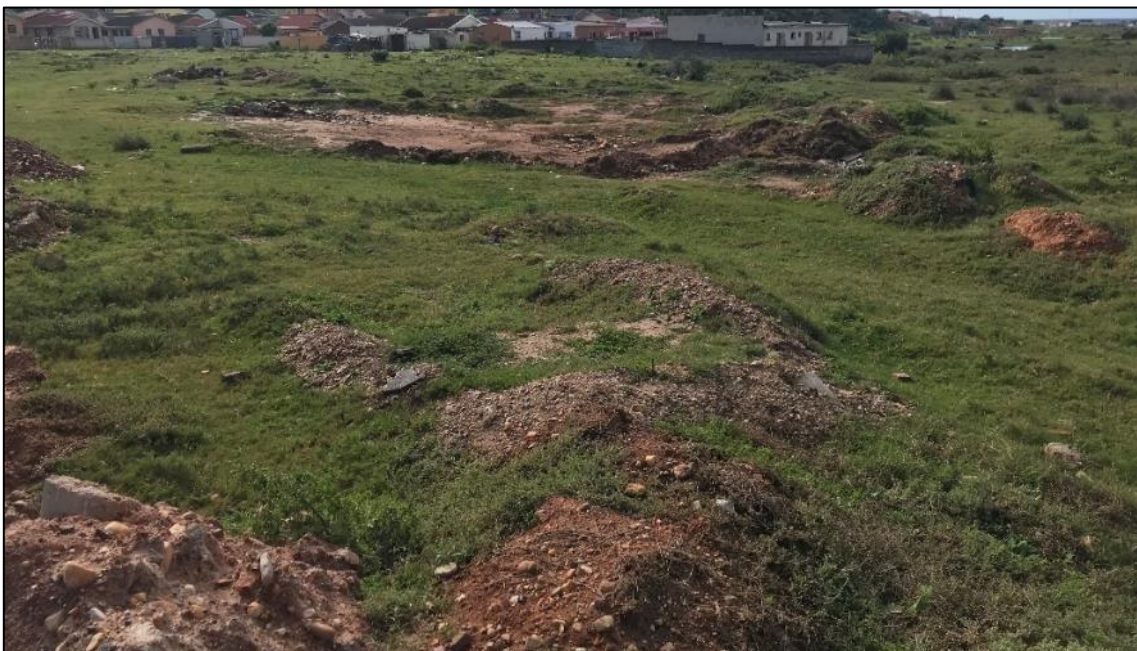
Figure 3-37 Evidence of recent infilling of rubble used for construction in CVB 1. It was noted that a homestead structure had recently been built using some of the rubble pictured here.

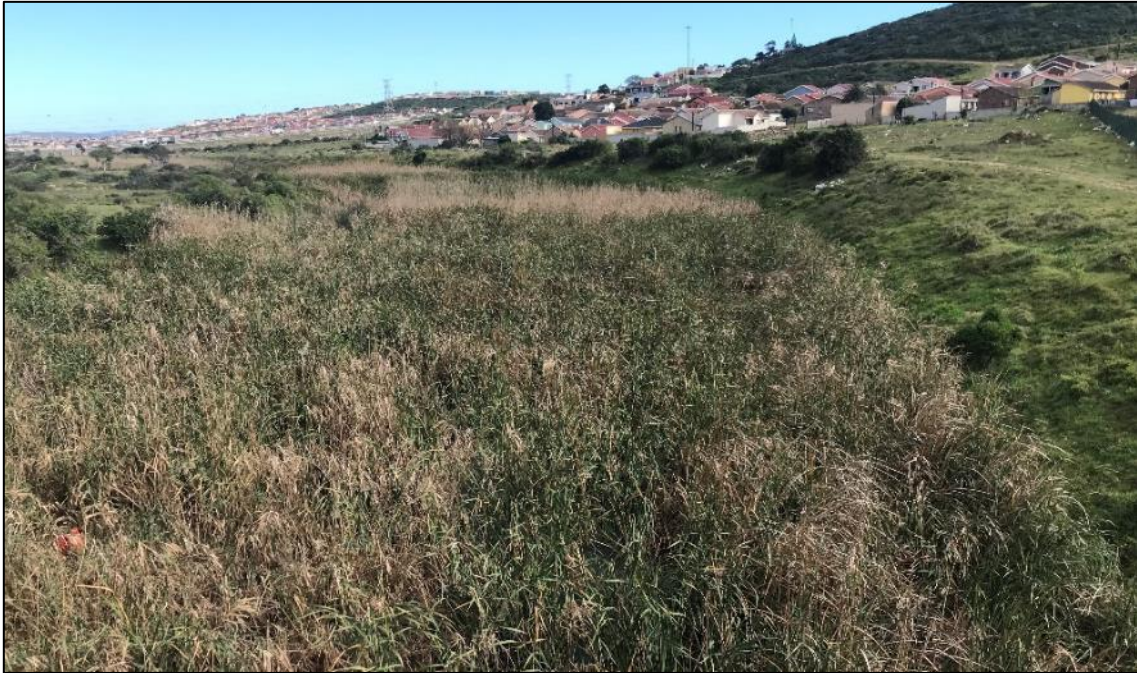
Figure 3-38 Photograph captured from one of the bridges crossing the CVB 1 wetland – with evidence of large scale canalisation of the channel as indicated by the large bank on the right hand-side of the photograph.

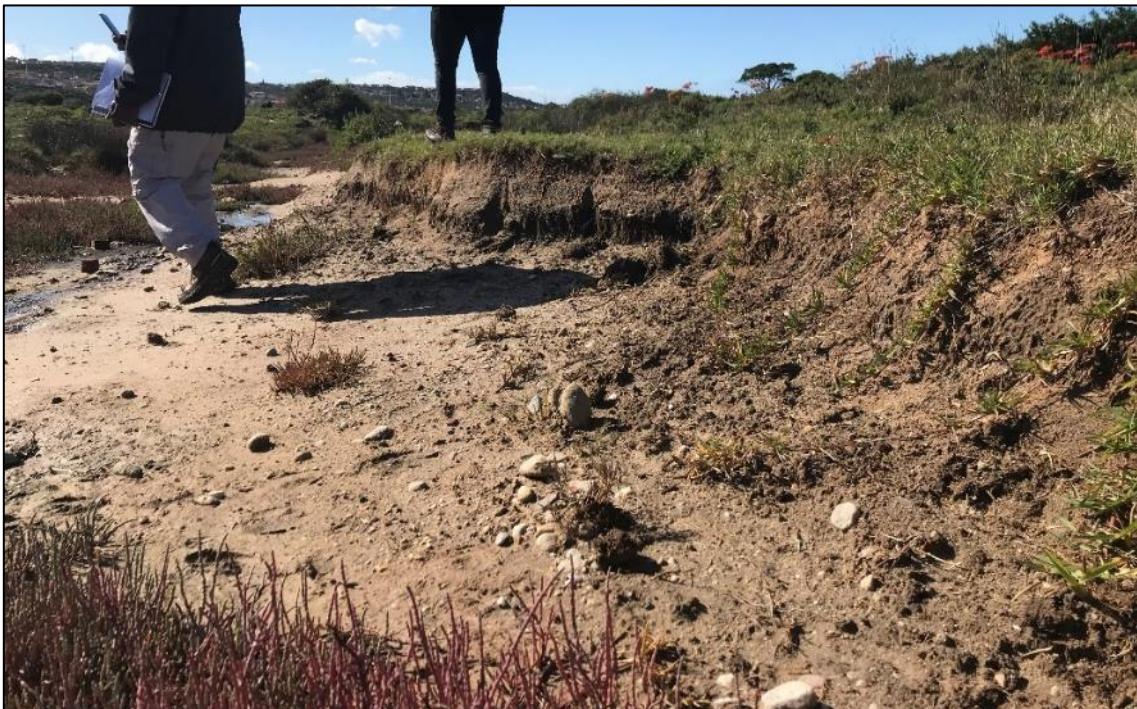
Figure 3-39 A lateral erosion gully that has been created directly downstream of one of the stormwater drains inputting water into the CVB 1 wetland. It appeared to be moderately active, with a stand of *Pennisetum clandestinum* growing across the active face of the headcut.

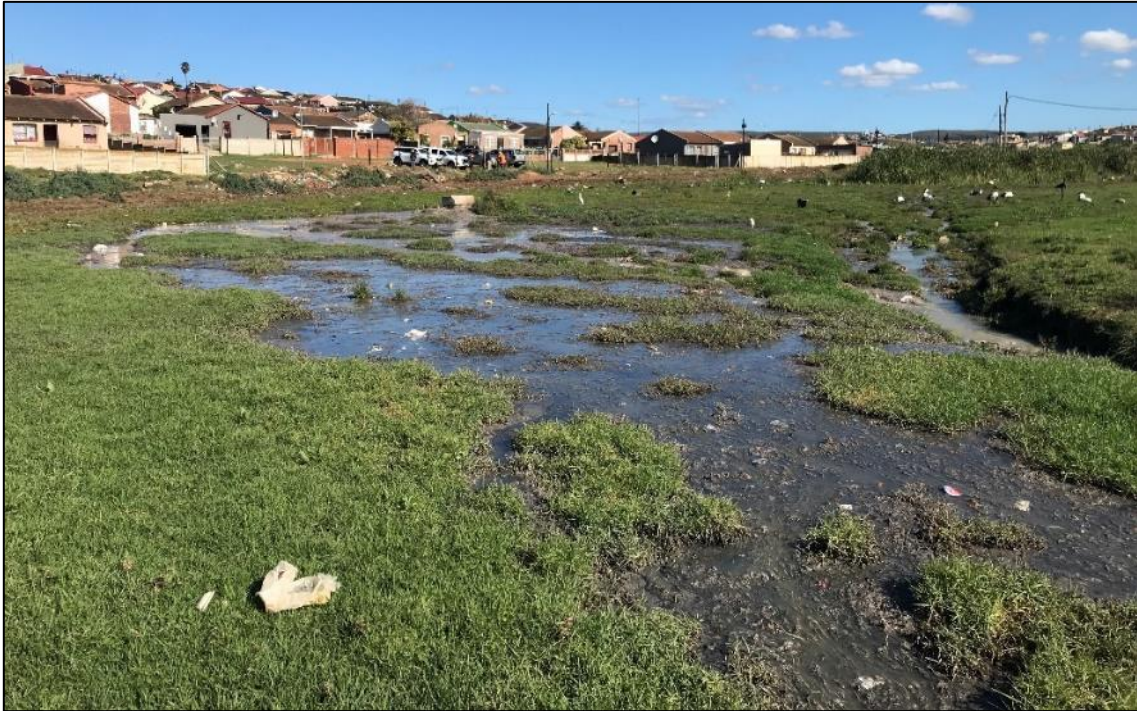
Figure 3-40 A surcharging sewer manhole pictured centrally, and a newly incising channel pictured to the right located in CVB 3. The lateral tongues of the incising channel (heading towards the manhole) and the proximity of the point of incision to this surcharging manhole indicate that this manhole has been a large causal factor in the incision of this channel

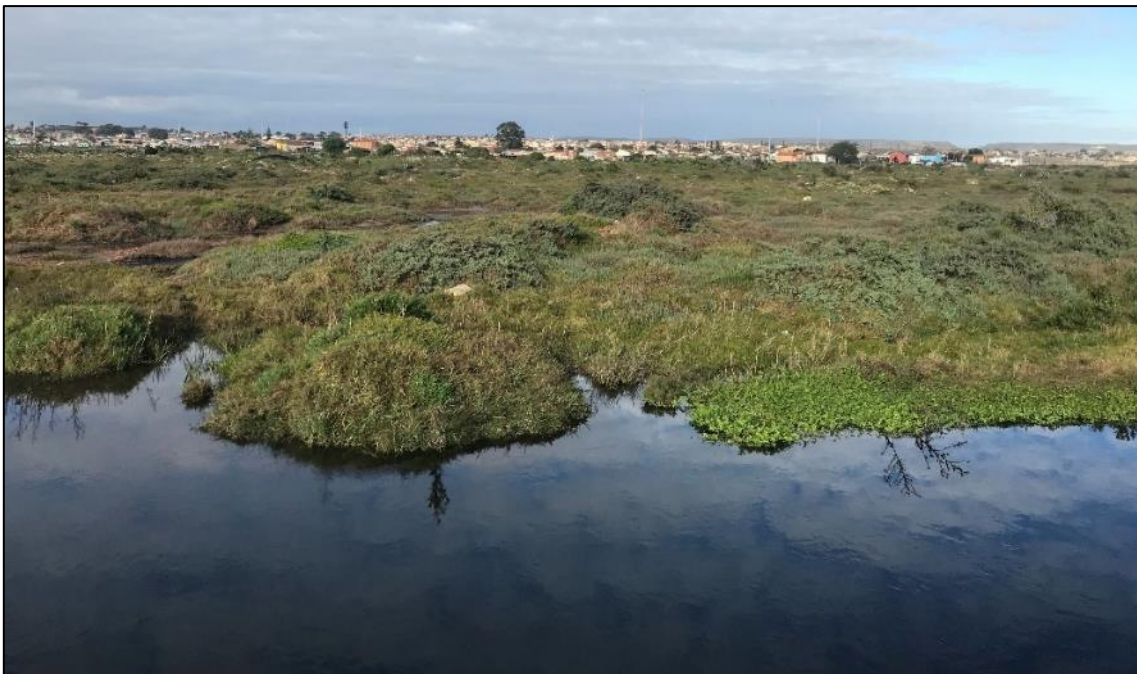
Figure 3-41 Relatively clear and non-odourous water flowing through the toe of the wetland. In addition, this lower section of the system coincided with the most intact vegetation observed across the entire site.
