Determination of Water Resource Classes, Reserve and the Resource Quality Objectives in the Keiskamma and Fish to Tsitsikamma Catchments

WP11354 Wetland Field Survey Report

REPORT NO.:
WEM/WMA7/00/CON/RDM/0522

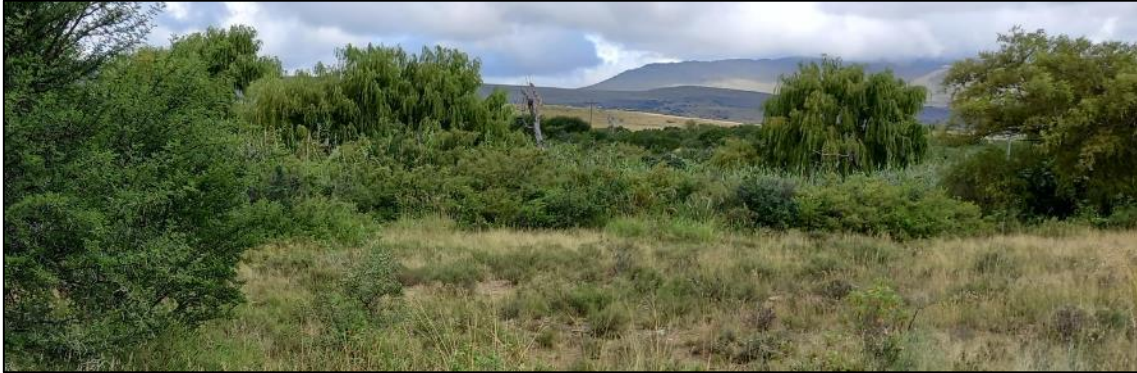
Figure 3-43 The upper portions of Grootvlei wetland, with extensive woody vegetation, including alien eucalypts, poplars and willows and the indigenous *Vachellia karroo*. The predominant herbaceous species is the indigenous common reed *Phragmites australis*

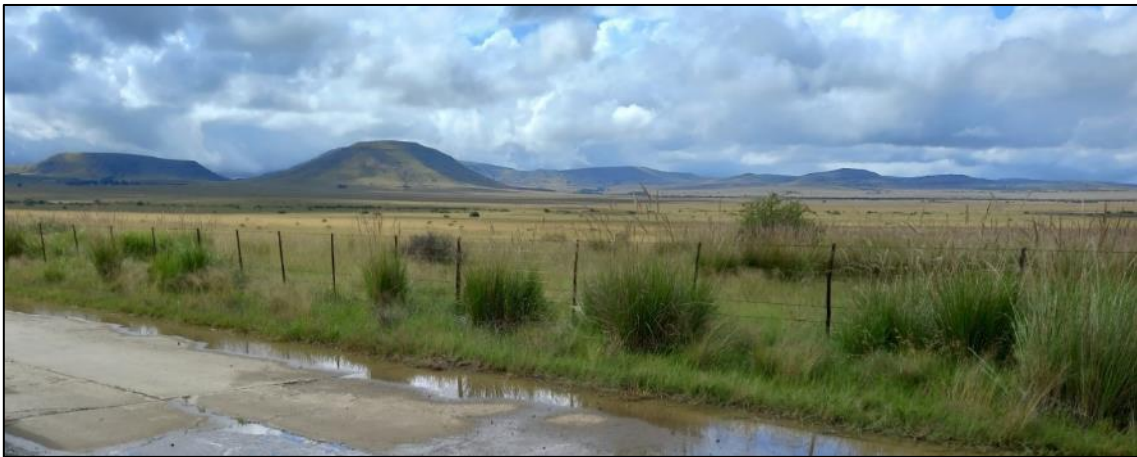
Figure 3-44 An unchanneled valley bottom feeding the central portion of the wetland, with robust clumps of the grass *Miscanthus capensis*. Where the otherwise-gravel road crosses this wetland, it is concrete (as seen in the photo) suggesting at least periodic saturation in this wetland area.

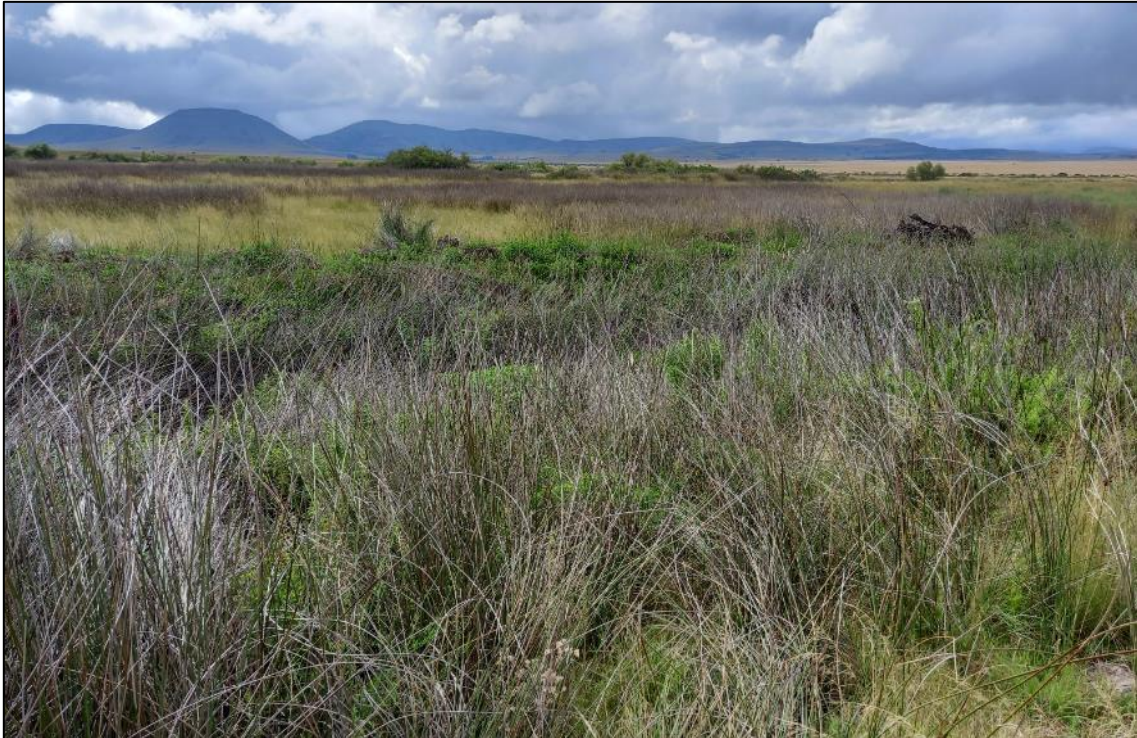
Figure 3-45 The central floodplain portion of the Grootvlei wetland, here dominated by the robust sedge *Pseudoschoenus inanus*.

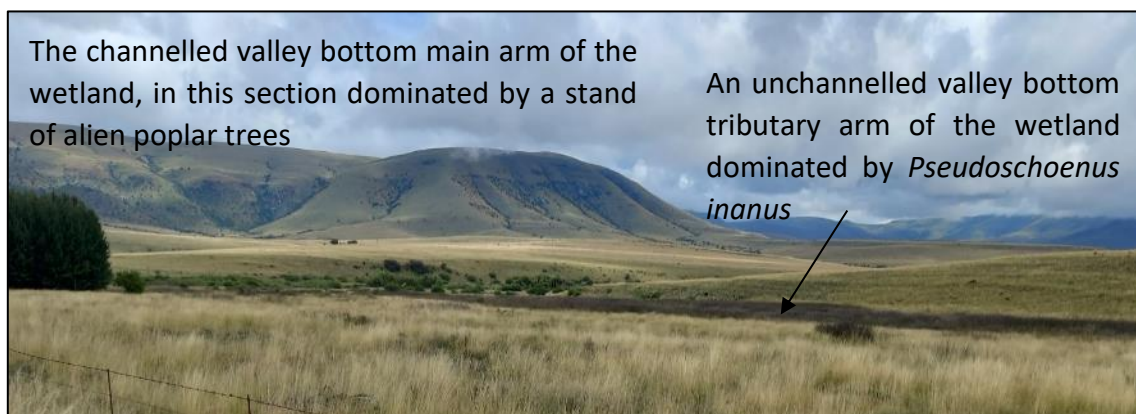
Figure 3-46 The lower portions of the Grootvlei wetland

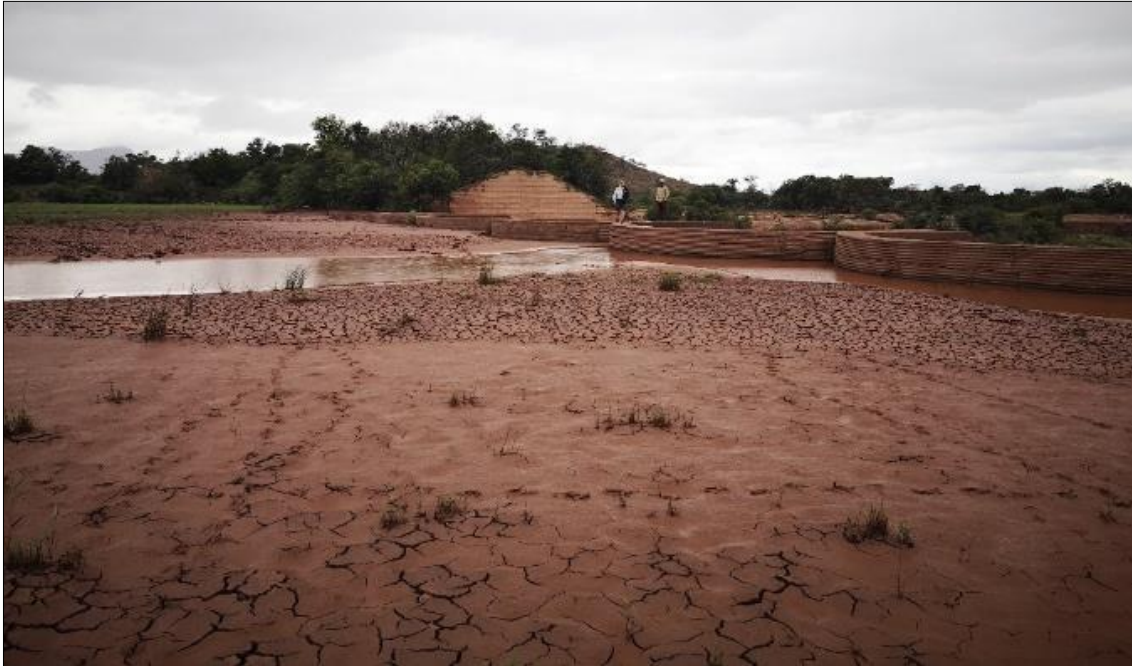
Figure 3-48 Views of the sediment directly upstream of an intervention and the remaining pool of water

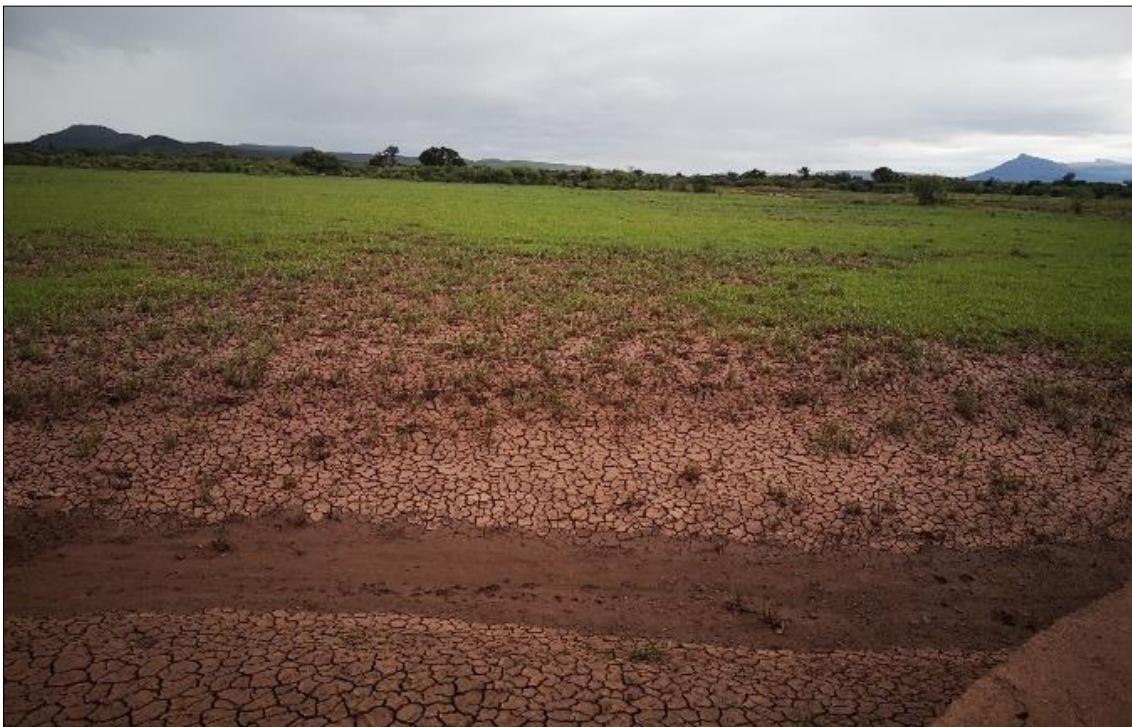
Figure 3-49 View of the accumulated sediment upstream of the weir and heavily grazed grassland

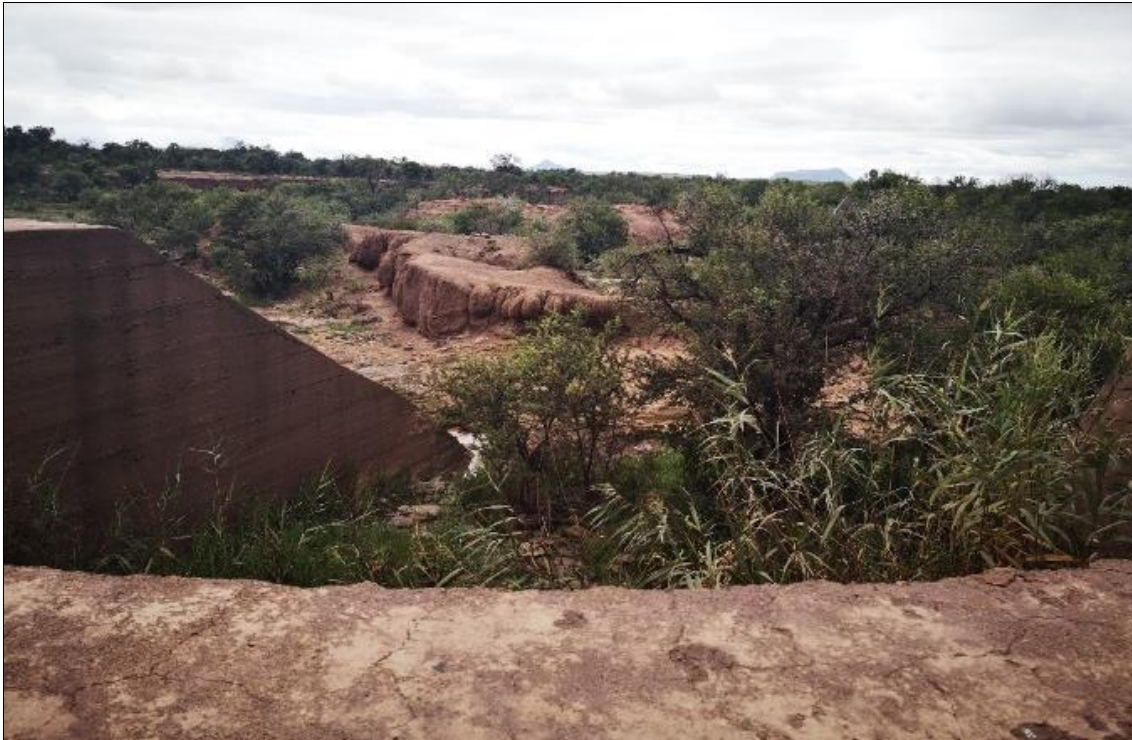
Figure 3-50 View of the erosion gully downstream of a weir

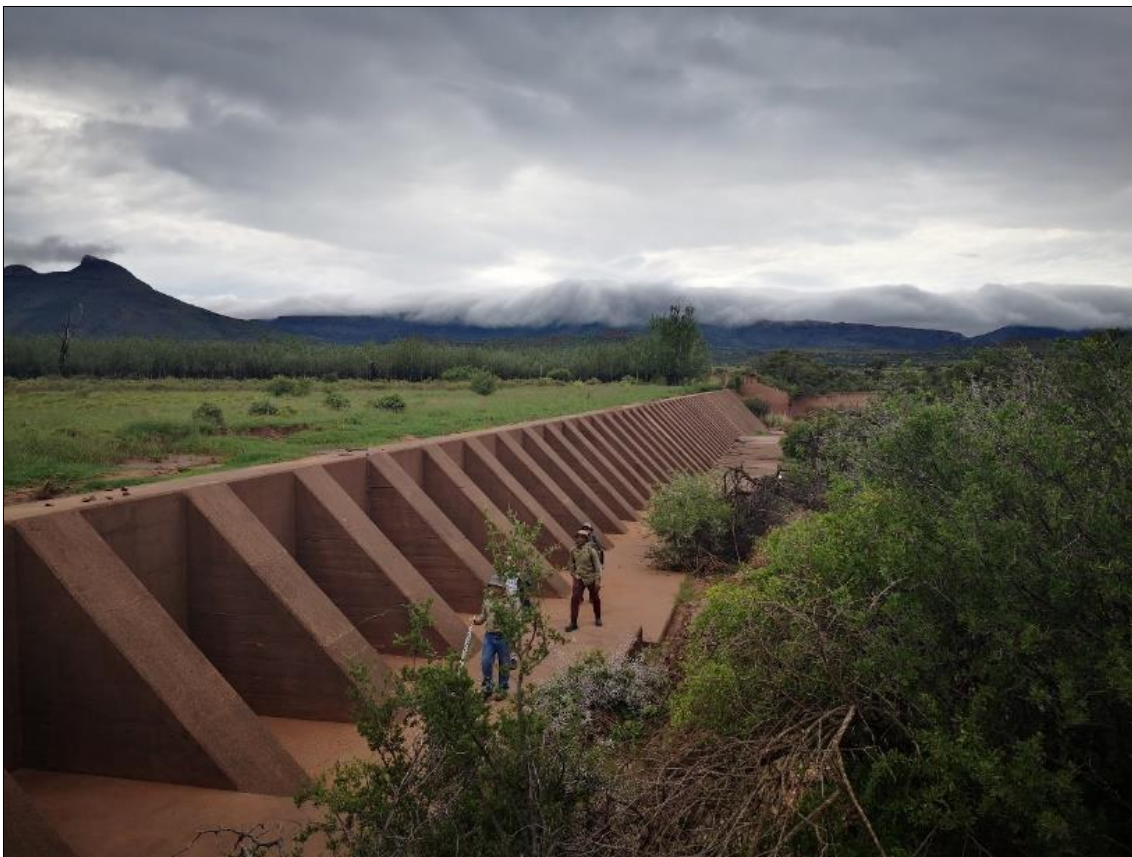
Figure 3-51 View of a buttress weir and the upstream grazing areas

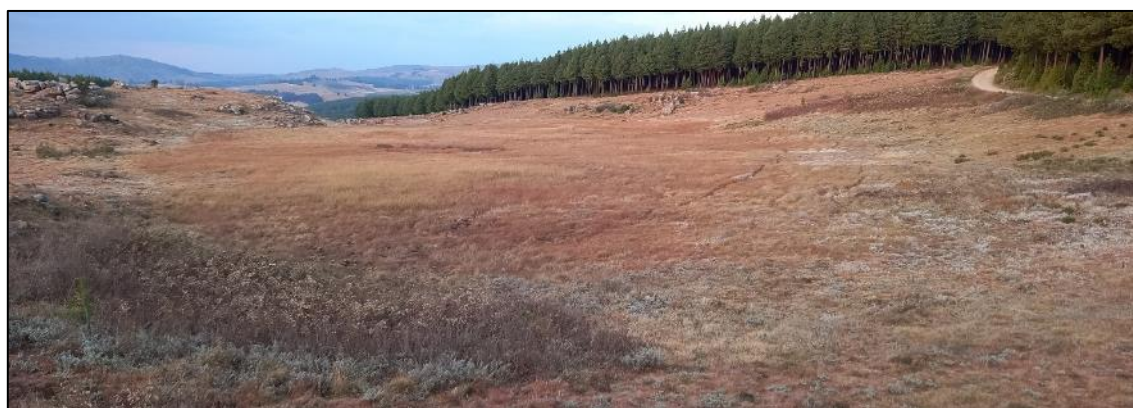
Figure 3-54 A well-buffered wetland seep on the Gaika road, supporting a diversity of grasses (notably *Festuca caprina*) and sedge (e.g. *Pyreus* sp.) and with its wettest core dominated by the rush *Juncus pectorius*

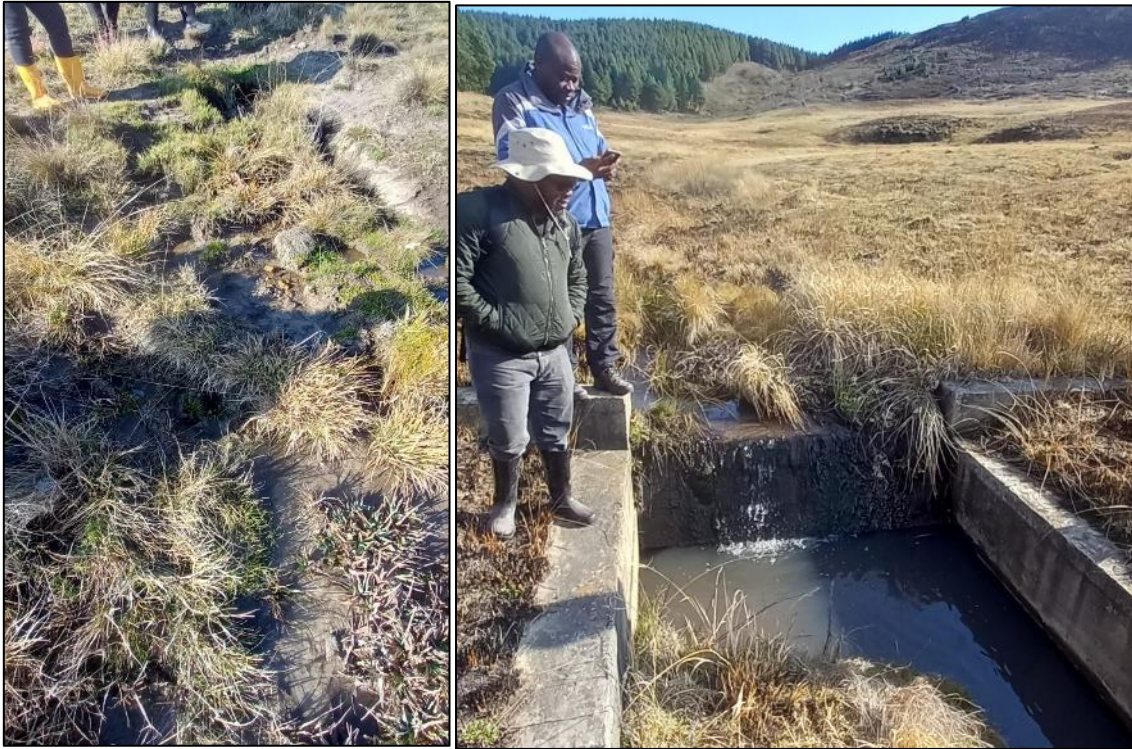
Figure 3-55 Left: A wetland seep heavily used by livestock. Right: One of Working for Wetlands rehabilitation interventions in a channelled valley bottom which was identified as incised

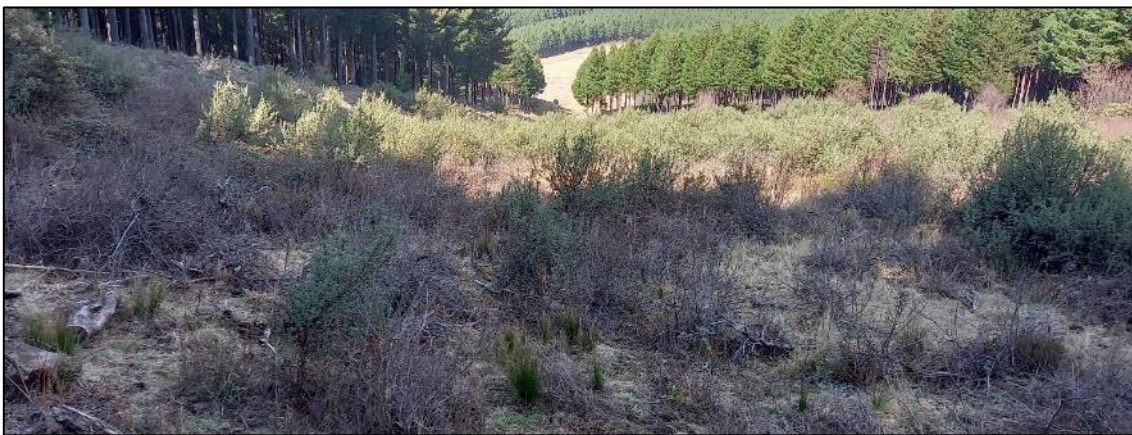
Figure 3-56 A wetland seep area with extensive *Leucosidea sericea* trees, which are favoured by an absence/infrequency of fires.

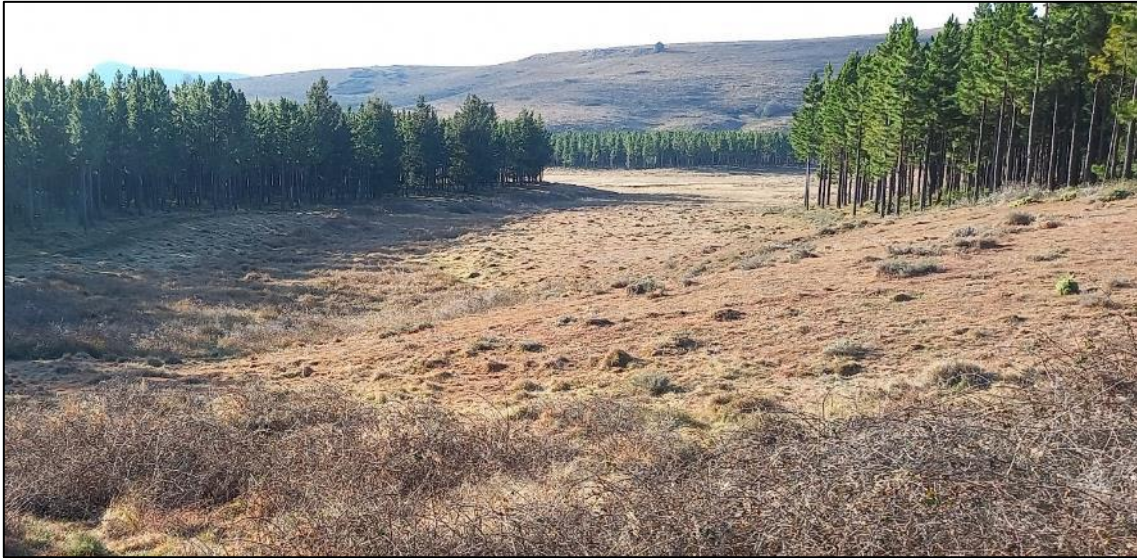
Figure 3-57 A wetland seep area infested with American bramble

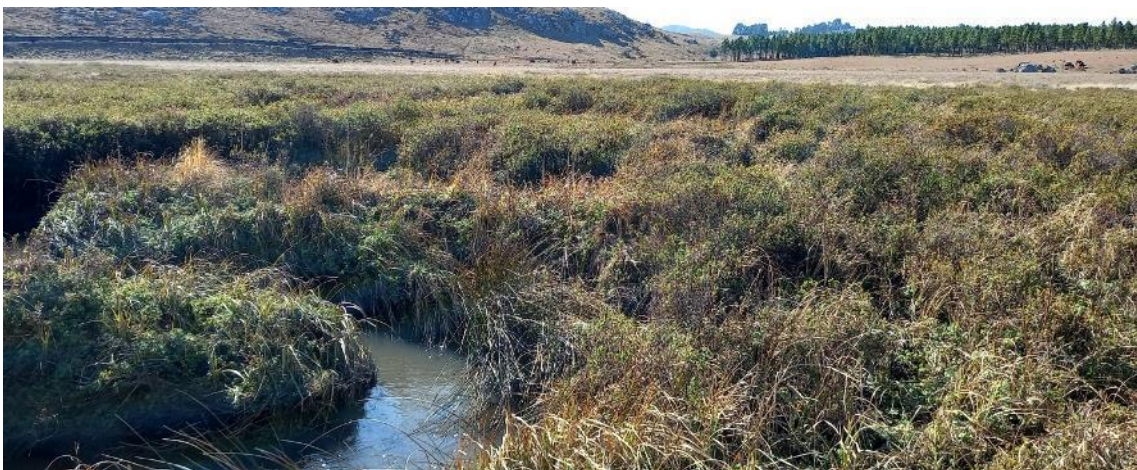
Figure 3-58 A floodplain wetland, showing the sinuous main stream channel and vigorous vegetation including the sedge *Carex acutiformis* and the short shrub *Clutia* sp.

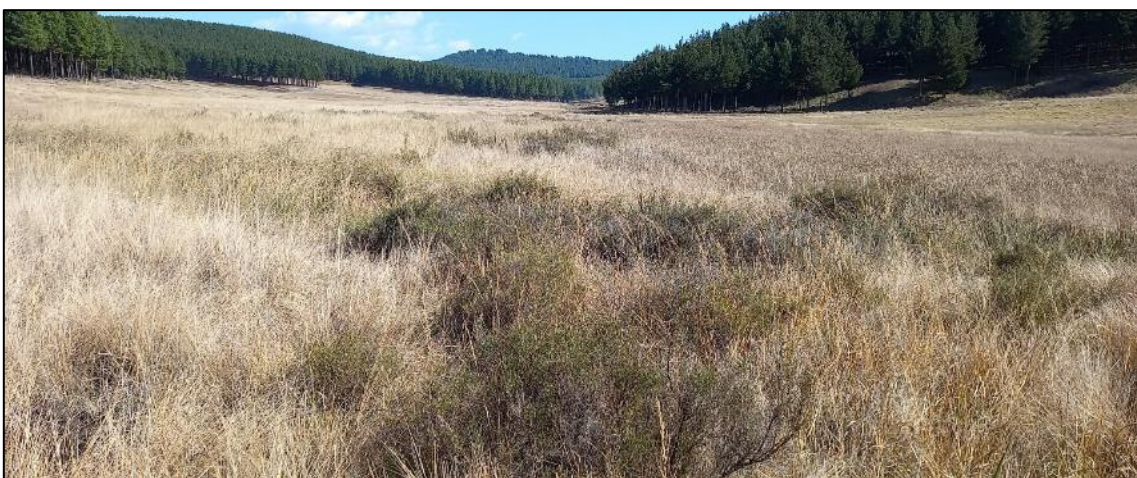
Figure 3-59 A floodplain wetland with grasses, sedges and the shrub *Cliffortia linearifolia*

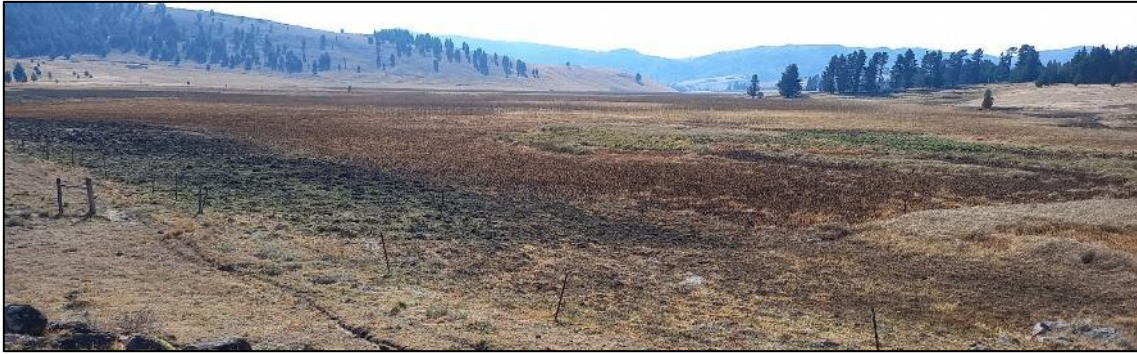
Figure 3-60 The most extensive unchannelled valley bottom in the Hogsback area, dominated mainly by *Carex acutiformis* and seen here after a recent fire.

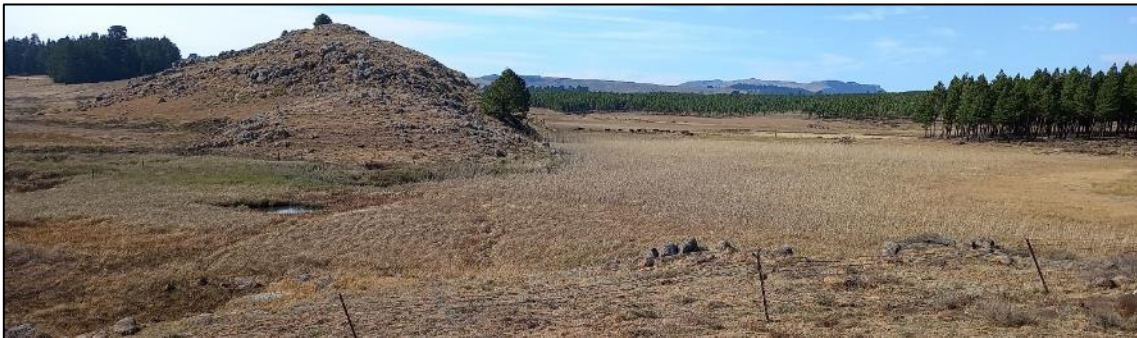
Figure 3-61 An unchannelled valley bottom with abundant *Carex acutiformis* and *Phragmites australis*.

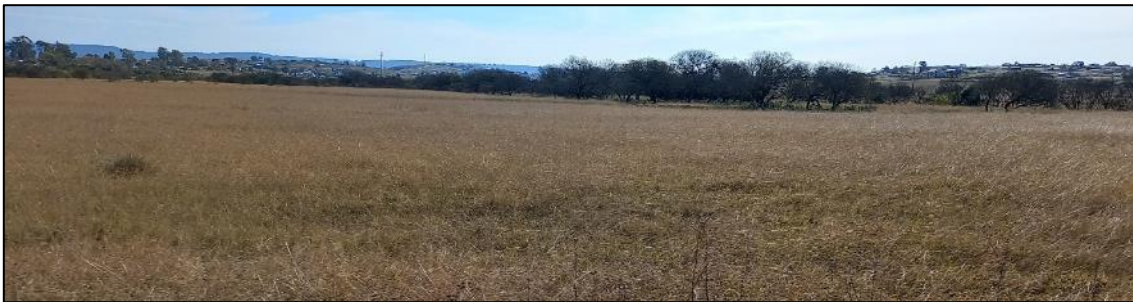
Figure 3-64 An historically-cultivated area in the eastern arm of the upper floodplain, with *Vachellia karroo* trees (visible in the background) dominating the stream channel.

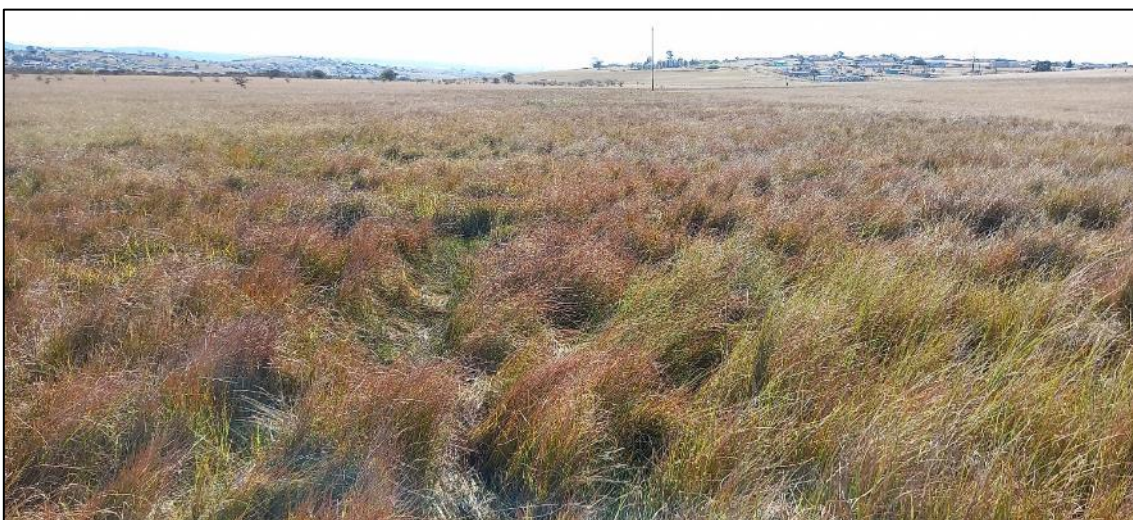
Figure 3-65 One of the most extensive seasonally-saturated wetland areas in the floodplain, located in the eastern arm of the upper floodplain.

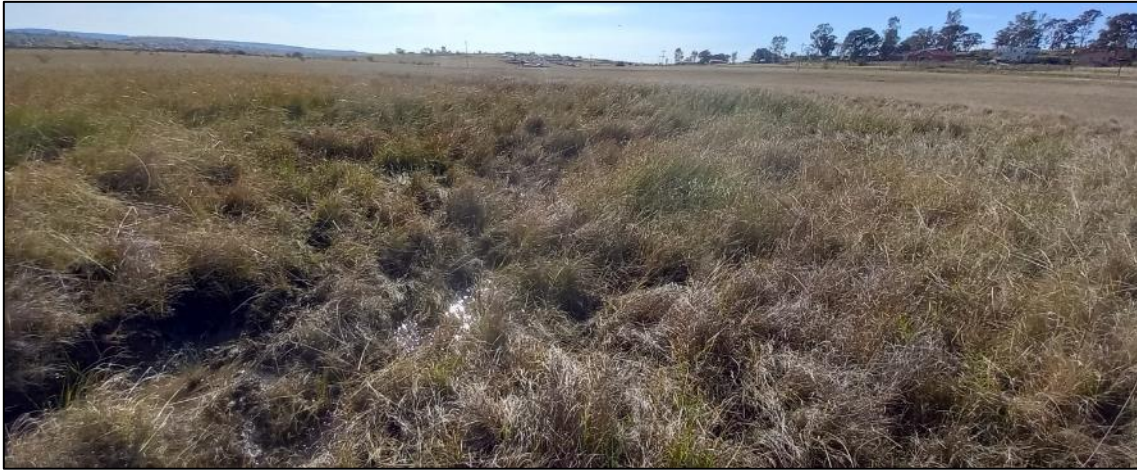
Figure 3-66 A minor headcut erosional feature currently subject to moderate levels of livestock trampling. Although currently the level of activity of the erosion is moderately low, it could potentially increase and threatens to advance into one of the naturally wettest portions of the wetland (shown in the previous photo) which, in turn, will likely have a significant draining effect on this area of the floodplain.

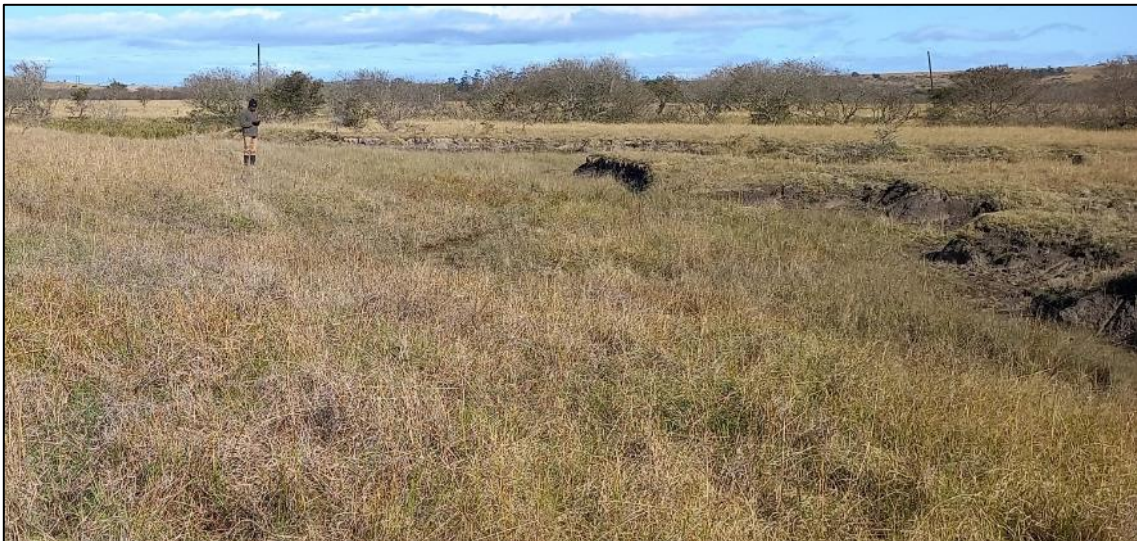
Figure 3-67 A shallow erosion gully lying downstream of the headcut shown in the previous photo. Note the well vegetated nature of the areas adjacent to the erosion.

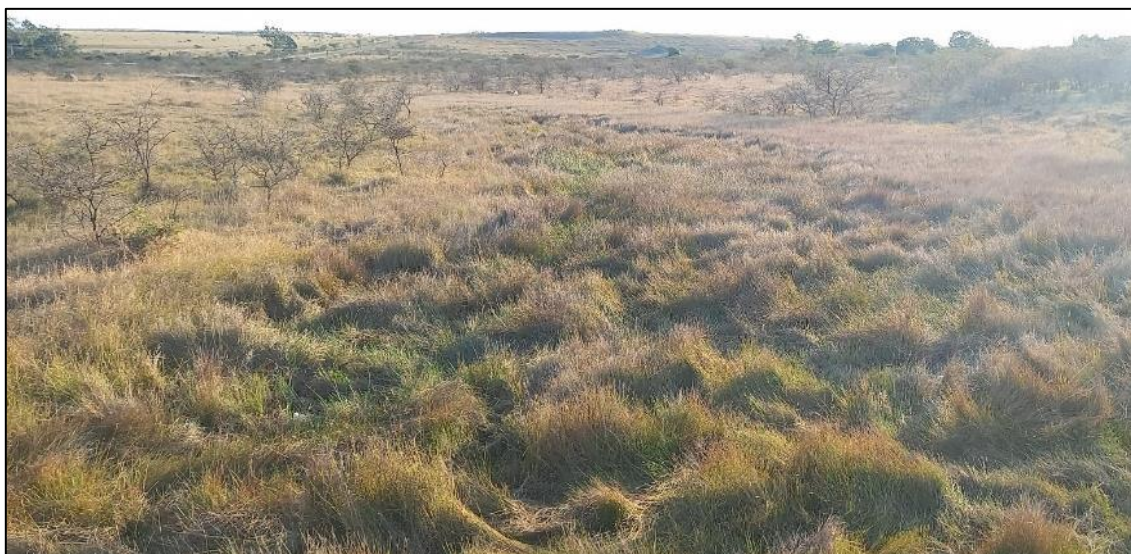
Figure 3-68 A low-lying (possibly paleochannel) area in the lower iDrayini floodplain, dominated by the sedge *Eleocharis dregeana*, with *Cyperus pulcher* on the edge. The adjacent higher lying areas are characterized by *Eragrostis* spp. and other grasses favoured by disturbance, together with scattered young *Vachellia karroo* trees.

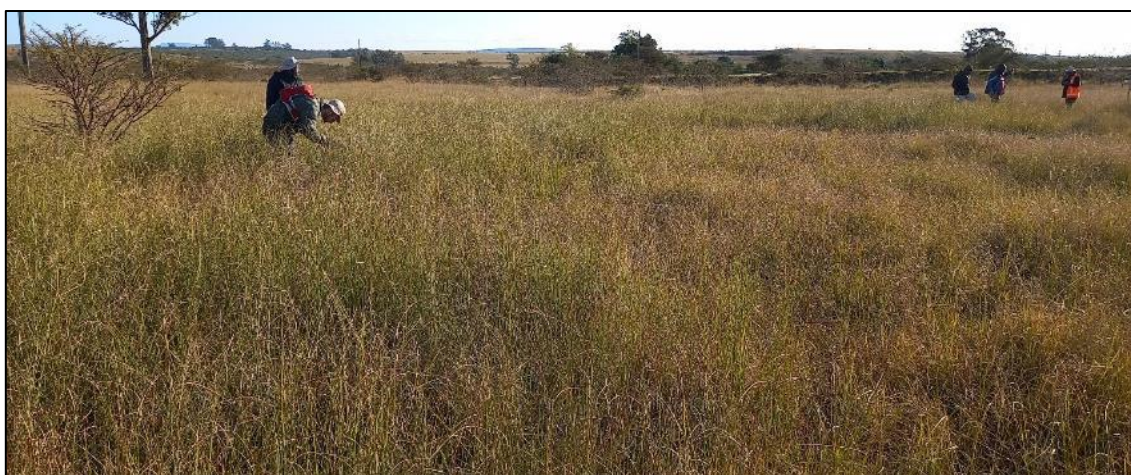
Figure 3-69 A temporarily-saturated area dominated by sedges near the margins of the lower iDrayini floodplain, which seems to be maintained by lateral inflows to the wetland

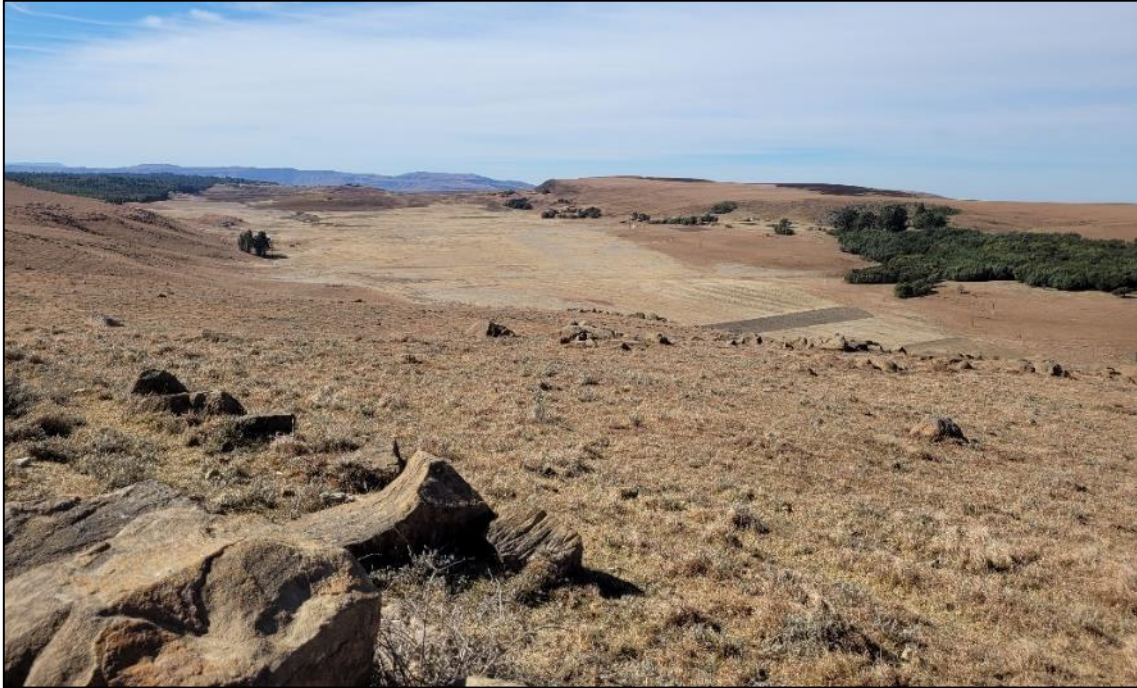
Figure 3-71 View of the Cala wetland from the upper catchment area

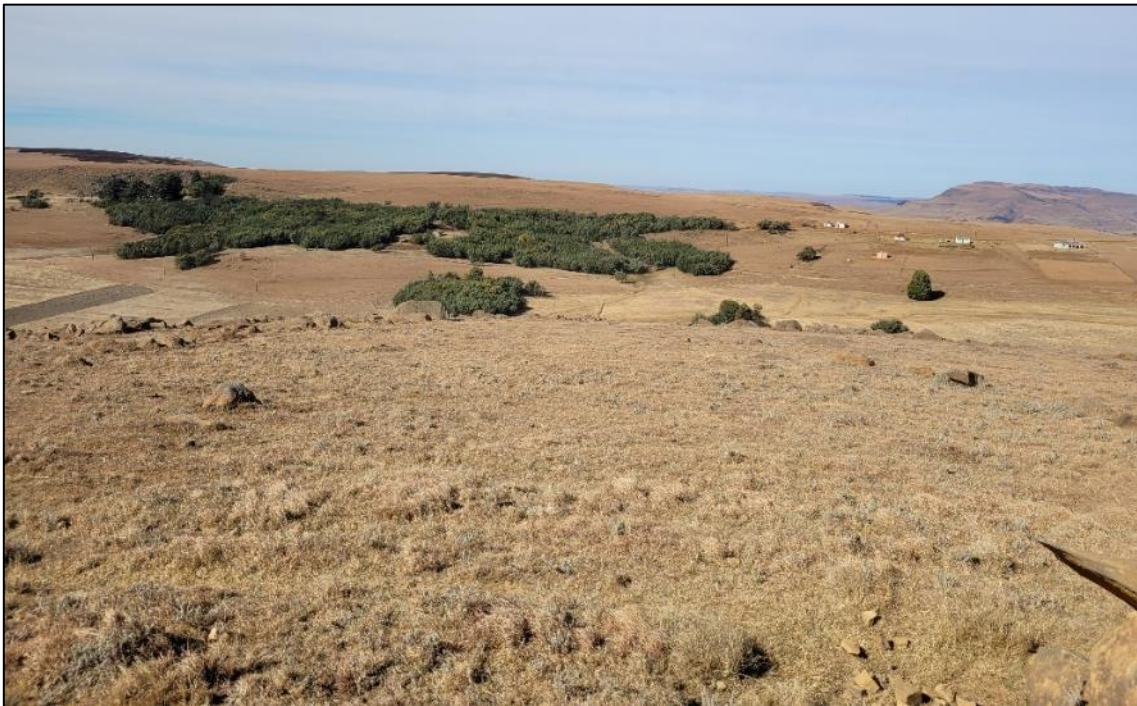
Figure 3-72 View of the scrub wattle within a portion of the wetland's catchment

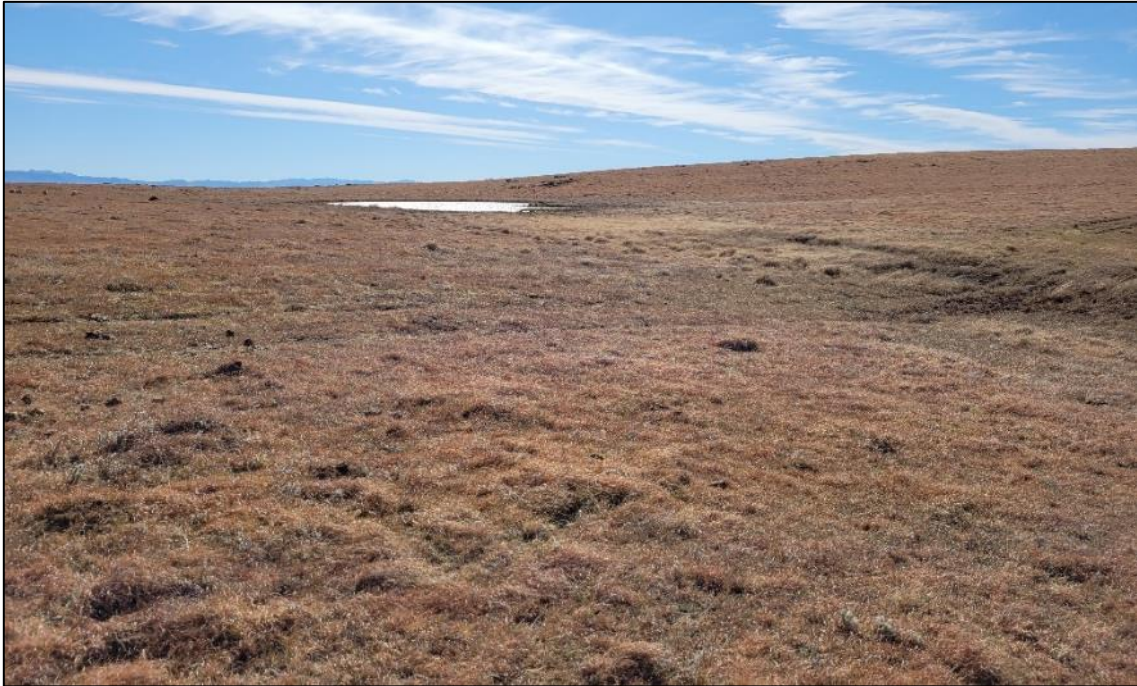
Figure 3-73 View of the depression wetland within the catchment of the system

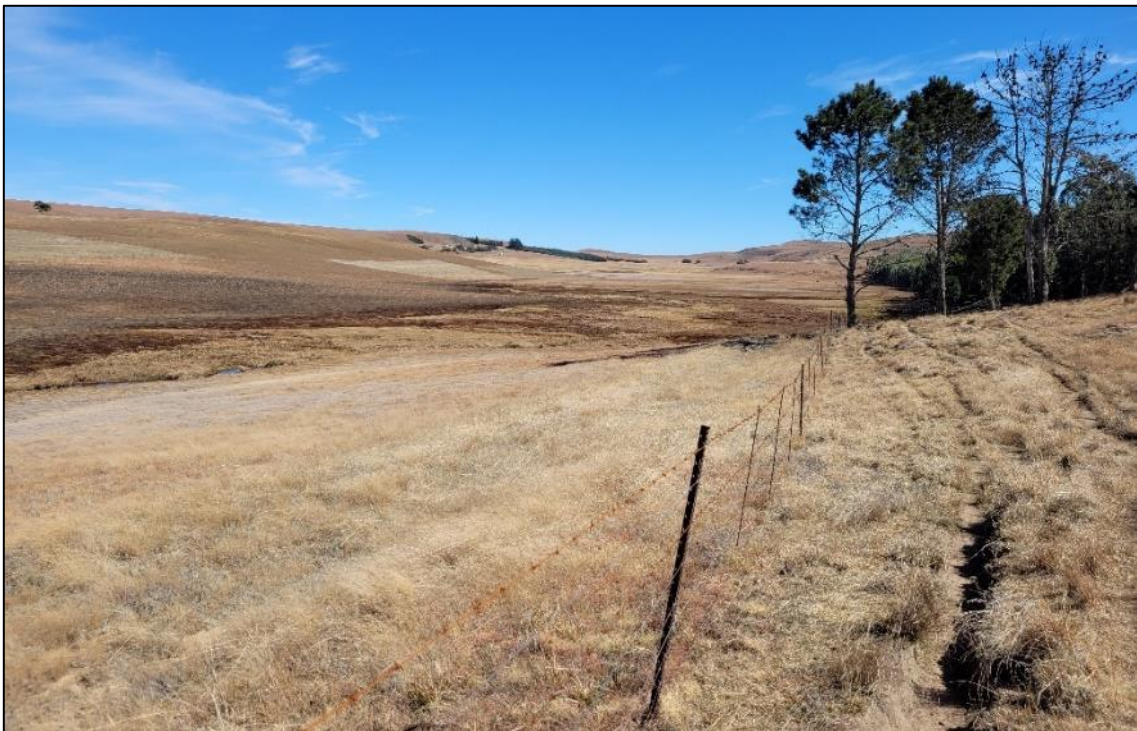
Figure 3-74 View of the lowest portion of the valley-bottom wetland, which is characterised by permanent wetness.

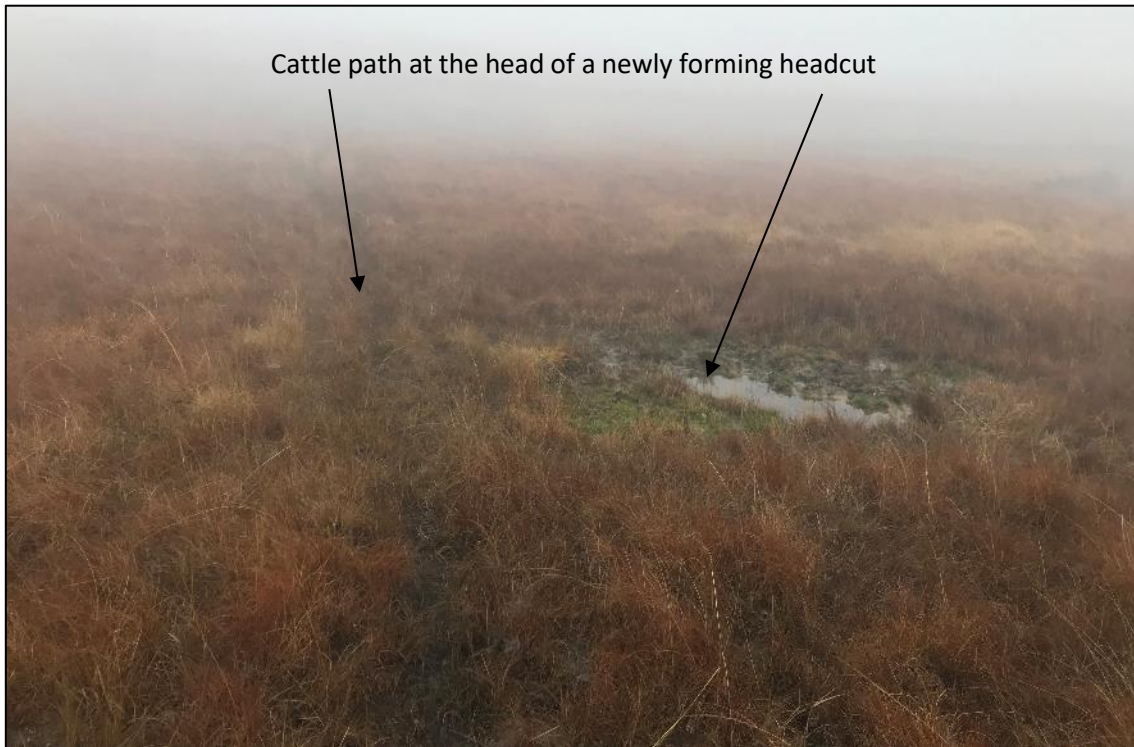
Figure 3-76 Evidence of trampling by cattle across one of the seeps. The cattle path coincides with a new headcut which is forming, possibly as a result of the cattle path which may channel water into the headcut.

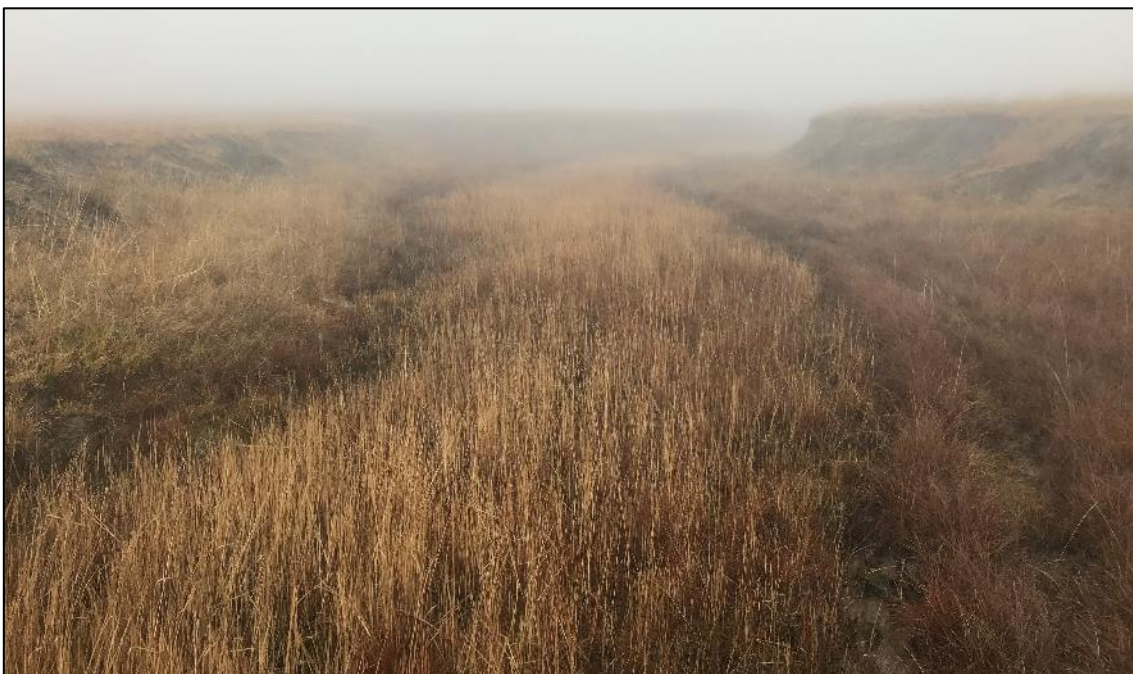
Figure 3-77 A large gully within a seepage wetland, characterised by a large depositional feature in its centre which has been colonised by *Eragrostis planiculmis* and *Fuirena pubescens*.

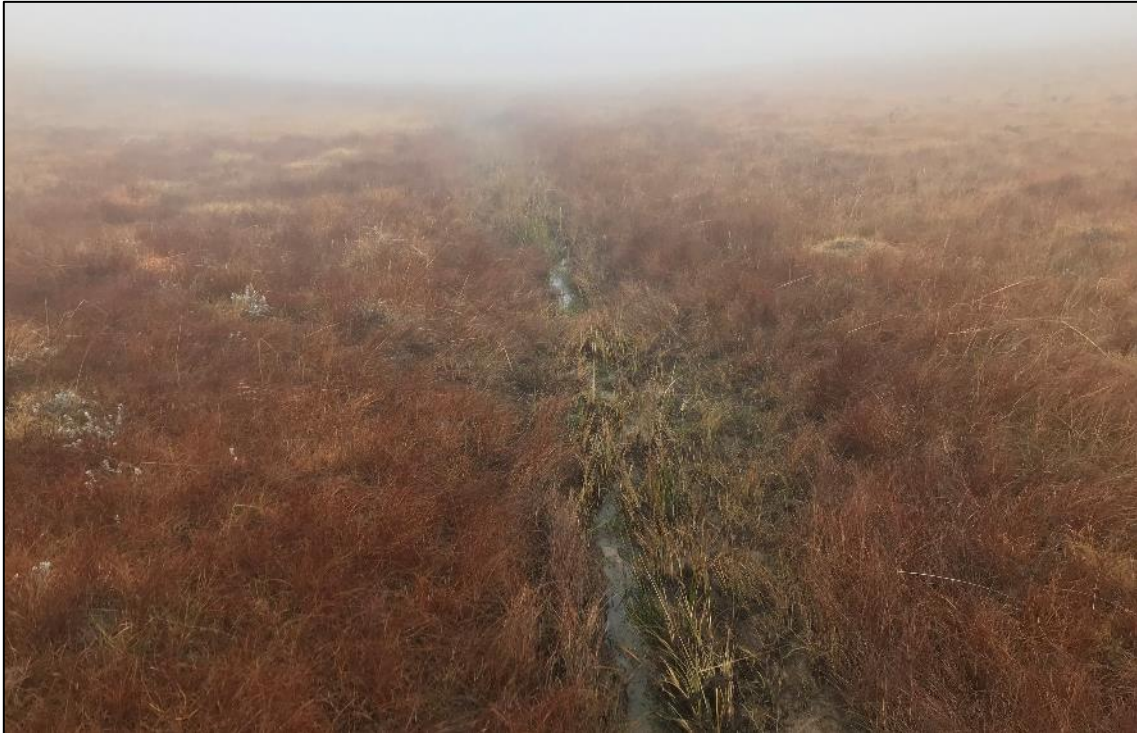
Figure 3-78 Preferential flow path in one of the seep wetlands which has been extensively trampled by cattle that now use this feature to drink water.

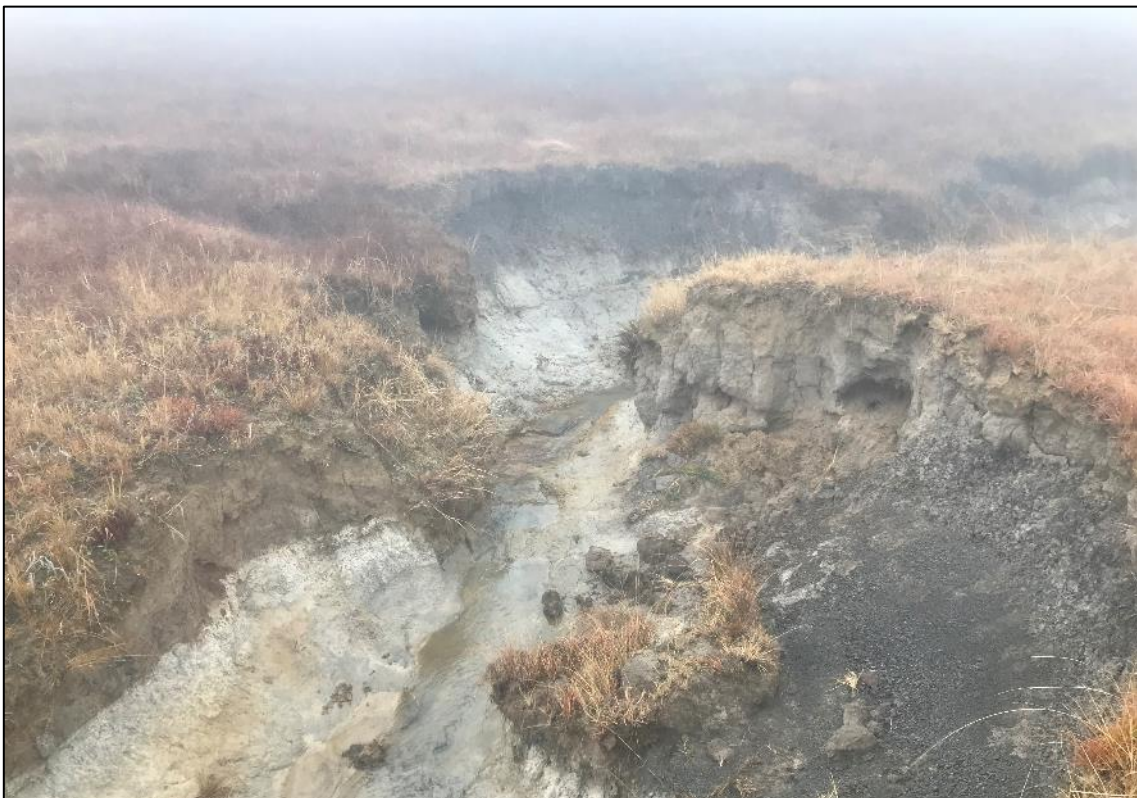
Figure 3-79 Deeply incised channel in the valley-bottom wetland – predominantly eroded down onto bedrock. This channel sets the geomorphological base level for all the seep wetlands which feed into this wetland and explains much of the erosion observed within the seep wetlands.

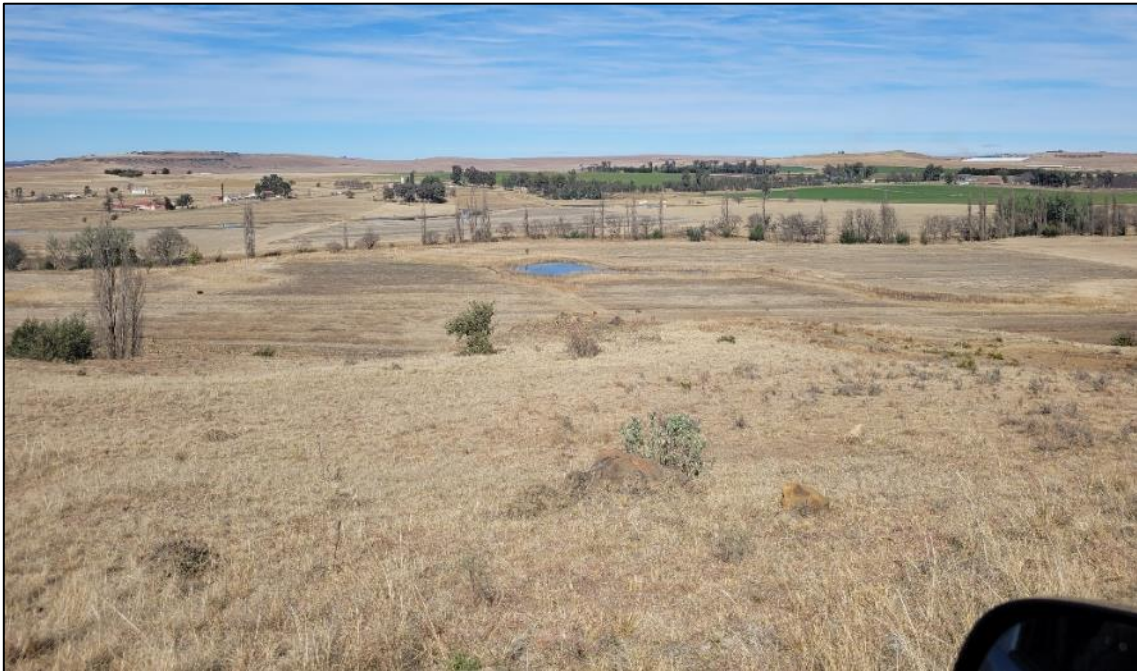
Figure 3-81 View of a portion of the floodplain and the small artificially impounded areas on the adjacent floodplain terrace, and agricultural activities

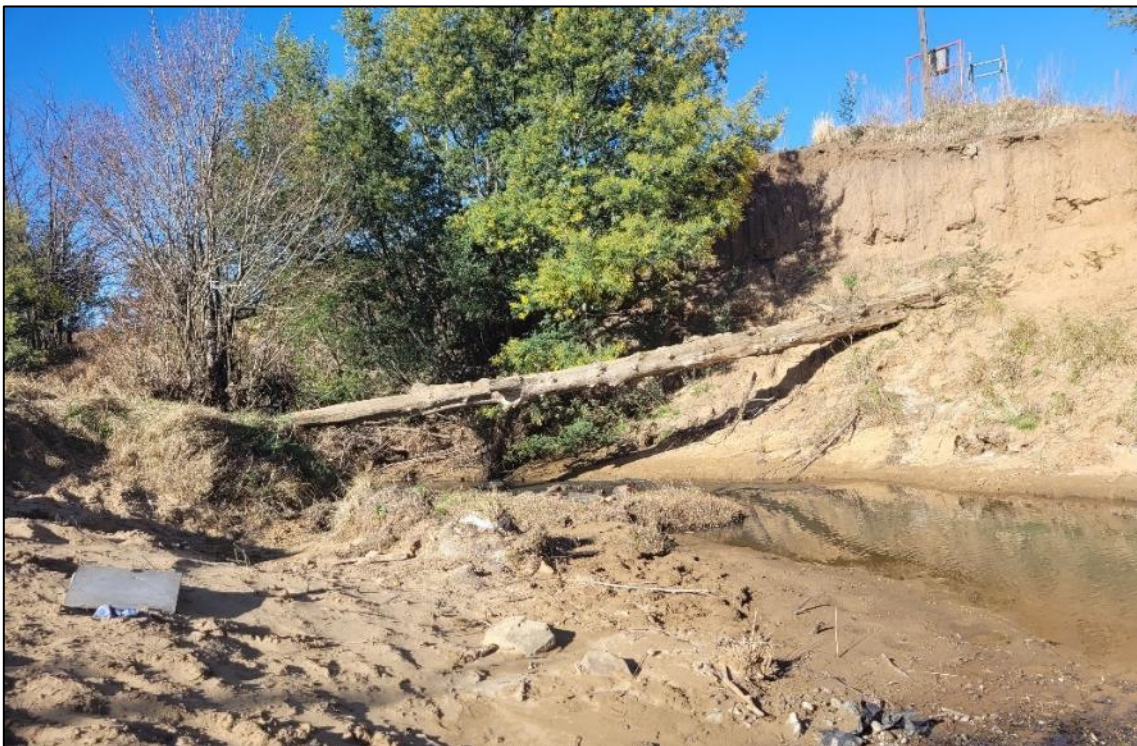
Figure 3-82 Incised river channel within the floodplain, with the discharge point from the waste ponds slightly upstream from this point.
