Determination of Water Resource Classes, Reserve and the Resource Quality Objectives in the Keiskamma and Fish to Tsitsikamma Catchments

WP11354 Wetland Field Survey Report

REPORT NO.:
WEM/WMA7/00/CON/RDM/0522

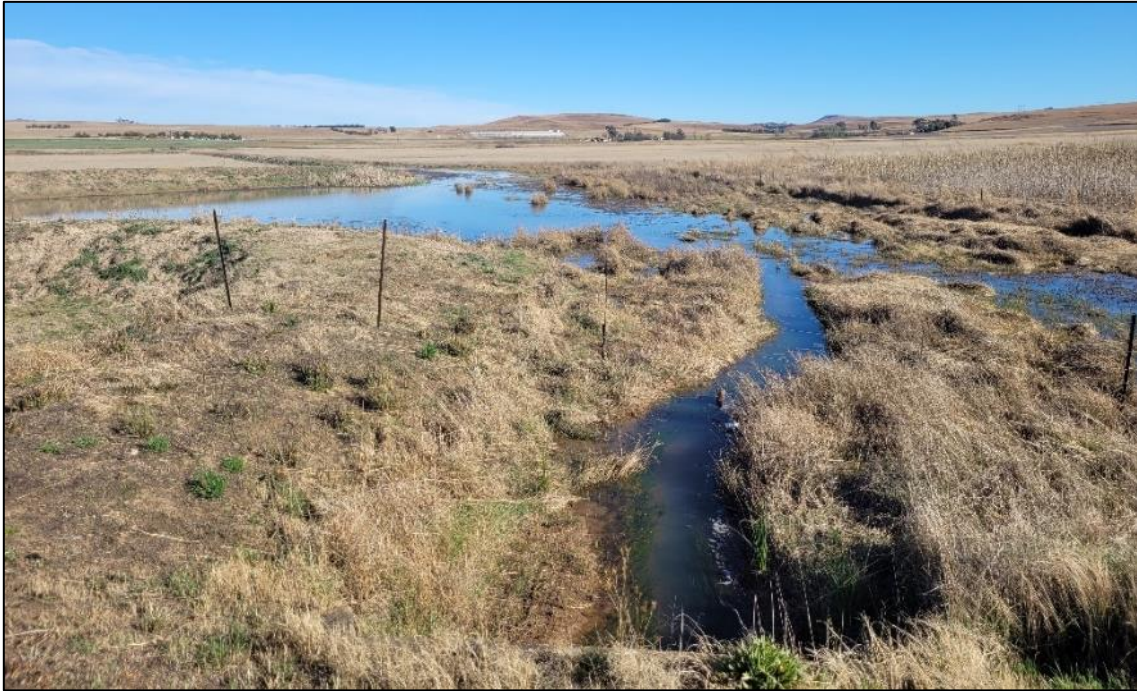
Figure 3-83 View of the flows along the diversion channel supplying the off-channel dam.

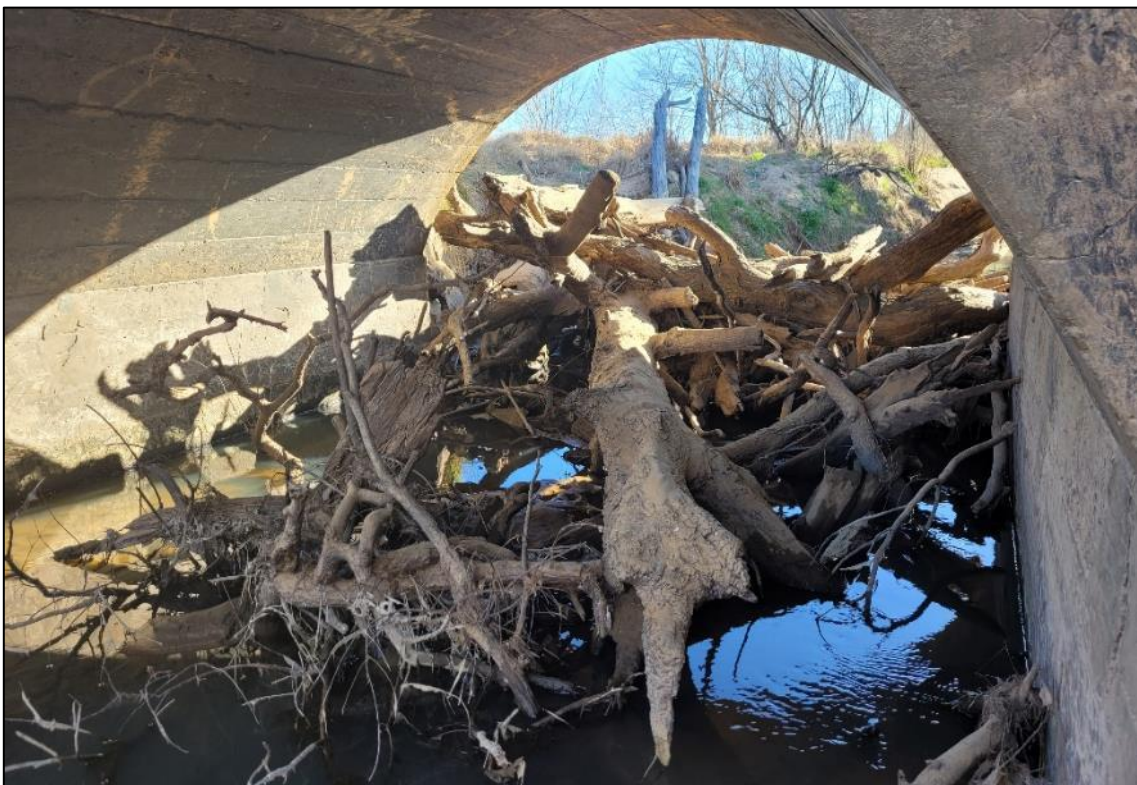
Figure 3-84 Debris below a large road culvert across the incised portion of the floodplain.

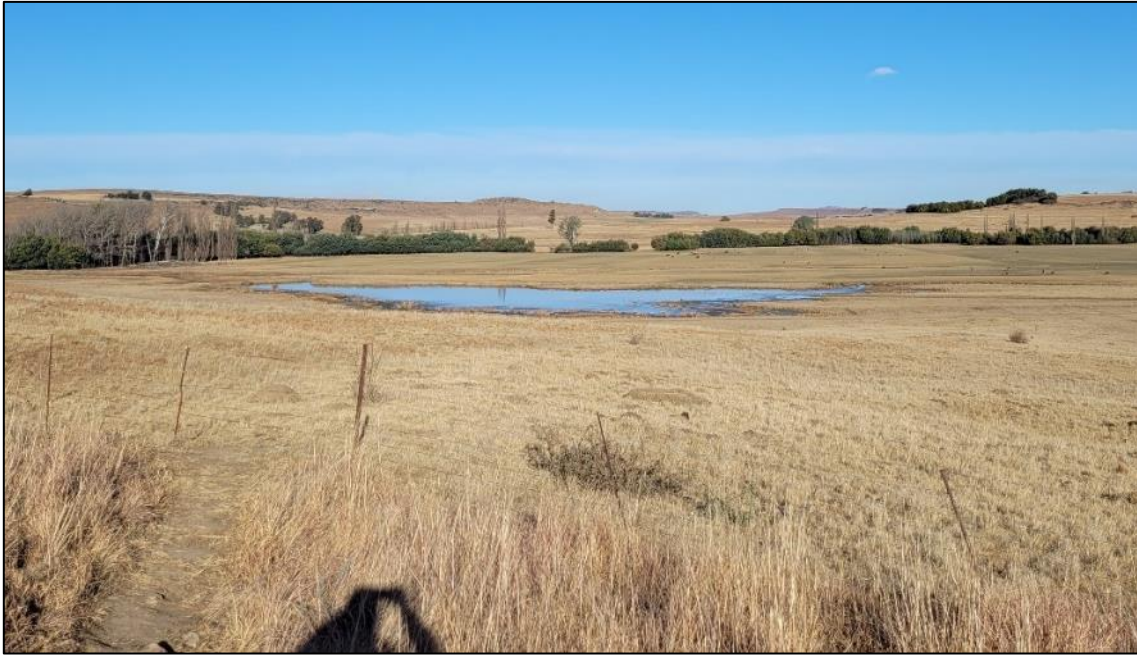
Figure 3-85 Artificially impounded area in the lower portion of the floodplain which is serving as a source of water for the livestock

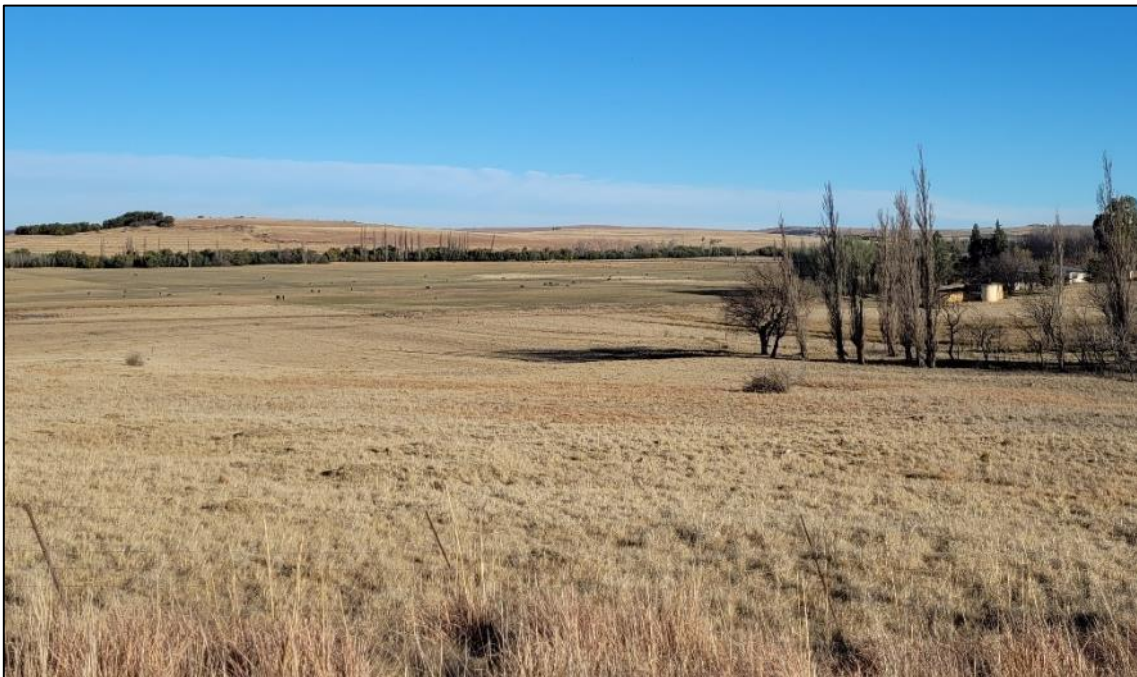
Figure 3-86 Grazing lands within the lower portion of the floodplain system

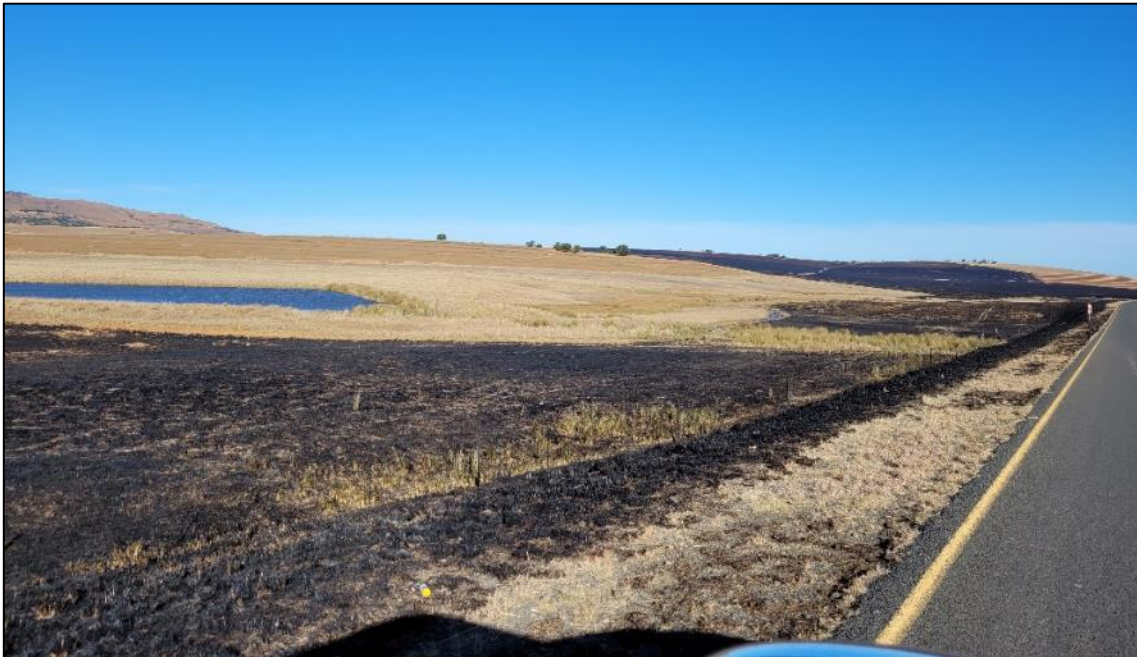
Figure 3-88 View of one of the tributaries flowing into the floodplain. This portion of the system has a series of dams to assist with the commercial agricultural practices which include crop cultivation and livestock grazing

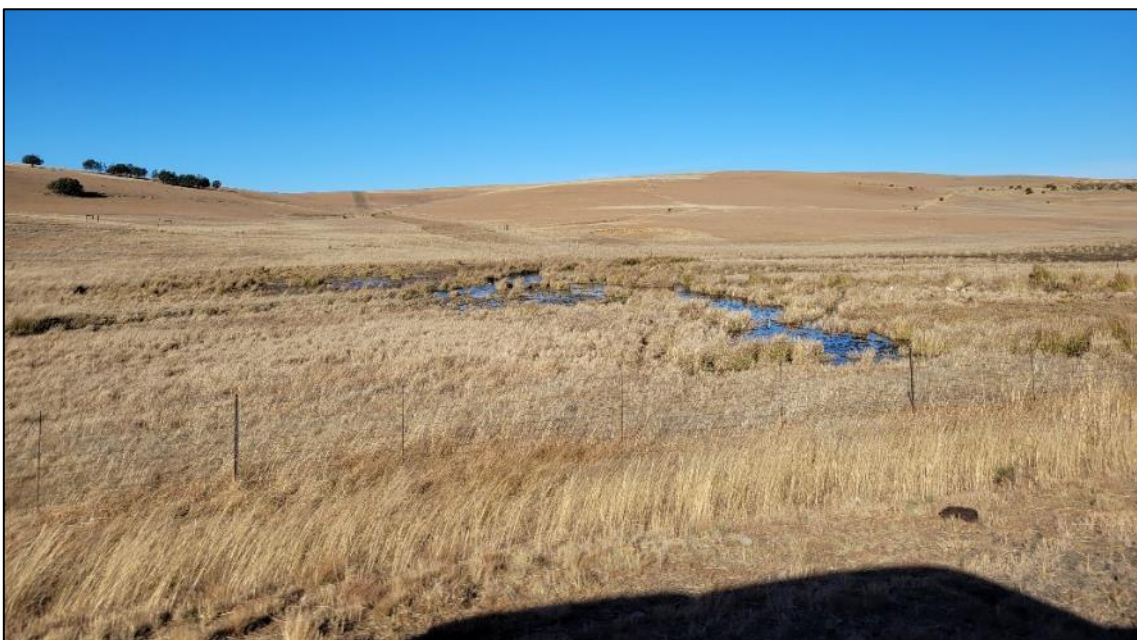
Figure 3-89 View of an intact portion of the channelled valley-bottom wetland associated with the floodplain wetland

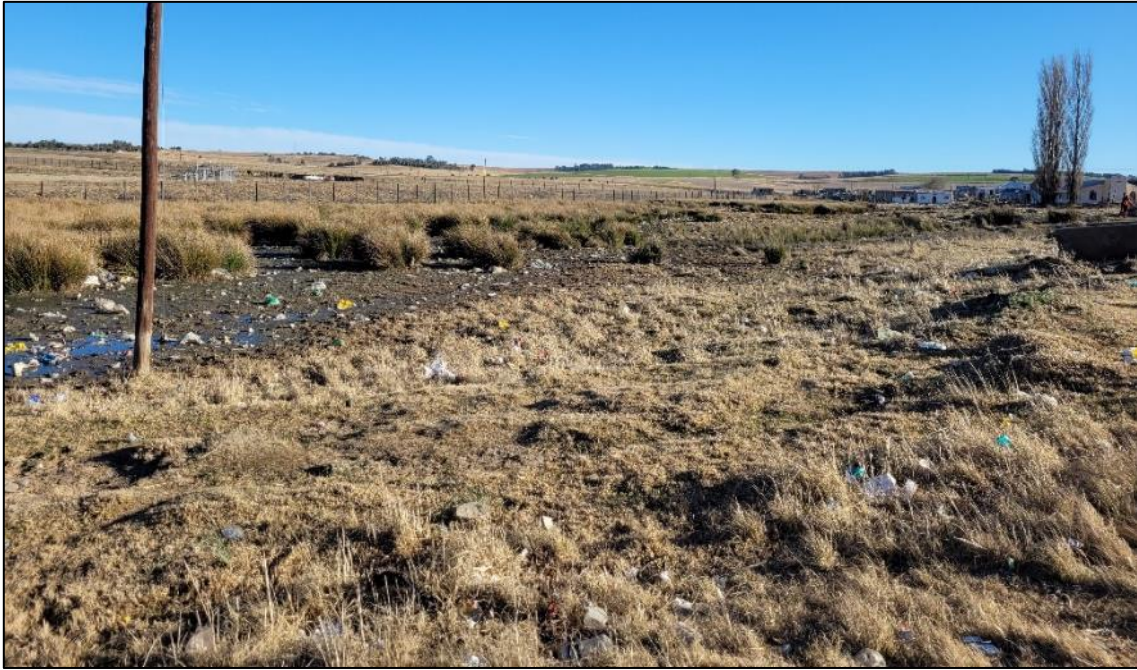
Figure 3-90 Solid waste and die back of wetland vegetation due to sewage contamination

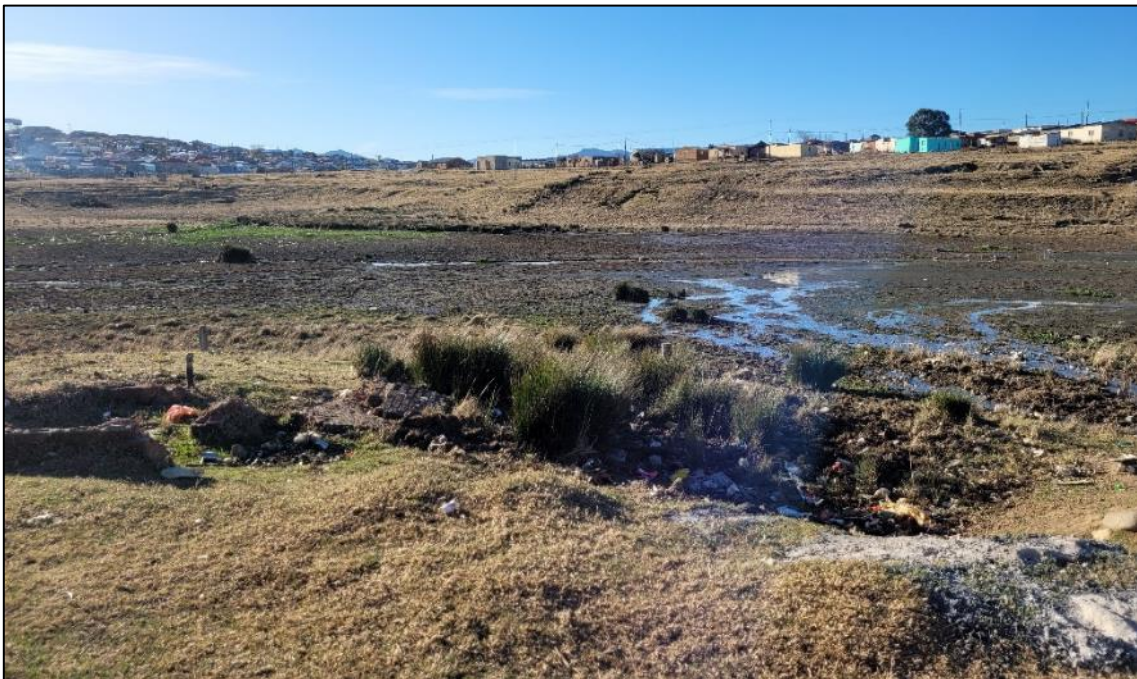
Figure 3-91 View of die back of vegetation due to the accumulation of sewage within the wetland as a result of the surcharging sewerage infrastructure

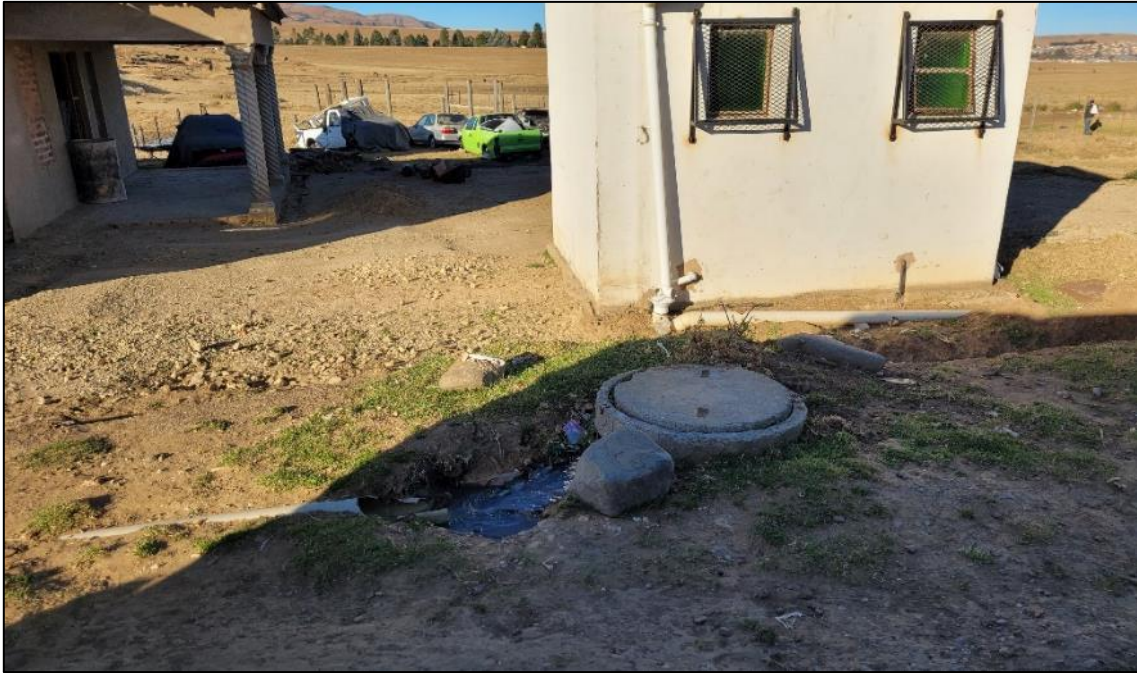
Figure 3-92 Surcharging manhole with the sewage being directed towards the wetland

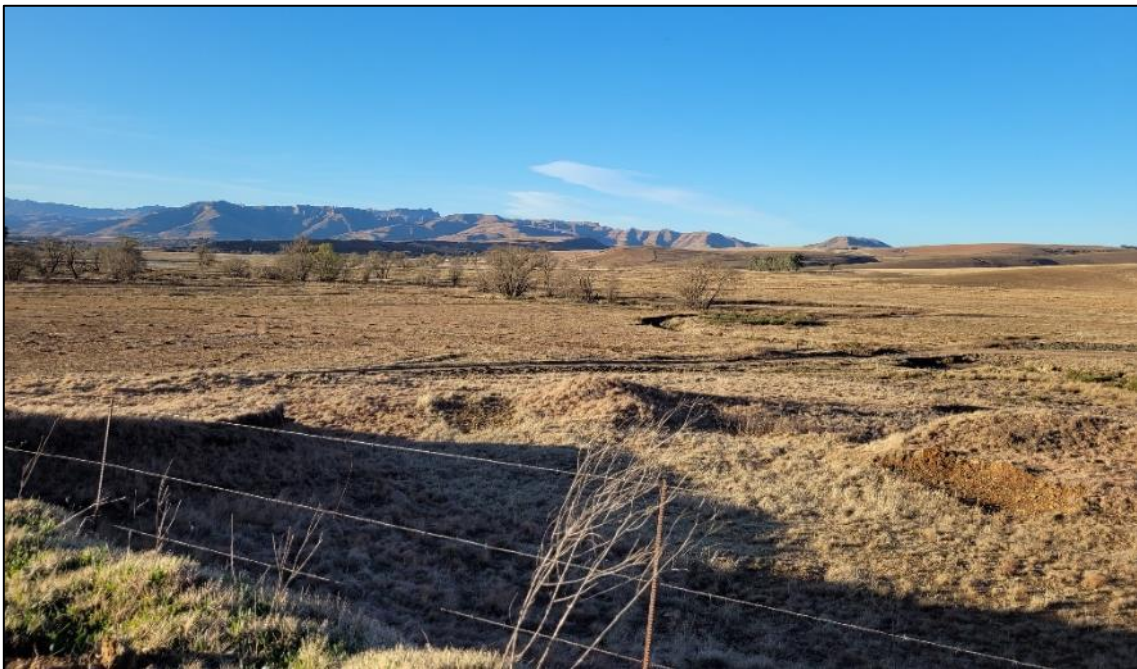
Figure 3-93 Downstream portion of the floodplain, which is directly upstream of the geological control. This portion of the wetland resembles the most intact portion of the system and is also home to breeding cranes

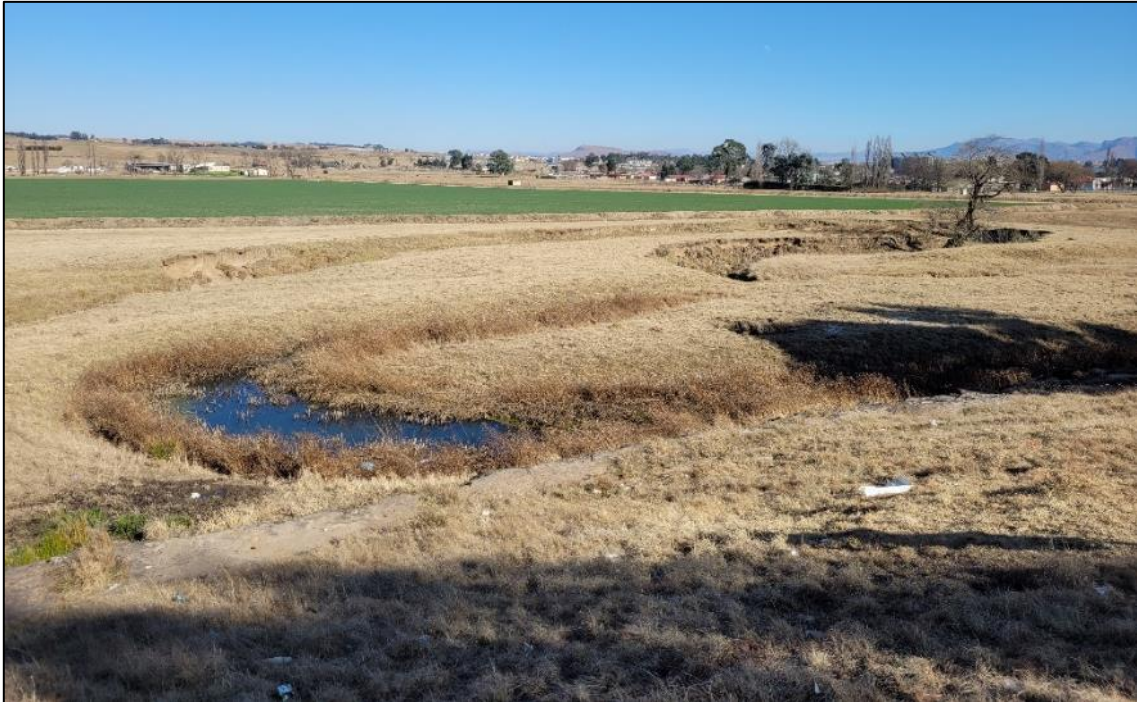
Figure 3-94 Incised floodplain channel (in the background), which has been restricted in its movements due to a geological control along its northern boundary and a flood protection berm along its southern boundary.

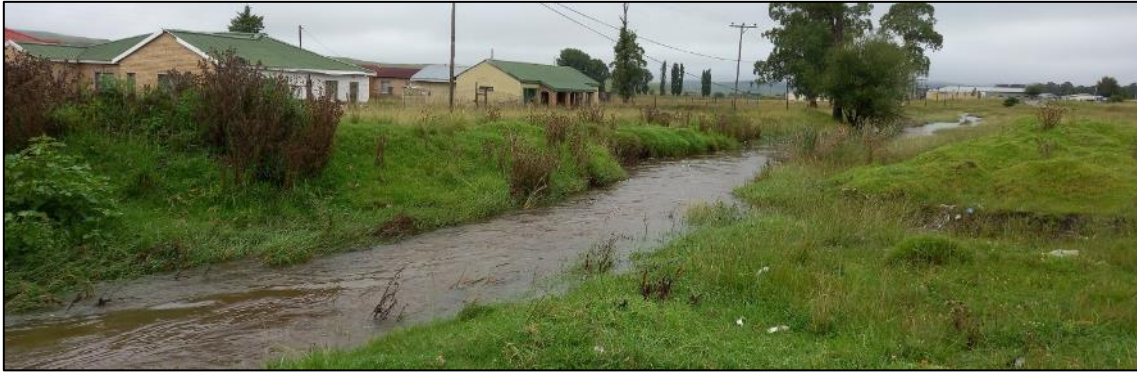
Figure 3-96 Flood-prone houses lying adjacent to the enlarged and straightened channel shown in the previous photo.

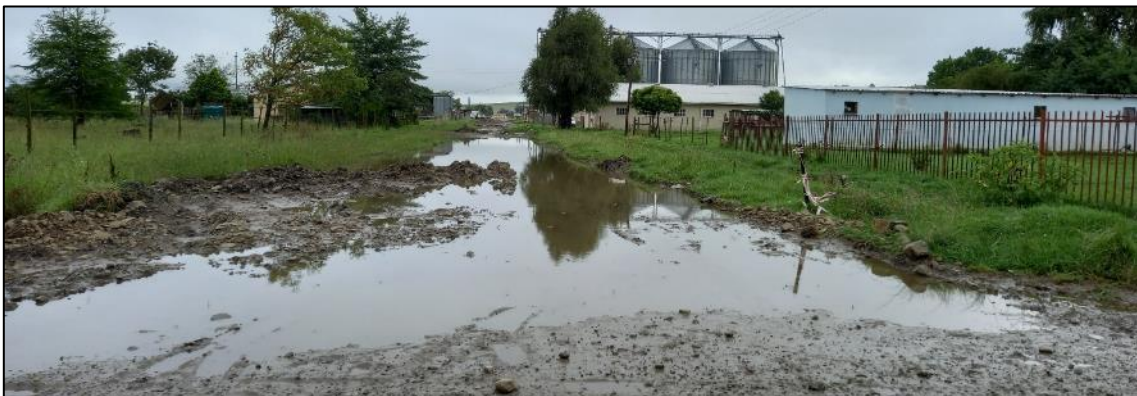
Figure 3-97 A low-lying flood-prone area of Elliot town located within the wetland complex.

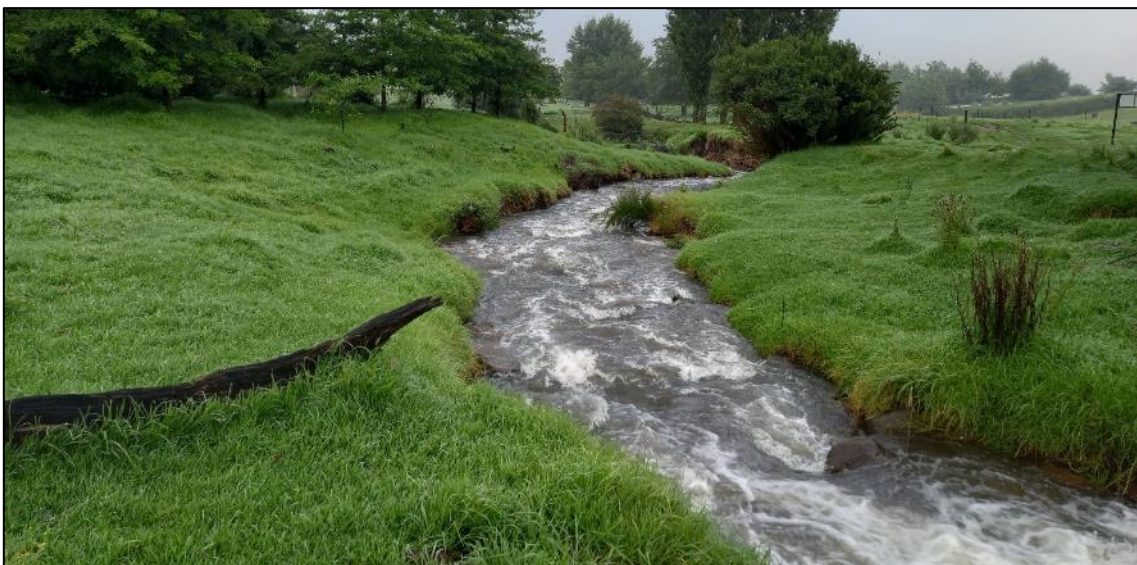
Figure 3-98 The Slang River at the inflow to the upper portions of the Elliot floodplain, showing the vegetation dominated by kikuyu (*Pennisetum clandestinum*) an alien pasture grass species.

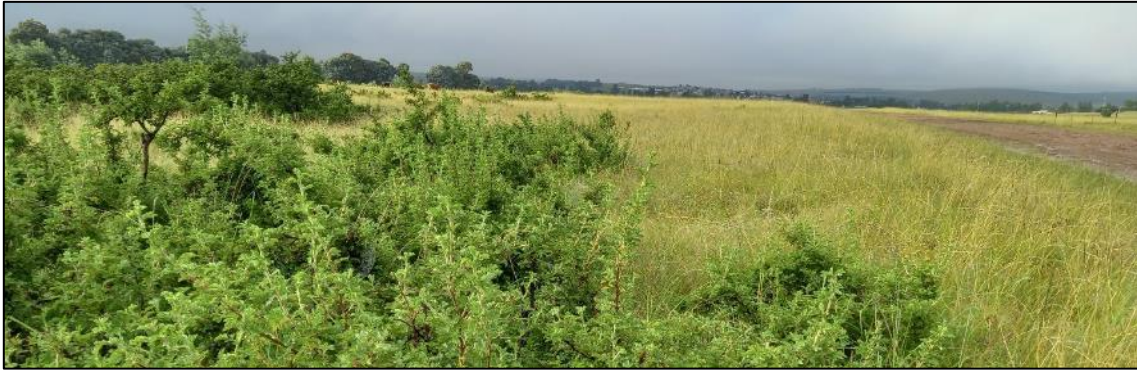
Figure 3-99 Some of the upper portions of the Elliot floodplain, with the indigenous shrub *Leucosidea sericea* and predominantly indigenous pioneer grasses, including *Eragrostis* and *Sporobolus* spp.

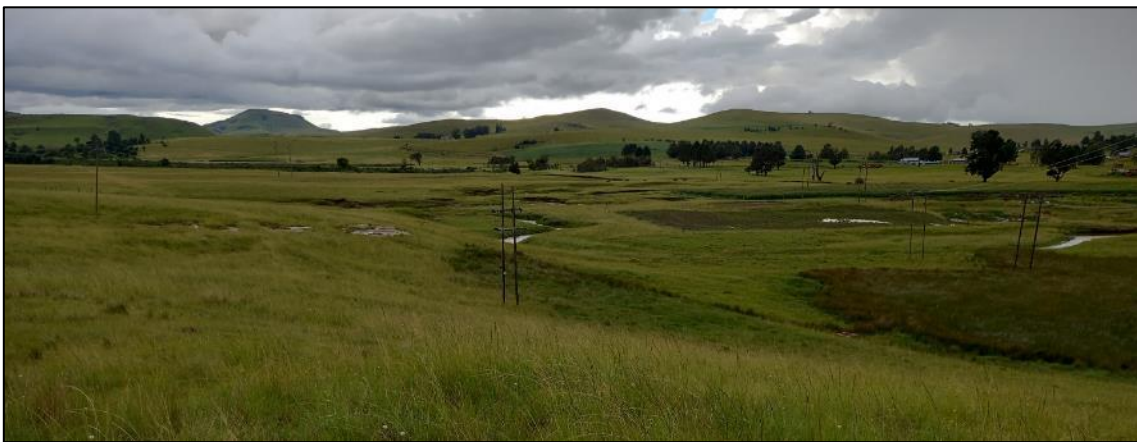
Figure 3-100 Some of the upper portion of the Elliot floodplain, with the higher-lying areas dominated by grasses and the lower-lying areas by sedges.

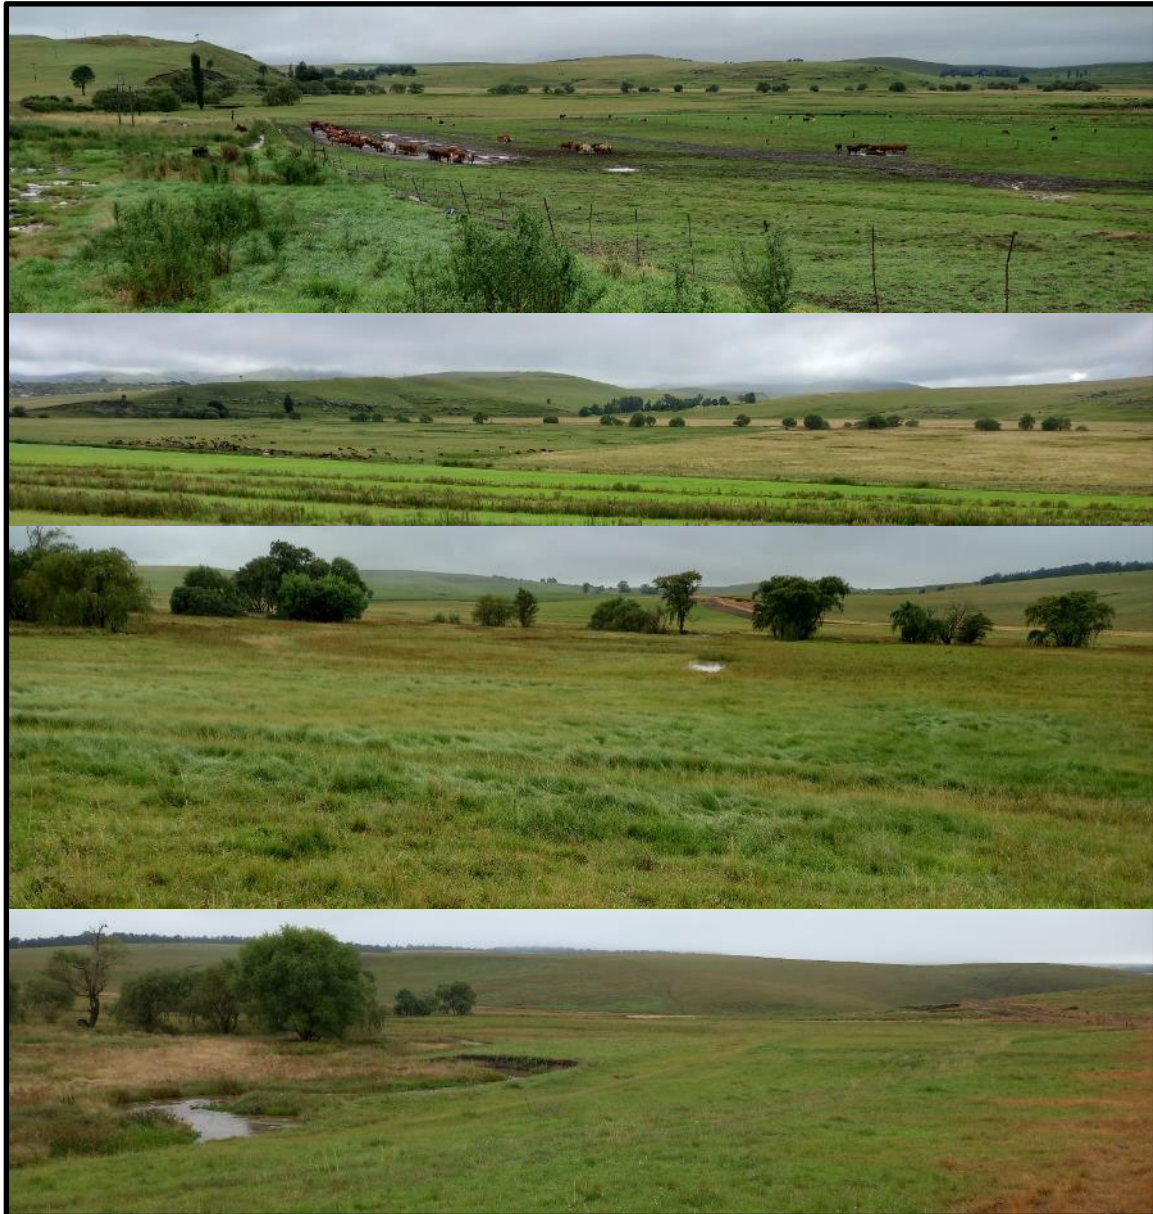
Figure 3-101 The central portions of the Elliot floodplain, which contain some planted pastures as well as the most extensive areas still remaining under natural vegetation. The trees growing along the main river channel are alien willow tree species *Salix babylonica* and *Salix fragilis*, and a flooded oxbow lake can be seen in the third photo.

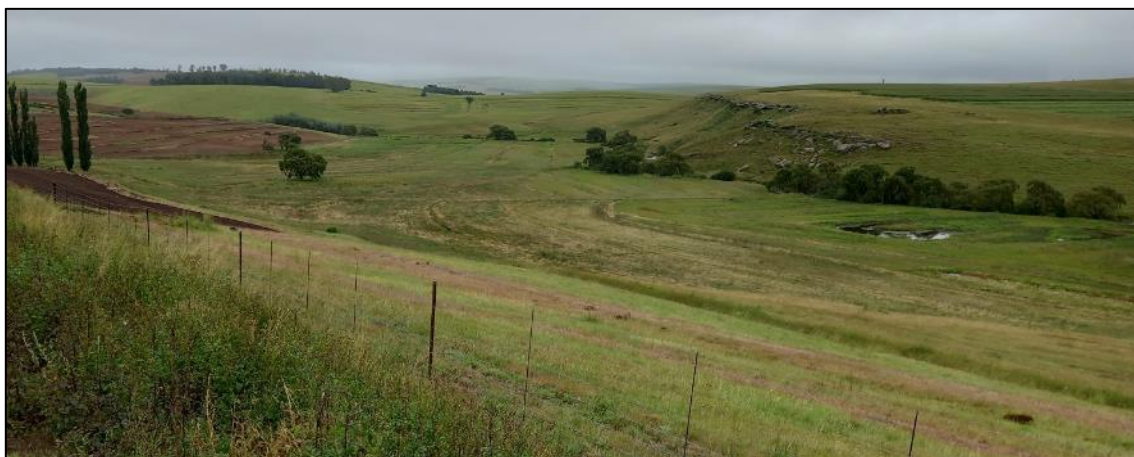
Figure 3-102 The lower portions of the Elliot floodplain which have largely been drained and converted to planted pastures except for a few low-lying oxbow lakes, which still support indigenous vegetation such as the sedge *Cyperus fastigiatus*.

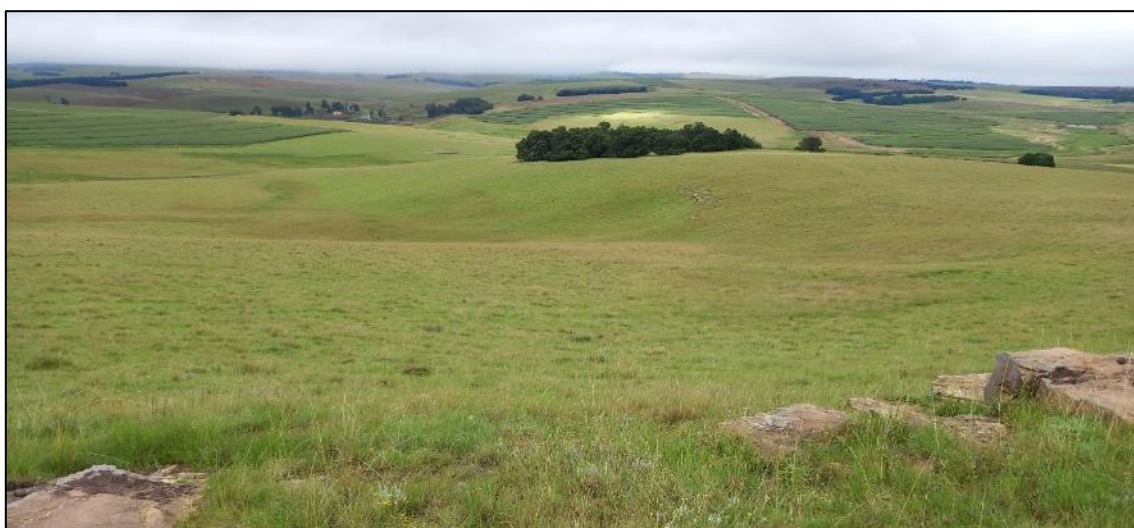
Figure 3-103 Hillslope seep wetland feeding one of the main valley bottom tributary arms of the Elliot floodplain, characterized by the short sedge *Fuirena pubescence* and grasses typically associated with good condition veld such *Tristachya leucothrix* and *Themeda triandra*.

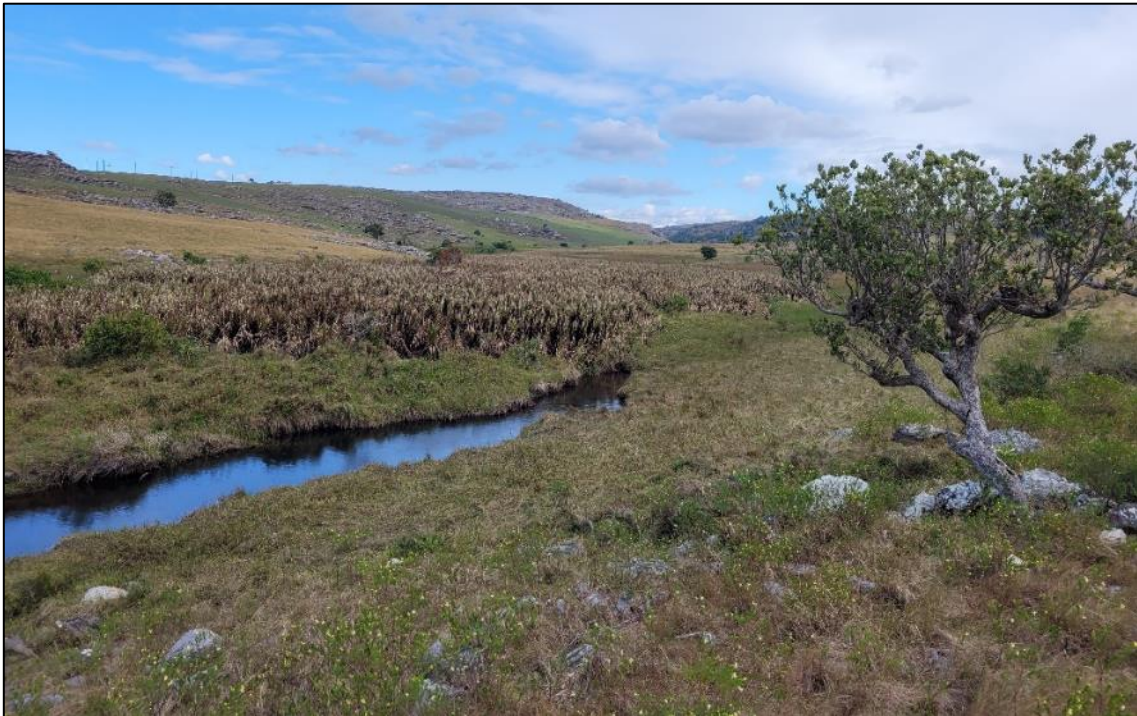
Figure 3-105 Sikombe wetland: View of the upstream habitat of one of the major tributaries, which has been recently burnt

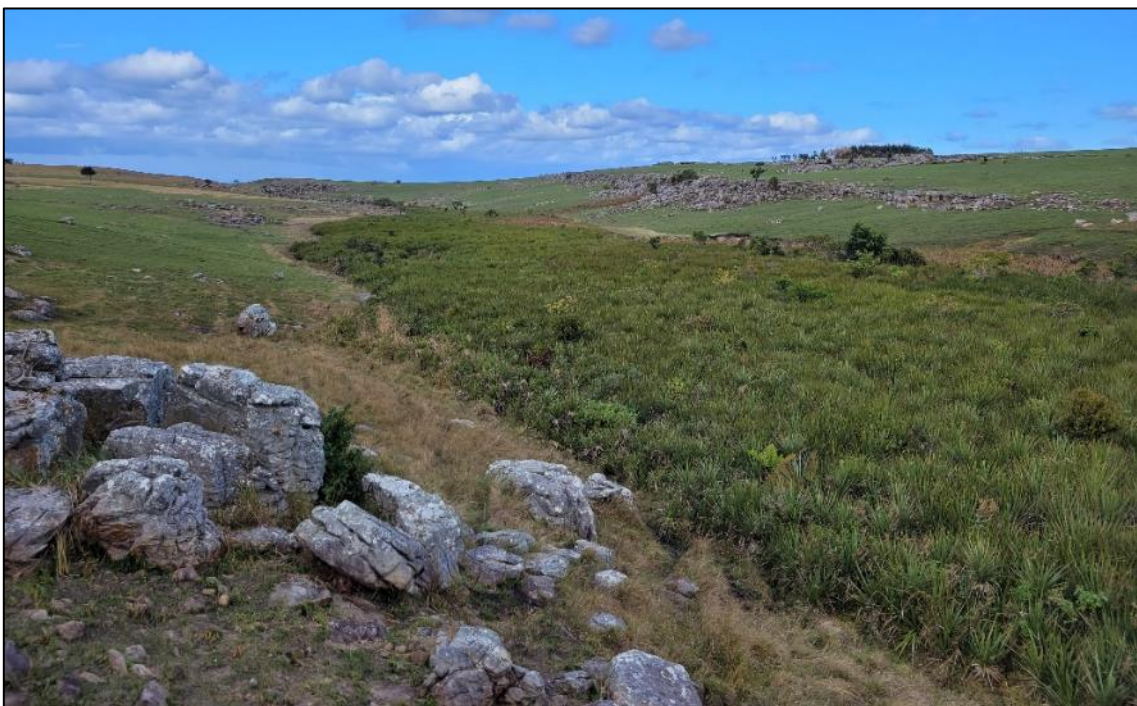
Figure 3-106 Sikombe wetland: View of the Palmiet wetland and the establishment of some woody species within the drier portions of the system

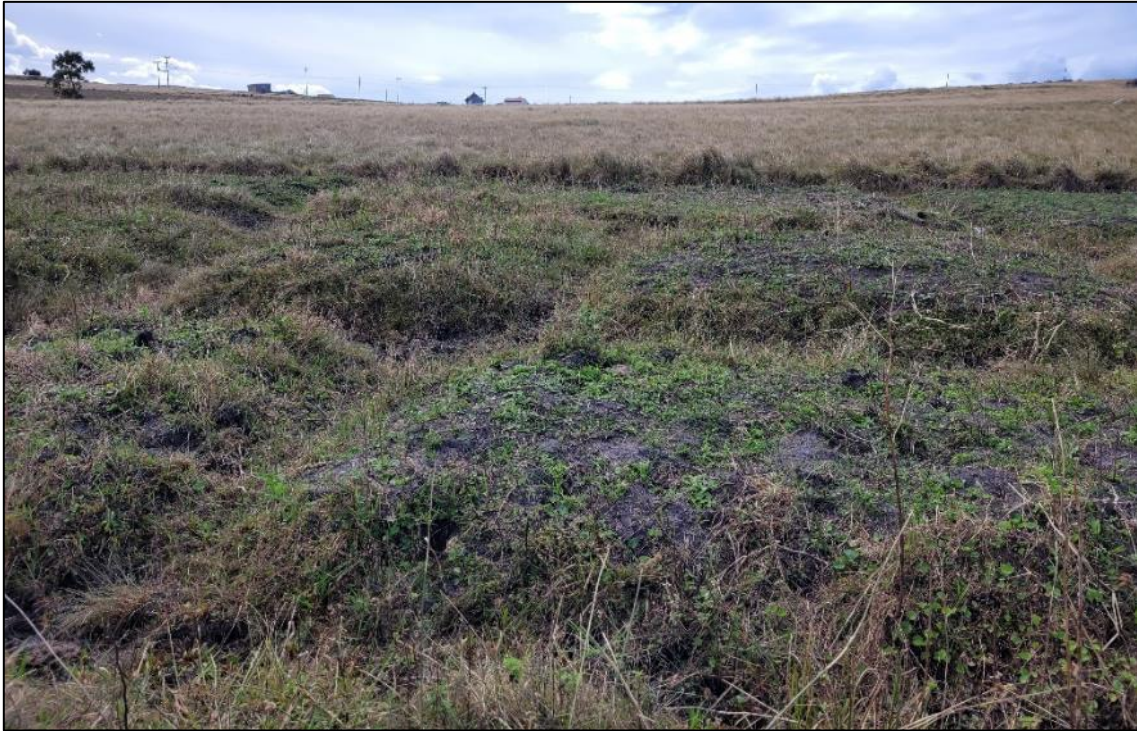
Figure 3-107 Sikombe wetland: Rotational madumbe/taro crop field adjacent to the valley bottom wetland in the seepage zones.

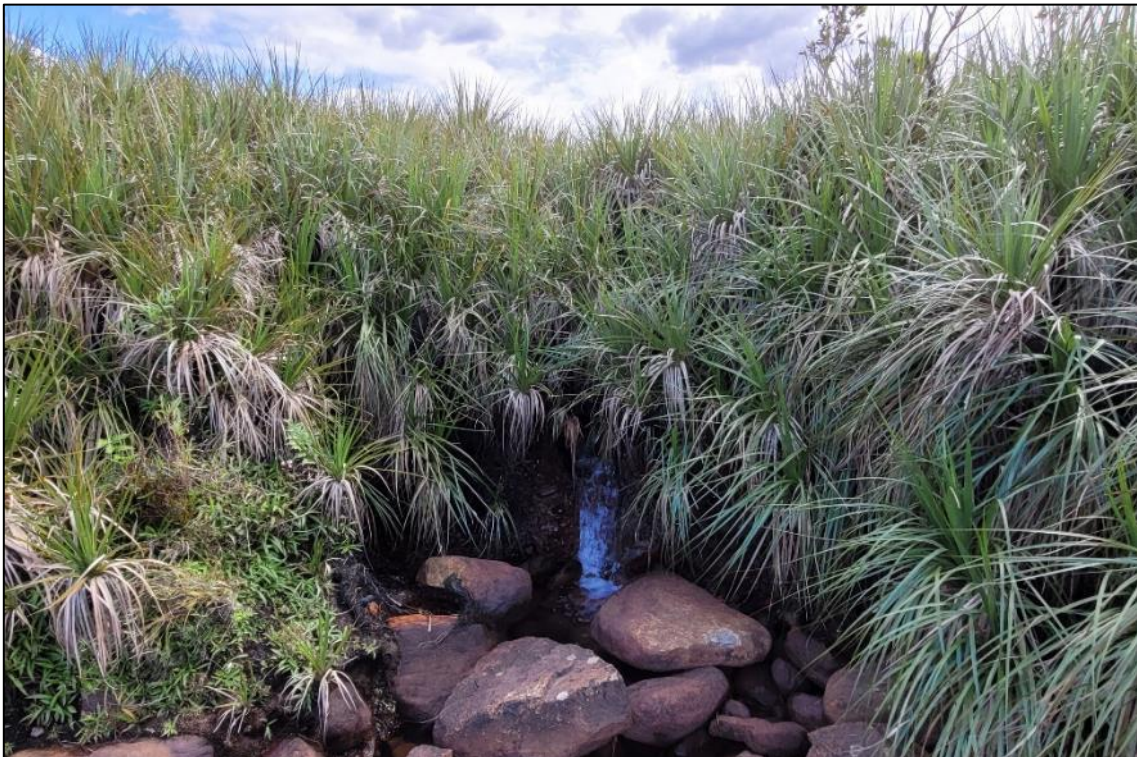
Figure 3-108 Sikombe wetland: Headcut erosion within the lower portion of the system.

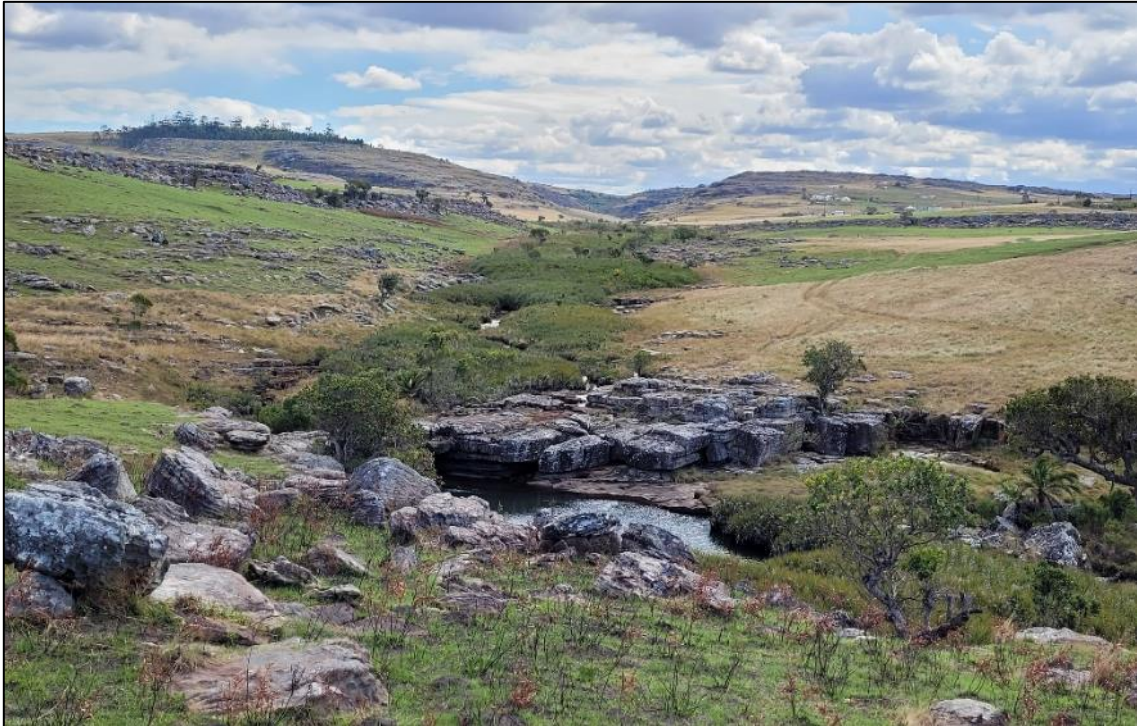
Figure 3-109 Sikombe wetland: View of the geological control at the base of the palmiet wetland

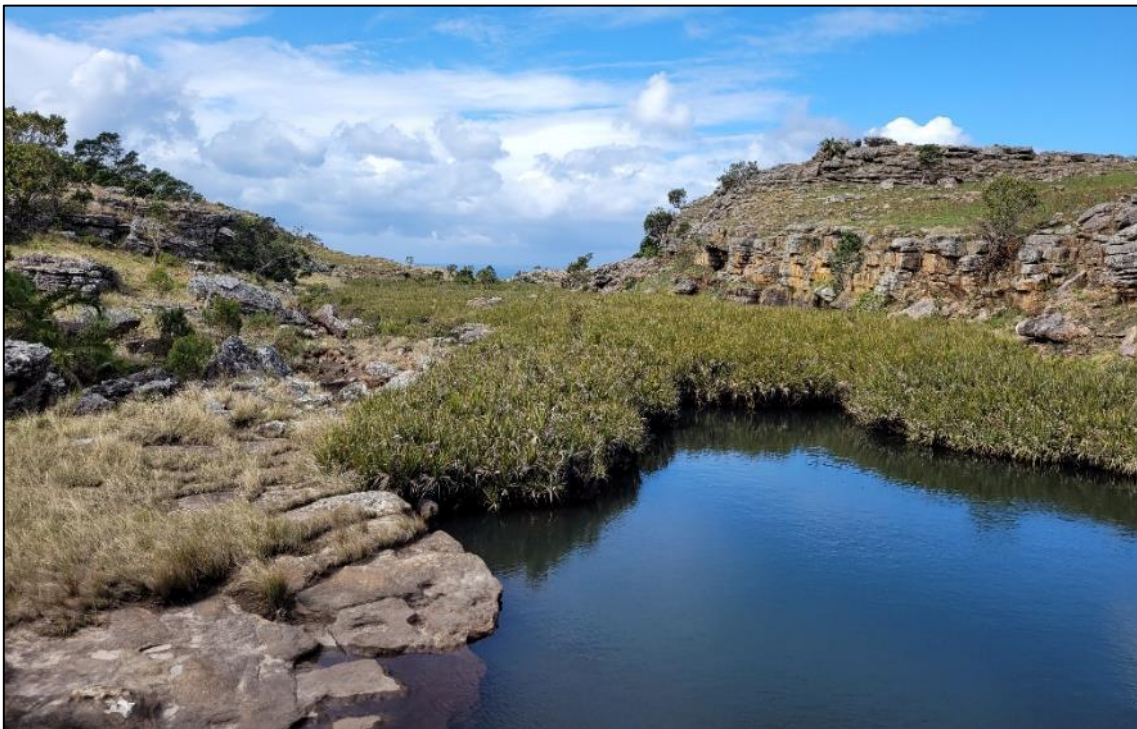
Figure 3-110 Sikombe wetland: Palmiet wetland below the geological control

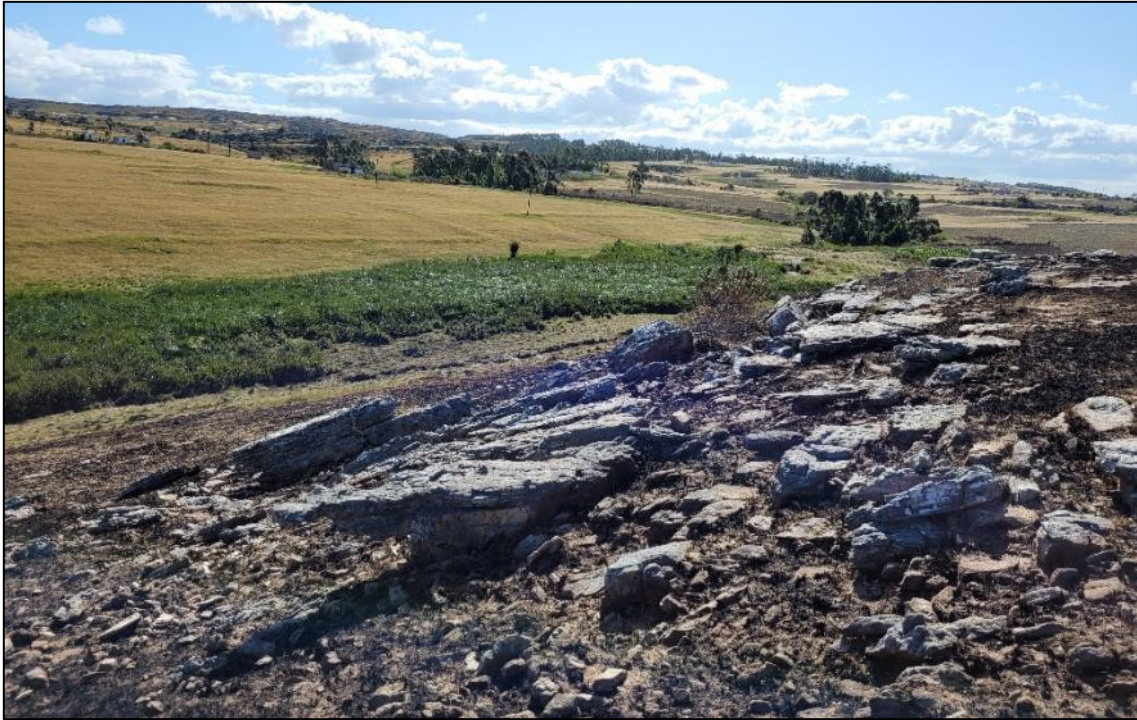
Figure 3-111 Xolobeni wetland: View of the upstream portion of the palmiet wetland and the woodlots within the wetland habitat

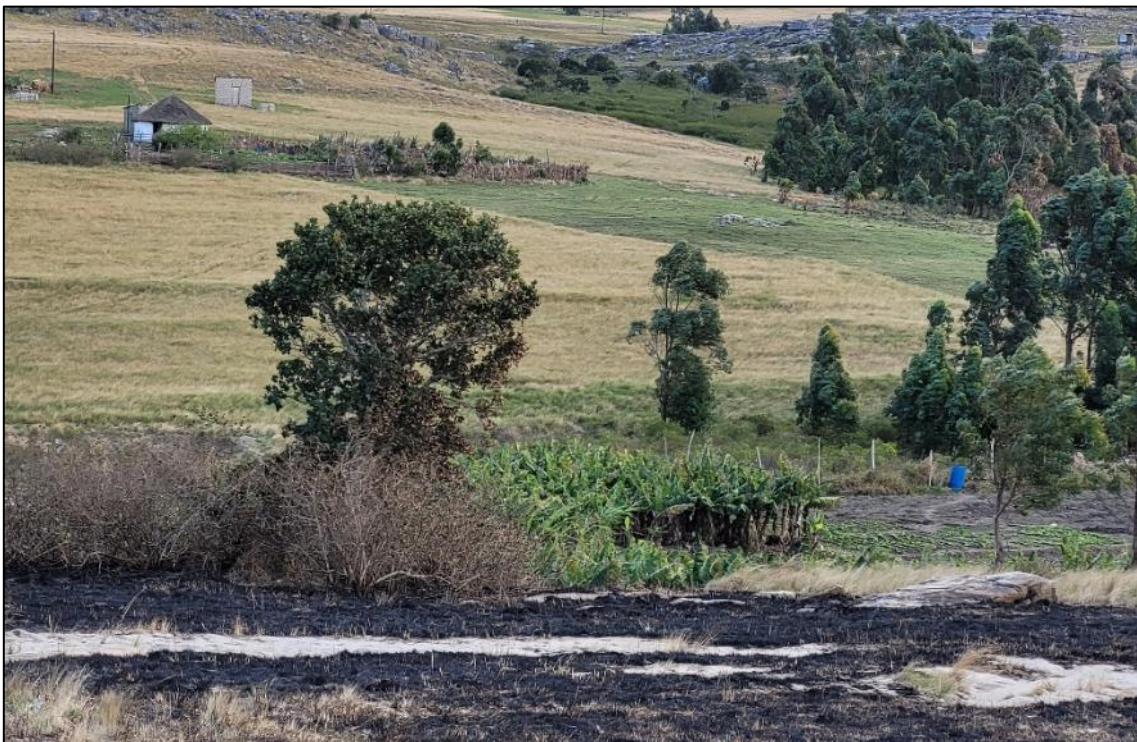
Figure 3-112 Xolobeni wetland: cultivation within the temporary zones of wetness associated with the seepage zones adjacent to the valley bottom wetland habitat

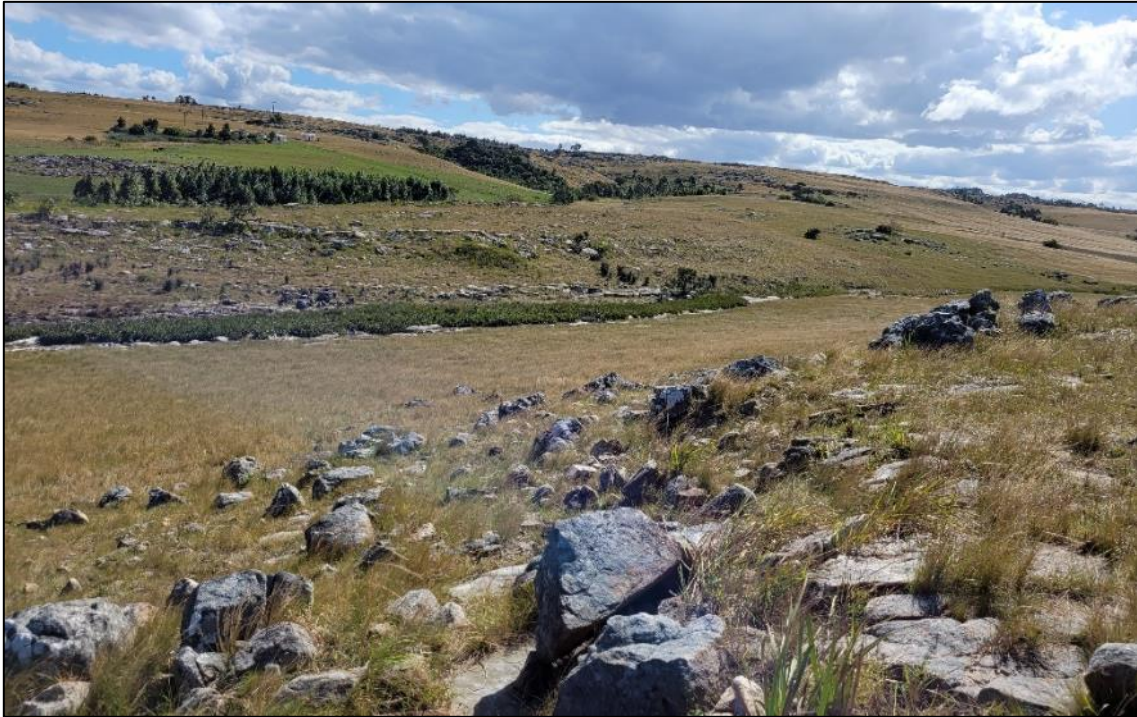
Figure 3-113 Xolobeni wetland: View of some of the catchment impacts, and the channel which has eroded onto bedrock (lighter areas)

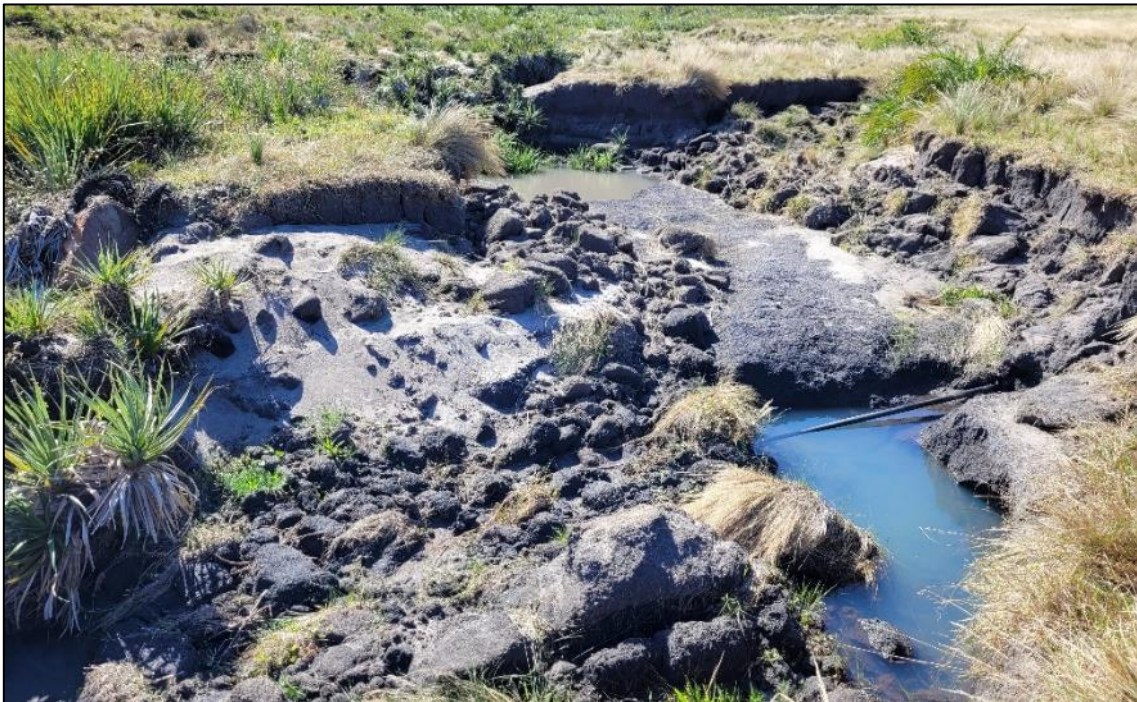
Figure 3-114 Xolobeni wetland: Headcut erosion upstream of the water abstraction point
