Determination of Water Resource Classes, Reserve and the Resource Quality Objectives in the Keiskamma and Fish to Tsitsikamma Catchments

WP11354 Wetland Field Survey Report

REPORT NO.:
WEM/WMA7/00/CON/RDM/0522

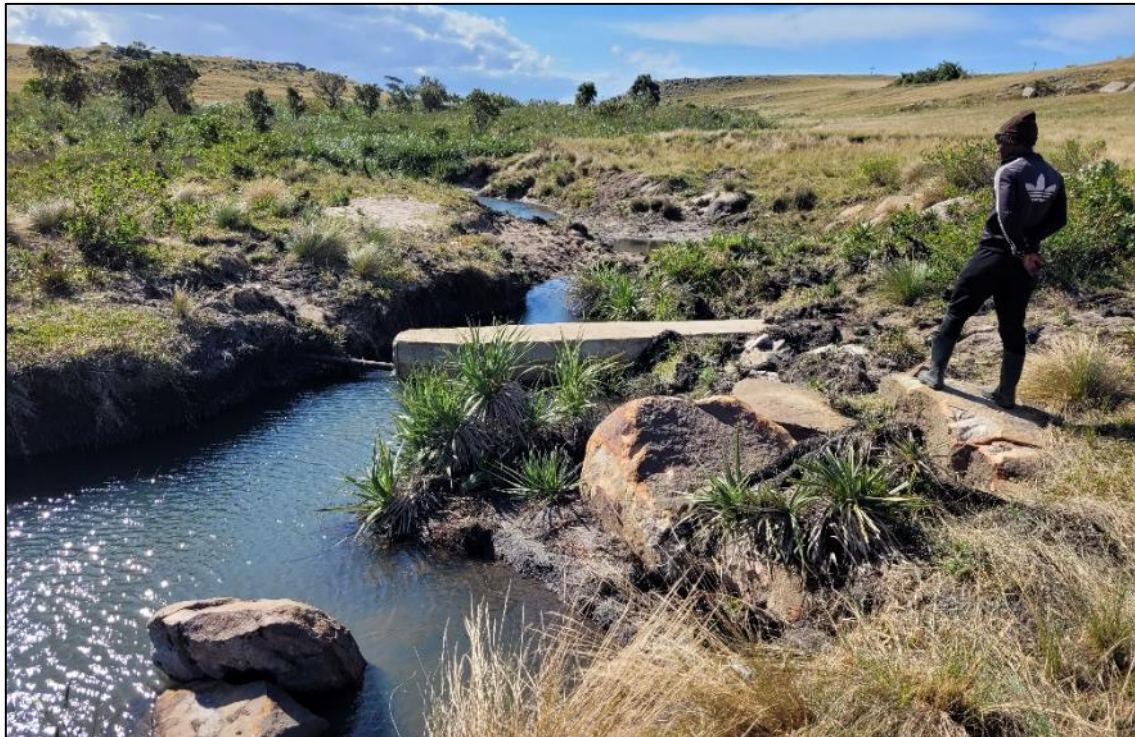
Figure 3-115 Xolobeni wetland: Eroded palmiet wetland upstream of the water supply pipeline crossing point. Portions of the pipeline has been encased in concrete, however the channel has bypassed the concrete and has exposed portions of the pipeline

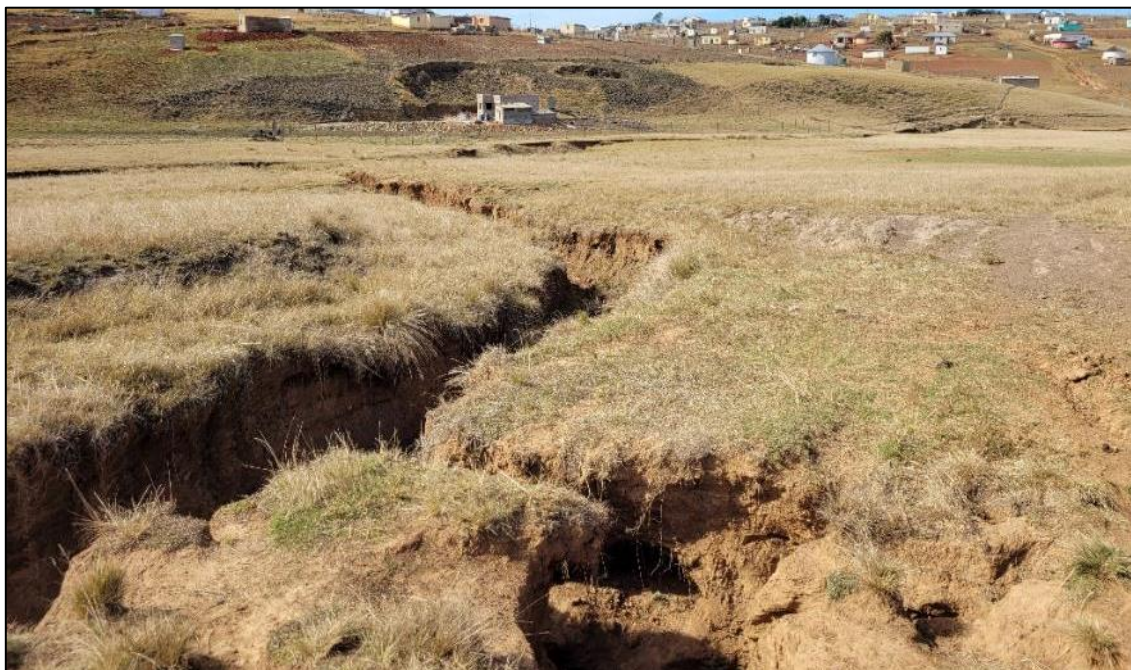
Figure 3-117 Eroded main channel with the seepage wetland maintained on the adjacent valley bottom terrace. The seepage wetland is entirely independent of the valley-bottom system and is still considered to provide some ecosystem services within the modified landscape

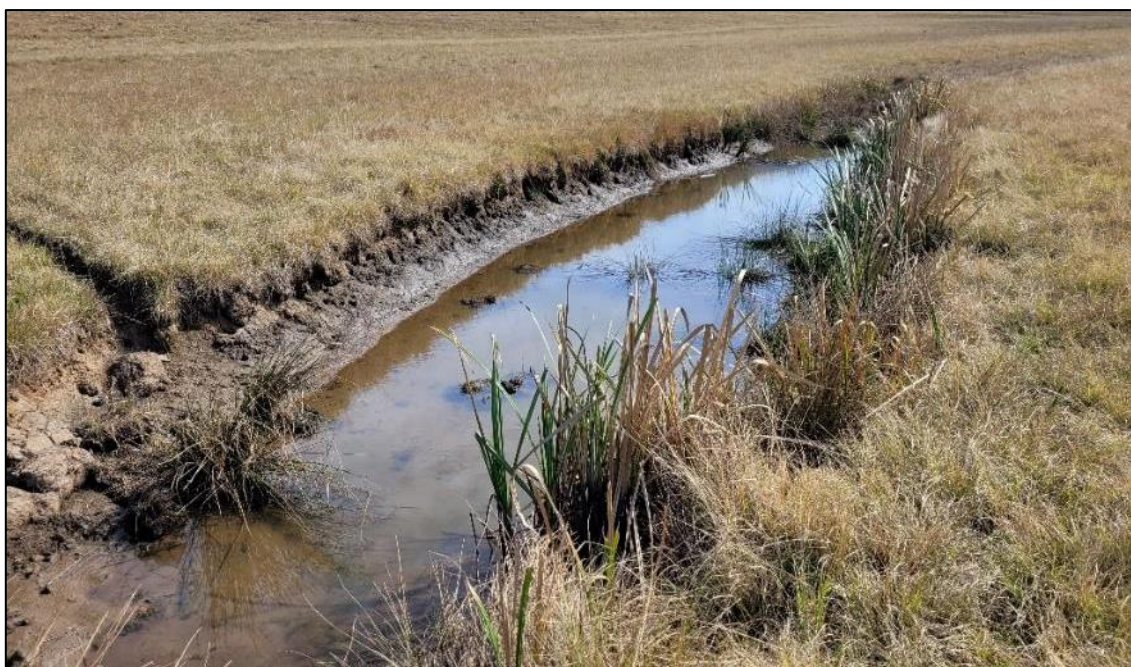
Figure 3-118 An old flood channel associated with the valley-bottom wetland. A drain has been excavated from this pool of water towards the main channel, assisting with the desiccation of this feature and thereby, making the adjacent habitat more easily accessible for grazing purposes

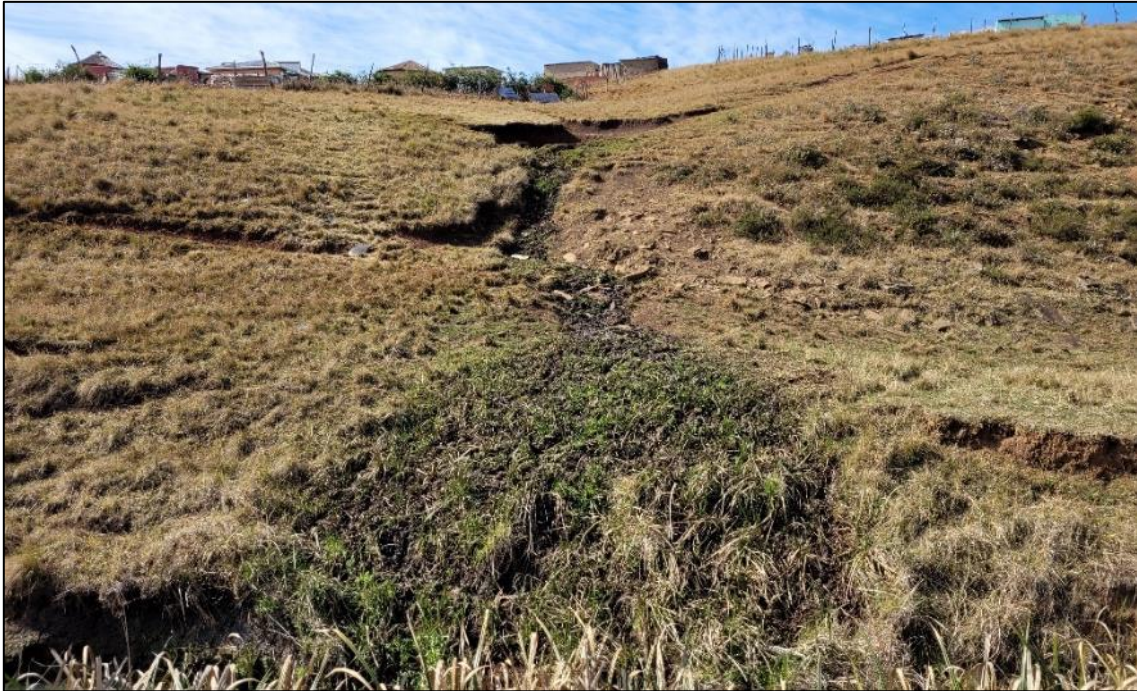
Figure 3-119 Seepage wetland adjacent to the valley-bottom wetland, however, erosional features are present upstream thereof, threatening the integrity of the seepage wetland

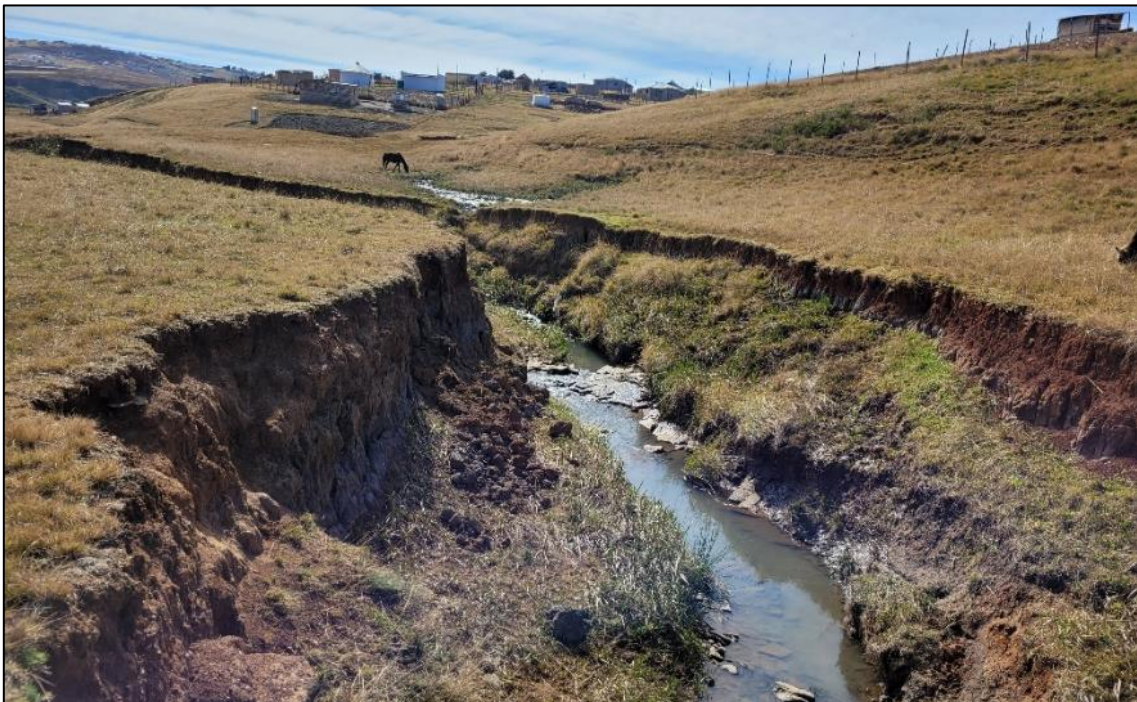
Figure 3-120 Incised channel associated with the main valley-bottom wetland.

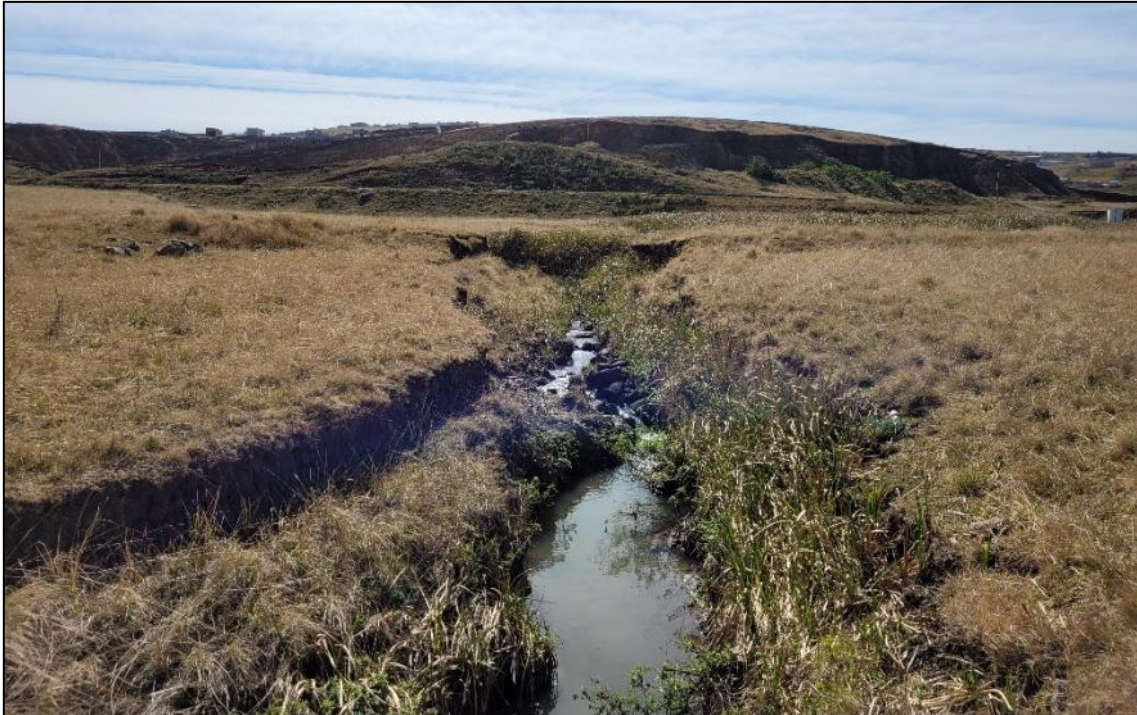
Figure 3-121 Breached dam wall within the valley-bottom wetland. The breach is most likely as a result of the advancing headcut erosional feature.

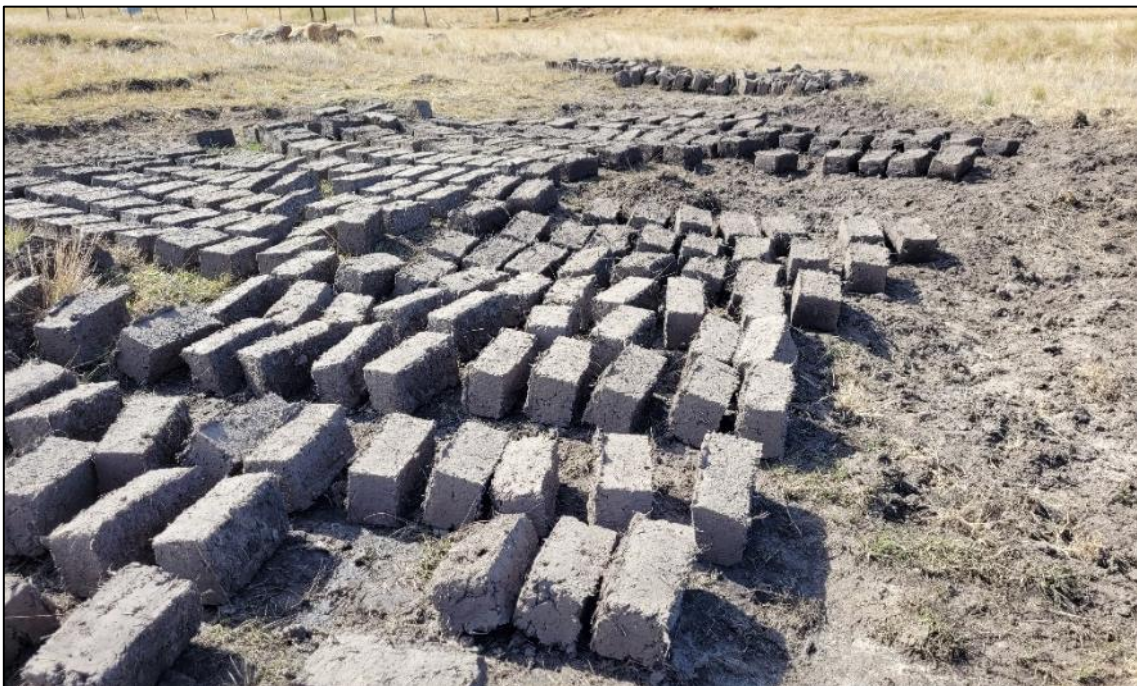
Figure 3-122 Evidence of brick making along the main portion of the Ludeke Halt wetland.

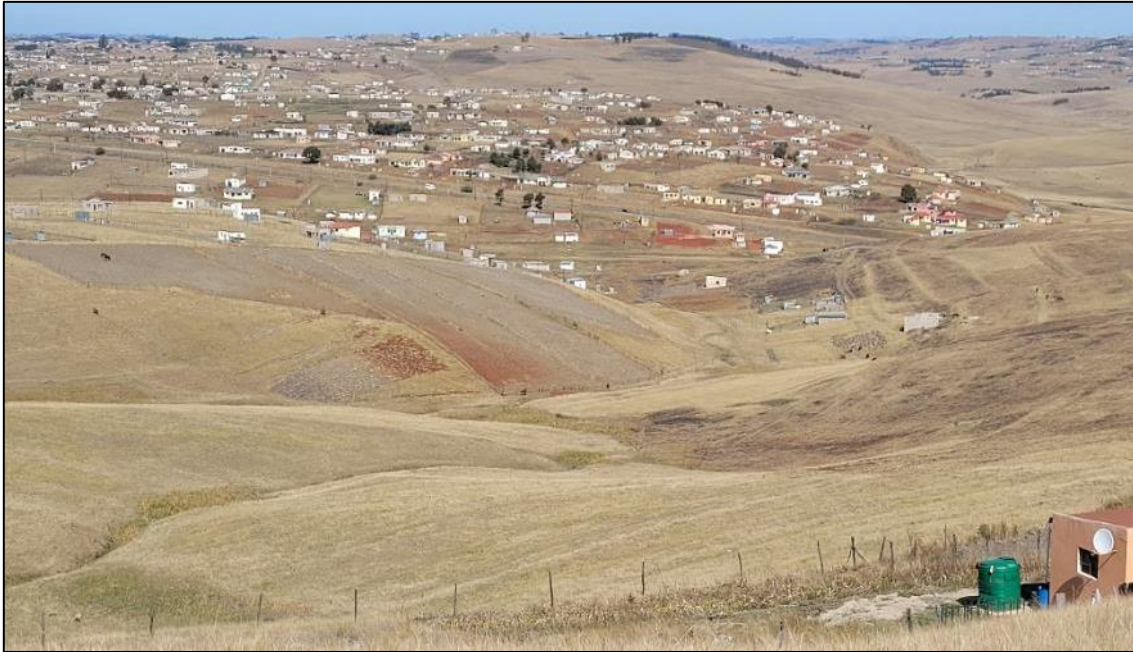
Figure 3-123 This tributary is more heavily impacted than some of the adjacent tributaries. The density of houses and anthropogenic impacts on the wetlands are greater than the areas of the wetland. The seepage wetlands have in some instances been transformed to croplands. Additional impacts include grazing by livestock and over utilisation of the system resulting in the formation of headcut erosional features.

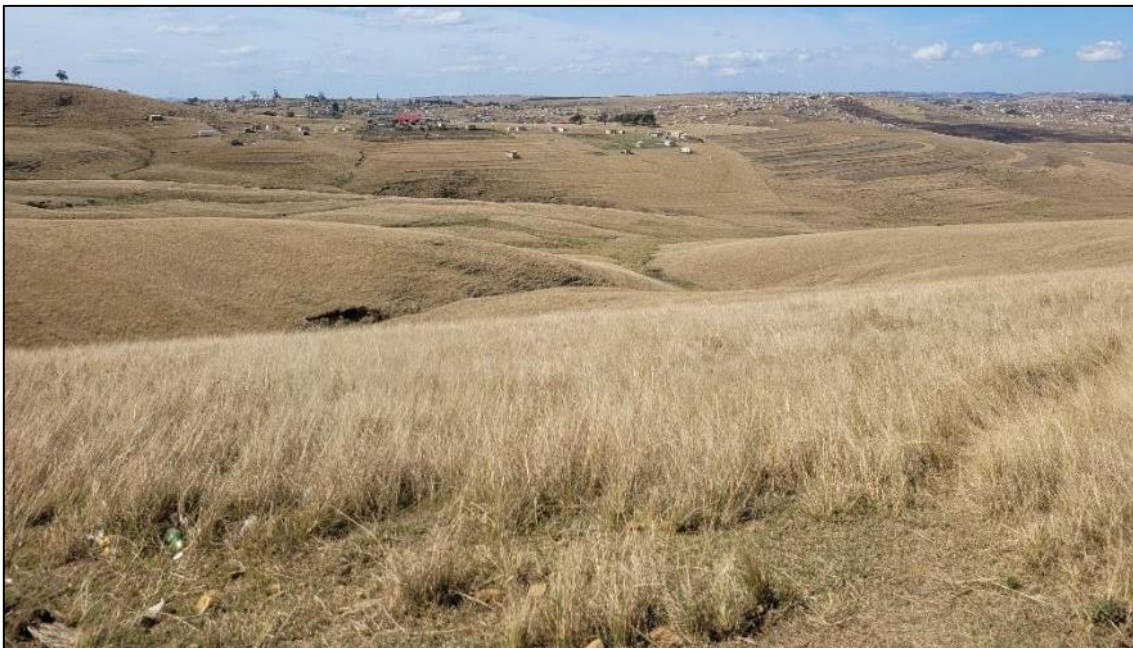
Figure 3-124 This tributary of the Ludeke Halt wetland is considered to be relatively intact with limited catchment and in-system impacts. The major impact on the system is associated with grazing by livestock, however, the limited number of livestock seen in the catchment area were not posing a threat to the seepage and valley-bottom wetland habitat

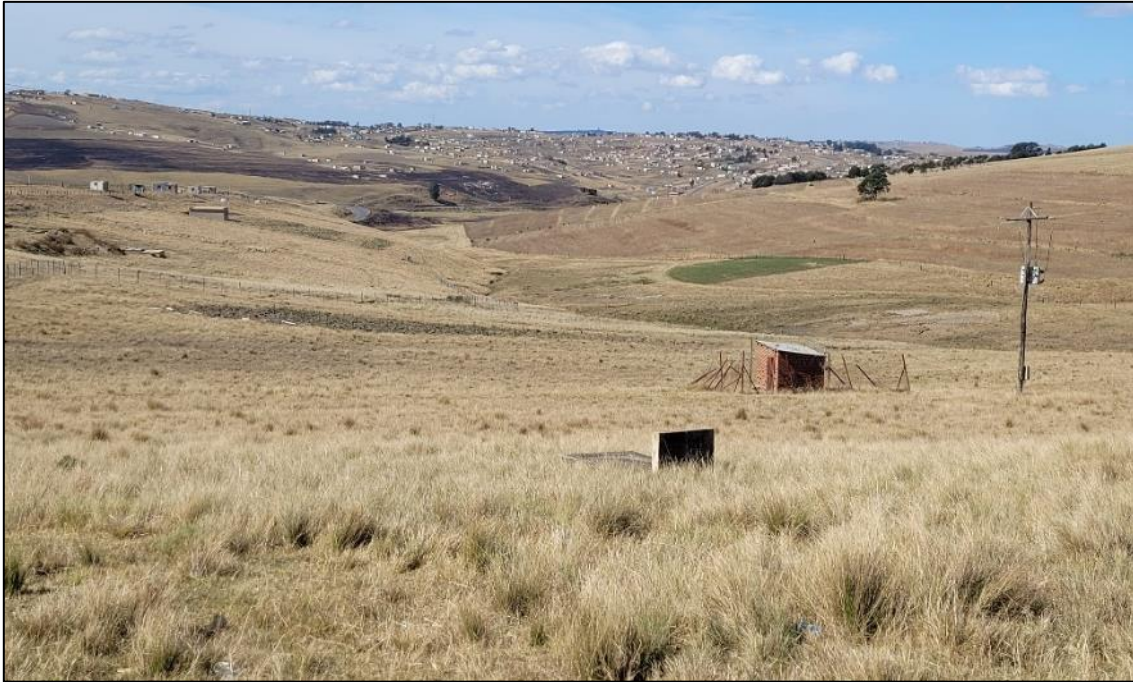
Figure 3-125 A tributary of the Ludeke Halt wetland, which has been encroached into by agricultural fields. Soils are also being harvested for brick making. Within the downstream portion of the tributary there is evidence of an old drain, which served as a cut-off drain along the edge of the system

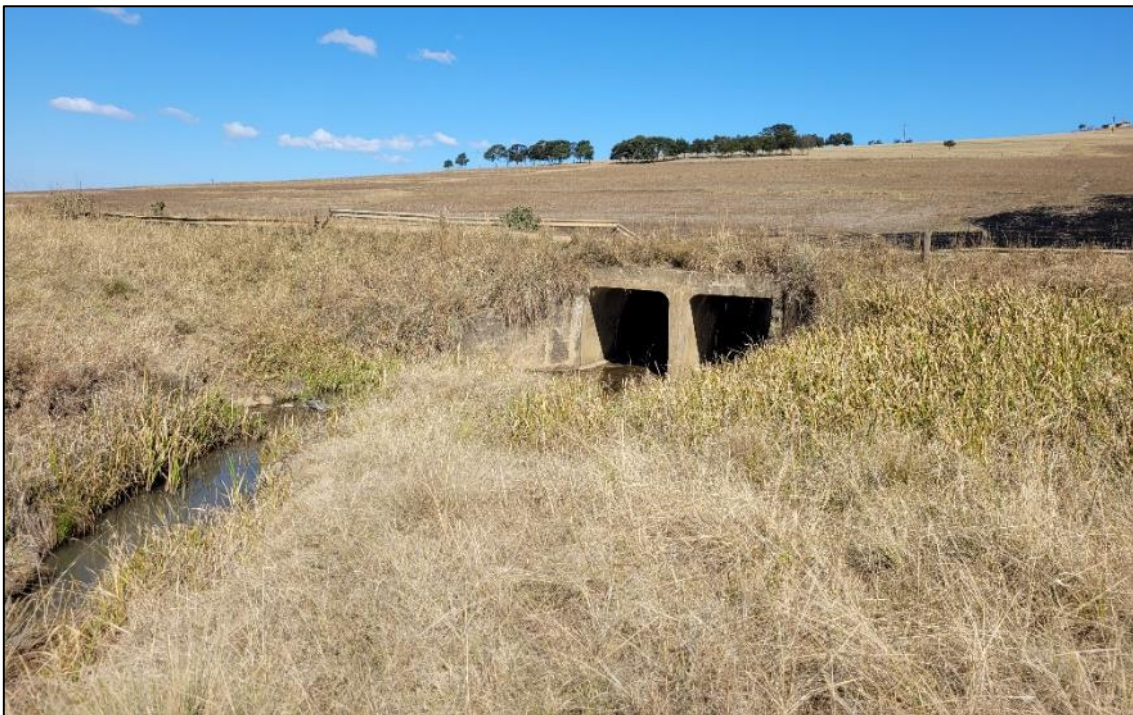
Figure 3-126 View of the road culvert associated with the R61 which has led to the formation of a small headcut erosional feature upstream of the culvert. The headcut has not progressed too far due to the shallow bedrock layer within the system

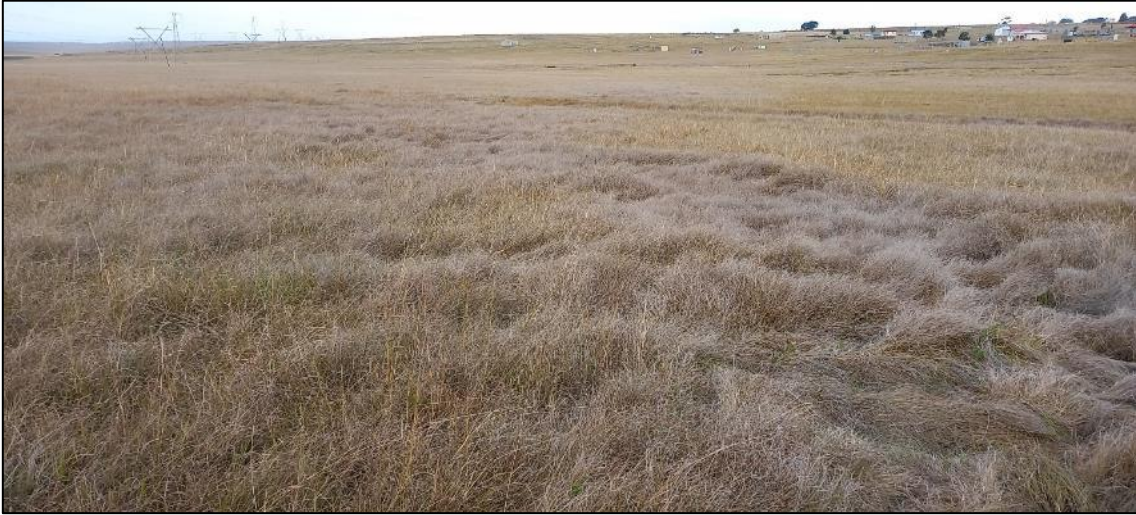
Figure 3-128 A hillslope seep dominated by the sedge *Fuirena pubescence* near the western inflow to the wetland, located in an area which is fenced off and, recently at least, appears to have been more leniently grazed than the central and eastern portions of the wetland.

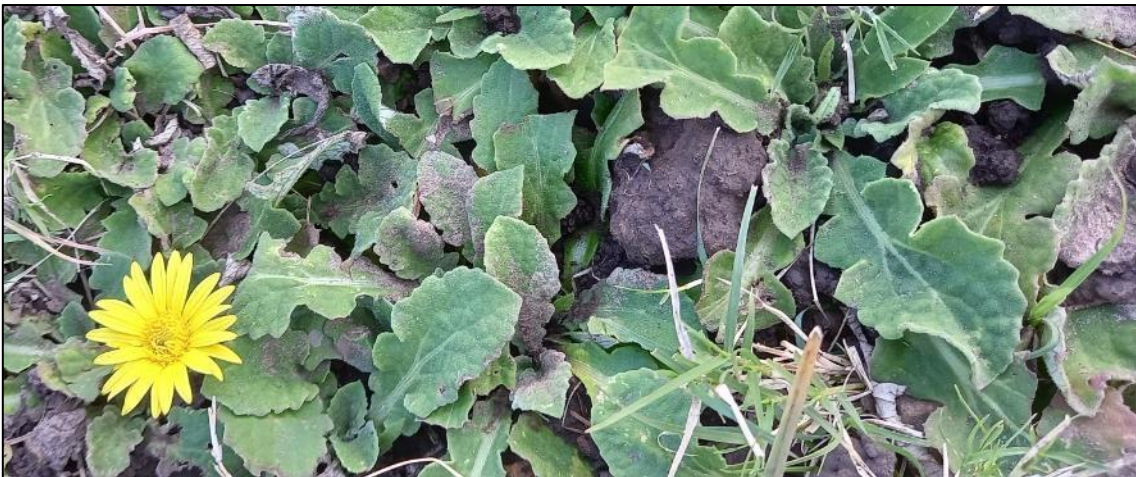
Figure 3-129 *Arctotis debensis* growing in a kommetjievlaakte area of the wetland amongst abundant earthworm casts. This is a vulnerable species known from only eight locations in a limited geographical area between Qonce and Perie Forest, and which appears well adapted to the extensive earthworm-mediated soil turnover characteristic of Kommetjievlaakte (Dold et al. 2021)

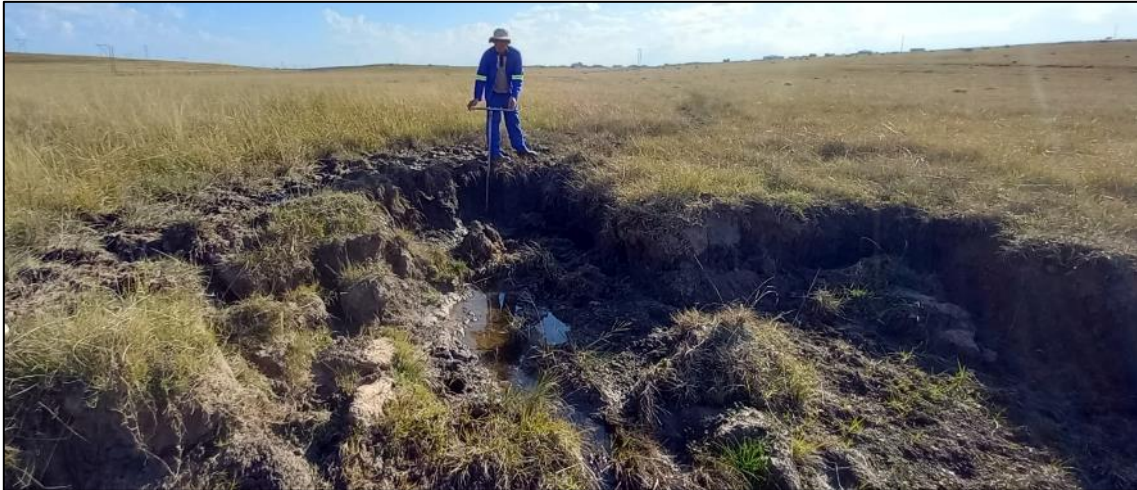
Figure 3-130 The primary headcut at the head of the main gully (see the following four photos) which has advanced through an extensive area of unchannelled valley bottom and threatens a further large area of unchannelled valley bottom upstream. An active cattle path immediately upstream of the headcut can be seen, which is likely weakening the area under immediate threat of erosion.

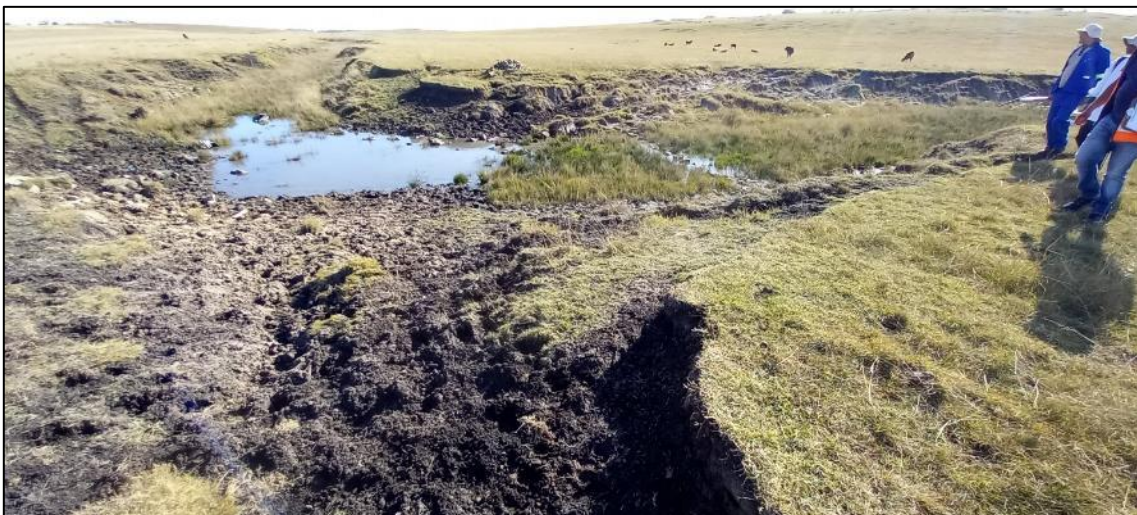
Figure 3-131 The primary livestock crossing point through the main erosion gully in the wetland, subject to intense localized trampling.

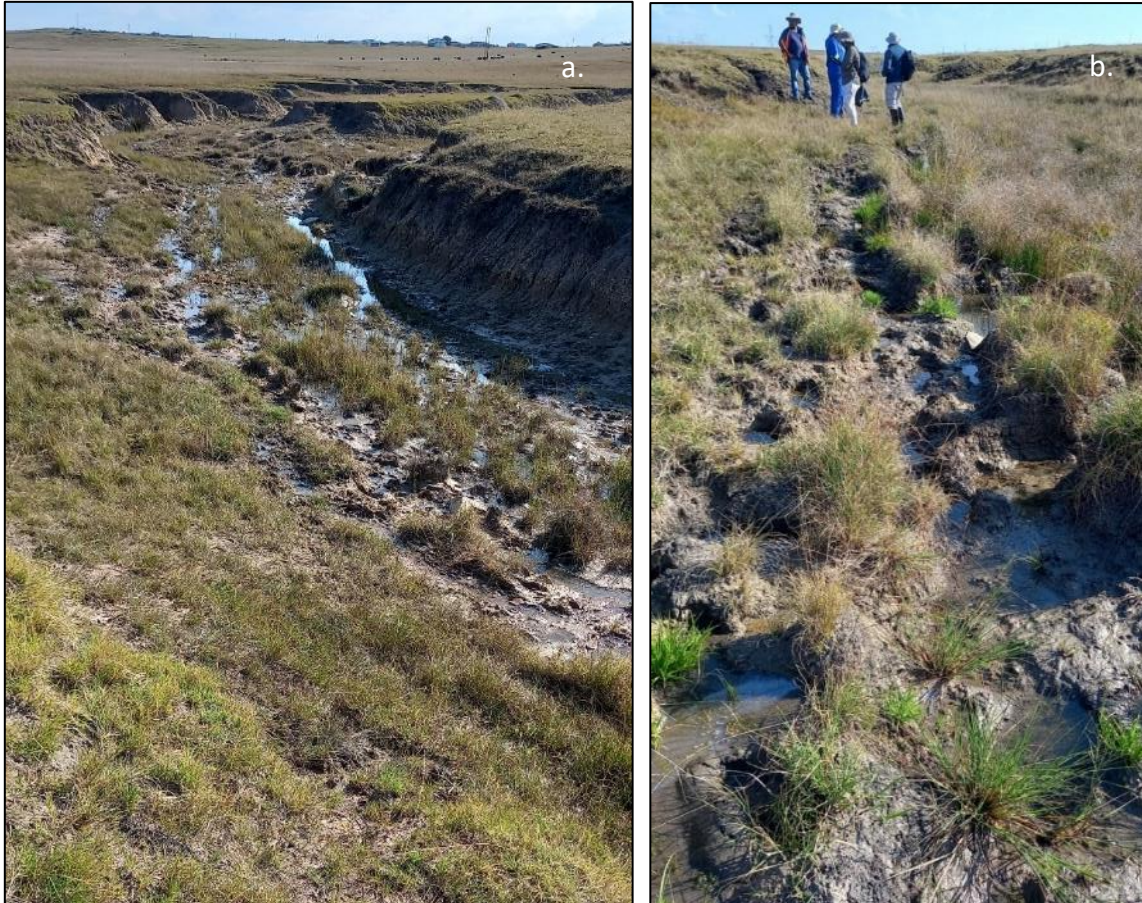
Figure 3-132 The main erosion gully in the wetland (downstream of the headcut shown in the previous photo) with (a.) located shortly downstream with incomplete vegetation cover and (b.) somewhat further downstream where vegetation cover is generally higher and more sediment has accumulated than above but a cattle path has provided a focal point for localized incision and remobilization of some of the deposited sediment

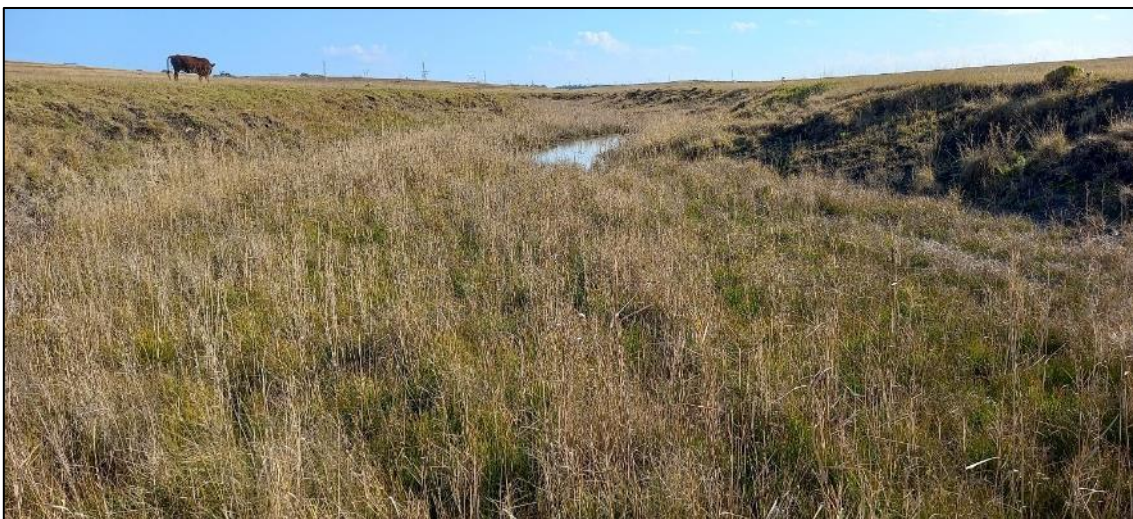
Figure 3-133 The mid portions of the main erosion gully characterized by vigorous vegetation growth and the accumulation of sediment, indicating gully recovery is occurring here.

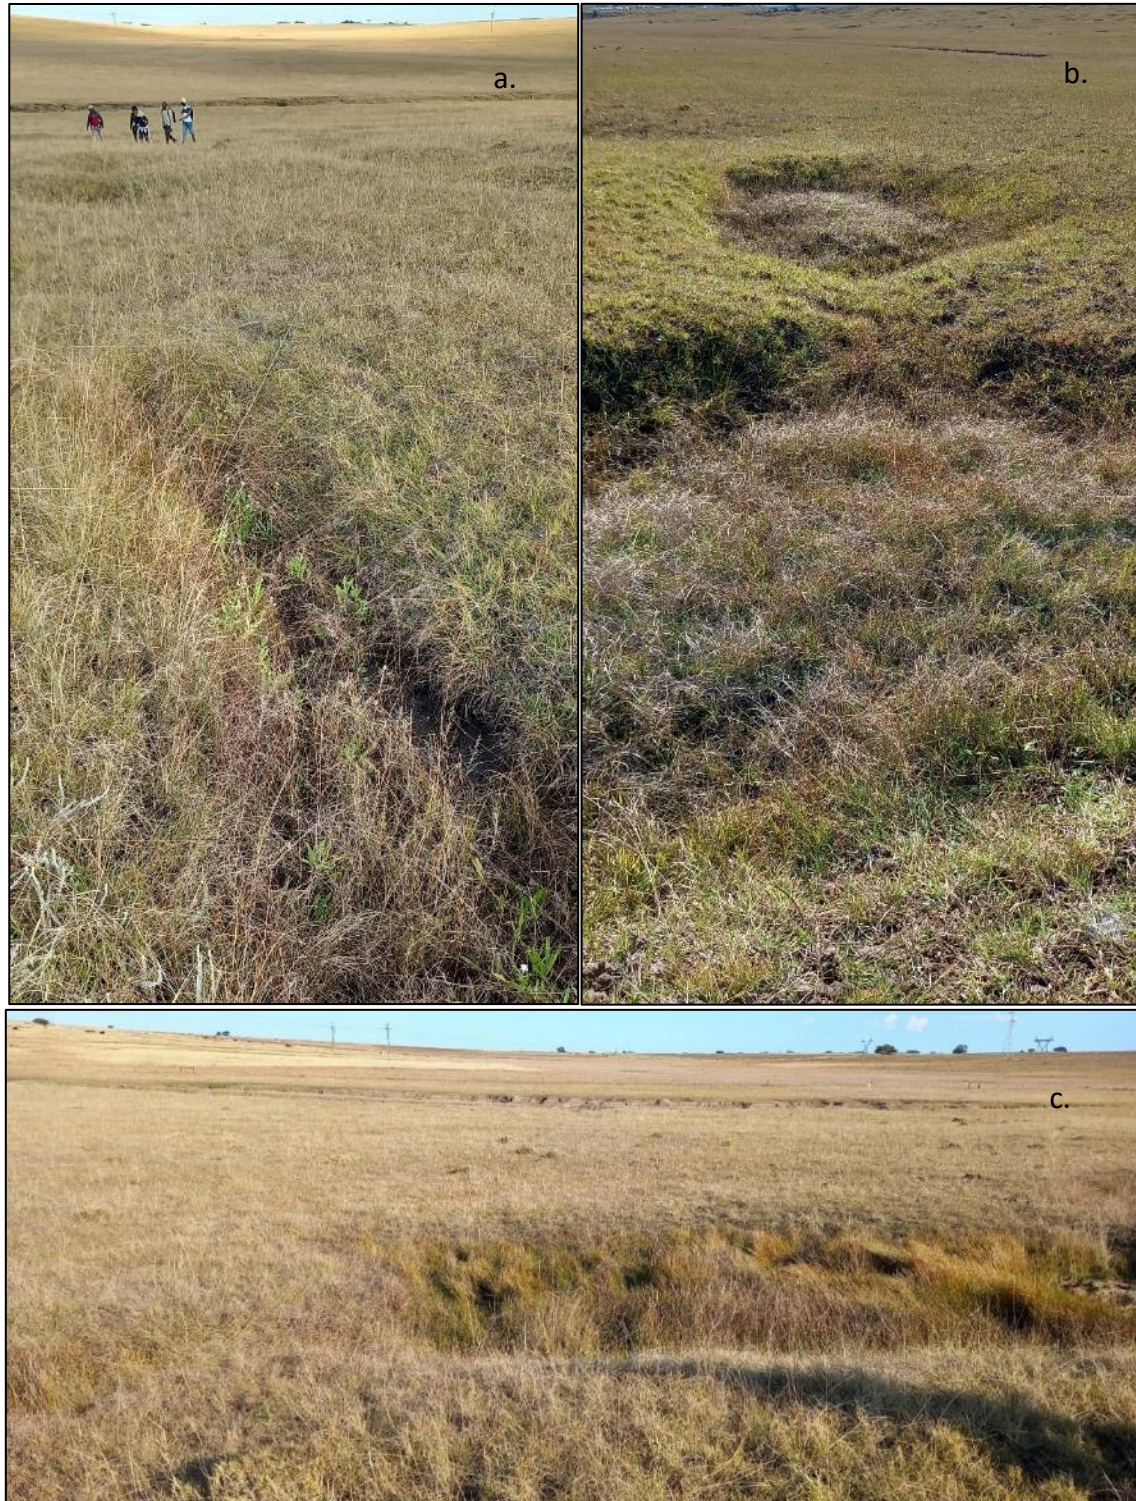
Figure 3-134 Three different locations where the hillslope component of KwaMasele wetland extends into adjacent Kommetjievlaakte terrain, with (a.) on a midslope and the wetland areas confined to only a few of the deepest hollows such as that shown in the foreground; (b.) also on a footslope and wetland areas present in most of the hollows; and (c.) located at the transition between the hillslope and valley bottom.

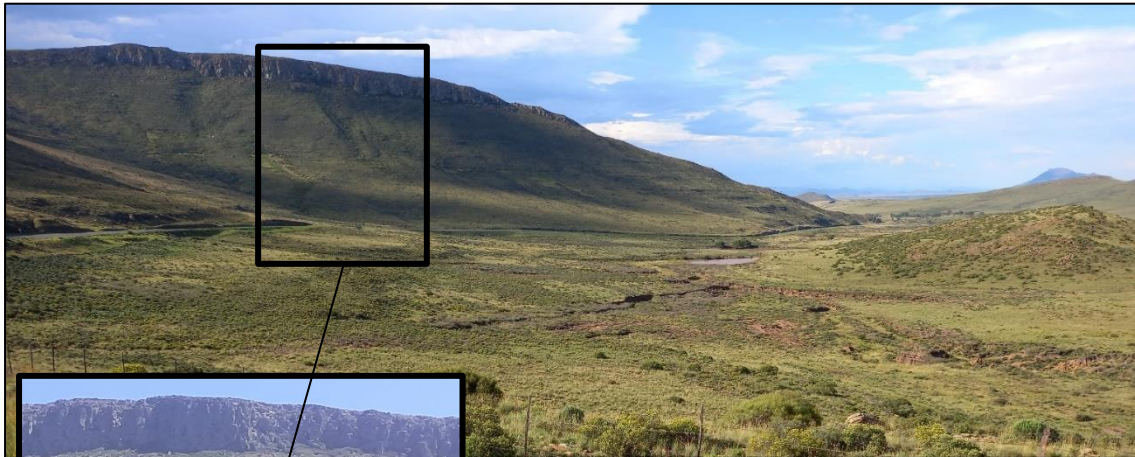
Figure 3-136 Eroded upper portions of the main valley bottom in the area and cluster of seep wetlands on the lower south-facing slopes of the adjacent mountain, with one of the seep wetlands shown in the insert.

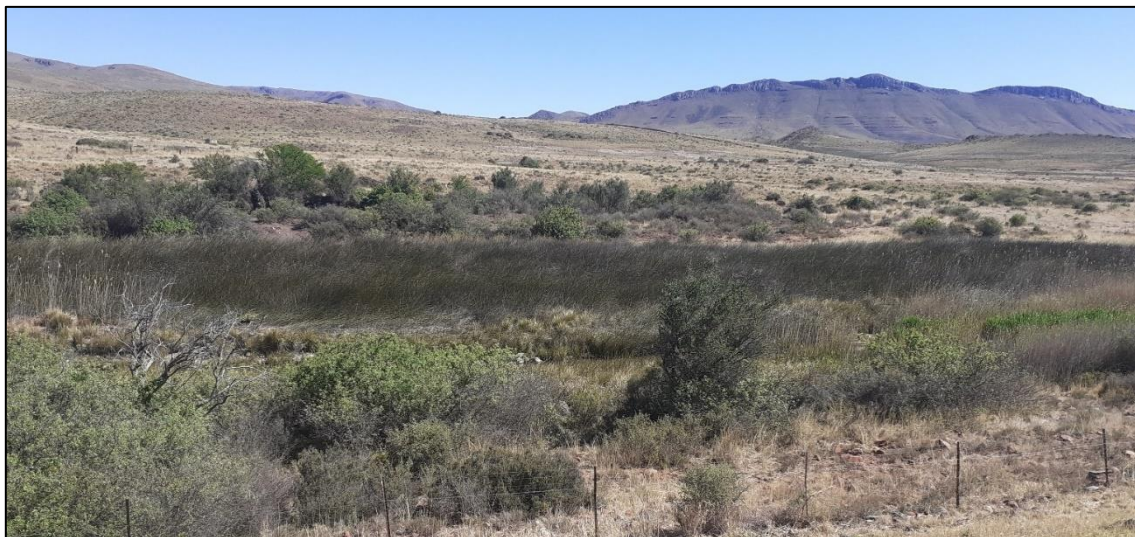
Figure 3-137 The lower portions of the valley bottom wetland, still largely intact and dominated by the sedge *Pseudoschoenus inanus* as well as with localized shrub-dominated and *Phragmites australis*-dominated areas.

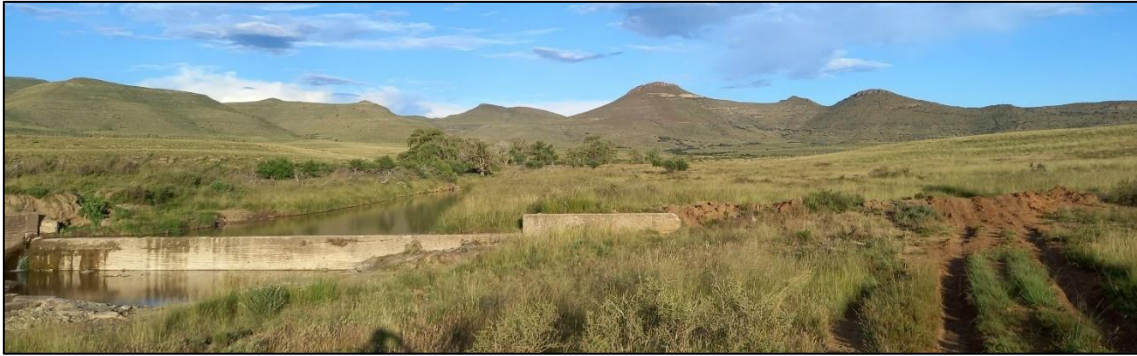
Figure 3-138 An erosion-control concrete weir in a small valley bottom in the Loodsberg foothills, likely constructed several decades ago through Department of Agriculture's soil conservation initiative.

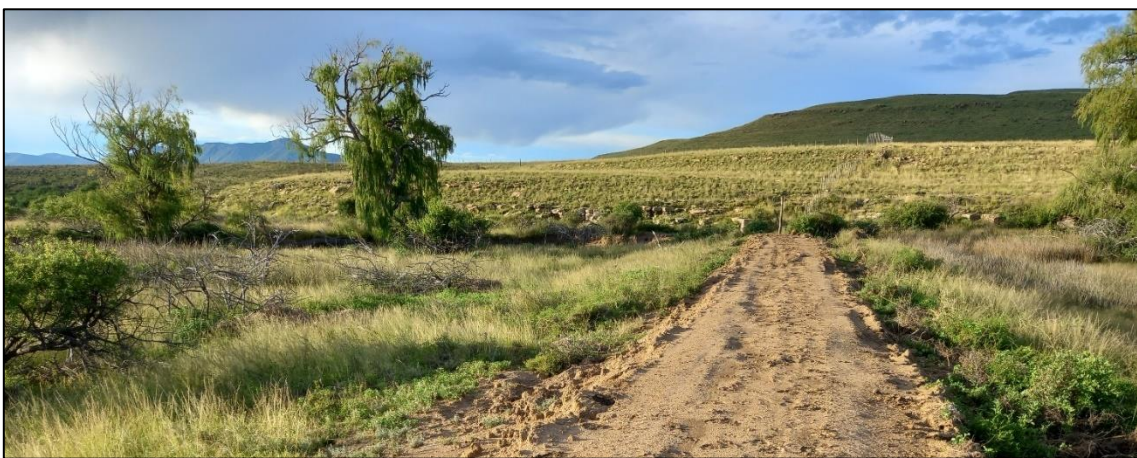
Figure 3-139 A soil berm associated with the weir shown above and which has been recently maintained. Also visible are *Salix babylonica* growing along the stream channel.

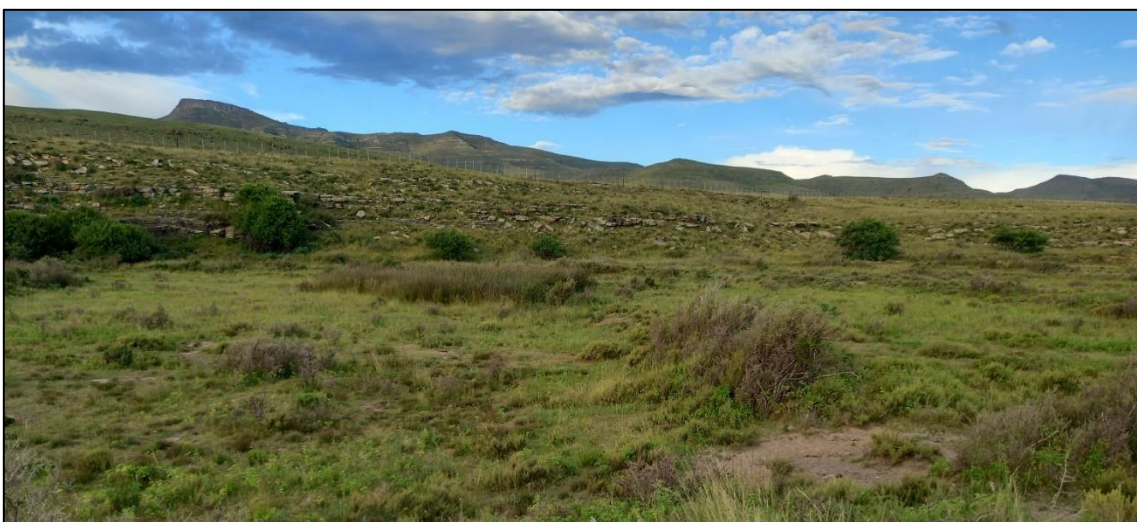
Figure 3-140 An historically-cultivated valley-bottom wetland in the Loodsberg foothills, characterized by pioneer grasses and shrubs and clumps of *Pseudoschoenus inanus* sedges.
