Department:  
Water Affairs  
**REPUBLIC OF SOUTH AFRICA**

## **Dam Safety Office**

# **2009-2010 Annual Report**

**ADMINISTRATION OF THE DAM SAFETY  
LEGISLATION IN TERMS OF  
CHAPTER 12 OF THE NATIONAL WATER ACT,  
1998 (ACT № 36 OF 1998)**

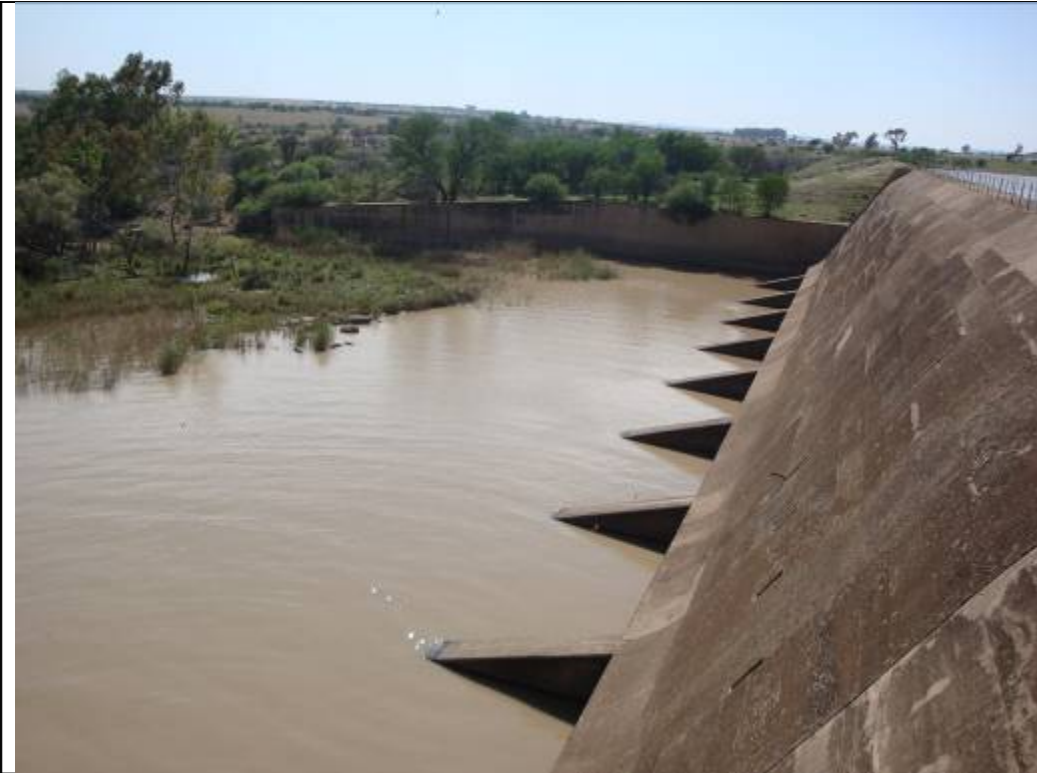
**Mockes Dam east of Bloemfontein**

View of siphon spillway structure from downstream side.

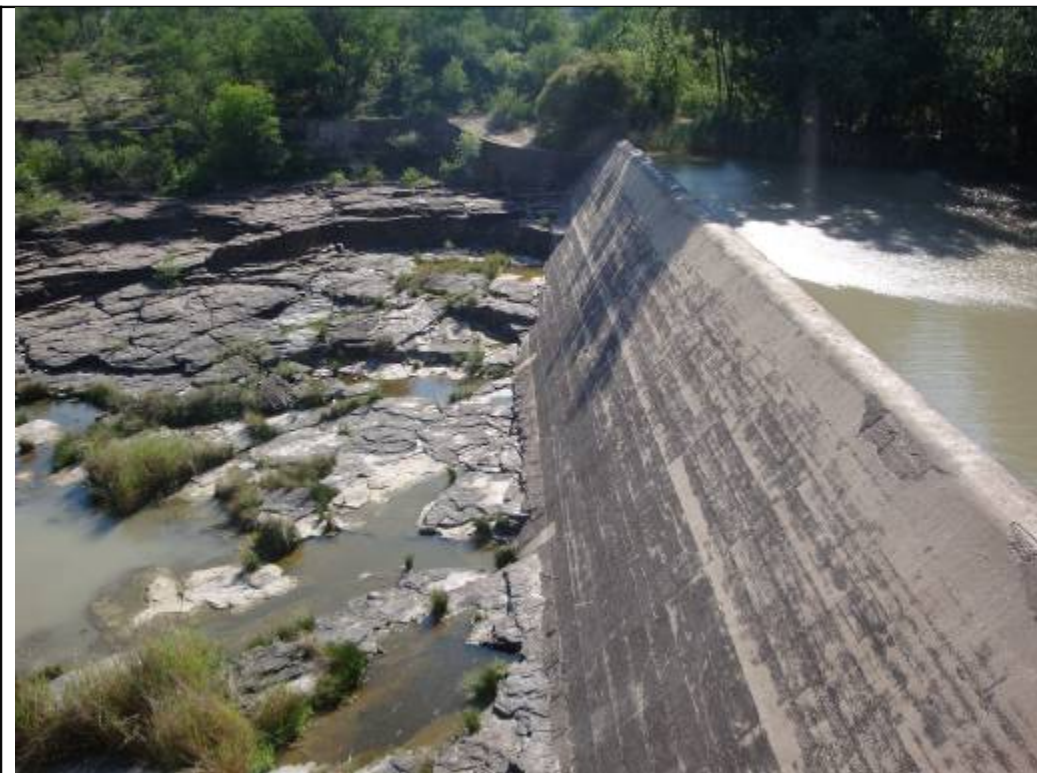
**Mazelspoort Dam east of Bloemfontein.**

View of spillway structure from downstream side.

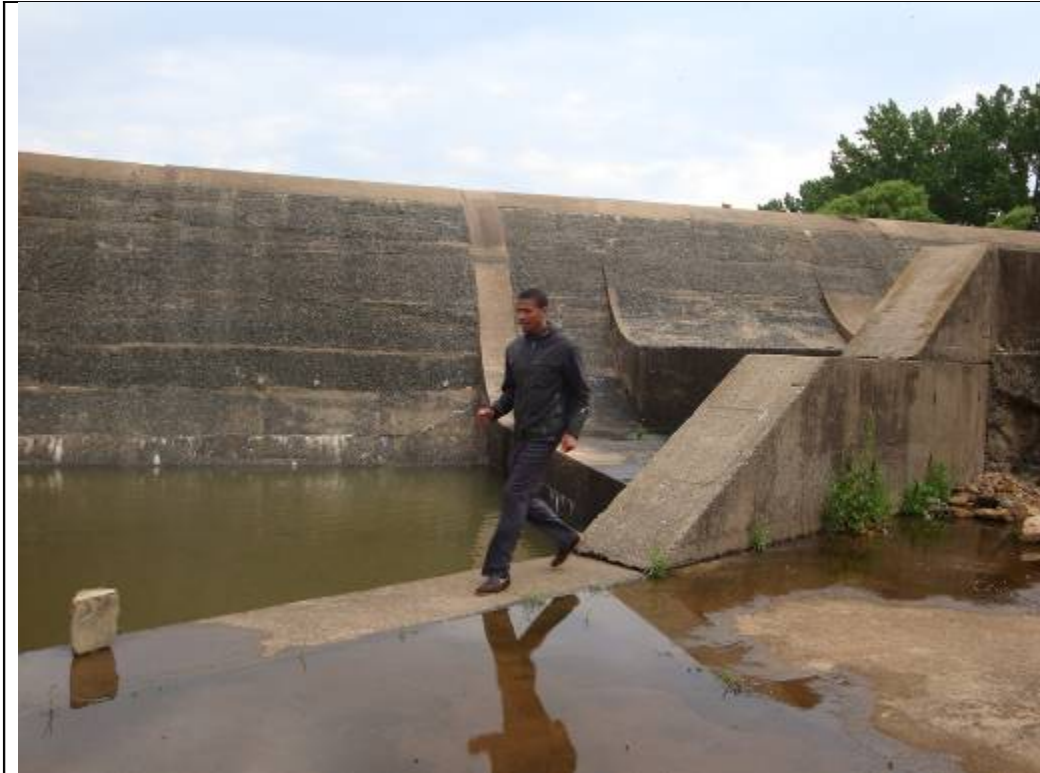
**Petrus van der Merwe Haarhof Dam near Balfour.**

Inspection by Dam Safety Office Staff of the downstream toe of the dam.

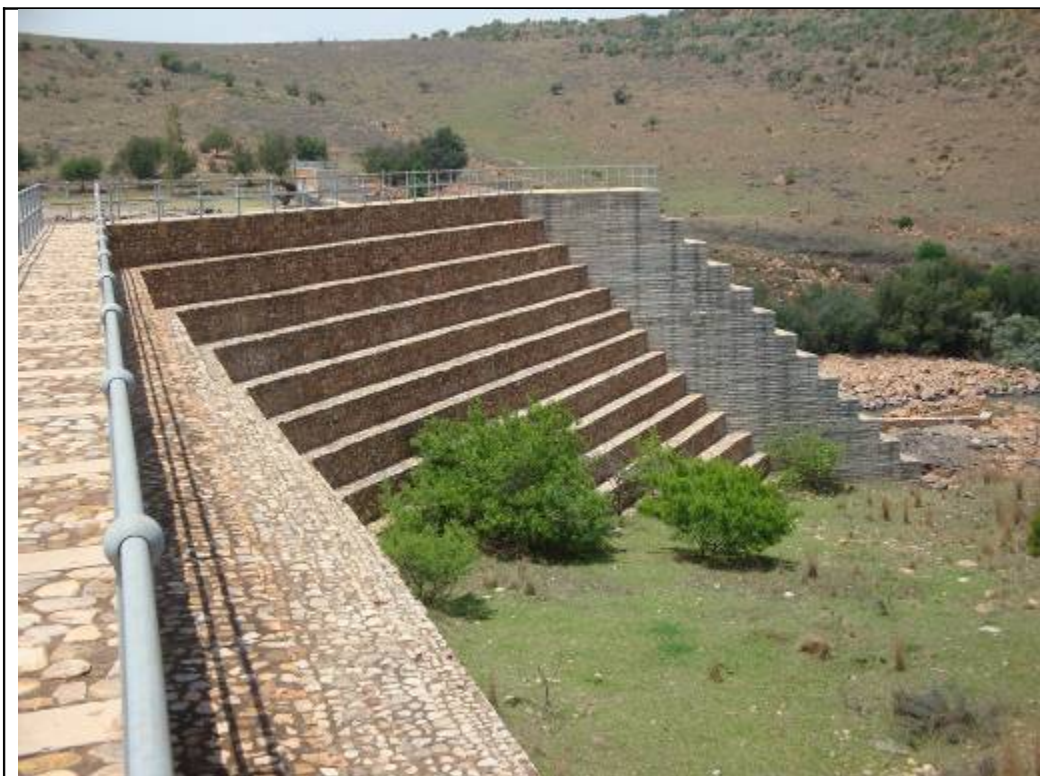
**Balfour/Siyathemb a Dam near Balfour.**

Downstream face of the Rubble Masonry Concrete Dam.

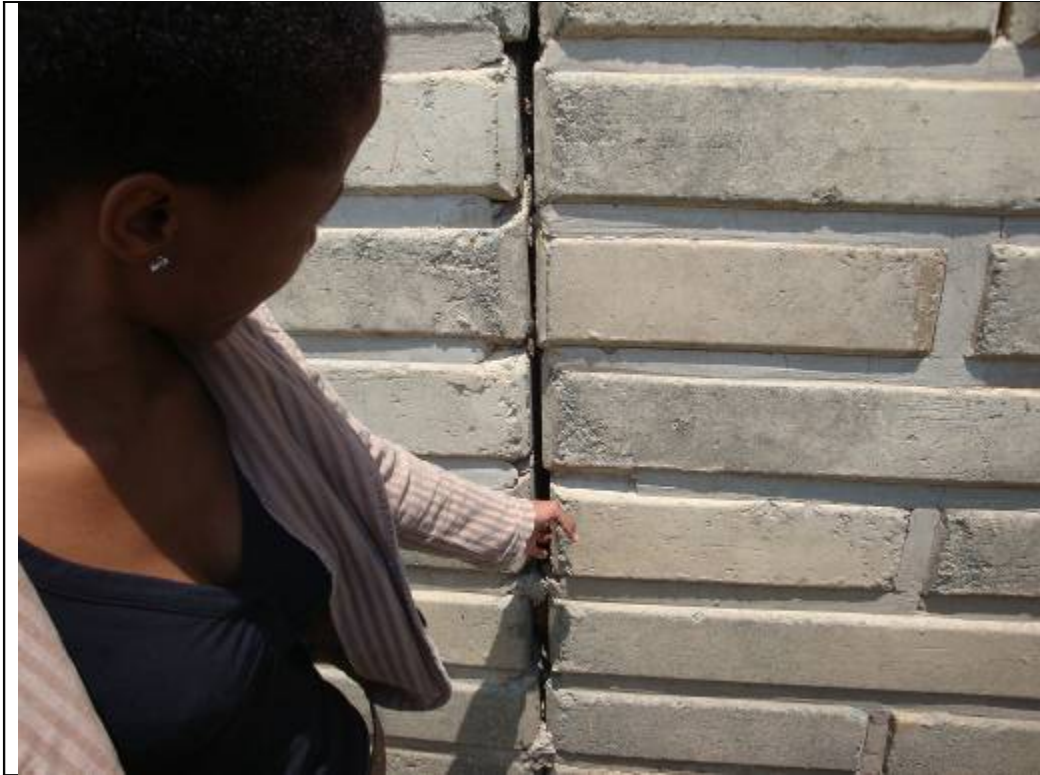
**Balfour/Siyathemb  
a Dam near  
Balfour.**

Inspection of  
contraction joins at  
upstream face of  
Rubble Masonry  
Concrete Dam by  
Dam Safety Office  
staff.

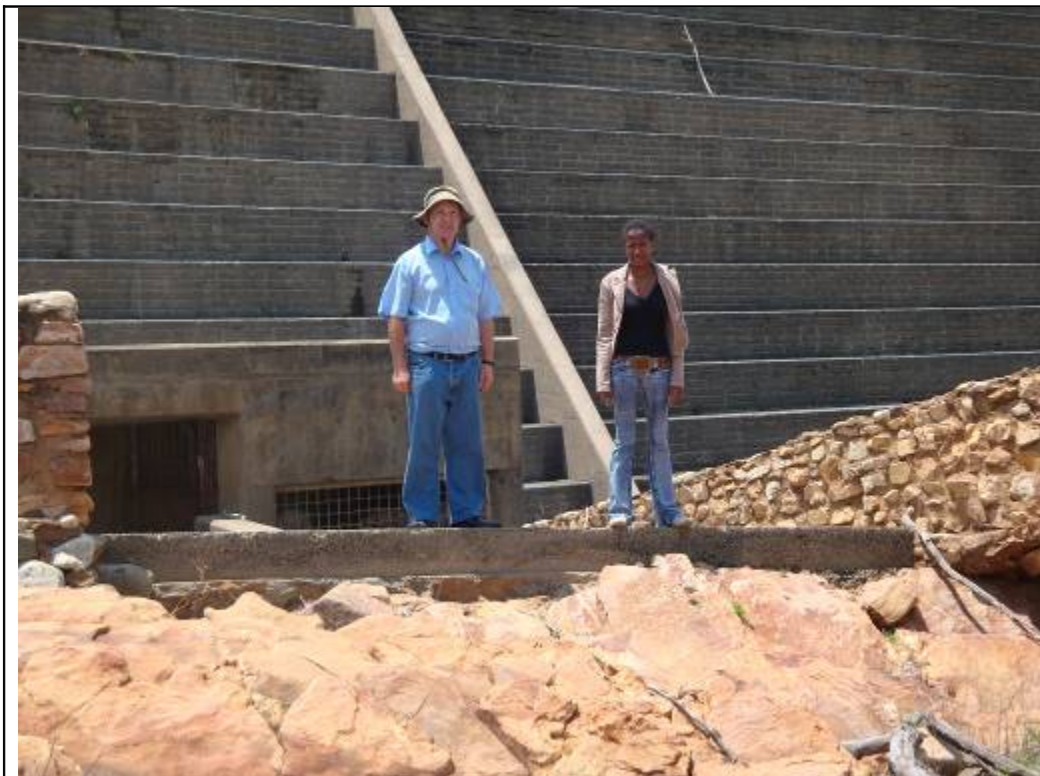
**Balfour/Siyathemb  
a Dam near  
Balfour.**

Inspection of  
downstream toe of  
Rubble Masonry  
Concrete Dam by  
Dam Safety Office  
staff.

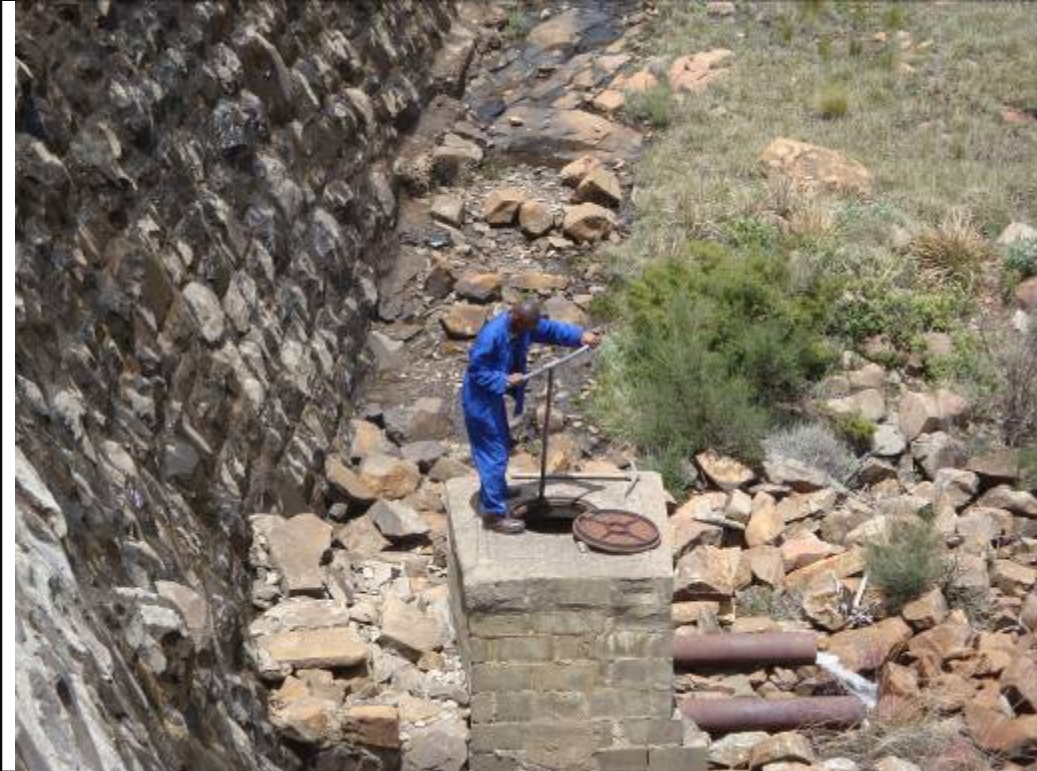
**Gibson Dam on top of the Platberg Mountain near Harrismith.**

Rubble Masonry  
Concrete Arch Dam  
constructed in 1906.

Municipal worker  
opening the outlet  
pipe to release  
water to the two  
municipal dams  
below the dam.

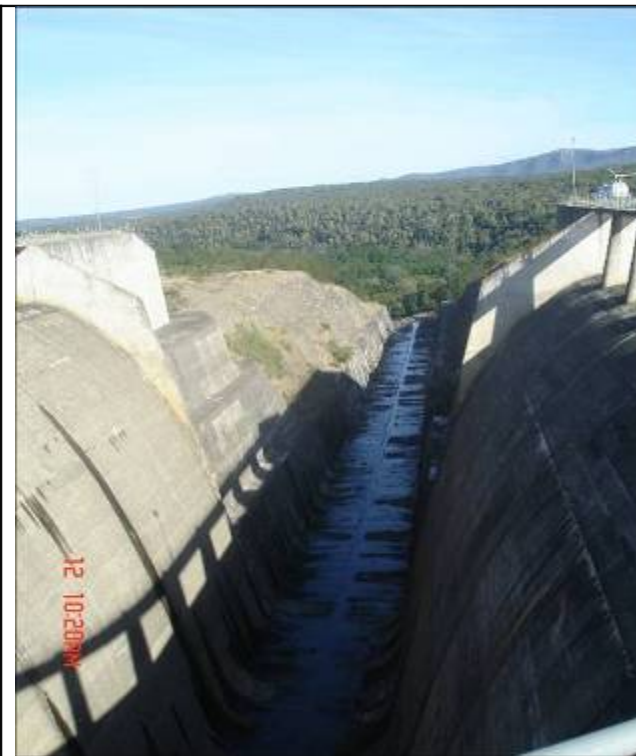
**Binfield Dam  
in the Eastern  
Cape.**

Dam safety  
Inspection  
in June 2009  
by Eastern  
Cape Regional  
Staff.

View of  
spillway  
channel  
showing  
drainage flow.

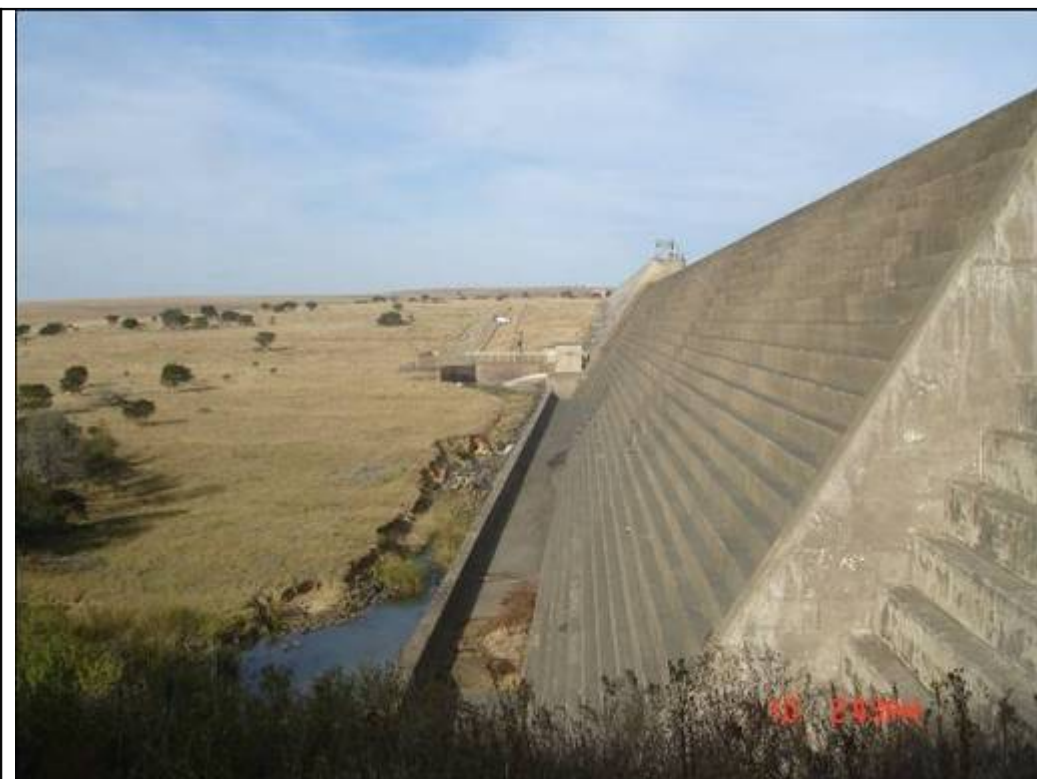
**Wriggleswade Dam in the Eastern Cape.**

Dam safety Inspection in June 2009 by Eastern Cape Regional Staff.

View of spillway taken from left flank

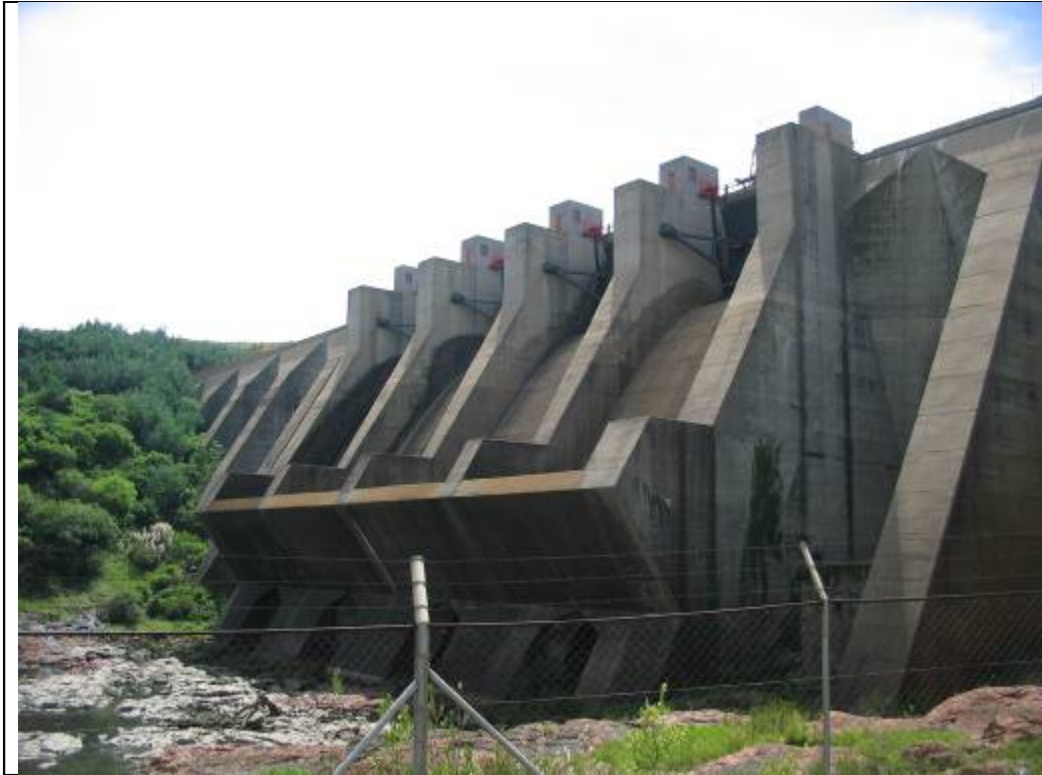
**Witbank Dam near Witbank.**

This concrete butress dam wall with heavily reinforced butress heads and provided with a radial gate spillway system was completed in 1972.

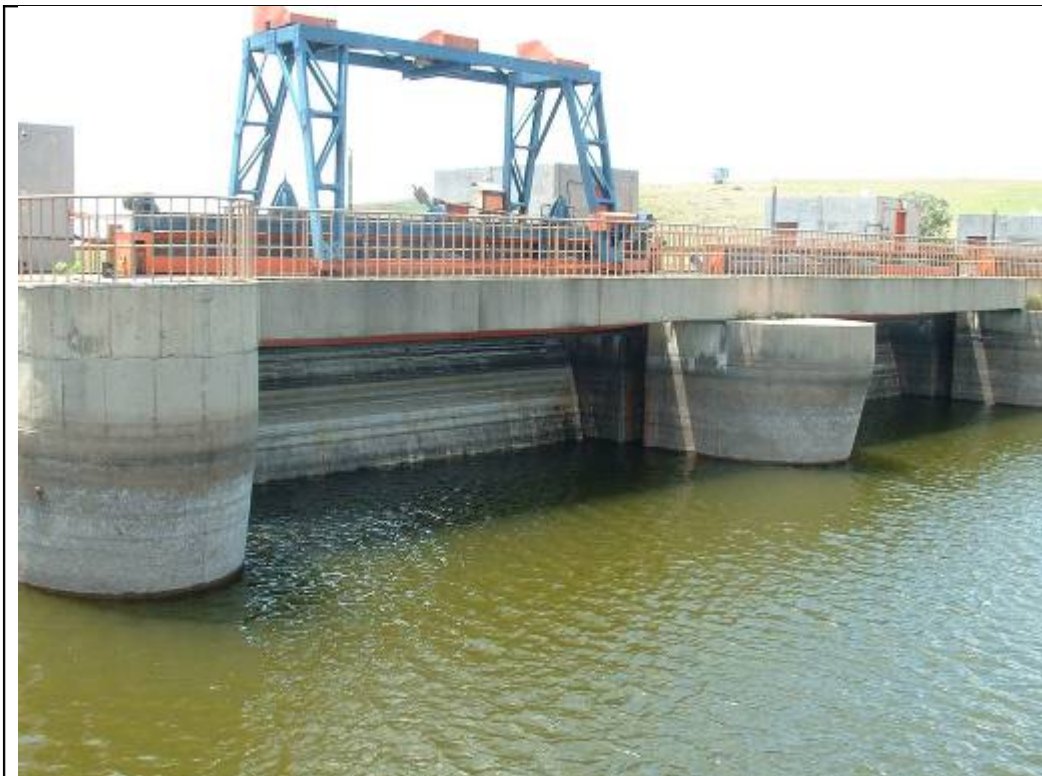
**Witbank Dam near Witbank.**

The water in the dam has a low pH level and a high sulphate level due to extensive opencast coal mining in the catchment of the dam.
