# **FINAL REPORT**

STUDY INTO THE CAUSES OF THE JAGERSFONTEIN FINE TAILINGS STORAGE

**DAM FAILURE ON 11 SEPTEMBER 2022**

Prepared by: University of Pretoria and University of the Witwatersrand

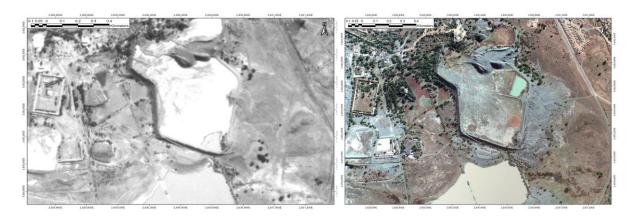
Returning to the 1973 configuration of the De Beers Dam, an access ramp leading to the southwestern corner of the dam, not visible in earlier images, can be seen (Figure A5). Also, there appears to be a poolwall in the north-western corner of the dam and water ponding in the south-eastern corner of the dam (Figure A5). Figure 4 compares two images of the Jagersfontein Dam, one captured in 1973, approximately two years after the 1971 mine closure, and another one captured in May 2010, shortly before the reprocessing of the legacy mine waste began. The similarities between the two images confirm that the tailings dam remained inactive between 1973 and 2010.

FIGURE 4 COMPARISON BETWEEN 1973 AERIAL PHOTOGRAPH (LEFT) AND THE GOOGLE EARTH IMAGE DATED 29
MAY 2010 (RIGHT) SHOWS VIRTUALLY NO CHANGES TO THE DE BEERS TAILINGS DAM OVER 37 YEARS.

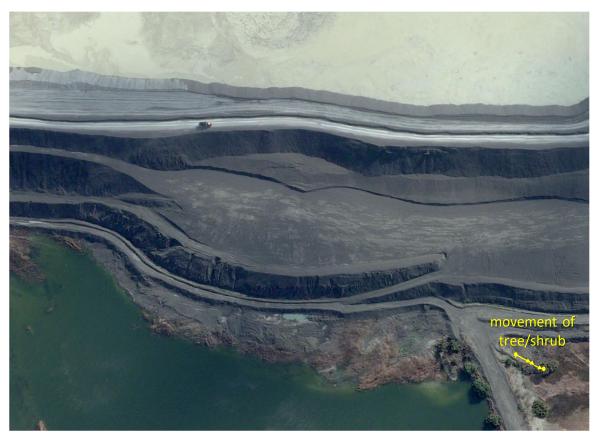
In addition to changes in the alignment of the southern access road, it is interesting to observe trees or shrubs in the south-eastern corner between the Dam 10 embankment and the tailings dam. Between 9 July 2020 and 28 July 2022 (Figures B15 to B22), a tree or large shrub, tracked in Figure 11, was displaced from the toe of the Dam 10 embankment by approximately 28 m towards the southeast. This occurred due to substantial ground movement. The fact that the tree remained green suggests that it was moved with at least some of its roots intact, suggesting deep-seated movement. Given this magnitude of movement, it is believed that the Dam 10 embankment must have required substantial maintenance to maintain its ability to hold water and structural integrity.

FIGURE 11 "THE WANDERING TREE": MOVEMENT OF A TREE OR LARGE SHRUB TRACKED NEAR THE NORTHERN END OF THE DAM 10 EMBANKMENT FROM SATELLITE IMAGES DATED 9 JULY 2020 TO 28 JULY 2022 (FIGURES B15 TO B22) (TOTAL EXTENT OF MOVEMENT WAS 28 M).

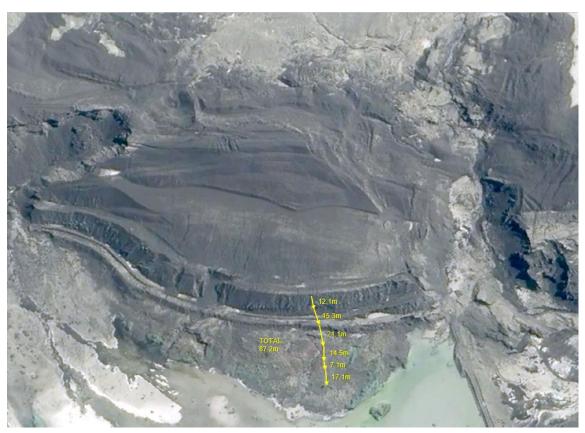
In addition, Figure 12 presents the displacement of a feature (probably a rock or shrub), originally located to the south of the access road along the toe of the tailings dam, tracked on satellite images from 22 March 2019 to 7 March 2023 (Figures B11 to B24). The displacement is plotted against time in Figure 13. The movement is in close agreement with the displacement of the access road.

FIGURE 12 IDENTIFIABLE FEATURE TRACKED USING SATELLITE IMAGES FROM 22 MARCH 2019 TO 7 MARCH 2023 (FIGURES B11 TO B24), SHOWING DISPLACEMENT AT THE TOE OF THE DAM WALL AMOUNTING TO 87 M.

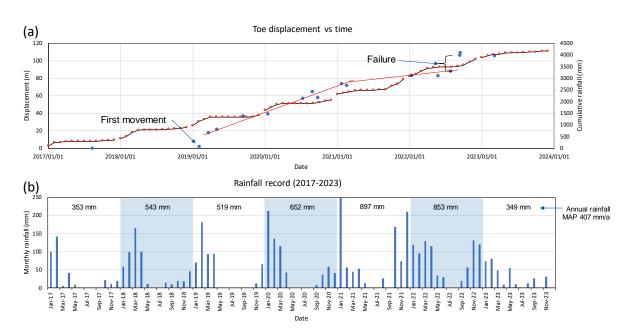
The displacement presented in Figure 10 is compared to the cumulative rainfall occurring from 2017 until the end of 2023 in Figure 14(a) and against the actual rainfall over this period in Figure 14(b). The Mean Annual Precipitation (MAP) of the Jagersfontein area of 407 mm is indicated, as well as the annual rainfall figures for each of the years presented. The years 2020 to 2022 were significantly wetter than the average, and resulted in Dam 10 at the toe of the tailings dam, holding water, starting from Feb 2019 until the time of the failure based on the available satellite imagery. The last rainfall event preceding the failure amounted to 30 mm occurring on 23 June 2022.

FIGURE 14 (A) COMPARING TOE DISPLACEMENT AND CUMULATIVE RAINFALL AND (B) ACTUAL RAINFALL (SOURCE FOR RAINFALL DATA: JAGERSFONTEIN DEVELOPMENTS).

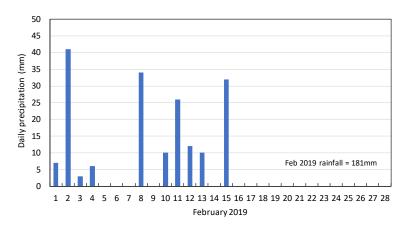
Figure 15 presents the rainfall record for February 2019, the month in which the first signs of instability were observed. PlanetScope images show Dam 10 to be empty at the beginning of February 2019. Dam 10 then received water from the rainfall in the first half of February 2019 and was never empty again until failure of the tailings dam. Water in Dam 10 would have contributed to an elevated water table at the toe of the tailings dam which would have reduced pore water suction and which is not beneficial to slope stability. A correlation between the observed movement at the toe of the dam wall and rainfall is not obvious.

FIGURE 15 JAGERSFONTEIN RAINFALL RECORD FOR FEBRUARY 2019 (SOURCE: JAGERSFONTEIN DEVELOPMENTS).

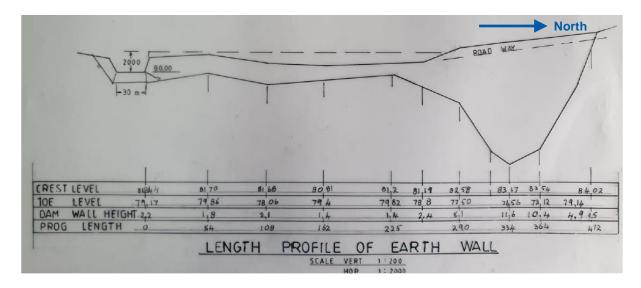
A safety inspection of Dam 10 was carried out in December 2021 (Jacobsz, 2021), nine months before the failure of the tailings dam. The dam safety inspection report includes a long-section survey of the Dam 10 embankment and showed the crest elevation of the Dam 10 wall to rise gradually, by approximately 3 m, from the mean crest level over a distance of approximately 150 m towards the tailings dam (see Figure 16). This is unusual because dam wall crests are normally constructed level. One possible explanation for this could be the construction of an access ramp by JD, linking up with the access roads along the southern wall of the tailings dam. However, given the large amount of displacement of the southern wall of the tailings dam towards the south, it seems plausible that the Dam 10 embankment acted like a prop, providing a buttressing action against the southward moving tailings dam wall. The upward heaving along the northern part of the Dam 10 embankment might have been as resulted of the large southward displacement of the toe of the tailings dam. As movement occurred both to the west and east of the Dam 10 embankment, forcing the Dam 10 embankment to thrust against the moving wall, it is perhaps not a coincidence that the main breach developed immediately adjacent to the Dam 10 embankment.

The presence of Dam 10 immediately to the south of the tailings dam provided a source of water which would have kept at least some of the material, which had been subjected to near-continuous displacement for three-and-a-half years leading up to the failure, saturated. The presence of water means that pore water suction could not develop and saturated conditions means that undrained conditions were possible at the tailings dam toe.

FIGURE 16 LONG-SECTION ALONG THE DAM 10 EMBANKMENT (LOOKING WEST) SHOWING THE CREST RISING TOWARDS THE TAILINGS DAM — DEC 2021 DAM SAFETY INSPECTION CREST SURVEY (JACOBSZ, 2021).

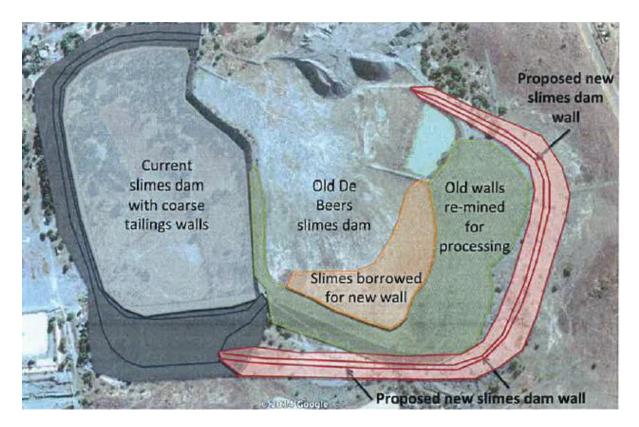
The layout of the extended tailings dam is presented in Figure 17, showing the proposed new wall for Compartment 2 in red. This corresponds relatively closely to what was eventually constructed. The design allowed for the removal (for reprocessing) of the coarse walls of the of the De Beers Dam and coarse dumps (presumably the North- and South Dumps identify in Figure A1) which would provide additional capacity. The plan was to develop the extended tailings dam on land already impacted by previous deposition which would serve to minimise the impact on ground water and further surface contamination. The report recognised that the very fine Kimberlite clay had insufficient strength to allow a self-supporting tailings dam and therefore advocated the construction of impoundment walls using the coarse grits to contain the slimes, similar to Compartment 1 which existed at the time. The design advocated for the use of dry fine tailings from the De Beers Dam (shown in orange in Figure 17) in combination with grits, the latter to provide strength for the construction of the new walls. It is presumed that the use of fine tailings was considered to make up the shortfall in terms of the availability of grits.

FIGURE 17 PLAN FOR THE EXTENSION OF THE JD TAILINGS DAM, SHOWING THE PROPOSED NEW WALL IN RED (ROBINSON, 2015).

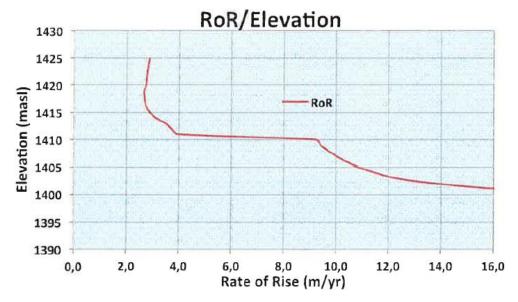
The anticipated rate of rise of the tailings dam at the design stage is presented in Figure 18 versus slimes elevation. A very high initial rate was anticipated until ground had been broken and the De Beers Dam covered, but then the predicted rate of rise stabilised at about 3 m per year (based on the

figure). However, 4 m per year was mentioned in the report as the designed rate of rise. It was stated that at 4 m per year, upstream walls can be raised around the perimeter by dumping along the inside crest and dozing material into the basin. Heavier grits were expected to "displace fines, compressing and pushing them into the basin". The slimes were expected to gain strength through compression until they could support the overlying grits. A 15 to 20 m wide crest was recommended.

FIGURE 18 ANTICIPATED RATE OF RISE FROM DESIGN REPORT (ROBINSON, 2015)

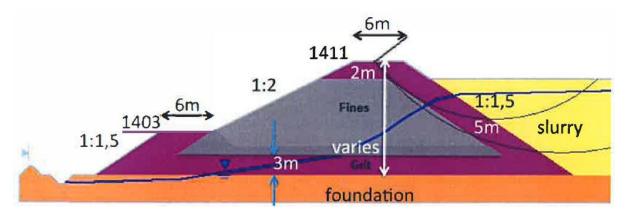
A downstream slope of 1:2 (27°) was recommended, which Robinson considered insufficient and it was therefore recommended to add a "buttress (of grits) along the toe of the slope below 1403 masl, creating a bench that effectively flattens the overall slope angle, enhancing stability." The proposed starter wall cross-section design is presented in Figure 19. Seepage was expected to flow form the slurry into the upstream grits zone and along the blanket drain, idealised by a "conservative" phreatic surface as shown. An idealised cross-section profile for the raising of the tailings dam is presented in Figure 20.

FIGURE 19 PROPOSED CROSS-SECTION OF STARTER WALL (ROBINSON, 2015).

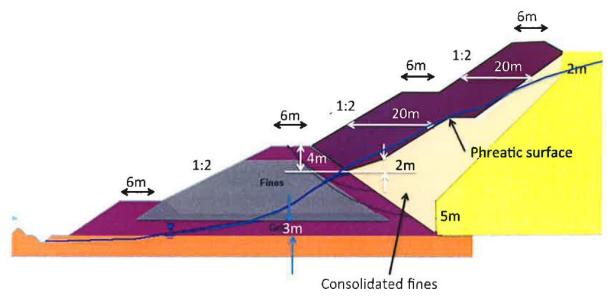
FIGURE 20 PROPOSED CROSS-SECTION FOR RAISING OF THE WALL (ROBINSON, 2015).

The assumed February 2019 profile along the alignment shown in Figure 8, was presented in Figure 33. The downstream slope was at the angle of repose of the coarse tailings, i.e. approximately 33°, significantly steeper than the 1:2 (27°) slope angle recommended by Robinson (2015) (Figure 20). The base of the embankment is believed to be underlain by fine tailings from Dump 10. The piezocone investigation did identify layers of clay-like material that may correspond to material from Dump 10 (Appendix F). An idealised cross-section profile used for the stability analysis of the downstream slope, as estimated from survey data and the CPTu soundings, is shown in Figure 47.

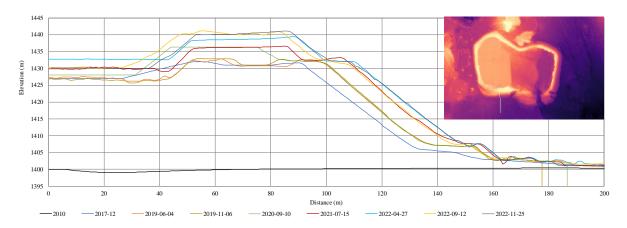
The integrity of the survey data was verified by plotting cross-section profiles at a second section towards the west of the failure zone where it is apparent from the satellite imagery that significant movement had not occurred. The cross-section profiles are presented in Figure 22. It can be seen that some of the profiles do not line up well at the toe of the dam. Significantly, the

12 September 2022 survey (yellow profile), taken the day after the failure, also does not line up well at the toe. Adjustment of the surveys dated 4 June 2019, 6 November 2019, 10 September 2020 and 12 September 2022 by 4 m towards the south resulted in profiles matching well. The profiles after adjustment are shown in Figure 23, showing improved alignment. The 4 m correction to the south was applied at the cross-sections taken where the dam failed for data from the abovementioned dates, the result of which is presented in Figure 24. No adjustment was made to the elevation data.

FIGURE 22 CROSS-SECTION PROFILES AT CONTROL SECTION BEFORE ADJUSTMENT.

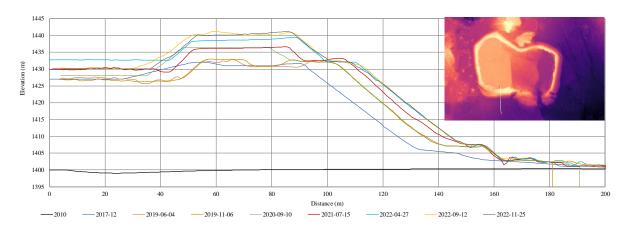
FIGURE 23 CROSS-SECTION PROFILES AT CONTROL SECTION AFTER ADJUSTMENT.

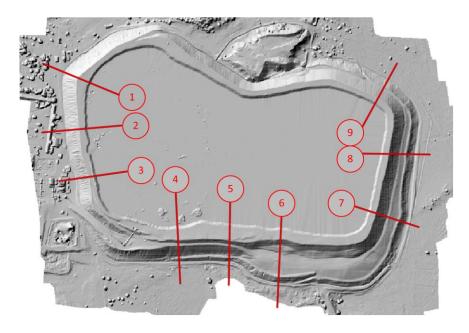
The side slope geometry of the outer walls of the tailings dam was investigated based on the 27 April 2022 survey to assess slope angles and hence the angle of repose of the material comprising the walls. Cross-section profiles were studied at the locations shows in Figure 25. The average slope angle measured was approximately 34°, but the side slopes were as steep as nearly 40° at location 3, opposite the plant, and 36° on the eastern slopes at location 8. An effective friction angle of 33° was assumed to be a cautious estimate of the shear strength of the coarse tailings based on the measured angles of repose. This value was used for slope stability assessments presented in Section 7.2, informed by limited triaxial testing of the coarse tailings (see Appendix E).

FIGURE 25 LOCATIONS WHERE CROSS-SECTION PROFILES WERE STUDIED (27 APRIL 2022 SURVEY).

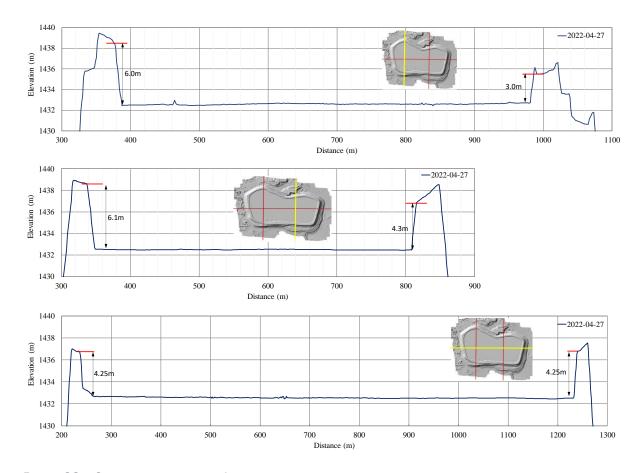
Figure 26 presents two north-south and one east-west cross-section through the tailings dam at the locations shown to illustrate the pond and freeboard at the time of the 27 April 2022 survey. The relevant cross-section is indicated by the yellow line in the plan view in each figure. The mean pond elevation was at 1432.5 m. The pond was essentially level across both compartments based on the survey. The dividing wall between the two compartments had by now been submerged by the pool. The freeboard varied from 3 m in the southwestern part of the dam to more than 6 m along the northern wall.

FIGURE 26 SECTIONS THROUGH THE JAGERSFONTEIN TAILING DAM SHOWING THE POND AND FREEBOARD BASED ON THE 27 APRIL 2022 SURVEY. NOTE: THE INSET SHOW IN YELLOW THE CROSS-SECTIONS BEING PRESENTED.

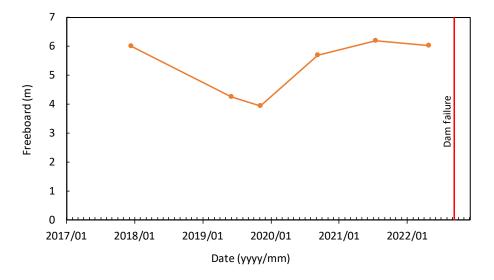
The survey pre-dates the failure by approximately 4.5 months. The freeboard was subsequently also estimated from the 28 July 2022 satellite image by scaling the slope length from the ortho rectified image and multiplying by multiplying by the tangent of the upstream slope of the wall which was estimated to be 33°. This calculation yielded a free board of approximately 7 m. The variation in freeboard at the failure zone determined from survey data is presented in Figure 27.

FIGURE 27 FREEBOARD OVER TIME FROM SURVEY DATA TAKEN AT THE EMBANKMENT CROSS-SECTION WHERE THE FAILURE OCCURRED.

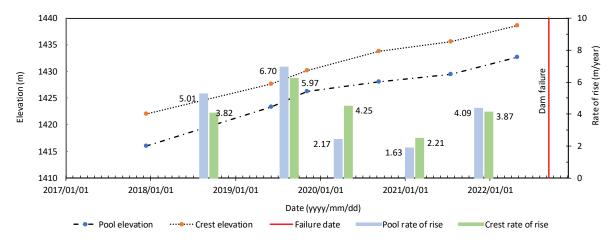
The annualised rates of rise in the crest and pond levels, measured on the critical cross-section (Figure 8), determined from the available survey data, were found to amount to an average of 3.8 m per year for both the pond and embankment crest since 2018. Figure 28 presents the embankment crest and pool elevations plotted against time, as well as the annualised crest and pool rates of rise recorded between surveys. Rates of rise on a number of occasions exceeded the rate of rise of 4 m per year quoted in the design report (Robinson, 2015) (see Section 5).

FIGURE 28 RATE OF RISE DETERMINED FROM SURVEY DATA.

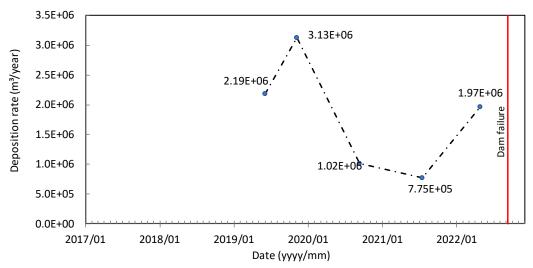
The deposition record on the tailings dam, measured in cubic metres per year as measured from the survey data is, presented in Figure 29. The deposition volume was calculated by measuring the surface area of the pond and multiplying the average area between surveys by the difference in pool elevation and annualising the result.

FIGURE 29 ANNUALISED DEPOSITION RECORD IN CUBIC METRES PER YEAR CALCULATED FROM SURVEY DATA.

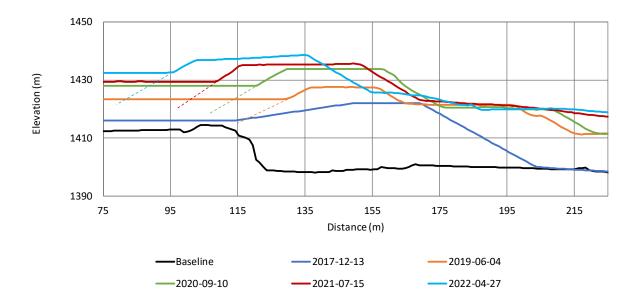
The satellite images in Appendix B show that the surface of the compartments on the dam was generally kept submerged under tailings, maintaining tailings ponding right up against the outer walls. There was no beach present, except near the southwestern corner of the dam (Compartment 1) where some vegetation growth is evident. Figure 30 shows the development of the dam wall crest over time determined from survey data. As the dam was raised in the upstream direction, each successive lift rested partially on tailings that had been hydraulically deposited. Given that the water pond often rested right against the containment wall, it is likely that this resulted on lifts being built on unconsolidated tailings. It is not clear whether this led to instability problems along the inside slope of the raised wall prior to the failure. Stability problems along the inside slope is an aspect that the investigation panel would have wished to discuss with JD employees, had communication been allowed.

FIGURE 30 CROSS-SECTIONS ON THE SOUTHERN WALL FROM SURVEYS ILLUSTRATING THE RAISING OF THE OUTER DAM WALL OVER TIME.

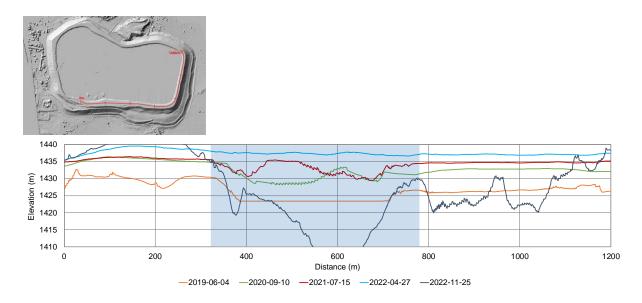
Figure 32 presents long-section profiles extracted from survey data available for the period 2019 to 2022 along the section of crest indicated. The area affected by the breach is shaded in blue in the figure. The 2020 and 2021 profiles are generally smooth except along the portion that would eventually fail. This could be a manifestation of the pre-failure instability issues encountered along this length of wall which could have prompted the large amount of construction activity seen along this stretch of the embankment in the high-resolution satellite images.

FIGURE 32 LONG-SECTION SURVEY DATA ALONG THE SOUTHERN AND EASTERN WALLS OF THE TAILINGS DAM FROM 2019 TO 2022. (SHADED AREA = AREA IMPACTED BY BREACH.)

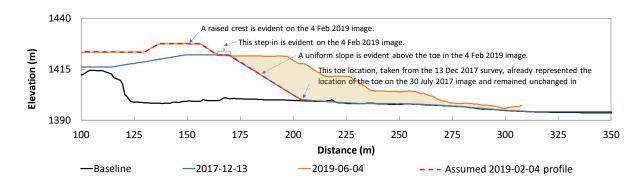
It is significant to note that the entire downstream buttress representing the difference between the 13 December 2017 and 4 June 2019 surveys, shaded light brown in Figure 33, was built from February to early June 2019. The intense activity in the area can be seen in the satellite images and was presumably an effort to stabilise the slope. However, as shown by subsequent surveys and satellite images, these efforts were not successful to arrest movement.

FIGURE 33 CROSS-SECTION PROFILES CLOSEST IN TIME TO FEB 2019.

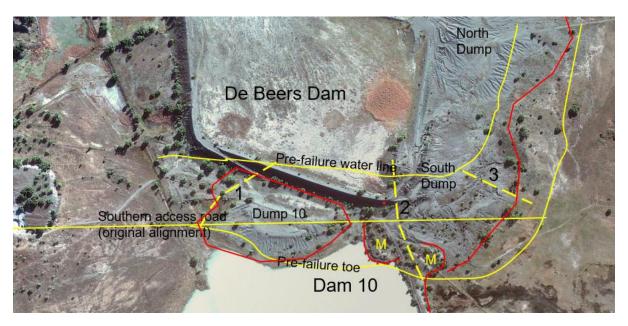
The approximate extent of Dump 10 and tailings from the North and South dumps are indicated on the 29 May 2010 satellite image in Figure 38 using red curves. A colour-enhanced satellite image from 12 November 2010 by Photosat (Nell, 2024), shows the extent of the dump material more clearly (see Figure 39) and assisted with the delineation of its extent. (Considering how the material appears to fan out from a central discharge point resembles material deposited from a pipe, but this is speculation.) The upstream pre-failure water line and the pre-failure toe, as determined from the 28 July 2022 satellite image (Figure B22), are indicated by yellow curves in Figure 38. The 2014 alignment of the access road along the southern toe of the dam is also indicated in yellow. Two "heaps" of presumably tailings and identified as "raised features" in selected images in Appendix B, located to the east and west of the northern end of the Dam 10 embankment, are labelled M. These heaps are also identifiable in the 1944 aerial photograph (see Figure A1). Figure 38 also shows the locations of failure Scars 1, 2 and 3. There is a strong correlation between the extent of the parts of the embankment that failed (the part between Scars 1 and 3), the extent of Dump 10 and tailings presumably left behind after reprocessing the South Dump and the heaps or raised features labelled M.

FIGURE 38 THE PRE-FAILURE EMBANKMENT GEOMETRY AND FAILURE SCARS SHOWN IN YELLOW, OVERLYING TAILINGS DEPOSITS FROM DUMP 10, THE SOUTH DUMP AND THE NORTH DUMP (DUMP TOE SHOWN IN RED). COMPILED FROM THE PRESENT IMAGE (29 May 2010) AND EARLY AERIAL IMAGES.

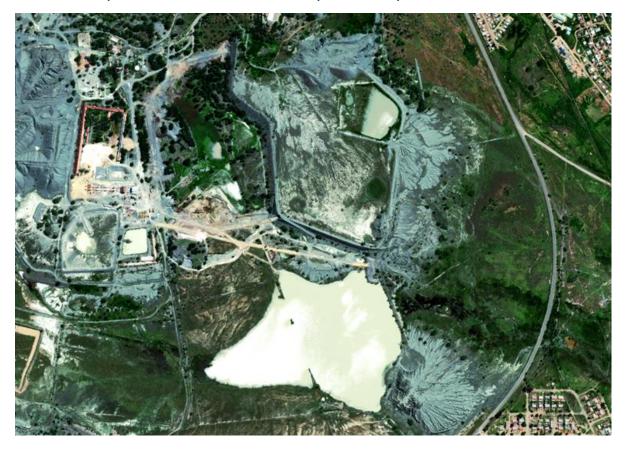
FIGURE 39 EXTRACT FROM 22 NOVEMBER 2010 SATELLITE IMAGE COLOUR ENHANCED BY PHOTOSAT (NELL, 2024).

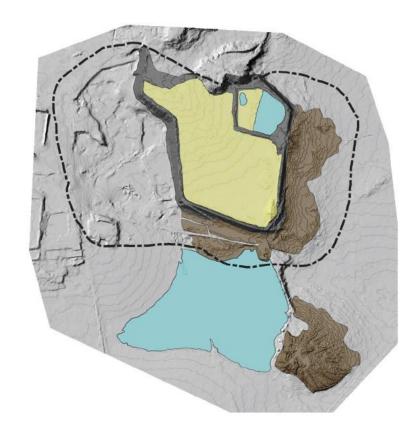
FIGURE 40 CONTOUR DRAWING BASED ON 26 FEBRUARY 2011 SATELLITE IMAGERY IDENTIFYING VARIOUS MATERIALS IDENTIFIED (SOURCE: RIVET, 2023 (PHOTOSAT)). THE OUTLINE OF THE "UNKNOWN MATERIAL" CORRESPONDS CLOSELY WITH THE TOES OF THE TAILINGS DUMPS OUTLINED IN RED IN FIGURE 38.

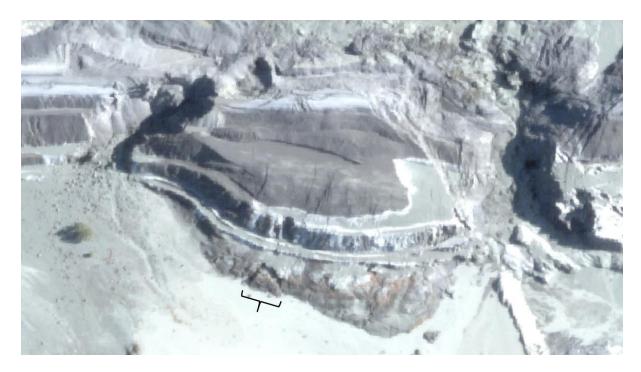
Figure 43 presents a portion of the 12 September 2022 satellite image captured shortly after the failure indicating a block of material separating from the toe of the embankment. This is a further suggestion of sliding on an underlying interface.

FIGURE 43 EVIDENCE OF SLIDING ON THE BASE SUGGESTED BY BLOCK SEPARATING FROM EMBANKMENT TOE (CURLY BRACKET).

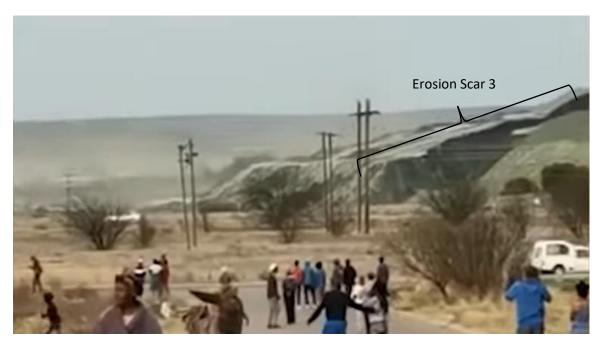
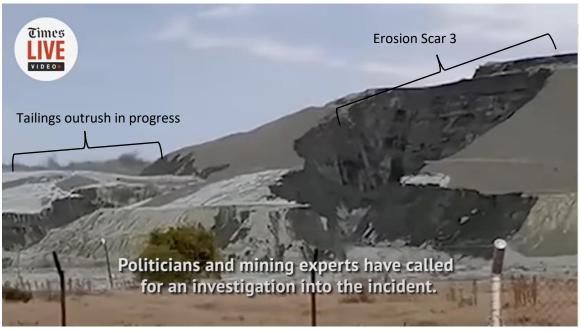
In light of the foregoing observations, Scars 1 and 3 in Figure 34 are believed to be the result of piping (internal seepage) along the shear interfaces which formed where blocks A and B displaced relative to the adjacent stationary parts of the embankment. The dispersive nature of the tailings would have contributed to the material's tendency to pipe (see Appendix E). The locations of the cracks visible in the 24 September 2020 satellite image (Figure B17), superimposed on the post-failure image dated 12 September 2022 (Figure B23), are presented in Figure 45. The locations of the Scars 1 and 3 correspond closely with these cracks, with the western crack occurring along the southern edge of Scar 1 and the eastern crack passing through Scar 3.

The Investigation Panel believe that shearing along the location of scars 1 and 3 created preferential seepage paths. Seepage resulting in piping and erosion likely formed these scars. Tests on a coarse

FIGURE 44 SCAR 3 ALREADY DEVELOPED AS THE OUTRUSH OF FINE TAILINGS FROM THE DAM WAS OCCURRING THROUGH THE MAIN BREACH. (SOURCE: <a href="https://www.youtube.com/watch?v="https://www.youtube.com/watc

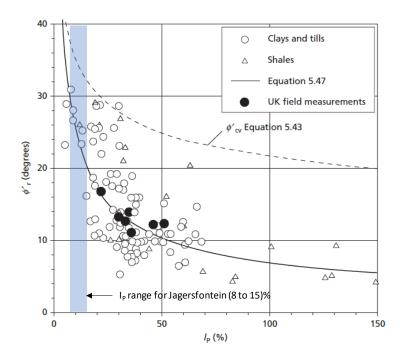
Substantial evidence suggests that Blocks A and B (Figure 34) slid on an underlying weak layer or interface. The interface between the coarse tailings forming the dam embankment with the fine tailings from Dump 10 and tailings left behind after reclaiming the South Dump appears a likely candidate. The satellite image record indicates that, in the case of Block A, a southward movement approaching 90 m had taken place since February 2019 up to the time of the failure. The magnitude of movement would have been more than adequate for the mobilisation of low residual frictional strengths along the shearing interface. It was reported in Section 6.7 that it appears that the slippage was occurring along the baseline surface indicated in Figure 31 along a slope of approximately 2.7° (1:21.4). Figure 46 presents residual friction angle values for clays, tills and shales, plotted against plasticity index (I<sub>P</sub>) (Knappett & Craig, 2012). The range of I<sub>P</sub> values measured during the investigation at Jagersfontein was narrow, falling between 8% and 15%, for which Figure 46 indicates residual friction angle values between about 16° and 31°.

The drained factor of safety (FoS) against slip parallel to a uniform infinite dry slope can be expressed as  $FoS = \frac{tan\phi'}{tan\beta}$ , where  $\phi'$  is the effective friction angle and  $\beta$  the slope angle. Even when considering a very low residual friction angle value of 10° and the 2.7° slope angle mentioned above, the calculation yields a factor of safety of 3.7, indicating stability. In the presence of a water table with flow occurring parallel to an infinite slope, the expression for the drained factor of safety reduces to  $FoS = \frac{\gamma'}{\gamma} \frac{tan\phi'}{tan\beta}$ , with  $\gamma'$  the buoyant unit weight and  $\gamma$  the saturated unit weight. Taking the ratio  $\frac{\gamma'}{\gamma}$  to be approximately 0.5, a drained factor of safety of 1.9 is calculated for saturated conditions and the parameters above. This still indicates stability despite being a very conservative idealisation of the Jagersfontein situation. Drained instability therefore does not appear to explain the movement over time along the flat 2.7° slope. It is therefore believed that slippage has been occurring under

FIGURE 46 RESIDUAL FRICTION ANGLE VALUES FOR CLAYS, TILLS AND SHALES AGAINST PLASTICITY INDEX (I<sub>P</sub>), WITH THE I<sub>P</sub> RANGE FOR JAGERSFONTEIN INDICATED (KNAPPETT & CRAIG, 2012).

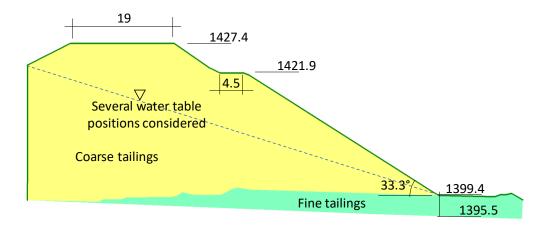
FIGURE 47 CROSS-SECTION PROFILE FOR SLOPE STABILITY ANALYSIS OF FEBRUARY 2019 DOWNSTREAM SLOPE.

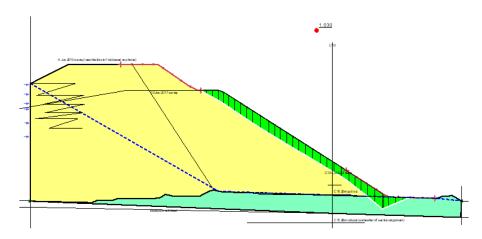
The slope stability analysis was carried out using the Morgenstern-Price limit equilibrium method. The most critical slip surface for this analysis is relatively shallow and is shown in Figure 48. The associated factor of safety was 1.03, indicating marginal stability. Figure 49 presents the situation with a water table extending from the edge of the pool in the tailings dam to the toe of the dam, giving a factor of safety of only 0.92, indicating instability. Figure 50 presents the factor of safety of 0.96 for a failure surface extending to the dam crest which is believe to be representative of the situation illustrated in the March 2019 satellite photo where signs of severe instability, reaching the dam crest, were evident (Figure B11). Although the position of the water table is not known, the water table in Figure 50 is considered realistic. (A steady-state seepage analysis assuming an upstream water level at the pool edge predicts a substantially higher water table and hence a considerably lower drained factor of safety.) The low factors of safety and the large associated failure surface are consistent with the instability experienced in 2019 and indicates an unstable slope when analysed based on drained conditions.

FIGURE 48 Drained SLOPE STABILITY ANALYSIS 1 (FOS = 1.03).

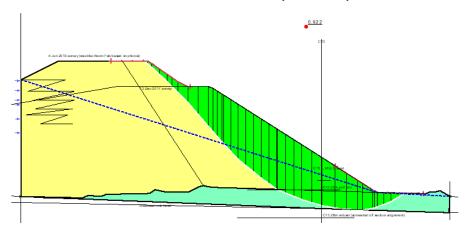
FIGURE 49 Drained SLOPE STABILITY ANALYSIS 2 (FoS = 0.92).

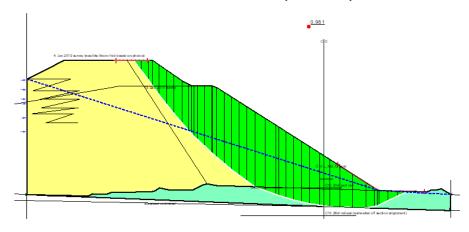
FIGURE 50 DRAINED SLOPE STABILITY ANALYSIS 3 (FOS = 0.96).

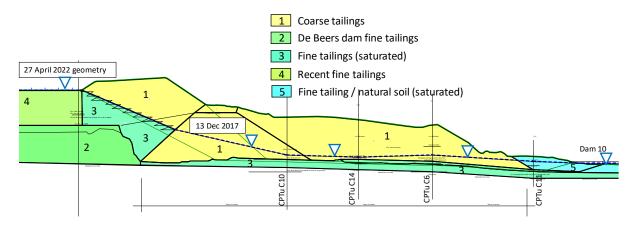
FIGURE 54 MATERIALS ZONES ANALYSED FOR FINAL STABILITY ANALYSIS

The cross-section at the failure was subdivided into material types as indicated in Figure 54. Approximate bounds were set for the slip surface entry and exit zones to match what occurred during the actual failure. Again, the Morgenstern-Price method was used and slip surface optimisation was applied. For the purposes of the stability back-analysis, all fine tailing zones located below the water table were again assumed to act undrained, with the same yield strength ratio. An undrained strength ratio of 0.175 resulted in a factor of safety of unity for the large overall failure surface shown in Figure 57. This strength ratio falls between the ranges for the yield strength ratio (0.23 to 0.31) and liquefied strength ratio (0.02 to 0.12) back calculated from failure case studies quoted by Olson & Stark (2002 and 2003) and is at the lower bound of yield strength ratios quoted by Olson & Matson (2008) for triaxial shear, but in the mid-range for values determined from simple shear for fine sands and silty sands. The observation that movement seems to have reduced in the months preceding the failure (see Figure 10) may have resulted in mixed drainage conditions along the slip interface, resulting in the single back-calculated strength ratio falling between the normal bounds for peak and liquefied values quoted above.

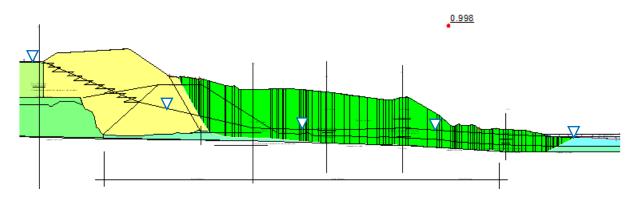
FIGURE 55 FAILURE SURFACE ASSOCIATED WITH A YIELD STRENGTH RATIO OF **0.11** GIVING A FACTOR OF SAFETY OF UNITY MATCHING LONG-TERM MOVEMENT OBSERVED ON EMBANKMENT (FOS = 1.00).

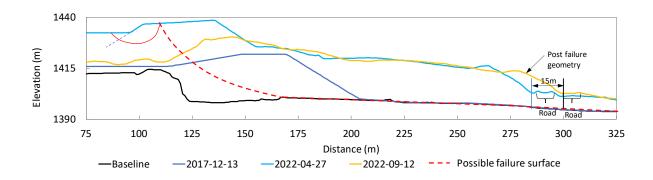
FIGURE 56 HYPOTHETICAL CROSS-SECTION ASSOCIATED WITH THE 11 SEPTEMBER 2022 FAILURE EVENT.

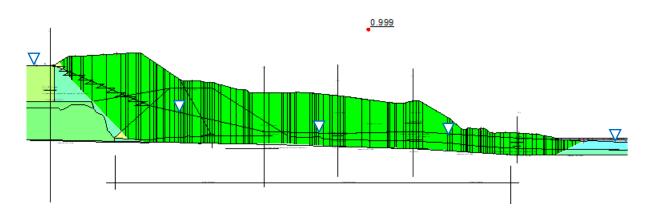
A drained friction angle of 9° is required to produce a factor of safety of unity (1) for a similar failure surface under drained conditions, again illustrating that undrained instability was the likely mechanism.

FIGURE 57 OVERALL SLIP SURFACE ASSOCIATED WITH A YIELD STRENGTH RATIO OF **0.175** GIVING A FACTOR OF SAFETY OF ONE.

The critical failure surface can be seen to extend through the zone of saturated fine tailings underneath the embankment crest. This zone was subsequently modelled as drained with the same properties as that of the coarse tailings, which reduced the required yield strength ratio for a factor of safety of one to 0.16, not very different from the 0.175 first calculated.

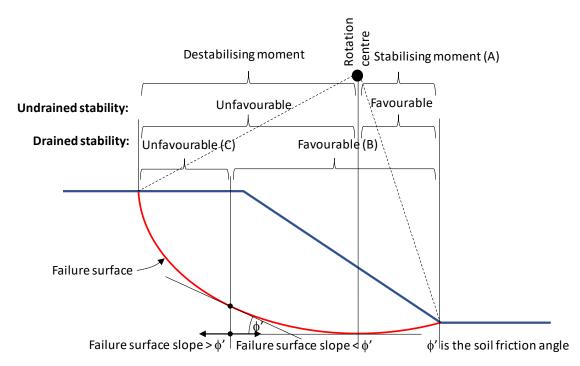
The influence of weight placed to the left of the centre of rotation is more complex and a distinction needs to be drawn between drained and undrained conditions. Under undrained conditions, weight placed here will add to the destabilising moment without affecting soil strength. The effect on slope stability will therefore always be negative. In the case of drained conditions, the added weight will affect both the component of the weight driving failure, but also the soil strength. If the slope of the failure surface under the area where weight is placed is flatter than the friction angle of the soil, the increase in soil strength will exceed the additional component of weight driving failure ("B" in Figure 58). If the underlying failure surface is steeper than the friction angle of the soil ("C" in Figure 58), the increase in the component of weight driving failure will exceed the increase in strength and the effect on slope stability will be negative.

In the case of a planar failure surface, the effect of weight added to the slope will always be negative under undrained conditions. In the case of drained conditions, the effect of weight will be negative if the failure surface is steeper than the soil friction angle and positive if the failure surface is flatter than the soil friction angle.

FIGURE 58 THE EFFECT OF PLACEMENT OF MATERIAL ON A SLOPE ON THE STABILITY OF THE SLOPE UNDER DRAINED AND UNDRAINED CONDITIONS.

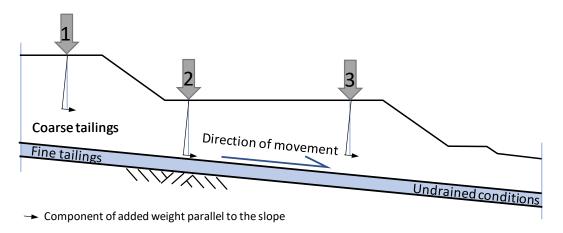
Figure 59 presents a simplified idealised cross-section of the Jagersfontein Tailings Dam at the section that failed. It shows the coarse tailings embankment overlying a zone of fine tailings in which undrained conditions have been mobilised. Undrained conditions are sustained by constant movement along this interface. Placement of weight, irrespective of the location (1, 2 or 3), will not stabilise the slope because of the undrained conditions on the interface where movement is taking place. In fact, it will add to the component of the weight parallel to the slope driving movement, although the component will be small due to the flat slope on which slip is occurring. In addition, the added weight may serve to sustain the undrained conditions if placed rapidly. In order to stabilise the slope, movement must first be arrested to stop the generation of undrained conditions. Only then may weight be placed on the slope to increase the effective stress and hence drained strength of the fine tailings layer, taking care not to cause further undrained conditions by excessively rapid placement. Any structure to stabilise the slope, such as construction of a buttress at the toe, must be founded on a sound foundation below the interface on which movement occurs.

FIGURE 59 SIMPLIFIED CROSS-SECTION OF THE CRITICAL SECTION OF THE JAGERSFONTEIN TAILINGS DAM.

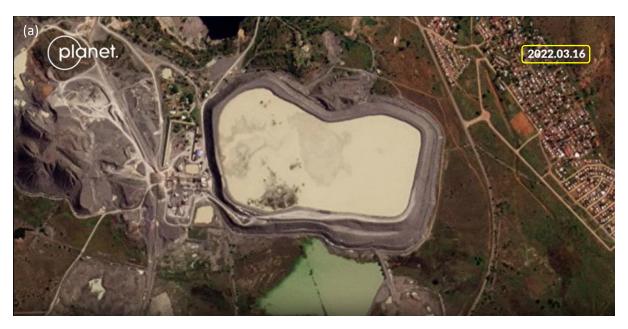
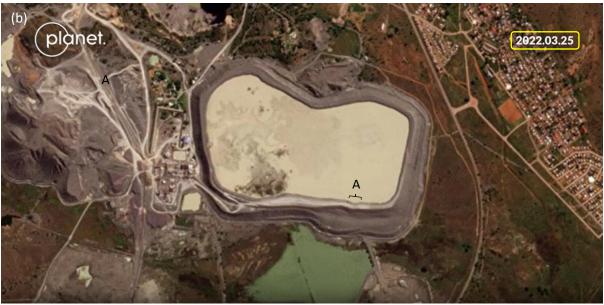
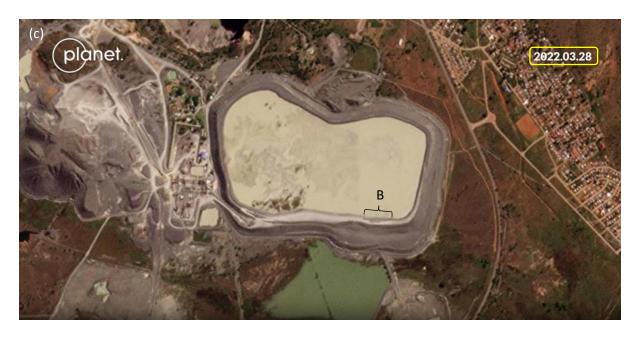
New information concerning the "donut"-shaped embankment visible on satellite images from late 2019 to early 2020 (Figures B14 – B17 in the failure study report) was brought to the attention of the Investigation Panel, suggesting that this embankment was constructed as part of efforts to recover plant that presumably fell or slipped off the wall crest into the pond. The fact that such an event had occurred also points to the possibility of poor stability along the inside crest edge of the dam, possibly a consequence of raising the dam wall over weak unconsolidated material.

In conclusion: Evidence does suggest that pre-failure instability along the inside crest edge of the Jagersfontein Tailings Dam wall may have occurred.

FIGURE 1 PLANETSCOPE IMAGES FROM MARCH 2022 SHOWING SIGNED OF INSTABILITY ALONG INTERNAL CREST EDGE OF DAM WALL.

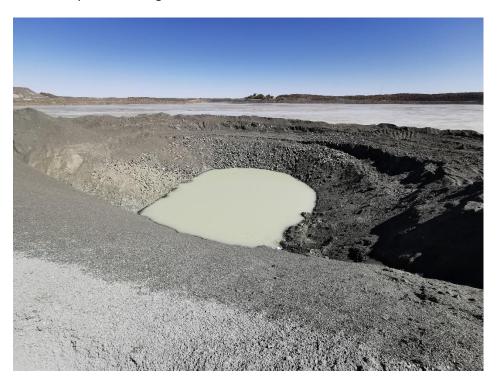
Our report refers to a "donut shaped" embankment (see p 24), which can be identified on satellite images from late September 2019 until July 2020. The reason for this structure was not clear, but according to the information provided to us in April 2025 the circular embankment was constructed as part of an effort to recover a bulldozer which ended up in the dam due to what was reported to be a suicide attempt by the operator. Accordingly, it is not believed that this structure played a role in the stability of the tailings dam wall.

FIGURE 1 VIEW TOWARDS THE INSIDE OF THE "DONUT-SHAPED EMBANKMENT" SEEN FROM THE SOUTHERN DAM WALL CREST. (DATED 12 DECEMBER 2019.)

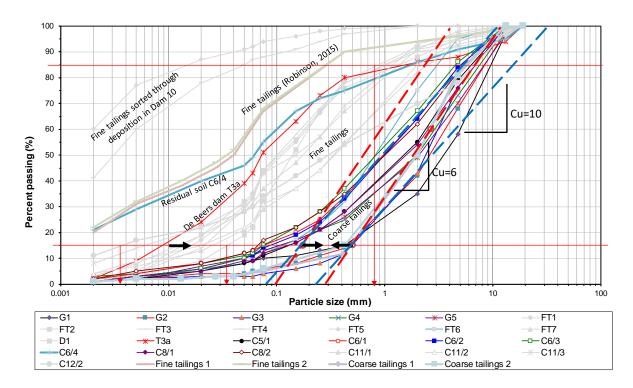
FIGURE 11 PARTICLE SIZE DISTRIBUTIONS OF VARIOUS MATERIALS SAMPLED DURING THE FIELD INVESTIGATION AT THE JAGERSFONTEIN TAILINGS DAM.

Figure 11 also includes the grading curves for fine materials taken from Robinson (2015). Using the filter criteria above, the coarse tailing was found to be sufficiently fine to also retain this material, while, in this case, being coarse enough to allow free drainage of this material.

The results suggest that piping is unlikely to have been a primary cause of the failure. However, piping may have occurred as a consequence of failure after internal displacement had taken place within the dam wall.

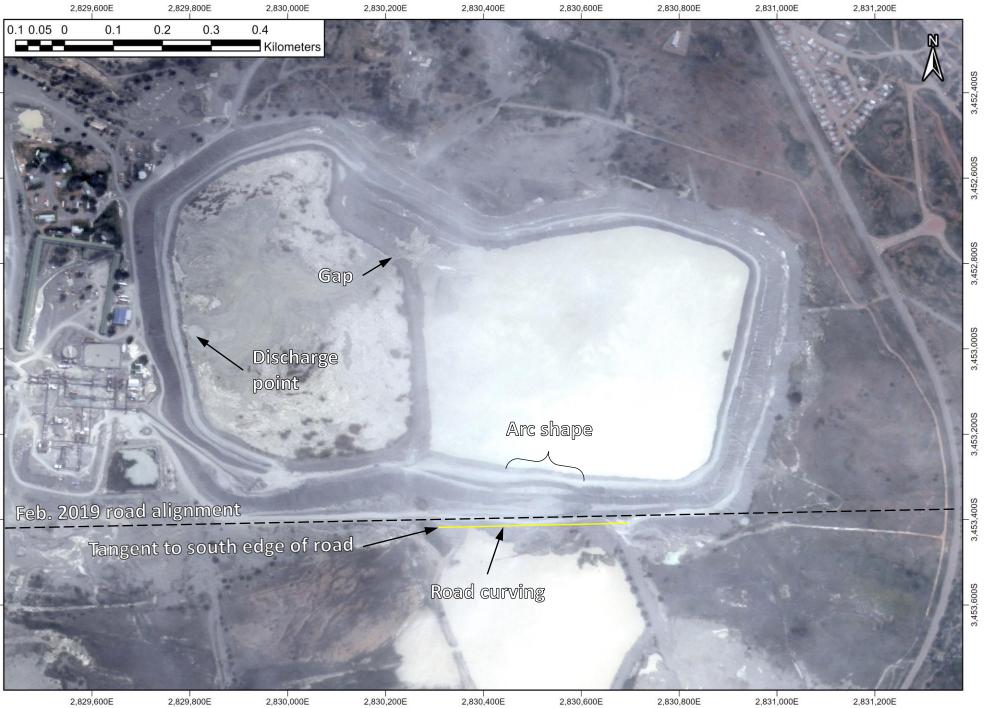
Figure B11: 2019-03-22
TripleSat satellite image highlighting the separation between the February 2019 (Figure B10) and the current location of the southern edge of the southern access road.

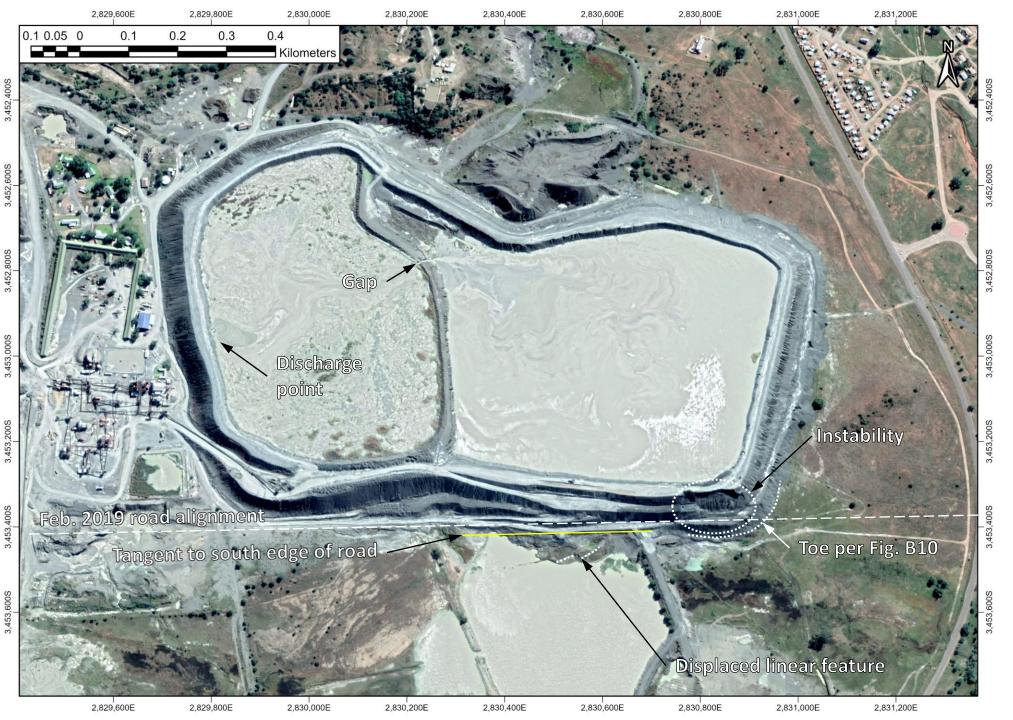
Figure B12: 2019-05-02
WorldView 2 satellite
image highlighting the
separation between the
February 2019 (Figure
B10) and the current
location of the southern
edge of the southern
access road.

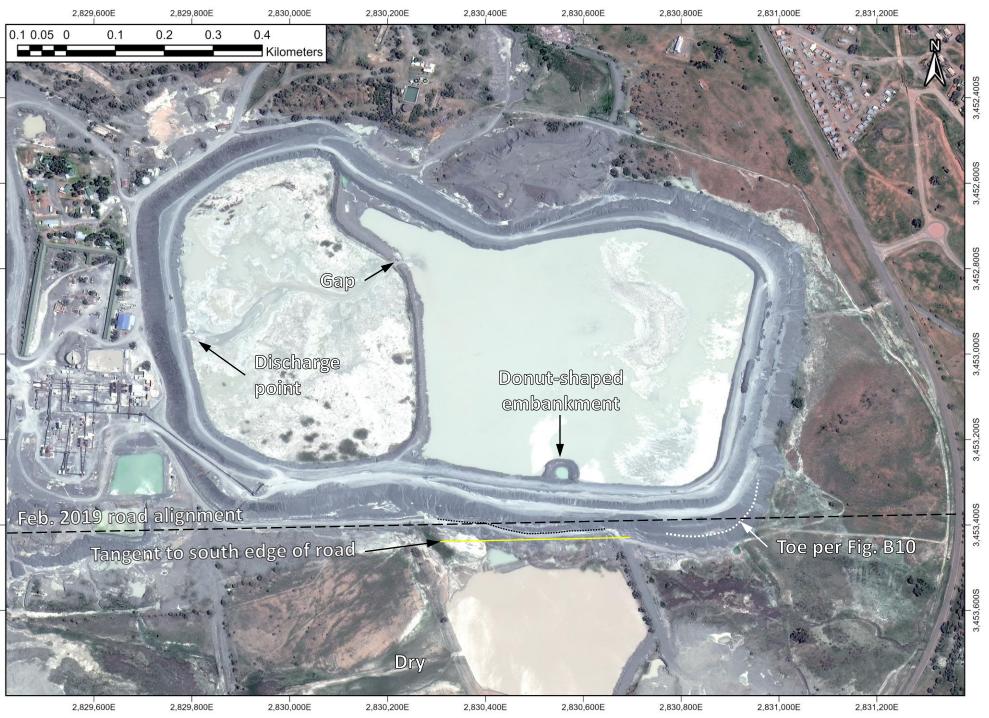
Figure B14: 2020-01-16
SuperView satellite image highlighting the separation between the February 2019 (Figure B10) and the current location of the southern edge of the southern access road. A donutshaped embankment built against the southern wall is visible.

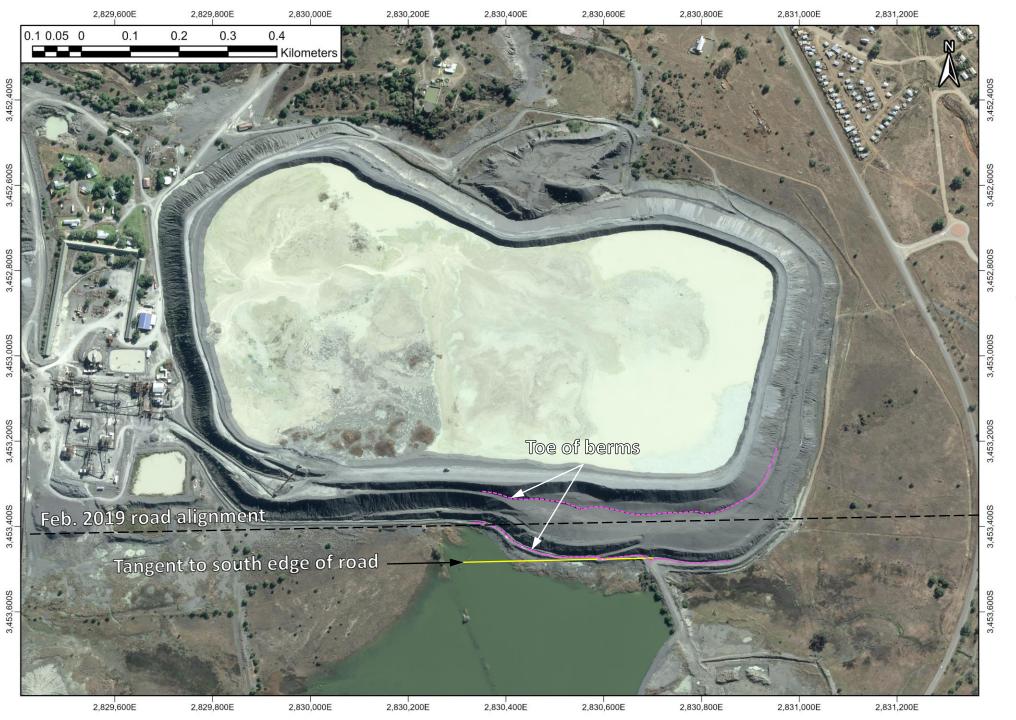
Figure B21: 2022-05-24
Pléiades Neo satellite
image highlighting the
separation between the
February 2019 (Figure
B10) and the current
location of the southern
edge of the southern
access road. The prefailure location of the toe
of the upper and lower
benches is highlighted.

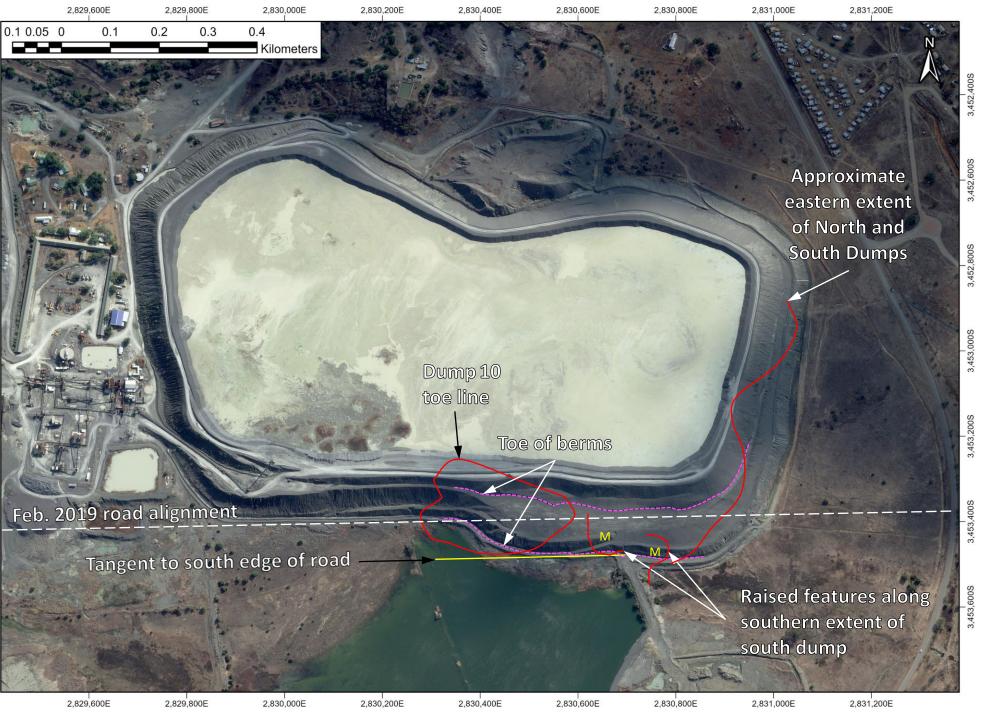
**Figure B22:** 2022-07-28 Pléiades Neo satellite image showing: the separation between the February 2019 (Figure B10) and the current location of the southern edge of the southern access road; the location of the toe of the upper and lower benches; and the extent of the historic dumps.

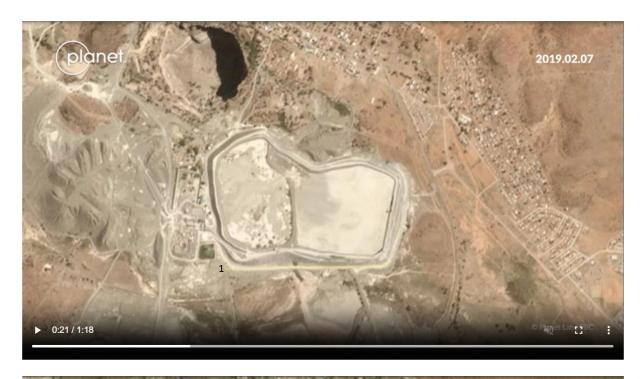
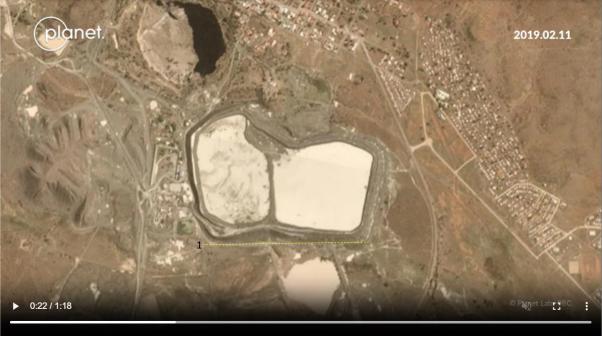
Figure 1 (a) and (b) respectively present images taken on 2019/02/07 and 2019/02/11. The access road along the southern wall of the tailings dam is straight and is indicated by a thin yellow dotted line. Dam 10, immediately to the south of the wall of Compartment 2, appeared empty on 2019/02/07. The dam's natural catchment is located towards the west. By 2019/02/11 the dam had received a significant amount of water. However, no water is visible to the west of the embankment bordering the water body, indicating that the influx of water from the dam was not from its natural catchment. In fact, water can be observed to spill from Dam 10 towards the west on 2019/02/16 as shown in Figure 2, suggesting that water in Dam 10 is coming from a source other than its natural catchment.

FIGURE 1 PLANETSCOPE SATELLITE IMAGES TAKEN ON 2019/02/07 AND 2022/02/11 SHOWING RAPID FILLING OF DAM 10.

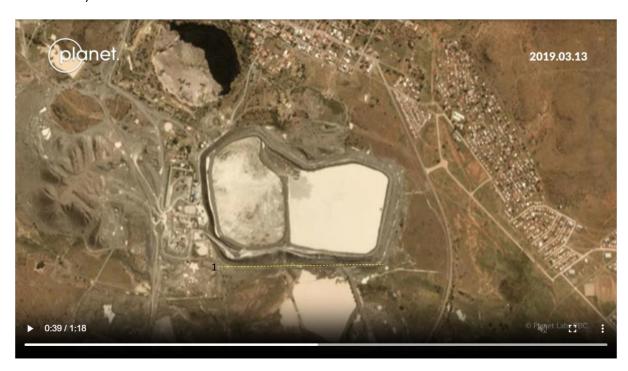
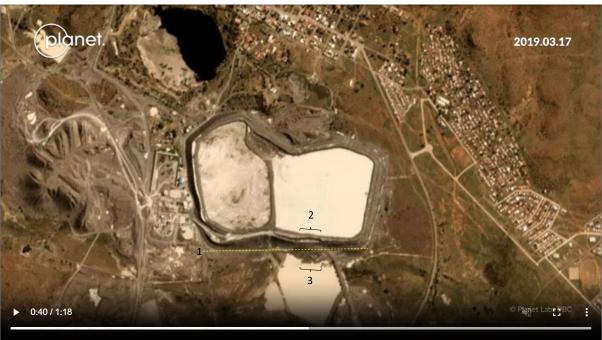
Figure 4 (a) and (b) present PlanetScope images respectively recorded on 2019/03/13 and 2019/03/17, demonstrating further signs of slope instability, with a significant slip visible towards the south on 2019/03/17. Closer examination of the toe of the southern wall of compartment 2, where the wall borders Dam 1, reveals an amount of movement that appears to amount to several metres towards the south (Label 3).

FIGURE 4 PLANETSCOPE SATELLITE IMAGES TAKEN ON 2019/03/13 AND 2022/03/17 SHOWING FURTHER SIGNS OF SLOPE INSTABILITY ALONG THE SOUTHERN WALL OF COMPARTMENT 2.

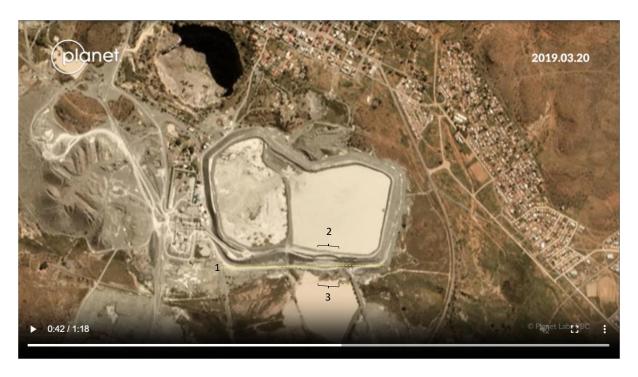
The PlanetScope satellite image in Figure 5, taken on 2019/03/20, shows that the access road along the toe of the southern wall of Compartment 2 had been displaced to the south by several metres

where it runs along Dam 10 and that it was no longer a straight road. Additional signs of movement taking place over the remainder of March and April 2019 are evident in PlanetScope imagery (not shown here).

FIGURE 5 PLANETSCOPE SATELLITE IMAGE TAKEN ON 2019/03/20 SHOWING MOVEMENT ALONG THE TOE OF THE SOUTHERN WALL OF COMPARTMENT 2.
