# **FINAL REPORT**

STUDY INTO THE CAUSES OF THE JAGERSFONTEIN FINE TAILINGS STORAGE

**DAM FAILURE ON 11 SEPTEMBER 2022**

Prepared by: University of Pretoria and University of the Witwatersrand

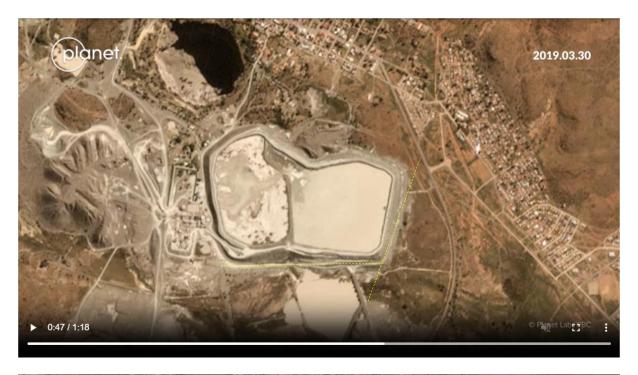
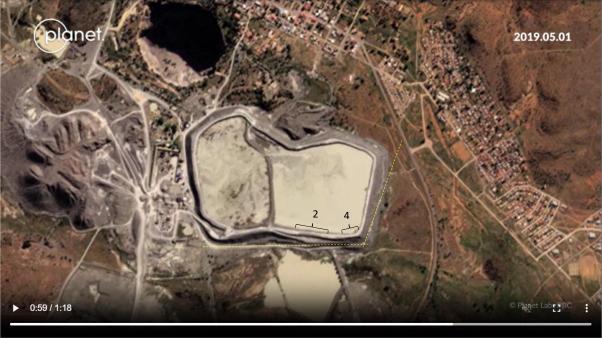
Probably in response to the instability described above, JD placed a large amount of additional material on the slopes of the southern wall of Compartment 2 during the course of April 2019. An impression of the amount of material placed and the work done can be gained by comparing images recorded on 2019/03/30 and 2019/05/01, presented in Figure 6. Comparing Figure 5 and Figure 6 (a) also reveals a significant amount of additional movement along the toe of the wall into Dam 10 (opposite label 4). Previously unidentified movement in the southeastern corner of the dam, extending from label 4 outwards to the toe in a south-southeasterly direction, can be identified when comparing Figure 6 (a) and (b).

FIGURE 6 PLANETSCOPE SATELLITE IMAGES TAKEN ON 2019/03/30 AND 2019/05/01 SHOWING THE PLACEMENT OF MATERIAL ON THE SLOPE OF THE SOUTHERN WALL OF COMPARTMENT 2.

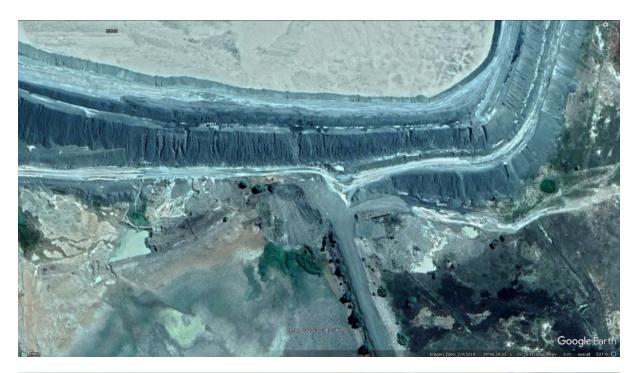
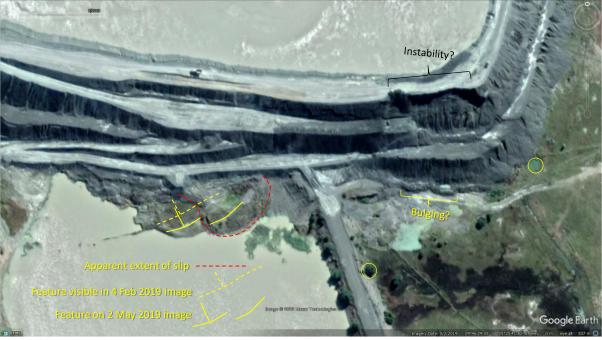
Signs of instability at the crest of the southeastern corner of the dam are evident by 2019/05/02, possibly due to the movement reported above. This is also visible in a GoogleEarth image, dated the same day, see Figure 7 (b). Signs of bulging are visible at the toe of this zone of instability. A linear feature visible in Figure 7 (a) is identified in Figure 7 (b), demonstrating movement and deformation along the toe of the southern wall against Dam 10.

FIGURE 7 GOOGLEEARTH IMAGERY DATED (A) 2019/02/04 AND (B) 2019/05/02, WITH THE LATTER SHOWING SIGNS OF INSTABILITY IN THE SOUTHEASTERN CORNER OF THE DAM.

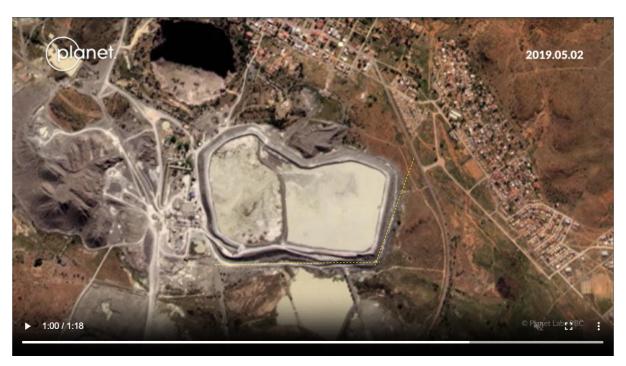
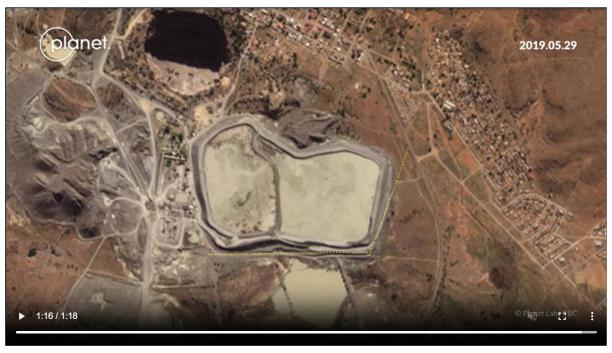
Figure 8 presents PlanetScope images recorded on 2019/05/02 and 2019/05/29. It illustrates considerable activity on the slopes of the southern wall of Compartment 2 and material placed along the southern and southeastern toe of the dam. A significant amount of movement to the south is evident along the toe, especially near the southeastern corner of the dam. Take note of the position of the original straight access road along the southern wall of the dam which has by the end of May 2019 undergone a large amount of displacement towards the south.

FIGURE 8 PLANETSCOPE SATELLITE IMAGES TAKEN ON 2019/05/02 AND 2019/05/29 SHOWING ACTIVITY AND MOVEMENT ALONG THE SOUTHERN AND SOUTHEASTERN TOE OF COMPARTMENT 2.

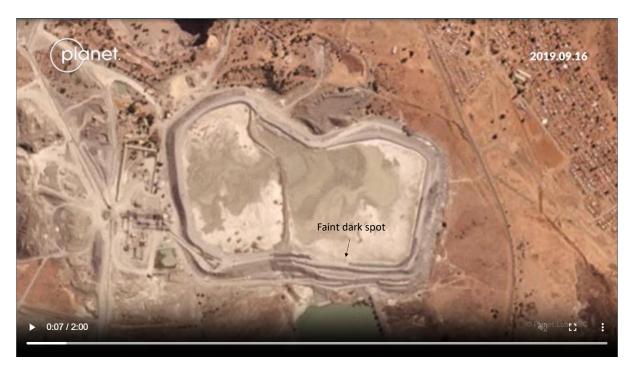
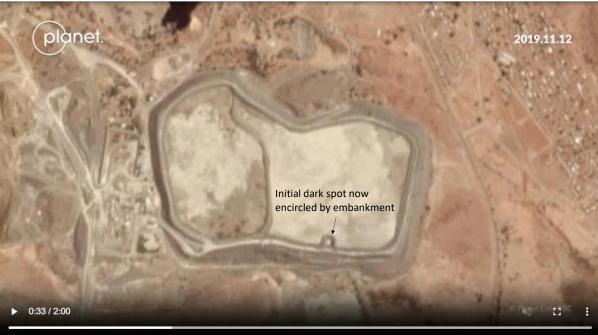
On 2019/09/16 a faint dark spot can be identified against the inside-crest of the southern wall of Compartment 2 as shown in Figure 9 (a). (Check water index before and after this time). By 2019/10/20 the dark spot had been encircled by an embankment which appeared to fade until 2019/11/10 when a large amount of deposition seemed to have taken place (10-12 Nov 2019). The deposition made the circular embankment feature stand out prominently. The feature remained visible for several months, eventually fading towards the end of July 2023 as deposition on the dam proceeded and the walls were raised.

FIGURE 9 PLANETSCOPE IMAGING DATED (A) 2019/09/16 AND (B) 2019/11/12 SHOWING A DARK SPOT APPEARING ALONG SOUTHERN EMBANKMENT, SUBSEQUENTLY ENCIRCLED BY EMBANKMENT.

The question is "What was the intention with the circular embankment?" Without further information it could be speculated that it was intended as a measure to isolate a sinkhole / rathole, which might possibly have been drawing water(?) (check water index before and after this time). It will be of interest to discuss this matter with JD.

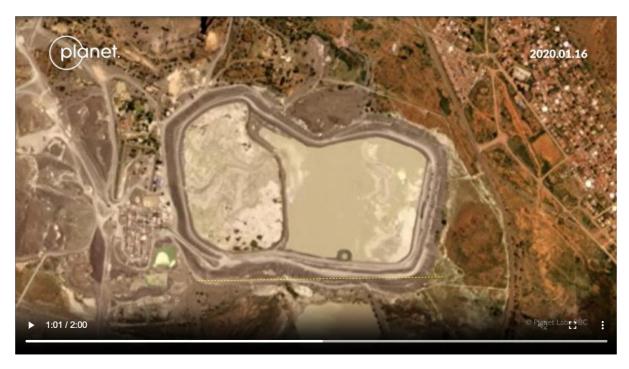
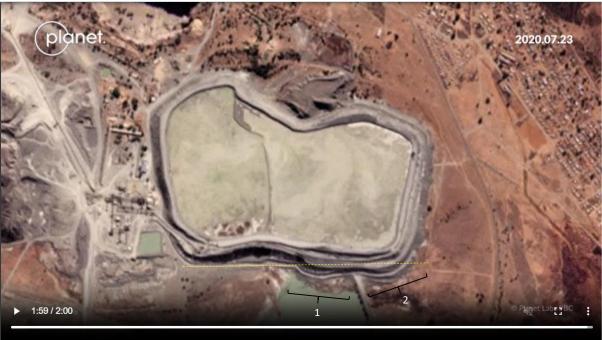
Compartment 2 to the east and west of the Dam 10 embankment during the first half of 2020 (locations 1 and 2 indicated in Figure 10 (b)). A large amount of material seems to have been placed on the slopes of the southern wall of Compartment 2, but not against the toe.

A question is raised "Why does movement seem to take place to the east and west where the Dam 10 embankment abuts the southern wall of Compartment 2, and why does less movement appear to have taken place where the embankment meets the tailings dam?" The impression is gained that the Dam 10 embankment may have been acting as a restraint against the toe of the dam, locally limiting movement towards the south. The effect is especially visible in Figure 10 (b).

FIGURE 10 PLANETSCOPE IMAGING DATED (A) 2020/01/16 AND (B) 2020/07/23 SHOWING DISPLACEMENT ALONG THE SOUTHERN AND SOUTHEASTERN WALLS OF COMPARTMENT 2.

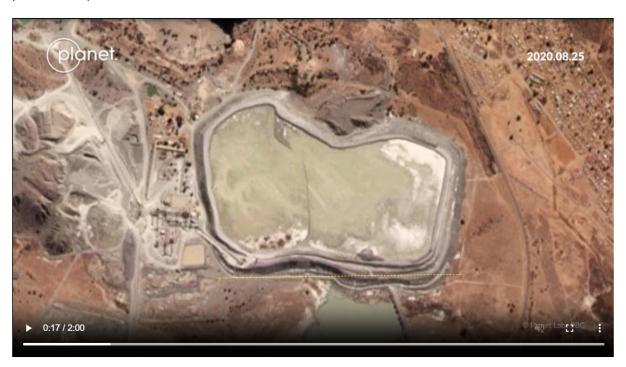
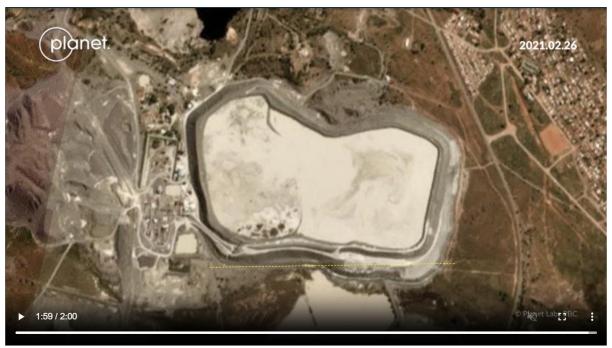
Figure 11 presents PlanetScope imaging dated (2020/08/25) and (2021/02/26) from which further bulging towards the south and southeast is apparent. The southern wall also seemed to have expanded towards the north into the dam basin, most probably reflecting the raising of the walls as part of the operation of the dam.

FIGURE 11 PLANETSCOPE IMAGING DATED (A) 2020/08/25 AND (B) 2021/02/26 SHOWING MORE DISPLACEMENT ALONG TOE OF THE SOUTHERN AND SOUTHEASTERN WALLS OF COMPARTMENT 2.

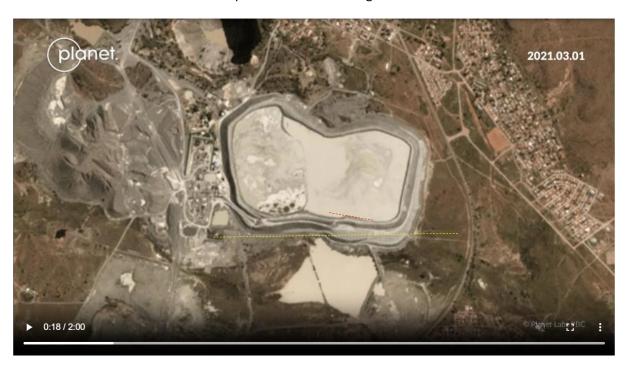
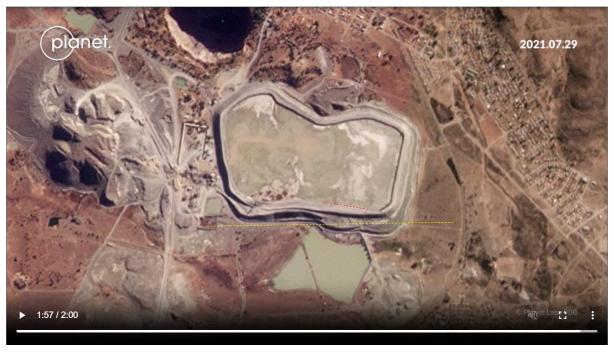
Figure 15 (a) and (b) present PlanetScope images dated 2021/03/01 and 2021/07/29 respectively. Examining the alignment of the southern access road does not suggest visible movement over this five-month period along the toe of the southern wall. However, looking at the location of the inside toe of the wall (red dotted line), it appears that wall raising occurred towards the outside, allowing the crest of the southern wall of Compartment 2 to be straightened.

FIGURE 12 PLANETSCOPE IMAGING DATED (A) 2021/03/01 AND (B) 2021/07/29 SHOWING NO VISIBLE SOUTHWARDS MOVEMENT ALONG SOUTHERN TOE OF COMPARTMENT 2, BUT WALL RAISING EVIDENT (DOTTED RED LINE).

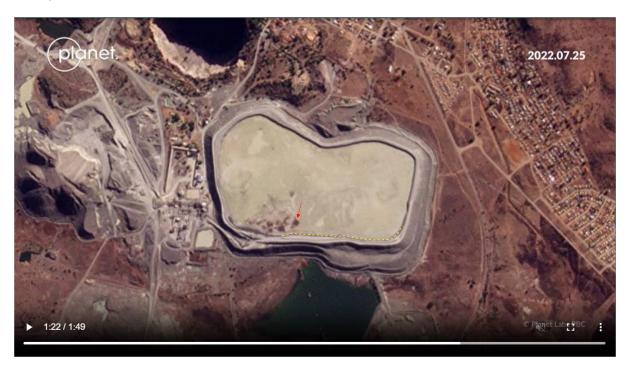
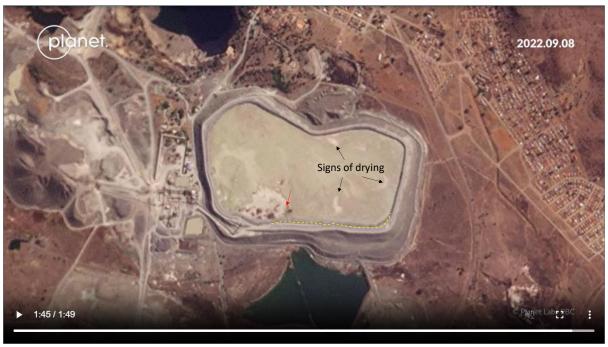
Figure 14(a) and (b) present PlanetScope images dated 2022/07/25 and 2022/09/08, shortly before the failure. Similar images from April to July 2022 show a large amount of turbid water on the dam during the winter of 2022, but the dam seemed to show significant signs of drying during August as indicated by dry patches in the basin identifiable in Figure 14 (b). The red arrow in Figure 14 (a) indicates the location of a patch of vegetation at the end of July. The same location is indicated in Figure 14 (b). It is apparent that the patch of vegetation moved to the east during the six weeks between the two images. It can be noted that the two compartments on the dam had merged into one by this time.

FIGURE 14 PLANETSCOPE IMAGING DATED (A) 2022/07/25 AND (B) 2022/09/08 SHOWING SIGNS OF DRYING.

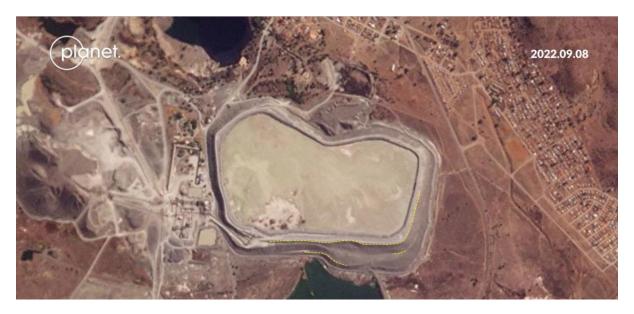
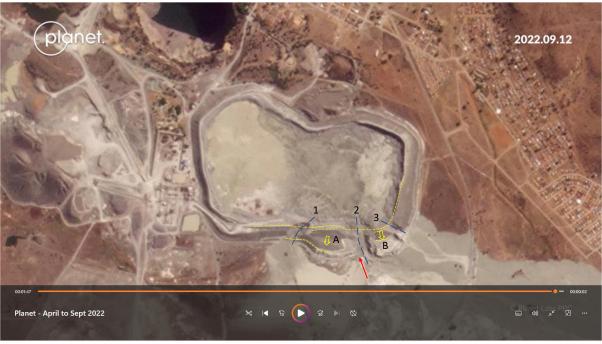
Figure 15 (a) and (b) respectively present PlanetScope satellite imagery of the Jagerfontein tailings dam taken shortly before and after the failure event that took place on 11 September 2022. Prominent slope break-lines are highlighted in both images by yellow dotted lines. Comparison of the two images is best achieved by flicking between them when displayed electronically on a screen. Studying the two images reveal that a considerable amount of movement occurred along the southern wall of the tailings dam associated with the failure. Block A, bordered by the blue broken lines numbered 1 and 2 respectively in Figure 15 (b) can be observed to have moved in a generally southerly direction, with block B, located between the blue broken lines numbered 2 and 3, moving in the south-southeasterly direction. The magnitude of movement associated with the failure event was estimated using before and after Google Earth imagery to be of the order of 20 m.

FIGURE 15 PLANETSCOPE SATELLITE IMAGES TAKEN BEFORE (2022/09/08) AND AFTER (2022/09/12) THE FAILURE EVENT

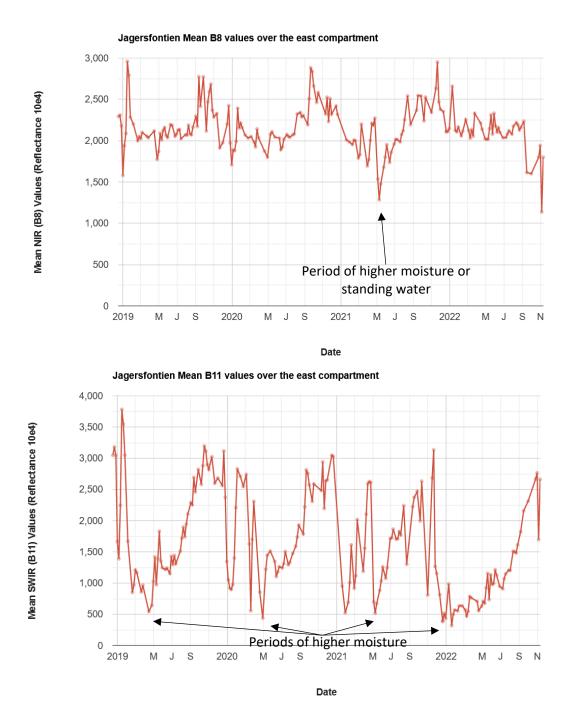
Figure D3 Mean NIR (B8) and SWIR (B11) values for the Jagersfontein Tailings Dam Eastern Compartment with time

In Figure D3, high mean values of NIR and SWIR correspond to dryer conditions over the eastern compartment, while low mean values of NIR and SWIR correspond to wetter conditions. It should be noted that NIR reflectance is sensitive to deeper open water, while SWIR is sensitive to very shallow water bodies as well as soil moisture content. As such, low NIR reflectance is likely to indicate the presence of standing water. However, the turbidity of and suspended solids within a water body will increase the water surface's NIR reflectance, leading to difficulty distinguishing it from other. On the other hand, high SWIR reflectance values indicate dry soil conditions, while low SWIR values are strongly associated with water, both shallow and deep, as well as high soil moisture content. As such, in the context of a tailings dam, low SWIR reflectance values may indicate standing water, or recently

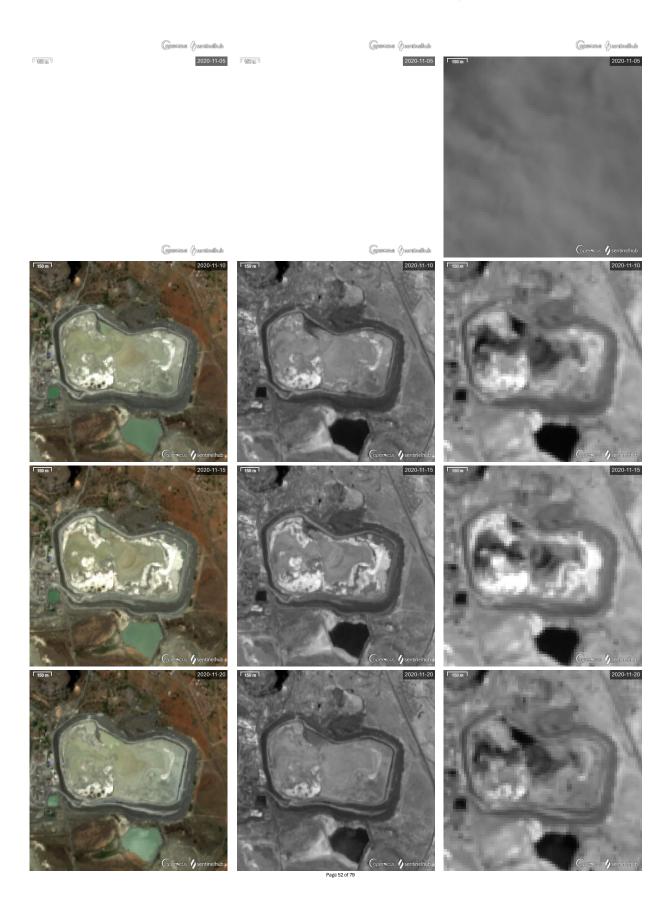
2020-10-31

Shortwave Infrared (SWIR - Band 11)

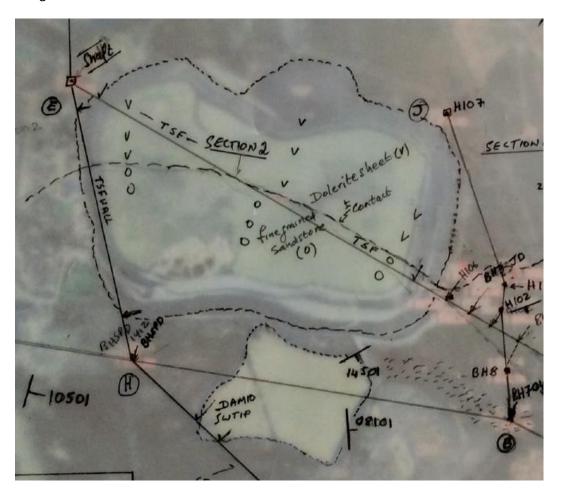
Colliston (2021) presents the local geology from the Jagerfontein tailings dam area, with an excerpt of his geological map reproduced below in Figure 2. Approximately the northern half of the tailings dam footprint is underlain by a dolerite sheet. Over the southern half of the dam footprint, the dolerite is overlain by fine-grained sandstone, followed by lower siltstone at depth. The sandstone cover increases in thickness towards the southeast to about 10m under the eastern wall. An excerpt along Section 2, indicated on the geological map, is presented in Figure 3 and an excerpt along Section EH in Figure 4.

FIGURE 2 EXCERPT FROM GEOLOGICAL MAP OF THE JAGERSFONTEIN TAILINGS DAM AREA BY COLLISTON (2021).

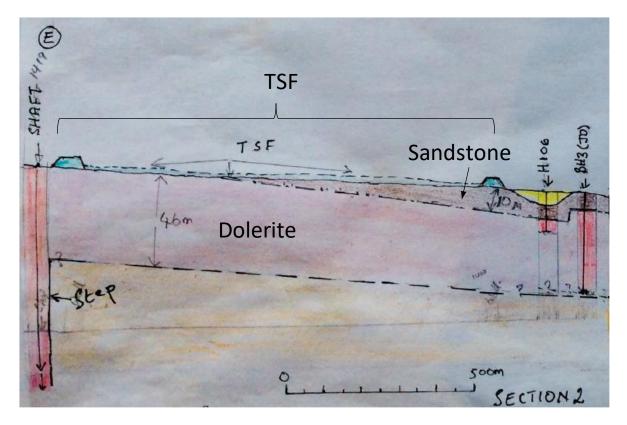
FIGURE 3 SECTION 2, EXTENDING FROM NORTHWEST TO SOUTHEAST ACROSS THE TAILINGS DAM BASIN (MODIFIED FROM COLLISTON, 2021).

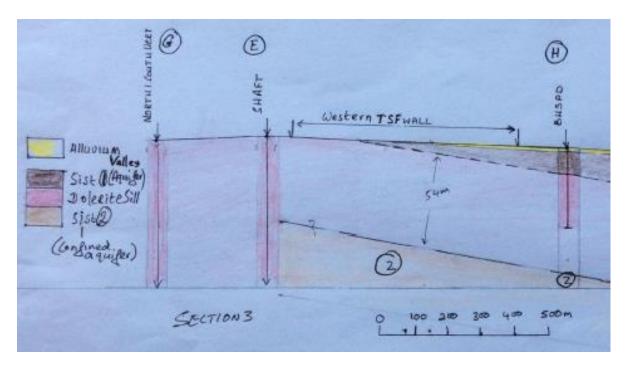
FIGURE 4 SECTION EH, EXTENDING APPROXIMATELY NORTH-SOUTH UNDER THE WESTERN WALL OF THE TAILINGS DAM (FROM COLLISTON, 2021).

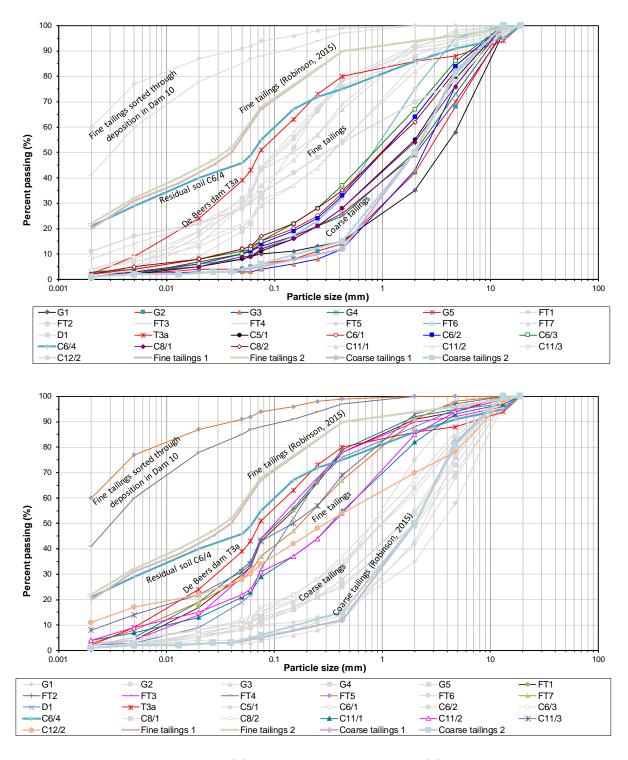
Figure 6 presents the particle size distribution of various material collected. Figure 6(a) focuses on coarse tailings, while Figure 6(b) focuses on the fine tailing. The following samples are highlighted: Residual soil sample from Mostap sample C6/4, De Beers tailings T3a, the fine tailings grading from the design report by Robinson (2015), as well as the coarse tailings grading by Robinson (2015). Very fine graded material sampled from immediately adjacent to the Dam 10 water's edge is indicated.

FIGURE 6 PARTICLE SIZE DISTRIBUTION (A) FOCUSSING ON COARSE TAILINGS; (B) FOCUSSING ON FINE TAILINGS.

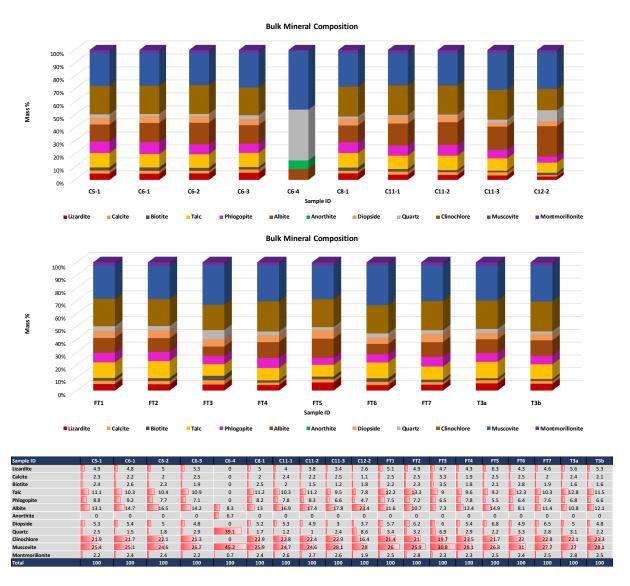
FIGURE 7 SUMMARY OF MINERALOGY DETERMINED FROM XRD ANALYSIS.

The XRD analysis showed the mineralogy of all samples tested to be very similar, with the exception of C6/4, which is believed to represent the residual material underlying the dam wall. The bulk of the minerals are from the mica family and low-grade metamorphic products, which is to be expected given that the tailings originate from Kimberlite. Of the minerals, only Lizardite, talc and montmorrilonite classify as clay minerals. They represent respectively about 5%, 10% and 2.5% of the bulk of the tailings, which together, represents a significant clay component. This is of interest to take note of because clay minerals are subject to reorientation upon large shear displacements, resulting in the mobilisation of potentially low residual friction angle values.

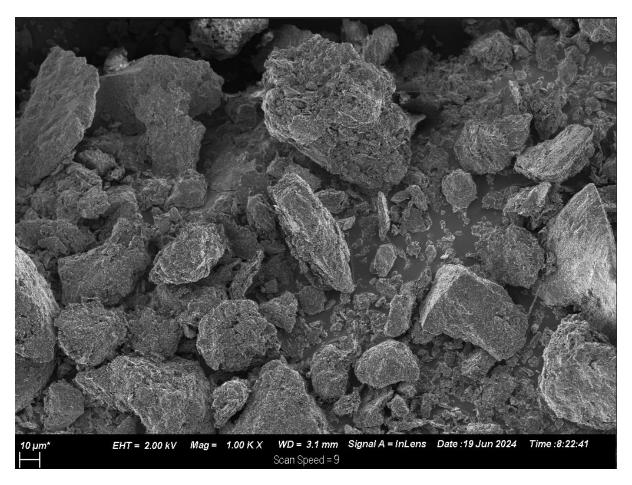
Scanning electron microscope (SEM) images were taken of the fine tailings to identify platy particles associated with the clay content of the material. At a magnification of 1000 times the tailings appear as agglomerations of finer particles (see Figure 8).

FIGURE 8 FINE TAILINGS MAGNIFIED 1000 TIMES SHOWING AGGLOMERATIONS OF PARTICLES.

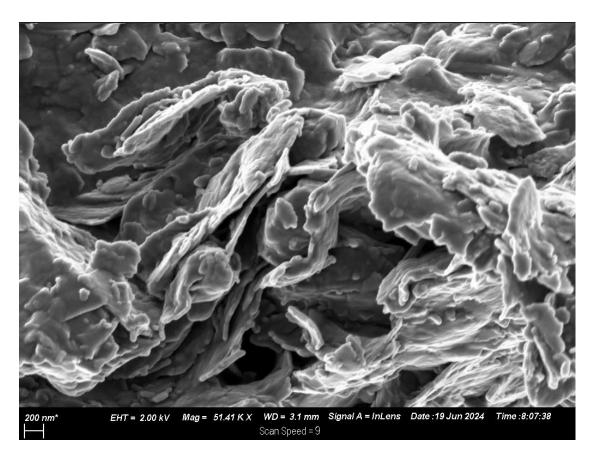
At a magnification of 50 000 times platy minerals are clearly visible which may suggest that the material will be prone to developing low residual shear strengths associated with the reorientation of particles, given sufficient shear displacement (see Figure 9 and Figure 10).

FIGURE 9 PLATY MINERALS VISIBLE AT 50 000 TIMES MAGNIFICATION.

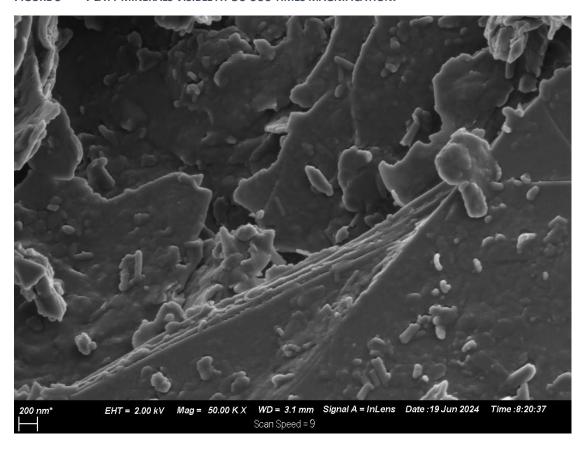
FIGURE 10 SECOND IMAGE OF PLATY MINERALS VISIBLE AT 50 000 TIMES MAGNIFICATION.

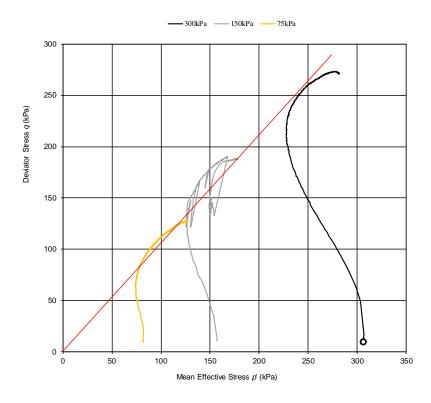
FIGURE 11 P-Q STRESS PATHS FROM CU TRIAXIAL TESTS ON FINE TAILINGS SUGGESTING AN EFFECTIVE FRICTION ANGLE OF 26°.

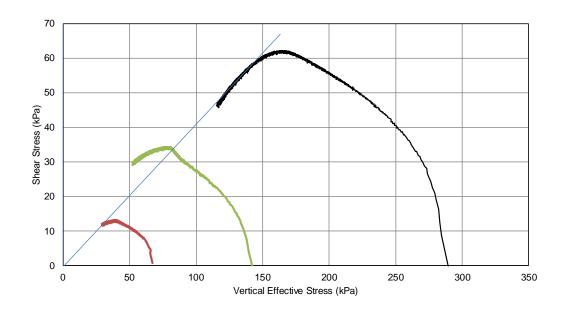
FIGURE 12 SHEAR STRESS – NORMAL STRESS STRESS PATHS FOR UNDRAINED DIRECT SIMPLE SHEAR TESTS ON FINE TAILINGS SUGGESTION AN EFFECTIVE FRICTION ANGLE OF 22.5°.

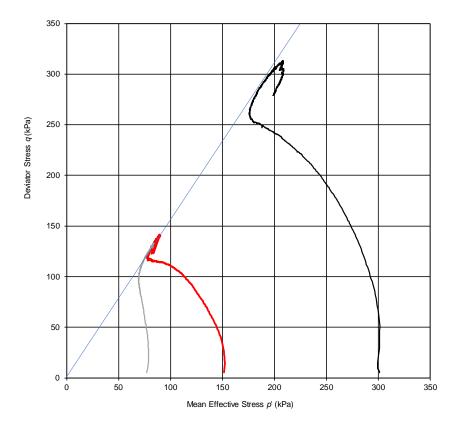
FIGURE 13 P-Q STRESS PATHS FROM CU TRIAXIAL TESTS ON COARSE TAILINGS SUGGESTING AN EFFECTIVE FRICTION ANGLE OF 38.7°.

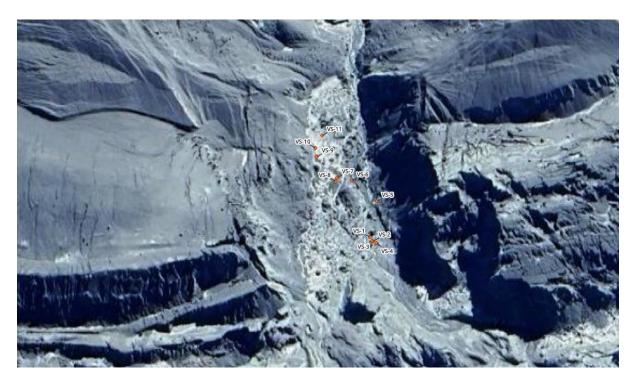
Figure 14 Locations of vane shear test results in breach floor.

A number of hand vane shear tests were carried out in the floor of the breach on 29 January 2024 at locations shown in Figure 14. The handheld apparatus used for the vane shear tests has a built-in dial that yields the shear strength. This value was taken as the result without any further modifications. Table 4 presents the peak shear strength recorded at locations VS1 to VS4. At these four locations, tests were conducted only at a depth of 0.3 m. A number vane shear tests were also performed over a range of depths to a maximum depth of 1.45 m. These tests focused on characterising the peak strength of the tailings that remained in the breached portion of the southern wall.

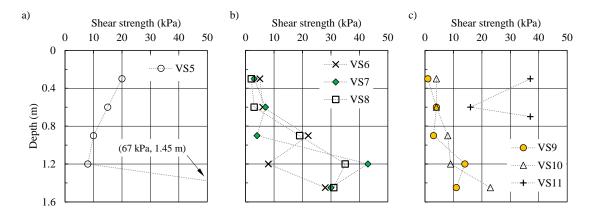
Figure 15 presents the results of the Vane Shear test at locations VS5 to VS11, all of which included tests at different depths, also in the floor of the breach. While hand-held VSTs are generally assumed to provide measurements of undrained shear strength, in tailings, it is difficult to ascertain whether undrained conditions were indeed achieved (Reid et al., 2023). In addition, the vane shear tests were carried out approximately 18 months after the failure which implies that the overburden stress was removed and, due to the long time after failure, significant drainage and hence softening would have occurred, mostly likely completely changing the undrained shear strength. Given this uncertainty, the results of the VSTs were not considered further.

FIGURE 15 RESULTS OF VANE SHEAR TEST CARRIED OUT IN THE FLOOR OF THE BREACH ON 29 JAN 2024.

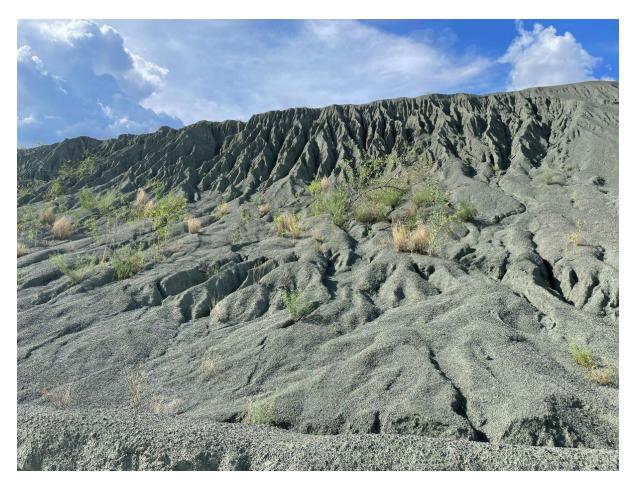
Signs of quite severe side slope erosion is evident on especially the western and south-western walls of the Jagerfontein tailings dam. A sample was submitted for chemical dispersion tests, the result of which is tabulated below.

FIGURE 16 SIGNIFICANT SLOPE EROSION SUGGESTION POTENTIAL FOR DISPERSIVENESS.

Based on the recommendations of Gerber & Harmse (1987) the material classifies as dispersive, in fact highly dispersive. Its dispersive nature means that the tailings material may be prone to piping.

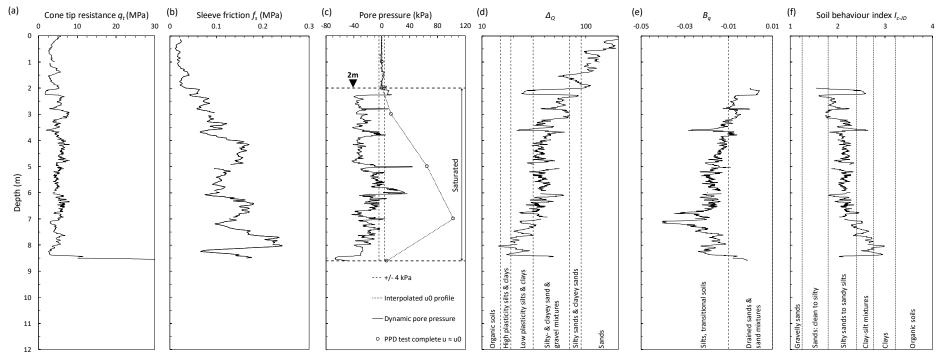
For sounding CPT01, the ground level was 1.3 m below the level of the baseline as inferred from the survey data. We believe this could be due to remining of the historic dumps or due to erosion that took place during failure. For seven soundings, the CPT did not extend deep enough to reach the baseline depth. For the remaining nine soundings, at least two of the

three soil behaviour type indices ( $\Delta_Q$ ,  $B_q$  and  $I_{c-JD}$ ) indicate the presence of clay-like soils below the depth of the baseline level. These clay-like soils may correspond to historic dumps. This observation is consistent with our hypothesis that the failure occurred due to shearing through the legacy slimes. It is worth noting that in several soundings clay-like soils are also identified above the baseline level. We believe this reflects the fine-grained nature of the tailings generated at Jagersfontein.

FIGURE 27 PROFILES OF CPT01: (A) CONE TIP RESISTANCE  $Q_T$  (B) SLEEVE FRICTION  $F_S$  (C) DYNAMIC AND INTERPOLATED  $U_0$  PORE PRESSURES (D)  $\Delta_Q$  (E)  $B_Q$  AND (F) SOIL BEHAVIOUR INDEX  $I_{C-JD}$ .

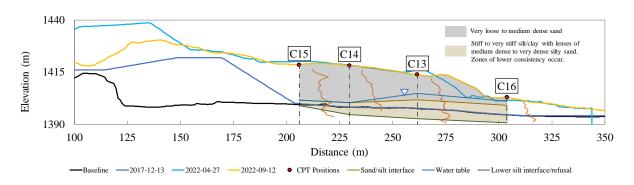
FIGURE 61 CROSS SECTION PROFILE SHOWING MATERIAL ZONES FOR STABILITY ANALYSIS.

A representative cross section profile through the dam embankment as informed by the CPTu investigation is presented in Figure 61. For the purposes of compiling this profile, the soil classification identification chart by Jones and Rust (1983) was used in addition to the methods referred to earlier in this appendix as, in addition to offering a soil description, this method also indicates the soil consistency. This method employs penetration resistance and dynamic pore pressure for material identification. As such, it can only be employed in the saturated zone. The method generally offers material identification at a higher resolution than methods employing sleeve friction as the latter is measured over a certain length of the probe shaft, while dynamic pore pressure is measured at a single position just above the cone shoulder.

In general, the downstream slope profile probed can be subdivided into an upper coarse and lower fine-grained zone. The coarse material represents the coarse tailings (grits) which generally classified as a sand. The consistency varies from very loose at the surface, with density increasing with depth, generally to a medium dense consistency above the underlying fine-grained material. The fine-grained material is not homogeneous. This material classified as a dense silty sand at C10 and clayey silt at C15, interbedded with layers that classified as stiff clayey silt or clay at C6, C13 and C14. The fine-grained material appeared most heterogeneous at C11 (near the embankment toe) where alternating

layers of loose silty sand, very soft clayey silt and firm clay occurred. The consistency of the fine-grained material was found to be lower closer to the toe of the dam.

The phreatic surface as inferred from the piezocone investigation occurs above the interface between the coarse- and fine-grained material, implying that the fine-grained material was saturated at the time of the piezocone investigation. It is therefore reasonable to assume that the fine-grained material was also saturated at the time of the failure in Sept 2022.

In addition to penetration resistance, sleeve friction and dynamic pore pressure, the SCPTu investigation included measurement of the shear wave velocity at locations C13 to C16 (Figure 2). Qualitative plots of shear wave velocity are included in Figure 61. A higher shear wave velocity indicates soil of greater shear stiffness. There appears to be some evidence of a somewhat reduced shear wave velocity just above the depths of refusal (C13, C15 and C16). This may be indicative of the depth where the slip surface passed through, although the shear zone cannot be located with complete certainty from the information available. The detailed seismic CPTu results are included in Attachment F3.
