Report Number: P WMA 06/D00/00/3423/2

# Greater Mangaung Water Augmentation Project Site Visit Report

## Xhariep Pipeline Feasibility Study

| <b>Date</b> | : | 04 September 2023 |

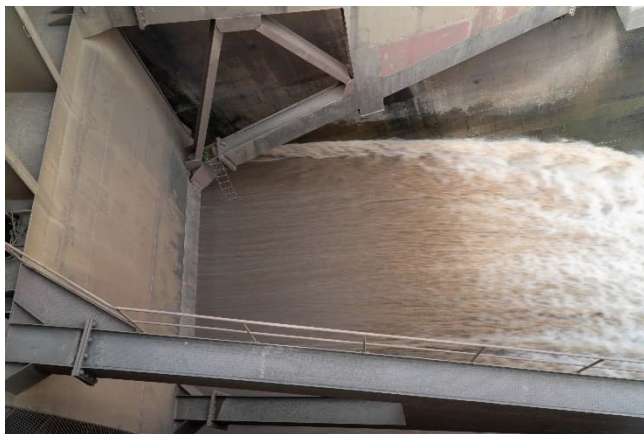
- ▶ Evidence of the siltation of the dam basin is clearly visible and most of the dam basin is covered with reeds.
- ▶ Releases from Knellpoort takes roughly 1.5-2 days to reach Welbedacht with high (50% according to the operators) losses along the route.
- ▶ Upstream scouring of the dam basin is not effective as only two sluice gates are functioning.

**Figure 3-31: Sluice Gate 5 open**

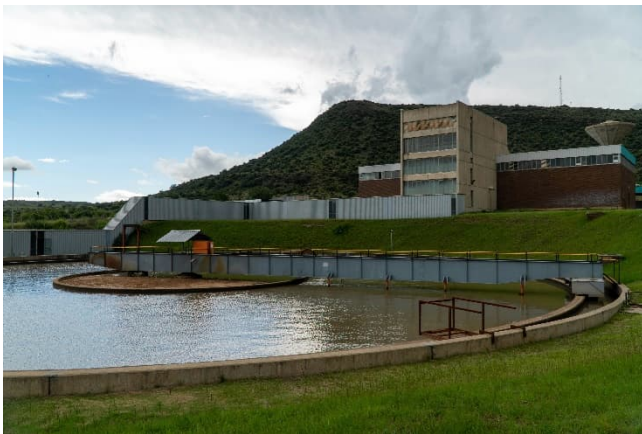
- Primary sedimentation - clariflocculator
    - The rotating bridge and the attached flocculation mixers have reportedly not been functional for over a year. The combined flocculation and sedimentation processes of the clariflocculator cannot function without the mixing and settled sludge collection provided by the bridge. The process is thus compromised and should be repaired urgently. Failing this, both flocculation and sedimentation are inefficient, resulting in

**Figure 3-41: Primary sedimentation - clariflocculator**

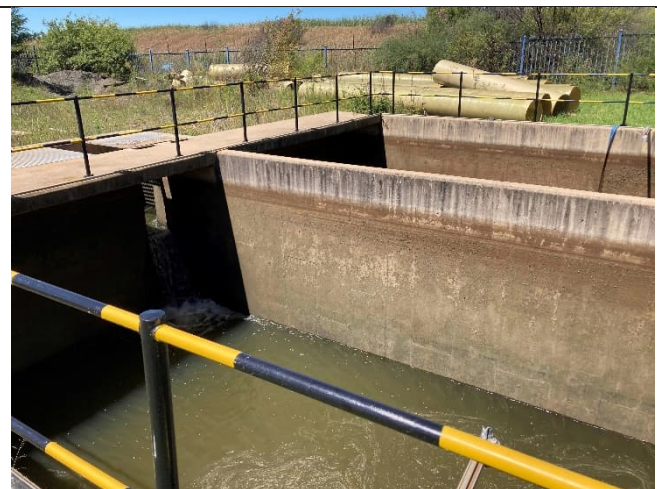
**Figure 3-66: Residuals holding tanks**

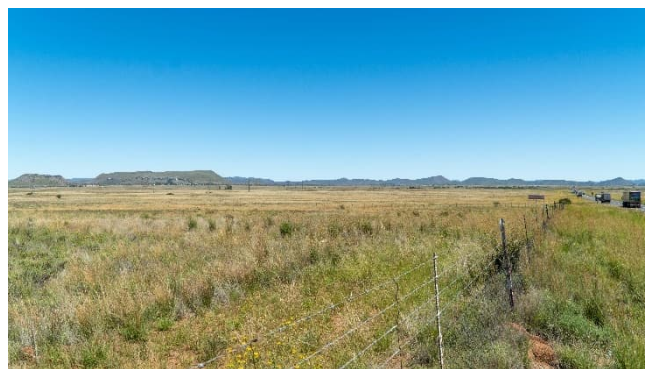
Figure 4-10: View towards the western boundary
