DAM SAFETY EVALUATION REPORT:

ROODEFONTEIN

FOURTH REPORT

MARCH 2020

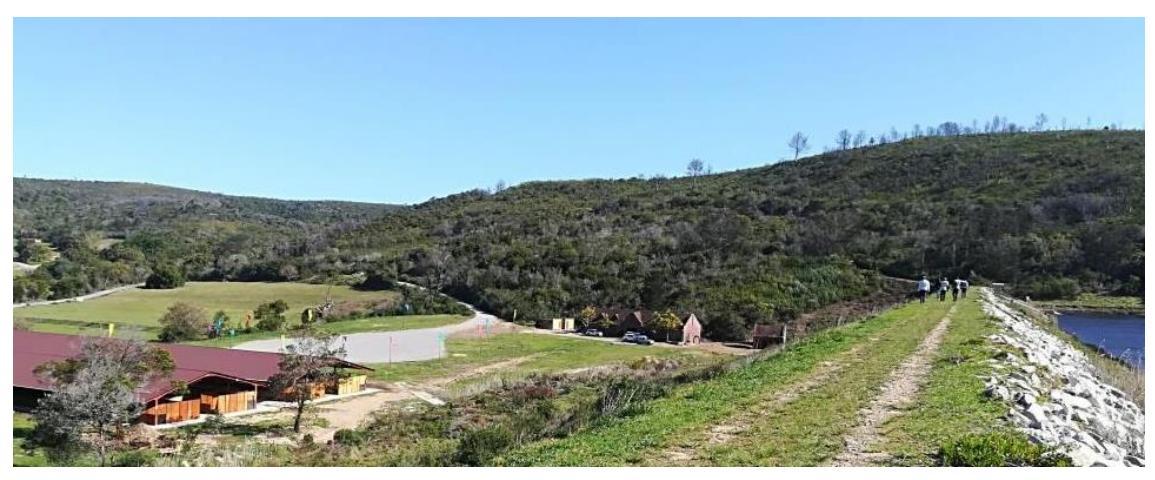
The valley opens up on the downstream side of the dam. This side of the dam has recreational facilities comprising of a golf course, and a newly built horse stables, refer to Figure 19 below.

Figure 19: A valley downstream side of the dam with a newly built horse stables

- j) Department should determine an appropriate action concerning the newly built horse stable downstream of the earthfill embankment.
- k) Rehabilitate the earthfill embankment in order to address the horizontal crack on the embankment and the slope instability.

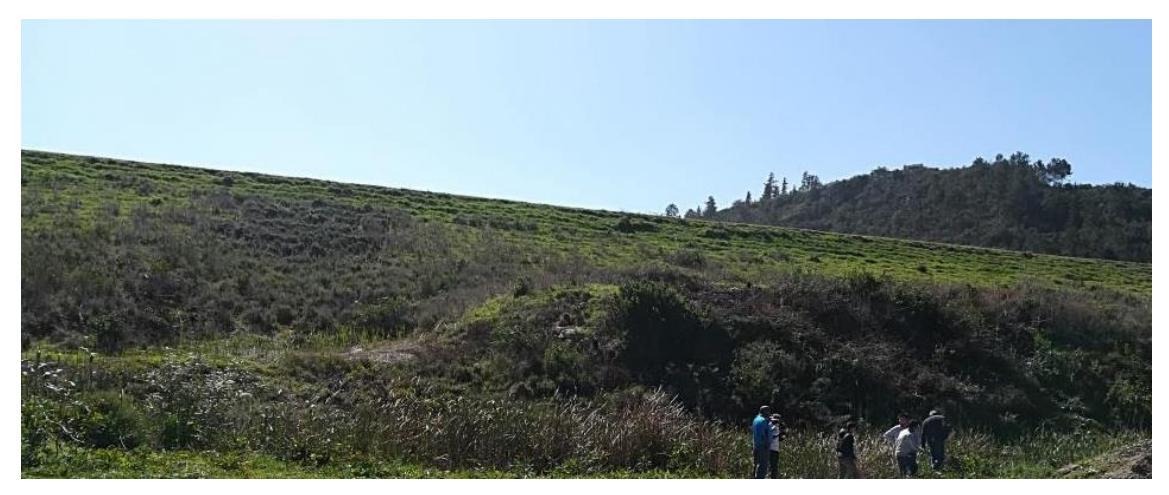
A layer of crimping grass protects the downstream slopes, see Figure 33 and Figure 34 below. As mentioned in the previous sub-section, the grass layer was well taken care off and it was performing satisfactory.

Figure 33: View of the downstream slope from the toe.

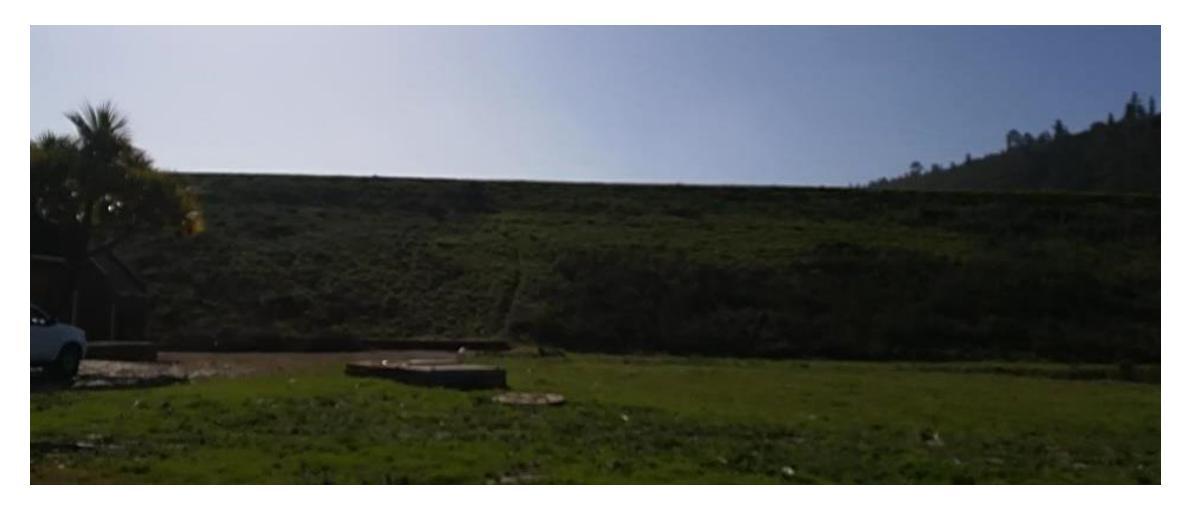
Figure 34: Grass protection on the downstream slope of the dam.

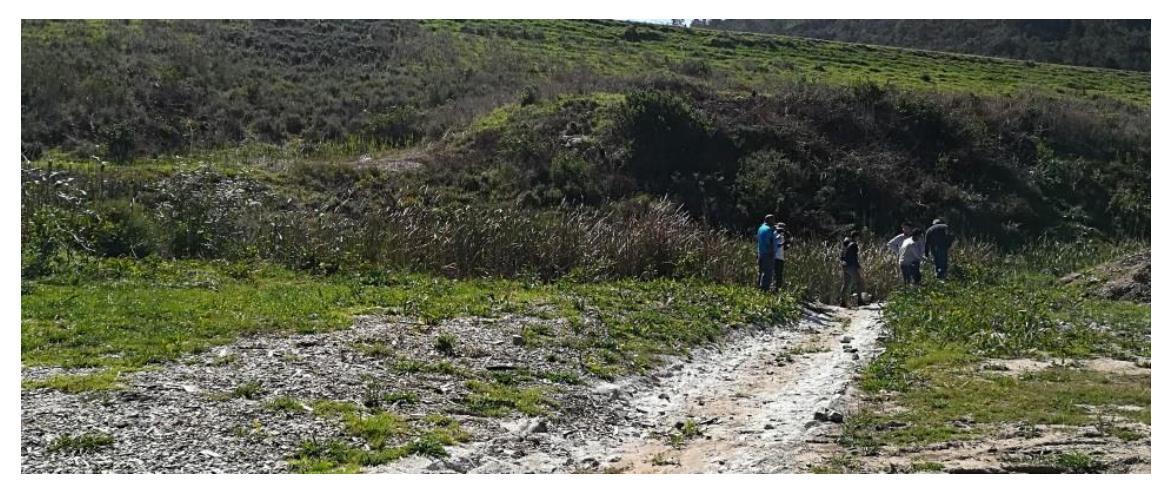
A lined-channel from the downstream property discharges into the toe-channel of the dam and therefore, the amount of water ponding downstream of the dam increases due to this new structure, see Figure 39.

Figure 39: Lined Surface drain from the downstream property discharging into the Toe-Channel

- i) Request owners of the property immediate downstream of the dam to re-route the newly installed surface drain away from the dam to avoid saturating the toe of the dam which might trigger slip failure of the earthfill embankment.

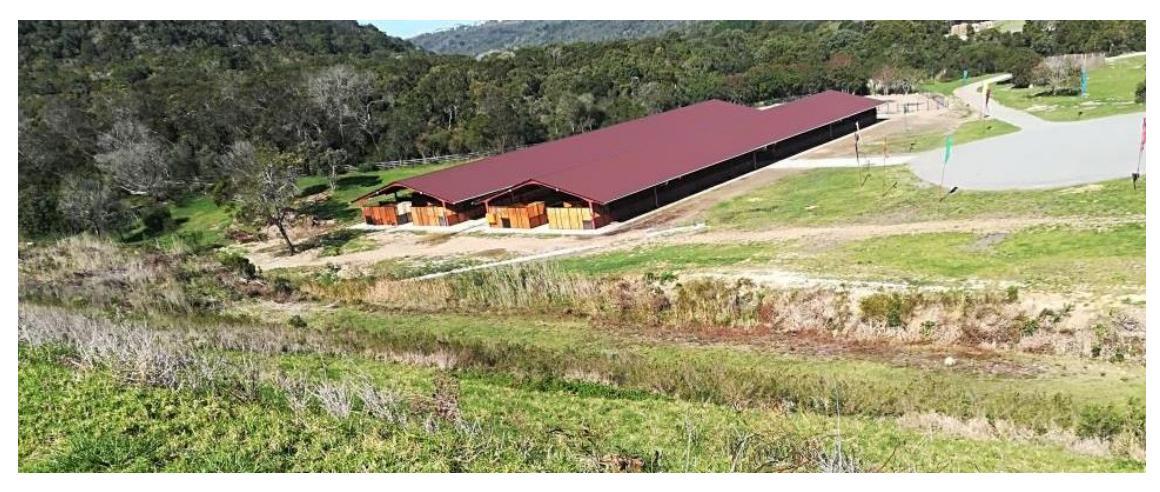
A new horse stable has been constructed on the downstream side of the dam. This new structure is located less than 100 m from the toe of the dam, see Figure 46 and Figure 47.

Figure 46: A horse stable constructed on the downstream of the dam wall

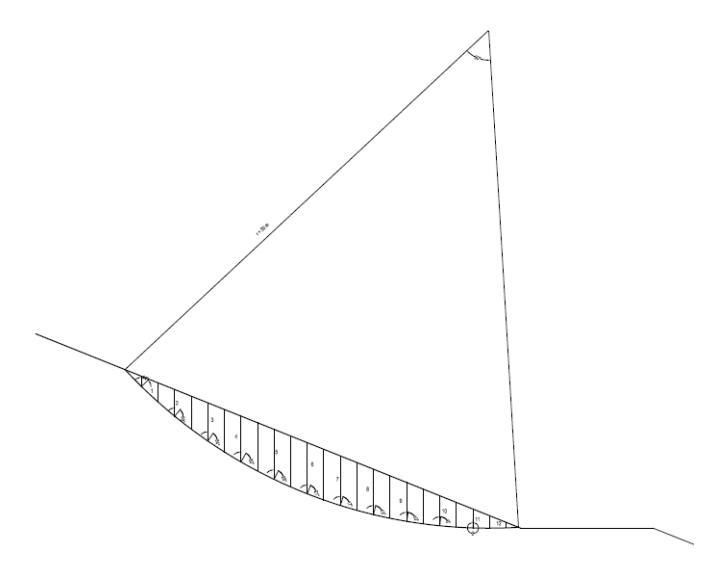
Figure 1: Trial slip circle

The trial slip circle used to determine the safety factor for the downstream slope is shown in Figure 1 and the used input parameters relevant to the slip circle are listed below.

- a) Steady state seepage.
- b) Rapid drawdown.
- c) Steady state combined with Earthquake.
- d) Rapid drawdown combined with earthquake.
