# Der Brochen Dam

## FOURTH DAM SAFETY EVALUATION REPORT

DAM SAFETY INSPECTION CARRIED OUT ON 27 JULY 2010 AS  
REQUIRED IN TERMS OF GOVERNMENT NOTICE R. 1560 OF JULY 1986

February 2011

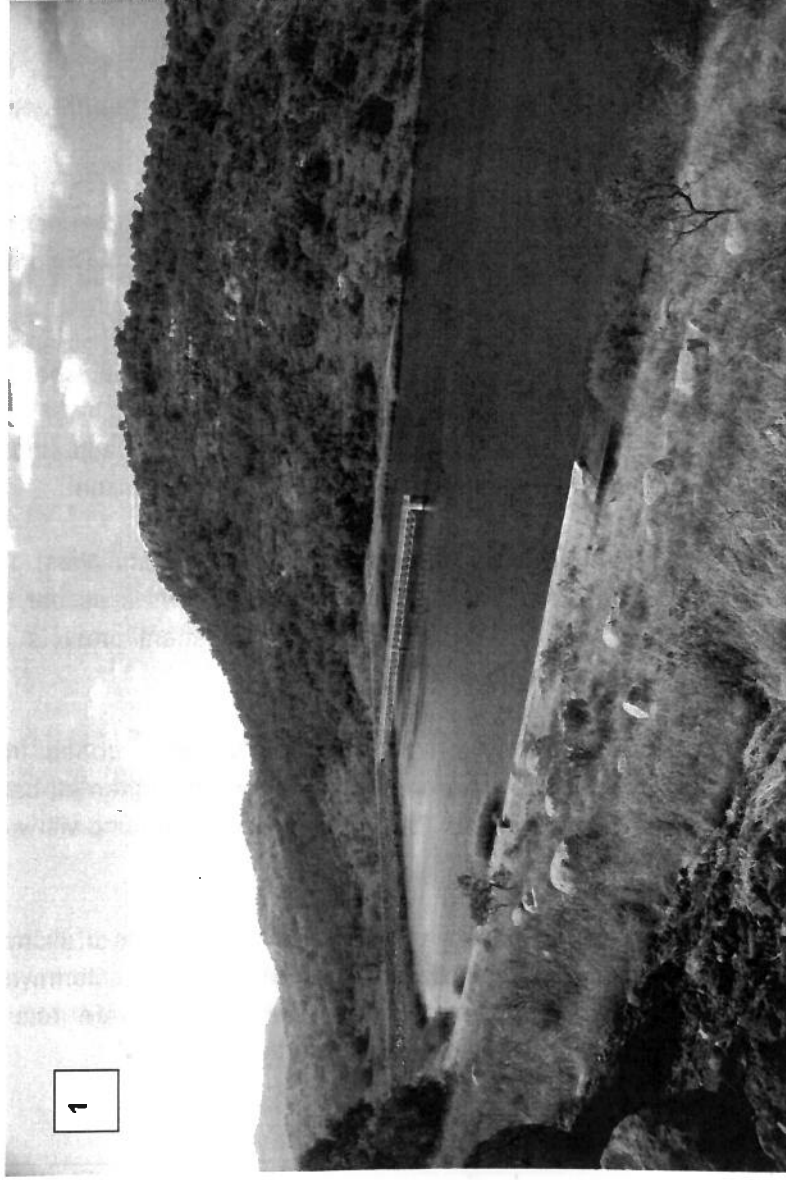
1

View of the upstream face of the earthfill embankment and intake tower (Photo 1)  
and side-channel spillway on the left bank (Photo 2)

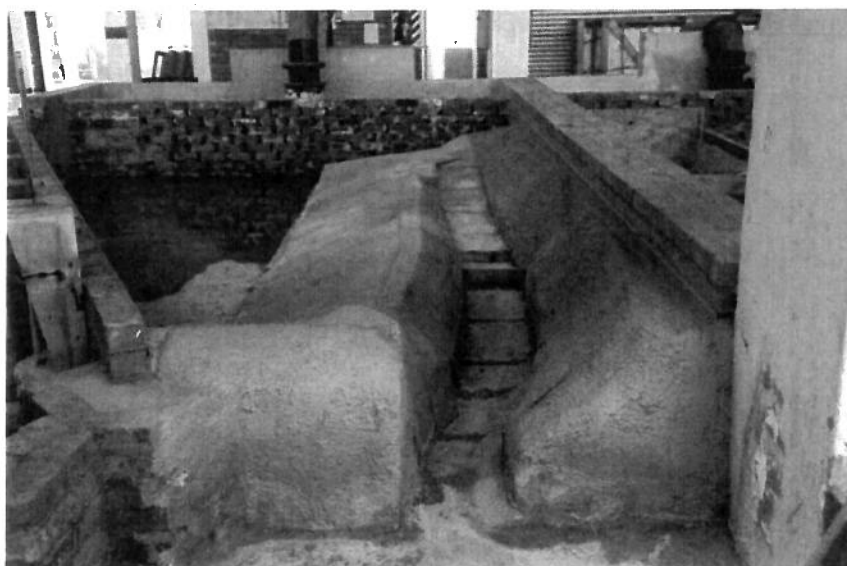
**Photo 4: Hydraulic model in Pretoria West**

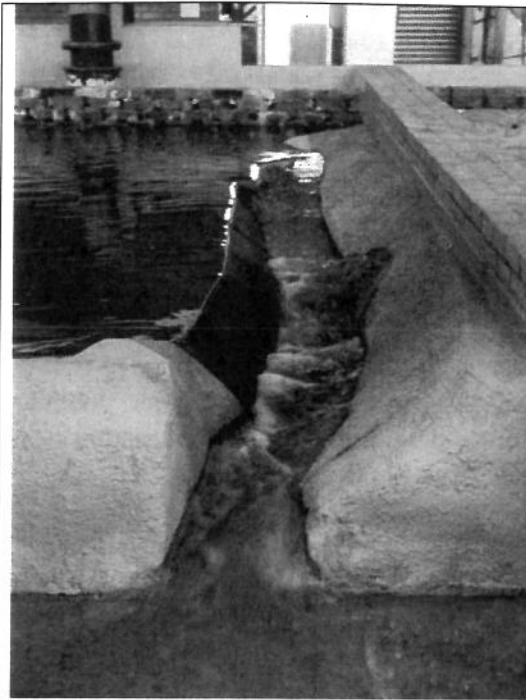
**Photo 5: Flow of 300 m<sup>3</sup>/s**

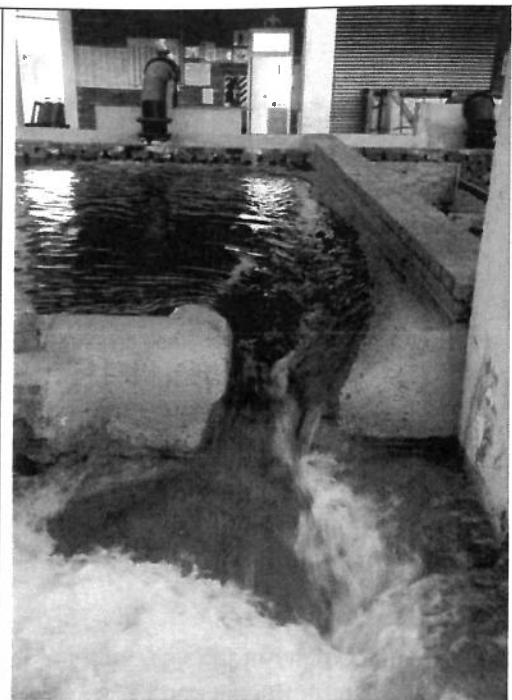
**Photo 6: Flow of 700 m<sup>3</sup>/s**

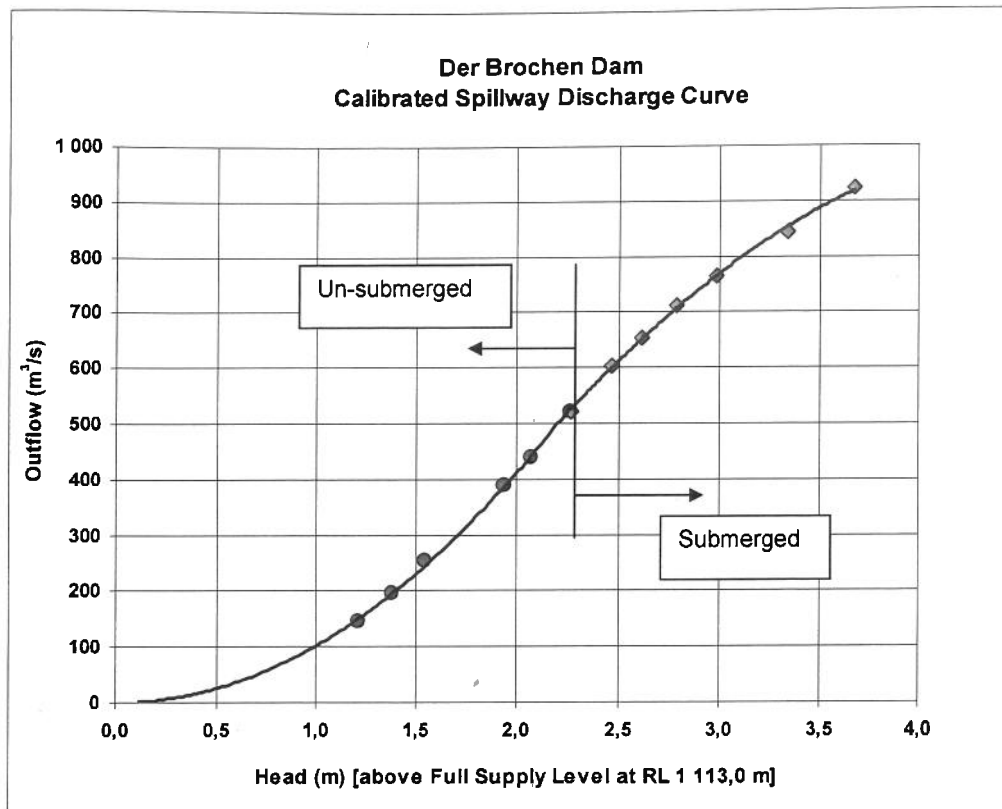
**Figure 5.1** shows the maximum spillway capacity. The maximum capacity at the design NOC at RL 1 116,5 m was calculated at 886 m<sup>3</sup>/s. The discharge capacity at the surveyed (2010) crest level of RL 1 116,0 m is 764 m<sup>3</sup>/s.

Figure 5.1: Spillway discharge curve

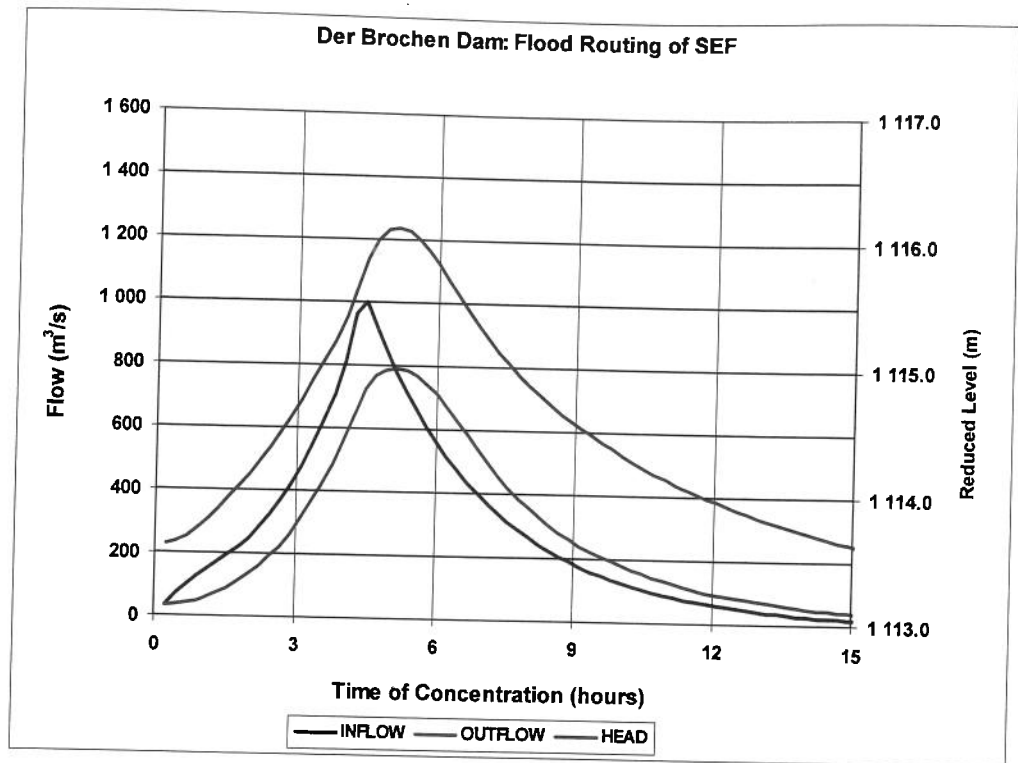
Routing of the inflowing peak of 1 000 m<sup>3</sup>/s was done. The out flowing peak was determined as 793 m<sup>3</sup>/s. This is less than the spillway capacity if the NOC would be at RL 1 116,50 m. Figure 5.2 shows the flood routing.

Figure 5.2: Routed flows (Van Deventer 2010)

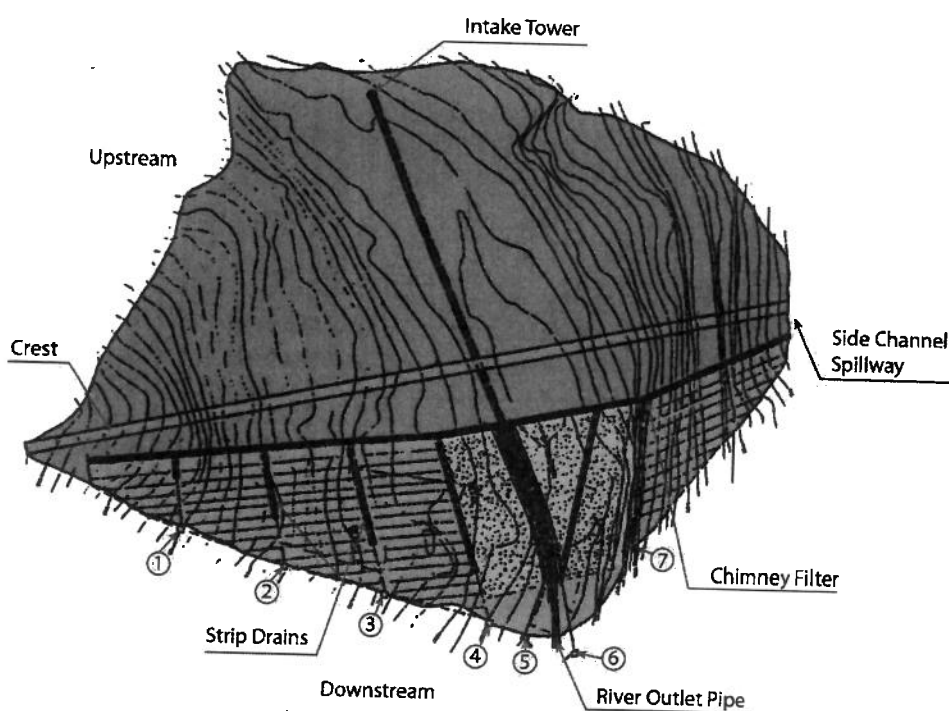
Seven (7) shallow manholes without lids collect and monitor seepage water from the internal chimney and blanket drain by means of strip drains. Refer to **Figure 6.1**.

**Figure 6.1: Manholes and collector strip drain layout**

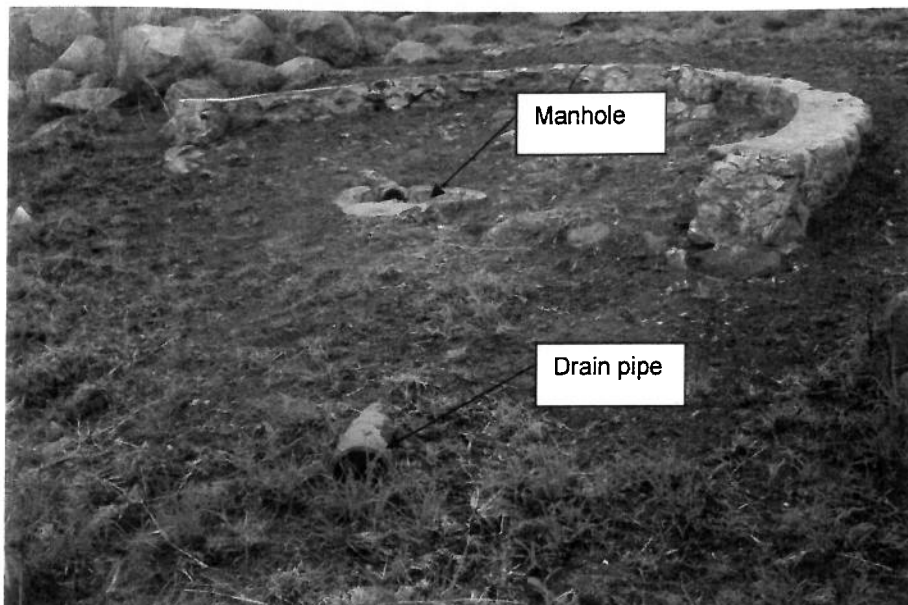
**Photo 8: Typical manhole layout (2010/11/17)**

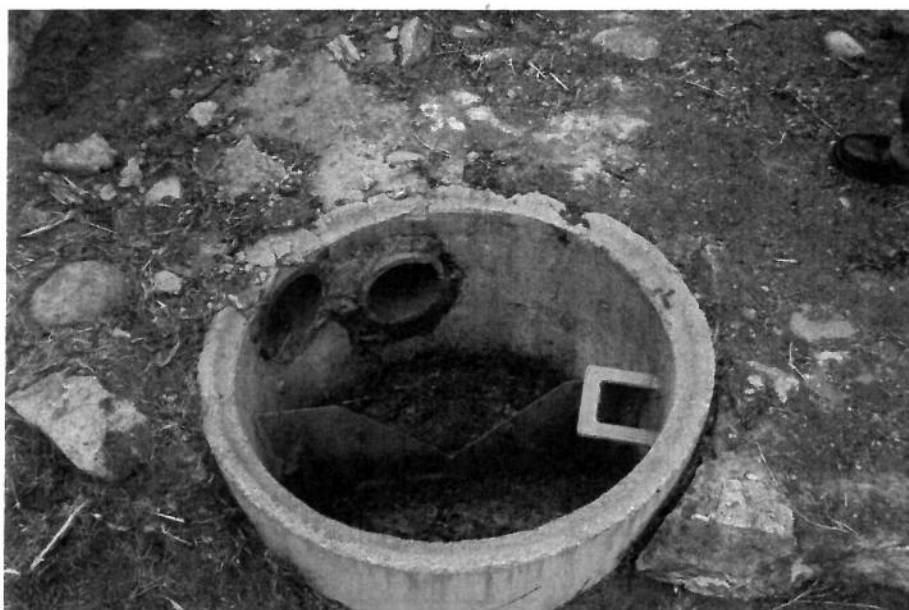
**Photo 9: Detail of a manhole (2010/11/17)**

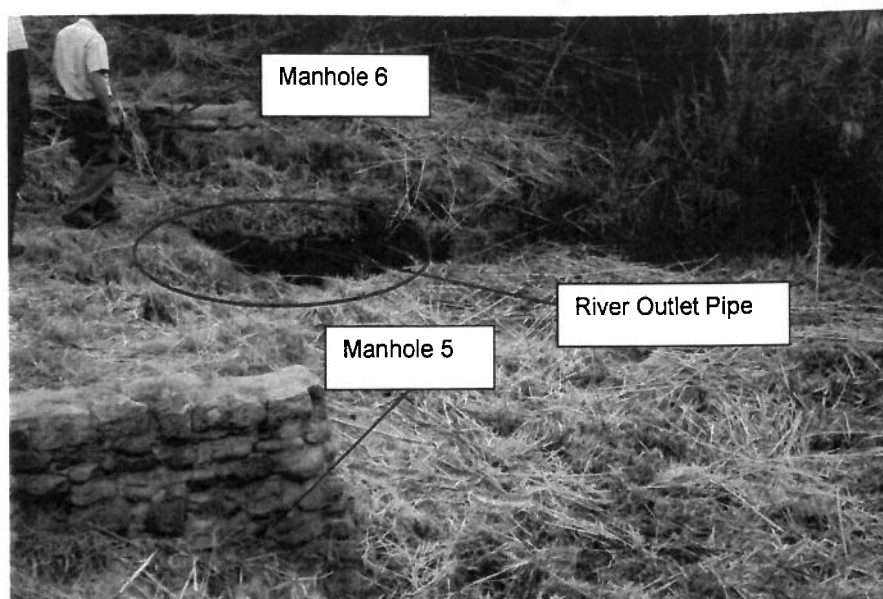
**Photo 13: Outlet pipe to river (2010/11/17)**

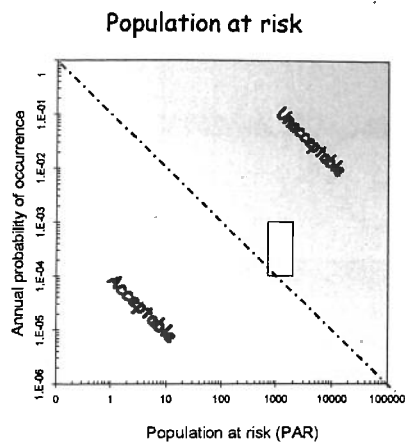
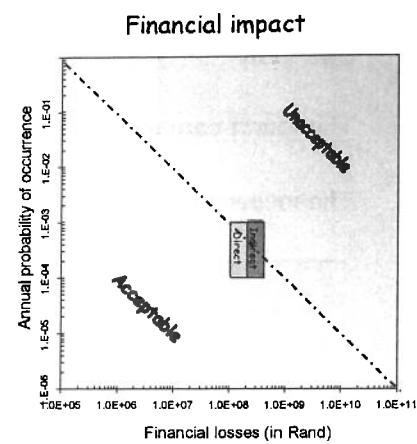
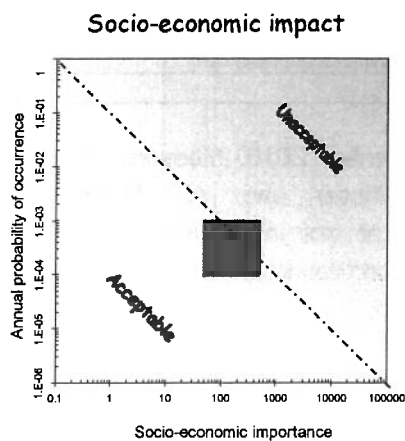
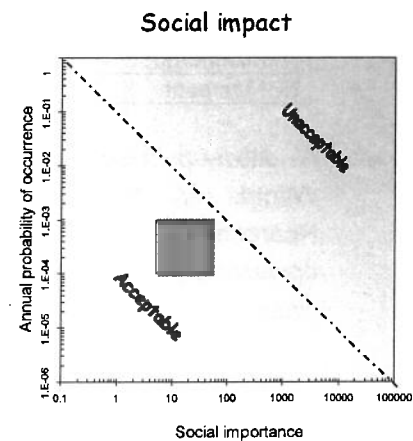
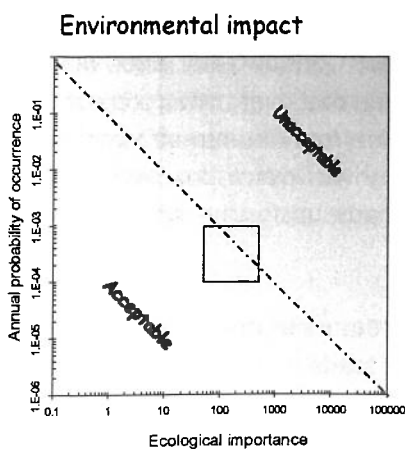
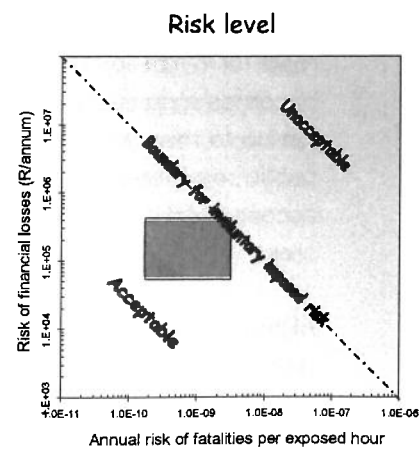
The different impacts resulting from a dam failure were determined using graphs (Oosthuizen: 2000). The results are presented in **Figures 9.1 to 9.6**. From these graphs it is determined that the population at risk is *unacceptable*, the financial impact, approached unacceptable, and the the socio-economic impact, the social impact as well as the ecological impact are all relatively *acceptable*.

Using the methodology described by Oosthuizen (2000), it was determined that 20 to 30 persons could lose their lives as a result of a dam failure (refer to **Appendix L**). According to the slope stability analysis as well as the visual inspection there was no apparent deficiency, the probability of failure of the dam was assumed to be between  $1 \times 10^{-3}$  and  $1 \times 10^{-4}$ . Using this, the annual risk of fatalities per exposed hour was calculated to be between  $3,3 \times 10^{-9}$  and  $1,7 \times 10^{-10}$  and the risk of monetary losses to be between R 54 000/annum and R 420 000/annum. These values were used to determine the risk level (see **Figure 9.6**). According to **Figure 9.6** the risk level of the dam is approaching unacceptable.

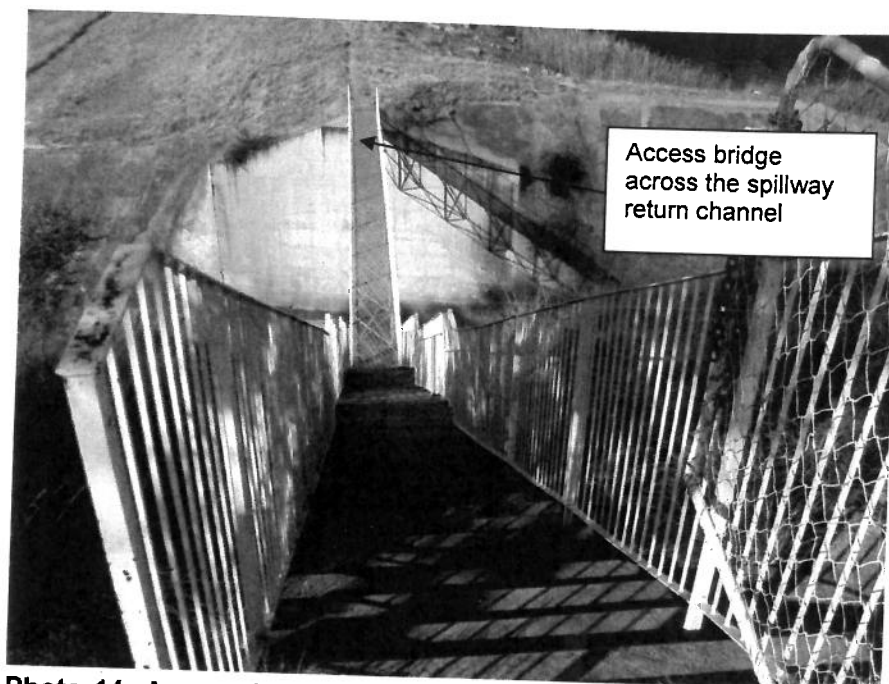
**Photo 14: Access bridge over side channel spillway for access to the earthfill embankment**

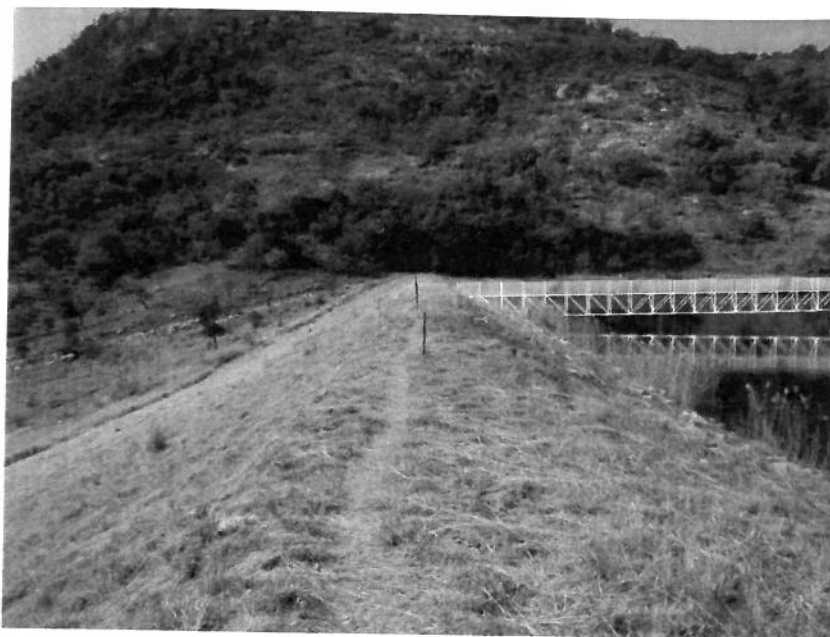
The NOC is covered with thin grass cover. Minor signs of local settlement are present on the crest, but no animal burrows, cracks or holes are present. Settlement has occurred under the support of the inlet tower bridge, as well as on the right abutment of the bridge across the spillway. The crest is uneven causing, downstream erosion due to surface water not being drained upstream. It is recommended that the crest be shaped to ensure proper surface run-off, as part of reinstating the design freeboard. This will also prevent ponding of water. Trees close to the toe of the wall should be removed.

**Photo 16: Non-overspill crest of the earthfill embankment on the left hand side of the Intake Tower access bridge seen on this photo. The grass on the upper portions of the dam was cut.**

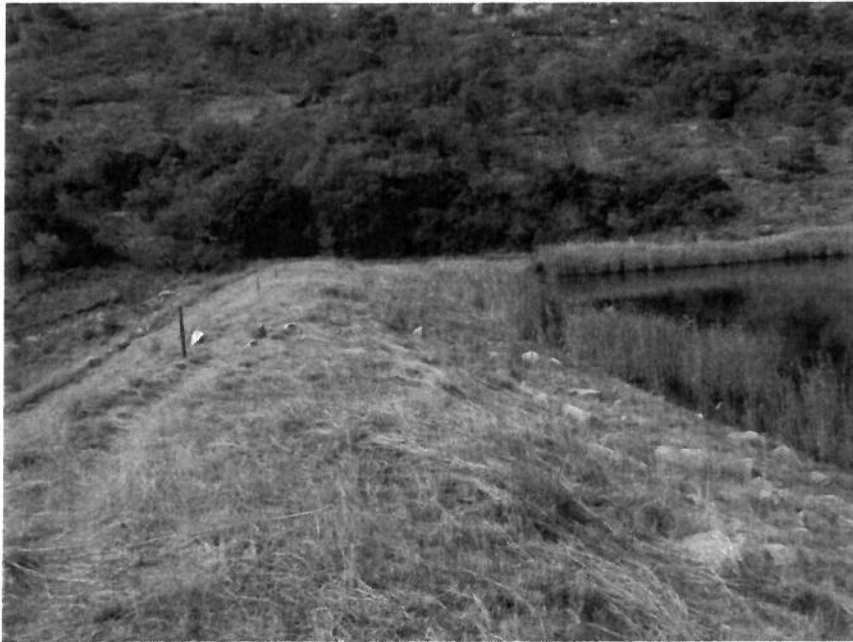
**Photo 18: Non-overspill crest of the earthfill embankment on the right hand side of the access bridge towards the Intake Tower. The grass on the upper portions of the dam was cut.**

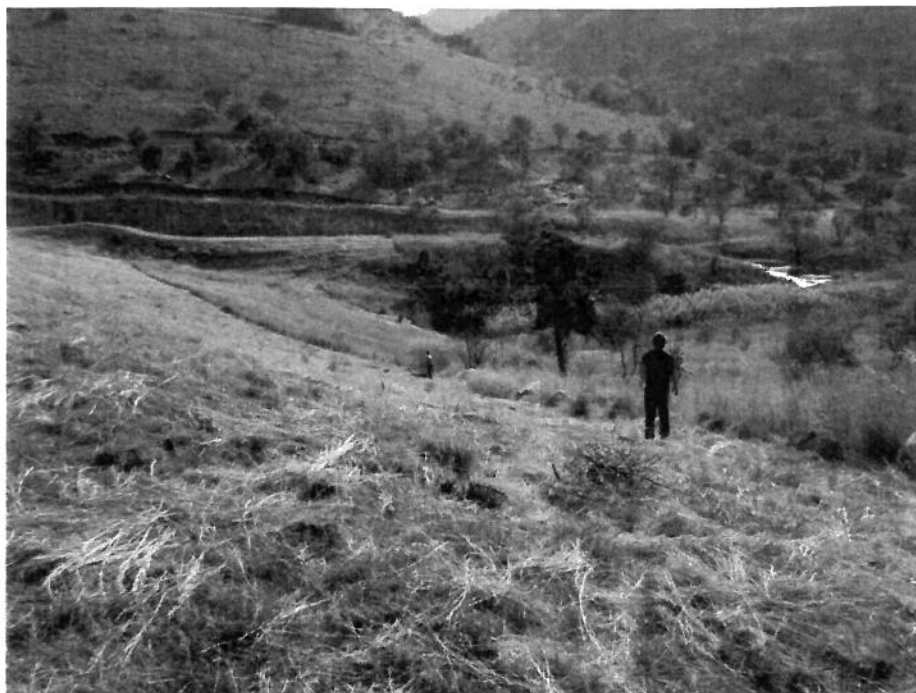
The downstream slope protection consists of grass cover. The grass was partially cut during the first inspection, and burned during the second inspection, enabling inspection of the slope for seepage and the manholes. No animal/termite activity was noticed. Grass and reeds in the proximity of the gauging weir should be removed. Erosion on the downstream slope close to the downstream toe is evident due to stormwater run-off over a large downstream surface.

**Photo 19: Downstream slope of the embankment seen from the right bank NOC. Cutting of grass took place for only the top half of the dam wall in July 2010. Subsequently, the cutting was completed and the slope burned.**

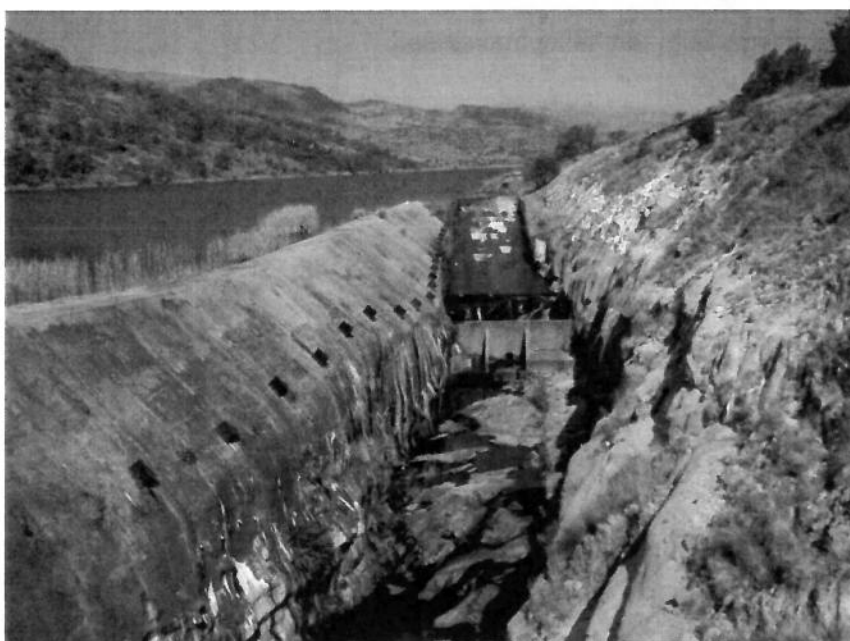
**Photo 25: View of side channel spillway from the pedestrian foot bridge.**
