# DEPARTMENT OF WATER AND SANITATION

## Determination of Water Resource Classes, Reserve and the Resource Quality Objectives in the Keiskamma and Fish to Tsitsikamma Catchments

### WP11354 River Field Survey Report 2

REPORT NO.:  
WEM/WMA7/00/CON/RDM/1423

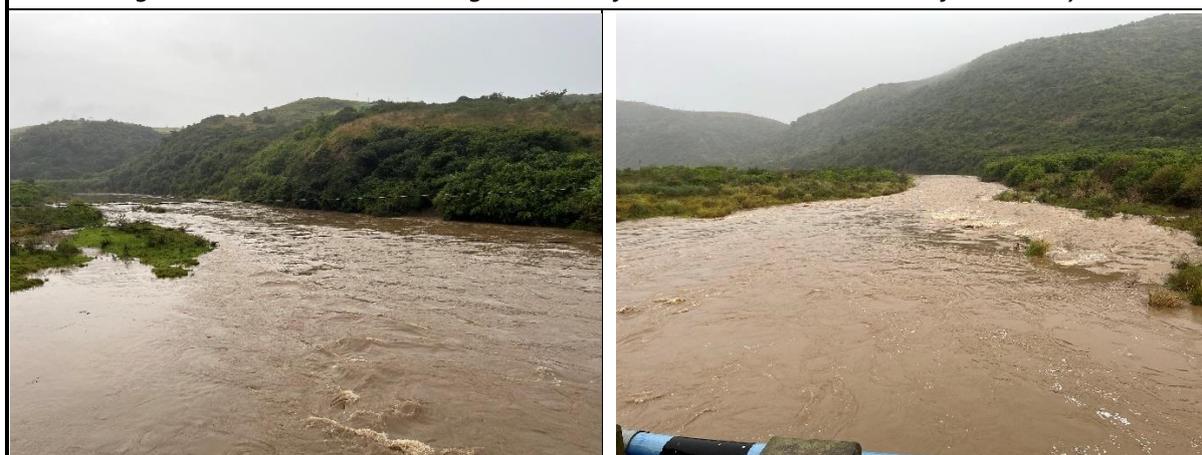
Owing to constant rainfall conditions at the time of the May 2023 survey, saw the Mthatha River in flood and burst banks. Consequently, only water and slope levels could be measured, and the riparian vegetation assessed.

*Drone images could not be taken owing to the rainfall conditions at the time of the survey.*

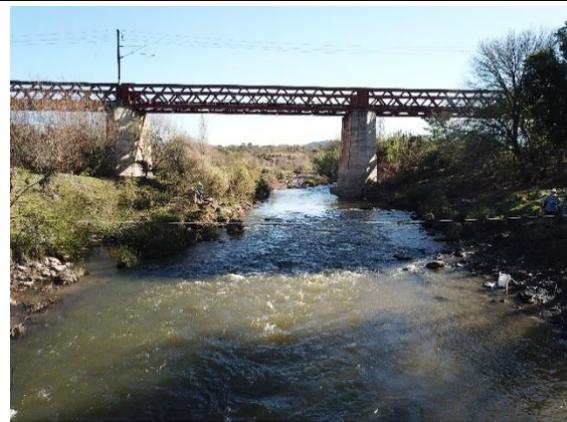
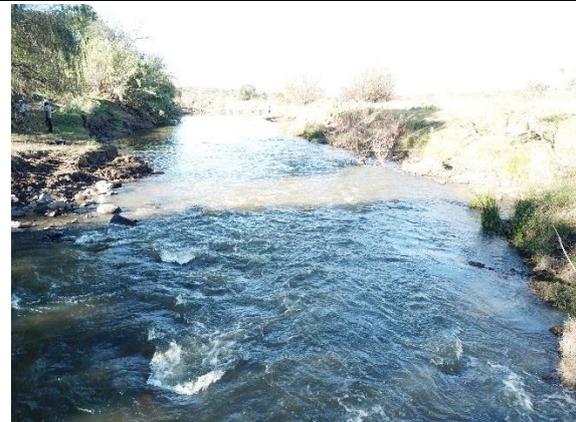
Following the flood event that took place in February 2023, clear evidence of bank collapse and further bank erosion was observed, particularly along the left bank. This was exasperated by the continued cattle trampling and grazing along that bank.

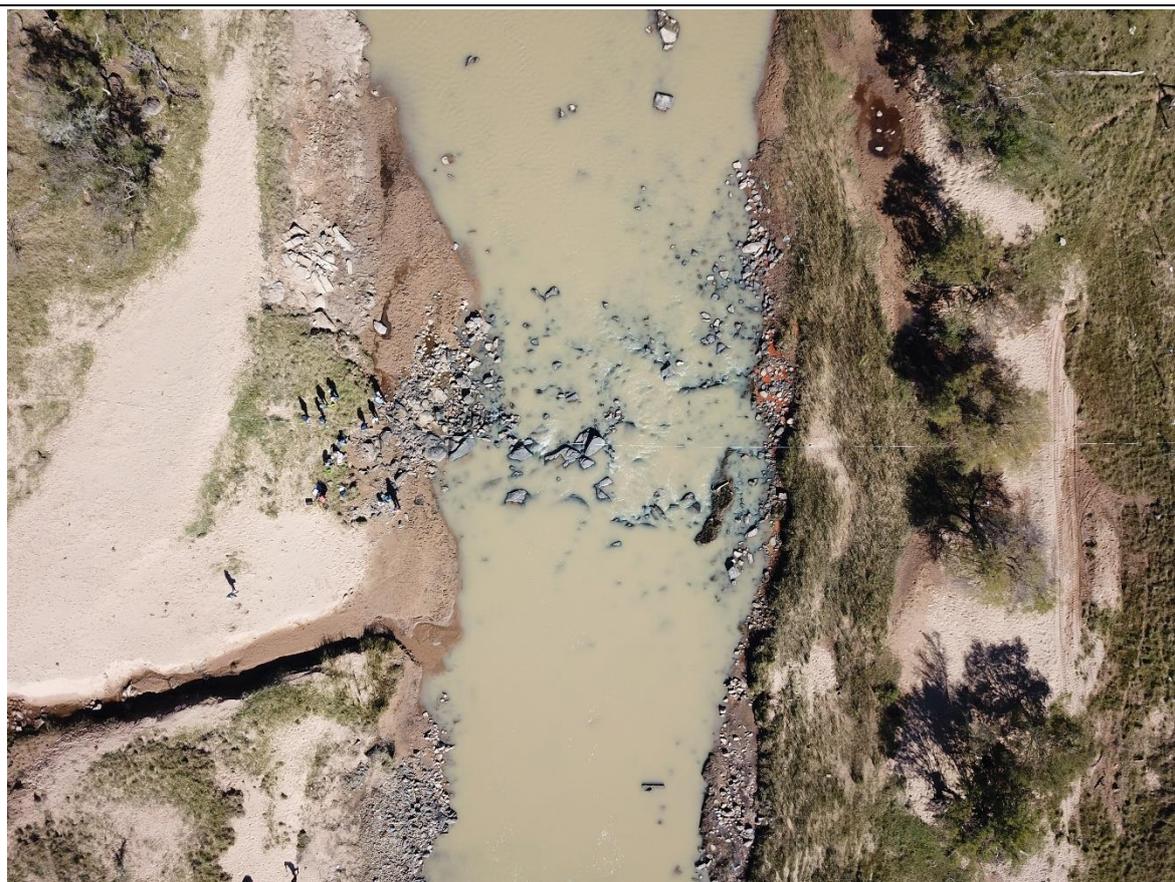
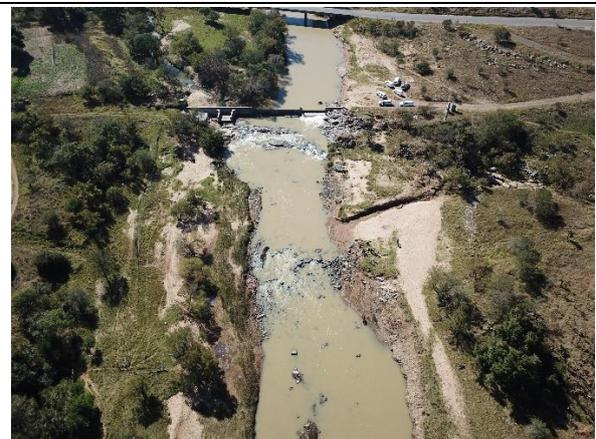
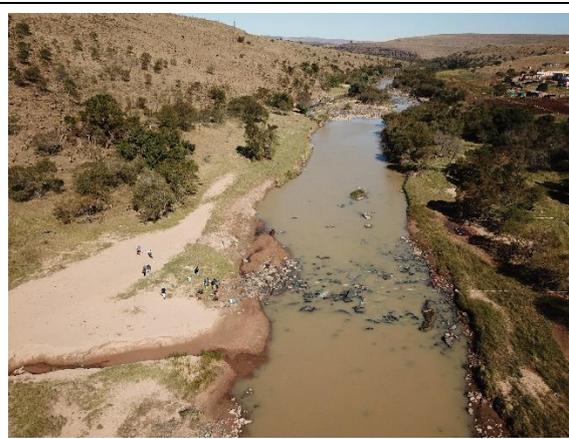
The marginal zone had been mostly scoured out by recent floods with only remnants of vegetation clumps scattered between bedrock/boulder/cobble with newly deposited alluvia in-between. Vegetation comprised mostly *Cyperus longus*, *Gomphostigma virgatum* and *Hemarthria altissima*, although the latter had been grazed to form lawns. Flood benches and the floodplain were extensively covered by new, mostly unvegetated sediment deposits from recent floods and flood damage and flood-related plant deaths were extensive. The *Vachellia robusta* population which had dominated the floodplain before has been vastly reduced, although much remained, and dominance persisted. Other floodplain species included *Ficus sur*, *Combretum caffrum*, *Gymnosporia buxifolia* and *Lantana camara*. The banks were dominated by thickets of *L. camara* and wood removal and overgrazing were extensive.

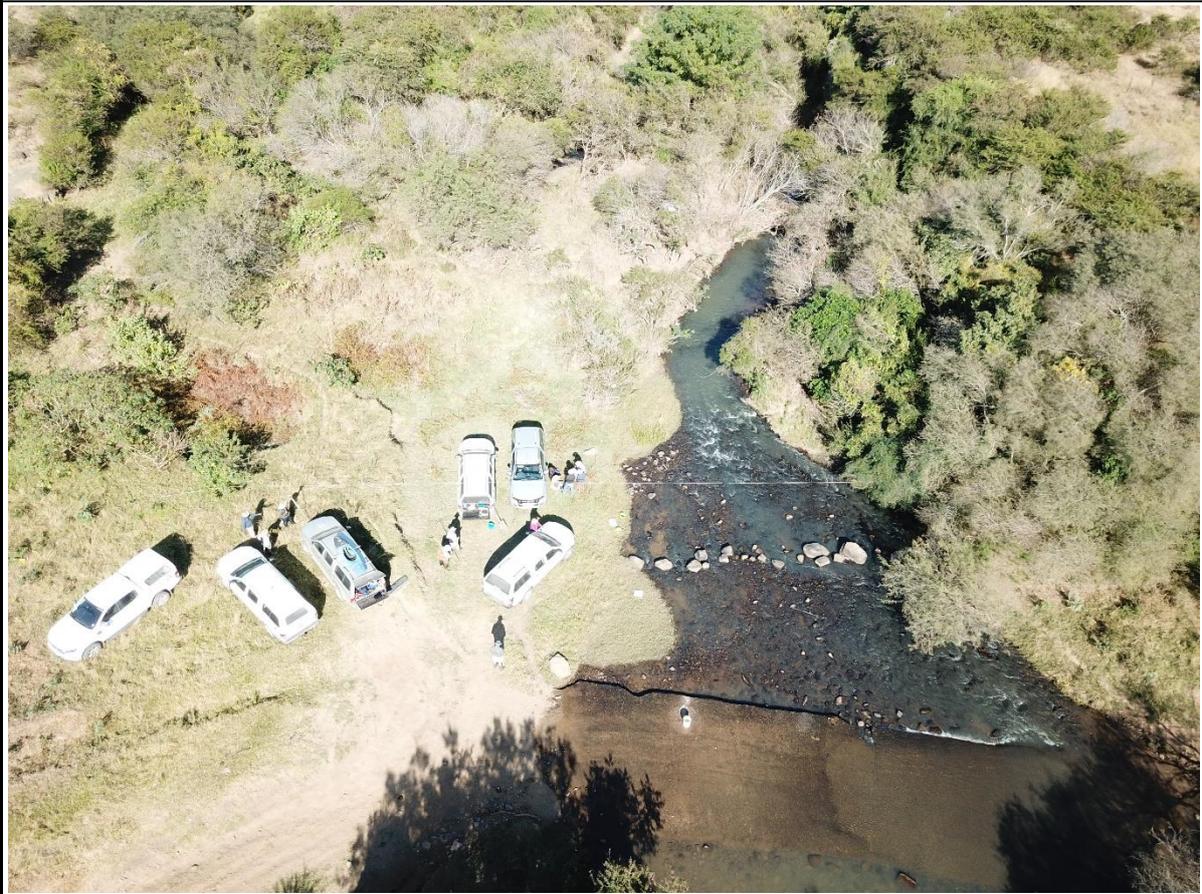
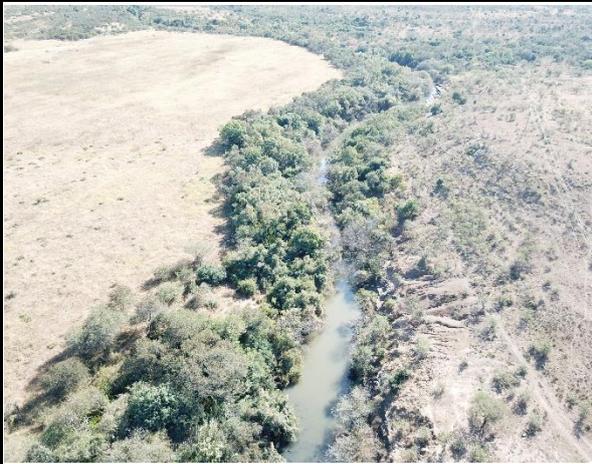
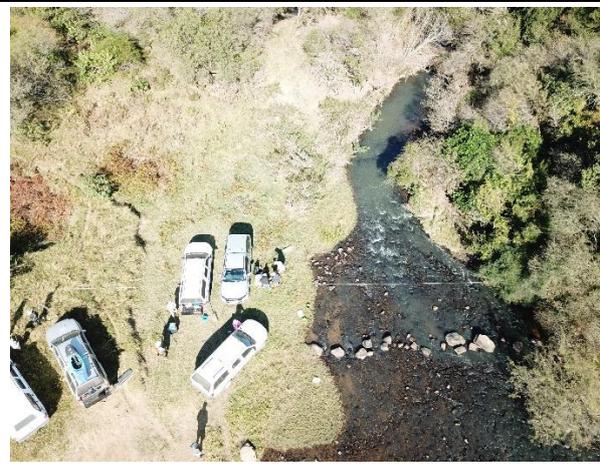
and cobbles along the riffle have a significant silt component, indicating high silt loads during higher flows. This can be seen in the pools with thick silt drapes across the various low velocity habitats. Livestock grazing and trampling is widespread, with localised sand mining along the flood features. There are moderate levels of erosion along the banks, but is more severe at the causeway due to altered flow patterns. Woody encroachment is evident along the channel, with sandy lee bars forming behind thick vegetation. Sand deposition takes place on the lower flood features.

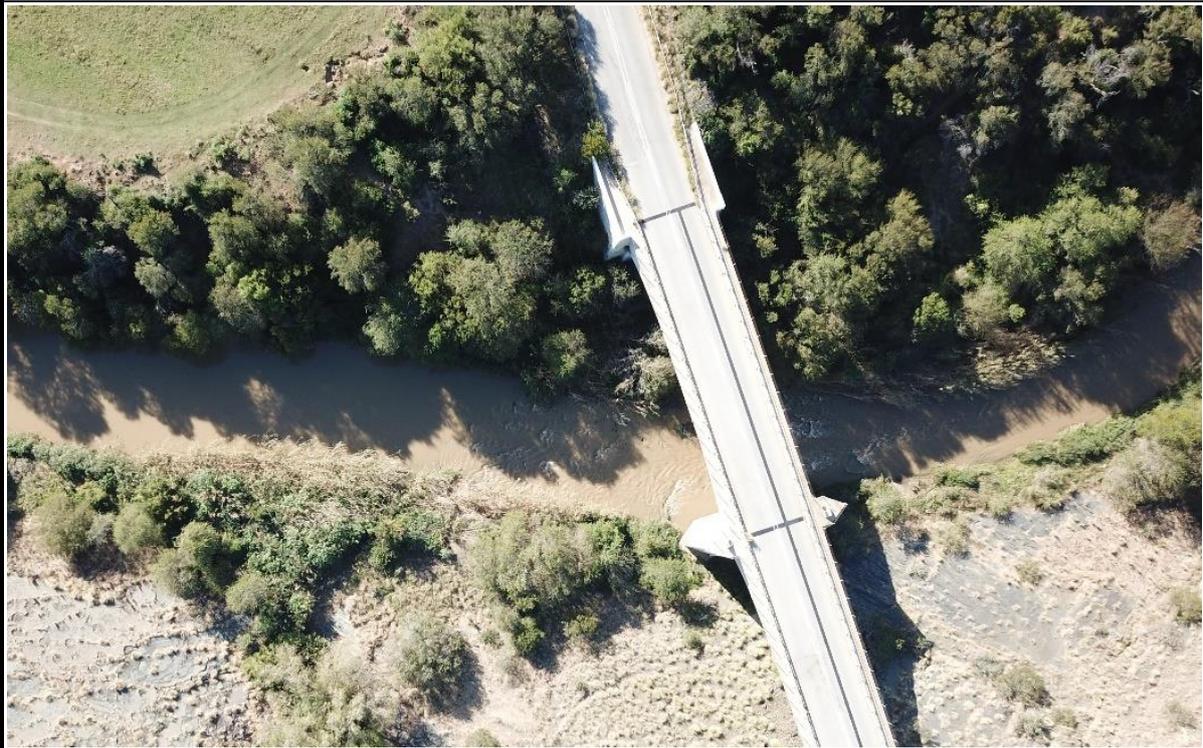
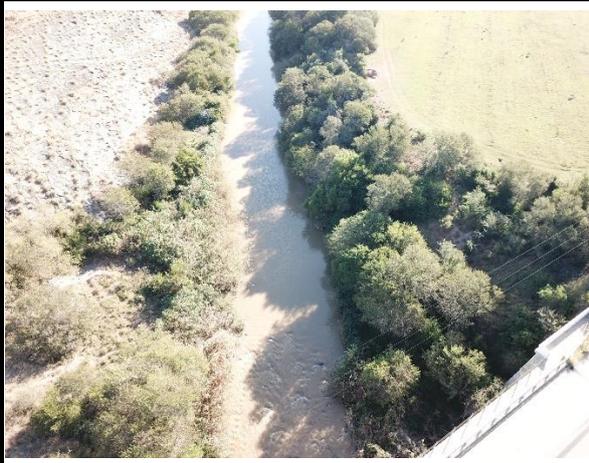
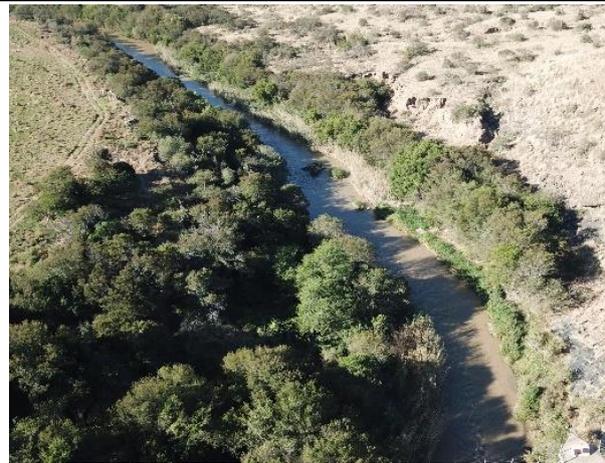
**Site Photographs: Survey 2 (May 2023)**

The site is located in a moderately confined valley setting with a single channel and narrow flood features within a deeply incised macro channel. The channel is straight to wandering and follows the sinuous valley alignment. It follows a pool-riffle and pool-rapid reach type and is dominated by boulder, cobble, gravel and silt sediment types. The banks and benches are composed of fine sand and silt, with bedrock along rapids and along the outer bends. The channel has dense sedge, reed and tree vegetation with some localised trampling where game cross or drink from the channel. Bank erosion is localised and the bed along the riffle has a limited gravel and sand deposits, due to increased flow levels. Siltation takes place along the pools with a silt drape covering slow flowing habitats.

The marginal zone appeared scoured with extensive undercutting of reedbeds and an absence of dicotyledonous forbs such as *Persicaria* and *Ludwigia*. The zone was narrow and confined and dominated by *Phragmites australis* and *Cyperus textilis*. The flood bench was also dominated by non-woody vegetation, notably *Phragmites australis*, *C. textilis*, *C. sexangularis* and *Paspalum distichum*, but with scattered *Vachellia karroo* saplings and young adults. The macro-channel bank was dominated by dense, tall woody vegetation, mainly *V. karroo*, but also *Searsia lancea*. Alien invasive plant species were minimal and comprised mainly *Opuntia ficus-indica* and *Ricinus communis*, as well as annual weed species such as *Tagetes minuta*, *Bidens pilosa* and *Conyza bonariensis*.

- Interbasin Transfer scheme (flow modification)
- Drainage channel
- Cattle trampling and grazing
- Upstream town (Cradock)
- High sedimentation (highly turbid)

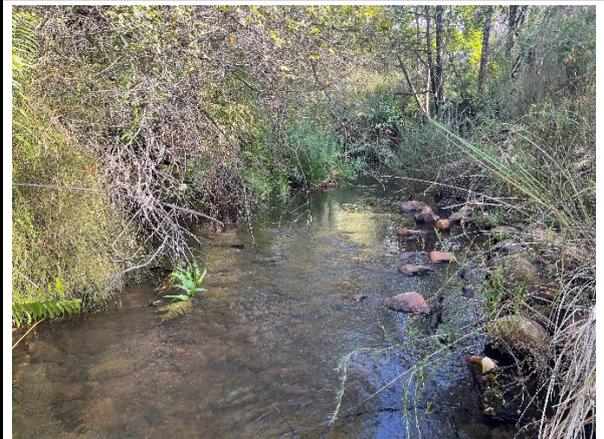
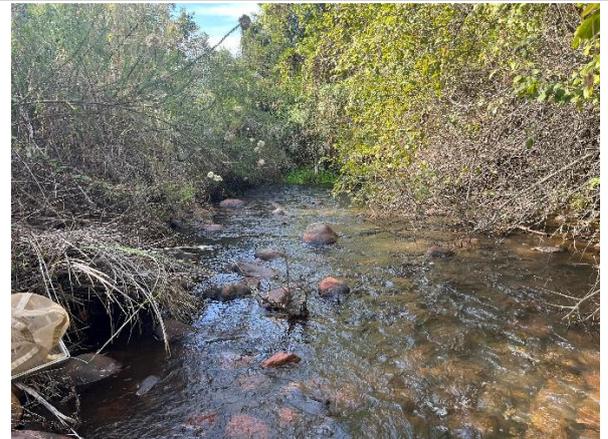
<b>Site Photographs: Survey 2 (May 2023)</b>

The site is located in a partly confined valley setting with a single channel and floodplain along the left bank. The active channel has narrow flood benches and is deeply incised into the valley floor. The channel is straight to wandering and follows the sinuous valley alignment. It follows a pool-riffle reach type and is dominated by boulder, cobble, gravel and sand sediment types. The floodplain, banks and benches are composed of boulder, cobble, gravel and sand, with bedrock cliffs or steep hillslopes along parts of the outer bends. The channel is densely vegetated with shrubs, sedges and tall grasses. There were very limited signs of grazing and trampling along the banks. Undercut banks and bank erosion is fairly common and the bed along the riffle and pools have very low embeddedness, possibly due to sediment starvation caused by the Groendal Dam. Small inset benches are forming and are composed of medium sand.

The channel was confined and bedrock controlled with some lateral sediment deposition which supported patches of grass (*Leersia hexandra*) and sedge (*Schoenoplectus decipiens*), but the marginal zone was mostly narrow and limited to sedges and waterfern (*Cyclosorus interruptus*) with overhanging shrubs (*Cliffortia strobilifera*). *Prionium serratum* was also present but only small pockets here and there. Banks were either non-vegetated loose cobble or vegetated with mainly shrubs (*C. strobilifera*) and tall trees (*Podocarpus falcatus*). A flood terrace dominated by cobble/ boulder was terrestrial, mainly Fynbos species such as *Erica*.

- Upstream Groendal Dam
- Limited impacts (conservation area – Groendal Nature Reserve)

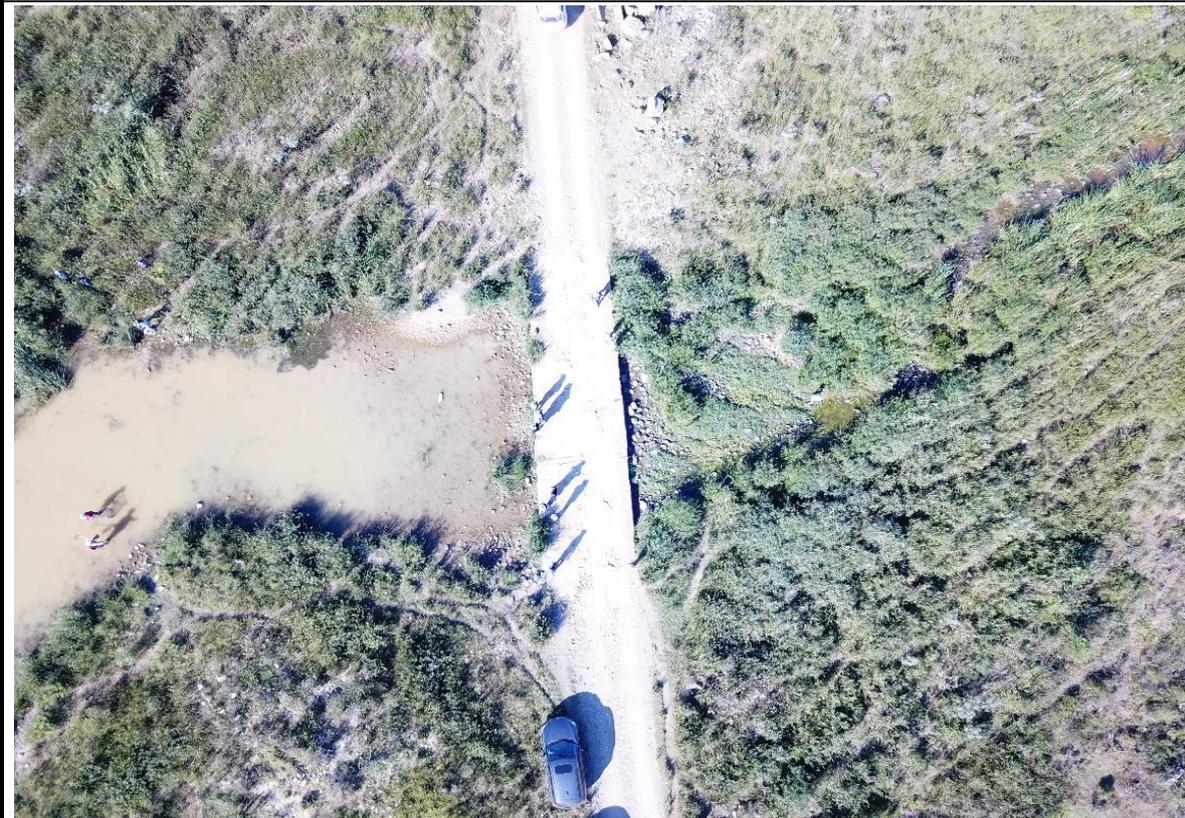
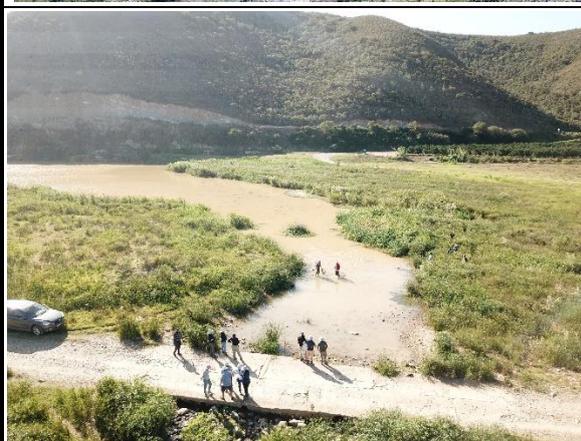
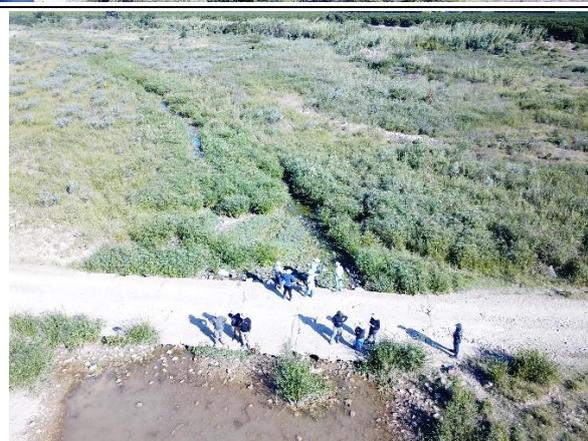
Site Photographs: Survey 2 (May 2023)

The site is located in an unconfined valley setting with a single channel and floodplain along both banks. The valley floor is composed of cobbles, boulders and gravel with a fairly shallow channel. Inset benches and shallow flood channels are present. Terraces and alluvial fans are common along the valley floor and buffer the channel from the steep hillslopes. The channel is straight to wandering and follows the sinuous valley alignment. It follows a pool-riffle reach type and is dominated by boulder, cobble, gravel and sand sediment types. The floodplain, banks and benches are composed of boulder, cobble, gravel and sand, with bedrock cliffs or steep hillslopes along parts of the outer bends. The channel margins and flood features are vegetated with small shrubs and sedges. Grazing and trampling takes place along the banks and floodplain. Undercut banks and bank erosion is fairly uncommon at the site and the bed along the riffle and pools have a moderate level of embeddedness. A silt drape is present across coarser sediment in slow flowing habitats, such as pools.

During the May 2023 survey, flow conditions were zero. The water had pooled upstream of the low water bridge, with zero flow and limited water downstream of the bridge. Consequently, macroinvertebrates were not sampled. The rest of the components were conducted.

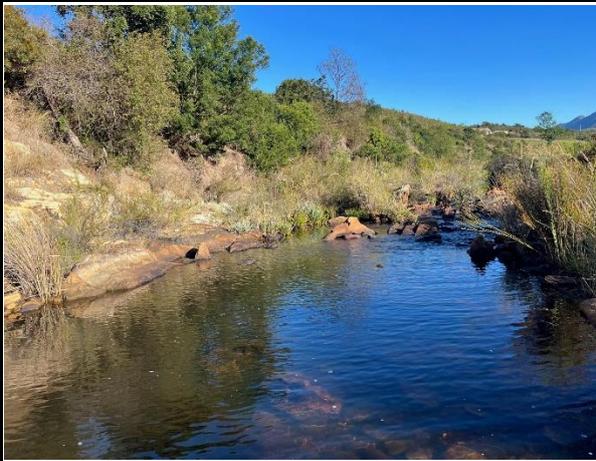
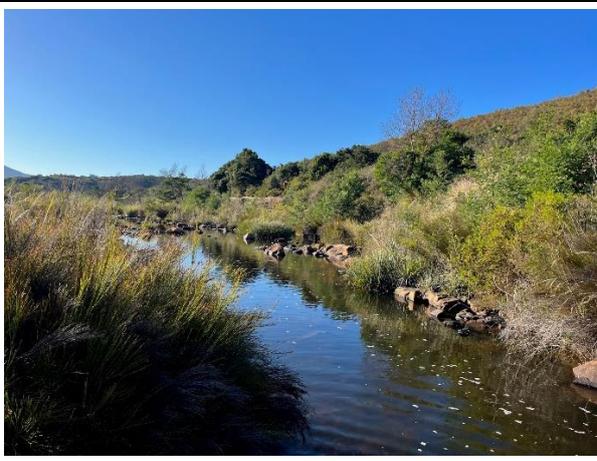
Upstream		Downstream	
<b>Site Description:</b>			
<p>The site is located along the Kromme River valley with cobble-bed or mixed bedrock-cobble bed habitats, with a mix of sand, gravel and cobbles. There are large gravel and cobble bars along the left bank of the channel, with the benches composed of silt and sand. There is very low embeddedness along riffles, runs and pools. This may be owing to sediment starvation from the upstream weir. The active channel has narrow flood benches and is relatively incised into the valley floor. The channel is straight to wandering and follows the sinuous valley alignment. The channel is braided in some areas along the reach, and which is densely vegetated with shrubs, sedges and</p>

pockets of peat. There are sections of steep bank erosion, likely owing to the last flood event which took place in 2015.

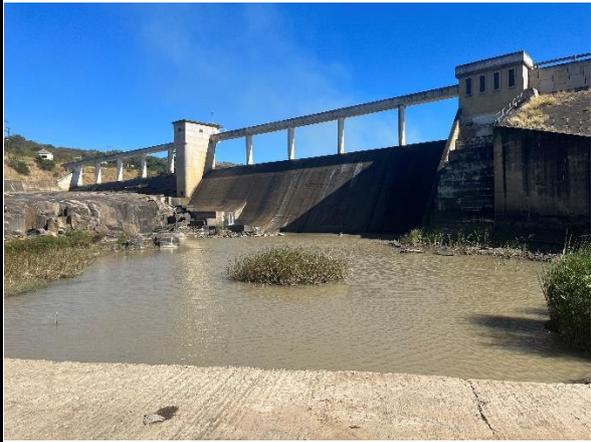
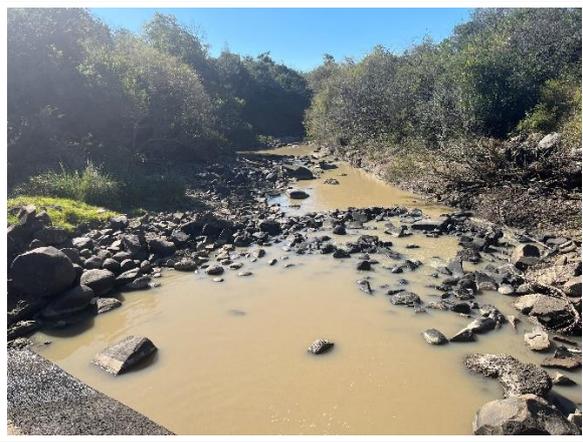
<b>Upstream</b>		<b>Downstream</b>	
<b>Site Description:</b>			
<p>This highly turbid reach of the Gcuwa River is located just upstream of Butterworth town, downstream of the Gcuwa Dam wall. This was the only suitable site upstream owing to significant impacts from raw sewage entering into the Gcuwa River downstream of Butterworth.</p> <p>The single channel is within a deeply incised channel with extensive bank erosion particularly along the left bank. Upstream of the bridge is a pool receiving the overflow from the Gcuwa Dam, while downstream of the bridge is narrowed and follows a pool-riffle and pool-rapid reach type and is dominated by embedded boulder, cobble, gravel and silt sediment types.</p> <p><i>Biota habitats available</i></p> <p>The aquatic macroinvertebrate biotopes were dominated by bedrock and boulders, including SIC, SOOC and GSM. Marginal vegetation was limited. Fish habitats only included FS, FD, SS and SD.</p>

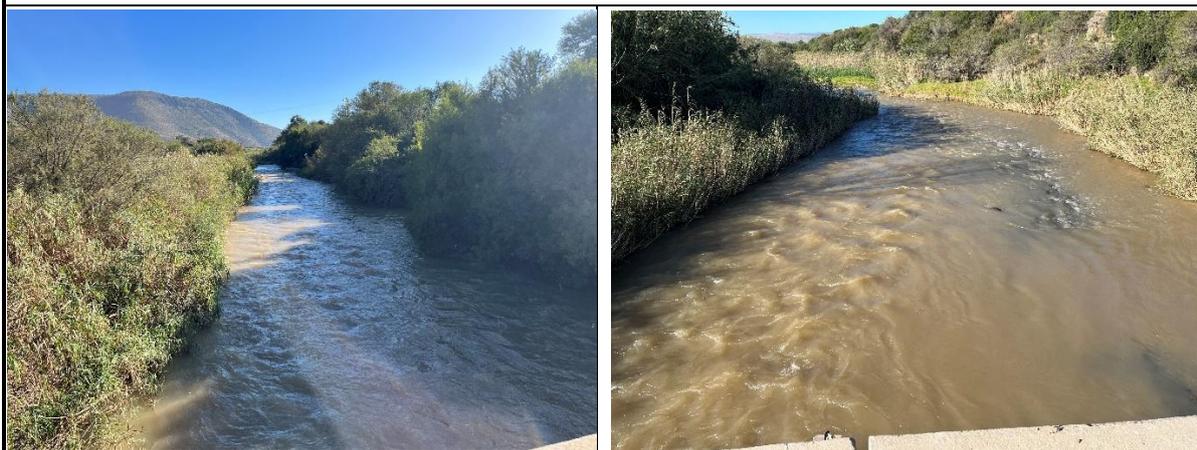
**Site Photographs: Survey 2 (May 2023)**

*This site still could not be surveyed owing to continued high flows (Fish Interbasin transfer (IBT)) and safety risk. This site was assessed however, the levels continue to be high as the farmers have only 4 weeks left to order water for their dams and irrigation prior to switching the transfer off for maintenance purposes until July 2023. A Flow Management Plan (FMP) may be considered for this reach which is experiencing extensive flow modifications owing to the IBT.*

The site is located in a partly confined valley setting with a single channel and narrow flood features. The channel is incised into the surrounding landscape. The channel is straight to wandering and follows the sinuous valley alignment. It follows a pool-riffle reach type and is dominated by cobble, gravel, fine sand and silt sediment types. The banks and benches are composed of sand and silt. Dense reeds are stabilising the active channel banks, leading to steep active channel banks. Grazing is absent from the channel banks and flood features, leading to low bank and marginal zone degradation. Finer sediment bars, such as sand and gravel bars, are missing, possibly due to increased transport rates entraining these sediment types, limiting their residence time along the system.
