**WASTE-TECH (PTY) LIMITED**

**Geotechnical and Geo-hydrological Conditions**

**Proposed SA Quarry Site**

**Project 199.111**

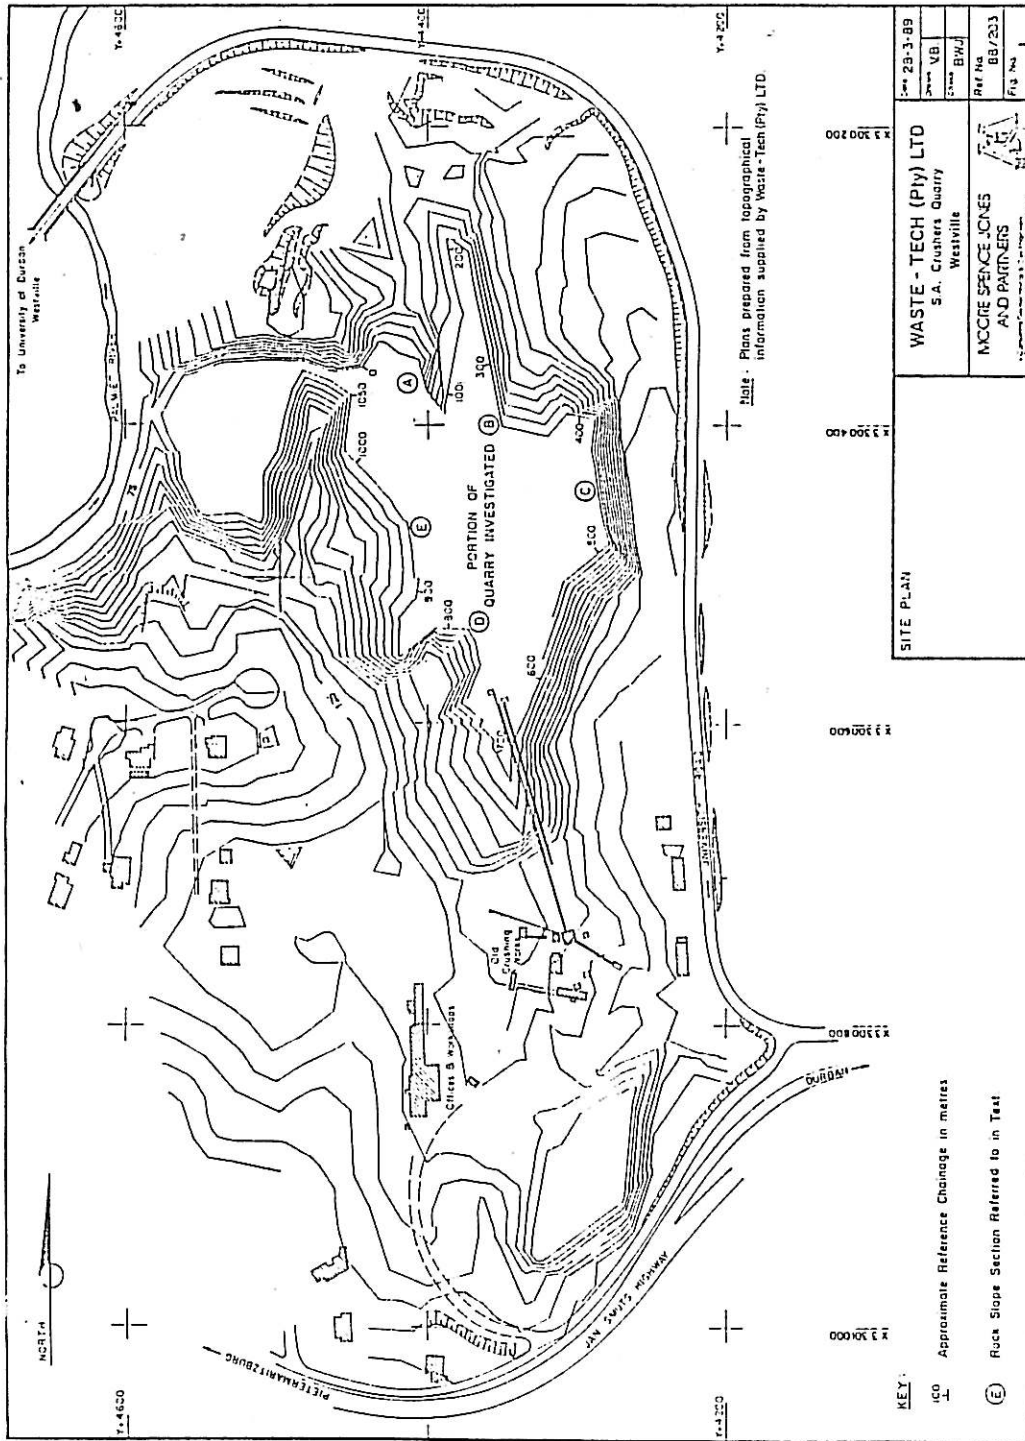
FIGURE 6. WASTE-TECH (PTY) LTD: PROPOSED SA CRUSHERS SITE, WESTVILLE. Plan showing sections where detailed structural data was collected on the stability of the rock slopes. See also Table II. All data from MSJ&P<sup>1</sup>.

The MSJ&P report describes 12 individual areas where the structural stability of the quarry slopes has been assessed. At practically all of these localities evidence has been found of varying degrees of instability. A summary of their data is reproduced in Table II of this report. The explanatory diagram to Table II is given in figure 6.

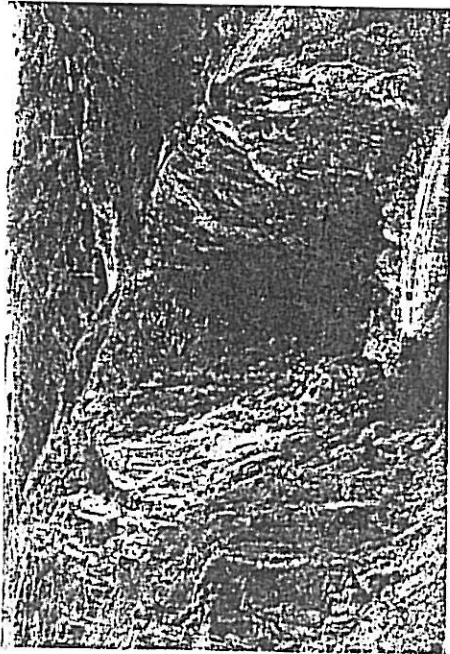
Section	Chainage * (metres)	Slope Face	Plate No.	Description
SECTION A	0 to 20	East facing	4	Approximately 40 metre high rock slope, comprising highly fractured and jointed tillite adjacent to shear zone. Potential toppling failure along Joint A1, as shown in Figure 7c. Potential circular slip failure similar to that along Section E. Slope considered unstable. Recommend slope be battered back to at least a gradient of 1 in 1½. Removed shear zone material should be suitable for use as a cover material in the landfill operation.
	20 to 50	South facing	5	Approximately 25 metre high rock slope of medium to widely jointed W2/3 tillite, overlain by thin soil cover. Potential for small wedge failures along joints 1A and 4B, and 1B and 3B, and also potential toppling failures due to joints 2A and 3A - See Figure 6b. Considered relatively stable, low probability of slope failure except for minor blocks. Recommend that loose blocks be barred down, and weathered, overburdened sloped back to 1 in 1½.

PLATE 3 - General view of SECTION A of Quarry Looking north. The east facing slope on the left and the peninsular section on the right, are north-south trending shear zones in the Dwyka Tillite which have been left unmined.

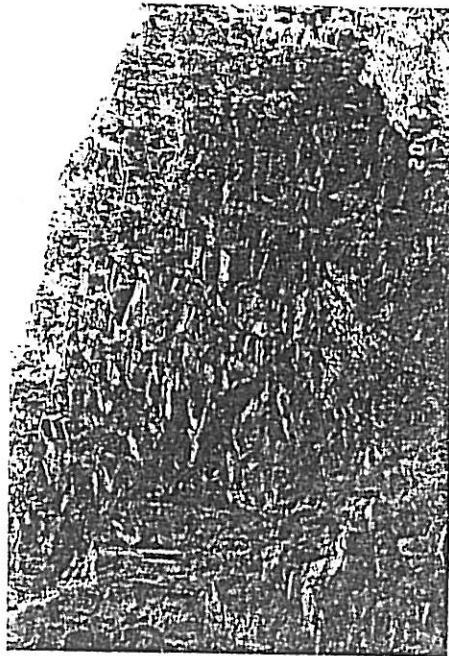
PLATE 5 - South facing slope of 'box-cut', SECTION A.

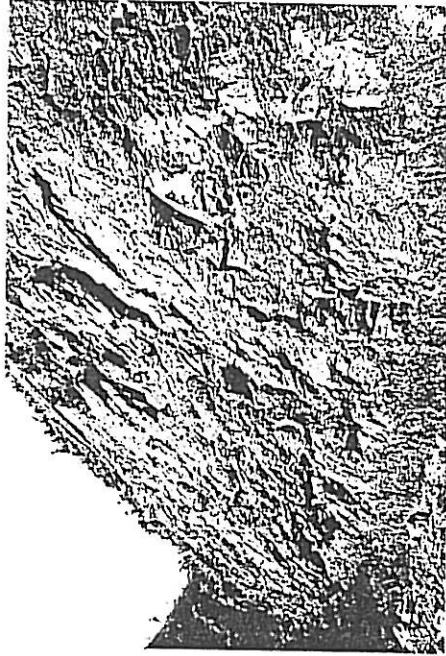
SECTION B	50 to 150	Rock Peninsular	3, 6 & 7	Rock peninsular, comprising a near vertical shear zone together with the unmined slightly weathered tillite on either side. This rock peninsular is considered unstable and it is recommended that it be removed. The removed material should prove suitable for use as cover material in the landfill operation.
	250 to 340	West facing slope	8 & 9	Approximately 20 metre high rock slope overlain by residual soil and fill material. Prominent north to south trending joint set well exposed. Rock slope considered relatively stable. However, loose overburden requires to be trimmed back to a slope of 1 in 1½. Dense aquatic vegetation, indicating shallow groundwater level, occurs at the toe of this slope.
	340 to 390	Rock buttress	8 & 10	Approximately 15 to 20 metre high peninsular, comprising highly fractured and weathered tillite overlying W3/2 tillite. Seepage is evident at the toe of this buttress. This buttress of highly fractured rock, left unmined, is considered unstable. Mining on 3 sides has resulted in the joints opening up due to stress release. This rock buttress requires to be removed and the exposed south facing slope battered back to a safe slope angle.

PLATE 6 - West facing slope of peninsular.

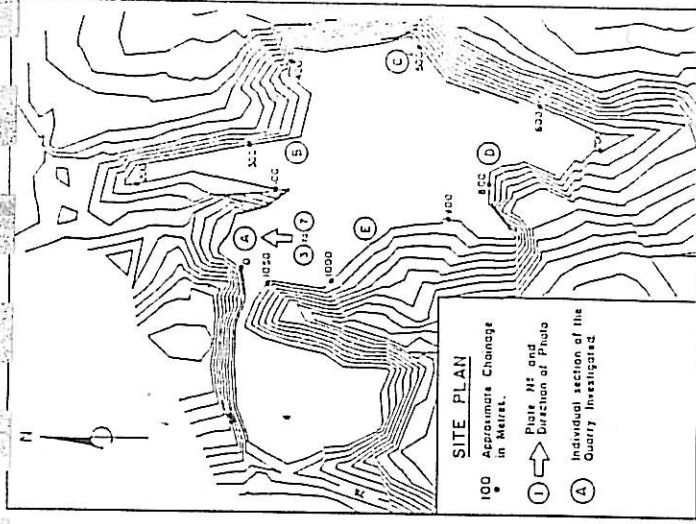
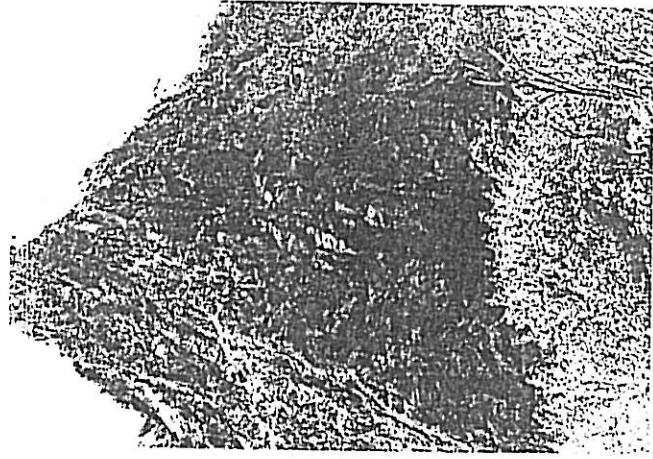
PLATE 7 - Nose of peninsular.

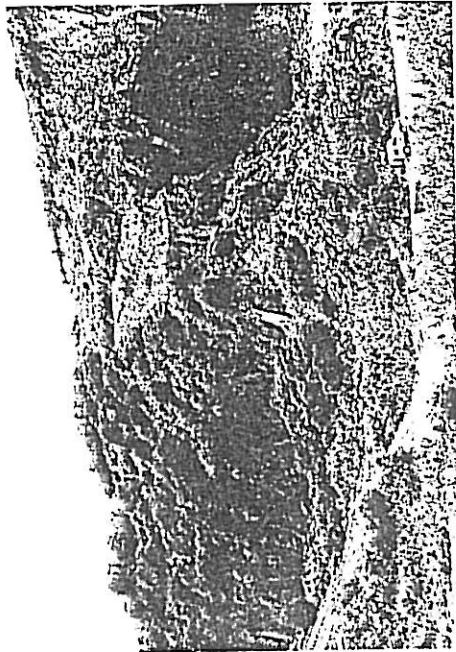
PLATE 8 - General view of SECTION B of Quarry looking northeast. Buttersill in the foreground comprises loose scree material.

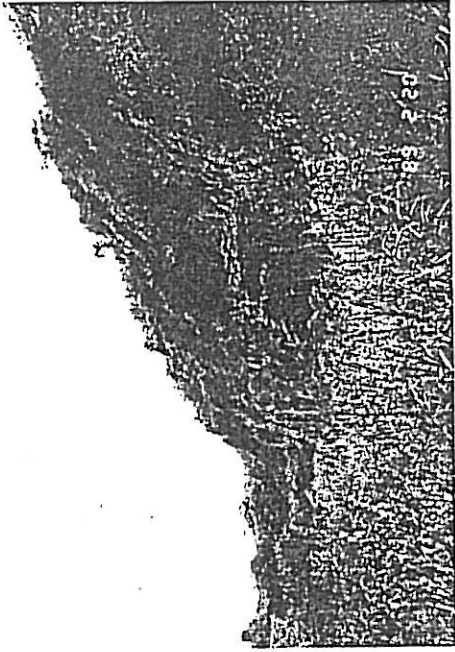
PLATE 9 - West facing slope adjacent to road entering the Quarry.

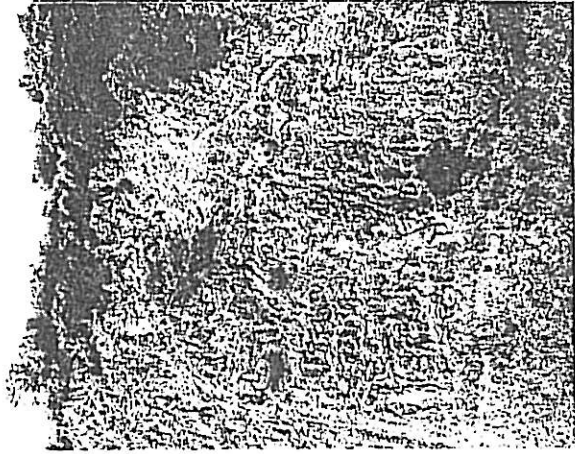
390 to 410	South facing slope	11 & 12	Approximately 30 metre high rock slope overlain by loose residual tillite and fill material. The loose overburden is considered unstable as is evident from the failure, and scree material present at the toe of the slope - See Plate 12. The loose overburden requires to be battered back to a slope of at least 1 in 1½ from the crest of the hard competent blue tillite. Groundwater seepage is evident in this rock slope, approximately

PLATE 11 - South facing slope of Quarry.

Section	Chainage * (metres)	Slope Face	Plate No.	Description
<u>SECTION D</u> (Cont'd)	390 to 410	South facing slope	11 & 12	10 metres up from the toe. Potential wedge type failures along joint sets 1A and 4B, and 1B and 3B, as shown in Figure 6b, are considered possible. In addition, toppling type failure is also considered likely due to joints 2A and 4A. The overall stability of this south facing slope is considered sensitive. The stability of this slope will have to be carefully assessed by a detailed investigation.
<u>SECTION C</u>	410 to 650	West facing slope	13 & 14	Approximately 60 metre high W2/3 tillite rock slope dipping at about 80 degrees from the horizontal. W2/3 tillite overlain by residual soil and brown, highly weathered and fractured tillite. The overall rock slope considered stable except for the possibility of relatively small potential wedge type failures along joint sets 2A and 3B, 1A and 3A, and 3B and 4A, as shown in Figure 7b. The sensitivity of this slope to wedge type failures will have to be carefully assessed. The residual soil and weathered overburden will require to be battered back to a slope of at least 1 in 1½.

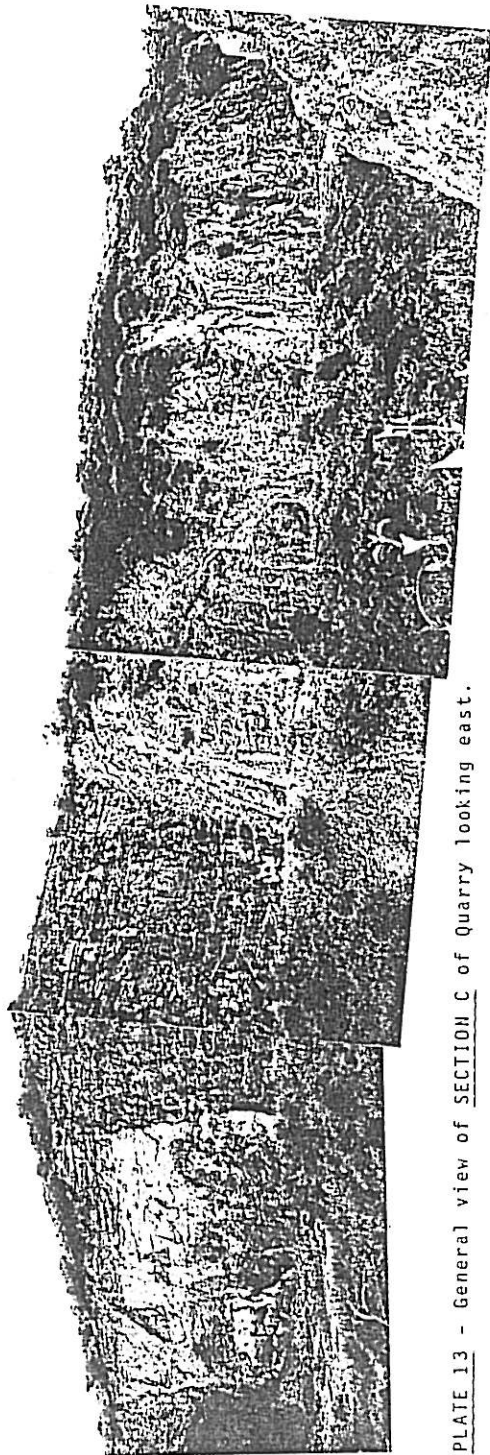
410 to 625	Northwest facing	13, 15 and 16	Approximately 50 metre high tillite rock slope. The tillite is bisected by a number of near vertical shear zones which trend in north to south and east to west directions. The presence of these shear zones have reduced the overall stability of the rock slope. Plate 15 shows the intersection of two shear zones at approximately 90 degrees to each other behind a wedge of W2/3 tillite. Note the failure which has occurred in the shear zone material at the crest of this section of the slope. The wedge of W2/3 tillite in front of the shear zones is considered unstable. The overall stability of this portion of the quarry will have to be carefully assessed by a detailed investigation.
<u>SECTION D</u>	700 to 750	East facing	17	This east facing slope, situated adjacent to the primary crusher, is considered unstable. A large portion of this section of the rock face overhangs. Toppling failure along joint set A1 is considered likely, as shown in Figure 7c. This type of failure is evident in the exposed rock face.

In addition, there are a number of other thin, near vertical shear zones present within the tillite. These zones, however, are generally less than 3 metres wide. The trends and extent of these thin shear zones observed in the quarry faces are shown on the site plan in Figure 1, and in Plates 13, 15 and 16.

PLATE 13 - General view of SECTION C of Quarry looking east.

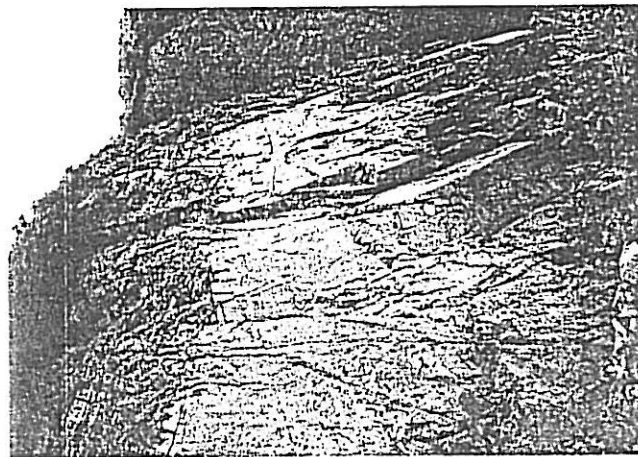
Joint Set 1 - This is the most prominent joint set, as shown on Plates 13 and 14. The joint is smooth and planar, but exhibits a zig-zag pattern, which is continuous over distances in excess of 20 metres. This joint set trends in the same direction as the major shear zones which bisect the site.

PLATE 14 - Steeply inclined north-south trending major joint set, J1.

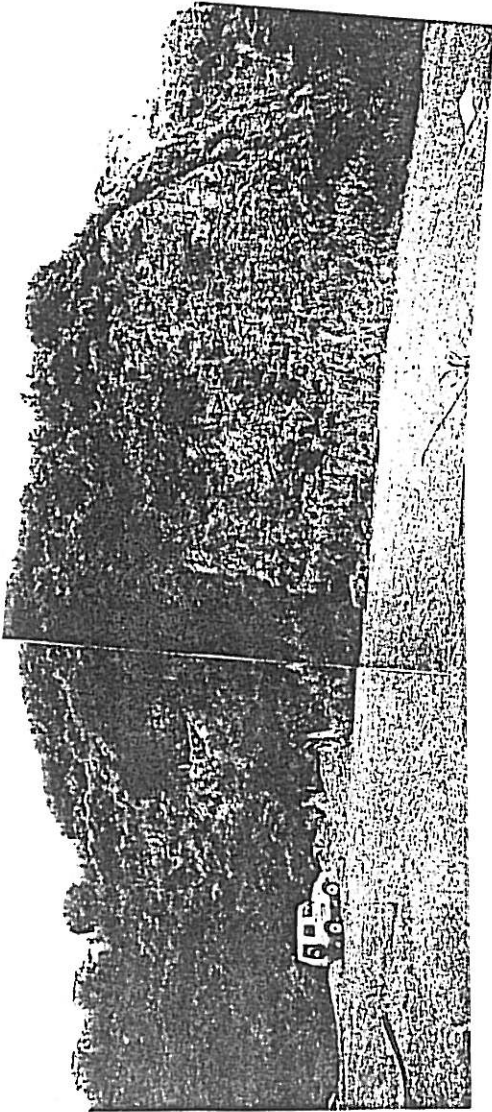
PLATE 17 - General view of east facing slope of SECTION D.

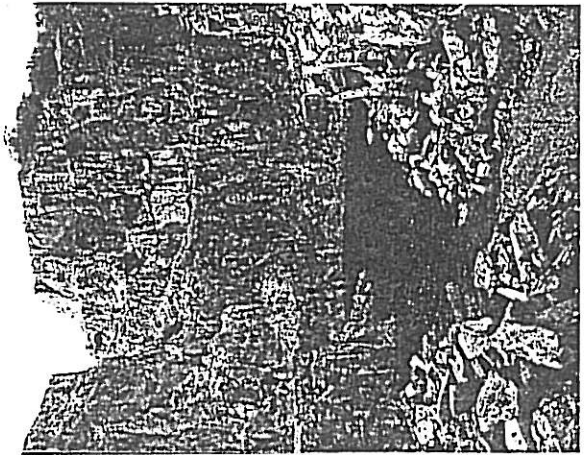
PLATE 25 - Southern face.

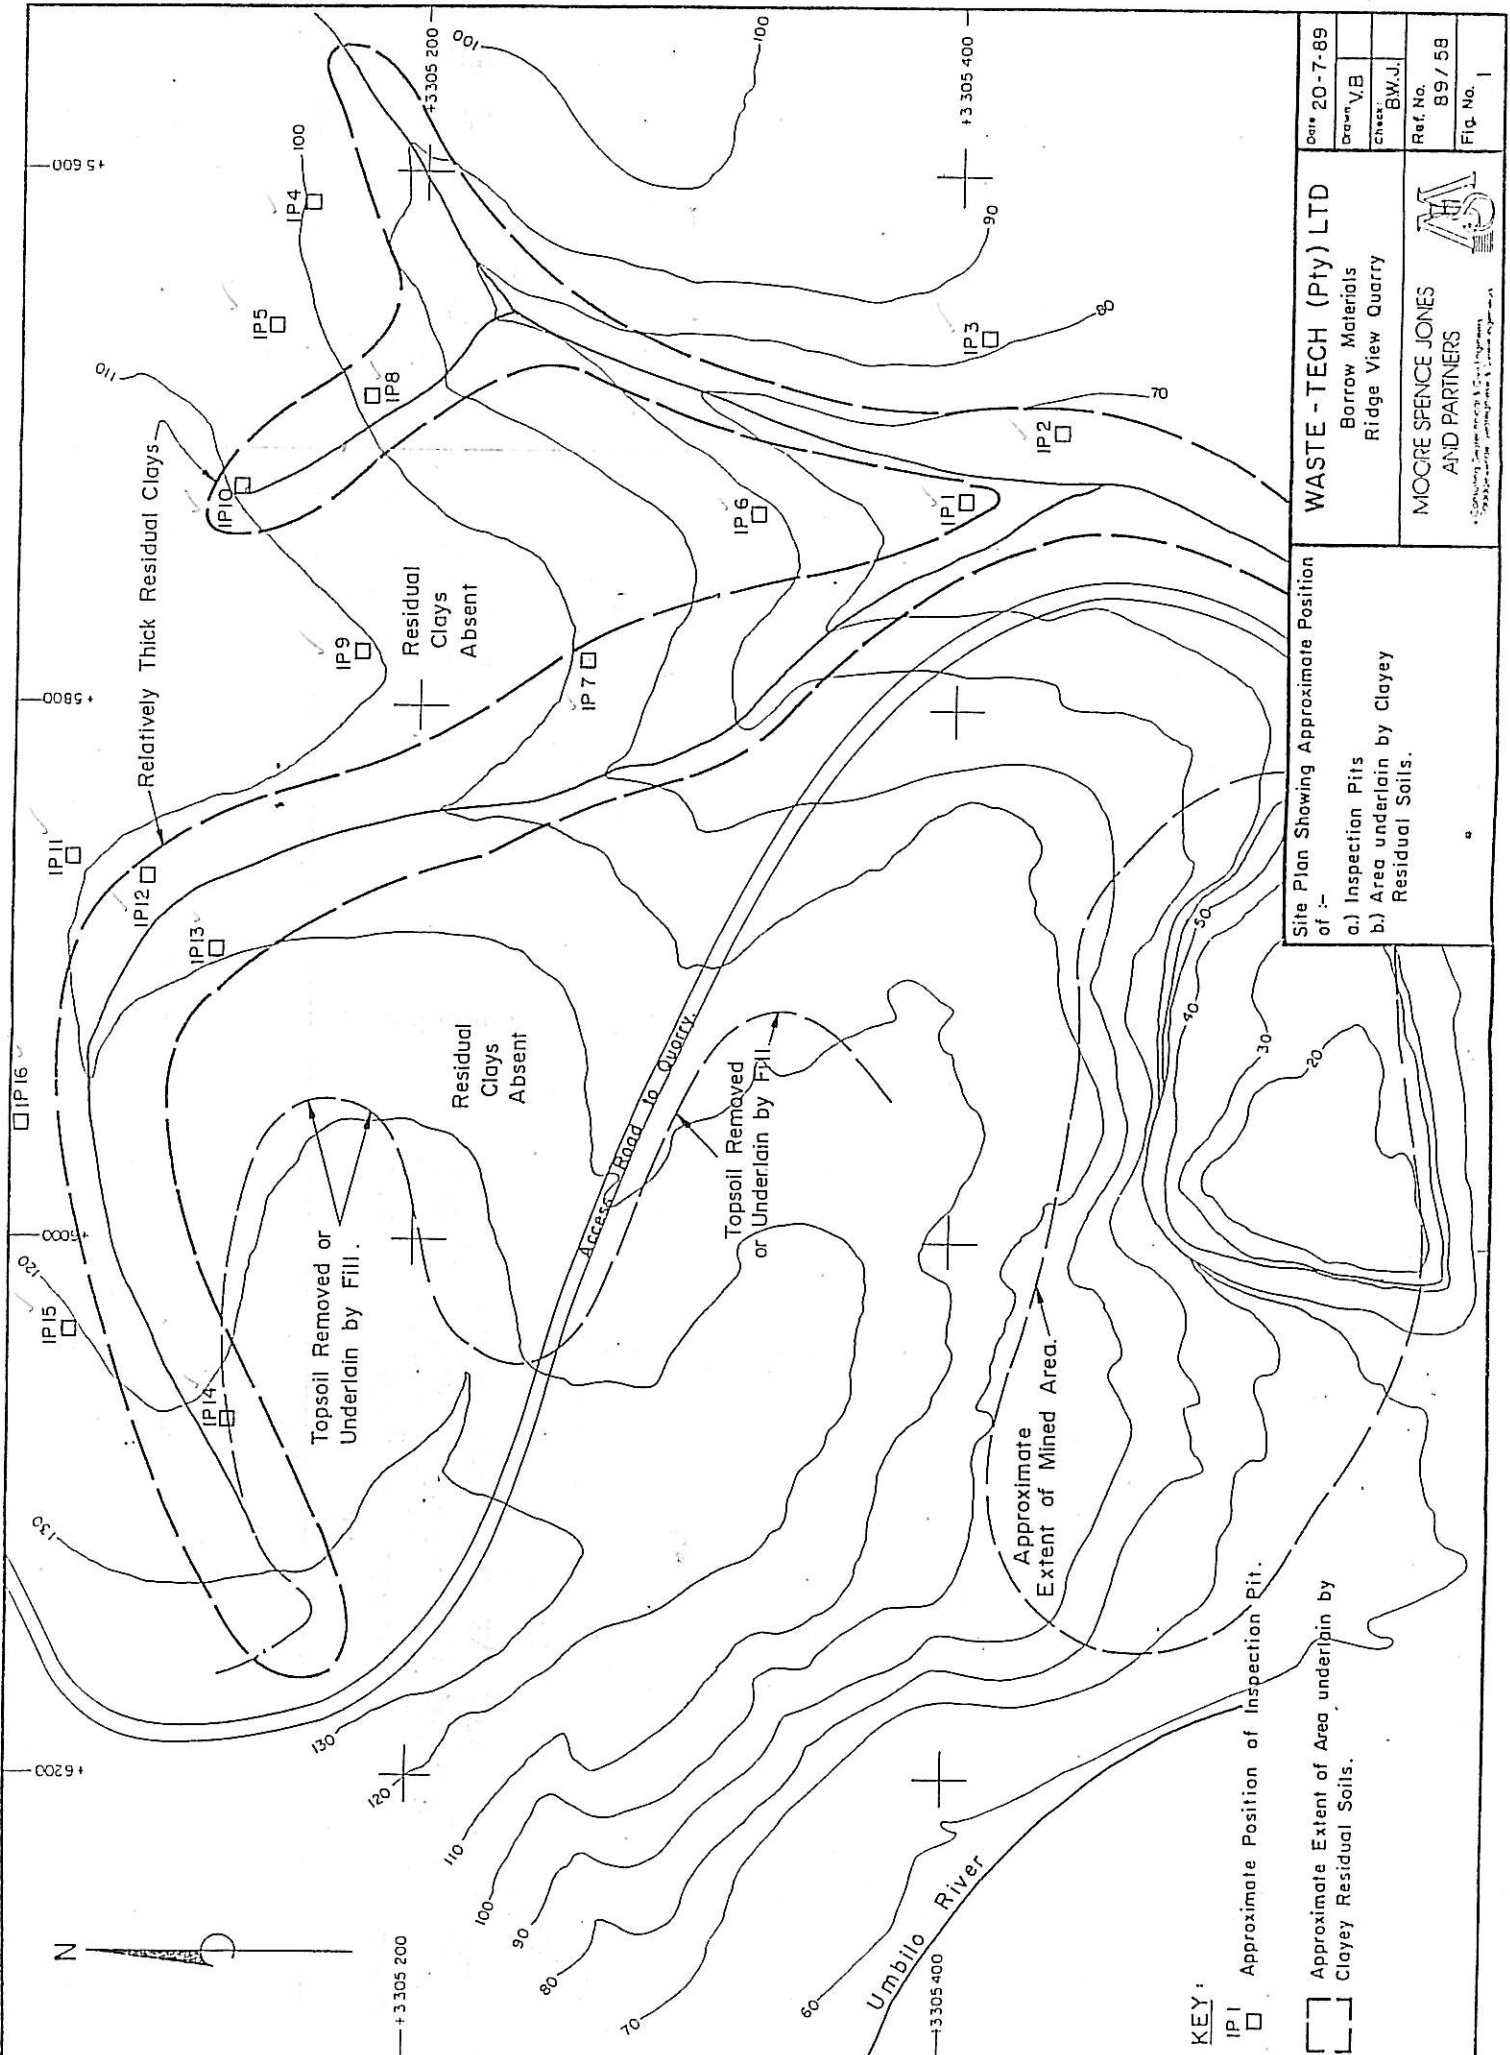
<b>WASTE - TECH (Pty) LTD</b>		Drawn: V.B	Scale: 20-7-89
Borrow Materials Ridge View Quarry		Checked: B.W.J.	
MOCRE SPENCE JONES AND PARTNERS		Ref. No. 89 / 58	Fig. No. 1

Site Plan Showing Approximate Position of :-  
 a.) Inspection Pits  
 b.) Area underlain by Clayey Residual Soils.

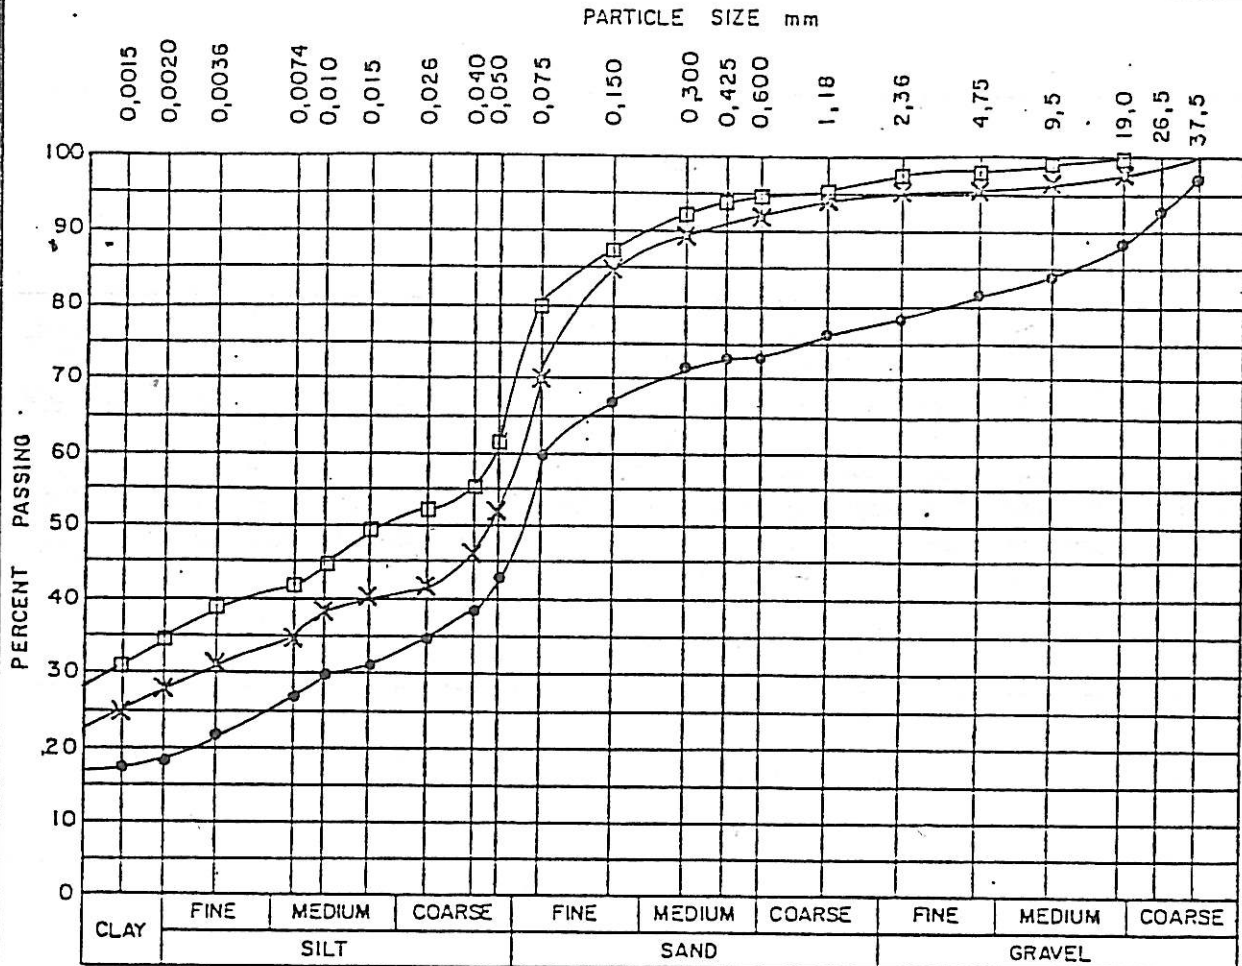
Fig. No.  
2

Taking into account the clay content and plasticity index, it is considered that the residual clays have a medium to high potential for expansiveness. It will, therefore, be important to control moisture content variations in the clays, to prevent shrinkage cracks within the clay liner.

HOLE N°	IP 1	IP 2	IP 8
DEPTH	0,6 - 1,6	0,2 - 1,4	1,5 - 2,1
SYMBOL	—○—	—×—	—□—
LIQUID LIMIT	30	50	54
PLASTICITY INDEX	11	22	27
LINEAR SHRINKAGE	5,5	10,5	3,0
% CLAY	18 %	28 %	35 %
% SILT	27 %	32 %	35 %
% SAND	33 %	35 %	28 %
% GRAVEL	22 %	5 %	3 %

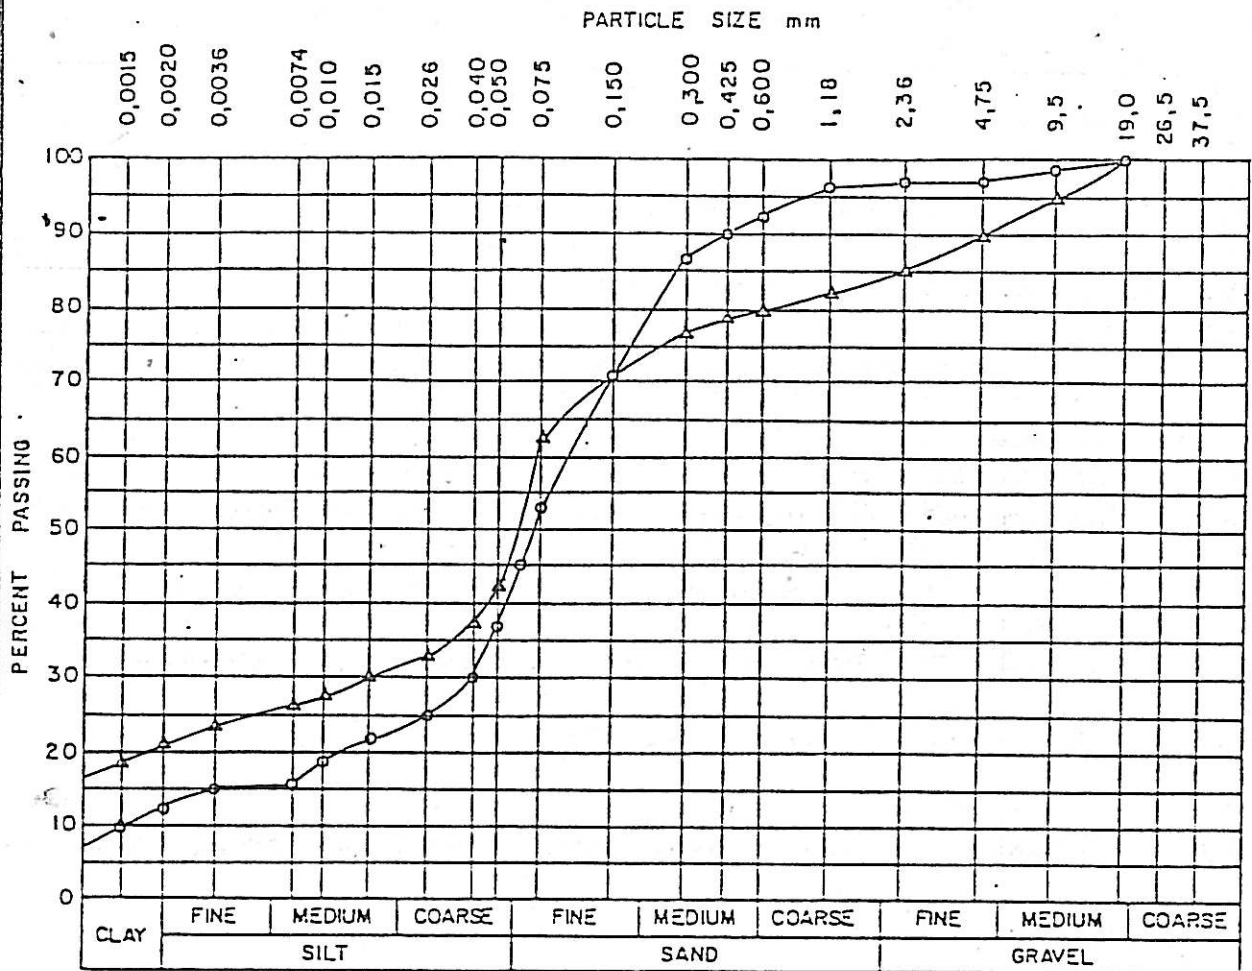
HOLE N°	IP 10	IP 14	
DEPTH	0,3 - 1,7	0,3 - 0,9	
SYMBOL	—△—	—○—	
LIQUID LIMIT	33	22	
PLASTICITY INDEX	14	7	
LINEAR SHRINKAGE	7,0	3,0	
% CLAY	21%	12%	
% SILT	29%	33%	
% SAND	35%	52%	
% GRAVEL	15%	3%
