**HYDROGEOLOGICAL INVESTIGATION  
SPRINGS at KWANOVUKA  
IMPENDLE LOCAL MUNICIPALITY**

## HYDROGEOLOGICAL INVESTIGATION - SPRINGS KWANOVUKA – IMPENDLE LOCAL MUNICIPALITY

### 1. Introduction and Terms of Reference.

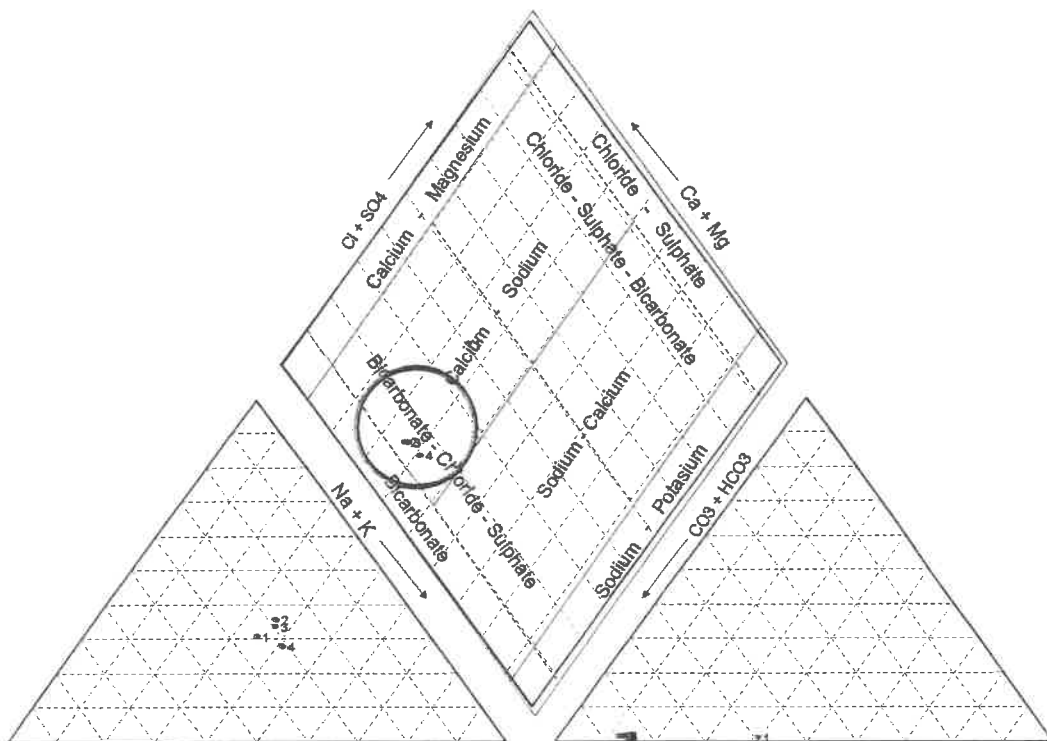
PIPER DIAGRAM

In general, the water sampled and tested of the four springs can be classified as Class 0 in terms of health and Class 0 in terms of Aesthetic value. The exception is for spring 19 where the E-coli count is 12 and to a lesser extent Spring 22 where an E-coli count of 1 was observed. This is caused mainly by the unprotected state of the springs and as a result of the contamination caused by animals sharing the water source as well as unsafe sanitation practices. The risk factor is high especially towards infectious disease transmission. Other than that only one substance is found in excess namely Fe at spring 19. Upon closer inspection of the spring source it became clear that some metal wreckage located at the spring eye could be the cause of these high values. See also Photo 5 in the top left corner. The remainder of the other sources' water is generally regarded to be of good quality and suitable for long term domestic use without any detrimental effects. The Piper diagram shown below indicates the chemical distribution of the four springs tested and analyzed to be water of good quality. The center plot of the diagram indicates that there is no excessive concentration of mineral salts and based on this, could be considered a Calcium – Bicarbonate water. This is further evidence that the water is recently recharged and therefore relatively fresh. The classification details of the chemical analyses are also attached in the Appendix.

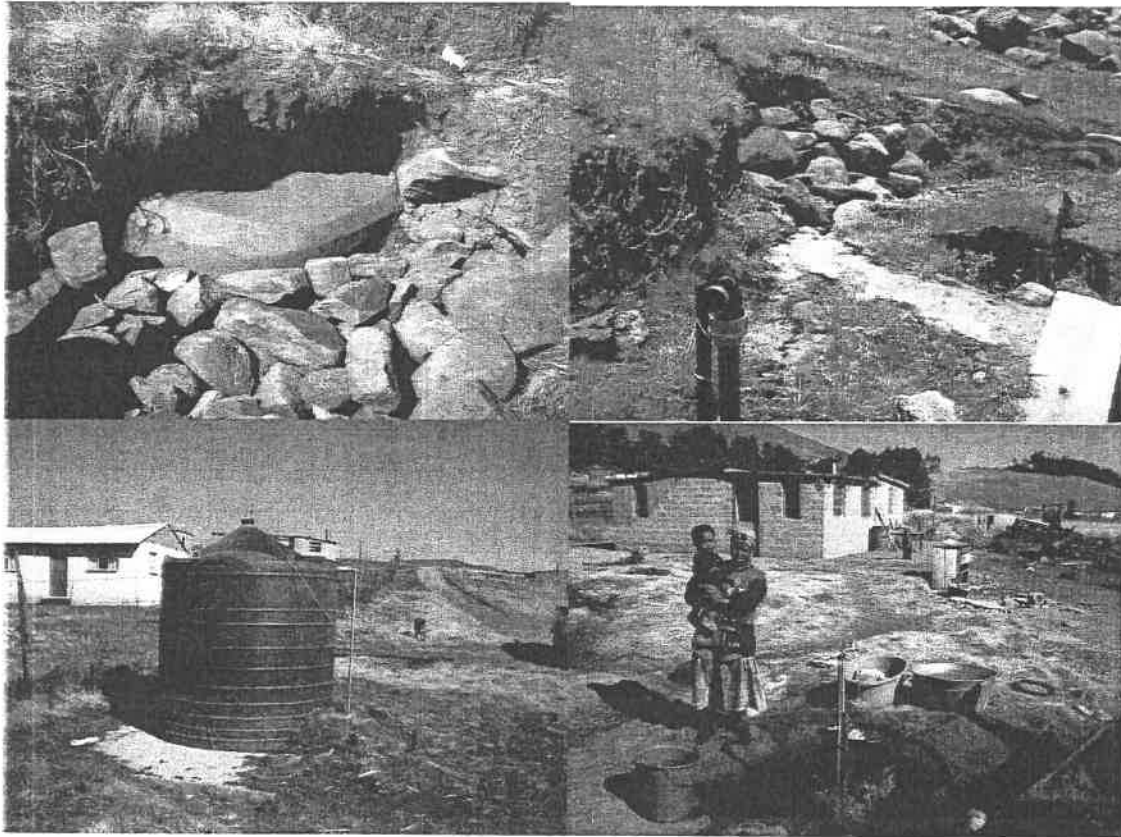
3. A second reservoir was also installed on the other side of the community. This was done in order to provide all the excess water to be stored for use by the furthest part of the community. When water is in excess at the first storage reservoir, it is channeled to the second stage reservoir. (see photo 2 on previous page)
