## **GROUNDWATER MONITORING OPTIMISATION WITHIN THE UPPER VAAL SUB-CATCHMENT AREA**

**PART A: EVALUATION AND RECOMMENDATIONS ON THE  
PROPOSED NETWORK AT MATHOPESTAD AREA**

**June 2023**

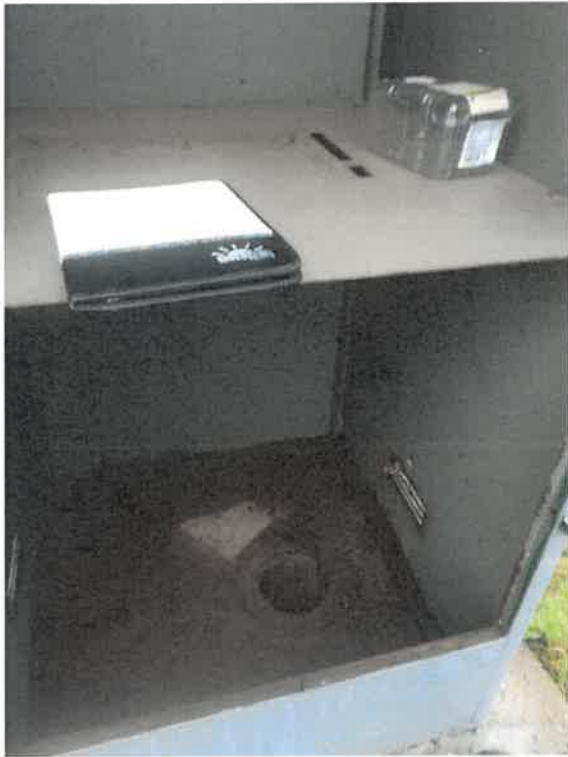
Photo 1: View of C2N0082 Geo-site

The Malmani Formation in this area (C23F) is well represented by DWS boreholes on the west, east and south sides. However, the north side, which is just upper stream of Klerkskraal Dam has no monitoring and hence new baseline/trendlines site are proposed (Figure 3). The construction of the boreholes is durable and reliable since it lasted for more than four decades (see photo 1, 2, 3 & 2). There are currently no instrumentations installed inside the monitoring station. However, in the past some of the boreholes were installed with the autographic chart recorders which are no longer functioning, but data is stored safely in the archives (photo 1). Due to the fact that the dolomite is unstable the boreholes were cased all the way down with a steel pipe casing. The casings are sealed on top (except for C2N0082 & C2N0180) with small holes to allow the dip meter probe inside. The sealed tops are very important since it prevent termites from building shelter inside the wells. The surface casings are painted on regular basis by the Boskop-Hydrometry maintenance team in order to avoid rusting. The sanitary seal of concrete mixture was used to supports the sides of the holes and protecting water from contamination. The Timeball Hill Formation (C23F) is represented existing trendline monitoring (2 ZQM quality monitoring). The condition of these ZQM borehole stations is unknown.

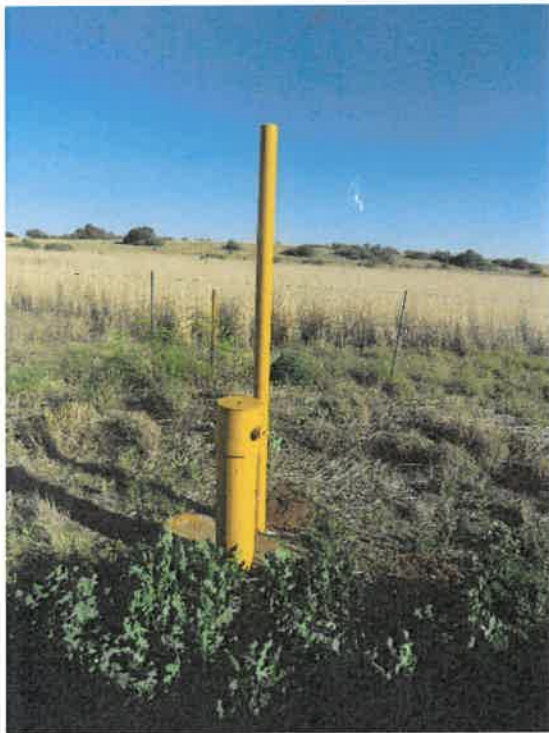
Photo 3: View of C2N1026 Geo-site

Groundwater level measurements on the western side of the Malmani Formation were collected on monthly for more 3 decades using a water level dipper meter (Figure 4). Water level fluctuated between -25 and -50 m below ground surface at C2N1025, while at C2N1026 ranged between -70 and -75 m mark. It can also be observed that from 2020 to date, data was mixed up between the two borehole stations. The existing monitoring on the eastern side (Tarlton) shows signs of recovery after 2 decades. The groundwater trend shows similar patterns from A2N0612 and A2N0615 borehole stations, range between (-53 and -58 m) and (-66 and -72m) respectively. The impact of the 2015/16 drought event can be observed were both wells received the lowest readings. The groundwater monitoring on the southern side, just downstream of Klerkskraal Dam, where data is collected using autographic chart recorder at C2N0082 borehole station. The groundwater level is fair shallow and fluctuate between -1 and -5 m below the ground surface. Figure 6 indicate that the Karst aquifers of Malmani Formation respond rapidly to rainfall events. The lowest record of -5.30 m on the 15/02/1996 quickly recovered to -1.90m on 20/02/1996 from the rainfall event of 125 mm recorded on 17 - 18/02/1996 at C2E018 meteorological station.
