RIPARIAN CONTENTS

RIPARIAN

1. Hydrological Modification

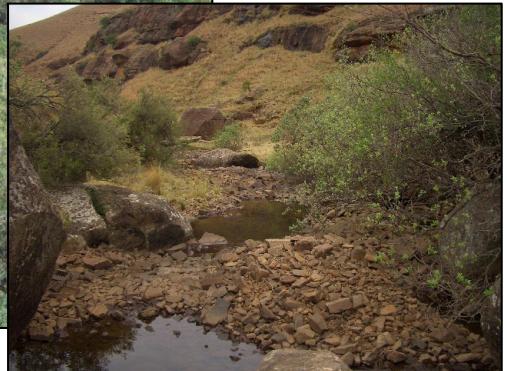
NECF Funeray Plantation

Afforestation in upper catchment and trees within the riparian zone have dramatically reduced base flows. Photo inset shows normally perennial river reduced to seasonal pools.

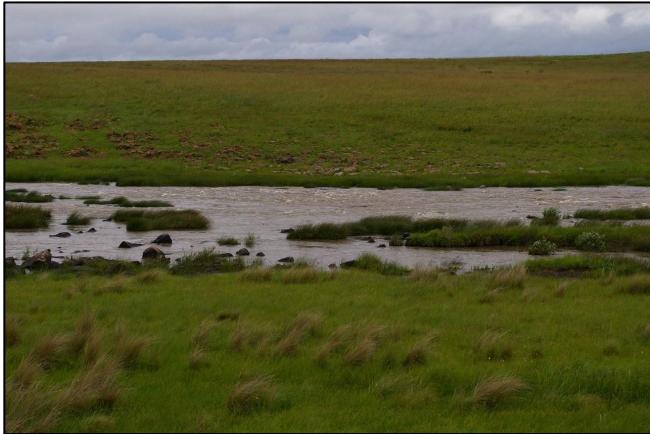
Vaal River Prior to flooding

Prior to moderate flooding and freshes, the riparian vegetation in the Vaal and Mzintlava rivers in the photographs below, is clearly obvious. During flooding this riparian vegetation is inundated temporarily.

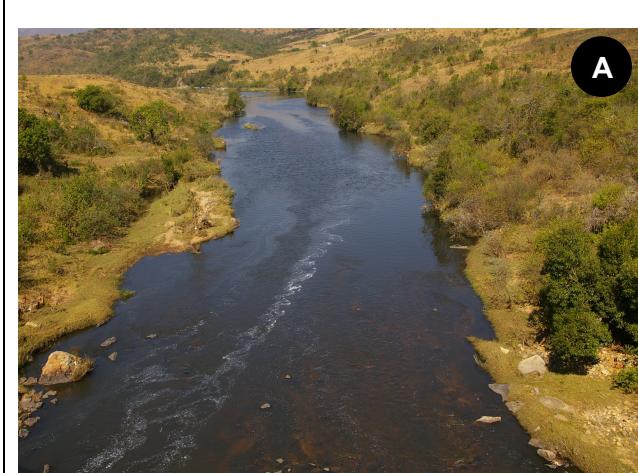
Usuthu

Left and right banks are well covered by a combination of grass, trees and shrubs. Very little substrate is exposed.

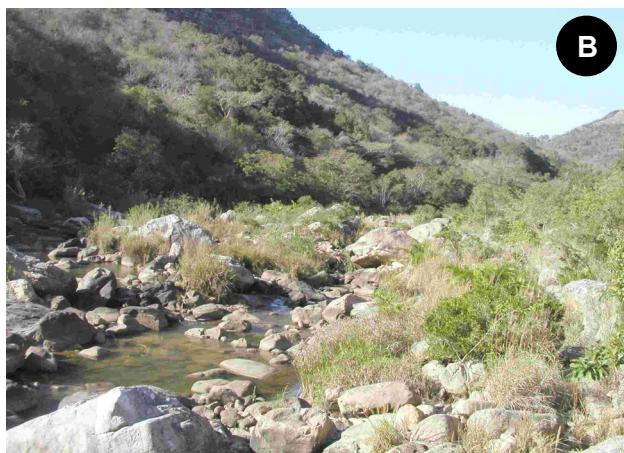
Mzimkhulwana (at Oribi Gorge)

Stable bedrock and boulder riparian zone with very little natural modification.

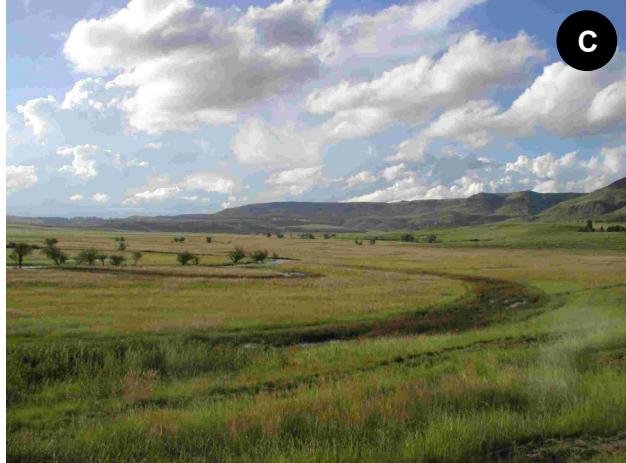
Pholela

Meandering river with dense sedge and grass riparian zone. No exposed substrate.

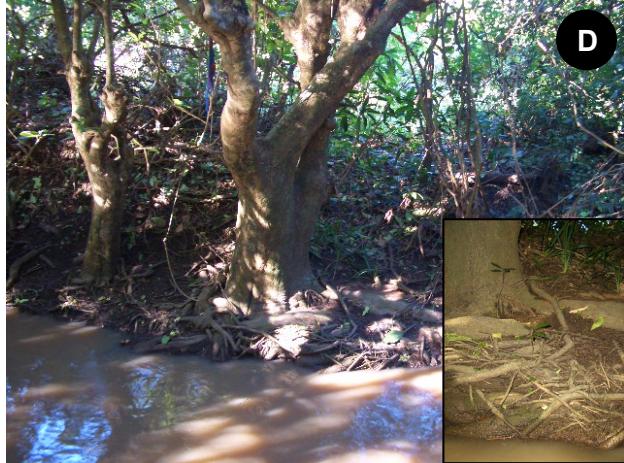
Mdlotane

Healthy and intact riparian zone with well established riparian zone tree species. Insert shows how roots are holding bank structure together resulting in minimal substrate exposure.

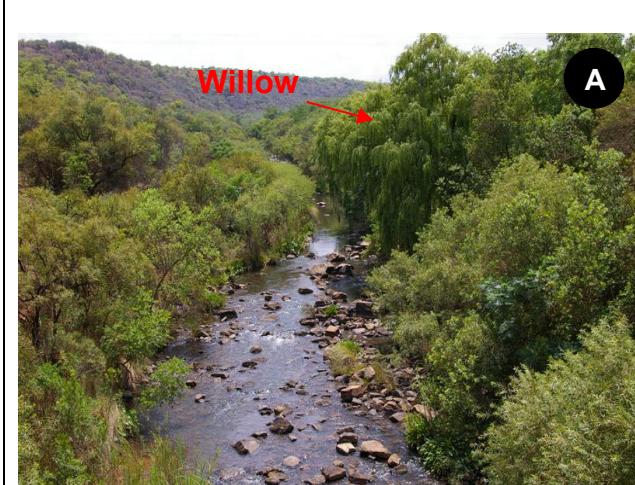
Kaaloog-se-Loop

Minimal alien invasion along riparian bank – one willow tree can be seen but few other aliens are evident. There is also minimal upstream impact that can affect vegetation.

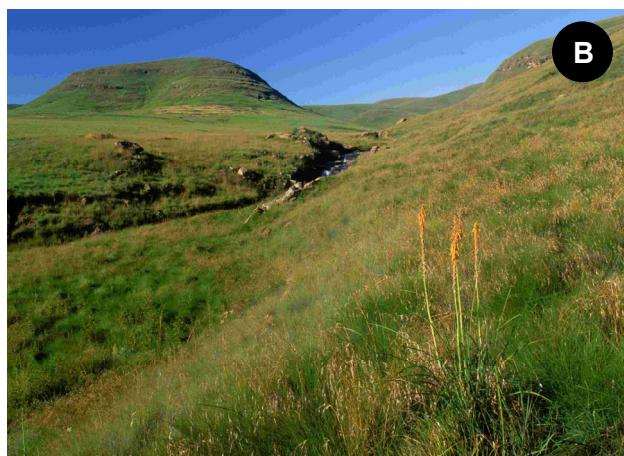
Coleford Stream

No aliens along riparian zone. Healthy and intact banks.

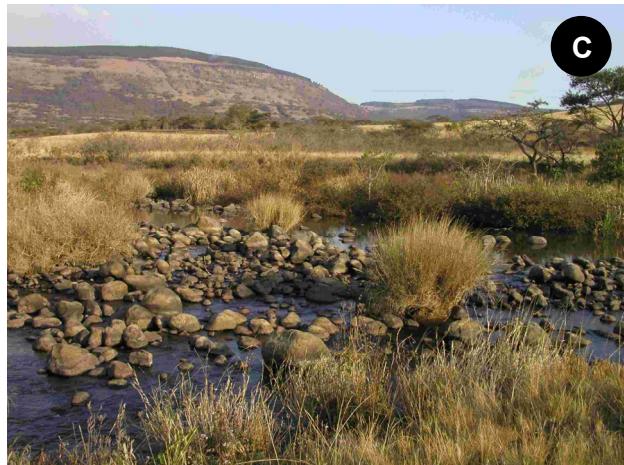
Karkloof River (at Game Valley)

No alien infestation of riparian zone. Healthy and intact banks.

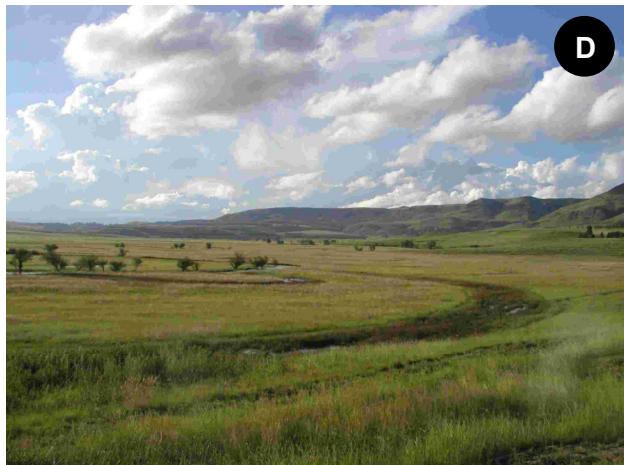
Pholela

Natural grassland with no alien invasion.

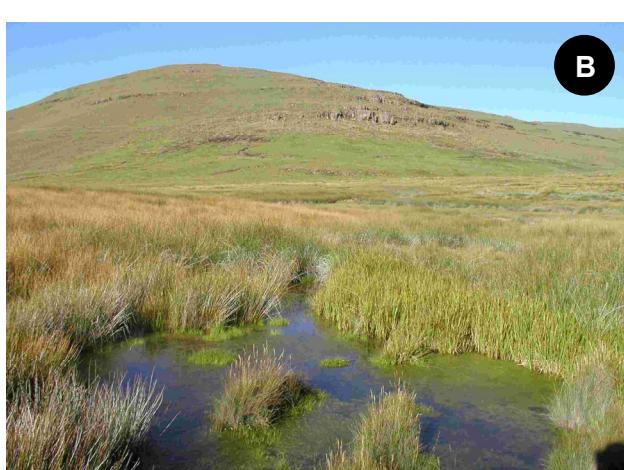
Source zone/seep wetland with extensive wetland vegetation along riparian zone and no erosion.

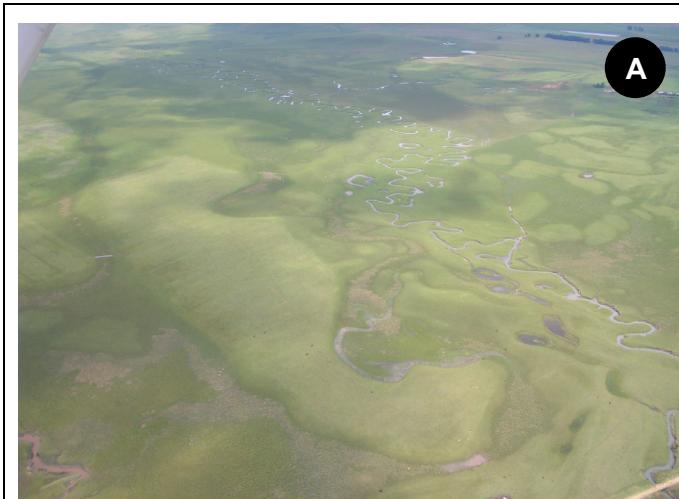
NECF Sephton wetland

Natural grasslands and no alien weeds and lack of cultivation allowing for flux of all riparian zone elements enabling full lateral connectivity in the riparian zone.
