MZIMVUBU RIVER SPRING SURVEY

SEPTEMBER 2008

Mkosana Kululwa Resource Protection, Department of Water Affairs & Forestry (ELS)

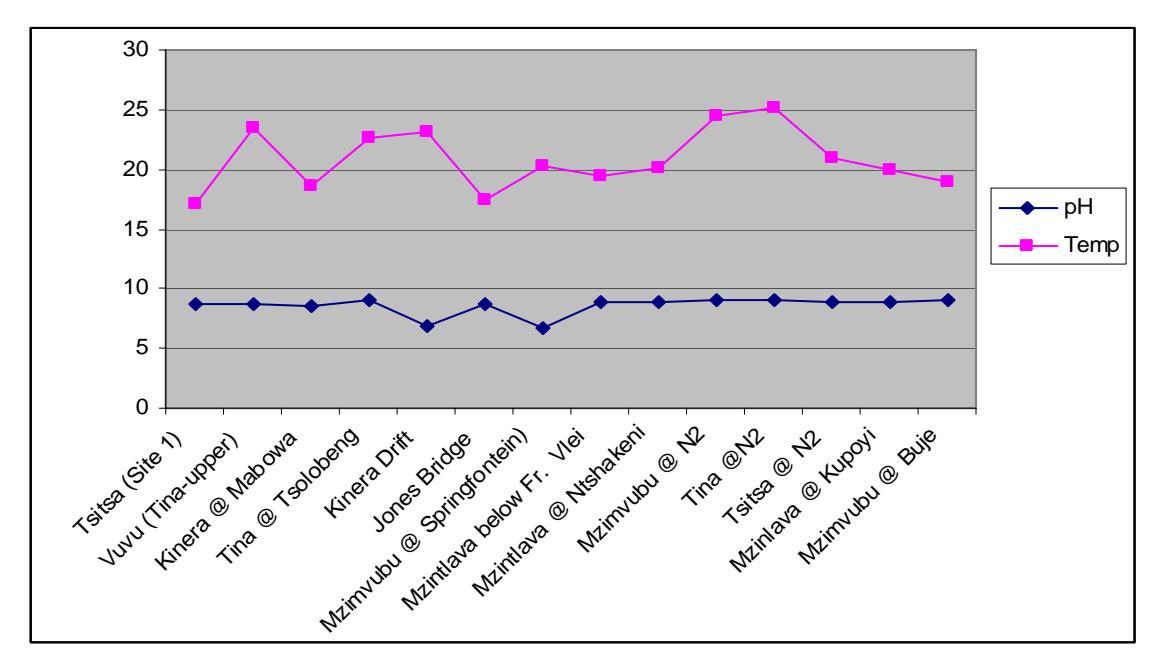
Figure14 Comparing temperature and pH.

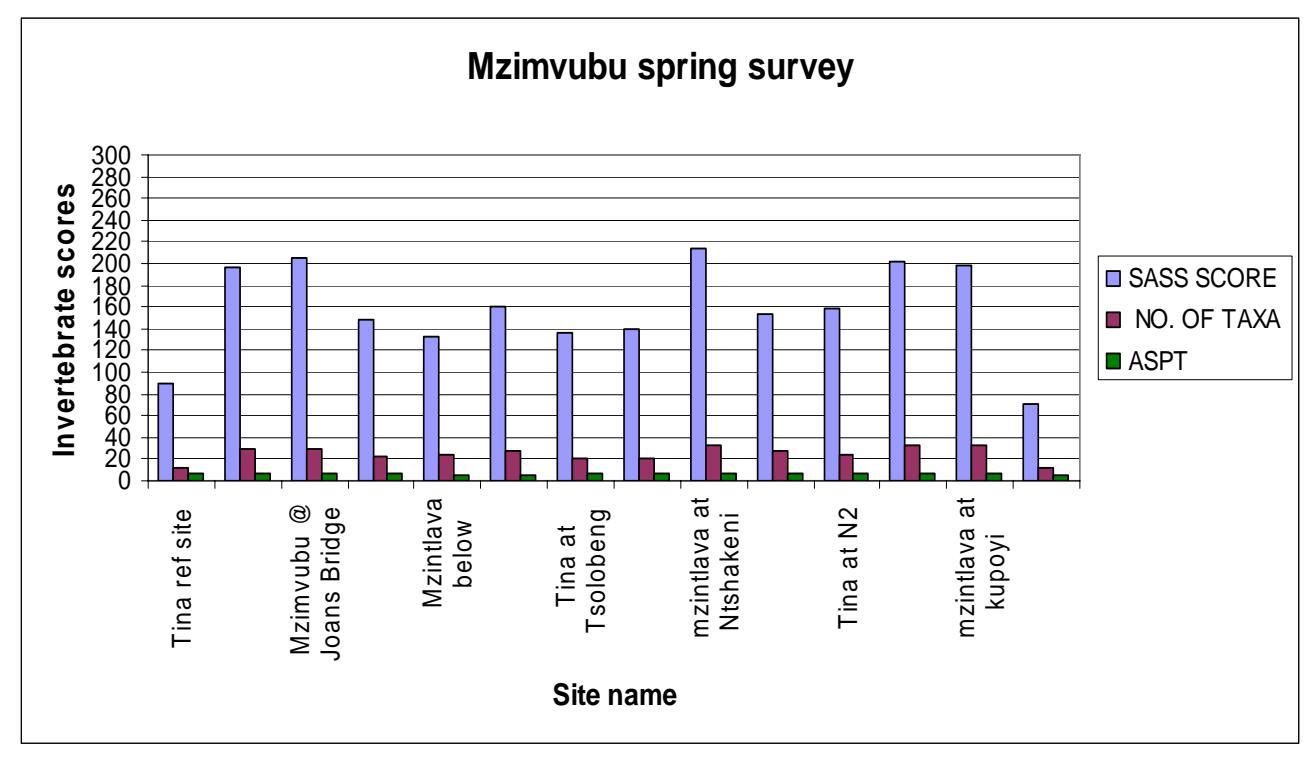
The results of invertebrate assessment during the survey is shown in the figure below.

Figure 15. Results of invertebrate sampling in the Mzimvubu River Basin.

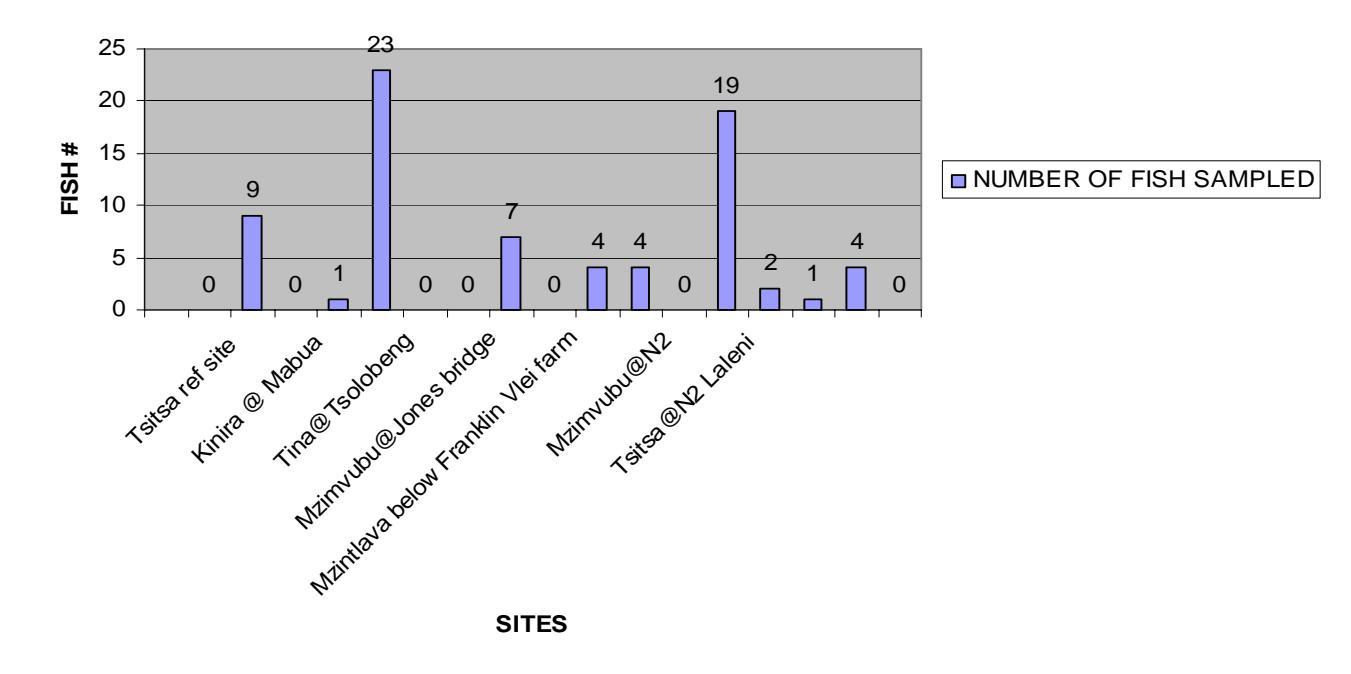
<u>Mzimvubu @ Jones bridge</u>	Oncorhynchus mykiss	7
<u>Mzimvubu @ Springfontein</u>		
<u>farm</u>	No fish caught	0
Mzintlava below Franklin Vlei		
farm	Micropterus salmoides	4
<u>Mzintlava @ Ntshakeni</u>	Cyprinus carpio	4
<u>Mzimvubu@N2</u>	No fish caught	0
<u>Tina@N2</u>	Barbus anoplus	19
<u>Tsitsa@N2 Laleni</u>	Anguilla mossambica	2
<u>Mzintlava KuPoyi</u>	Barbus anoplus	1
	Cyprinus carpio	4
Buje	No fish caught	0

Figure 16: Fish results.
