**PRE-FEASIBILITY AND FEASIBILITY STUDIES FOR AUGMENTATION
OF THE WESTERN CAPE WATER SUPPLY SYSTEM BY MEANS OF
FURTHER SURFACE WATER DEVELOPMENTS**

**REPORT No.1 – VOLUME 1
Riverine Environmental Water Requirements**

APPENDIX No.5

Habitat Integrity – Breede River

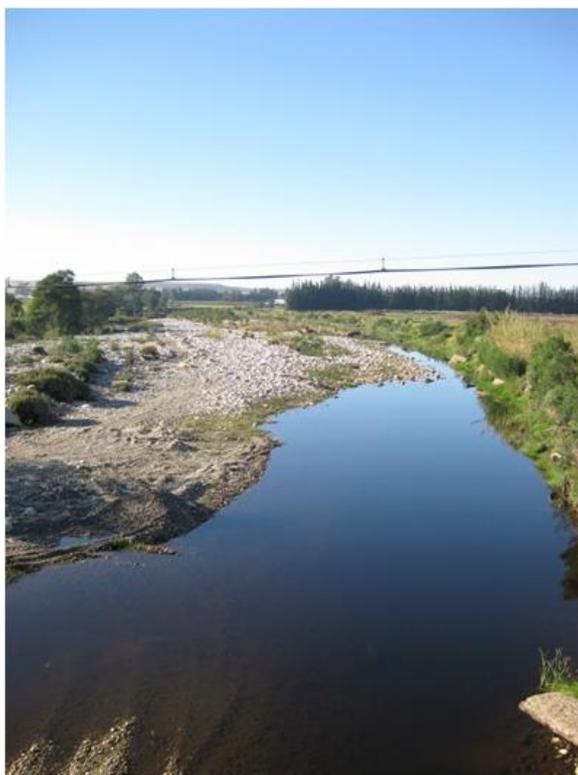
Figure 3.38 Niv25, lower Buffeljags River

The river was heavily modified by dredging and clearing of the riparian zone and over-abstraction (Figure 3.38; Table 3.121). There was little flow at the time of the site assessment. The macroinvertebrates were poor (Table 3.122 and Table 3.123).

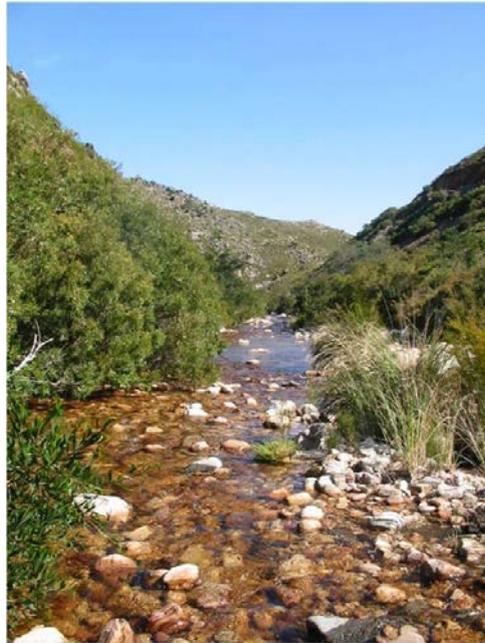
Figure 3.42 Nvii10: Du Toits River

There were few impacts on the river upstream of Theewaterskloof Reservoir, although some water is abstracted for Franschhoek. The river was in good ecological condition (Figure 3.42; Table 3.126 to Table 3.128).

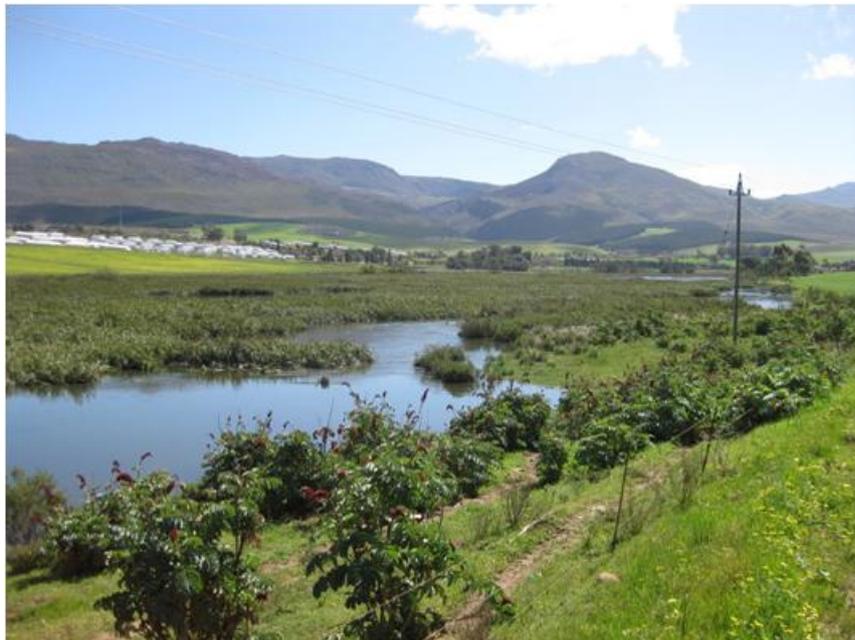
Figure 3.43 Nv7: Riviersonderend River, Helderstroom

Agriculture had encroached on the floodplain wetland and associated riparian vegetation but a fair amount remained that was in good condition (Figure 3.43; Table 3.130 to Table 3.132).

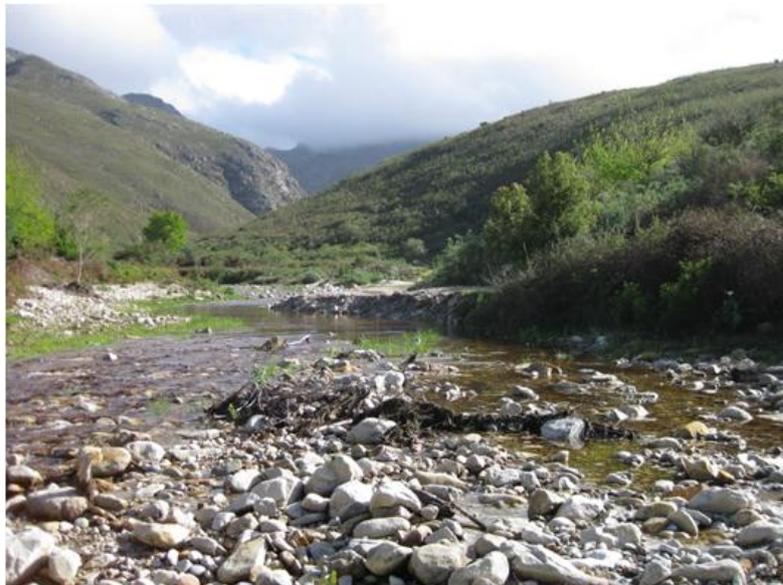
Figure 3.44 Niv28: Baviaans River

This is the closest node to IFR Site 6, but is located downstream of the town of Genendendal at the confluence with the Rivieronderend River, whereas IFR Site 6 is upstream of the town and the DWA gauging weir, and is in much better condition. There is a dam, which supplies water to Genadendal situated upstream of IFR Site 6.

There was mature riparian vegetation on the river banks despite evidence of dredging and bulldozing in the channel, and the presence of woody exotics. The wet bank was less well vegetated. The macroinvertebrates were poor (Table 3.134 and Table 3.135)

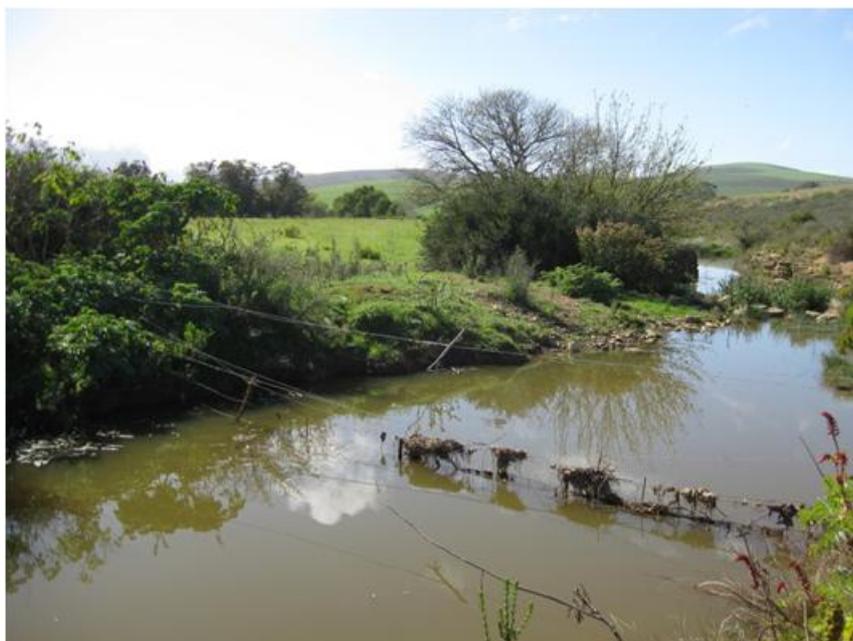
Figure 3.45 Niv29: Sersants River

The river channel did not appear to have been dredged, but the much of the riparian vegetation had been removed. There were, however, pockets of indigenous and exotic vegetation clustered along the river channel bank (Figure 3.45; Table 3.137). The water had high sediment and suspended algal loads, and macroinvertebrates were poor (Table 3.138).

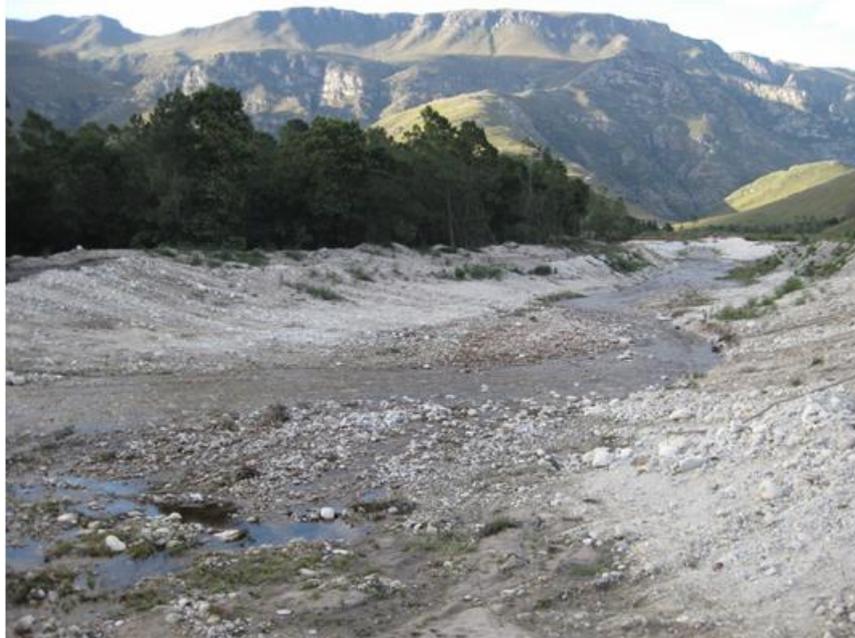
Figure 3.46 Niv30: Gobos River

The river was heavily modified by dredging and clearing of the riparian zone and over-abstraction (Figure 3.46; Table 3.140). There was no flow at the time of the site assessment and macroinvertebrates were depauperate (Table 3.141).

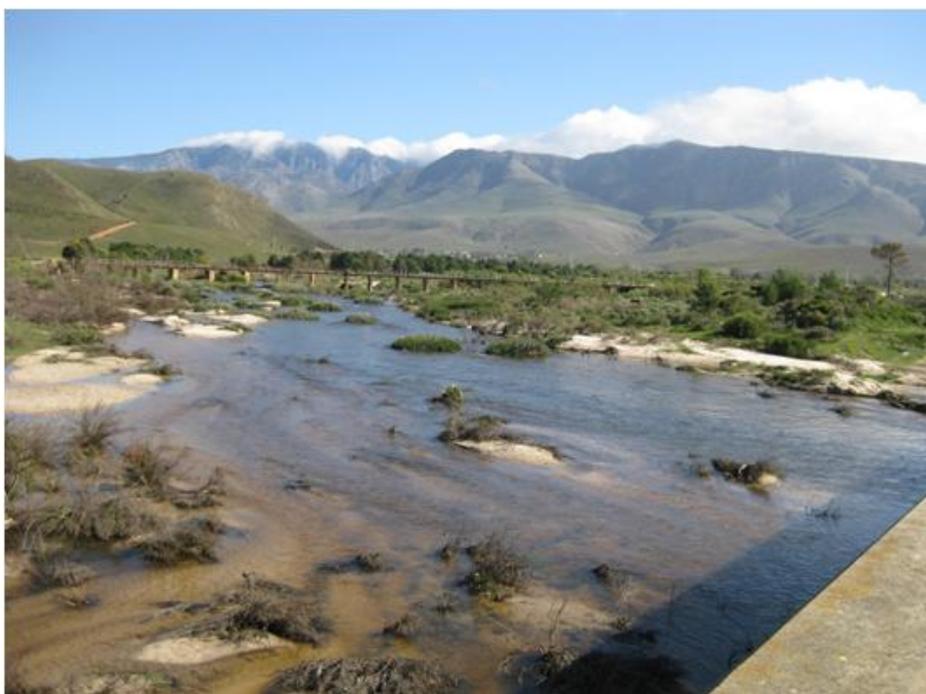
Figure 3.47 Nv8: Riviersonderend River, Genadendal

The width of the macrochannel was reduced relative to natural, and many of the meanders had been cut off, but the structure of the main channel was intact (Figure 3.47). The river carried a high fine sediment load, of unknown origin. The riparian zone comprised a mixture of disturbance-triggered annuals, fynbos, scrub and woody/non-woody exotic species (Table 3.143). Macroinvertebrates were in a fair condition (Table 3.144).

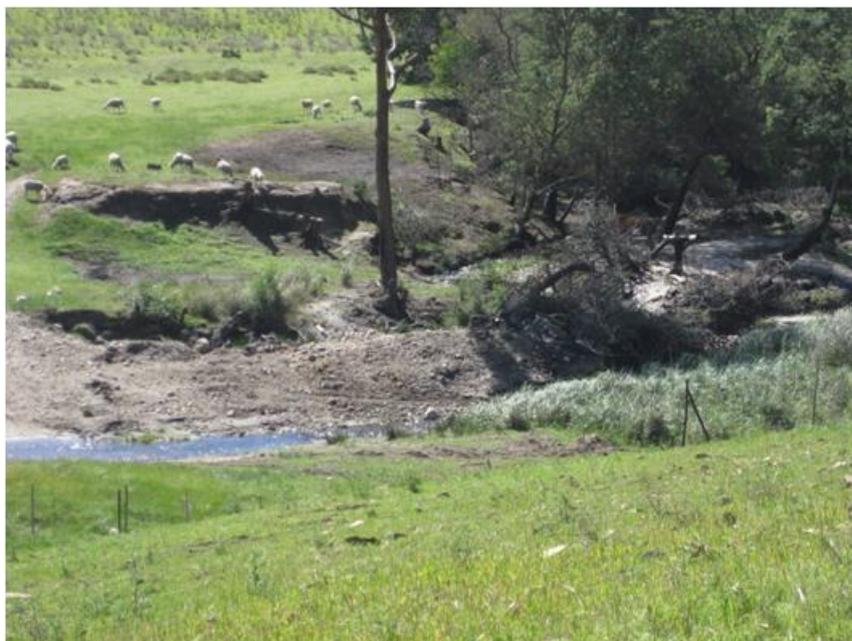
Figure 3.48 Niv31: Kwartel River

The river had been heavily impacted and modified by agricultural activities, including abstraction, bulldozing, infilling and grazing. There was a high fines sediment load and the riparian zone was dominated by exotic woody species (Figure 3.48; Table 3.146). There was little flow at the time of the assessment and macroinvertebrates were poor (Table 3.147).

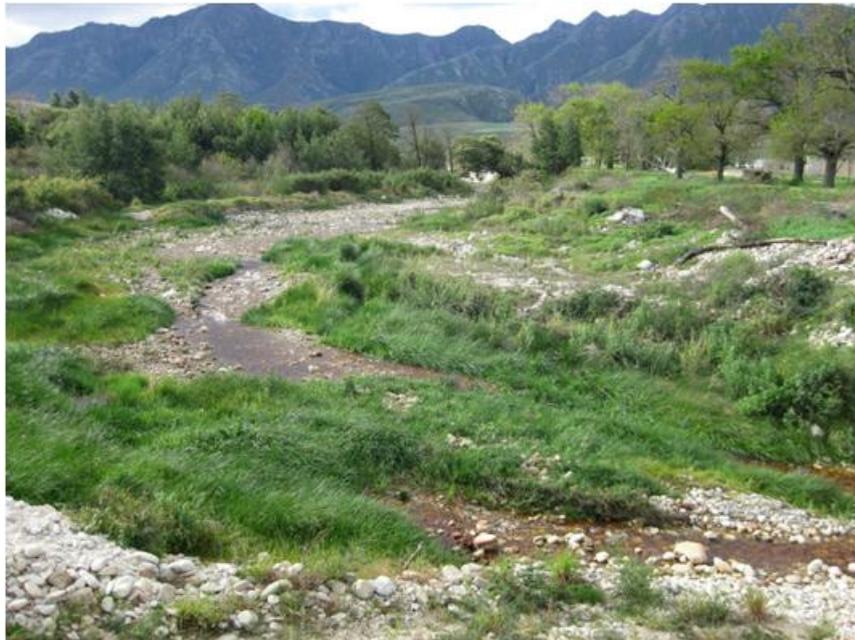
Figure 3.49 Niv33: Soetmelksvlei River

The river was heavily impacted by dredging of the channel and clearing of the riparian area. This was probably an unchannelised wetland under natural conditions (hence the name Soetmelksvlei). There was hardly any flow at the time of the site (Figure 3.49; Table 3.149) and macroinvertebrates were (Table 3.150 and Table 3.151).

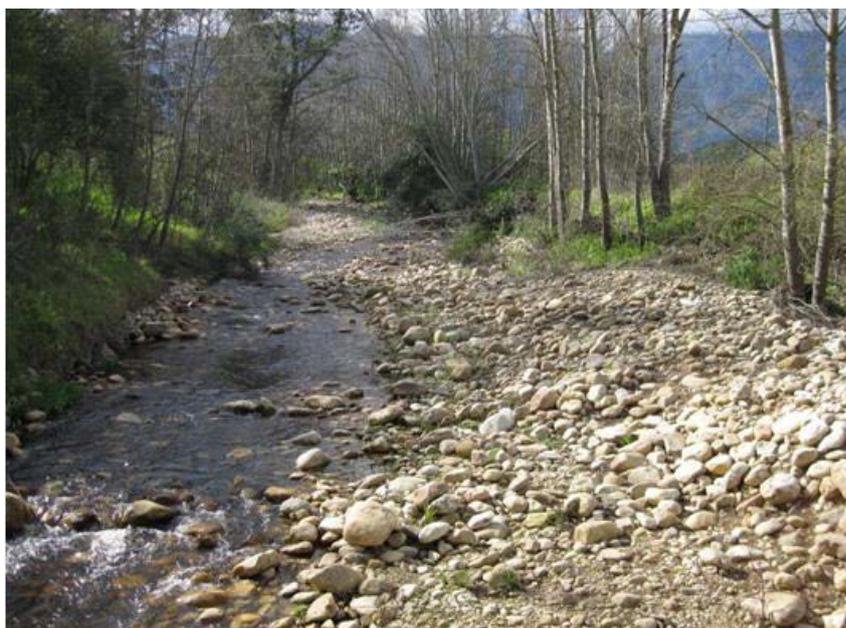
Figure 3.50 Niv34: Slang River

The river flowed through cultivated fields but had a relatively intact riparian zone (Figure 3.50; Table 3.153) and although there were a few exotic species they were not dominant. The water was of good quality and macroinvertebrates were in good condition (Table 3.154 and Table 3.155).

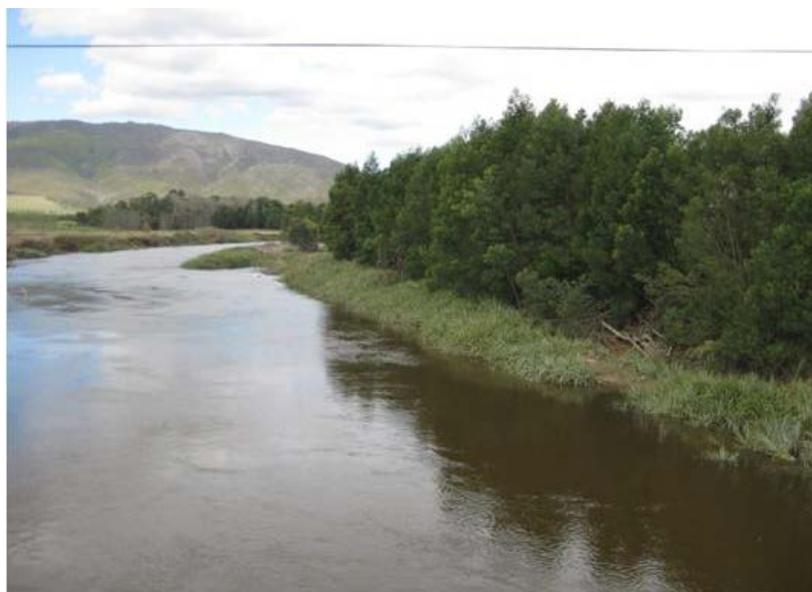
Figure 3.51 Nv10: Riviersonderend River, u/s Riviersonderend

The river flowed within naturally shaped banks (Figure 3.51). There were many woody exotic species in the riparian zone but the channel fringe was well vegetated with indigenous species (Table 3.157). Macroinvertebrates were impoverished (Table 3.158 and Table 3.159).

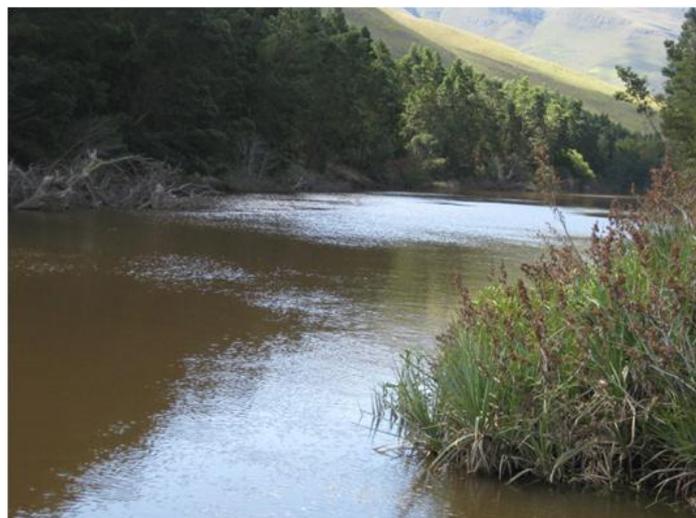
Figure 3.52 Nv11: Riviersonderend River, d/s Riviersonderend

The riparian zone was heavily infested with exotic woody species, and there were few indigenous woody species present (Figure 3.52 and Table 3.161). There was a high fines sediment load. Macroinvertebrates were poor (Table 3.162 and Table 3.163).

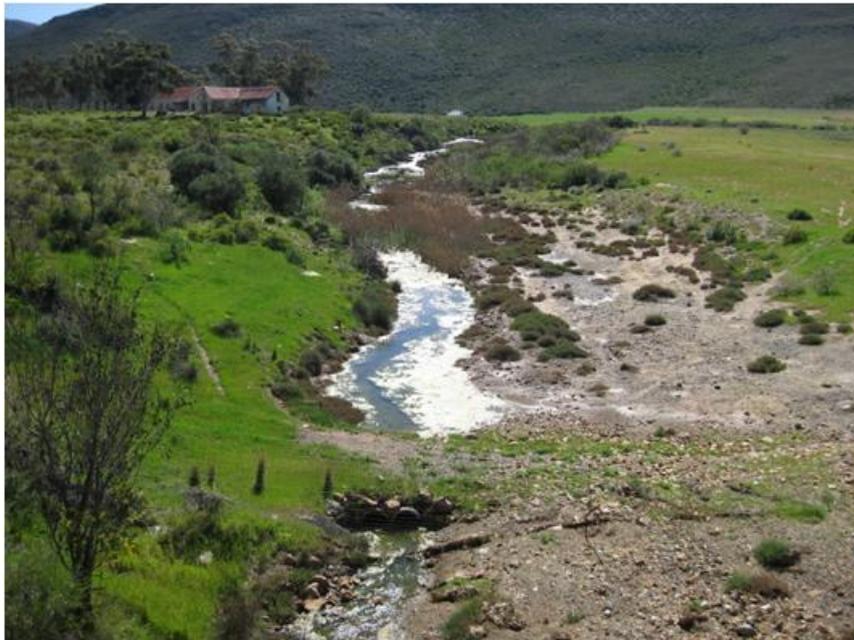
Figure 3.53 Niv35: Kwassadie River

The river had been dredged and the riparian vegetation cleared (Figure 3.53; Table 3.165). There was no little flow at the time of the site assessment and the river carried a high fines sediment load and excessive algal growth suggested elevated nutrient concentrations. Macroinvertebrates were depauperate (Table 3.166).
