Determination of Water Resource Classes, Reserve and the Resource Quality Objectives in the Keiskamma and Fish to Tsitsikamma Catchments

WP11354 River Field Survey Report 2

REPORT NO.:
WEM/WMA7/00/CON/RDM/1423

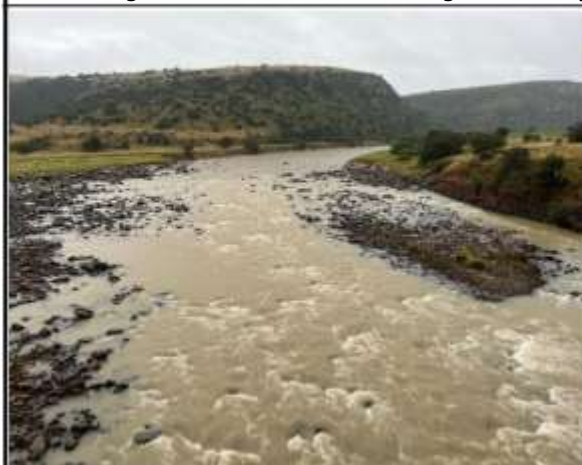
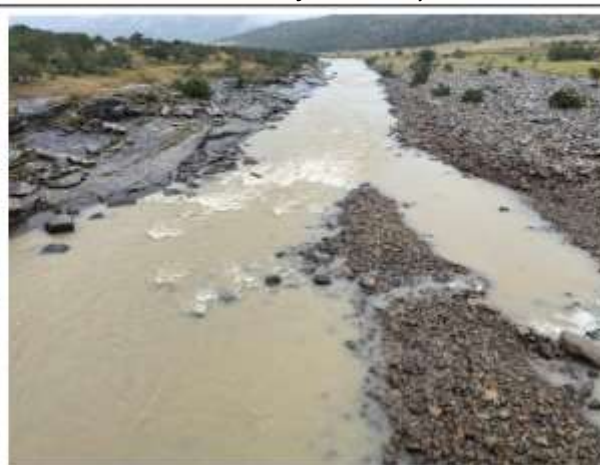
The marginal zone and portions of the flood benches had been scoured or removed from recent floods. Marginal zone vegetation was sparse and scattered and comprised clumps of *Phragmites mauritianus*, *Cyperus longus* or scattered remnants of *Gomphostigma virgatum*. Flood benches were a mix of scoured bedrock/boulder/cobble, mostly unvegetated and consolidated alluvia with overgrazed lawns dominated by *Cynodon dactylon*. The left bank was steep, with *C. dactylon*, *Agrostis lachnantha*, scattered trees, mostly *Combretum caffrum* or *Vachellia karroo* and a band of *V. karroo* seedlings and saplings. The right bank had been altered with artificially piled rocks and incised by a lateral tributary feeding into the main channel just upstream of the site. As such, vegetation was artificially aligned and comprised mostly alien shrub species including *Sesbania punicea*, *Lantana camara*, *Senna didymobotrya* and *Solanum torvum*.

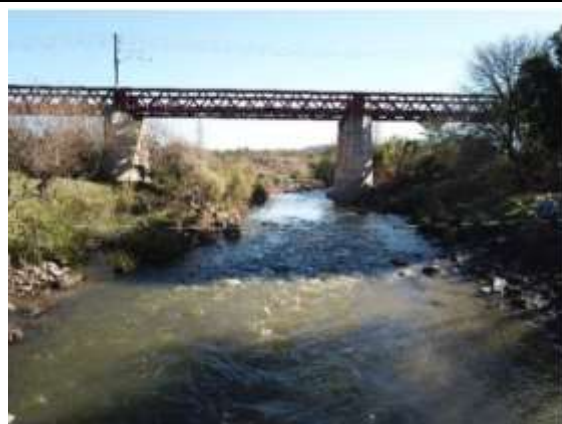
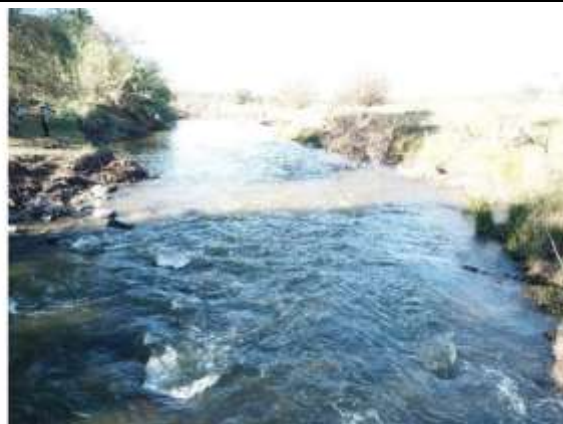
Following the flood event that took place in February 2023, clear evidence of bank collapse and further bank erosion was observed, particularly along the left bank. This was exasperated by the continued cattle trampling and grazing along that bank.

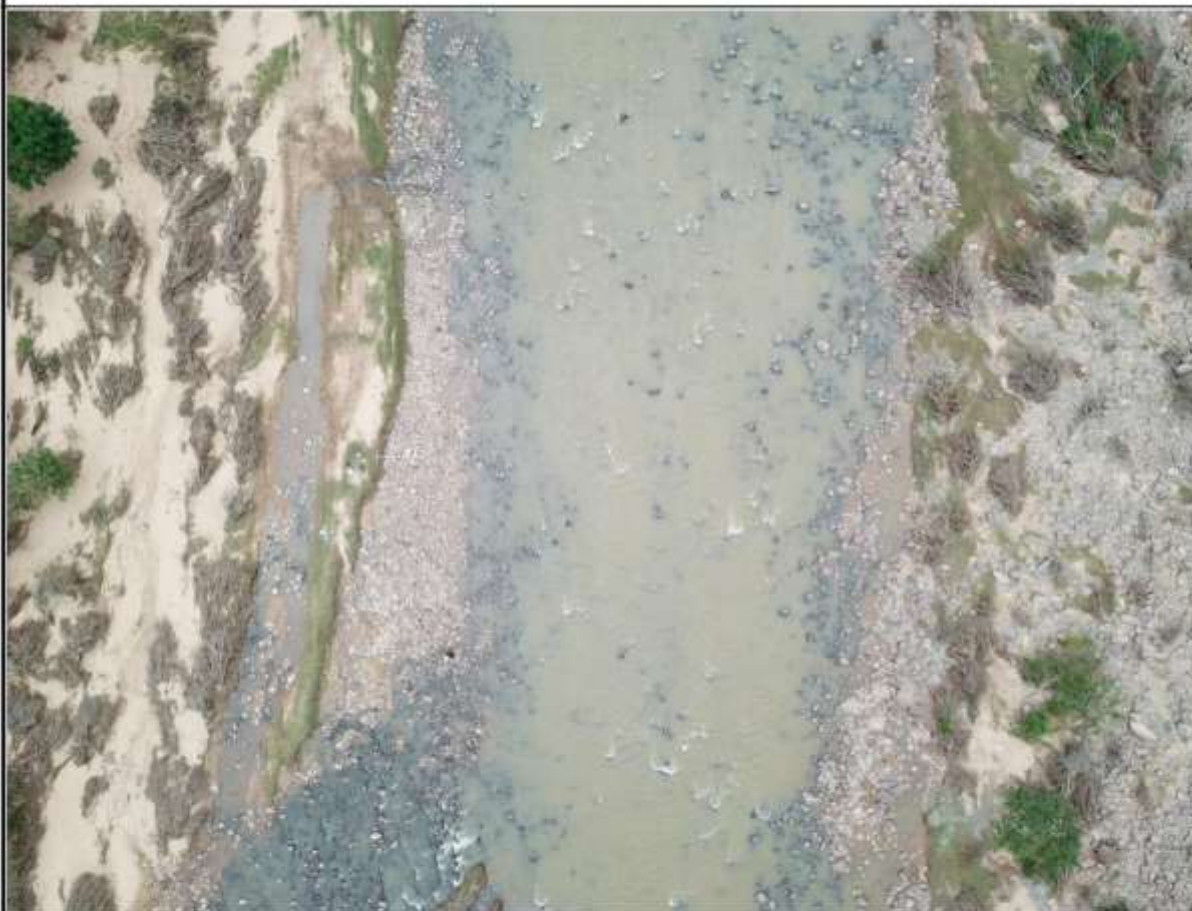
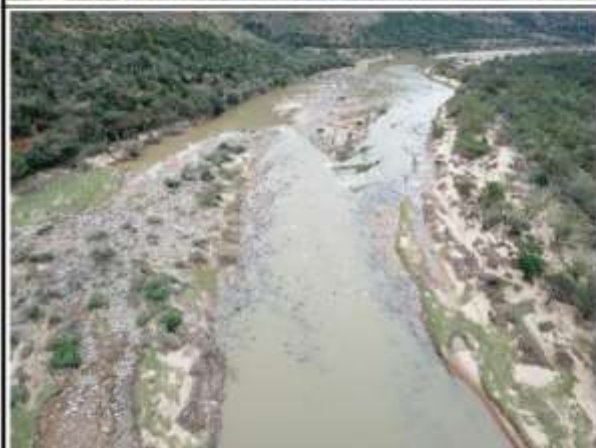
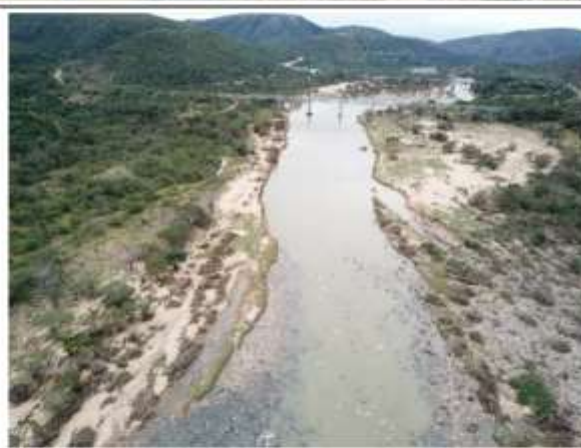
Following the flood event which took place in February 2023, it was clearly observed that this reach of the Great Kei has been positively reset. Considerable sediment deposits were observed along both banks and terrestrial species (i.e *Vachellia robusta* (*Splendid Thorn*)) flooded out along the riparian marginal zone. The boulders and SIC, SOOC have been scoured and a considerable difference in the population of Simuliidae larvae, which previously smothered and dominated the biotopes.

The marginal zone had been mostly scoured out by recent floods with only remnants of vegetation clumps scattered between bedrock/boulder/cobble with newly deposited alluvia in-between. Vegetation comprised mostly *Cyperus longus*, *Gomphostigma virgatum* and *Hemarthria altissima*, although the latter had been grazed to form lawns. Flood benches and the floodplain were extensively covered by new, mostly unvegetated sediment deposits from recent floods and flood damage and flood-related plant deaths were extensive. The *Vachellia robusta* population which had dominated the floodplain before has been vastly reduced, although much remained, and dominance persisted. Other floodplain species included *Ficus sur*, *Combretum caffrum*, *Gymnosporia buxifolia* and *Lantana camara*. The banks were dominated by thickets of *L. camara* and wood removal and overgrazing were extensive.

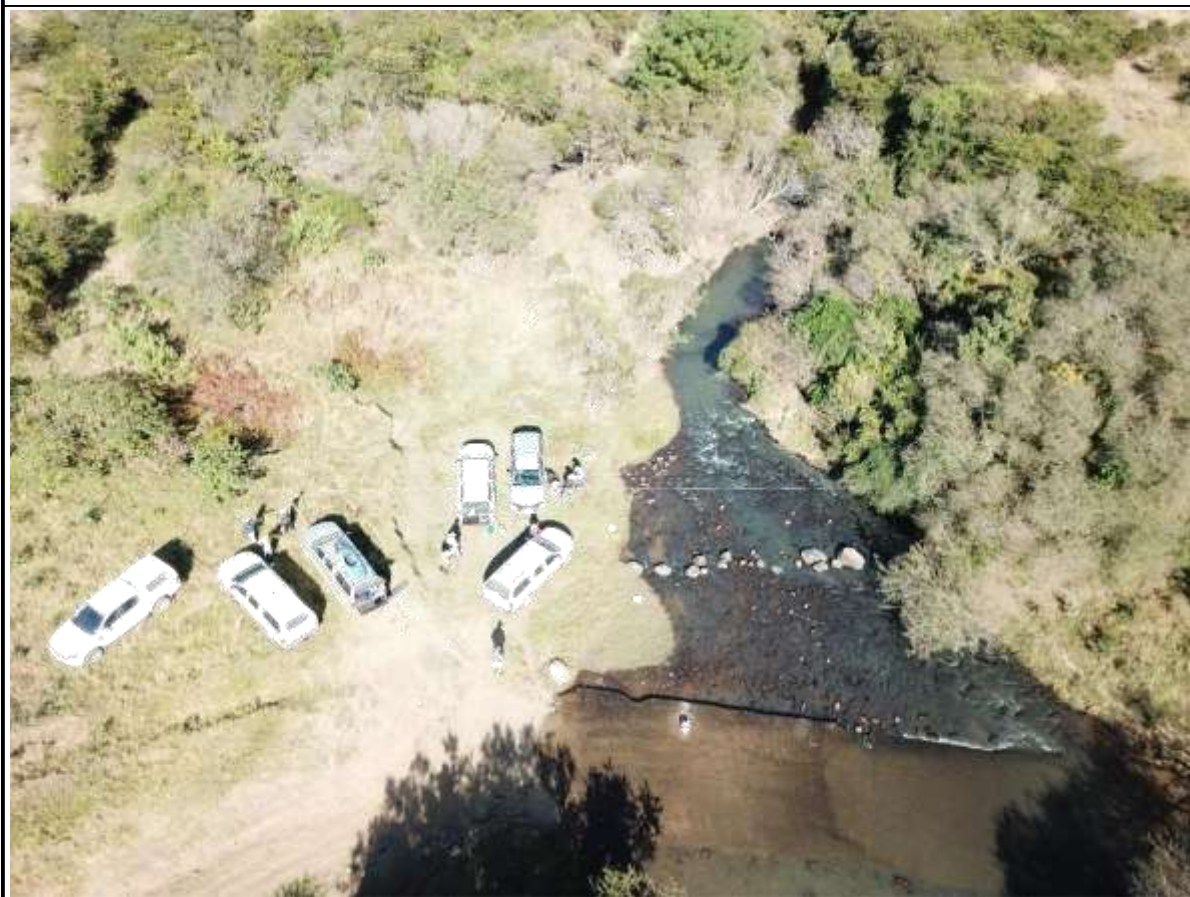
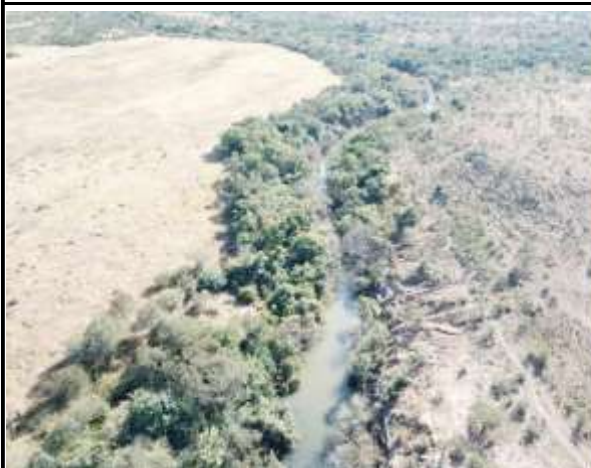
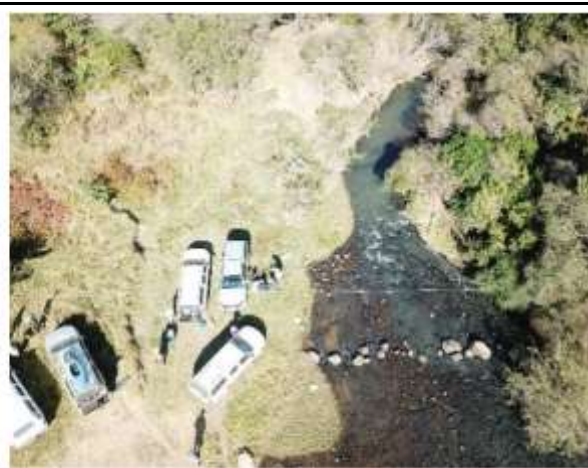
and cobbles along the riffle have a significant silt component, indicating high silt loads during higher flows. This can be seen in the pools with thick silt drapes across the various low velocity habitats. Livestock grazing and trampling is widespread, with localised sand mining along the flood features. There are moderate levels of erosion along the banks, but is more severe at the causeway due to altered flow patterns. Woody encroachment is evident along the channel, with sandy lee bars forming behind thick vegetation. Sand deposition takes place on the lower flood features.

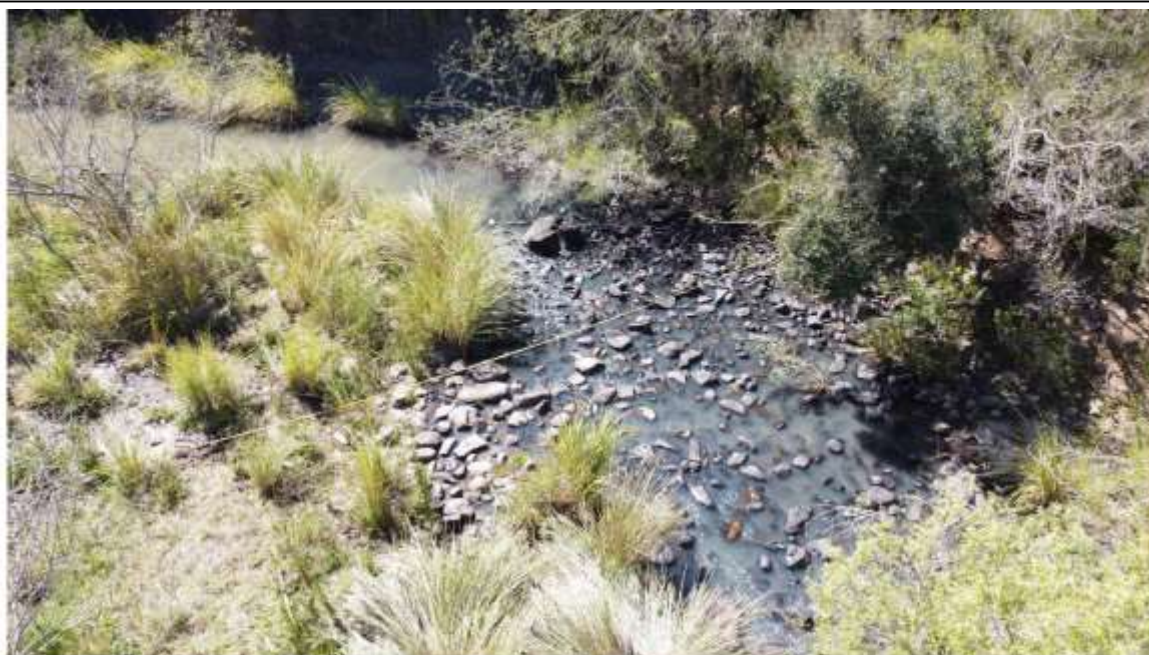
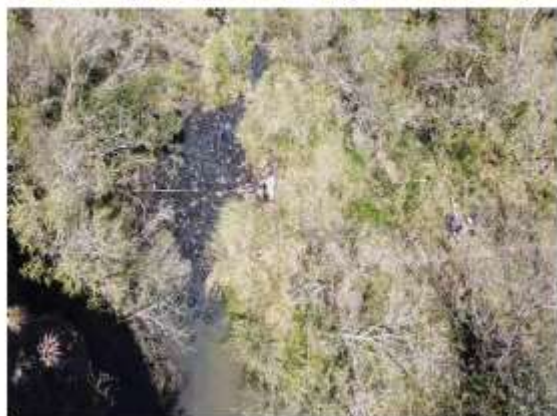
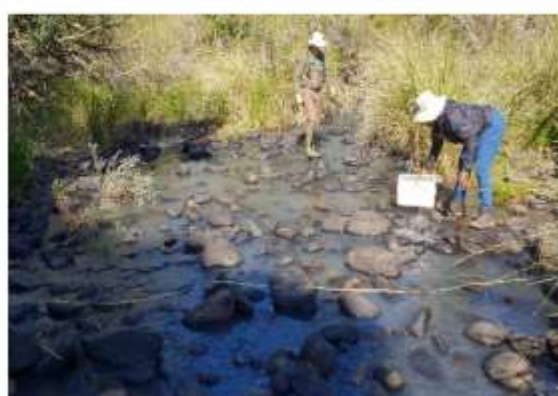
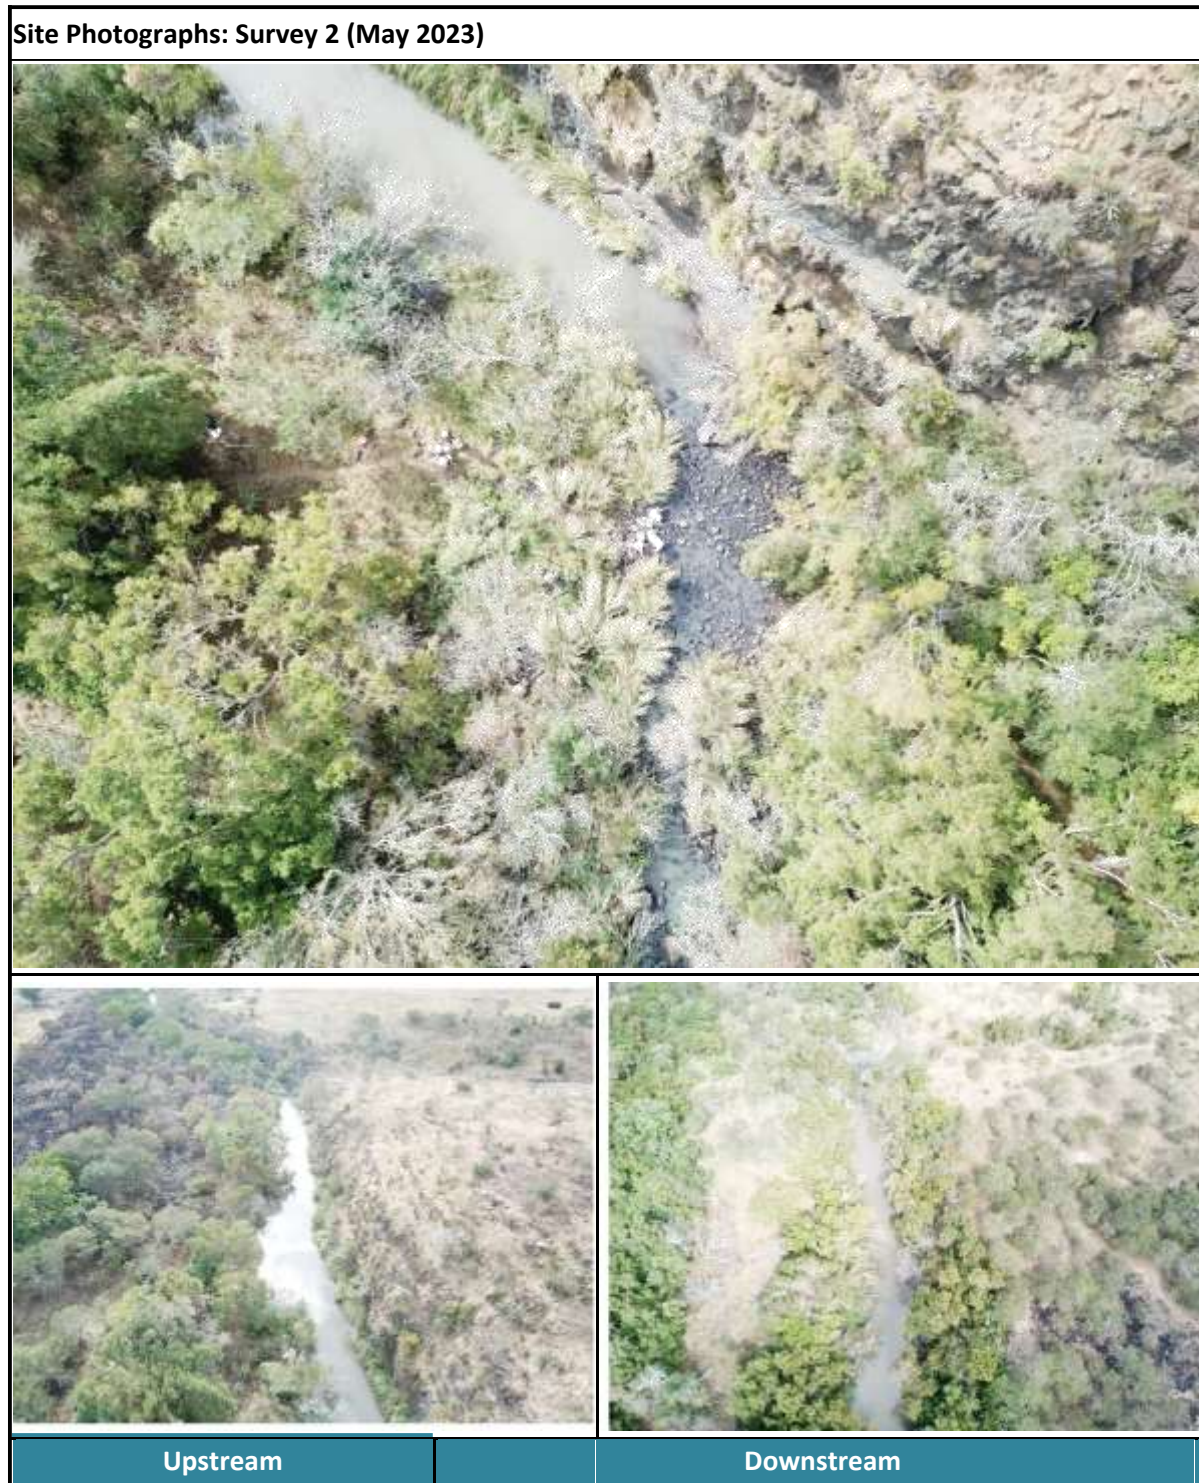
5.8 Kat River (Upper)

The site is located in a confined valley setting with a single channel and narrow flood features within a deeply incised macro channel. The channel is straight to wandering and follows the sinuous valley alignment. It follows a pool-riffle and pool-rapid reach type and is dominated by boulder, cobble, gravel and silt sediment types. The banks and benches are composed of sand and silt, with bedrock cliffs along the outer bends. The channel has dense tree and grass vegetation with some

localised trampling where livestock cross the channel. Bank erosion is localised and the bed along the riffle has a limited gravel and sand deposits, possibly due to sediment starvation. Siltation takes place along the pools with a silt drape covering slow flowing habitats. There are numerous weirs along the river, increasing pool type habitats.

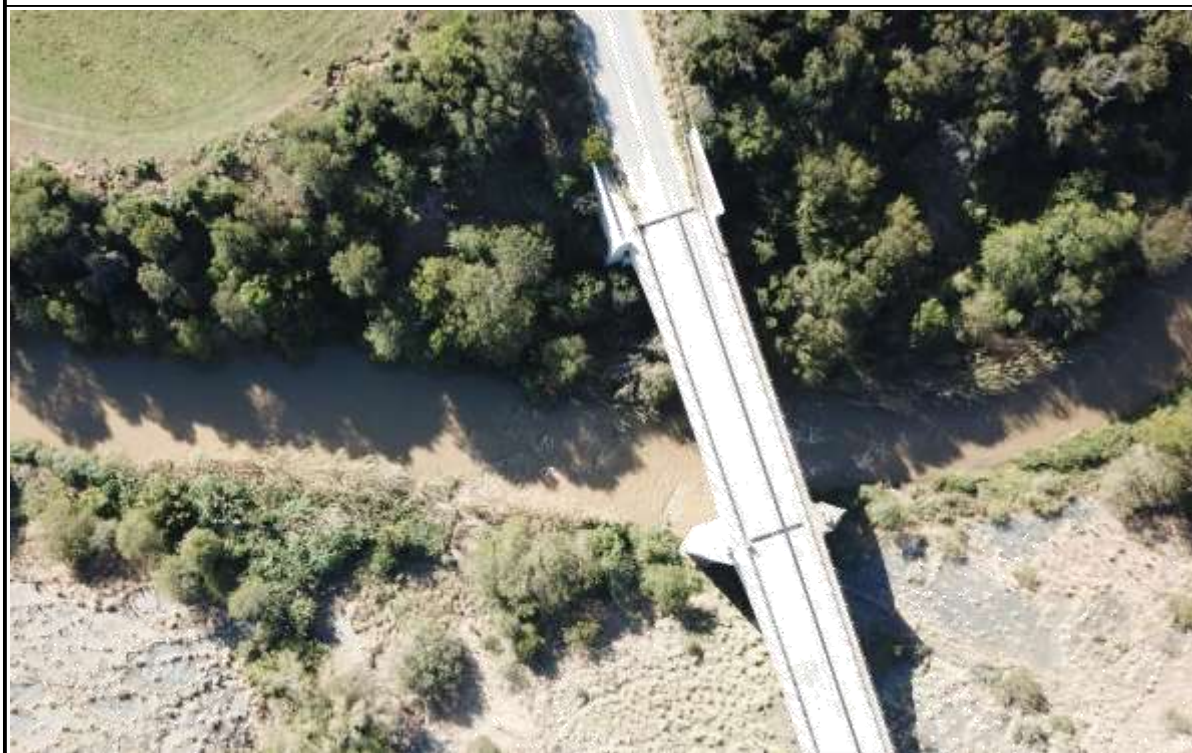
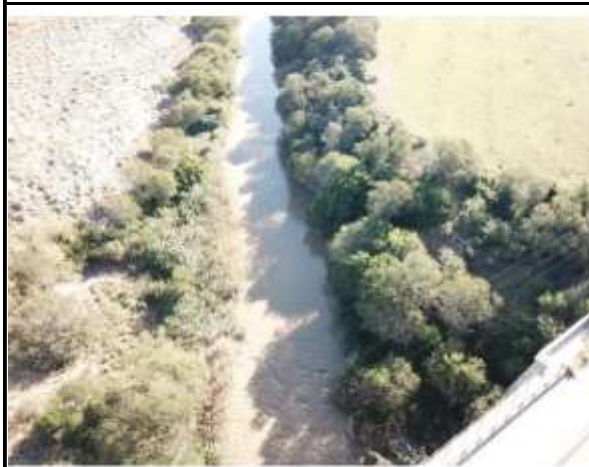
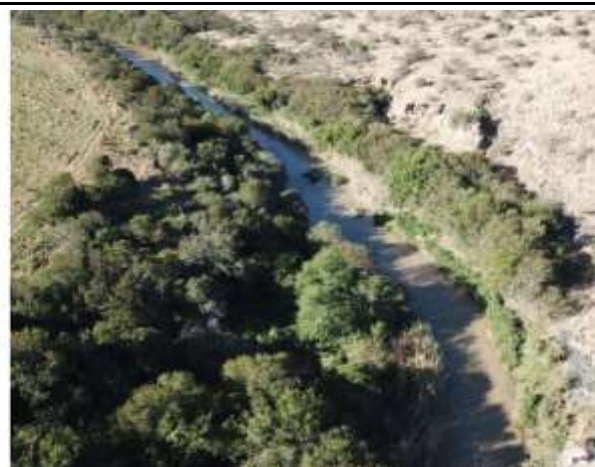
Site Photographs: Survey 2 (May 2023)

The site is located in a moderately confined valley setting with a single channel and narrow flood features within a deeply incised macro channel. The channel is straight to wandering and follows the sinuous valley alignment. It follows a pool-riffle and pool-rapid reach type and is dominated by boulder, cobble, gravel and silt sediment types. The banks and benches are composed of fine sand and silt, with bedrock along rapids and along the outer bends. The channel has dense sedge, reed and tree vegetation with some localised trampling where game cross or drink from the channel. Bank erosion is localised and the bed along the riffle has a limited gravel and sand deposits, due to increased flow levels. Siltation takes place along the pools with a silt drape covering slow flowing habitats.

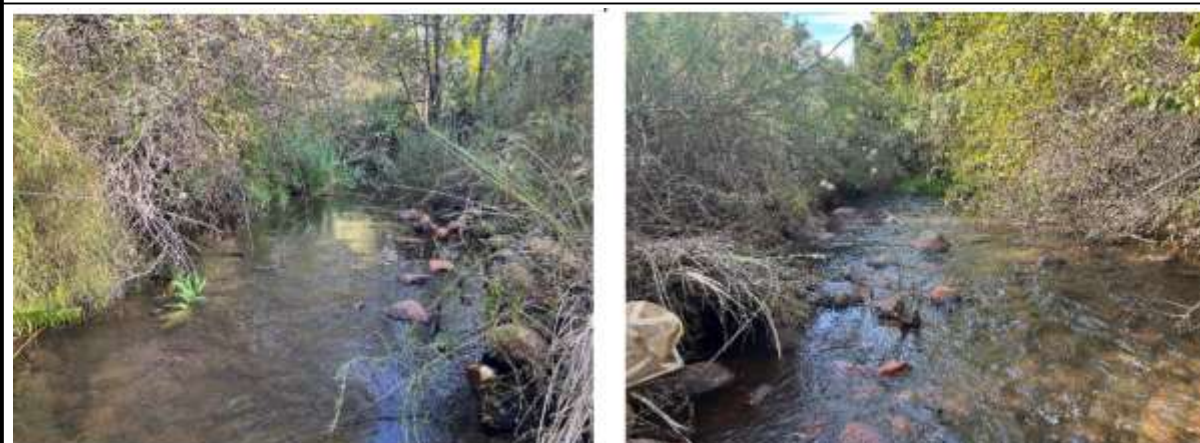
Site Photographs: Survey 2 (May 2023)

During the May 2023 survey, the site had no flow, stagnant pool upstream of the bridge and limited water downstream. Consequently, aquatic macroinvertebrates and discharge was not conducted. However, fish, riparian vegetation and water levels were measured, retaining this site as Intermediate.

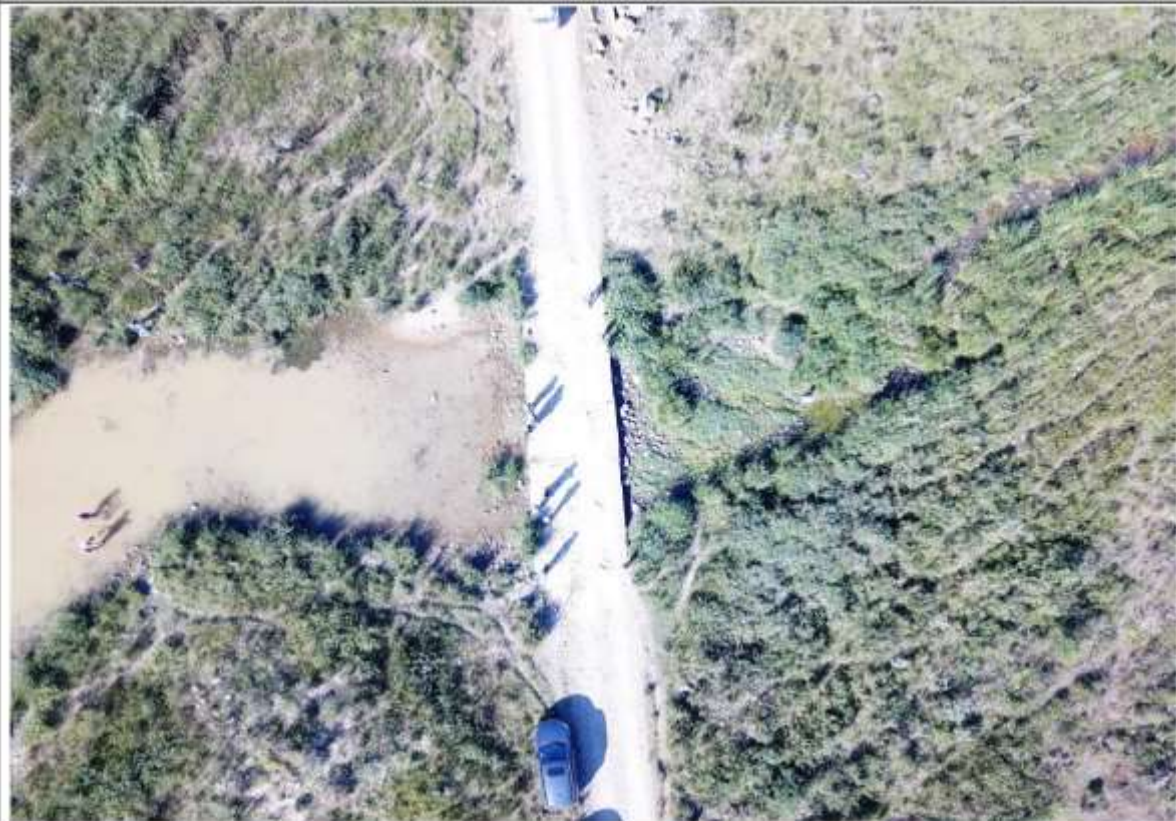
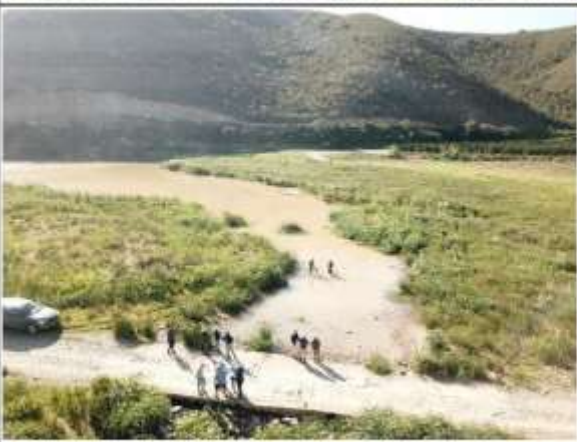
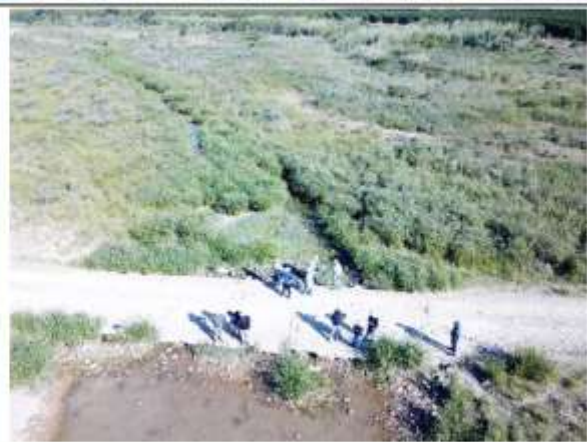
Site Photographs: Survey 2 (May 2023)

During the May 2023 survey, flow conditions were zero. The water had pooled upstream of the low water bridge, with zero flow and limited water downstream of the bridge. Consequently, macroinvertebrates were not sampled. The rest of the components were conducted.

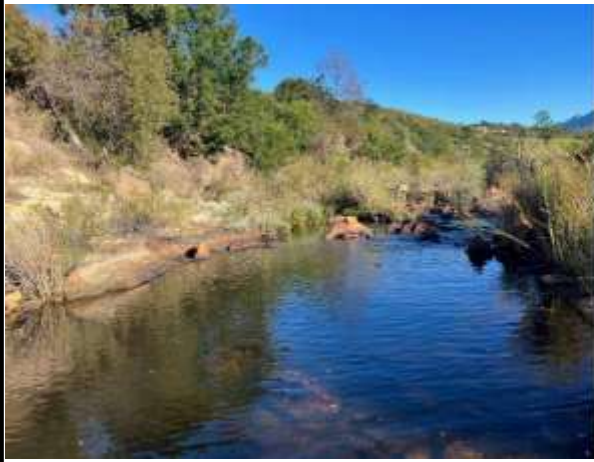
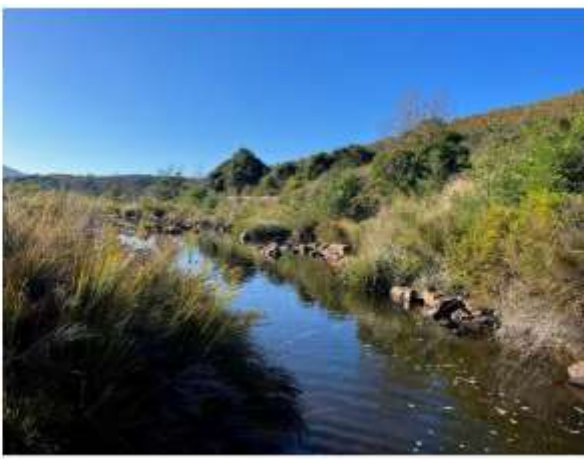
Upstream		Downstream	
Site Description:			
<p>The site is located along the Kromme River valley with cobble-bed or mixed bedrock-cobble bed habitats, with a mix of sand, gravel and cobbles. There are large gravel and cobble bars along the left bank of the channel, with the benches composed of silt and sand. There is very low embeddedness along riffles, runs and pools. This may be owing to sediment starvation from the upstream weir. The active channel has narrow flood benches and is relatively incised into the valley floor. The channel is straight to wandering and follows the sinuous valley alignment. The channel is braided in some areas along the reach, and which is densely vegetated with shrubs, sedges and</p>

pockets of peat. There are sections of steep bank erosion, likely owing to the last flood event which took place in 2015.

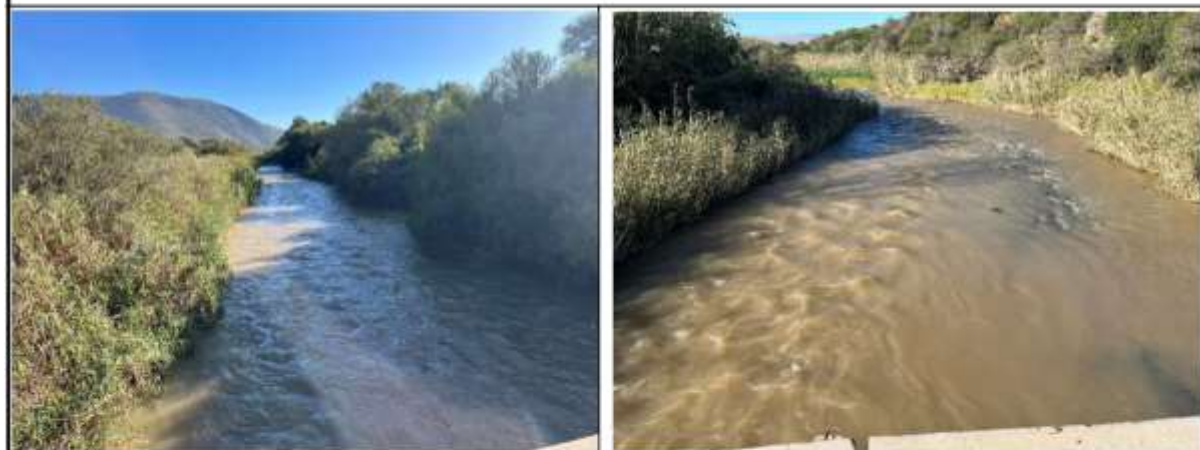
Site Photographs: Survey 2 (May 2023)

This site still could not be surveyed owing to continued high flows (Fish Interbasin transfer (IBT)) and safety risk. This site was assessed however, the levels continue to be high as the farmers have only 4 weeks left to order water for their dams and irrigation prior to switching the transfer off for maintenance purposes until July 2023. A Flow Management Plan (FMP) may be considered for this reach which is experiencing extensive flow modifications owing to the IBT.

The site is located in a partly confined valley setting with a single channel and narrow flood features. The channel is incised into the surrounding landscape. The channel is straight to wandering and follows the sinuous valley alignment. It follows a pool-riffle reach type and is dominated by cobble, gravel, fine sand and silt sediment types. The banks and benches are composed of sand and silt. Dense reeds are stabilising the active channel banks, leading to steep active channel banks. Grazing is absent from the channel banks and flood features, leading to low bank and marginal zone degradation. Finer sediment bars, such as sand and gravel bars, are missing, possibly due to increased transport rates entraining these sediment types, limiting their residence time along the system.

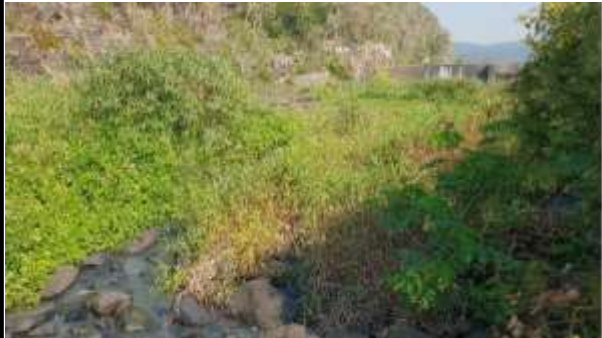
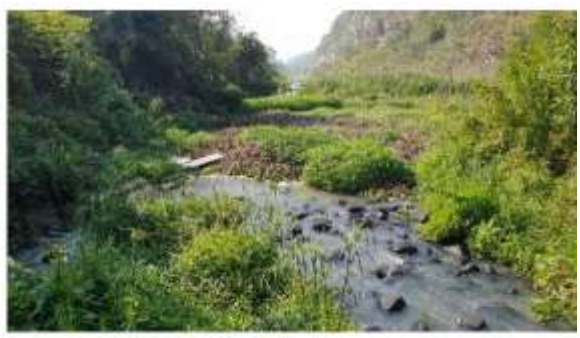
Site Photographs: Survey 1 (May 2023)			
<i>Not surveyed</i>			
Upstream		Downstream	
Site impacts:			
<ul style="list-style-type: none"> • Considerate raw sewage inputs from adjacent residential area • Nutrients (algae) mainly from WWTW pipeline leakage downstream • Upstream weir • Water abstraction • Alien invasive aquatic macrophytes (<i>Eichhornia crassipes</i> – Hyacinth) • Cattle trampling and grazing • Alien invasive trees within riparian zone (<i>Syringa</i> sp., <i>Caesalpinia pulcherrima</i> - Pride of Barbados) • Downstream of Bridle Drift Dam

Red Flag for actioning from the Department			
<p>During the May 2023 survey, evidence of raw sewage flowing directly into the lower reaches of the Buffalo River, where our EWR site is located, was observed. The source of this sewage appears to be sourced from the residential and rural area of Reeston and beyond. The observed flow of raw sewage was higher than what was previously observed in September 2022. The bypassing of the Wastewater</p>

Treatment Works (WWTW), which is located just downstream of this site and adjacent to the water pump house along the River, exacerbates these issues, posing health hazards to both humans and the environment.

At the time of the survey, DWS colleagues observed the raw sewage inputs with the specialist project team, and discussions were had regarding the severity of the current state of this river, emphasizing the need for urgent attention and action to be taken by the Catchment Management Agency (CMA).
