## A High Confidence Reserve Determination Study for Surface Water, Groundwater, and Wetlands in the Upper Orange

### WP11343 River Survey Report 1

REPORT NO.:  
RDM/WMA13/00/CON/COMP/0722

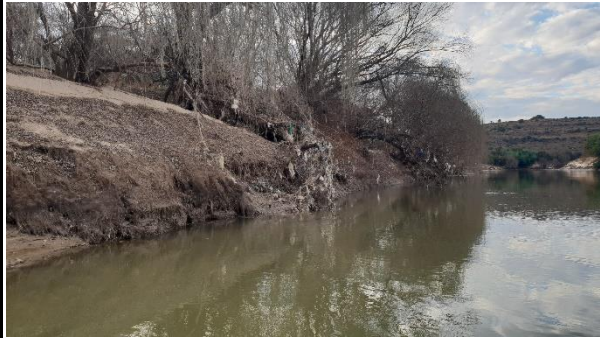
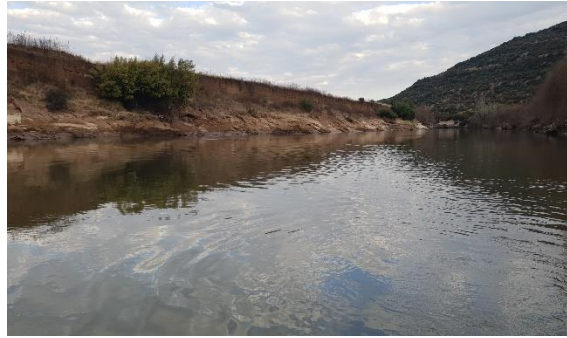
| <b>Components sampled:</b> IHI, <i>in situ</i> water quality, diatoms, geomorphology. Intermediate study not conducted during the low flows owing to limited access across the channel and limited habitats for macroinvertebrates. Cross sectional data will be utilised from a previous study conducted in the same eco-region upstream of this site (July 2021), along with JBS3 biological data collected in October 2021. The site will be re-surveyed during the wet season survey in November 2022. | | | |
| <b>Site Description:</b><br>This site is ORASECOM JBS3 site (15_6) and the DWS River Health Montiroing Programme (REMP) site D2CALE-LADY2. The reach is partly confined with a deeply incised channel. The site is a wide and homogenous channel with limited habitat overall. The confluence with the Phuthiatsana River is just 5 km upstream and the confluence with a bigger river, also called the Phuthiatsana is about 30 km upstream. Lesotho’s capital city of Maseru lies ~7 km upstream. The surrounding area is a mix of settlements, grazing areas and small-scale croplands. The Lesotho side is heavily overgrazed and eroded contributing to the already high fine sediment load and evidence of sediment deposition (but not extensive along both banks). The banks are sandy and steep and potentially highly erodible. The banks have clusters of Salicaceae and Salix trees upstream and a heavy infestation of Poplus sp. on the riverbanks downstream of the site. The river is ~50m wide and with some inundanted sandbars along the channel. The water is turbid, and the riverbed is very muddy.<br><br>Biotopes available for macroinvertebrates is dominated by sand and silt, with small gravel deposits over the sandy substrate. Marginal vegetation was absent owing to recent erosion of inset benches | | | |

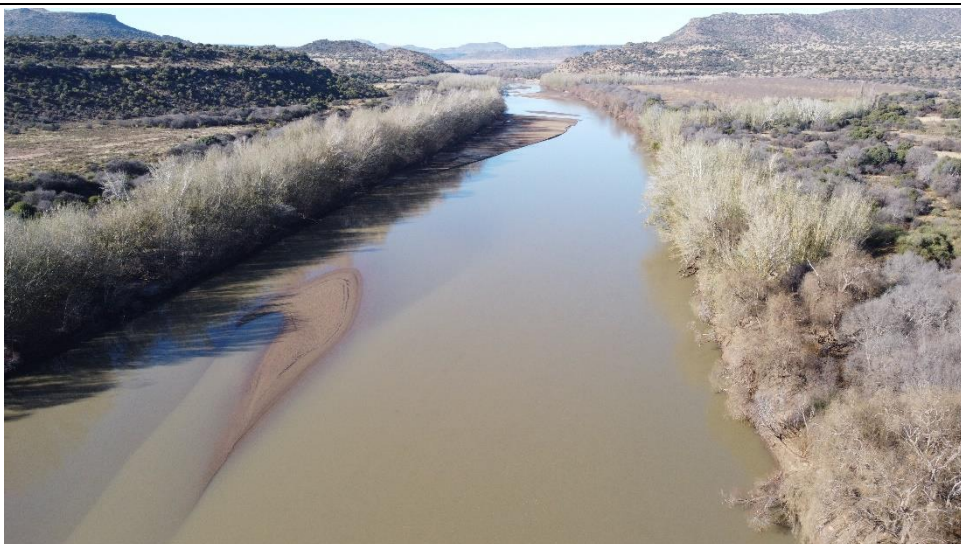
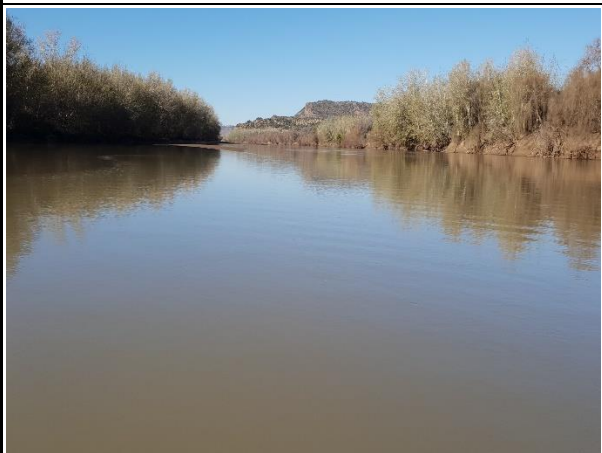
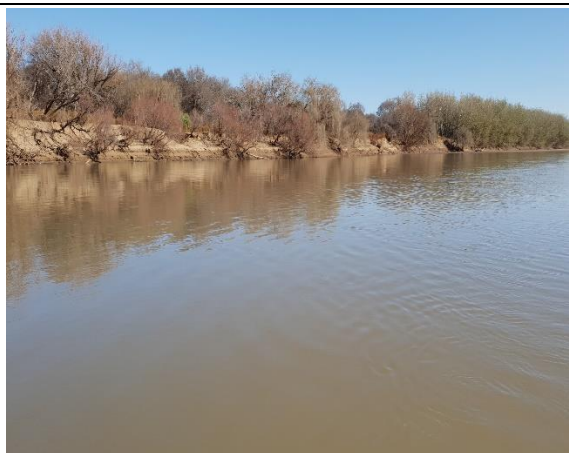
| Components sampled: Fish, aquatic macroinvertebrates, IHI, <i>in situ</i> water quality, diatoms, cross-section, discharge, geomorphology | | | |

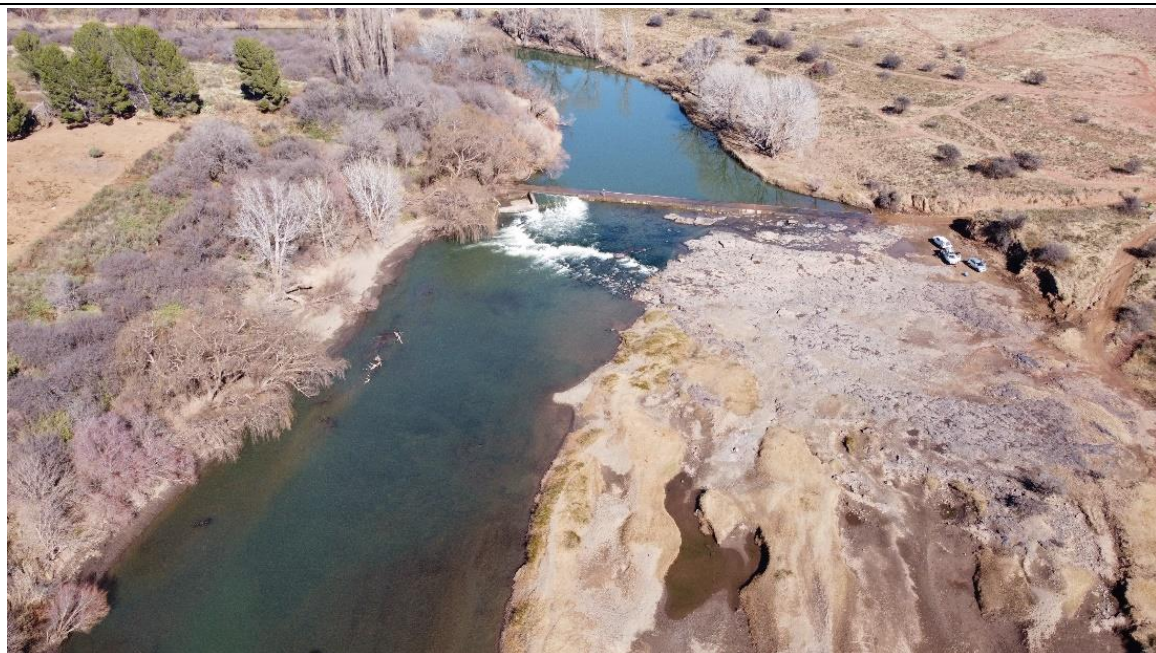
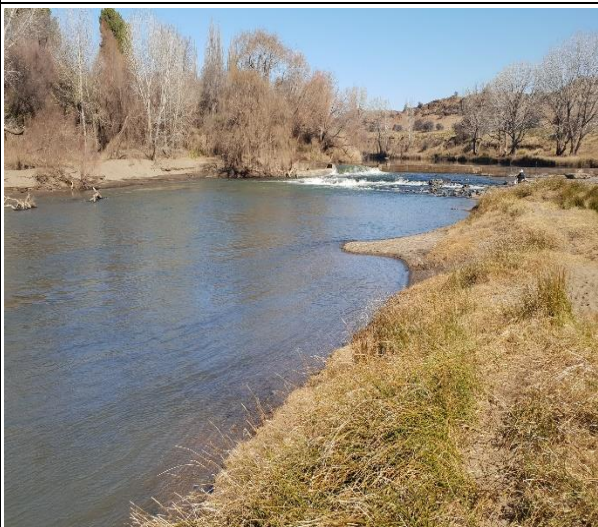
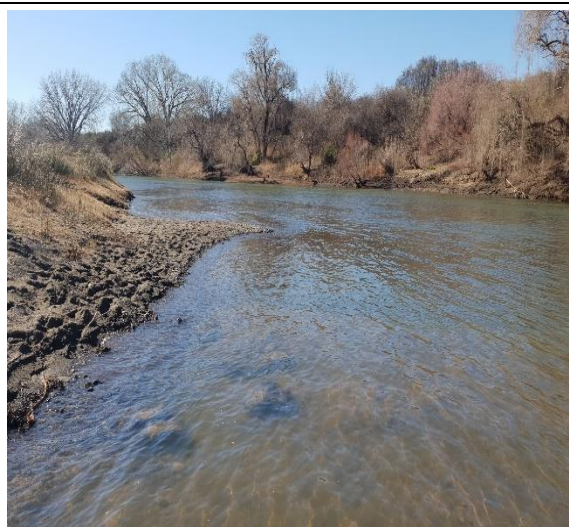
| Components sampled: Fish, aquatic macroinvertebrates, IHI, <i>in situ</i> water quality, diatoms, cross-section, discharge, geomorphology | | | |

This site is ORASECOM JBS3 site (26\_11) and the DWS REMP site D1KRAA-ALIWA. The reach has a partly confined valley setting, straight to wandering channel form and pool-riffle sequences. The channel is incised with narrow flood features. The site is immediately downstream of a causeway/bridge which is frequently used by farmers. There is a sluice gate on the right end of the bridge – which can be closed in times of drought or should the Orange River dry up. This functions in pooling up the river upstream of the bridge for Basic Human Needs support. This river is a free flowing river, ~30 m wide and has a range of biotopes. There is a solid igneous bedrock base with riffles and runs below the causeway. Much filamentous algae coverage over the SIC biotopes. Most of the river in the area has deeper, slow flowing pools. The river comprises various sections of riffles and pools downstream of the bridge, providing a range of habitats. All biotopes for the macroinvertebrates are present, SIC, SOOC, GSM, although vegetation is limiting owing to undercut banks and vegetation die back/erosion. For fish, there are FD, SD, SS and FS habitats.

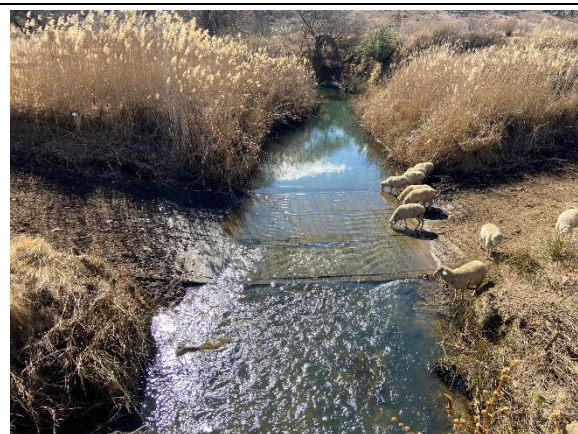
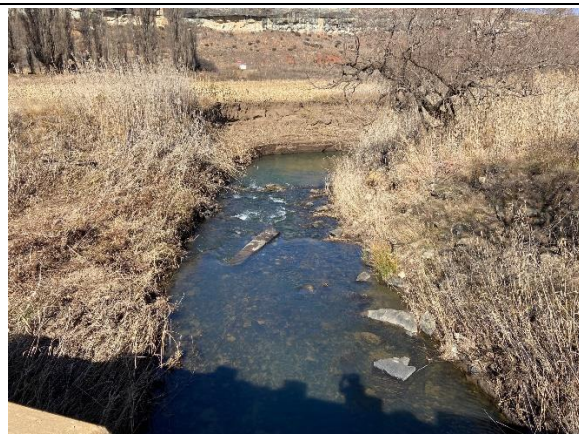
| <p>The site is located downstream from the town of Clarens along an incised floodplain reach. Localised channel modification and bank modification are evident. Farm road/bridge crossing, along with just immediately upstream a causeway/bridge which is frequently used by farmers and cattle crossing the river. Both banks show localised erosion. No large upstream dams. The river is ~5m wide and has a range of biotopes for both macroinvertebrates (marginal vegetation, Stones-In-Current and Stones-Out-of-Current (SIC, SOC) and Gravel, Sand, Mud (GSM). For fish, Slow Deep (SD), Slow Shallow (SS) and Fast Shallow (FS). The marginal vegetation is limited owing to steep undercut banks and vegetation die-back. There is much in-stream vegetation debris, additional habitat for biota. The riparian vegetation zone is modified primarily owing to agriculture/croplands encroachment, although some <i>Phragmites sp.</i> and <i>Salix sp.</i> Just downstream of the bridge there is a section of riffles and runs downstream of the causeway. There are upstream deep pools with a meandering channel. The flows were higher than expected for the dry season owing to enhanced baseflows due to a very wet and late rainfall season.</p> <p>The main land use in the area is agriculture, croplands and cattle trampling and grazing. <i>Salix</i> trees line the banks both upstream and downstream, facilitating erosion, currently taking place along both banks.</p> | | | |

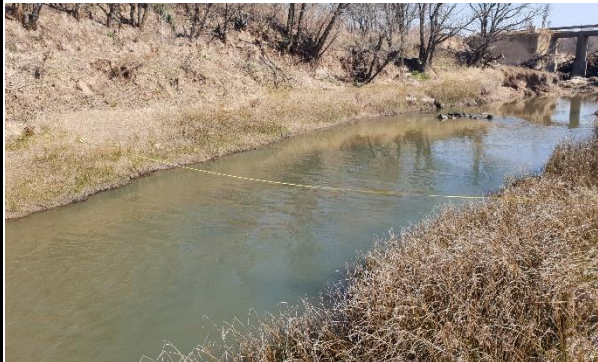
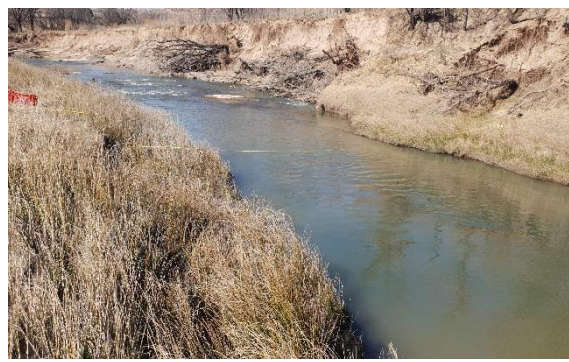
| <p>The site is located off R26 and S872 along a confined valley setting. Upstream of the site is a derelict weir, a cross-over bridge, along with a broken-up causeway bridge, where much of the bridge rubble and log jams are impeding the hydraulics of the river and associated left bank. The site on the Mopeli is considerably modified – both the channel, banks and high flow modification. The highly eroded banks, particularly the right bank is being scoured as a result of the blockage at the bridge altering the local hydraulics. Following recent flood events, much vegetation debris has accumulated upstream by the cross-over bridge, resulting in blocking and slowing the high flows, reducing flow velocities directly downstream of the bridge leading to excessive sediment deposition. This has formed a large lee bar that is diverting the river to the right, eroding the right bank and eroding the side/approach of the bridge. Furthermore, consolidated mud islands have formed further downstream due to erosion of former consolidated floodplain deposits along the channel.</p> <p>Biotopes available for macroinvertebrates is dominated by bedrock, with mud, but limited gravel and sand. Marginal vegetation was absent owing to undercut banks and vegetation die back. For fish there was SD, SS and FS. The system is eutrophic, with significant algae content smothering the bedrock habitat and turbid water. The riparian zone on the left bank is degraded with much of the sediment loading taking place, while the right bank is slightly more vegetation with trees, although some have fallen down due to the erosion. Baseflows were higher than expected for the time of year as a result of the high rainfall during the latter part of summer.</p> | | | |

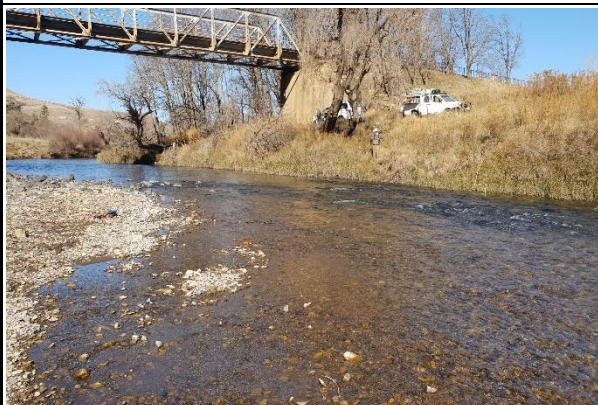
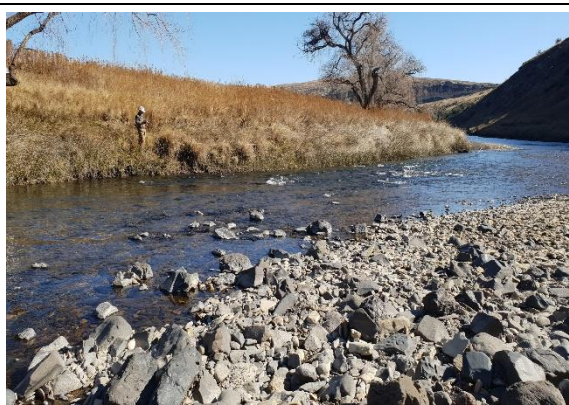
| <p>The upper Kraai site is located along a partly confined valley. The channel approximately 40m wide and follows a pool-riffle longitudinal pattern. It is located approximately 200m downstream of the confluence of the Bell River with the Sterkspruit. Localised bed and channel modification is observed downstream of the large bridge crossing and upstream weir, along with some cattle trampling along the riparian zone. Localized erosion and lateral head cut erosion, mostly up and downstream of the bridge. Some scouring along both banks with several lee bars in-stream and along the left bank downstream. The riparian zone is partly intact, representative of the season. The left bank is generally covered with grasses, shrubs (blackjacks) and trees (<i>Salix sp.</i>). The right bank is along a cliff face and shrubs.</p> <p>The river comprises various sections of riffles up and downstream of the bridge, composed of boulder, and cobble material along the riffles and gravel and sand along the pools. All biotopes for the macroinvertebrates are present, SIC, SOOC, GSM, although vegetation is limiting owing to undercut banks and vegetation die back. Localised algae covering the SIC biotope and detritus along the substrate. Fish habitats include SD, FD, SS and FS.</p> <p>The land use is predominantly farmlands, with small croplands and cattle grazing.</p> <p>Baseflows were very high as a results of the high rainfall during the latter part of summer.</p> | | | |

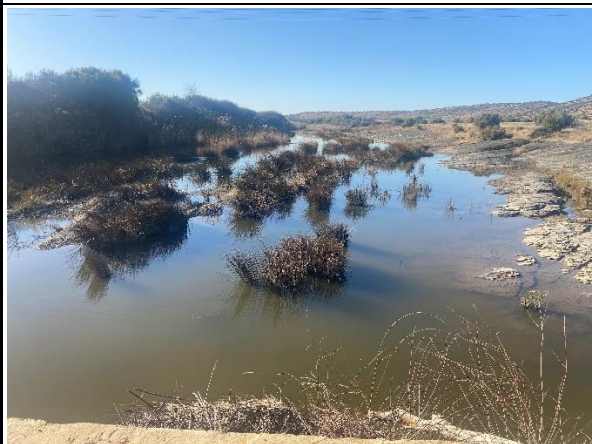
| <b>Site Description:</b><br>The Kromellenboog is a main tributary of the Riet. The site is located along a gravel road amongst private game farms, approximately 20km north of the town Jagersfontein. The confluence with the Prossesspruit, a tributary of the Kromellenboog is approximately 13km upstream. Owing to the recent floods, high baseflows remain within the system which is not representative of this system during the dry season. The reach is located along a partly confined valley setting with a straight to sinuous macro channel plan form. The macro channel is incised into the surrounding landscape, with poorly developed flood features. The active channel is braided downstream of the bridge, owing to various in-stream vegetated islands. Bedrock, gravel, sand and silt are the main substrates forming habitats. The site is located at a low water cross-over bridge, where log jams have occurred upstream of the bridge, impeding the hydraulics of the river and associated left bank. The turbid channel is ~35 m wide. The left bank is dominated by slated bedrock, while the riparian zone along the right bank is intact with grasses, sedges, <i>Phragmites sp.</i> and trees, with limited bank erosion. All biotopes are present for macroinvertebrates, which include SIC (which also comprised broken down slate bedrock), SOOC, GSM and both in-stream (including freshwater alien invasive macrophytes) and marginal vegetation. Some fine silt and algae growth (slimy) predominantly over the SIC biotope. Fish habitats include SS, SD and FD.<br><br>The primary land use is game farming, small scale cattle farming and upstream mining. | | | |

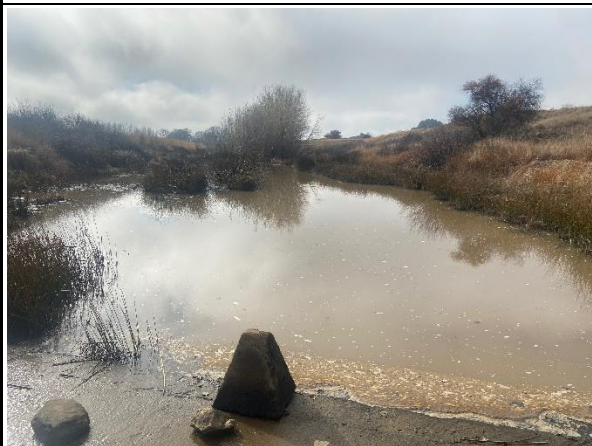
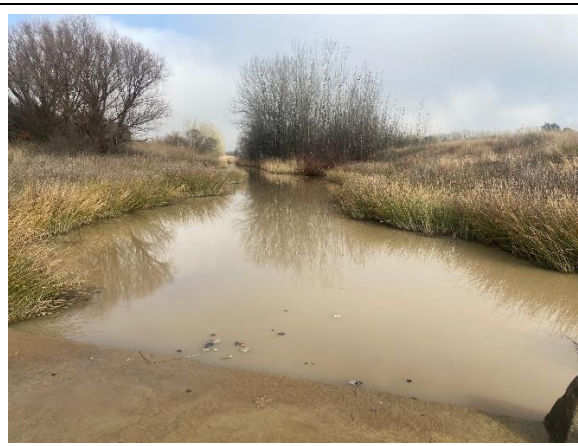
| <p>The site is located downstream from Van Stadensrus along an incised valley with limited floodplain development. The site is inundated through successive weirs with alluvial deposition. There is a weir located upstream with in-stream consolidated sediment islands. The flow is limited by a low water causeway and a downstream weir, resulting in deep slow flowing habitats.</p> <p>The biotopes present for the macroinvertebrates includes both marginal and in-stream vegetation along with GSM. Slow deep and deep pools present for fish. Some algae present within the water column and high turbidity. The riparian zone is intact, with some wetland features, although pockets of high density <i>Populus sp</i> stands along both banks.</p> | | | |

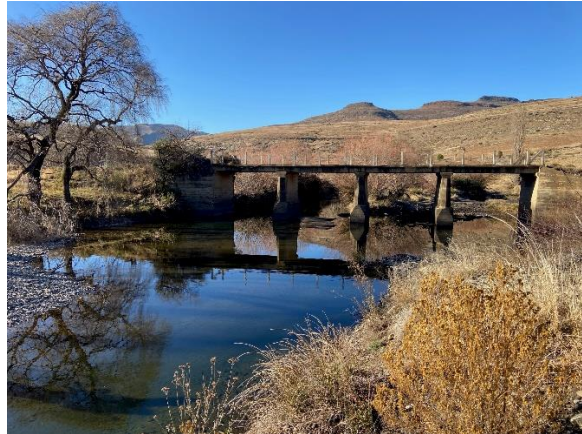
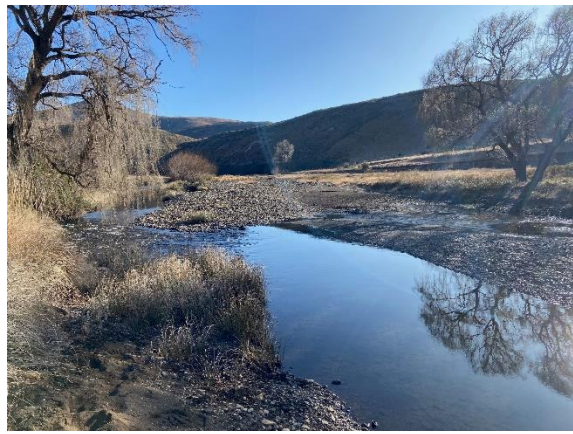
| <p>The Bokspuit, a tributary of the Sterkspruit (Kraai River system), is in good condition (full river reach) and approximately 10m wide. The reach has a partly confined valley setting with narrow flood features. However, owing to the bridge at the sampling site, coupled with some log and debris jams on the left side, are impeding the hydraulics of the river, scouring and resulting in localised erosion, particularly on the left bank, both up and downstream of the bridge. The scouring is contributing to the downstream lee bar on the left, although further downstream, another lee bar was observed on the right bank. Owing to the <i>Salix sp</i> on the left bank, the banks are stabilised thus avoiding further localised bank erosion. Both bed and channel modification at this site, but localised. The riparian zone is partly intact, representative of the season, mostly covered with grasses, shrubs and trees, most of which are alien invasive namely <i>Salix spp.</i> and <i>Pyracantha</i>.</p> <p>The river comprises various sections of riffles up and downstream of the bridge. All biotopes for the macroinvertebrates are present, SIC, SOOC, GSM, although vegetation is limiting owing to undercut banks and vegetation die back. Localised algae covering the SIC biotope. For fish, there is SD, SS and FS habitats.</p> <p>The land use is predominantly farmlands, with small croplands and cattle grazing.</p> | | | |

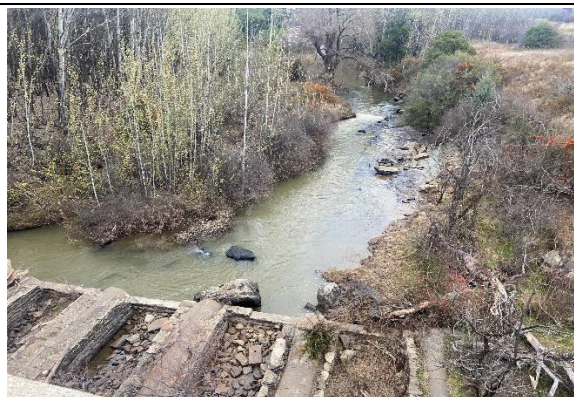
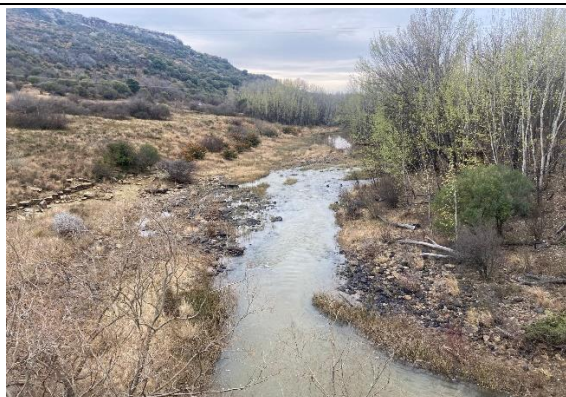
| <p>The site is located near Floukraal along a confined valley. The Holspruit has localised modifications owing to a cross-over bridge which impedes the river channel, along with a small upstream weir and derelict and broken-down culverted bridge coupled with construction debris. Furthermore, beneath the cross-over bridge in-stream are artificial cement slabs. Both banks up and downstream of the bridge is well vegetated although dominated by alien invasives namely <i>Populus sp.</i>, as well as pockets of <i>Salix sp.</i> and <i>Pyracantha</i>. Although these are aiding in bank stability. All these impediments have resulted in the multiple diversions of the river flowing downstream, with a lee bar on the left bank downstream of the bridge. Turbid waters with some algae and sediment loads over the stone's biotopes.</p> <p>Biotopes available for macroinvertebrates is dominated by various sections of riffles, SIC, SOOC, marginal vegetation, although limited owing to undercut banks and vegetation die-back (representative of the season). Fish habitats comprised SD, SS, FD and FS.</p> | | | |

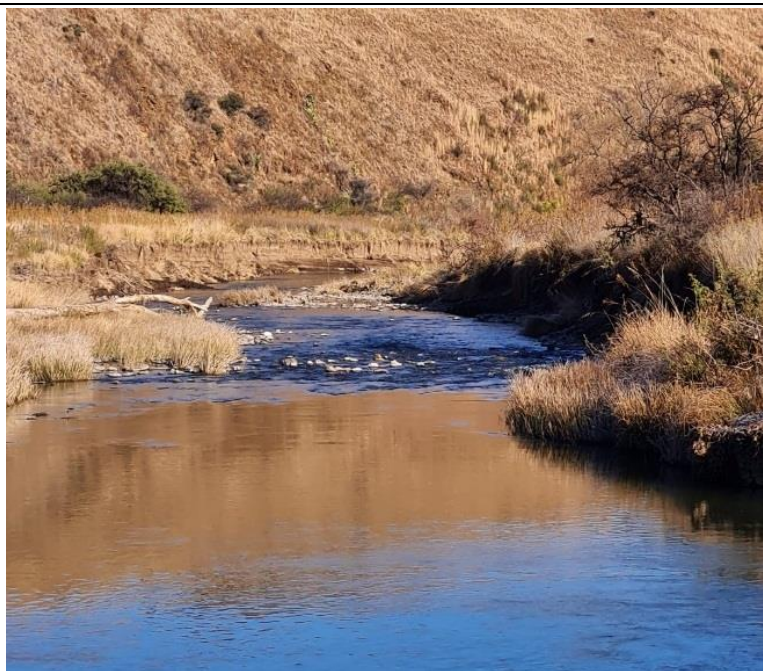
| <p>The Sterkspruit, a tributary of the Bell/Kraai River is in a good condition at the site and approximately 10m wide. The bridge at the sampling site is resulting in scouring of both banks, resulting in localised erosion up and downstream of the bridge. Bank rehabilitation in the form of gabions have been constructed up and downstream of the bridge for stabilisation. However, the gabions on the banks above the bridge have destabilised and disassembled, and gabion material and debris is impeding the flow beneath the bridge and slightly downstream of the bridge, with gabion material observed in-stream. Most of the gabions on the banks below the bridge are still intact and functioning to alleviate bank erosion and further scouring. Nonetheless, the scouring is contributing to the downstream lee bar on the left bank. Both bed and channel modification at this site is localised. The riparian zone is partly intact, representative of the season, mostly covered with grasses, shrubs and trees (limited <i>Salix sp.</i>, further downstream and evidence of <i>Populus sp.</i> upstream.</p> | | | |

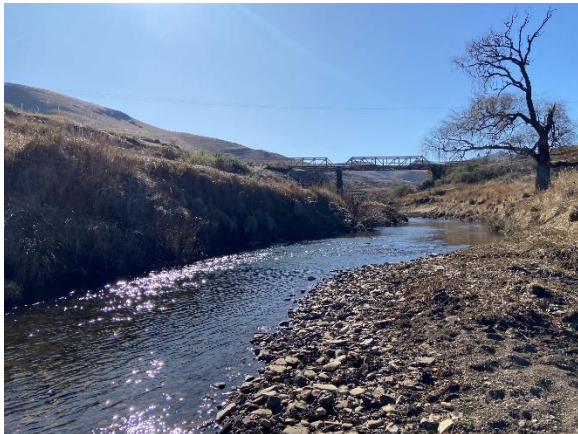
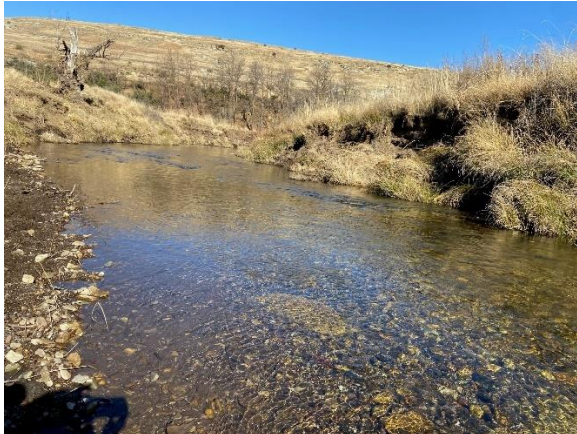
| Upstream | | Downstream | |

| Components sampled: IHI, <i>in situ</i> water quality, diatoms, discharge | | | |
| <p>This reach of the river is called the Bell (although still named the Kraai according to PES, 2014), and which lies approximately 3km upstream from UO_EWR04_R (upper Kraai). This meandering river is still in a good condition with limited impacts and approximately 10m wide. There is an upstream bridge although it is built on solid boulders and bedrock on the right bank, with slight head cut erosion taking place on the left bank of the bridge. There is some scouring and bank erosion on both banks going downstream, the recent floods being a contributing factor coupled with on-going widespread cattle grazing and trampling. Gravel and cobble bars are common along the reach. The riparian zone is intact, mostly covered with grasses, shrubs (blackjacks) and trees (<i>Salix sp.</i>) along the reach.</p> <p>The river comprises various sections of riffles and pools up and downstream of the bridge. All biotopes for the macroinvertebrates are present, SIC, SOOC, GSM, although vegetation is limiting owing to undercut banks and vegetation die-back. Localised algae covering the SIC biotope. For fish, there is FD, SS and FS habitats.</p> <p>The land use is predominantly farmlands, with small croplands and widespread cattle grazing.</p> | | | |

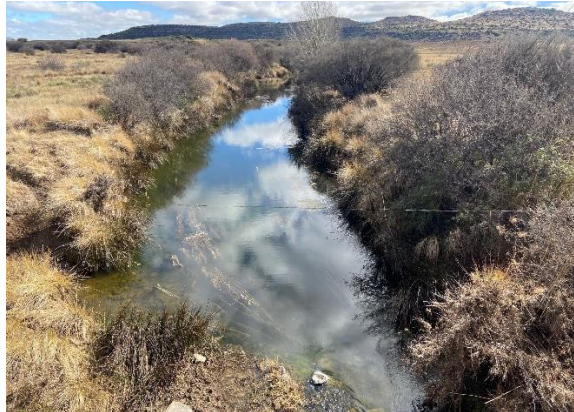
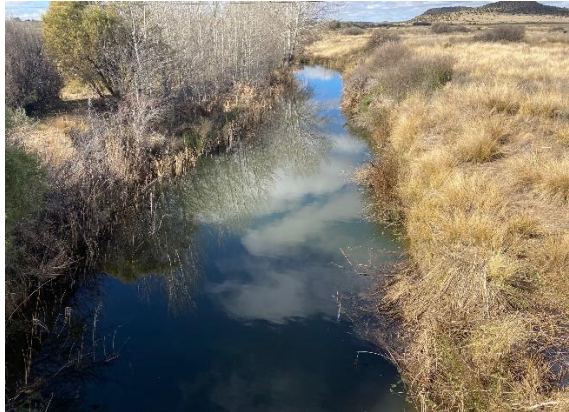
| Upstream | | Downstream | |

| Components sampled: IHI, <i>in situ</i> water quality, diatoms | | | |
