Hydrogeological report for: Disaster Management, Rural Community Water Services, Resource Assessment and Resource Management for 21 Groundwater Production Boreholes within the Mtubatuba and Hlabisa Local Municipalities as part of the Umkhanyakude District Municipality

Version - Final
 20 June 2016

Maragela Consulting Engineers
 GCS Project Number: 15-150
 Client Reference: KDR022b

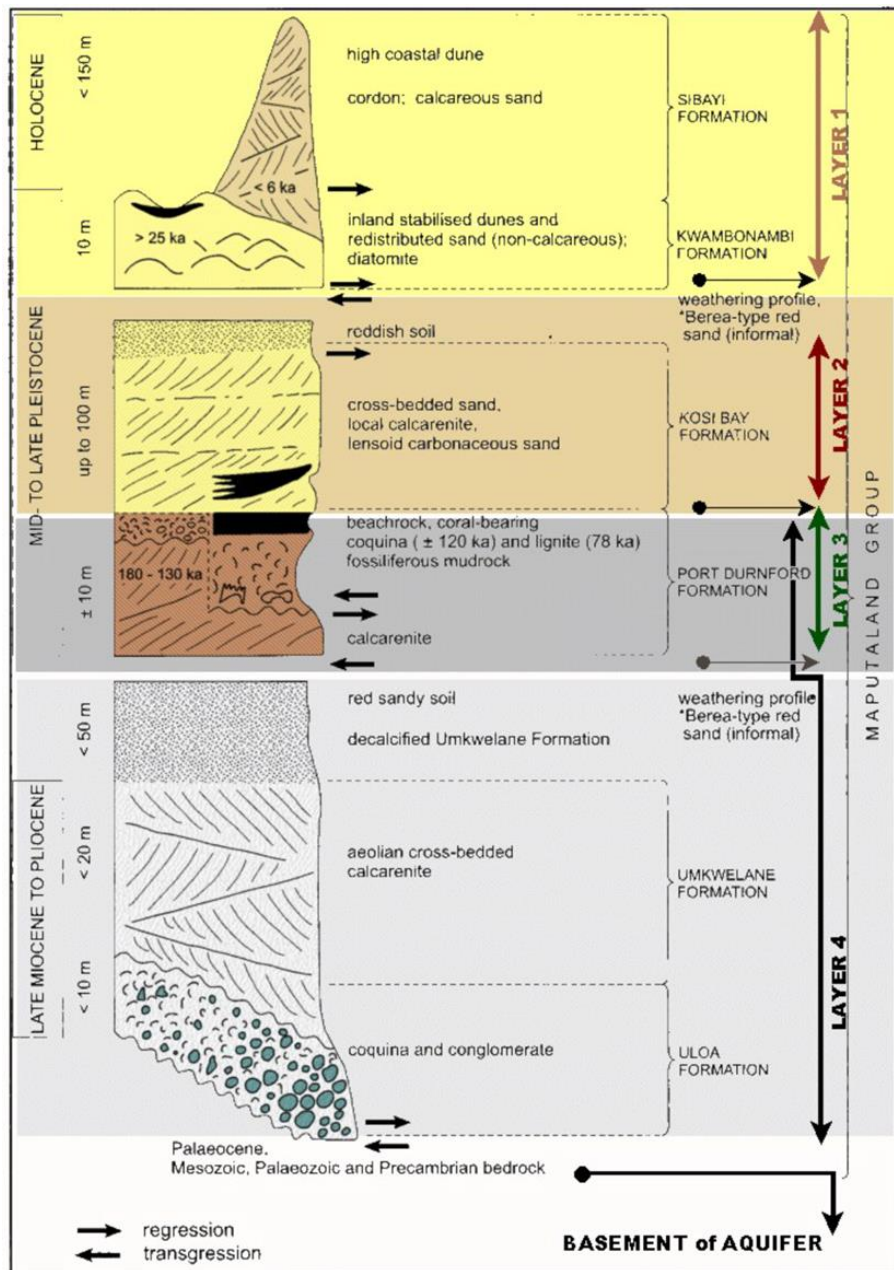
Figure 3-3: Maputaland Stratigraphy

The Maputaland group sediments characterized the eastern part of the study area within Mtubatuba local municipality and comprise of unconsolidated to semi-consolidated sand deposits which are divided into six Formations, Uloa, uMkwelane, Port Durford, Kosi Bay, Kwambonambi and Sibayi Formations. Figure 3-3 illustrates a schematic diagram of the Maputaland stratigraphy. These sand deposits occur mainly to the east of the project area.

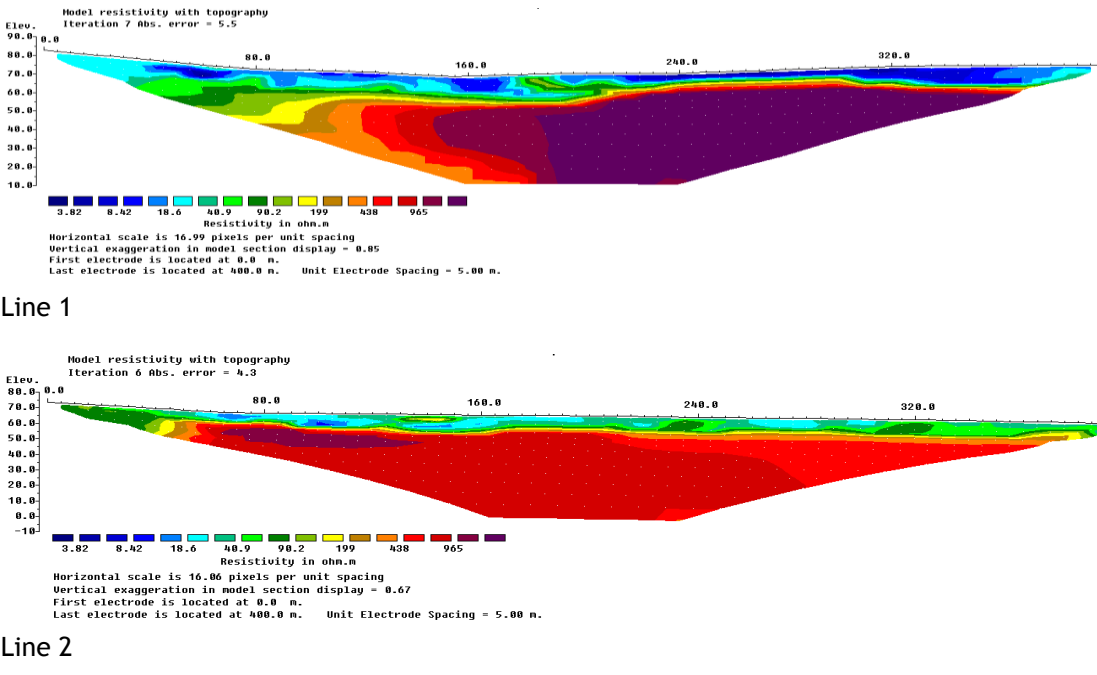
Community Name	Ward number	Local Municipality	Models	Description
apheleni	16	Mtubatuba

<p>Line 1</p> <p>Model resistivity with topography Iteration 7 Abs. error = 5.5</p> <p>Elev. 90.0, 80.0, 70.0, 60.0, 50.0, 40.0, 30.0, 20.0, 10.0, 0.0</p> <p>Resistivity in ohm.m: 3.82, 8.42, 18.6, 48.9, 98.2, 199, 438, 965</p> <p>Horizontal scale is 16.99 pixels per unit spacing Vertical exaggeration in model section display = 0.85 First electrode is located at 0.0 m. Last electrode is located at 400.0 m. Unit Electrode Spacing = 5.00 m.</p> <p>Line 2</p> <p>Model resistivity with topography Iteration 6 Abs. error = 4.3</p> <p>Elev. 80.0, 70.0, 60.0, 50.0, 40.0, 30.0, 20.0, 10.0, 0.0, -10.0</p> <p>Resistivity in ohm.m: 3.82, 8.42, 18.6, 48.9, 98.2, 199, 438, 965</p> <p>Horizontal scale is 16.06 pixels per unit spacing Vertical exaggeration in model section display = 0.67 First electrode is located at 0.0 m. Last electrode is located at 400.0 m. Unit Electrode Spacing = 5.00 m.</p>	<p>Line 1: Line 1 has resistivity highs of >965 Ωm at depth (70 mamsl) indicative of a substratum. The substratum is however interrupted, at $x \approx 125$ m, by the lithology of relatively suppressed resistivities values (<438 Ωm) indicative of weathering, prompting placement of a groundwater exploration borehole at $x \approx 110$ m along the survey line.</p> <p>Line 2: The inverted resistivity model for resistivity data obtained along survey Line 2 indicate very shallow substratum revealed by relatively high resistivity values (>238 Ωm) overtop which is a shallow weathered zone as shown by relatively low resistivity (≤ 90 Ωm). The weathered zone was considered too shallow to be deemed a good groundwater avenue medium; consequently, no groundwater exploration borehole was recommended along this survey line.</p>

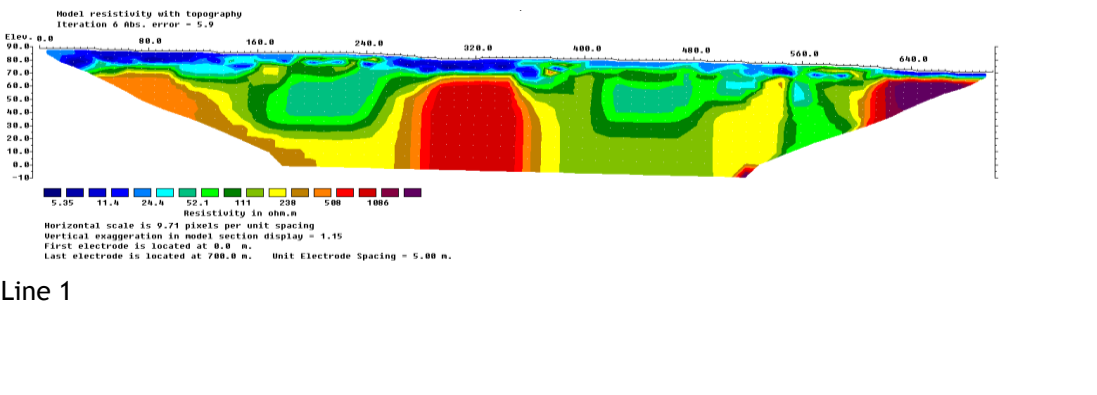
Nkombose	13	Mtubatuba

<p>Line 1</p> <p>Model resistivity with topography Iteration 6 Abs. error = 5.9</p> <p>Elev. 90.0, 80.0, 70.0, 60.0, 50.0, 40.0, 30.0, 20.0, 10.0, 0.0, -10.0</p> <p>Resistivity in ohm.m: 5.05, 11.4, 24.4, 52.1, 111, 238, 508, 1086</p> <p>Horizontal scale is 9.71 pixels per unit spacing Vertical exaggeration in model section display = 1.15 First electrode is located at 0.0 m. Last electrode is located at 700.0 m. Unit Electrode Spacing = 5.00 m.</p>	<p>Line 1: Using an interpretation from an inverted resistivity model for the data obtained from Line 1, no groundwater exploration borehole was recommended for there was no clear-cut anomalous resistivity distributions across the said model.</p> <p>Line 2: Line 2 was surveyed across Line 1 above and the results revealed clear resistivity contrasts in the subsurface; the model is characterised by high and shallow resistivity values (≈ 1461 Ωm) from the start (0 m). This zone of resistivity highs, however, deepens at $x=200$ m overtop which is a zone characterised by relatively low resistivity interpreted as deep weathering possibly facilitated by weathering by groundwater mobilisation; subsequently, a groundwater exploration borehole was recommended at $x \approx 220$ m along the survey line.</p>

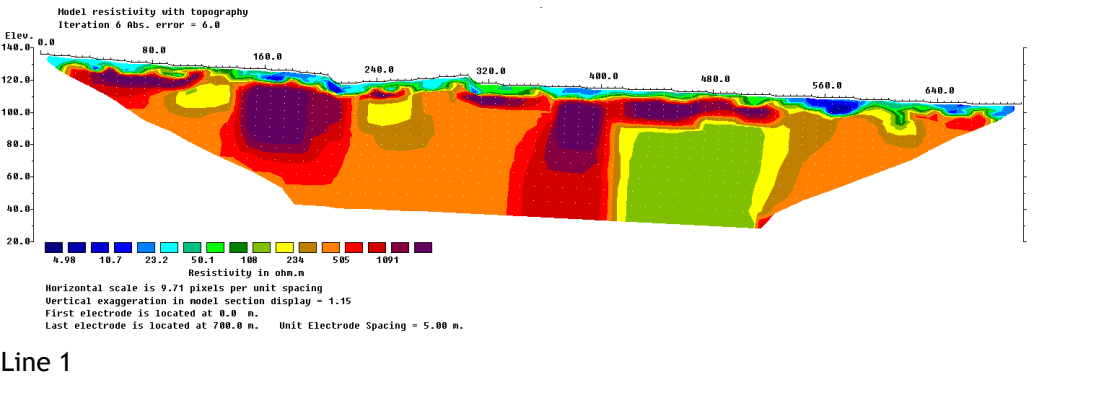
Ophaphase	13	Mtubatuba

<p>Line 1</p> <p>Model resistivity with topography Iteration 6 Abs. error = 6.0</p> <p>Elev. 140.0, 120.0, 100.0, 80.0, 60.0, 40.0, 20.0</p> <p>Resistivity in ohm.m: 4.98, 10.7, 23.2, 50.1, 108, 234, 505, 1091</p> <p>Horizontal scale is 9.71 pixels per unit spacing Vertical exaggeration in model section display = 1.15 First electrode is located at 0.0 m. Last electrode is located at 700.0 m. Unit Electrode Spacing = 5.00 m.</p>	<p>Line 1: Beside the shallow weathered zone with resistivity values of 23 Ωm, the inversion model for Line 1 is characterised by average resistivity distributions of ≥ 504 Ωm indicative of a local country rock. However, the model is characterised further by an abrupt and localised area of relatively low resistivity values between $x \approx 415$ m and $x \approx 520$ m indicative of a localised weathering of the host rock which could potentially serve as a groundwater avenue zone thereby prompting placement of a groundwater exploration at $x \approx 480$ m.</p> <p>Line 2:</p>

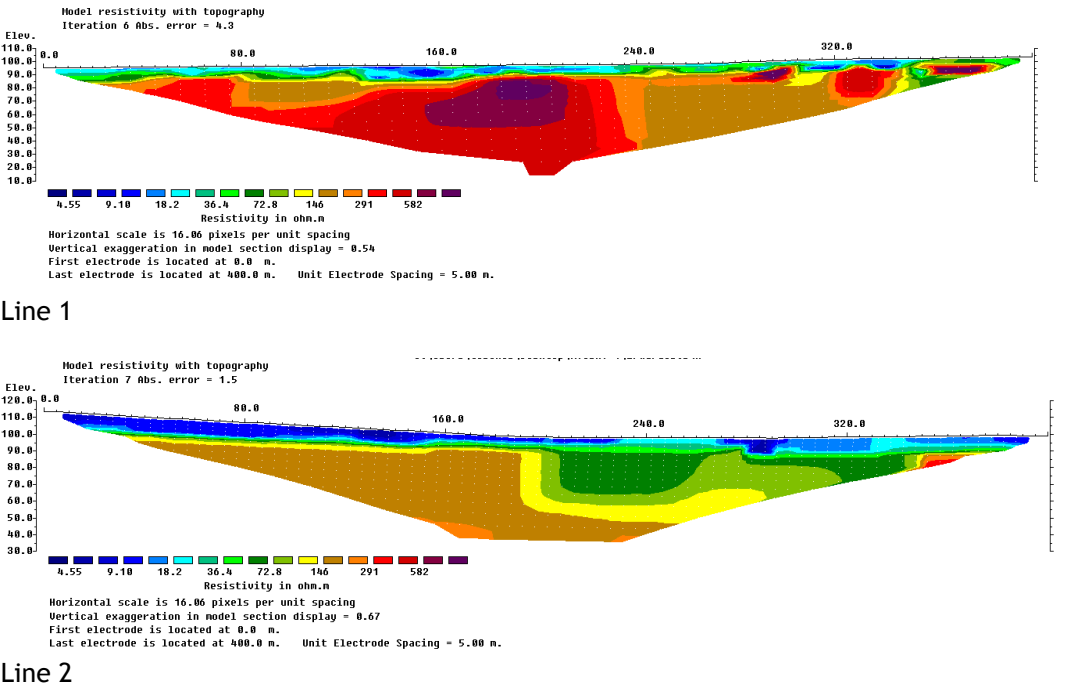
Community Name	Ward number	Local Municipality	Models	Description
Nkodibe	6	Mtubatuba

<p>Model resistivity with topography Iteration 6 Abs. error = 4.3</p> <p>Horizontal scale is 16.06 pixels per unit spacing Vertical exaggeration in model section display = 0.54 First electrode is located at 0.0 m. Last electrode is located at 400.0 m. Unit Electrode Spacing = 5.00 m.</p> <p>Line 1</p> <p>Model resistivity with topography Iteration 7 Abs. error = 1.5</p> <p>Horizontal scale is 16.06 pixels per unit spacing Vertical exaggeration in model section display = 0.67 First electrode is located at 0.0 m. Last electrode is located at 400.0 m. Unit Electrode Spacing = 5.00 m.</p> <p>Line 2</p>	<p>Line 1: Using an interpretation from an inverted resistivity model for the data obtained from Line 1, no groundwater exploration borehole was recommended for there was no clear-cut anomalous resistivity distributions across the said model.</p> <p>Line 2: Line 2 was surveyed across Line 1 above and the results revealed clear resistivity contrasts in the subsurface; the model is characterised by high and shallow resistivity values ($\approx 1461 \Omega\text{m}$) from the start (0 m). This zone of resistivity highs, however, deepens at $x=200$ m overtop which is a zone characterised by relatively low resistivity interpreted as deep weathering possibly facilitated by weathering by groundwater mobilisation; subsequently, a groundwater exploration borehole was recommended at $x \approx 220$ m along the survey line.</p>

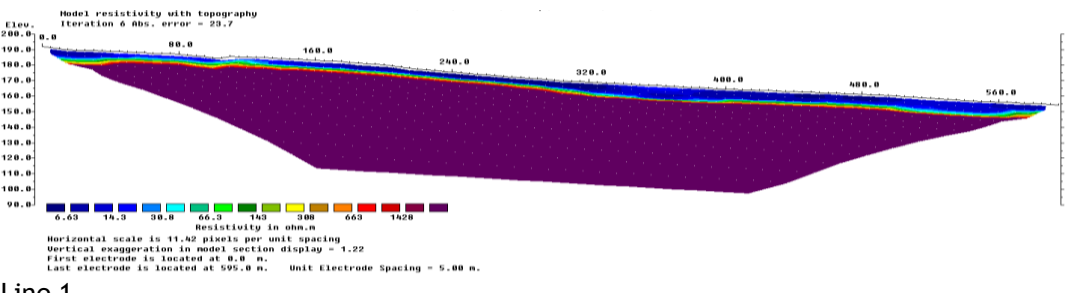
Nkonjaneni	7	Mtubatuba

<p>Model resistivity with topography Iteration 6 Abs. error = 23.7</p> <p>Horizontal scale is 11.02 pixels per unit spacing Vertical exaggeration in model section display = 1.22 First electrode is located at 0.0 m. Last electrode is located at 500.0 m. Unit Electrode Spacing = 5.00 m.</p> <p>Line 1</p>	<p>The inverted resistivity model for the line surveyed in Nkonjaneni indicates very simple resistivity distribution with very shallow and competent substratum revealed by resistivity of over $663 \Omega\text{m}$. Overtop this shallow substratum is a weathered zone revealed resistivity values of $\leq 31 \Omega\text{m}$. The competent and shallow substratum is usually unfavourable for placement of groundwater production boreholes; nevertheless, a secondary (low confidence) groundwater exploration borehole was recommended at $x \approx 360$ m hoping for fracture interceptions across the substratum. The rationale is that, with long survey lines, the resolution tends to conceal highly localised and low intensity micro fractures</p>

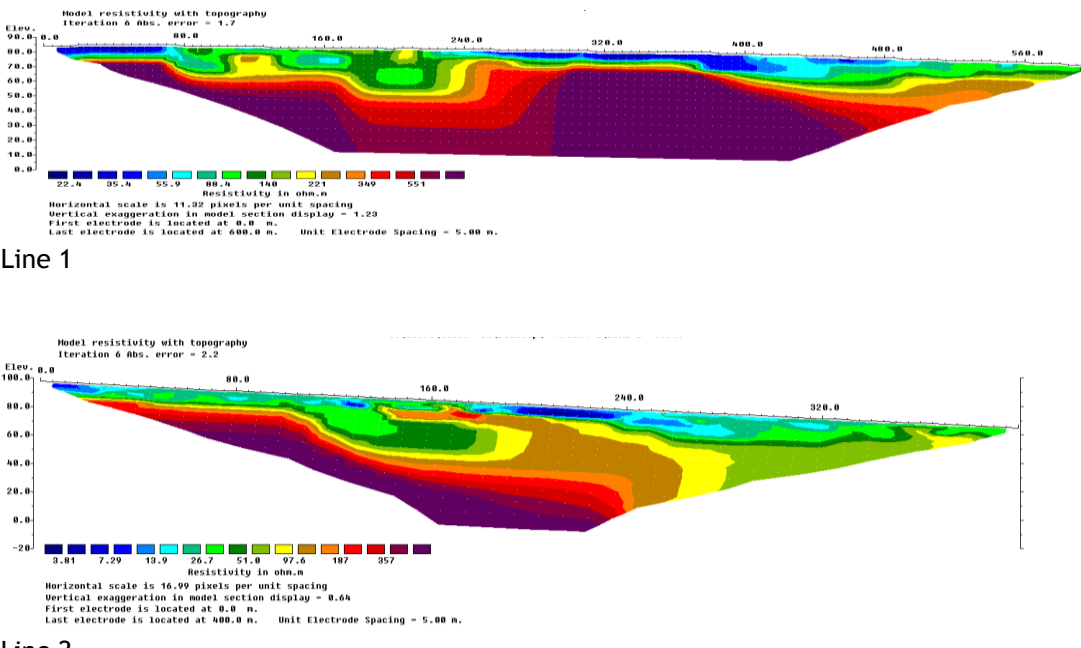
Kwamshaya	14	Mtubatuba

<p>Model resistivity with topography Iteration 6 Abs. error = 1.7</p> <p>Horizontal scale is 11.02 pixels per unit spacing Vertical exaggeration in model section display = 1.22 First electrode is located at 0.0 m. Last electrode is located at 600.0 m. Unit Electrode Spacing = 5.00 m.</p> <p>Line 1</p> <p>Model resistivity with topography Iteration 6 Abs. error = 2.2</p> <p>Horizontal scale is 16.99 pixels per unit spacing Vertical exaggeration in model section display = 0.64 First electrode is located at 0.0 m. Last electrode is located at 400.0 m. Unit Electrode Spacing = 5.00 m.</p> <p>Line 2</p>	<p>Line 1: The inverted subsurface resistivity model of the ERT survey Line 1 is characterised by low apparent resistivity values ranging between $22 \Omega\text{m}$ and $221 \Omega\text{m}$ at shallow depth (approximately 80 mamsl). This (low resistivity range) is interpreted as a shallow weathered formation underlying a formation with relatively higher resistivity values ($\geq 349 \Omega\text{m}$) interpreted as a competent substratum. A very important feature of the model is that the area with low resistivity extends to a deeper depth between $x \approx 175$ m and $x \approx 2400$ m. This characteristic (deepening of area of low resistivity values as a designated zone) may be interpreted as a weathering through. If deep enough, the weathering through would be targeted for placement of a groundwater exploration borehole; however, it was deemed not deep enough in this particular case.</p>

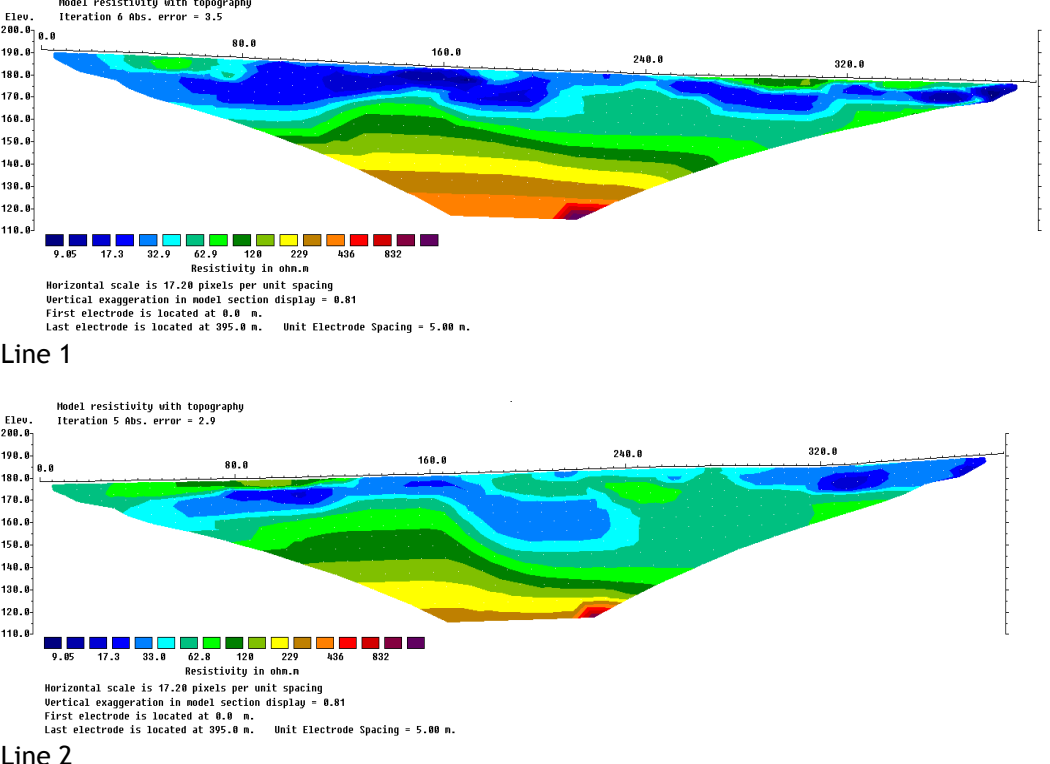
Community Name	Ward number	Local Municipality	Models	Description
Hlambanyathi	1	Hlabisa

<p>Model resistivity with topography Iteration 6 Abs. error = 3.5</p> <p>Horizontal scale is 17.20 pixels per unit spacing Vertical exaggeration in model section display = 0.81 First electrode is located at 0.0 m. Last electrode is located at 395.0 m. Unit Electrode Spacing = 5.00 m.</p> <p>Line 1</p> <p>Model resistivity with topography Iteration 5 Abs. error = 2.9</p> <p>Horizontal scale is 17.20 pixels per unit spacing Vertical exaggeration in model section display = 0.81 First electrode is located at 0.0 m. Last electrode is located at 395.0 m. Unit Electrode Spacing = 5.00 m.</p> <p>Line 2</p>	<p>Line 1: The inverted resistivity data for both Line 1 and Line 2 in Hlambanyathi indicate almost near similar resistivity distributions; Line 1 is characterised by resistivity lows (<229 Ωm) at an approximate depth of z≈140 mamsl. This is interpreted as deep weathering below which is a zone with relatively increased resistivity values, interpreted as a weakened substratum perhaps due to fracturing and/or weathering. As such a groundwater exploration borehole was recommended at x=200 m along the survey line.</p> <p>Line 2: On Line 2, the weathering occurs relatively deeper compared to that identified in Line 1 prompting a primary (high confidence) groundwater exploration borehole at x≈220 m along the survey line.</p>

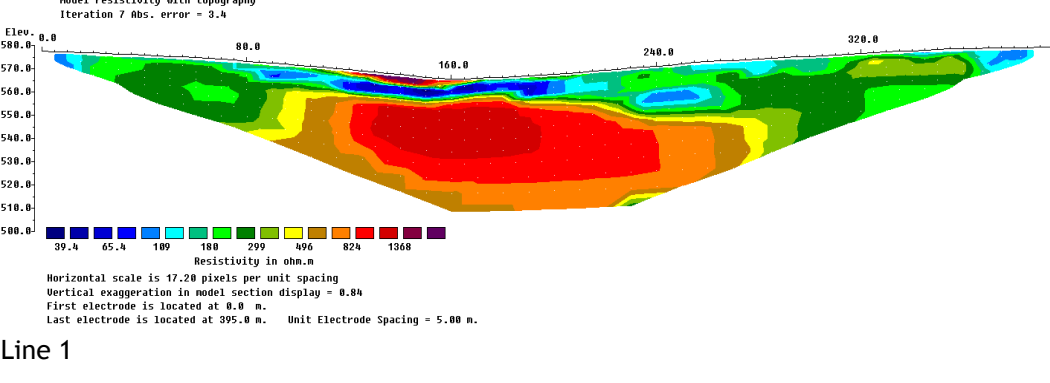
Ngebeza	1	Hlabisa

<p>Model resistivity with topography Iteration 7 Abs. error = 3.4</p> <p>Horizontal scale is 17.20 pixels per unit spacing Vertical exaggeration in model section display = 0.84 First electrode is located at 0.0 m. Last electrode is located at 395.0 m. Unit Electrode Spacing = 5.00 m.</p> <p>Line 1</p>	<p>Line 1: The resistivity model for the survey undertaken in Ngebeza shows relatively low resistivity ($\leq 299 \Omega m$) zones in the peripheries of the model. Between $x \approx 120$ and $x \approx 275$ m, the model is characterised by relatively high resistivities ($\geq 496 \Omega m$). Interesting is a much localised feature at $x \approx 230$, located at about 514 mamsl, with resistivity values ranging between $180 \Omega m - 496 \Omega m$. Since this line was surveyed upstream an active/flowing spring, this zone of low resistivities at greater depth was targeted for a primary groundwater production borehole.</p>

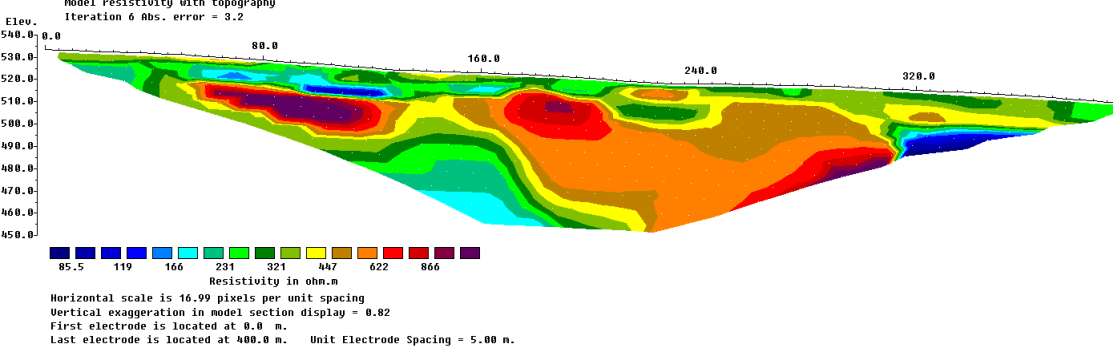
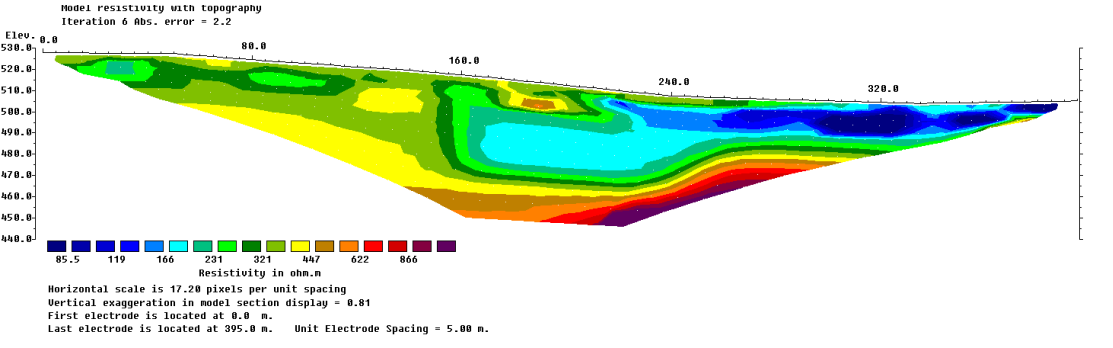
Community Name	Ward number	Local Municipality	Models	Description
Nkanjini	2	Hlabisa	<p>Model resistivity with topography Iteration 6 Abs. error = 3.2</p>

<p>Line 1</p> <p>Model resistivity with topography Iteration 6 Abs. error = 2.2</p>

<p>Line 2</p>	<p>Line 1 and Line 2: While large variation in the resistivity of the subsurface materials is apparent across the inversion model area which gives a good insight on the possible area to place required groundwater exploration borehole on both lines, Line 1 was considered more favourable in terms of proximity to the target community. On Line 1, there is a deeper zone characterised by resistivity lows (166 Ωm-231 Ωm) relative to the ambient resistivity distributions and interpreted as comprehensive weathering. This zone appears to be connected to the recharge surface at $x \approx 120$ m as marked by a rift across the resistivity highs. As such a primary groundwater exploration borehole was recommended at $x \approx 120$</p>

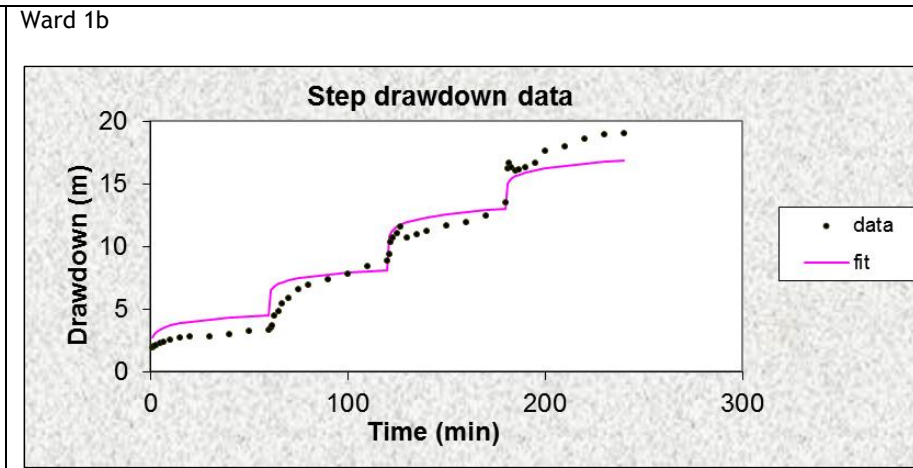
Method	Sustainable yield (l/s)	Std. Dev	Early T (m ² /d)	Late T (m ² /d)	S
Basic FC	2.17		1.44	20	1.10E-03
Cooper-Jacob	8.57		5.55		1.00E-06

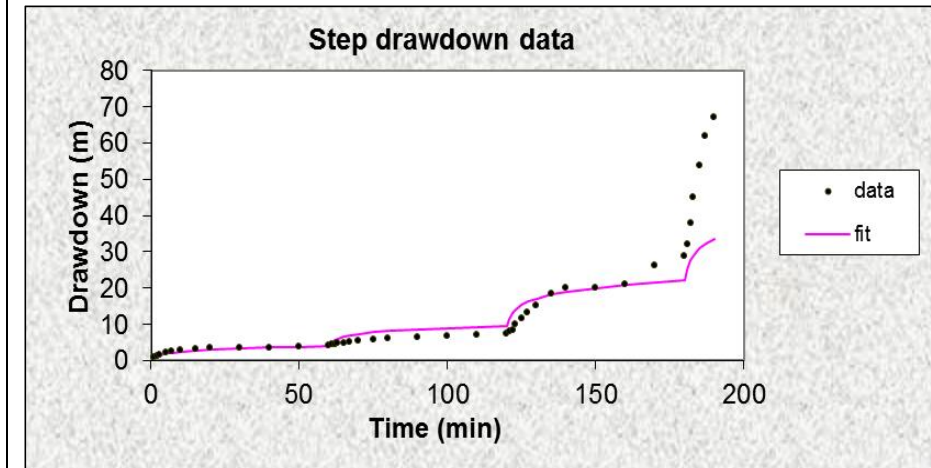
Ward 13a

Method	Sustainable yield (l/s)	Std. Dev	Early T (m ² /d)	Late T (m ² /d)	S
Basic FC	0.03	0.02	5	0.1	1.10E-03
Cooper-Jacob	1.00	0.65		7.2	2.80E-05

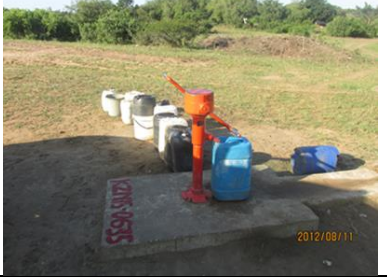
Borehole ID	KZN15-0635	PHOTOGRAPH
Ward number	9

Community name	Nkundusi	
Municipality	Mtubatuba	
Depth (mbgl)	49 (m)	
Pump Type	Hand Pump	
Pump installation depth	40 (m)	
Borehole ID	KZN15-0639	PHOTOGRAPH
Ward number	12

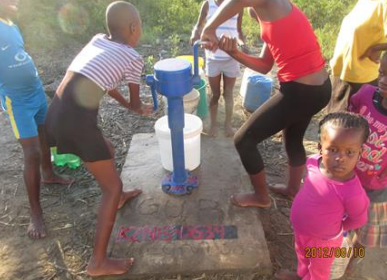
Community name	Shikishela	
Municipality	Mtubatuba	
Depth (mbgl)	140 (m)	
Pump Type	Hand Pump	
Pump installation depth	50 (m)	
Borehole ID	KZN15-0640	PHOTOGRAPH
Ward number	12

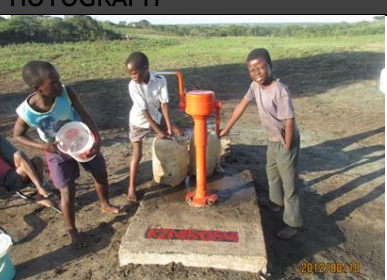
Community name	Madwaleni	
Municipality	Mtubatuba	
Depth (mbgl)	120 (m)	
Pump Type	Hand Pump	
Pump installation depth	50 (m)	
Borehole ID	KZN15-0641	PHOTOGRAPH
Ward number	6

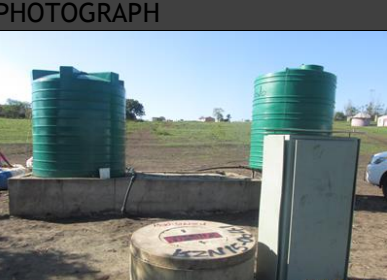
Community name	Nkodibe	
Municipality	Mtubatuba	
Depth (mbgl)	110 (m)	
Pump Type	Electric Pump	
Pump installation depth	60 (m)	
Borehole ID	KZN15-0642	PHOTOGRAPH
Ward number	14

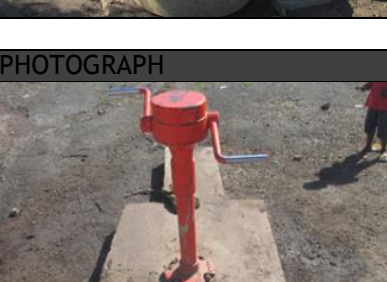
Community name	kwaMshaya	
Municipality	Mtubatuba	
Depth (mbgl)	120(m)	
Pump Type	Hand Pump	
Pump installation depth	60 (m)	
Borehole ID	KZN15-0643	PHOTOGRAPH
Ward number	13

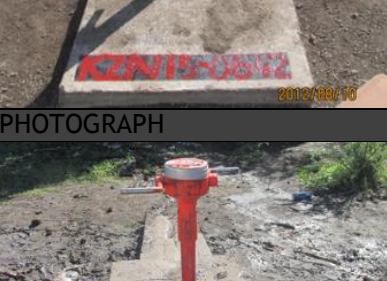
Community name	Nkombose	
Municipality	Mtubatuba	
Depth (mbgl)	80 (m)	
Pump Type	Hand Pump	
Pump installation depth	60 (m)	
Borehole ID	KZN15-0644	PHOTOGRAPH
Ward number	13	 
Community name	Ophaphase	
Municipality	Mtubatuba	
Depth (mbgl)	120 (m)	
Pump Type	Hand Pump	
Pump installation depth	100 (m)	
Borehole ID	KZN15-0645	PHOTOGRAPH
Ward number	17

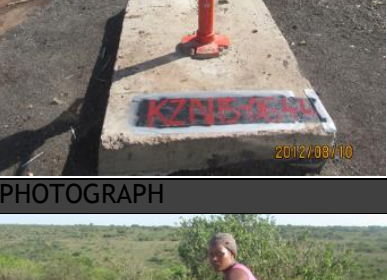
Community name	Ogengele	
Municipality	Mtubatuba	
Depth (mbgl)	120 (m)	
Pump Type	Hand Pump	
Pump installation depth	60 (m)	
Borehole ID	KZN15-0646	PHOTOGRAPH

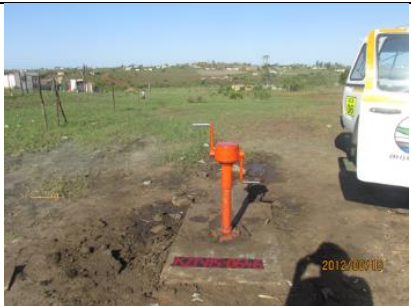
Ward number	16

Community name	Ebaswazini	
Municipality	Mtubatuba	
Depth (mbgl)	144 (m)	
Pump Type	Hand Pump	
Pump installation depth	60 (m)	
		PHOTOGRAPH
Borehole ID	KZN15-0647

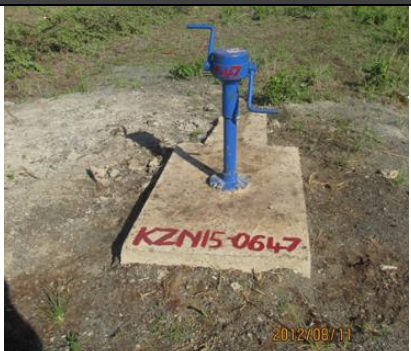
Ward number	97	
Community name	Nkonjaneni	
Municipality	Mtubatuba	
Depth (mbgl)	132 (m)	
Pump Type	Hand Pump	
Pump installation depth	60 (m)

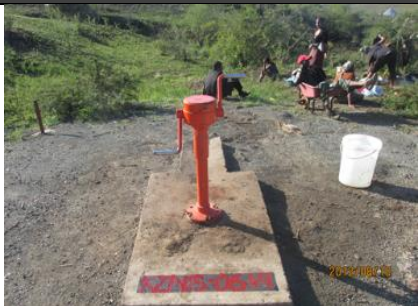
PHOTOGRAPH
Borehole ID	KZN15-0649

Ward number	16	
Community name	Mapheleni	
Municipality	Mtubatuba	
Depth (mbgl)	140 (m)	
Pump Type	Hand Pump	
Pump installation depth	50 (m)

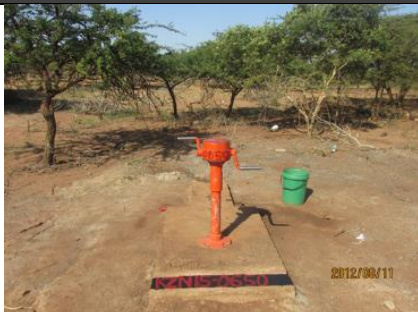
PHOTOGRAPH
Borehole ID	KZN15-0650

Ward number	1	
Community name	Hlambanyathi	
Municipality	Hlabisa	
Depth (mbgl)	66 (m)	
Pump Type	Hand Pump	
Pump installation depth	60 (m)

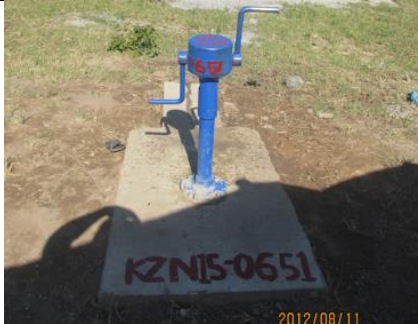
PHOTOGRAPH
Borehole ID	KZN15-0651

Ward number	1	
Community name	Ngebeza	
Municipality	Hlabisa	
Depth (mbgl)	90 (m)	
Pump Type	Hand Pump	
Pump installation depth	50 (m)

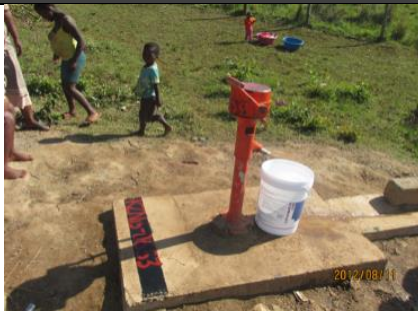
PHOTOGRAPH
Borehole ID	KZN15-0653

Ward number	2	
Community name	Nkanjini	
Municipality	Hlabisa	
Depth (mbgl)	90 (m)	
Pump Type	Hand Pump	
Pump installation depth	50 (m)

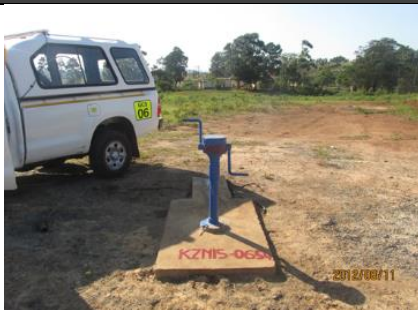
PHOTOGRAPH
Borehole ID	KZN15-0654

Ward number	2	
Community name	Macekeni	
Municipality	Hlabisa	
Depth (mbgl)	72 (m)	
Pump Type	Hand Pump	
Pump installation depth	50 (m)

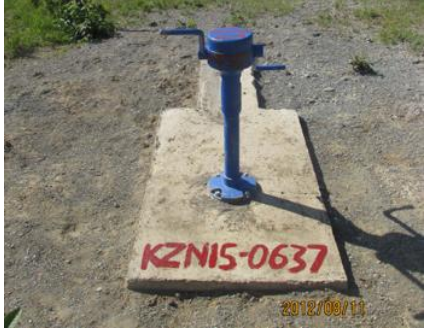
PHOTOGRAPH
Borehole ID	KZN15-0637	
Ward number	3	
Community name	Banzaneni	
Municipality	Hlabisa	
Depth (mbgl)	120 (m)	
Pump Type	Hand Pump

Pump installation depth	80 (m)

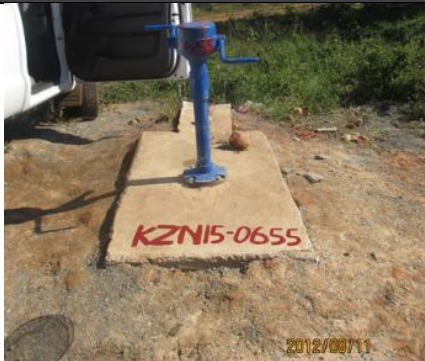
PHOTOGRAPH
Borehole ID	KZN15-0655

Ward number	2	
Community name	Emajikeni	
Municipality	Hlabisa	
Depth (mbgl)	140 (m)	
Pump Type	Hand Pump	
Pump installation depth	60 (m)
