Extension of the Kwazulu-Natal Groundwater Monitoring Network

Hydrogeological Report

Report Number 488058/2

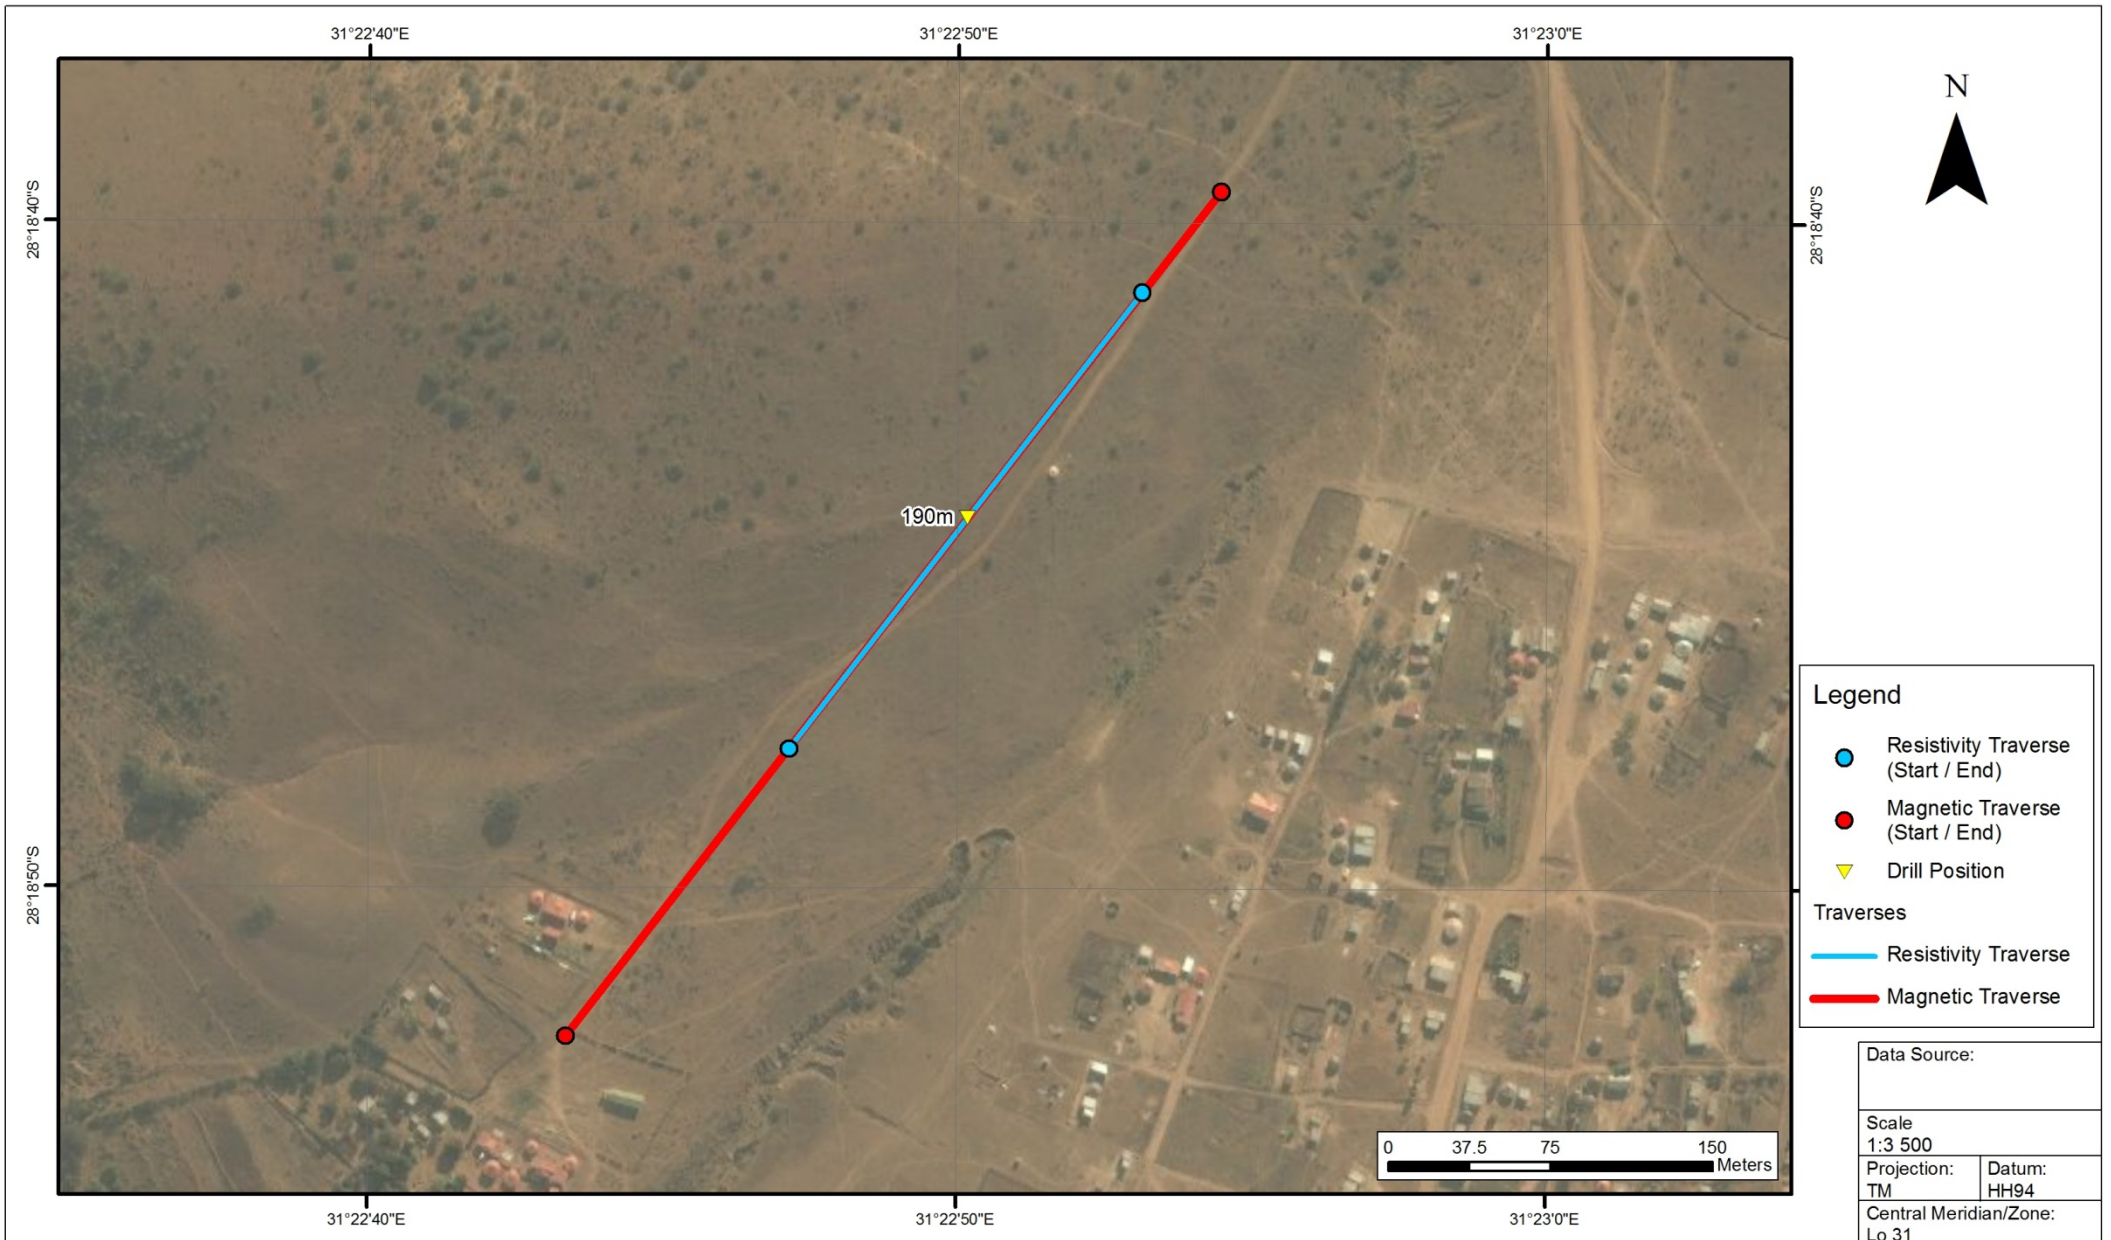
EXTENSION TO THE KWAZULU-NATAL GROUNDWATER MONITORING NETWORK
AERIAL PHOTOGRAPH SHOWING THE GEOPHYSICAL TRAVERSES - SITE A- ULUNDI

- Resistivity Traverse (Start / End)
- Magnetic Traverse (Start / End)
- ▼ Drill Position

Based on an interpretation of the geophysical data, two potential drilling targets were identified for Site A and one target was identified for Site B. For Site A, the primary and secondary drilling targets were at 190 m (-28.31242 and 31.3807) and 240 m (-28.31272 and 31.38033), respectively. The single drilling target for Site B was at 330 m (-28.18506 and 30.60956). The location of the geophysical traverses is shown on Figure 5-1 and Figure 5-2, for Site A and Site B and the graphs for the geophysical data are shown in Figure 5-3 and Figure 5-4, respectively. The actual geophysical data are included in Appendix A.

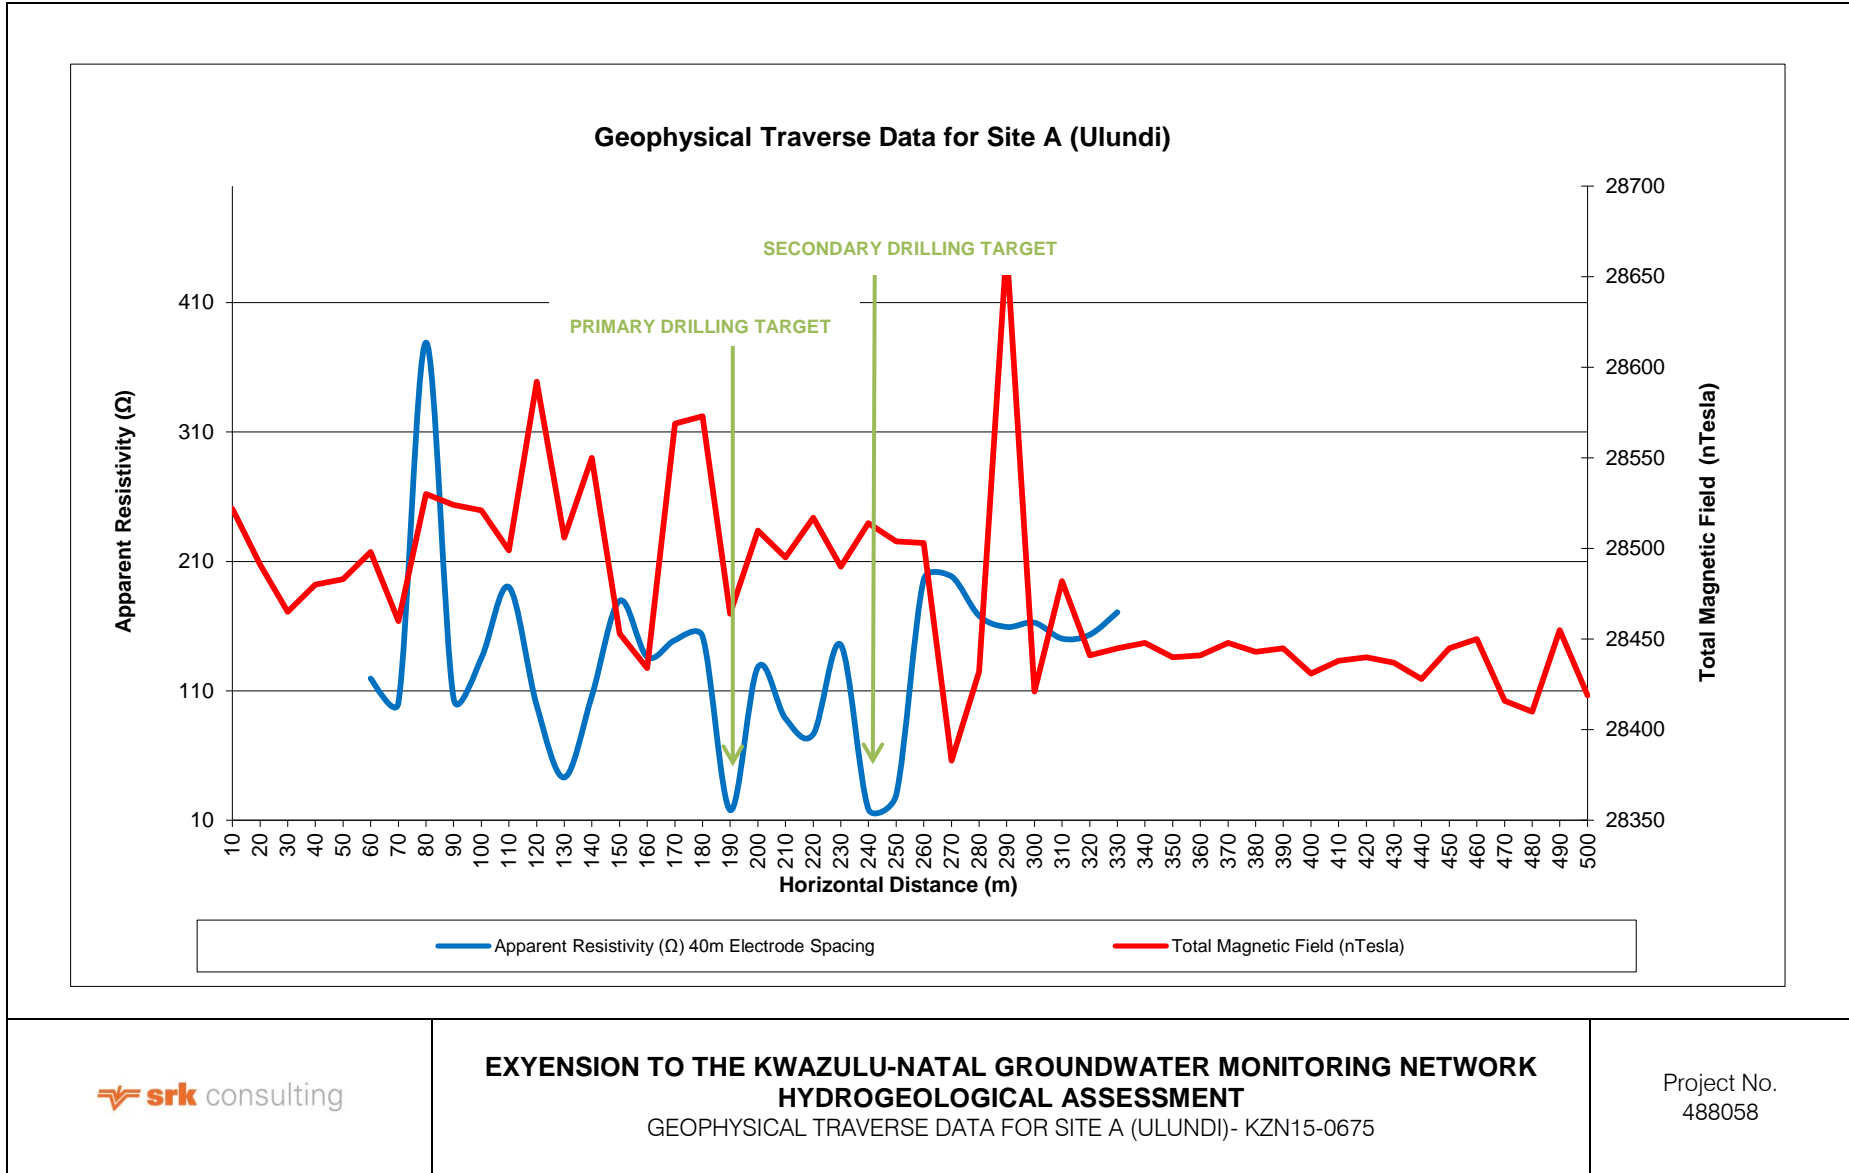
**EXENSION TO THE KWAZULU-NATAL GROUNDWATER MONITORING NETWORK
HYDROGEOLOGICAL ASSESSMENT
GEOPHYSICAL TRAVERSE DATA FOR SITE A (ULUNDI)- KZN15-0675**

Figure 5-3: Graph for the Magnetic and Resistivity Data- Site A- Ulundi KZN15-0675 13

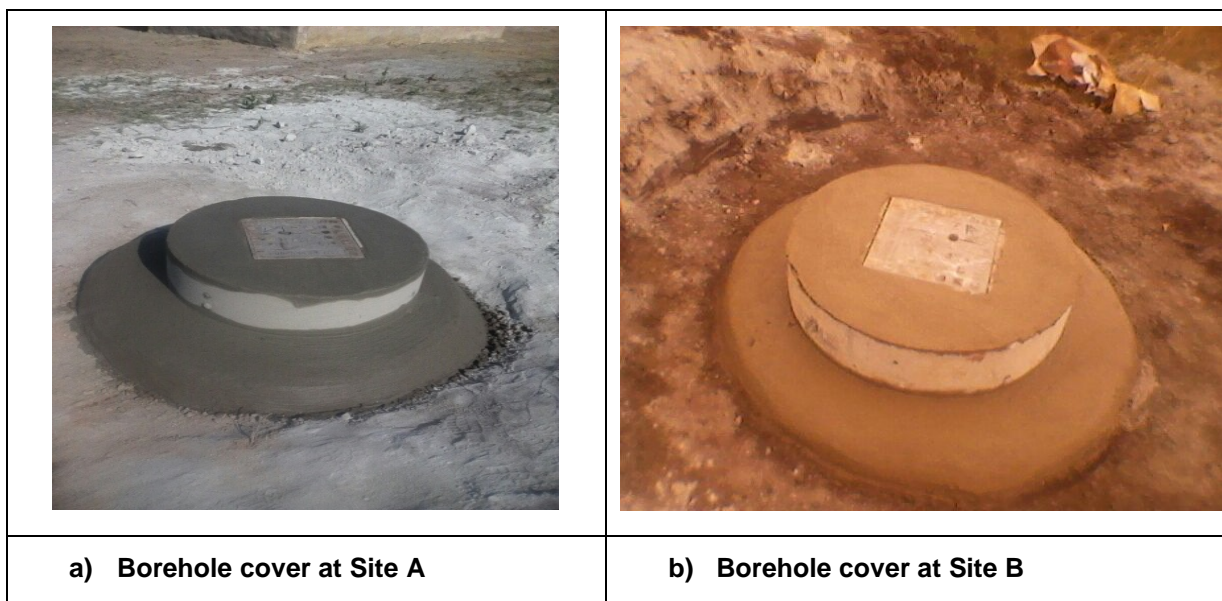
Figure 6-1: Installed borehole covers

Photographs of the installed borehole caps at each of the sites are provided in Figure 6-1 below.

- The top of the casing was raised by at least 30- 50 cm above the general ground surface to ensure that the surface run-off does not flow into the borehole during flood conditions.
- A concrete block was installed around the top of the casing, to protect the casing and borehole, as well as to prevent surface pollution from flowing down the side of the casing with a minimum dimension of 750 mm x 750 mm x 300 mm.
- A lockable cap obtained from the DWS to prevent tampering or vandalism was installed at each of the boreholes.

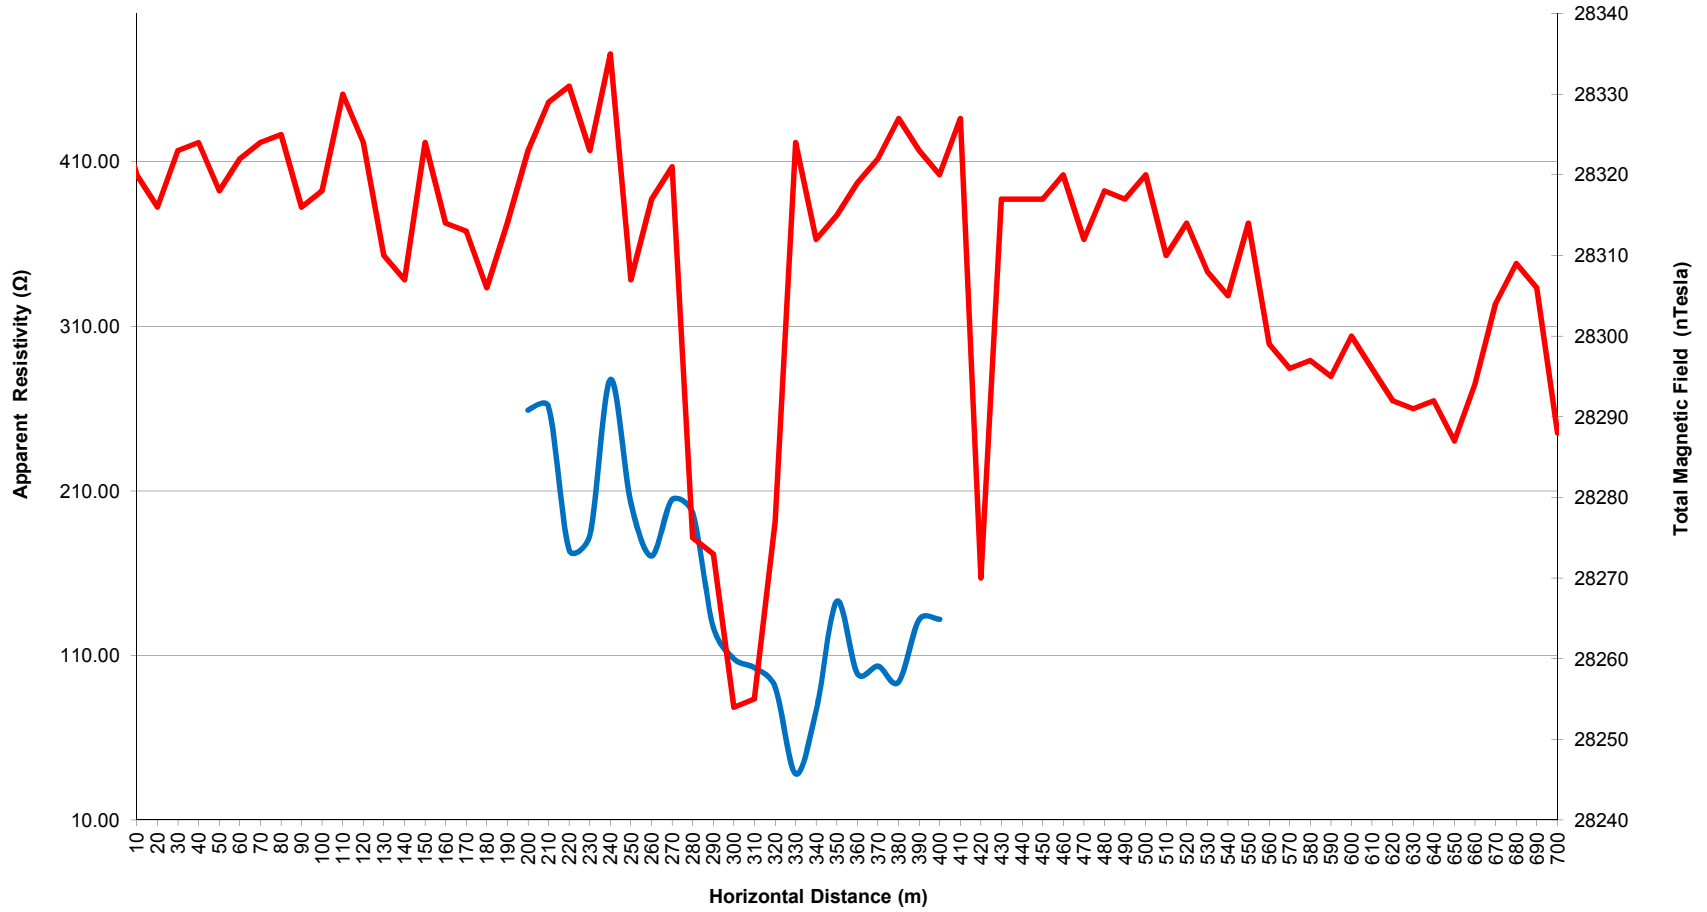
Geophysical Traverse Data for Nquthu

— Apparent Resistivity (Ω) 40m Electrode Spacing

— Total Magnetic Field (nTesla)
