ILEMBE DISTRICT MUNICIPALITY SCHOOLS GROUNDWATER ASSESSMENT REPORT FOR ISINYABUSI TECHNICAL SCHOOL

REPORT NO.: ID 20200021/5

NOVEMBER 2020

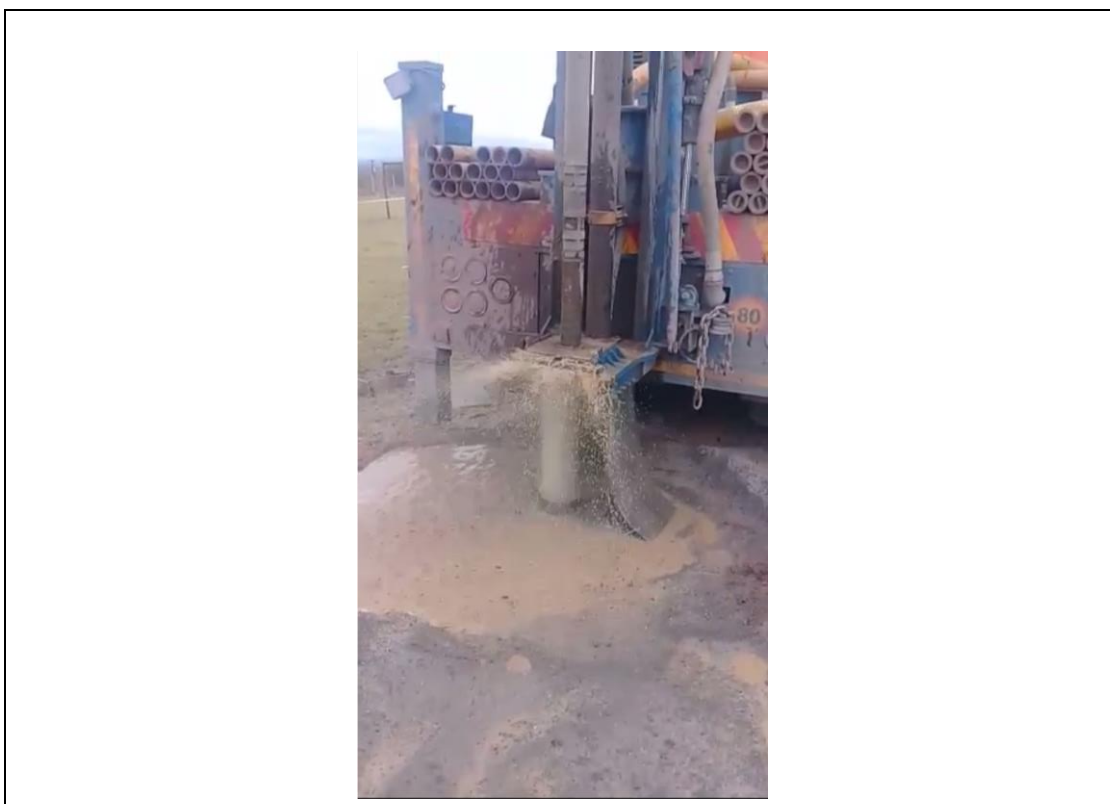
Figure 4-1: Drilling at Isinyabusi Technical High School

The borehole was drilled and completed on 18 October 2020. The total depth of the borehole was 46 mbgl after a decision by the hydrogeologist on site, due to the softer formation that was encountered deeper at 30 mbgl which was threatening to collapse the borehole, together with the high yielding fracture. The 8 inch (203 mm) diameter was used from surface, down to 21 mbgl. Steel casing was then installed from 0 – 21 mbgl. The 6.5 inch diameter drill bit was used from 21 – 46 mbgl to complete the borehole. Groundwater was intercepted at the depths of 24 mbgl (0.14 L/s) and 30 mbgl (1.25 L/s), accumulatively. The total blow yield of 2.08 L/s was measured at the end of drilling.

The borehole was subjected to a maximum of 1 hours of development after the final depth.
