REPUBLIC OF BOPHUTHATSWANA
DEPARTMENT OF WATER AFFAIRS

**REPORT ON THE SITING
DRILLING AND TESTING OF BOREHOLES,
AND THE TESTING OF EXISTING
BOREHOLES - DITSOBOTLA DISTRICT
JUNE 1991 - FEBRUARY 1993**

**VOLUME 1 - TEXT
AND APPENDIX I**

PARTRIDGE MAUD AND ASSOCIATES

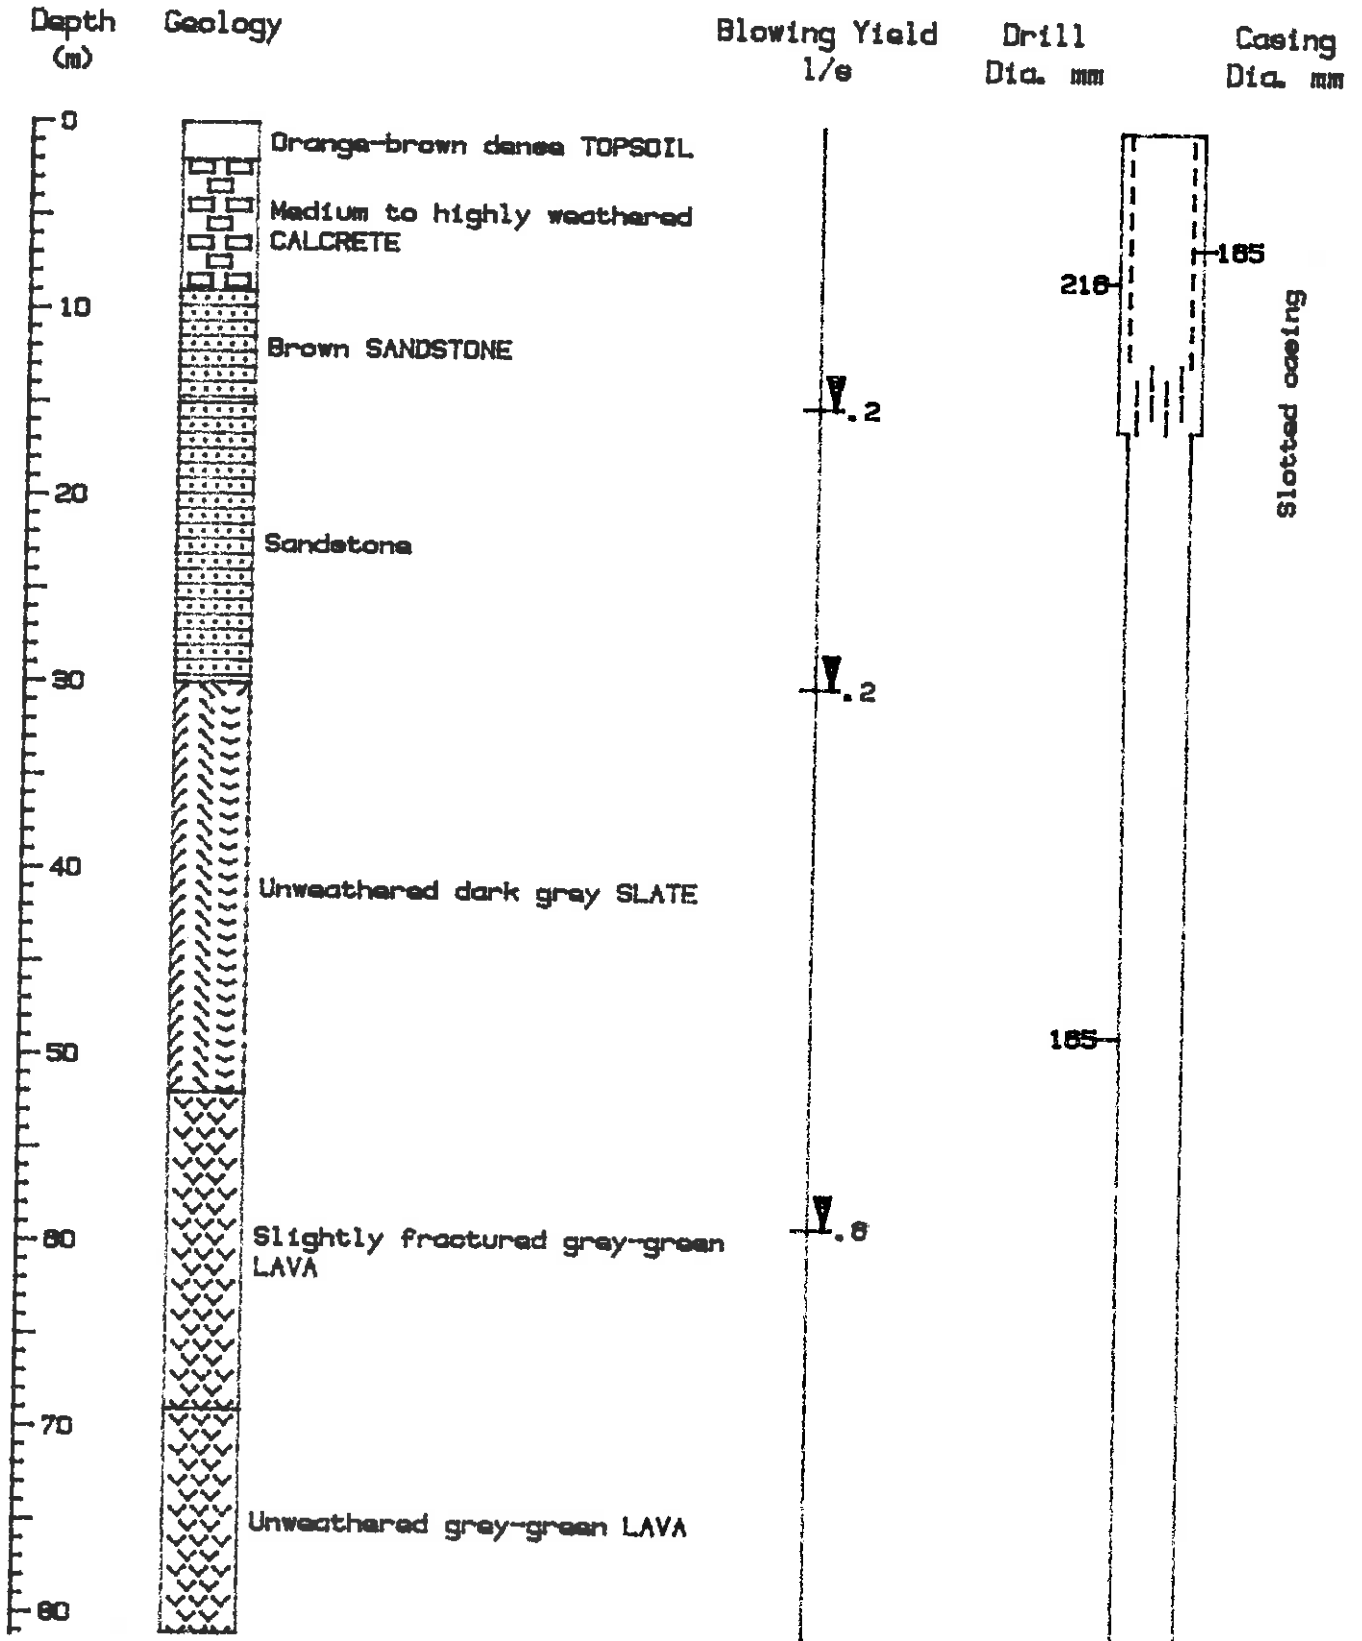
Coordinates +2899525X -63400Y

Elev. (m) 1378

End of Hole 81

Borehole 10-77283 was drilled to a final depth of 81m and intersected a sequence of calcrete, sandstone, slate and lava. The three water strikes were associated with weathering and minor fracturing (Table 3). A final blowing yield of 1 l/s was obtained. In contrast 10-77299 intersected 20m of calcrete, underlain by 21m of residual dolomite with slate and lava at depth. The final depth was 76m, and a total blowing yield of 0.45 l/s was obtained from 2 water strikes.

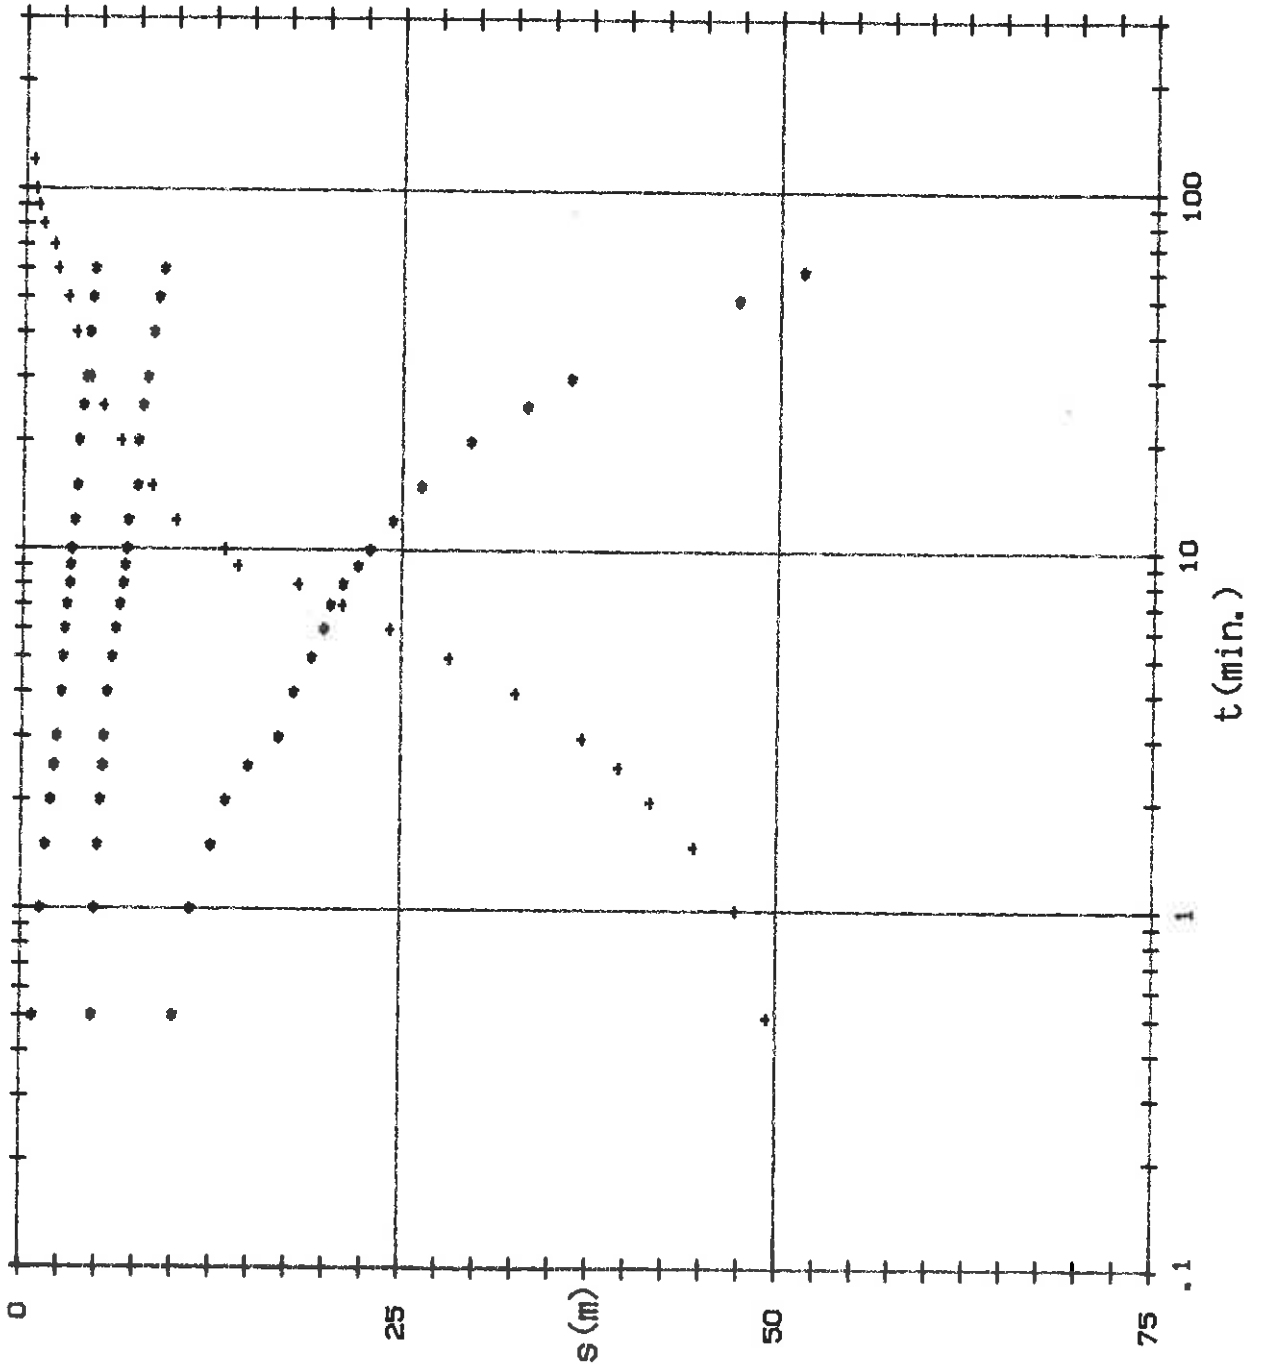
STEP DRAWDOWN TEST

$Q_3 = 1.1 \text{ l/s}$

S.W.L. = 6.97 m

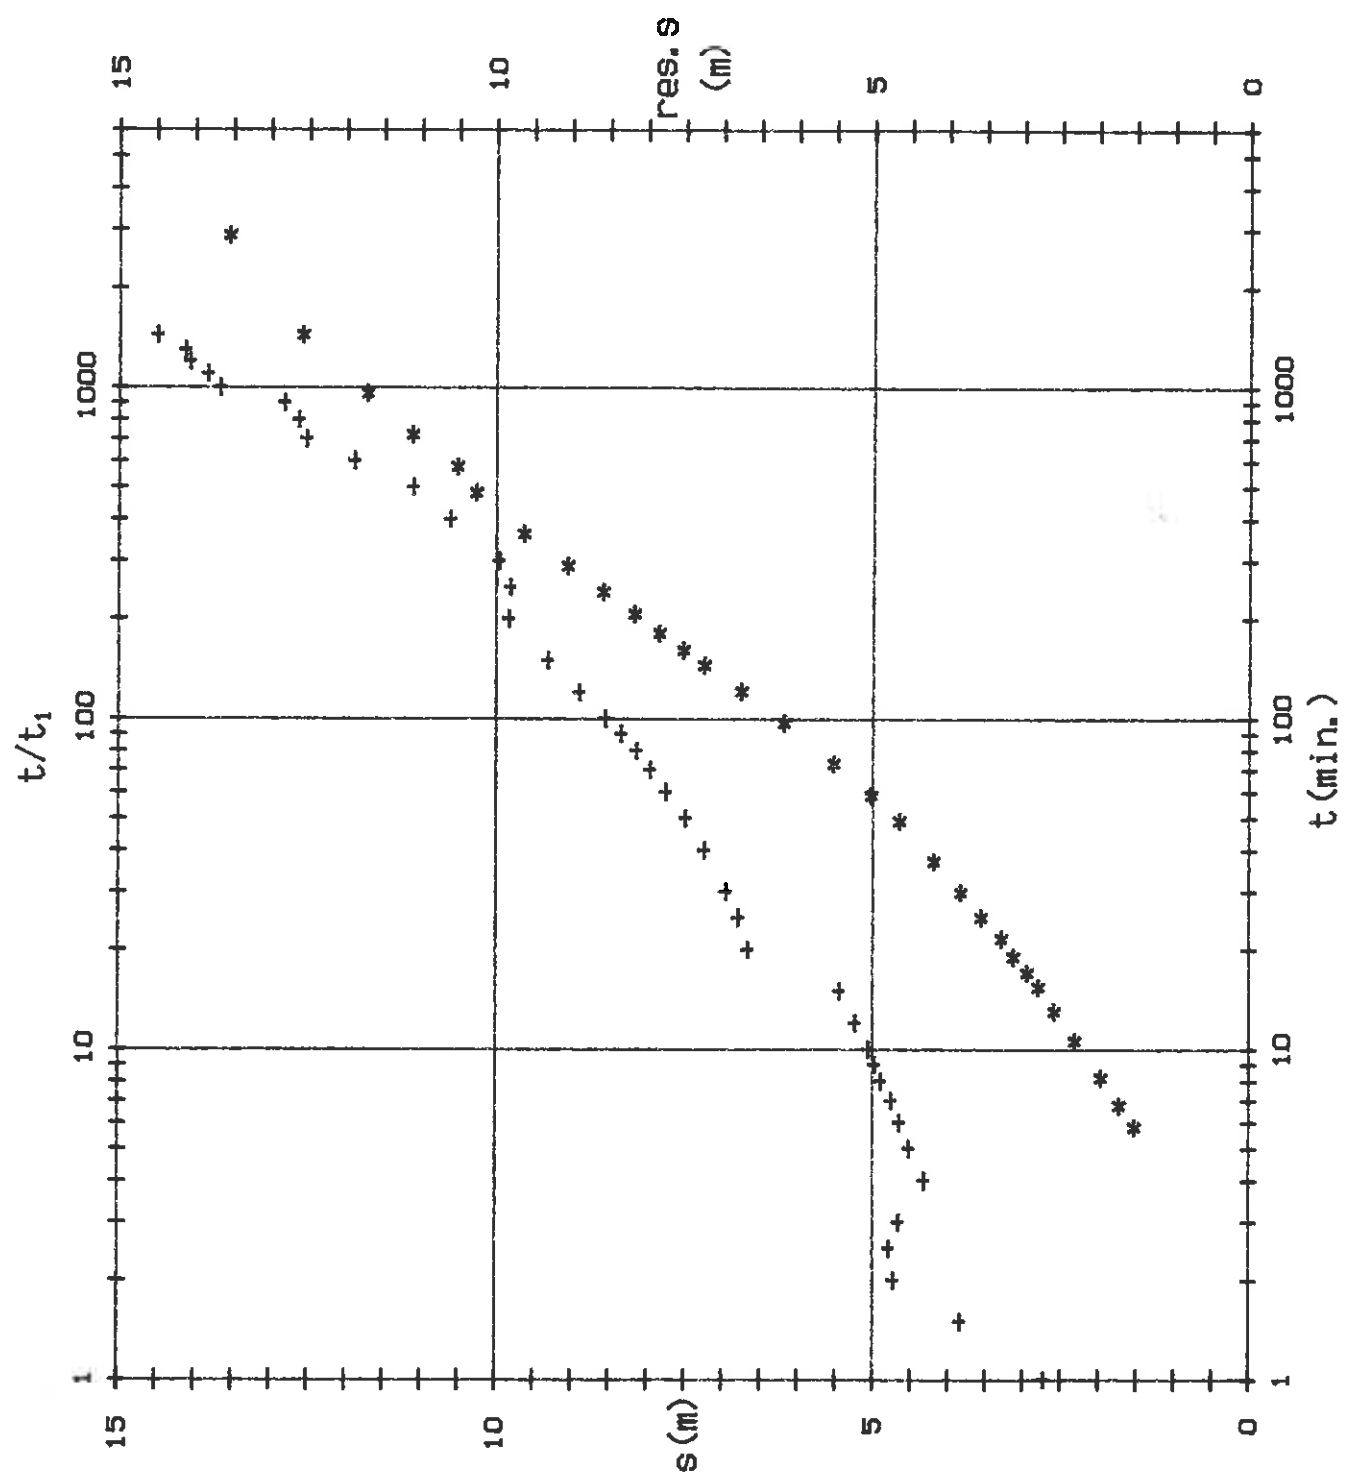
CONSTANT DISCHARGE TEST

- + Drawdown data.
- * Recovery data.

S.W.L. = 6.97 m

$T = 5 \text{ m}^2/\text{d}$

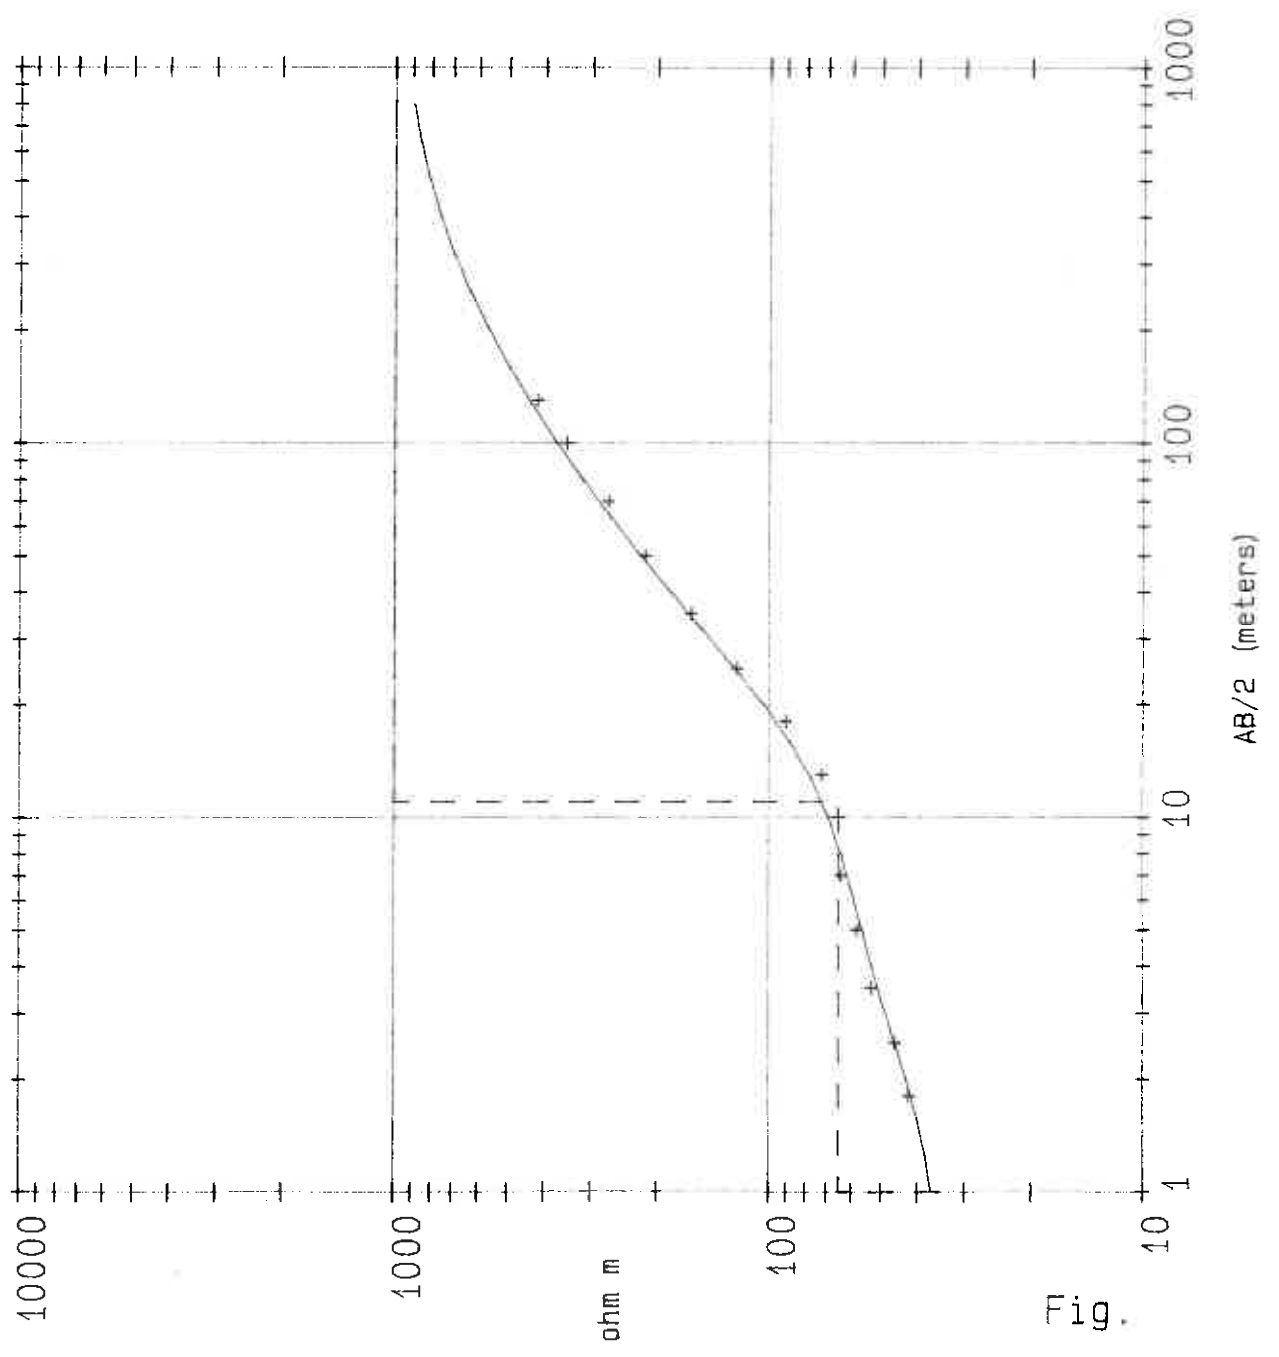
+ Field data
 --- Computer model
 - - - d - r model

BAPONG

CO-ORDINATES
 +2898975X -66380Y

GEOLOGY
 LAVA

The hydrogeophysical survey undertaken for the village borehole comprised 2 calibration VES run at 2 existing windpumps, and five exploratory VES. These indicated generally shallow weathering, <15m, with low resistivities, <30 ohm-metres. VES 02 was selected for drilling. Here a 30m deep zone with a resistivity of 60 ohm-metres indicated more favourable conditions.

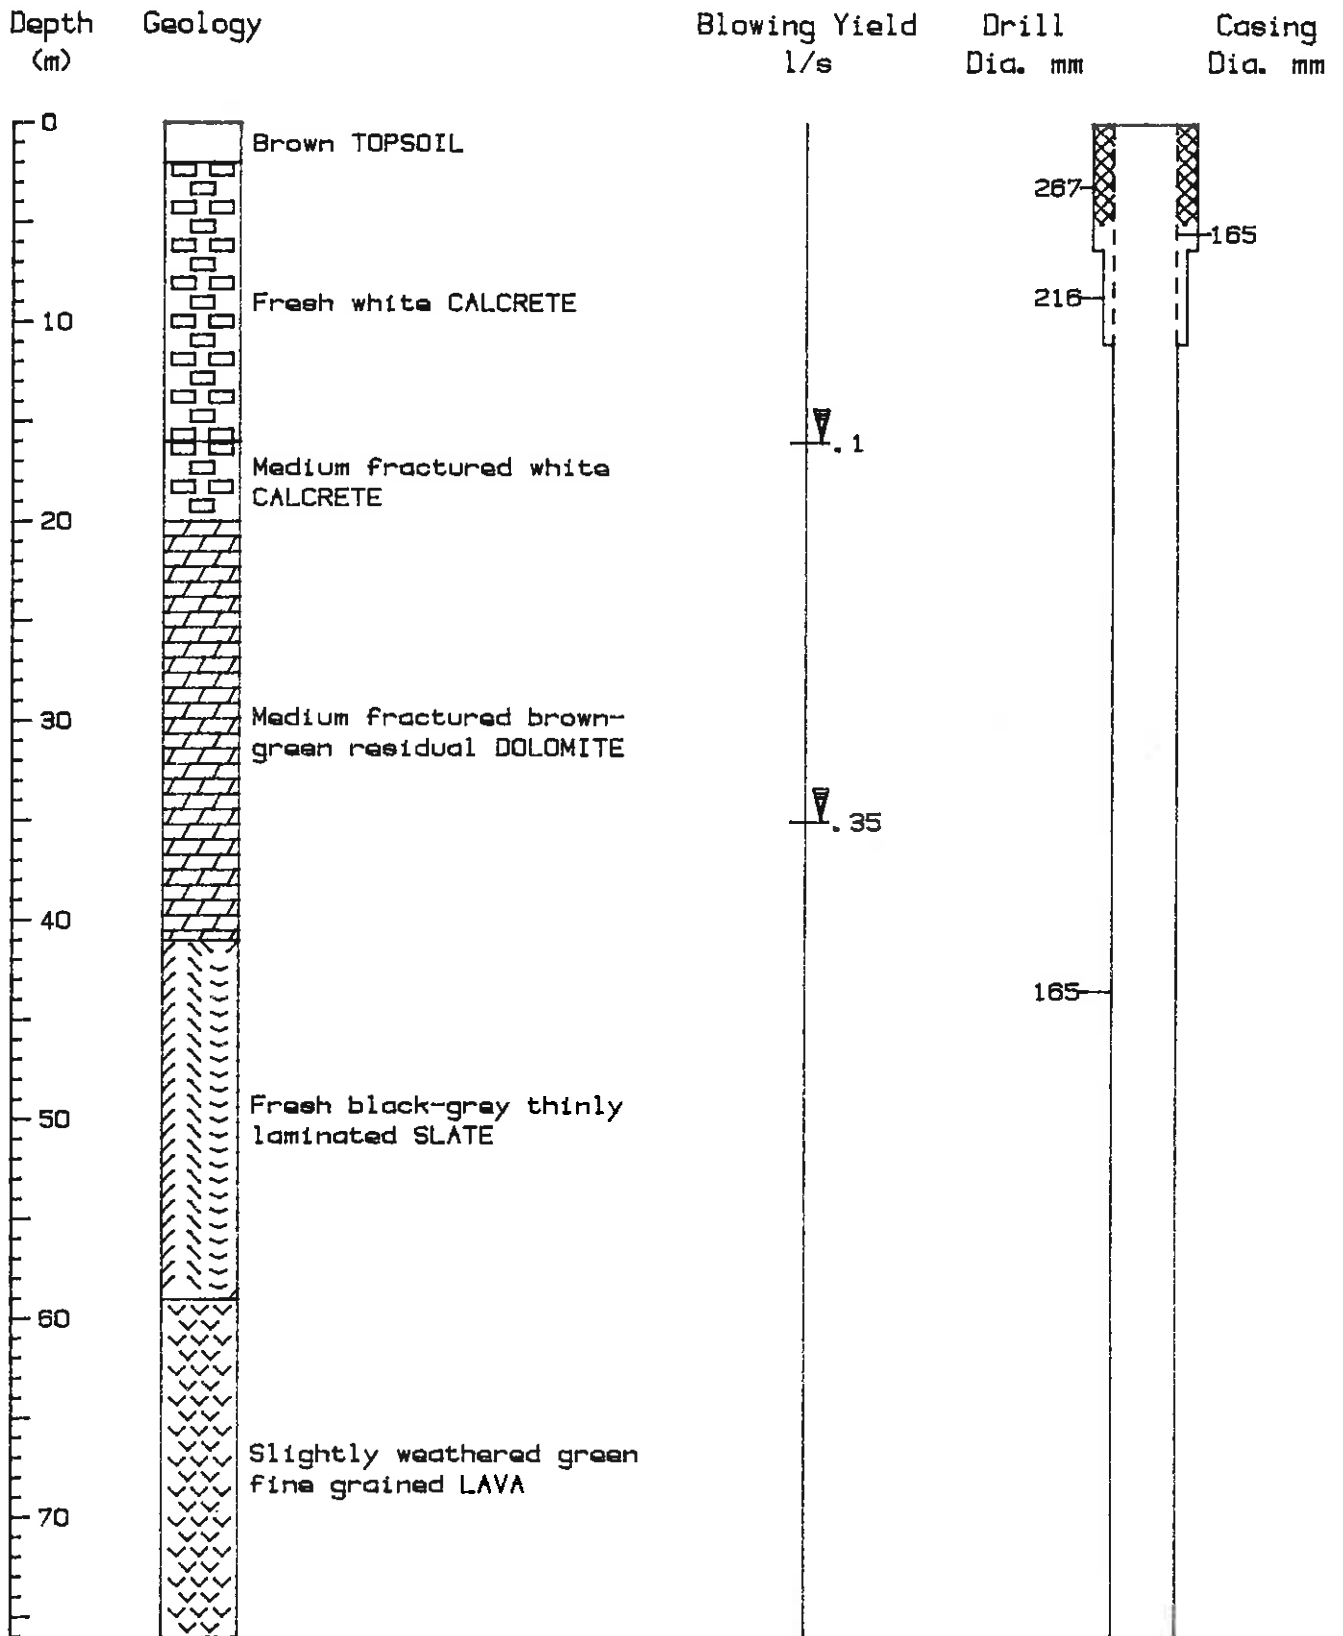
Coordinates +2898975X -066380Y

Elev. (m) 1388

End of Hole 76

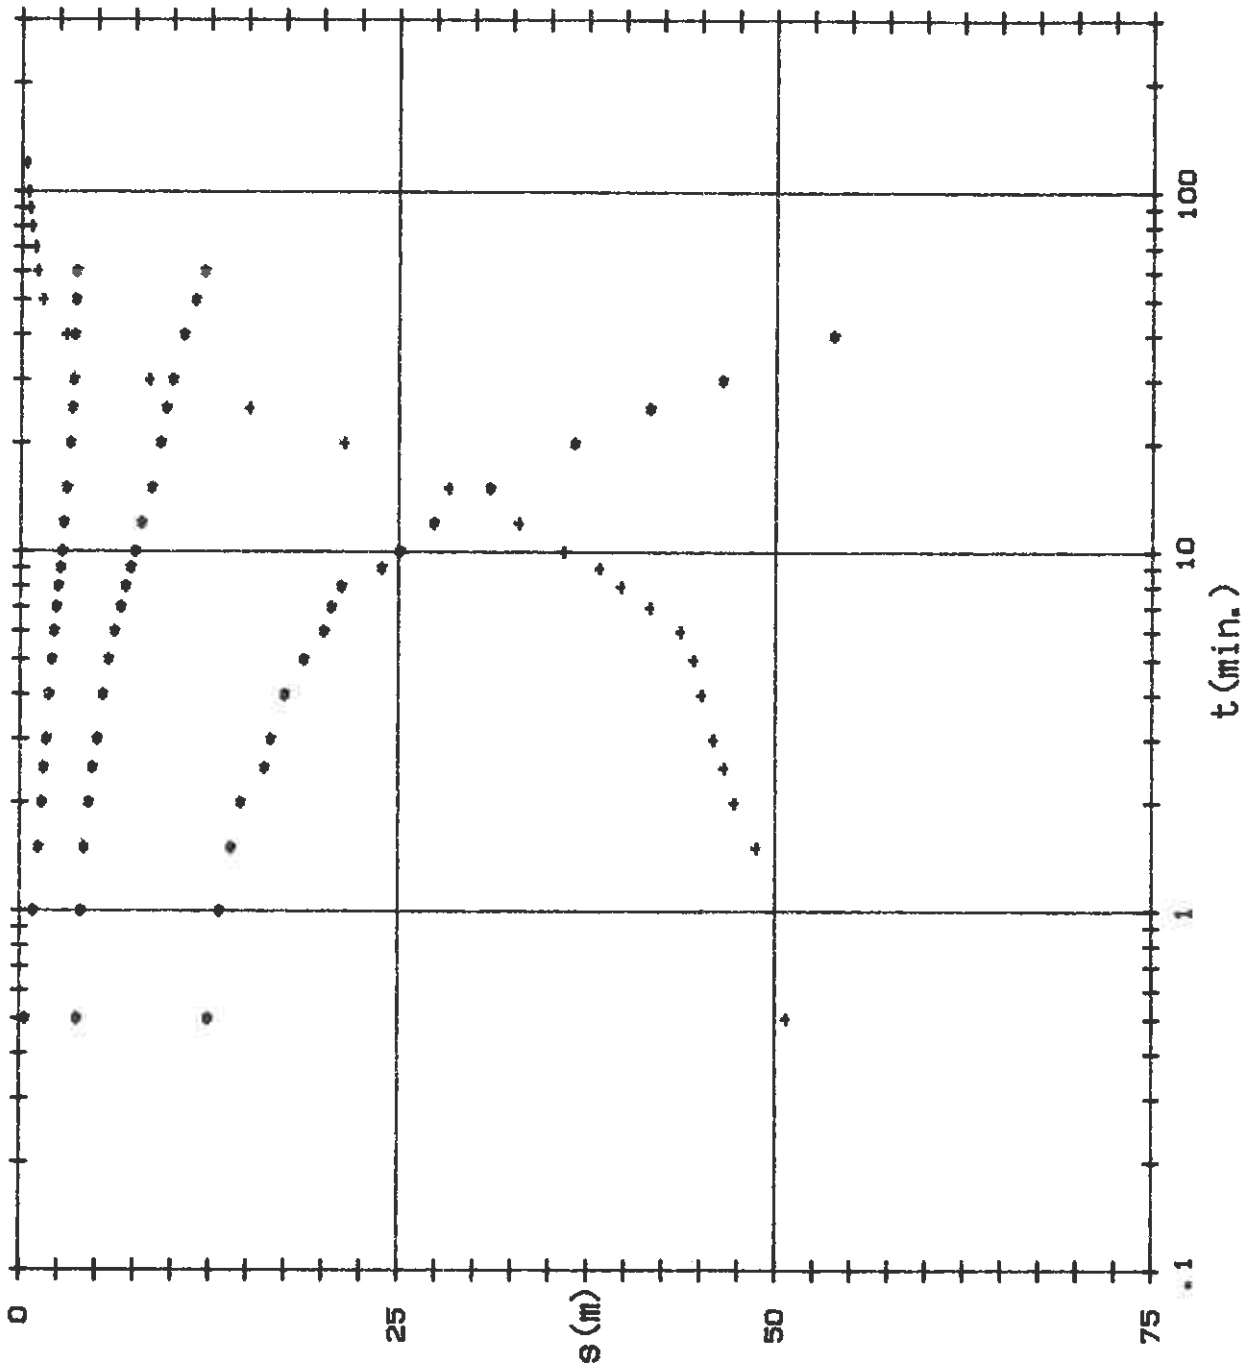
STEP DRAWDOWN TEST

$Q_3 = .8 \text{ l/s}$

S.W.L. = 5.35 m

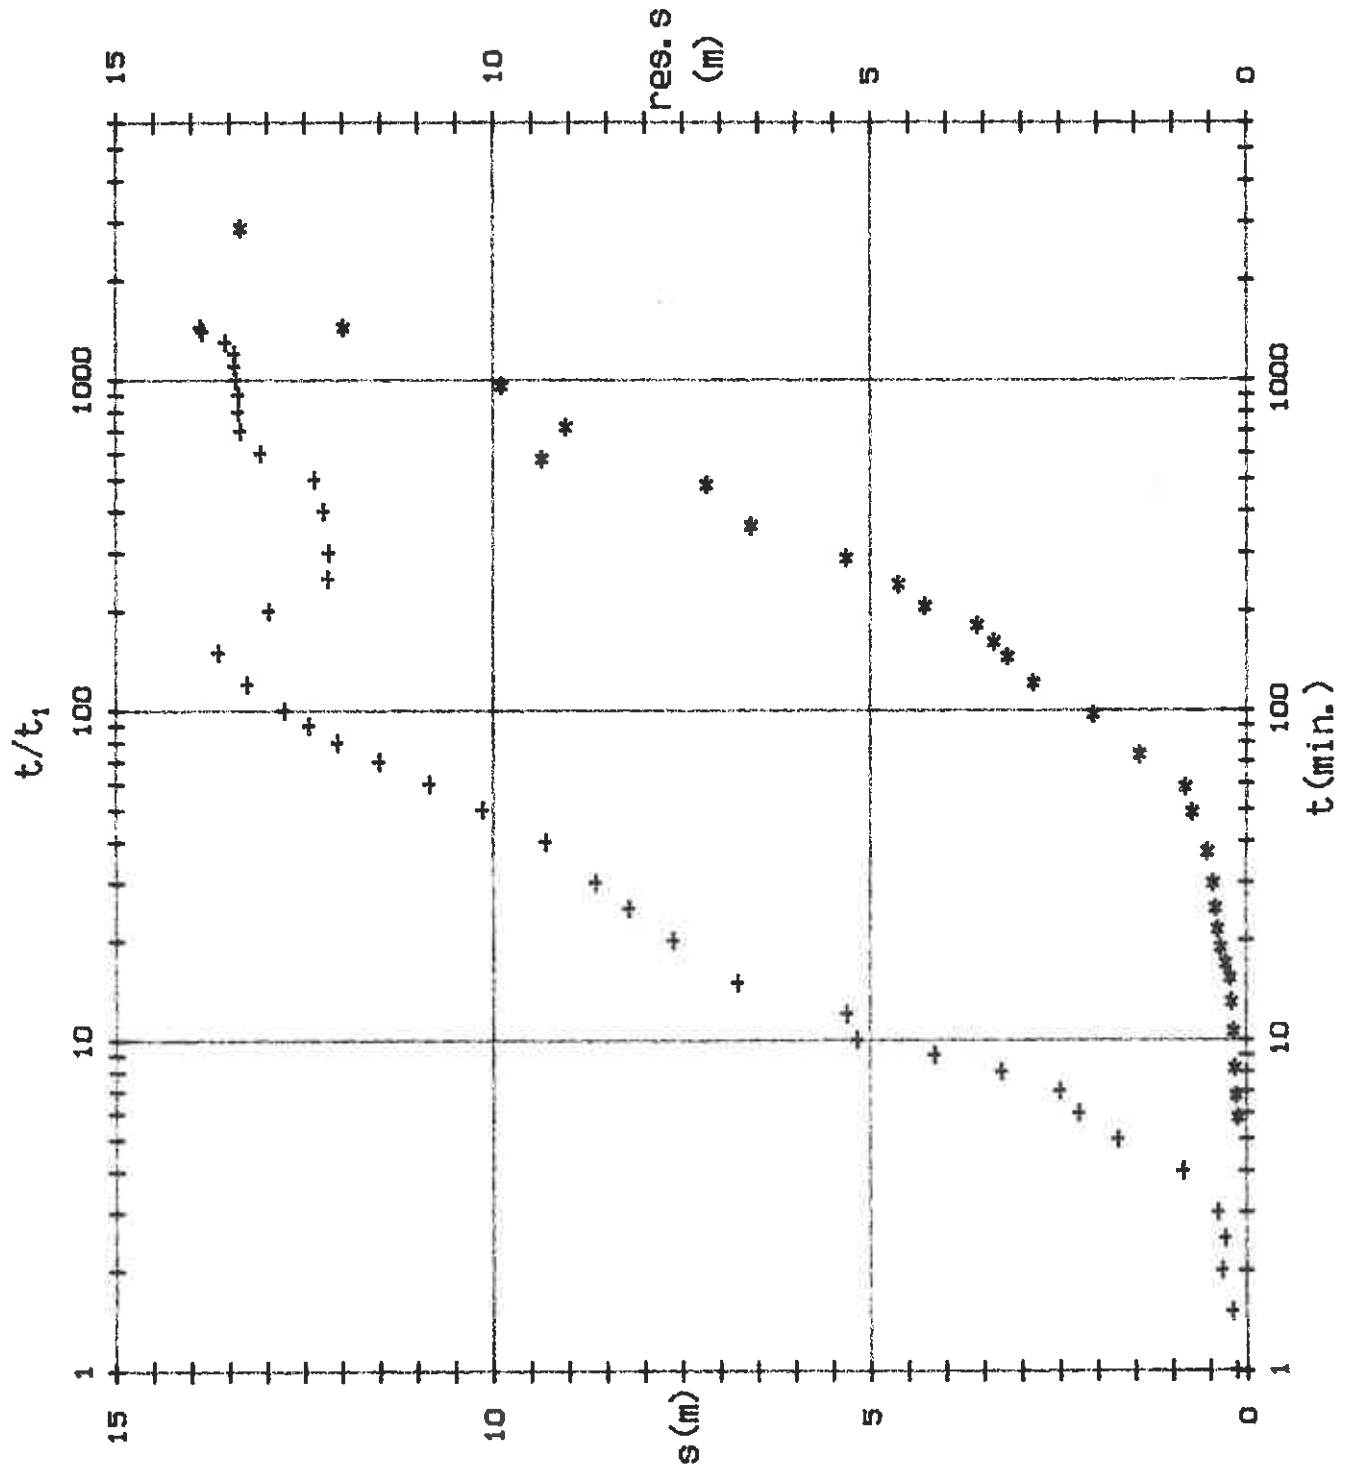
CONSTANT DISCHARGE TEST

- + Drawdown data.
- * Recovery data.

$S.W.L. = 5.35 \text{ m}$

$T = 1 \text{ m}^2/\text{d}$

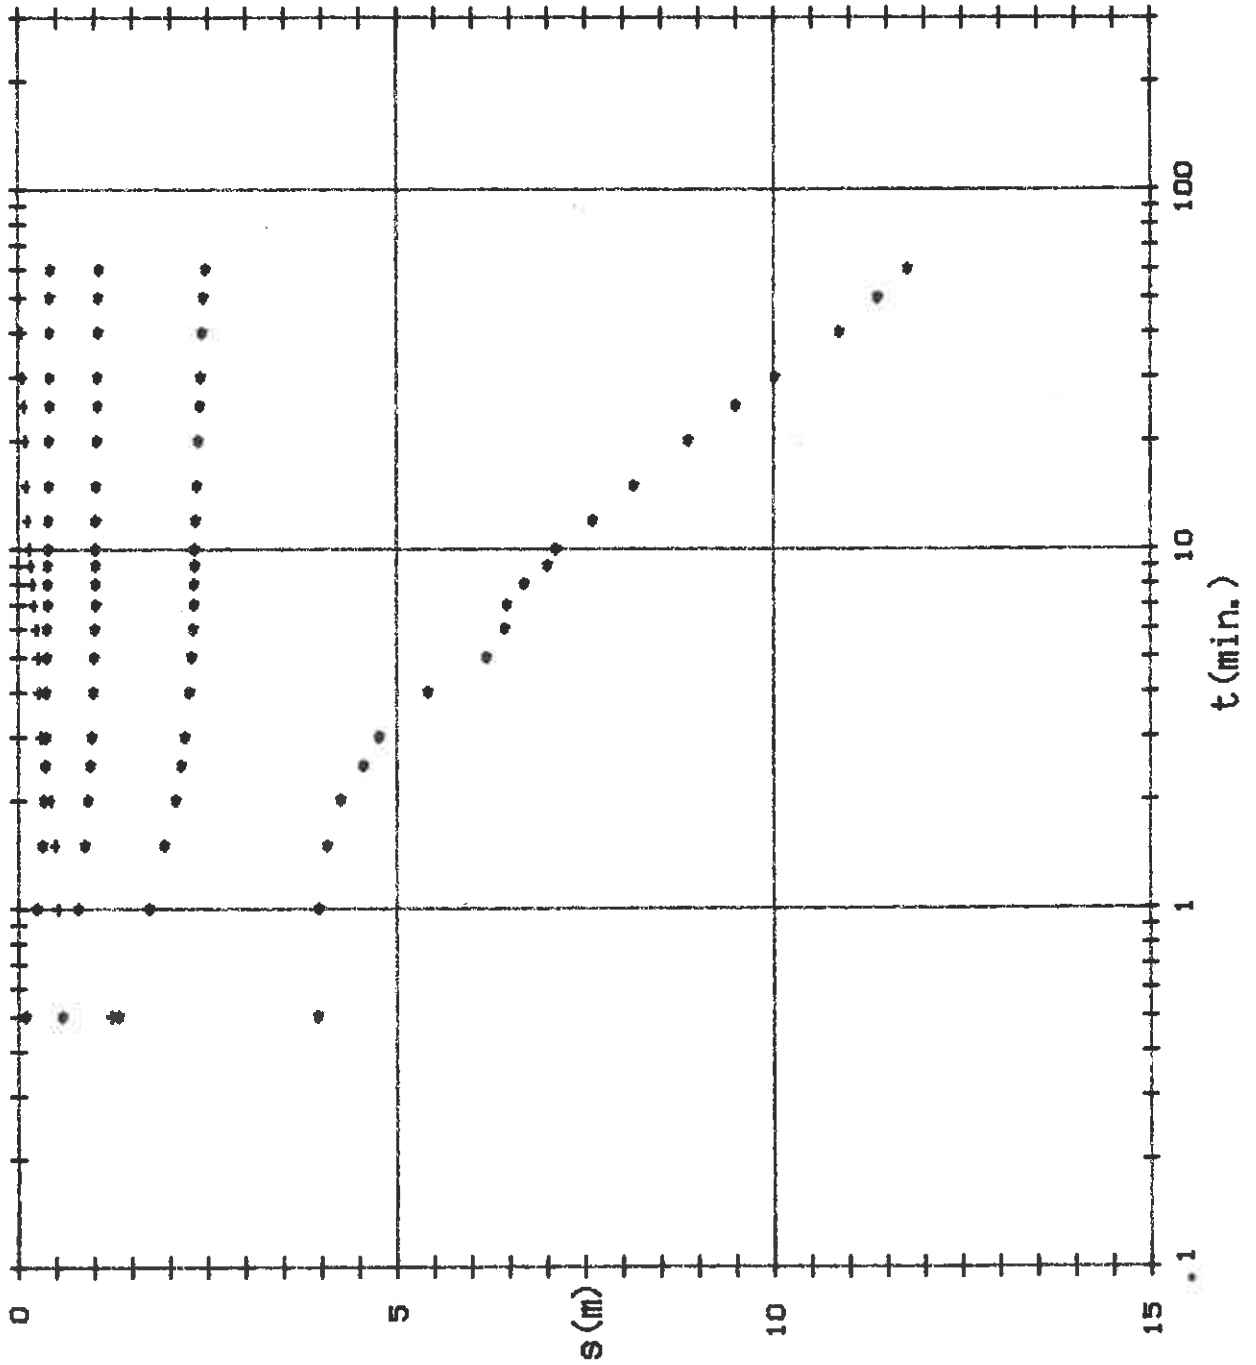
STEP DRAWDOWN TEST

$Q_1 = .28 \text{ l/s}$
 $Q_2 = .62 \text{ l/s}$
 $Q_3 = 1.3 \text{ l/s}$
 $Q_4 = 2.65 \text{ l/s}$

S.W.L. = 6.08 m

The static water level on 6th August 1992 was recorded as 6,68mbgl. A step test comprising 4 discharges, with a maximum of 2,65 l/s, was followed by a 48 hour constant rate test run at 1,5 l/s. This produced a steady drawdown indicating the fracture zone intersected is areally extensive. The transmissivity of 10 m²/d shows the permeation properties of the aquifer are moderately poor. Recovery of the water level was complete, confirming the long term sustainability of the borehole at the recommended production yield of 1 l/s (Table 9). The water quality is good and suitable for human consumption.

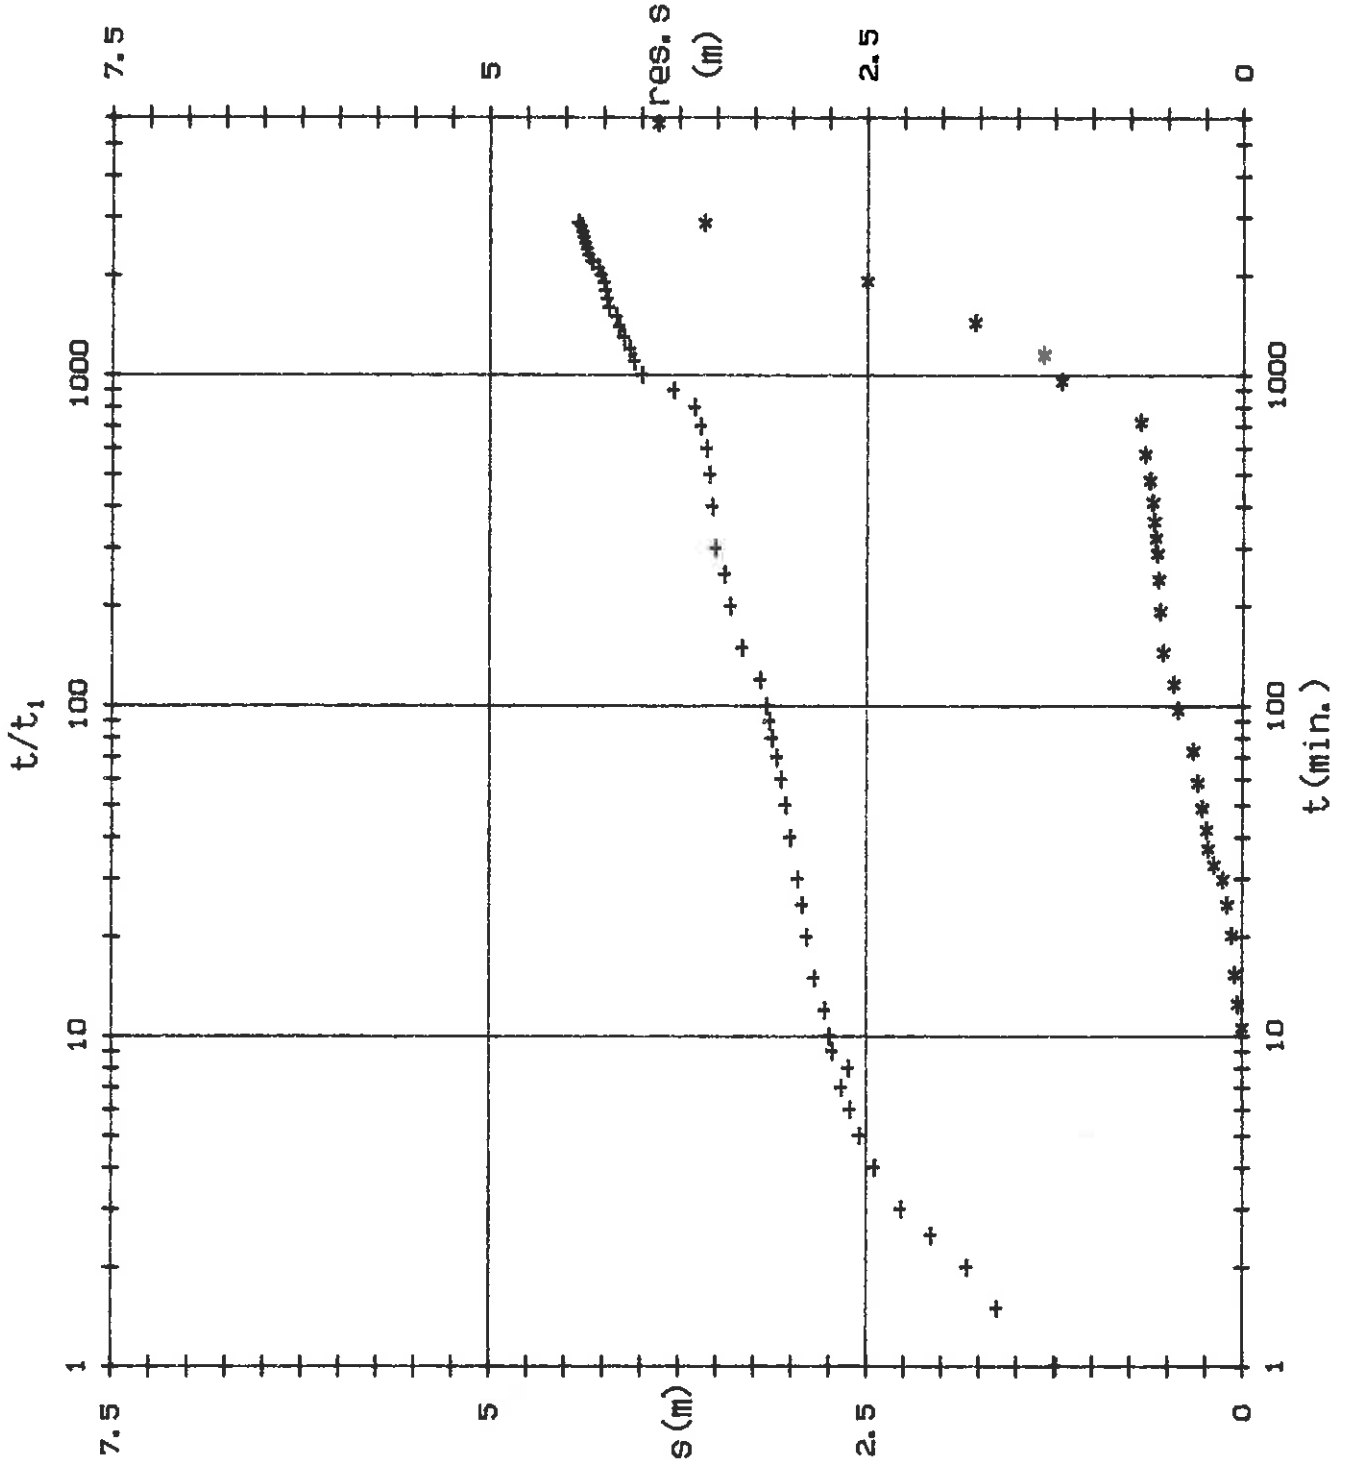
CONSTANT DISCHARGE TEST

+ Drawdown data.
* Recovery data.

S.W.L. = 6.08 m

T = 10 m²/d

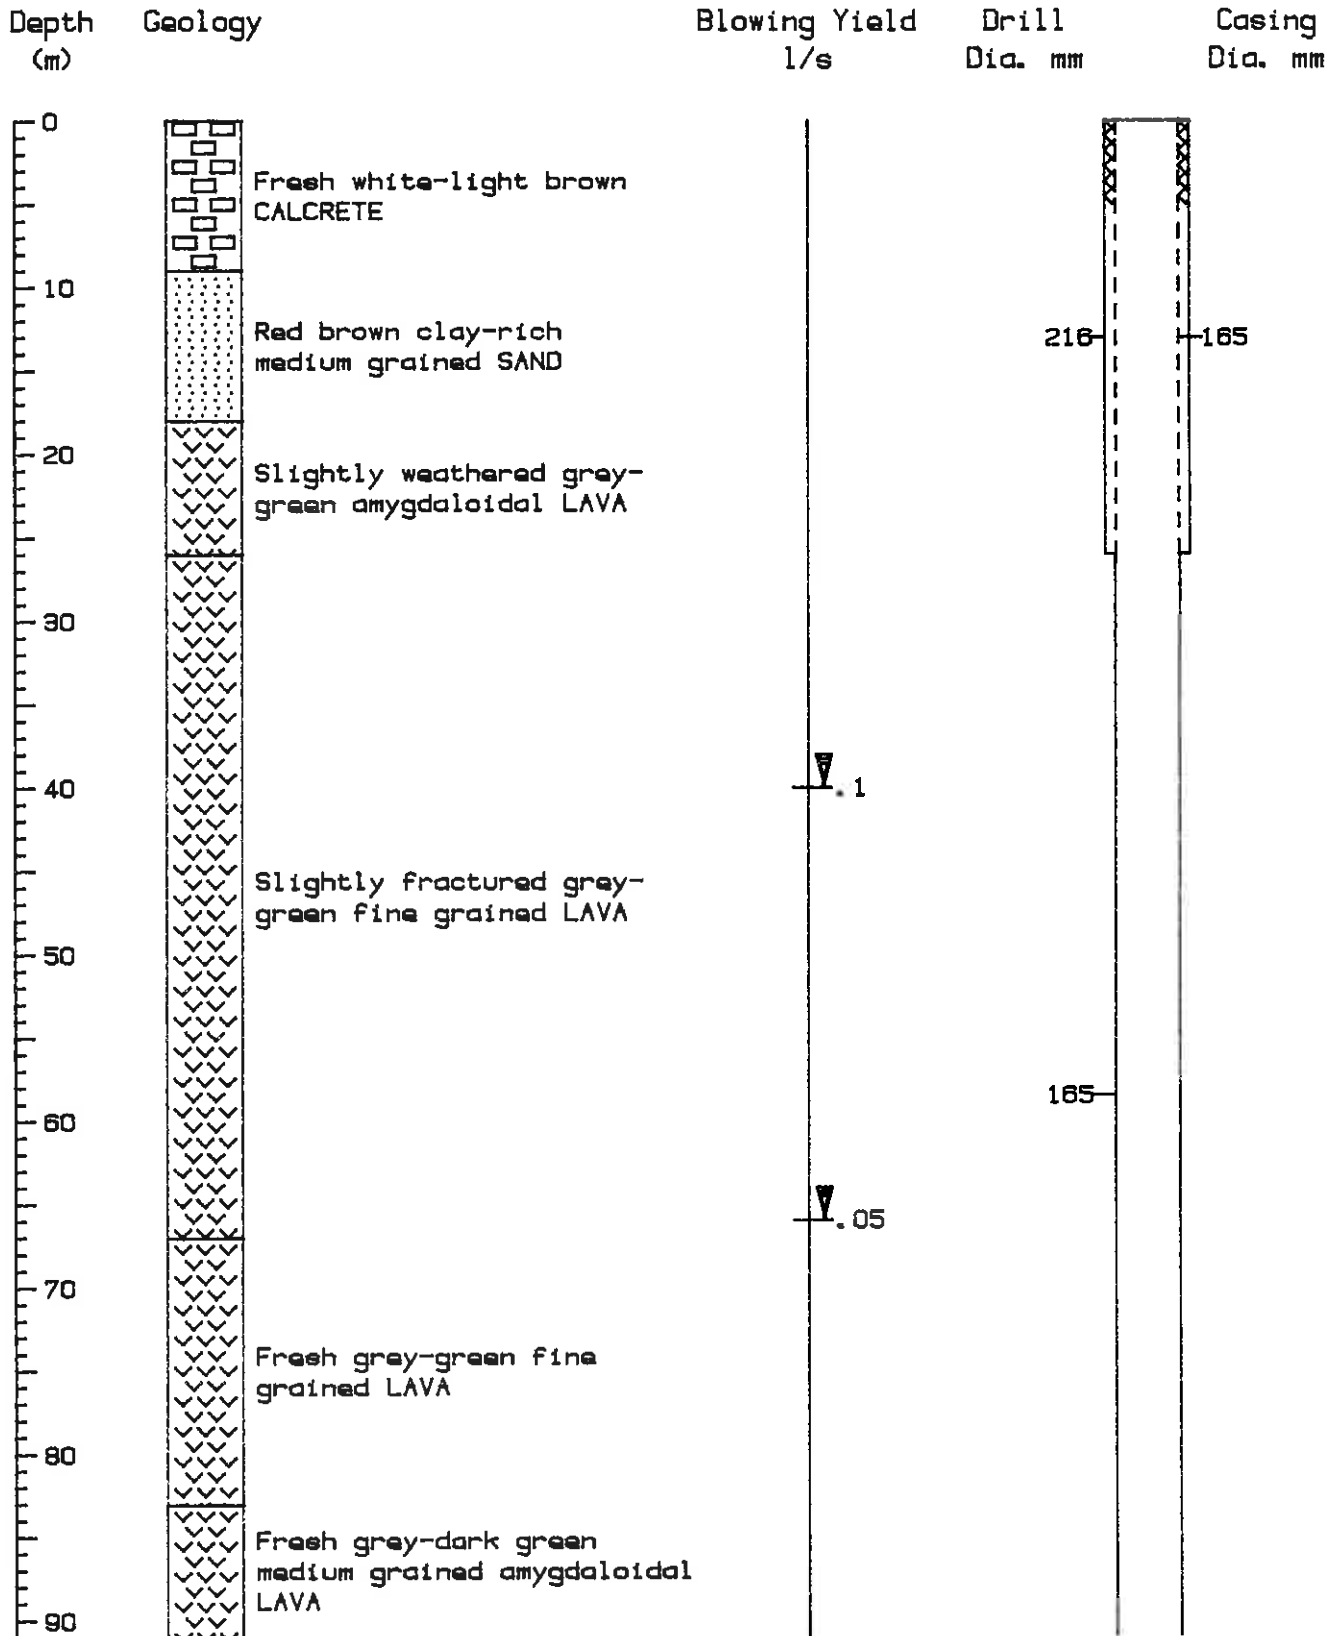
Coordinates +2914110X -058780Y

Elev. (m) 1351

End of Hole 91

Borehole 10-77296 was drilled to 91m and 10-77297 to 96m. Both intersected weathered and fractured lava to the depths indicated by the geophysical survey. Final blowing yields of 0,15 l/s (10-77296) and 0,3 l/s (10-77297) were obtained from water strikes in the lava (Table 3).

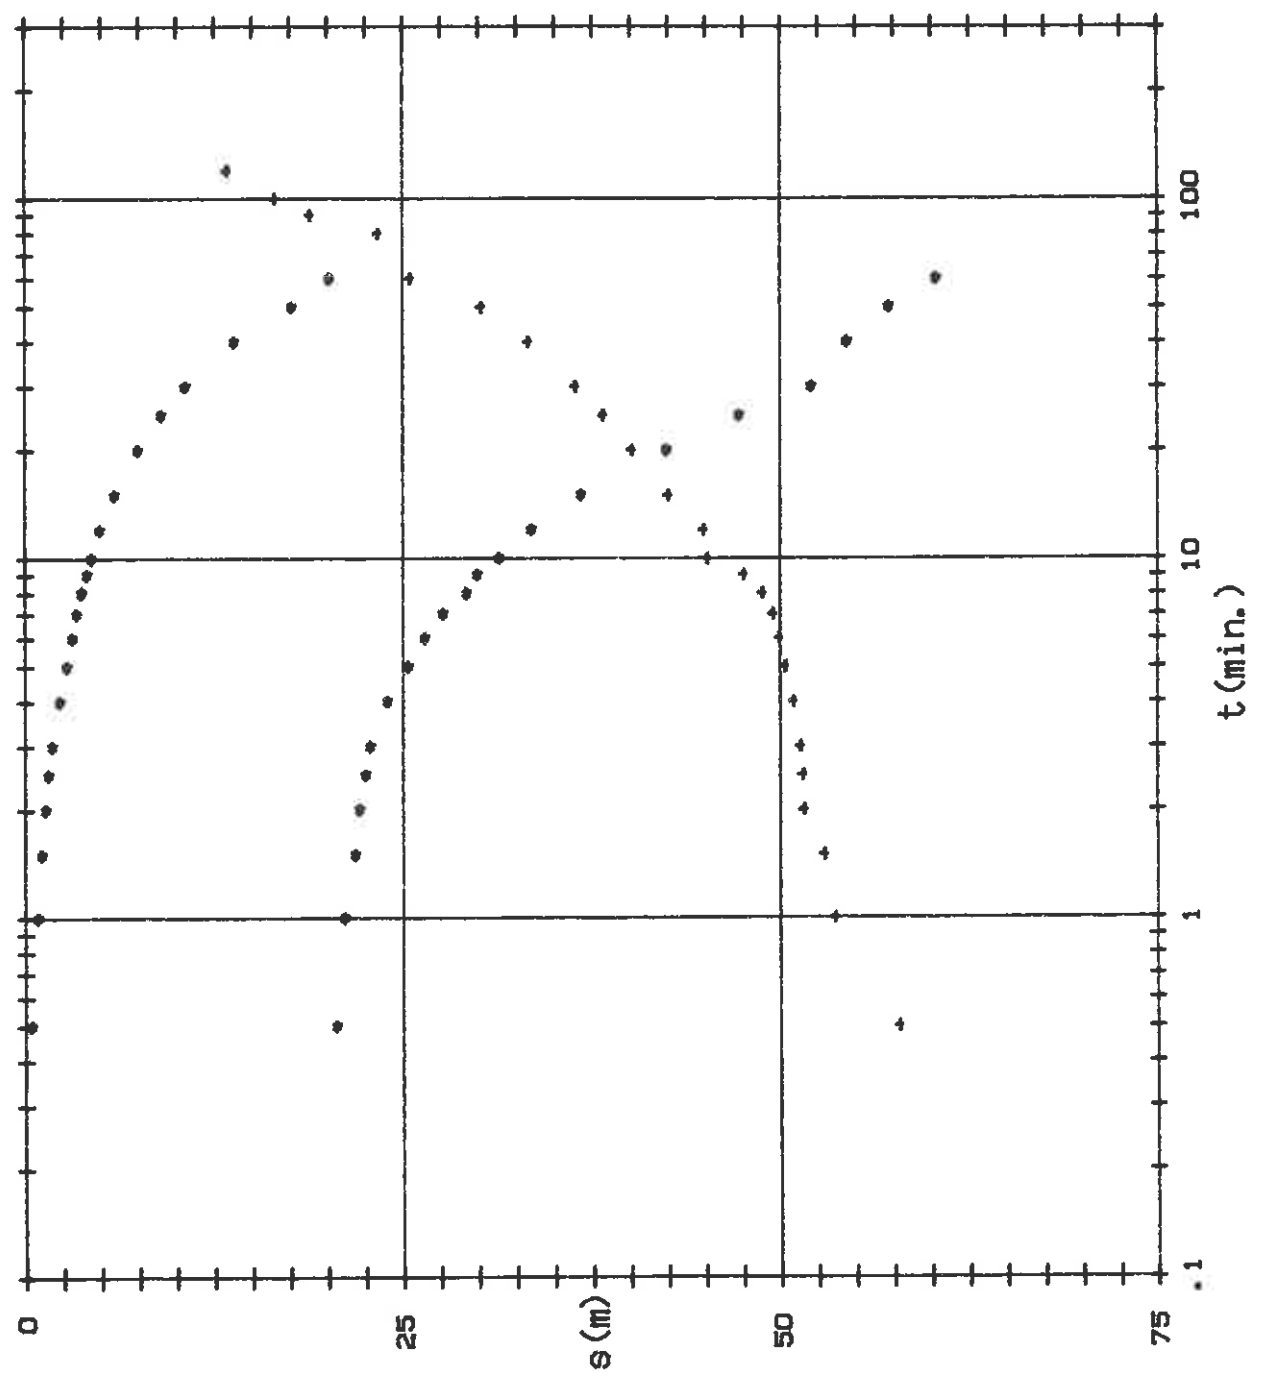
STEP DRAWDOWN TEST

$Q_2 = .48 \text{ l/s}$

S.W.L. = 5.01 m
