REPUBLIC OF BOPHUTHATSWANA
DEPARTMENT OF WATER AFFAIRS

**REPORT ON THE SITING
DRILLING AND TESTING OF BOREHOLES,
AND THE TESTING OF EXISTING
BOREHOLES - DITSOBOTLA DISTRICT
JUNE 1991 - FEBRUARY 1993**

**VOLUME 1 - TEXT
AND APPENDIX I**

PARTRIDGE MAUD AND ASSOCIATES

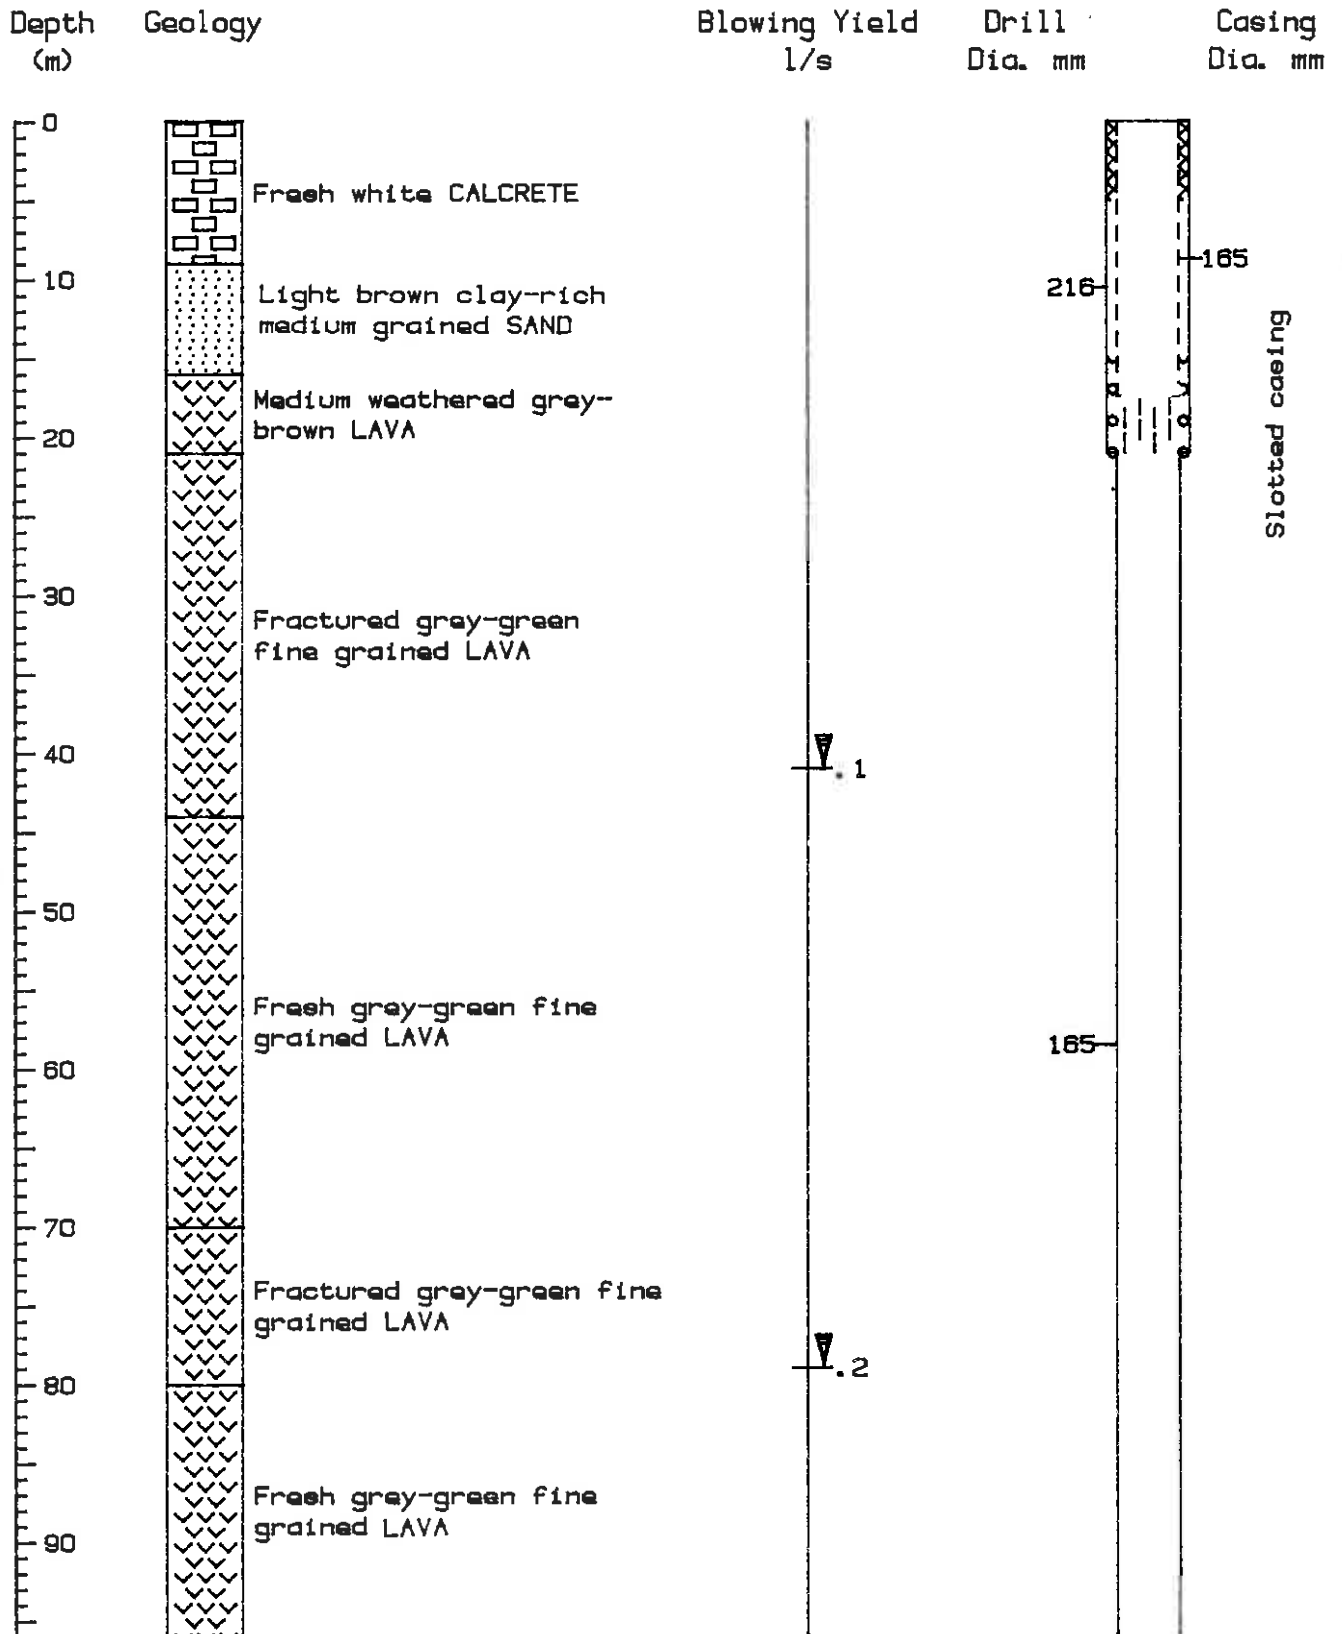
Coordinates +2913760X -059305Y

Elev. (m) 1351

End of Hole 96

Borehole 10-77296 was drilled to 91m and 10-77297 to 96m. Both intersected weathered and fractured lava to the depths indicated by the geophysical survey. Final blowing yields of 0,15 l/s (10-77296) and 0,3 l/s (10-77297) were obtained from water strikes in the lava (Table 3).

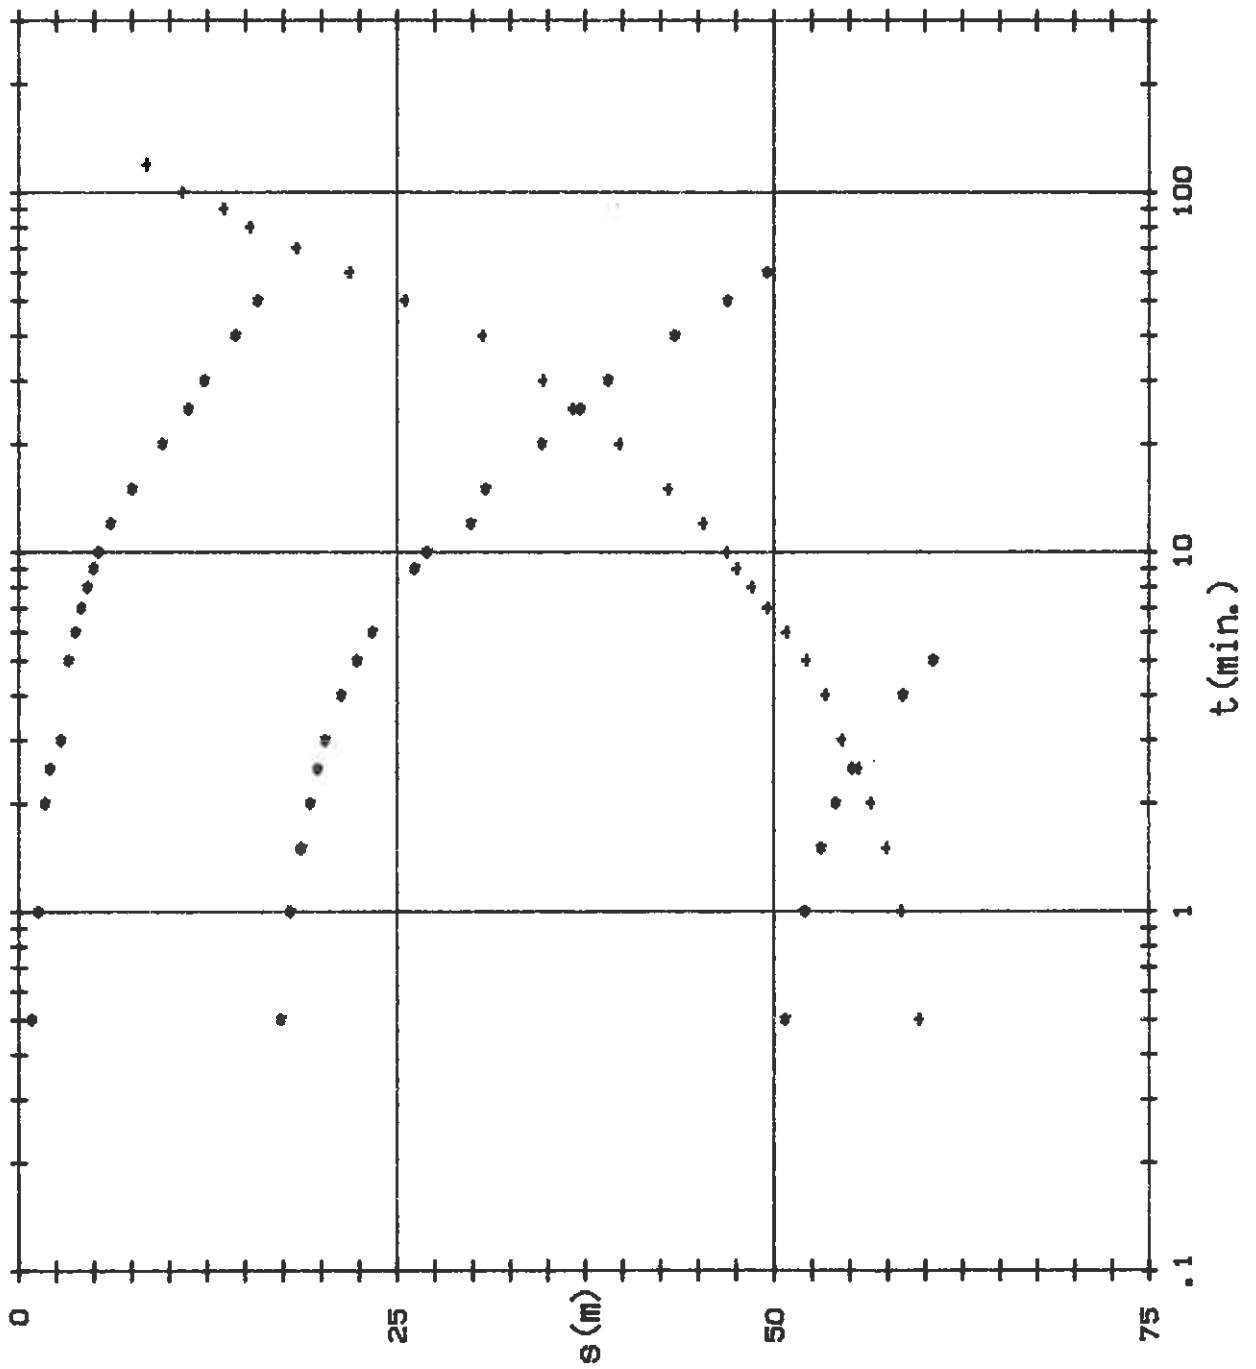
STEP DRAWDOWN TEST

$Q_3 = 1.1 \text{ l/s}$

S.W.L. = 5 m

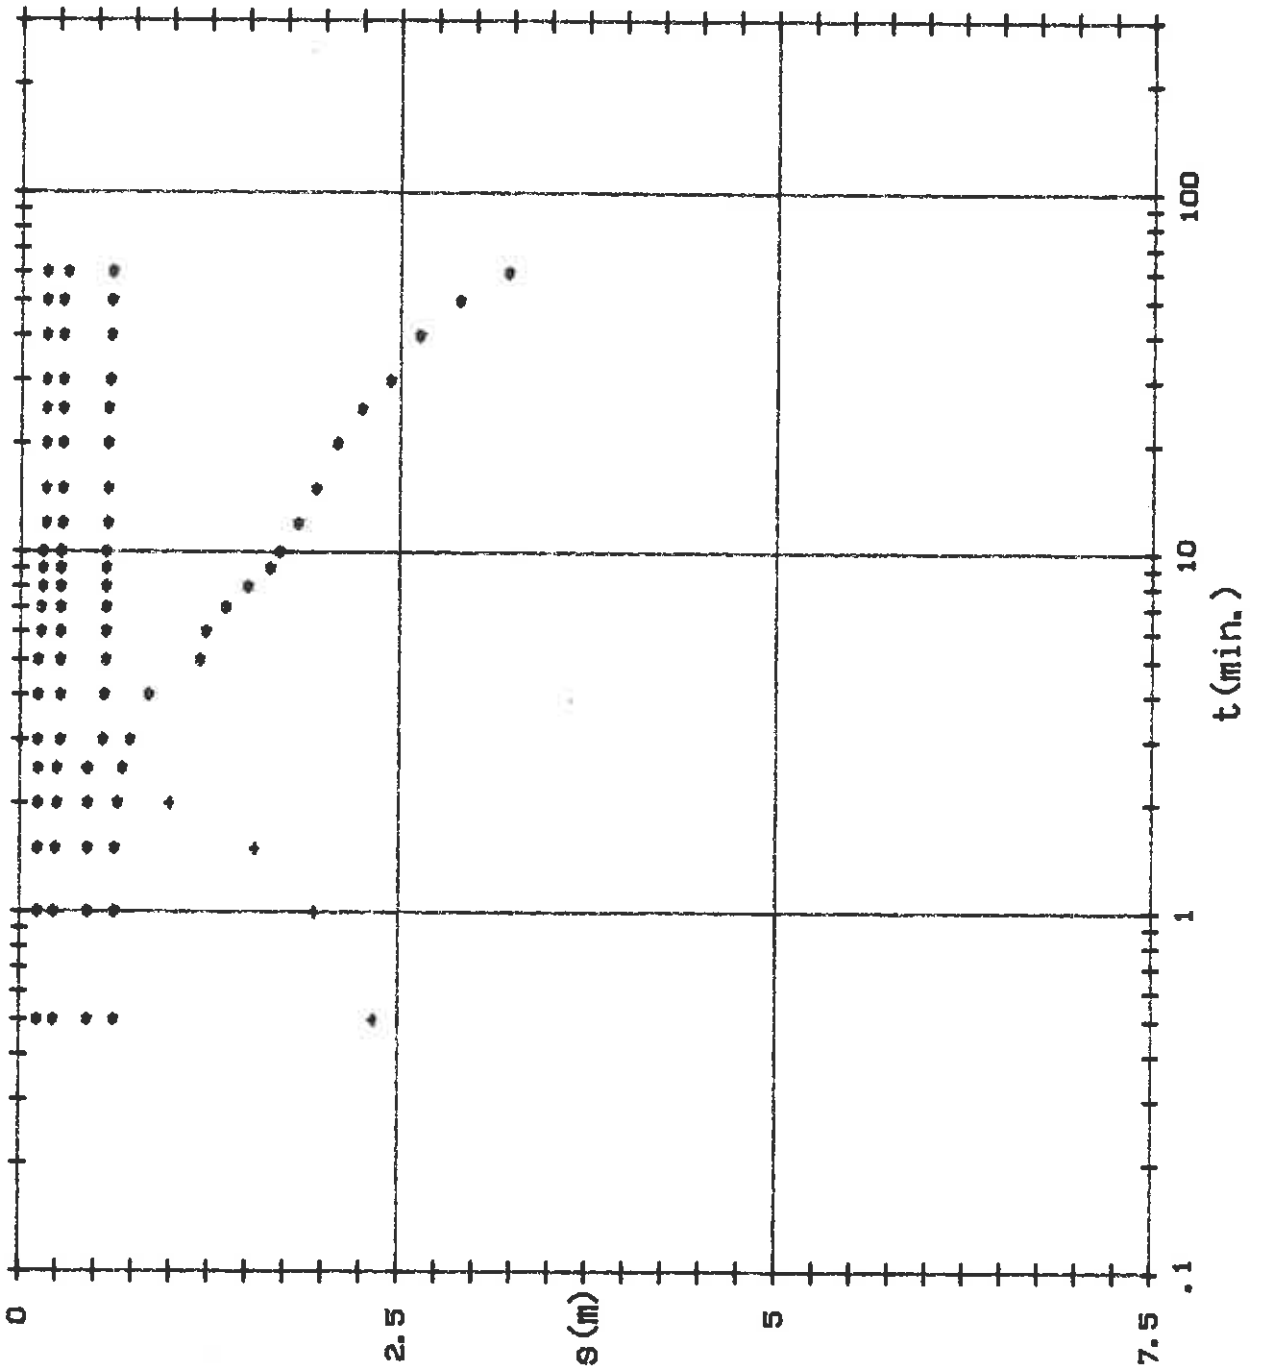
STEP DRAWDOWN TEST

* Pumping data
+ Recovery data

$Q_1 = 1 \text{ l/s}$
 $Q_2 = 2.11 \text{ l/s}$
 $Q_3 = 3.95 \text{ l/s}$
 $Q_4 = 7.6 \text{ l/s}$

S.W.L. = 4.83 m

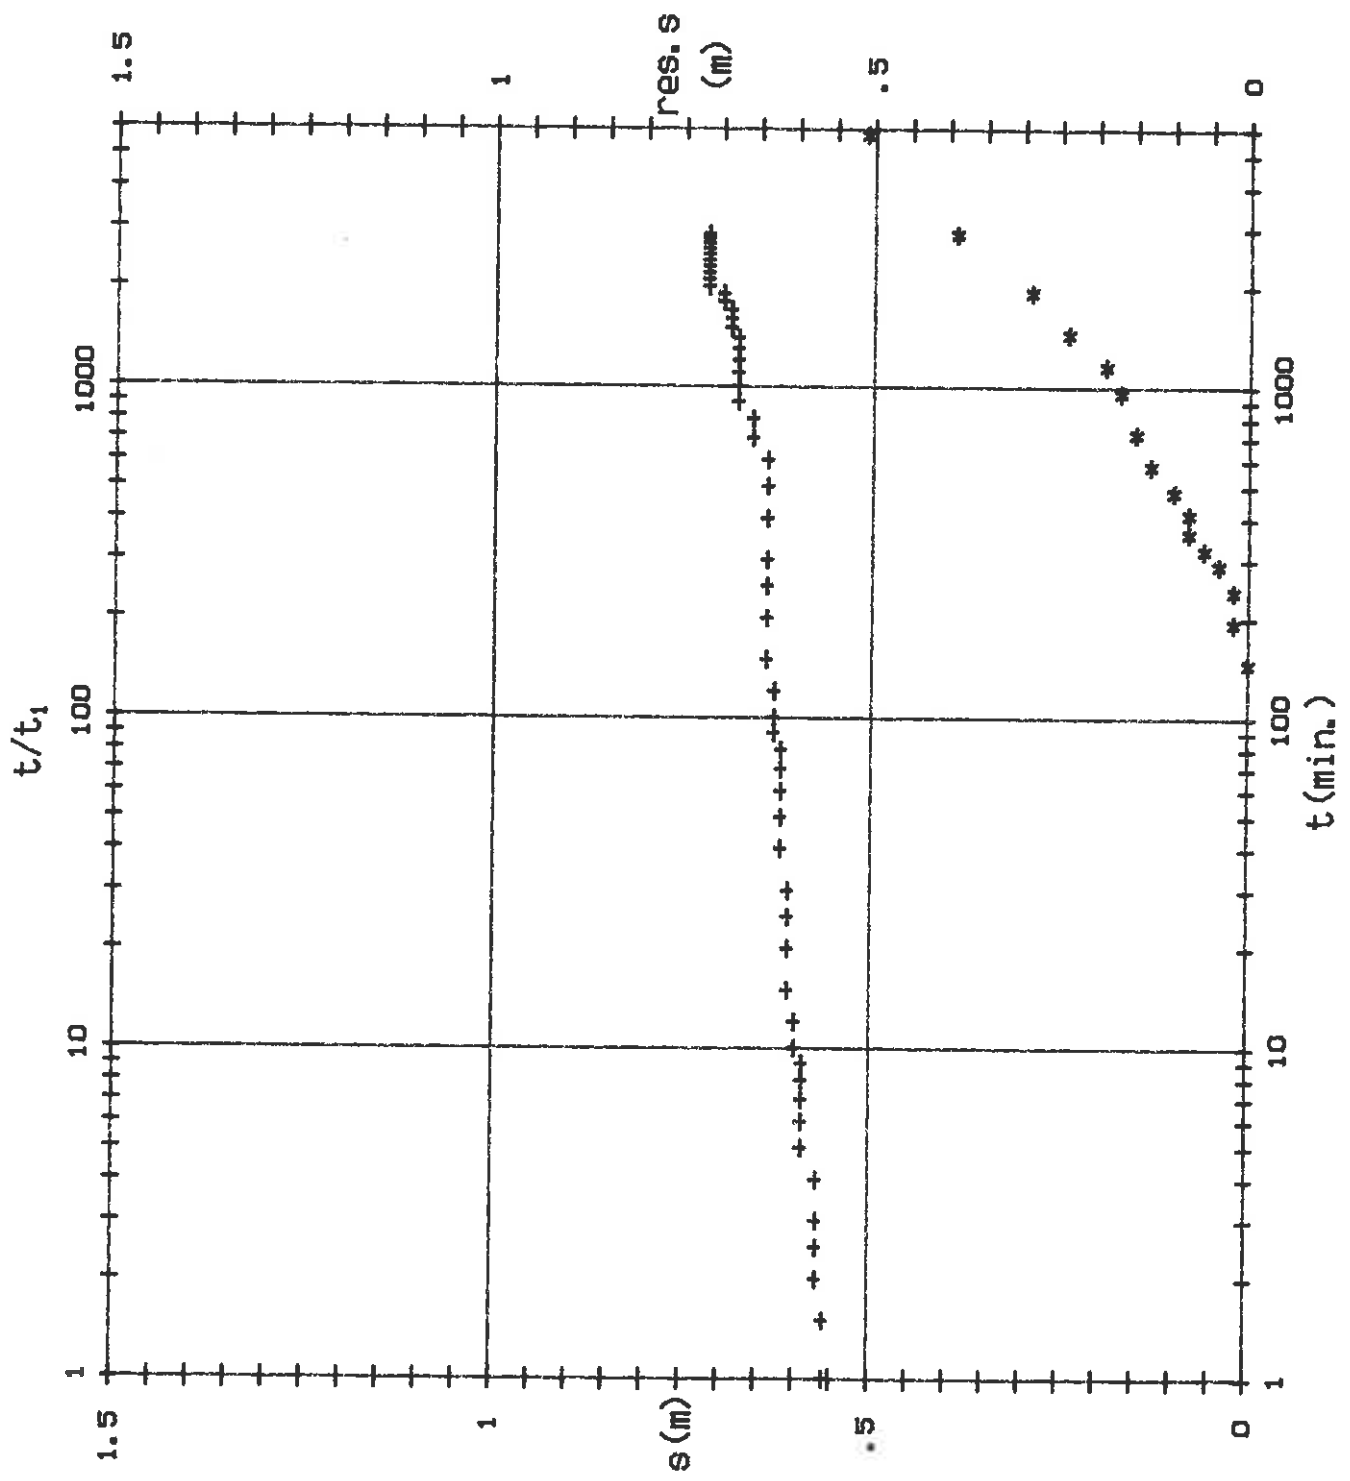
CONSTANT DISCHARGE TEST

+ Drawdown data.
* Recovery data.

S.W.L. = 4.83 m

T = 200 m²/d

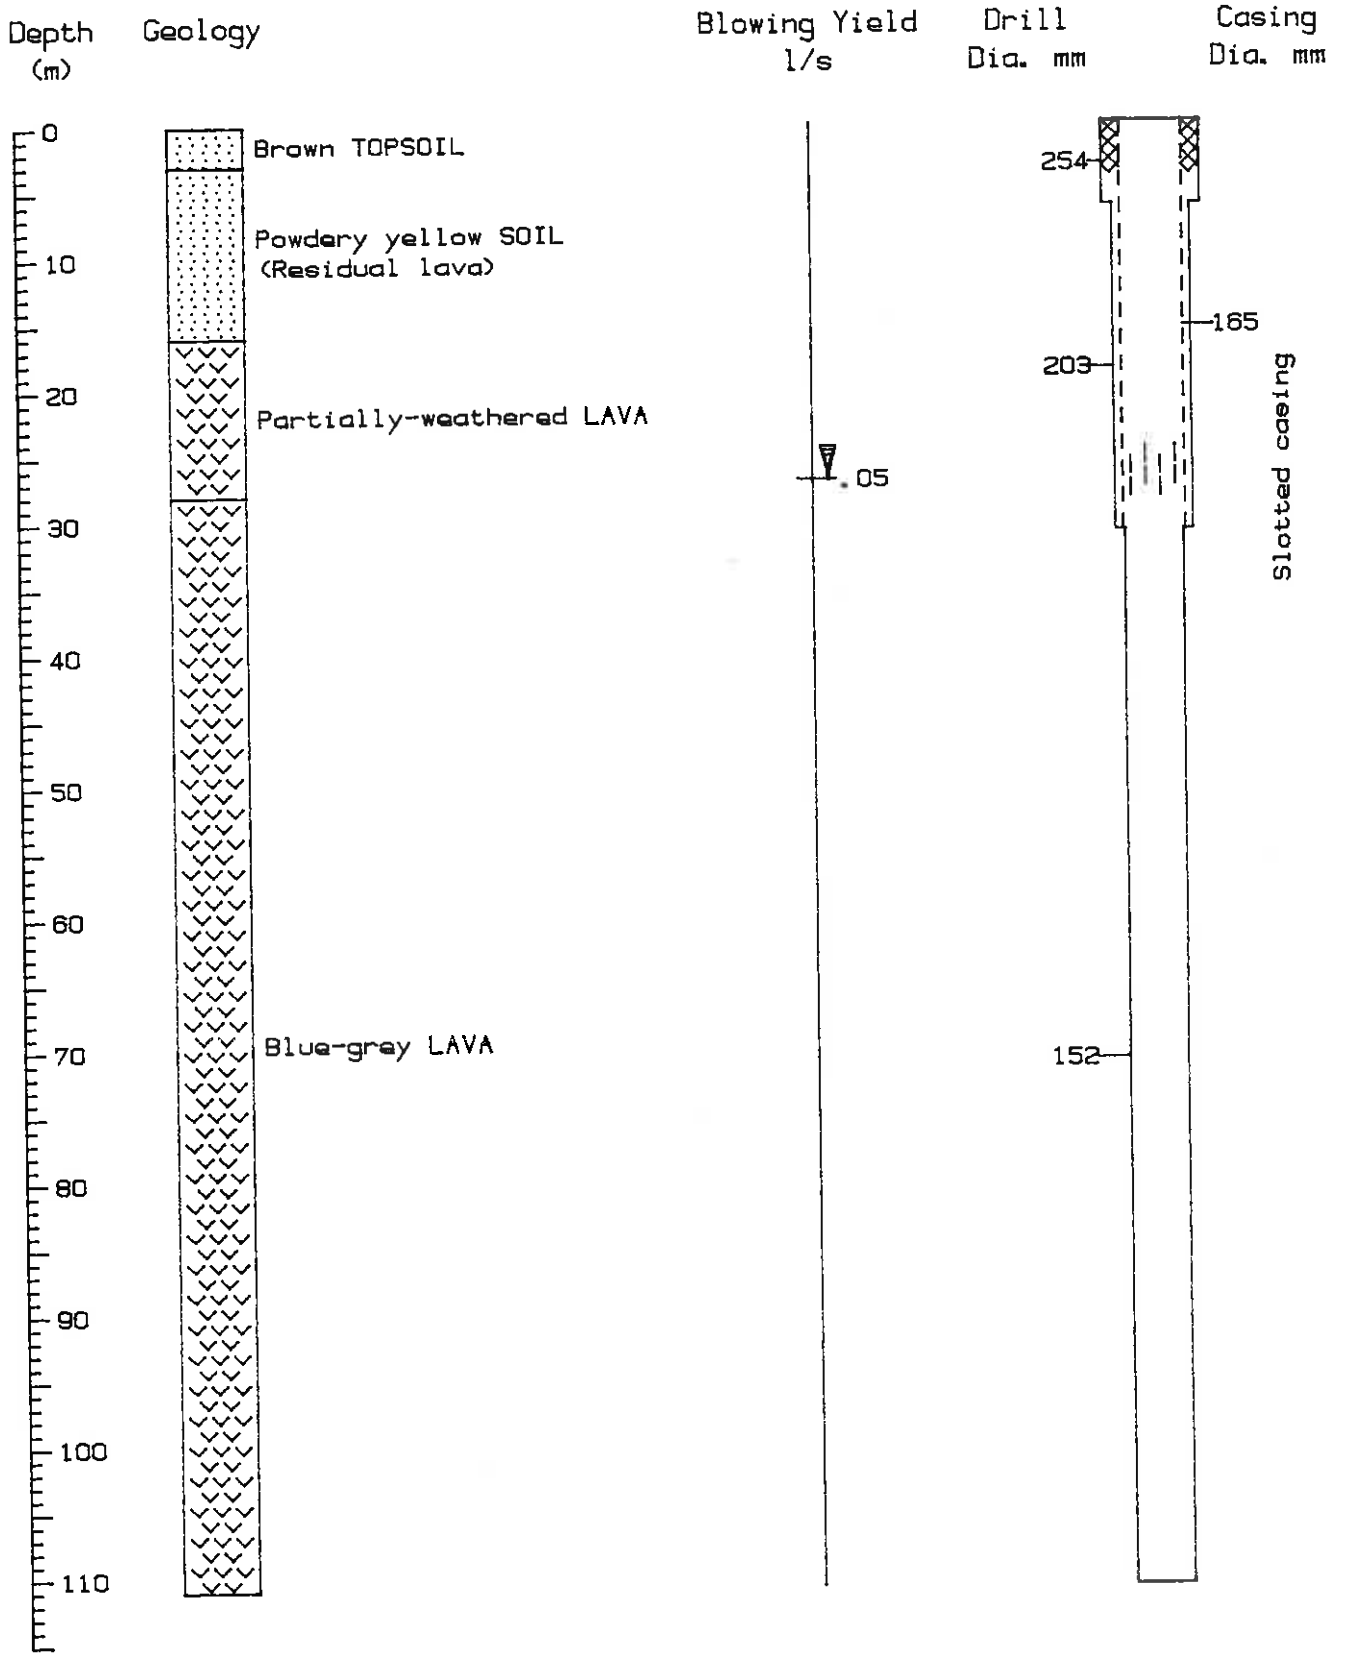
Coordinates +2925825X -50975Y

Elev. (m) 1375

End of Hole 111

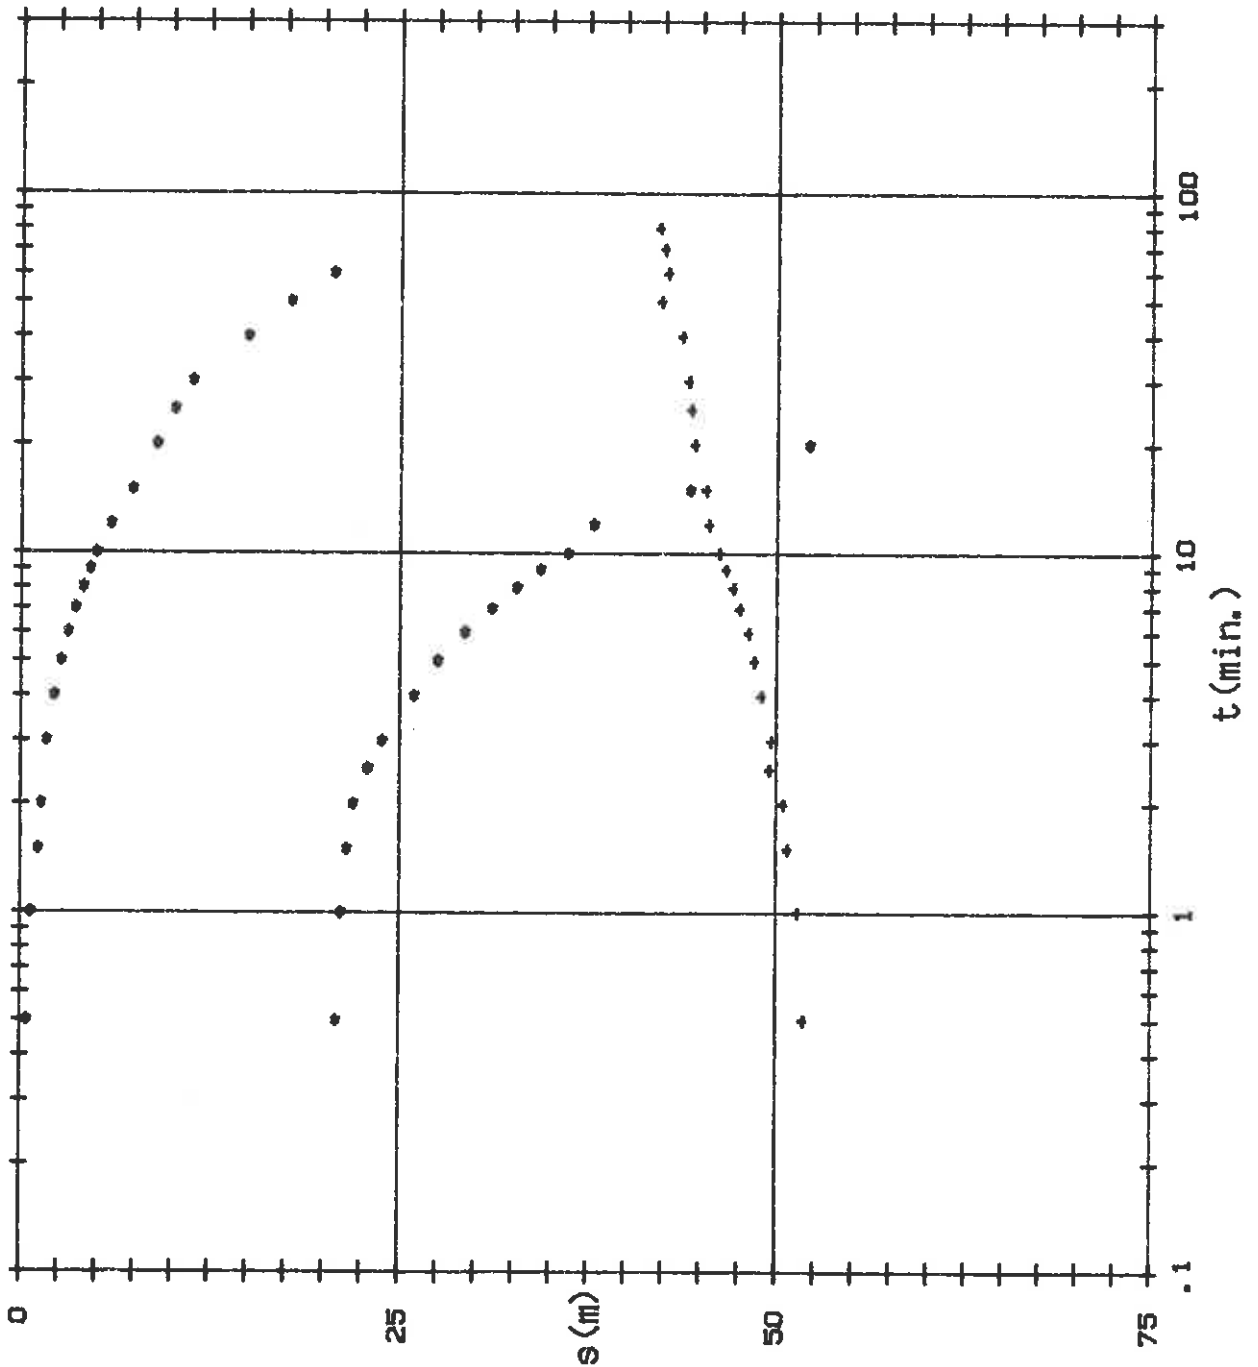
STEP DRAWDOWN TEST

$Q_2 = .6 \text{ l/s}$

S.W.L. = 10.7 m

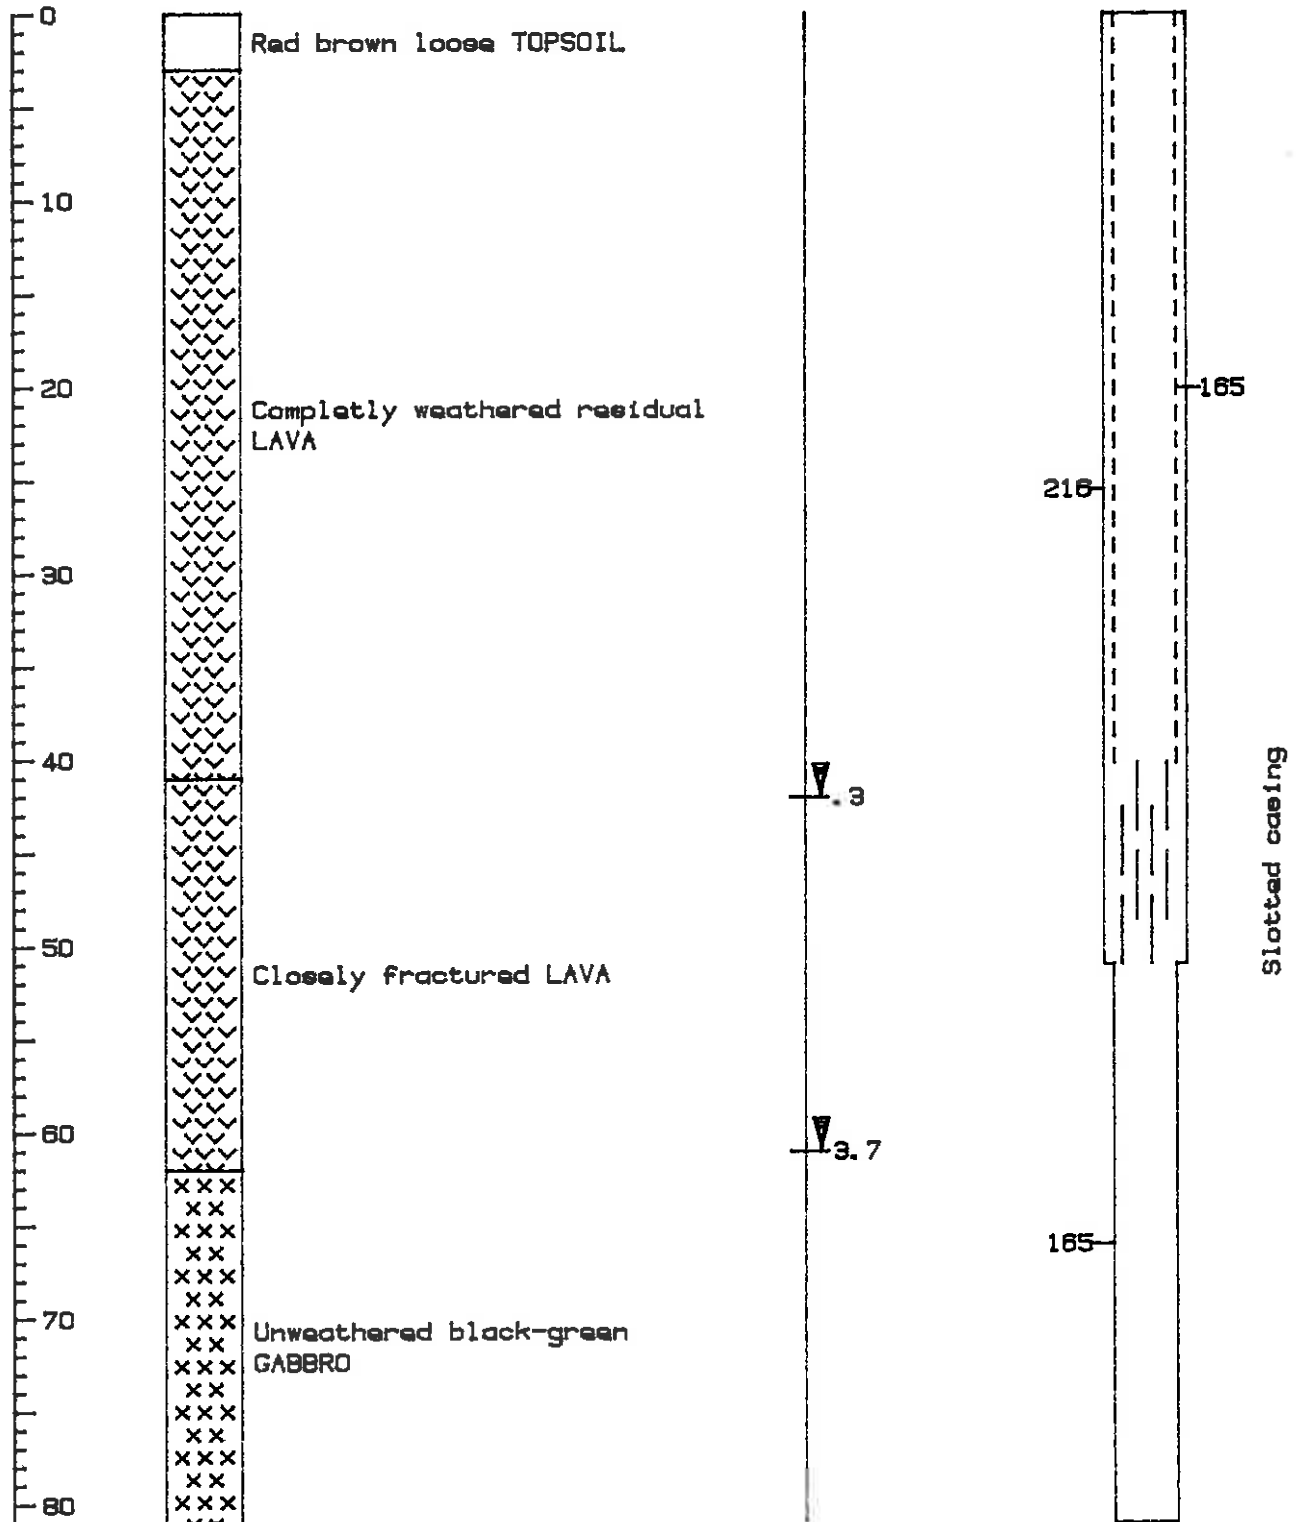
BOREHOLE LOG

Elev. (m) 1375

Depth (m)	Geology	Blowing Yield l/e	Drill Dia. mm	Casing Dia. mm
-----------	---------	-------------------	---------------	----------------

End of Hole 81

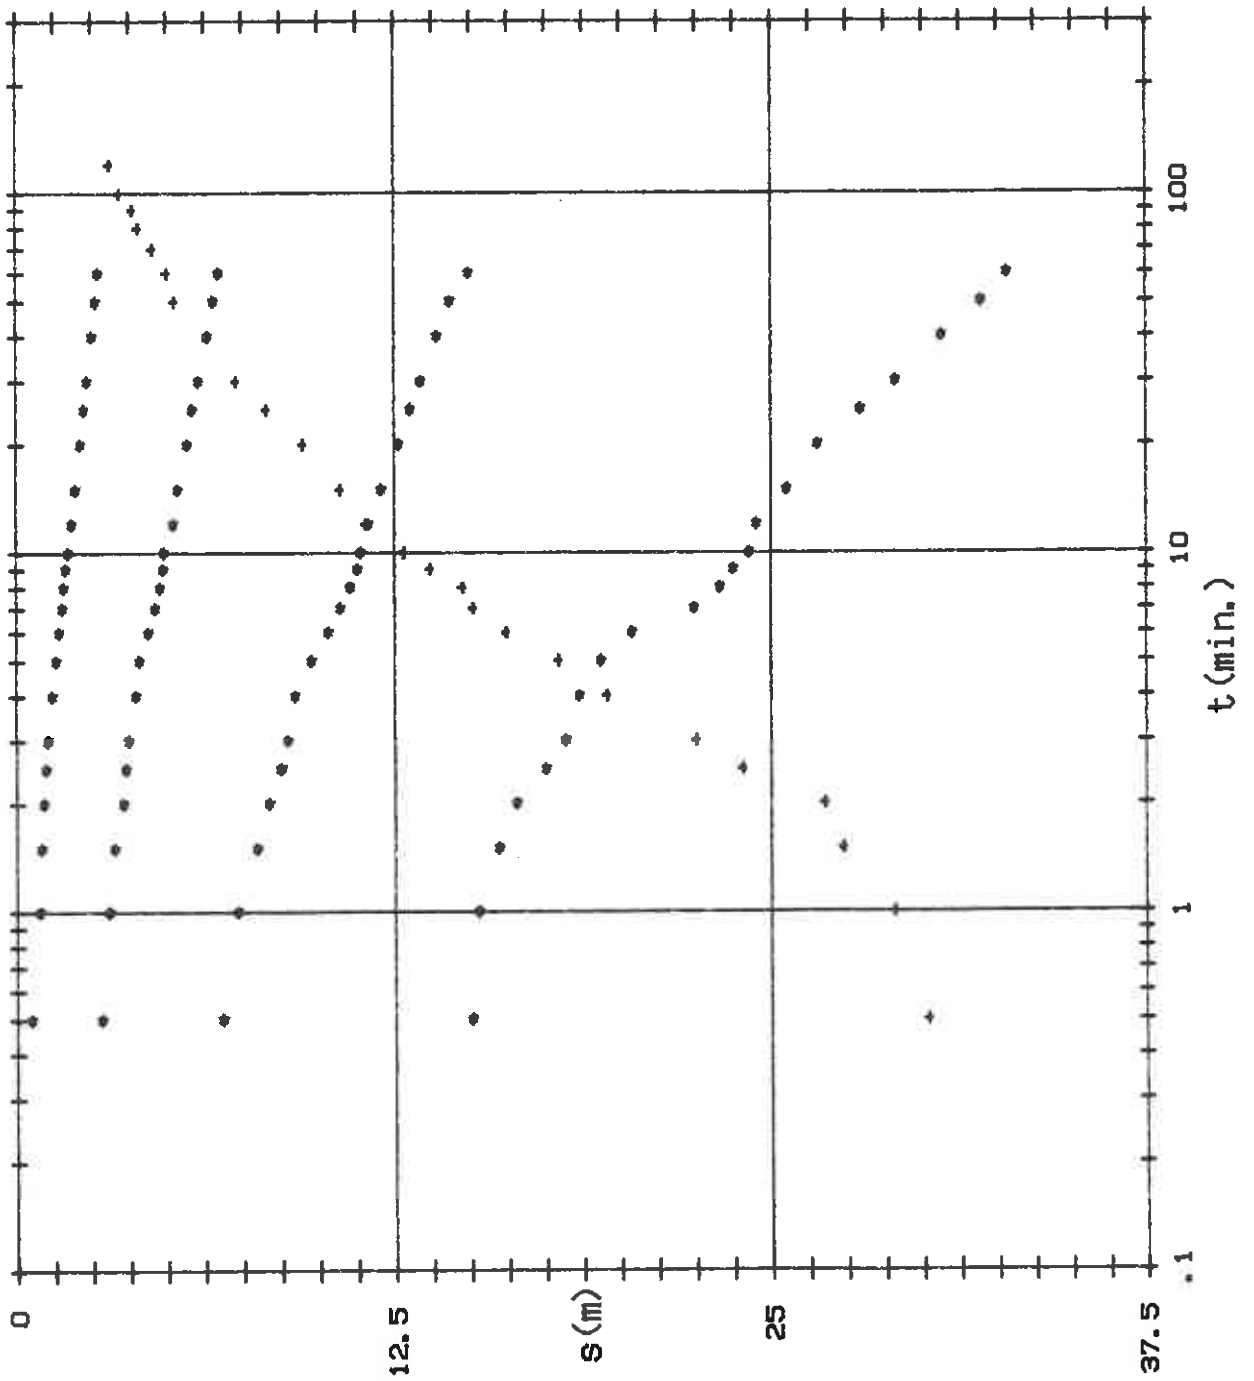
STEP DRAWDOWN TEST

- $Q_1 = .5 \text{ l/s}$
- $Q_2 = 1.17 \text{ l/s}$
- $Q_3 = 2.1 \text{ l/s}$
- $Q_4 = 4 \text{ l/s}$

S.W.L. = 14.36 m

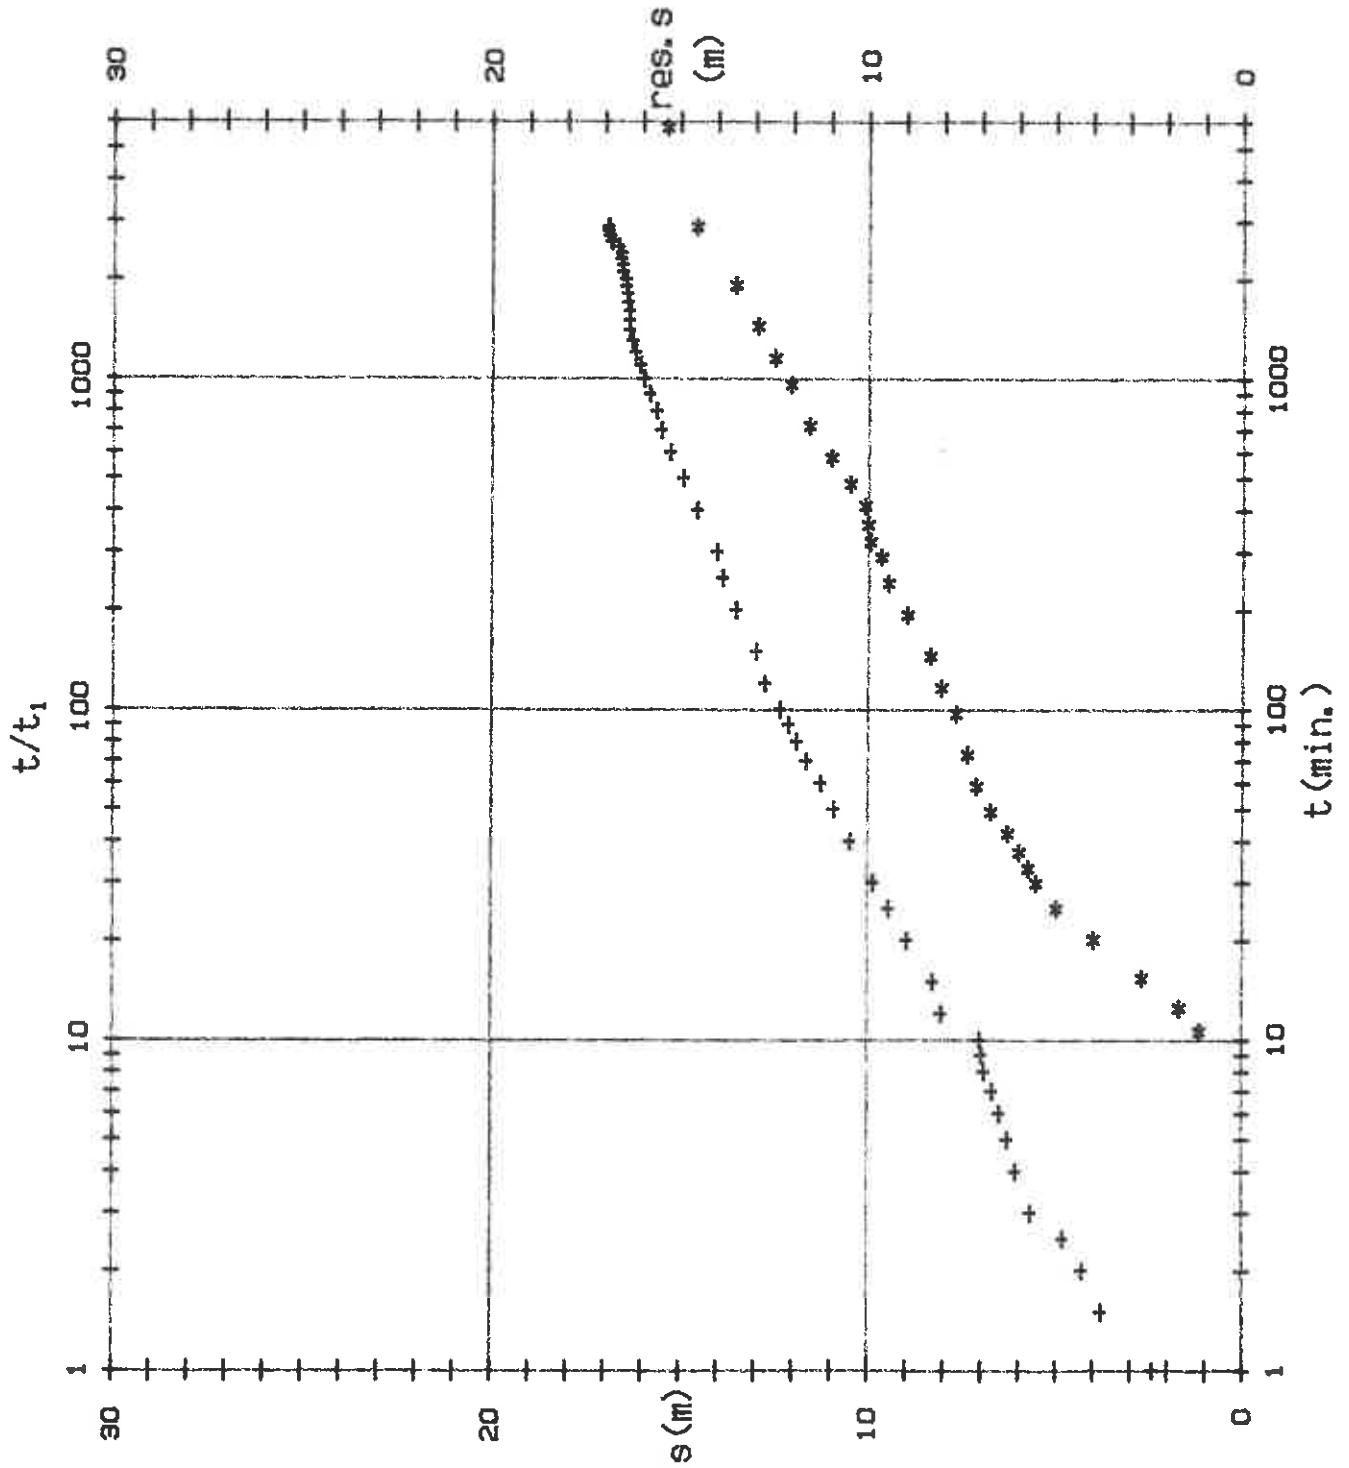
CONSTANT DISCHARGE TEST

- + Drawdown data.
- * Recovery data.

S. W. L. = 14.36 m

T = 6 m²/d

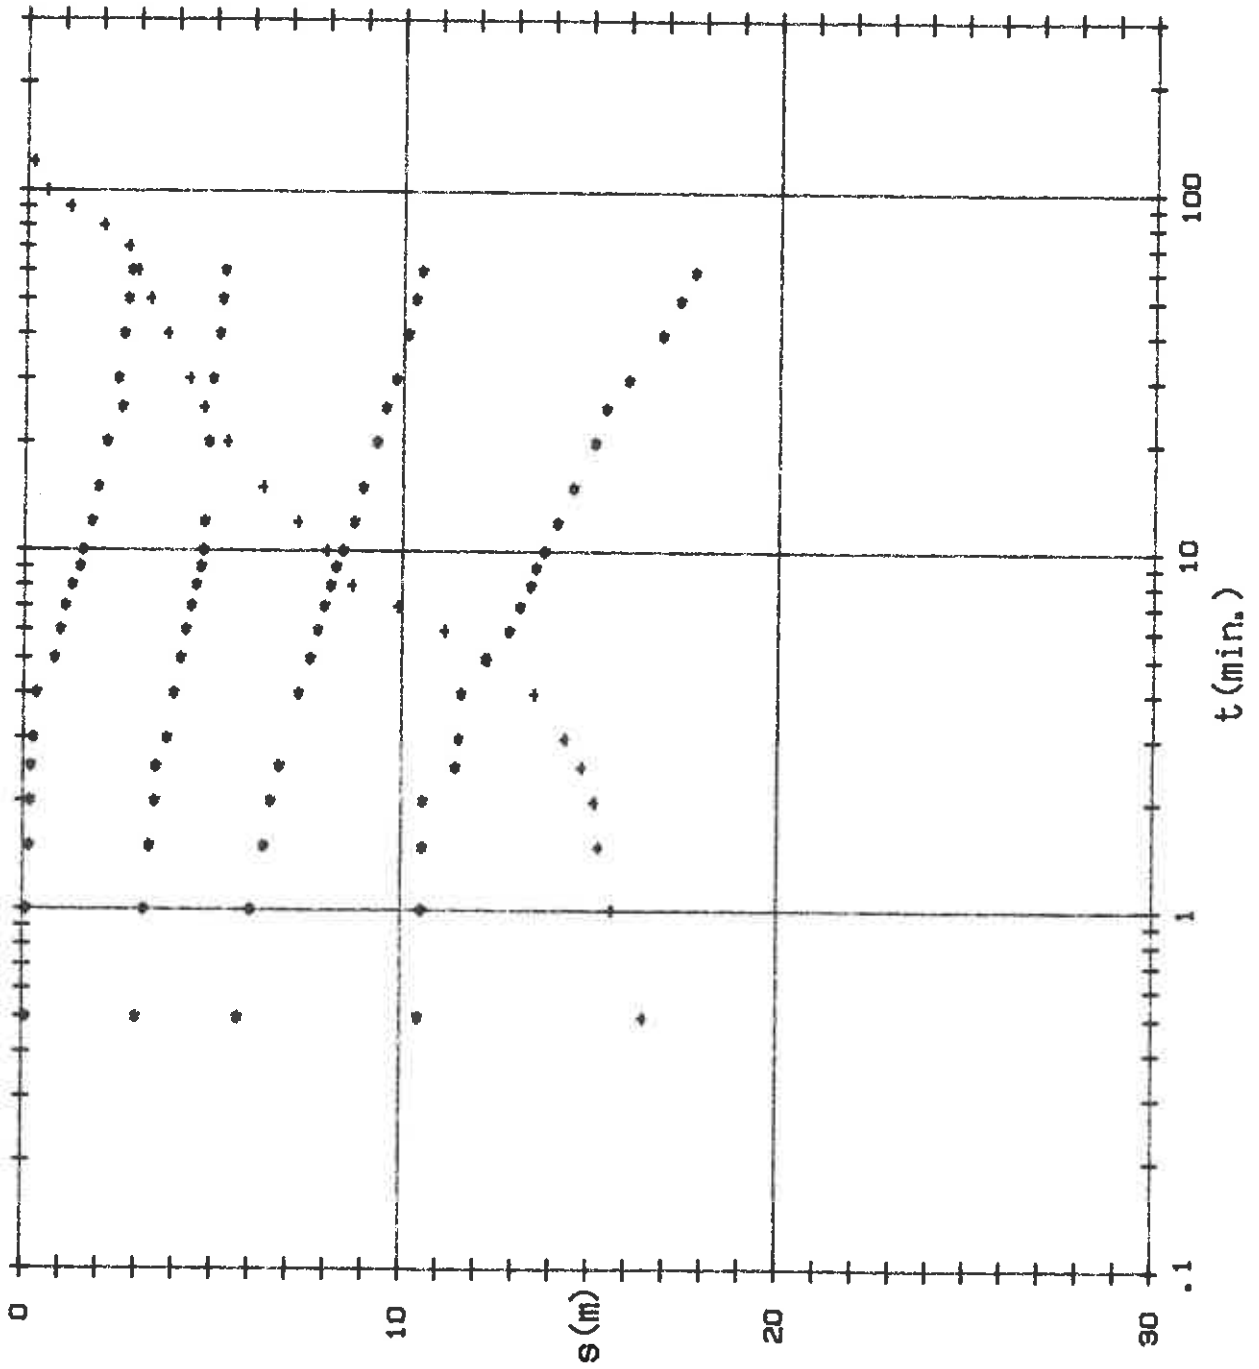
STEP DRAWDOWN TEST

* Pumping data
+ Recovery data

$Q_4 = 2.1 \text{ l/s}$

S.W.L. = 13.36 m

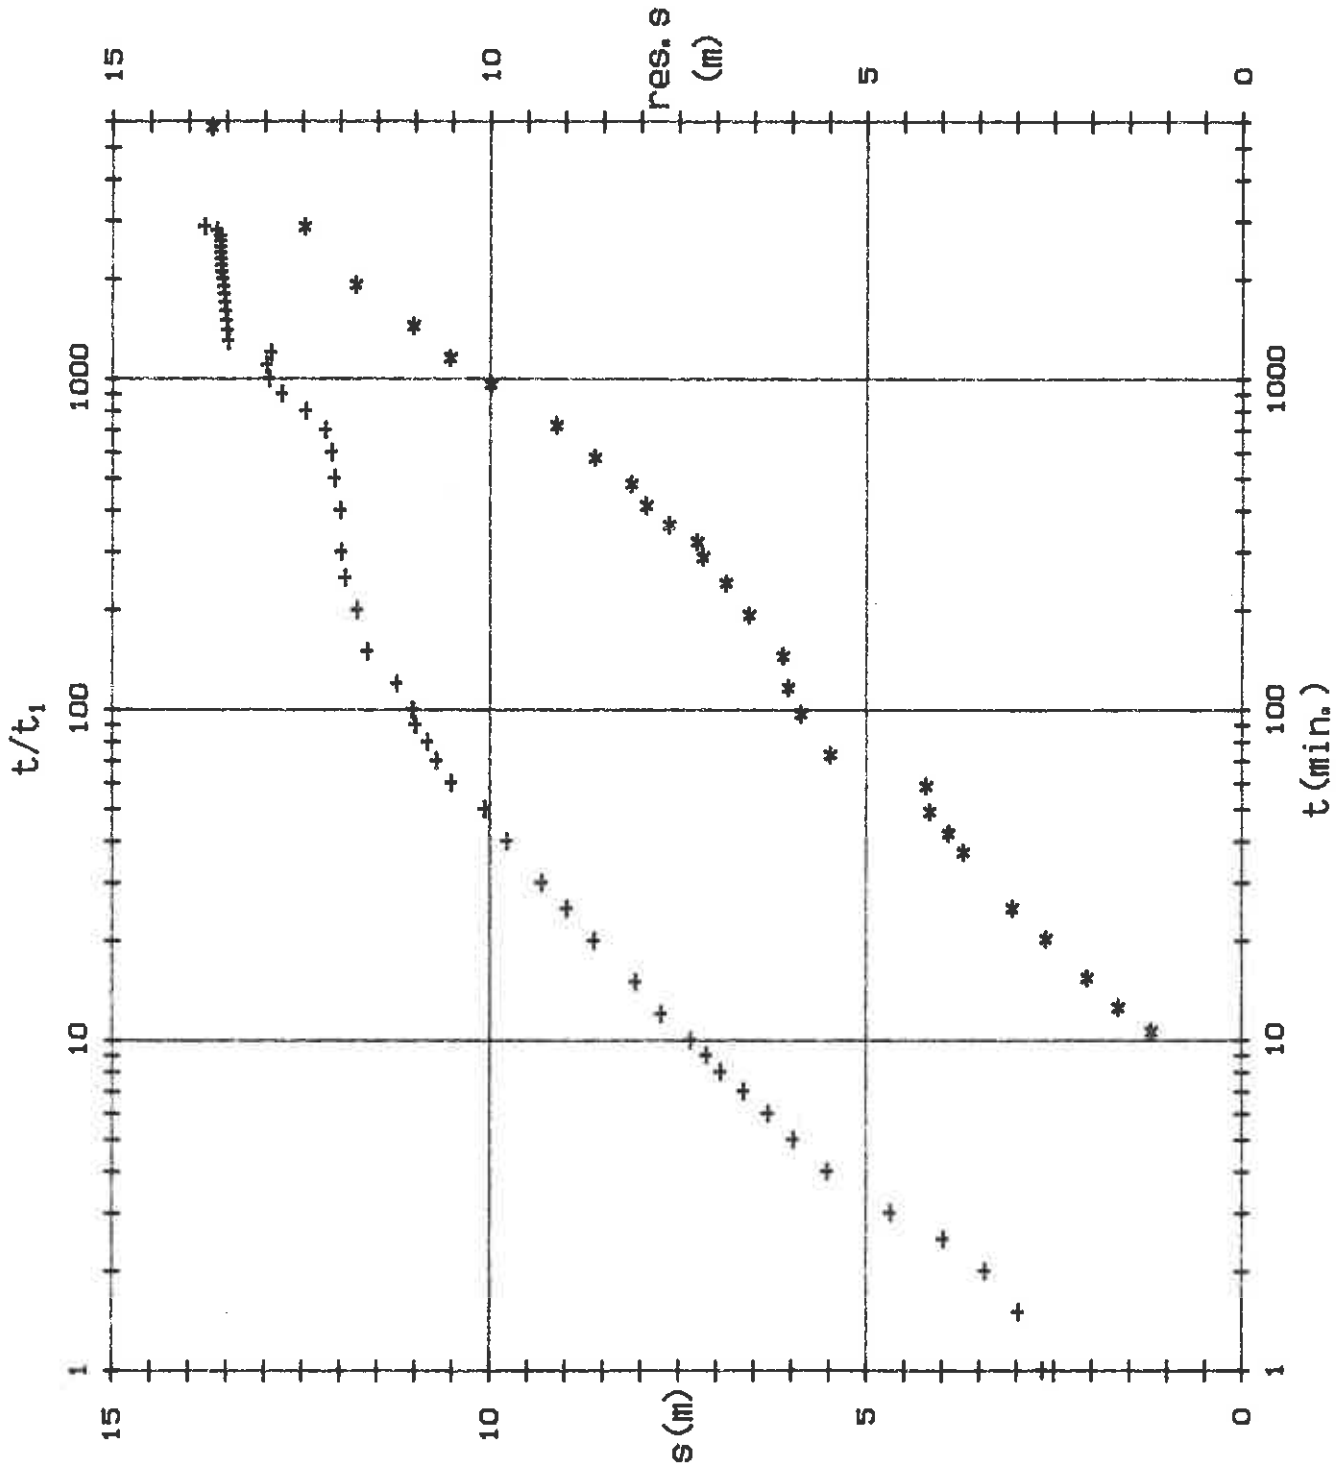
CONSTANT DISCHARGE TEST

- + Drawdown data.
- * Recovery data.

S.W.L. = 13.36 m

T = 3 m²/d

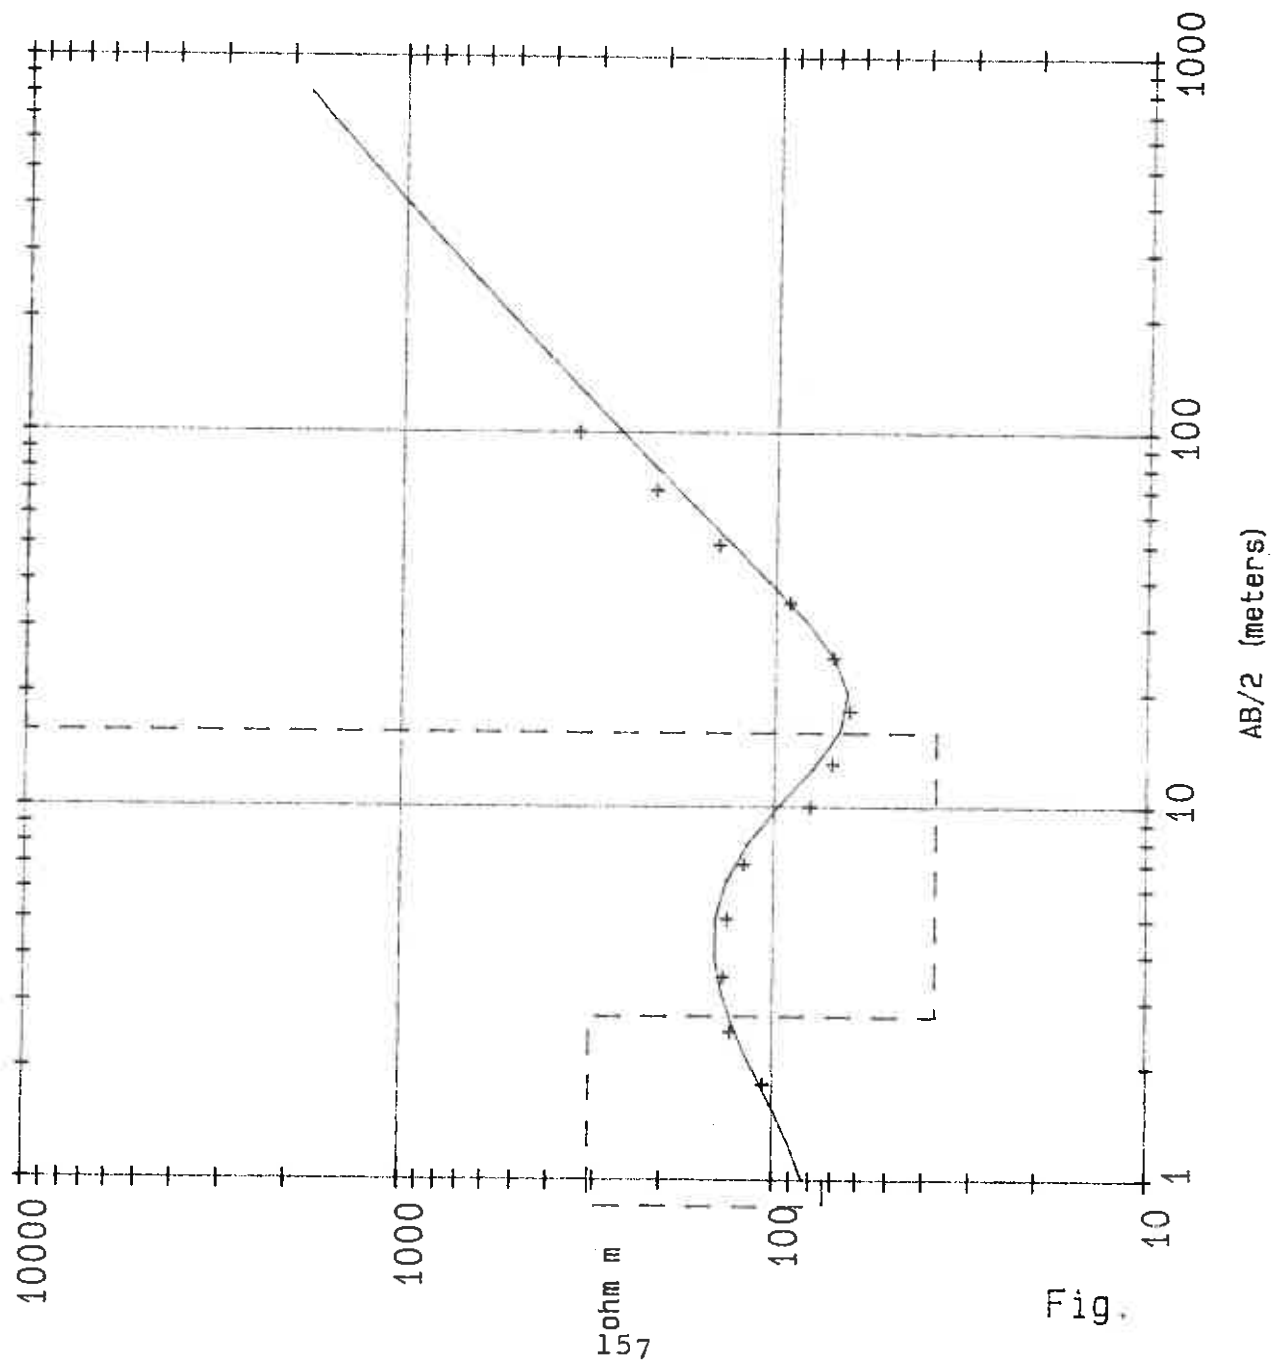
+ Field data
 — Computer model
 - - - d - r model

CO-ORDINATES
 +2901225X -51855Y

GEOLOGY
 LAVA
