REPUBLIC OF BOPHUTHATSWANA
DEPARTMENT OF WATER AFFAIRS

**REPORT ON THE SITING
DRILLING AND TESTING OF BOREHOLES,
AND THE TESTING OF EXISTING
BOREHOLES - DITSOBOTLA DISTRICT
JUNE 1991 - FEBRUARY 1993**

**VOLUME 1 - TEXT
AND APPENDIX I**

PARTRIDGE MAUD AND ASSOCIATES

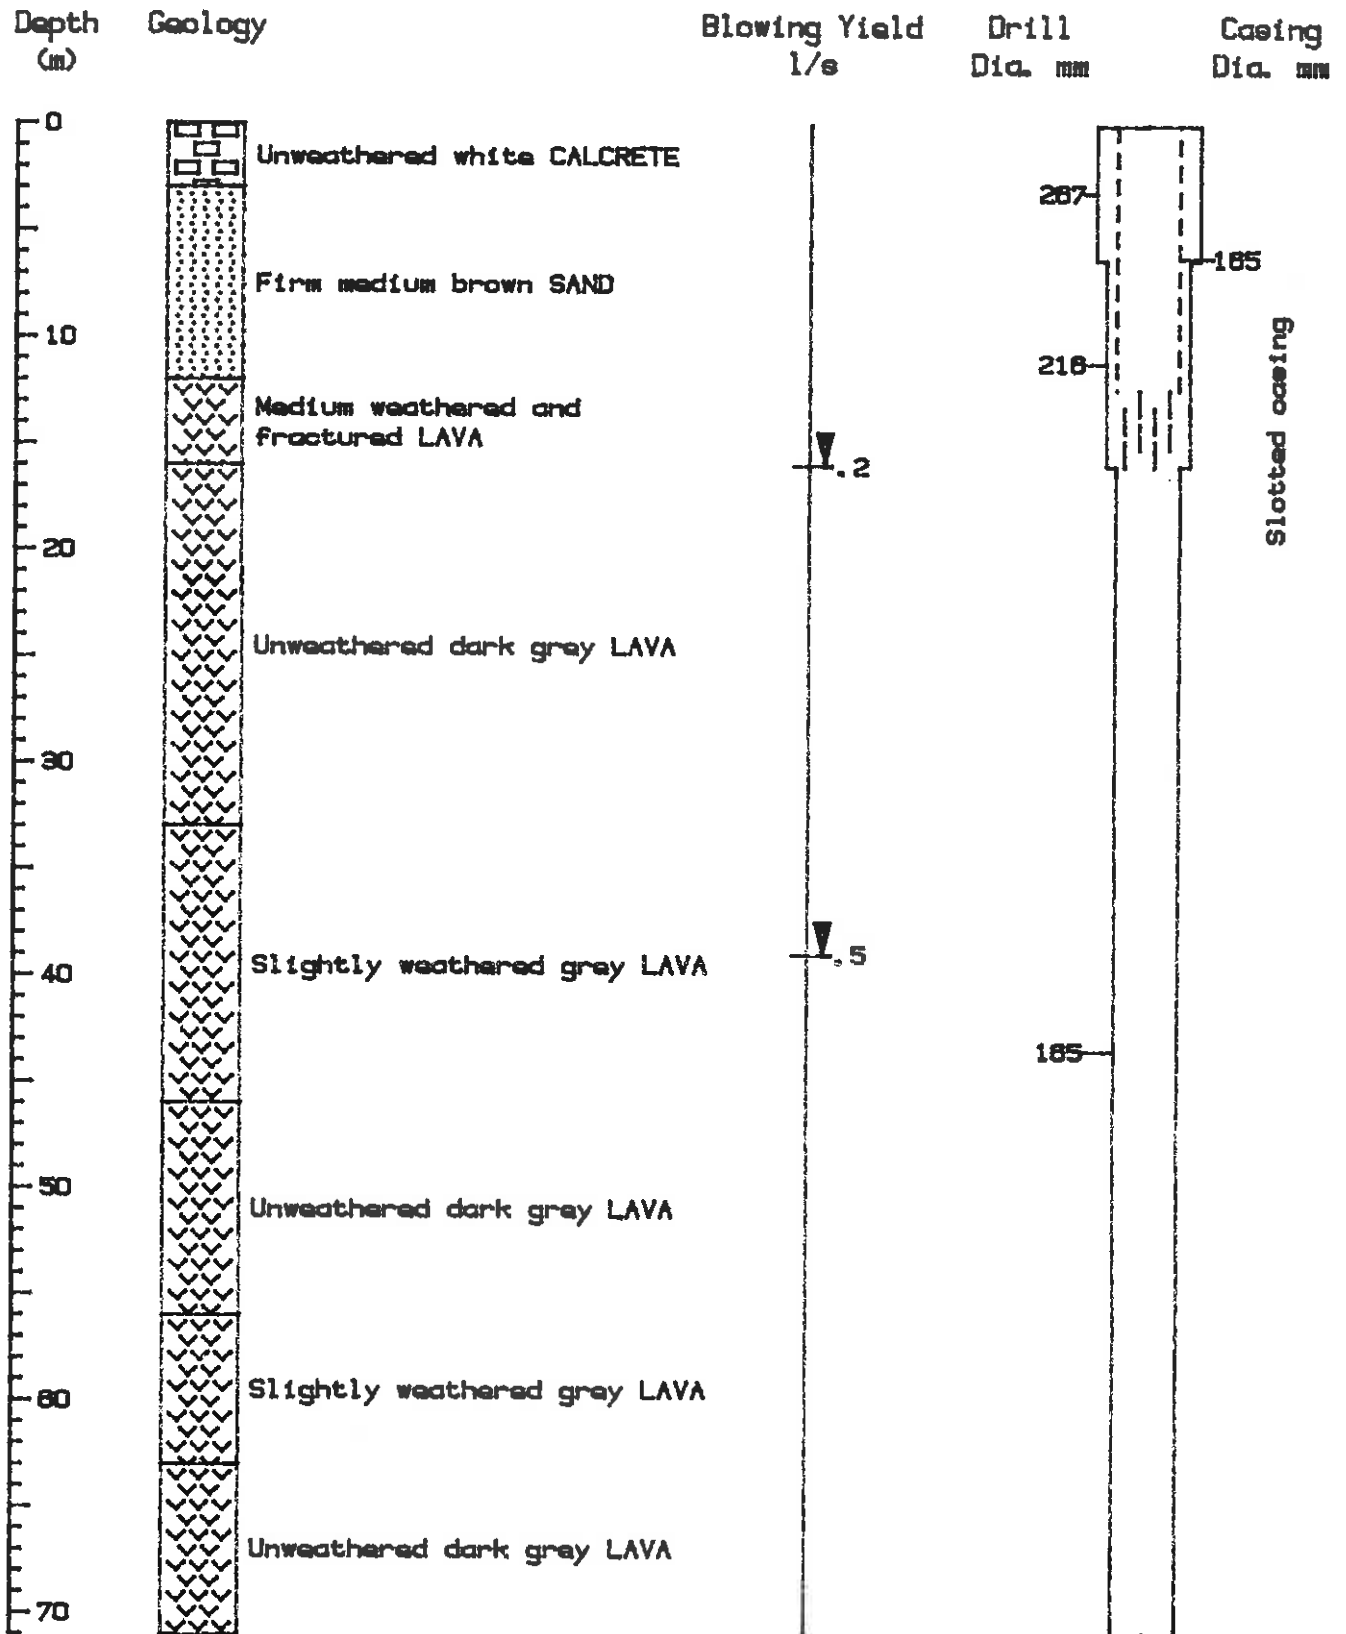
BOREHOLE LOG

Coordinates +2901225X -51850Y

Elev. (m) 1357

End of Hole 71

Borehole 10-77275 intersected calcrete and sand to 12m, weathered and fractured lava to 16m, and occasionally fractured lava to the full depth of 71m. A moderate water strike with a

blowing yield of 0,5 l/s was made in fracturing at 39m. The water level rose to 7,7mbgl, as measured on 25th April 1992.

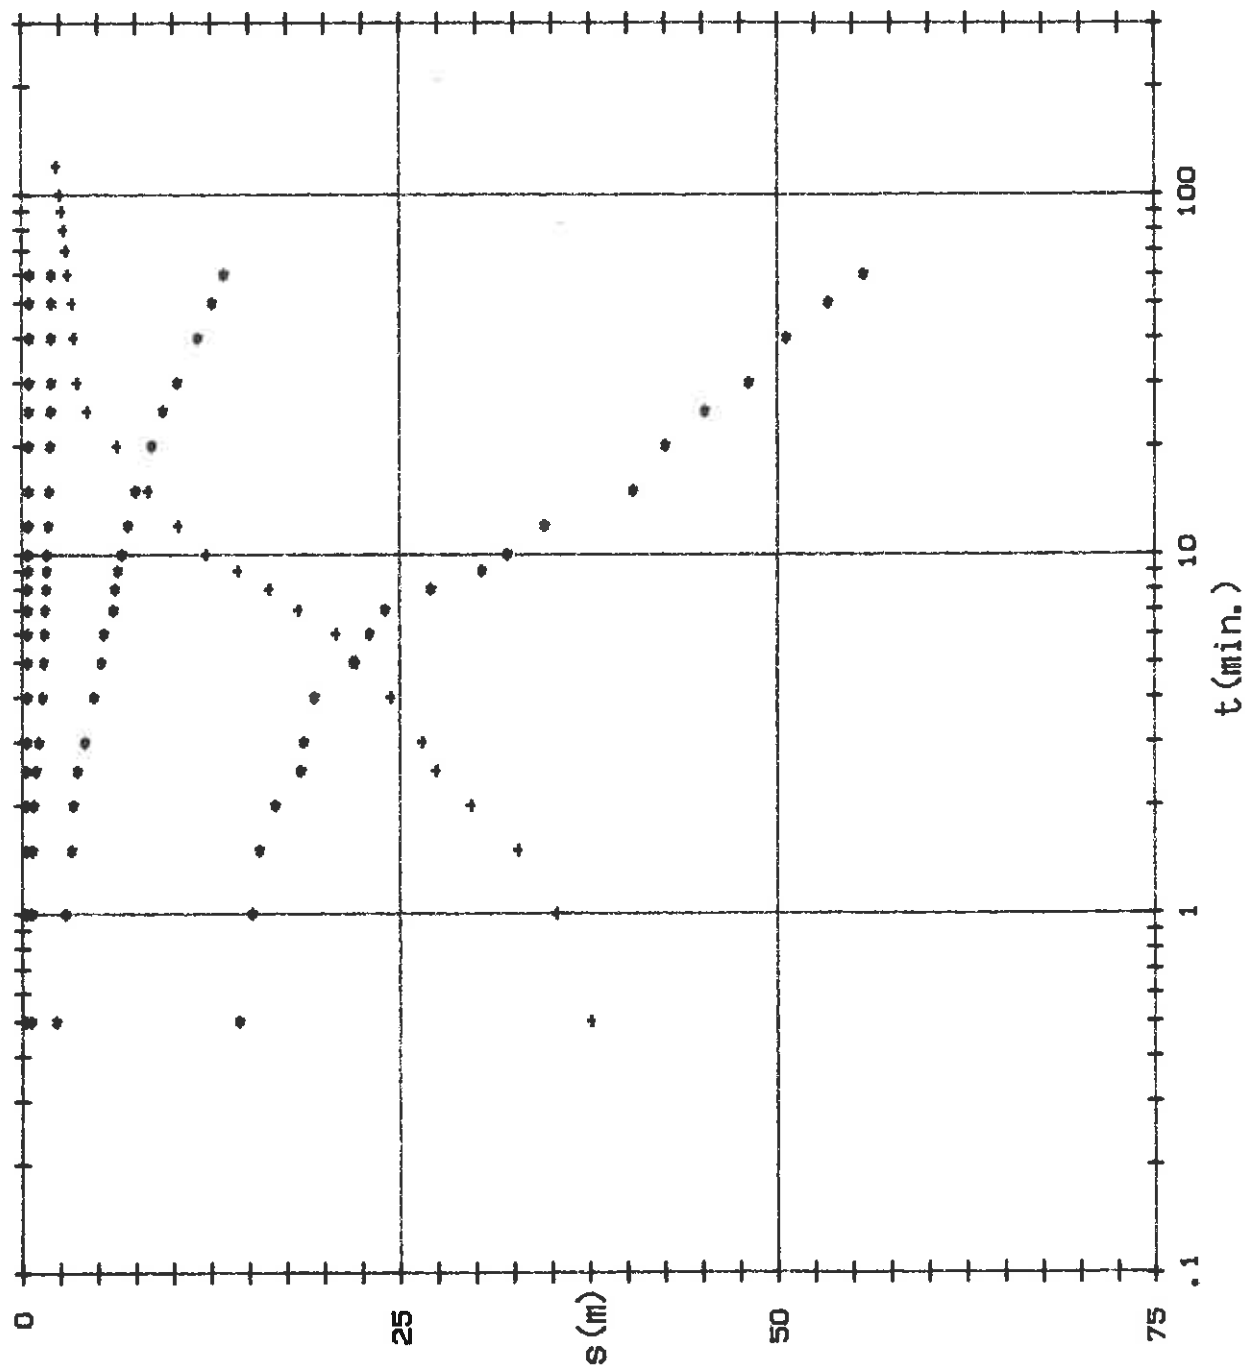
STEP DRAWDOWN TEST

$Q_4 = 1.2 \text{ l/s}$

S.W.L. = 7.7 m

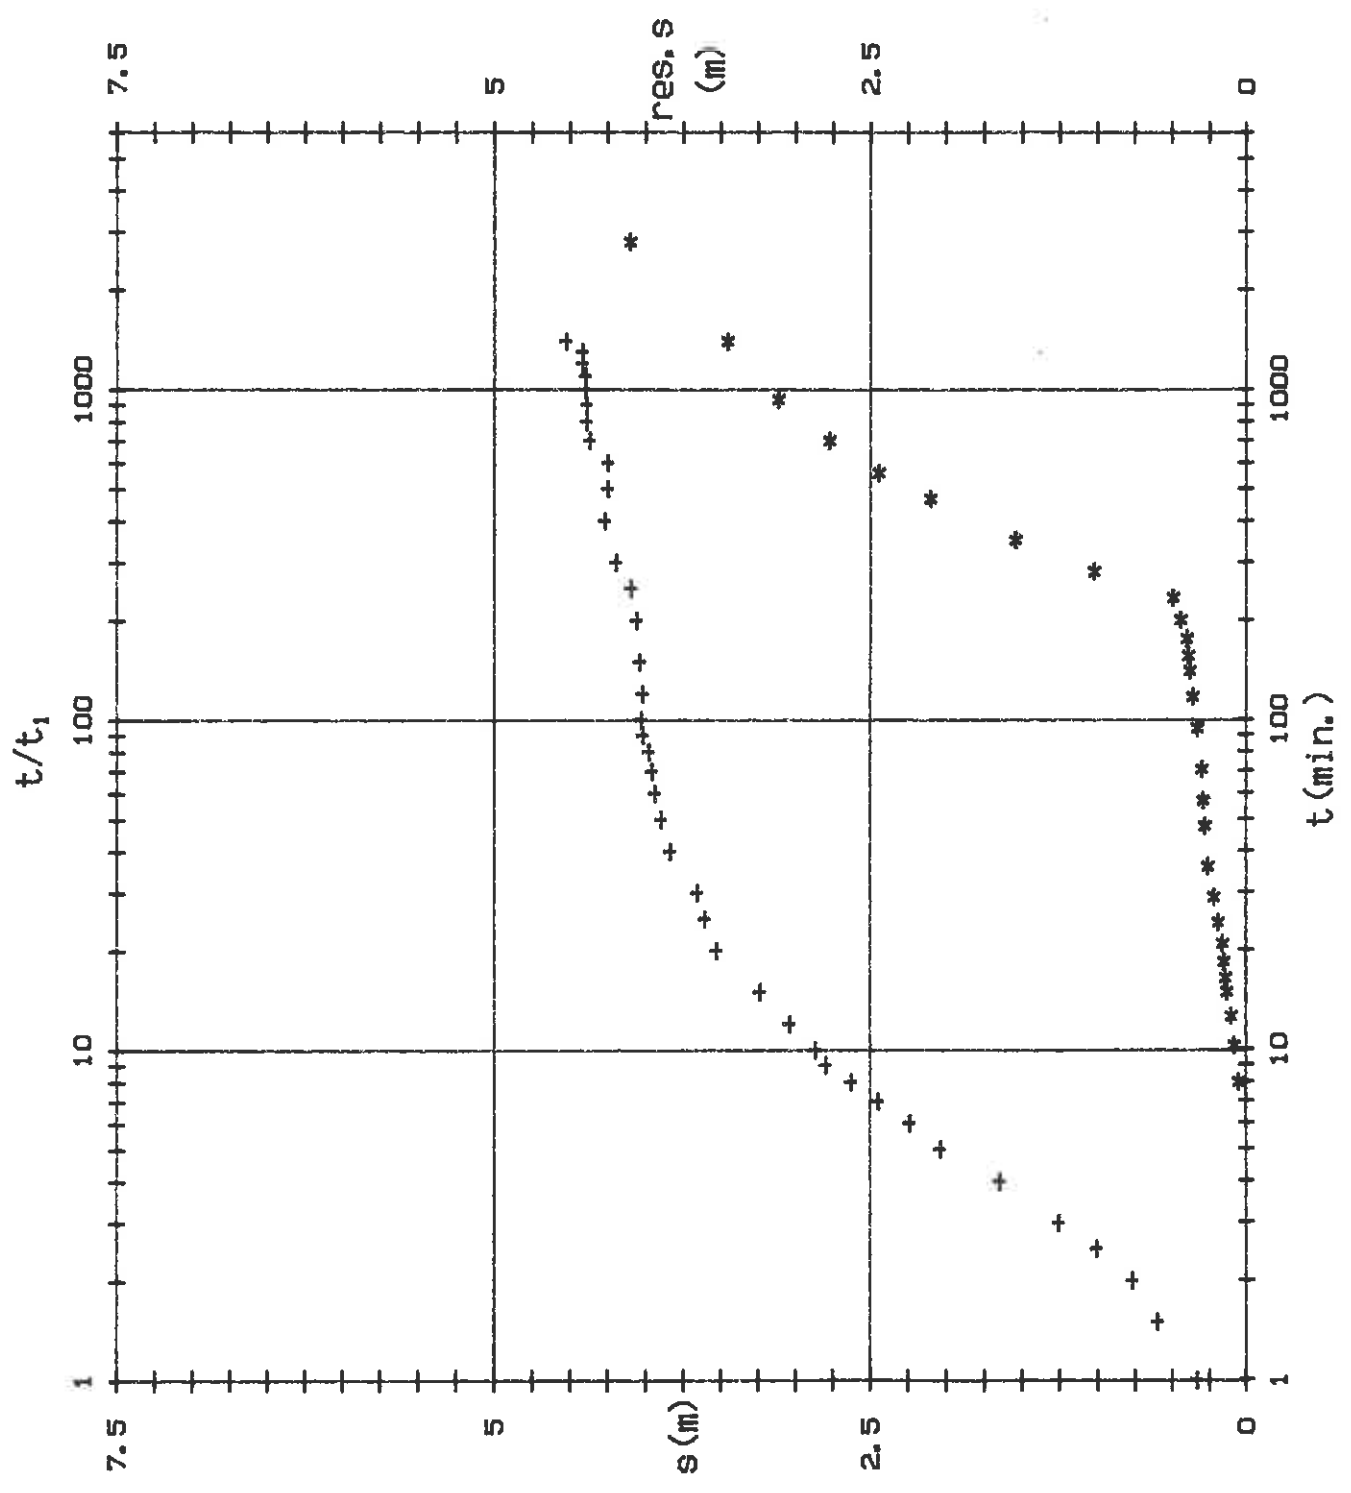
CONSTANT DISCHARGE TEST

- + Drawdown data.
- * Recovery data.

S.W.L. = 7.7 m

$T = 3 \text{ m}^2/\text{d}$

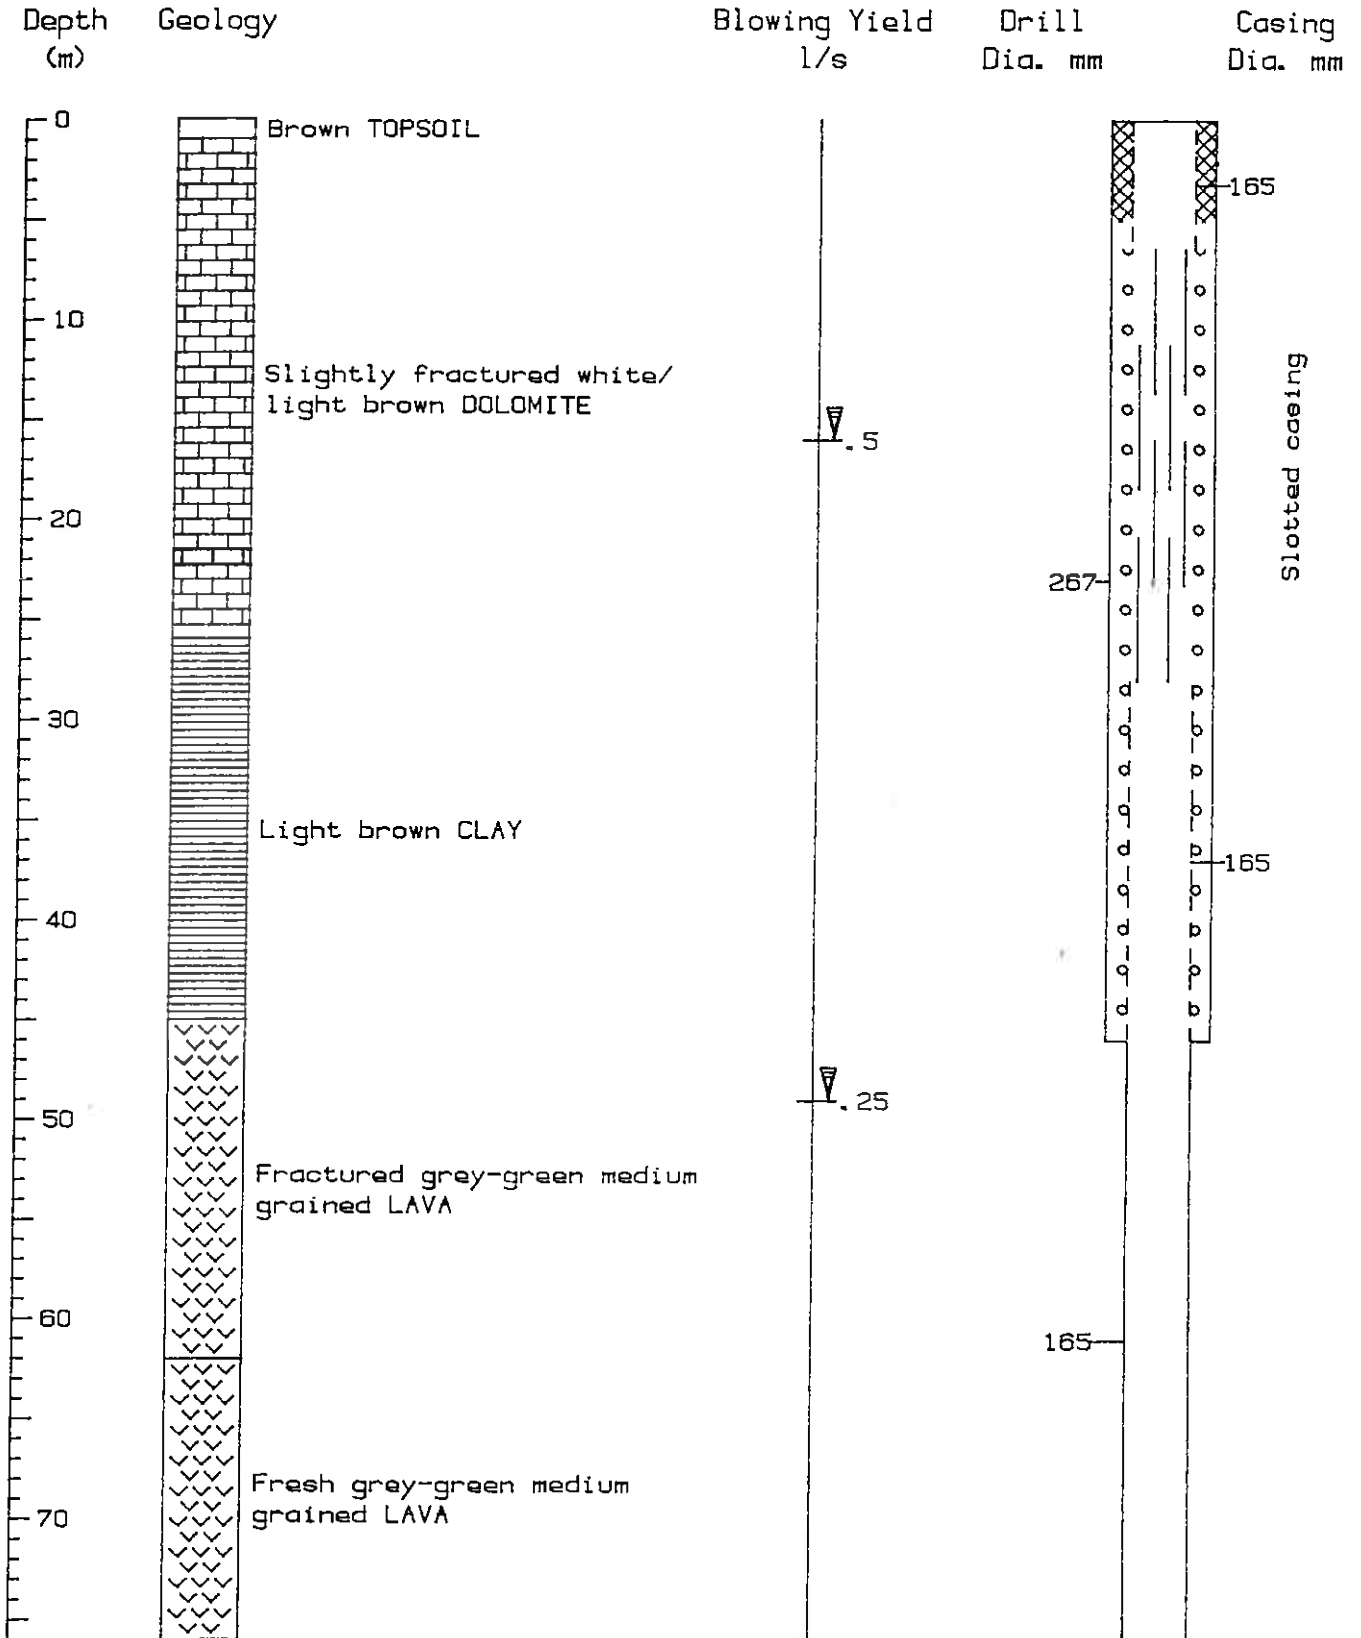
BOREHOLE LOG

Coordinates +2899905X -068855Y

Elev. (m) 1390

End of Hole 76

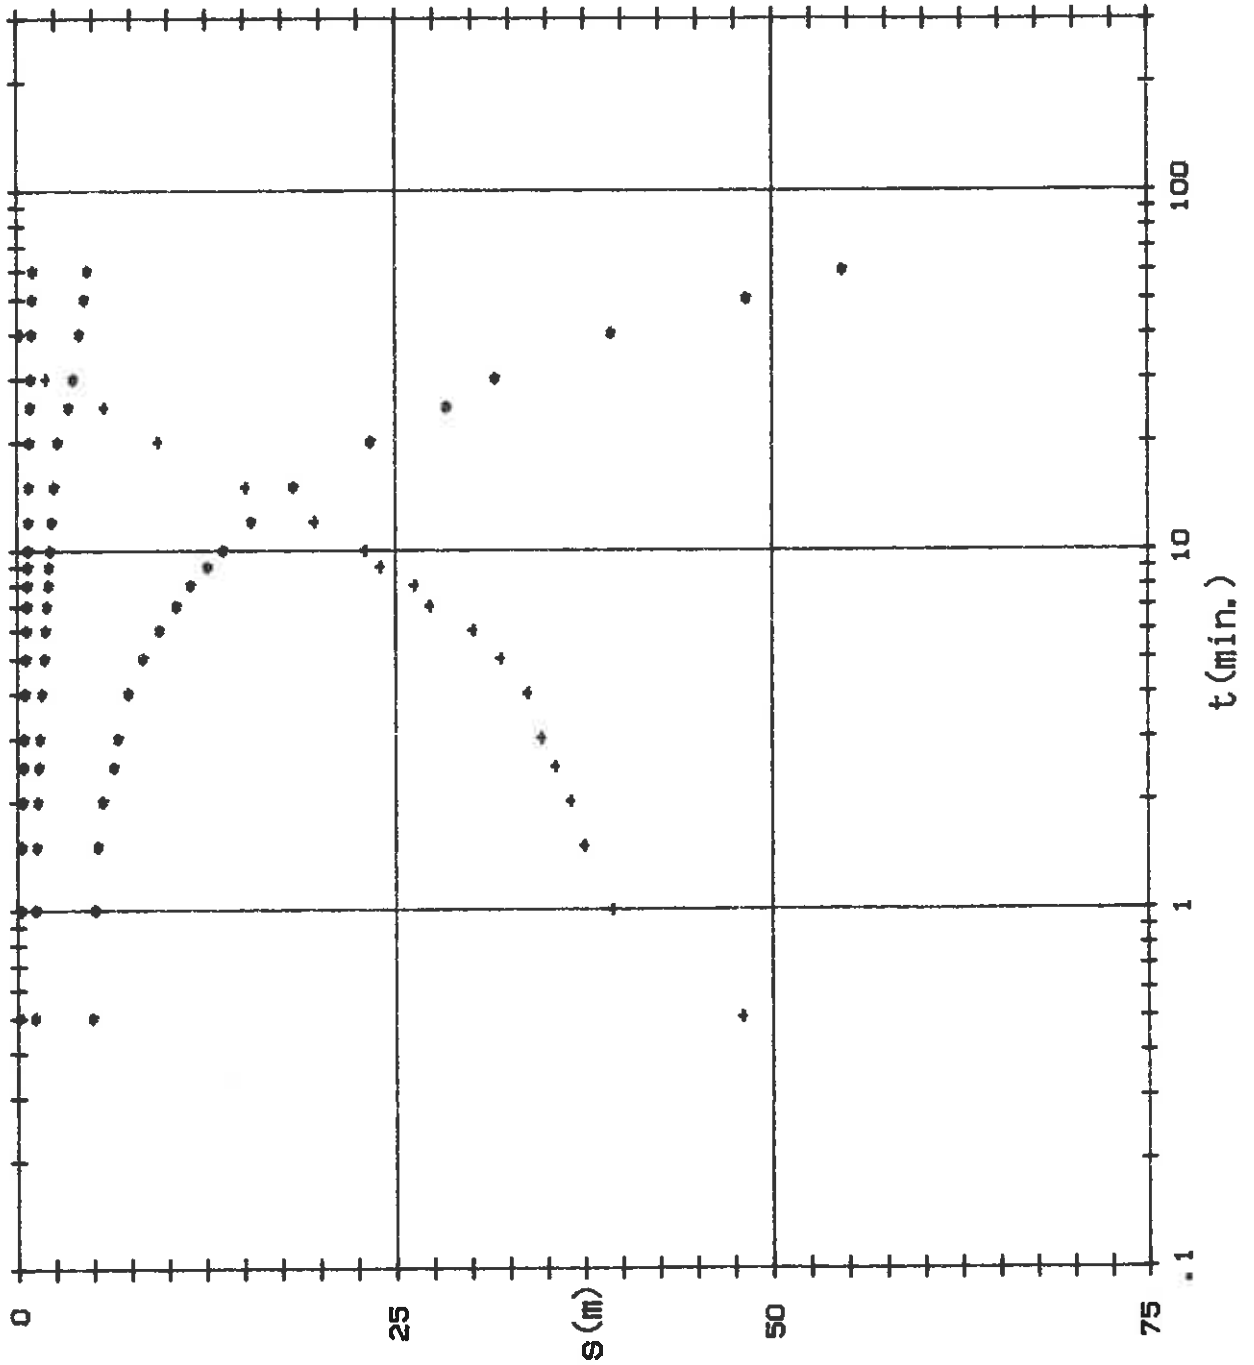
STEP DRAWDOWN TEST

$Q_3 = .94 \text{ l/s}$

S.W.L. = 5.66 m

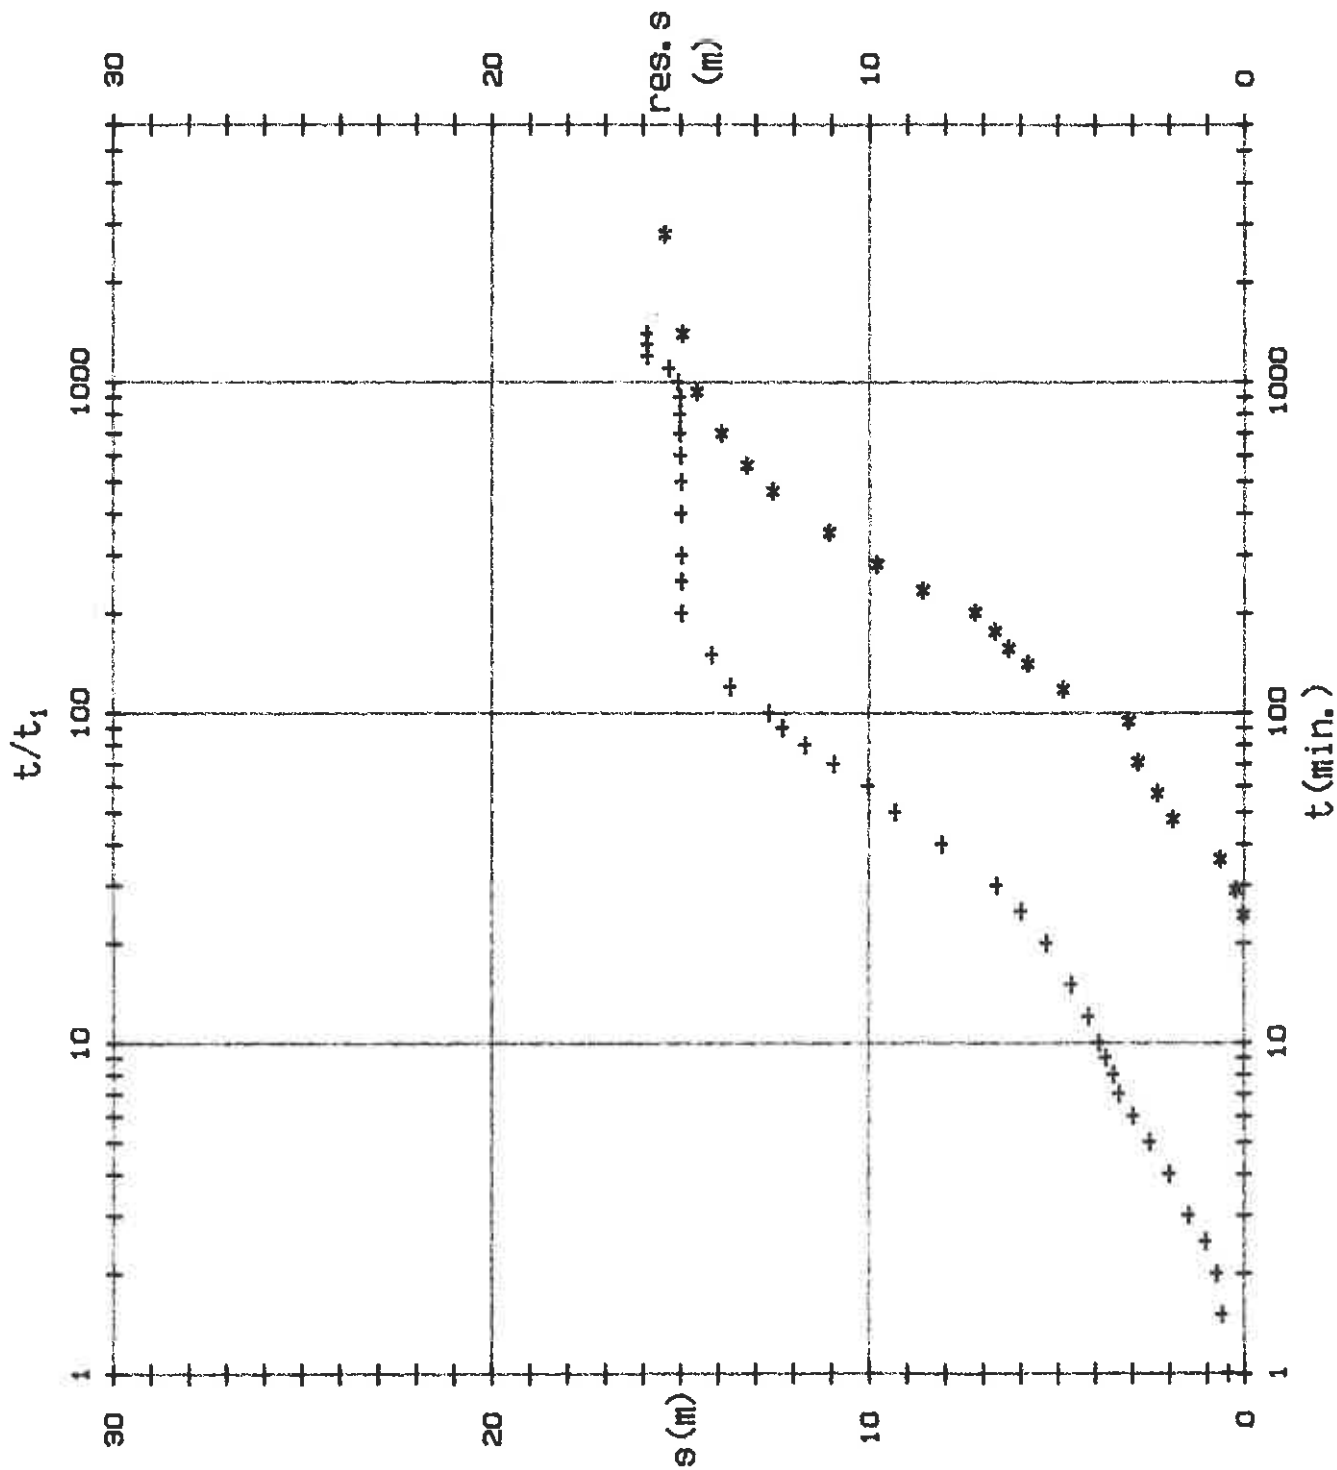
CONSTANT DISCHARGE TEST

- + Drawdown data.
- * Recovery data.

S.W.L. = 5.66 m

T = 1.5 m²/d

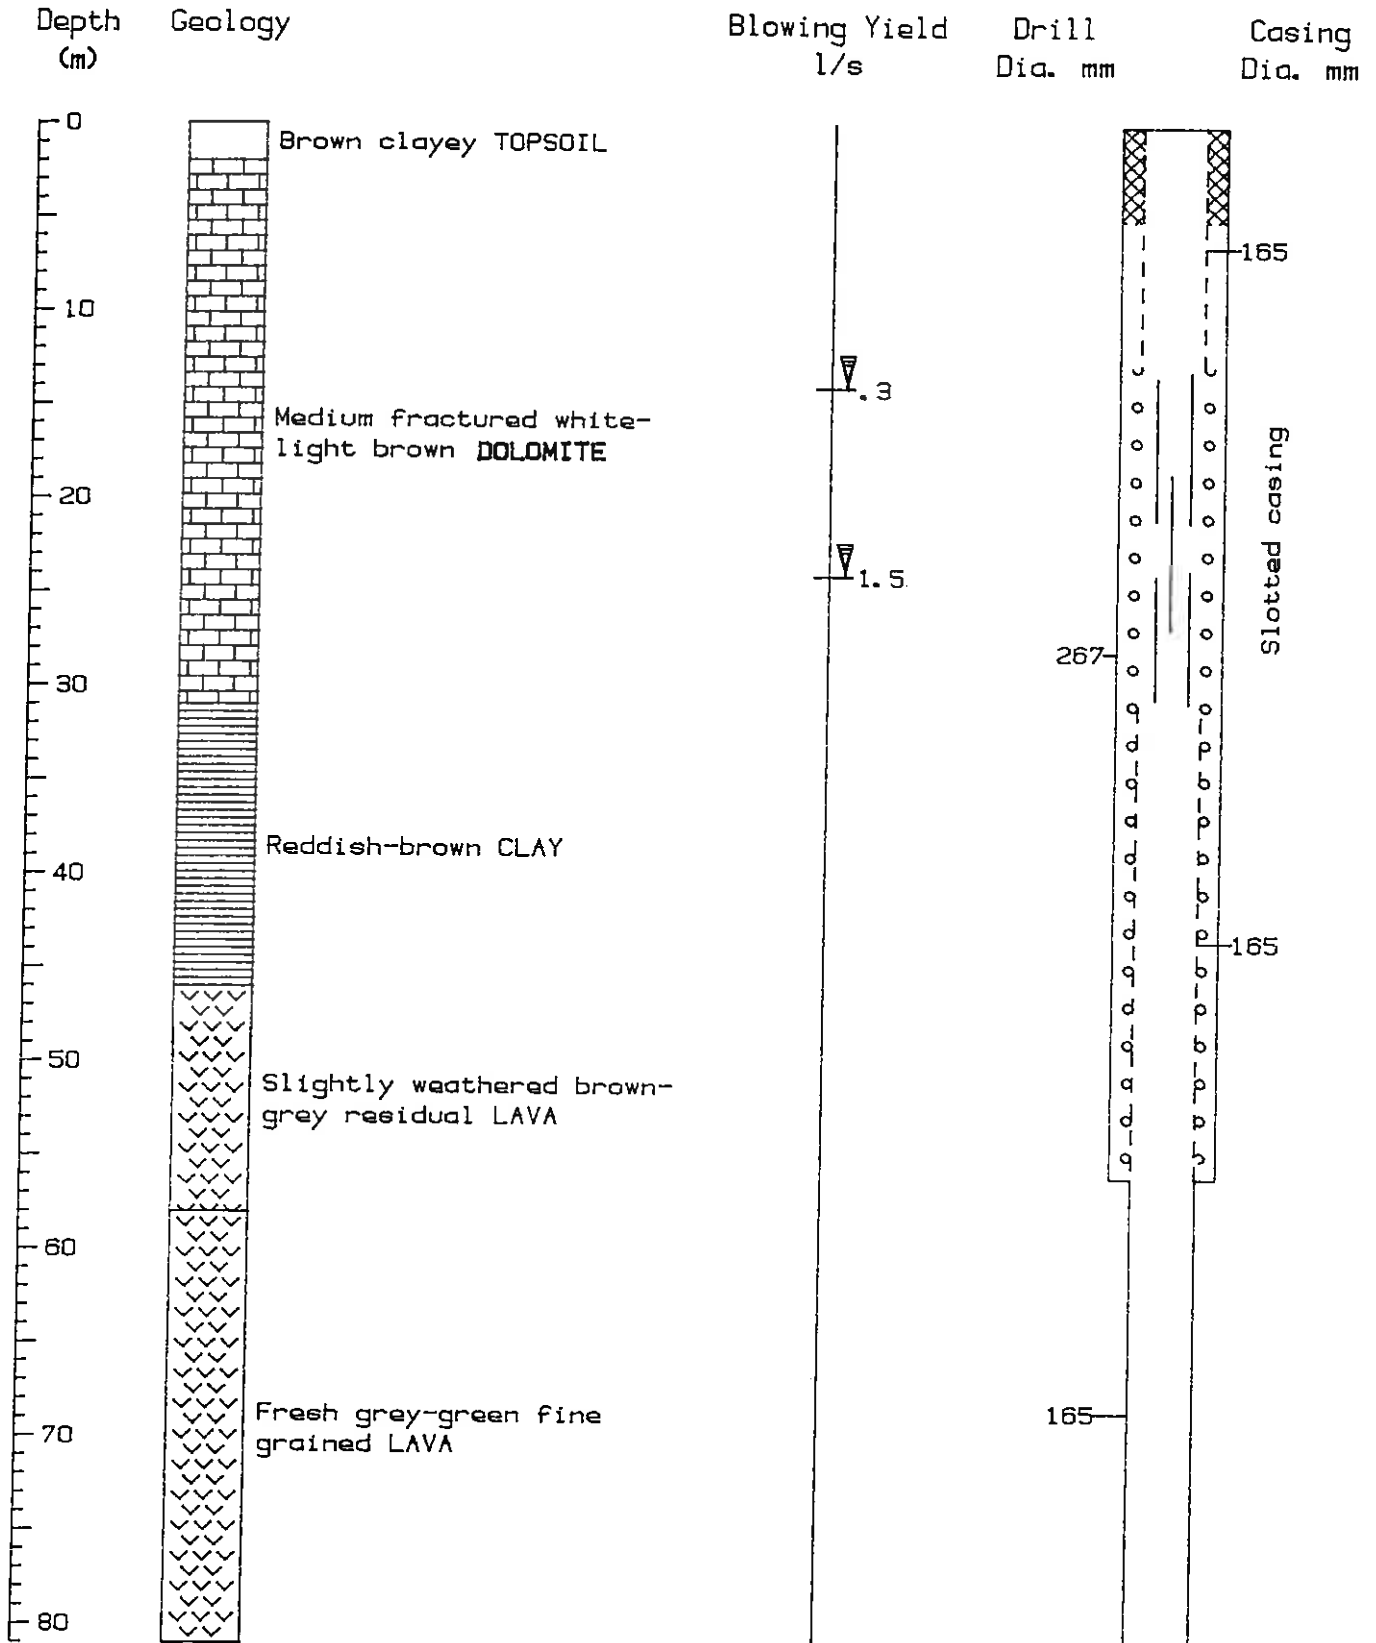
Coordinates +2899555X -069490Y

Elev. (m) 1388

End of Hole 81

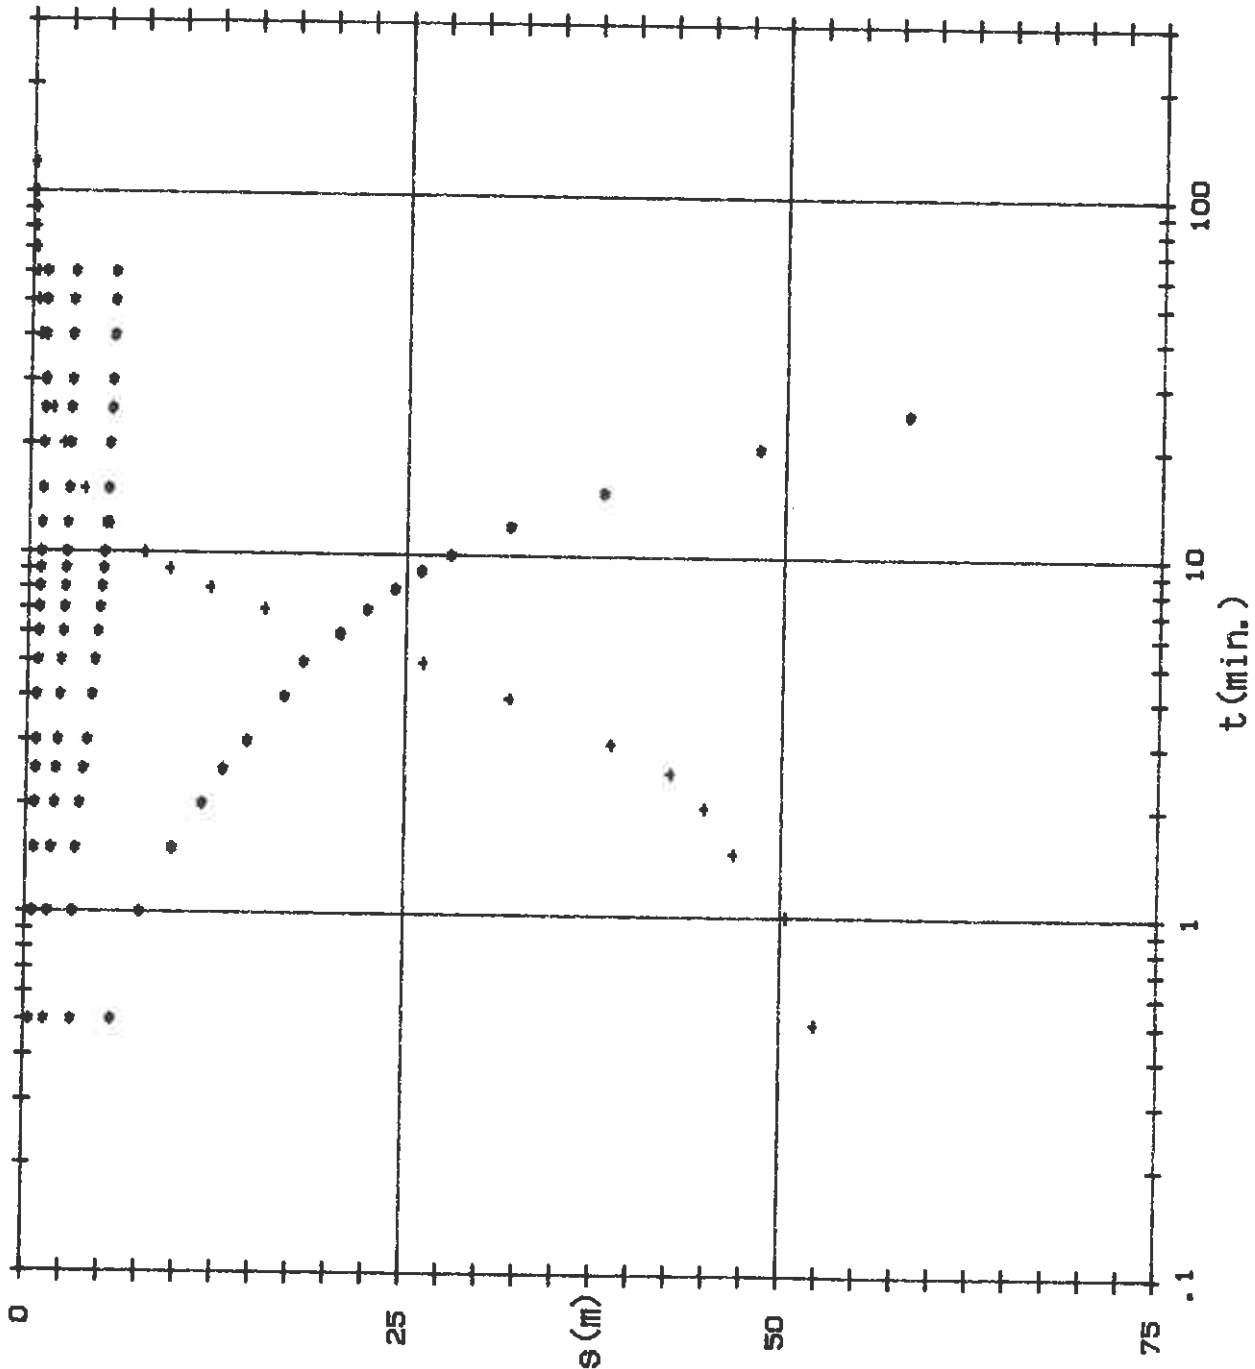
STEP DRAWDOWN TEST

$Q_1 = .16 \text{ l/s}$
 $Q_2 = .45 \text{ l/s}$
 $Q_3 = .89 \text{ l/s}$
 $Q_4 = 3.4 \text{ l/s}$

S.W.L. = 15.44 m

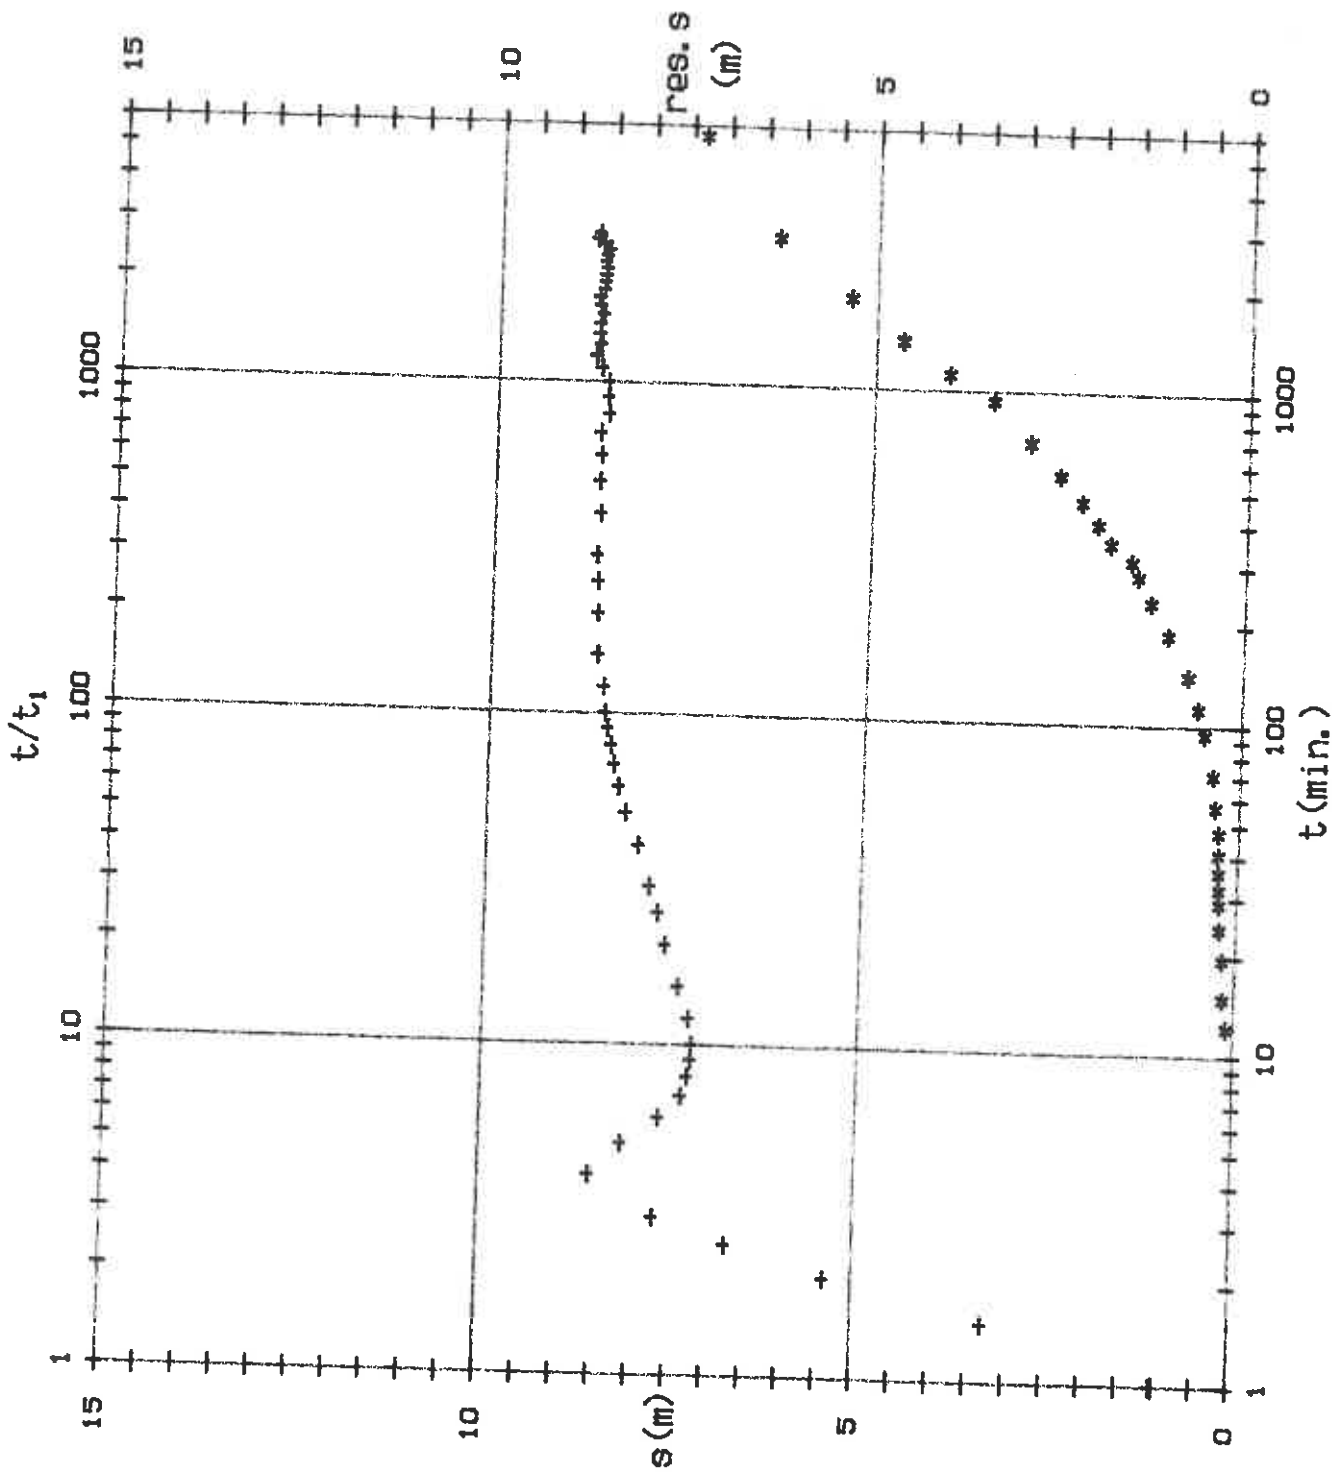
CONSTANT DISCHARGE TEST

- + Drawdown data.
- * Recovery data.

S.W.L. = 15.44 m

$T = 4 \text{ m}^2/\text{d}$

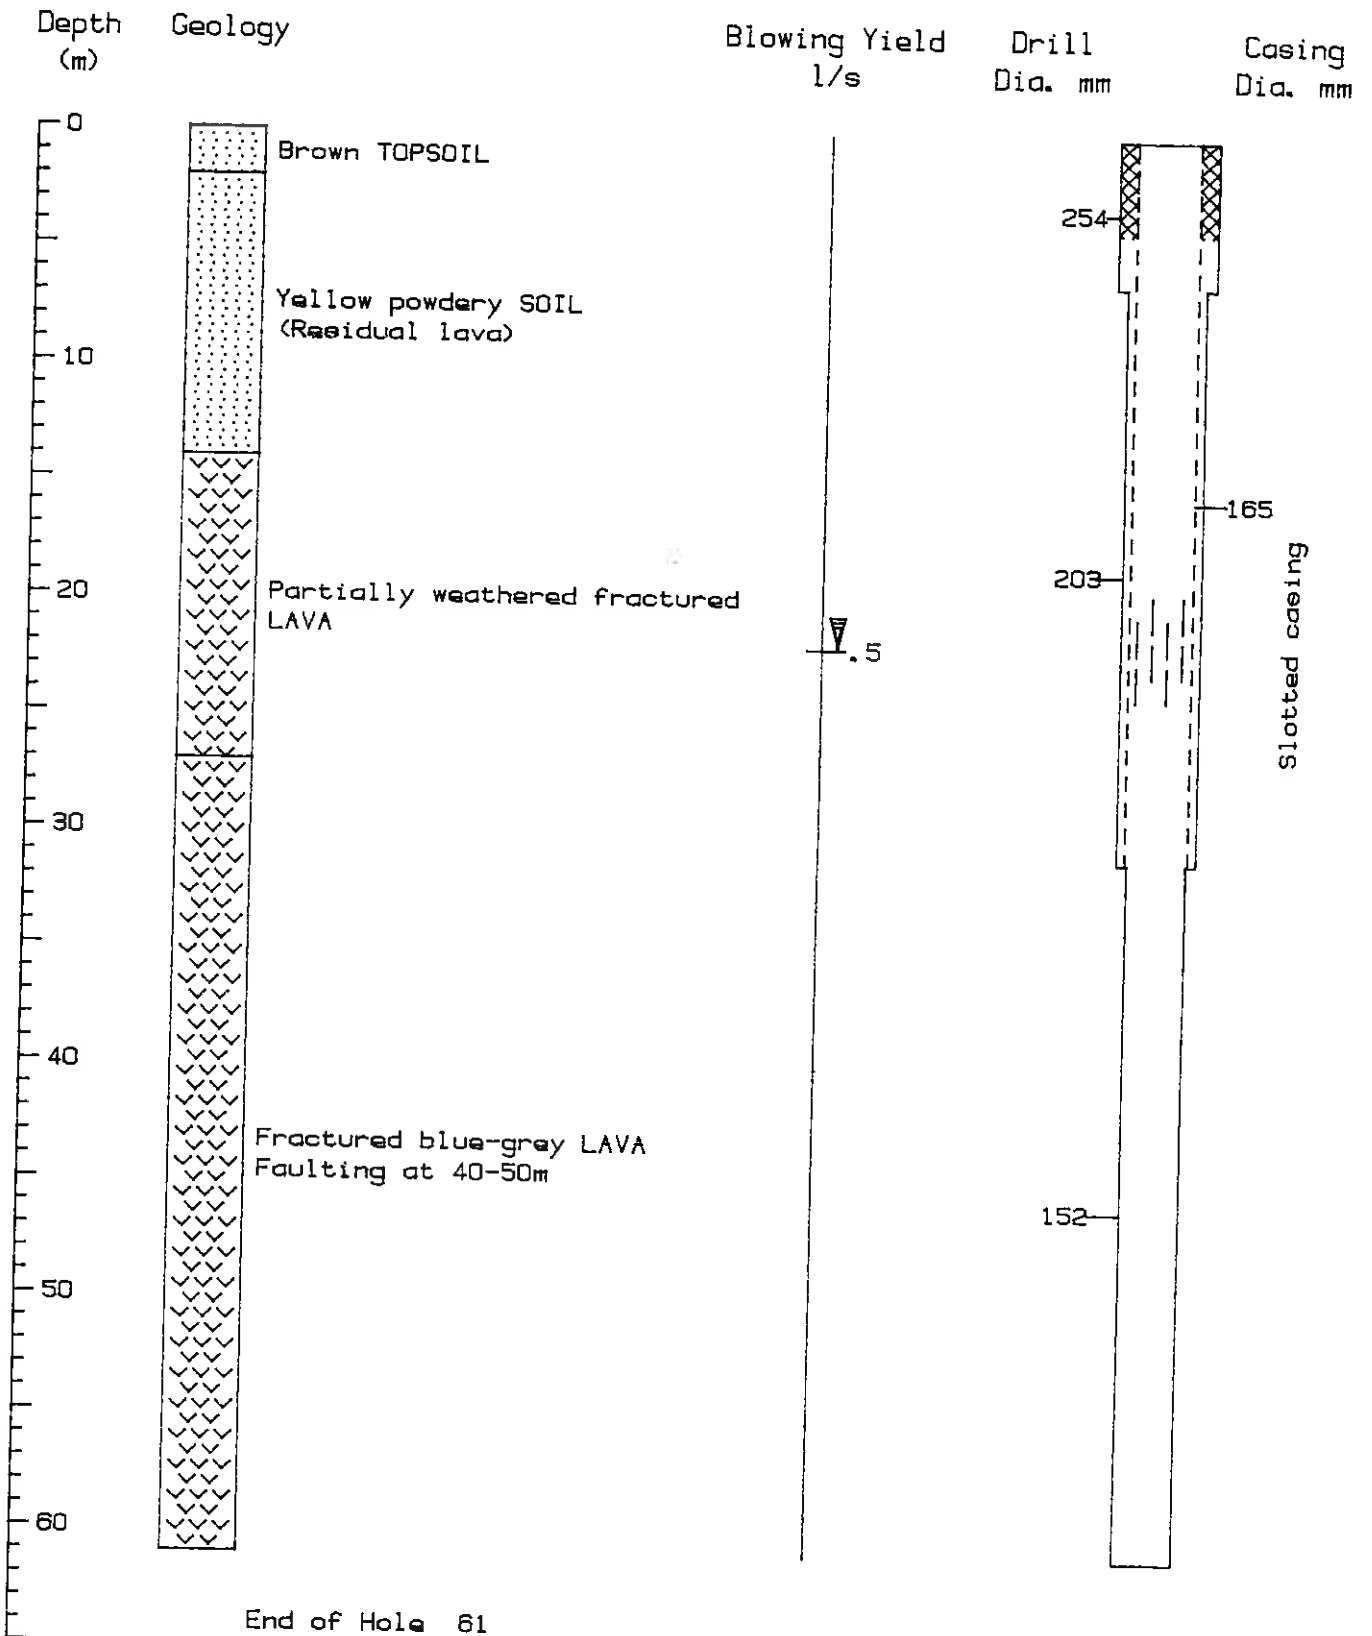
Coordinates +2923300X -50975Y

Elev. (m) 1380

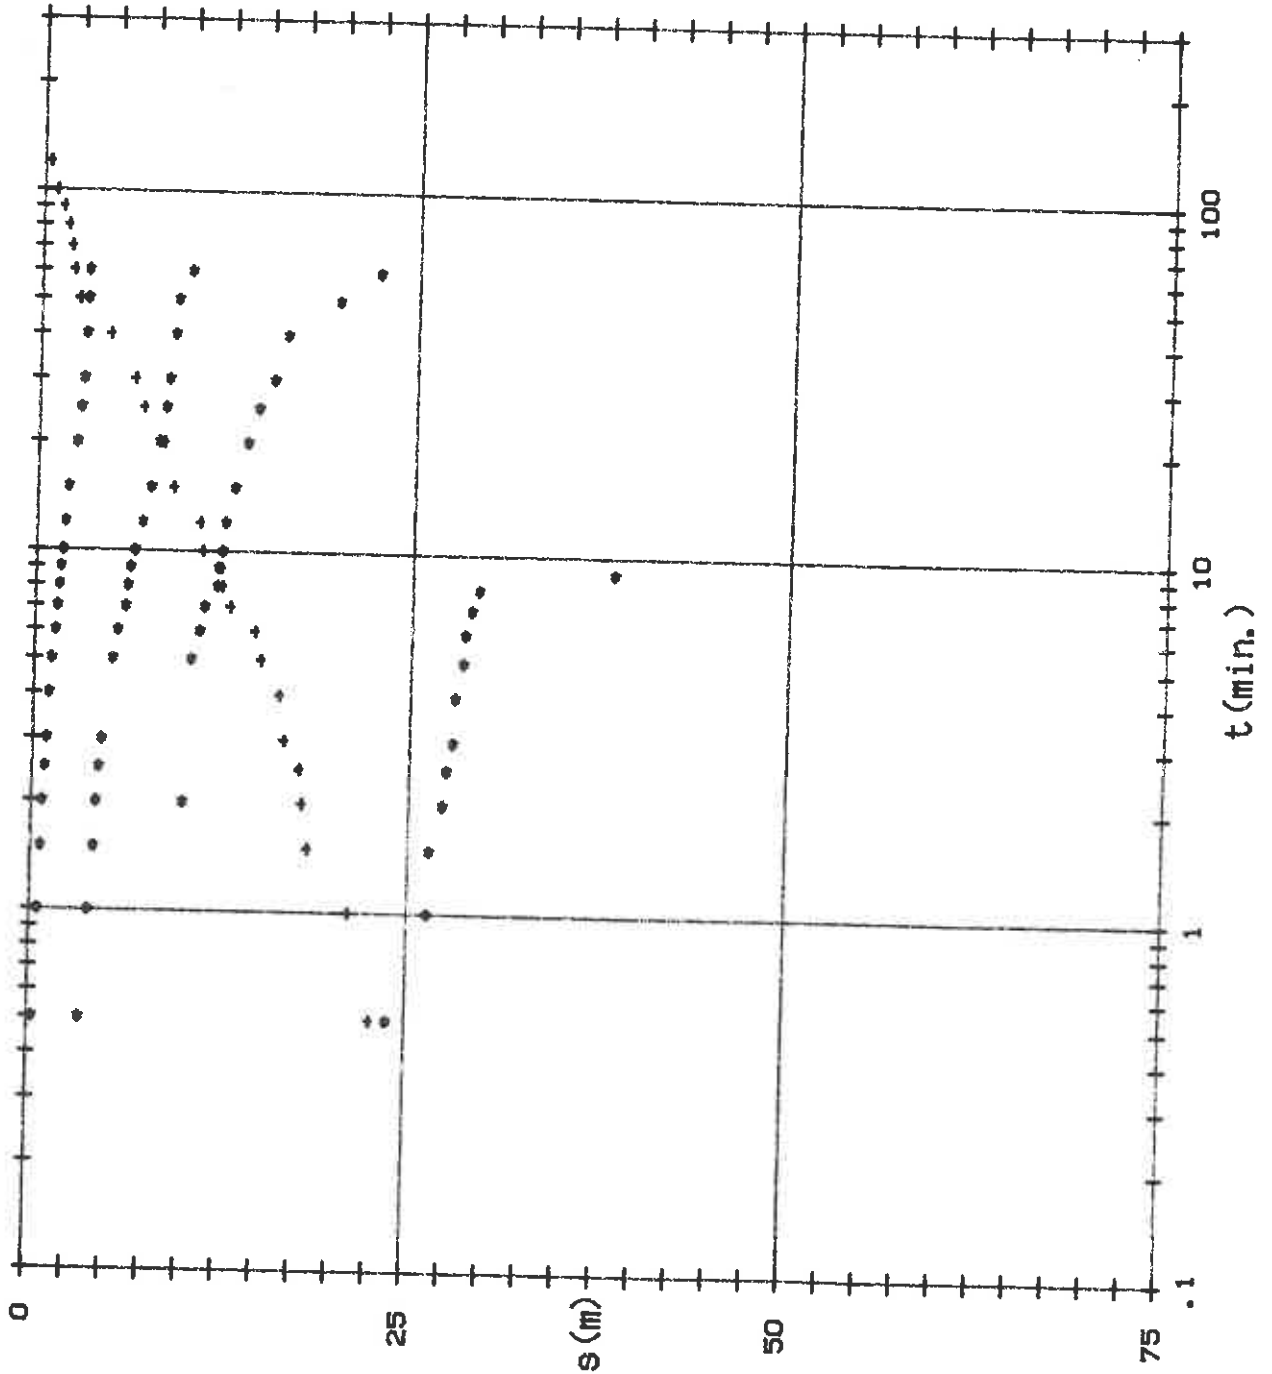
STEP DRAWDOWN TEST

* Pumping data
+ Recovery data

$Q_4 = 2.1 \text{ l/s}$

S.W.L. = 11.35 m
