REPUBLIC OF BOPHUTHATSWANA
DEPARTMENT OF WATER AFFAIRS

**REPORT ON THE SITING
DRILLING AND TESTING OF BOREHOLES,
AND THE TESTING OF EXISTING
BOREHOLES - DITSOBOTLA DISTRICT
JUNE 1991 - FEBRUARY 1993**

**VOLUME 1 - TEXT
AND APPENDIX I**

PARTRIDGE MAUD AND ASSOCIATES

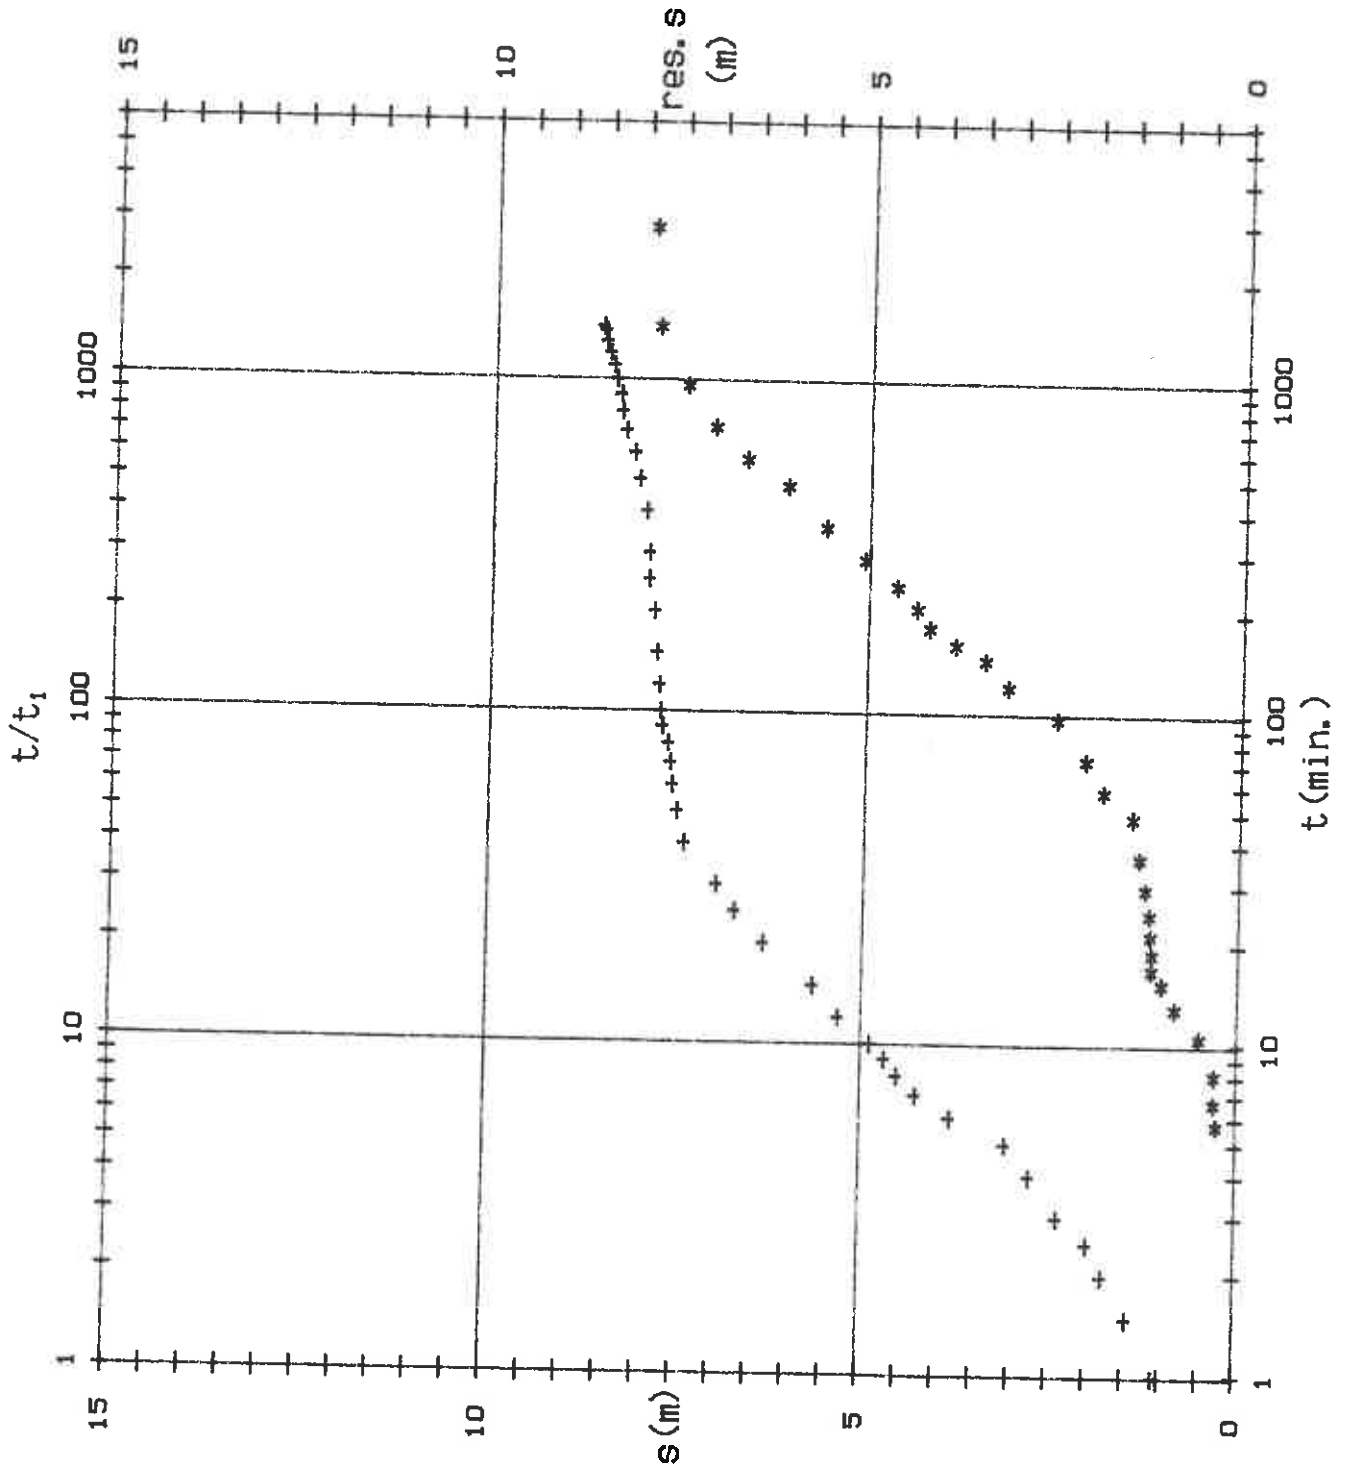
CONSTANT DISCHARGE TEST

+ Drawdown data.
* Recovery data.

S.W.L. = 11.35 m

$T = 2 \text{ m}^2/\text{d}$

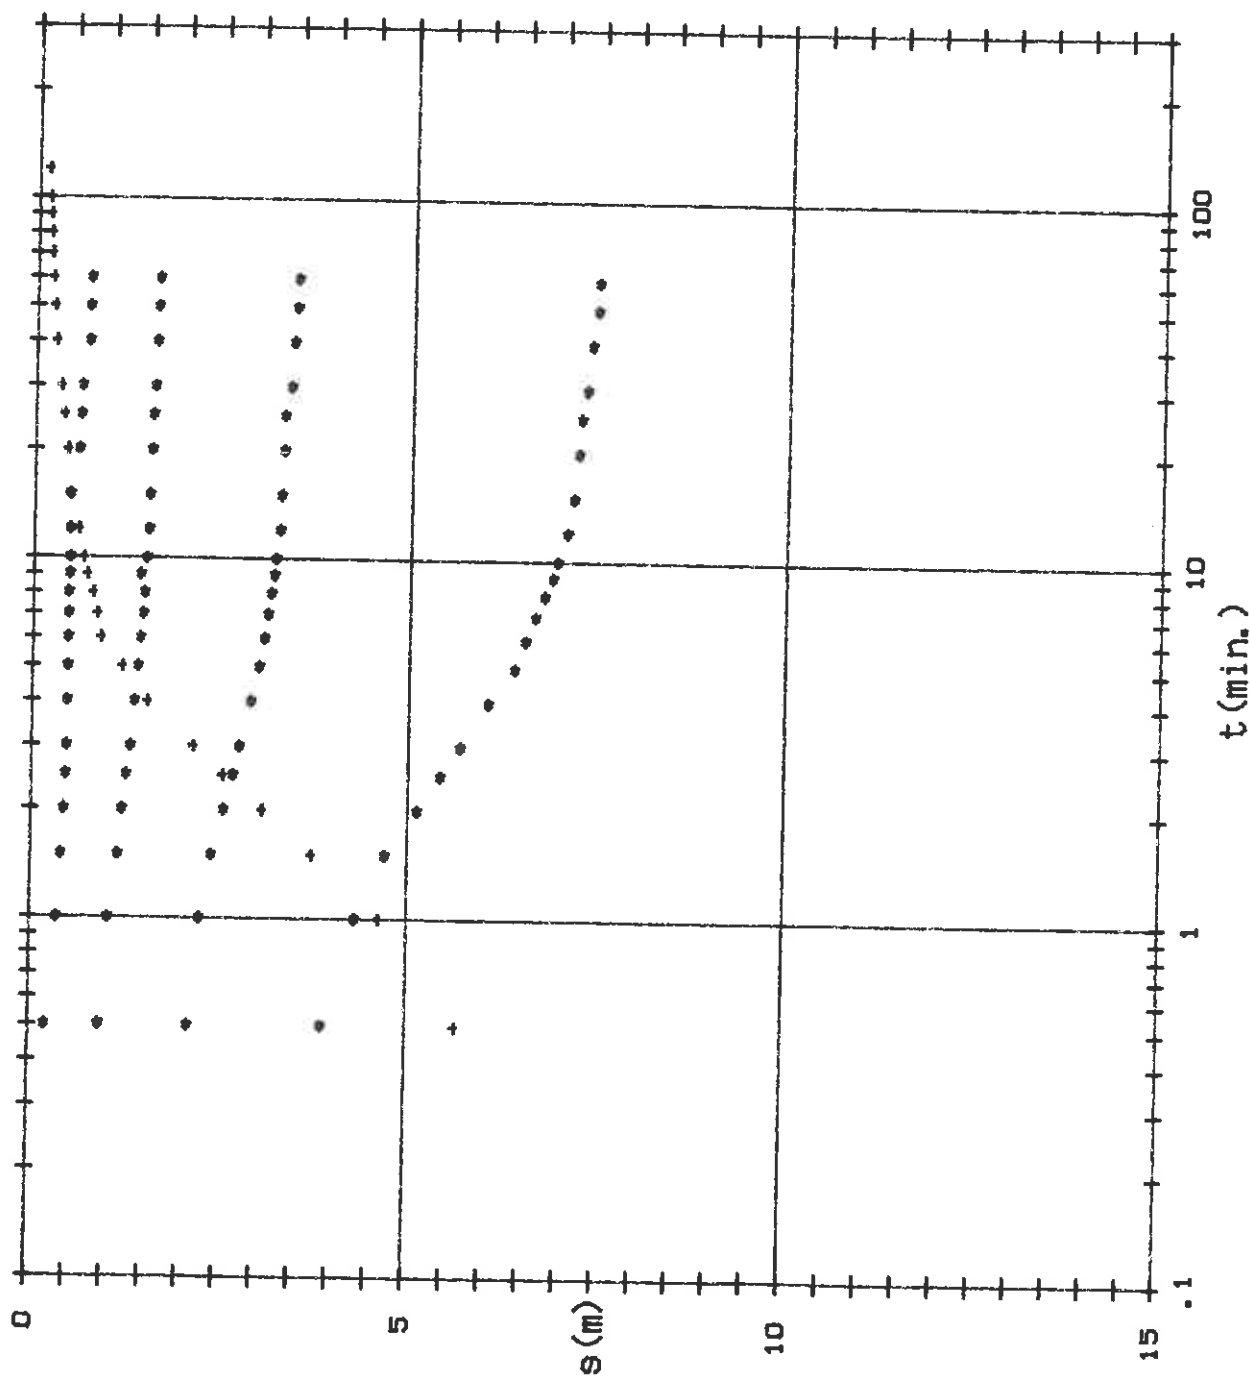
STEP DRAWDOWN TEST

* Pumping data
 + Recovery data

$Q_1 = .15 \text{ l/s}$
 $Q_2 = .45 \text{ l/s}$
 $Q_3 = .9 \text{ l/s}$
 $Q_4 = 1.81 \text{ l/s}$

S.W.L. = 15.72 m

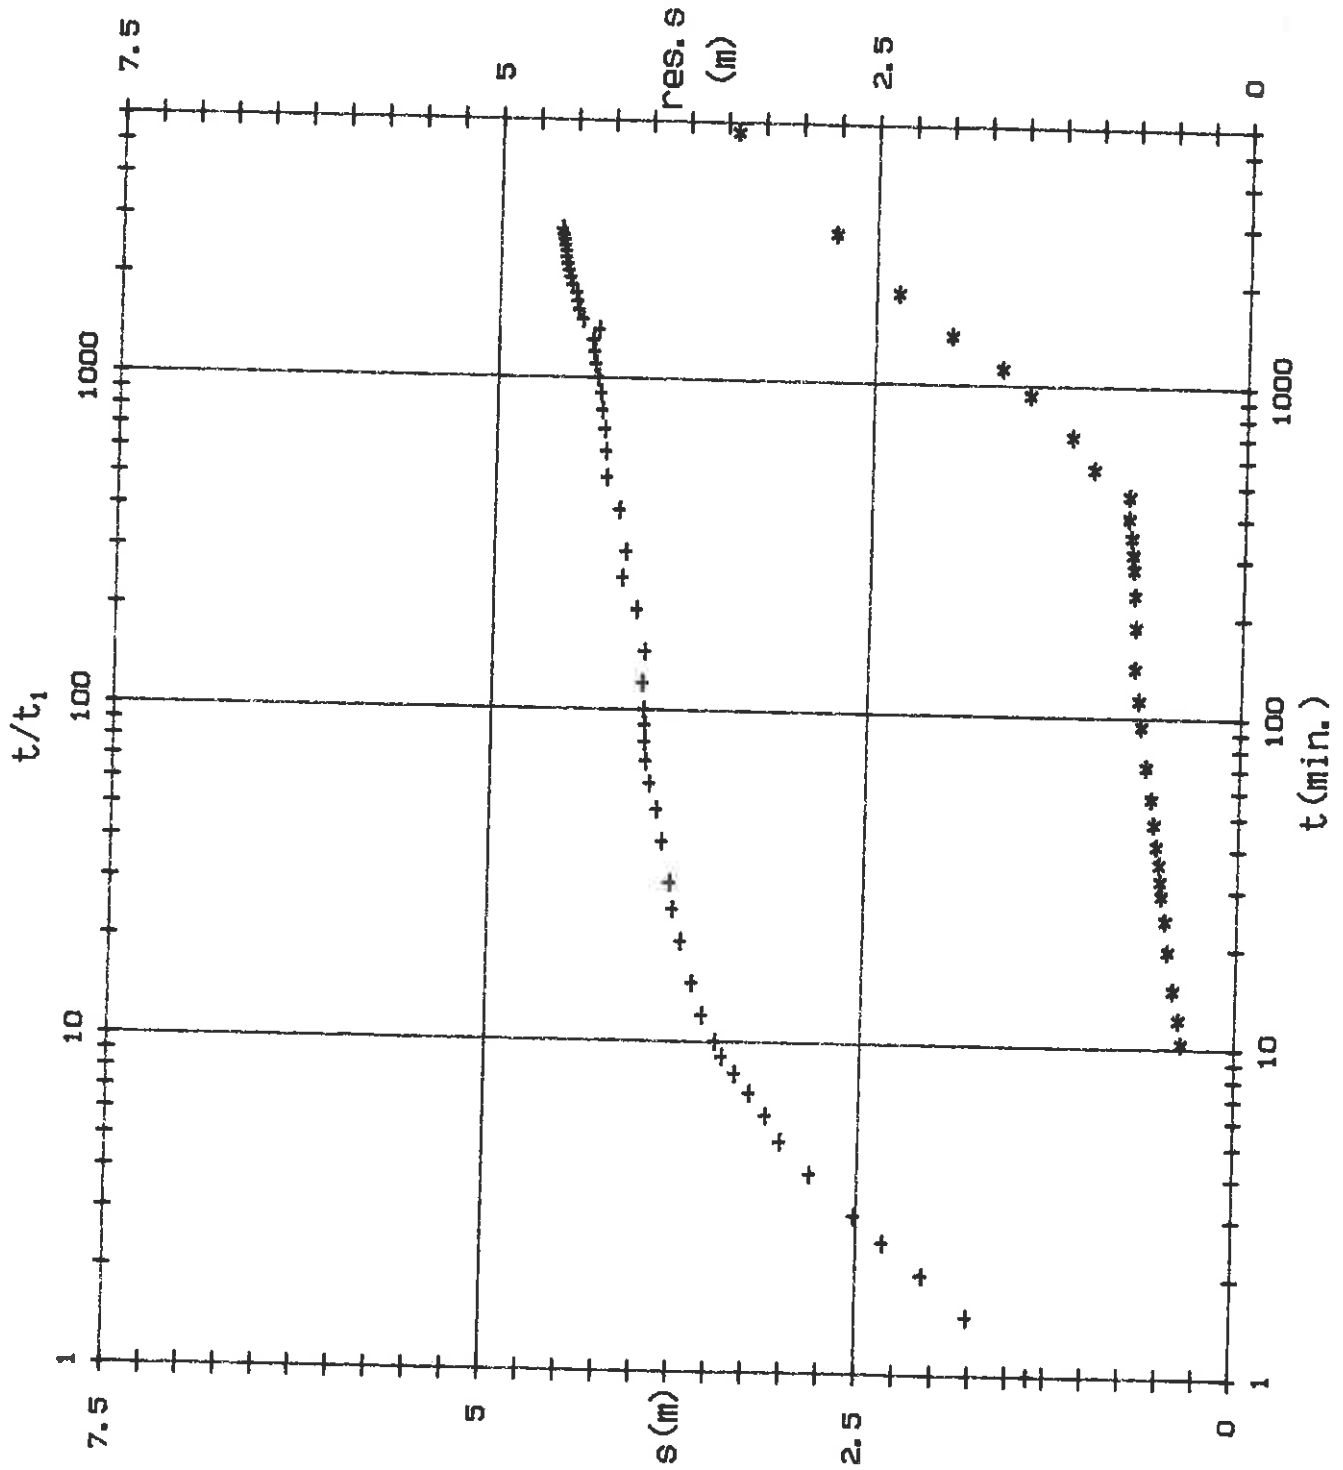
CONSTANT DISCHARGE TEST

+ Drawdown data.
* Recovery data.

S.W.L. = 15.72 m

T = 7 m²/d

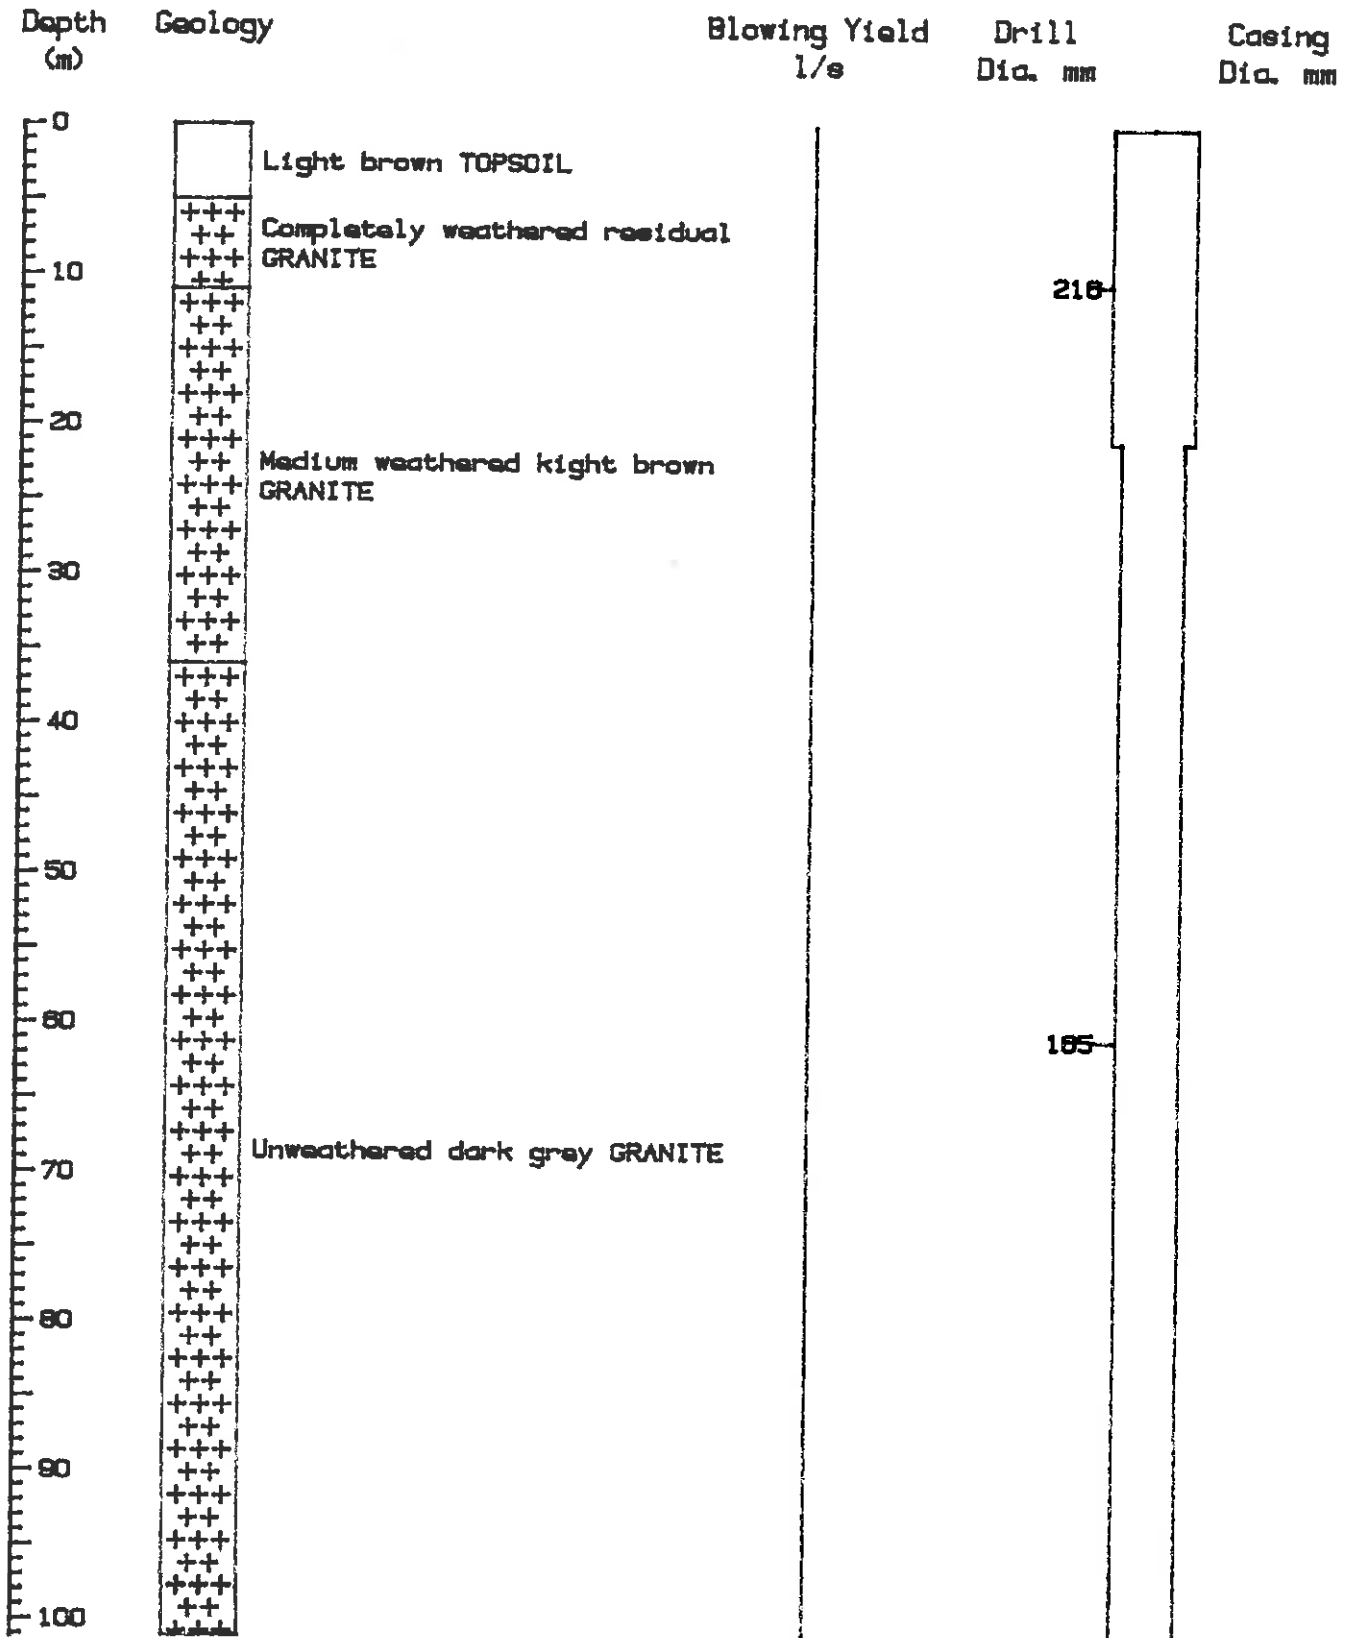
BOREHOLE LOG

Coordinates +2909275X -29000Y

Elev. (m) 1279

End of Hole 101

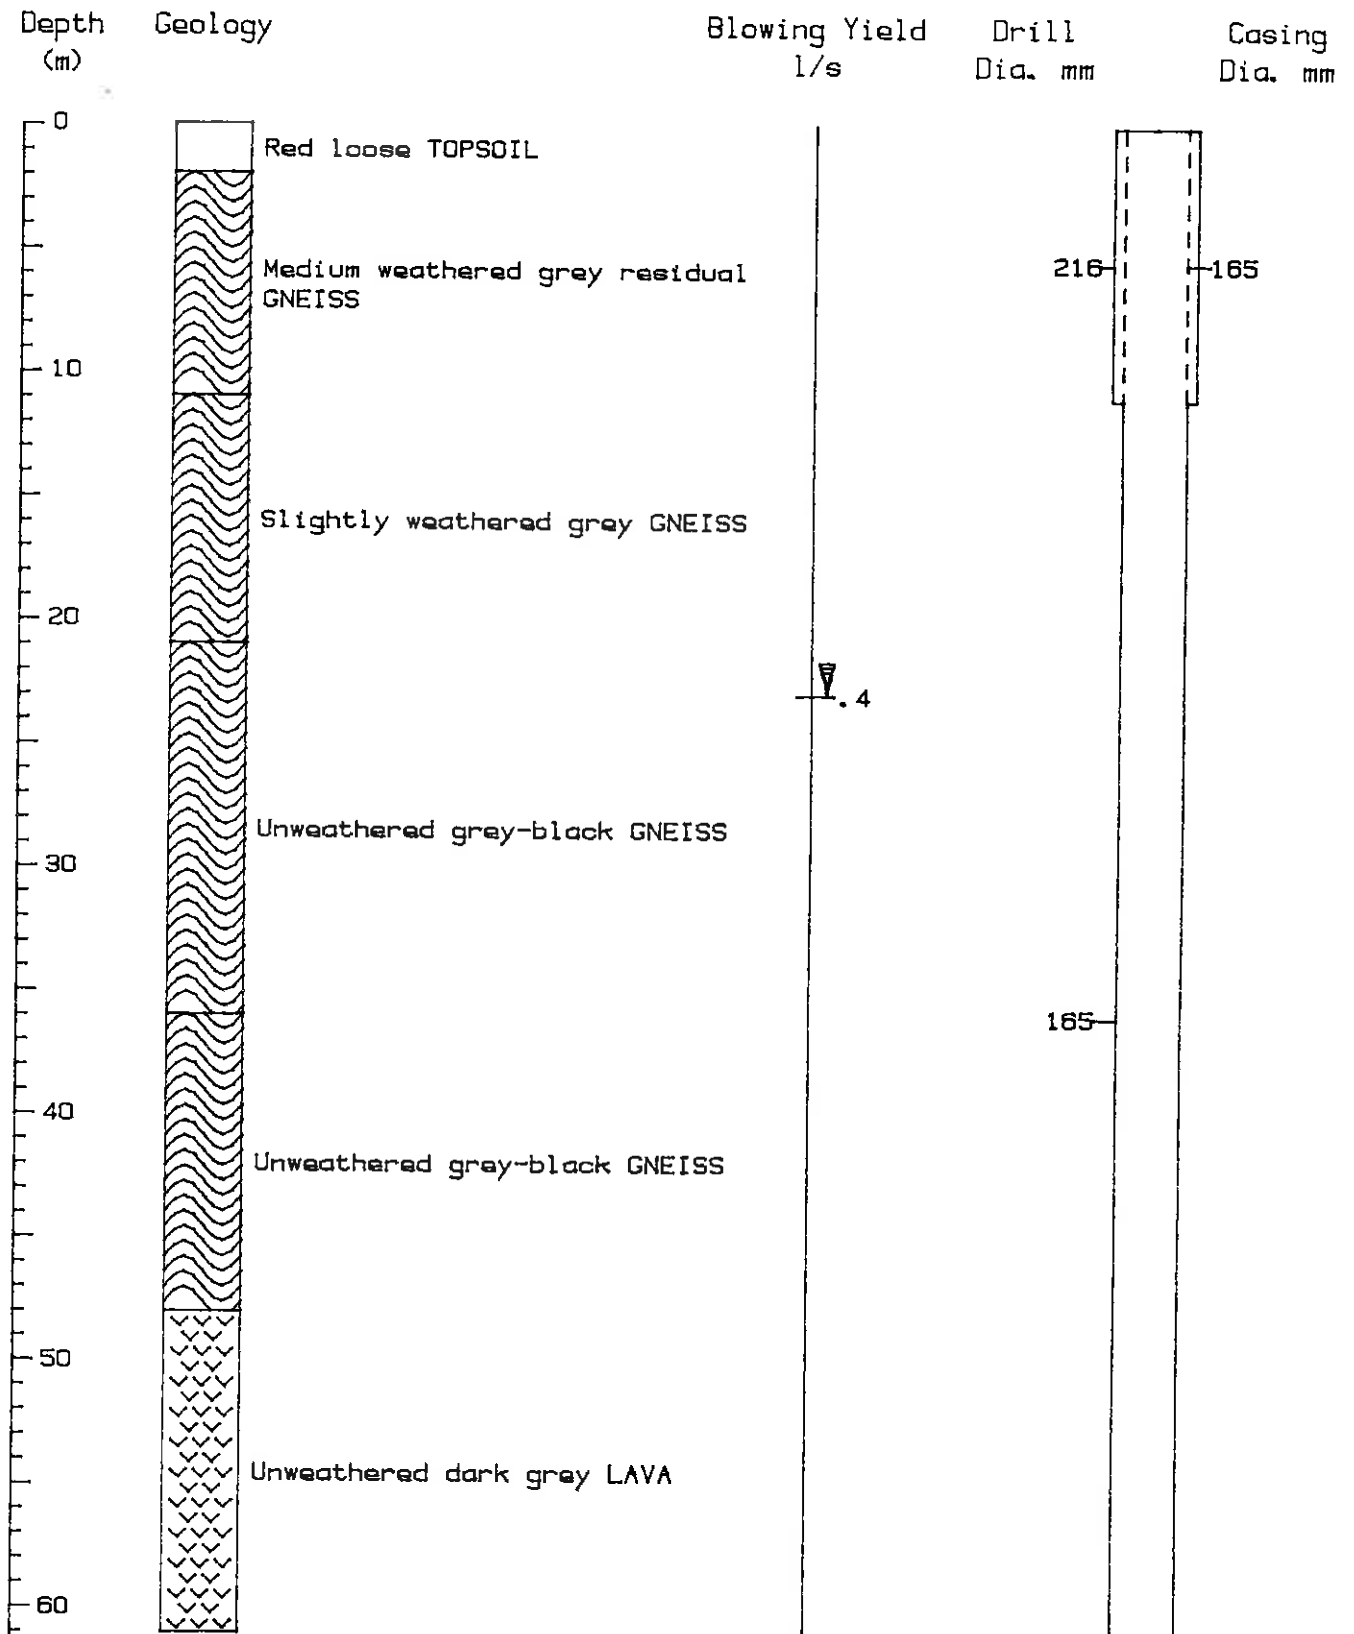
BOREHOLE LOG

Coordinates +2908100X -30150Y

Elev. (m) 1268

End of Hole 61

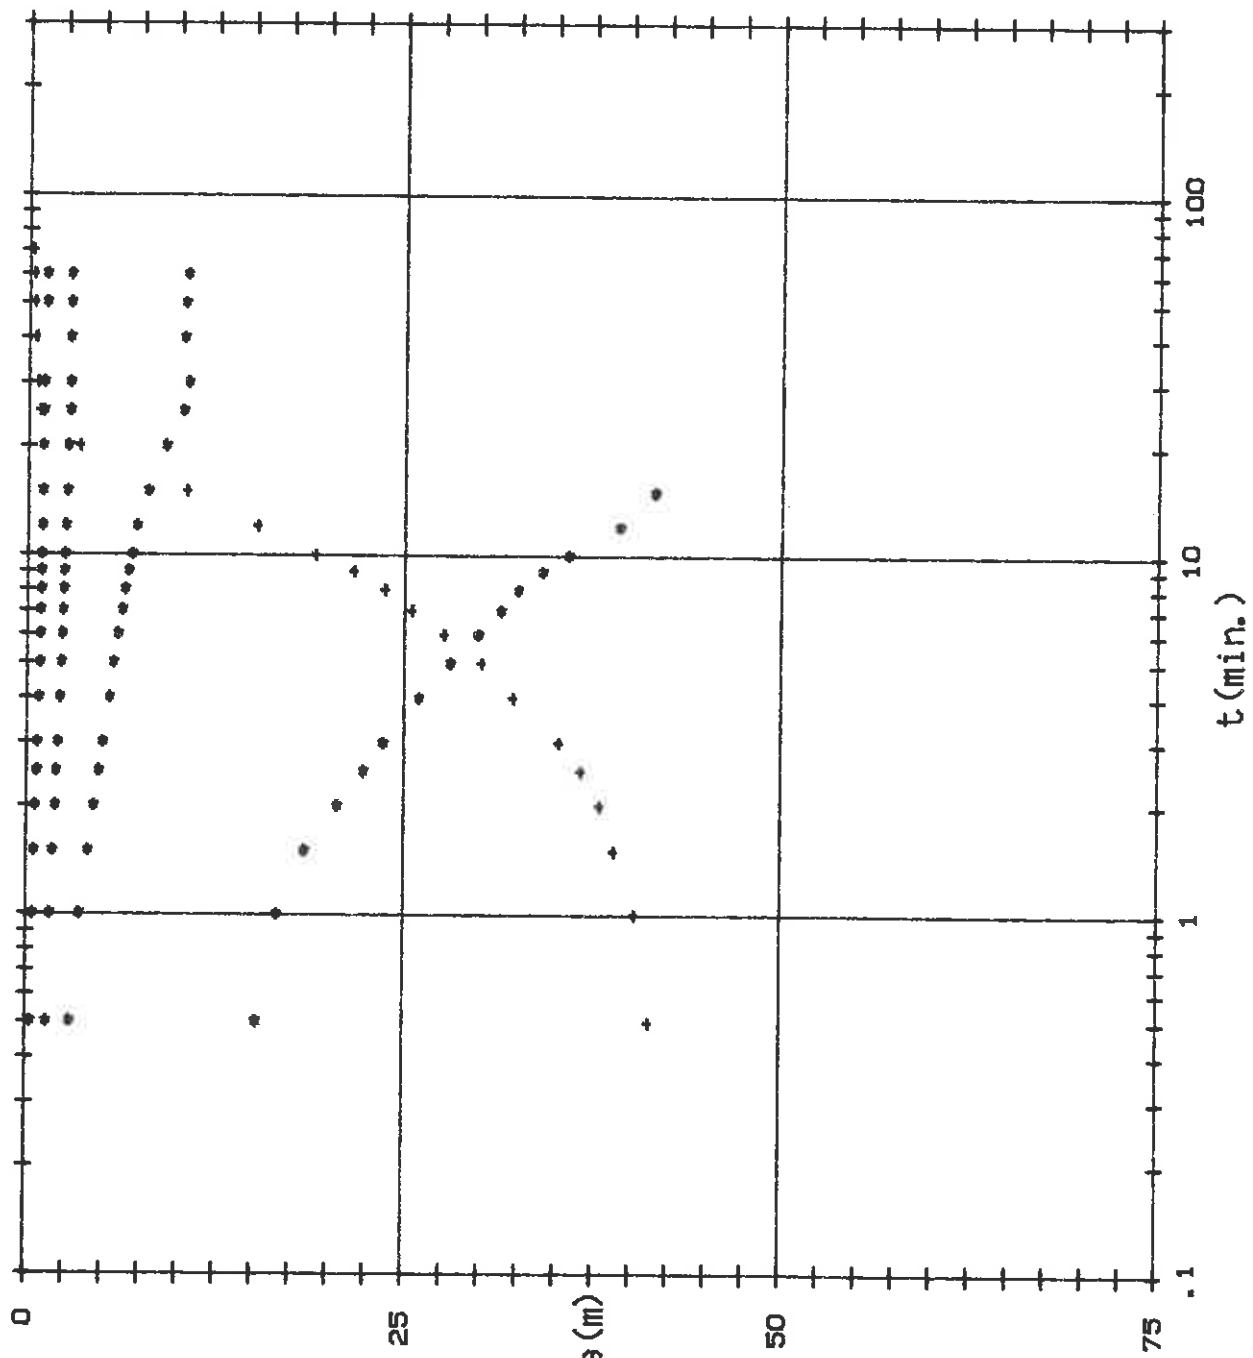
STEP DRAWDOWN TEST

$Q_4 = 1.3 \text{ l/s}$

S.W.L. = 11.5 m

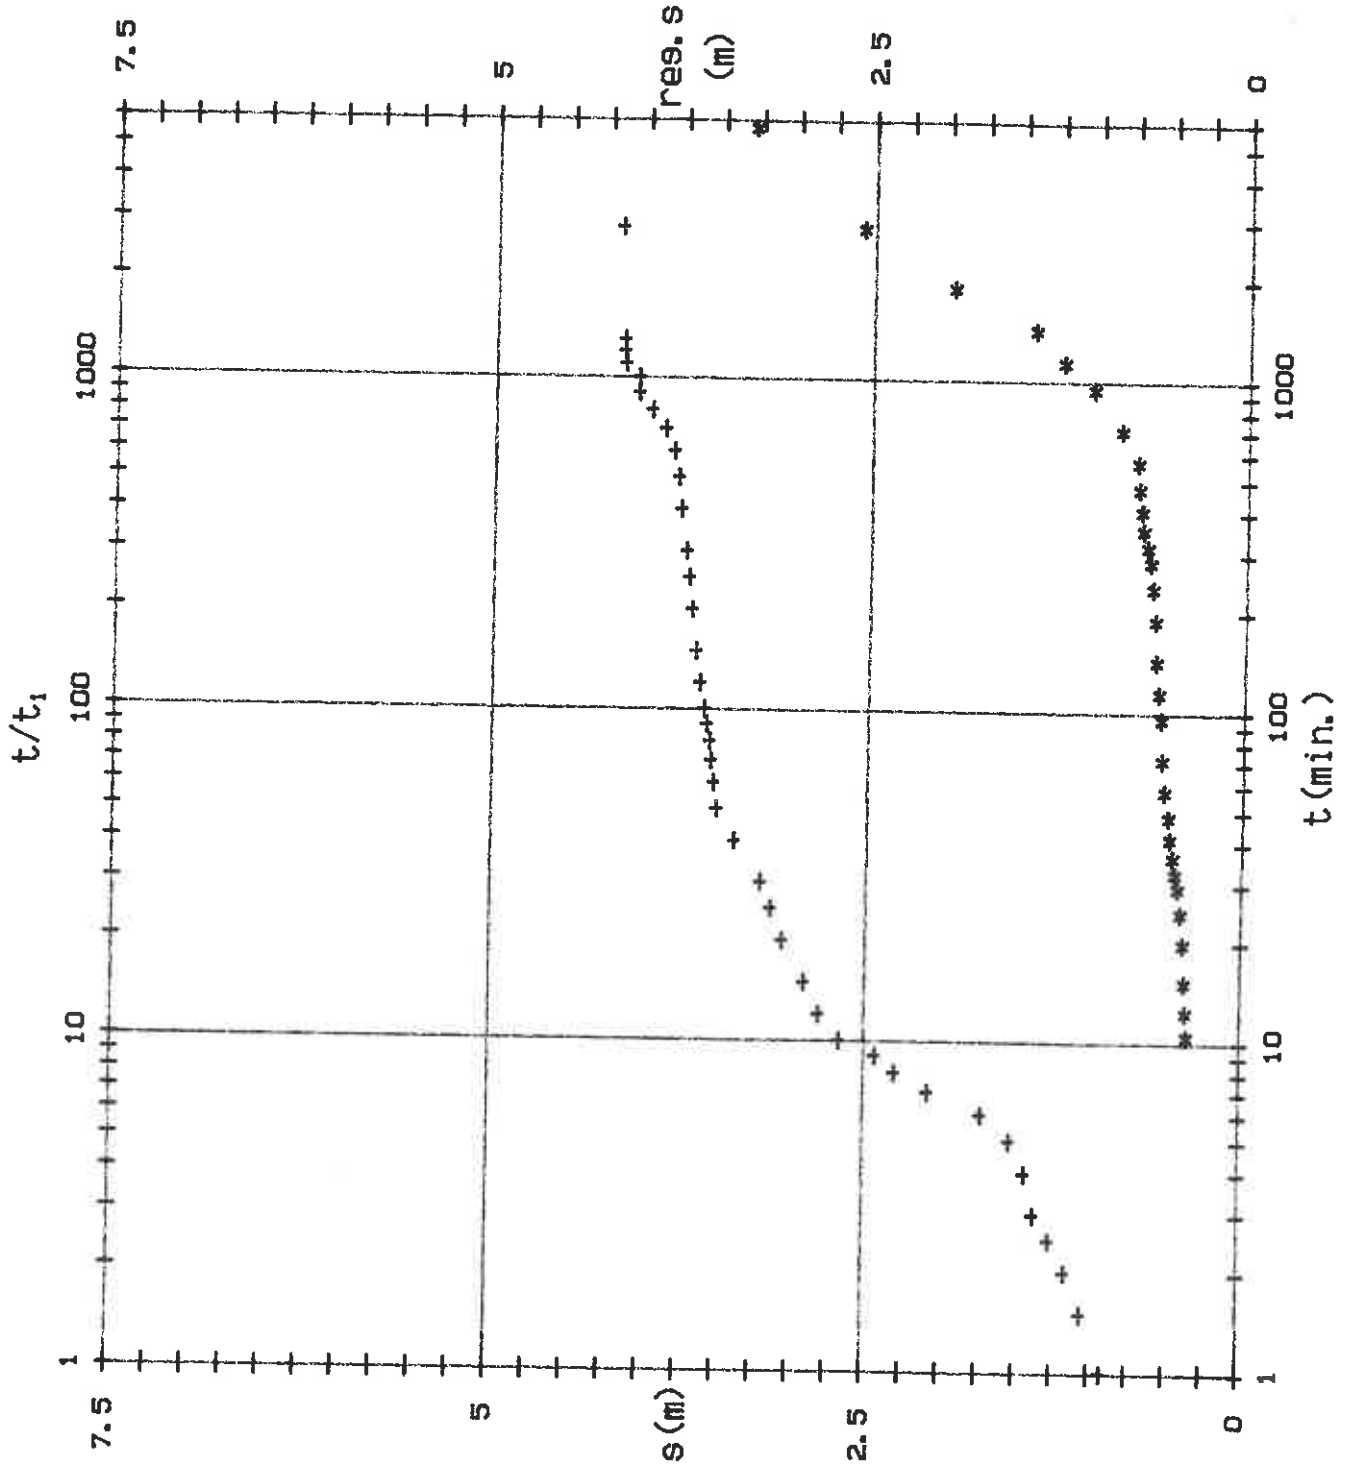
CONSTANT DISCHARGE TEST

+ Drawdown data.
* Recovery data.

S.W.L. = 11.5 m

T = 3 m²/d

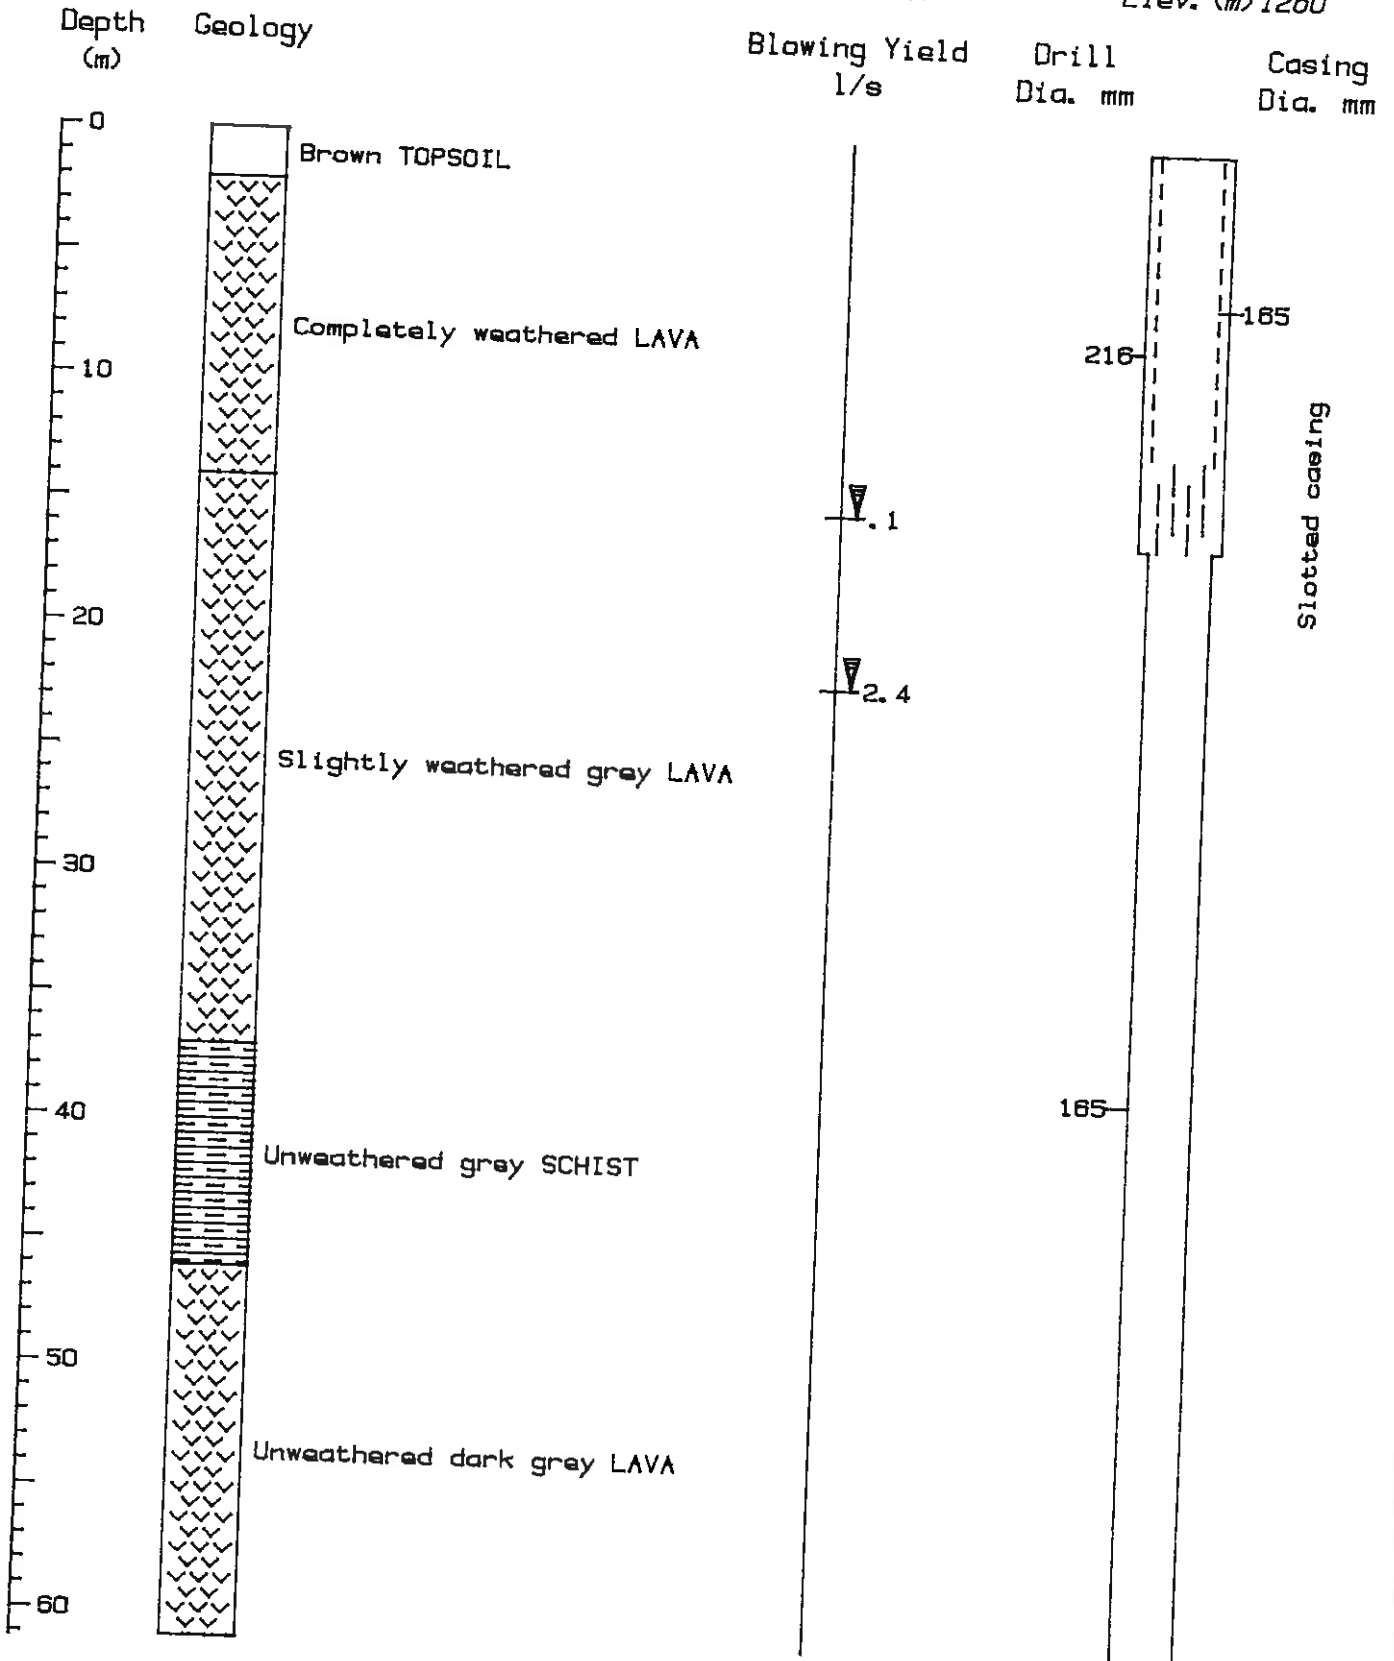
BH. No. 10-77289

Elev. (m) 1260

End of Hole 61

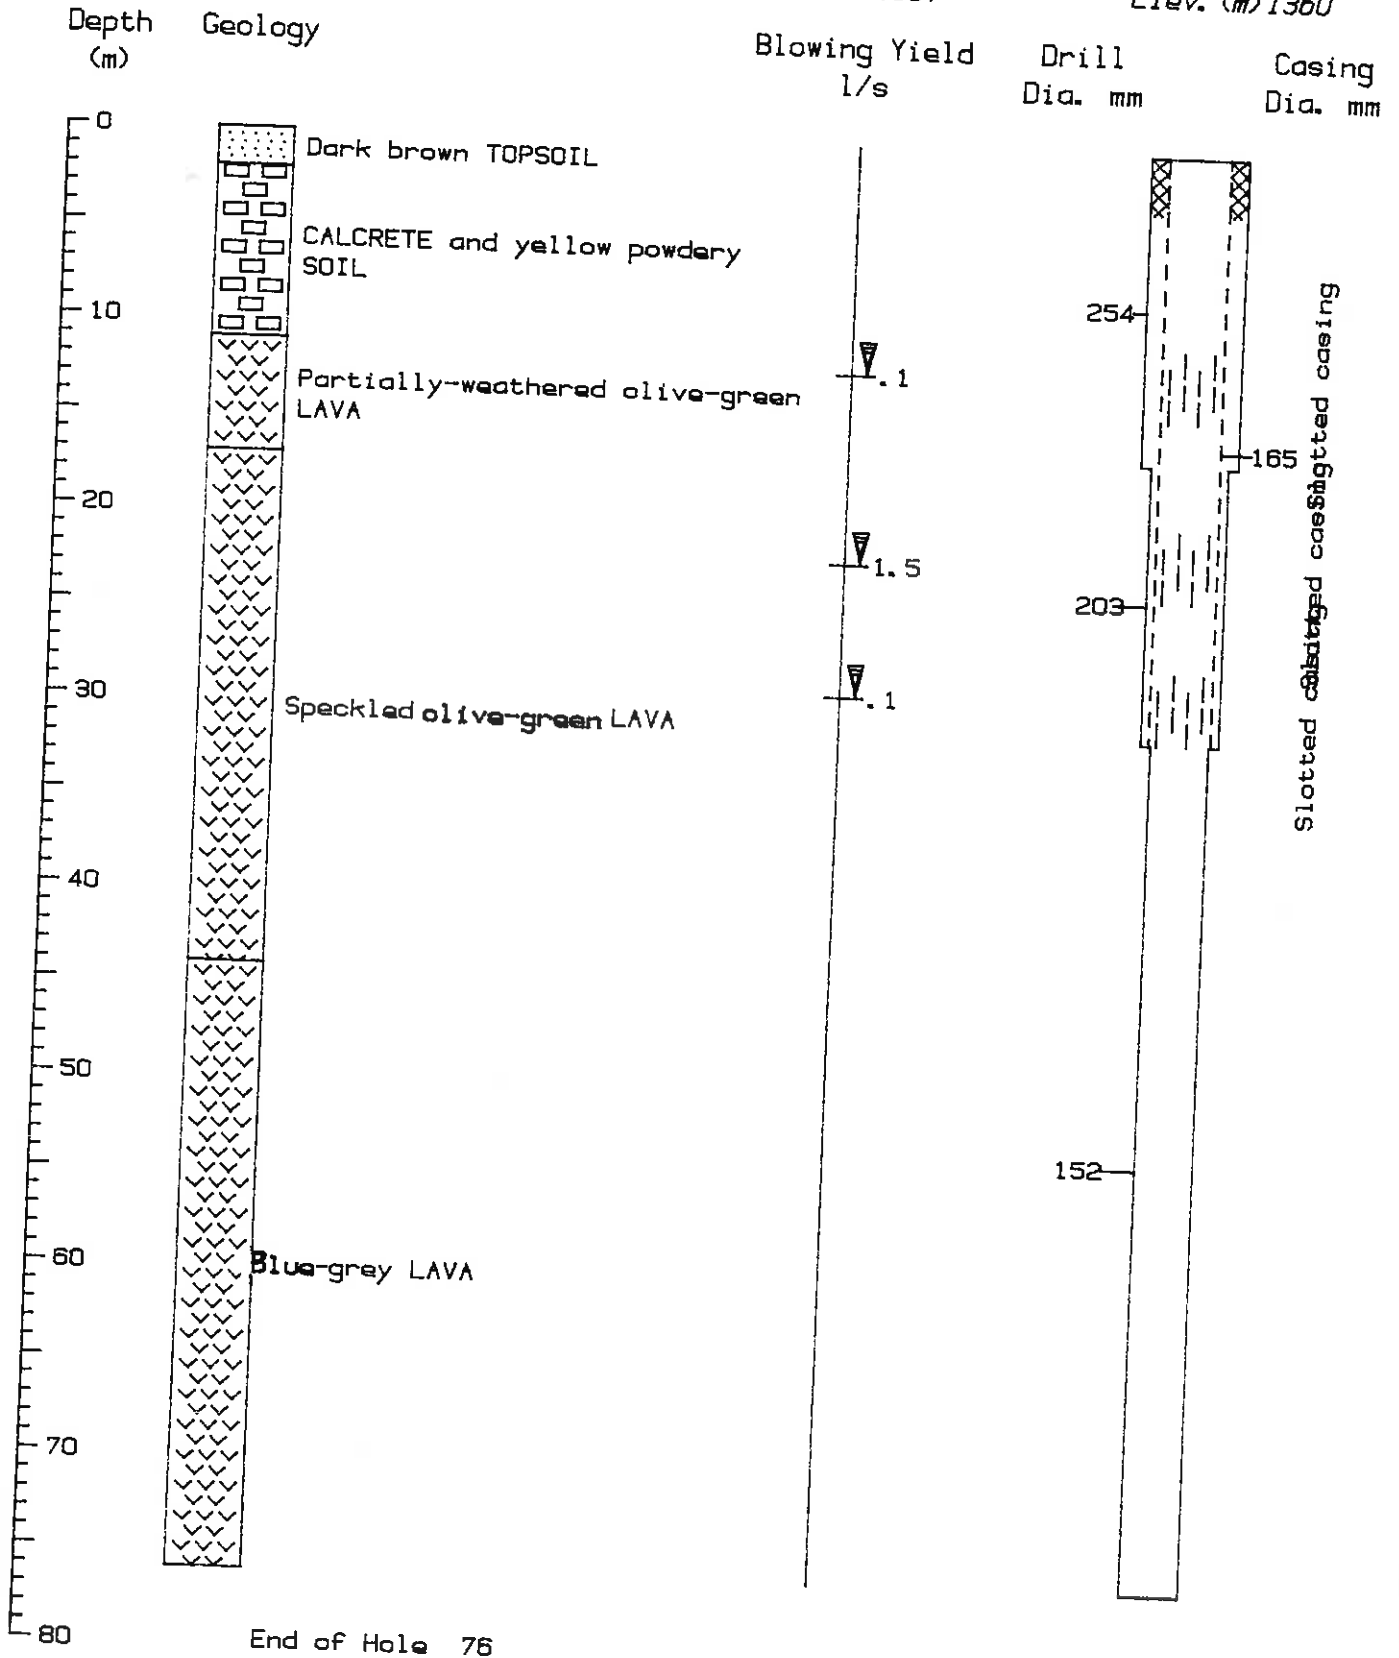
BH. No. 10-77252

Elev. (m) 1360

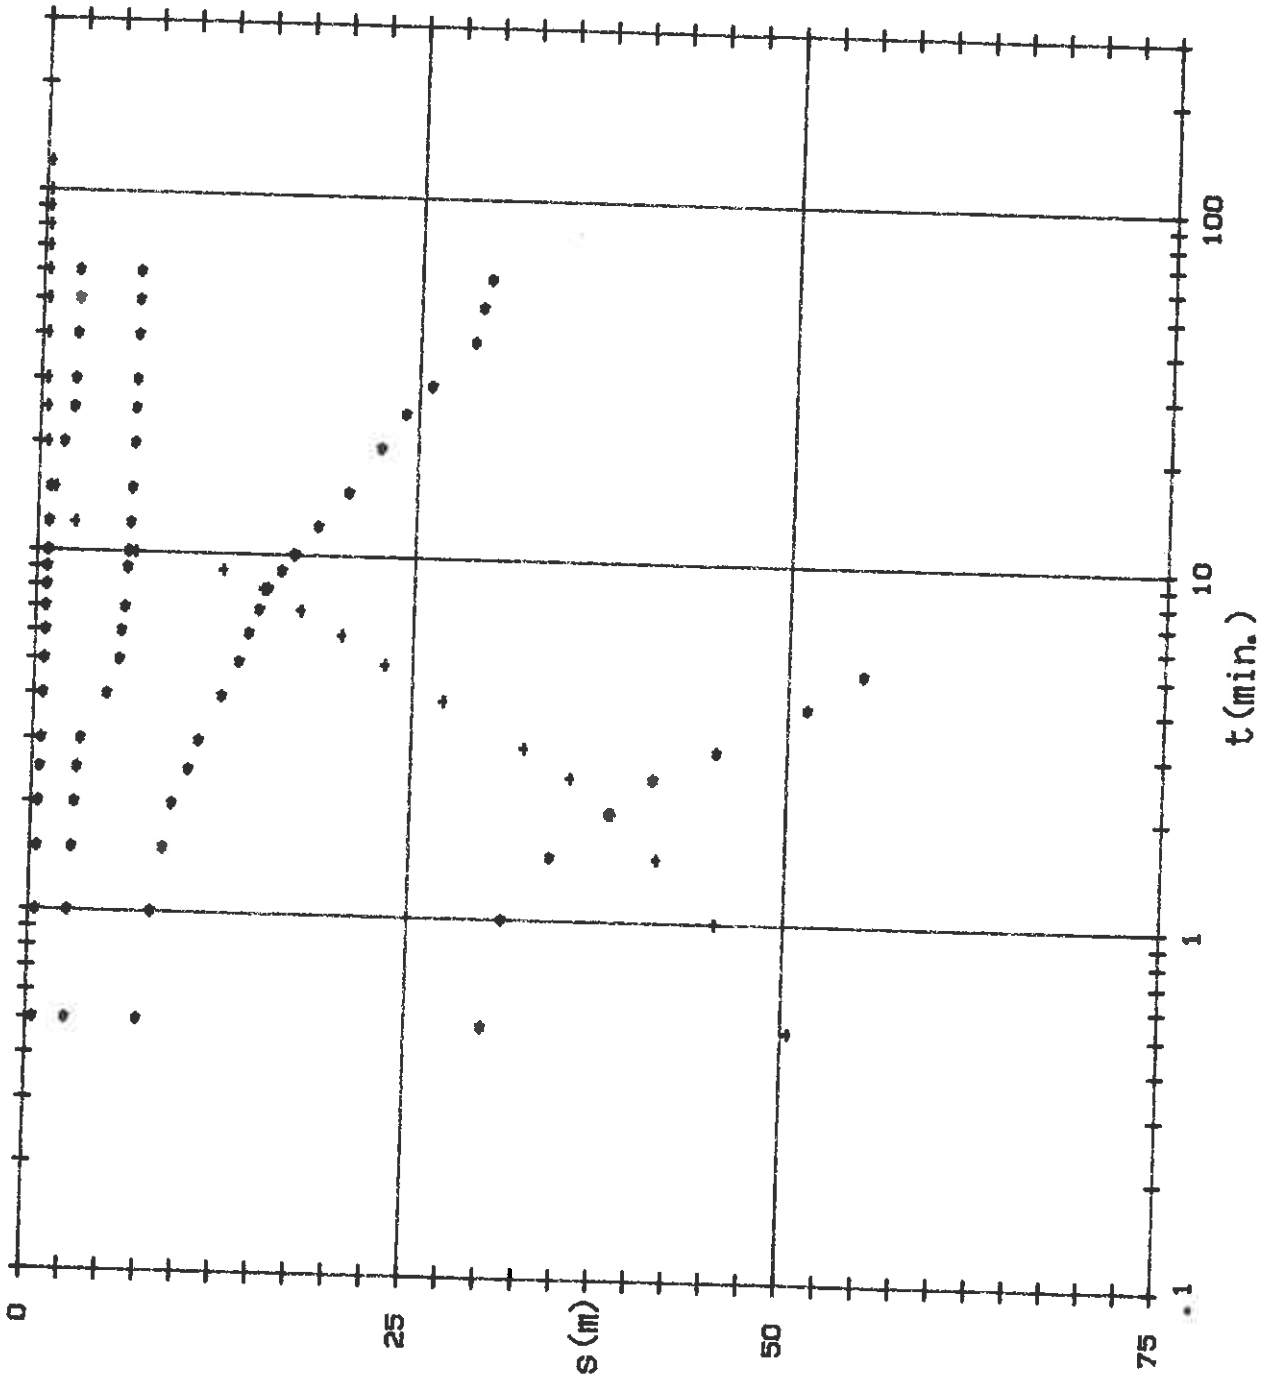
STEP DRAWDOWN TEST

* Pumping data
+ Recovery data

$Q_4 = 4 \text{ l/s}$

S.W.L. = 6.68 m

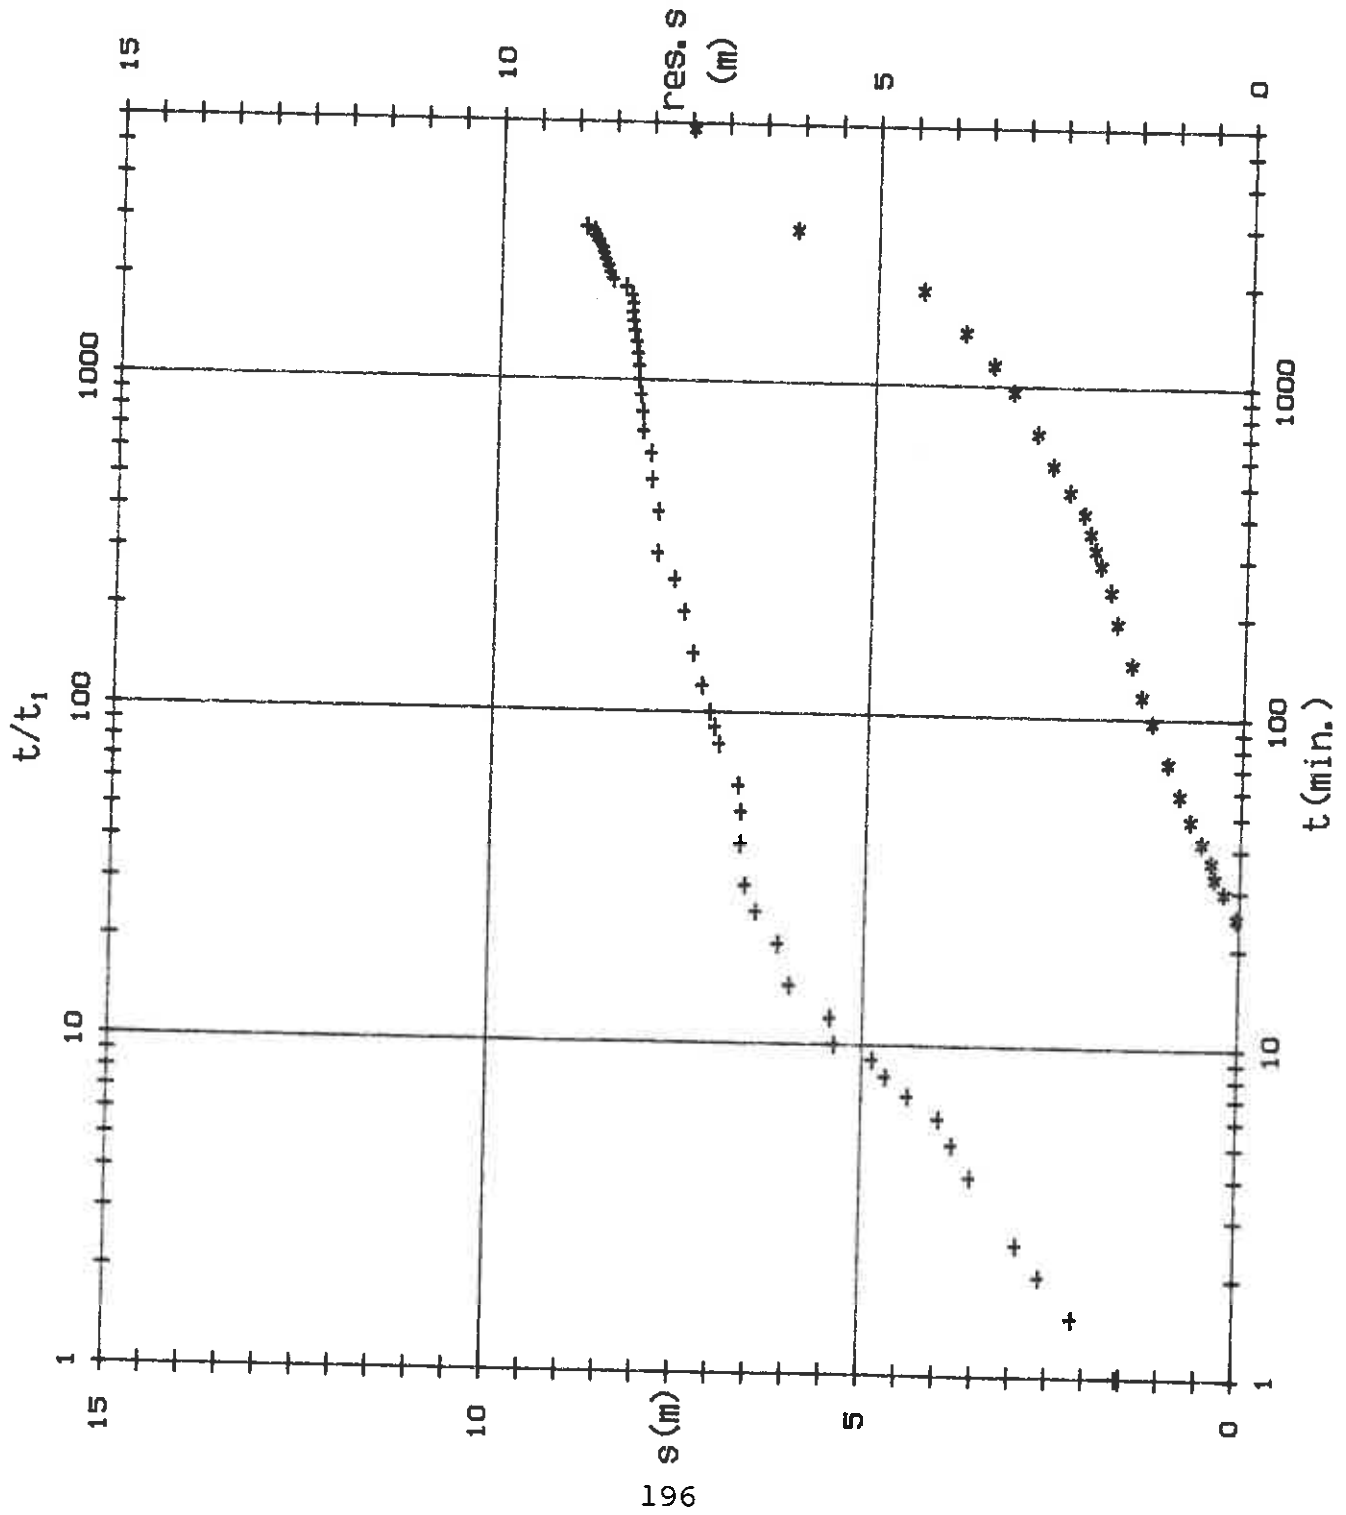
CONSTANT DISCHARGE TEST

- + Drawdown data.
- * Recovery data.

S. W. L. = 6.68 m

T = 5 m²/d
