REPUBLIC OF BOPHUTHATSWANA
DEPARTMENT OF WATER AFFAIRS

**REPORT ON THE SITING
DRILLING AND TESTING OF BOREHOLES,
AND THE TESTING OF EXISTING
BOREHOLES - DITSOBOTLA DISTRICT
JUNE 1991 - FEBRUARY 1993**

**VOLUME 1 - TEXT
AND APPENDIX I**

PARTRIDGE MAUD AND ASSOCIATES

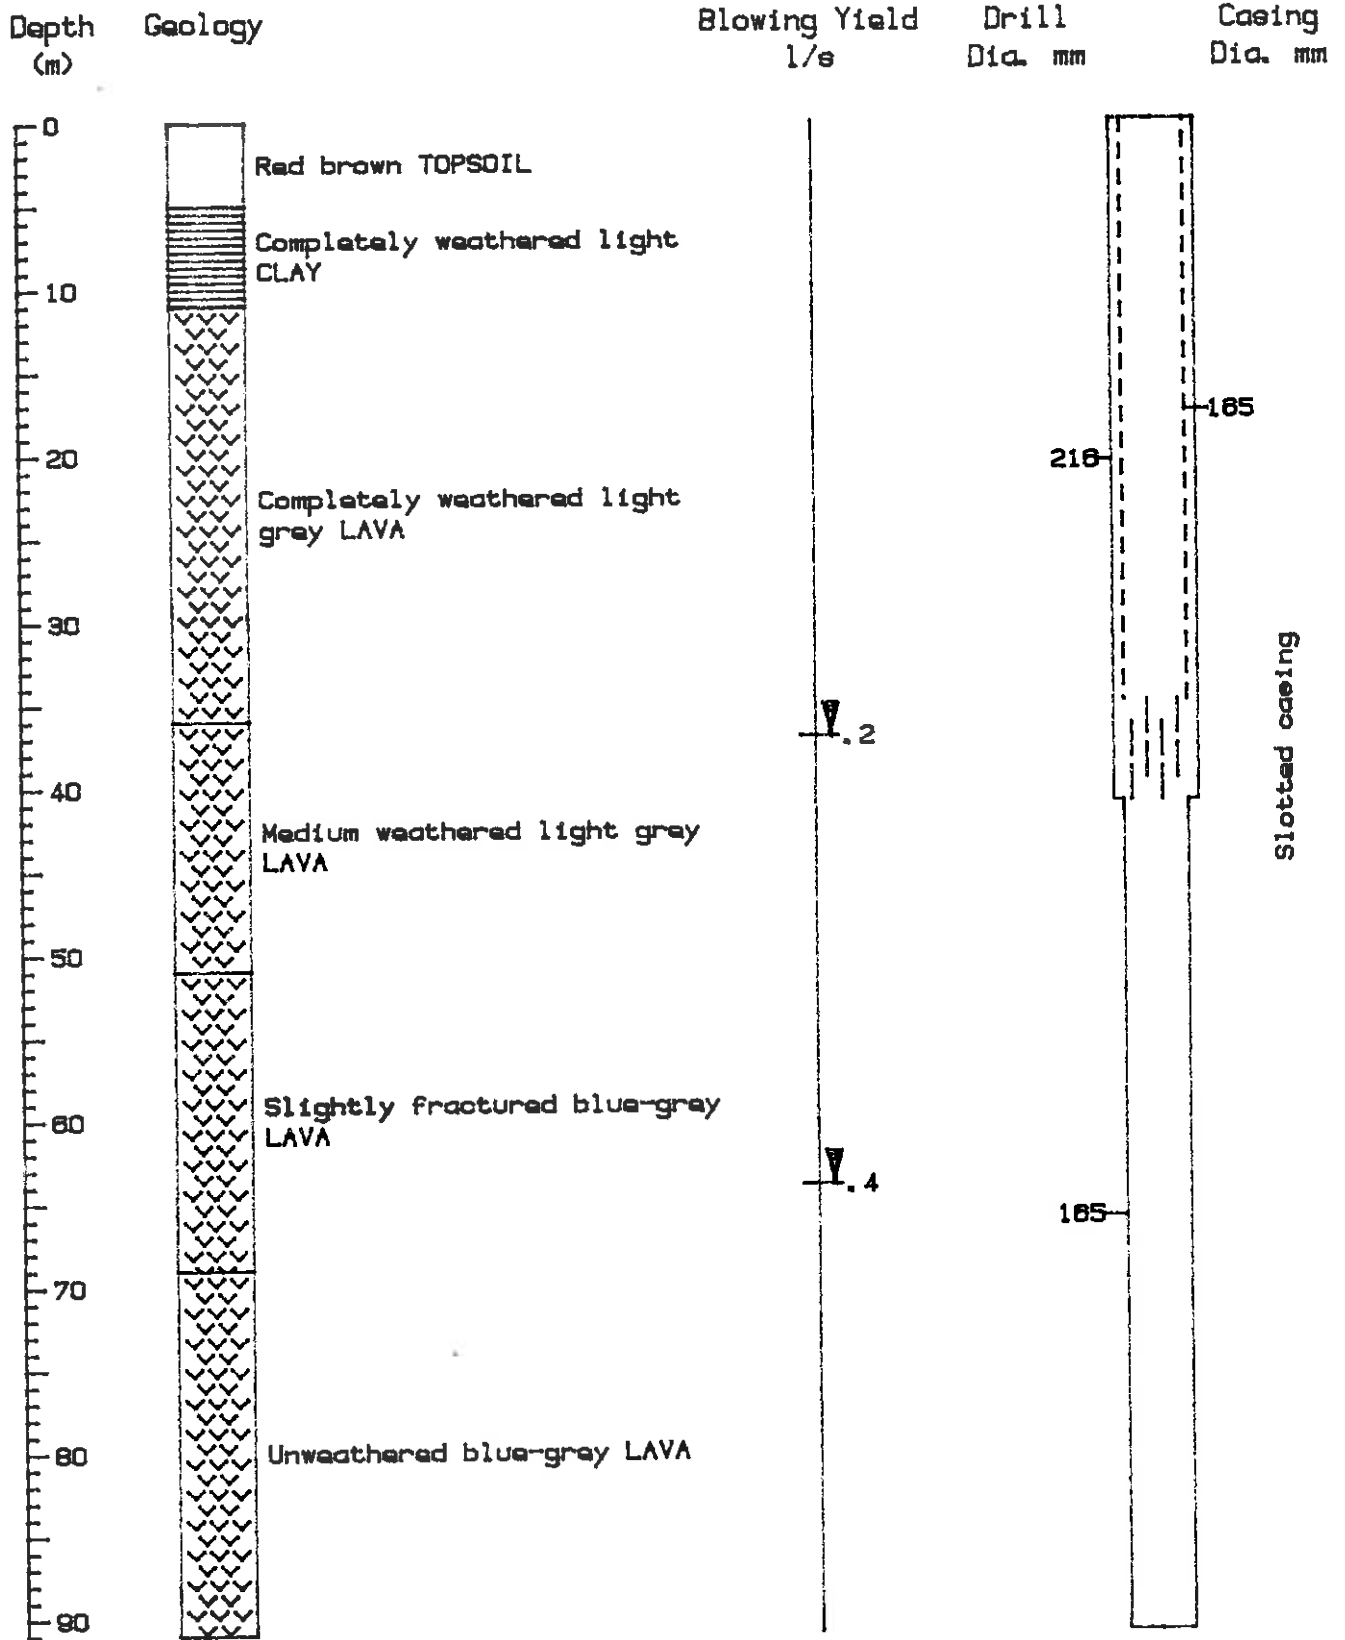
BOREHOLE LOG

Coordinates +2903700X -47300Y

Elev. (m) 1366

End of Hole 91

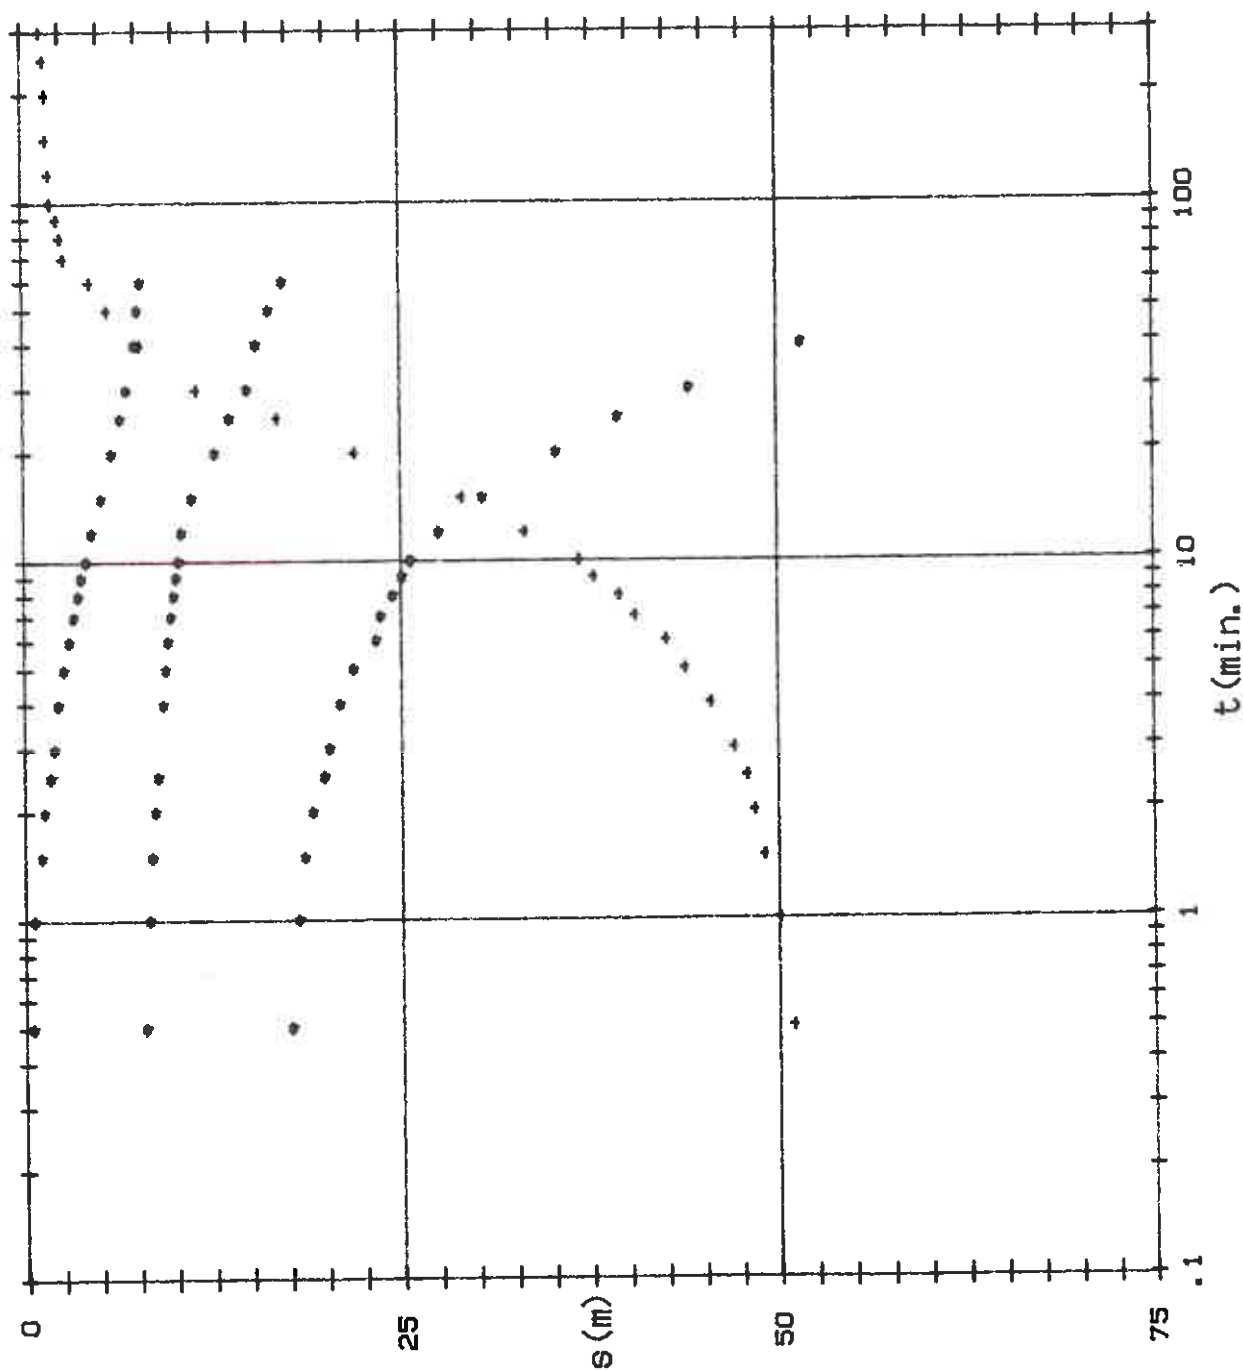
STEP DRAWDOWN TEST

$Q_3 = .81 \text{ l/s}$

S.W.L. = 19.25 m

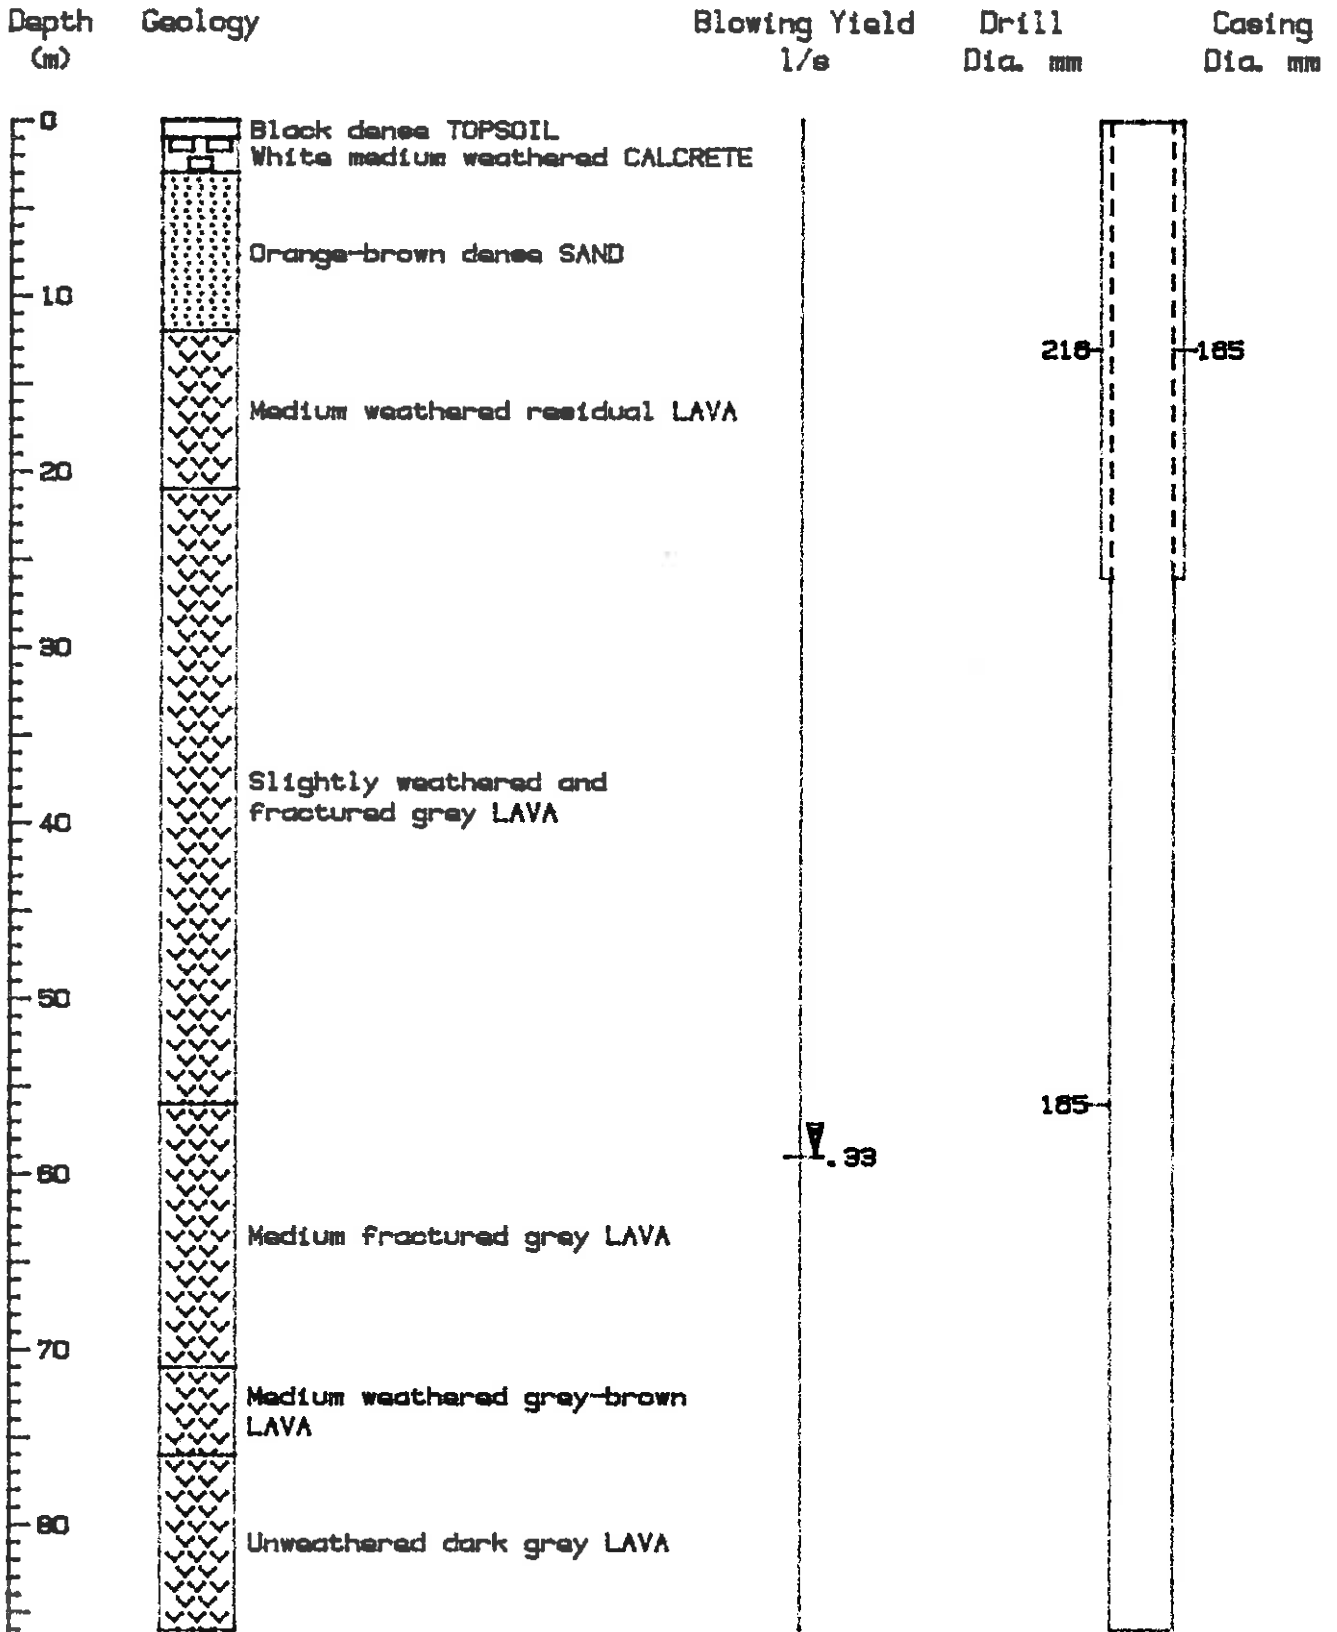
BOREHOLE LOG

Coordinates +2904350X -47500Y

Elev. (m) 1361

End of Hole 88

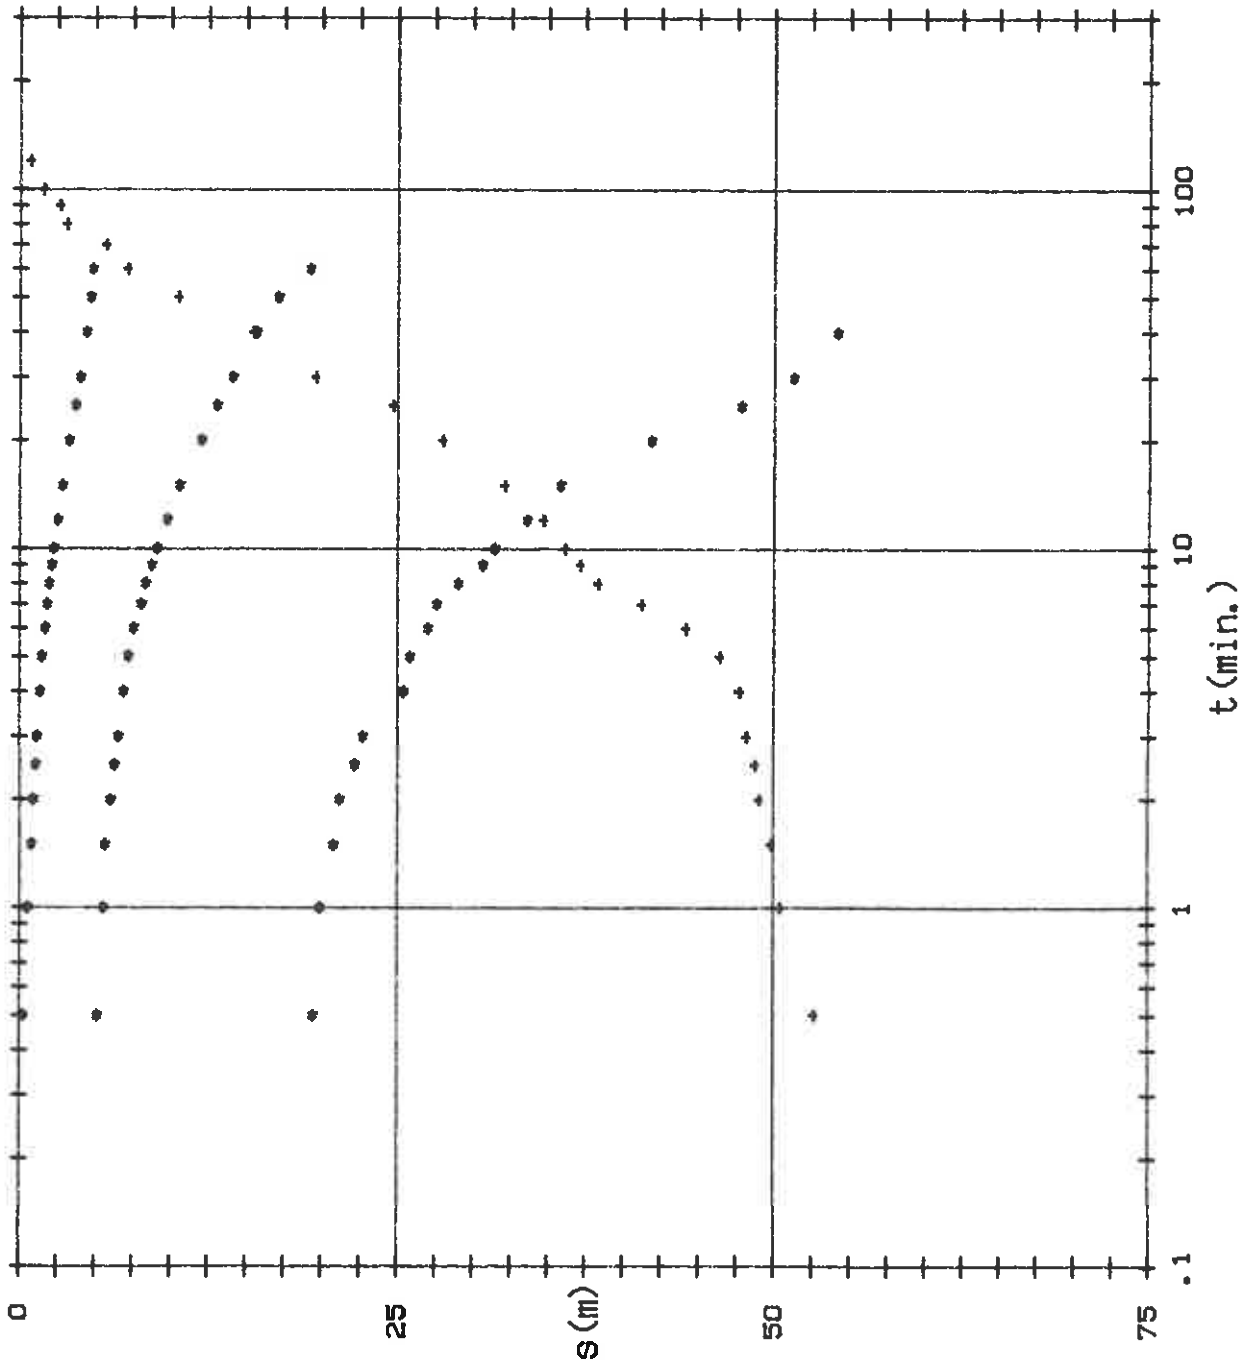
STEP DRAWDOWN TEST

$Q_3 = .65 \text{ l/s}$

S.W.L. = 19.02 m

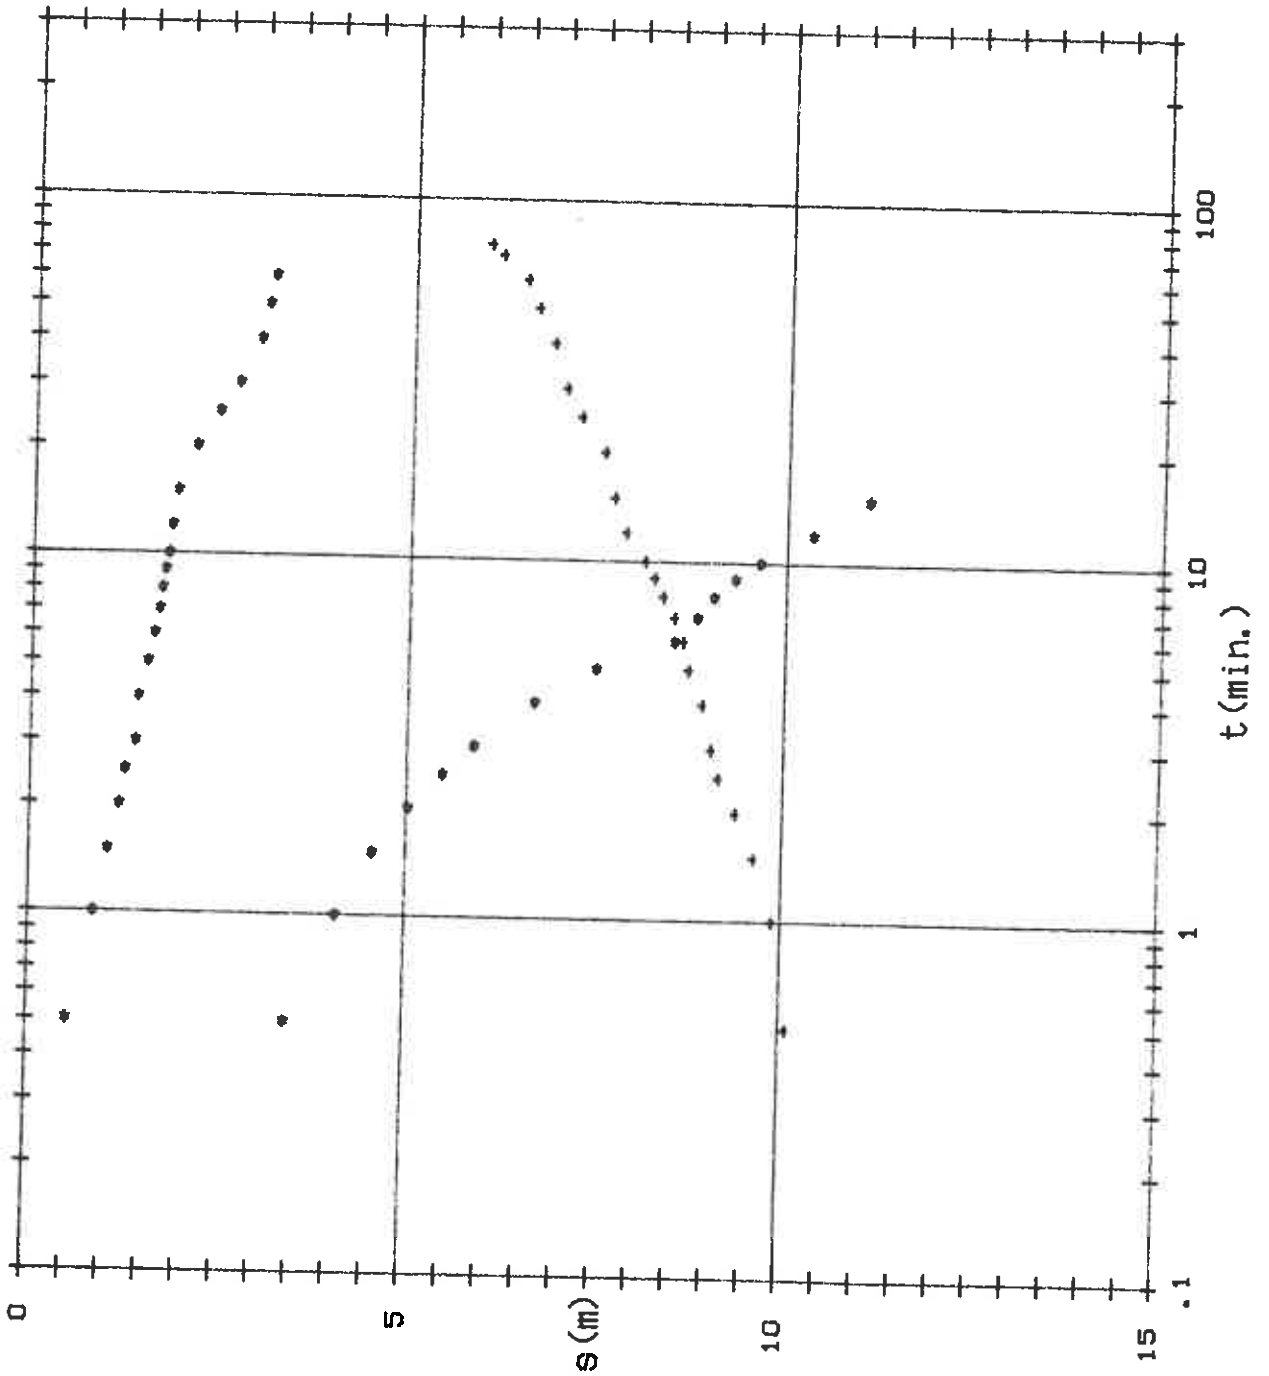
$Q_2 = .45 \text{ l/s}$

S.W.L. = 22.83 m

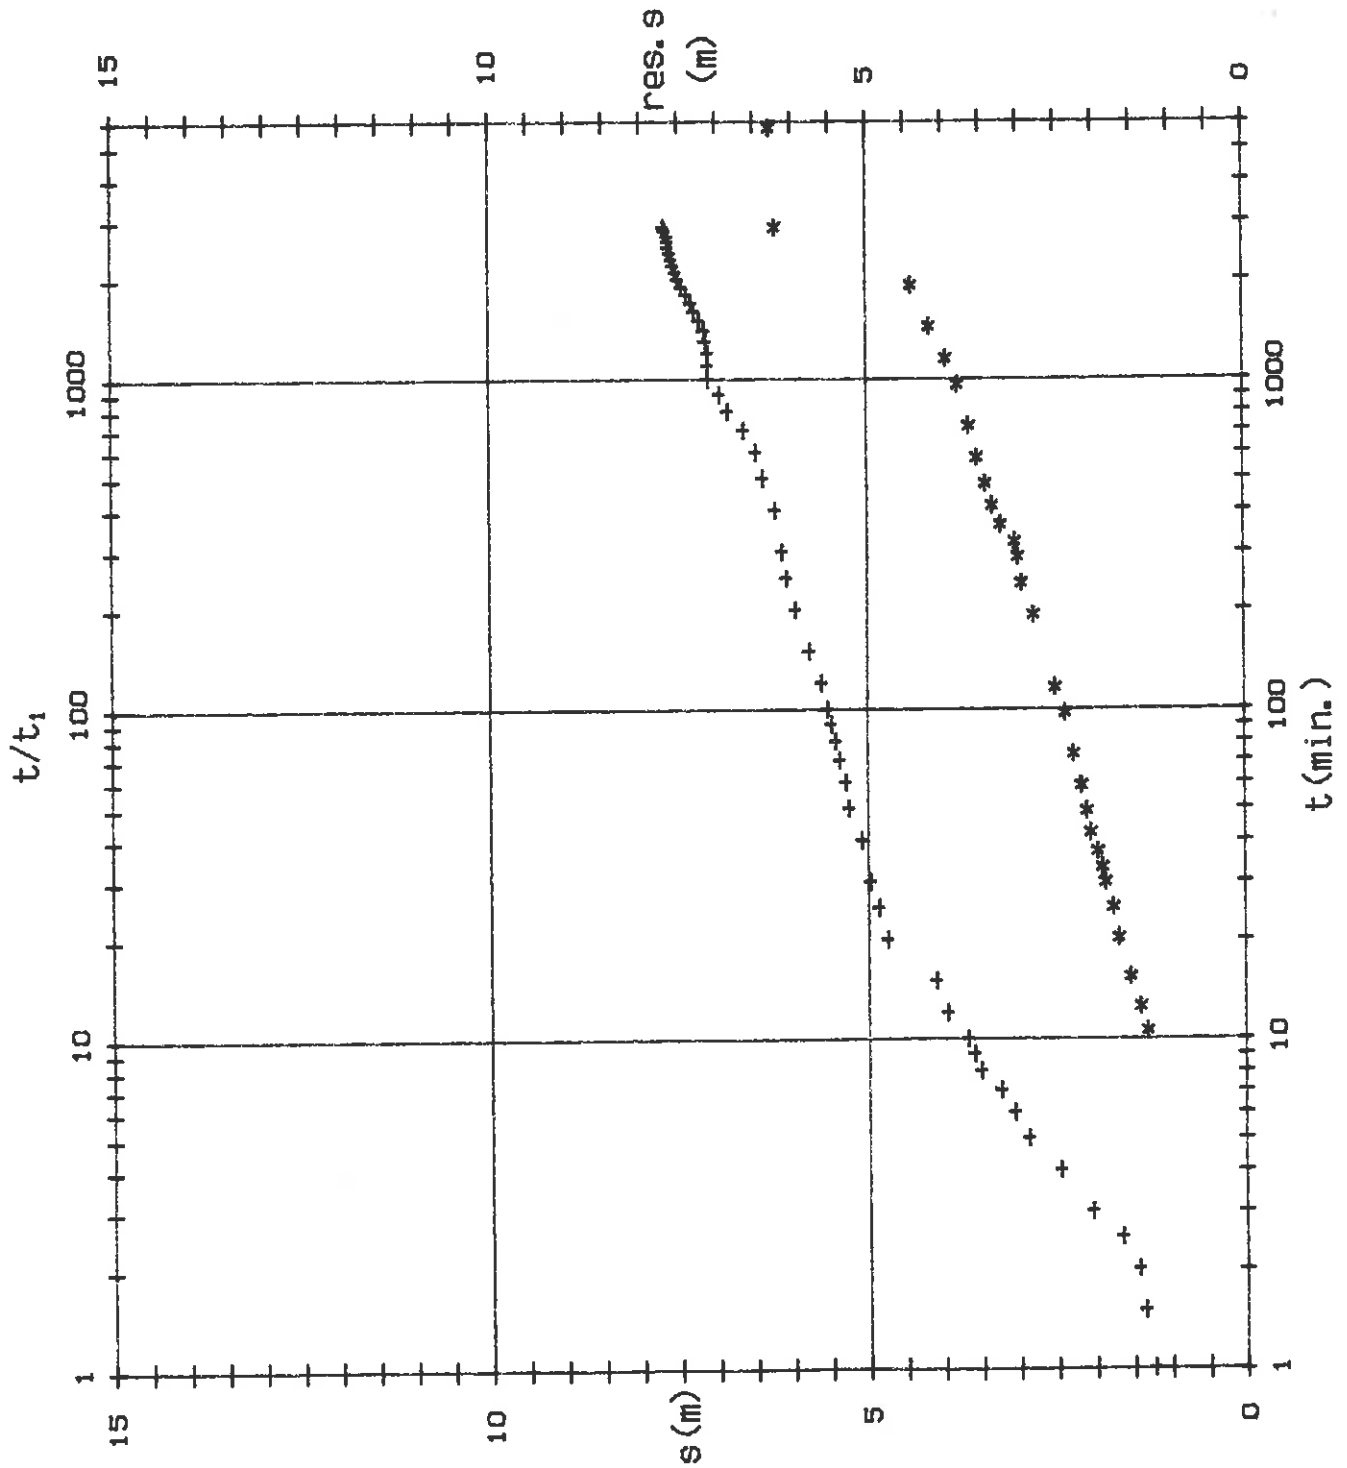
STEP DRAWDOWN TEST

- * Pumping data
- + Recovery data

$Q_4 = 2.7 \text{ l/s}$

S.W.L. = 24.58 m

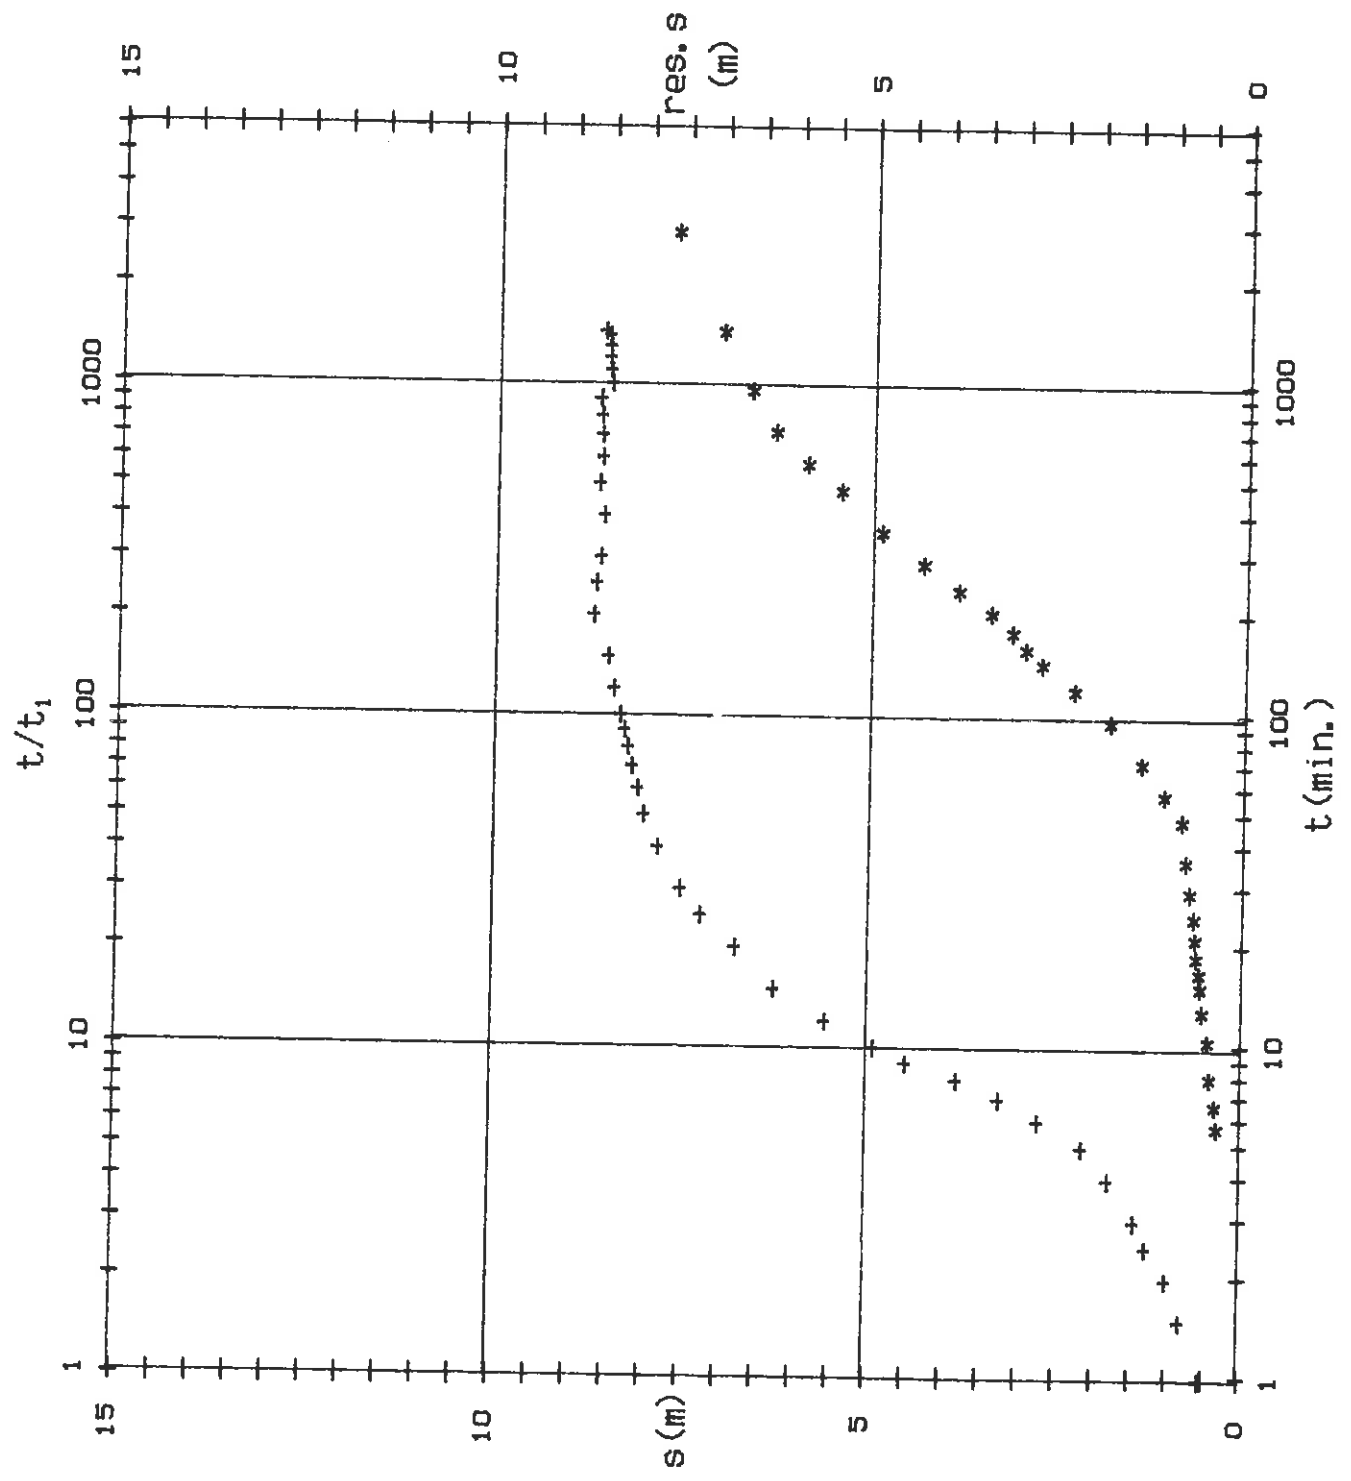
STEP DRAWDOWN TEST

$Q_3 = 1.1 \text{ l/s}$

S.W.L. = 10.03 m

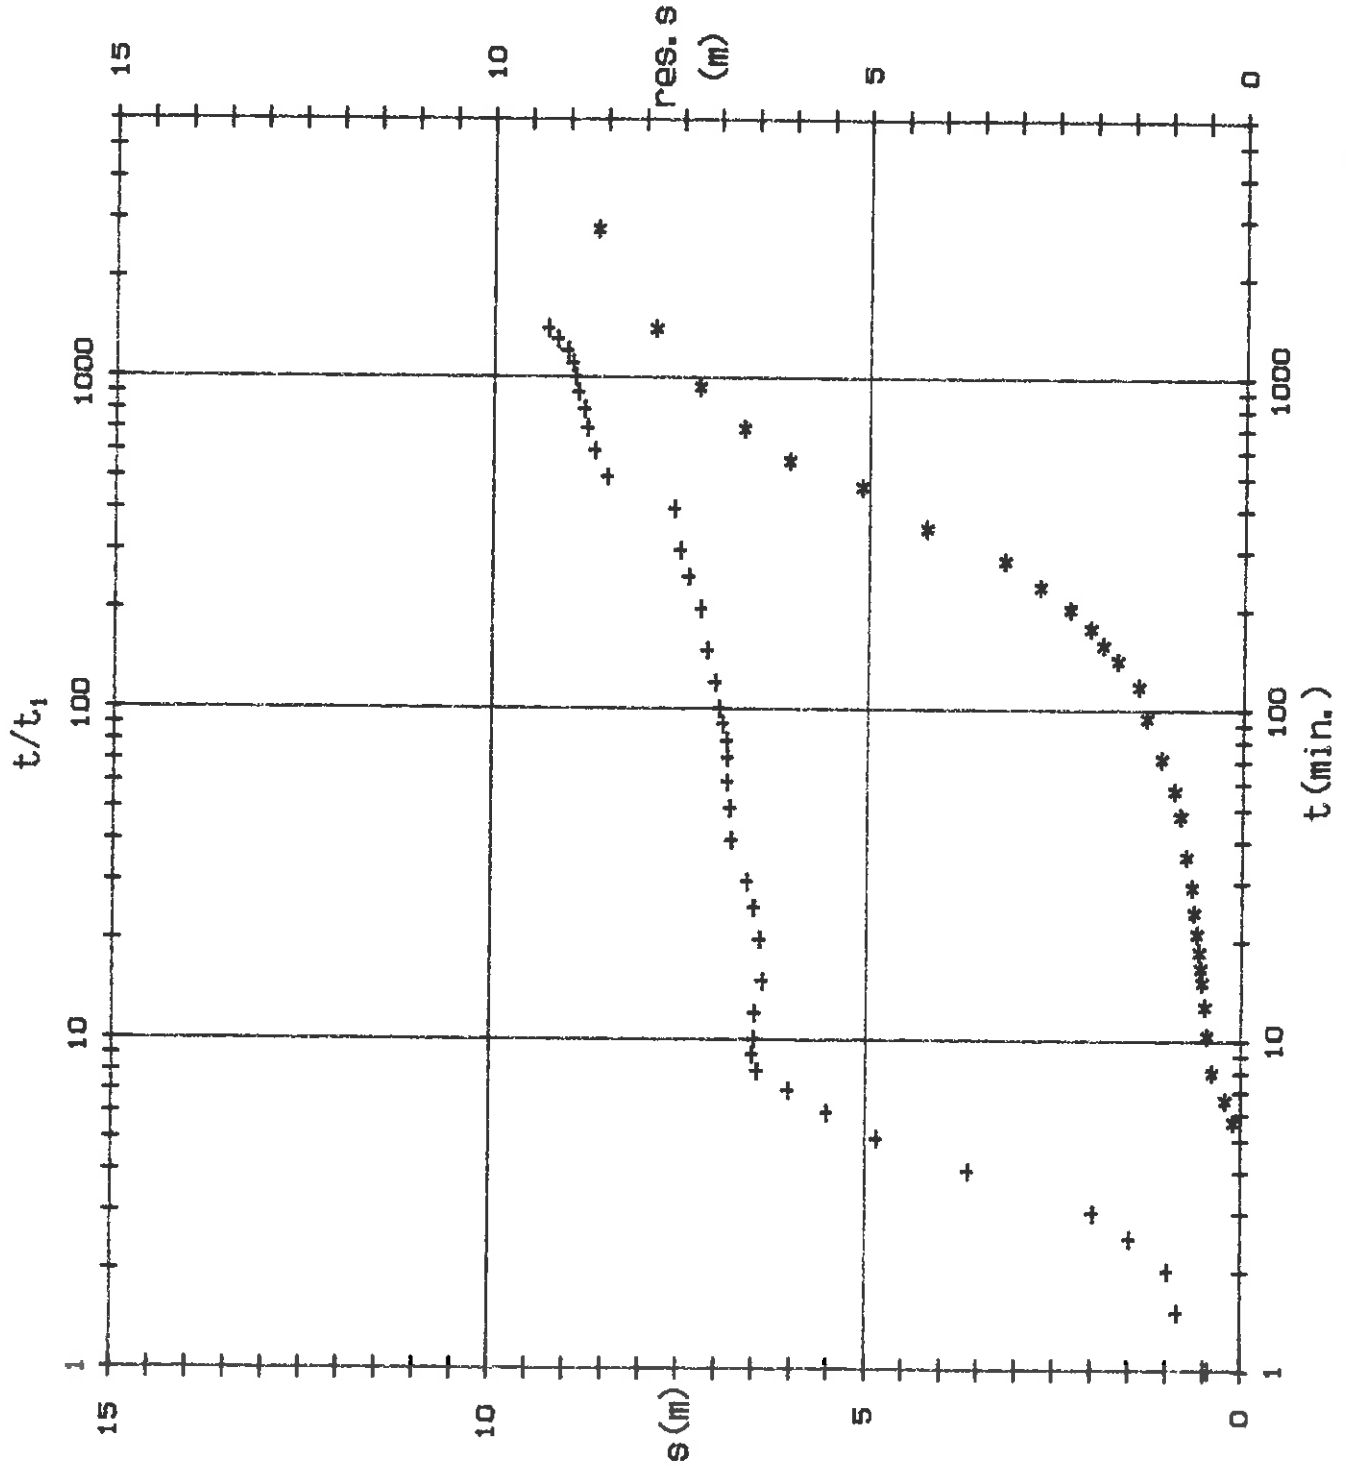
STEP DRAWDOWN TEST

$Q_4 = 1.5$ l/s

S.W.L. = 25.25 m

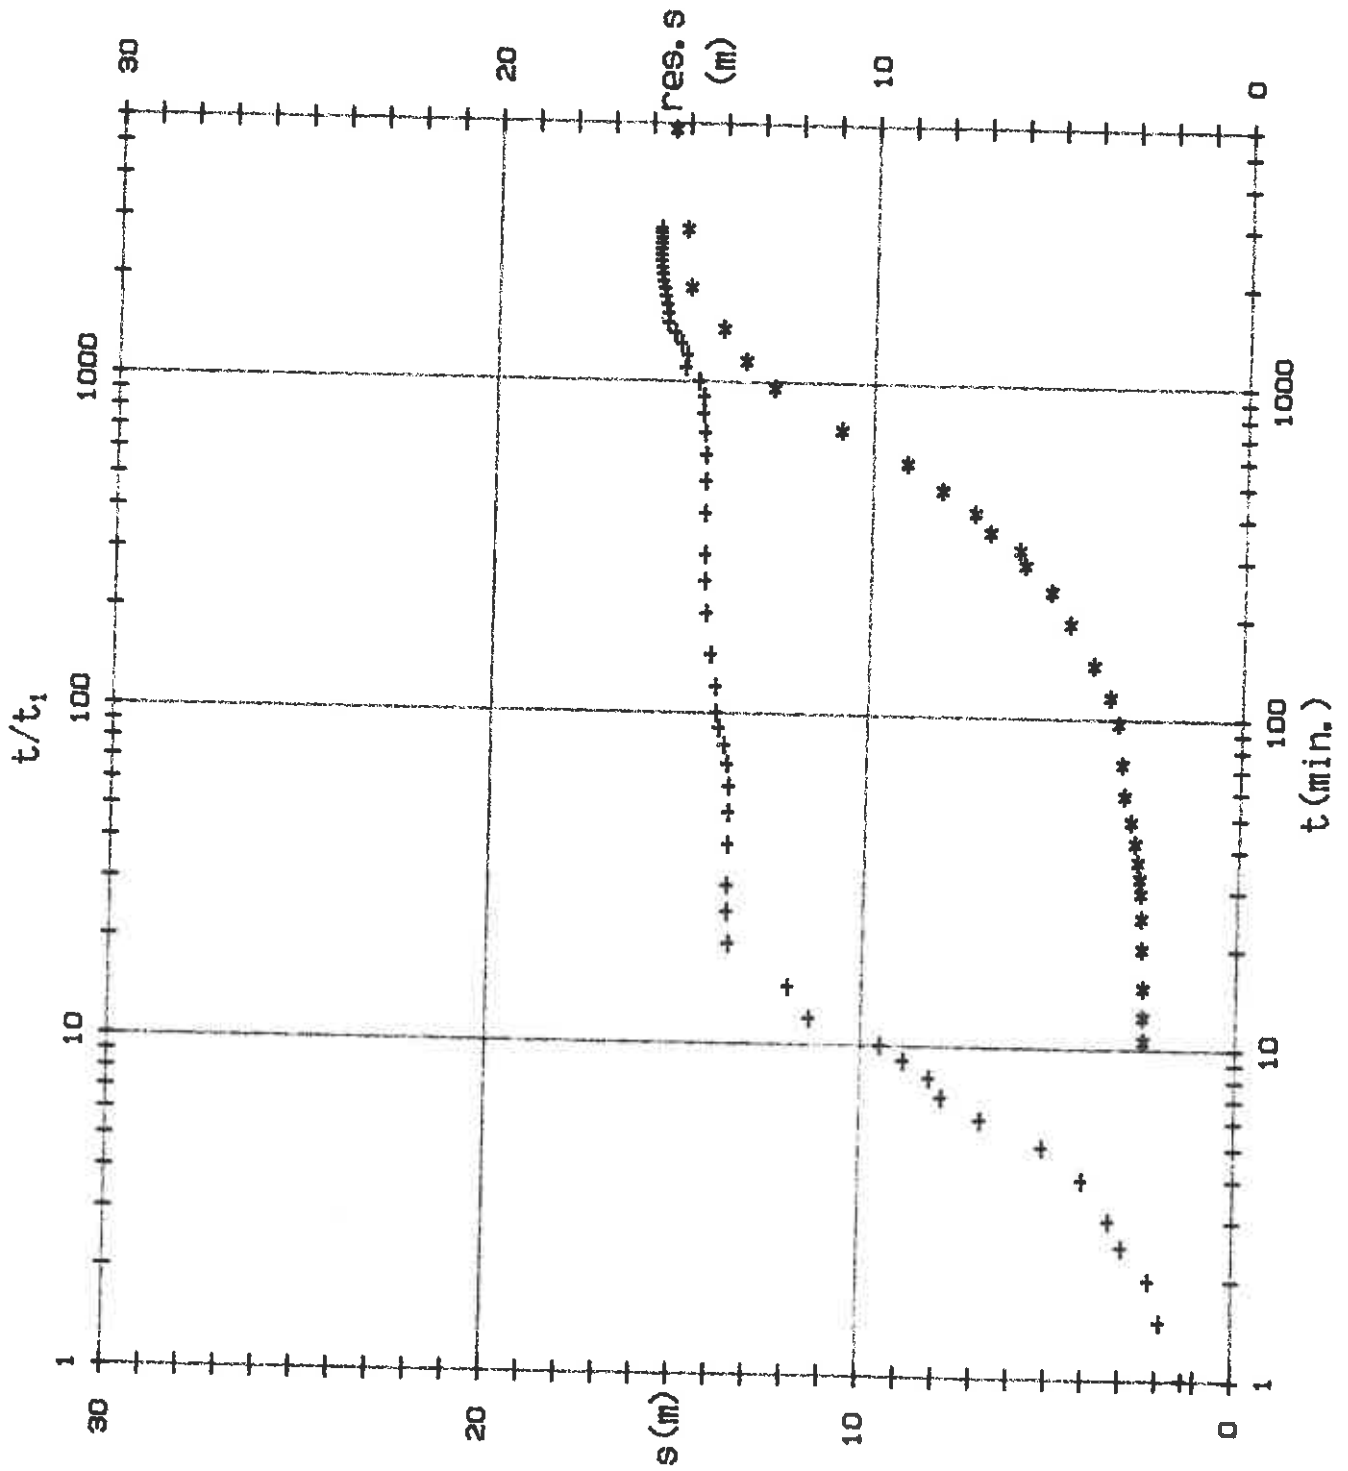
STEP DRAWDOWN TEST

$Q_4 = 1.5 \text{ l/s}$

S.W.L. = 17.96 m

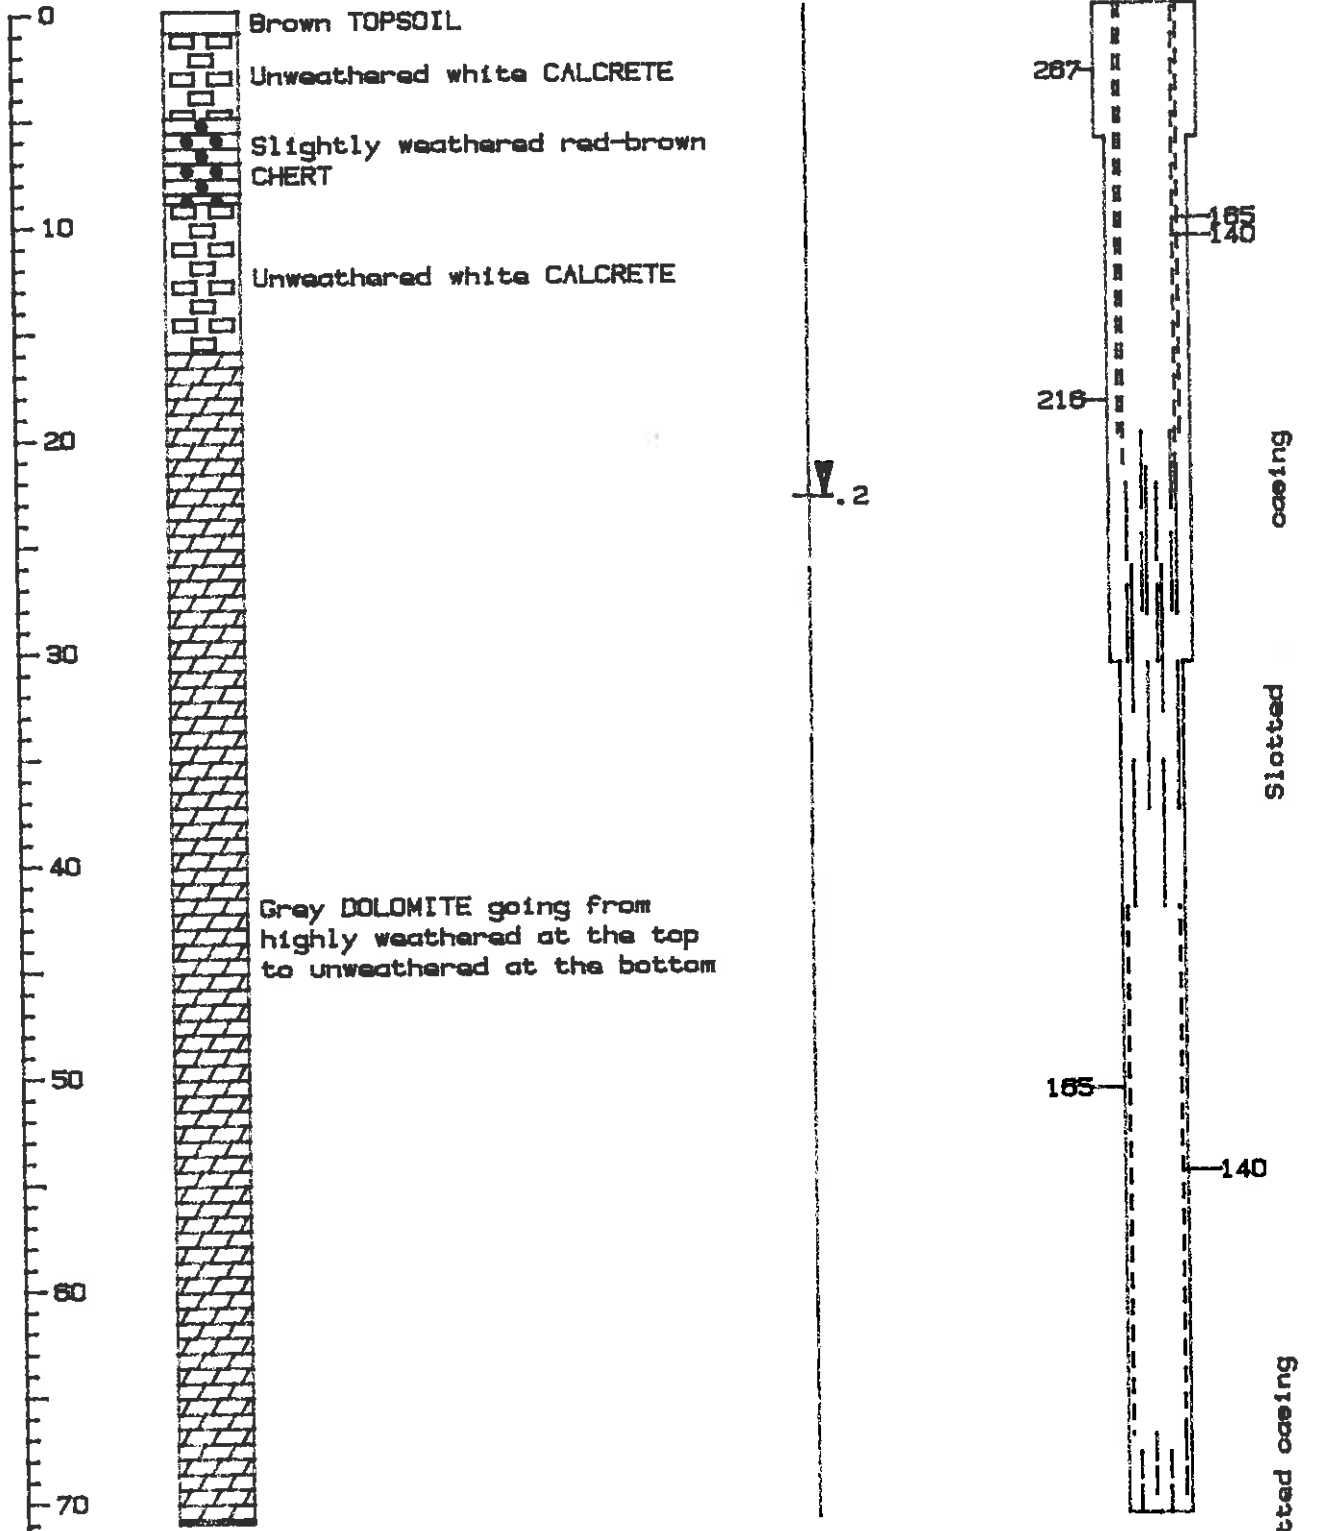
BOREHOLE LOG

Elev. (m) 1421

Depth (m)	Geology	Blowing Yield l/s	Drill Dia. mm	Casing Dia. mm
-----------	---------	-------------------	---------------	----------------

End of Hole 71

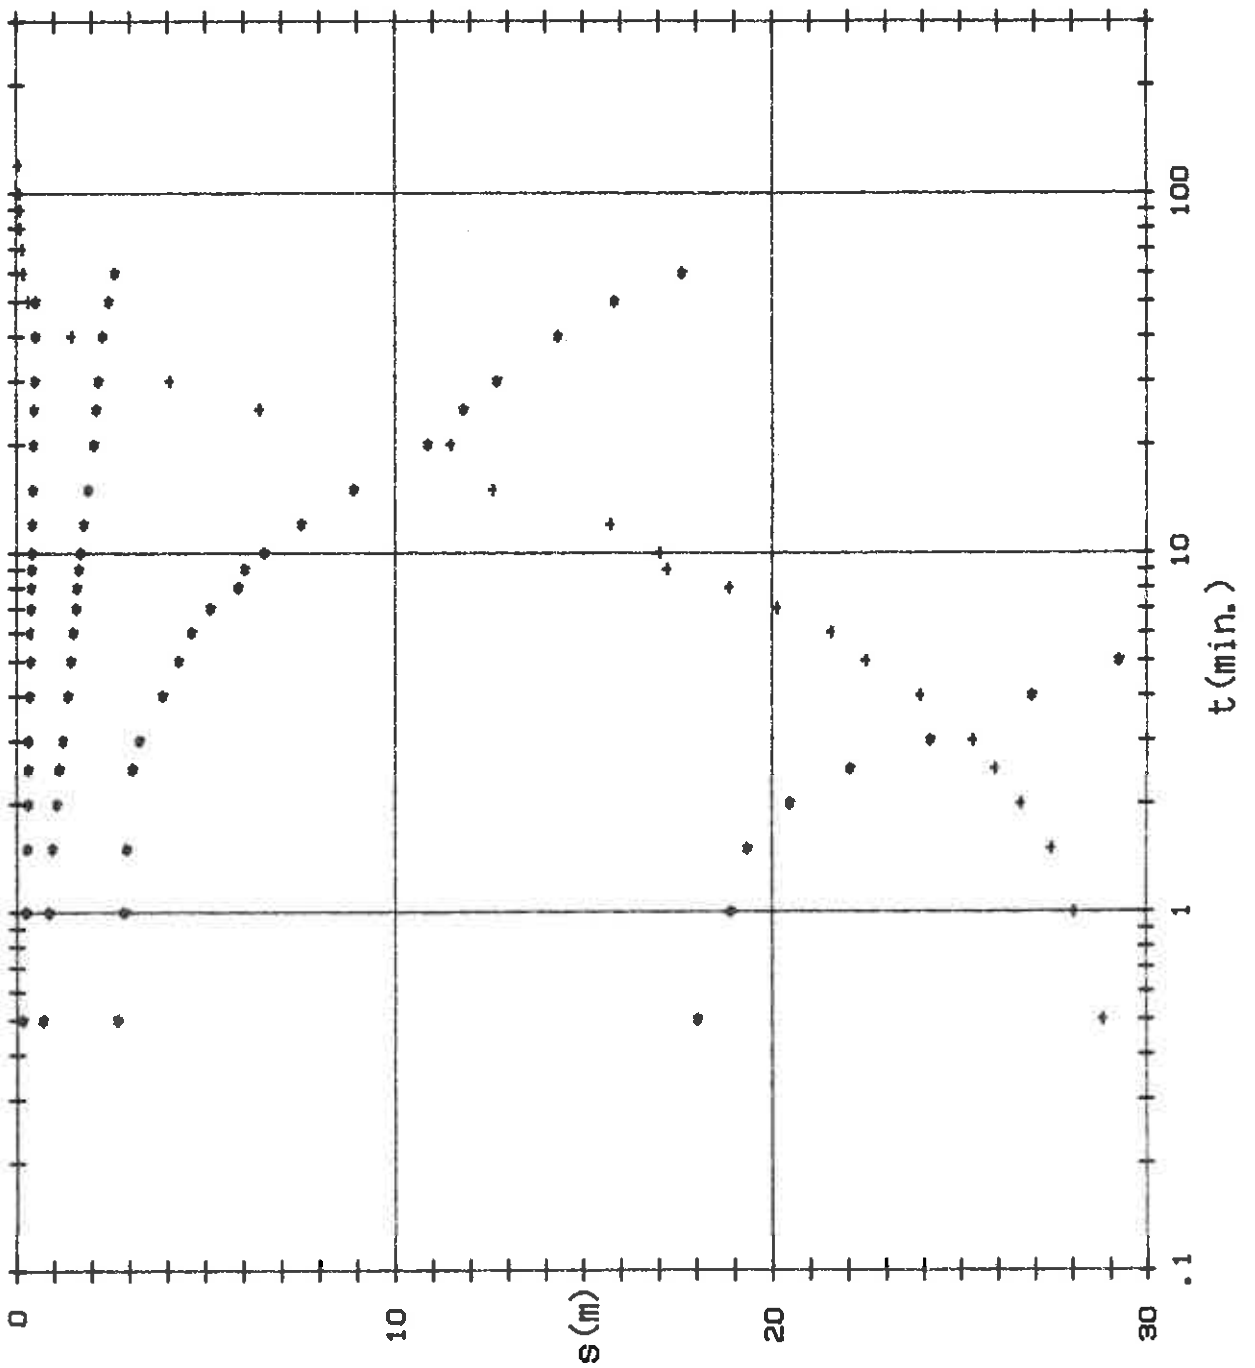
STEP DRAWDOWN TEST

$Q_4 = 1.2$ l/s

S.W.L. = 10.66 m
