REPUBLIC OF BOPHUTHATSWANA
DEPARTMENT OF WATER AFFAIRS

**REPORT ON THE SITING
DRILLING AND TESTING OF BOREHOLES,
AND THE TESTING OF EXISTING
BOREHOLES - DITSOBOTLA DISTRICT
JUNE 1991 - FEBRUARY 1993**

**VOLUME 1 - TEXT
AND APPENDIX I**

PARTRIDGE MAUD AND ASSOCIATES

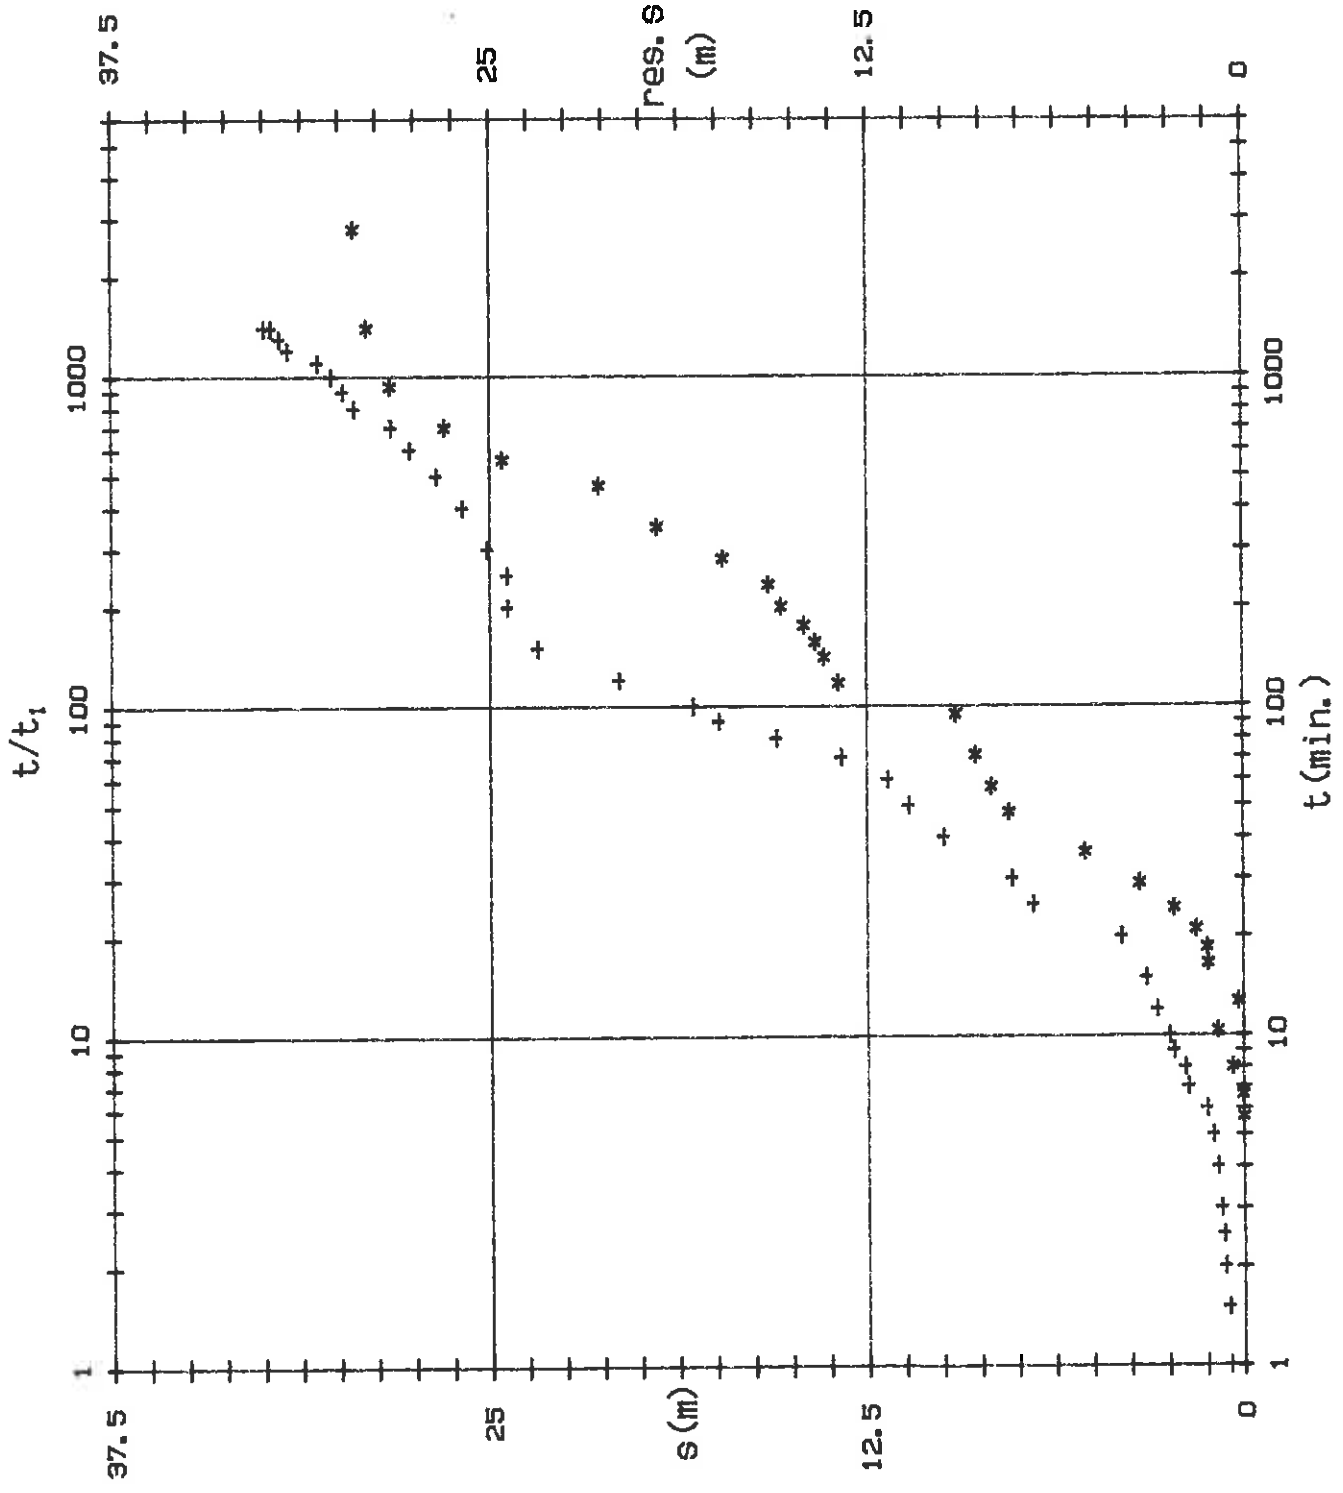
CONSTANT DISCHARGE TEST

+ Drawdown data.

S.W.L. = 10.66 m

$T = .5 \text{ m}^2/\text{d}$

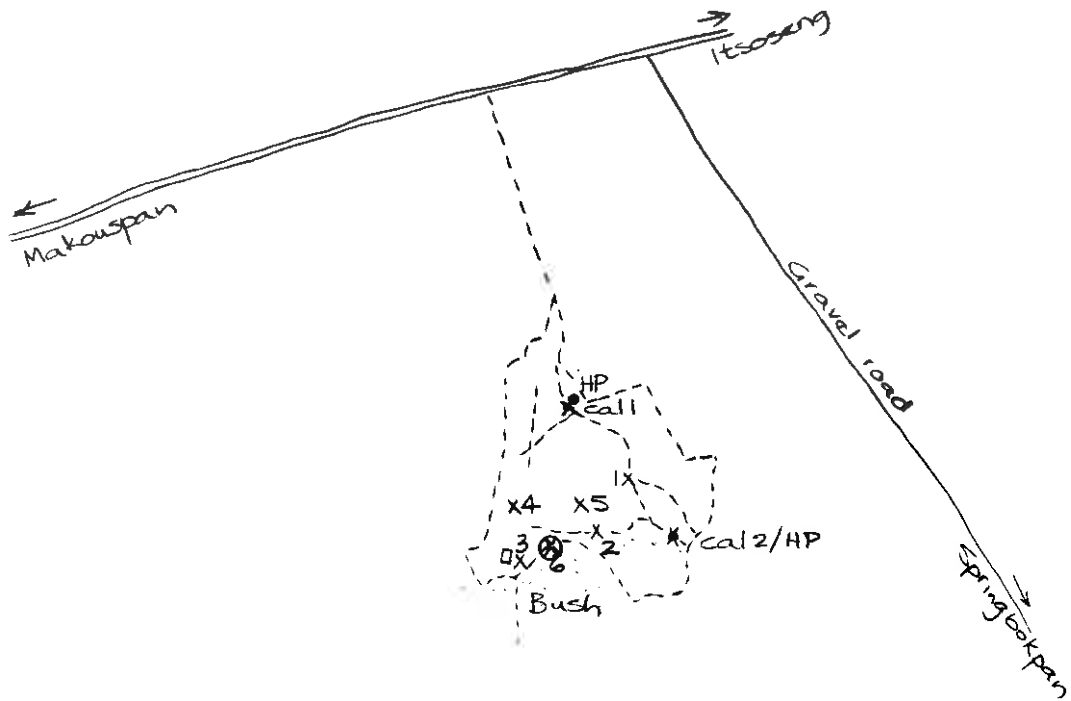
Locality Plan of Matila 2
Overlay to Photo No 049 (strip 12)

Approx Scale 1:30 000

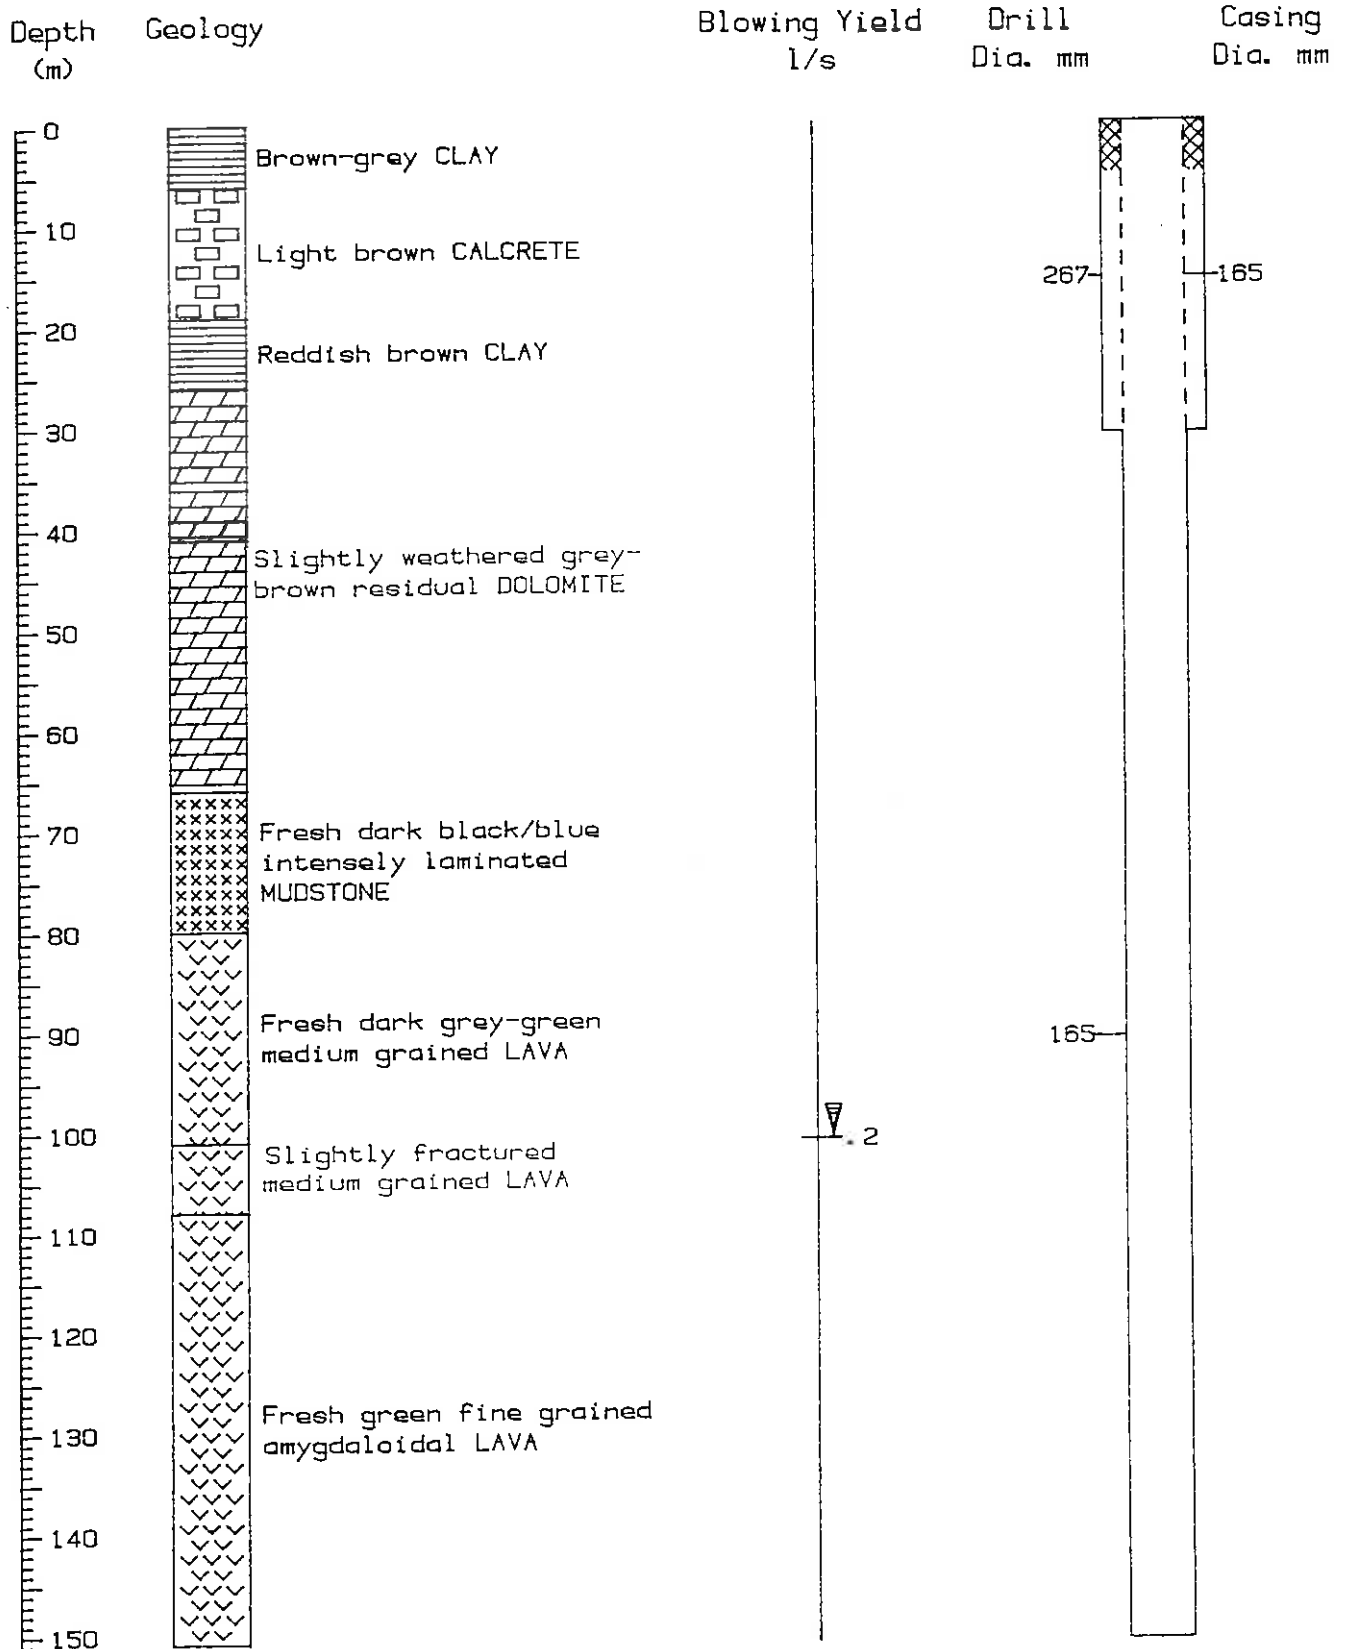
BOREHOLE LOG

Coordinates +2883400X -73050Y

Elev. (m) 1421

End of Hole 151

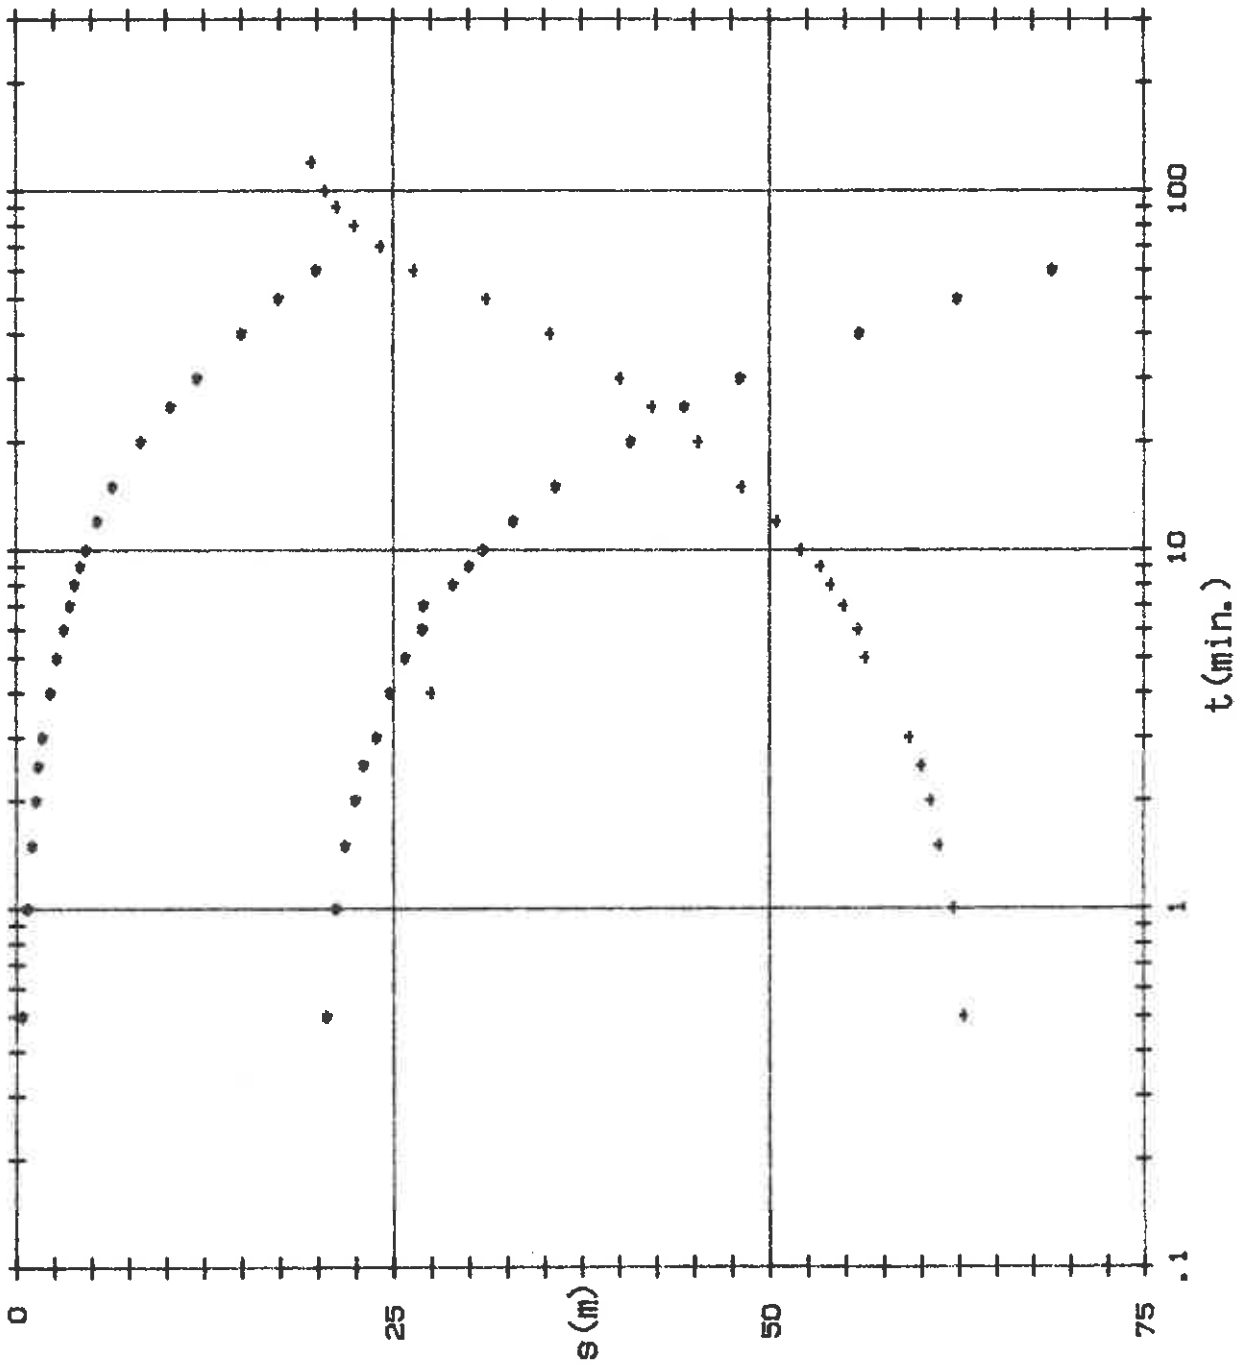
STEP DRAWDOWN TEST

$Q_2 = .48 \text{ l/s}$

S.W.L. = 13.74 m

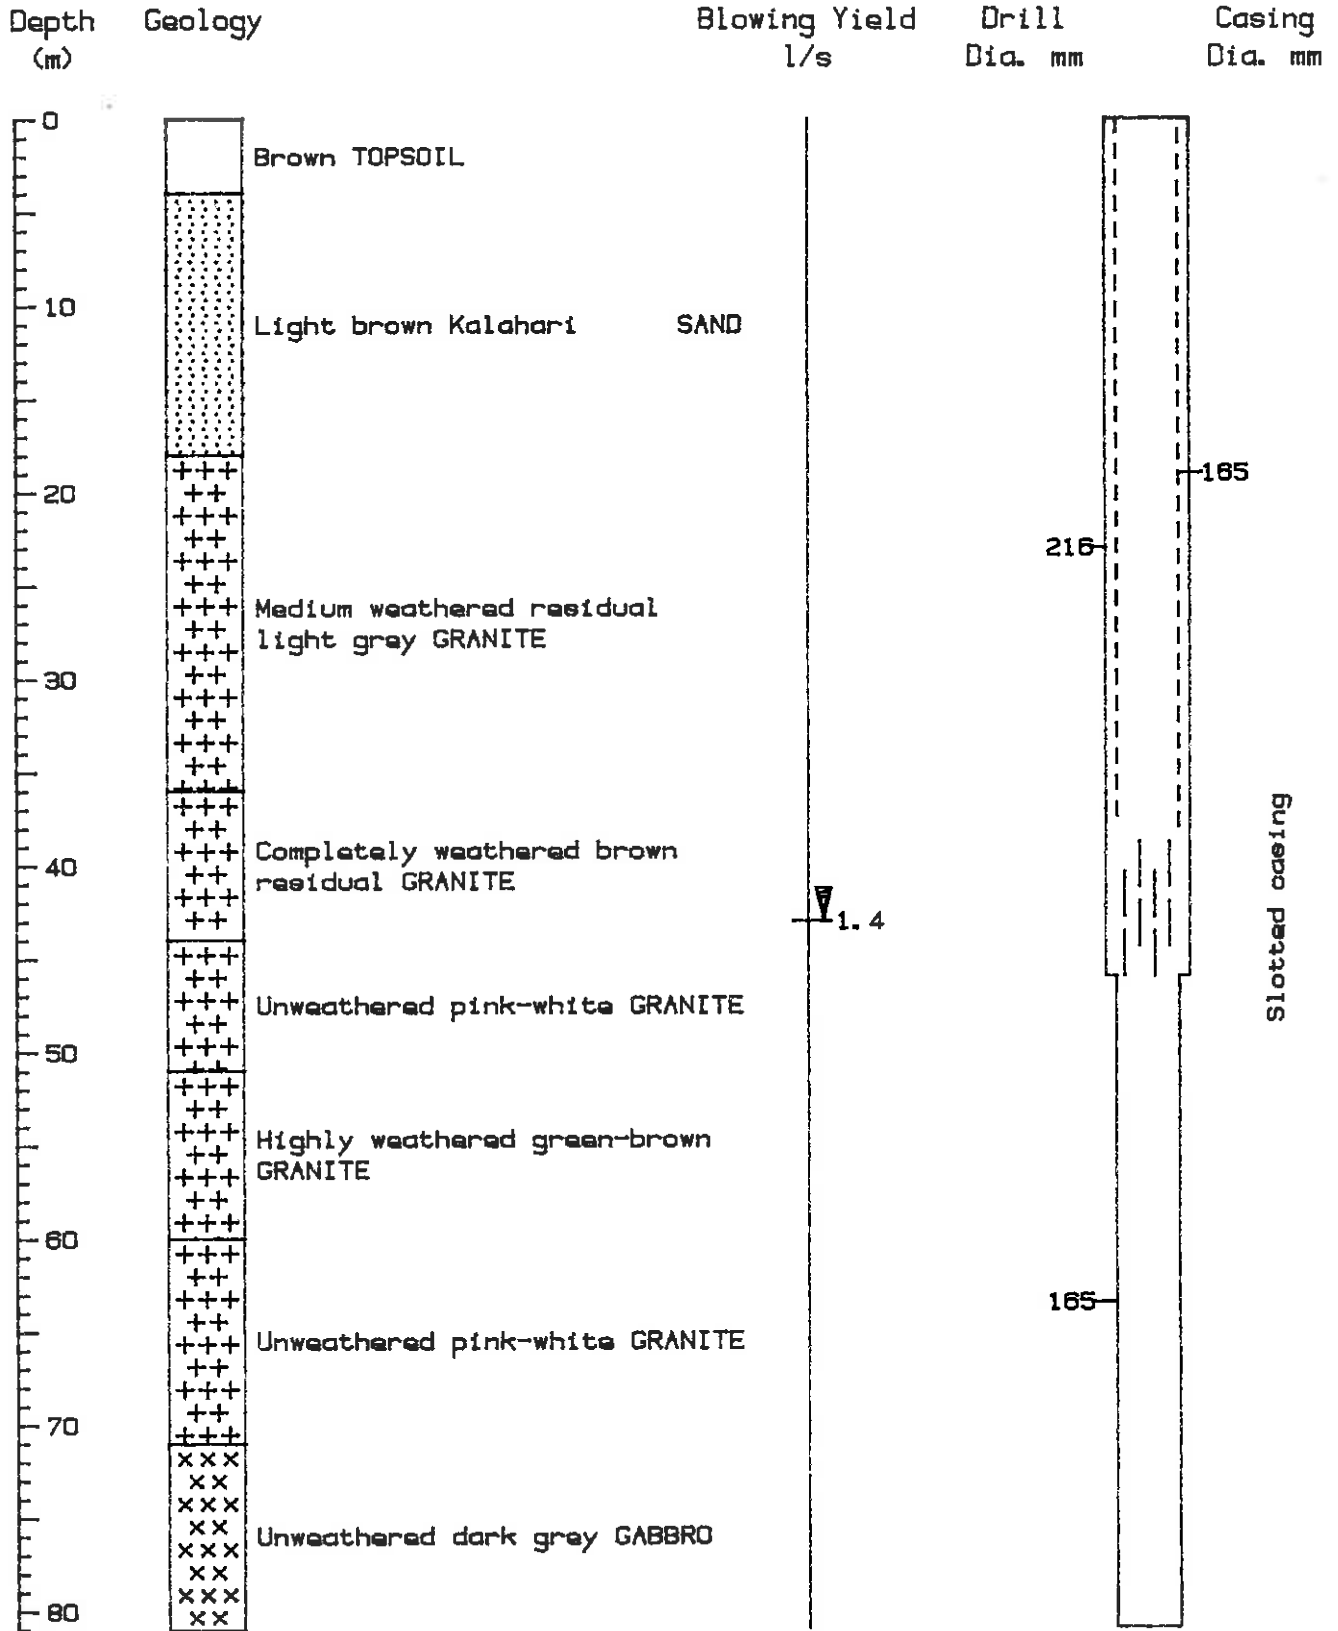
Coordinates +2930150X -33050Y

Elev. (m) 1369

End of Hole 81

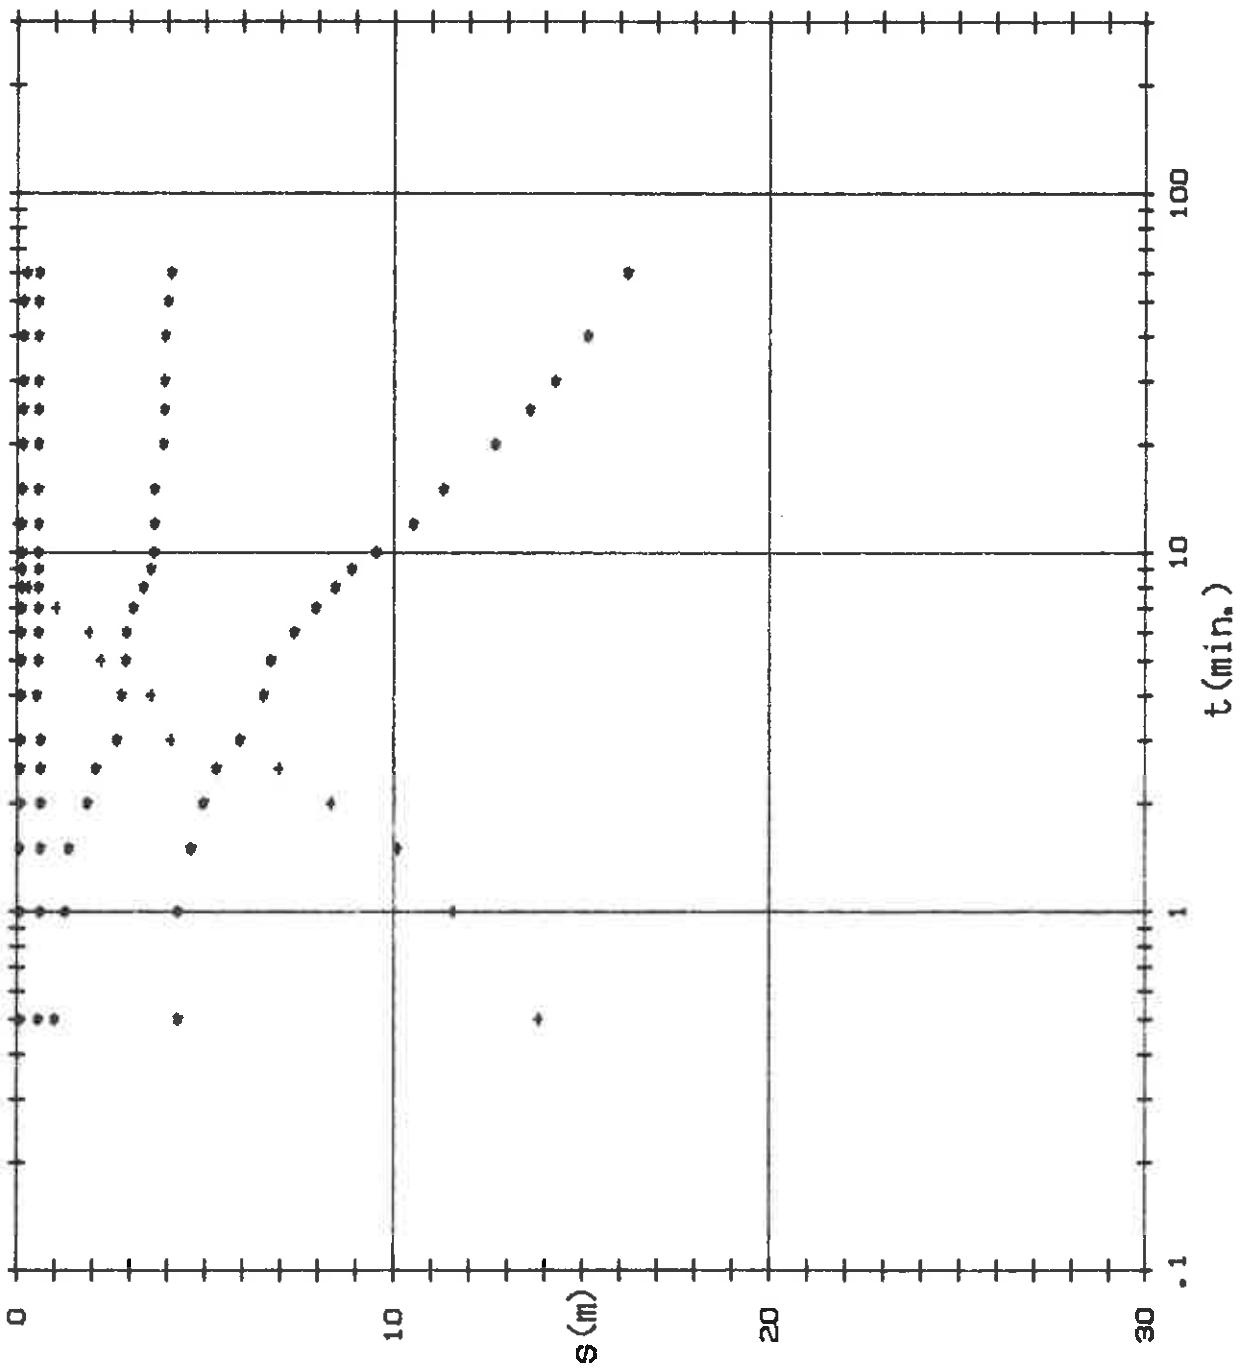
STEP DRAWDOWN TEST

$Q_4 = 2.45 \text{ l/s}$

S.W.L. = 18.87 m

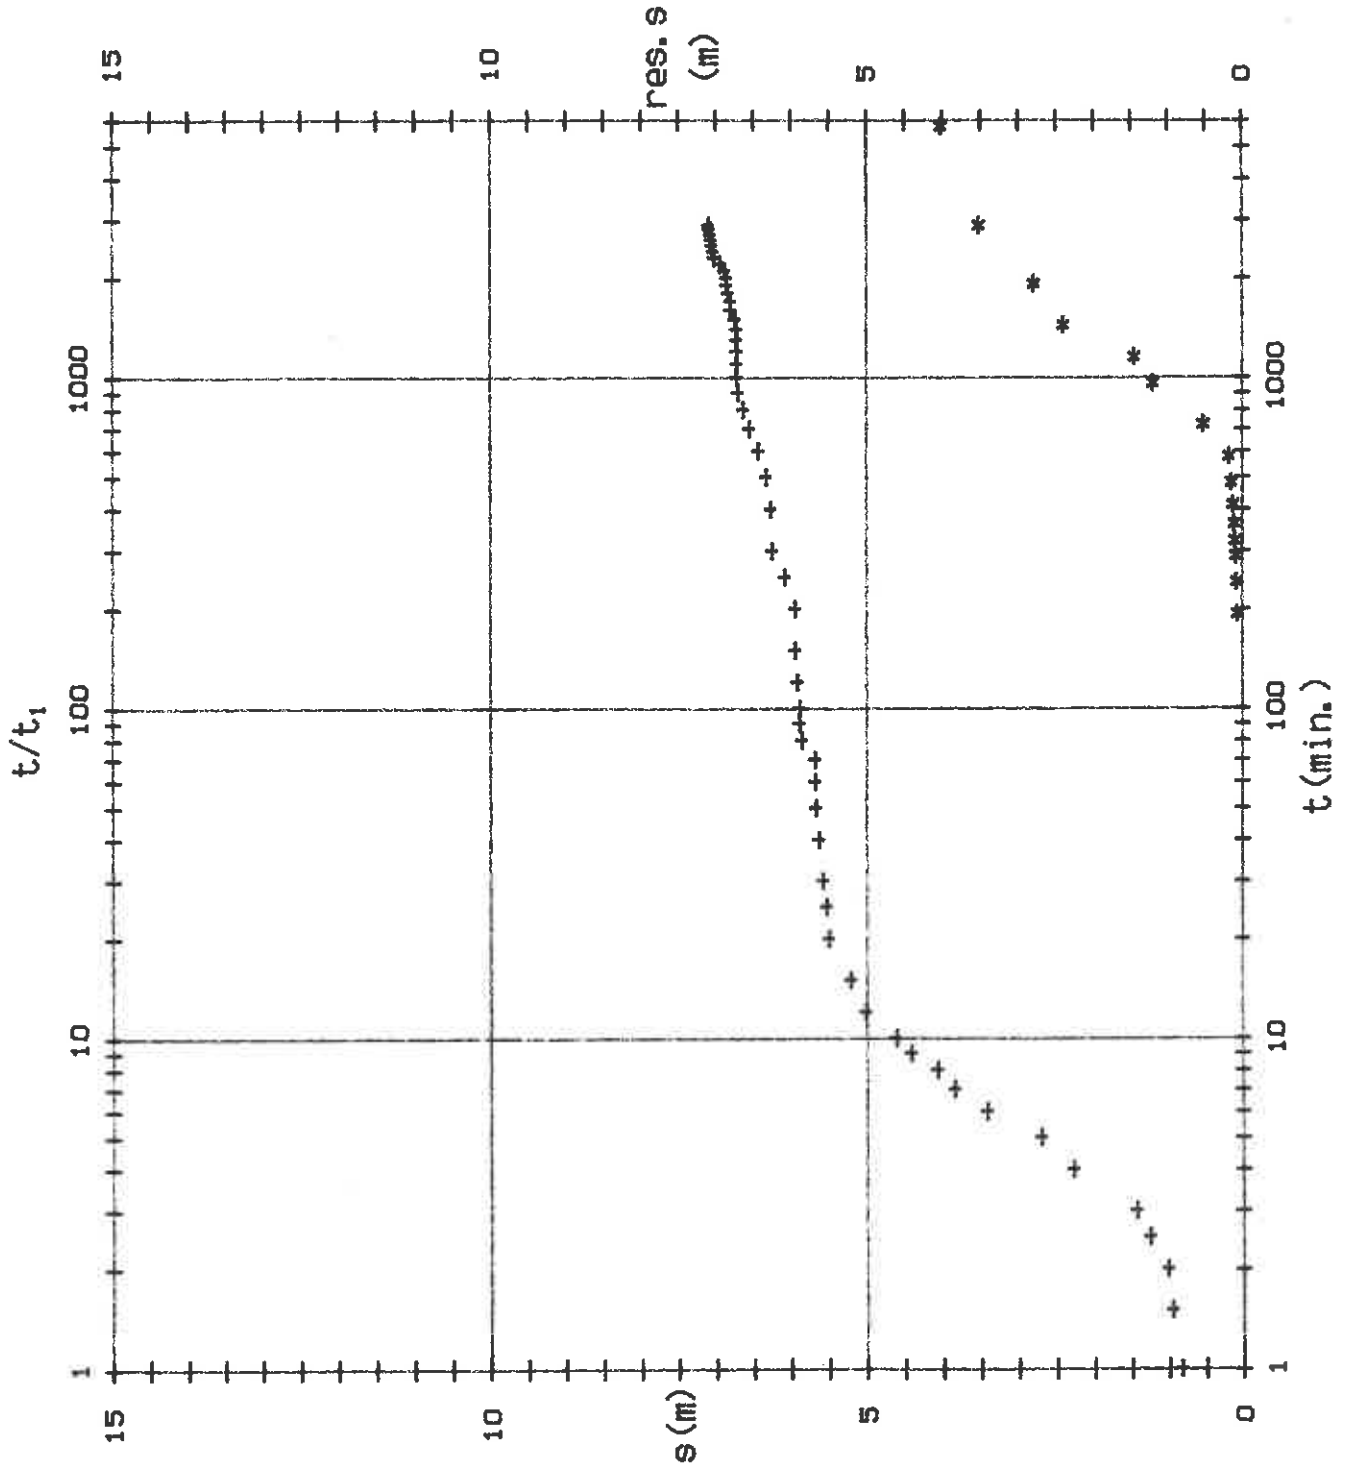
CONSTANT DISCHARGE TEST

+ Drawdown data.
* Recovery data.

S.W.L. = 18.87 m

$T = 4 \text{ m}^2/\text{d}$

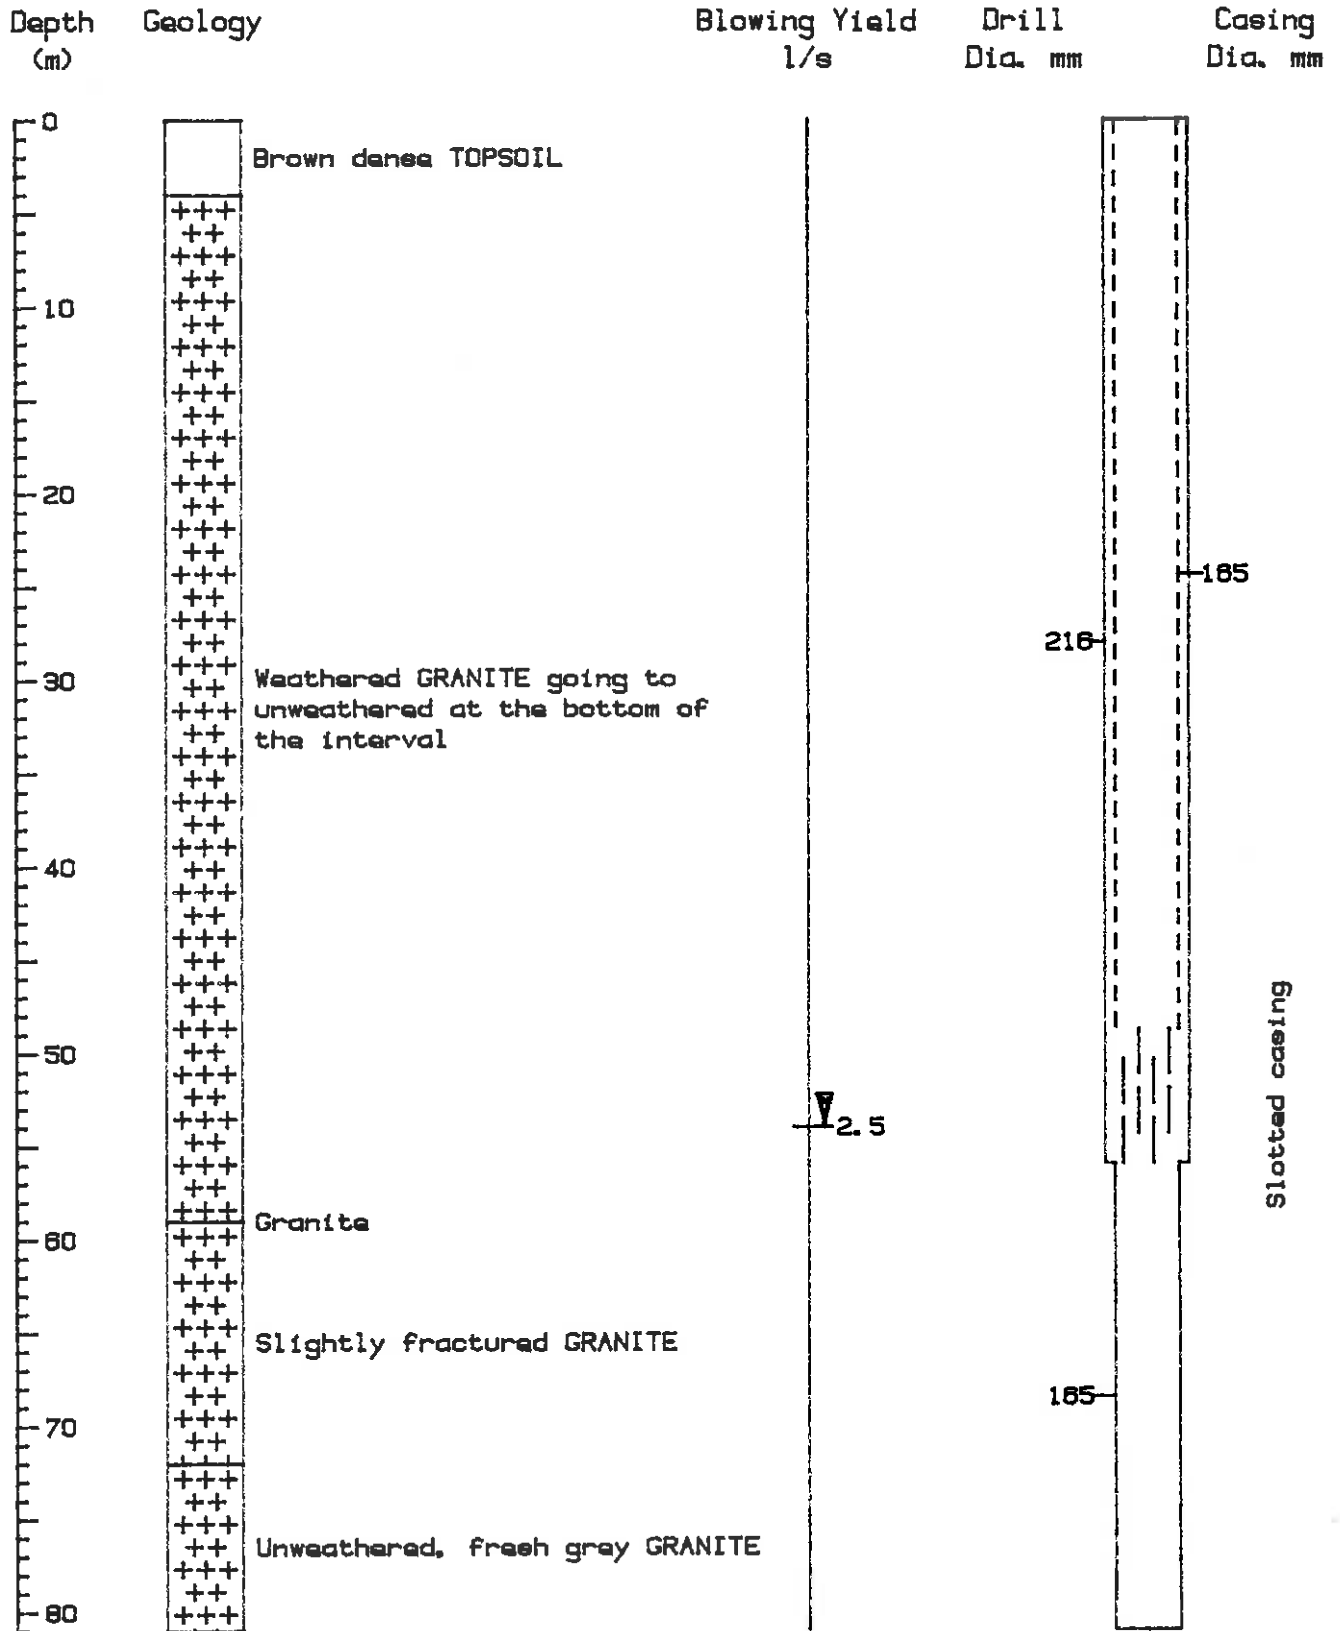
Coordinates +2930025X -36825Y

Elev. (m) 1400

End of Hole 81

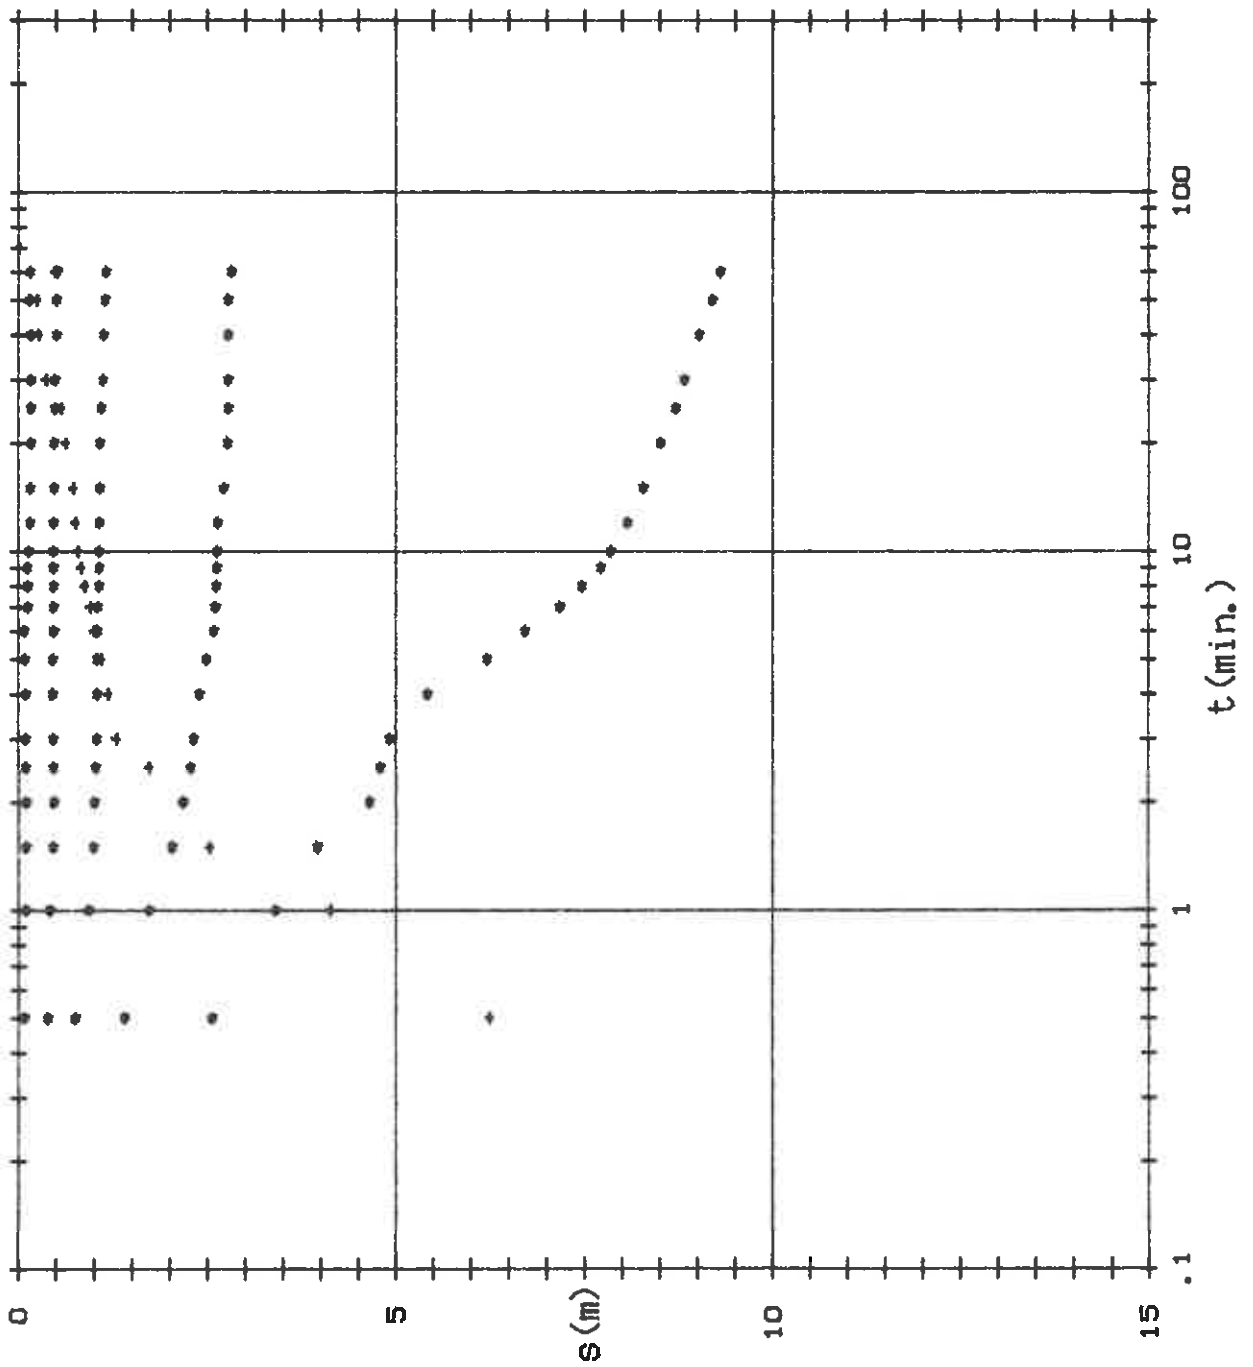
STEP DRAWDOWN TEST

$Q_5 = 4 \text{ l/s}$

S.W.L. = 34.89 m

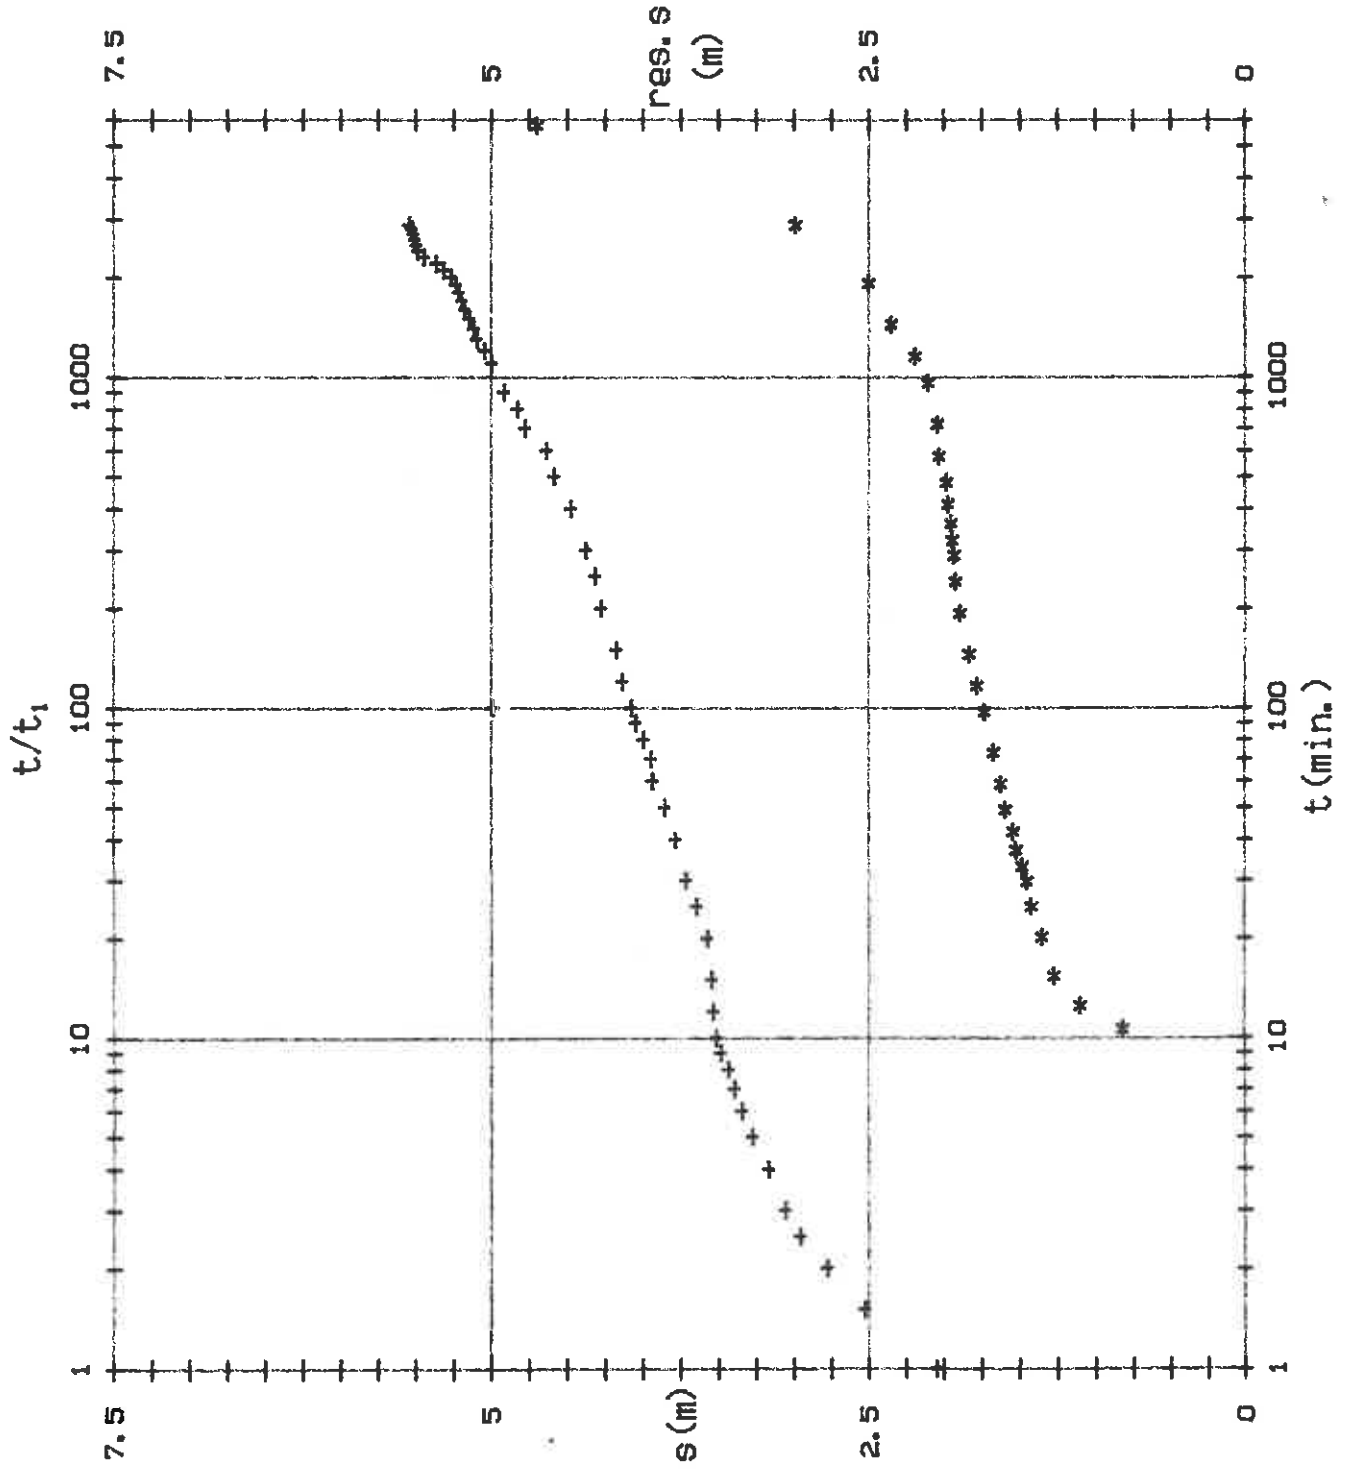
CONSTANT DISCHARGE TEST

+ Drawdown data.
* Recovery data.

S.W.L. = 34.89 m

T = 50 m²/d

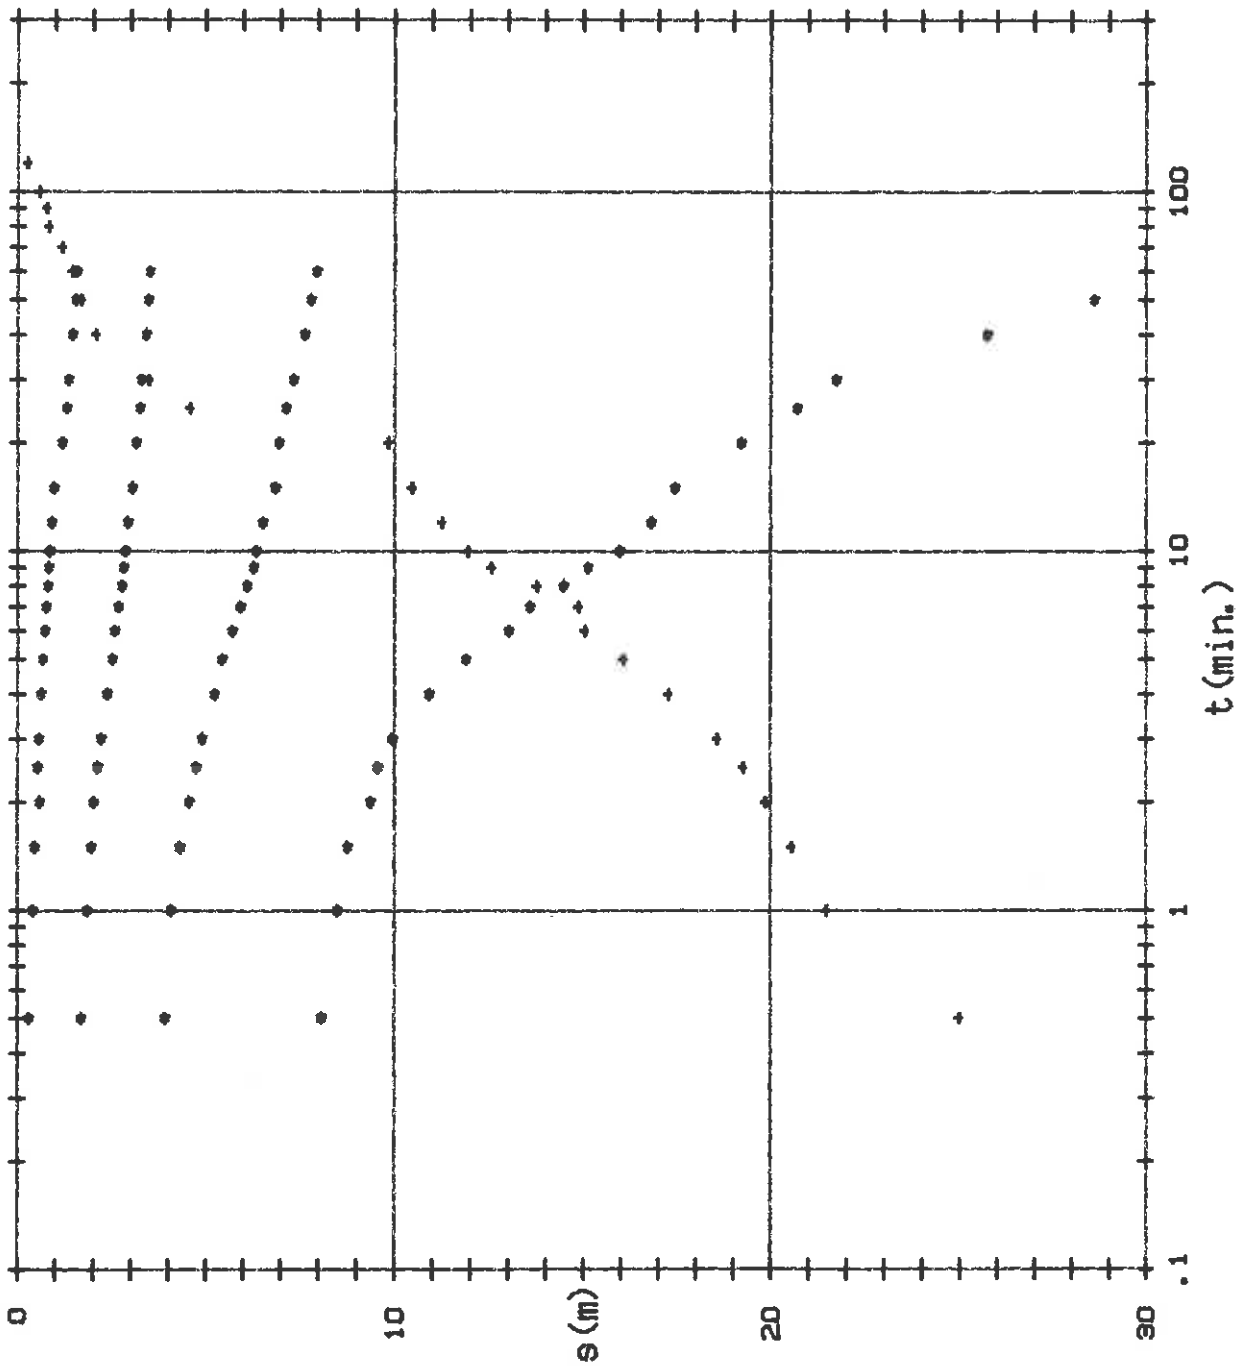
STEP DRAWDOWN TEST

* Pumping data
 + Recovery data

$Q_1 = .19 \text{ l/s}$
 $Q_2 = .41 \text{ l/s}$
 $Q_3 = .81 \text{ l/s}$
 $Q_4 = 1.86 \text{ l/s}$

S.W.L. = 10.74 m

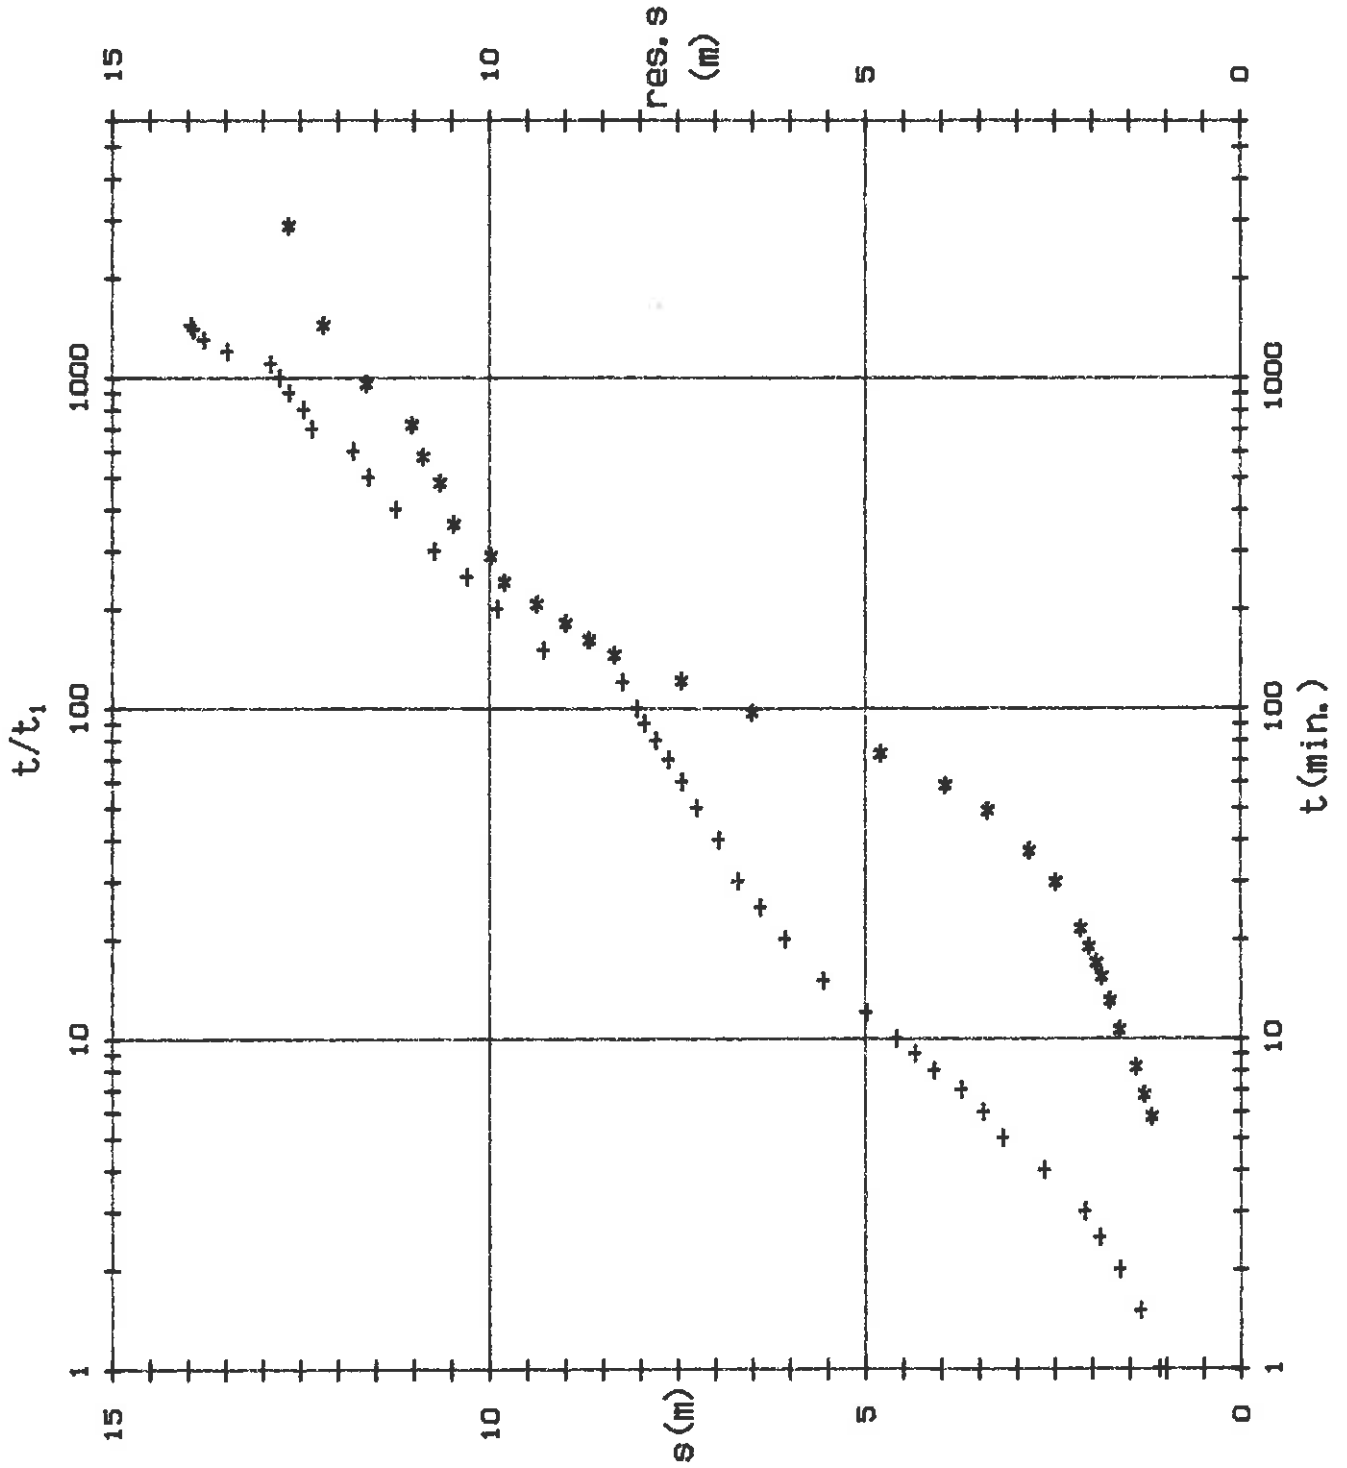
CONSTANT DISCHARGE TEST

+ Drawdown data.
* Recovery data.

S.W.L. = 10.74 m

$T = 3 \text{ m}^2/\text{d}$
