REPUBLIC OF BOPHUTHATSWANA
DEPARTMENT OF WATER AFFAIRS

**REPORT ON THE SITING
DRILLING AND TESTING OF BOREHOLES,
AND THE TESTING OF EXISTING
BOREHOLES - DITSOBOTLA DISTRICT
JUNE 1991 - FEBRUARY 1993**

**VOLUME 1 - TEXT
AND APPENDIX I**

PARTRIDGE MAUD AND ASSOCIATES

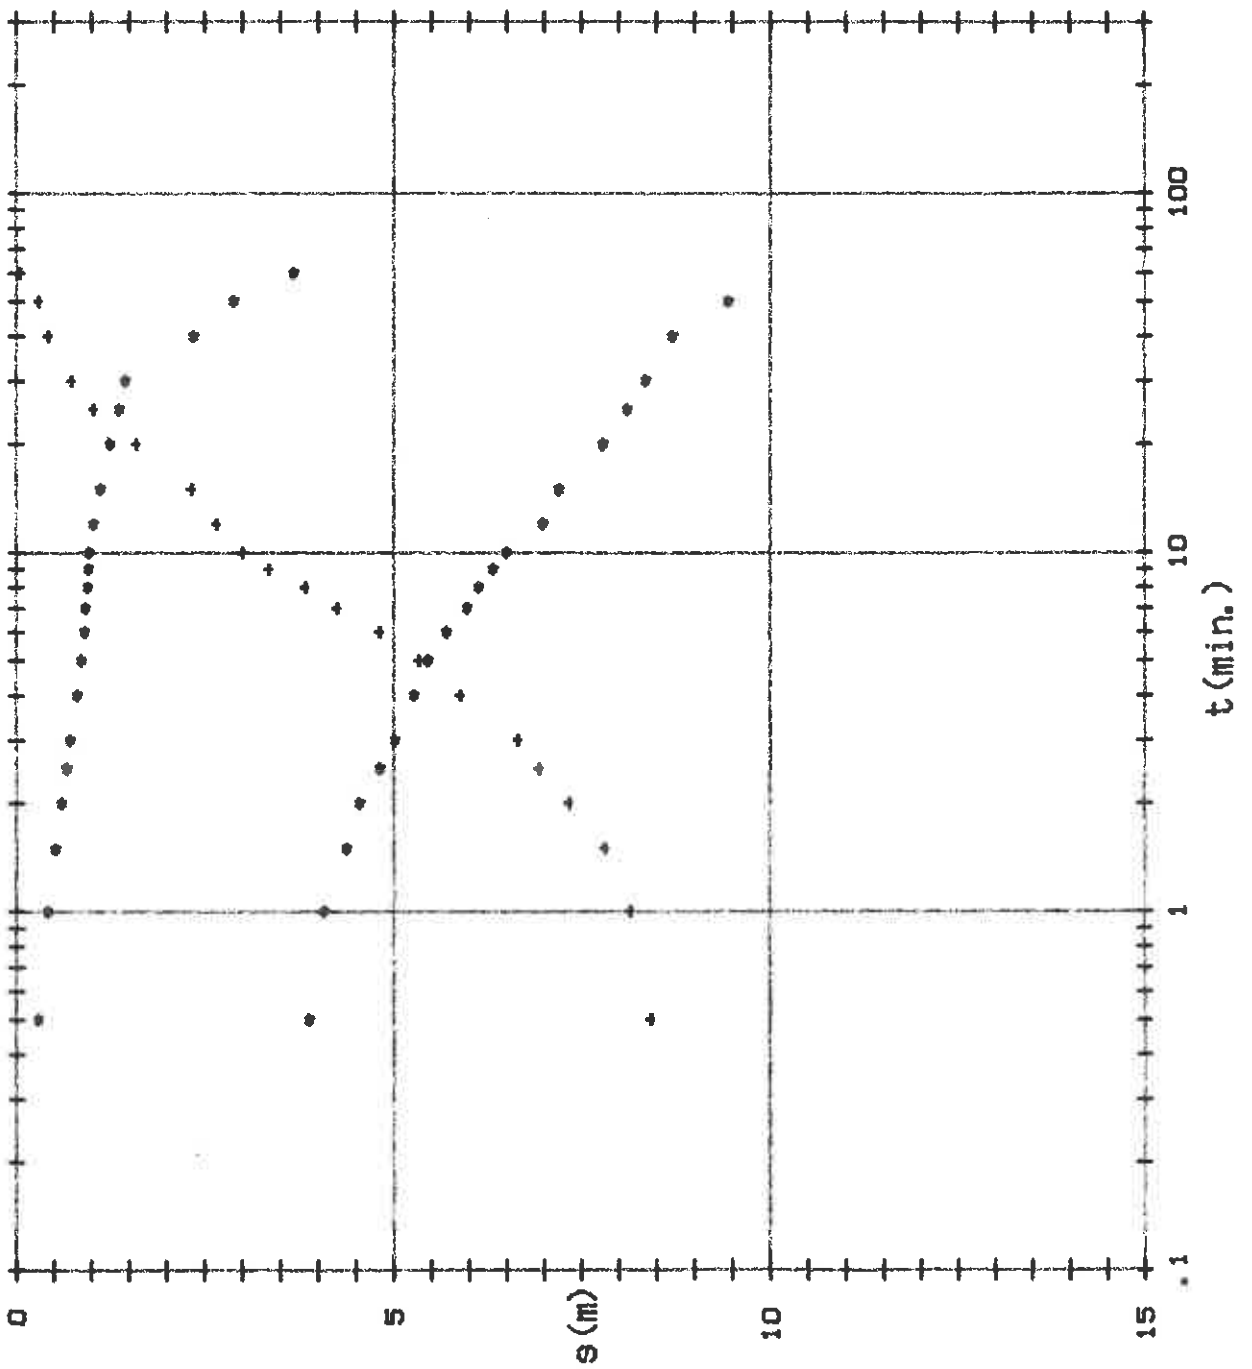
STEP DRAWDOWN TEST

- * Pumping data
- + Recovery data

$Q_2 = .54 \text{ l/s}$

S.W.L. = 26.13 m

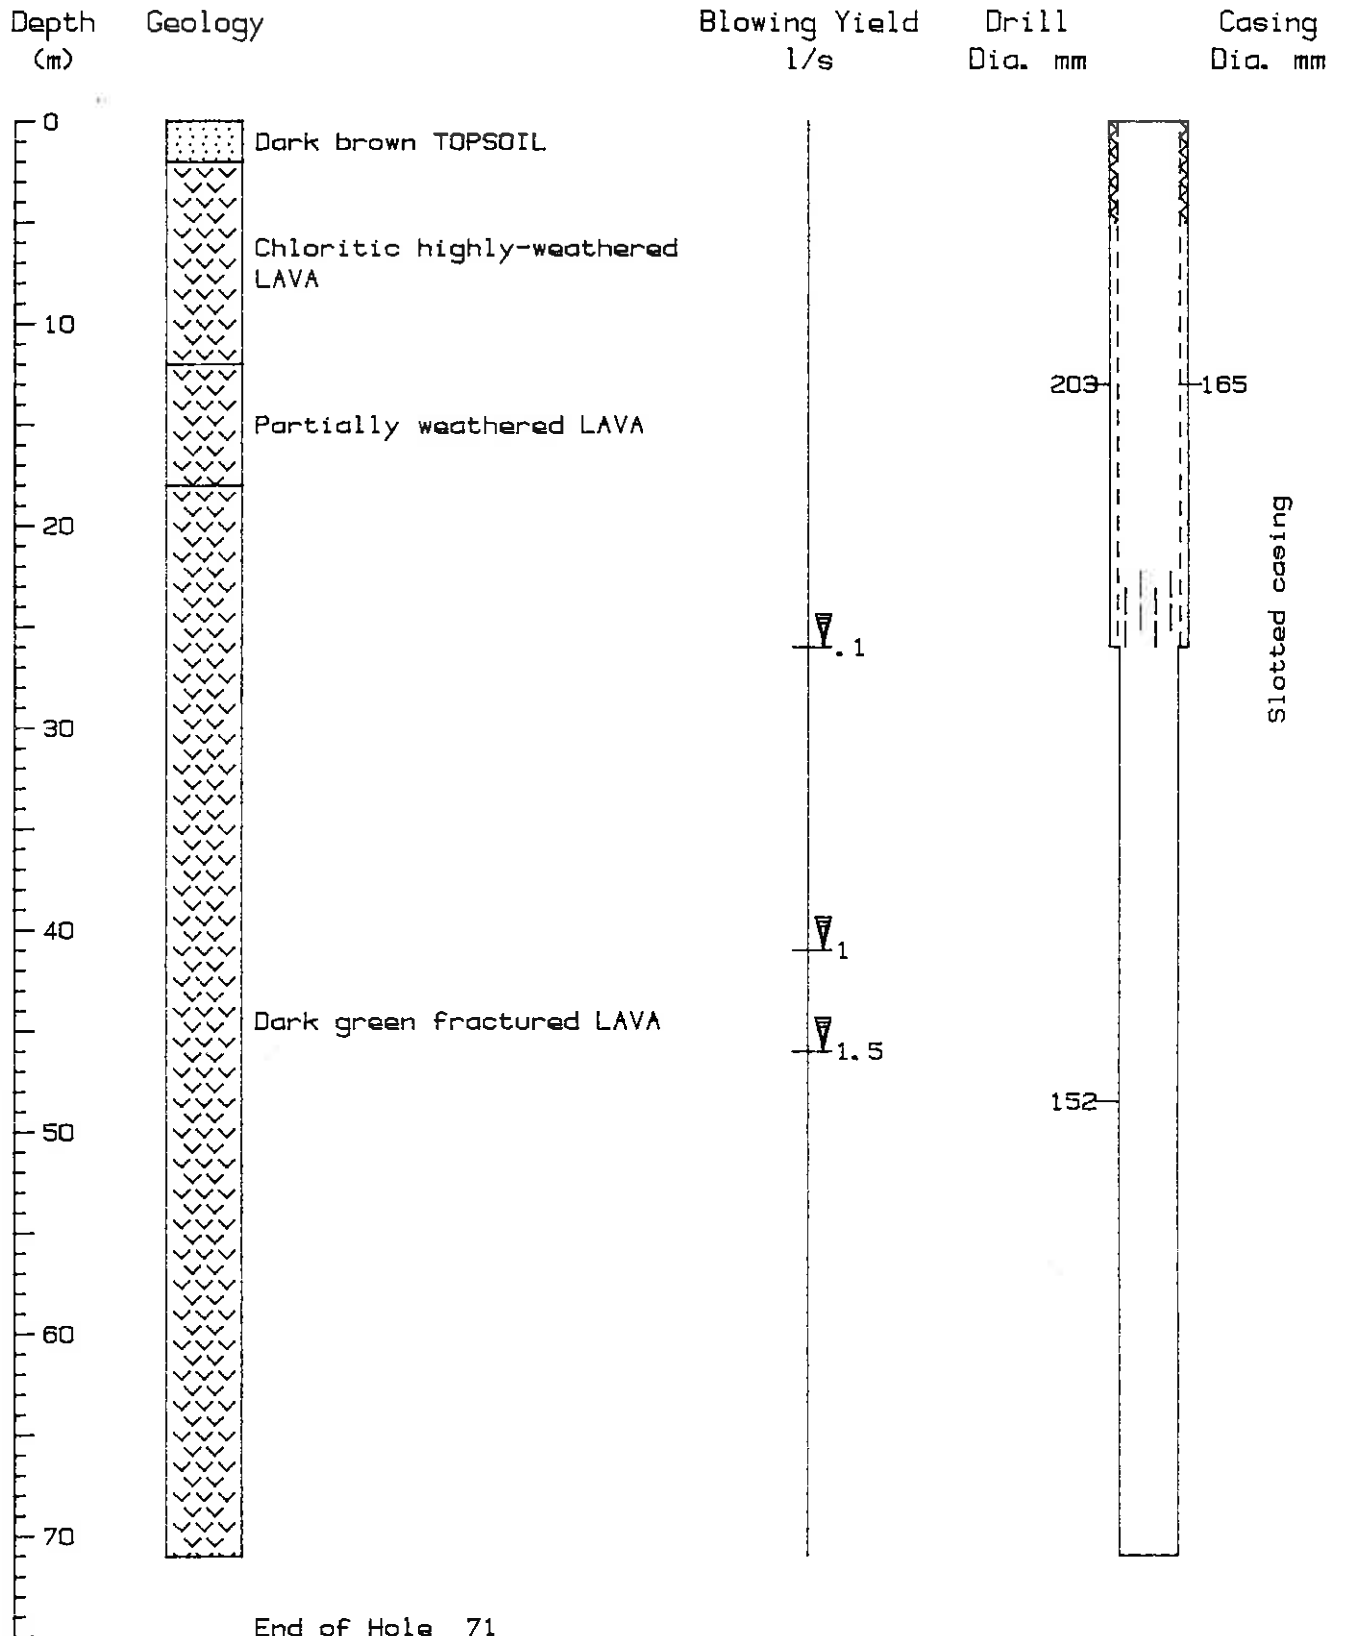
BOREHOLE LOG

Coordinates +2918000X -32000Y

Elev. (m) 1330

Borehole 10-77246 was drilled to 71m in lava. A final blowing yield of 2,6 l/s was recorded from three water strikes made in fractured zones (Table 3).

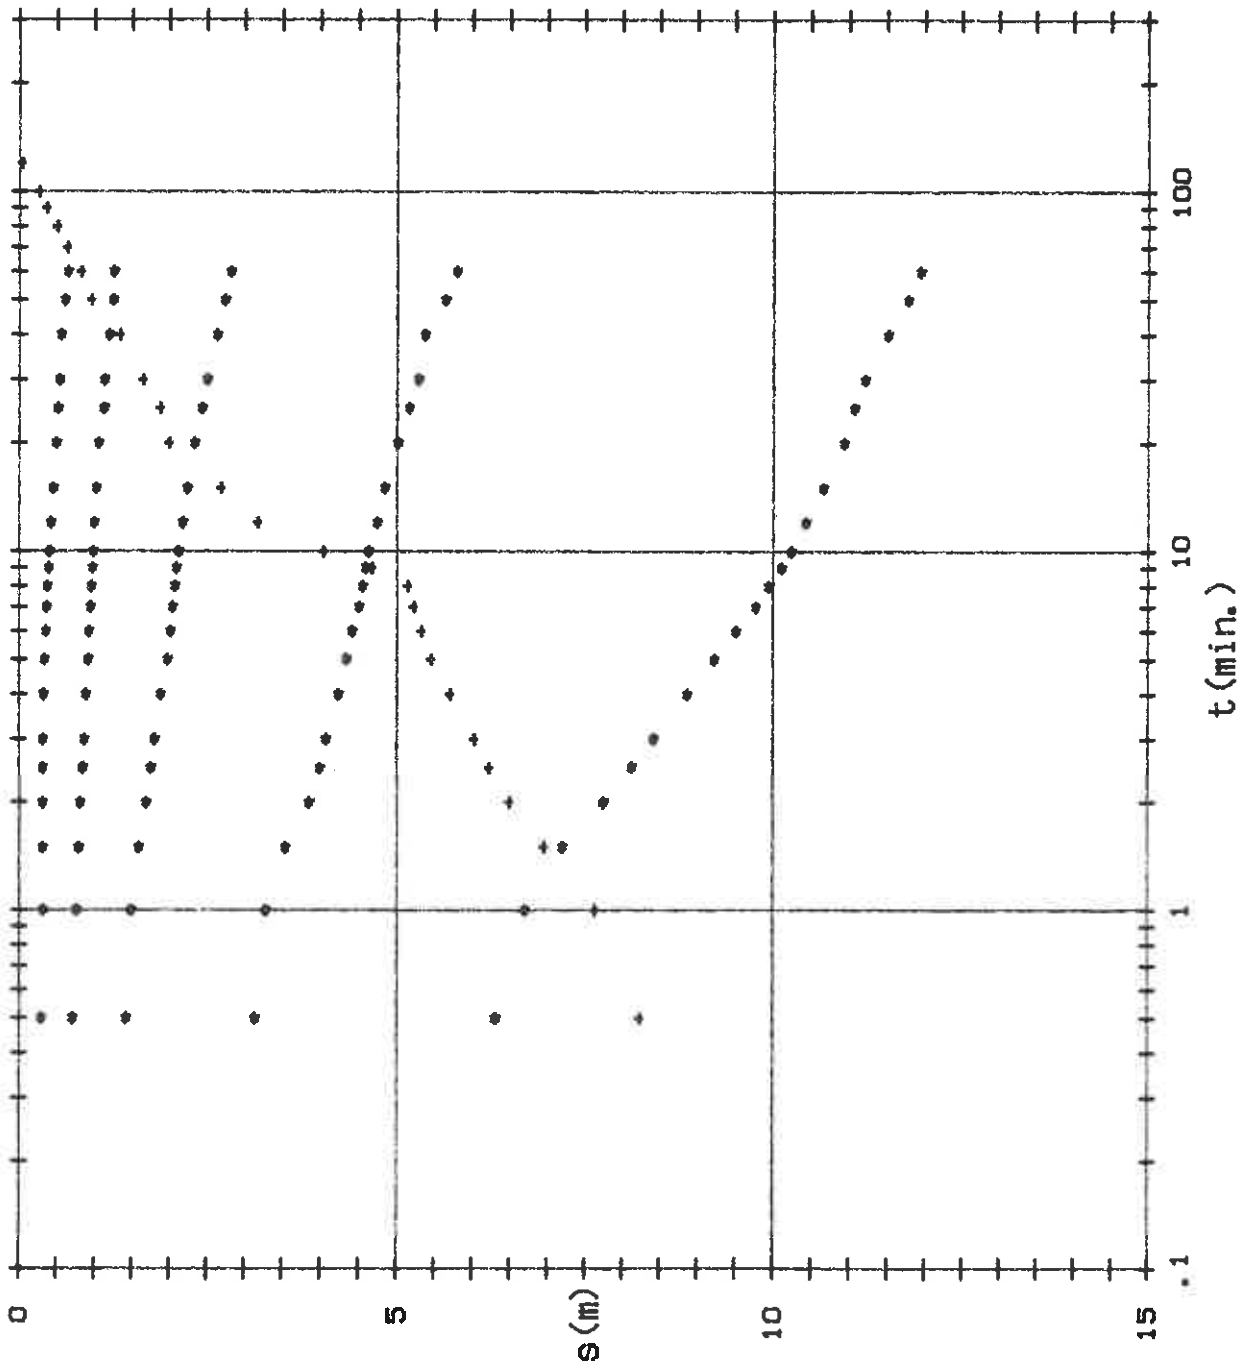
STEP DRAWDOWN TEST

* Pumping data
 + Recovery data

$Q_1 = .2 \text{ l/s}$
 $Q_2 = .41 \text{ l/s}$
 $Q_3 = .9 \text{ l/s}$
 $Q_4 = 1.84 \text{ l/s}$
 $Q_5 = 3.5 \text{ l/s}$

S.W.L. = 21.19 m

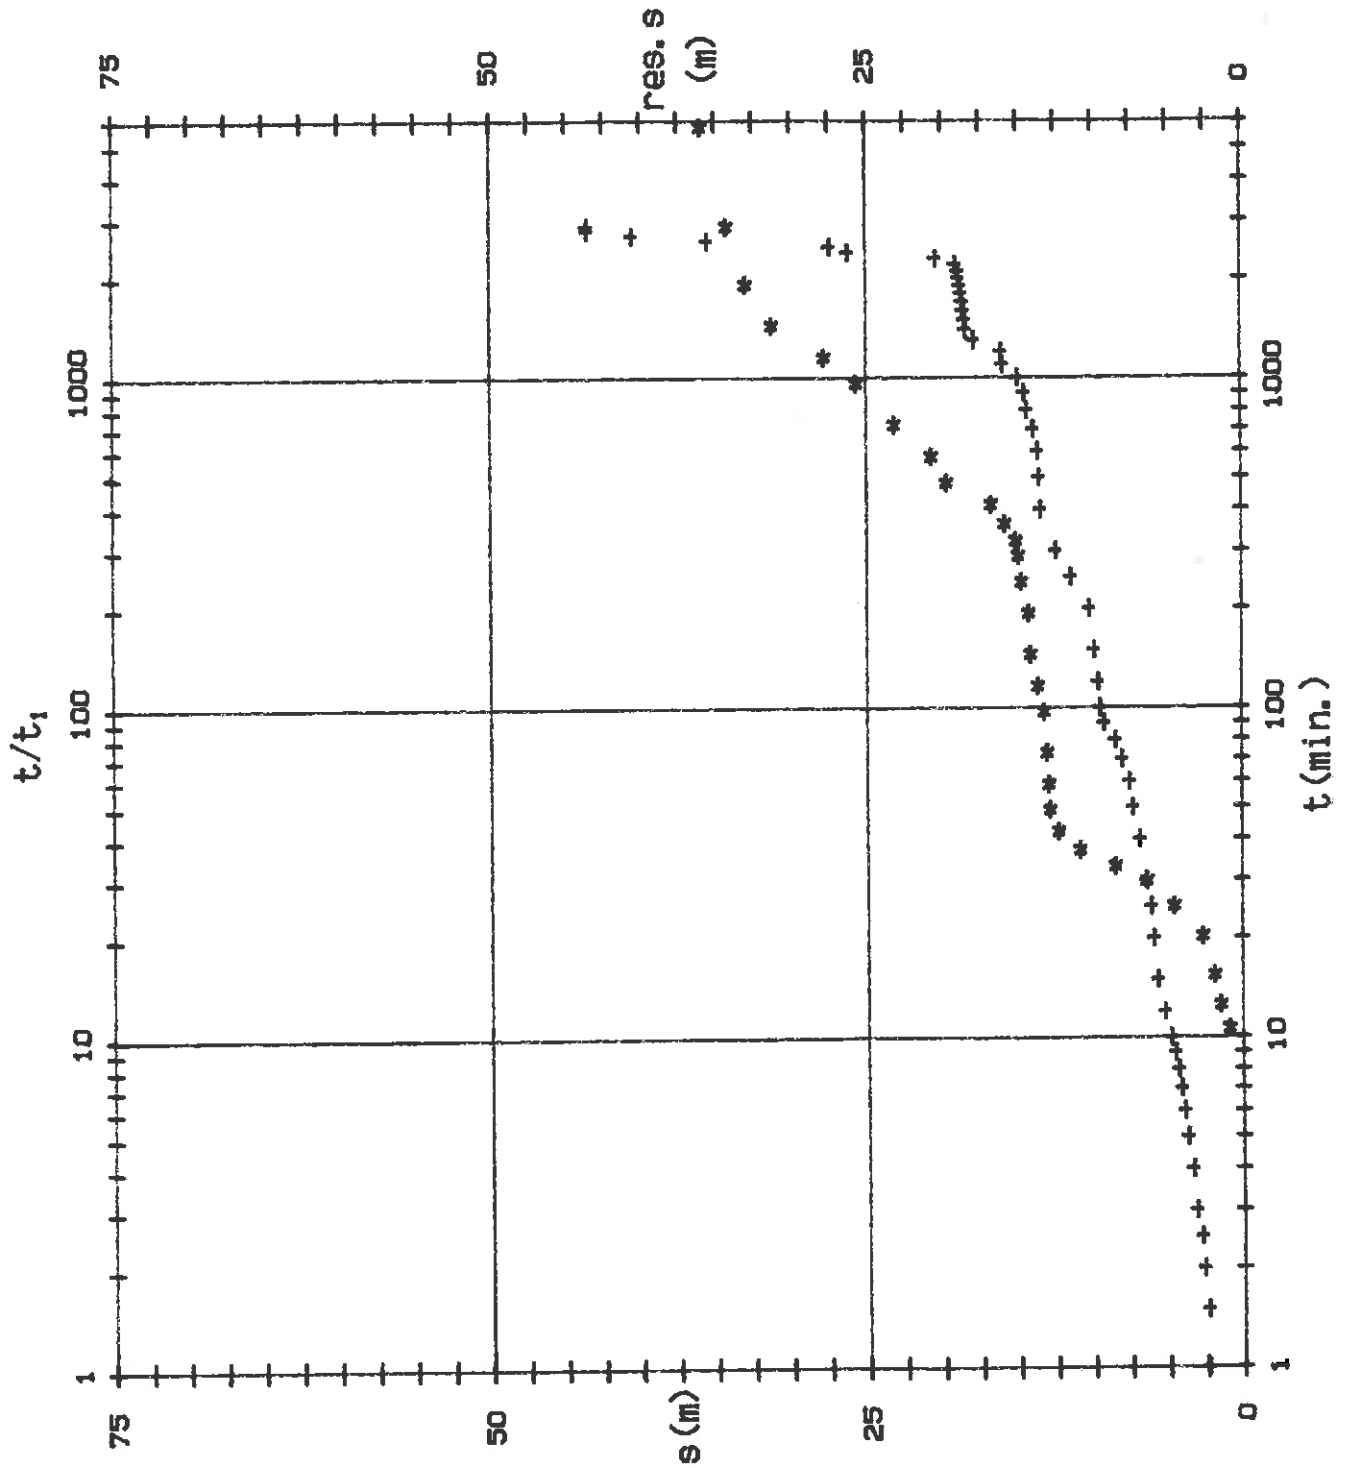
CONSTANT DISCHARGE TEST

+ Drawdown data.
* Recovery data.

S.W.L. = 21.19 m

T = 8 m²/d

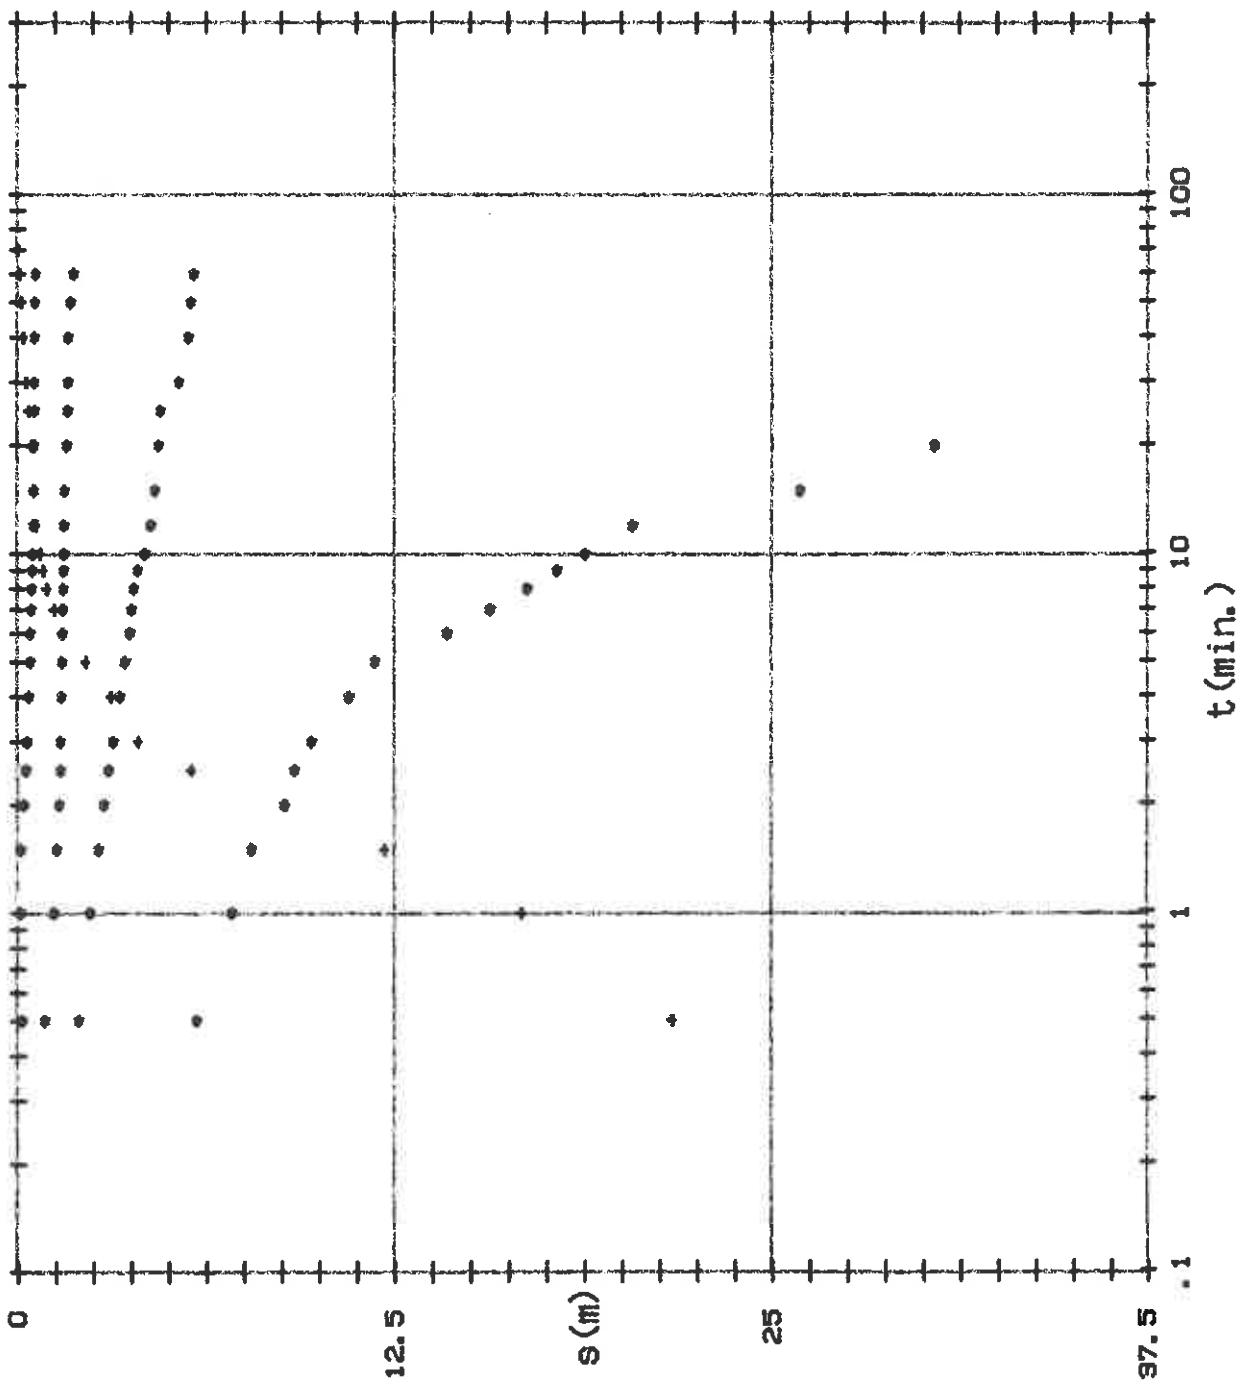
$Q_4 = 4.04$ l/s

S.W.L. = 5.89 m

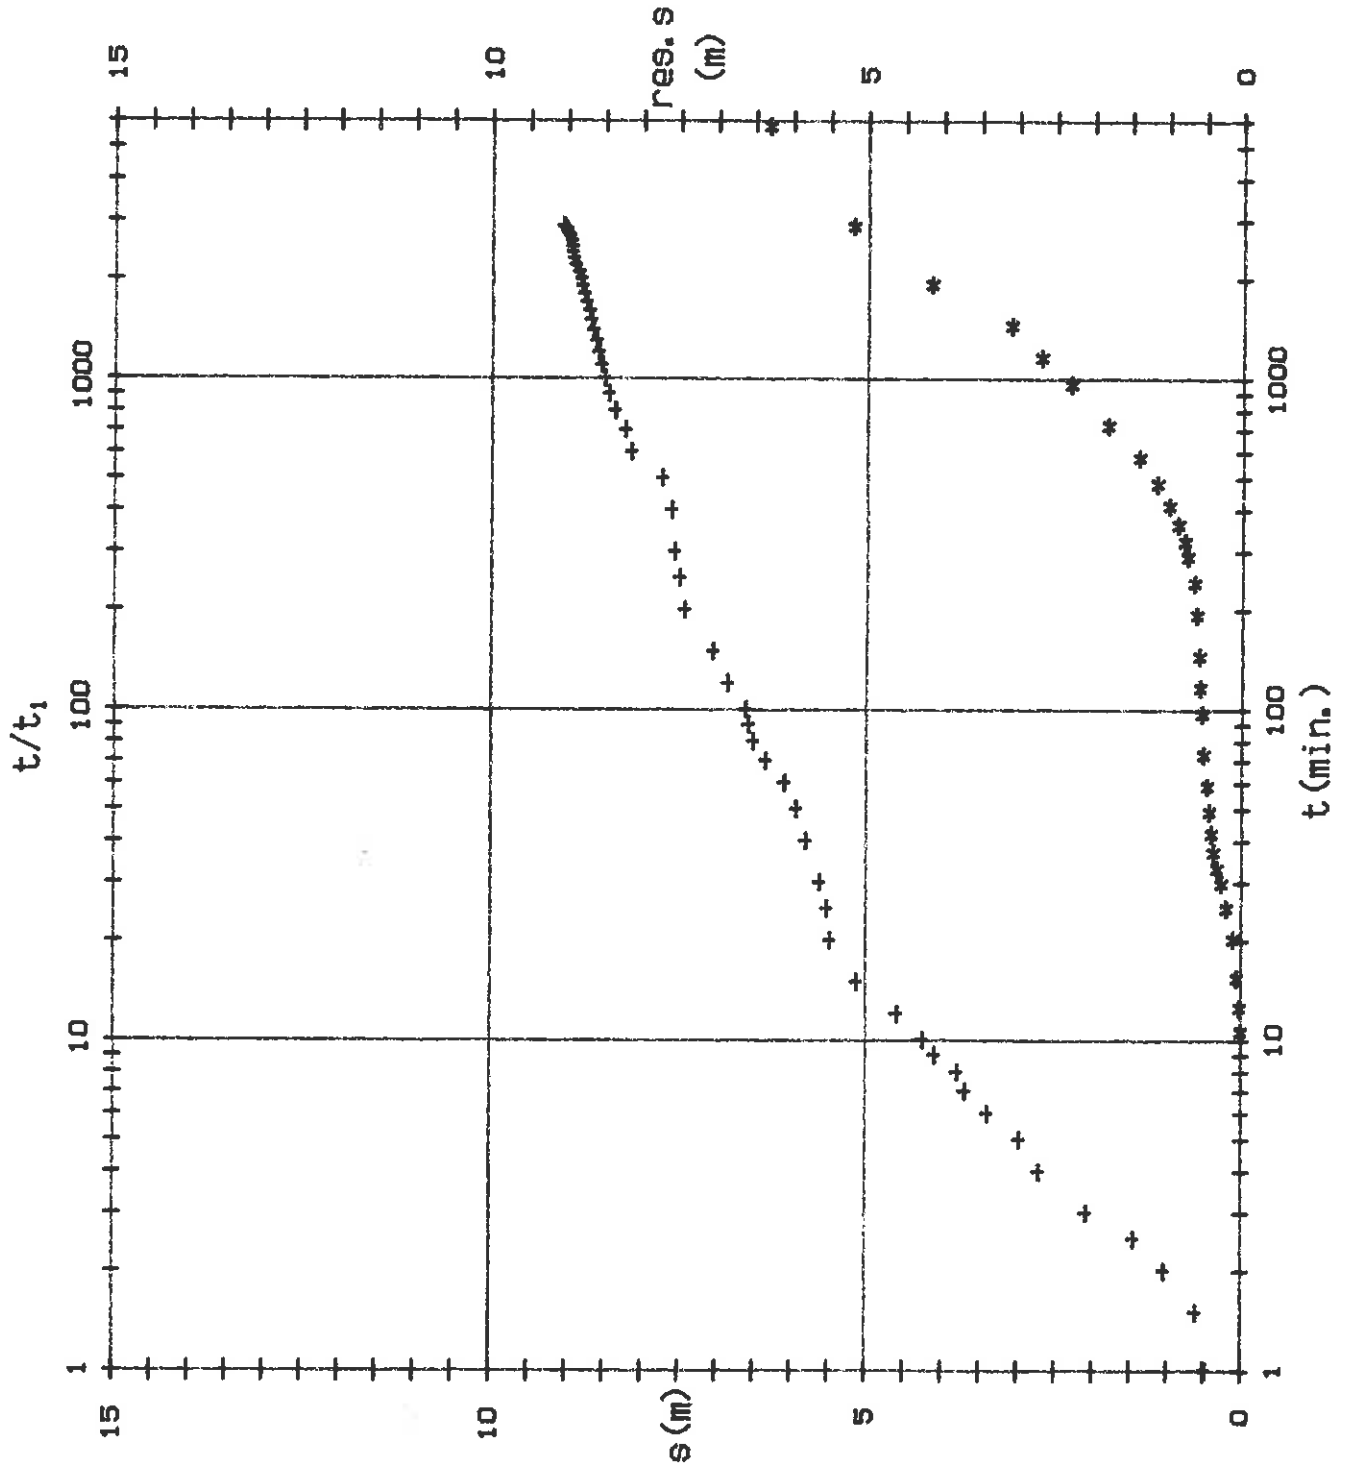
CONSTANT DISCHARGE TEST

- + Drawdown data.
- * Recovery data.

S.W.L. = 5.89 m

$T = 8 \text{ m}^2/\text{d}$

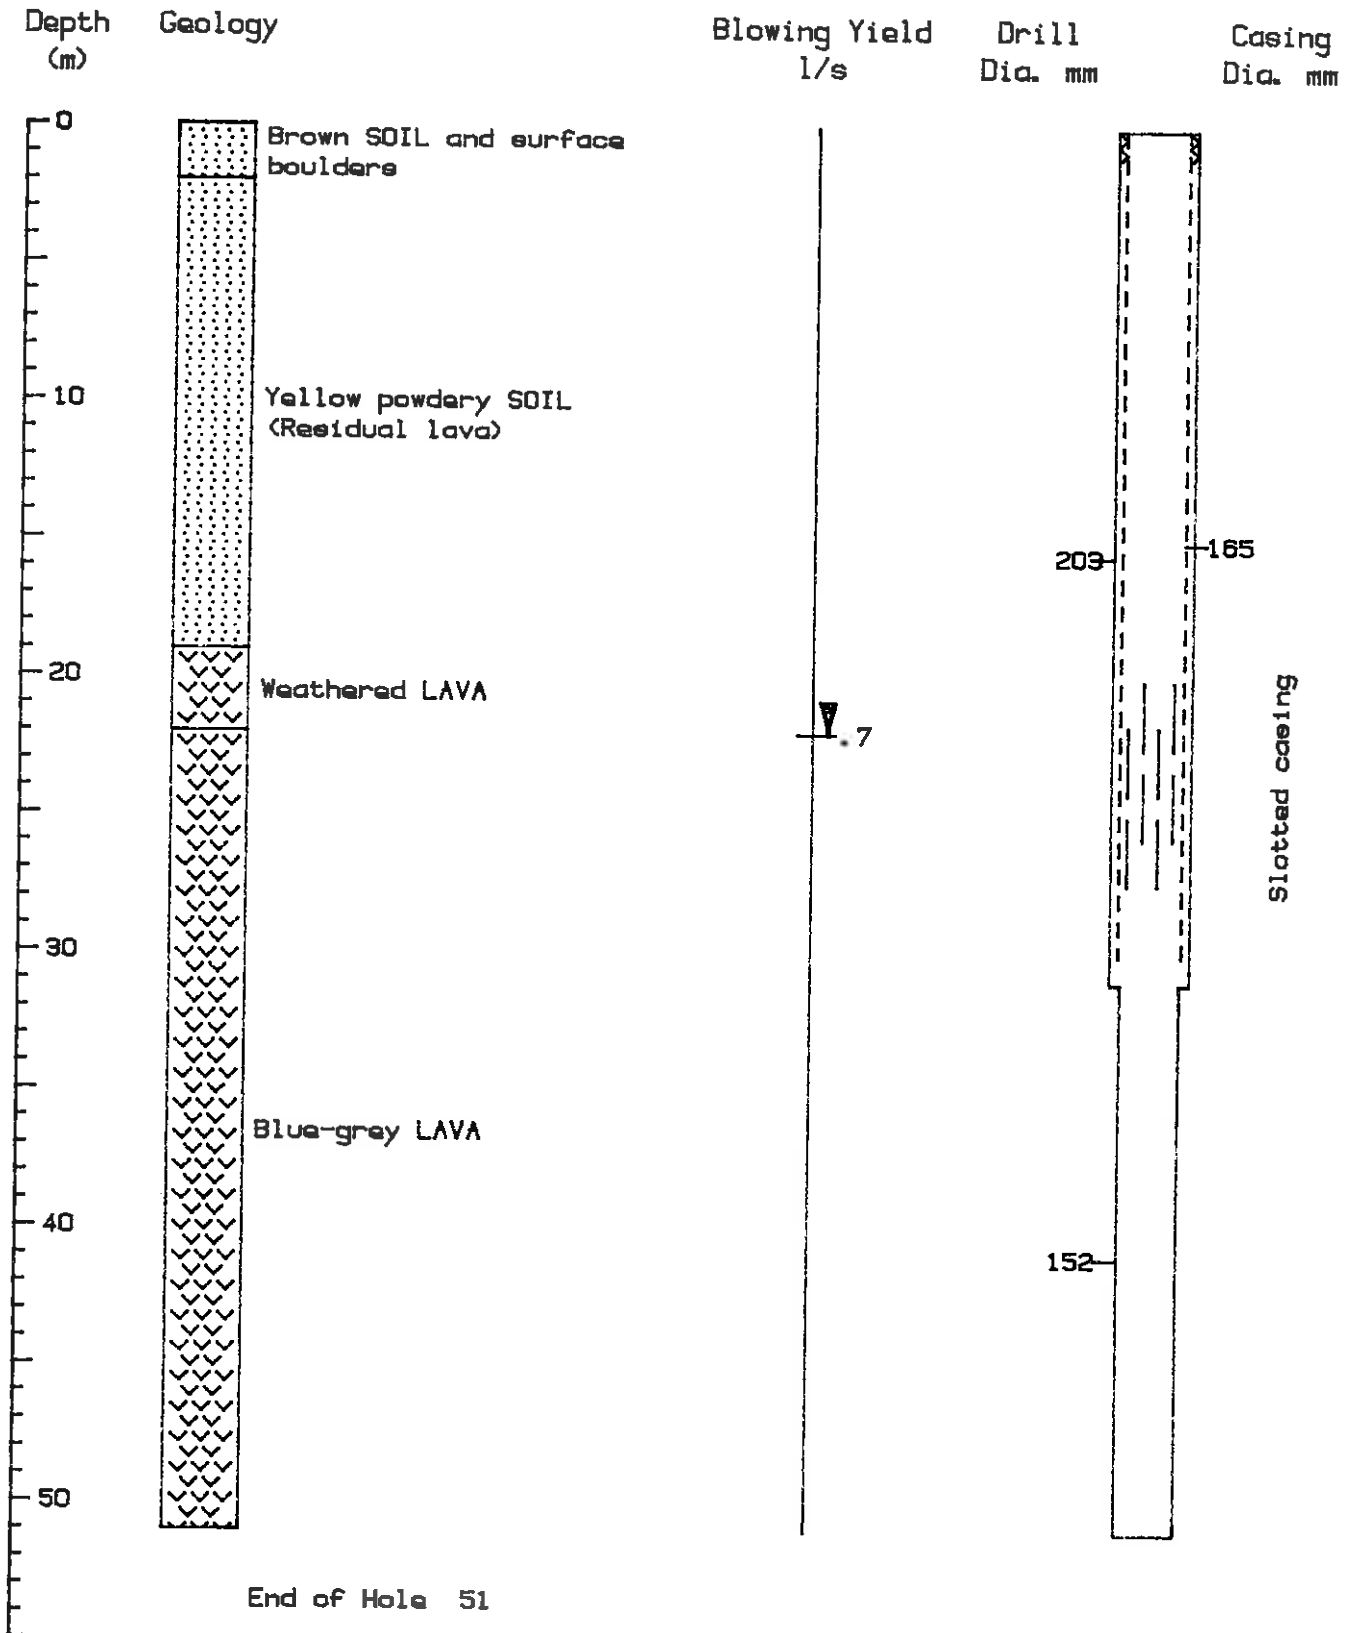
BOREHOLE LOG

Coordinates +2915775X -52650Y

Elev. (m) 1375

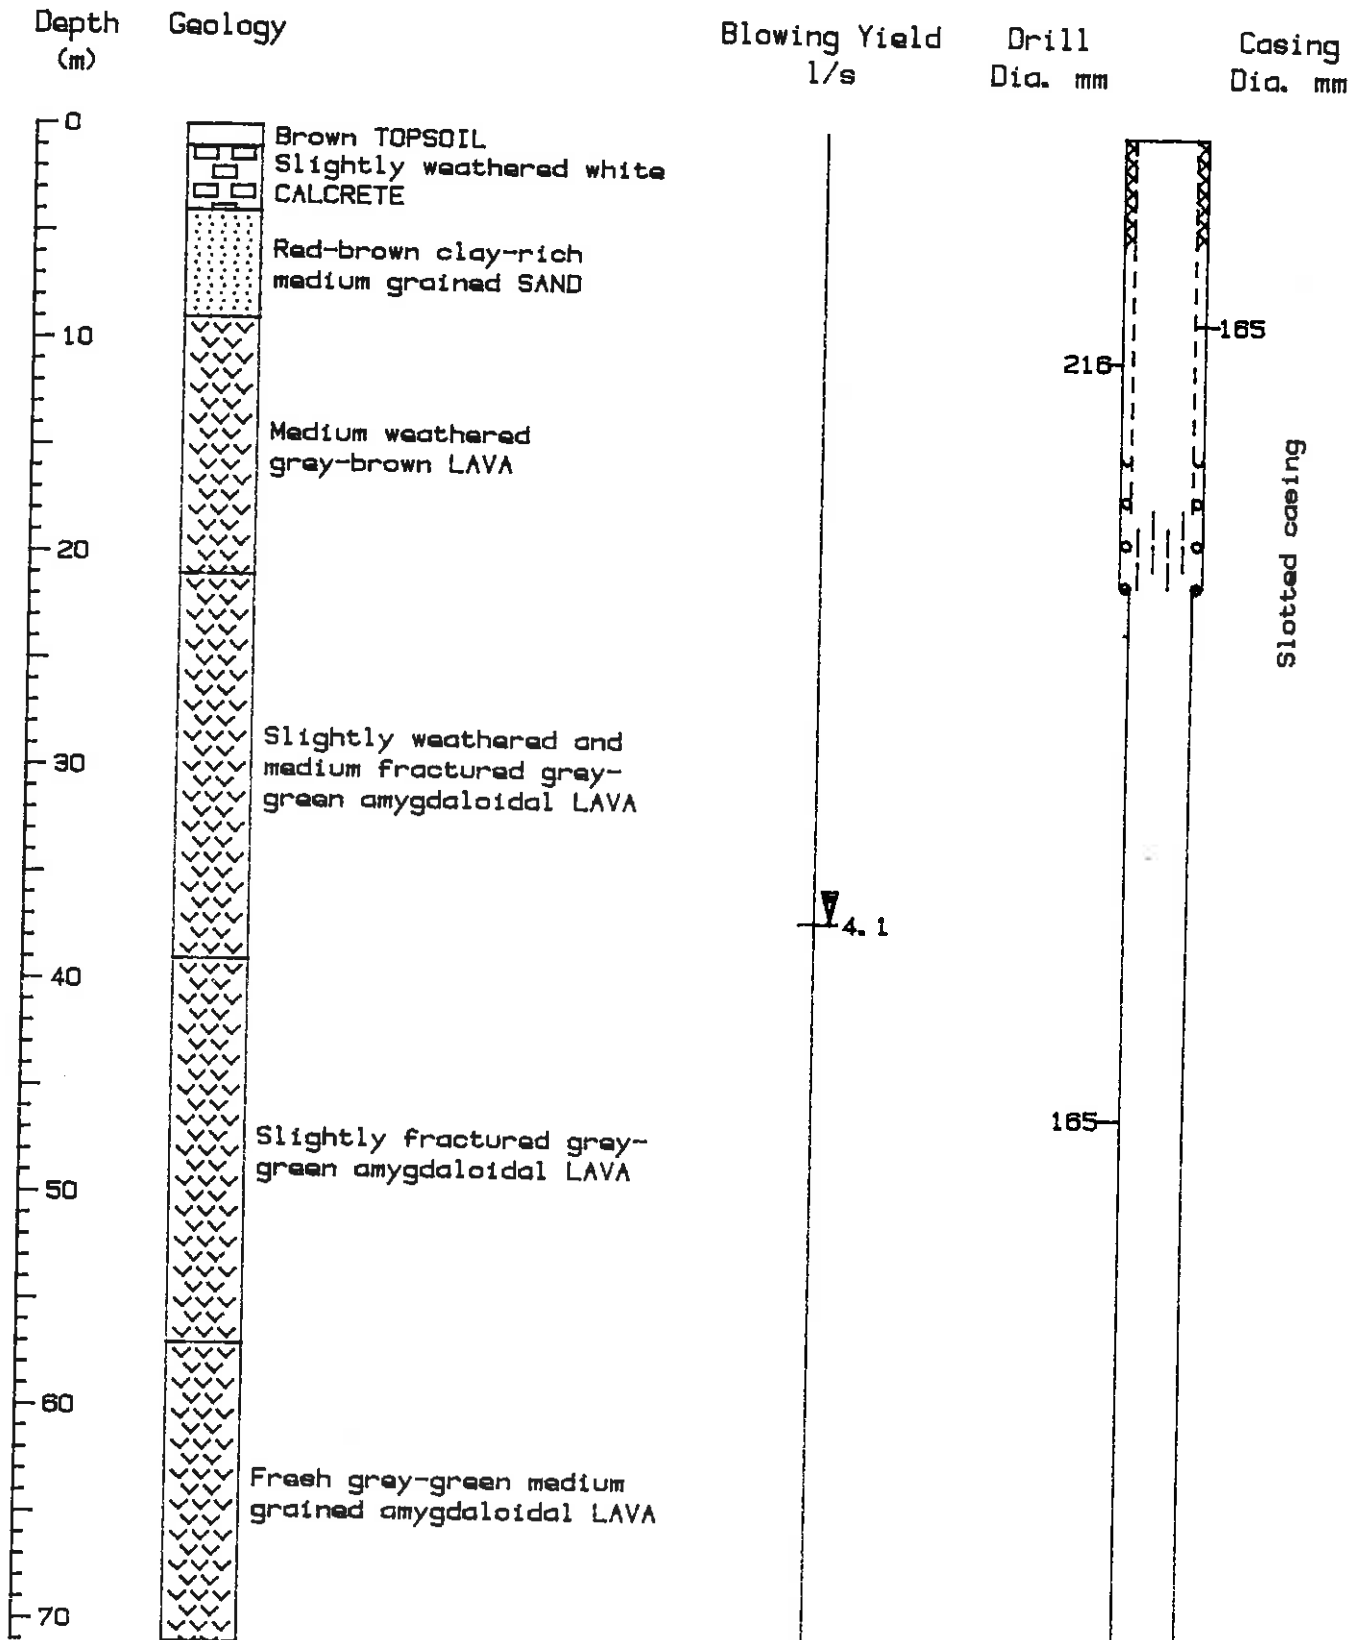
Coordinates +2915635X -051655Y

Elev. (m) 1383

End of Hole 71

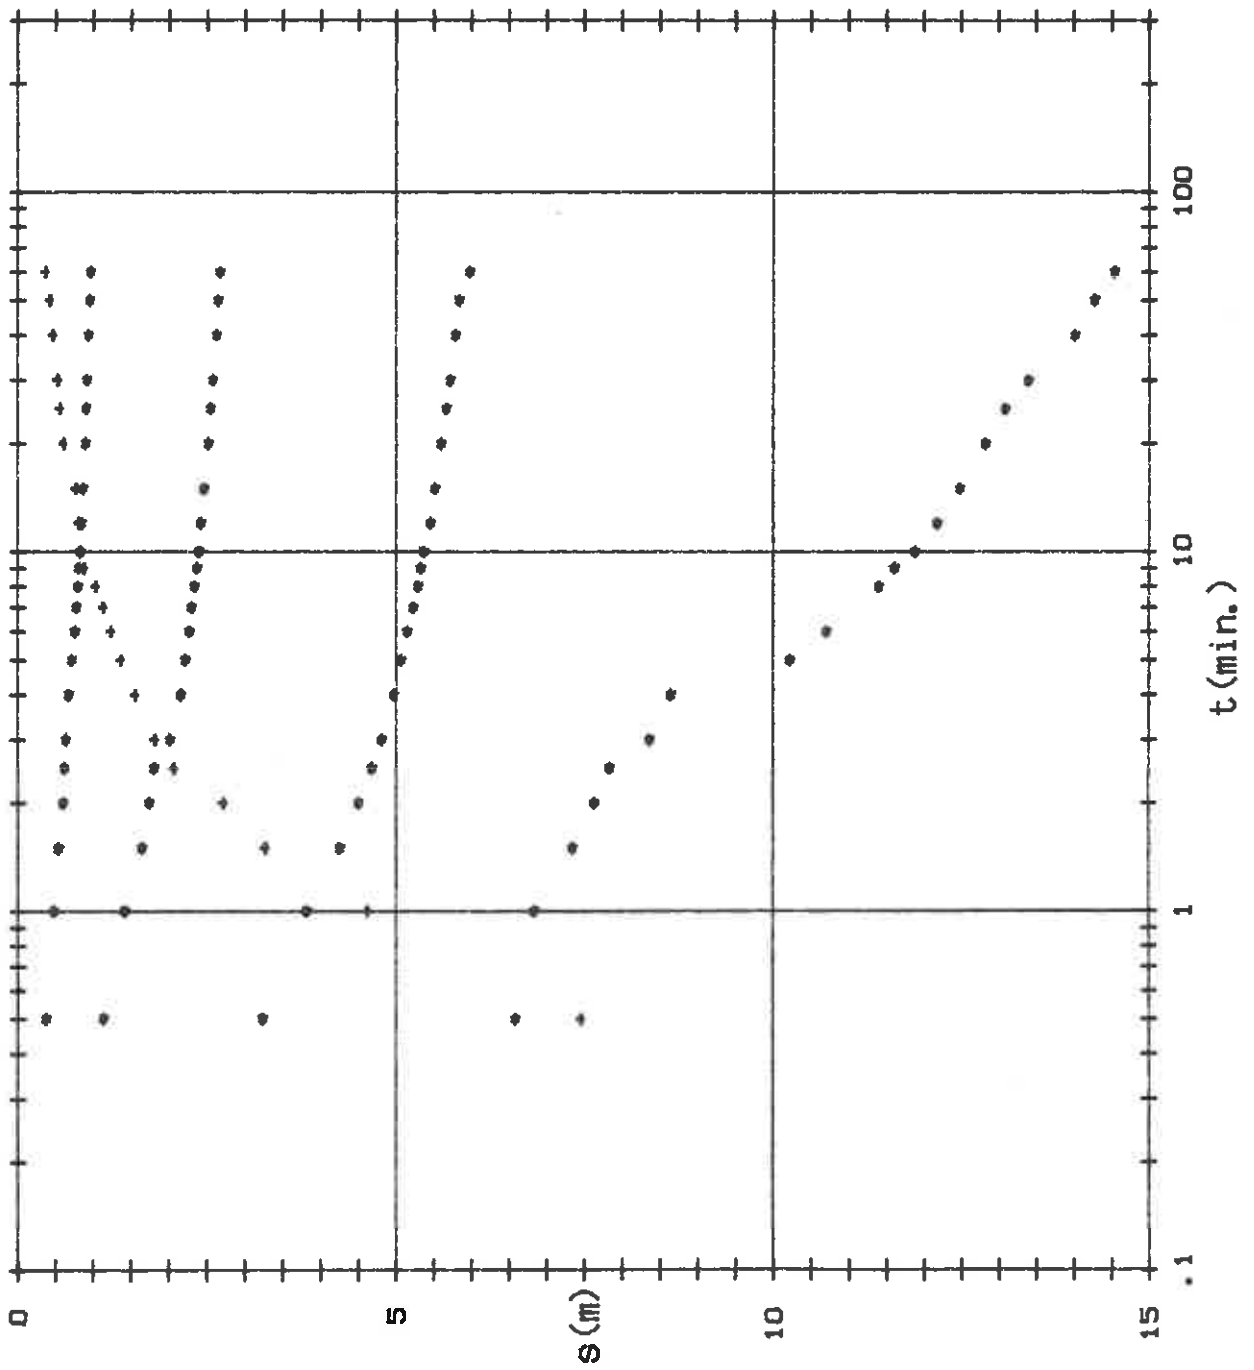
STEP DRAWDOWN TEST

$Q_1 = .51 \text{ l/s}$
 $Q_2 = 1.02 \text{ l/s}$
 $Q_3 = 1.97 \text{ l/s}$
 $Q_4 = 3.96 \text{ l/s}$

S.W.L. = 9.82 m

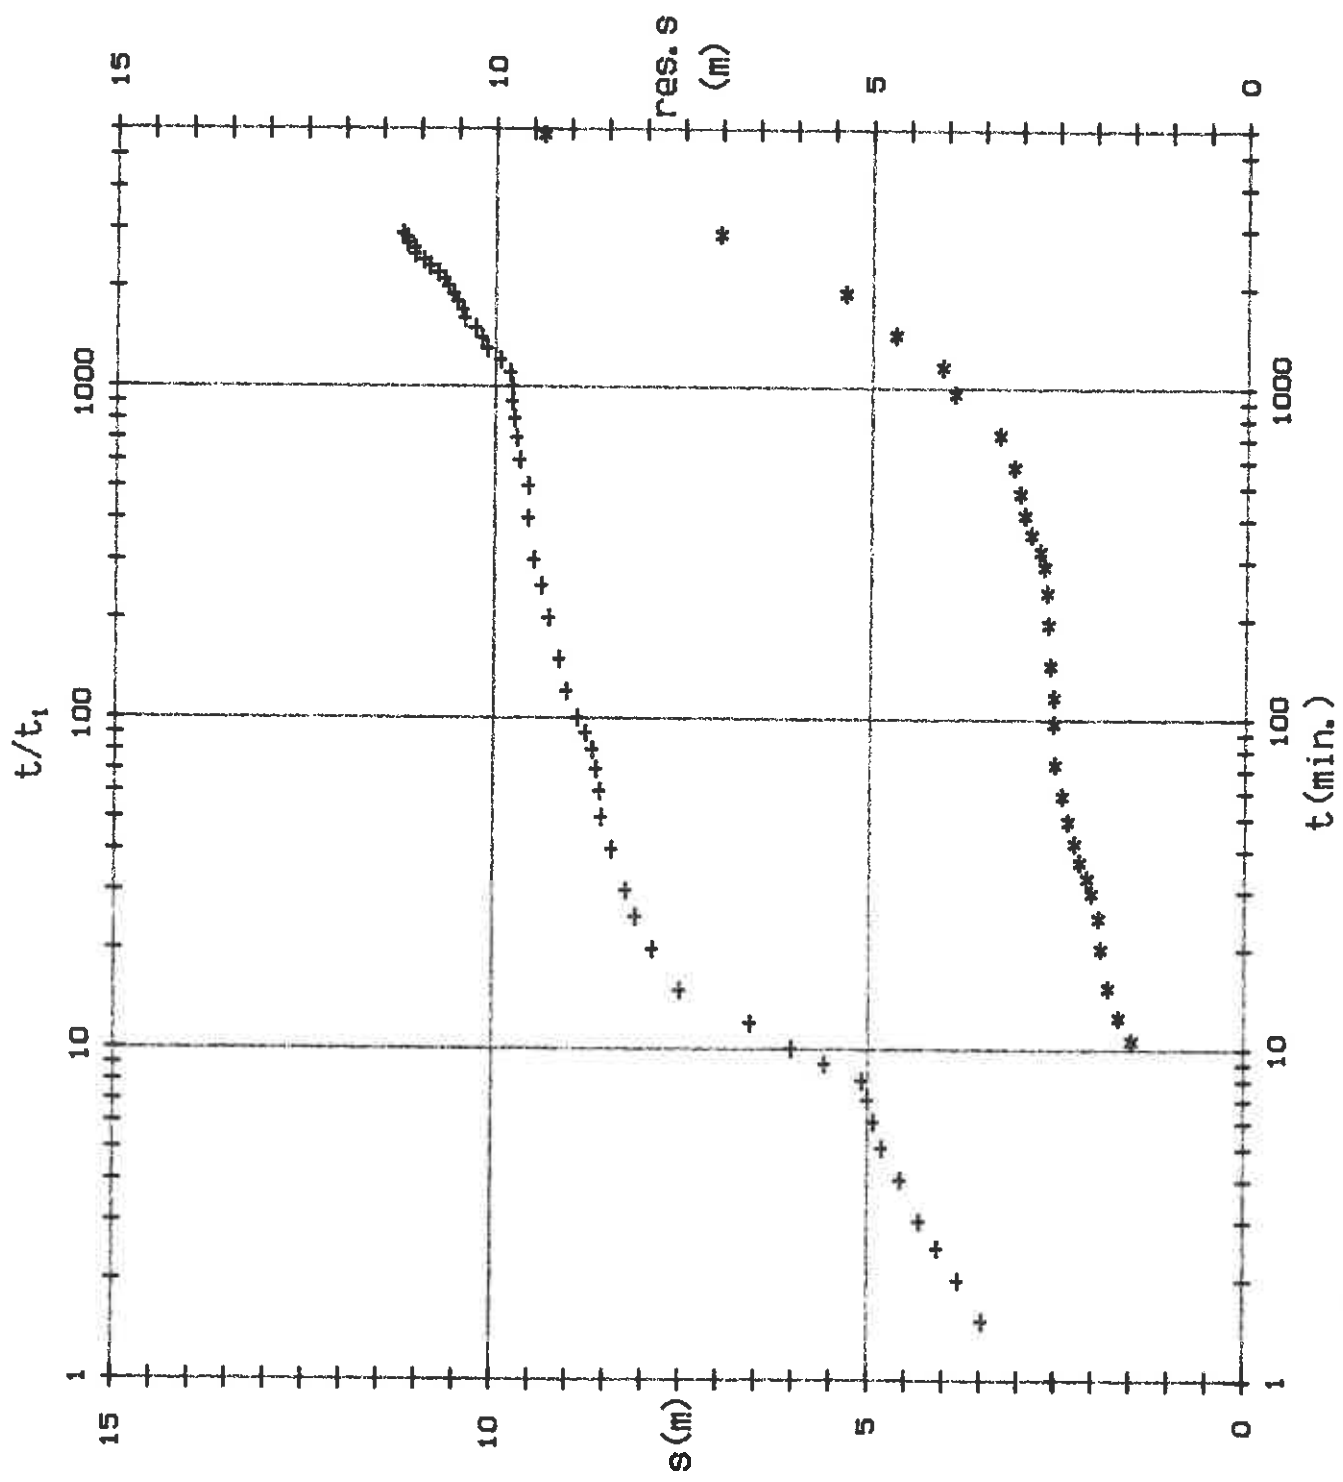
CONSTANT DISCHARGE TEST

+ Drawdown data.
* Recovery data.

S.W.L. = 9.82 m

T = 11 m²/d

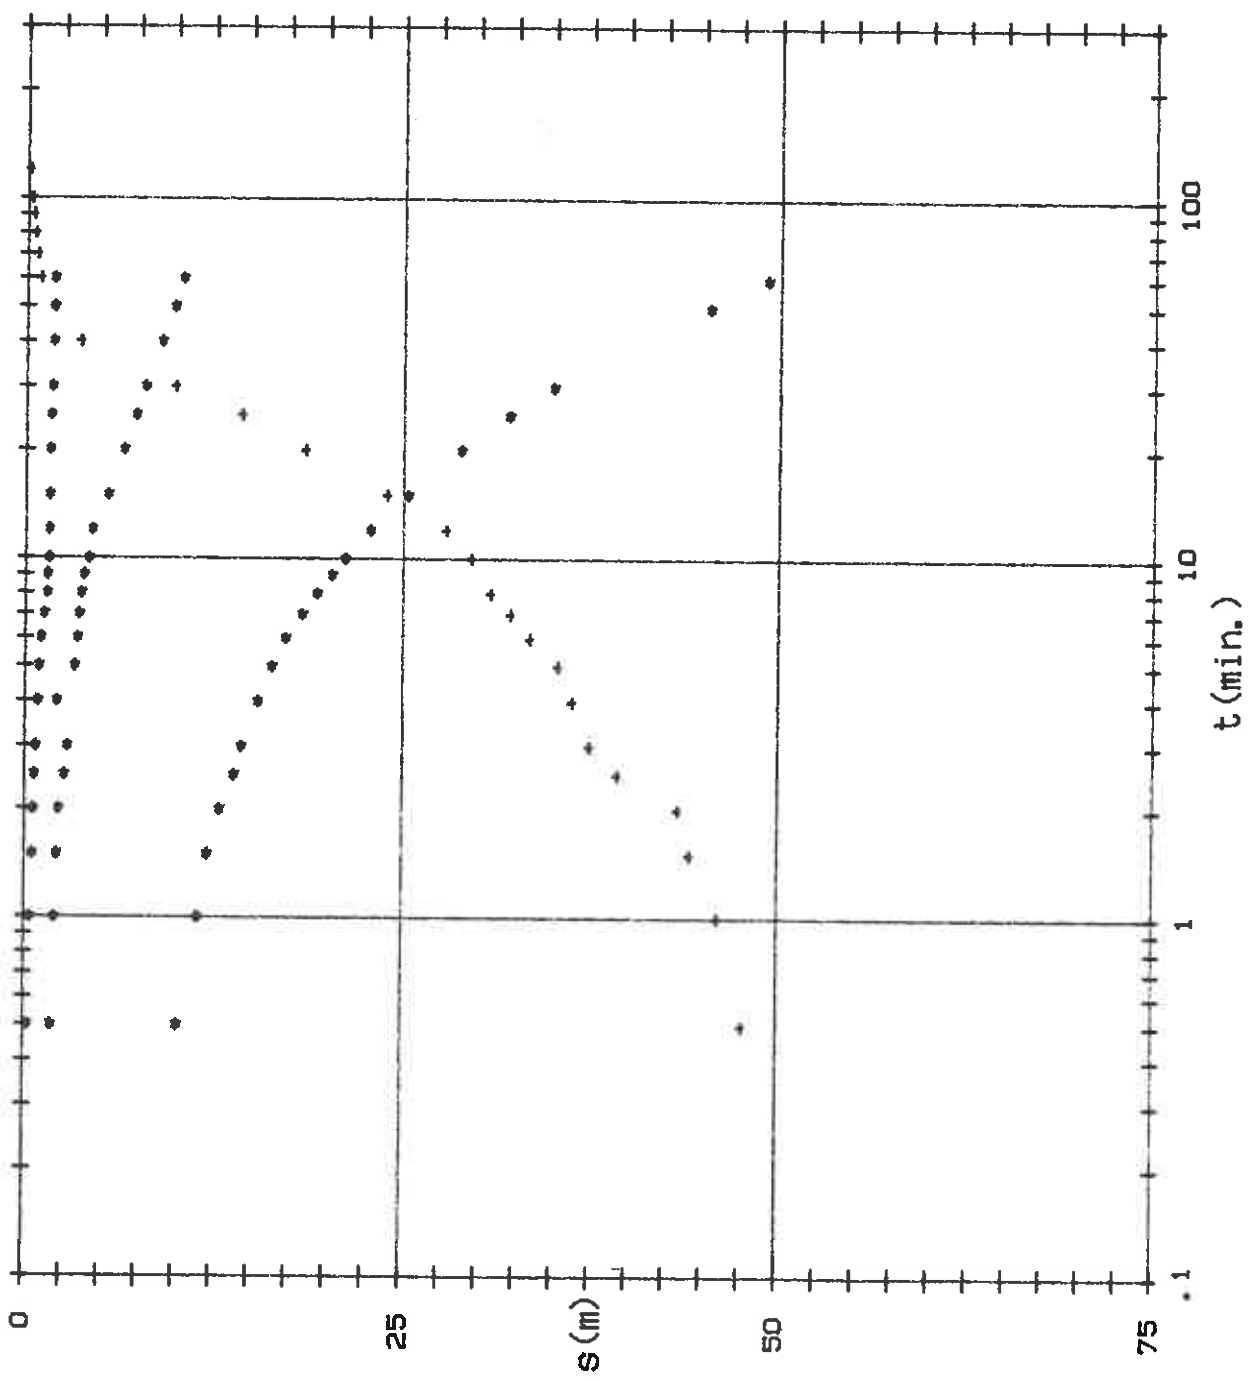
$Q_1 = .16 \text{ l/s}$
 $Q_2 = .43 \text{ l/s}$
 $Q_3 = .85 \text{ l/s}$

S.W.L. = 7.4 m

Step tests run on 10-77183 and 10-77340 showed the aquifers to be poorly developed. The maximum yield pumped in 10-77183 was 0,85 l/s which resulted in the water level plunging 50m towards pump suction. The maximum discharge obtained from 10-77340 was also 0,85 l/s, which caused the water level to hit the pump with a drawdown of 10m. Testing of this borehole was severely limited by the shallow depth and lack of pumpable drawdown, although it is evident the aquifer is unsuitable for a motorpump. The step test indicated that the aquifer intersected in 10-77340 is very shallow. Recovery of the water levels was good in both boreholes. These boreholes are already equipped with suitable equipment. (Table 9). The water quality is good and poses no constraint for either agricultural or potable use.
