REPUBLIC OF BOPHUTHATSWANA
DEPARTMENT OF WATER AFFAIRS

**REPORT ON THE SITING
DRILLING AND TESTING OF BOREHOLES,
AND THE TESTING OF EXISTING
BOREHOLES - DITSOBOTLA DISTRICT
JUNE 1991 - FEBRUARY 1993**

**VOLUME 1 - TEXT
AND APPENDIX I**

PARTRIDGE MAUD AND ASSOCIATES

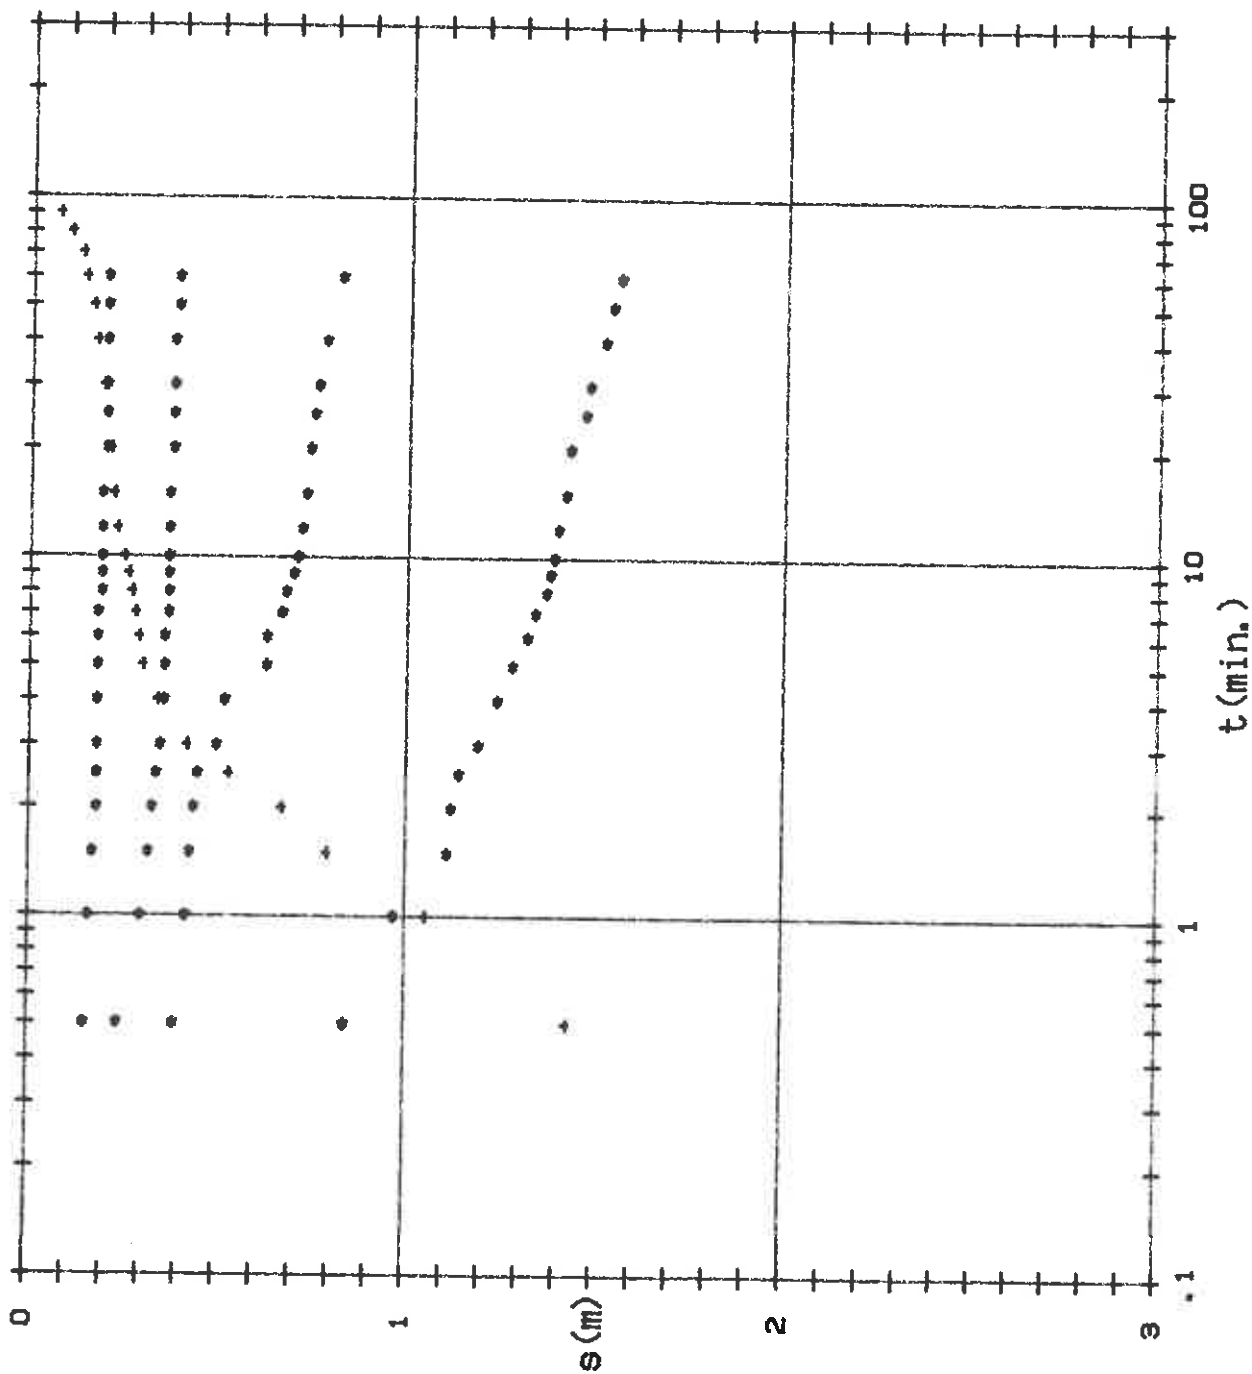
STEP DRAWDOWN TEST

* Pumping data
+ Recovery data

$Q_4 = 2 \text{ l/s}$

S.W.L. = 7.55 m

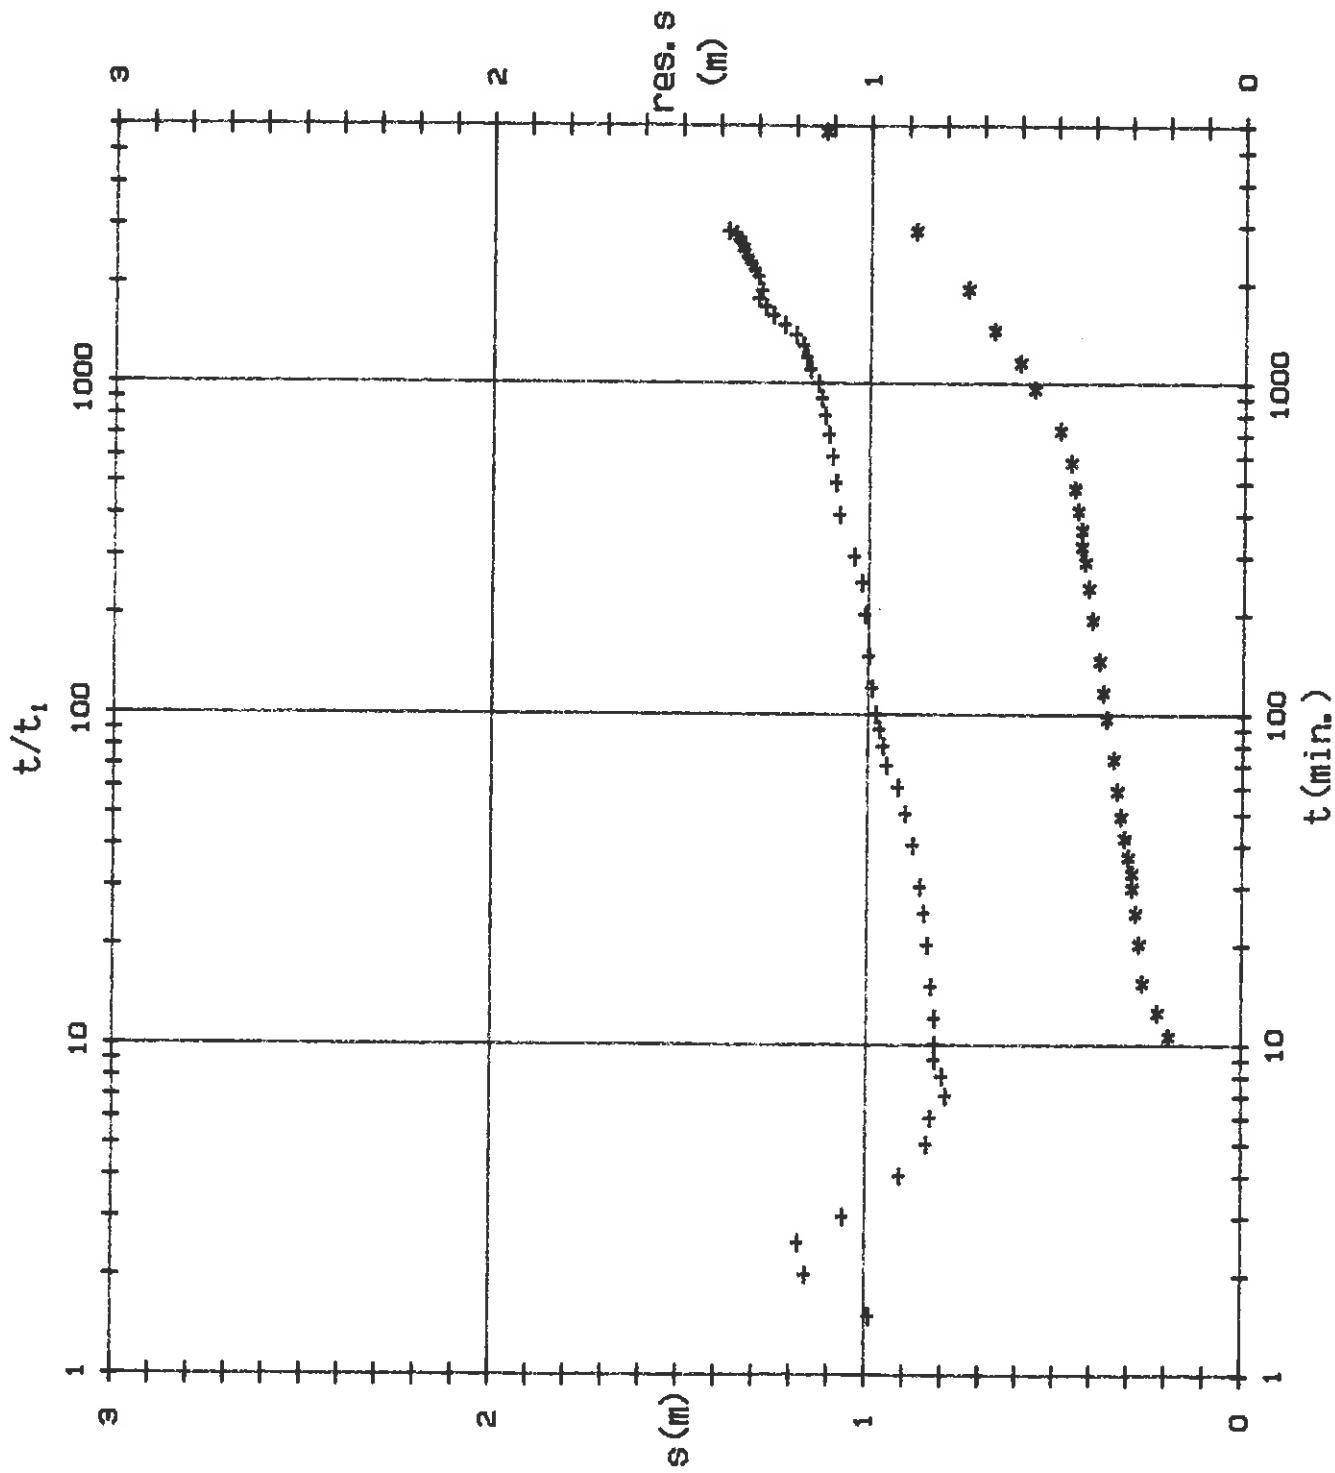
CONSTANT DISCHARGE TEST

+ Drawdown data,
* Recovery data.

S.W.L. = 7.55 m

T = 25 m²/d

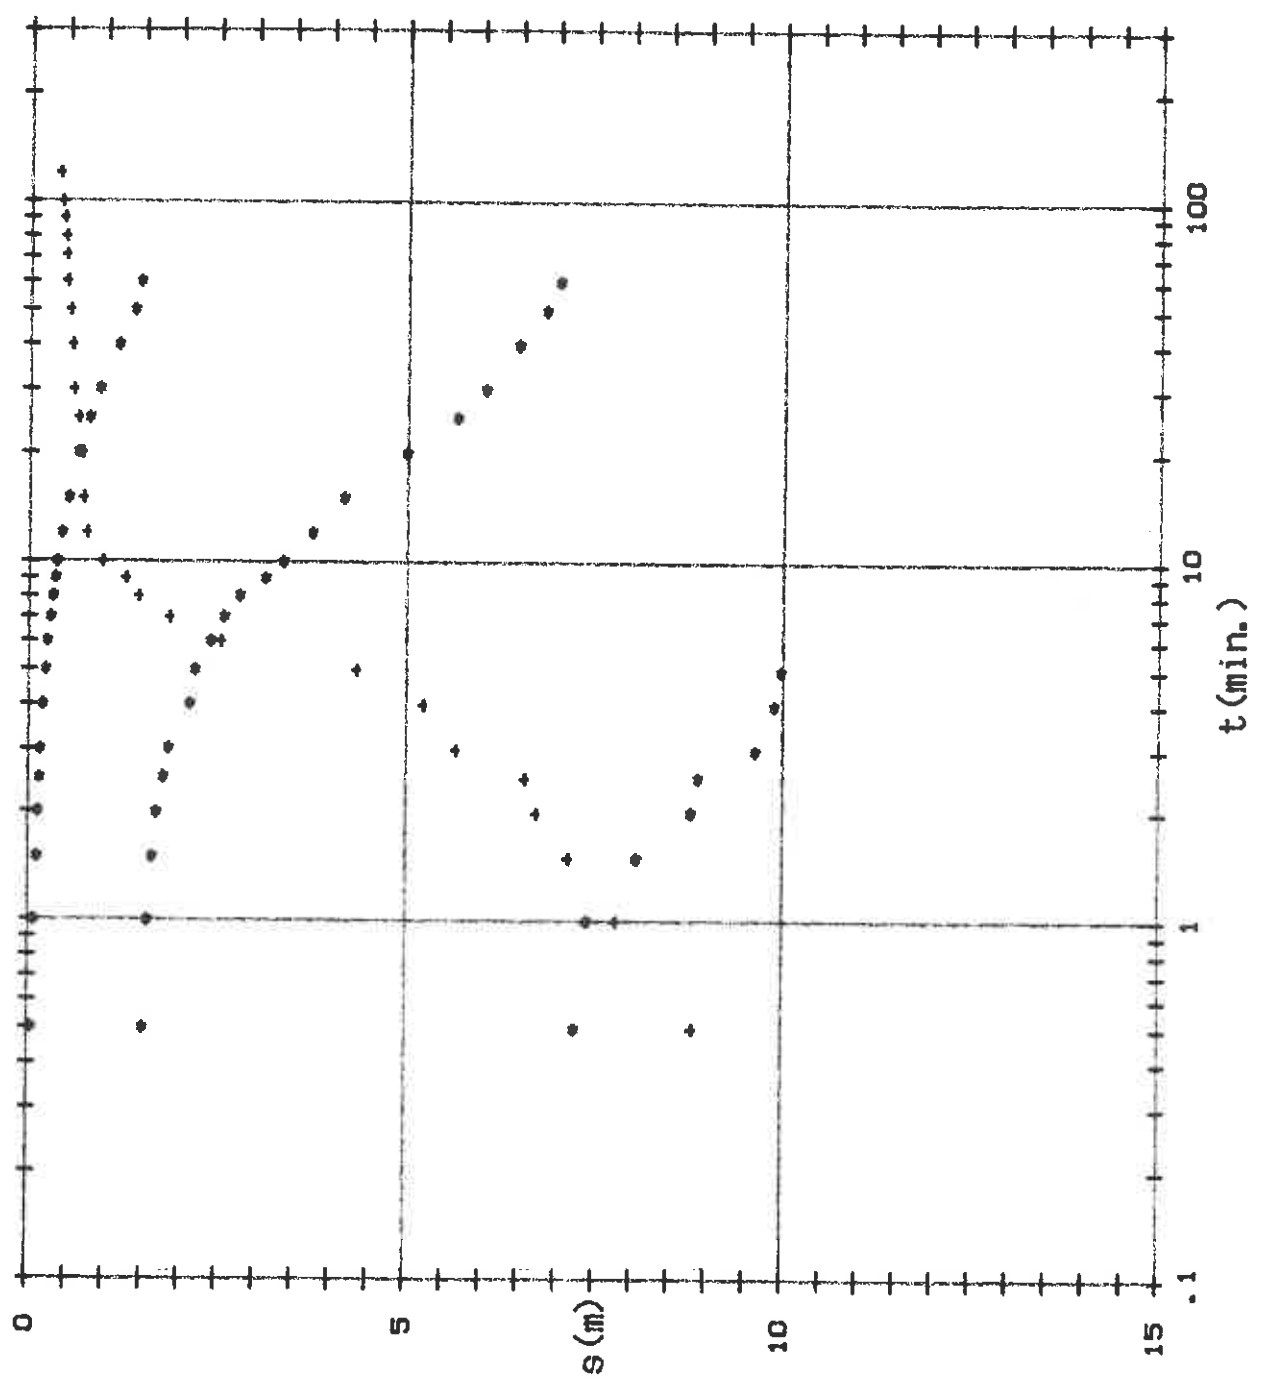
STEP DRAWDOWN TEST

- * Pumping data
- + Recovery data

$Q_3 = .85 \text{ l/s}$

S.W.L. = 7.34 m

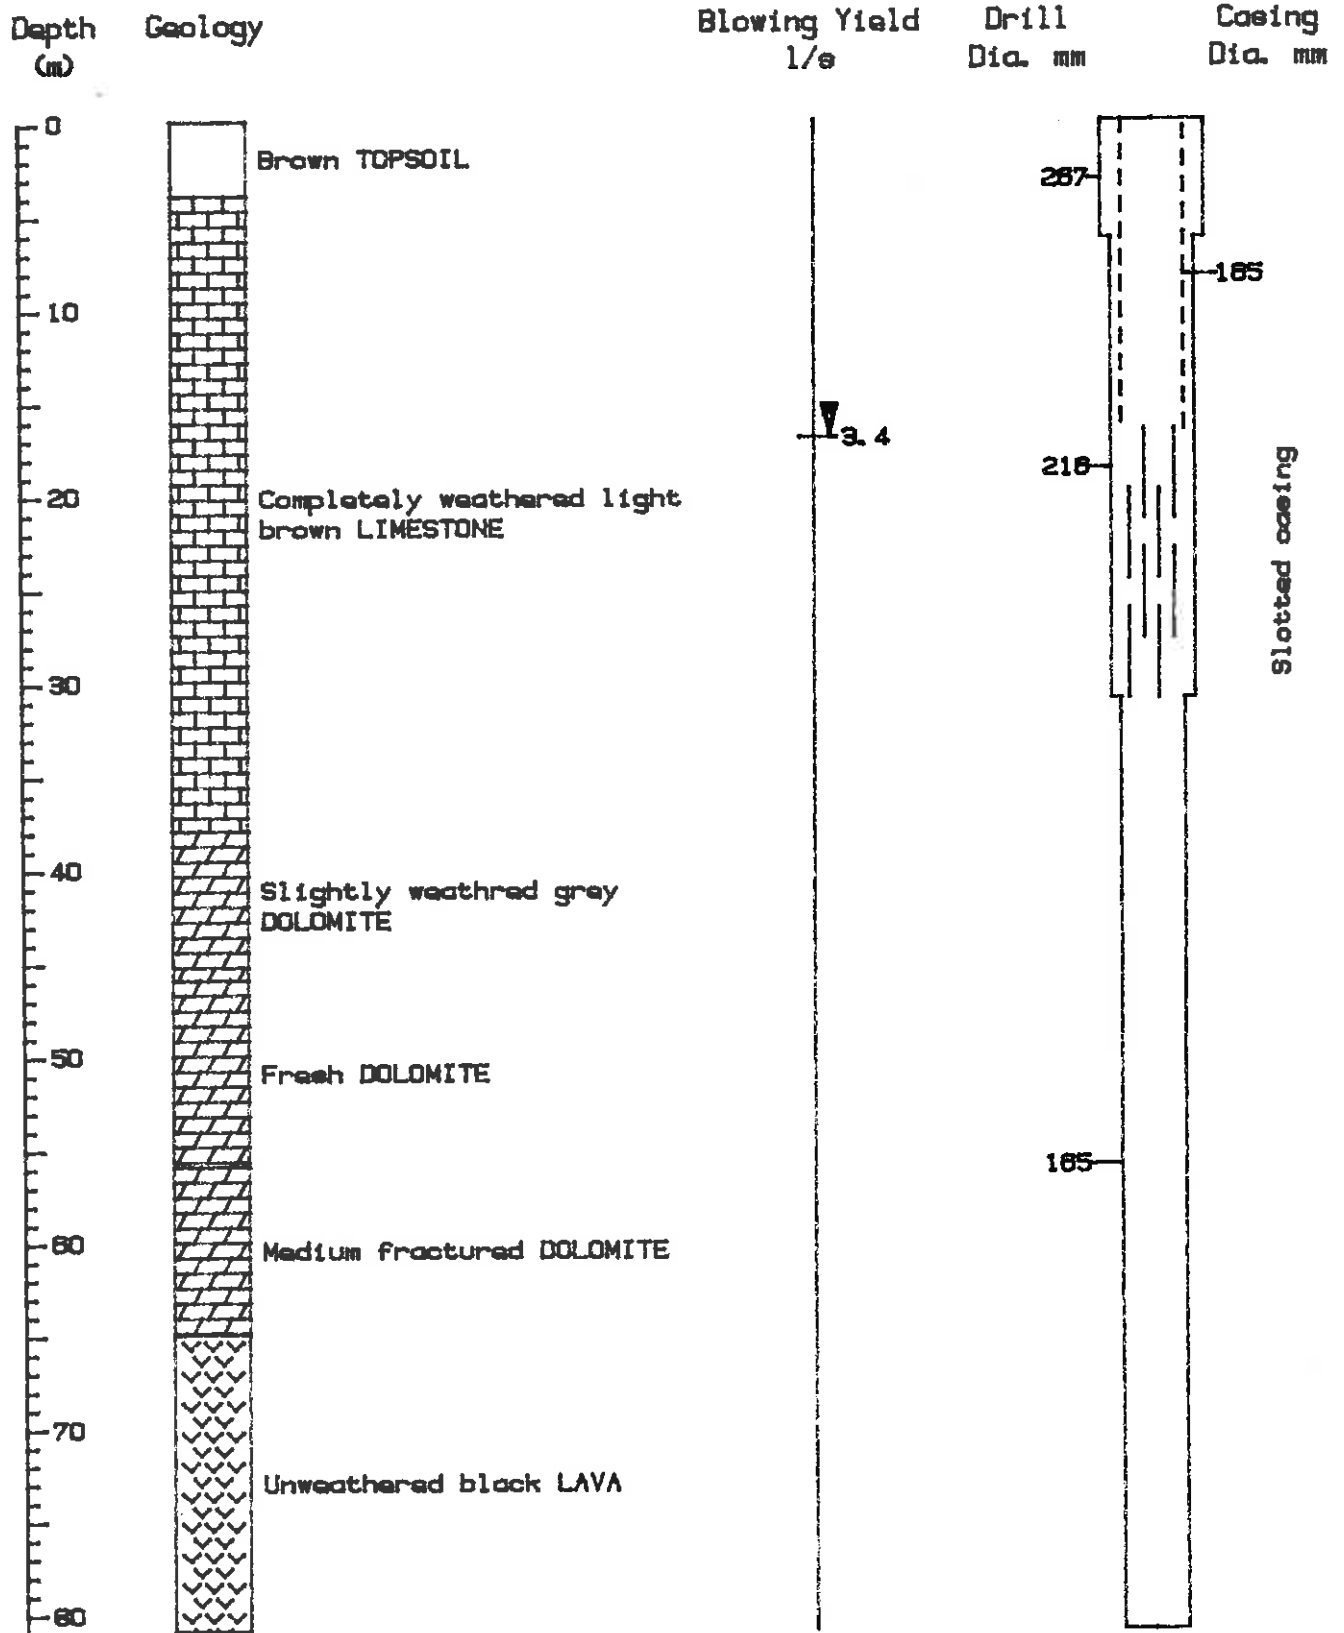
BOREHOLE LOG

Coordinates +2893975X -63600Y

Elev. (m) 1381

End of Hole 81

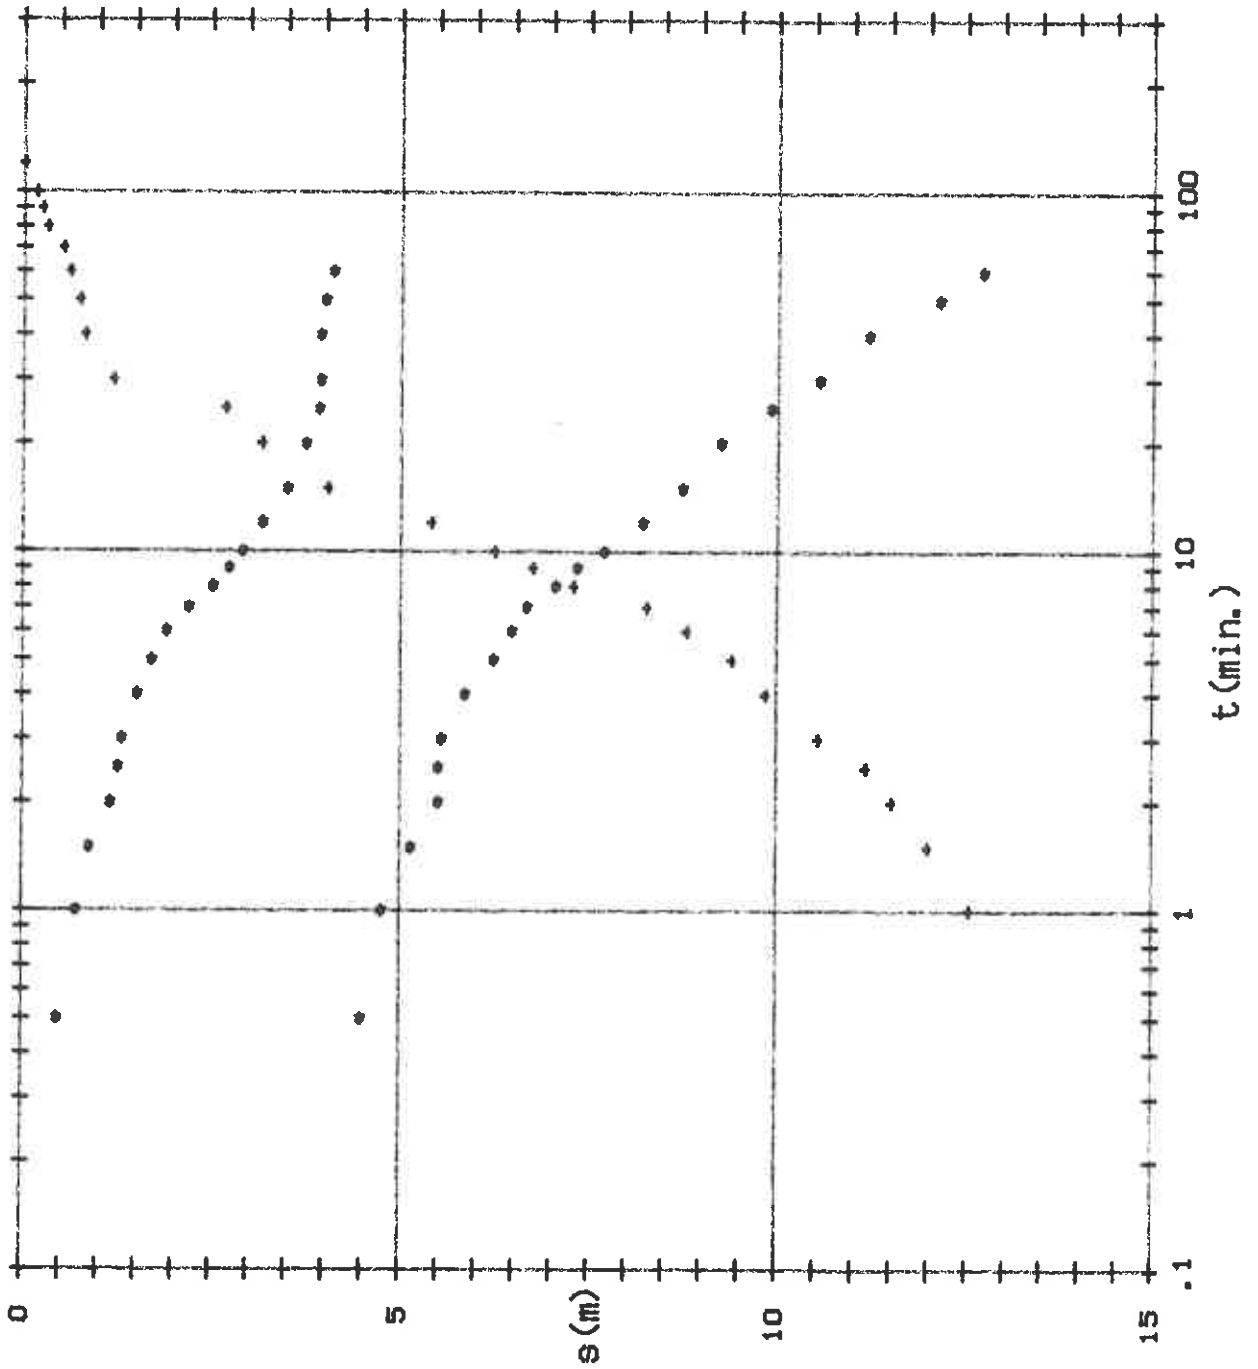
STEP DRAWDOWN TEST

$Q_2 = .6 \text{ l/s}$

S.W.L. = 5.93 m

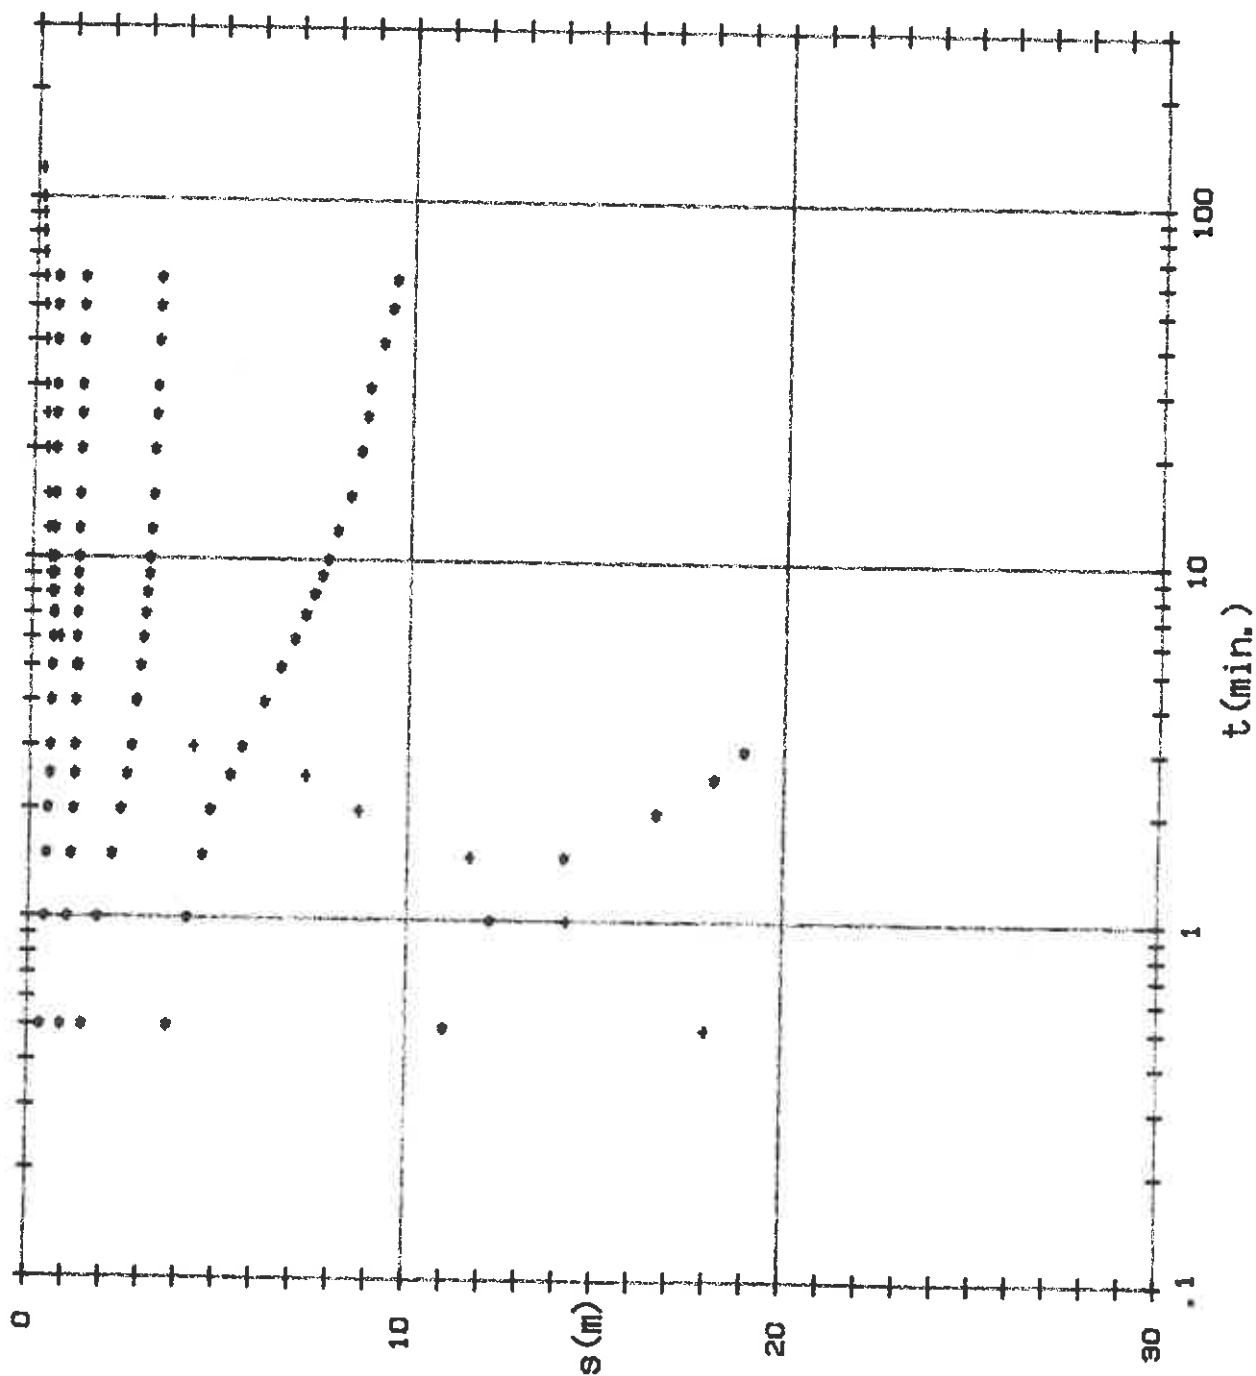
STEP DRAWDOWN TEST

* Pumping data
+ Recovery data

$Q_5 = 4 \text{ l/s}$

S.W.L. = 5.76 m

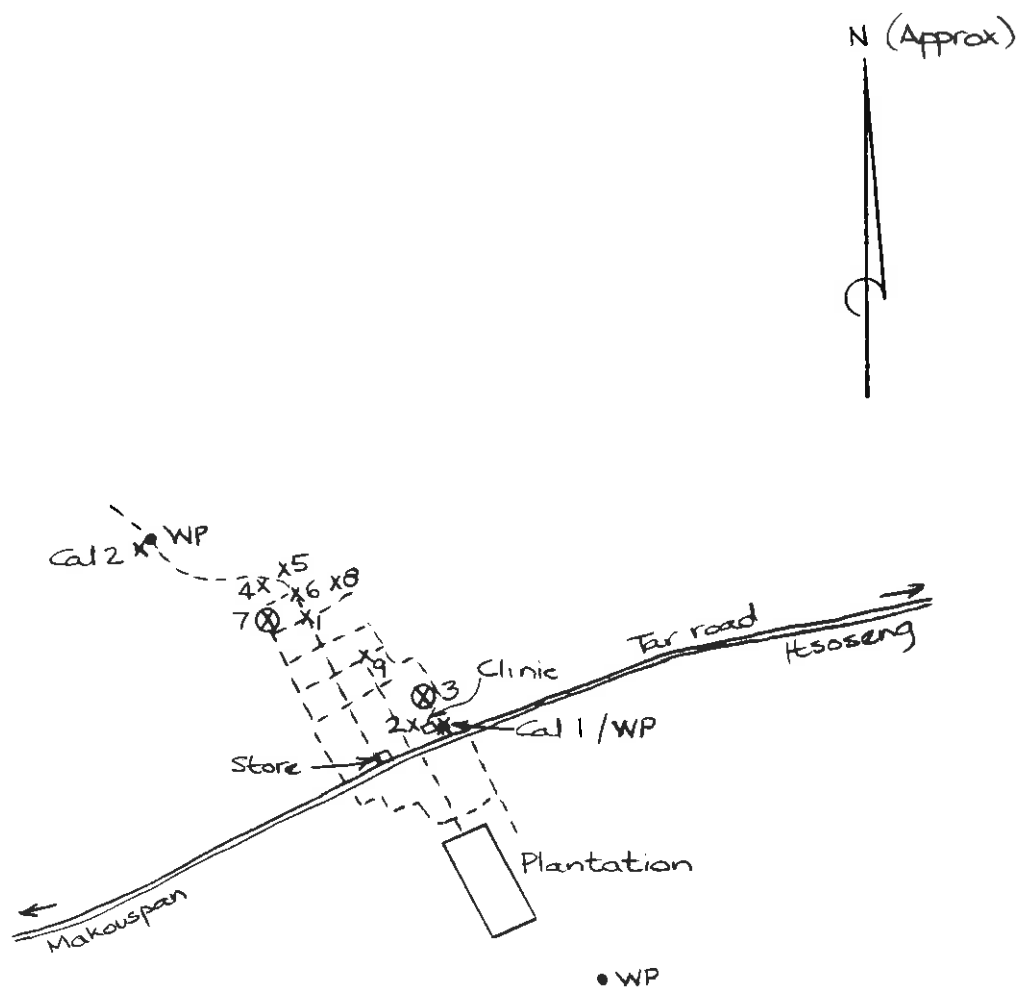
Locality Plan of Skoongezicht
 Overlay to Photo No 050 (strip 11B)
 Approx Scale 1:30 000

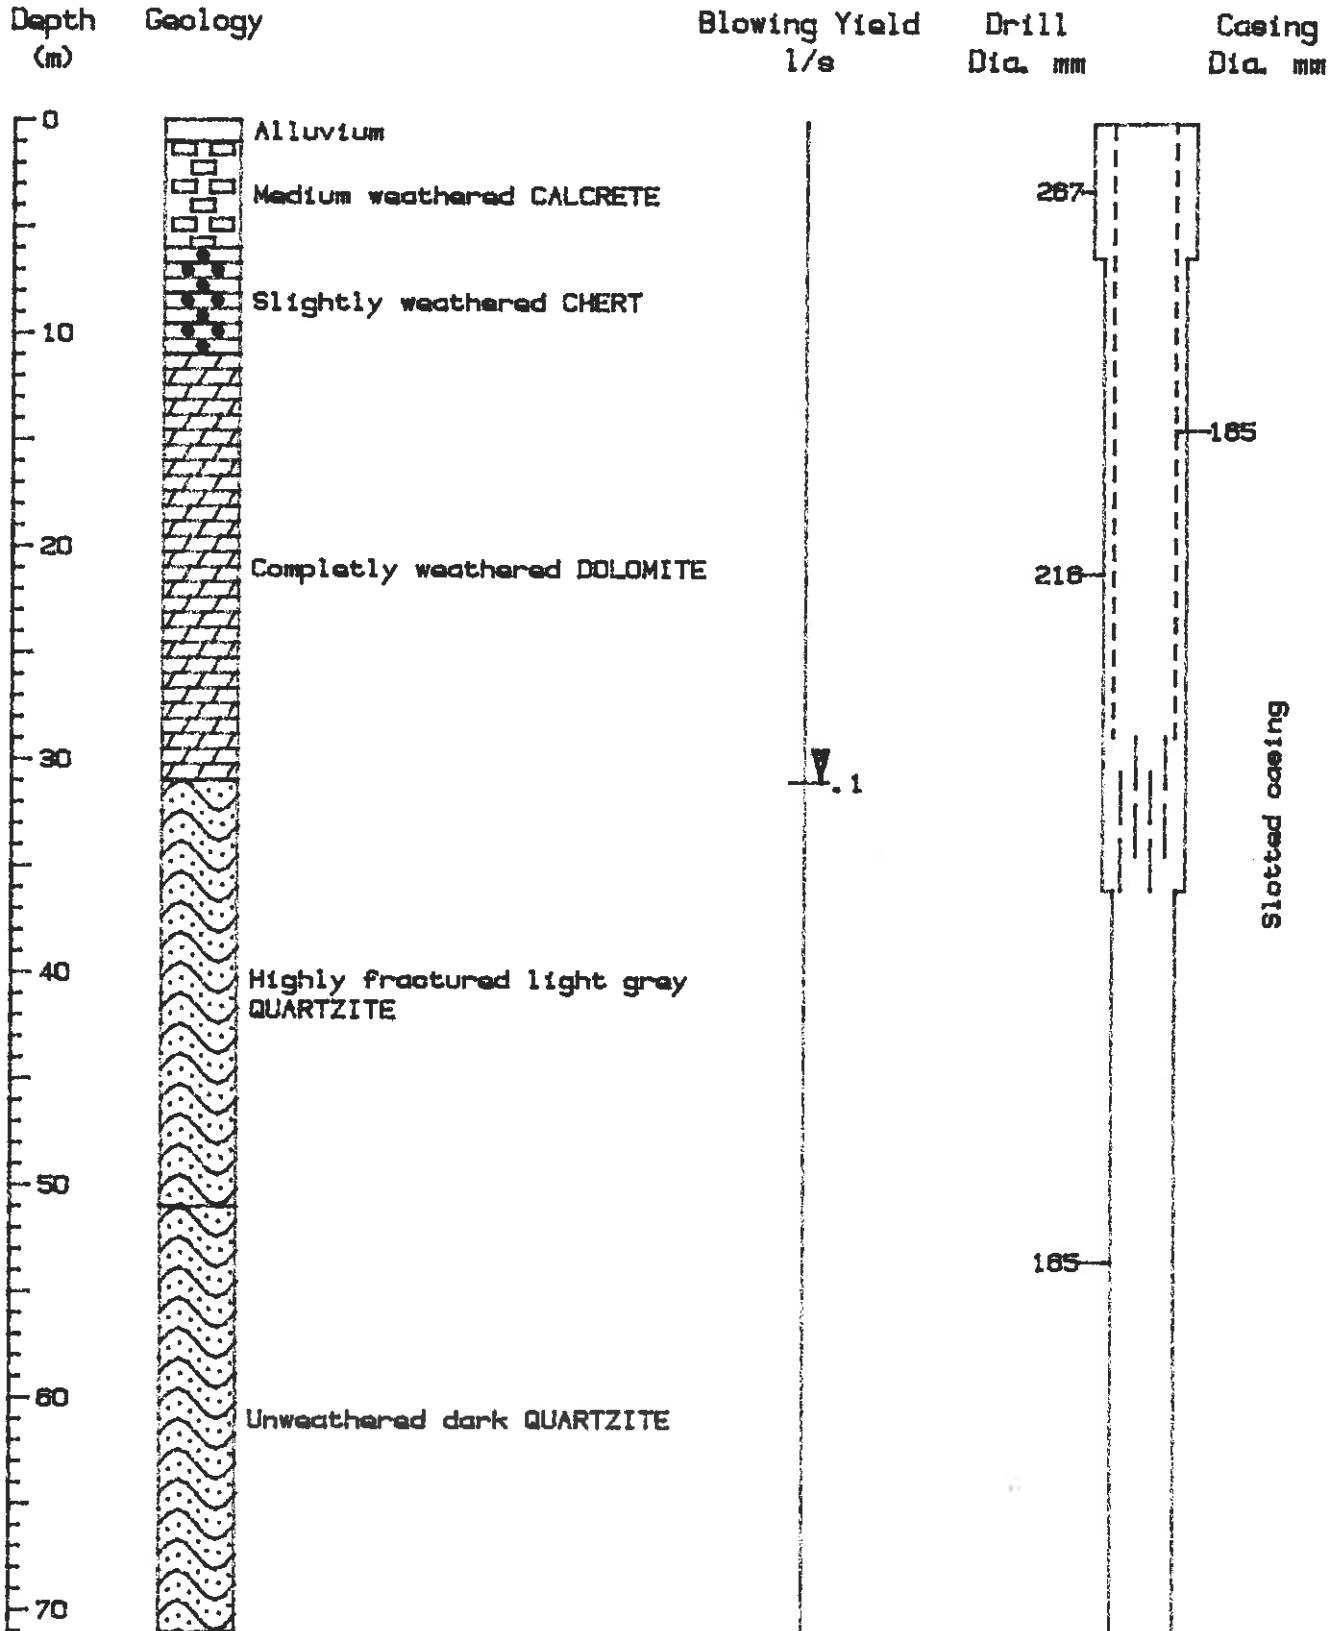
Coordinates +2881750X -71125Y

Elev. (m) 1389

End of Hole 71

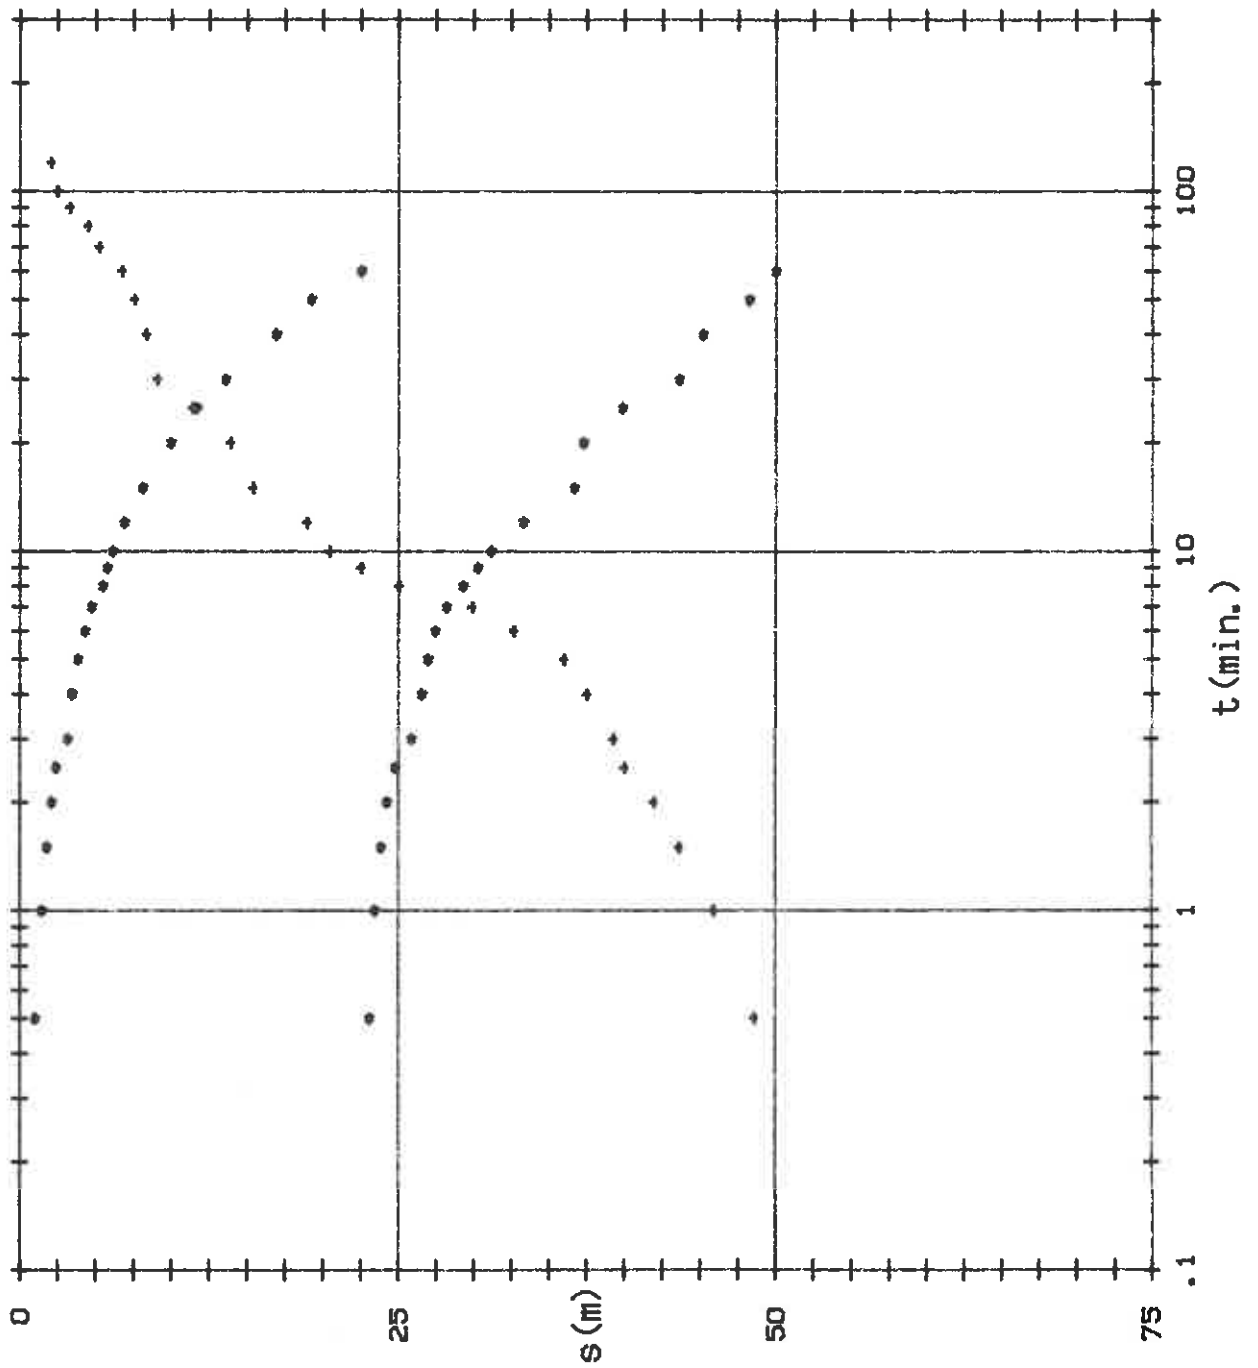
STEP DRAWDOWN TEST

$Q_2 = .5 \text{ l/s}$

S.W.L. = 9.34 m

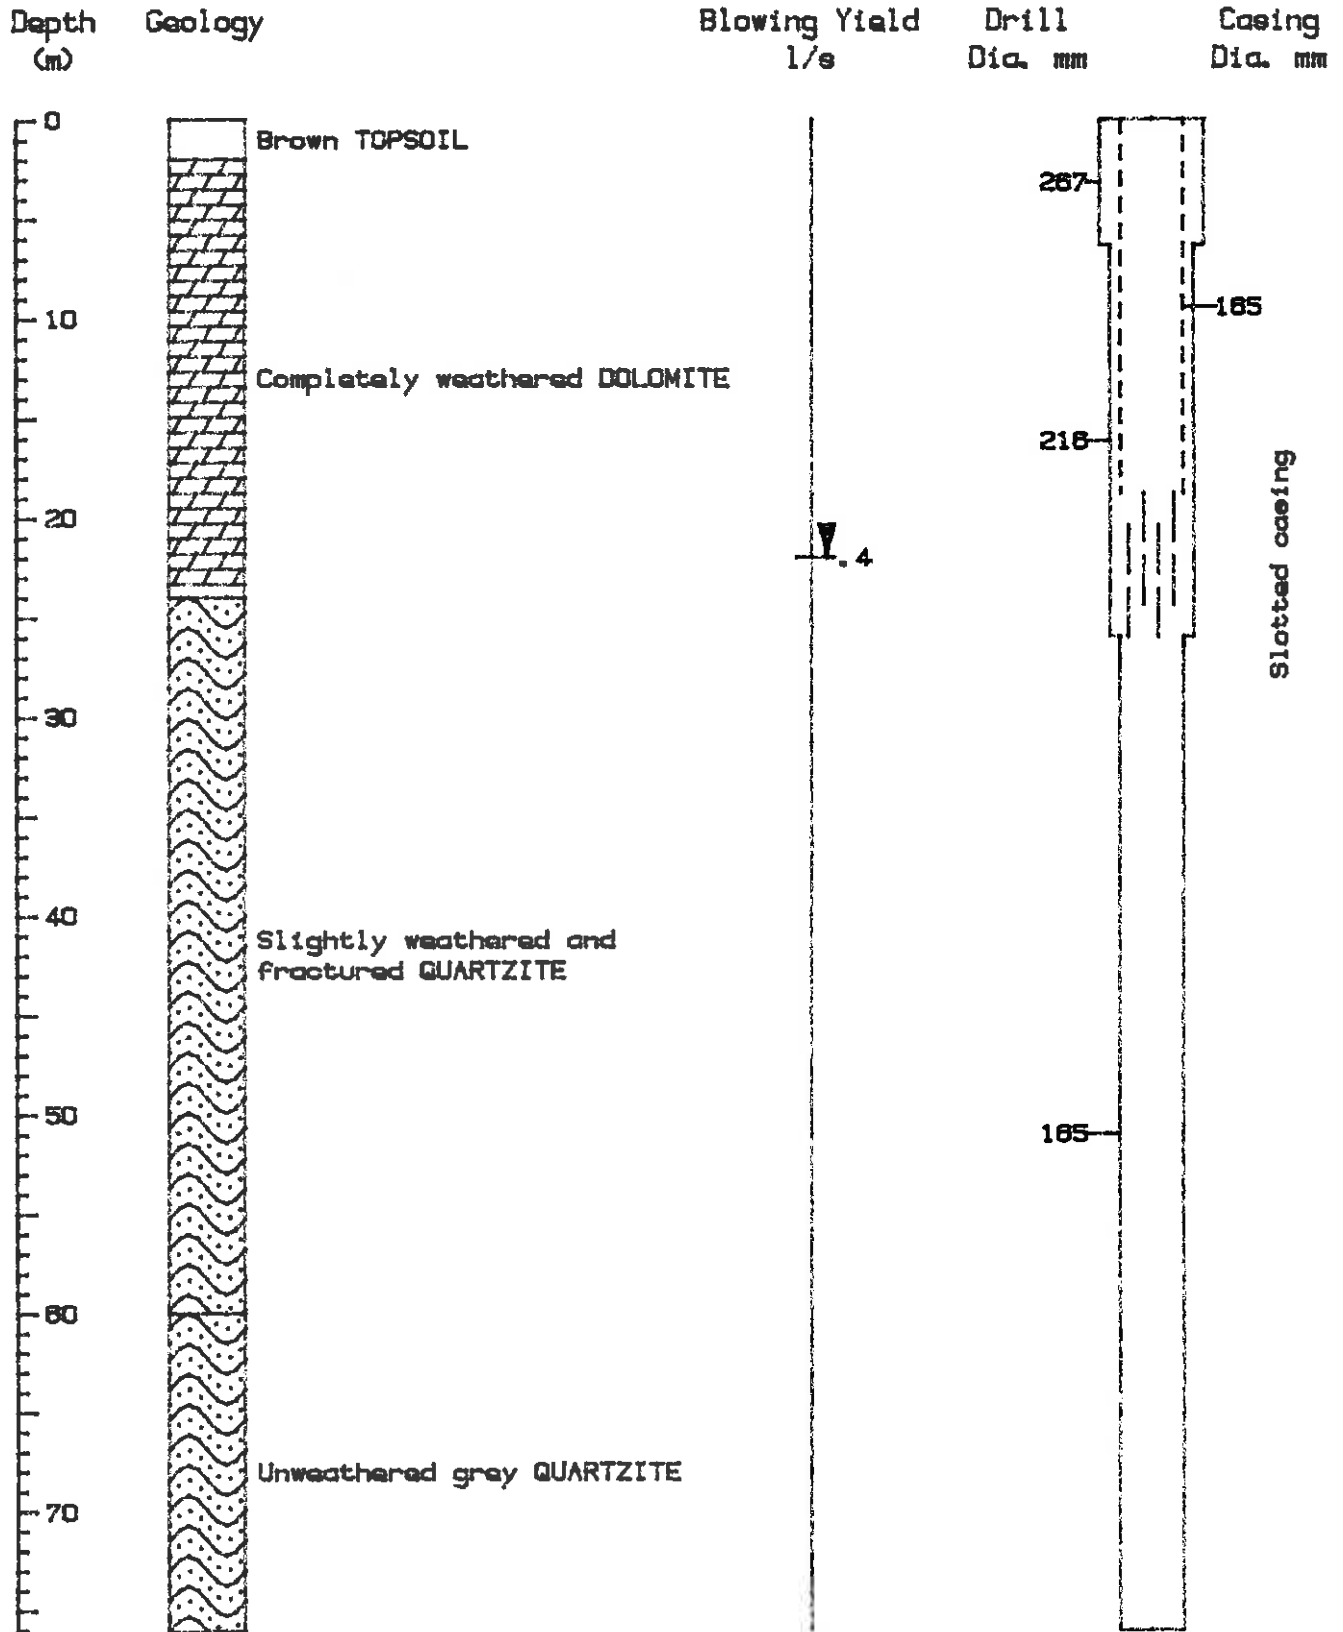
Coordinates +2881675X -70750Y

Elev. (m) 1389

End of Hole 76

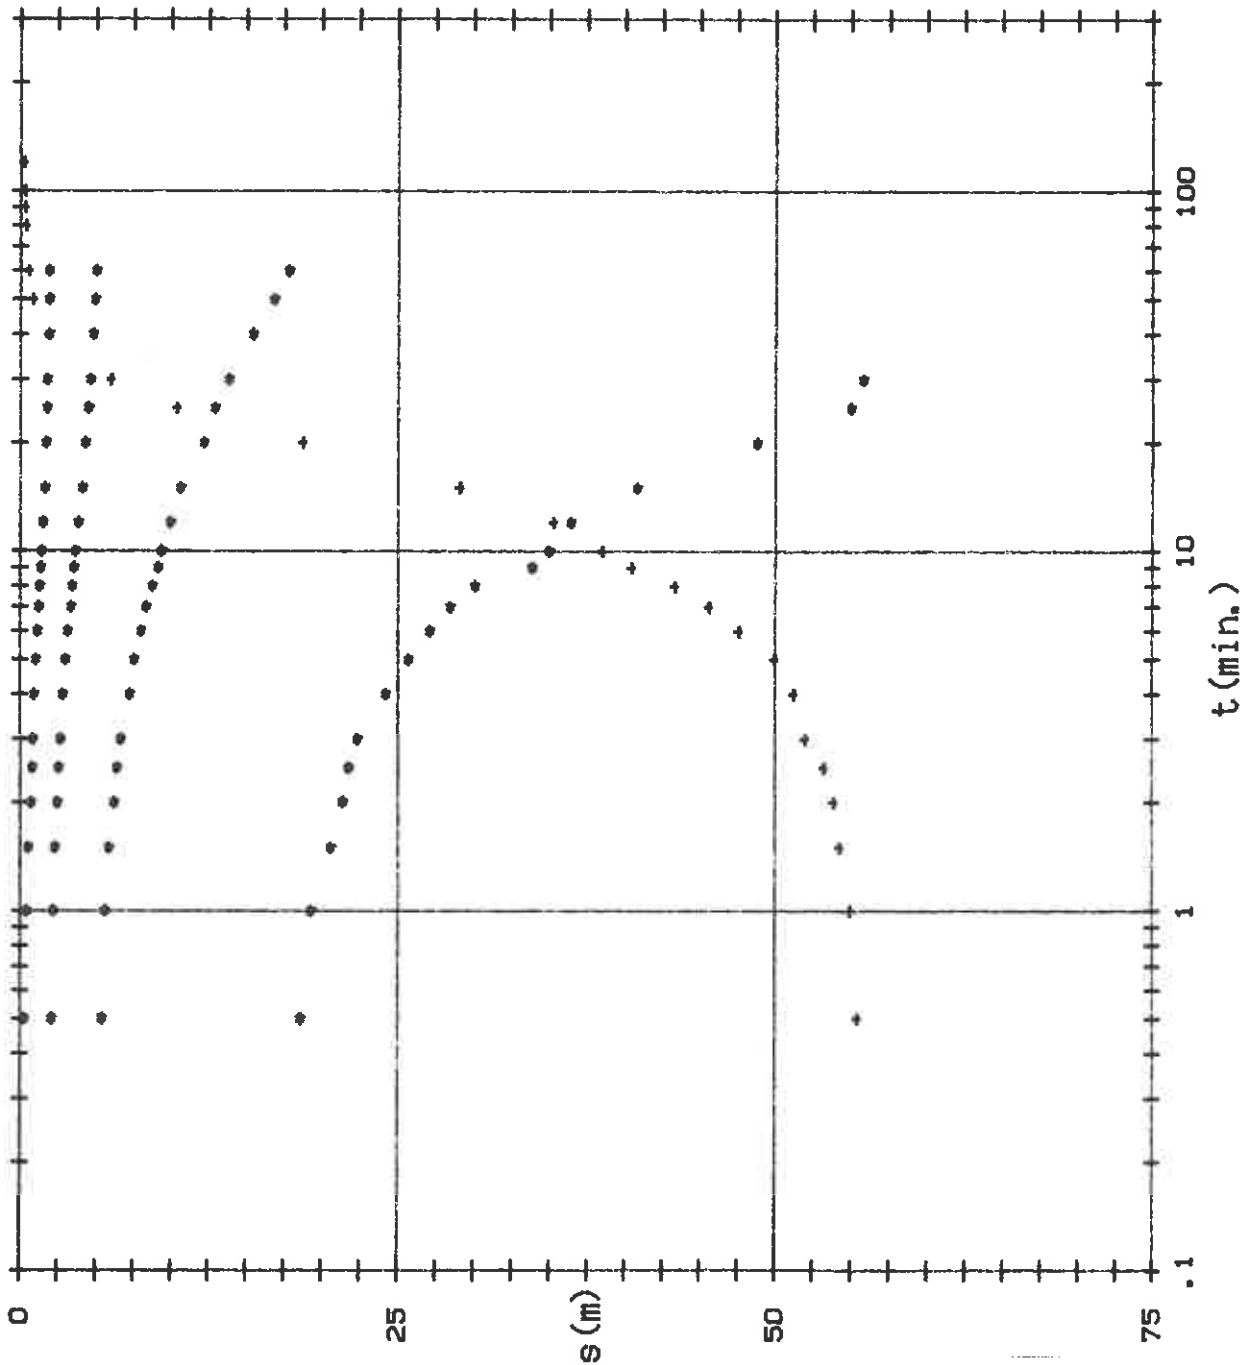
STEP DRAWDOWN TEST

$Q_1 = .18 \text{ l/s}$
 $Q_2 = .35 \text{ l/s}$
 $Q_3 = .65 \text{ l/s}$
 $Q_4 = 1.06 \text{ l/s}$

S.W.L. = 9.44 m

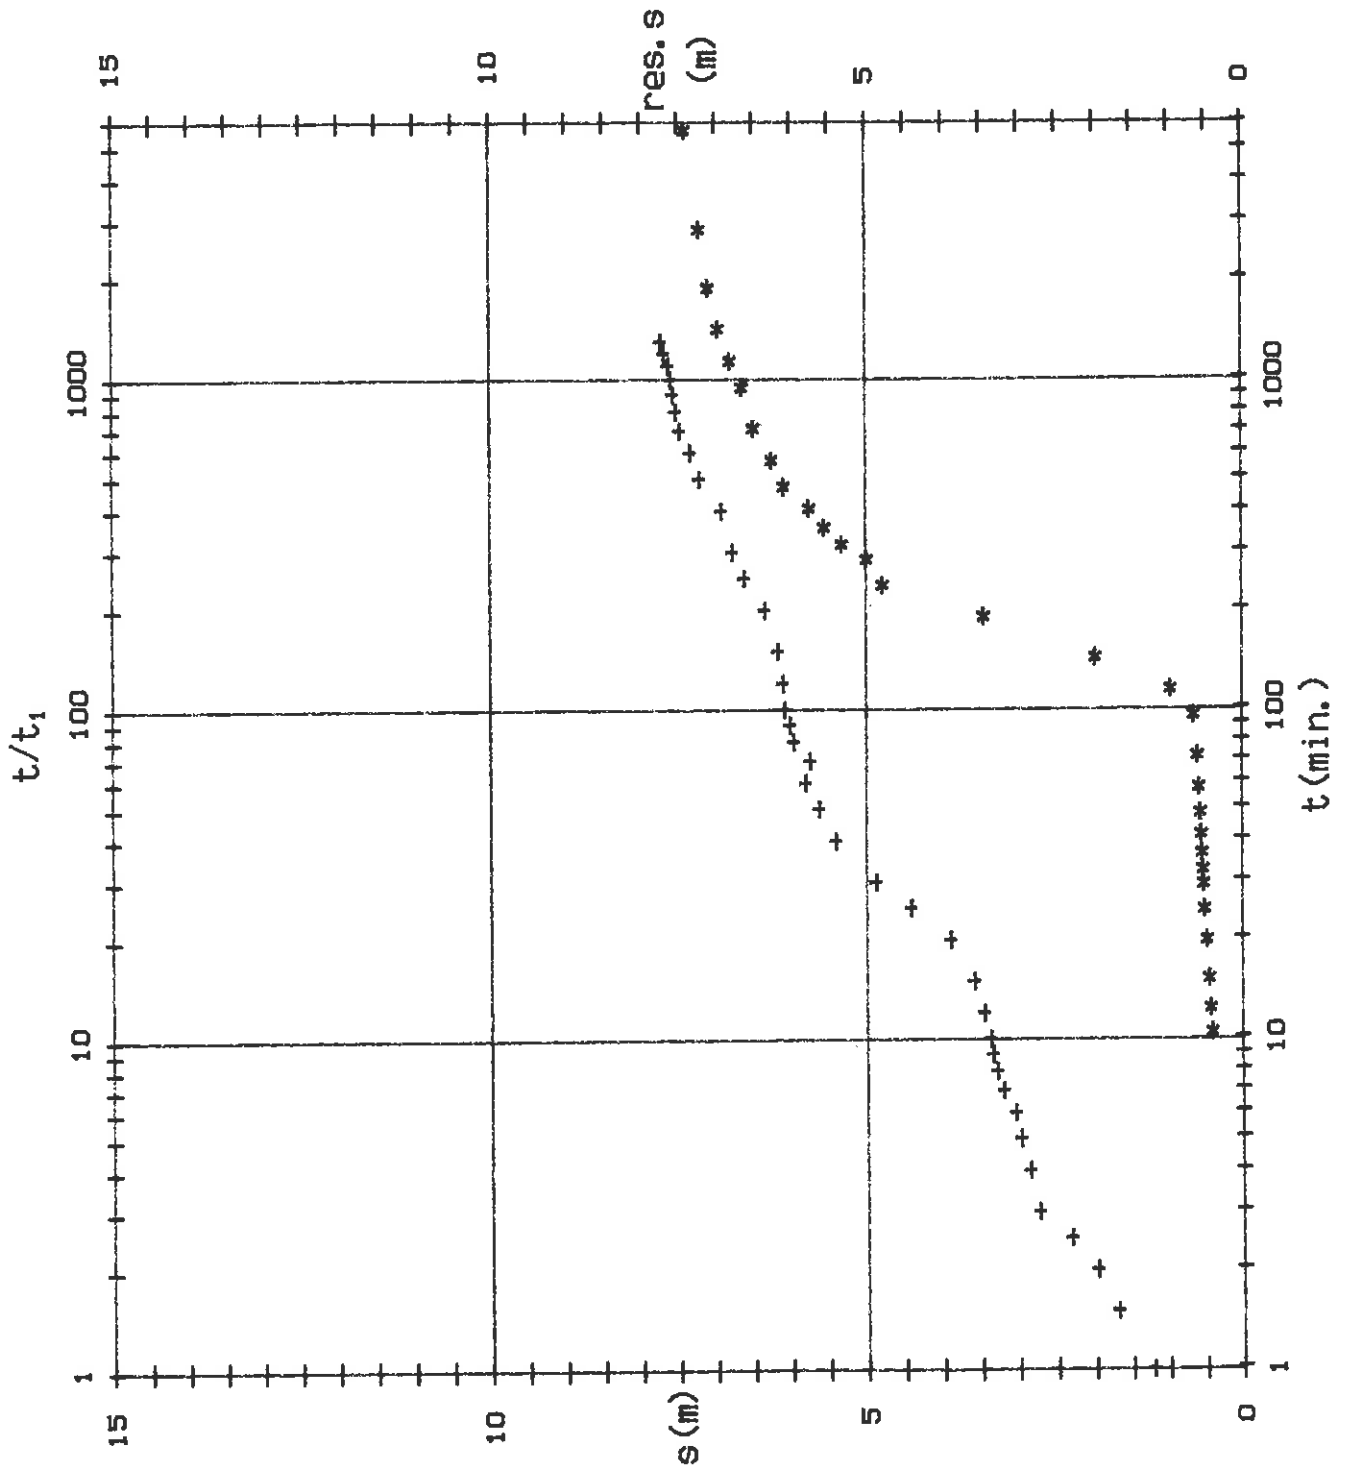
CONSTANT DISCHARGE TEST

+ Drawdown data.
* Recovery data.

S.W.L. = 9.44 m

$T = 3 \text{ m}^2/\text{d}$
