REPUBLIC OF BOPHUTHATSWANA
DEPARTMENT OF WATER AFFAIRS

**REPORT ON THE SITING
DRILLING AND TESTING OF BOREHOLES,
AND THE TESTING OF EXISTING
BOREHOLES - DITSOBOTLA DISTRICT
JUNE 1991 - FEBRUARY 1993**

**VOLUME 1 - TEXT
AND APPENDIX I**

PARTRIDGE MAUD AND ASSOCIATES

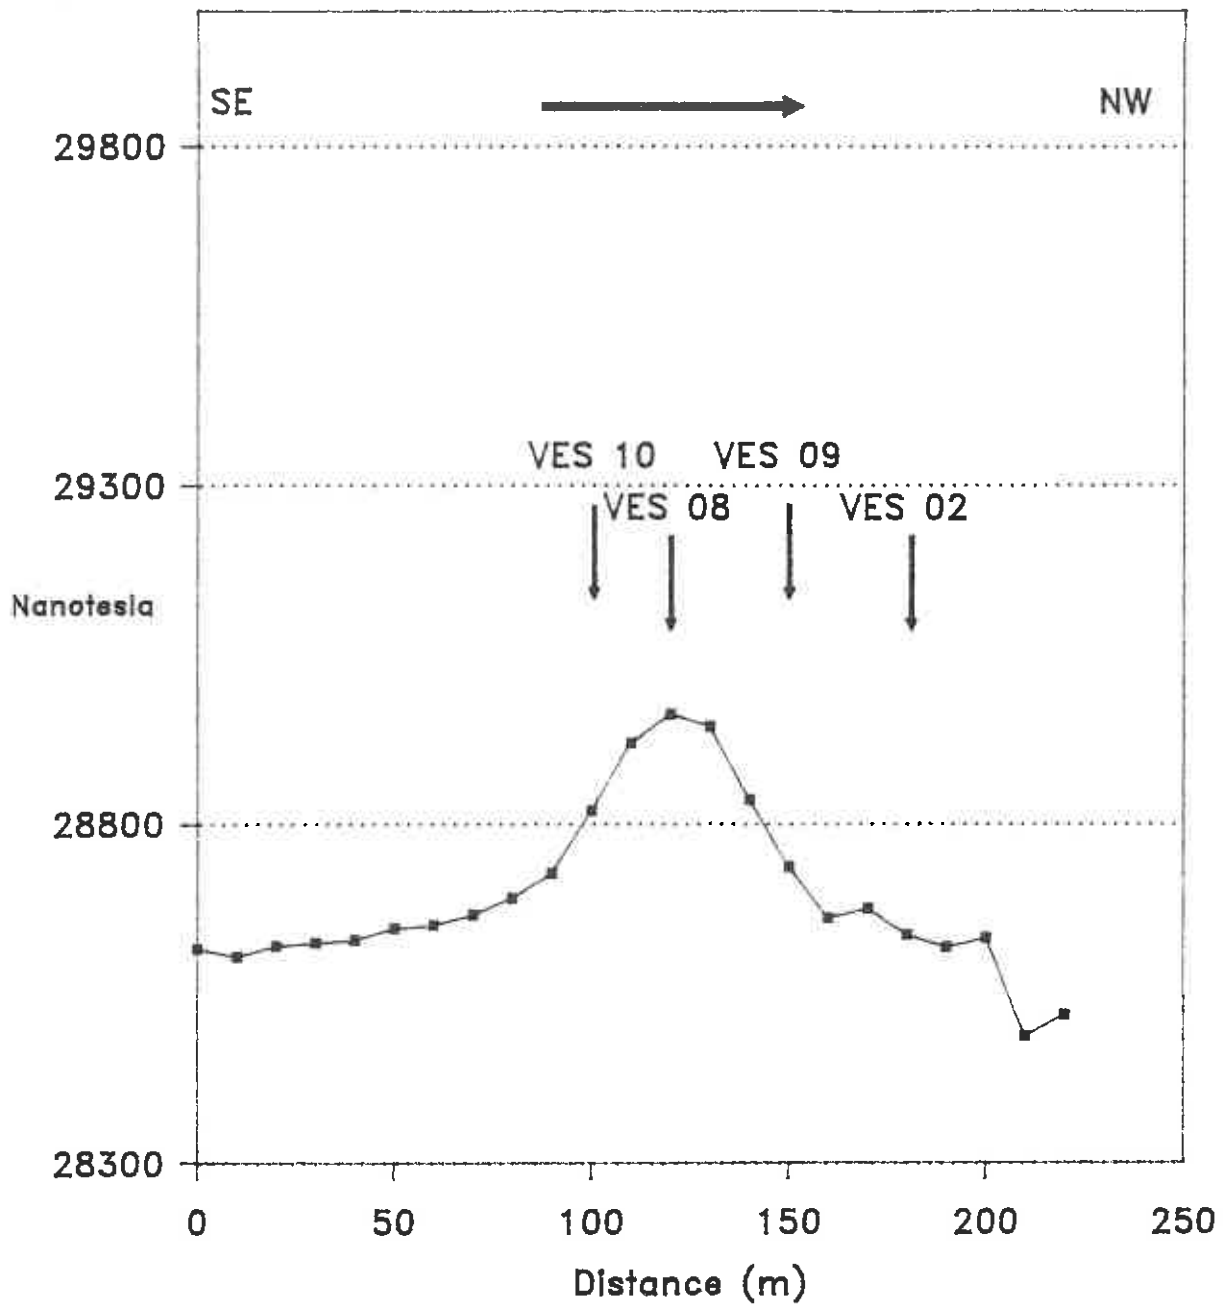
Magnetic Traverse #01
District: Ditsobotla
Locality: Shaleng

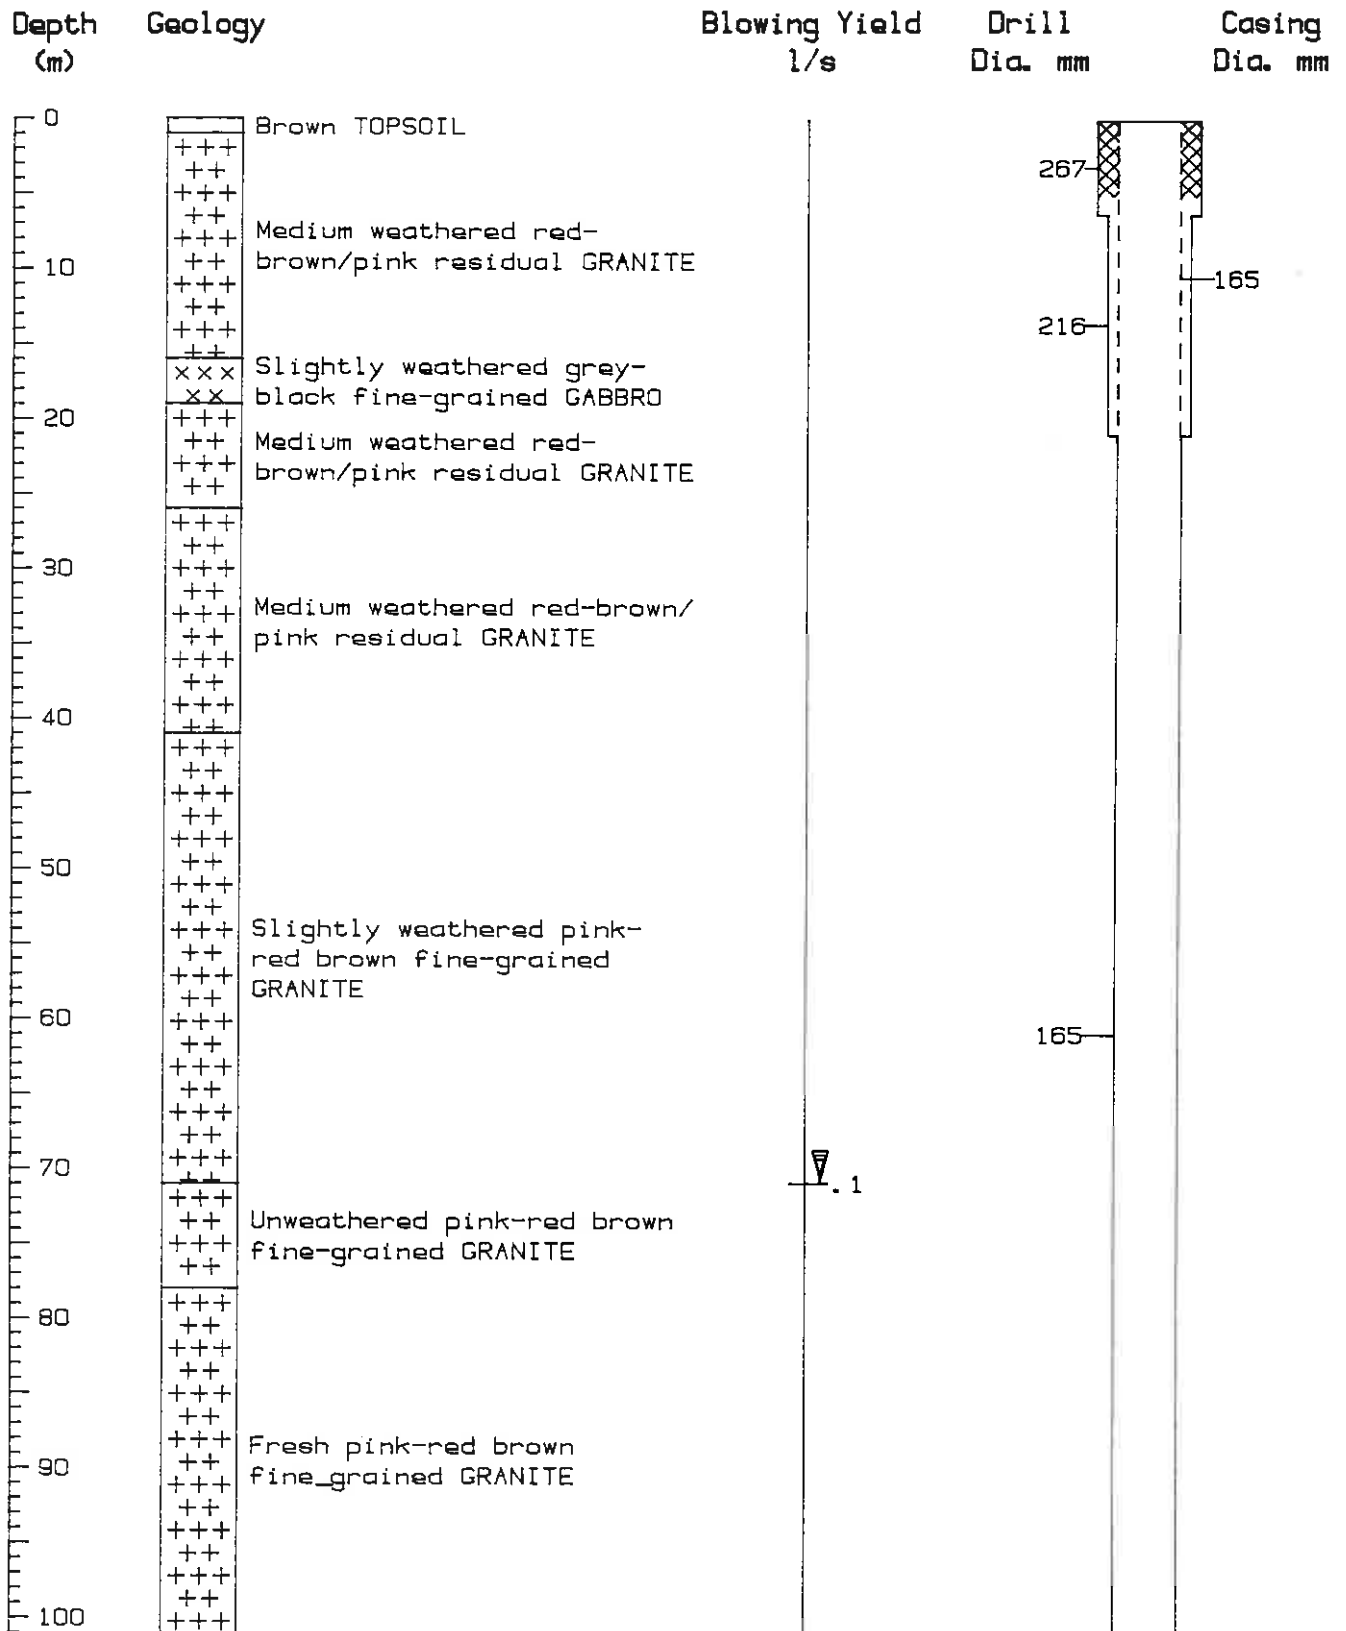
Coordinates +2922455X -034180Y

Elev. (m) 1339

End of Hole 101

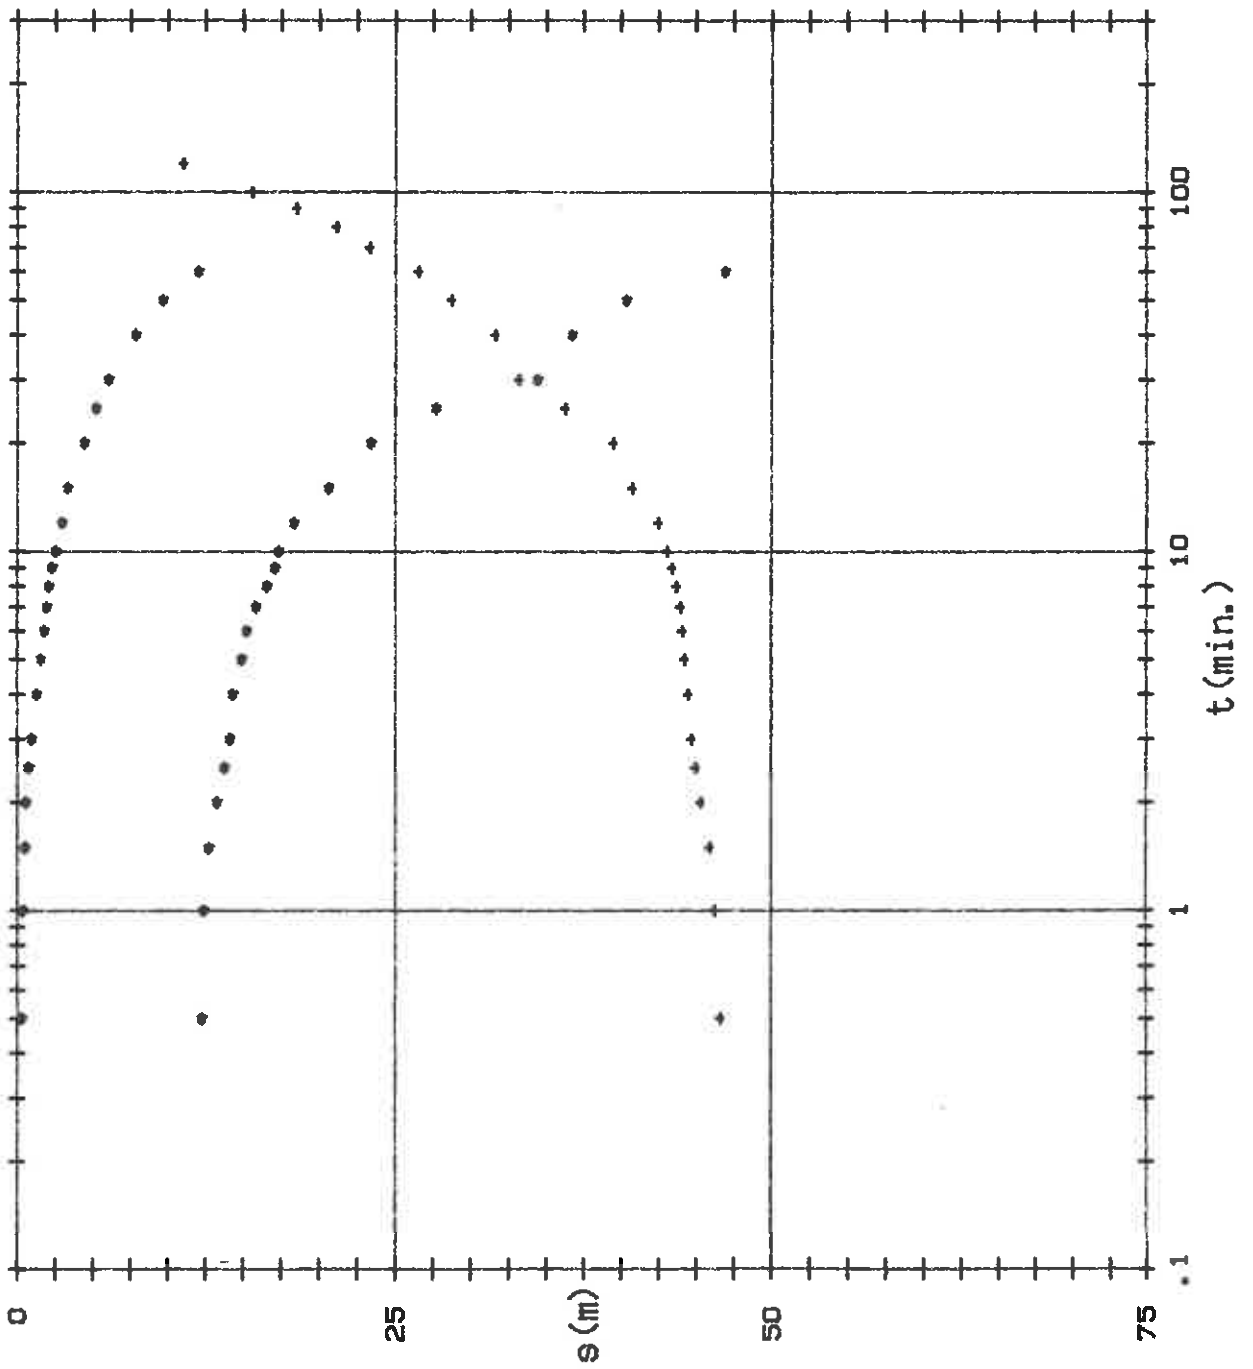
STEP DRAWDOWN TEST

$Q_2 = .3 \text{ l/s}$

S.W.L. = 7.84 m

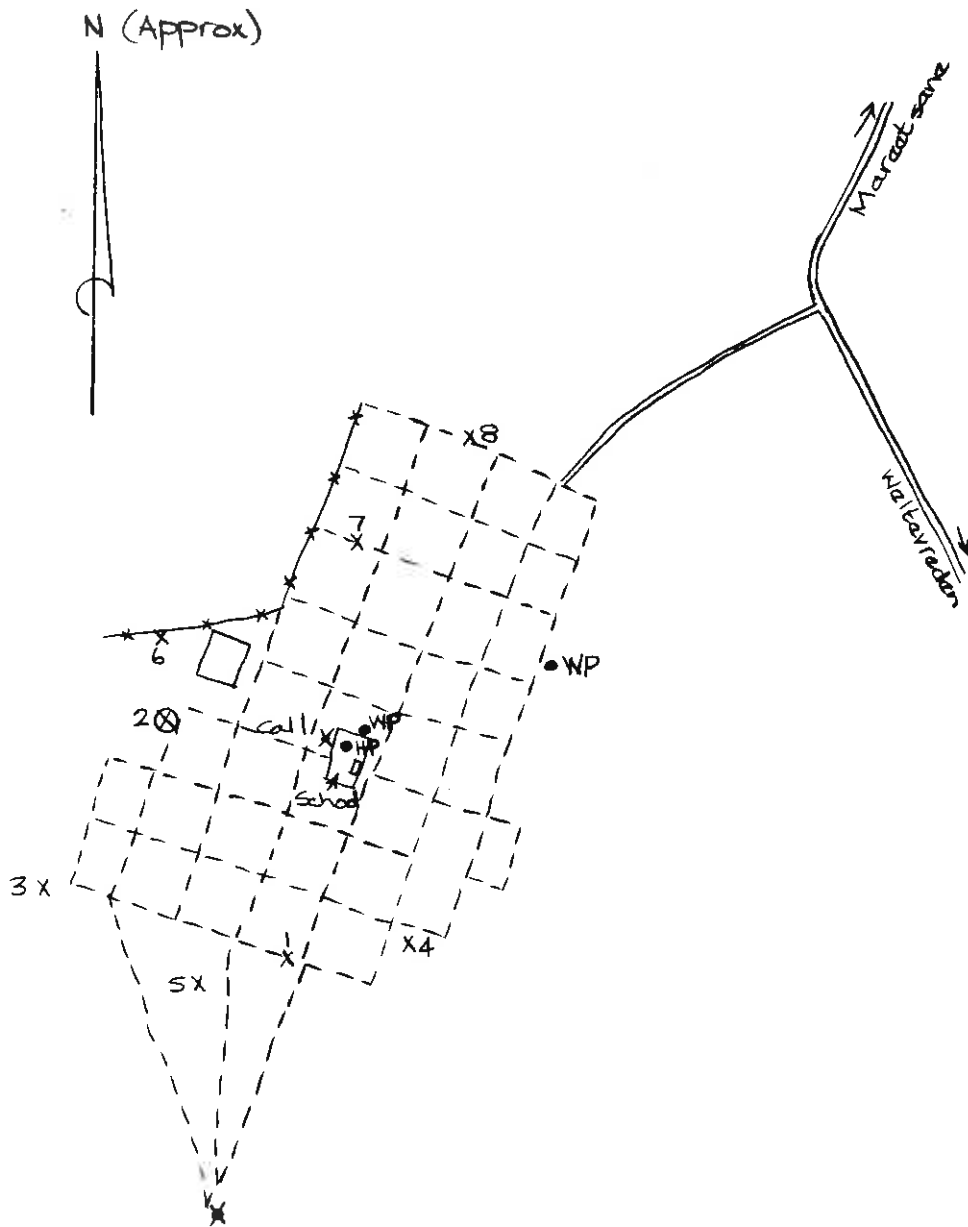
Locality Plan of Siberia
 Overlay to Photo No. 1429 (strip 7)
 Approx Scale 1:15 000

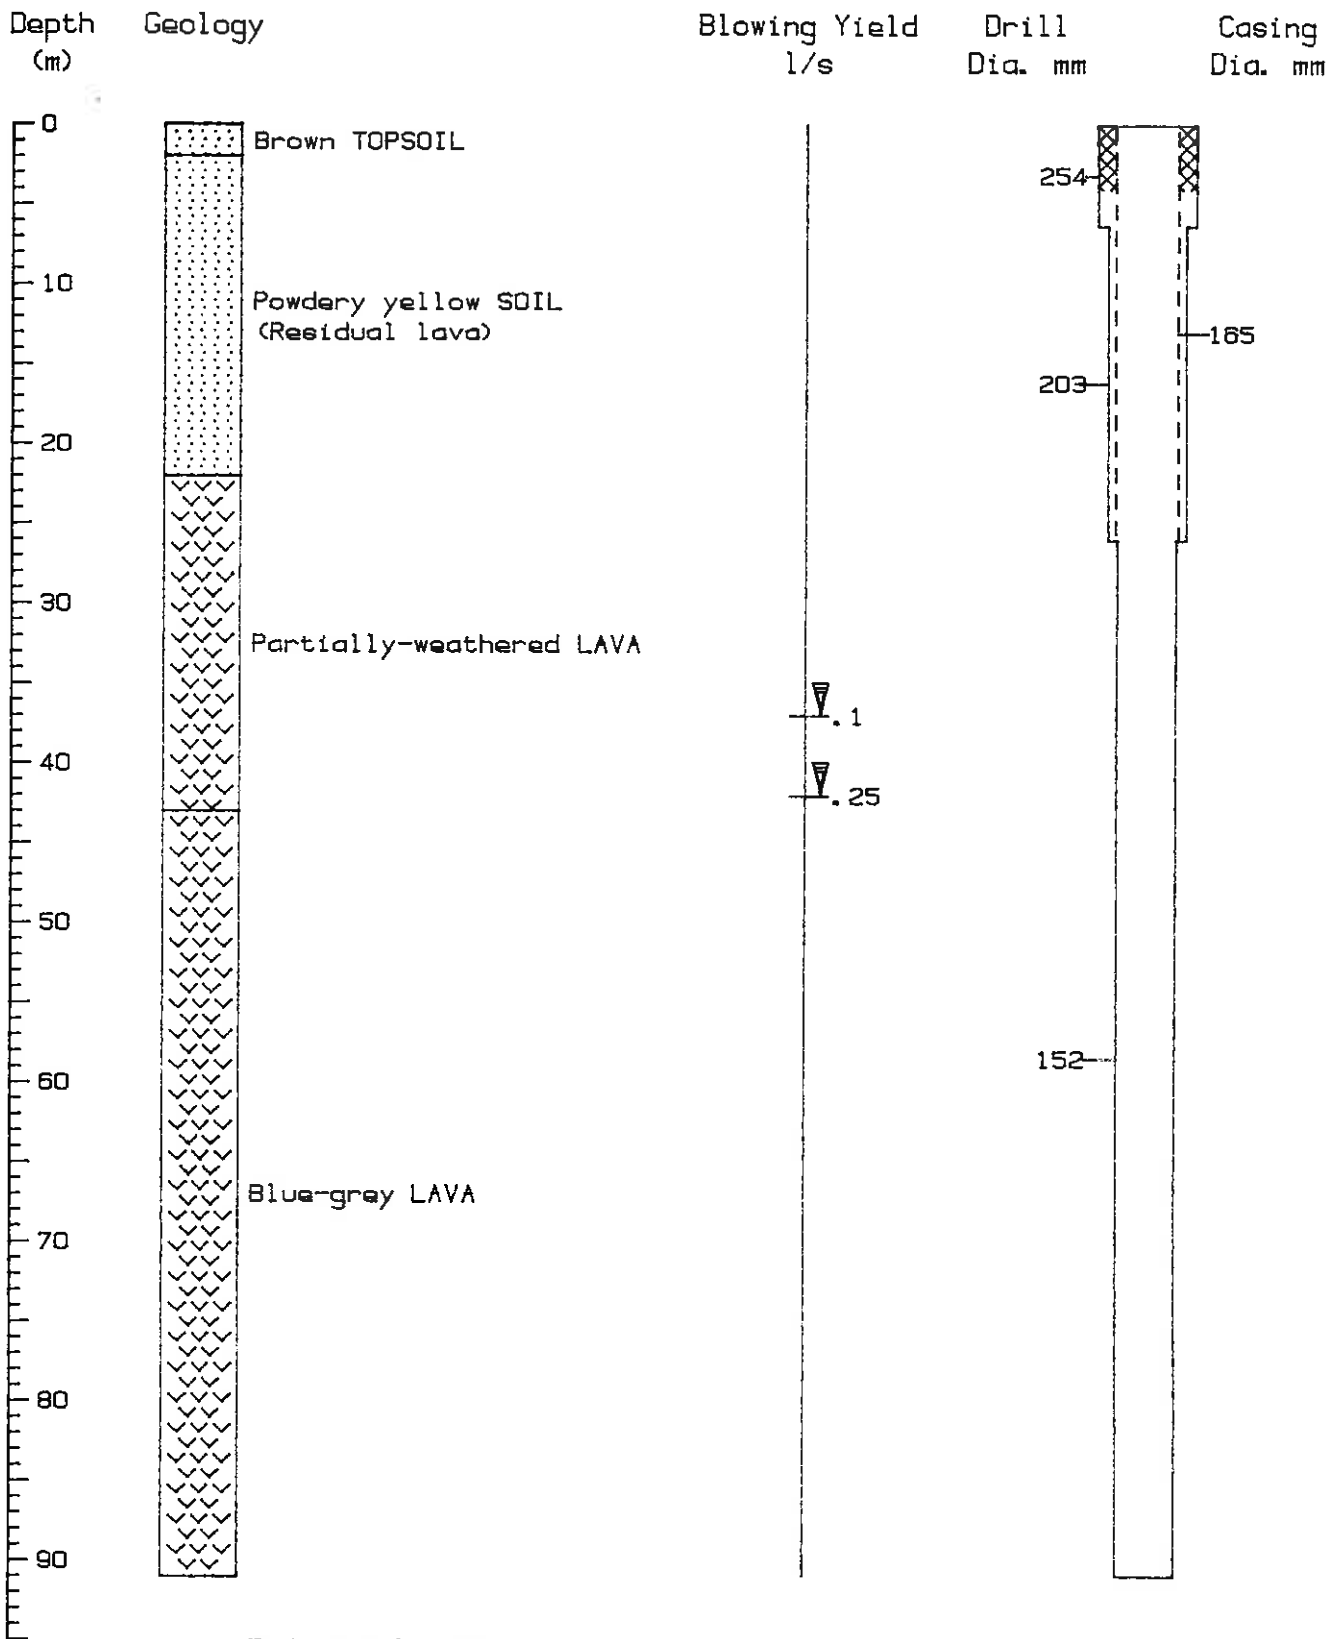
BOREHOLE LOG

Coordinates +2906050X -45950Y

Elev. (m) 1370

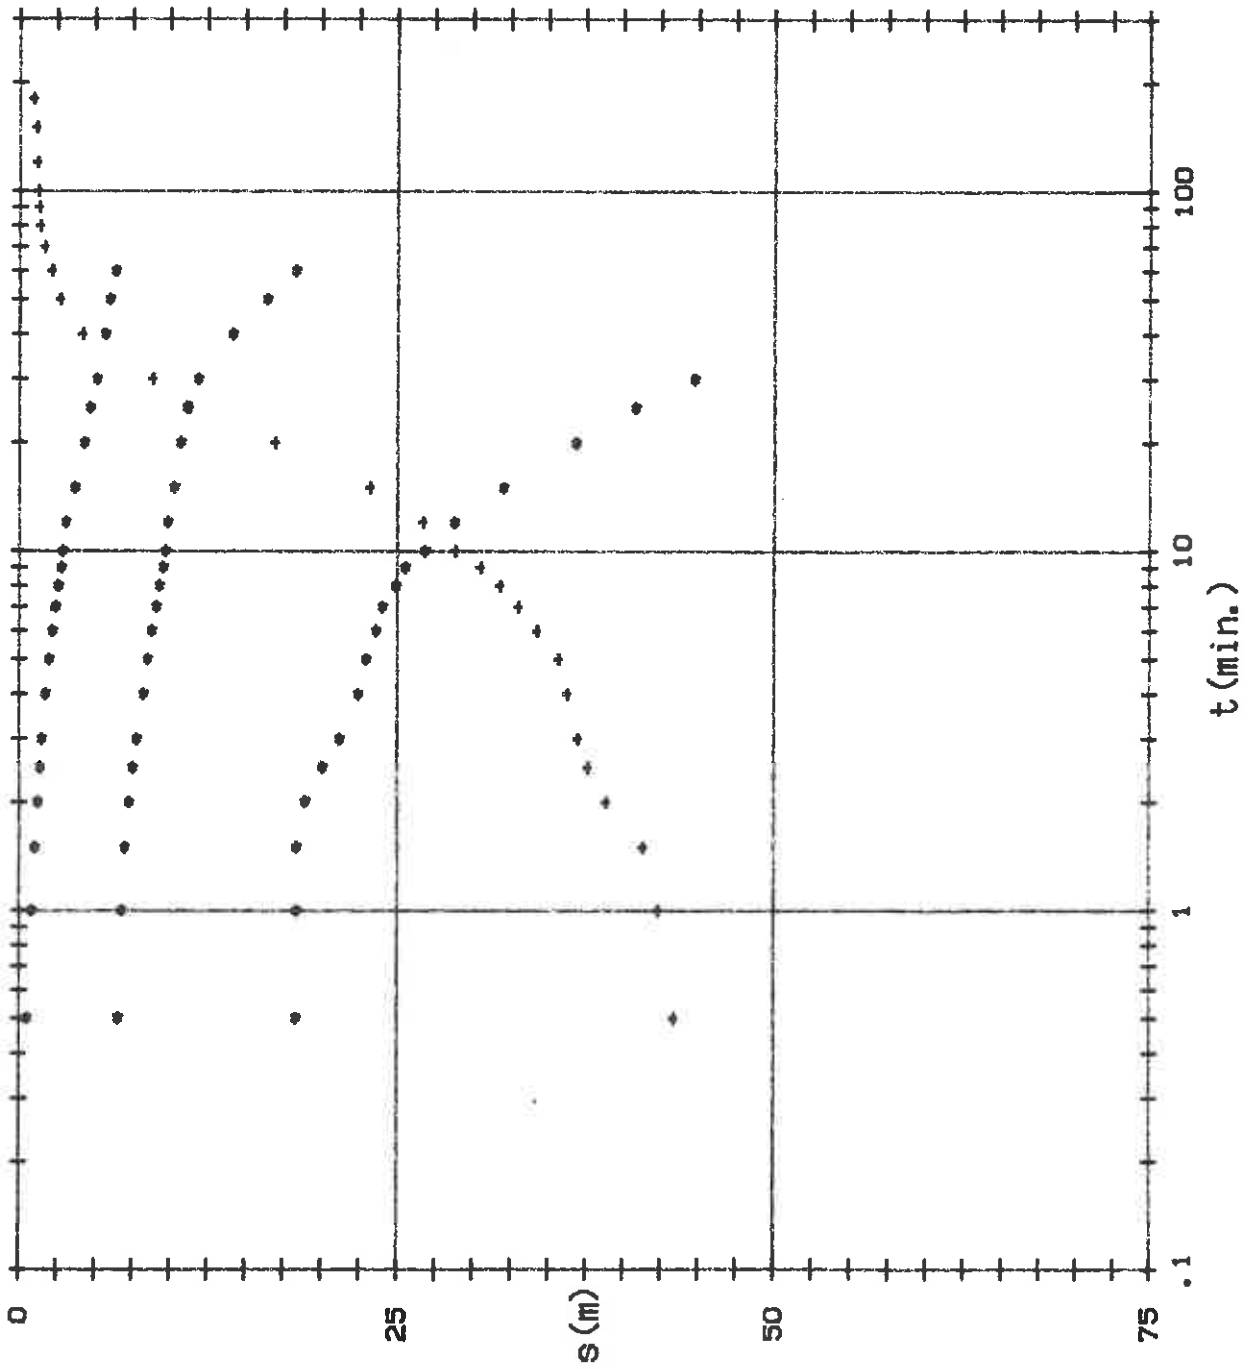
STEP DRAWDOWN TEST

* Pumping data
+ Recovery data

$Q_3 = .71 \text{ l/s}$

S.W.L. = 26.89 m

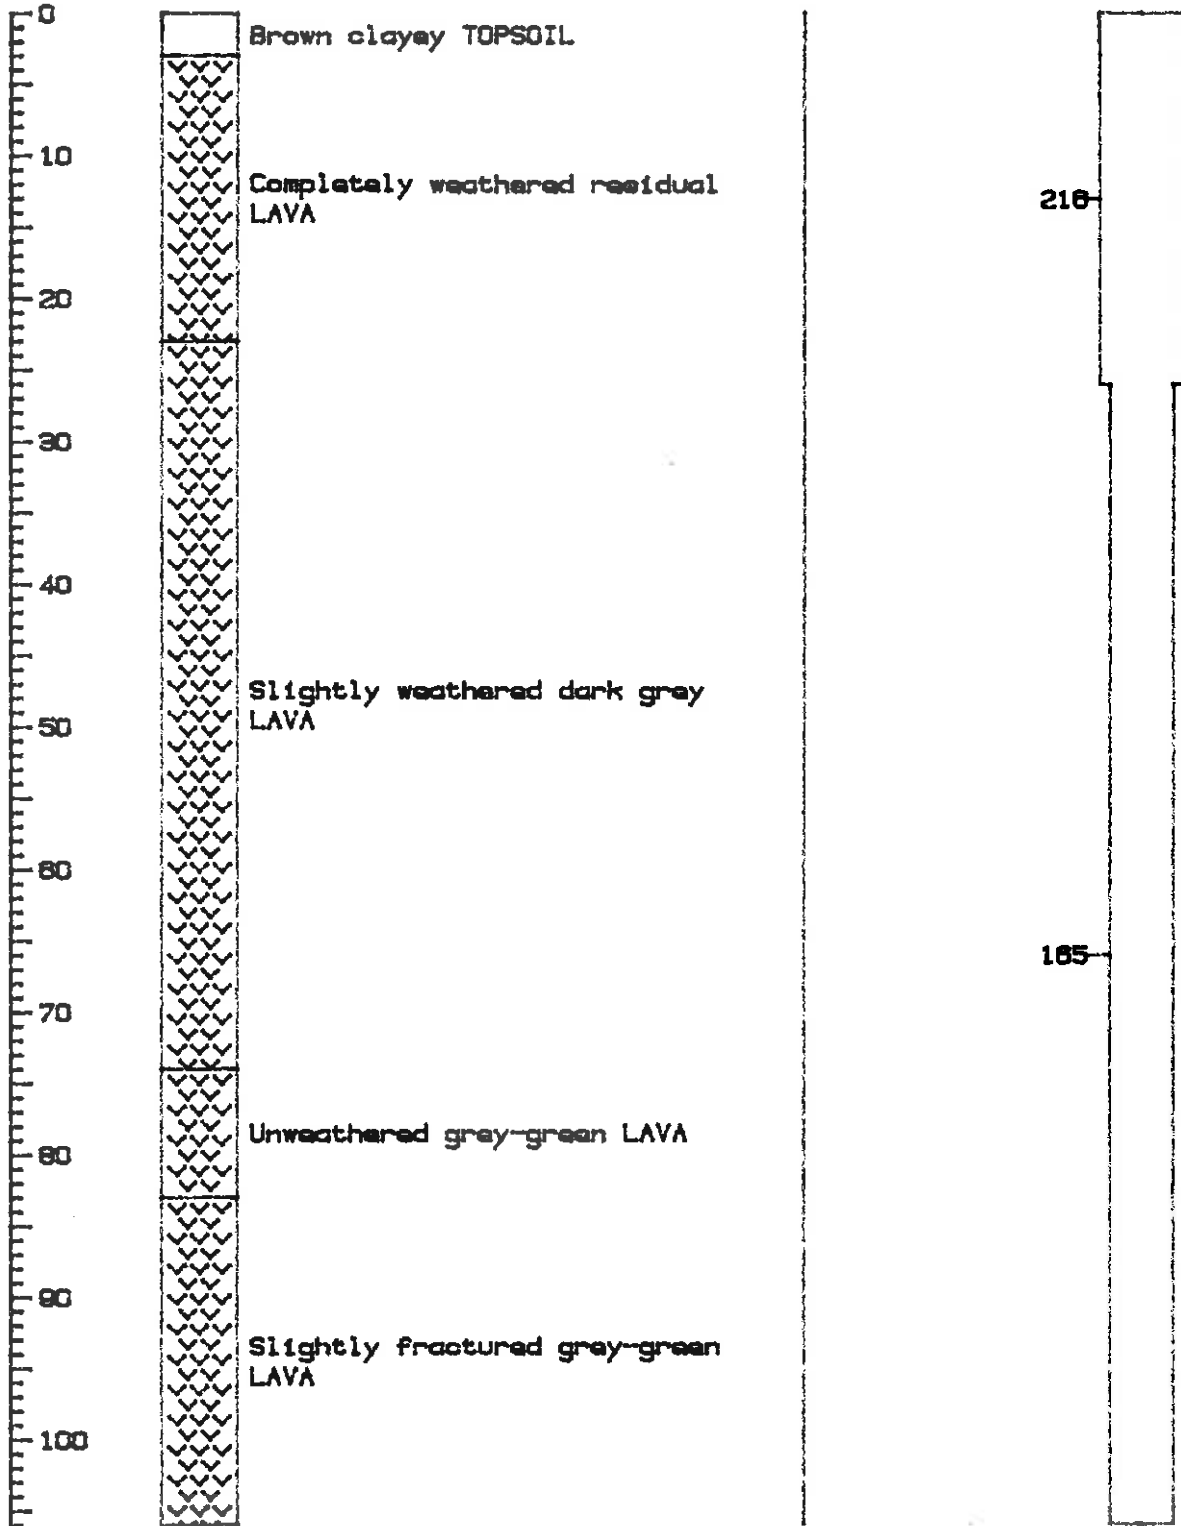
Elev. (m) 1364

Depth (m)	Geology	Blowing Yield l/s	Drill Dia. mm	Casing Dia. mm
-----------	---------	-------------------	---------------	----------------

End of Hole 108

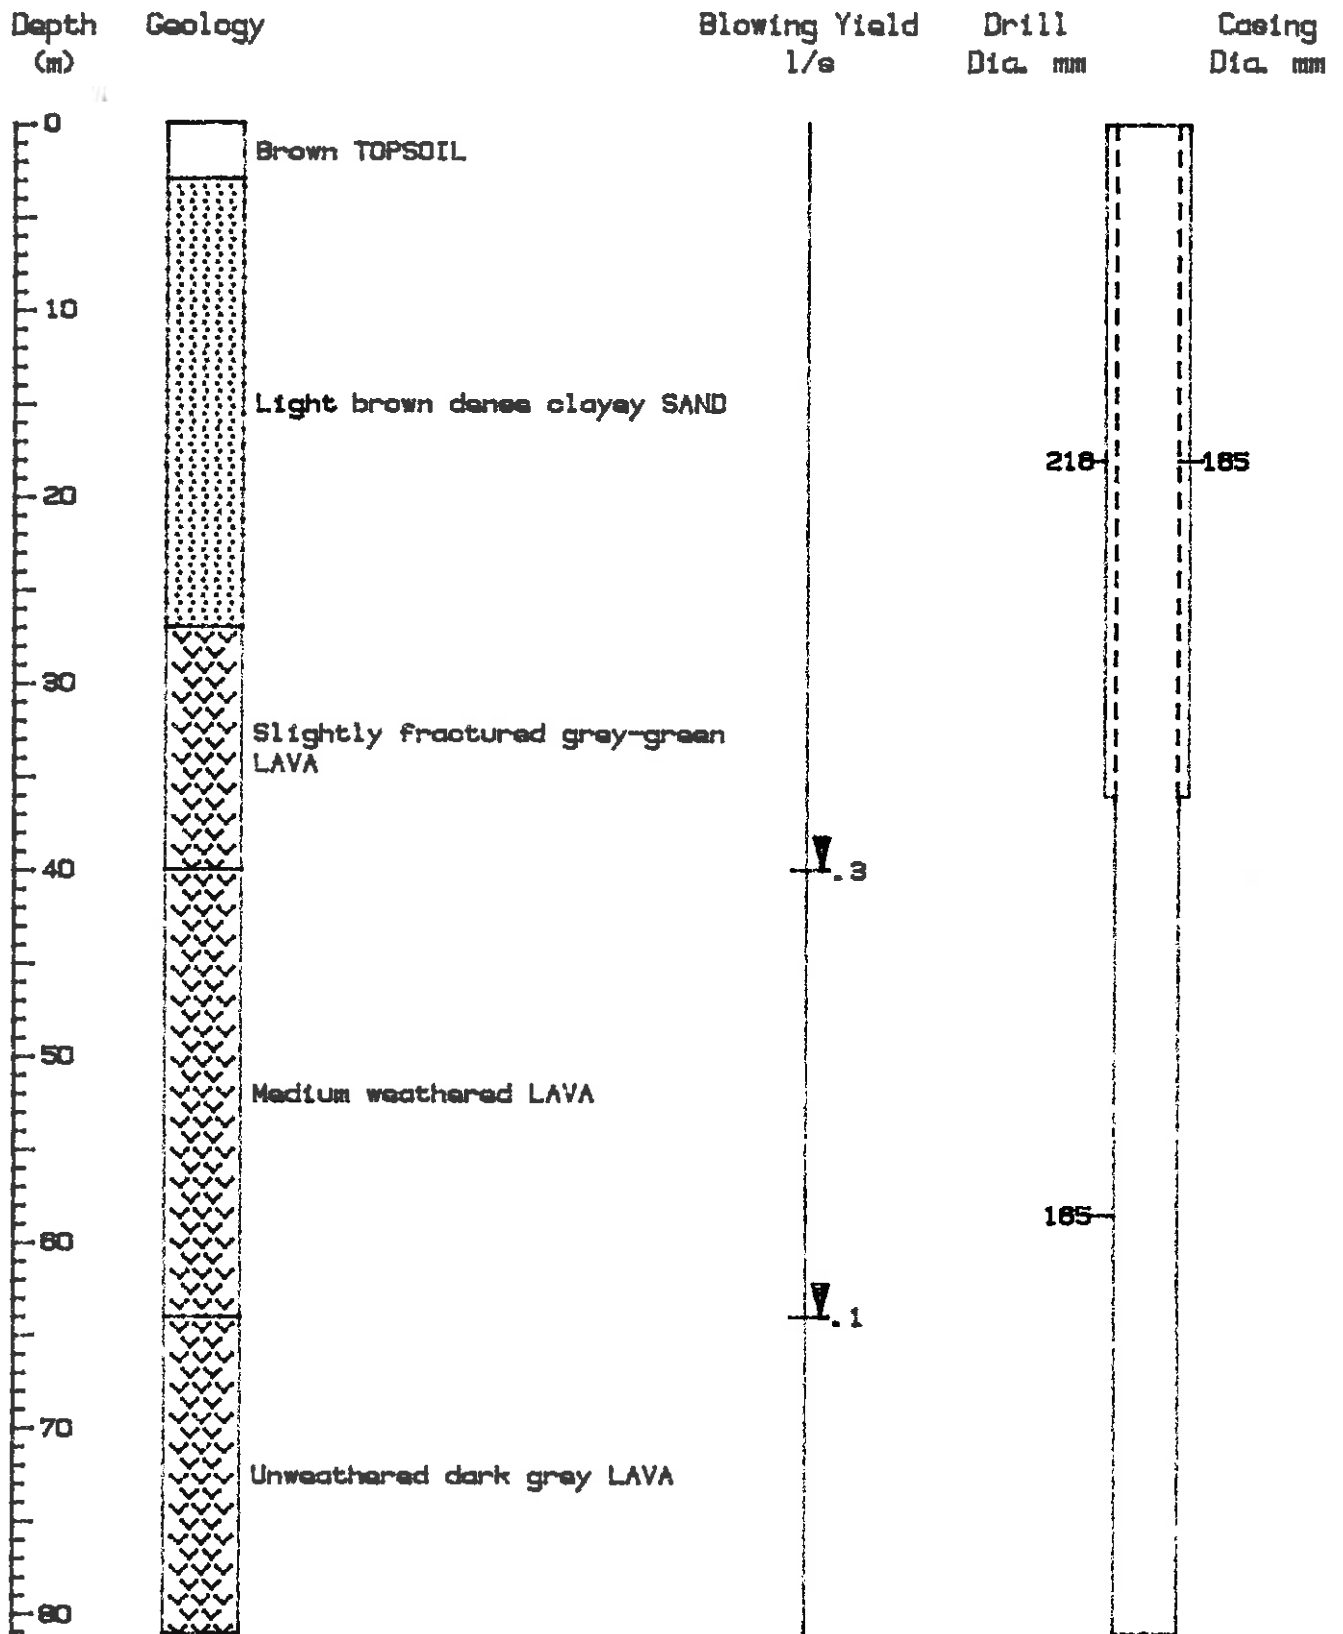
BOREHOLE LOG

Coordinates +2905425X -46150Y

Elev. (m) 1372

End of Hole 81

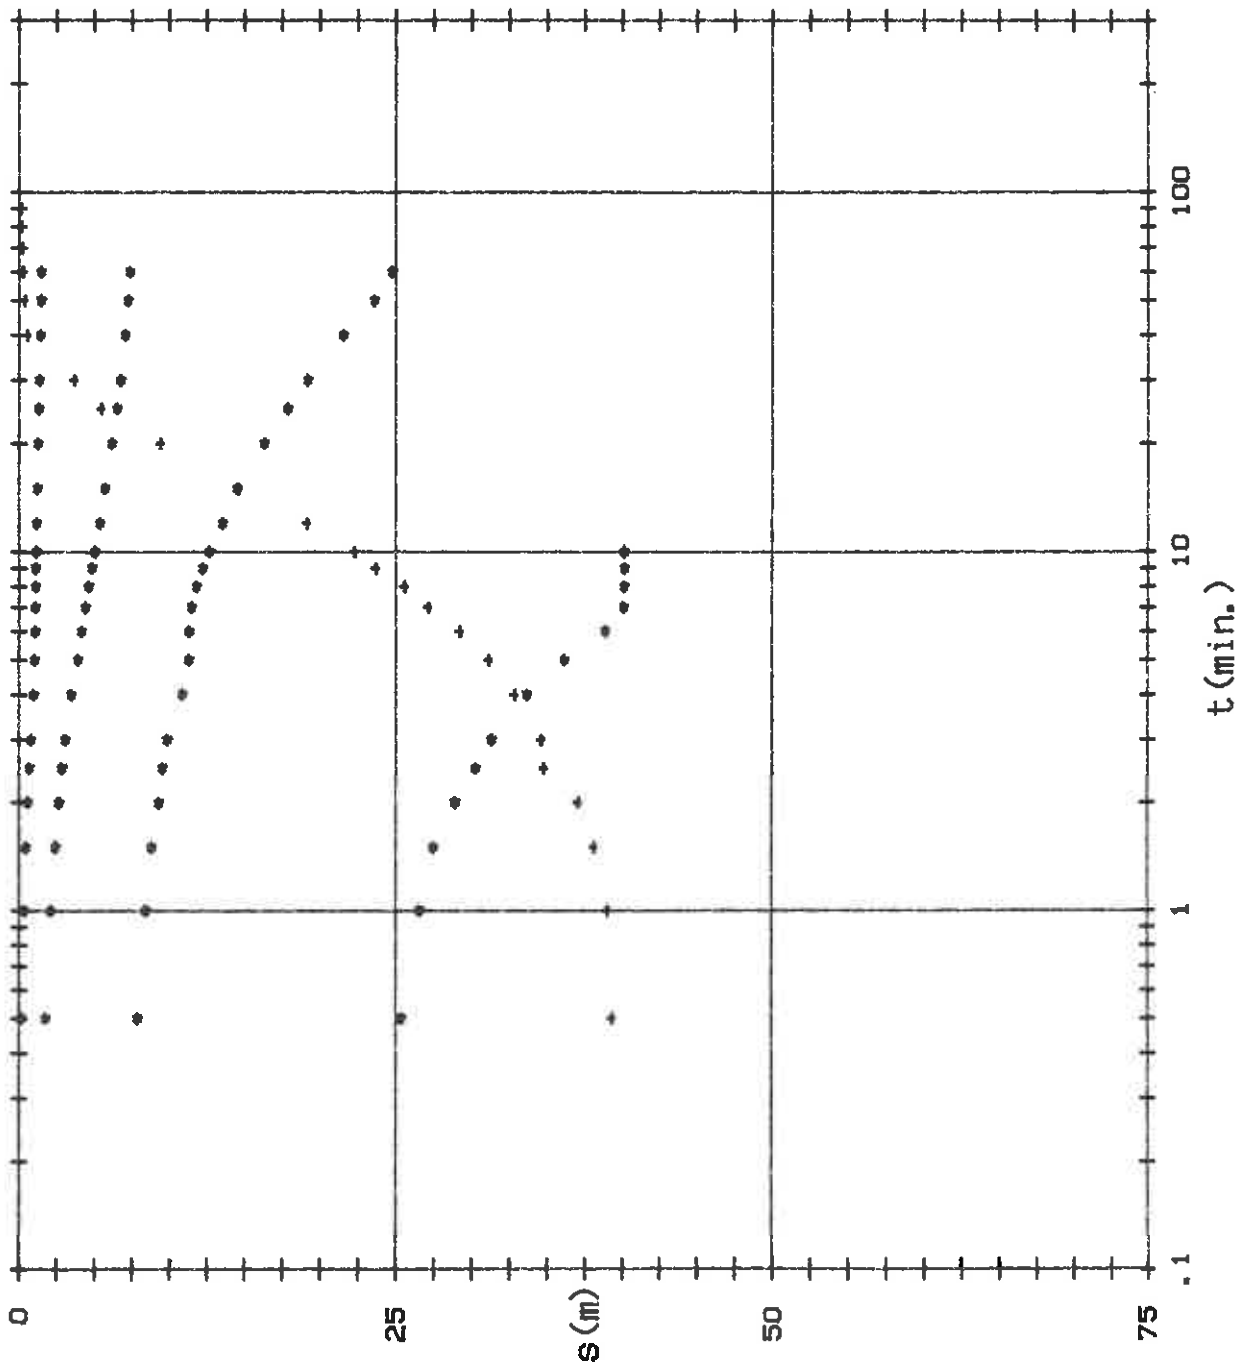
STEP DRAWDOWN TEST

$Q_4 = 1.3$ l/s

S.W.L. = 29.89 m

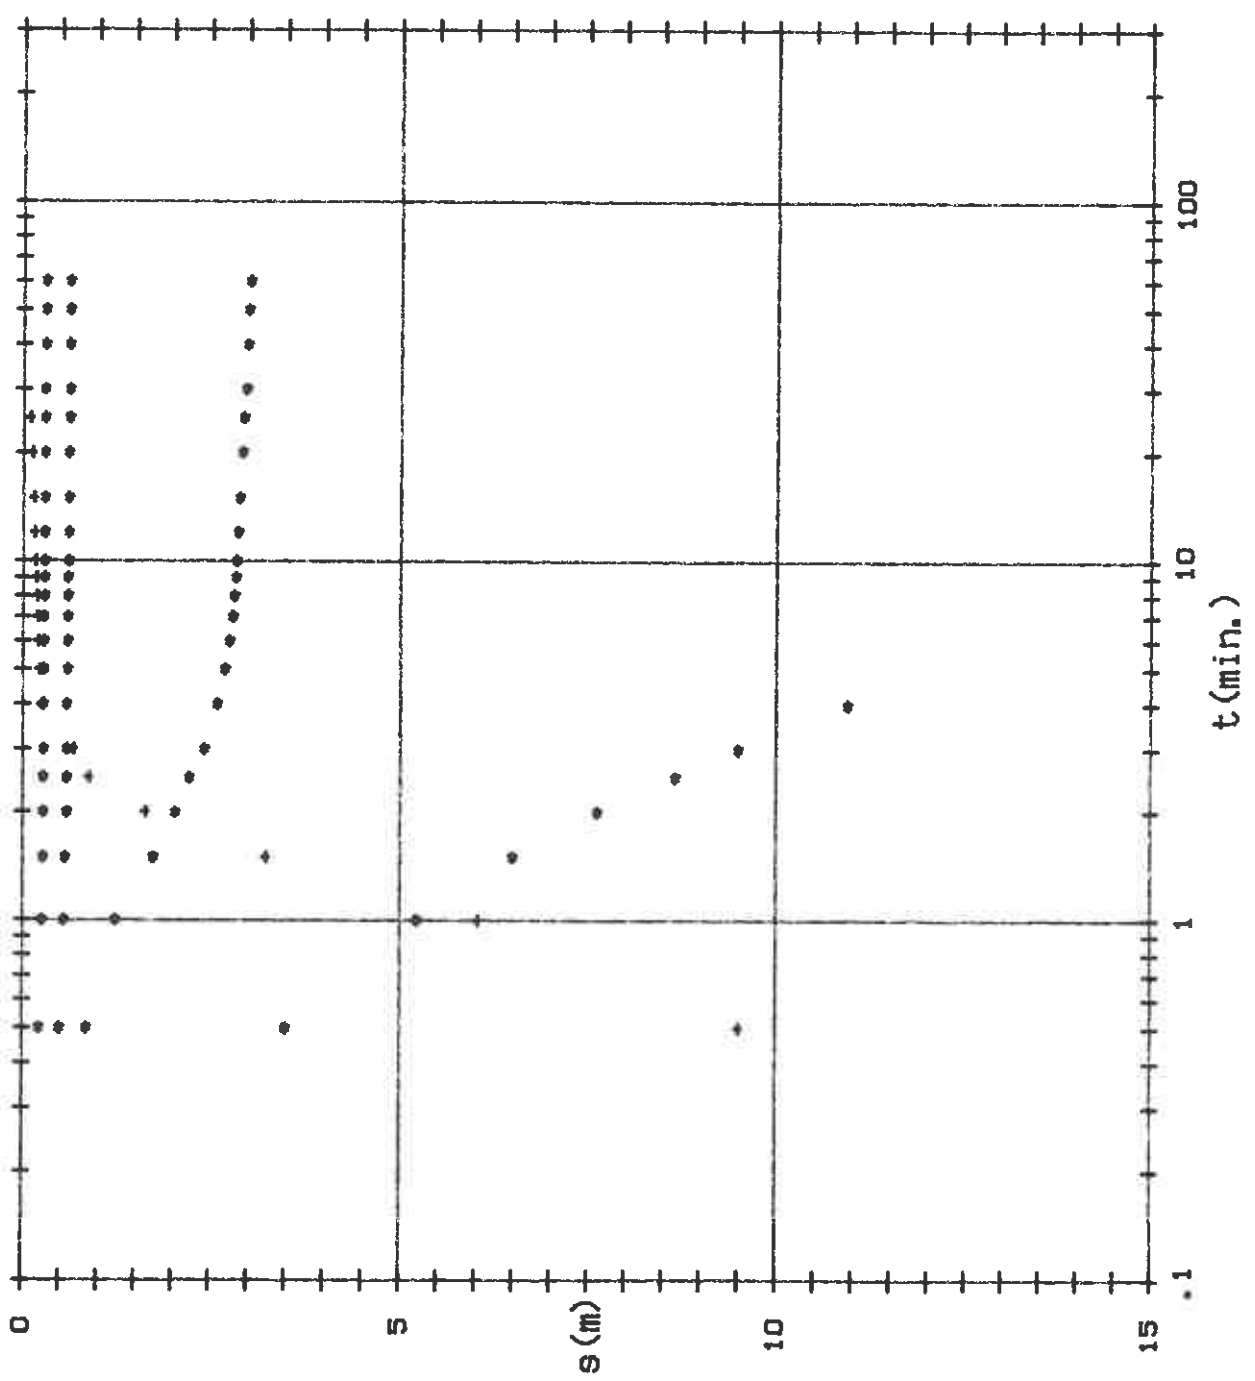
CONSTANT DISCHARGE TEST

- + Drawdown data.
- * Recovery data.

S.W.L. = 5.9 m

$T = 50 \text{ m}^2/\text{d}$

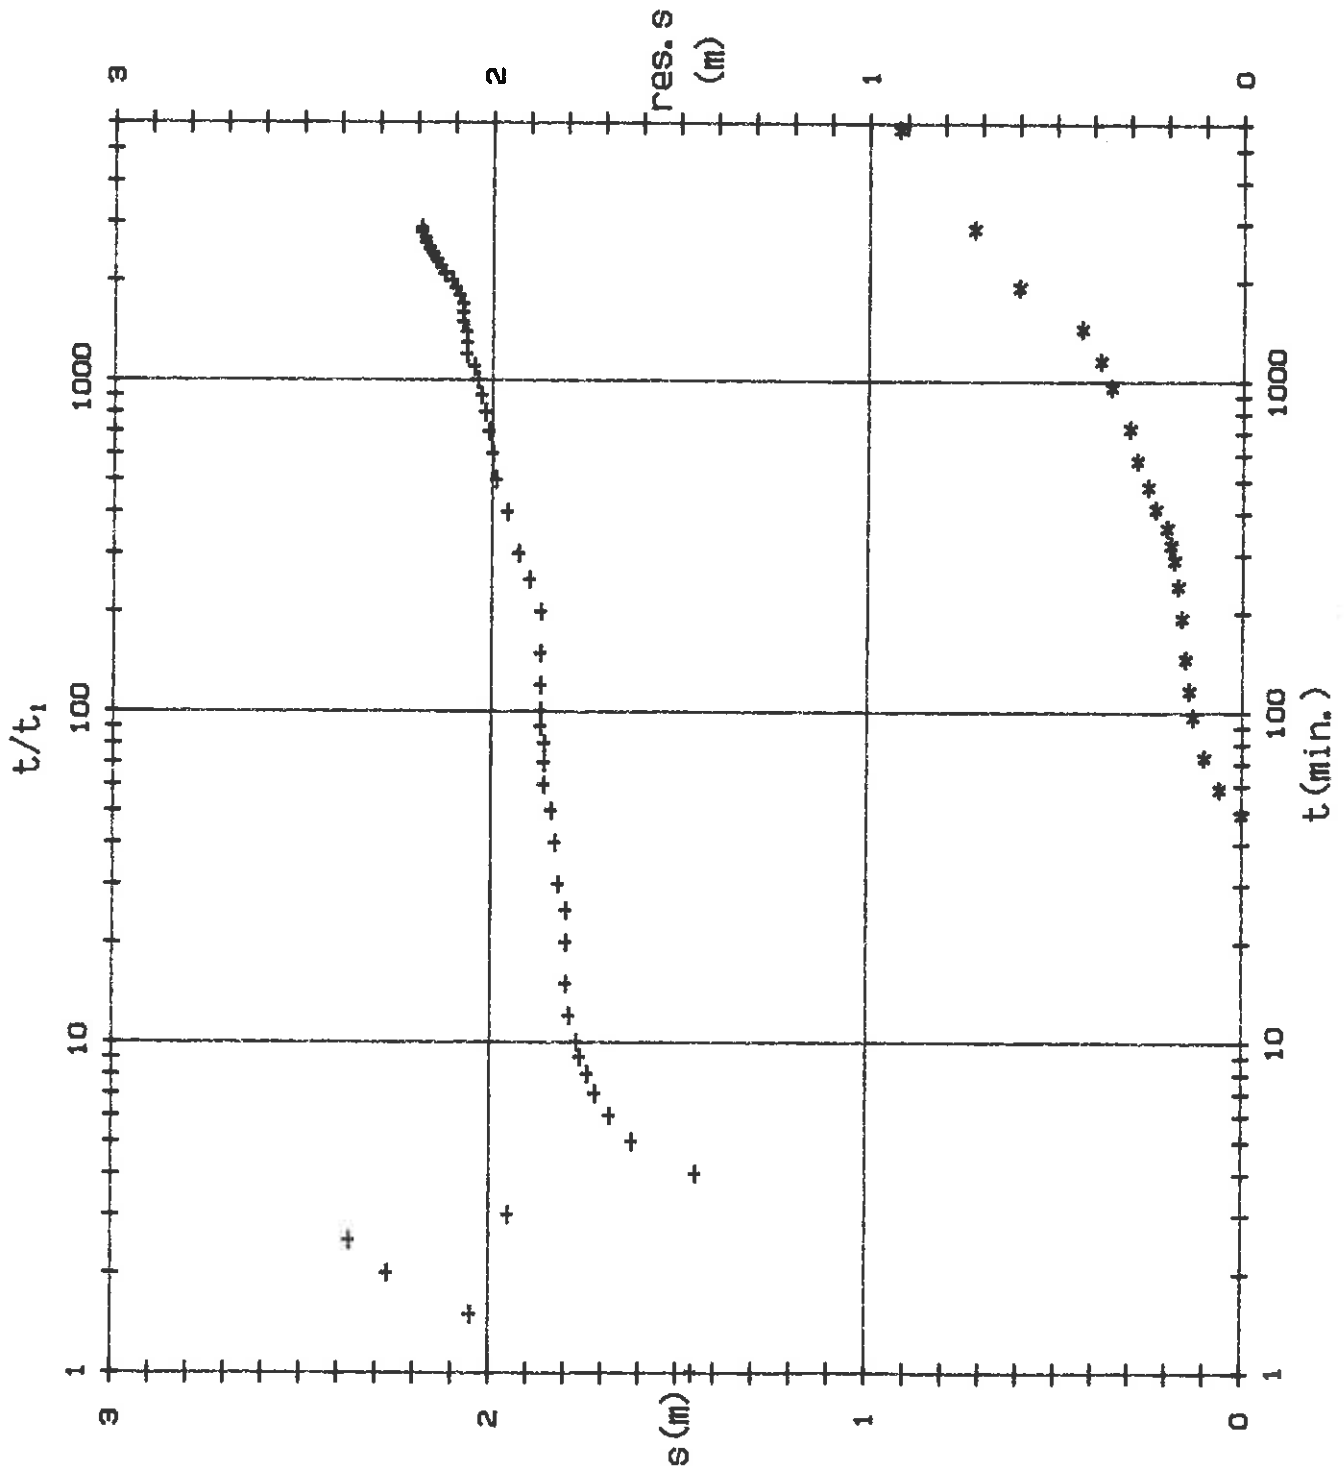
STEP DRAWDOWN TEST

* Pumping data
+ Recovery data

$Q_3 = 1.1 \text{ l/s}$

S.W.L. = 5.06 m

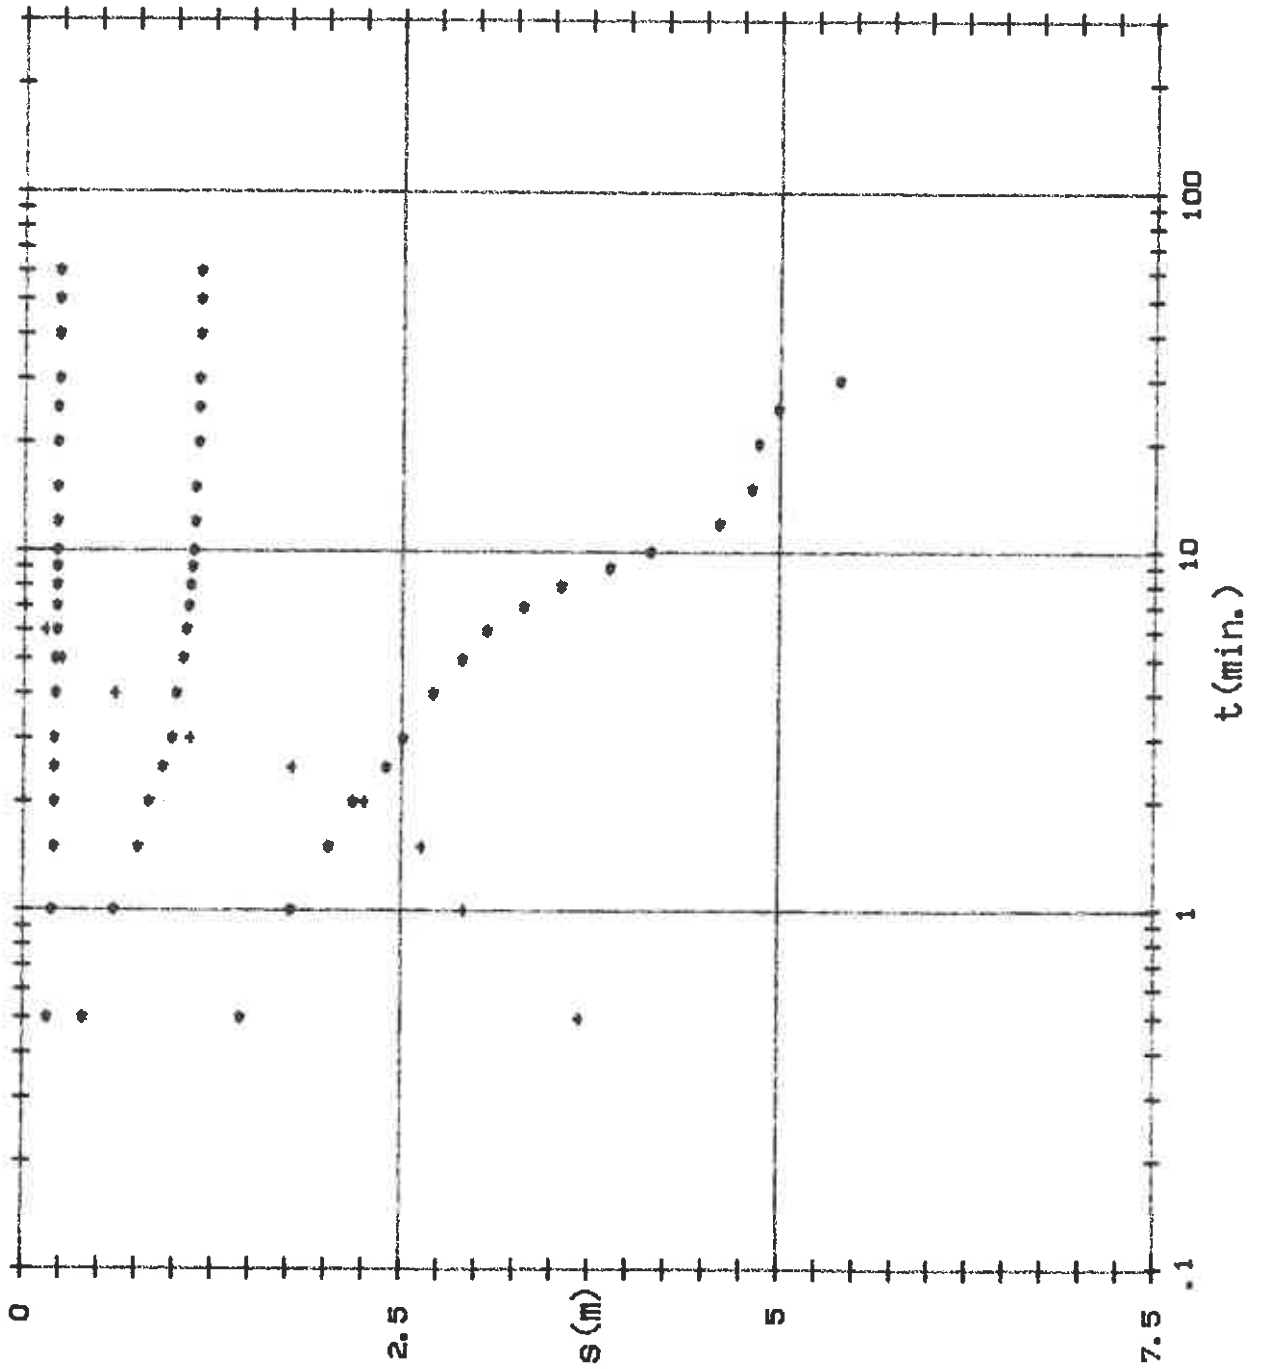
CONSTANT DISCHARGE TEST

- + Drawdown data.
- * Recovery data.

S.W.L. = 5.06 m

$T = 15 \text{ m}^2/\text{d}$
