REPUBLIC OF BOPHUTHATSWANA
DEPARTMENT OF WATER AFFAIRS

**REPORT ON THE SITING
DRILLING AND TESTING OF BOREHOLES,
AND THE TESTING OF EXISTING
BOREHOLES - DITSOBOTLA DISTRICT
JUNE 1991 - FEBRUARY 1993**

**VOLUME 1 - TEXT
AND APPENDIX I**

PARTRIDGE MAUD AND ASSOCIATES

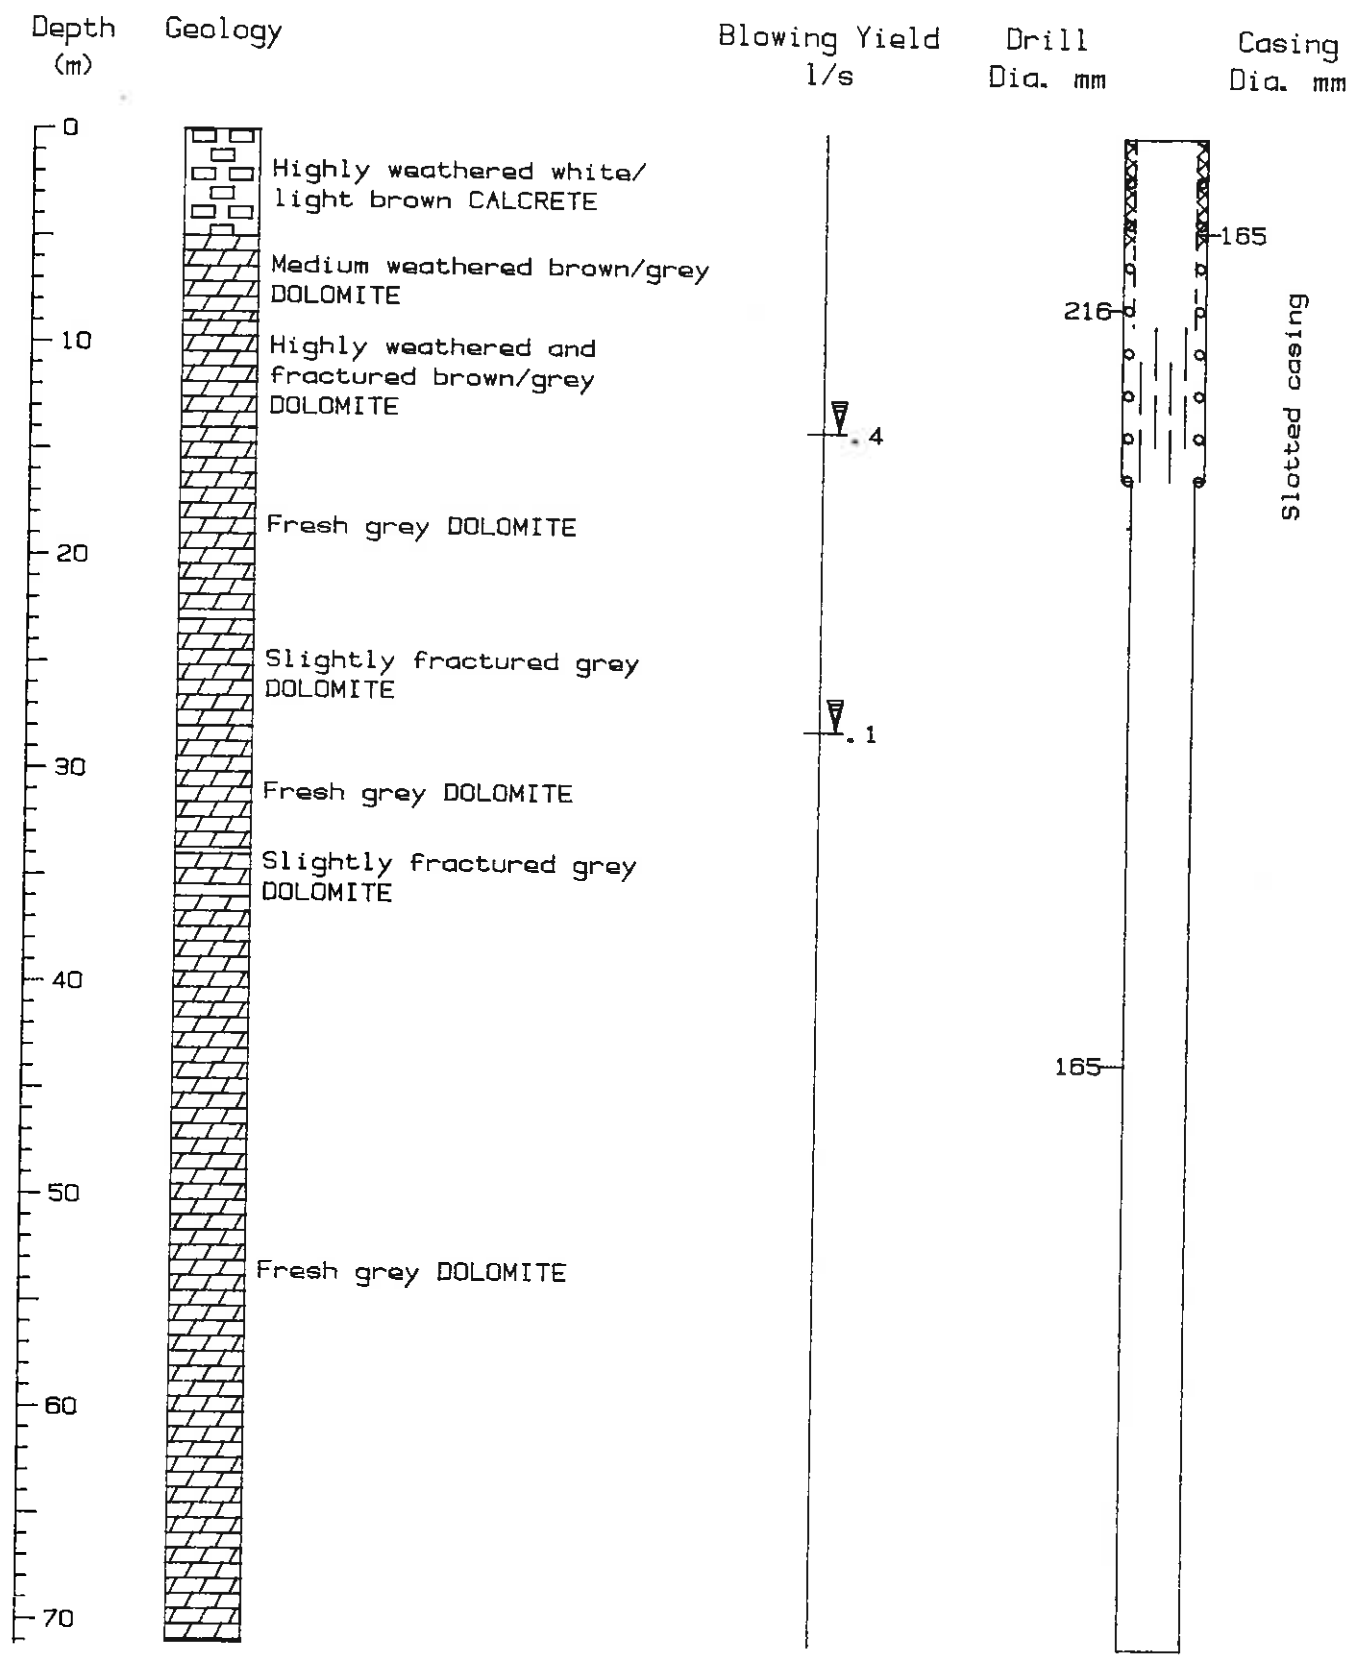
Coordinates +2889630X -078115Y

Elev. (m) 1425

End of Hole 71

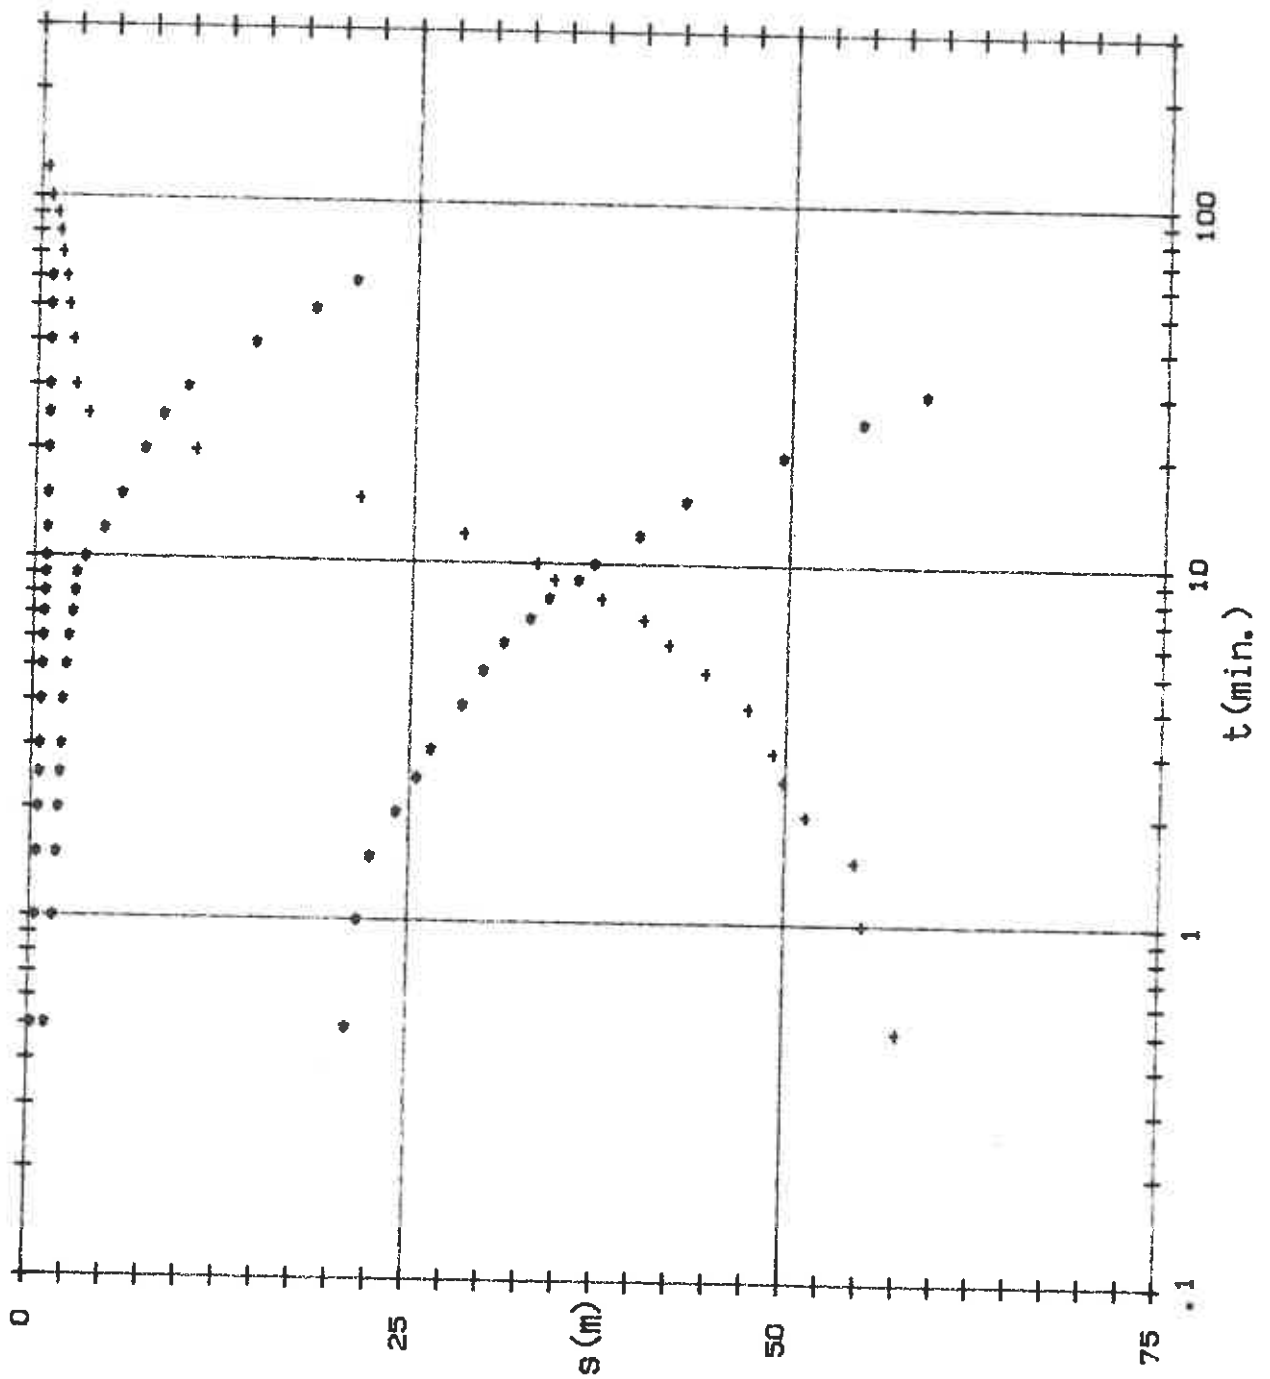
STEP DRAWDOWN TEST

$Q_3 = .68 \text{ l/s}$

S.W.L. = 6.02 m

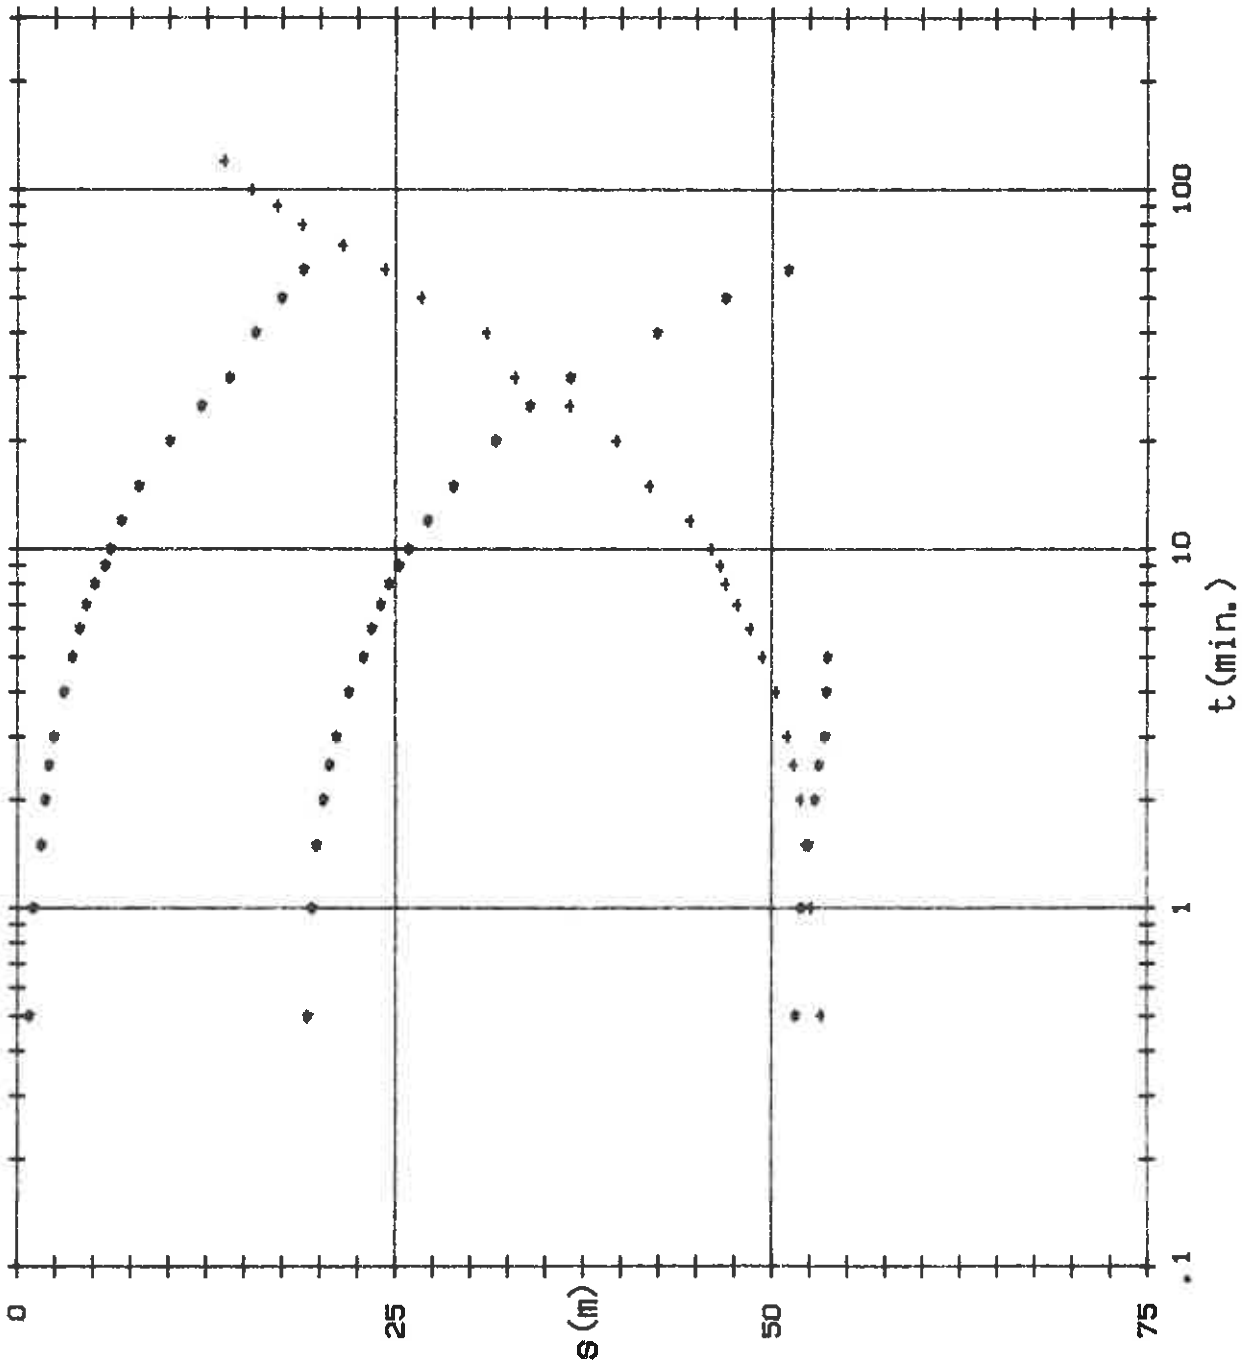
STEP DRAWDOWN TEST

$Q_3 = .8 \text{ l/s}$

S.W.L. = 11.6 m

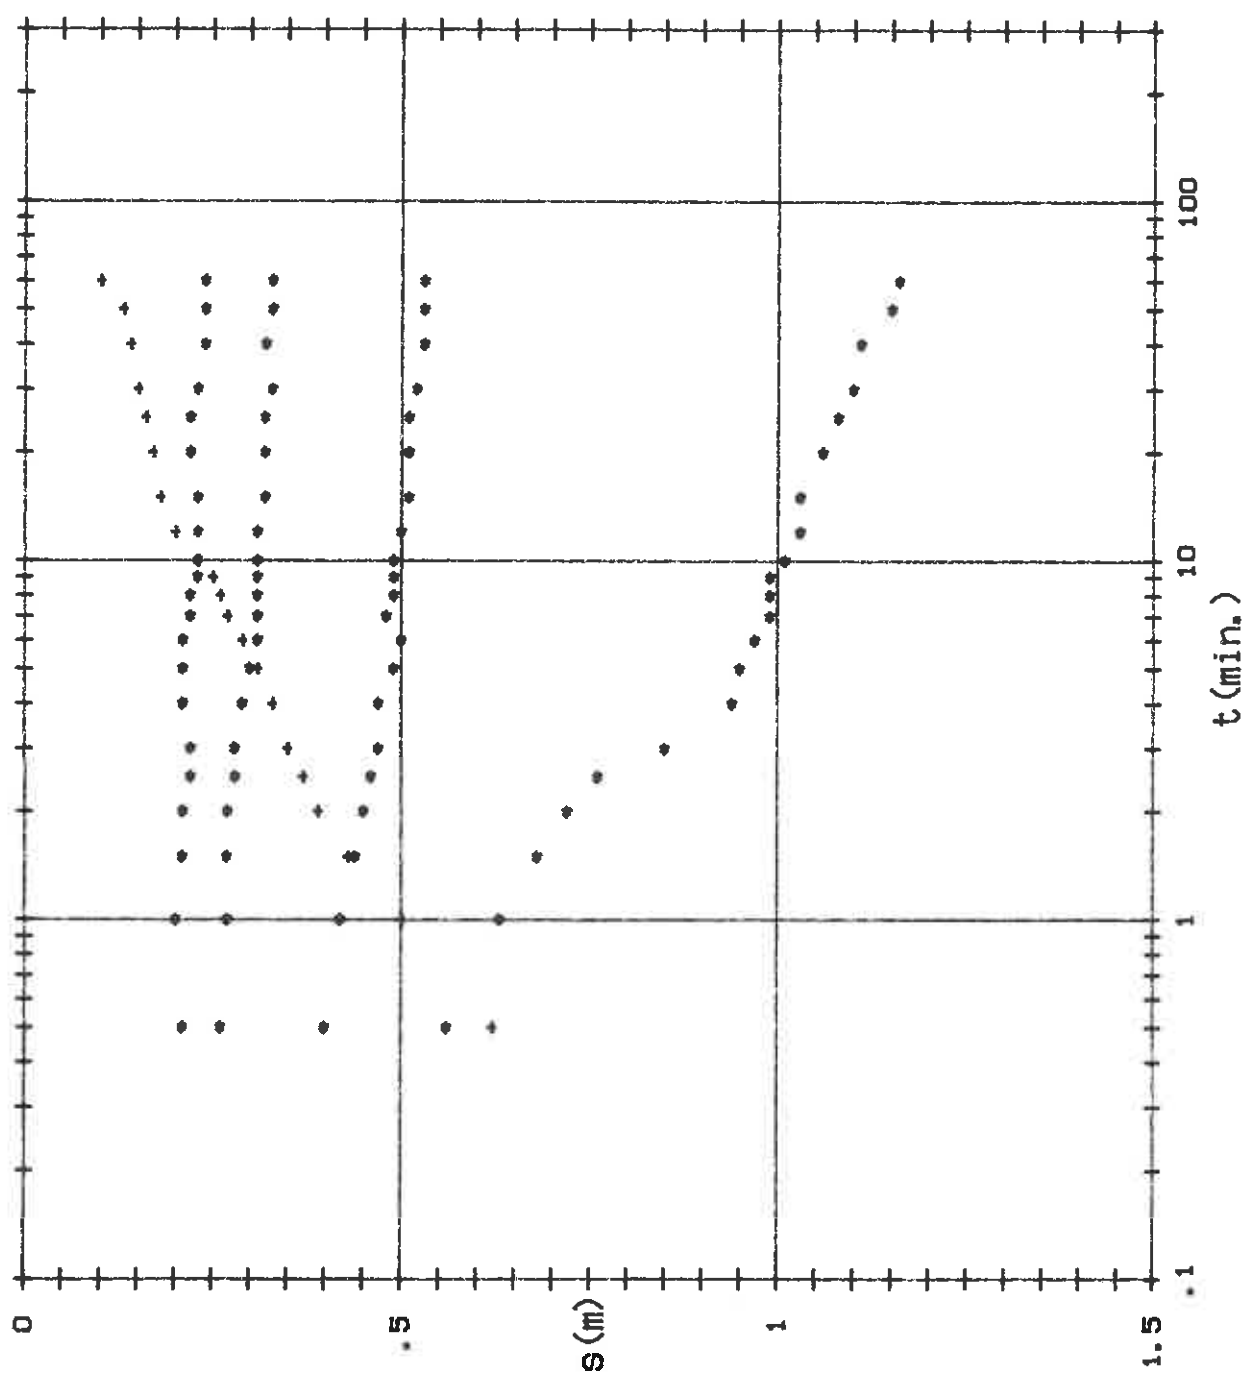
$Q_4 = 2.12 \text{ l/s}$

S.W.L. = 5.45 m

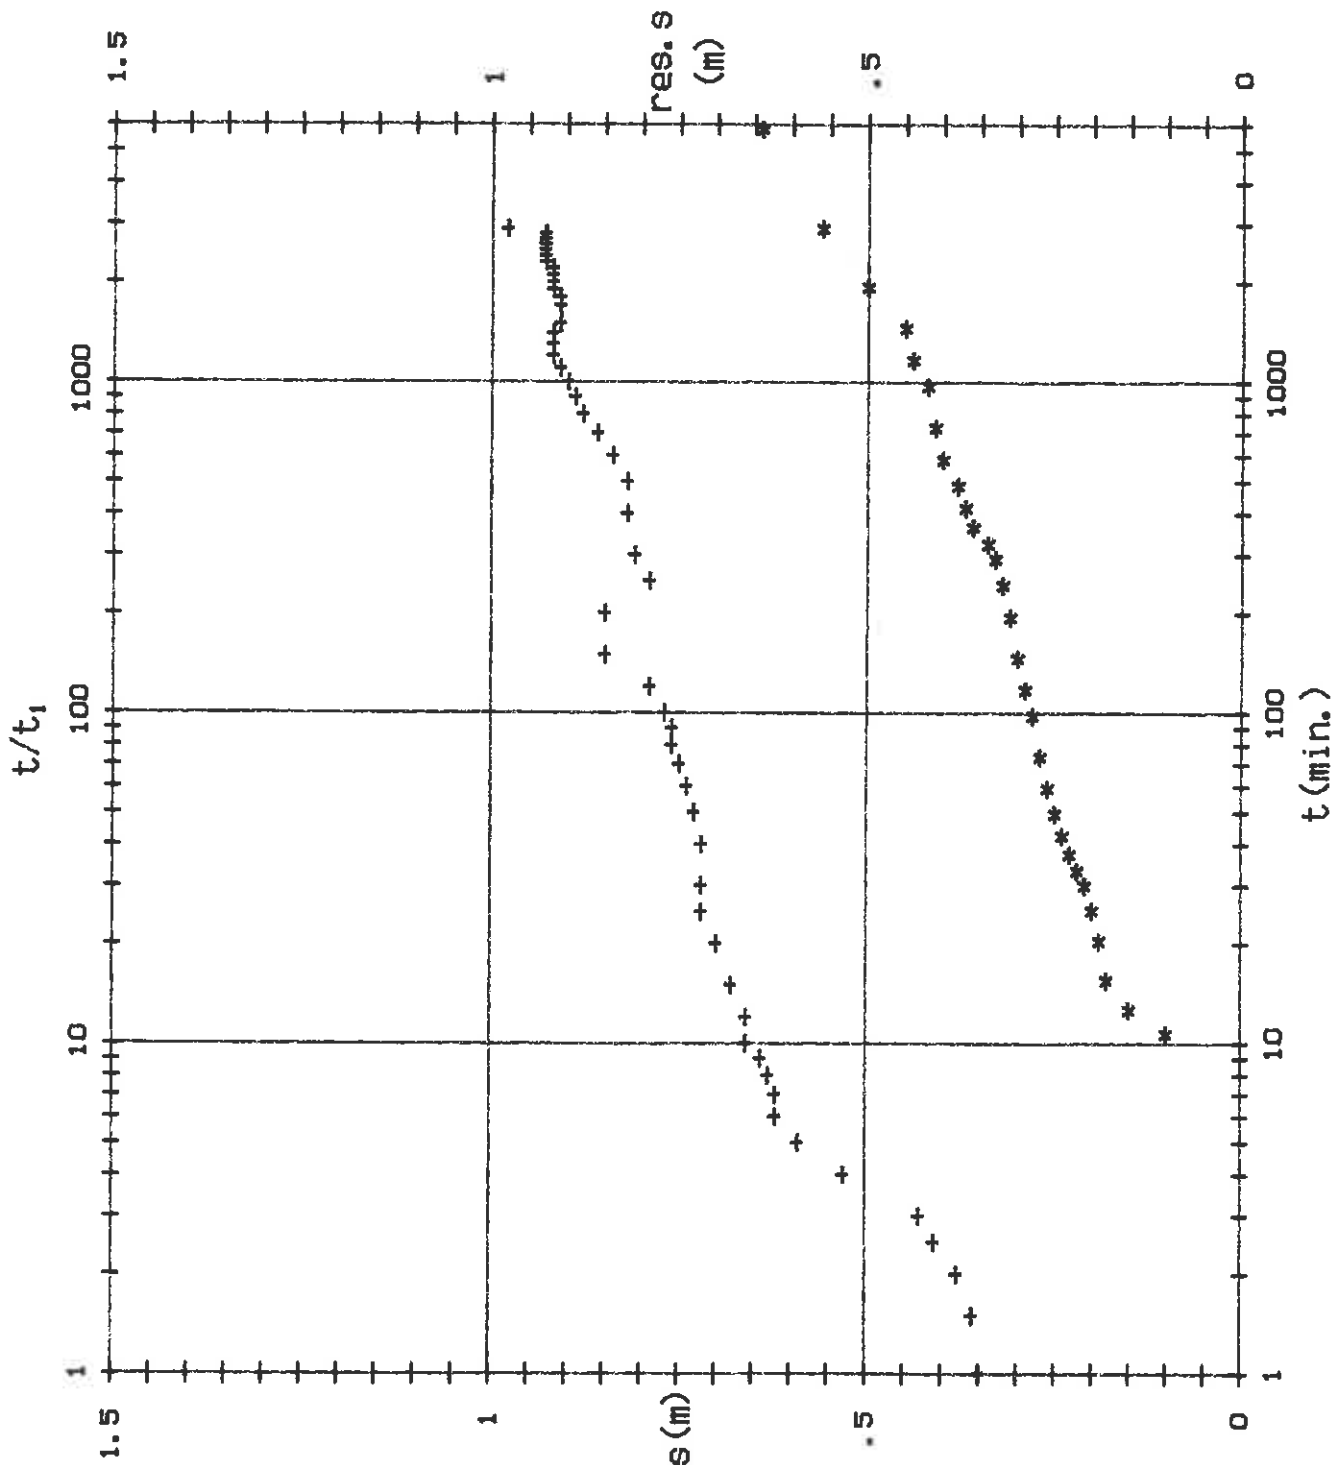
CONSTANT DISCHARGE TEST

- + Drawdown data.
- * Recovery data.

S.W.L. = 5.45 m

T = 110 m²/d

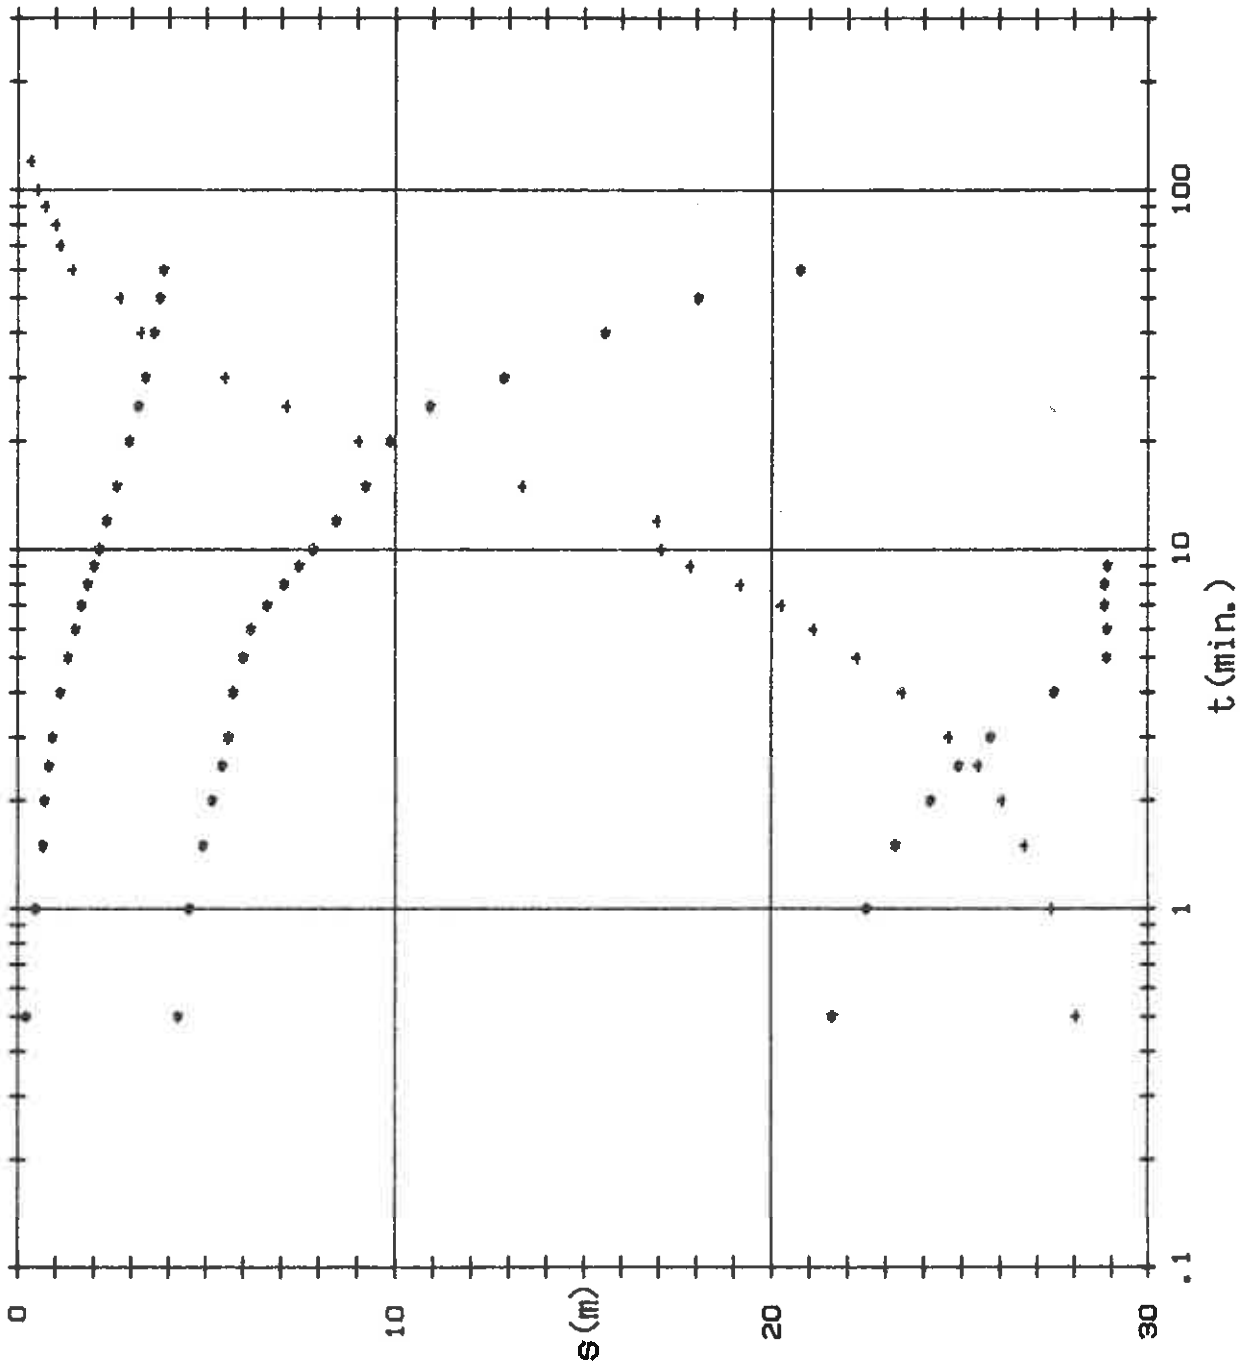
STEP DRAWDOWN TEST

$Q_3 = .8 \text{ l/s}$

S.W.L. = 12.1 m

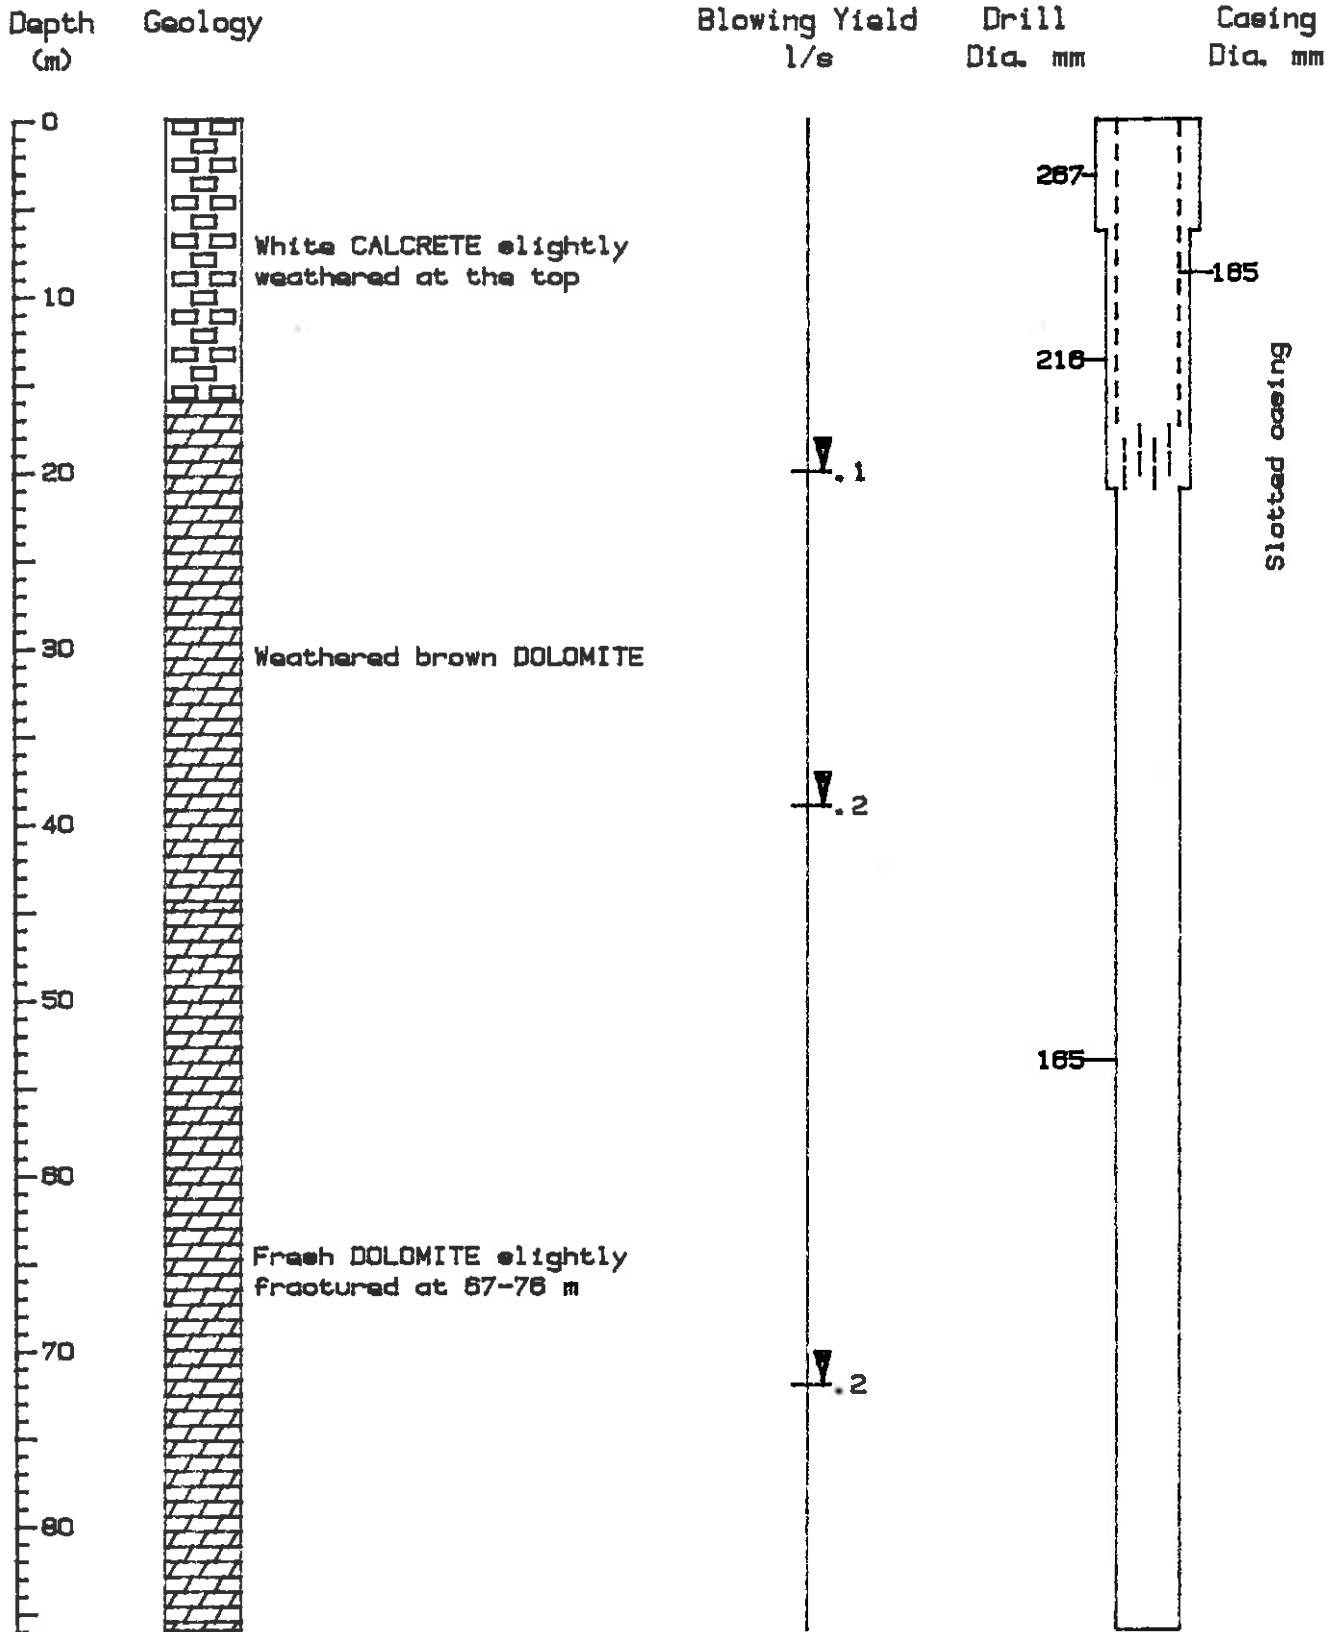
+ Field data
 — Computer model
 - - - d - r model

Coordinates +2882300X -75575Y

Elev. (m) 1410

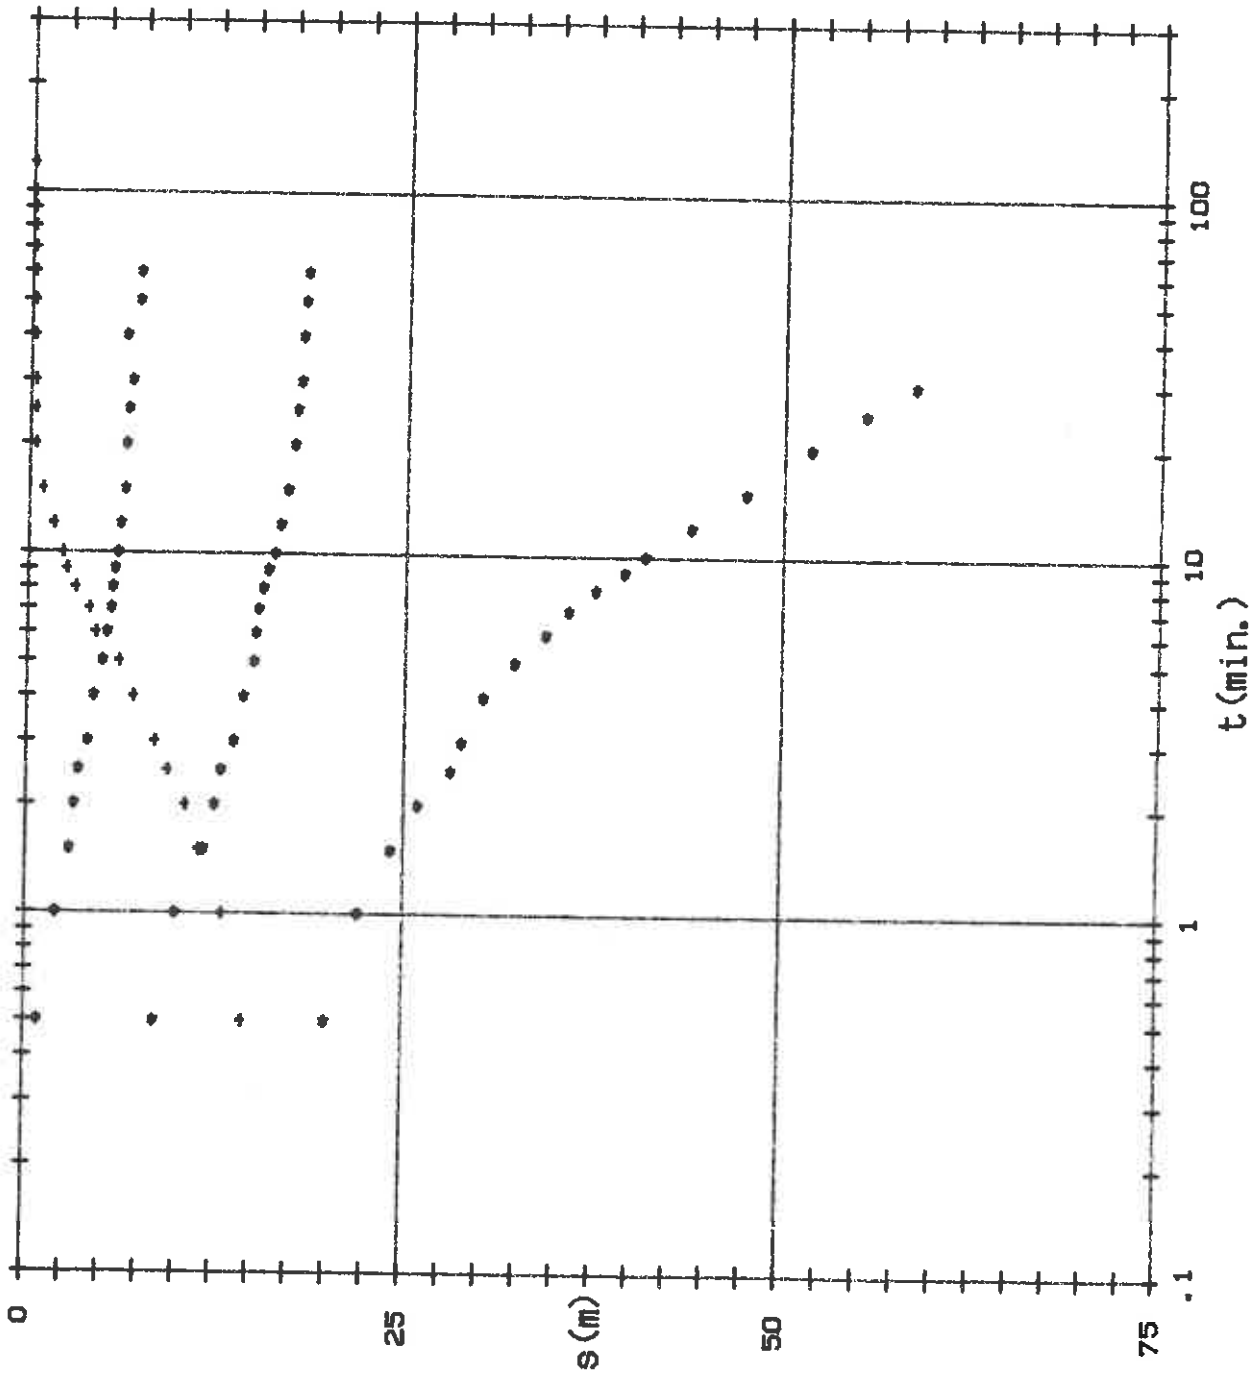
End of Hole 86

STEP DRAWDOWN TEST

$Q_3 = 1 \text{ l/s}$

S.W.L. = 6.06 m

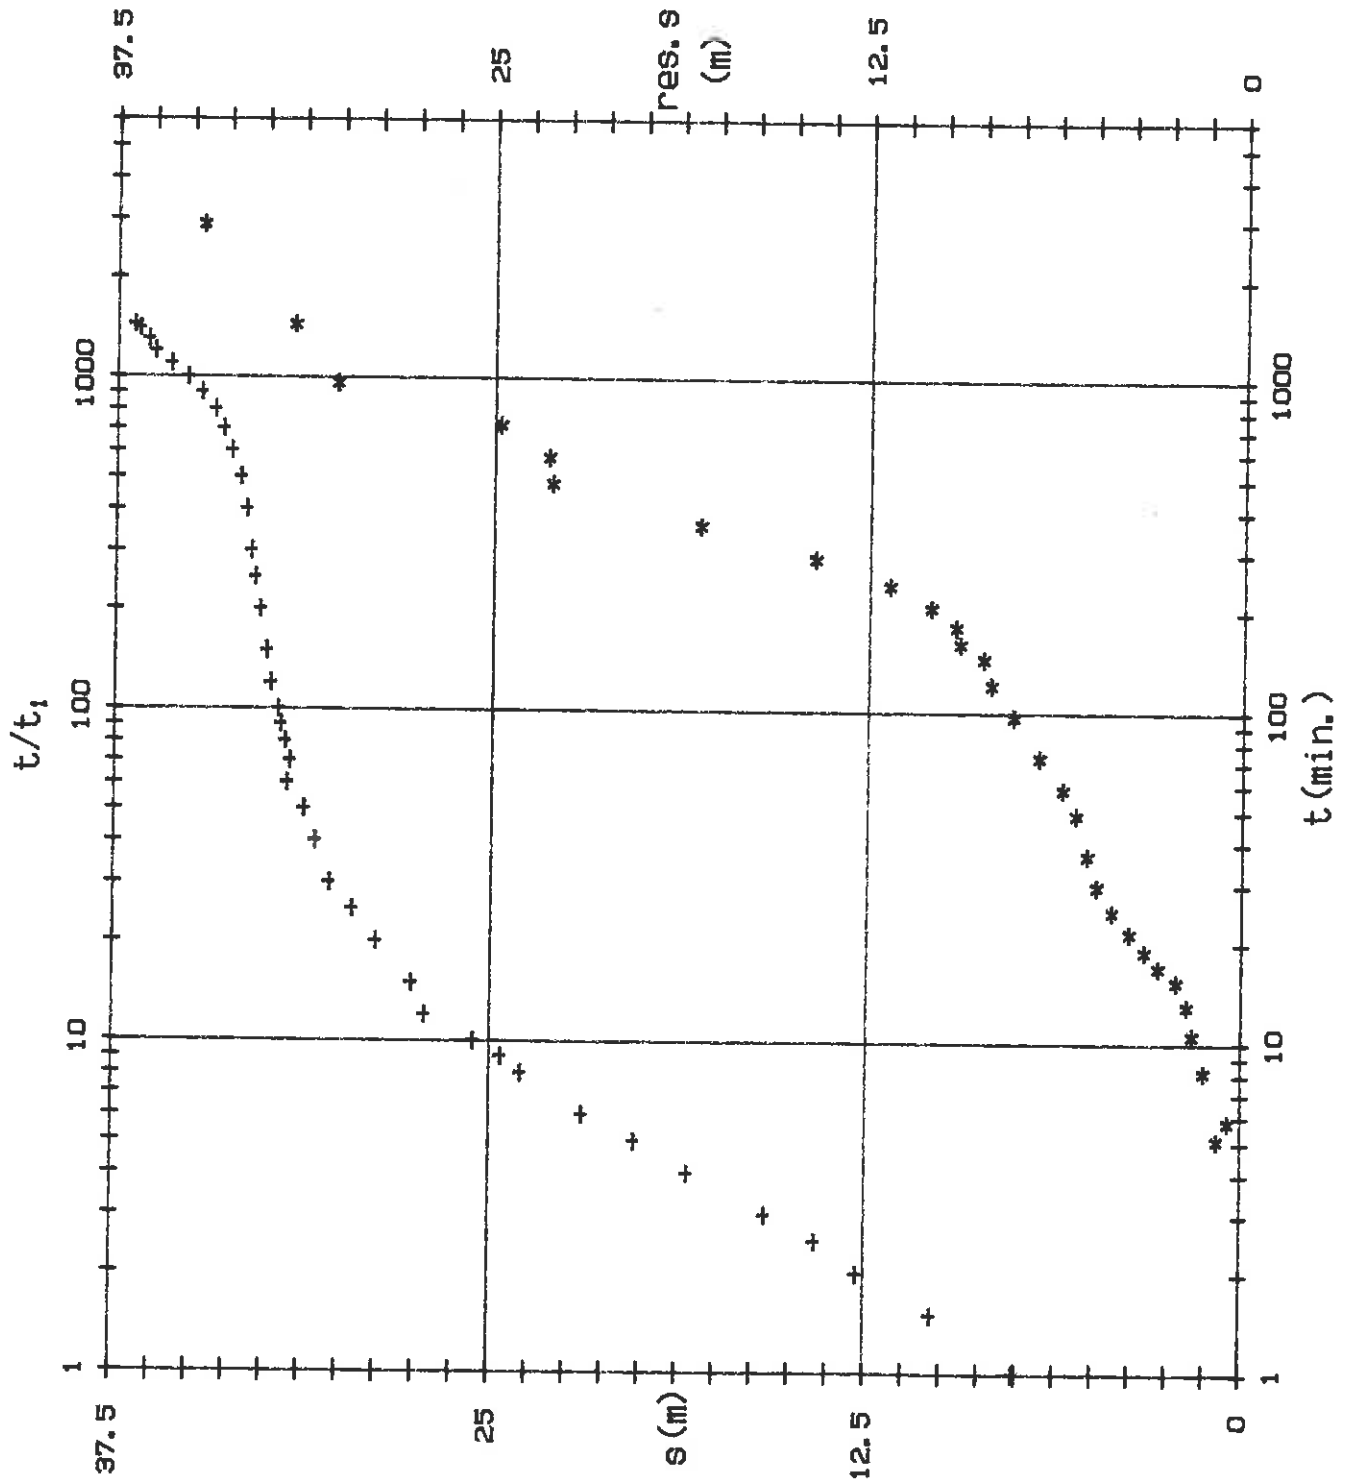
CONSTANT DISCHARGE TEST

+ Drawdown data.
* Recovery data.

S.W.L. = 6.06 m

$T = .5 \text{ m}^2/\text{d}$

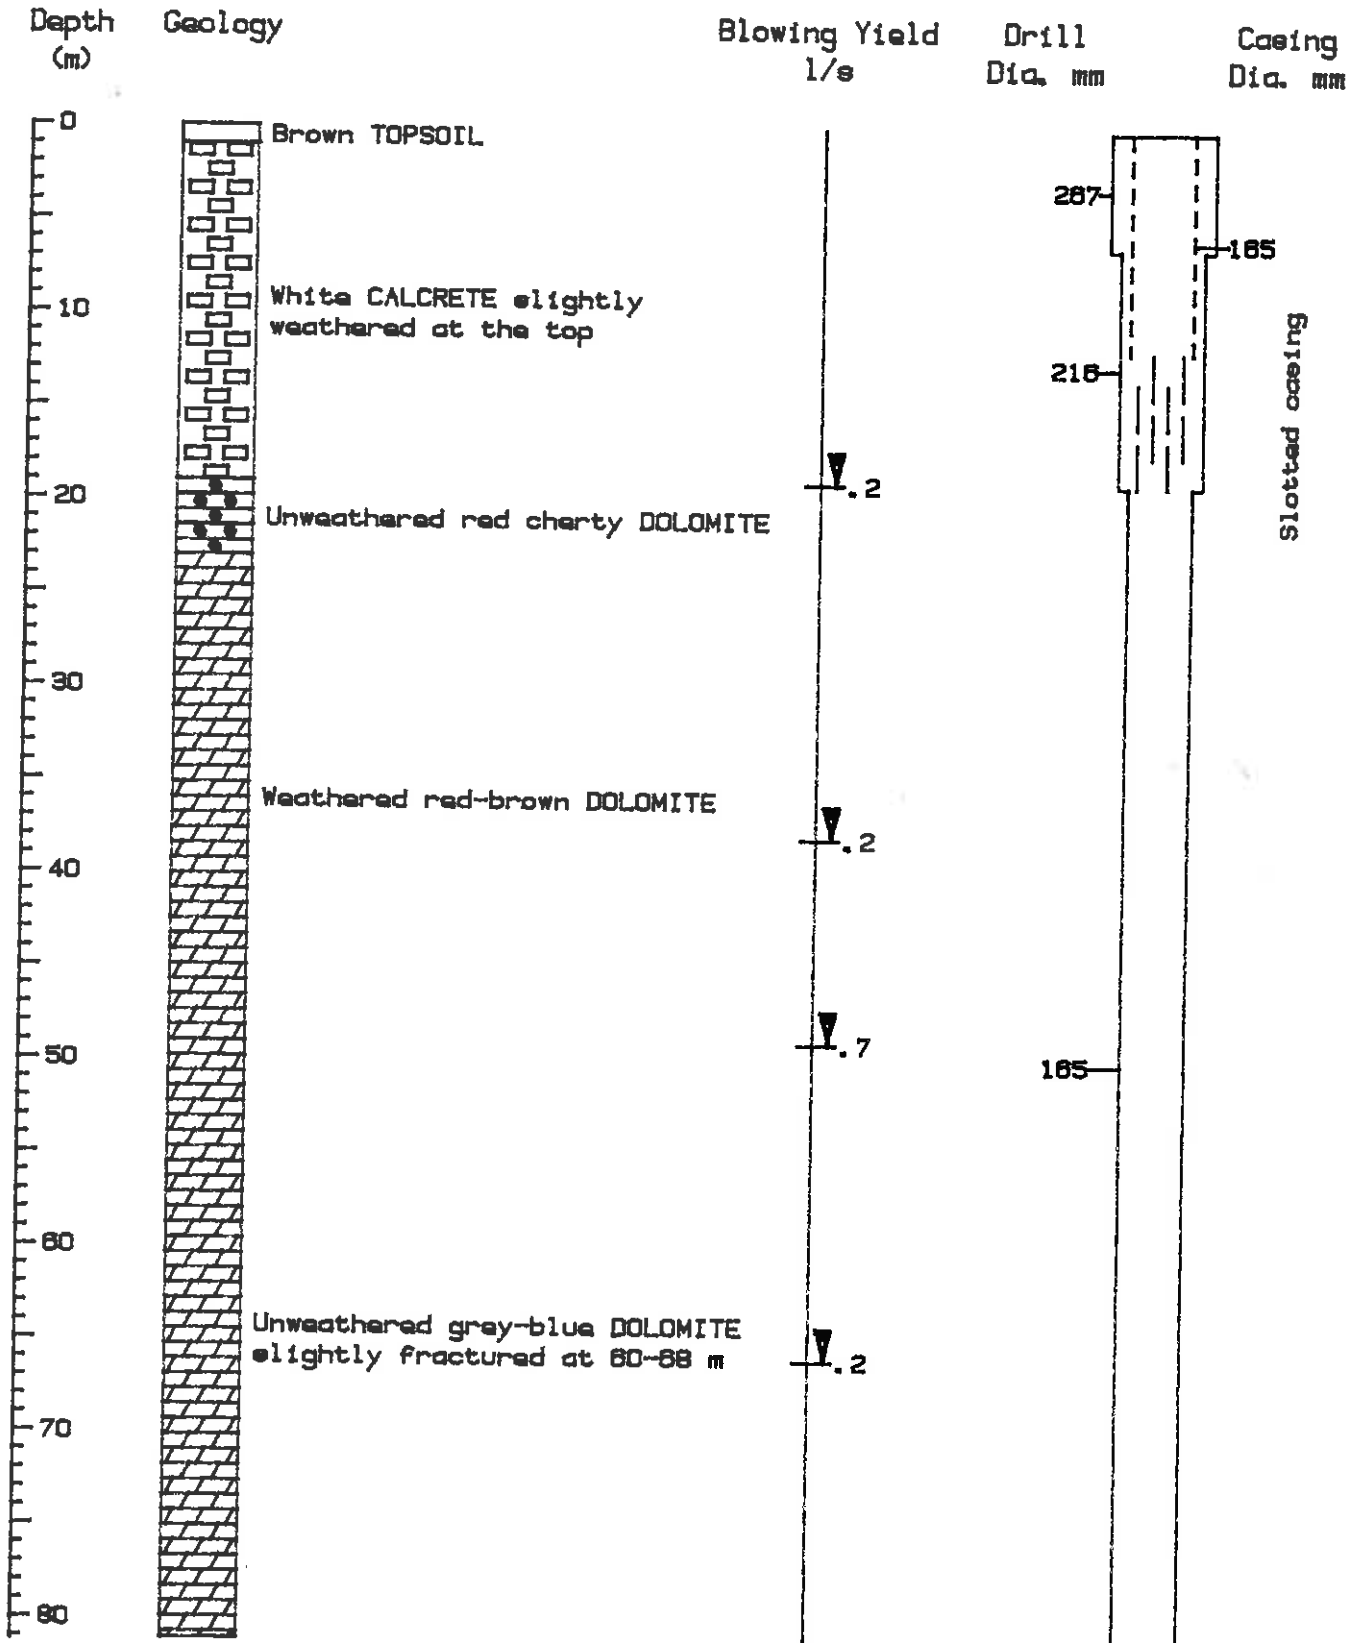
Coordinates +2881675X -75550Y

Elev. (m) 1410

End of Hole 81

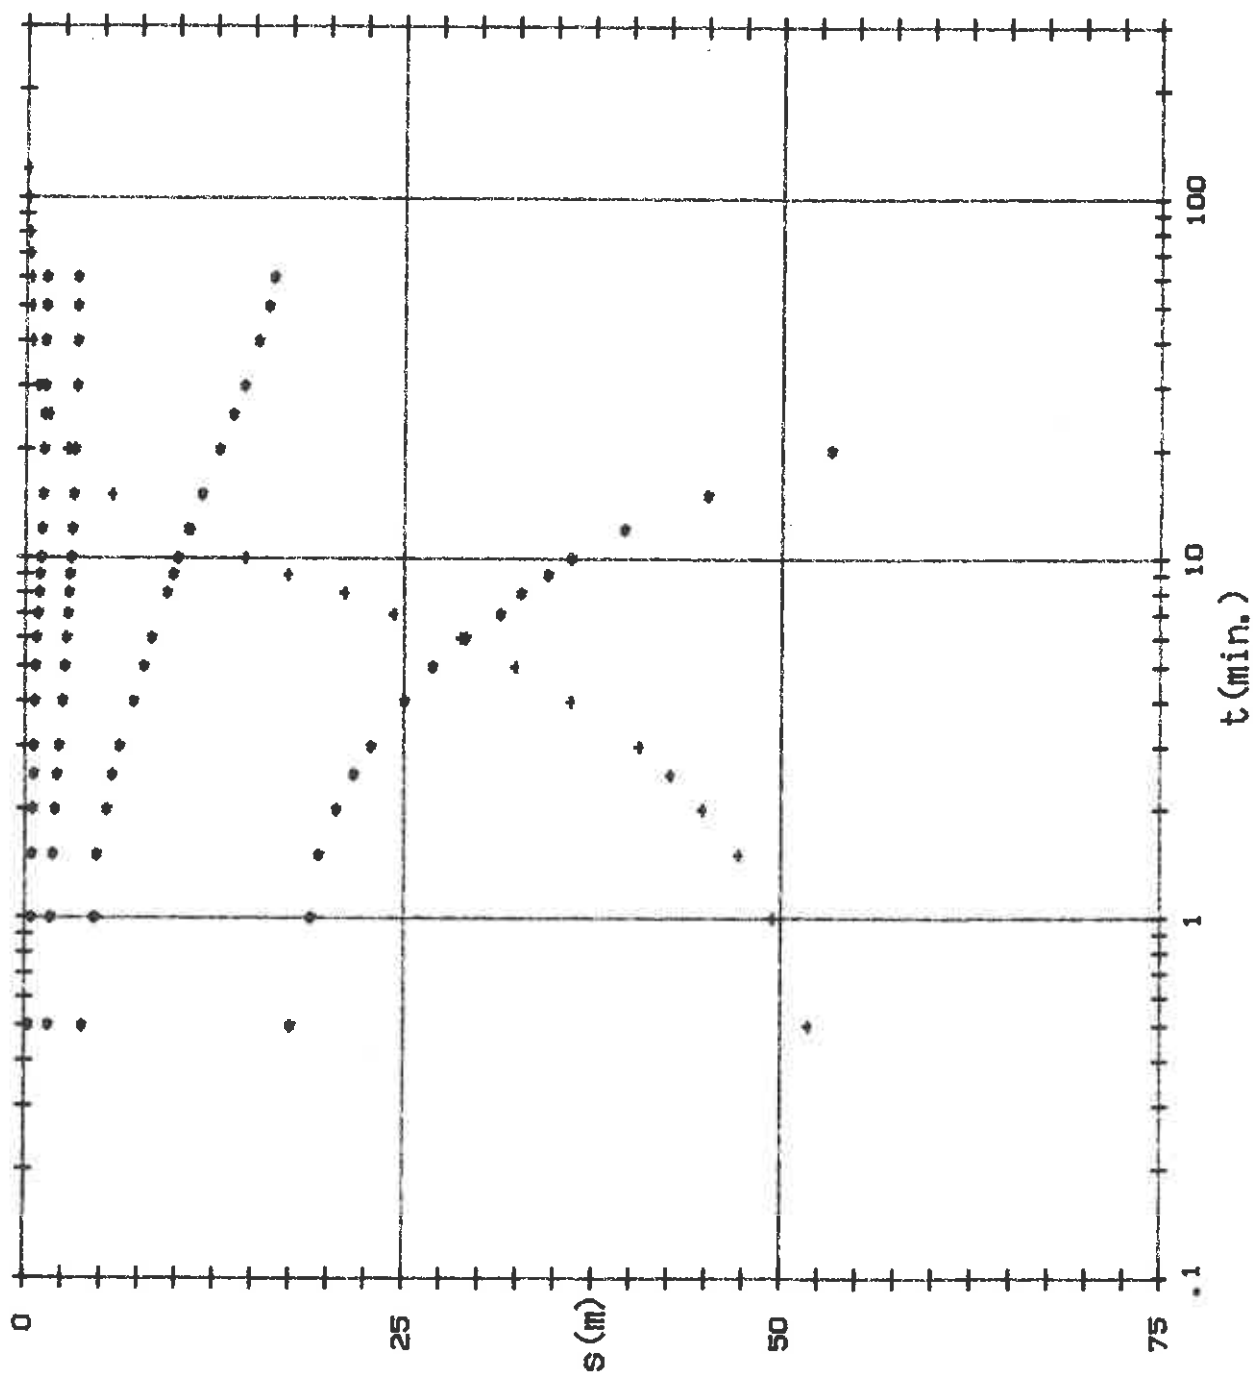
STEP DRAWDOWN TEST

$Q_4 = 2 \text{ l/s}$

S.W.L. = 6.88 m

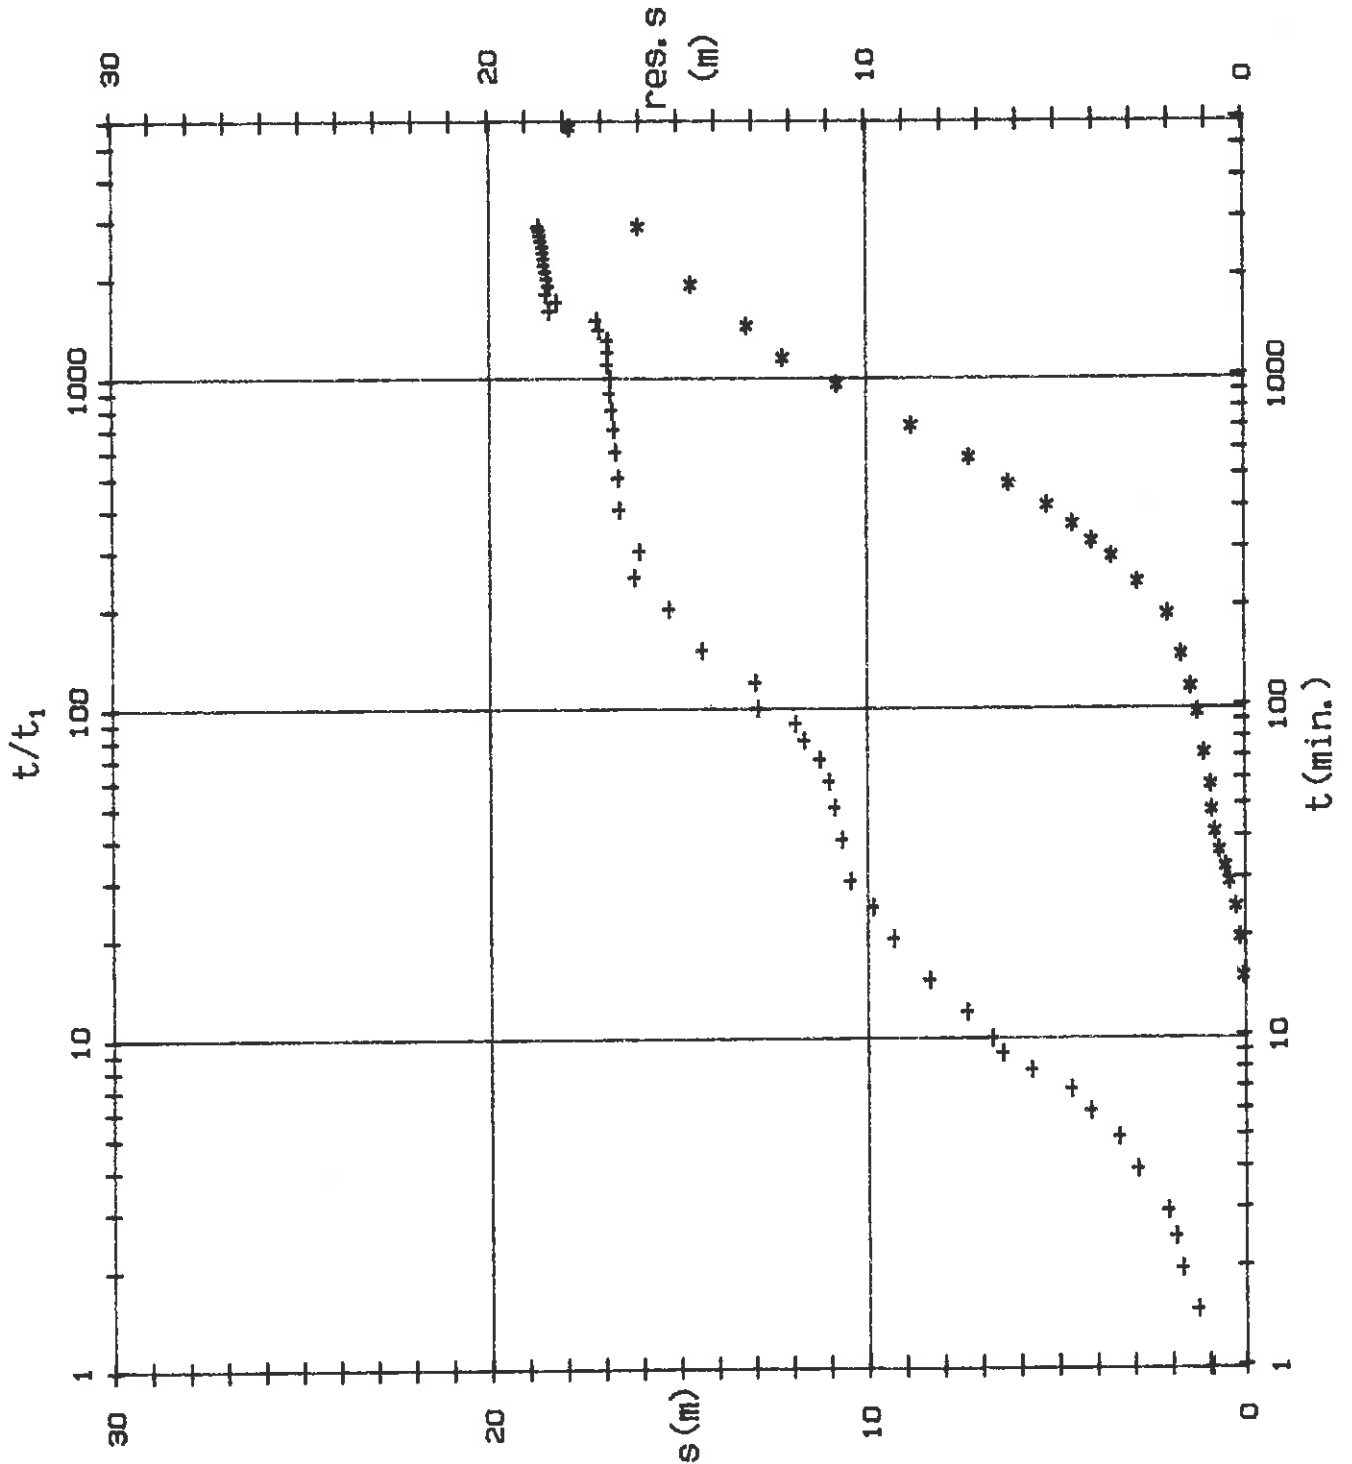
CONSTANT DISCHARGE TEST

+ Drawdown data.
* Recovery data.

S.W.L. = 6.88 m

$T = 2 \text{ m}^2/\text{d}$
