REPUBLIC OF BOPHUTHATSWANA
DEPARTMENT OF WATER AFFAIRS

**REPORT ON THE SITING
DRILLING AND TESTING OF BOREHOLES,
AND THE TESTING OF EXISTING
BOREHOLES - DITSOBOTLA DISTRICT
JUNE 1991 - FEBRUARY 1993**

**VOLUME 1 - TEXT
AND APPENDIX I**

PARTRIDGE MAUD AND ASSOCIATES

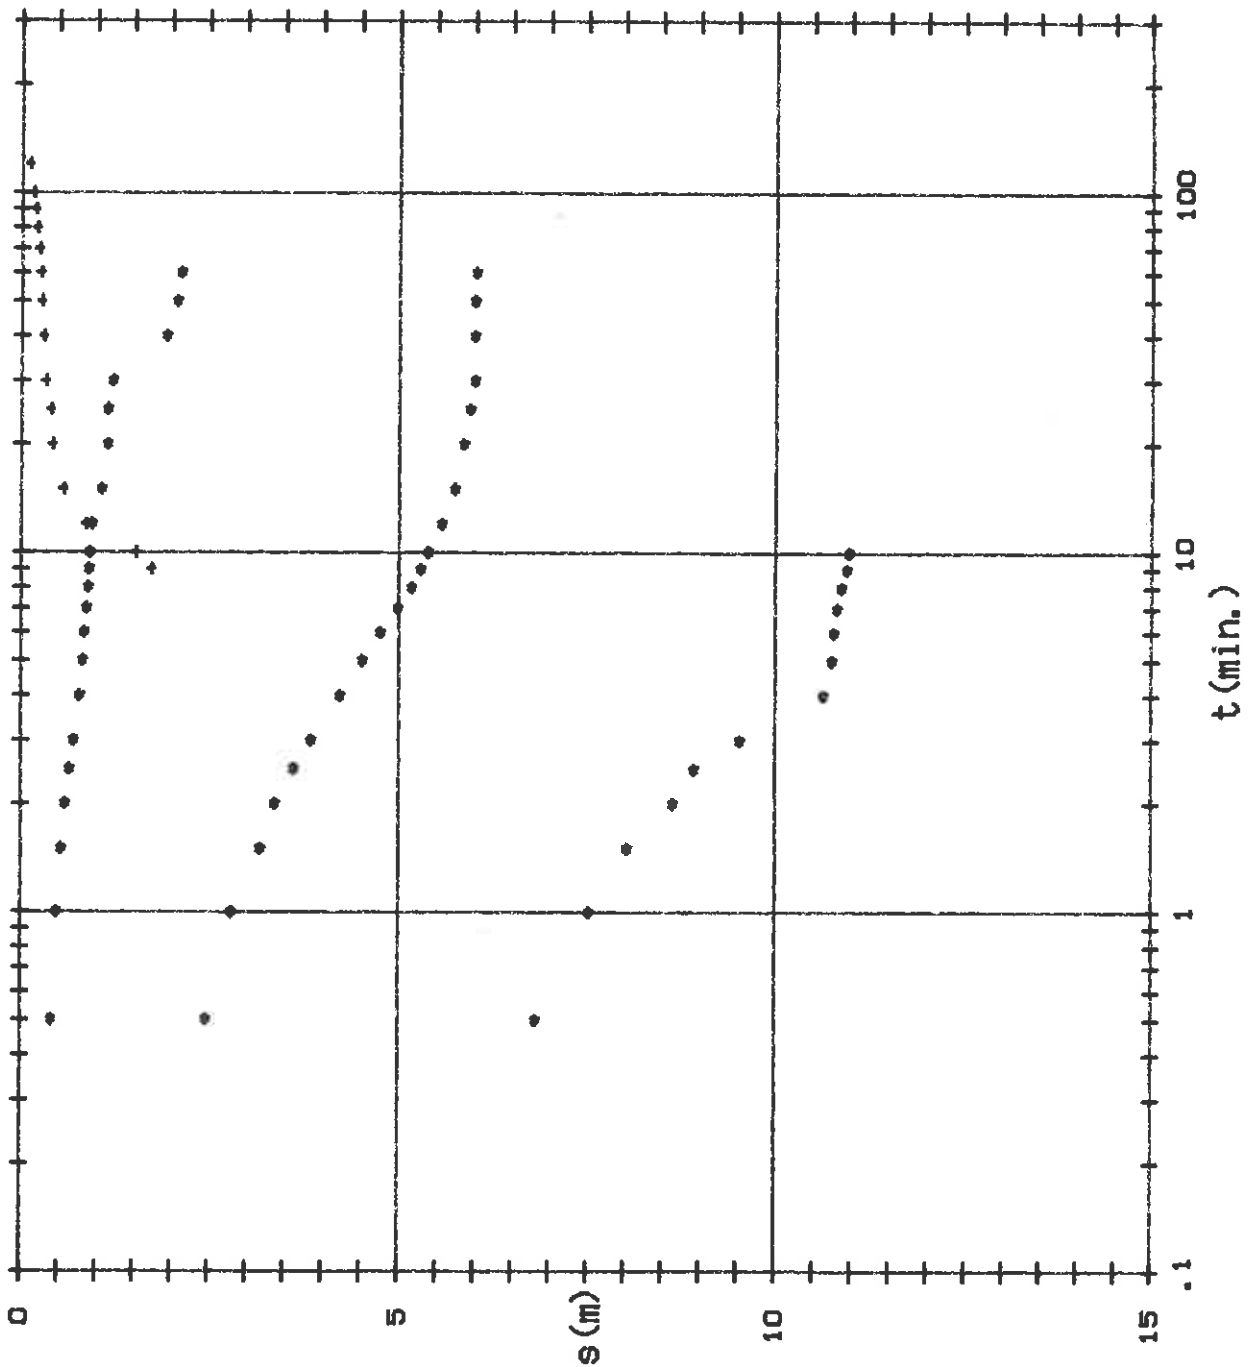
STEP DRAWDOWN TEST

- * Pumping data
- + Recovery data

$Q_3 = .89 \text{ l/s}$

S.W.L. = 7.04 m
