VAALHARTS IRRIGATION SETTLEMENT

Geologist's Preliminary Reclamation Report before
visiting the area

B.N. Temperley

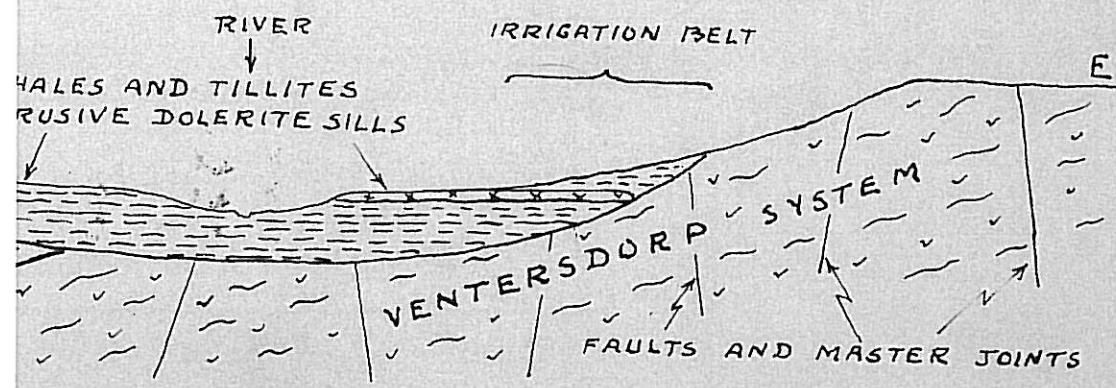
Fig. 3. Geological section across the Harts-Dry Harts valley. Diagrammatic.

as the Harts - Dry Harts valley. Kalahari Sand
grammatic.

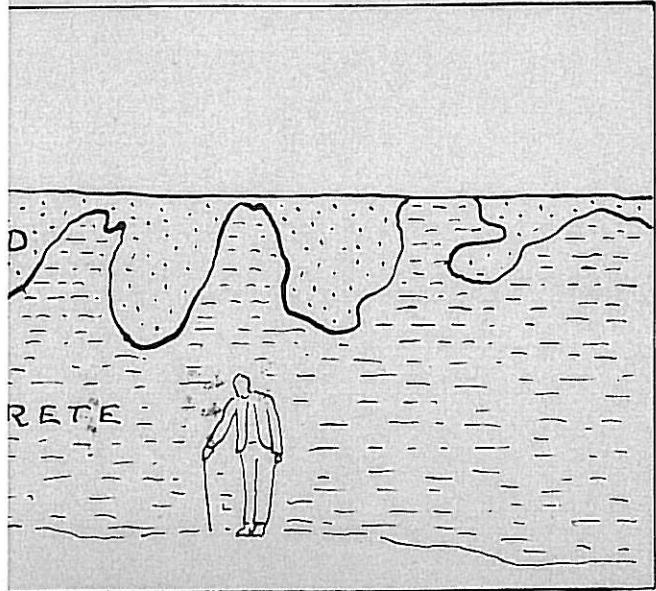
Fig. 4. Sectional exposure of "Kalahari Sand on Lime" south of Modder River Station. After photo by C.R. van der Merwe, 1940, plate 11, p. 63.

Sectional exposure of "Kalahari
on Lime" south of Modder River Station
photo by C.R. v.d. Merwe (1940), plate II,

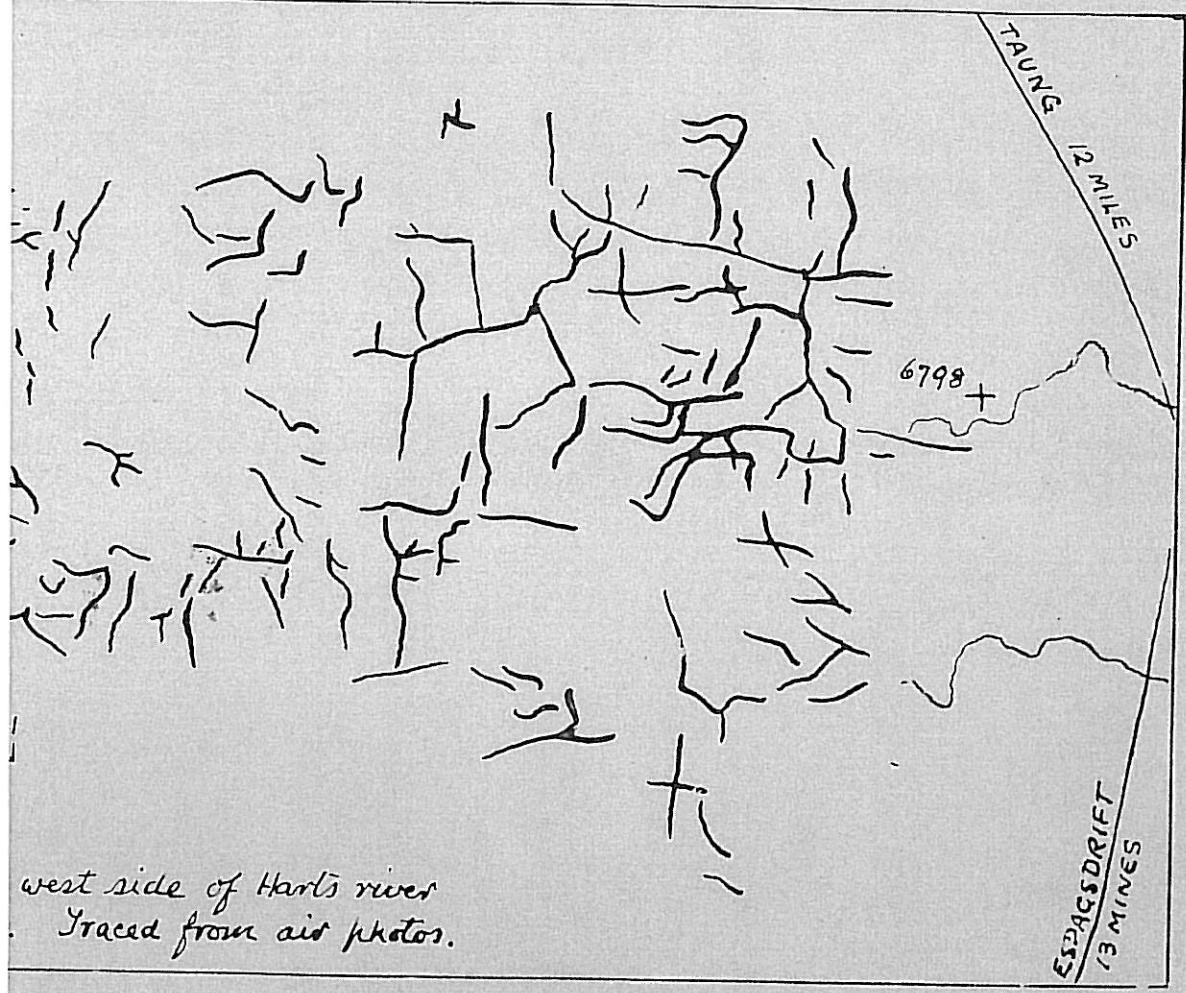
Fig. 5. Calcrete ridges on west side of Harts river, 12 miles south of Taung. Traced from air photos.

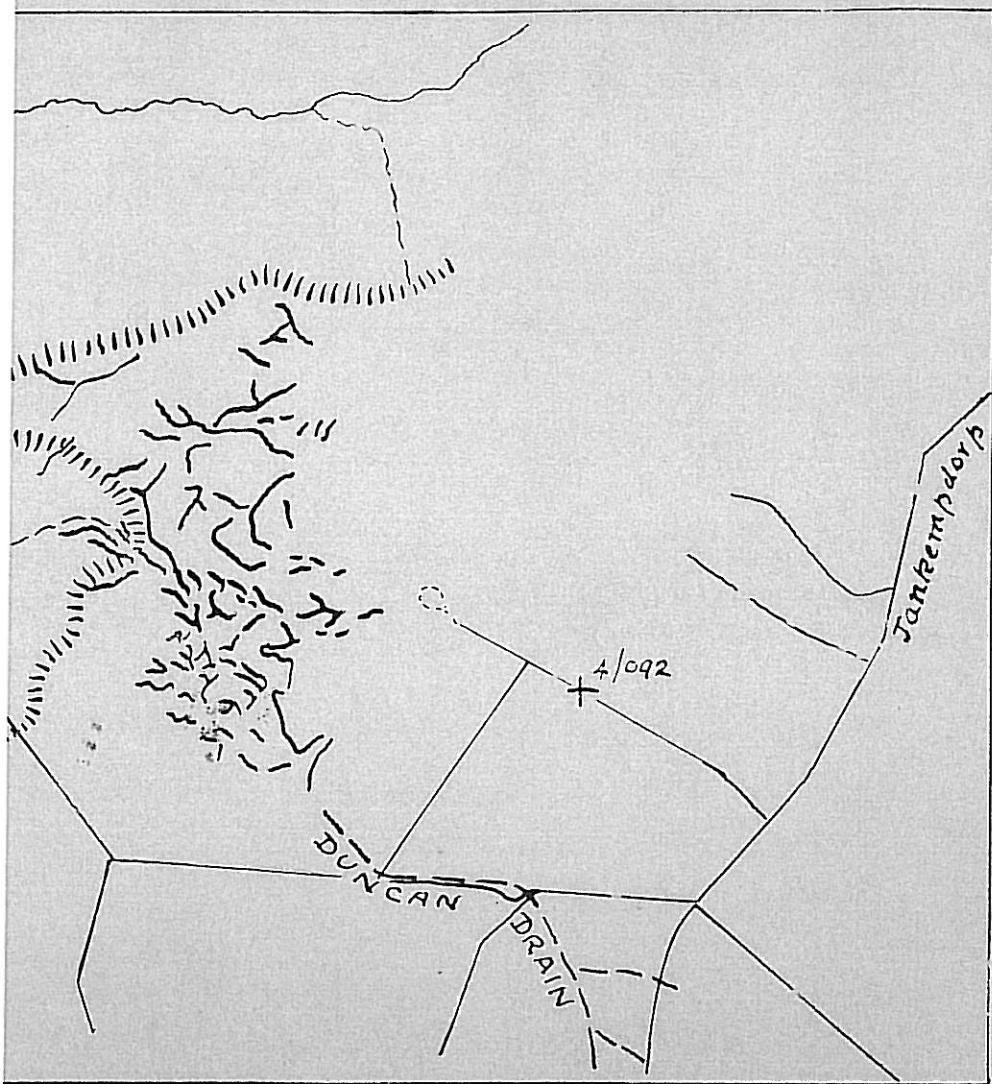
Fig. 6. Calcrete ridges near Duncan Drain, West Canal, 12 miles southwest of Jankempdorp. Traced from air photos.

near Duncan Drain, West Canal, 12 miles southwest of
Traced from air photos.

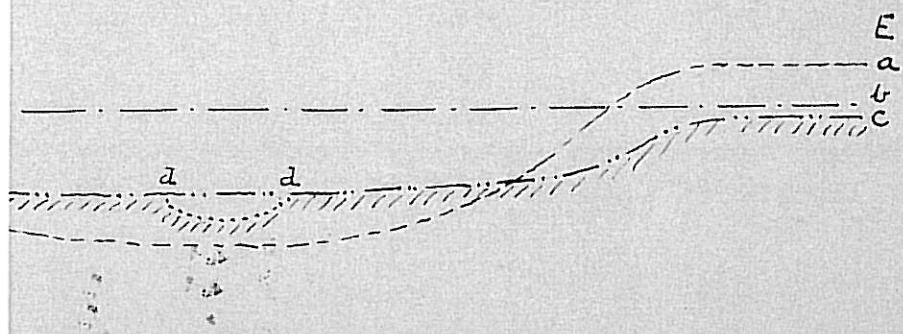
Fig. 7. Topographical section across Harts valley showing the relationship of erosion surfaces of four different ages. Diagrammatic.

section across the Harts valley showing the
surfaces of four different ages. Diagrammatic.
b-b post-Karoo, c-c (?) end-Tertiary and

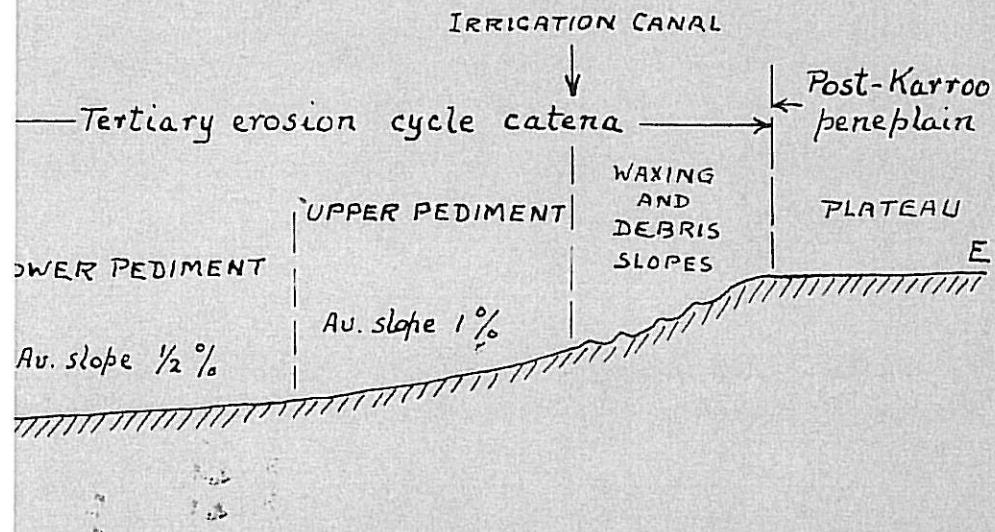
topographical section across the eastern side of the Harts
elements of the topographical catenas of three

Diagrammatic. The upper pediment of the
is largely irrigable but its lower pediment
tertiary erosion surfaces carry only scattered
irrigable land.

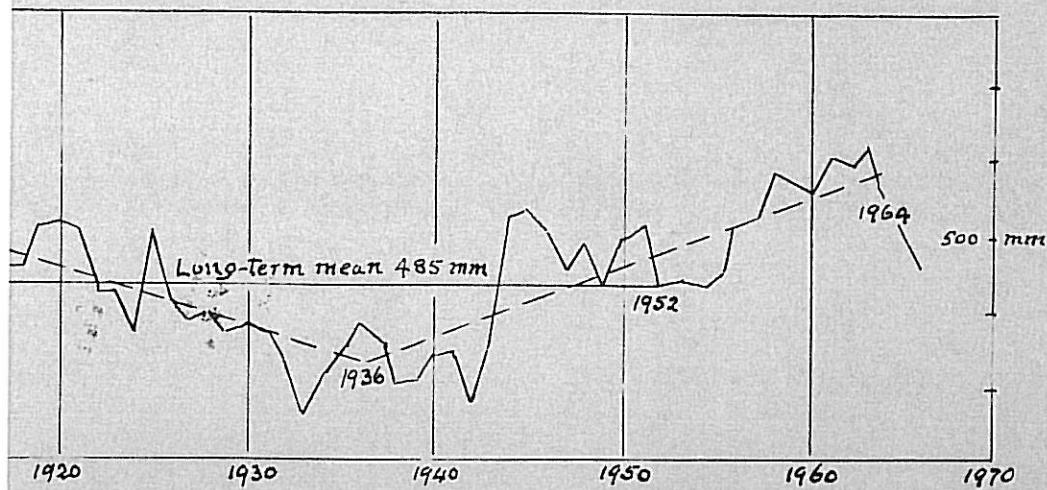
Fig. 9. Residual-mass annual rainfall curve for Weather Bureau Rainfall District No. 19 (Vryburg).

means (cumulative departure from the mean) annual
rainfall for Weather Bureau Rainfall District 19 (Vryburg).
from published data.

It will be noted that the whole period of record is divisible into two sub periods with different annual means, viz.
