Department:
Water Affairs
REPUBLIC OF SOUTH AFRICA

SOUTH AFRICAN ENVIRONMENTAL HEALTH MONITORING PROGRAMME

MINI TECHNICAL REPORT: July 2010 KEISKAMMA RIVER BIOMONITORING TRENDS

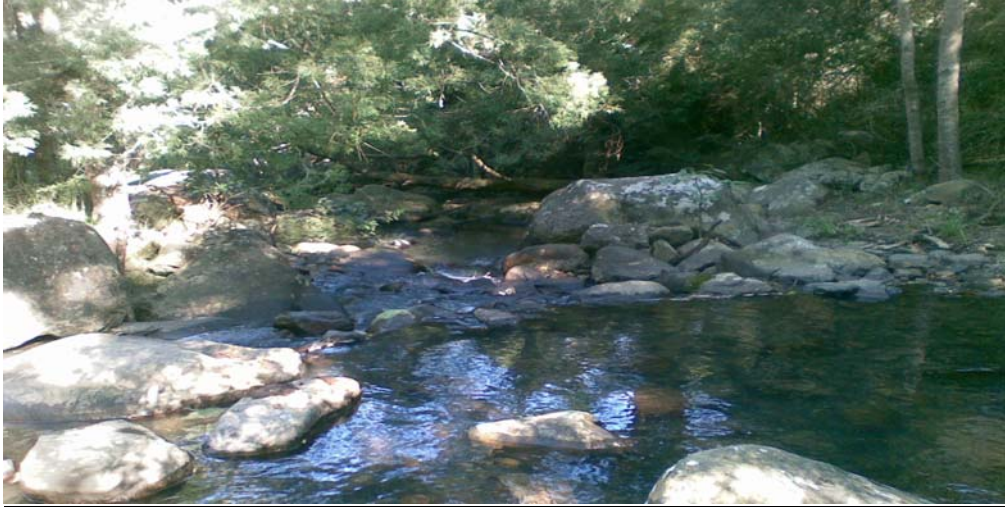
Plate 1: Tyume River at Hogsback

Altitude: 789 masl.

Present Ecological Status (PES) using GAI: **A**

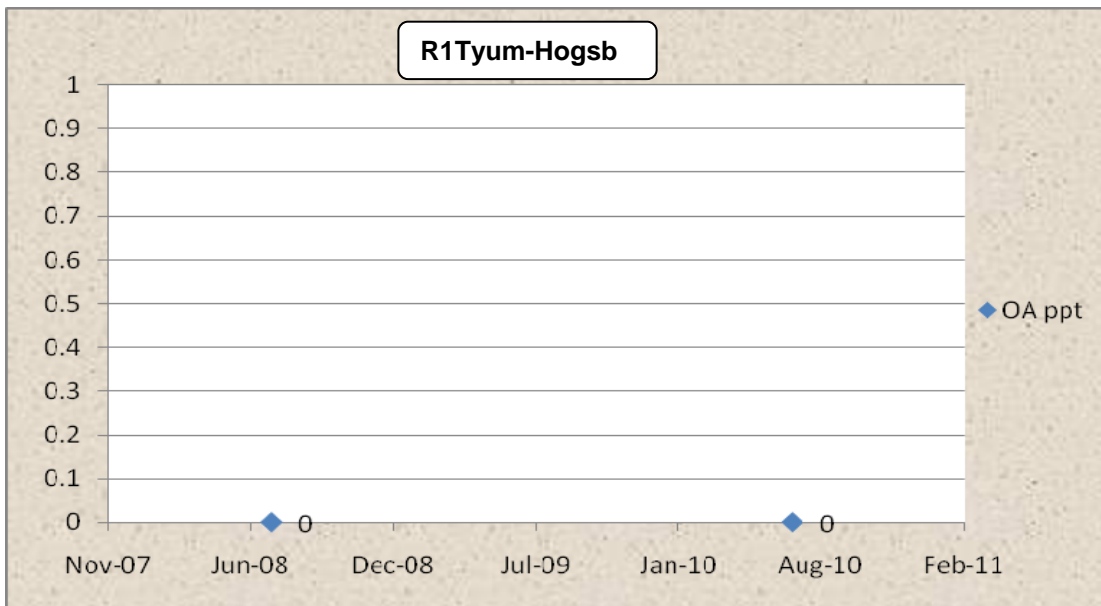
Figure 3: On site Oxygen absorbed assessment, concentrations too low to detect, period July 2008 to July 2010, using Hanna pH & EC combo. These findings are consistied with unimpacted headwater streams and agrees with geomorphological class A (unimpacted) and SASS 5 rating of 7.0 (natural), see figure 4 and discussion under plate one..

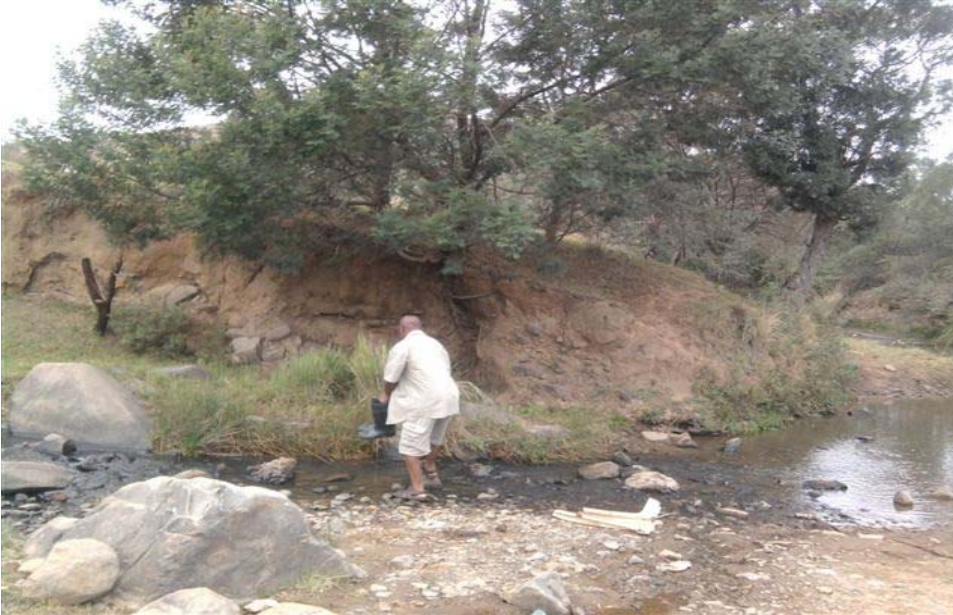
Plate 2: Keiskamma River above St Mathews

Altitude: 687 masl.

Present Ecological Status: B

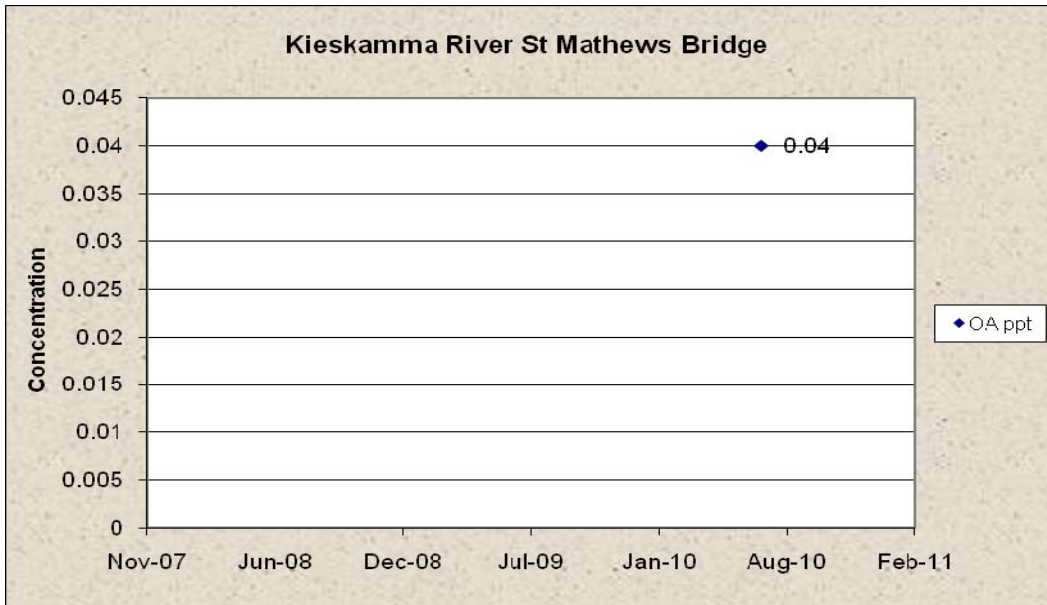
Figure 7: On site oxygen absorbed trends from march 2008 to july 2010,over apperiod of two years.

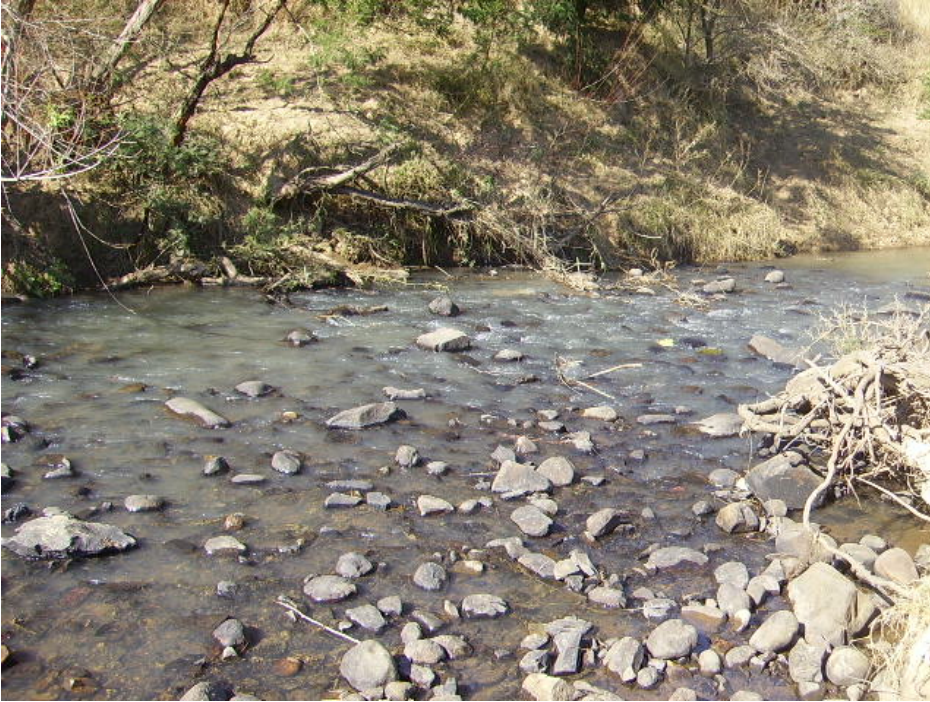
Plate 3: Keiskamma River below St Mathews

Altitude: 631 masl.

Present Ecological Status: B/C

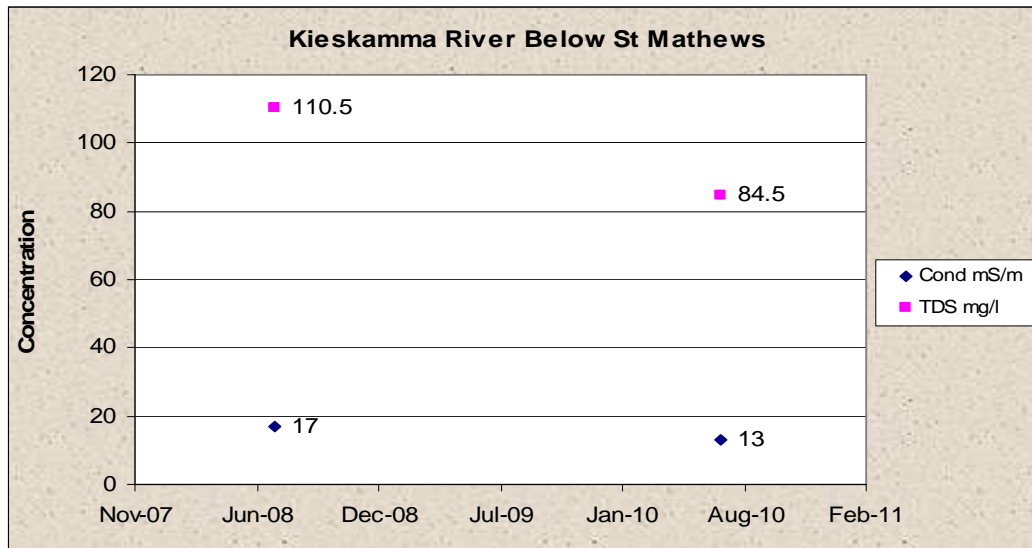
Figure 10: On site conductivity and total dissolved solids trends from March 2008 to July 2010, over a period of two years. Average total dissolved inorganic salts (+/- 97.5 mg/l) and the trend indicates water quality improvement. This still suggests that this site has good dilution and buffering capacity. Therefore, if one takes into consideration, surrounding land use activity and other catchment processes, the conditions are quite realistic and acceptable.

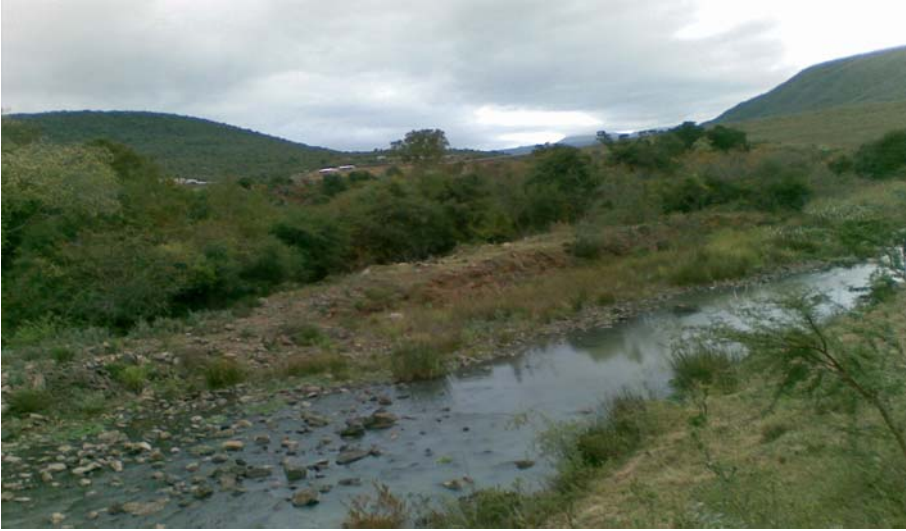
Plate 4: Keiskamma River below Sandile Dam

Altitude: 548 masl.

Present Ecological Status: **C**

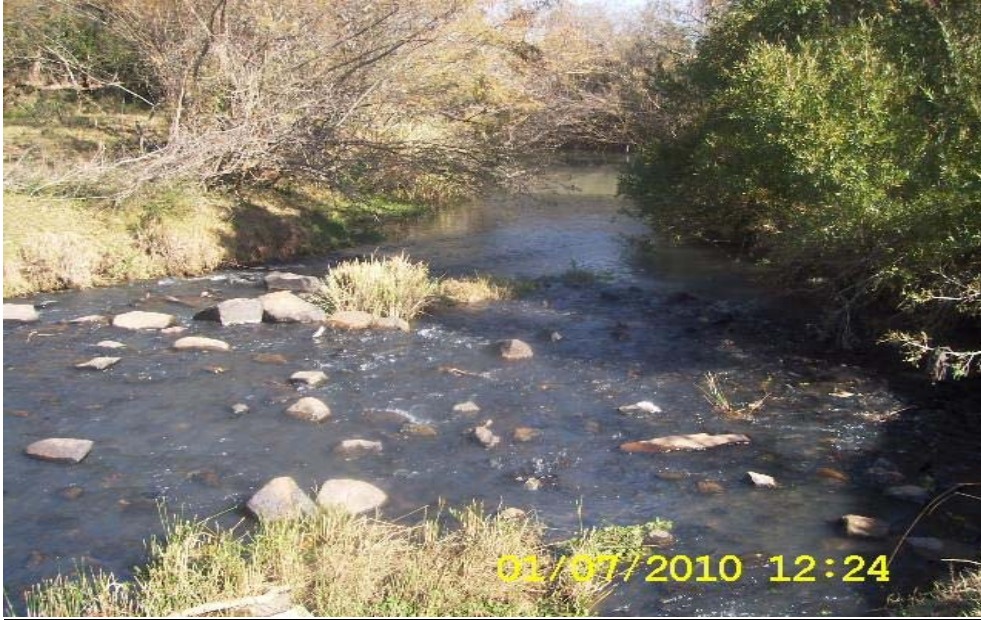
Plate 5: Tyume River at Fort Hare

Altitude: 524 masl.

Present Ecological Status: C

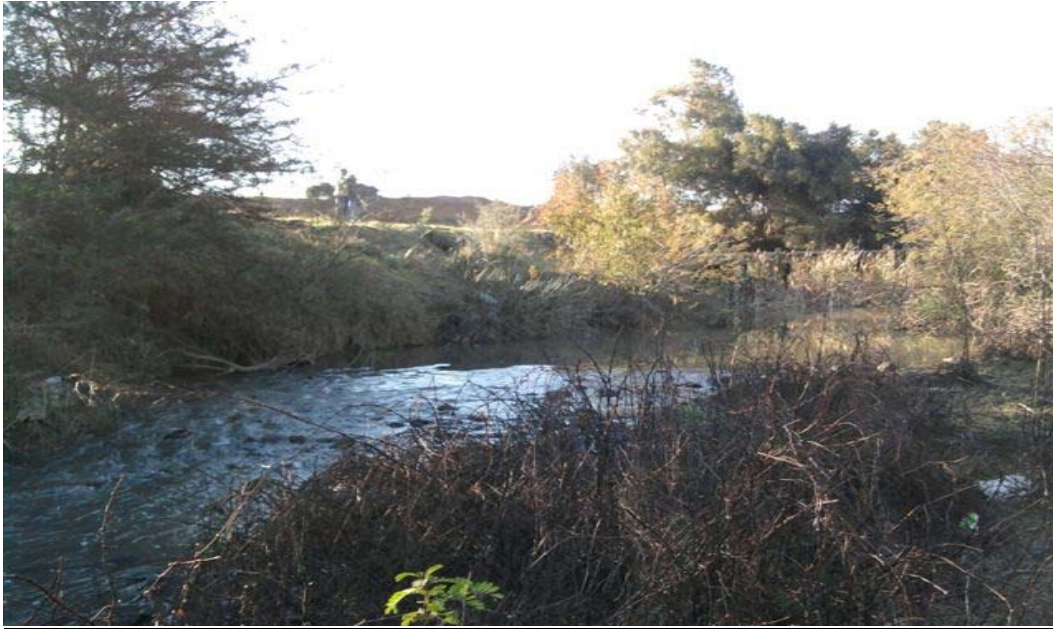
Plate 7: Keiskamma River below R63 Bridge

Altitude: 433 masl.

Present Ecological Status: A/B
