SOUTH AFRICAN ENVIRONMENTAL HEALTH MONITORING PROGRAMME

MINI TECHNICAL REPORT: July 2010 MZIMVUBU RIVER BIOMONITORING TRENDS

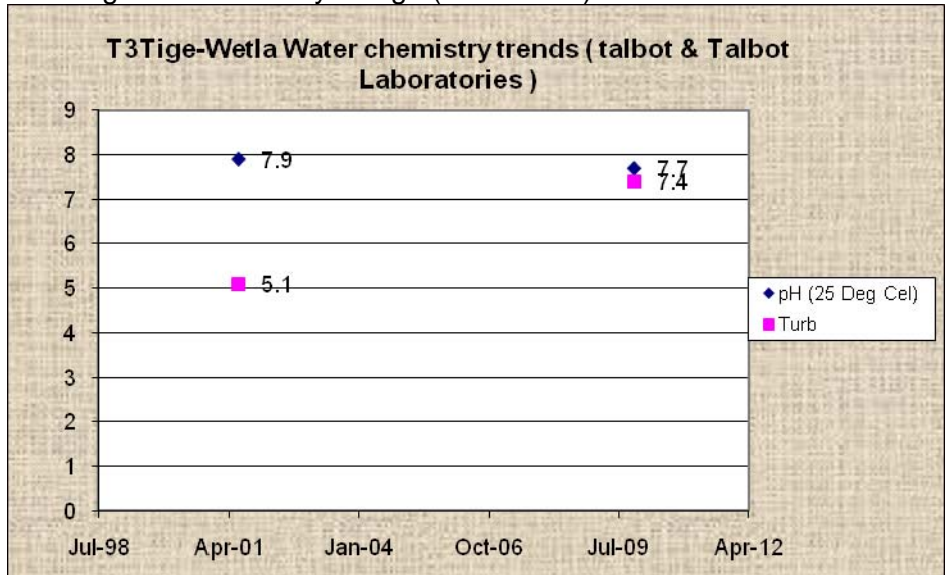
Figure 3: pH and turbidity fluctuations at Tiger Valley Spruit below the wetland (by Talbot & Talbot Laboratories). pH trends indicates compliance with Target Water Quality Range while turbidity has exceeded the the target range for domestic use(DWA 2008)

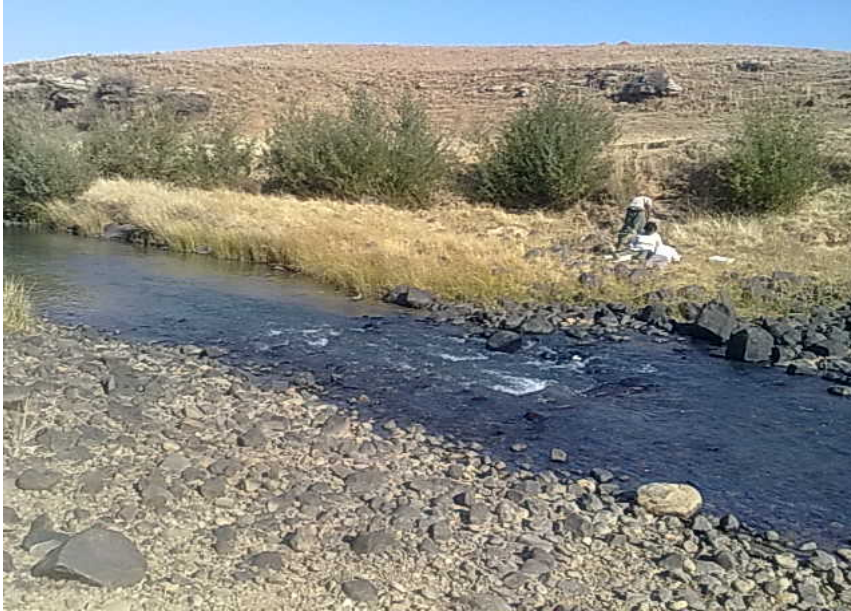
Plate 2: Tina Head waters (T3TinaR316R)

The site is located at an incised channel with flood benches. No significant changes identified during the survey except the slight increase in morphological units (62.5% as compared to 50% of the spring survey). Such increases could be due to flow changes, as the recent survey was done during periods of base flows, and therefore exposure of other biotopes that were submerged by the water during 2009 spring survey. It could be observed that minor erosion occurred at a local scale. The Geomorphological Assessment Index (GAI) model shows that the site is at **A/B** class in terms of its present ecological state.

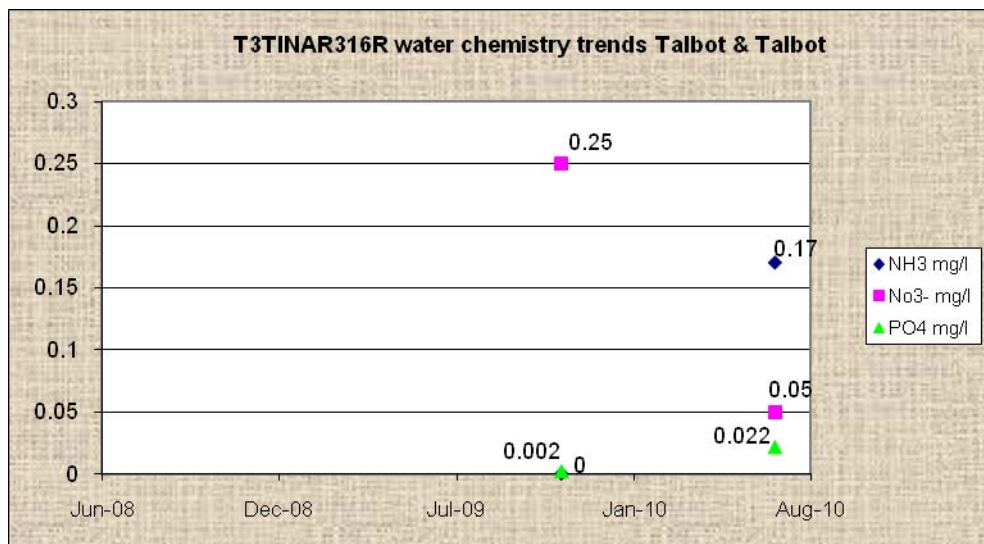
Figure 5: Ammonia, nitrates and phosphates fluctuations at Tina head waters (by Talbot & Talbot Laboratories). Water chemistry data indicate compliance with Target Water Quality Range (DWA 2008).

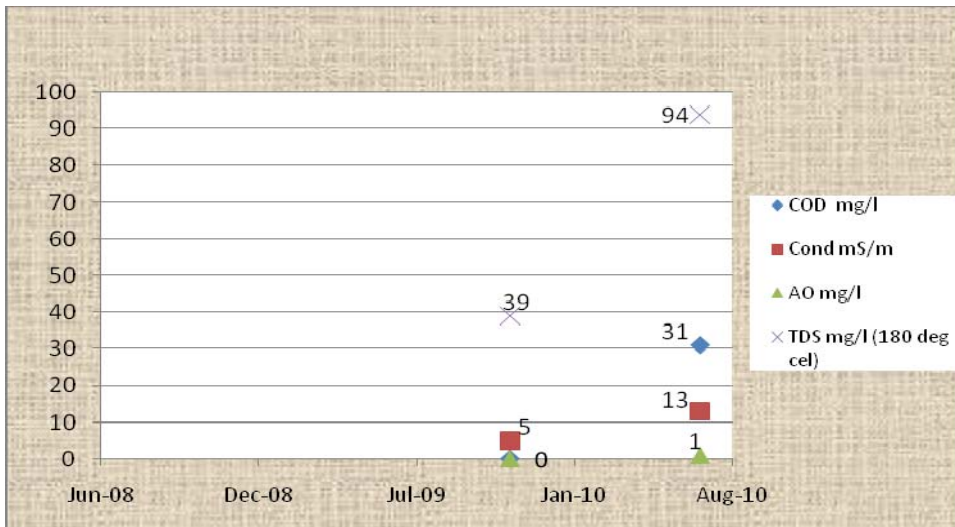
Figure 8: COD, Conductivity, Oxygen absorbed and Total dissolved solids fluctuations at Tentkop Spruit River Pass (by Talbot & Talbot Laboratories). Water chemistry data indicate compliance with Target Water Quality Range (DWA 2008).

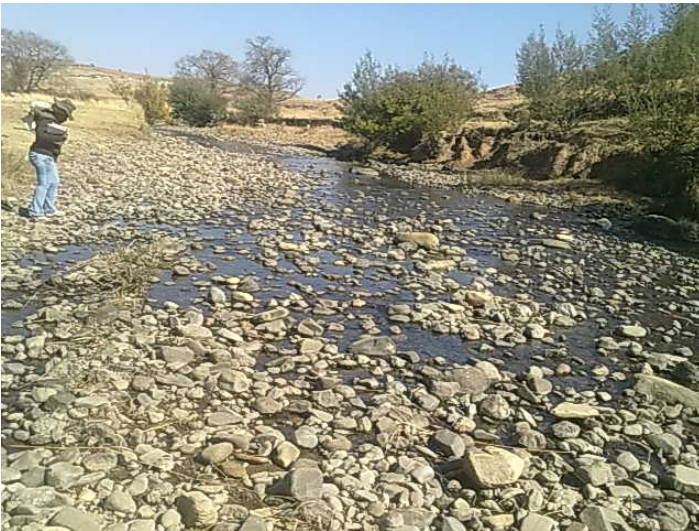
Plate 4: Kinira River at Mabua

The site is also located at a reach confined on one side. It is a single thread pool-riffle system in an active meandering state. Overflow channel was observed, suggesting increased flooding combined with vegetation removal. The sources of sediment at a reach scale are gullies and sheet erosion on the hillslope, accompanied by presence of alien *Acacia meansii* species. Comparing with previous survey (2009), a lot of boulders had been exposed, suggesting recent removal of fines (mainly sand). Figure 2 below shows the comparison between the variability of sediments found in the channel during 2009 spring survey and recent 2010 winter survey.

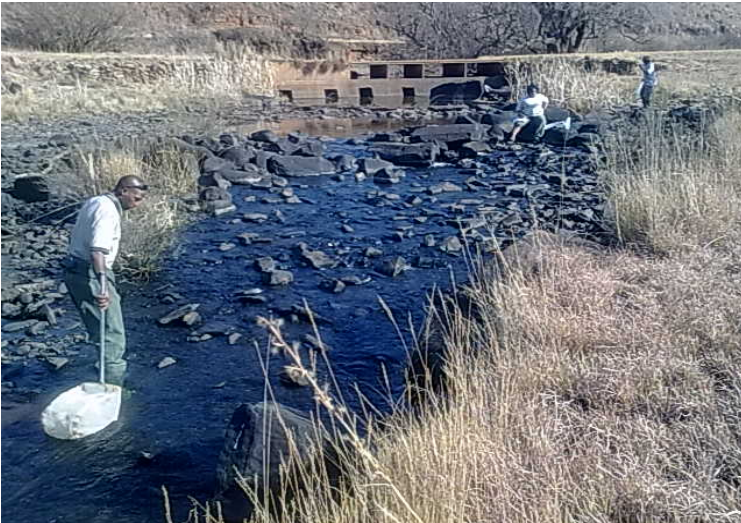
Plate 6: Mzintlava at Franklin Vlei

The site is located where alternating bedrock cliffs are opposite moderate slopes hence irregular shapes on alluvium found on the river bed and river banks. The river bed material is boulder-dominated. No significant changes were observed at a site. The site has about 39% of the morphological units. The GAI model suggests that the river at a site is at **B**, which has few modifications in terms of its fluvial geomorphology.

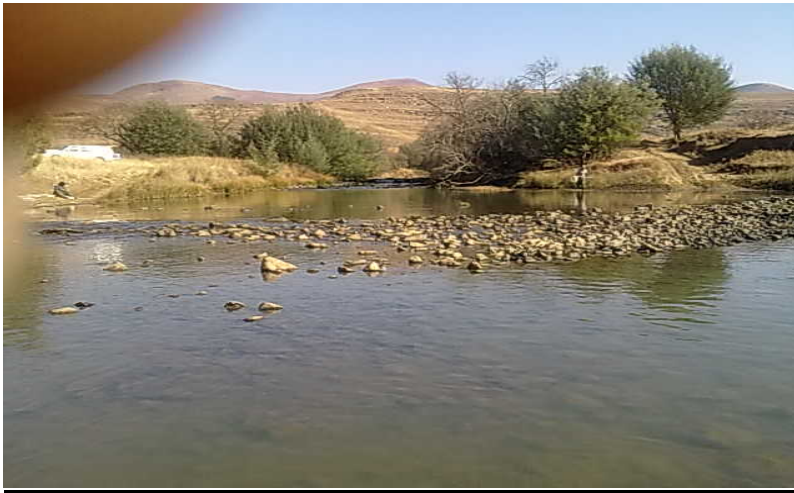
Plate 7: Mzimvubu River at Springfontein Farm

The site is also located at a reach where the floodplain is confined on one side. This means that the eroded sediment from the hillslope can either be trapped alternatively at a floodplain either at the right or the left side of the river, but never both. It is a single thread, alluvial and a pool-riffle system. This is where the river is experiencing a sinuous situation, with erosion of the river bank alternating with deposition of sediment on either left or right bank. Comparing with the previous survey, cobbles have become dominant over boulders, as well as additional proportions of fines. Therefore in the mean time there has been minimal increased sedimentation along the segment, probably due to plowing of fields on the hillslope, together with decreased flows. The morphological units on a river constitute about 33.5%. The figure below shows sediment proportions of a site.

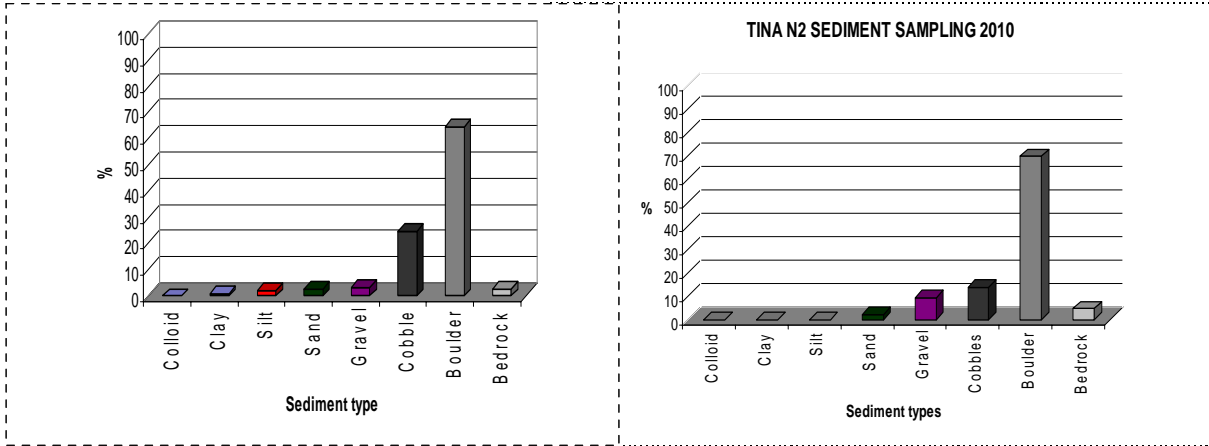
A: Spring survey 2009

B: Winter survey 2010

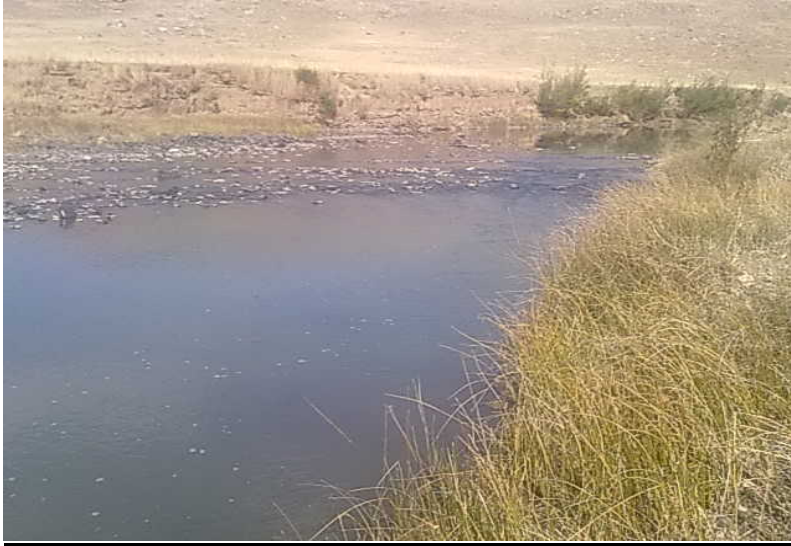
Plate 8: Tina River at Tsolobeng

This site is situated at a confined valley flood plain. The site is in a single thread, pool-rapid and mixed with bedrock and cobbles; the latter being dominant. A lot of sheet erosion and deep gullies as well as grazing are major catchment processes occurring on the adjacent hillslopes. No embeddings could be noticed during the survey, as compared to that of 2009 spring assessment and therefore most of the fine material has been removed. About 71% of morphological units were observed at a site of which these comprise diversity of habitat for aquatic flora and fauna.

The GAI model shows that the river at a site is at **B/C** class; a situation whereby the geomorphic changes have been largely modified.

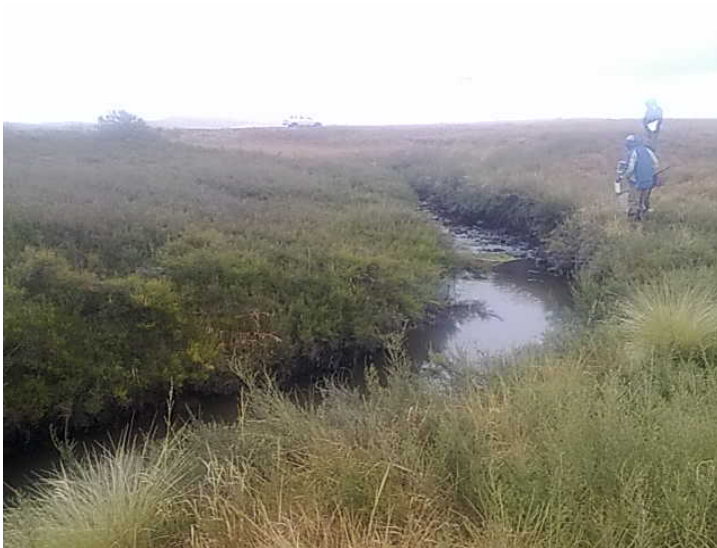
Plate 9: Gatberg River at Forestation

The site is located in a confined valley floodplain. It is a single thread, sinuous, pool-riffle, flat bed system dominated by cobbles as a substrate. Two road culverts have inhibitory effect on upstream-downstream connectivity of the river system at a site. Due to this, the GAI index reveals that the site is at **B/C** class in terms of its PES.

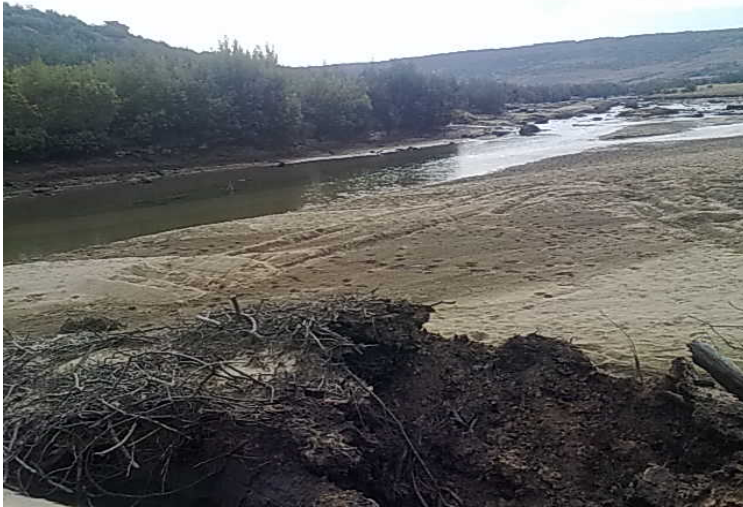
Plate 10: Kinira River at Drift

This site is situated at a confined valley flood plain. The site is at a single thread, sinuous, pool-riffle system dominated by sand. It is rich in morphological units about 83%, which means that it is naturally a 'home' for diversity of species. The channel is almost braided upstream of the bridge due to a lot of sedimentation. Scouring is also evident immediately below the bridge that is blocked by debris. Active erosion on the hillslope could be observed, and this erosion is accelerated by *Acacia meansii* invasion. Because the site is dominated by bedrock and sand deposits only, no sediment samples taken. The GAI model puts the site at a **B/C** category, with moderate modifications.

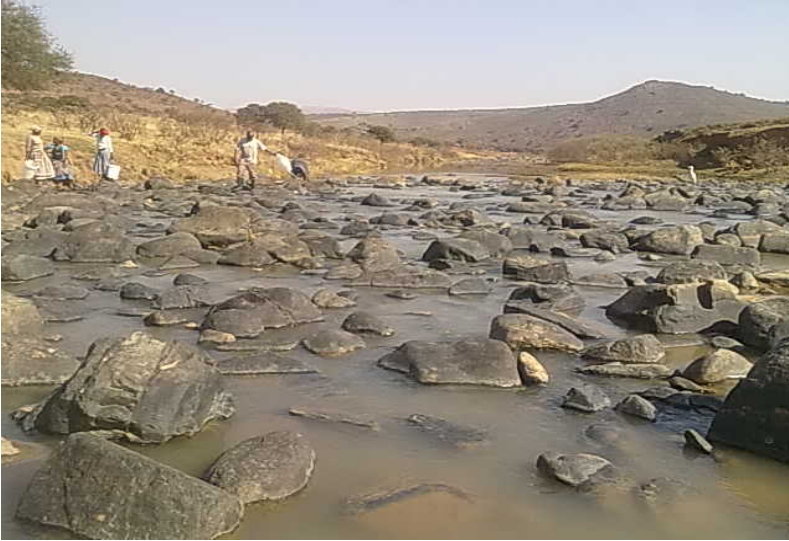
Plate 11: Mzintlava River at Ntshakeni

This is also a confined valley floodplain. It a pool-riffle river system with a straight and a single thread channel. Newly formed mid channel bars could be observed, associated with fine sediment from sources like gullies and collapsed river banks. In fact active hillslope erosion, vegetation removal and overgrazing are abundant. The river at a site is dominated by boulders; a character of a transitional zone. It has about 80% of morphological units suggesting diversity of habitat for aquatic biota. This is a characteristic of poor pasture management which can affect adjacent water resources. No sediment sampling could be done at a site due to fixed boulders in a river system (refer also to 2009 survey). It could be observed that at a site, sand, silt and clay deposits that were observed previously have been removed. When running the GAI model, the site can be classified as in a B class on its Present Geomorphological State.

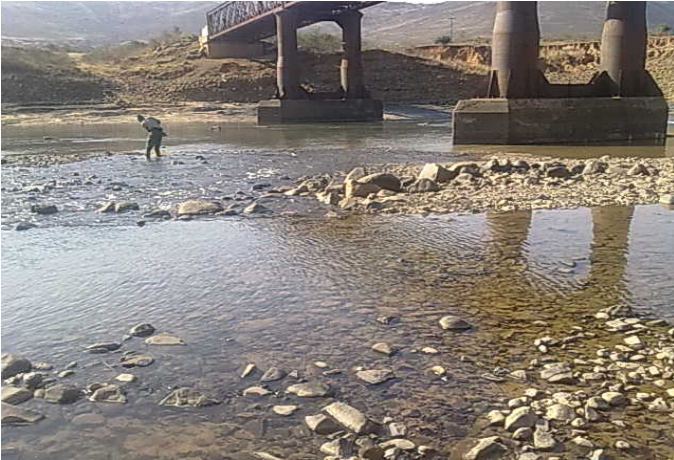
Plate 12: Mzimvubu River at N2 Road

The site is geographically located on a confined valley floodplain. It is an anastomosing channel with numerous bars and sub-channels. The river at a site is at a dynamic sinuous condition. It is a mixed alluvial, pool-riffle system where both the bedrock and alluvium are dominant features. Moderate erosion occurs at a reach scale. Extensive sediment mining (cobbles, boulders and cobbles) had been taking place directly in a river channel. In addition, concrete material was deposited in the river channel and thus no sediment sampling whatsoever would be taken. Morphological units constituted about 42.5%. The GAI model demonstrates that the river at a site is at **C** class.

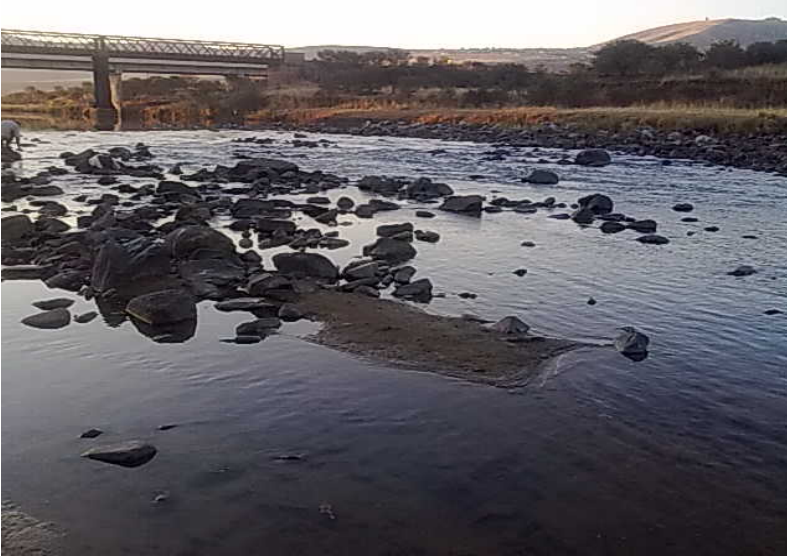
Plate 13: Tina River at N2 Road
Altitude: 782 masl.

The site is in a confined valley floodplain. It is a multi-thread, mixed, pool-riffle system dominated by boulders. Erosion at catchment scale very minimal and there is less vegetation removal. About 83% of morphological units were present. As it can be illustrated in the figure below, very little fine material is found in the river at that site.

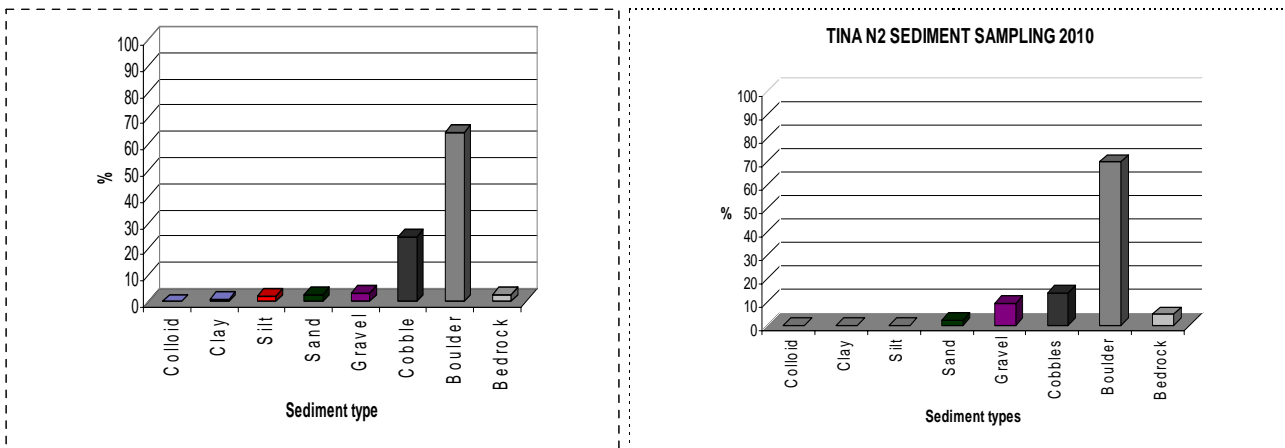
A: Spring survey 2009

B: Winter survey 2010
