A High Confidence Reserve Determination Study for Surface Water, Groundwater, and Wetlands in the Upper Orange

WP11343 River Survey Report 1

REPORT NO.:
RDM/WMA13/00/CON/COMP/0722

Title: River Survey Report

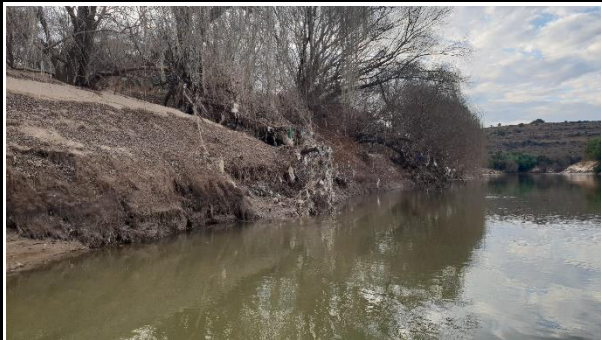
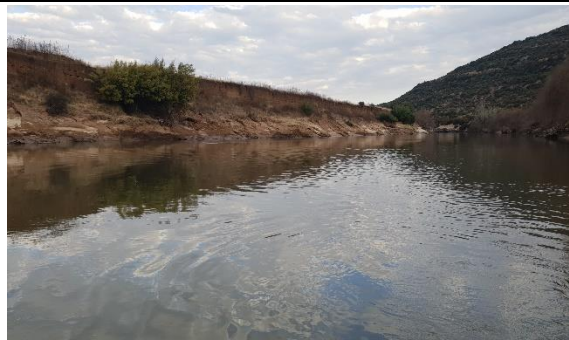
Upstream		Downstream

<p>Site Description:</p> <p>This site is ORASECOM JBS3 site (15_6) and the DWS River Health Montiroing Programme (REMP) site D2CALE-LADY2. The reach is partly confined with a deeply incised channel. The site is a wide and homogenous channel with limited habitat overall. The confluence with the Phuthiatsana River is just 5 km upstream and the confluence with a bigger river, also called the Phuthiatsana is about 30 km upstream. Lesotho’s capital city of Maseru lies ~7 km upstream. The surrounding area is a mix of settlements, grazing areas and small-scale croplands. The Lesotho side is heavily overgrazed and eroded contributing to the already high fine sediment load and evidence of sediment deposition (but not extensive along both banks). The banks are sandy and steep and potentially highly erodible. The banks have clusters of Salicaceae and Salix trees upstream and a heavy infestation of Populus sp. on the riverbanks downstream of the site. The river is ~50m wide and with some inundated sandbars along the channel. The water is turbid, and the riverbed is very muddy.</p> <p>Biotopes available for macroinvertebrates is dominated by sand and silt, with small gravel deposits over the sandy substrate. Marginal vegetation was absent owing to recent erosion of inset benches</p>

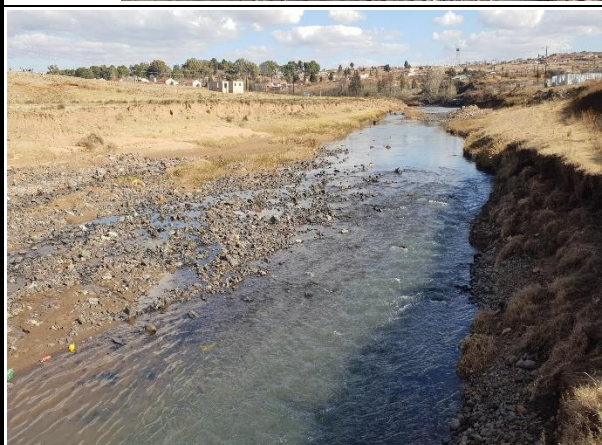
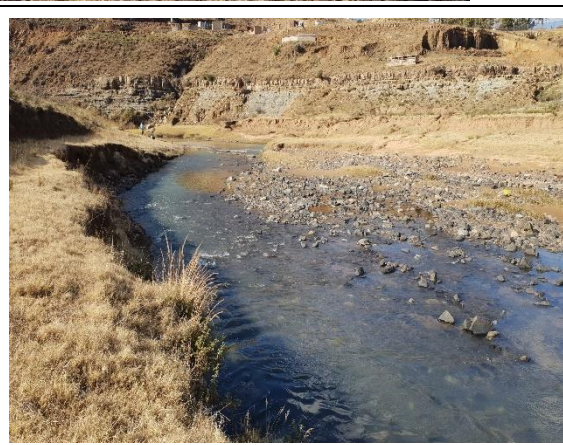
Upstream

Downstream

cattle trampling and grazing. Biotopes available for macroinvertebrates included SIC, SOOC and slated/fractured bedrock, along with Gravel, Sand, Mud (GSM) and limited marginal vegetation, owing to undercut banks and vegetation die-back. For fish there was SD, SS and Fast-Shallow (FS). Various sections of riffles and runs present. Moderate algae content and very high macroplastics in-stream, including domestic plastic (nappies). The riparian zone is mostly grassed on the left bank, with localised sand mining on the right bank and sediment deposition.

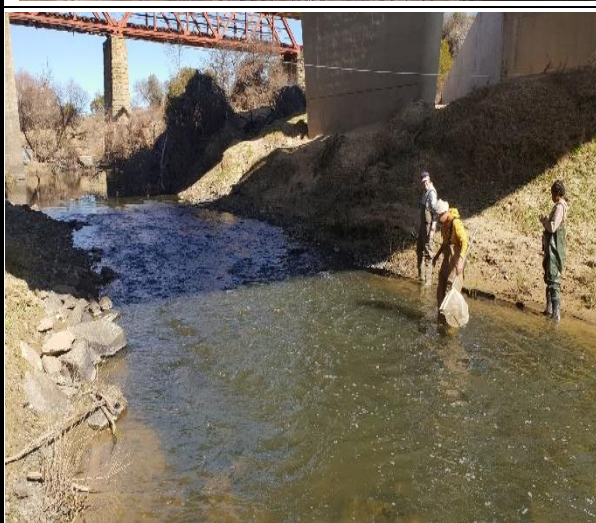
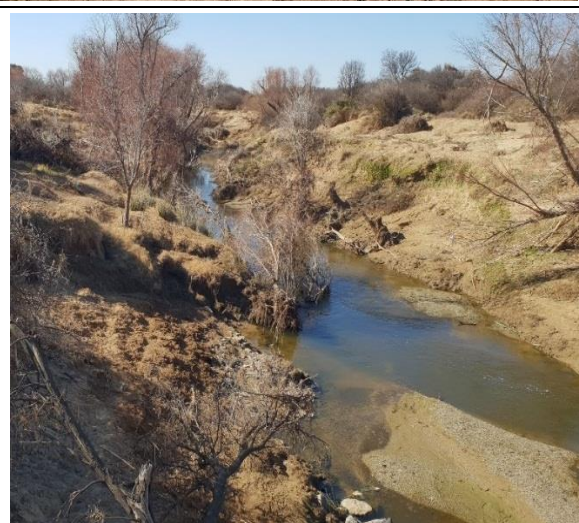
Upstream

Downstream

The reach is largely unconfined, with gently sloping hillslopes and an incised channel with narrow flood features. The site is bedrock controlled with silty banks and introduced coarser bed material. Gravel and sand bars are present downstream of the site. The site along the upper reaches of the Modder River is located ~30km east of Bloemfontein off the N8, with its confluence downstream with the Riet River near the town of Ritchie. The site is situated approximately 13 km downstream of Rustfontein Dam. It is impeded by two (2) railway crossings and a large bridge. Furthermore, a gauging weir is located just upstream of the site. The river width varies from 3 m to 15 m in places with inundation taking place just upstream of the weir. Owing to these influences and impediments, much of the instream substrate, downstream of the weir comprises riffles with artificial loose SIC, and some SOOC. However, bedrock is the dominant substrate from the bridge and further downstream. There is relatively good GSM, but marginal vegetation, being grasses and sedges, was limited owing to undercut banks and vegetation die back (representative of the season). Sedimentation is present downstream of the weir forming a back eddie along the sandbank with algae on the rocks at the river's edge. Overall, considerable channel and bed modification is present at this site. Both banks are heavily eroded owing to recent flooding, flow modifications and cattle trampling.

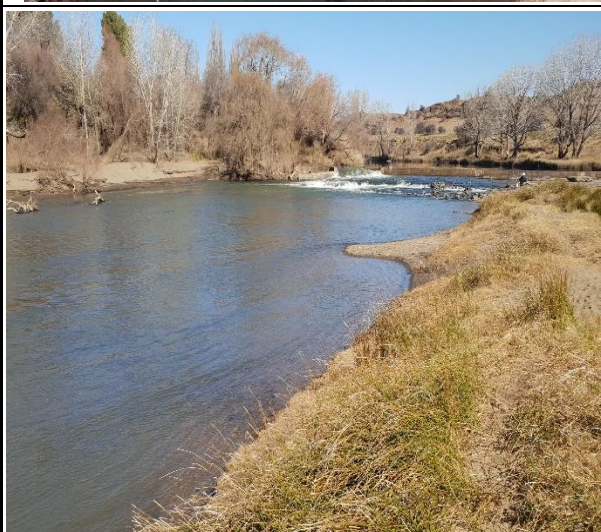
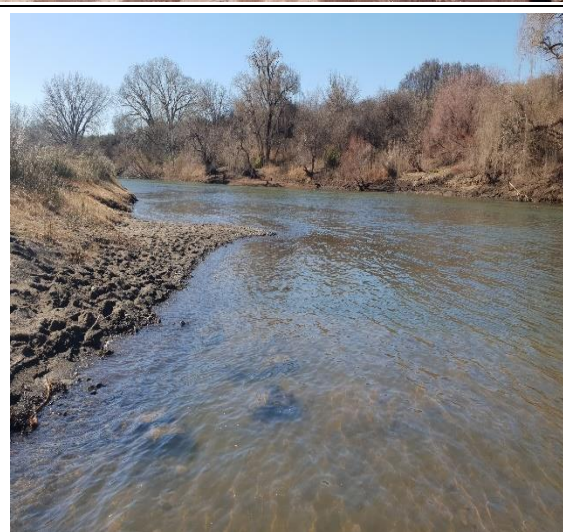
Upstream

Downstream

This site is ORASECOM JBS3 site (26_11) and the DWS REMP site D1KRAA-ALIWA. The reach has a partly confined valley setting, straight to wandering channel form and pool-riffle sequences. The channel is incised with narrow flood features. The site is immediately downstream of a causeway/bridge which is frequently used by farmers. There is a sluice gate on the right end of the bridge – which can be closed in times of drought or should the Orange River dry up. This functions in pooling up the river upstream of the bridge for Basic Human Needs support. This river is a free flowing river, ~30 m wide and has a range of biotopes. There is a solid igneous bedrock base with riffles and runs below the causeway. Much filamentous algae coverage over the SIC biotopes. Most of the river in the area has deeper, slow flowing pools. The river comprises various sections of riffles and pools downstream of the bridge, providing a range of habitats. All biotopes for the macroinvertebrates are present, SIC, SOOC, GSM, although vegetation is limiting owing to undercut banks and vegetation die back/erosion. For fish, there are FD, SD, SS and FS habitats.

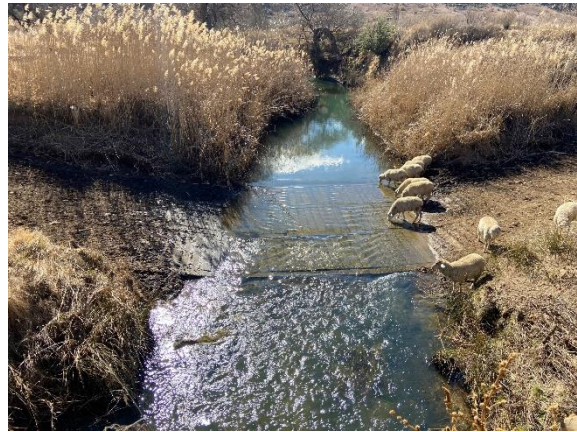
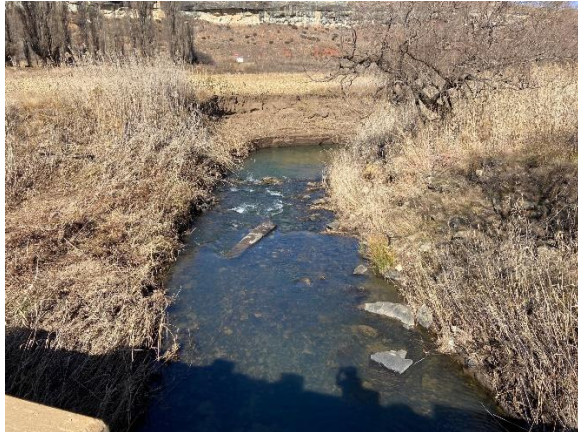
Upstream		Downstream	
Site Description:			
<p>The site is located downstream from the town of Clarens along an incised floodplain reach. Localised channel modification and bank modification are evident. Farm road/bridge crossing, along with just immediately upstream a causeway/bridge which is frequently used by farmers and cattle crossing the river. Both banks show localised erosion. No large upstream dams. The river is ~5m wide and has a range of biotopes for both macroinvertebrates (marginal vegetation, Stones-In-Current and Stones-Out-of-Current (SIC, SOC) and Gravel, Sand, Mud (GSM)). For fish, Slow Deep (SD), Slow Shallow (SS) and Fast Shallow (FS). The marginal vegetation is limited owing to steep undercut banks and vegetation die-back. There is much in-stream vegetation debris, additional habitat for biota. The riparian vegetation zone is modified primarily owing to agriculture/croplands encroachment, although some <i>Phragmites sp.</i> and <i>Salix sp.</i> Just downstream of the bridge there is a section of riffles and runs downstream of the causeway. There are upstream deep pools with a meandering channel. The flows were higher than expected for the dry season owing to enhanced baseflows due to a very wet and late rainfall season.</p> <p>The main land use in the area is agriculture, croplands and cattle trampling and grazing. <i>Salix</i> trees line the banks both upstream and downstream, facilitating erosion, currently taking place along both banks.</p>

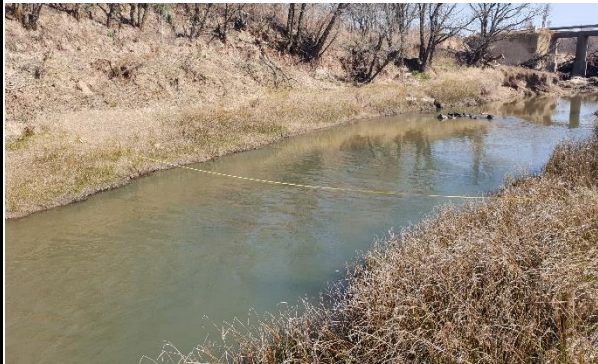
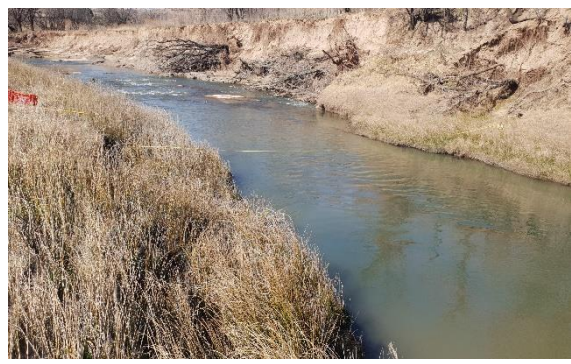
Upstream		Downstream	
Site Description:			
<p>The site is located off R26 and S872 along a confined valley setting. Upstream of the site is a derelict weir, a cross-over bridge, along with a broken-up causeway bridge, where much of the bridge rubble and log jams are impeding the hydraulics of the river and associated left bank. The site on the Mopeli is considerably modified – both the channel, banks and high flow modification. The highly eroded banks, particularly the right bank is being scoured as a result of the blockage at the bridge altering the local hydraulics. Following recent flood events, much vegetation debris has accumulated upstream by the cross-over bridge, resulting in blocking and slowing the high flows, reducing flow velocities directly downstream of the bridge leading to excessive sediment deposition. This has formed a large lee bar that is diverting the river to the right, eroding the right bank and eroding the side/approach of the bridge. Furthermore, consolidated mud islands have formed further downstream due to erosion of former consolidated floodplain deposits along the channel.</p> <p>Biotopes available for macroinvertebrates is dominated by bedrock, with mud, but limited gravel and sand. Marginal vegetation was absent owing to undercut banks and vegetation die back. For fish there was SD, SS and FS. The system is eutrophic, with significant algae content smothering the bedrock habitat and turbid water. The riparian zone on the left bank is degraded with much of the sediment loading taking place, while the right bank is slightly more vegetation with trees, although some have fallen down due to the erosion. Baseflows were higher than expected for the time of year as a result of the high rainfall during the latter part of summer.</p>

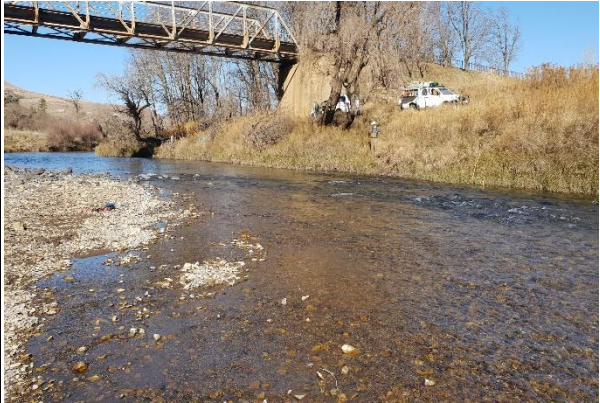
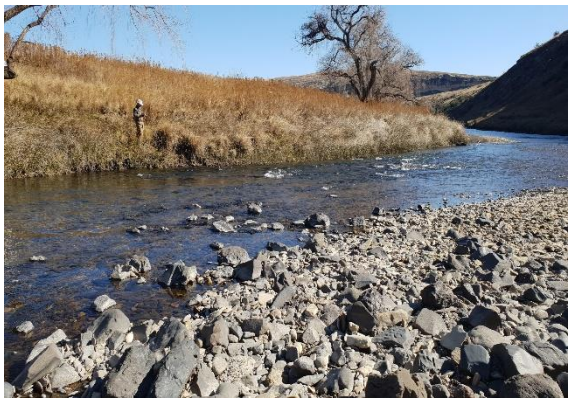
Upstream		Downstream	
Site Description:			
<p>The upper Kraai site is located along a partly confined valley. The channel approximately 40m wide and follows a pool-riffle longitudinal pattern. It is located approximately 200m downstream of the confluence of the Bell River with the Sterkspruit. Localised bed and channel modification is observed downstream of the large bridge crossing and upstream weir, along with some cattle trampling along the riparian zone. Localized erosion and lateral head cut erosion, mostly up and downstream of the bridge. Some scouring along both banks with several lee bars in-stream and along the left bank downstream. The riparian zone is partly intact, representative of the season. The left bank is generally covered with grasses, shrubs (blackjacks) and trees (<i>Salix sp.</i>). The right bank is along a cliff face and shrubs.</p> <p>The river comprises various sections of riffles up and downstream of the bridge, composed of boulder, and cobble material along the riffles and gravel and sand along the pools. All biotopes for the macroinvertebrates are present, SIC, SOOC, GSM, although vegetation is limiting owing to undercut banks and vegetation die back. Localised algae covering the SIC biotope and detritus along the substrate. Fish habitats include SD, FD, SS and FS.</p> <p>The land use is predominantly farmlands, with small croplands and cattle grazing.</p> <p>Baseflows were very high as a results of the high rainfall during the latter part of summer.</p>

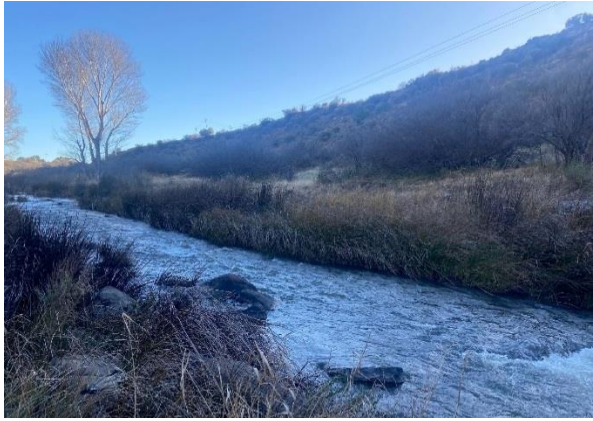
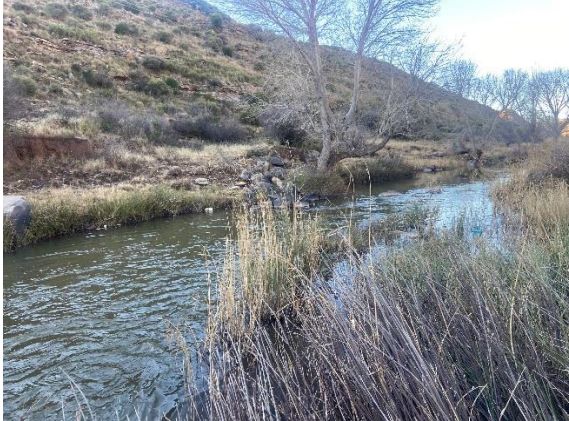
Upstream		Downstream	
Site Description:			
<p>The site is located downstream from the town Burgersfort off the R391. There is a large cross-over bridge upstream from the site, and a gauging weir approximately 500m downstream from the site on the Wonderboomspruit, that can result in inundation of the site during very high flows. The river is located within a valley setting which is confined, with cobbles, rocks and small boulders forming riffles and pools. The river is ~5m wide and flows relatively straight towards the gauging weir where it meanders further downstream. Some erosion on both banks, due to cattle trampling and grazing. Biotopes available for macroinvertebrates included SIC, SOOC, both marginal and in-stream aquatic vegetation and limited GSM. Fish habitats included FS, FD and SD. The stones biotopes were heavily smothered with algae and sludge, as the system has a significant input of nutrients with a clear sewage odour as well as black organic muds deposited in slow flowing sections. Very high macroplastics in-stream, as well as littered throughout the riparian zone and beyond. The riparian zone is mostly sedges on both banks, along with alien invasive vegetation namely <i>Eucalyptus sp.</i>, <i>Salix sp.</i> and <i>Populus</i> on both banks.</p> <p>The land use is predominantly urban (Burgersfort), rural development and open lands along the reach. Low intensity agriculture with some croplands and cattle grazing areas.</p> <p>Baseflows were higher than expected as a results of the high rainfall during the latter part of summer.</p>

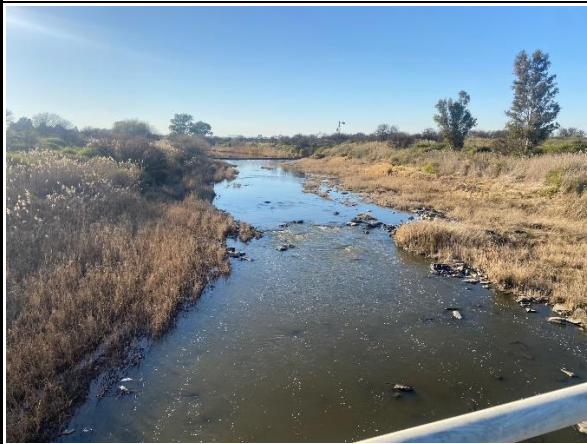
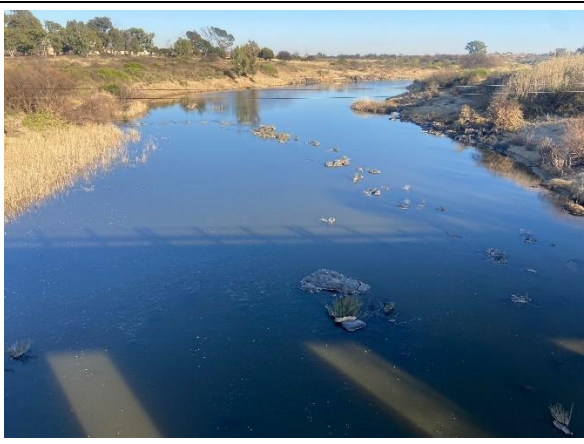
Upstream		Downstream	
Site Description:			
<p>The site is located off the R700 ~30km north of Bloemfontein, approximately 4km downstream of the confluence with the Doringspruit and within the boundary of the Soetdoring Nature Reserve. Downstream of the site is the Krugersdrif Dam which has resulted in large scale inundation of the lower system. The reach has an unconfined valley setting, with the macro channel incised into the surrounding landscape. Flood features are narrow along the channel margins and the bed is locally controlled by bedrock. The macro channel is straight to moderately sinuous with a pool-riffle sequence where habitats are not drowned out by dams or weirs. Boulder, cobble and gravel are deposited inbetween the bedrock sections, with sandy and silty inset banches forming along the margins. The site is located along a sinuous deep run which is dominated by bedrock and large rocks, smothered in algae and high silt loads. Marginal vegetation is well developed and dominated by Phragmites sp., blackjacks and other shrubs, although forms a small band along the banks with upper marginal zone dominated by large trees in riparian areas. Artificial habitat diversity is present under the road bridge in the form of riffles as well as instream vegetation. Aquatic macroinvertebrate biotopes includes SIC, SOOC, marginal vegetation and limited GSM. Fish habitats comprised FS, FD, SS and SD.</p> <p>Landuse influence on the system results predominantly from agriculture.</p>

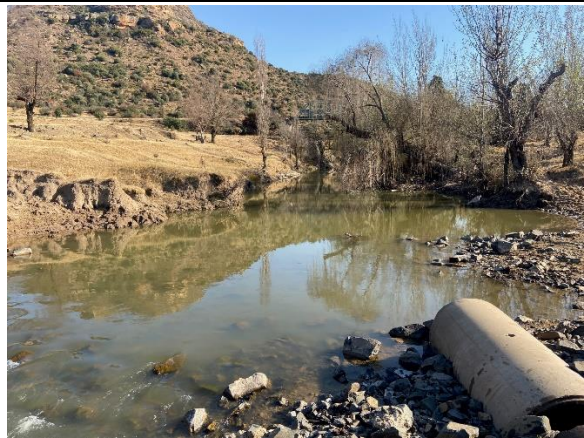
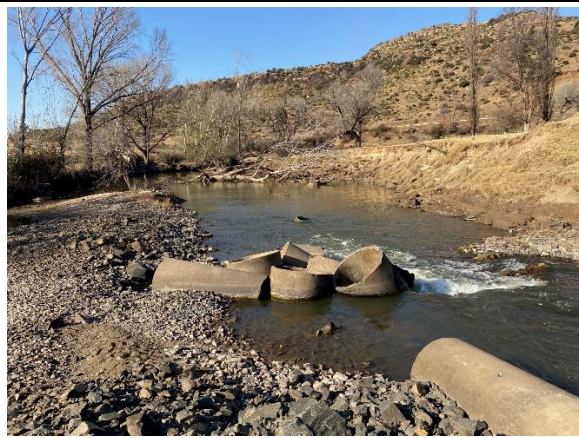
Upstream		Downstream	
Site Description:			
<p>The site is located just outside Ficksburg off the R26, just downstream of the Meulspruit Dam wall. The Meulspruit Dam has no release capacity and does not release into the Meulspruit. Thus, there are periods of this tributary being dry. The site on the Meulspruit is located upstream of the confluence with the Caledon, with high baseflows owing to recent flooding events.</p> <p>The site is located along a confined reach with possible bedrock influence. The river is ~6m wide with bed and channel modification owing to railway bridges constructed upstream, coupled with the construction of the Meulspruit Dam wall. The channel is highly scoured as a result of longitudinal sediment starvation downstream of the dam. Localised unnatural deposits of rocks at the site owing to a stream crossing. There is further cement barrels instream, along with fallen tree debris within the channel. High bank erosion and lateral head cut erosion at the stream crossing. Biotopes available for macroinvertebrates included SIC, SOOC with riffles and GSM. Marginal vegetation was absent owing to undercut banks and vegetation die-back. For fish there was SD, SS, FS and some deep pools upstream. High algae content and turbid water. The riparian zone is limited to grasses, shrubs, <i>Salix sp</i> and <i>Populus sp.</i> (<i>alien invasive</i>) located along mostly the left bank.</p>

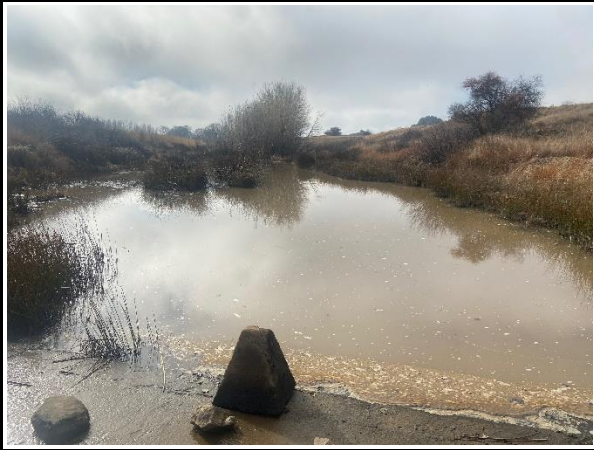
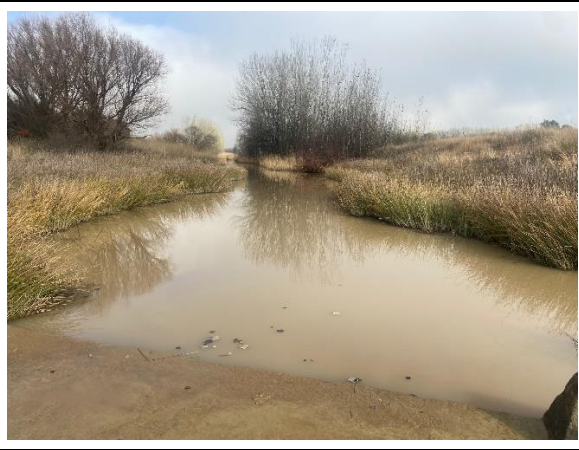
Upstream		Downstream	
Site Description:			
<p>The site is located downstream from Van Stadensrus along an incised valley with limited floodplain development. The site is inundated through successive weirs with alluvial deposition. There is a weir located upstream with in-stream consolidated sediment islands. The flow is limited by a low water causeway and a downstream weir, resulting in deep slow flowing habitats.</p> <p>The biotopes present for the macroinvertebrates includes both marginal and in-stream vegetation along with GSM. Slow deep and deep pools present for fish. Some algae present within the water column and high turbidity. The riparian zone is intact, with some wetland features, although pockets of high density <i>Populus sp</i> stands along both banks.</p>

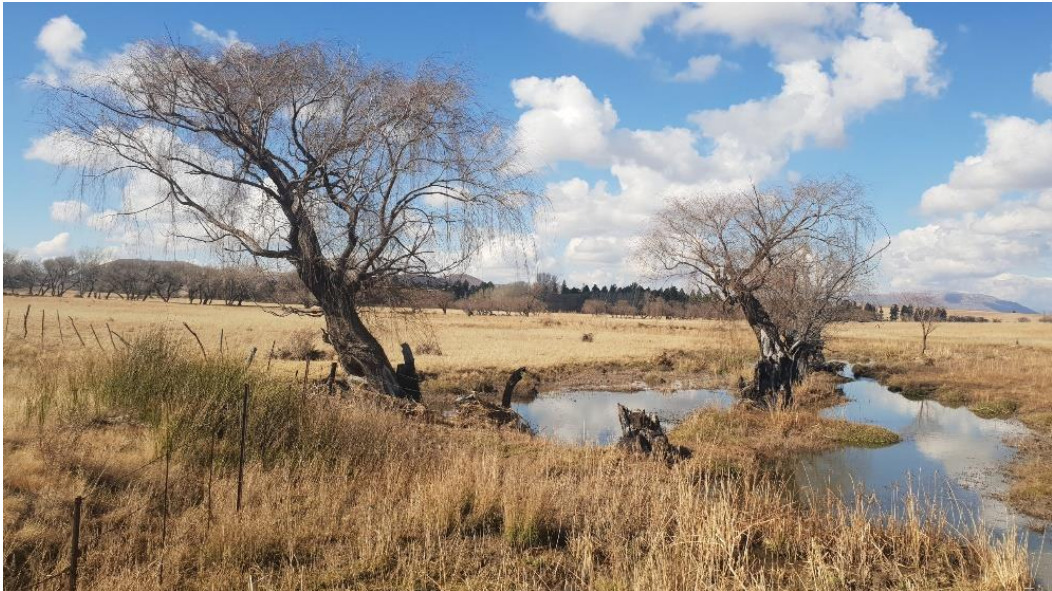
Downstream			
Site Description:			
<p>The site is located just upstream of Montegu Dam (Zastron), along an unconfined floodplain reach. The site is further characteristic of a channelled valley bottom wetland, possibly due to the backwater effects of the downstream dam. Upstream is dense wetland vegetation, however once the water flows through the low lying cross-over culverted bridge – the water dissipates downstream through the floodplain.</p> <p>Salix sp. are located within the channel downstream of the low-lying bridge.</p>

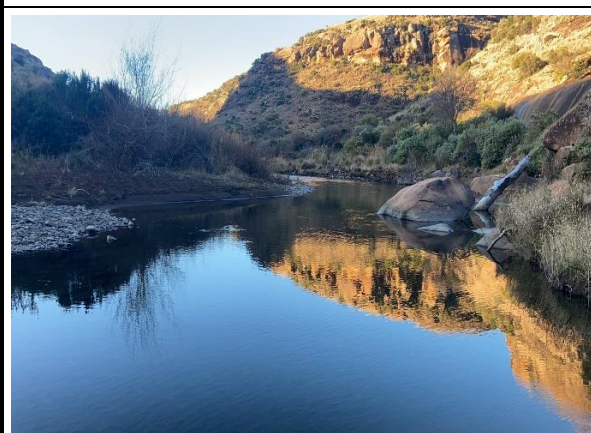
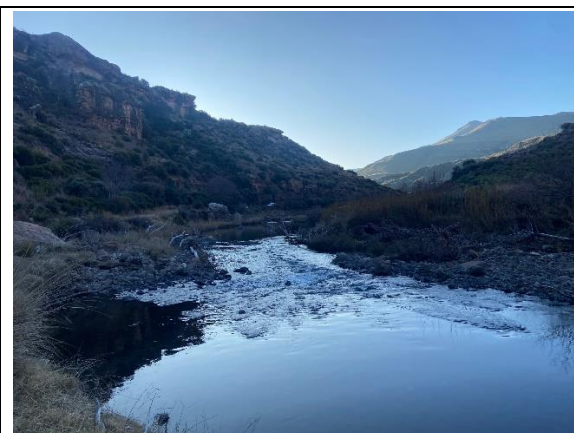
Upstream

Downstream

The Karringmelkspruit is a tributary of the Kraai River. The site was located along a confined valley dominated by boulder and cobble bed material. This pristine and bedrock meandering river within a gorge comprises all biotopes for the macroinvertebrates, SIC, SOOC, GSM, although vegetation is limiting owing to undercut banks and vegetation die-back. There is large fallen down boulders from the adjacent gorge in-stream, some with sediment abrasions from previous floods. The fish habitats comprise FS, SS and SD. Limited impacts, clear water and no algae present. Some bank erosion on both banks due to the recent floods. The riparian zone is partly intact, representative of the season, particularly the left bank while the right bank has some areas of bare soils. Some encroachment of alien invasives along the riparian, including blackjacks.

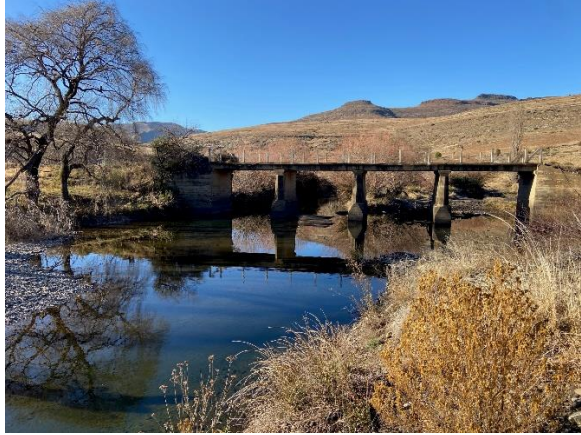
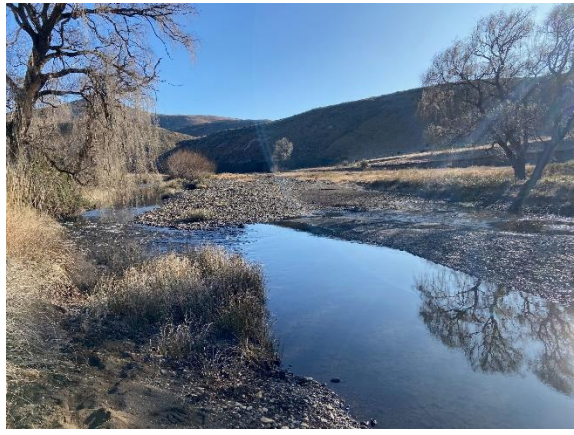
Upstream		Downstream	
Site Description:			
<p>The Bokspruit, a tributary of the Sterkspruit (Kraai River system), is in good condition (full river reach) and approximately 10m wide. The reach has a partly confined valley setting with narrow flood features. However, owing to the bridge at the sampling site, coupled with some log and debris jams on the left side, are impeding the hydraulics of the river, scouring and resulting in localised erosion, particularly on the left bank, both up and downstream of the bridge. The scouring is contributing to the downstream lee bar on the left, although further downstream, another lee bar was observed on the right bank. Owing to the <i>Salix sp</i> on the left bank, the banks are stabilised thus avoiding further localised bank erosion. Both bed and channel modification at this site, but localised. The riparian zone is partly intact, representative of the season, mostly covered with grasses, shrubs and trees, most of which are alien invasive namely <i>Salix spp.</i> and <i>Pyracantha</i>.</p> <p>The river comprises various sections of riffles up and downstream of the bridge. All biotopes for the macroinvertebrates are present, SIC, SOOC, GSM, although vegetation is limiting owing to undercut banks and vegetation die back. Localised algae covering the SIC biotope. For fish, there is SD, SS and FS habitats.</p> <p>The land use is predominantly farmlands, with small croplands and cattle grazing.</p>

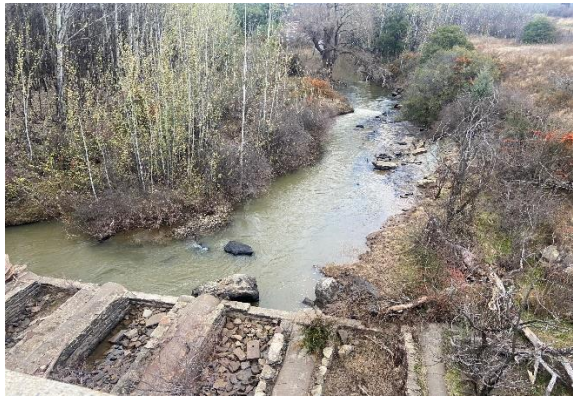
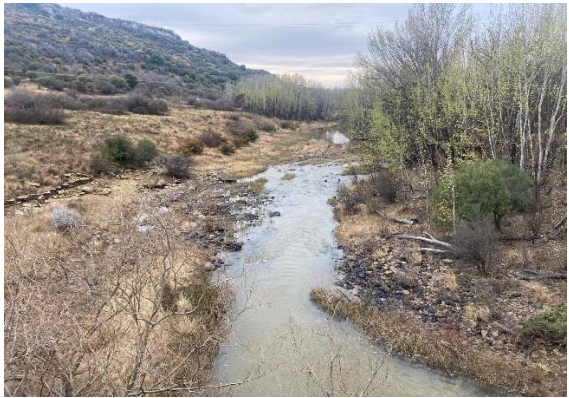
Upstream		Downstream	
Site Description:			
<p>The site is located near Floukraal along a confined valley. The Holspruit has localised modifications owing to a cross-over bridge which impedes the river channel, along with a small upstream weir and derelict and broken-down culverted bridge coupled with construction debris. Furthermore, beneath the cross-over bridge in-stream are artificial cement slabs. Both banks up and downstream of the bridge is well vegetated although dominated by alien invasives namely <i>Populus sp.</i>, as well as pockets of <i>Salix sp.</i> and <i>Pyracantha</i>. Although these are aiding in bank stability. All these impediments have resulted in the multiple diversions of the river flowing downstream, with a lee bar on the left bank downstream of the bridge. Turbid waters with some algae and sediment loads over the stone's biotopes.</p> <p>Biotopes available for macroinvertebrates is dominated by various sections of riffles, SIC, SOOC, marginal vegetation, although limited owing to undercut banks and vegetation die-back (representative of the season). Fish habitats comprised SD, SS, FD and FS.</p>

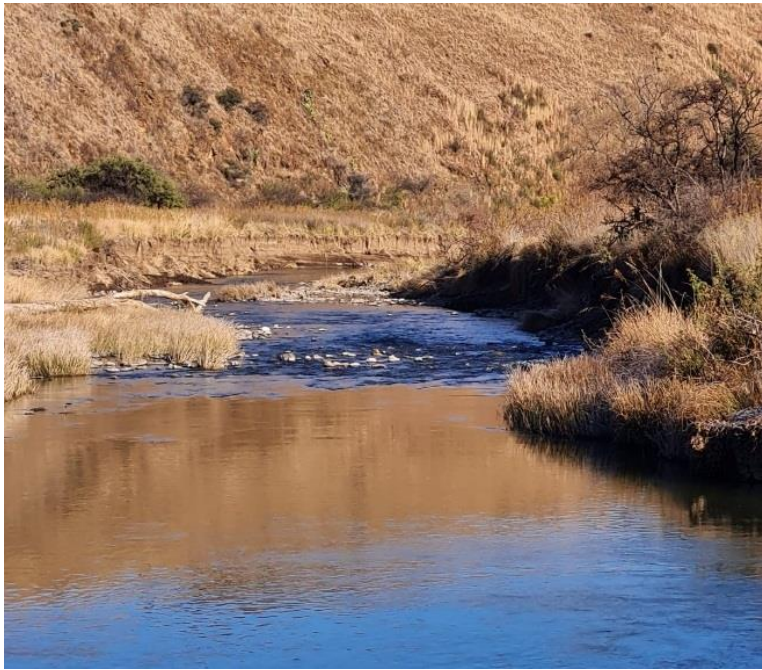
Downstream			
Site Description:			
<p>The Sterkspruit, a tributary of the Bell/Kraai River is in a good condition at the site and approximately 10m wide. The bridge at the sampling site is resulting in scouring of both banks, resulting in localised erosion up and downstream of the bridge. Bank rehabilitation in the form of gabions have been constructed up and downstream of the bridge for stabilisation. However, the gabions on the banks above the bridge have destabilised and disassembled, and gabion material and debris is impeding the flow beneath the bridge and slightly downstream of the bridge, with gabion material observed in-stream. Most of the gabions on the banks below the bridge are still intact and functioning to alleviate bank erosion and further scouring. Nonetheless, the scouring is contributing to the downstream lee bar on the left bank. Both bed and channel modification at this site is localised. The riparian zone is partly intact, representative of the season, mostly covered with grasses, shrubs and trees (limited <i>Salix sp.</i>, further downstream and evidence of <i>Populus sp.</i> upstream.</p>

The river comprises various sections of riffles and pools up and downstream of the bridge. All biotopes for the macroinvertebrates are present, SIC, SOOC, GSM, although vegetation is limiting owing to undercut banks and vegetation die-back. Localised algae covering the SIC biotope. For fish, there is SD, SS and FS habitats.

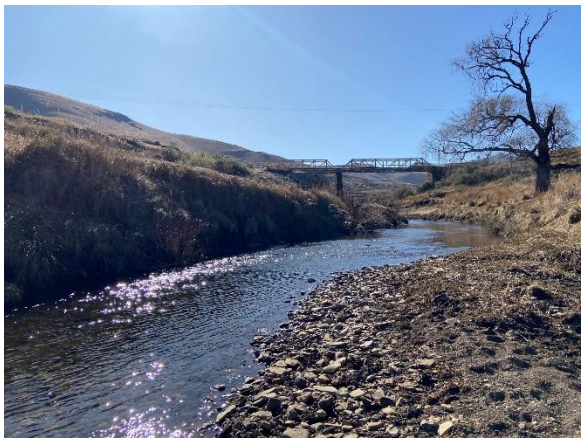
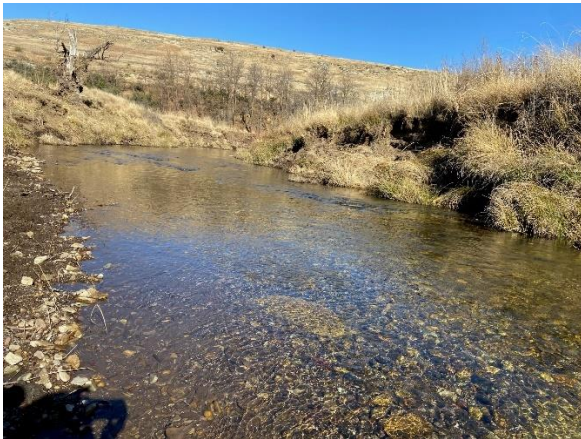
Upstream		Downstream	
Site Description:			
<p>This reach of the river is called the Bell (although still named the Kraai according to PES, 2014), and which lies approximately 3km upstream from UO_EWR04_R (upper Kraai). This meandering river is still in a good condition with limited impacts and approximately 10m wide. There is an upstream bridge although it is built on solid boulders and bedrock on the right bank, with slight head cut erosion taking place on the left bank of the bridge. There is some scouring and bank erosion on both banks going downstream, the recent floods being a contributing factor coupled with on-going widespread cattle grazing and trampling. Gravel and cobble bars are common along the reach. The riparian zone is intact, mostly covered with grasses, shrubs (blackjacks) and trees (<i>Salix sp.</i>) along the reach.</p> <p>The river comprises various sections of riffles and pools up and downstream of the bridge. All biotopes for the macroinvertebrates are present, SIC, SOOC, GSM, although vegetation is limiting owing to undercut banks and vegetation die-back. Localised algae covering the SIC biotope. For fish, there is FD, SS and FS habitats.</p> <p>The land use is predominantly farmlands, with small croplands and widespread cattle grazing.</p>

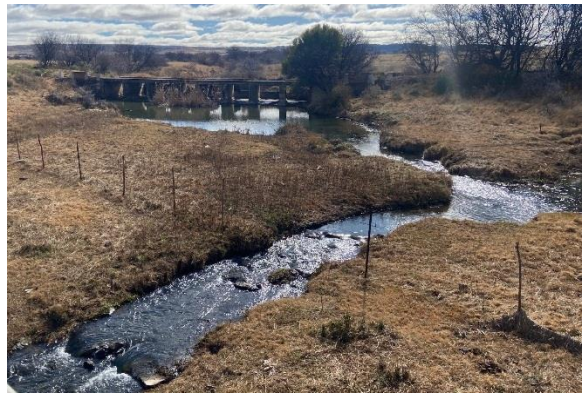
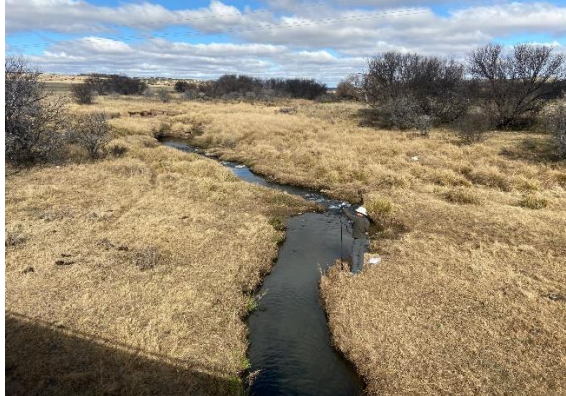
Upstream		Downstream	
Site Description:			
<p>The site is located off the N6 on the 1036/1981 bridge (main bridge), downstream of Smithfield. The Groenspruit is a tributary of the Skulpspruit, which is a tributary of the Caledon River within a partly confined floodplain setting. Several small farm dams upstream. A derelict bridge is located just upstream of the main bridge, whereby there is a bottleneck of vegetation debris build up and thus the river pools at this area. Downstream of the main bridge the channel narrows to approximately 1.5m wide, with head-cut erosion occurring along both banks downstream.</p> <p>The habitats available for macroinvertebrate include SIC, SOOC, GSM and no marginal vegetation owing to undercut banks and vegetation die back. Some algae smothering the SIC biotope. Fish habitats include SS, SD and FS. The riparian zone is dominated by grasses and shrubs, but limited trees.</p> <p>The land use is predominantly open lands, low intensity agriculture with some croplands and cattle grazing areas.</p>

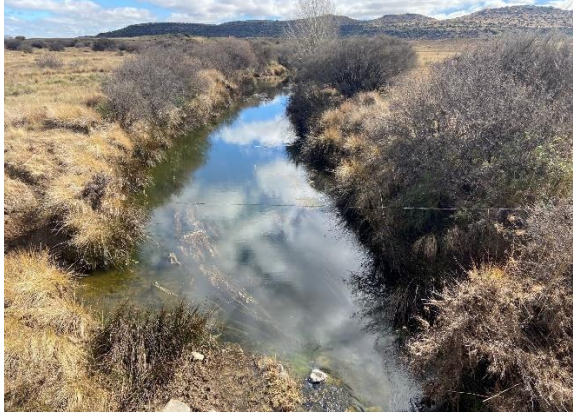
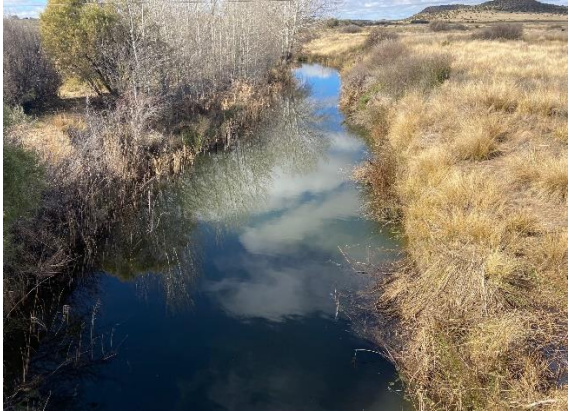
Upstream		Downstream	
Site Description:			
<p>The site is situated off the R701 at a single high water bridge crossing. The Skulpspruit is a tributary of the upper Caledon with no in-stream farm dams upstream, although primarily low intense agricultural activities. The river is further located within a partly confined floodplain setting. The channel is ~10 m wide and relatively homogenous up and downstream of the bridge. Although there is a small diversion whereby the channel has several sections of riffles with SIC and SOOC biotopes for macroinvertebrates. The increased flow has allowed aquatic grass to establish in the deep runs. Marginal vegetation was limiting owing to undercut banks and vegetation die-back/erosion. The habitats available for fish comprise SD, SS, FD and FS. The riparian vegetation is relatively intact with grasses, shrubs, as well as trees (both indigenous – <i>Searsia lancea</i> (Karee) and some <i>Salix sp</i> and wattle).</p> <p>The land use is predominantly open lands, low intensity agriculture with some croplands and cattle grazing areas.</p>
