Geotechnical Report: Lower Coerney Dam Site: Supplementary Investigations

17 September 2019 Revision: 03 Reference: 112546-G5

Support of the Water Reconciliation Strategy for the Algoa Water Supply System

# Geotechnical Report: Lower Coerney Dam Site: Supplementary Investigations

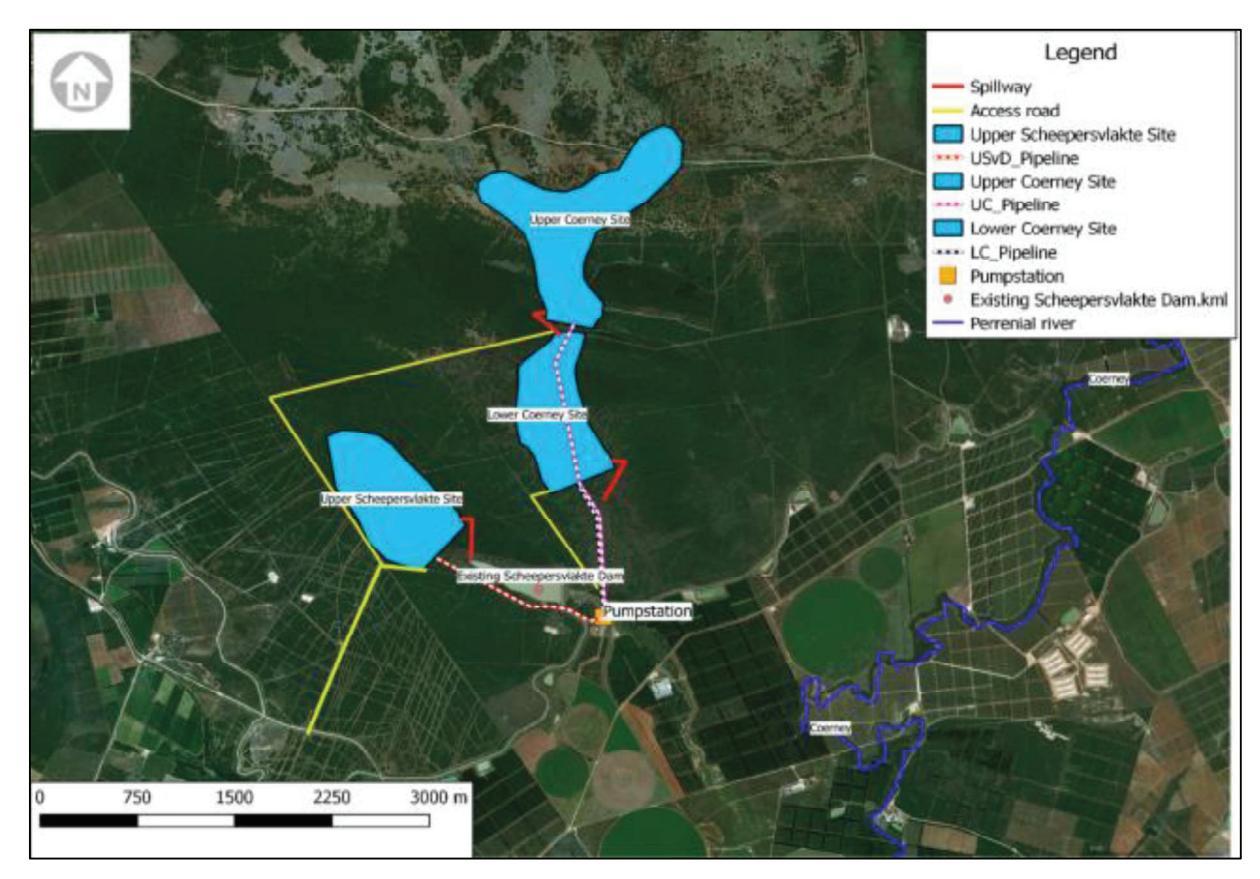
Figure 1.1: General locality plan of the respective alternate dam sites investigated

Aurecon South Africa (Pty) Ltd was appointed by the Department of Water & Sanitation (DWS) to investigate various options for improving the assurance of supply that is provided by the Scheepersvlakte Dam to the Nooitgedagt WTW, recommend a preferred storage site, and undertake feasibility design. After considering the various options identified, two possible alternate new dam sites were recognised as the most favourable, namely a site immediately upstream of the existing Scheepersvlakte Dam, called Upper Scheepersvlakte, and a site located in the adjacent catchment, designated the Lower Coerney site. The locations of these sites are illustrated below in **Figure 1.1**.

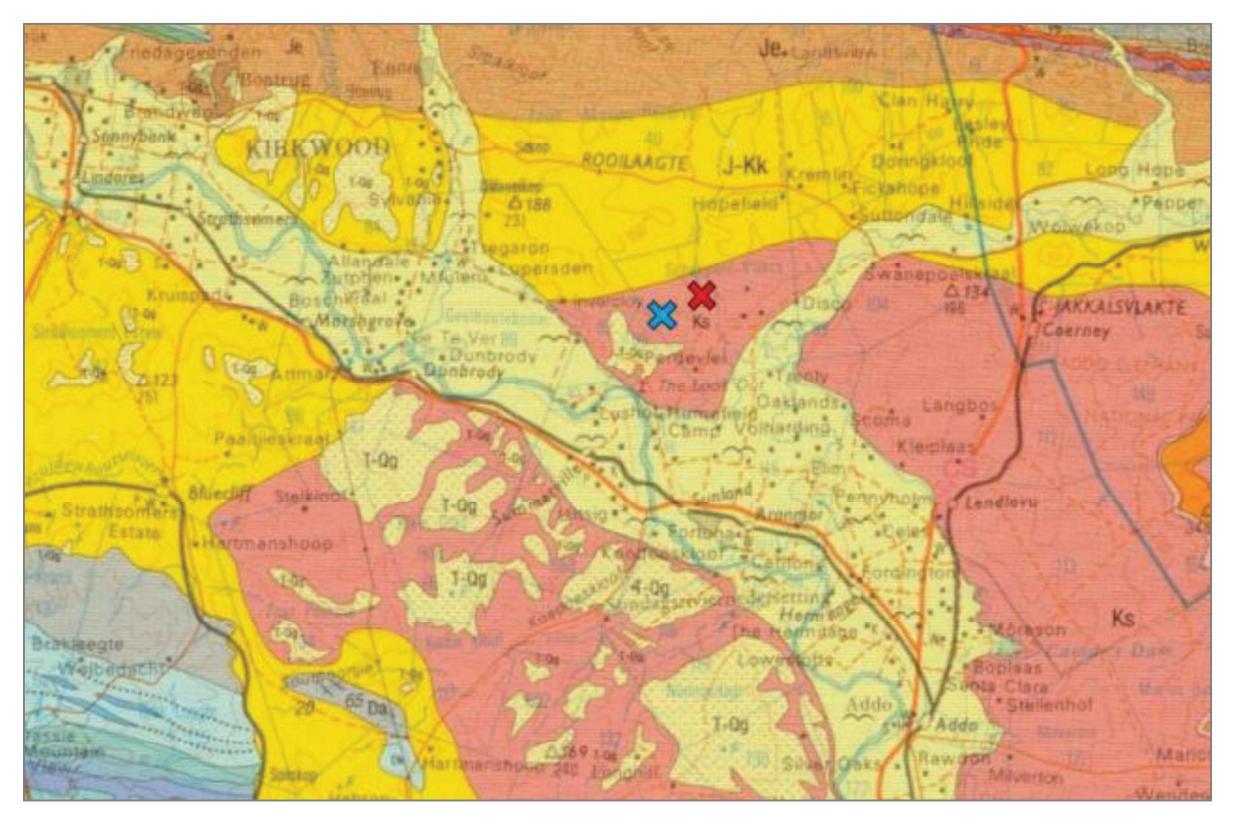
Figure 5.1: Excerpt of geological map (Sheet 3324) The two site options are marked with crosses (blue = Upper Scheepersvlakte, red = Lower Coerney)

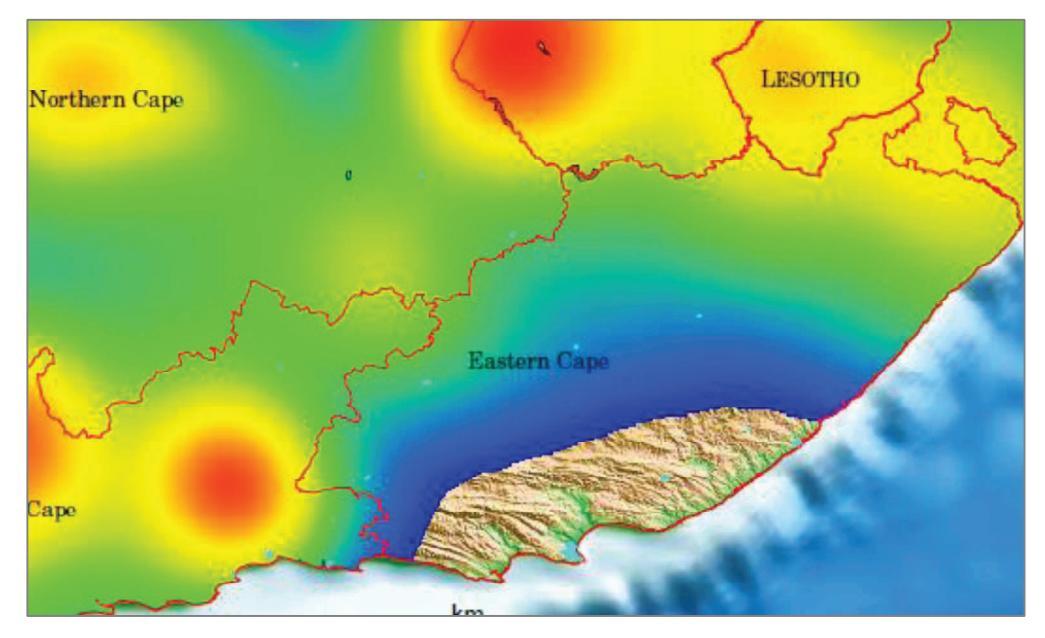
Figure 5.3: Excerpt of the seismic hazard map of South Africa (after Kijko et al, 2003)

Even though the very existence of the Algoa Basin is directly linked to faulting, and other regionalscale faults are also recognised, the seismic hazard of the area is considered to be very low. **Figure 5.3** is an excerpt of the seismic hazard map (after Kijko, et al, 2003) which shows the Peak Ground Acceleration (PGA) values of less than 0.02g, where these are with a 10% probability of being exceeded in a 50-year period.

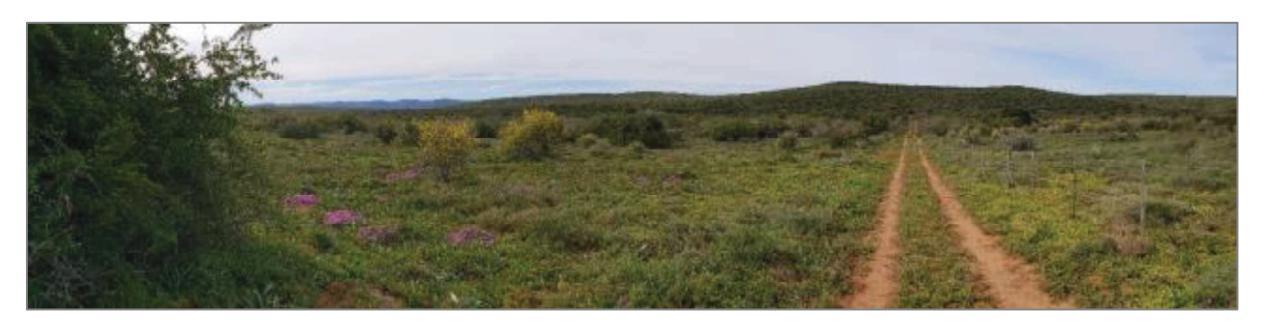
Plate 6-1 General panorama of Lower Coerney site, from the access track a short distance downstream of the centre-line (which is to the left)

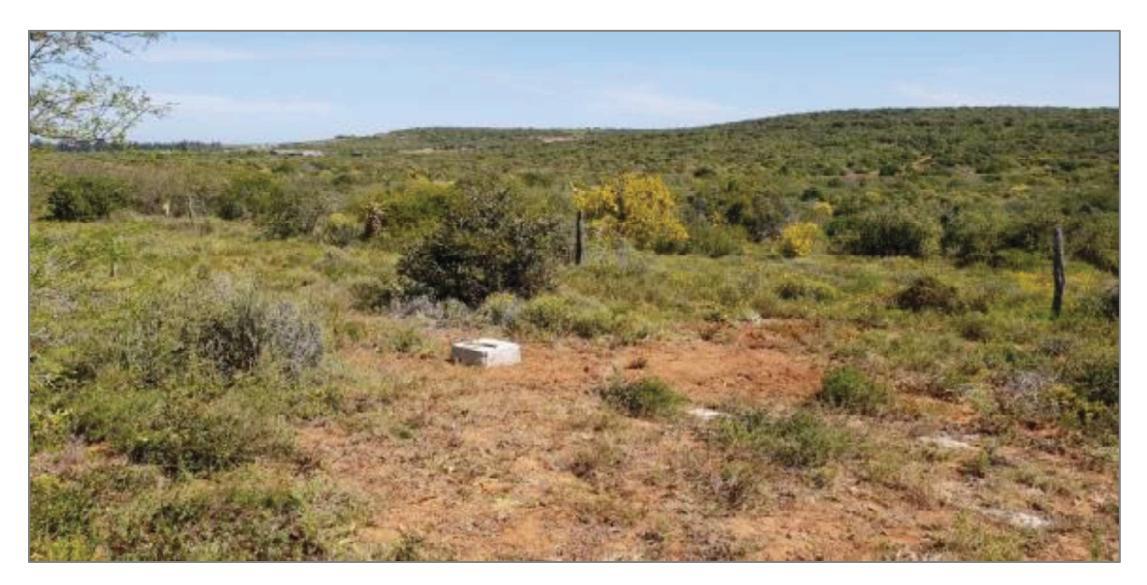
Plate 6-2: General view of left flank conditions, looking here along the spillway alignment in a downstream direction

Subsurface conditions on the left flank, inclusive of the spillway (**Plate 6.2**), have been investigated by geophysical traverses, test pits as well as boreholes, as shown on Drawing 112546-GEO-DRG-CC-001-B. The summarised findings are presented below in **Table 6-1** in the case of the test pits and **Table 6-2** for the boreholes. A longitudinal geological section has been compiled (drawings 112546-GEO-DRG-CC-002A-A and 112546-GEO-DRG-CC-002B-B).

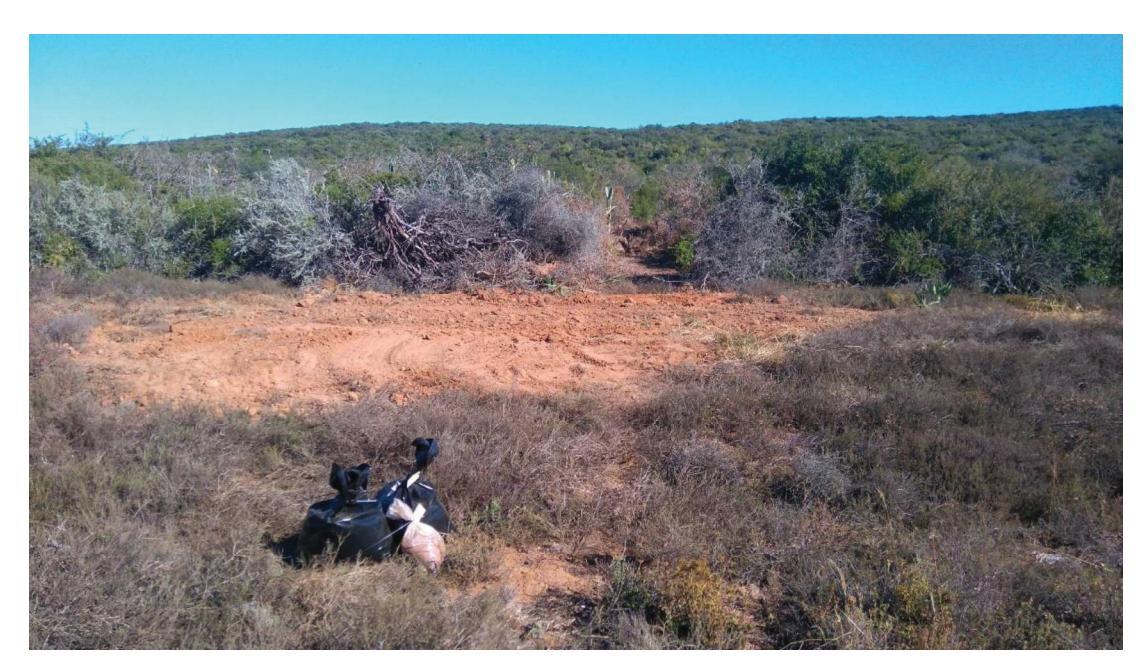
Plate 6-3: River section view, looking towards right flank (test pit LC03 in foreground)

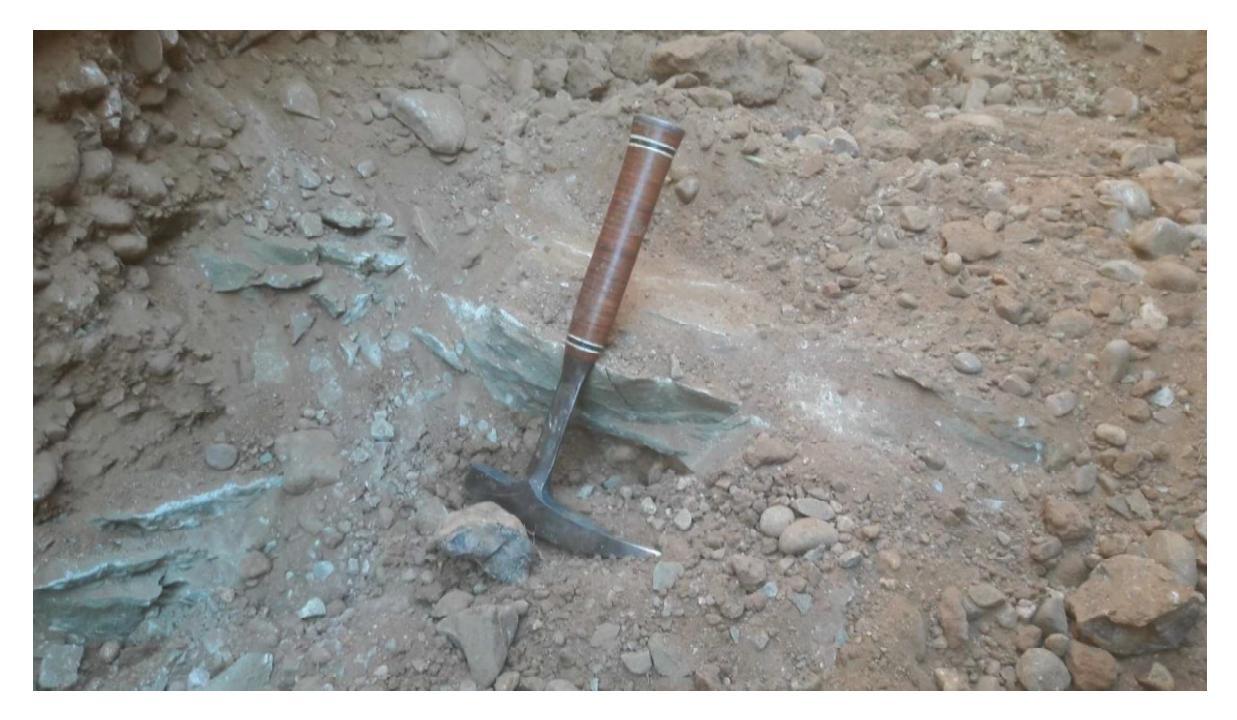
Plate 6-4: Bedrock encountered in TP102, at 2.8m depth

Bedrock comprises interbedded sandstone and mudstone horizons. In borehole LC BH01, drilled on the lower right flank, bedrock predominantly comprises mudstone strata with subordinate interbedded sandstone horizons. In LC BH04 the uppermost horizons, extending from the rockhead at a depth of 3.25 m (roughly 3 m as encountered in TP102) to a depth of 10,95 m, i.e. with a thickness of 7.7 m, the bedrock predominantly comprises sandstone with minor mudstone interbeds, while below 10.95 m depth the rock is predominantly mudstone but with minor sandstone interbeds.

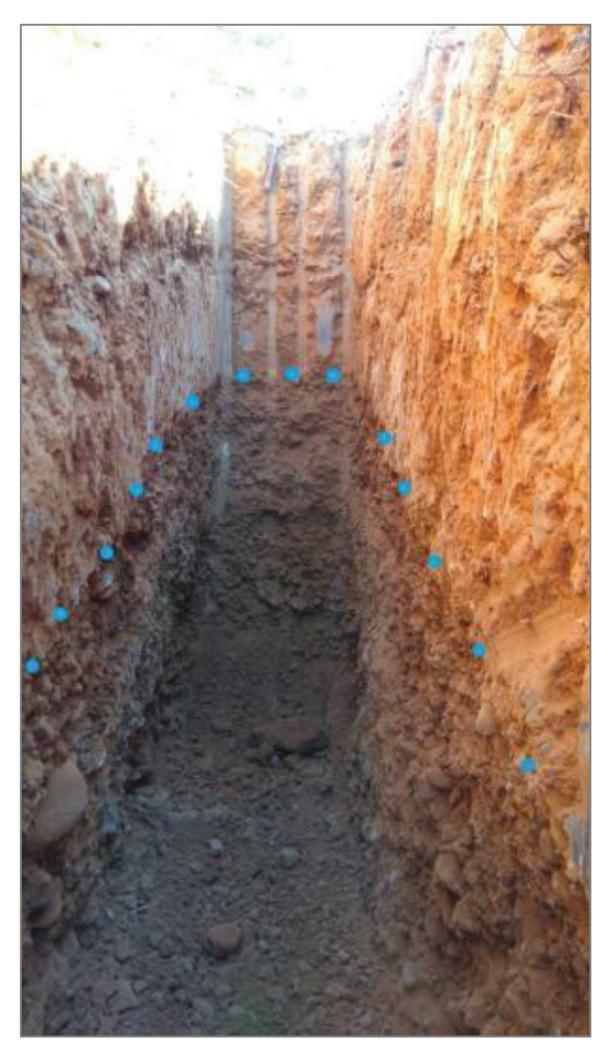
Plate 7-1: The gravelly layer as exposed within a test pit (this view test pit LC22); the boundary indicated by the dotted line

is tightly packed, i.e. clast-supported. It is possible that within these lower elevations this concentration of the coarser fraction might be representative of palaeo-alluvial activity, i.e. at least partly represent palaeo-channels.

The significance of this stratum for the dam design is that these materials are potentially highly pervious, and in such cases would represent potential preferred seepage paths. This aspect, including the implications for excavation depths, as well as foundation treatment is discussed in more detail below.

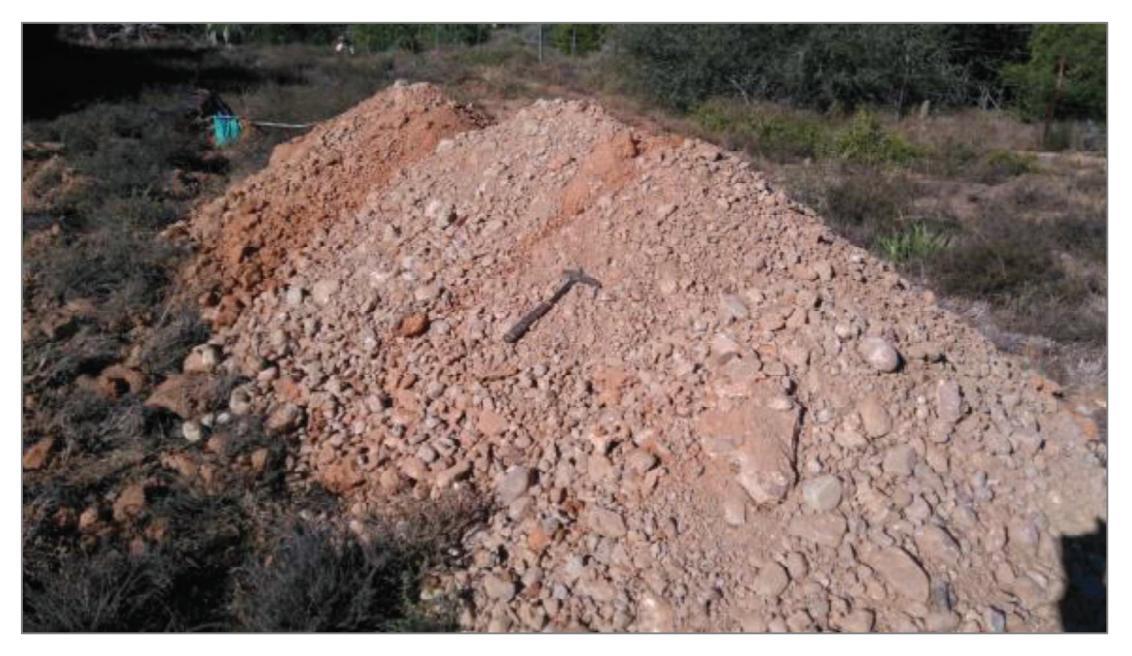
Plate 7-2: Spoil from the same test pit, better illustrating the nature of the gravelly material.
