MOKOLO AND CROCODILE RIVER (WEST) WATER AUGMENTATION PROJECT (MCWAP) FEASIBILITY STUDY: TECHNICAL MODULE

SUPPORTING REPORT NO. 8B DETAIL GEOTECHNICAL INVESTIGATIONS

PHASE 2

This report (Report 8 – Feasibility Stage, P RSA A000/00/8709) covers the detail geotechnical investigations that have been performed for Phase 2 of the MCWAP. These include the pump station site, pipeline route and borrow pits.

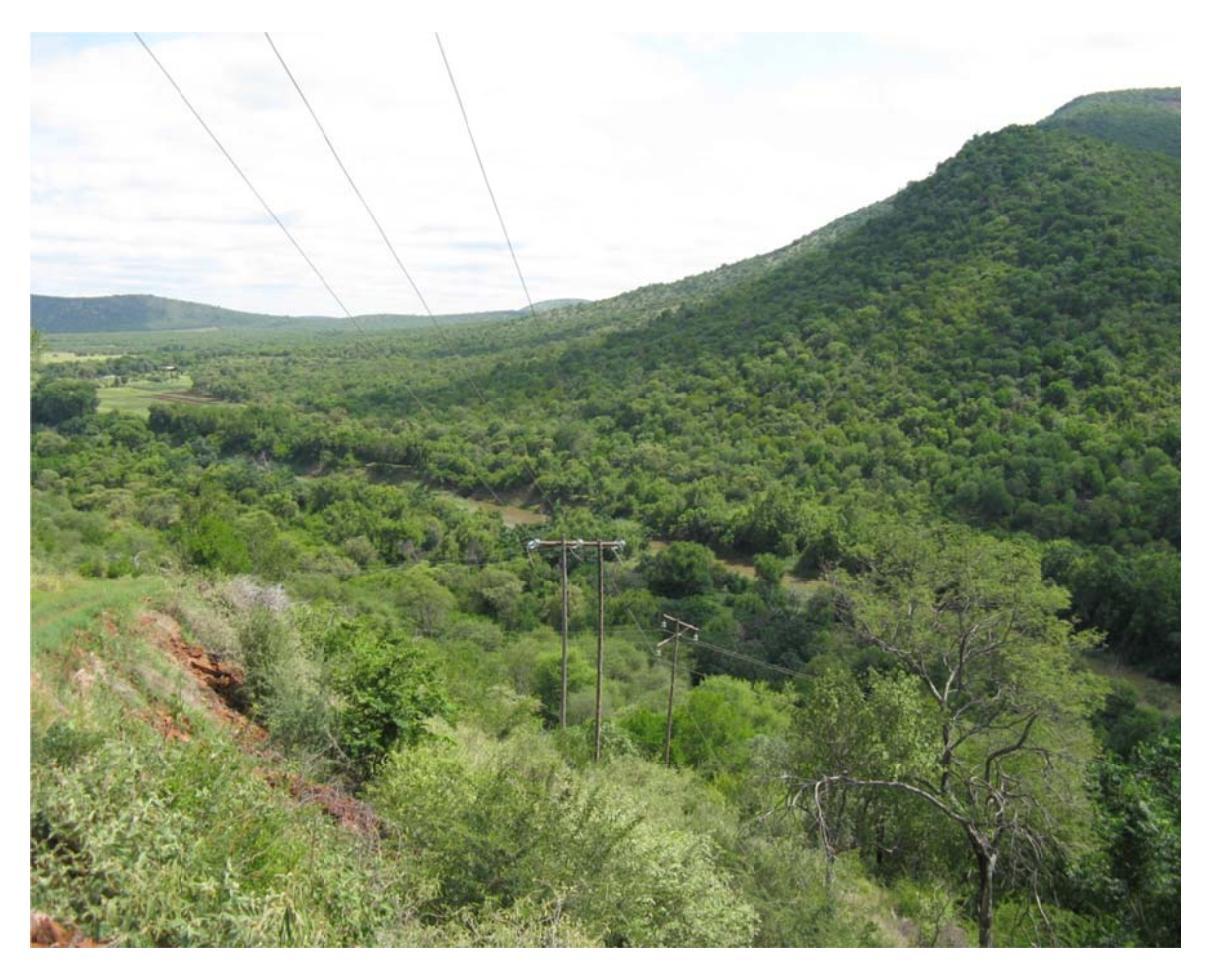
Figure 4-1: Plate 1: A General View of the Vlieëpoort Abstraction Weir site, viewed from high up on the left flank, showing the general site topography. The Crocodile River can be discerned in the Valley

The Vlieëpoortberge rise to elevations in excess of 1400 masl on either side of the river (Plate 1), where the elevation of the river bed is less than 900 masl. The site is characterised by a relatively wide river section, estimated in the order of 350 m.

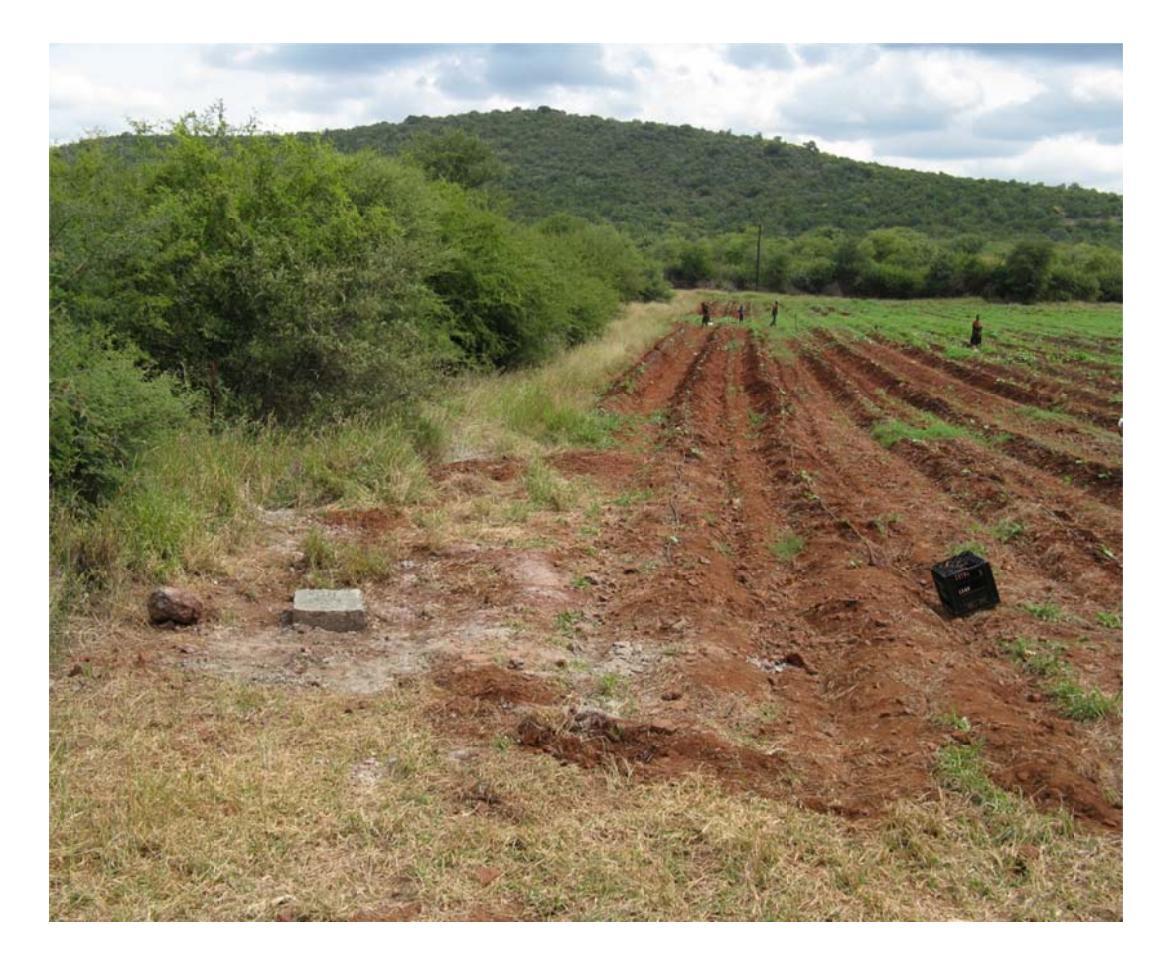
Figure 4-5: Plate 2: A General View of the Proposed Site of the Balancing Dam. The Proposed Footprint just encroaches on the Cultivated Land. Borehole VBH DAM2 is visible in the foreground

The proposed balancing dam site is characterised by gentle slopes, becoming slightly steeper towards the south, including in the area of the proposed silt trap. The proposed site is covered by dense bush, with cultivated lands located directly on the northern boundary and a short distance from the western boundary (Figures 4-4 and 4-5).
