**Would you
swim here?**

In March this year, Hartbeespoort Dam experienced one of the worst algae blooms in its history. Some three hectares of water close to the dam wall were covered with a 30cm-thick sludge of rotting toxic algae, releasing smelly gases and necessitating an emergency clean-up operation. It was just another episode in the ongoing controversy surrounding what has become one of South Africa's most popular recreational dams and elite country settlements.

HARTBEESPOORT – A 30-YEAR-OLD PROBLEM

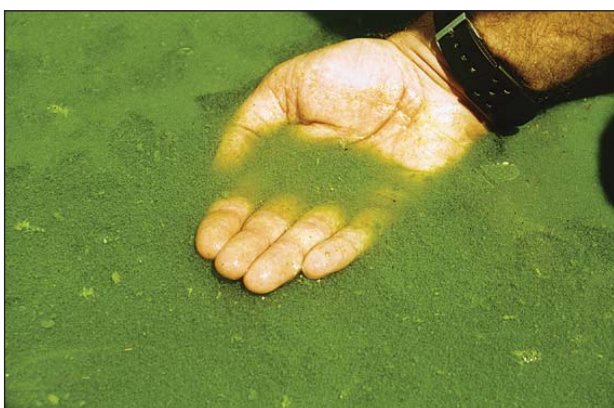
A typical cyanobacterial bloom initially looks like pea-green soup. Once it reaches the surface it is blown by wind into smaller inlets, where it accumulates and dies off.

Petrus Venter, Deputy Regional Director: Water Resource Management of the North West Province, explains that a typical cyanobacterial bloom initially has the appearance of green pea soup. “Cyanobacteria on the surface is blown by wind into smaller inlets where it accumulates and dies off,” he says.

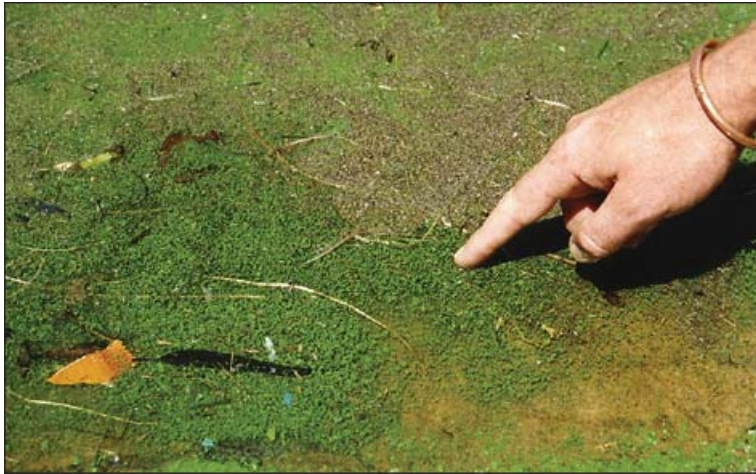
(Top) When excess nutrients are released into the water, they boost algae growth. This forms dense accumulations and floats to the surface.

"Much of the nutrients are trapped in the sediments at the bottom of the dam and remain inactive for extended periods," explains van Ginkel. "In summer, however, different thermal layers form in the water column. The deeper layer becomes anaerobic (oxygen depleted). Under these conditions phosphorus is released from the sediments. This process is known as internal loading. When mixed into the upper layers of the

water, these nutrients boost algal growth. The cyanobacteria are able to regulate their position in the water column for optimal growth. During a cyanobacterial bloom of *Microcystis* the cyanobacteria form dense accumulations, which then floats to the surface. Once exposed to sunlight, it starts to decompose, and toxins that are normally bound inside the algae, are released."

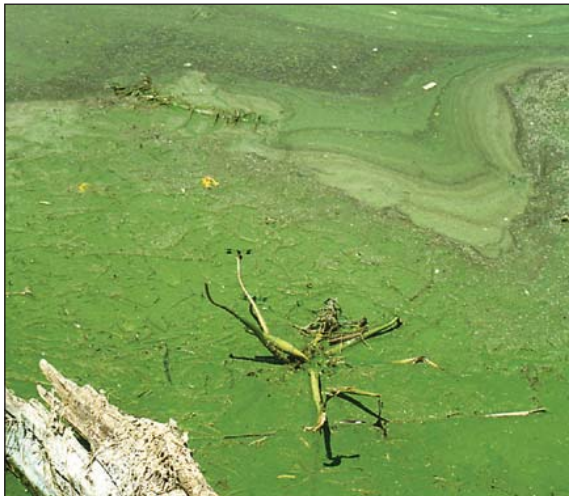
(Left) While cyanobacteria is not unique to Hartbeespoort, nowhere else do these "hyperscums" produce so rapidly or in such vast quantities.

Van Ginkel adds that the problem is not unique to Hartbeespoort, and occurs in about 20% of South Africa's monitored reservoirs. But for unknown reasons, nowhere else do these "hyperscums" produce so
